Visual Site Inspection Report

Project Name	H-600 Pipeline Spread G	AFE	124300137	Spread	H-600 Pipeline Spread G
Contractor	Precision			Report #	26691
Inspector	Jared Saunders			Date/Time	8/2/2021 5:24 PM
Permit #	TBD	Inspection Type	VA SWPP	Station Begin	11670+00
State	VA	Inspection Area	Partial	Station End	11788+52
County	Montgomery	Ground	Dry	Temperature (°F)	80.00
Municipality	N/A	Weather	Sunny	Rain Gauge (in)	0.00
				Rain Accumulation Time (days)	1.00

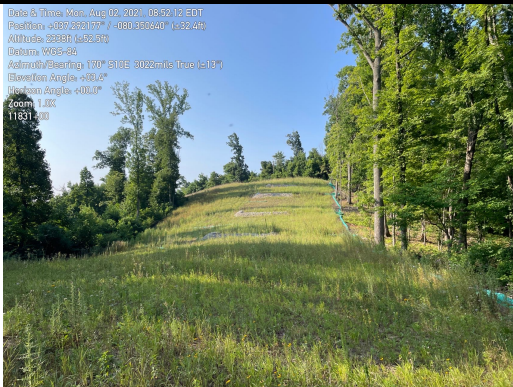
GPS Location				See photo				GPS Location				See photo			
Field Station#				11831+00				Field Station#				11900+00			
Pic 3 Desc.				Permanent waterbars with level spreaders in place				Pic 4 Desc.				RCE in place

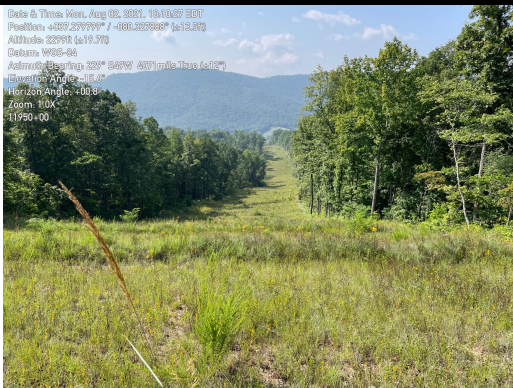
Date & Time: Mon, Aug 02, 2021, 10:04:07 EDT Position: +037.297797° / -080.327338° (±13.2m) Altitude: 2290ft (±19.7m) Datum: WGS-84 Azimuth/Bearing: 220° S45W 4007mils True (±12°) Elevation Angle: -15.4° Horizon Angle: -00.8° Zoom: 1.0X 11950+00				Date & Time: Mon, Aug 02, 2021, 10:31:40 EDT Position: +037.297797° / -080.327338° (±13.2m) Altitude: 1693ft (±19.7m) Datum: WGS-84 Azimuth/Bearing: 076° N76E 1351mils True (±12°) Elevation Angle: -13.9° Horizon Angle: -01.4° Zoom: 1.0X 11979+00											
GPS Location				See photo				GPS Location				See photo			
Field Station#				11950+00				Field Station#				11979+00			
Pic 5 Desc.				Waterbars in place				Pic 6 Desc.				P1 silt fence in place

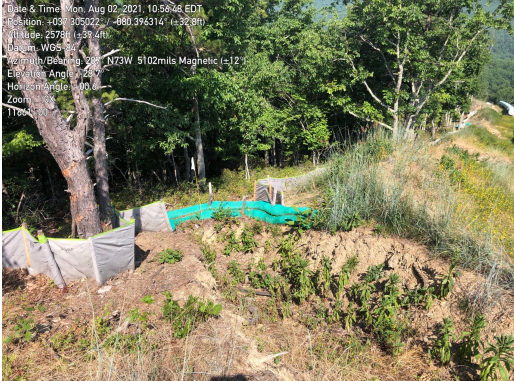
GPS Location	On photo	GPS Location	On photo		
Field Station#	11661+00	Field Station#	11637+00		
Pic 3 Desc.	Sumps and end treatments are in place and effective.	Pic 4 Desc.	Sumps and end treatments are in place and effective.

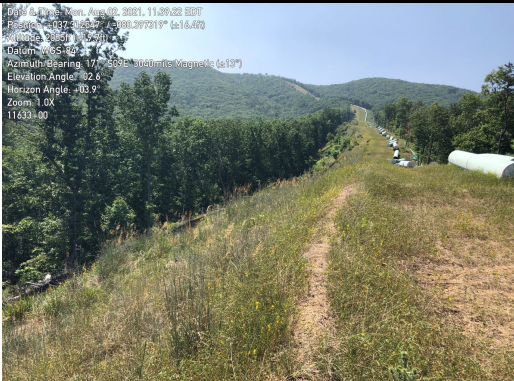
GPS Location	On photo	GPS Location	On photo		
Field Station#	11633+00	Field Station#	11628+00		
Pic 5 Desc.	The ROW surface has no erosion or slips.	Pic 6 Desc.	Perimeter ECDs are in place.

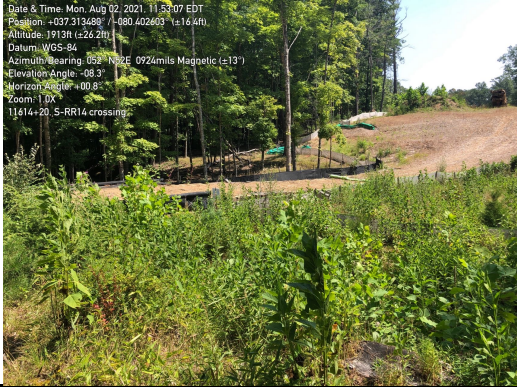
<p>Date & Time: Mon, Aug 02, 2021, 11:53:07 EDT Position: +037.313486° / -080.402603° (±164.4ft) Altitude: 1913ft (±26.2ft) Datum: WGS-84 Azimuth/Bearing: 65° N65E 6924mils Magnetic (±13°) Elevation Angle: -08.9° Horizon Angle: +00.8° Zoom: 1.0X 11614+20 S-RR14 crossing</p>

GPS Location	On photo	GPS Location	On photo		
Field Station#	11626+04	Field Station#	11614+20		
Pic 7 Desc.	The S-HH18 crossing is stable.	Pic 8 Desc.	The S-RR14 crossing is stable.		
<p>Date & Time: Mon, Aug 02, 2021, 11:56:38 EDT Position: +037.313528° / -080.405481° (±158.8ft) Altitude: 1929ft (±78.7ft) Datum: WGS-84 Azimuth/Bearing: 196° S16W 3484mils Magnetic (±13°) Elevation Angle: -05.9° Horizon Angle: -01.1° Zoom: 1.0X 11608+17 S-006 crossing</p>

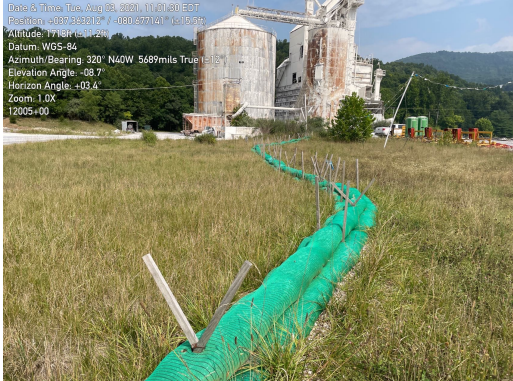
<p>Date & Time: Tue, Aug 03, 2021, 11:03:52 EDT Position: +037.36248° / -080.67726° (+15.5ft) Altitude: 1715ft (+11.2ft) Datum: WGS-84 Azimuth/Bearing: 145° S33E 6592mils True (+12°) Elevation Angle: -08.7° Horizon Angle: -00.4° Zoom: 1.0X 12005+00</p>			
GPS Location	See photo		GPS Location	See photo	
Field Station#	12005+00		Field Station#	12005+00	
Pic 1 Desc.	CFS triple stack perimeter control in place		Pic 2 Desc.	Secondary containment in place

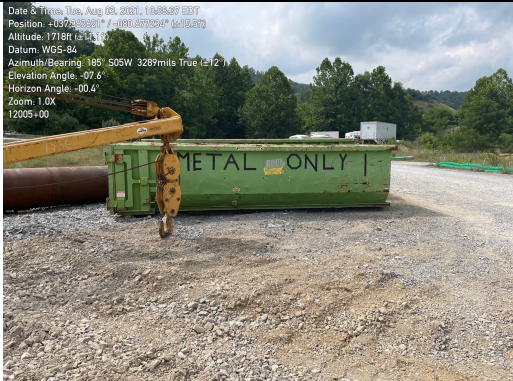
GPS Location	See photo		GPS Location	See photo	
Field Station#	12005+00		Field Station#	12005+00	
Pic 3 Desc.	Dumpsters in place		Pic 4 Desc.	Secondary containment in place

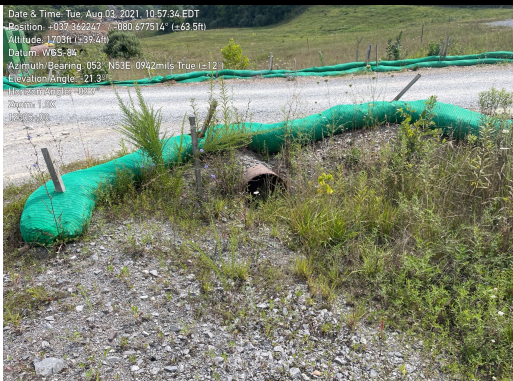
<p>Date & Time: Tue, Aug 03, 2021, 10:56:48 EDT Position: +037.36248° / -080.67726° (+15.5ft) Altitude: 1720ft (+11.2ft) Datum: WGS-84 Azimuth/Bearing: 180° N18W 201mils True (+12°) Elevation Angle: -00.4° Horizon Angle: -00.4° Zoom: 1.0X 12005+00</p>			
GPS Location	See photo		GPS Location	See photo	
Field Station#	12005+00		Field Station#	12005+00	
Pic 5 Desc.	Culvert in place		Pic 6 Desc.	Rock surface in acceptable condition

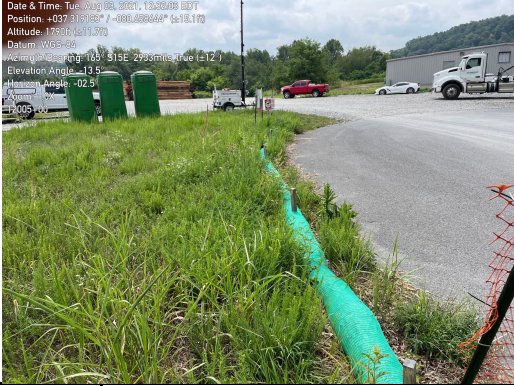
<p>Date & Time: Tue, Aug 03, 2021, 12:30:33 EDT Position: +029.316497° / -080.657003° ±0.1170 Altitude: 1757.0 ±1.20 Datum: WGS-84 Azimuth/Bearing: 099° S02E 172.0mils True ±12° Elevation Angle: -13.5° Horizon Angle: -02.5° Tilt: 0.0° Zoom: 1.0X 12005+00</p>			
GPS Location	See photo	GPS Location	See photo		
Field Station#	12005+00	Field Station#	12005+00		
Pic 1 Desc.	CFS perimeter control in place	Pic 2 Desc.	Secondary containment in place

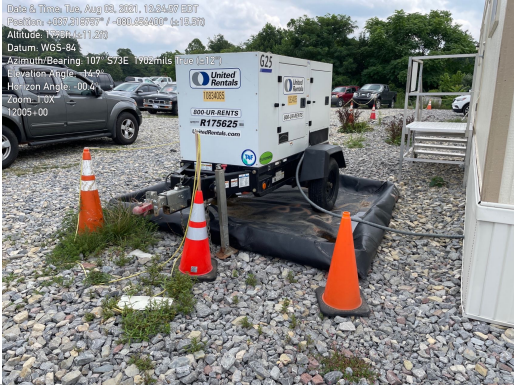
GPS Location	See photo	GPS Location	See photo		
Field Station#	12005+00	Field Station#	12005+00		
Pic 3 Desc.	Secondary containment in place	Pic 4 Desc.	Dumpsters in place

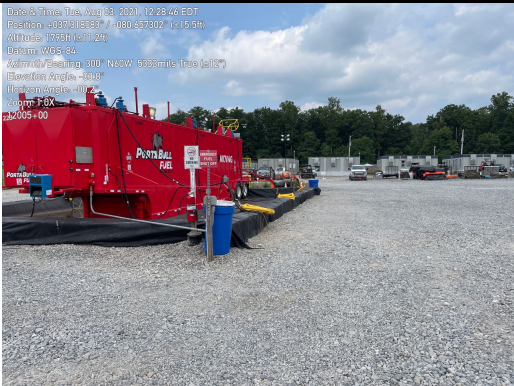
<p>Date & Time: Tue, Aug 03, 2021, 12:30:51 EDT Position: +029.316497° / -080.657003° ±0.1170 Altitude: 1757.0 ±1.20 Datum: WGS-84 Azimuth/Bearing: 200° S20W 202.0mils True ±12° Elevation Angle: -15.0° Horizon Angle: -06.5° Tilt: 0.0° Zoom: 1.0X 12005+00</p>			
GPS Location	See photo	GPS Location	See photo		
Field Station#	12005+00	Field Station#	12005+00		
Pic 5 Desc.	Rock surface in acceptable condition	Pic 6 Desc.	Orange safety fence in place

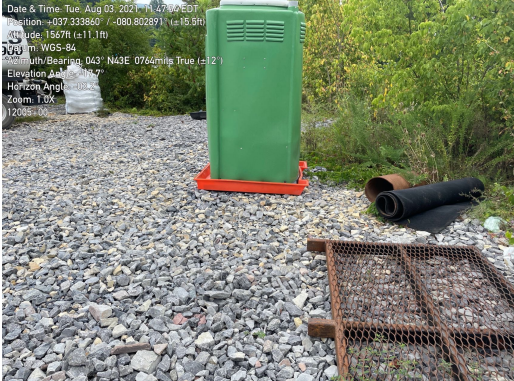
GPS Location	See photo	GPS Location	See photo		
Field Station#	12005+00	Field Station#	12005+00		
Pic 3 Desc.	Secondary containment in place	Pic 4 Desc.	Dumpsters in place

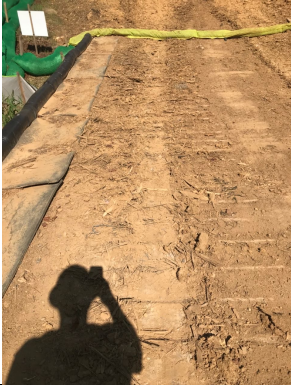
GPS Location	See photo	GPS Location	See photo		
Field Station#	10963+40	Field Station#	11024+00		
Pic 13 Desc.	Bridge punch listed	Pic 14 Desc.	Sump on pl		
Insert image here		Insert image here			
GPS Location		GPS Location			
Field Station#		Field Station#			
Pic 15 Desc.		Pic 16 Desc.			
Insert image here		Insert image here			
GPS Location		GPS Location			
Field Station#		Field Station#			
Pic 17 Desc.		Pic 18 Desc.

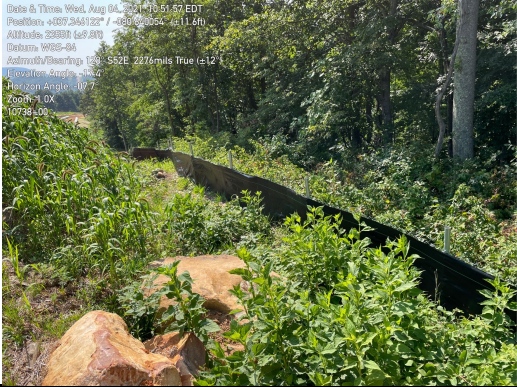
GPS Location		See photo		GPS Location	
Field Station#		10738+00		Field Station#	
Pic 7 Desc.		Supersilt fence perimeter control in place		Pic 8 Desc.	
<p>Date & Time: Wed, Aug 04, 2021, 11:45:06 EDT Position: +037.345322° / -80.68224° (+12.37) Altitude: 2300ft (+69.47) Datum: WGS-84 Azimuth/Bearing: 109.5822 1906mils True (+12°) Elevation Angle: -40.2 Horizon Angle: -10.8 Zoom: 1.0X 10741+00</p>

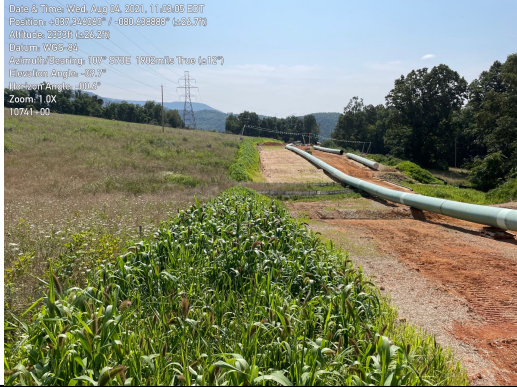
GPS Location		See photo		GPS Location	
Field Station#		10741+00		Field Station#	
Pic 9 Desc.		Clean water diversion berm in place		Pic 10 Desc.	
<p>Date & Time: Wed, Aug 04, 2021, 09:44:25 EDT Position: +037.345322° / -80.681132° (+12.37) Altitude: 2130ft (+65.51) Datum: WGS-84 Azimuth/Bearing: 103.2035 5594mils True (+12°) Elevation Angle: -31.7 Horizon Angle: -10.7 Zoom: 1.0X 10670+00</p>

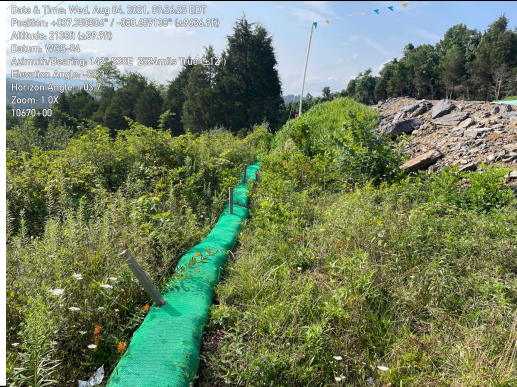
GPS Location		See photo		GPS Location	
Field Station#		10670+00		Field Station#	
Pic 11 Desc.		CFS perimeter control in place		Pic 12 Desc.

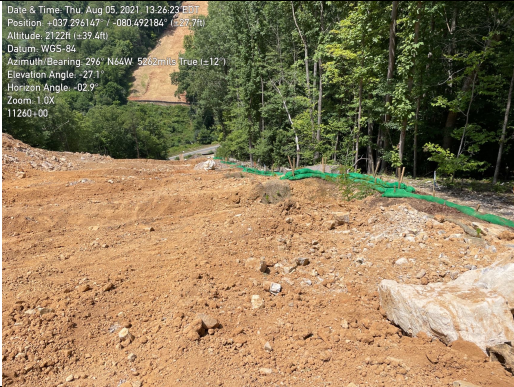
<p>Date & Time: Thu, Aug 05, 2021, 14:36:31 EDT Position: +037 293447 / +080 492184 (±39.4ft) Altitude: 2253ft (±39.4ft) Datum: WGS-84 Azimuth/Bearing: 269° S87W 2082mils True (±12.1°) Elevation Angle: -09.4° Horizon Angle: -10.1° Zoom: 1.0X 11285+00</p>			
GPS Location	See photo	GPS Location	See photo		
Field Station#	11260+00	Field Station#	11285+00		
Pic 1 Desc.	End treatments in place	Pic 2 Desc.	Erosion control blanket in place on fill slope

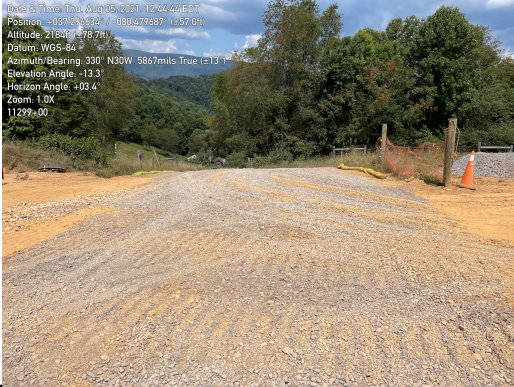
GPS Location	See photo	GPS Location	See photo		
Field Station#	11299+00	Field Station#	11311+00		
Pic 3 Desc.	RCE in place	Pic 4 Desc.	P1 silt fence perimeter control in place

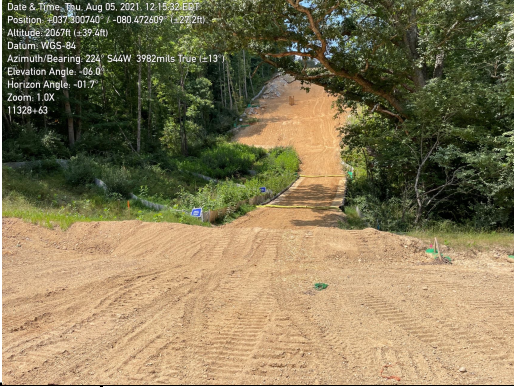
<p>Date & Time: Thu, Aug 05, 2021, 11:27:12 EDT Position: +037 310244 / +080 438703 (±15.3ft) Altitude: 2126ft (±11.2ft) Datum: WGS-84 Azimuth/Bearing: 271° N8W 4818mils True (±13.1°) Elevation Angle: -05.4° Horizon Angle: -05.5° Zoom: 1.0X 11385+00</p>			
GPS Location	See photo	GPS Location	See photo		
Field Station#	11328+63	Field Station#	11385+00		
Pic 5 Desc.	Stream buffer in place	Pic 6 Desc.	CFS perimeter control in place

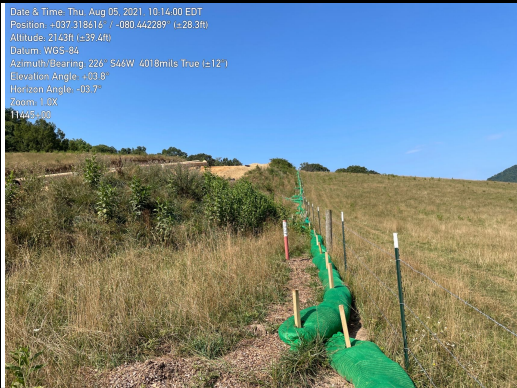
GPS Location		See photo				GPS Location		See photo			
Field Station#		11445+00				Field Station#		11477+00			
Pic 9 Desc.		CFS perimeter control in place				Pic 10 Desc.		Stone inlet protection in place			
<p>Date & Time: Thu, Aug 05, 2021, 09:40:43 EDT Position: +037.322595° / -080.433691° (+31.6m) Altitude: 2238ft (+19.7m) Datum: WGS-84 Azimuth/Bearing: 236° S48W 4376mils True (+12°) Elevation Angle: +04.8° Horizon Angle: +02.0° Zoom: 1.0X 11479+00</p>

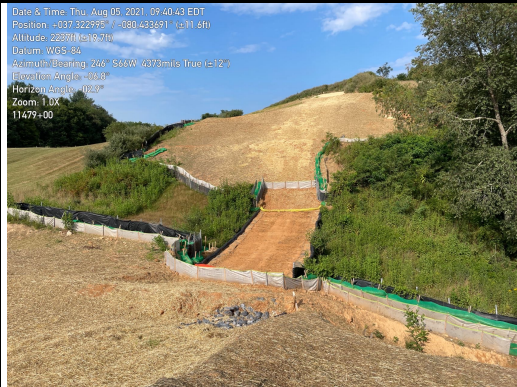
GPS Location		See photo				GPS Location		See photo			
Field Station#		11479+00				Field Station#		11504+00			
Pic 11 Desc.		Clean water drainage feature in place				Pic 12 Desc.		ROW has been stabilized

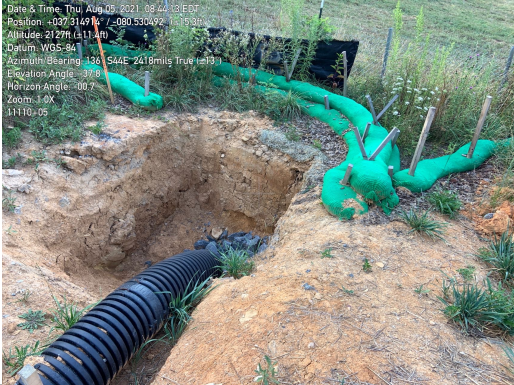
GPS Location	See photo	GPS Location	See photo		
Field Station#	11110+05	Field Station#	11131+00		
Pic 3 Desc.	Slope drain pipe, CFS and super silt fence functional	Pic 4 Desc.	Sensitive resource signage functional

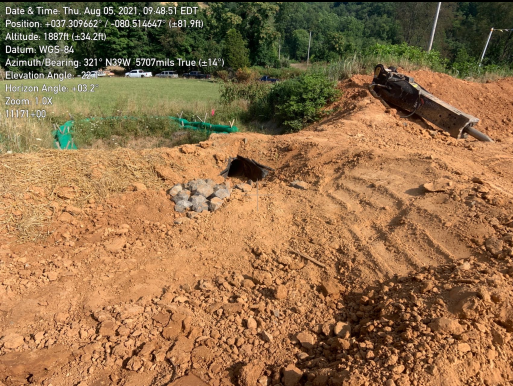
GPS Location	See photo	GPS Location	See photo		
Field Station#	11146+18	Field Station#	11171+00		
Pic 5 Desc.	Clean water diversion pipe and inlet functional	Pic 6 Desc.	Stone inlet protection needs maintenance

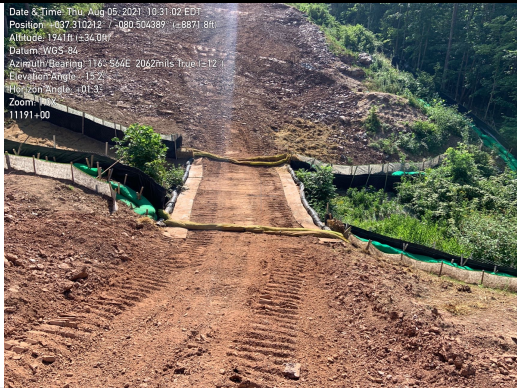
GPS Location	See photo	GPS Location	See photo		
Field Station#	11191+00	Field Station#	11210+00		
Pic 9 Desc.	Equipment bridge functional	Pic 10 Desc.	P1 functional		
<p>Date & Time: Thu, Aug 05, 2021, 11:05:37 EDT Position: +037.320335° / -080.493120° (±23.94 ft) Altitude: 2107ft (±36.3ft) Datum: WGS-84 Azimuth/Bearing: 010° N10E 5172mils True (±12°) Elevation Angle: +0.3° Horizon Angle: +07.8° Zoom: 1.0X 11232+85</p>

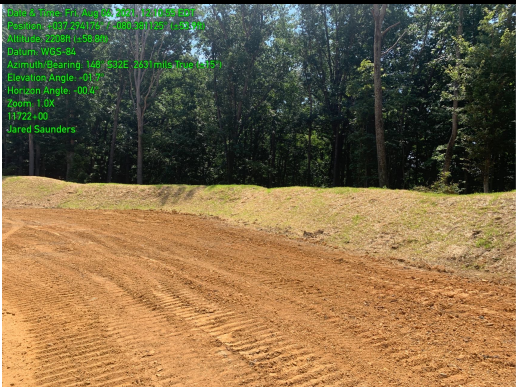
GPS Location	See photo for GPS location.		GPS Location	See photo for GPS location.	
Field Station#	11722+00		Field Station#	11747+00	
Pic 3 Desc.	Top soil stabilized with seed and mulch. Minor vegetation growth present.		Pic 4 Desc.	Logs removed from LOD.

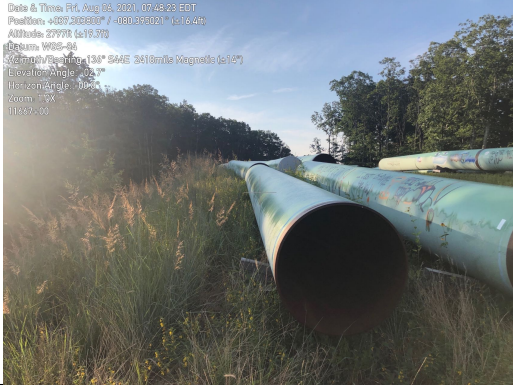
GPS Location				On photo				GPS Location				On photo			
Field Station#				11667+00				Field Station#				11664+00			
Pic 1 Desc.				ROW stable. No evidence of vandalism discovered.				Pic 2 Desc.				ROW stable. Perimeter ECDs in place.			
<p>Date & Time: Fri, Aug 06, 2021, 08:05:19 EDT Position: +037.306097° / -080.377277° (±16.4m) Altitude: 2805ft (±13.1ft) Datum: WGS 84 Azimuth/Bearing: 132° S48E 2347mils Magnetic (±12°) Elevation Angle: -59.3° Horizon Angle: -52.0° Zoom: 1.0x ROW stable</p>

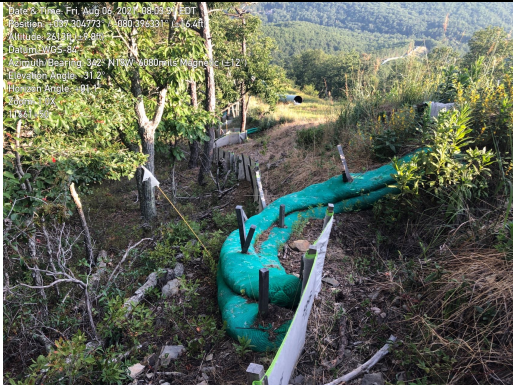
GPS Location				On photo				GPS Location				On photo			
Field Station#				11661+50				Field Station#				11656+50			
Pic 3 Desc.				Sumps and end treatments are functional.				Pic 4 Desc.				Slope breakers are functional.			
<p>Date & Time: Fri, Aug 06, 2021, 08:20:51 EDT Position: +037.306097° / -080.377427° (±16.4m) Altitude: 2791ft (±13.1ft) Datum: WGS 84 Azimuth/Bearing: 132° S48E 2347mils Magnetic (±12°) Elevation Angle: -59.3° Horizon Angle: -52.0° Zoom: 1.0x ROW stable</p>

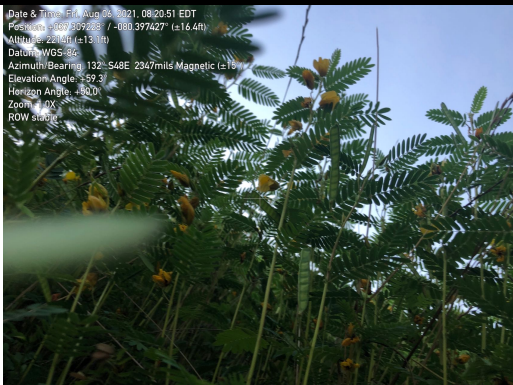
GPS Location				On photo				GPS Location				On photo			
Field Station#				11640+00				Field Station#				11638+00			
Pic 5 Desc.				Partridge pea has choked out all other vegetation.				Pic 6 Desc.				Perimeter ECDs effective.

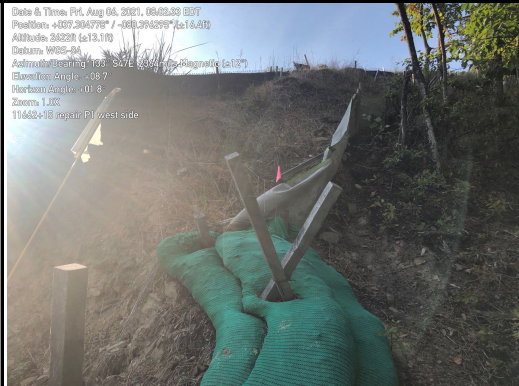
GPS Location	On photo	GPS Location	On photo		
Field Station#	11604+00	Field Station#	11662+15		
Pic 9 Desc.	Sparse vegetation but surface stable on private property.	Pic 10 Desc.	P1 repair need has been communicated.		
 		<div>Insert image here</div>			
GPS Location	On photo	GPS Location			
Field Station#	11665+00	Field Station#			
Pic 11 Desc.	SSF fabric to be re-attached to chain link. Repair need has been communicated with contractor.	Pic 12 Desc.

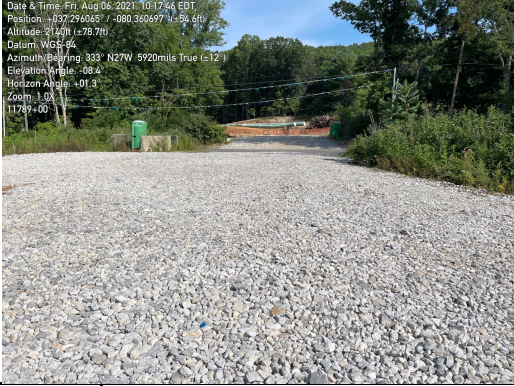
GPS Location	See photo	GPS Location	See photo		
Field Station#	11789+00	Field Station#	11795+00		
Pic 1 Desc.	RCE in place	Pic 2 Desc.	CFS perimeter control in place		
<p>Date & Time: Fri, Aug 06, 2021, 10:45:45 EDT Position: +437.33654° / -88.38671° (+88.38671°) Altitude: 217.52 (+22.50) Datum: WGS-84 Azimuth/Bearing: 186° S84W 3271mils True (+12°) Elevation Angle: -12.8° Horizon Angle: +06.1° Zoom: 1.0X 11827+00</p>

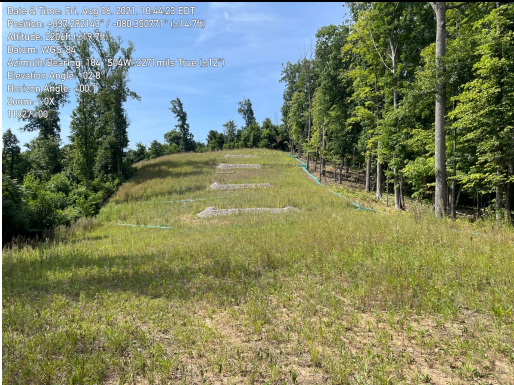
GPS Location	See photo	GPS Location	See photo		
Field Station#	11827+00	Field Station#	11845+00		
Pic 3 Desc.	Waterbars with level spreaders in place	Pic 4 Desc.	Supersilt fence perimeter control in place		
<p>Date & Time: Fri, Aug 06, 2021, 11:05:30 EDT Position: +437.23724° / -88.33269° (+88.33269°) Altitude: 228.56 (+19.70) Datum: WGS-84 Azimuth/Bearing: 174° S16E 3129mils True (+12°) Elevation Angle: +19.3° Horizon Angle: +0.6° Zoom: 1.0X 11905+00</p>

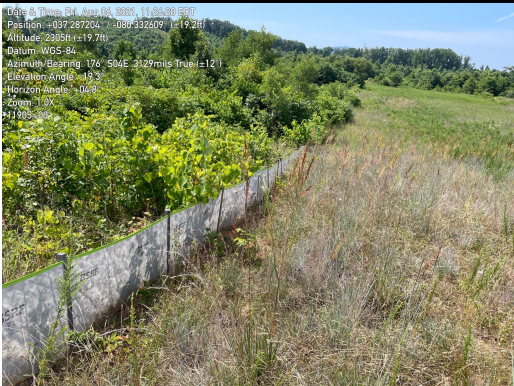
GPS Location	See photo	GPS Location	See photo		
Field Station#	11905+00	Field Station#	11945+00		
Pic 5 Desc.	P1 silt fence perimeter control in place	Pic 6 Desc.	Good vegetation on ROW
