# Visual Site Inspection Report

<b>Project Name</b>	H-600 Pipeline Spread G	<b>AFE</b>	124300137	<b>Spread</b>	H-600 Pipeline Spread G
<b>Contractor</b>	Precision			<b>Report #</b>	26968
<b>Inspector</b>	Patrick Shields			<b>Date/Time</b>	8/9/2021 6:18 PM
<b>Permit #</b>	TBD	<b>Inspection Type</b>	VA SWPP	<b>Station Begin</b>	12005+00
<b>State</b>	VA	<b>Inspection Area</b>	Full	<b>Station End</b>	12005+00
<b>County</b>	Giles	<b>Ground</b>	Dry	<b>Temperature (°F)</b>	85.00
<b>Municipality</b>	N/A	<b>Weather</b>	Sunny	<b>Rain Gauge (in)</b>	0.00
				<b>Rain Accumulation Time (days)</b>	1.00

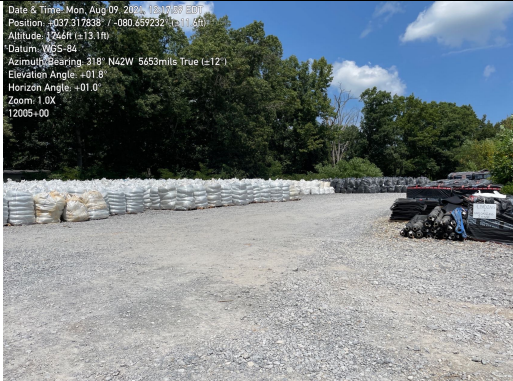
GPS Location				See photo				GPS Location				See photo			
Field Station#				12005+00				Field Station#				12005+00			
Pic 3 Desc.				CFS perimeter control in place				Pic 4 Desc.				Secondary containment in place			
<p>Date &amp; Time: Mon, Aug 09, 2021, 12:11:55 EDT Position: +037.317833 / -080.659232 (+15.5m) Altitude: 1844m (+13.1m) Datum: WGS-84 Azimuth/Bearing: 318° N42W 5653mils True (+12.1) Elevation Angle: +01.8° Horizon Angle: +01.0° Zoom: 1.0x 12005+00</p>

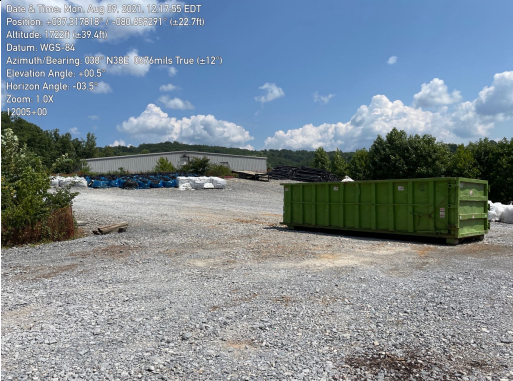
GPS Location				See photo				GPS Location				See photo			
Field Station#				12005+00				Field Station#				12005+00			
Pic 5 Desc.				Good housekeeping				Pic 6 Desc.				Dumpster in place

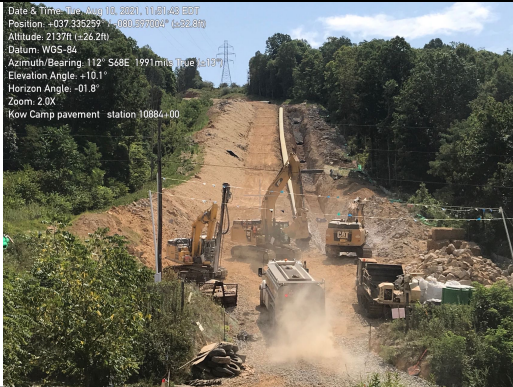
GPS Location		see photo				GPS Location		see photo							
Field Station#		108884+00				Field Station#		10859+00							
Pic 3 Desc.		Trenching crew at Kow Camp, pavement				Pic 4 Desc.		Kow camp gravel

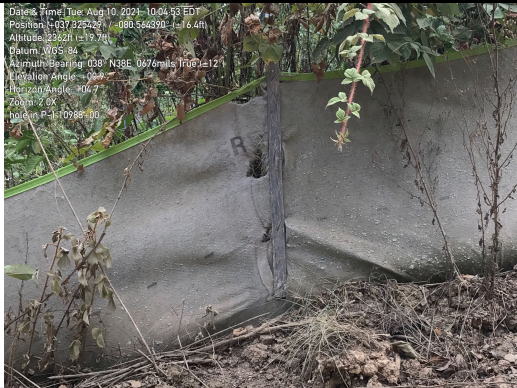
<p>Date &amp; Time: Tue, Aug 10, 2021, 10:12:38 EDT  Position: +037.341620° / -080.557199° (±5568.6ft)  Altitude: 2408ft (±148.0ft)  Datum: WGS-84  Azimuth/Bearing: 212° S32W 376.9mils True (±7°)  Elevation Angle: -30.7°  Horizon Angle: -103.1°  Zoom: 1.0X  slope drain needs cleaned 10978+00</p>  			
<b>GPS Location</b>	see photo	<b>GPS Location</b>	see photo		
<b>Field Station#</b>	10988+00	<b>Field Station#</b>	10978+00		
<b>Pic 9 Desc.</b>	Hole in P1	<b>Pic 10 Desc.</b>	Slope drain needs cleaned		
<p>Date &amp; Time: Tue, Aug 10, 2021, 10:26:32 EDT  Position: +037.329333° / -080.572100° (±132.8ft)  Altitude: 2260ft (±78.2ft)  Datum: WGS-84  Azimuth/Bearing: 298° N65W 524.6mils True (±12°)  Elevation Angle: -26.5°  Horizon Angle: -100.4°  Zoom: 1.0X  bridge needs cleaned 10963+33</p>  		<p>Date &amp; Time: Tue, Aug 10, 2021, 09:55:54 EDT  Position: +037.323933° / -080.568833° (±132.8ft)  Altitude: 2508ft (±26.2ft)  Datum: WGS-84  Azimuth/Bearing: 111° S49E 197.3mils True (±12°)  Elevation Angle: -10.9°  Horizon Angle: -101.2°  Zoom: 2.0X  lower in station #1101+00</p>

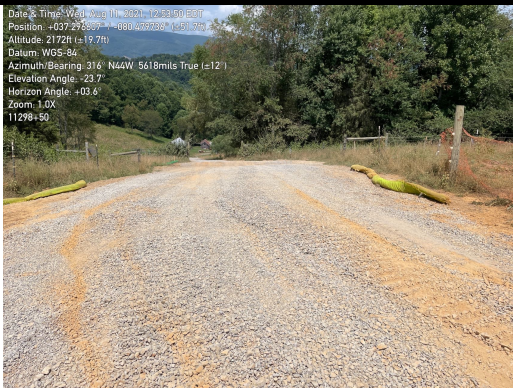
<b>Pic 5 Desc.</b>				RCE in place				<b>Pic 6 Desc.</b>				P1 silt fence perimeter control in place

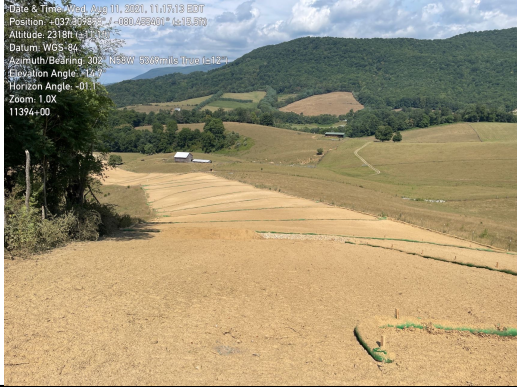
<b>GPS Location</b>	See photo	<b>GPS Location</b>	See photo		
<b>Field Station#</b>	11394+00	<b>Field Station#</b>	11412+00		
<b>Pic 9 Desc.</b>	Temporary CFS waterbars in place	<b>Pic 10 Desc.</b>	CFS perimeter controls and end treatments are in place

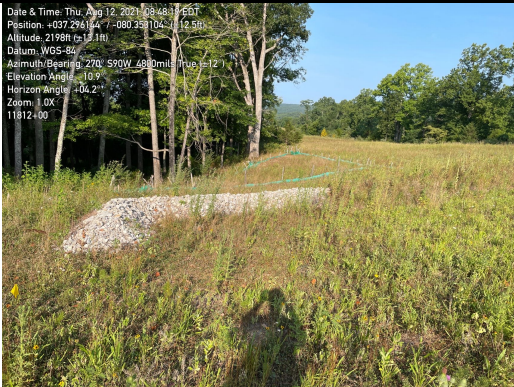
<b>GPS Location</b>	See photo	<b>GPS Location</b>	See photo		
<b>Field Station#</b>	11812+00	<b>Field Station#</b>	11830+00		
<b>Pic 1 Desc.</b>	Level spreader in place	<b>Pic 2 Desc.</b>	ECDs in place		
<p>Date &amp; Time: Thu, Aug 12, 2021 15:15:07 EDT  Position: +037.295252° / -080.395252° (-12.50)  Altitude: 2184ft (-66.24)  Datum: WGS-84  Azimuth/Bearing: 351° N09W 820mils True (-12)  Elevation Angle: -05.5°  Horizon Angle: -03.0°  Zoom: 1.0X  11845+00</p>

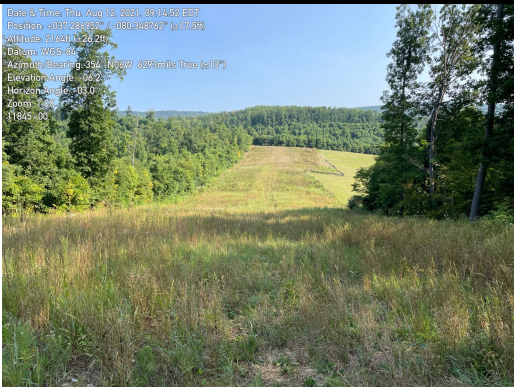
<b>GPS Location</b>	See photo	<b>GPS Location</b>	See photo		
<b>Field Station#</b>	11845+00	<b>Field Station#</b>	11922+50		
<b>Pic 3 Desc.</b>	Good vegetation on ROW	<b>Pic 4 Desc.</b>	Waterbars in place		
<p>Date &amp; Time: Thu, Aug 12, 2021 10:31:50 EDT  Position: +037.274592° / -080.326019° (-12.50)  Altitude: 2095ft (-63.56)  Datum: WGS-84  Azimuth/Bearing: 351° N09W 820mils True (-12)  Elevation Angle: +05.9°  Horizon Angle: +01.7°  Zoom: 1.0X  11950+00</p>

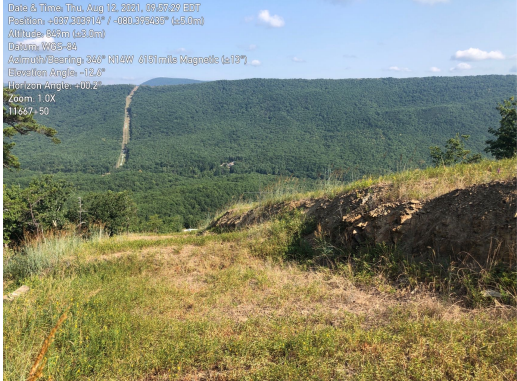
<p>Date &amp; Time: Thu, Aug 12, 2021, 10:53:30 EDT Position: +037.336917° / -080.398534° (±5.0m) Altitude: 586m (±12.0m) Datum: WGS-84 Azimuth/Bearing: 146° 11.74' 0.00" (12.0°) Elevation Angle: -10.4° Horizon Angle: -100.4° Zoom: 1.0X 11667+50</p>			
GPS Location	On photo		GPS Location	On photo	
Field Station#	11667+50		Field Station#	11661+50	
Pic 1 Desc.	ROW is stable on steep slopes. Slope breakers in place and functioning.		Pic 2 Desc.	Perimeter ECDs are in place. All CFS and SSF fabric is worn.

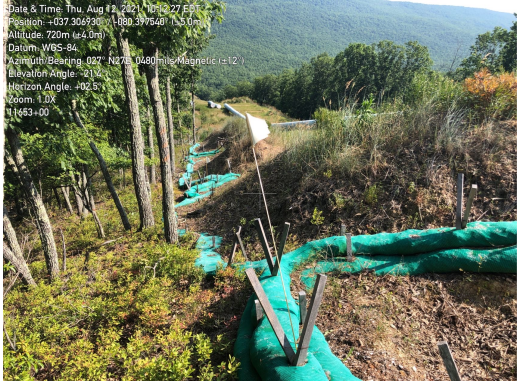
GPS Location	On photo		GPS Location	On photo	
Field Station#	11653+00		Field Station#	11626+35	
Pic 3 Desc.	Perimeter ECDs are in place. Many are worn.		Pic 4 Desc.	Perimeter ECDs are in place.

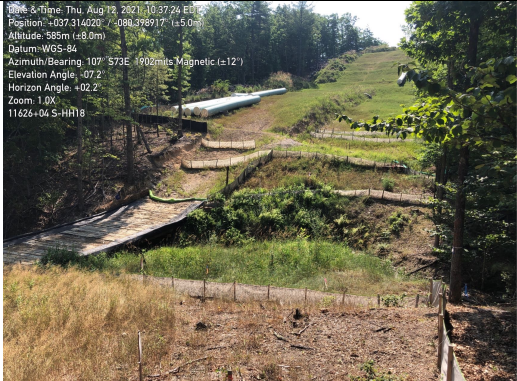
<p>Date &amp; Time: Thu, Aug 12, 2021, 10:41:16 EDT Position: +037.314607° / -080.40126° (±10.0m) Altitude: 591m (±12.0m) Datum: WGS-84 Azimuth/Bearing: 261° S81W 4640mils Magnetic (±18°) Elevation Angle: -01.4° Horizon Angle: -01.6° Zoom: 1.0X 11619+00</p>			
GPS Location	On photo		GPS Location	On photo	
Field Station#	11626+04		Field Station#	11619+00	
Pic 5 Desc.	The S-HH18 crossing is currently stable.		Pic 6 Desc.	Private lands are being stabilized with seed and mulch.

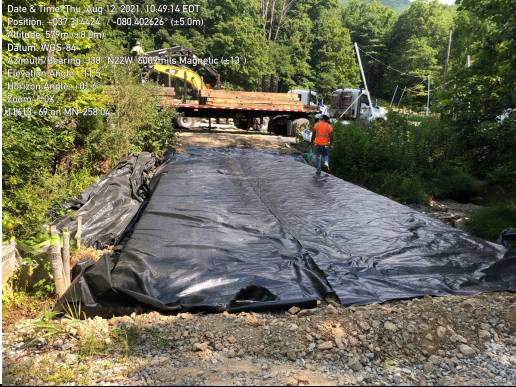
<p><small>Date &amp; Time: Thu, Aug 12, 2021, 10:49:14 EDT Position: +037 213426 / -080 402426 (±5.0m) Altitude: 579m (±8.0m) Datum: WGS-84 Azimuth/Bearing: 198° N22W 800mils Magnetic (±12°) Elevation Angle: -11.5° Horizon Angle: -03.7° Zoom: 1.0X 11613+69 on MN-258.04</small></p>		  <p><small>Date &amp; Time: Thu, Aug 12, 2021, 11:31:14 EDT Position: +037 213423 / -080 402424 (±5.0m) Altitude: 580m (±6.0m) Datum: WGS-84 Azimuth/Bearing: 004° N04E 0071mils Magnetic (±12°) Elevation Angle: -11.5° Horizon Angle: -03.7° Zoom: 1.0X 11609+00</small></p>			
<b>GPS Location</b>	On photo	<b>GPS Location</b>	On photo		
<b>Field Station#</b>	11613+69	<b>Field Station#</b>	11609+00		
<b>Pic 7 Desc.</b>	Equipment bridge repaired at S-RR13 on access road MN-258.04.	<b>Pic 8 Desc.</b>	End treatments are being replaced where needed.

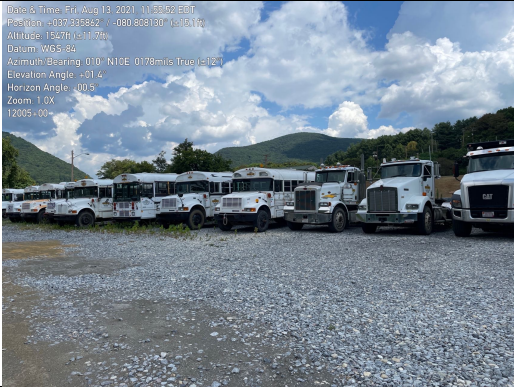
<b>GPS Location</b>		See photo		<b>GPS Location</b>	
<b>Field Station#</b>		12005+00		<b>Field Station#</b>	
<b>Pic 1 Desc.</b>		Vehicles not in use being stored at yard		<b>Pic 2 Desc.</b>	
<p>Date &amp; Time: Fri Aug 13, 2021 12:00:10 EDT Position: +037.333845° / -080.808190° (-0.0011°) Altitude: 1568ft (+11.2ft) Datum: WGS 84 Azimuth Bearing: 027° N27E 0480mils True (+15°) Elevation Angle: +07.6° Horizon Angle: +00.0° Zoom: 1.0X 12005+00</p>

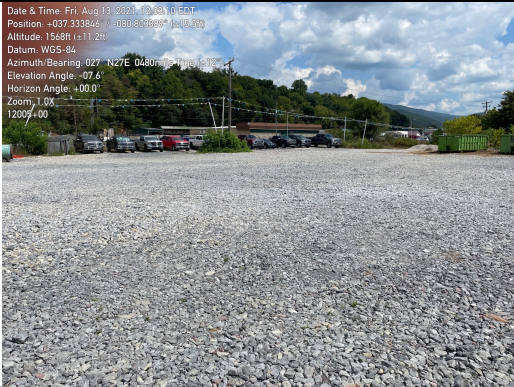
<b>GPS Location</b>		See photo		<b>GPS Location</b>	
<b>Field Station#</b>		12005+00		<b>Field Station#</b>	
<b>Pic 3 Desc.</b>		Rock surface in acceptable condition		<b>Pic 4 Desc.</b>	
<p>Date &amp; Time: Fri Aug 13, 2021 12:05:52 EDT Position: +037.333845° / -080.808190° (-0.0011°) Altitude: 1568ft (+11.2ft) Datum: WGS 84 Azimuth Bearing: 070° N70E 1702mils True (+12.4°) Elevation Angle: +01.1° Horizon Angle: +00.0° Zoom: 1.0X 12005+00</p>

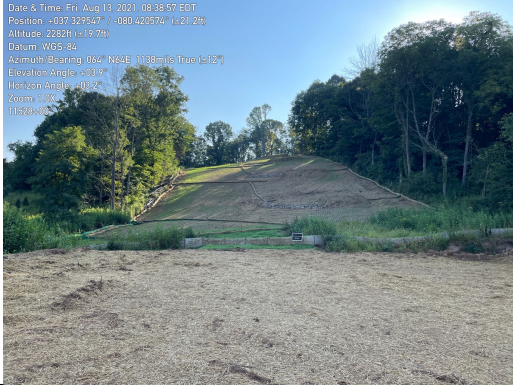
GPS Location		See photo				GPS Location		See photo			
Field Station#		11528+00				Field Station#		11533+00			
Pic 1 Desc.		Temporary CFS waterbars in place				Pic 2 Desc.		Good vegetation on ROW			
<p>Date &amp; Time: Fri, Aug 13, 2021, 09:15:49 EDT Position: +037.336177° / +080.416597° (+15.1M) Altitude: 2390ft (+13.1M) Datum: WGS-84 Azimuth/Bearing: 145° S09E 3394mils True (+2°) Elevation Angle: +35.8° Horizon Angle: -00.5° Zoom: 1.0X 11543+00</p>

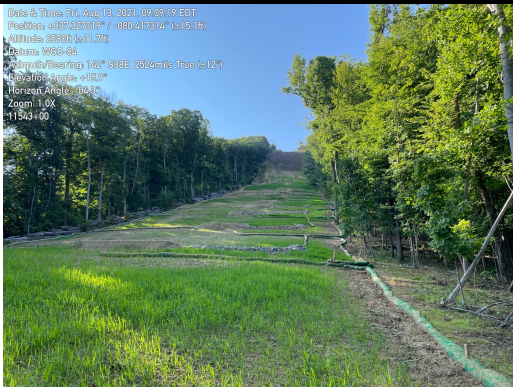
GPS Location		See photo				GPS Location		See photo			
Field Station#		11543+00				Field Station#		11545+00			
Pic 3 Desc.		Level spreaders in place				Pic 4 Desc.		CFS perimeter controls in place			
<p>Date &amp; Time: Fri, Aug 13, 2021, 09:44:30 EDT Position: +037.336577° / +080.416594° (+15.1M) Altitude: 2351ft (+12.6M) Datum: WGS-84 Azimuth/Bearing: 153° S27E 2720mils True (+12.1) Elevation Angle: -03.0° Horizon Angle: -00.5° Zoom: 1.0X 11563+00</p>

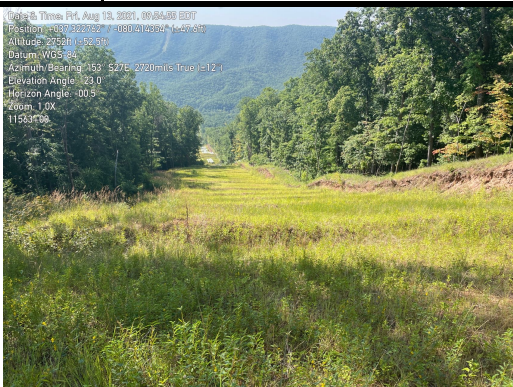
GPS Location		See photo				GPS Location		See photo			
Field Station#		11563+00				Field Station#		11583+00			
Pic 5 Desc.		Waterbars in place				Pic 6 Desc.		P1 silt fence perimeter control

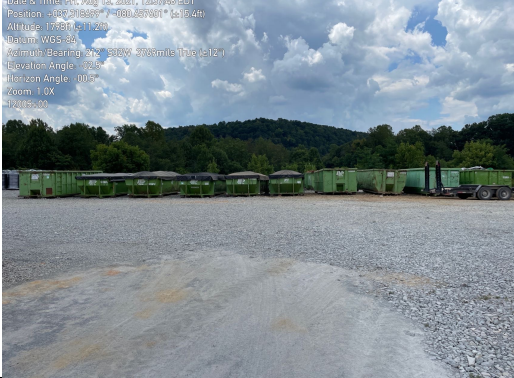
<p>Date &amp; Time: Fri, Aug 13, 2021, 12:25:21 EDT Position: +037319522 / -880.65767 / +15.5 ft Altitude: 1805ft (+15.5 ft) Datum: WGS-84 Azimuth Bearing: 232° S52W 12.2mils True (+12.2°) Elevation Angle: -48.8° Horizon Angle: -02.9° Zoom: 1.0X 12005+00</p>			
<b>GPS Location</b>	See photo	<b>GPS Location</b>	See photo		
<b>Field Station#</b>	12005+00	<b>Field Station#</b>	12005+00		
<b>Pic 1 Desc.</b>	Dumpsters in place	<b>Pic 2 Desc.</b>	Secondary containment in place

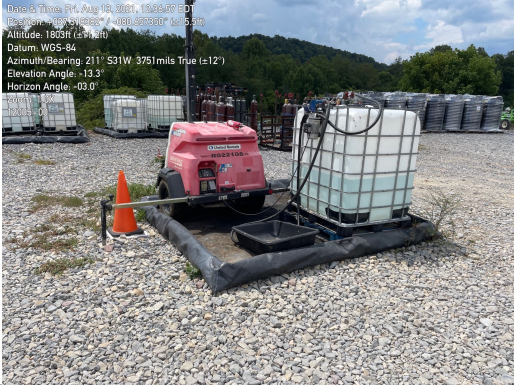
<b>GPS Location</b>	See photo	<b>GPS Location</b>	See photo		
<b>Field Station#</b>	12005+00	<b>Field Station#</b>	12005+00		
<b>Pic 3 Desc.</b>	Secondary containment in place	<b>Pic 4 Desc.</b>	Secondary containments place

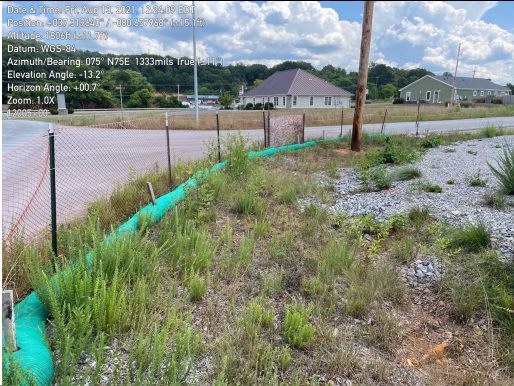
<p>Date &amp; Time: Fri, Aug 13, 2021, 12:41:38 EDT Position: +037319522 / -880.65767 / +15.5 ft Altitude: 1298ft (+11.8 ft) Datum: WGS-84 Azimuth Bearing: 331° N29W 5884mils True (+12.1°) Elevation Angle: -12.2° Horizon Angle: -00.5° Zoom: 1.0X 12005+00</p>			
<b>GPS Location</b>	See photo	<b>GPS Location</b>	See photo		
<b>Field Station#</b>	12005+00	<b>Field Station#</b>	12005+00		
<b>Pic 5 Desc.</b>	Orange construction safety fence in place	<b>Pic 6 Desc.</b>	CFS perimeter control in place
