# Visual Site Inspection Report

<b>Project Name</b>	H-600 Pipeline Spread G	<b>AFE</b>	124300137	<b>Spread</b>	H-600 Pipeline Spread G
<b>Contractor</b>	Precision			<b>Report #</b>	27289
<b>Inspector</b>	Patrick Shields			<b>Date/Time</b>	8/16/2021 5:54 PM
<b>Permit #</b>	TBD	<b>Inspection Type</b>	VA SWPP	<b>Station Begin</b>	10655+00
<b>State</b>	VA	<b>Inspection Area</b>	Full	<b>Station End</b>	10859+34
<b>County</b>	Giles	<b>Ground</b>	Wet	<b>Temperature (°F)</b>	75.00
<b>Municipality</b>	N/A	<b>Weather</b>	Light Rain	<b>Rain Gauge (in)</b>	1.50
				<b>Rain Accumulation Time (days)</b>	1.00

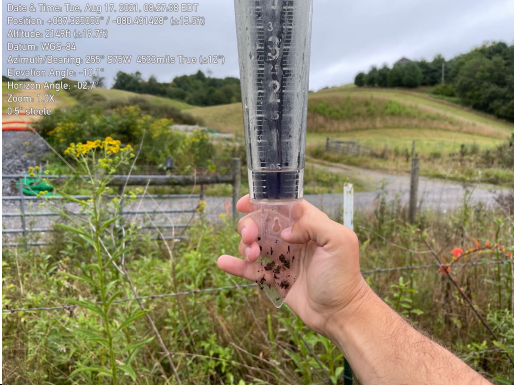
<p>Date &amp; Time: Tue, Aug 17, 2021, 05:46:31 EDT Position: +037.222655° / -080.451425° (±13.31) Altitude: 2017 ft (±13.10) Datum: WGS-84 Azimuth/Heading: 162° SWS 330mils True (±12°) Elevation Angle: -1.0° Horizon Angle: -0.02° Zoom: 1.0X 11505+00</p>			
<b>GPS Location</b>	See photo	<b>GPS Location</b>	See photo		
<b>Field Station#</b>	11490+00	<b>Field Station#</b>	11505+00		
<b>Pic 1 Desc.</b>	Rain gauge measured 0.5" of rainfall	<b>Pic 2 Desc.</b>	Clean water diversion berm in place

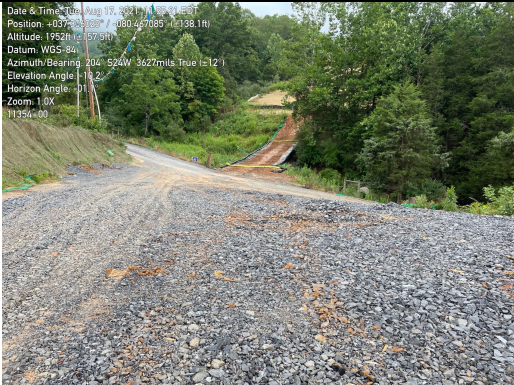
<b>GPS Location</b>	See photo	<b>GPS Location</b>	See photo		
<b>Field Station#</b>	11354+00	<b>Field Station#</b>	11477+00		
<b>Pic 3 Desc.</b>	RCE in place	<b>Pic 4 Desc.</b>	Rock inlet protection in place

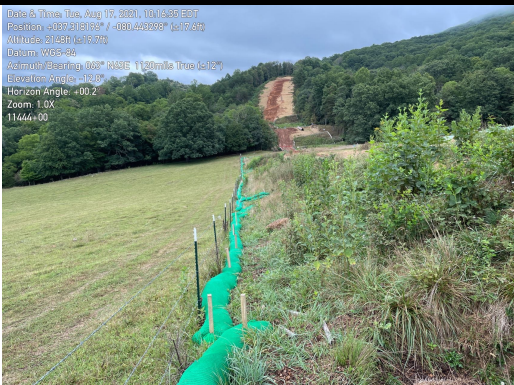
<p>Date &amp; Time: Tue, Aug 17, 2021, 10:16:01 EDT Position: +037.216542° / -080.455555° (±17.31) Altitude: 2218 ft (±13.31) Datum: WGS-84 Azimuth/Heading: 121° SWS 2016mils True (±12°) Elevation Angle: -0.2° Horizon Angle: -01.2° Zoom: 1.0X 11390+00</p>			
<b>GPS Location</b>	See photo	<b>GPS Location</b>	See photo		
<b>Field Station#</b>	11444+00	<b>Field Station#</b>	11390+00		
<b>Pic 5 Desc.</b>	CFS perimeter control in place	<b>Pic 6 Desc.</b>	Temporary CFS waterbars in place

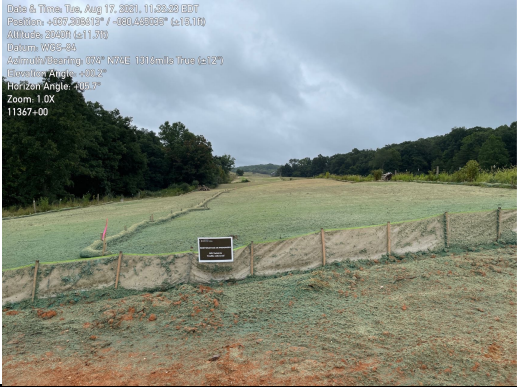
<b>GPS Location</b>	See photo	<b>GPS Location</b>	See photo		
<b>Field Station#</b>	11367+00	<b>Field Station#</b>	11328+75		
<b>Pic 7 Desc.</b>	Proper signage in place for restoration	<b>Pic 8 Desc.</b>	Stream buffer in place		
<p>Date &amp; Time: Tue, Aug 17, 2021, 12:03:16 EDT  Position: +037.216942° / -080.47026° (±18.10)  Altitude: 2307ft (±10.70)  Datum: WGS-84  Azimuth/Bearing: 197° S17W 3502mils True (±12°)  Elevation Angle: -13.2°  Horizon Angle: -00.7°  Zoom: 1.0X  11311+00</p>  		<p>Date &amp; Time: Tue, Aug 17, 2021, 12:44:44 EDT  Position: +037.216533° / -080.46346° (±18.10)  Altitude: 2280ft (±9.40)  Datum: WGS-84  Azimuth/Bearing: 248° S88W 3133mils True (±12°)  Elevation Angle: -07.8°  Horizon Angle: -07.6°  Zoom: 1.0X  11285+00</p>

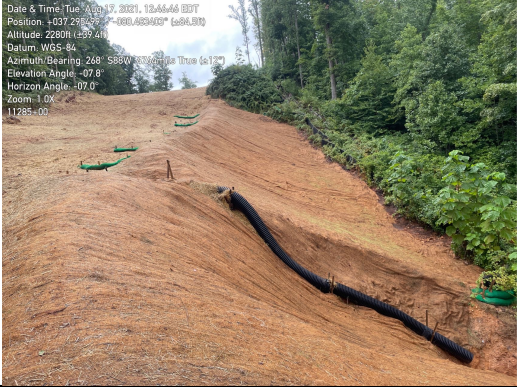
<b>GPS Location</b>	See photo	<b>GPS Location</b>	See photo		
<b>Field Station#</b>	11311+00	<b>Field Station#</b>	11285+00		
<b>Pic 9 Desc.</b>	P1 silt fence perimeter control in place	<b>Pic 10 Desc.</b>	Fill slope stabilized		
<p>Date &amp; Time: Tue, Aug 17, 2021, 12:49:32 EDT  Position: +037.219923° / -080.484572° (±15.10)  Altitude: 2308ft (±11.70)  Datum: WGS-84  Azimuth/Bearing: 062° N2E 1102mils True (±12°)  Elevation Angle: -07.2°  Horizon Angle: -00.7°  Zoom: 1.0X  11283+93</p>

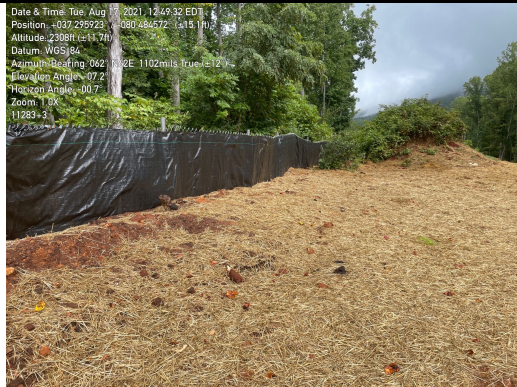
<b>GPS Location</b>	See photo	<b>GPS Location</b>	See photo		
<b>Field Station#</b>	11283+93	<b>Field Station#</b>	11260+50		
<b>Pic 11 Desc.</b>	Supersilt fence perimeter control in place	<b>Pic 12 Desc.</b>	End treatments in place

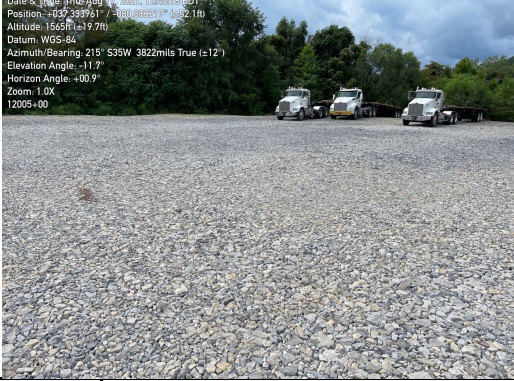
<b>GPS Location</b>	See photo	<b>GPS Location</b>	See photo		
<b>Field Station#</b>	12005+00	<b>Field Station#</b>	12005+00		
<b>Pic 1 Desc.</b>	Rock in acceptable condition	<b>Pic 2 Desc.</b>	Vehicles not in use being stored at yard		
<p>Date &amp; Time: Thu Aug 19, 2021, 15:45:30 EDT  Position: +43.233457° / -80.88914° (+11.2ft)  Altitude: 1570ft (+19.7ft)  Datum: WGS-84  Azimuth/Bearing: 240° S60W 426mils True (+13°)  Elevation Angle: -05°  Horizon Angle: +00.3°  Zoom: 1.0X  12005+00</p>

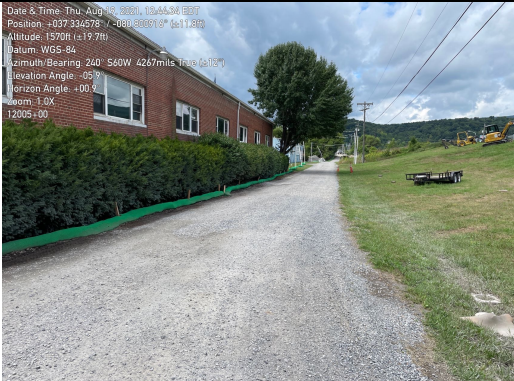
<b>GPS Location</b>	See photo	<b>GPS Location</b>	See photo		
<b>Field Station#</b>	12005+00	<b>Field Station#</b>	12005+00		
<b>Pic 3 Desc.</b>	CFS perimeter control in place	<b>Pic 4 Desc.</b>	Dumpsters in place		
<p>Date &amp; Time: Thu Aug 19, 2021, 15:45:30 EDT  Position: +43.233457° / -80.88914° (+11.2ft)  Altitude: 1570ft (+19.7ft)  Datum: WGS-84  Azimuth/Bearing: 310° N50W 551mils True (+14°)  Elevation Angle: -17.0°  Horizon Angle: +00.0°  Zoom: 1.0X  12005+00</p>

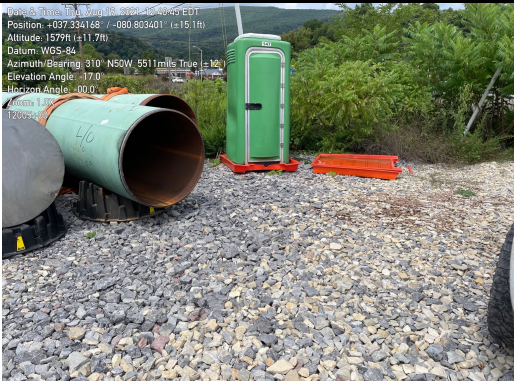
<b>GPS Location</b>	See photo	<b>GPS Location</b>	See photo		
<b>Field Station#</b>	12005+00	<b>Field Station#</b>	12005+00		
<b>Pic 5 Desc.</b>	Secondary containment in place	<b>Pic 6 Desc.</b>	RCE in place

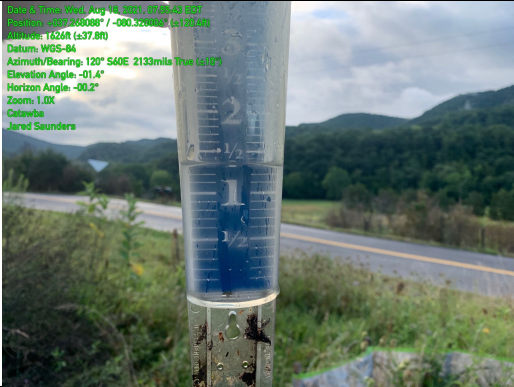
<b>GPS Location</b>	See photo for GPS location.		<b>GPS Location</b>	See photo for GPS location.	
<b>Field Station#</b>	11990+00		<b>Field Station#</b>	11789+00	
<b>Pic 1 Desc.</b>	Rain gauge at Catawba Road read 1.3 inches.		<b>Pic 2 Desc.</b>	Rain gauge at Mount Tabor Road reads 1.2 inches.

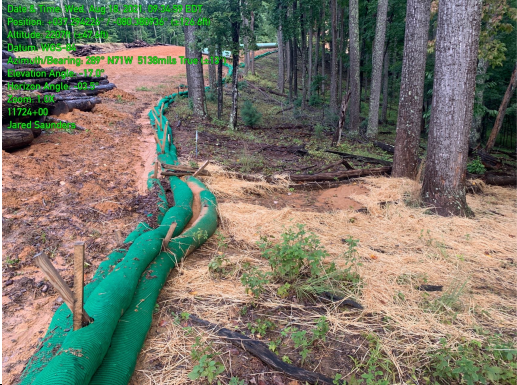
<p><small>Date &amp; Time: Wed, Aug 18, 2021, 10:52:23 EDT Position: +037.294042° / -080.363995° (±541.4ft) Altitude: 2132ft (±32.0ft) Datum: WGS-84 Azimuth/Bearing: 088° N88E 1564mils True (±18°) Elevation Angle: -07.4° Horizon Angle: -15.0° Zoom: 1.0X 11724+00 Jared Saunders</small></p>	
<b>GPS Location</b>	See photo for GPS location.	<b>GPS Location</b>	See photo for GPS location.		
<b>Field Station#</b>	11724+00	<b>Field Station#</b>	11776+00		
<b>Pic 7 Desc.</b>	Off ROW sediment located during inspection.	<b>Pic 8 Desc.</b>	Clean water diversion pipe.

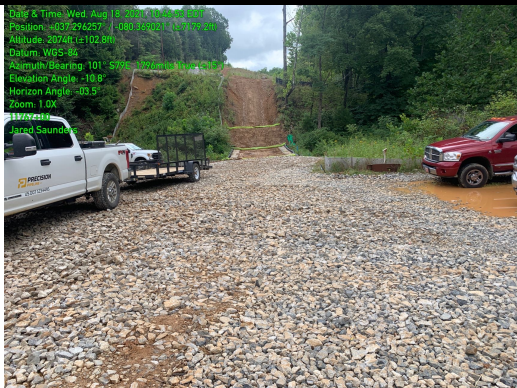
<b>GPS Location</b>	See photo for GPS location.	<b>GPS Location</b>	See photo for GPS location.		
<b>Field Station#</b>	11767+00	<b>Field Station#</b>	11788+00		
<b>Pic 9 Desc.</b>	RCE in place at Main Line Valve 26.	<b>Pic 10 Desc.</b>	Logs staged to be hauled off ROW.

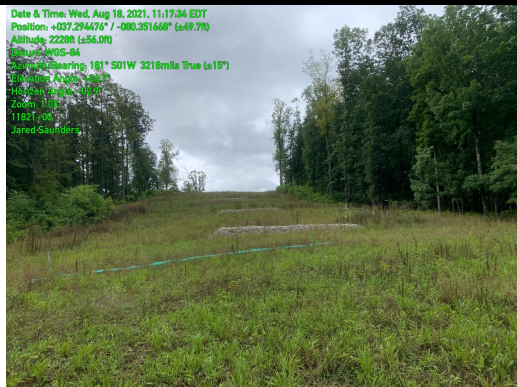
<b>GPS Location</b>	See photo for GPS location.	<b>GPS Location</b>	See photo for GPS location.		
<b>Field Station#</b>	11821+00	<b>Field Station#</b>	12005+00		
<b>Pic 11 Desc.</b>	Permanent waterbars and level spreaders in place. ROW heavily vegetated.	<b>Pic 12 Desc.</b>	Rock checks in place along access road 266.

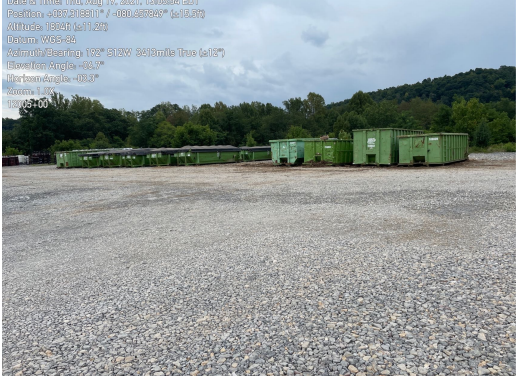
GPS Location	See photo		GPS Location	See photo	
Field Station#	12005+00		Field Station#	12005+00	
Pic 1 Desc.	Dumpsters in place		Pic 2 Desc.	Fuel island maintained in acceptable condition	
<p> Date &amp; Time: Thu, Aug 19, 2021, 12:05:14 EDT  Position: +409.316791° / +80.65722° ±0.1, 0.10  Altitude: 1800ft ±1.10  Datum: WGS-84  Azimuth Bearing: 49° S 38° 44.0mils True ±11°  Elevation Angle: -83.8°  Horizon Angle: -03.8°  Zoom: 1.0X  12005+00 </p>  		<p> Date &amp; Time: Thu, Aug 19, 2021, 12:05:05 EDT  Position: +409.316791° / +80.65722° ±0.1, 0.10  Altitude: 1794ft ±0.8, 0.02  Datum: WGS-84  Azimuth Bearing: 85° N 34° 16.0mils True ±13°  Elevation Angle: -83.0°  Horizon Angle: -07.8°  Zoom: 1.0X  12005+00 </p>

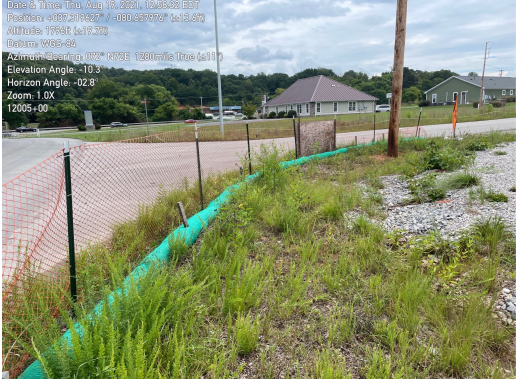
<p> Date &amp; Time: Thu, Aug 19, 2021, 12:05:13 EDT  Position: +407.11255° / -80.65712° ±0.2, 0.10  Altitude: 1787ft ±2.6, 2.1  Datum: WGS-84  Azimuth Bearing: 149° S 31° E 26.9mils True ±14°  Elevation Angle: -09.3°  Horizon Angle: -01.3°  Zoom: 1.0X  12005+00 </p>  			
GPS Location	See photo		GPS Location	See photo	
Field Station#	12005+00		Field Station#	12005+00	
Pic 5 Desc.	CFS perimeter control in place		Pic 6 Desc.	Good housekeeping

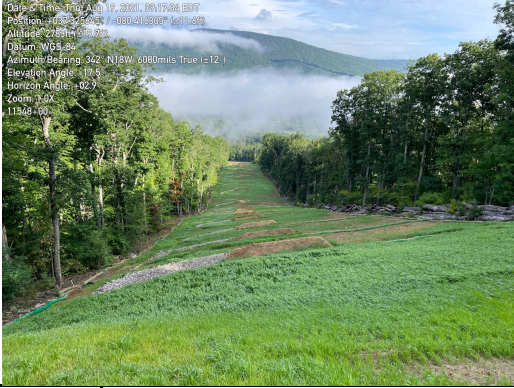
<p>Date &amp; Time: Thu, Aug 19, 2021, 05:17:54 EDT Position: +37.23432° / -80.41624° (+14.00) Altitude: 2358ft (+8.87) Datum: WGS-84 Azimuth/Bearing: 342° N18W 6880mils True (+12°) Elevation Angle: +12.5° Horizon Angle: +02.5° Zoom: 1.0X 11548+00</p>

<p>Date &amp; Time: Thu, Aug 19, 2021, 05:45:44 EDT Position: +37.23432° / -80.41624° (+14.00) Altitude: 2358ft (+8.87) Datum: WGS-84 Azimuth/Bearing: 342° N18W 6880mils True (+12°) Elevation Angle: +12.5° Horizon Angle: +02.5° Zoom: 1.0X 11546+00</p>			
<b>GPS Location</b>	See photo	<b>GPS Location</b>	See photo		
<b>Field Station#</b>	11548+00	<b>Field Station#</b>	11546+00		
<b>Pic 1 Desc.</b>	Permanent waterbars with level spreaders in place	<b>Pic 2 Desc.</b>	End treatments in place

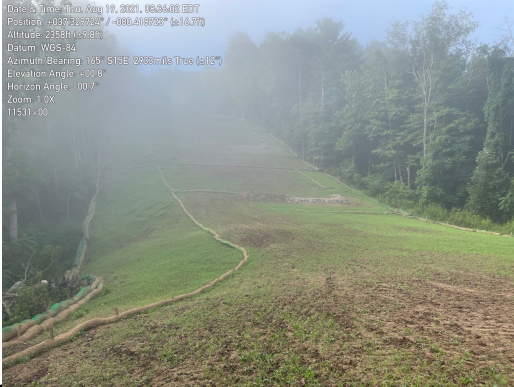
<p>Date &amp; Time: Thu, Aug 19, 2021, 05:44:46 EDT Position: +37.23432° / -80.41624° (+14.00) Altitude: 2358ft (+8.87) Datum: WGS-84 Azimuth/Bearing: 165° S15E 3988mils True (+15°) Elevation Angle: +02.8° Horizon Angle: +00.7° Zoom: 1.0X 11531+00</p>

<b>GPS Location</b>	See photo	<b>GPS Location</b>	See photo		
<b>Field Station#</b>	11531+00	<b>Field Station#</b>	11550+25		
<b>Pic 3 Desc.</b>	CFS perimeter controls in place	<b>Pic 4 Desc.</b>	P1 silt fence undermined

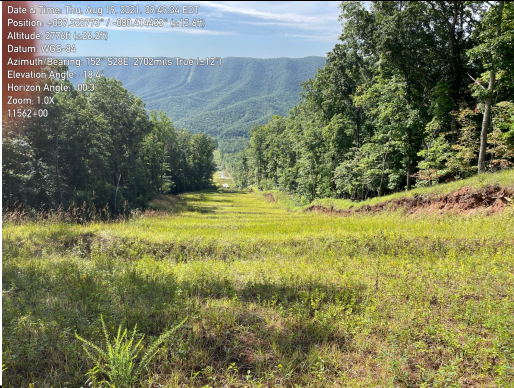
<p>Date &amp; Time: Thu, Aug 19, 2021, 05:43:50 EDT Position: +37.23432° / -80.41624° (+14.00) Altitude: 2358ft (+8.87) Datum: WGS-84 Azimuth/Bearing: 150° S38E 2702mils True (+12°) Elevation Angle: +13° Horizon Angle: +00.3° Zoom: 1.0X 11562+00</p>

<p>Date &amp; Time: Thu, Aug 19, 2021, 10:16:21 EDT Position: +37.23432° / -80.41624° (+14.00) Altitude: 2096ft (+7.70) Datum: WGS-84 Azimuth/Bearing: 353° S27E 2720mils True (+12°) Elevation Angle: -09.3° Horizon Angle: +00.3° Zoom: 1.0X 11585+00</p>			
<b>GPS Location</b>	See photo	<b>GPS Location</b>	See photo		
<b>Field Station#</b>	11562+00	<b>Field Station#</b>	11585+00		
<b>Pic 5 Desc.</b>	Waterbars in place	<b>Pic 6 Desc.</b>	Stream buffer in place

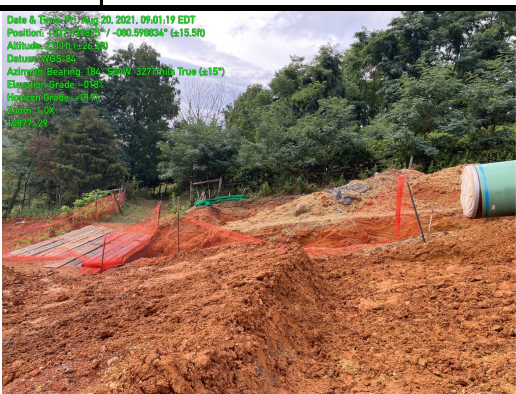
<p>Date &amp; Time: Fri Aug 20, 2021, 09:01:19 EDT Position: 43.323349° / -80.590634° (±15.5m) Altitude: 2631ft (±12.5m) Datum: WGS 84 Azimuth: 150.00° (±0.00°) Heading: 150.00° (±0.00°) Magnetic: 150.00° (±0.00°) True: 150.00° (±0.00°)</p>

GPS Location	See Photo		GPS Location	See Photo	
Field Station#	10877+29		Field Station#	10880+10	
Pic 3 Desc.	Culverted ditch relief pipe needed across the ditch line, and adjust the staggered water bar to match existing water bar across ditch line.		Pic 4 Desc.	Sump pit and CFS end treatment needing cleaned.

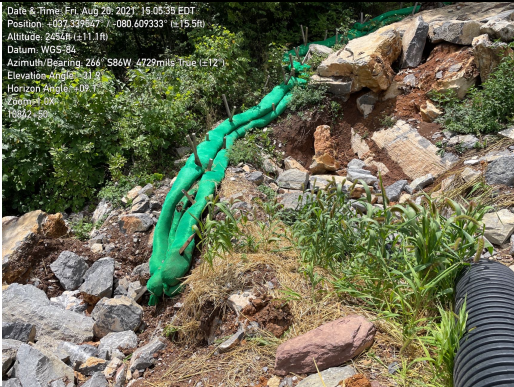
<p>Date &amp; Time: Fri Aug 20, 2021 15:05:35 EDT Position: +007.332497 / -080.609333 (+15.5ft) Altitude: 2454ft (+11.1ft) Datum: WGS-84 Azimuth/Bearing: 264.584W 4729mils True (+12.1) Elevation Angle: -21.1 Horizon Angle: -08.1 Zoom: 0.6x 10842+50</p>

<b>GPS Location</b>	See photo	<b>GPS Location</b>	See photo		
<b>Field Station#</b>	10842+50	<b>Field Station#</b>	10711+15		
<b>Pic 3 Desc.</b>	End treatment needs adjusted and restaked	<b>Pic 4 Desc.</b>	Sump needs cleaned out

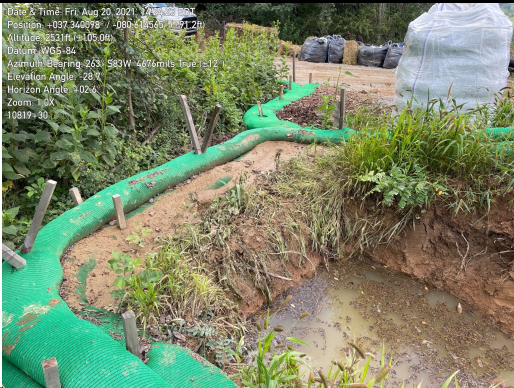
<p>Date &amp; Time: Fri Aug 20, 2021 14:02:03 EDT Position: +027.342697 / -080.635349 (+17.1 2ft) Altitude: 2531ft (+10.0ft) Datum: WGS-84 Azimuth/Bearing: 263.583W 4476mils True (+12.1) Elevation Angle: -28.1 Horizon Angle: -10.6 Zoom: 1.0x 10819+30</p>

<p>Date &amp; Time: Fri Aug 20, 2021 12:56:13 EDT Position: +039.344529 / -080.634413 (+15.5ft) Altitude: 2152ft (+1.2ft) Datum: WGS-84 Azimuth/Bearing: 170.506E 3124mils True (+12.1) Elevation Angle: -40.3 Horizon Angle: -06.3 Zoom: 1.0x 10755+25</p>			
<b>GPS Location</b>	See photo	<b>GPS Location</b>	See photo		
<b>Field Station#</b>	10819+30	<b>Field Station#</b>	10755+25		
<b>Pic 5 Desc.</b>	End treatment needs cleaned off	<b>Pic 6 Desc.</b>	Tree branches need cleaned up off of ECDs

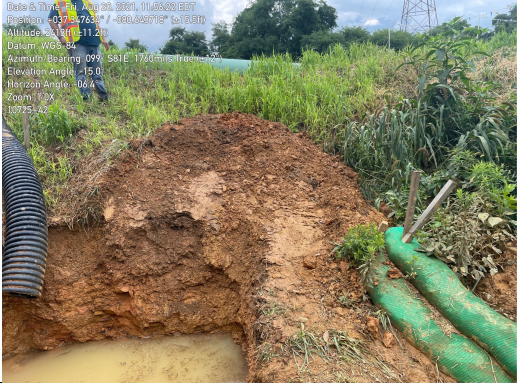
<b>GPS Location</b>	See photo	<b>GPS Location</b>	See photo		
<b>Field Station#</b>	10725+42	<b>Field Station#</b>	10825+91		
<b>Pic 7 Desc.</b>	Stabilization needed	<b>Pic 8 Desc.</b>	Perimeter control needs installed

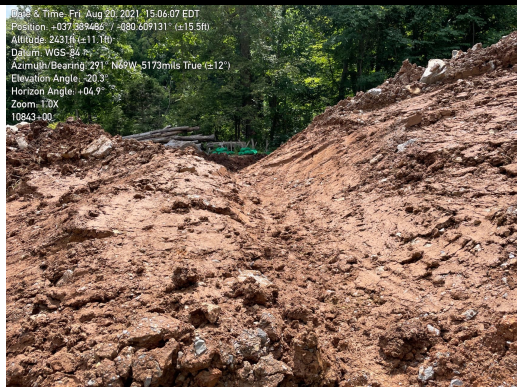
<b>GPS Location</b>	See photo	<b>GPS Location</b>	See photo		
<b>Field Station#</b>	10843+00	<b>Field Station#</b>	10855+00		
<b>Pic 11 Desc.</b>	Waterbar needs maintenance	<b>Pic 12 Desc.</b>	Stream buffer in place
