Visual Site Inspection Report

Project Name	H-600 Pipeline Spread G	AFE	124300137	Spread	H-600 Pipeline Spread G
Contractor	Precision			Report #	27618
Inspector	Clint Sears			Date/Time	8/23/2021 6:25 PM
Permit #	TBD	Inspection Type	VA SWPP	Station Begin	11064+53
State	VA	Inspection Area	Full	Station End	11254+99
County	Giles	Ground	Damp	Temperature (°F)	90.00
Municipality	N/A	Weather	Sunny	Rain Gauge (in)	0.00
				Rain Accumulation Time (days)	1.00

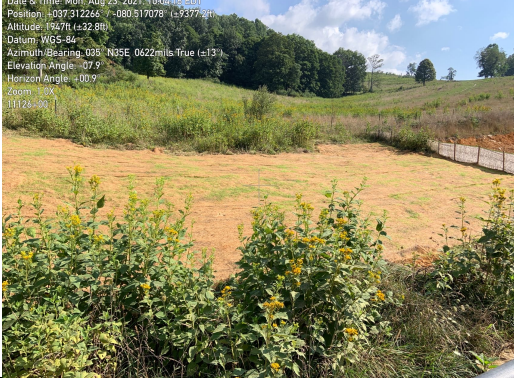
<p>Date & Time: Mon, Aug 23, 2021, 10:06:15 EDT Position: +037.31224° / -080.517076° (+9377.9ft) Altitude: 1927ft (+32.8ft) Datum: WGS-84 Azimuth/Bearing: 035° N35E 0622mils True (+13°) Elevation Angle: -07.9° Horizon Angle: -00.9° Zoom: 3.0x 11126+00</p>

<p>Date & Time: Mon, Aug 23, 2021, 10:06:29 EDT Position: +037.31238° / -080.52529° (+9471.9ft) Altitude: 1936ft (+33.2ft) Datum: WGS-84 Azimuth/Bearing: 216° S34W 3804mils True (+13°) Elevation Angle: -22.8° Horizon Angle: -00.2° Zoom: 3.0x 11127+00</p>			
GPS Location	See photo	GPS Location	See photo		
Field Station#	11226+00	Field Station#	11127+00		
Pic 1 Desc.	Erosion control blanket functional	Pic 2 Desc.	Rill in throat of water bar needs maintenance

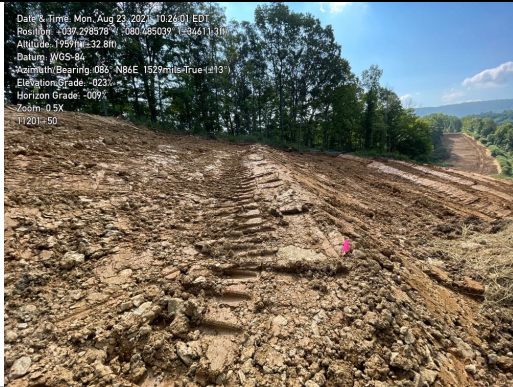
<p>Date & Time: Mon, Aug 23, 2021, 10:26:01 EDT Position: +039.228876° / -080.085027° (+9451.1ft) Altitude: 1959ft (+32.8ft) Datum: WGS-84 Azimuth/Bearing: 086° N86E 1529mils True (+13°) Elevation Angle: -023° Horizon Angle: -009° Zoom: 0.5X 11201+50</p>

GPS Location	See photo	GPS Location	See photo		
Field Station#	111133+00	Field Station#	11201+50		
Pic 3 Desc.	CFS, P1 and SSF all functional	Pic 4 Desc.	Water bar needs to be install to MVP standards

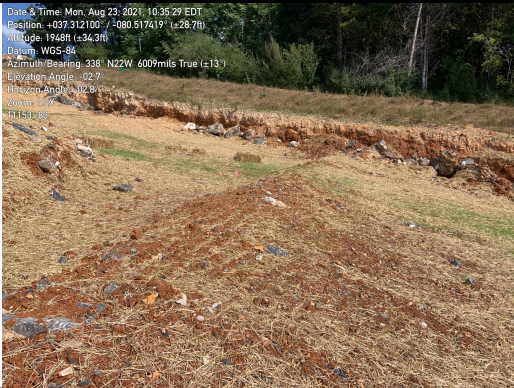
<p>Date & Time: Mon, Aug 23, 2021, 10:35:29 EDT Position: +037.312106° / -080.517419° (+928.7ft) Altitude: 1949ft (+34.2ft) Datum: WGS-84 Azimuth/Bearing: 338° N22W 6009mils True (+13°) Elevation Angle: -02.7° Horizon Angle: -00.8° Zoom: 3.0x 11153+80</p>

<p>Date & Time: Mon, Aug 23, 2021, 10:37:01 EDT Position: +037.311899° / -080.517271° (+968.9ft) Altitude: 1927ft (+27.3ft) Datum: WGS-84 Azimuth/Bearing: 159° S21E 2827mils True (+13°) Elevation Angle: -04.6ft (+2.7°) Horizon Angle: -00.3° Zoom: 1.8x 11154+20</p>			
GPS Location	See photo	GPS Location	See photo		
Field Station#	11153+80	Field Station#	11154+20		
Pic 5 Desc.	Water bar needs to be seeded and stabilized	Pic 6 Desc.	Subsoil needs removed from CFS

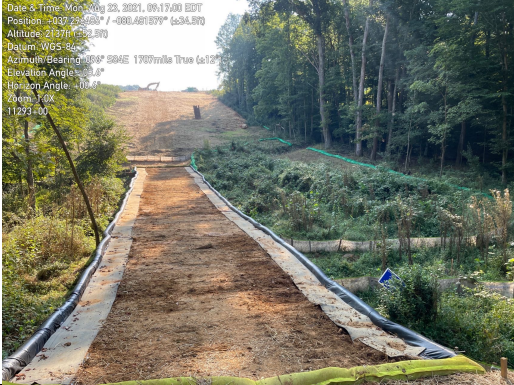
<p>Date & Time: Mon, Aug 23, 2021, 09:17:40 EDT Position: +037 302563 / -080 470409 (+27.8th) Altitude: 2131ft (+19.7th) Datum: WGS-84 Azimuth/Bearing: 071° S04E 1707mils True (+12°) Elevation Angle: +05.0° Horizon Angle: +00.0° Zoom: 1.0X 11293+00</p>

<p>Date & Time: Mon, Aug 23, 2021, 09:22:04 EDT Position: +037 292531 / -080 470413 (+27.8th) Altitude: 2204ft (+195.0th) Datum: WGS-84 Azimuth/Bearing: 348° N15W 1187mils True (+12°) Elevation Angle: +13.0° Horizon Angle: +02.4° Zoom: 1.0X 11317+50</p>			
GPS Location	See photo	GPS Location	See photo		
Field Station#	11293+00	Field Station#	11317+50		
Pic 1 Desc.	Stream buffer in place	Pic 2 Desc.	Karst feature ECDs in place

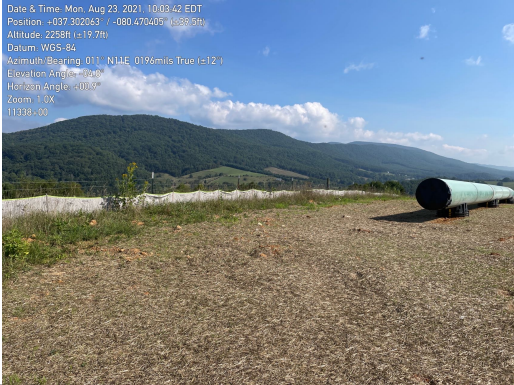
<p>Date & Time: Mon, Aug 23, 2021, 10:03:42 EDT Position: +037 302563 / -080 470409 (+27.8th) Altitude: 2258ft (+19.7th) Datum: WGS-84 Azimuth/Bearing: 071° N14E 0196mils True (+12°) Elevation Angle: +05.0° Horizon Angle: +00.0° Zoom: 1.0X 11338+00</p>

GPS Location	See photo	GPS Location	See photo		
Field Station#	11338+00	Field Station#	11388+00		
Pic 3 Desc.	P1 silt fence perimeter control in place	Pic 4 Desc.	CFS perimeter control in place

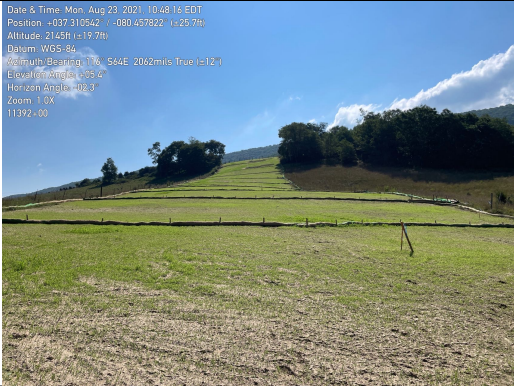
<p>Date & Time: Mon, Aug 23, 2021, 10:48:16 EDT Position: +037 310542 / -080 457822 (+27.7th) Altitude: 2145ft (+19.7th) Datum: WGS-84 Azimuth/Bearing: 174° S44E 2042mils True (+12°) Elevation Angle: +05.0° Horizon Angle: +02.3° Zoom: 1.0X 11392+00</p>

<p>Date & Time: Mon, Aug 23, 2021, 11:20:29 EDT Position: +037 307174 / -080 468077 (+27.7th) Altitude: 2330ft (+20.0th) Datum: WGS-84 Azimuth/Bearing: 077° S04E 1724mils True (+12°) Elevation Angle: +05.0° Horizon Angle: +00.0° Zoom: 1.0X 11458+00</p>			
GPS Location	See photo	GPS Location	See photo		
Field Station#	11392+00	Field Station#	11458+00		
Pic 5 Desc.	CFS temporary waterbars in place	Pic 6 Desc.	P1 silt fence perimeter control in place

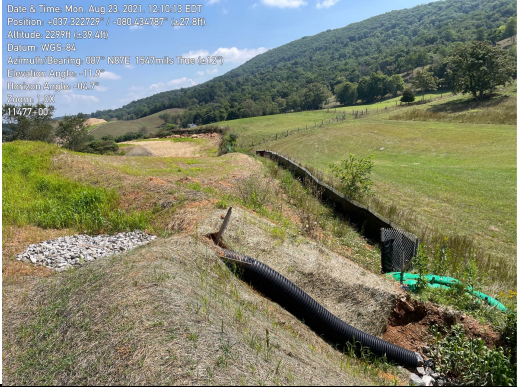
GPS Location		See photo		GPS Location	
Field Station#		11477+00		Field Station#	
Pic 7 Desc.		Supersilt fence perimeter control in place		Pic 8 Desc.	
<p>Date & Time: Mon, Aug 23, 2021 12:55:49 EDT Position: +037 318238° / -080 443340° (+25 02) Altitude: 2120ft (+3 70) Datum: WGS 84 Azimuth/Bearing: 365° N05W 6911mils True (East) Elevation Angle: +1.2° Horizon Angle: +0.0° Zoom: 1.0X 11452+66</p>

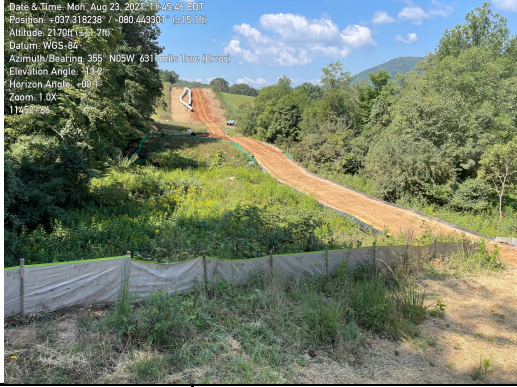
GPS Location		See photo		GPS Location	
Field Station#		11452+66		Field Station#	
Pic 9 Desc.		Stream buffer in place		Pic 10 Desc.	
<p>Date & Time: Mon, Aug 23, 2021 12:07:44 EDT Position: +037 322837° / -080 435147° (+23 40) Altitude: 2298ft (+39 40) Datum: WGS 84 Azimuth/Bearing: 020° N05E 1238mils True (+12°) Elevation Angle: +0.0° Horizon Angle: +0.0° Zoom: 1.0X 11475+00</p>

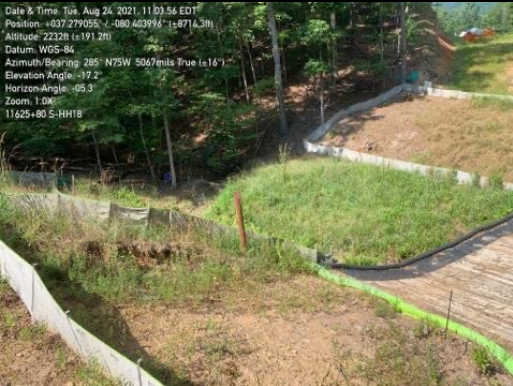
GPS Location	On photo	GPS Location	On photo		
Field Station#	11617+00	Field Station#	11626+04		
Pic 5 Desc.	Recently stabilized ROW on private tracts is stable.	Pic 6 Desc.	Resource buffers are stable. ECDs are in place.

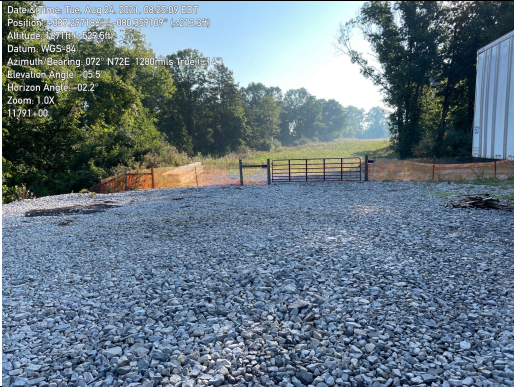
GPS Location		See photo		GPS Location	
Field Station#		11791+00		Field Station#	
Pic 1 Desc.		RCE in place		Pic 2 Desc.	
				Level spreaders in place	
<p>Date & Time: Tue, Aug 24, 2021, 05:45:00 EDT Position: +409.597554° / -86.336886° (s19.37) Altitude: 2231ft (s19.37) Datum: WGS-84 Azimuth/Bearing: 170° S10E 3022mils True (s12) Elevation Angle: -15.8 Horizon Angle: -03.5 Zoom: 1.0x 11906+00</p>

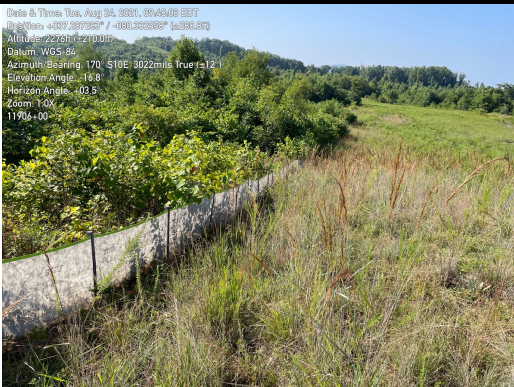
GPS Location		See photo		GPS Location	
Field Station#		11906+00		Field Station#	
Pic 3 Desc.		P1 silt fence perimeter control in place		Pic 4 Desc.	
				Waterbars in place	
<p>Date & Time: Tue, Aug 24, 2021, 06:38:10 EDT Position: +409.597554° / -86.336886° (s19.37) Altitude: 2164ft (s19.37) Datum: WGS-84 Azimuth/Bearing: 037° N23W 3991mils True (s12) Elevation Angle: -12.1 Horizon Angle: +01.3 Zoom: 1.0x 11820+00</p>

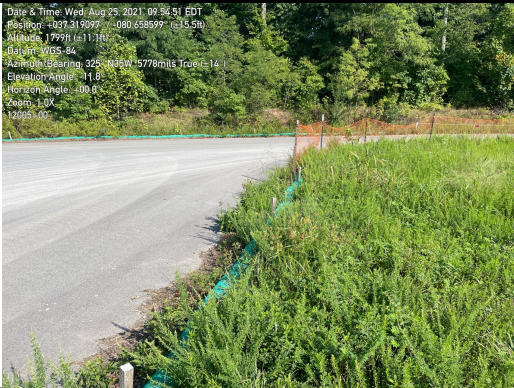
<p>Date & Time: Wed Aug 25 2021 09:54:51 EDT Position: -037.319287° / -080.658599° (-15.0N) Altitude: 1795ft (-11.1ft) Datum: WGS-84 Azimuth/Bearing: 190.311W (-200mils True (-14.7°)) Elevation Angle: -04.9° Horizon Angle: -03.0° Zoom: 1.0X 12005+00</p>			
GPS Location	See photo	GPS Location	See photo		
Field Station#	12005+00	Field Station#	12005+00		
Pic 5 Desc.	CFS perimeter control in place	Pic 6 Desc.	Rock surface in acceptable condition

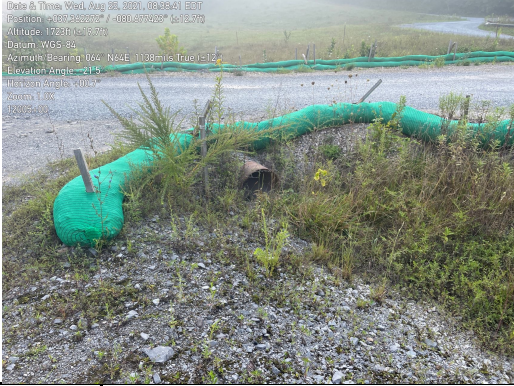
<p>Date & Time: Wed, Aug 25, 2021, 08:56:38 EDT Position: +37.345117° / -80.67762° (±11.4m) Altitude: 1734.8 (±11.5m) Datum: WGS-84 Azimuth: Bearing: 087° N45E 1032mils True (±12) Elevation Angle: -21.5° Horizon Angle: +00.7° Zoom: 1.0X 12005+00</p>			
GPS Location	See photo	GPS Location	See photo		
Field Station#	12005+00	Field Station#	12005+00		
Pic 1 Desc.	Culvert in place	Pic 2 Desc.	Dumpsters in place

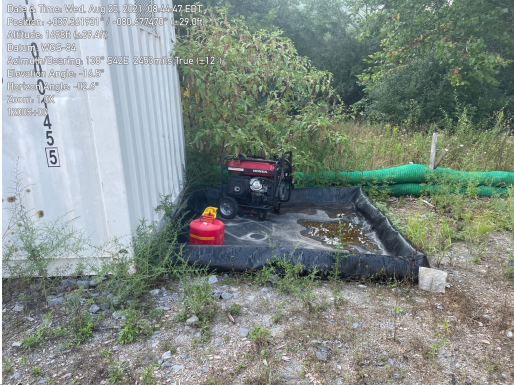
GPS Location	See photo	GPS Location	See photo		
Field Station#	12005+00	Field Station#	12005+00		
Pic 3 Desc.	Secondary containment in place	Pic 4 Desc.	Inspected fuel cell for any visible leaks or spills

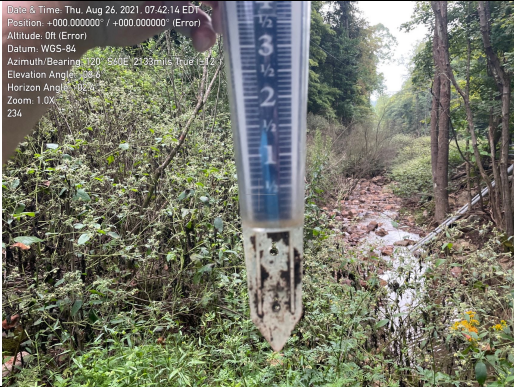
<p>Date & Time: Thu, Aug 26, 2021, 07:42:14 EDT Position: +00.00000° / +00.00000° (Error) Altitude: 0ft (Error) Datum: WGS-84 Azimuth/Bearing: 120° S08° 23.38mils True (±1.2°) Elevation Angle: -15.5° Horizon Angle: -11.8° Zoom: 1.0x 10665+00</p>

<p>Date & Time: Thu, Aug 26, 2021, 07:49:51 EDT Position: +037.34594° / -080.633025° (±11.9 2ft) Altitude: 2055ft (±157.5ft) Datum: WGS-84 Azimuth/Bearing: 289° N21°W 5138mils True (±1.6°) Elevation Angle: -15.5° Horizon Angle: -10.8° Zoom: 1.0x Buffalo</p>			
GPS Location	See photo	GPS Location	See photo		
Field Station#	10510+78	Field Station#	10698+77		
Pic 1 Desc.	AR 234 rain gauge	Pic 2 Desc.	Buffalo anklets rain gauge

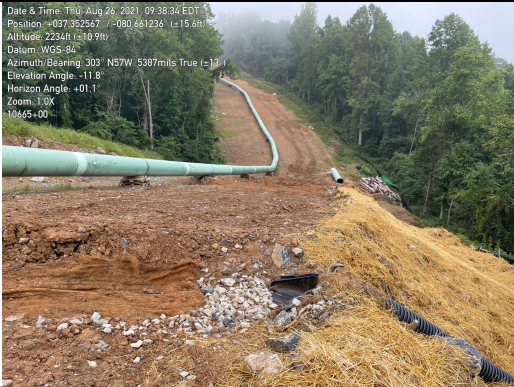
<p>Date & Time: Thu, Aug 26, 2021, 09:38:34 EDT Position: +037.352547° / -080.661234° (±15.6ft) Altitude: 2234ft (±10.9ft) Datum: WGS-84 Azimuth/Bearing: 302° N57°W 5387mils True (±1.3°) Elevation Angle: -11.8° Horizon Angle: -10.1° Zoom: 1.0x 10665+00</p>

GPS Location	See photo	GPS Location	See photo		
Field Station#	10665+00	Field Station#	10670+17		
Pic 3 Desc.	Waterbars in place	Pic 4 Desc.	AE 240 RCE

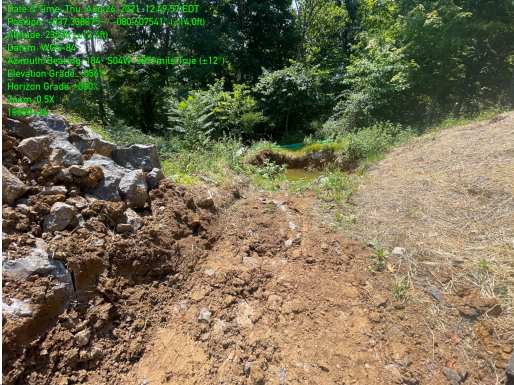
GPS Location	See Photo	GPS Location	See Photo		
Field Station#	10850+34	Field Station#	10850+34		
Pic 3 Desc.	Water bar should be 18" extended to the sump pit.	Pic 4 Desc.	View of spoil pile lacking stabilization

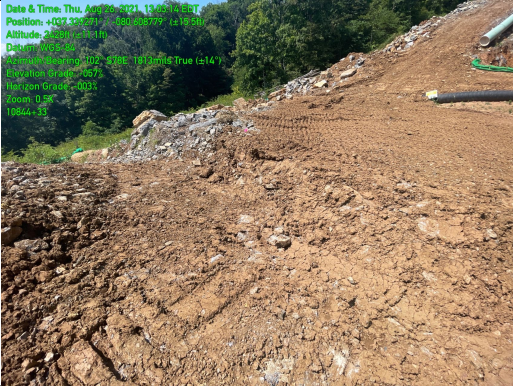
GPS Location	See Photo	GPS Location	See Photo		
Field Station#	10837+57	Field Station#	10844+33		
Pic 5 Desc.	Low spot in water bar.	Pic 6 Desc.	Undercut and no definitive water bar throat.

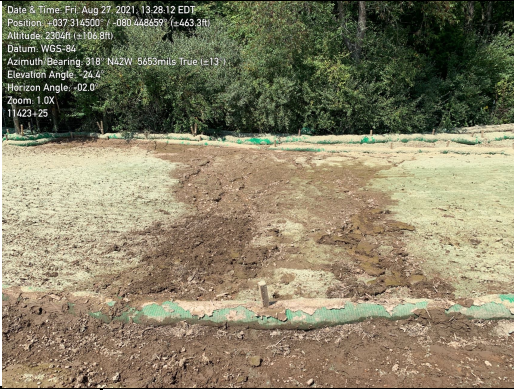
<p>Date & Time: Fri Aug 27, 2021 13:28:12 EDT Position: +037.3145297 / -080.4483997 (+463.9ft) Altitude: 2202ft (+113.3ft) Datum: WGS-84 Azimuth/Bearing: 018° N42W 5553mils True (+13°) Elevation Angle: -24.2° Horizon Angle: -02.0° Zoom: 1.0X 11423+25</p>

<p>Date & Time: Fri Aug 27, 2021 12:59:32 EDT Position: +037.308301 / -080.465923 (+415.4ft) Altitude: 2022ft (+111.3ft) Datum: WGS-84 Azimuth/Bearing: 098° S82E 1742mils True (+17°) Elevation Angle: -02.0° Horizon Angle: -05.4° Zoom: 1.0X 11363+00</p>		GPS Location	See photo for GPS location.
Field Station#	11425+50	Field Station#	11363+00	GPS Location	See photo for GPS location.
Pic 1 Desc.	Rilling added to punchlist.	Pic 2 Desc.	Tie-in crew welding pipe.	GPS Location	See photo for GPS location.

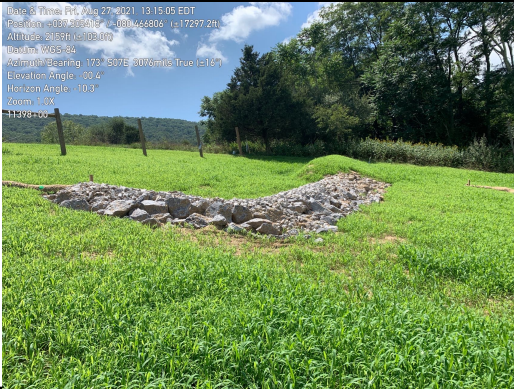
<p>Date & Time: Fri Aug 27, 2021 13:15:05 EDT Position: +038.2504547 / -080.4448064 (+17297.2ft) Altitude: 2183ft (+105.1ft) Datum: WGS-84 Azimuth/Bearing: 172° S07E 3076mils True (+18°) Elevation Angle: -00.2° Horizon Angle: -00.3° Zoom: 1.0X 11398+00</p>

Field Station#	11398+00	Field Station#	11369+00	GPS Location	See photo for GPS location.
Pic 3 Desc.	Permanent waterbar and level spreader in place.	Pic 4 Desc.	Permanent restoration. Sufficient vegetation growth present to assist in preventing erosion.	GPS Location	See photo for GPS location.

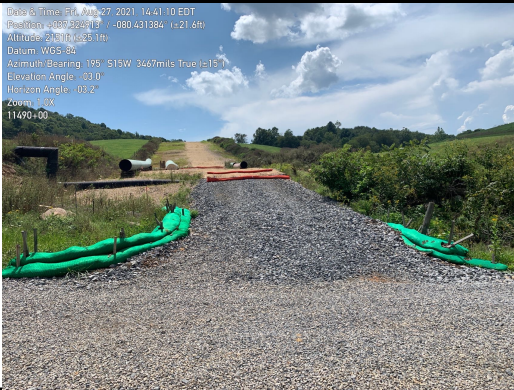
<p>Date & Time: Fri Aug 27, 2021 14:41:10 EDT Position: +039.282414 / -080.431384 (+21.6ft) Altitude: 2151ft (+103.1ft) Datum: WGS-84 Azimuth/Bearing: 195° S15W 3467mils True (+15°) Elevation Angle: -03.0° Horizon Angle: -02.2° Zoom: 1.0X 11490+00</p>

Pic 5 Desc.	RCE in place at Stevers Gap Road.	Pic 6 Desc.	Rough grade established with subsoil.	GPS Location	See photo for GPS location.

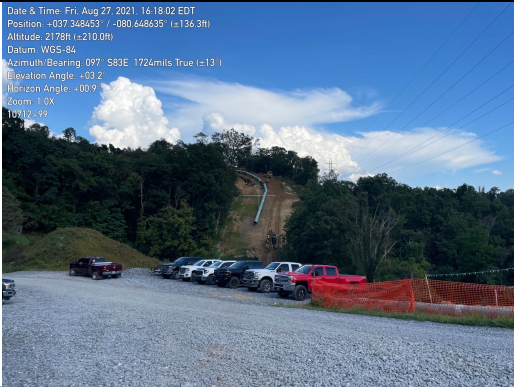
<p>Date & Time: Fri Aug 27, 2021, 10:38:22 EDT Position: +037.300595° / -080.472982° (+25.4m) Altitude: 2154ft (+39.4m) Datum: WGS-84 Azimuth/Bearing: 042° N63E 1120mils True (+14°) Elevation Angle: -1.6° Horizon Angle: +00.2° Zoom: 1.0X 11/328+63</p>

GPS Location	See photo	GPS Location	See photo		
Field Station#	10712+99	Field Station#	10328+63		
Pic 3 Desc.	ET @ end of open ditch	Pic 4 Desc.	Equipment bridge functional		
<p>Date & Time: Fri Aug 27, 2021, 10:03:29 EDT Position: +037.253453° / -080.476595° (+28.8m) Altitude: 2280ft (+39.4m) Datum: WGS-84 Azimuth/Bearing: 101° S17W 2296mils True (+0.3°) Elevation Angle: +03.4° Horizon Angle: +00.8° Zoom: 1.0X 11/321+00</p>

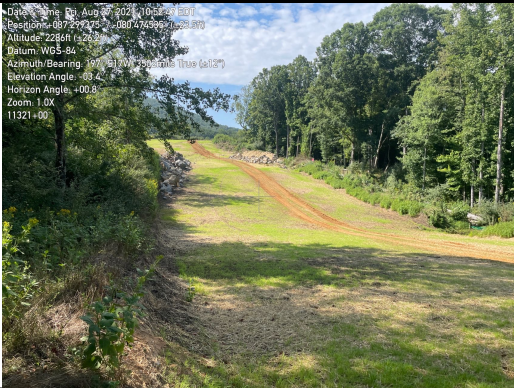
<p>Date & Time: Fri Aug 27, 2021, 10:30:05 EDT Position: +037.253453° / -080.481676° (+28.1m) Altitude: 2180ft (+39.4m) Datum: WGS-84 Azimuth/Bearing: 281° N74W 2096mils True (+12°) Elevation Angle: -28.9° Horizon Angle: -03.9° Zoom: 1.0X 11/293+00</p>

GPS Location	See photo	GPS Location	See photo		
Field Station#	11321+00	Field Station#	11293+00		
Pic 5 Desc.	Temporary stabilization in place	Pic 6 Desc.	P1 hole damaged by live stock

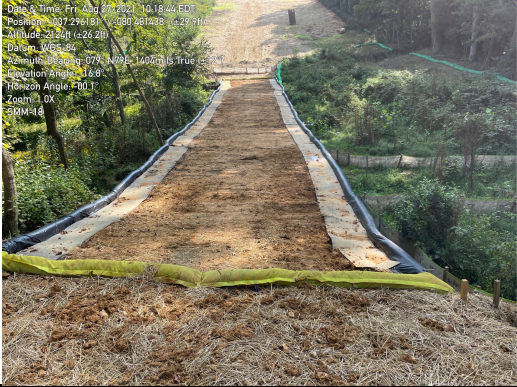
<p><small>Date & Time: Fri Aug 27, 2021 10:10:54 EDT Position: +037.275991° / -080.283841° (±14.3ft) Altitude: 2279ft (±13.3ft) Datum: WGS-84 Azimuth/Bearing: 022° N02E 1458mils True (±12°) Elevation Angle: +16.1° Horizon Angle: +03.9° Zoom: 1.0X 11285+00</small></p>

GPS Location	See photo	GPS Location	See photo		
Field Station#	11293+00	Field Station#	11285+00		
Pic 7 Desc.	Equipment bridge functional	Pic 8 Desc.	Erosion control blanket in place		
<p><small>Date & Time: Fri Aug 27, 2021 10:25:44 EDT Position: +037.280201° / -080.287011° (±22.9ft) Altitude: 2267ft (±13.3ft) Datum: WGS-84 Azimuth/Bearing: 281° N78W 4996mils True (±12°) Elevation Angle: -11.3° Horizon Angle: +00.1° Zoom: 1.0X 11275+00</small></p>

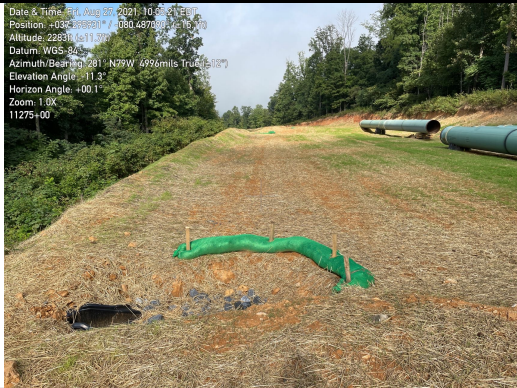
<p><small>Date & Time: Fri Aug 27, 2021 09:56:57 EDT Position: +037.280201° / -080.287011° (±22.9ft) Altitude: 2267ft (±13.3ft) Datum: WGS-84 Azimuth/Bearing: 284° N76W 5049mils True (±12°) Elevation Angle: -19.7° Horizon Angle: +05.1° Zoom: 1.0X 11260+47</small></p>

GPS Location	See photo	GPS Location	See photo		
Field Station#	11275+00	Field Station#	11260+47		
Pic 9 Desc.	Inlet protection functional	Pic 10 Desc.	ET in & functional		
<p><small>Date & Time: Fri Aug 27, 2021 08:58:58 EDT Position: +037.33597° / -080.47355° (±22.9ft) Altitude: 1980ft (±17.8ft) Datum: WGS-84 Azimuth/Bearing: 171° S09E 3040mils True (±12°) Elevation Angle: +06.1° Horizon Angle: +16.2° Zoom: 1.0X 11256+45</small></p>

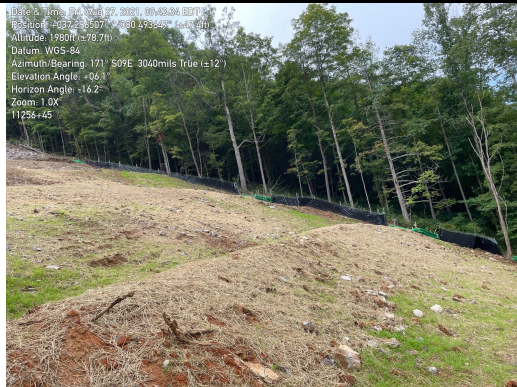
<p><small>Date & Time: Fri Aug 27, 2021 08:01:01 EDT Position: +037.348767° / -080.450191° (±35.1ft) Altitude: 2264ft (±52.5ft) Datum: WGS-84 Azimuth/Bearing: 240° S60W 4267mils True (±12°) Elevation Angle: -19.8° Horizon Angle: +19.8° Zoom: 1.0X 10703+45</small></p>

GPS Location	See photo	GPS Location	See photo		
Field Station#	11256+45	Field Station#	10703+45		
Pic 11 Desc.	Waterbars in place	Pic 12 Desc.	ECD's in place
