Visual Site Inspection Report

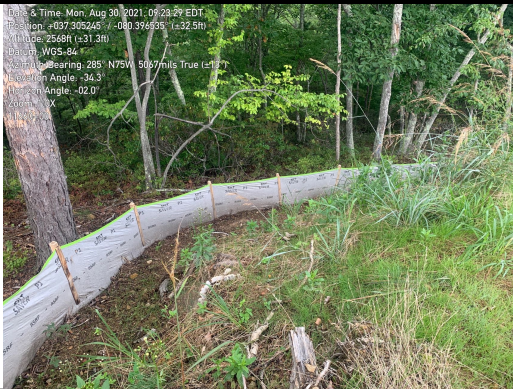
GPS Location	See photo for GPS location.		GPS Location	See photo for GPS location.	
Field Station#	11660+00		Field Station#	11661+00	
Pic 3 Desc.	Priority one silt fence in place along LOD.		Pic 4 Desc.	Super silt fence in place along LOD.

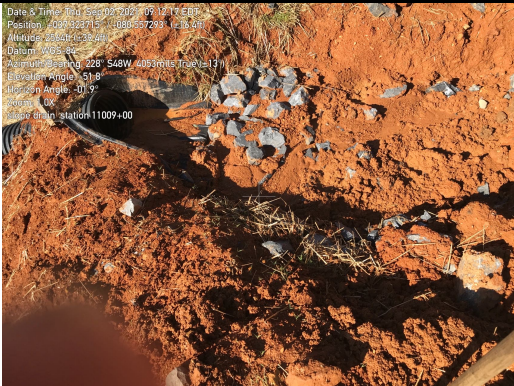
<p>Date & Time: Thu, Sep 02, 2021, 12:12:45 EDT Position: +037318466 / -080549293 (-35.4ft) Altitude: 2315ft (-26.2ft) Datum: WGS-84 Azimuth/Bearing: 228° S48W 4053mils True (-13°) Elevation Angle: -51.8° Horizon Angle: -01.9 Zoom: 1.0x slope drain station 11009+00</p>		  <p>Date & Time: Thu, Sep 02, 2021, 12:12:45 EDT Position: +037318466 / -080549293 (-35.4ft) Altitude: 2315ft (-26.2ft) Datum: WGS-84 Azimuth/Bearing: 261° S81W 4620mils True (-79°) Elevation Angle: -21.2° Horizon Angle: -01.6 Zoom: 1.0x sump needs cleaned - 11045+00</p>			
GPS Location	see photo		GPS Location	se	
Field Station#	11009+00		Field Station#	11045+00	
Pic 5 Desc.	Slope drain needs cleaned		Pic 6 Desc.	Sump needs cleaned

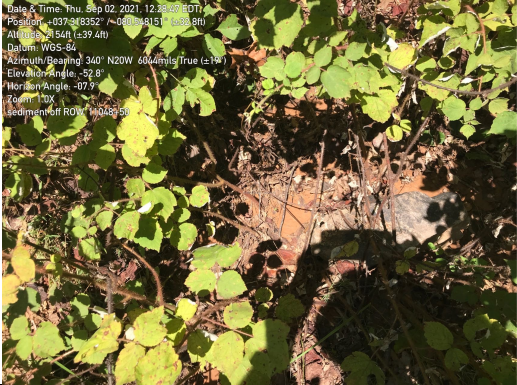
GPS Location	See photo	GPS Location			
Field Station#	11048+50	Field Station#			
Pic 13 Desc.	Sediment off ROW	Pic 14 Desc.			
Insert image here		Insert image here			
GPS Location		GPS Location			
Field Station#		Field Station#			
Pic 15 Desc.		Pic 16 Desc.			
Insert image here		Insert image here			
GPS Location		GPS Location			
Field Station#		Field Station#			
Pic 17 Desc.		Pic 18 Desc.

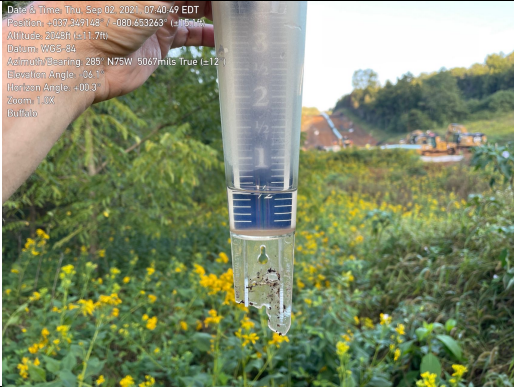
GPS Location	See photo	GPS Location	See photo		
Field Station#	10695+77	Field Station#	10510+78		
Pic 1 Desc.	Buffalo anklets rain gauge	Pic 2 Desc.	234 rain gauge

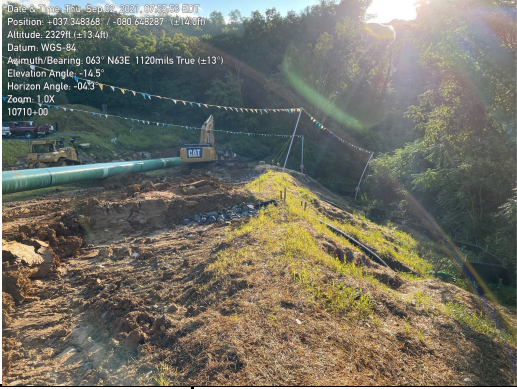
<p>Insert image here</p>			
GPS Location	See photo	GPS Location			
Field Station#	10710+00	Field Station#			
Pic 13 Desc.	Inlets in place	Pic 14 Desc.			
<p>Insert image here</p>		<p>Insert image here</p>			
GPS Location		GPS Location			
Field Station#		Field Station#			
Pic 15 Desc.		Pic 16 Desc.			
<p>Insert image here</p>		<p>Insert image here</p>			
GPS Location		GPS Location			
Field Station#		Field Station#			
Pic 17 Desc.		Pic 18 Desc.

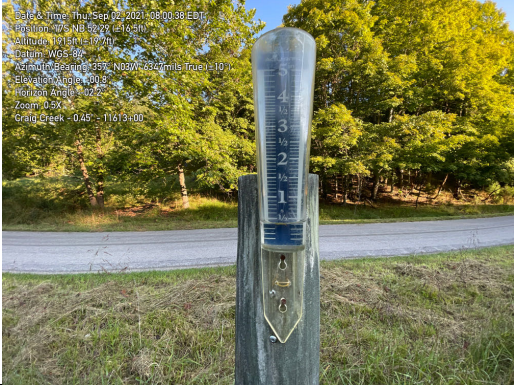
<p>Date & Time: Thu, Sep 02, 2021, 09:06:14 EDT Position: 175° NB 50.31' (=16.6m) Altitude: 2115ft (=645m) Datum: WGS-84 Azimuth/Bearing: 025° N25E 3044mils True (=12°) Elevation Angle: -02.6° Horizon Angle: -01.9° Zoom: 0.5X 11438+00 Stevers Gap 0.5"</p>			
GPS Location	1	GPS Location	2		
Field Station#	11613+00	Field Station#	11490+00		
Pic 1 Desc.	Rain gauge at Craig Creek rd indicating 0.45" of accumulation.		Pic 2 Desc.	Rain gauge at Stevers Gap indicating 0.5" of accumulation.

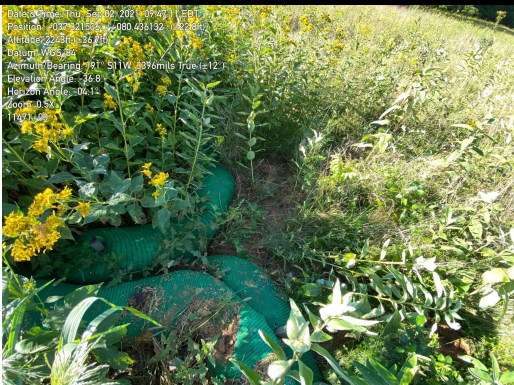
<p>Date & Time: Thu, Sep 02, 2021, 10:26:28 EDT Position: 175° NB 50.31' (=16.6m) Altitude: 2211ft (=673m) Datum: WGS-84 Azimuth/Bearing: 350° N10W 6222mils True (=12°) Elevation Angle: -19.9° Horizon Angle: -00.8° Zoom: 0.5X 11457+35 sump margin</p>			
GPS Location	5	GPS Location	6		
Field Station#	11471+00	Field Station#	11457+35		
Pic 5 Desc.	Sediment outside of LoD, remove sediment.		Pic 6 Desc.	Clean out sump.

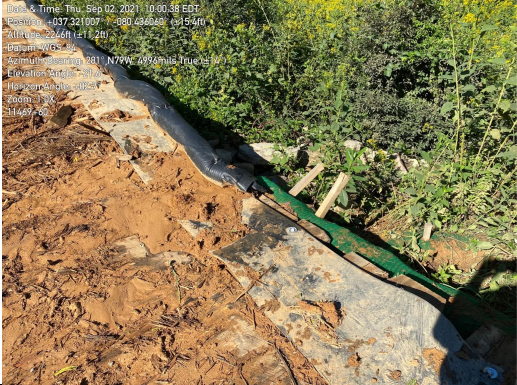
GPS Location	13	GPS Location	14		
Field Station#	11469+60	Field Station#	11441+70		
Pic 13 Desc.	Remove sediment from bridge and buffer, seed and stabilize buffer.	Pic 14 Desc.	Remove sediment from P-1.		
<p><small>Date & Time: Thu, Sep 02, 2021 11:50:45 EDT Position: +037.314083, -080.448924 (+24.30) Altitude: 2201ft (+23.00) Datum: WGS 84 Azimuth/Bearing: 388° N02W 436m/mis True (+12) Elevation Angle: -08.2 Horizon Angle: -01.7 Zoom: 0.5X 11421+00</small></p>

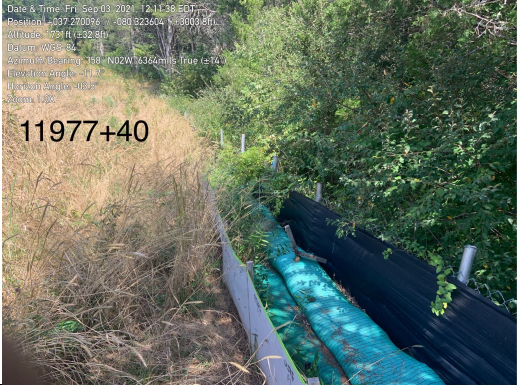
GPS Location		See photo		GPS Location	
Field Station#		11977+40		Field Station#	
Pic 7 Desc.		P1, CFS and SSF functional at sensitive resource area		Pic 8 Desc.	
				CFS needs replaced	
<p>Date & Time: Fri, Sep 03, 2021, 12:24:51 EDT Position: +037 268476 / -080 914017 / +22 30m Altitude: 1550ft (+23.2ft) Datum: WGS-84 Azimuth/Bearing: 012° N12E 0213mils True (+13°) Elevation Angle: -05.6° Horizon Angle: +05.8° Zoom: 1.0X 12001+00</p>

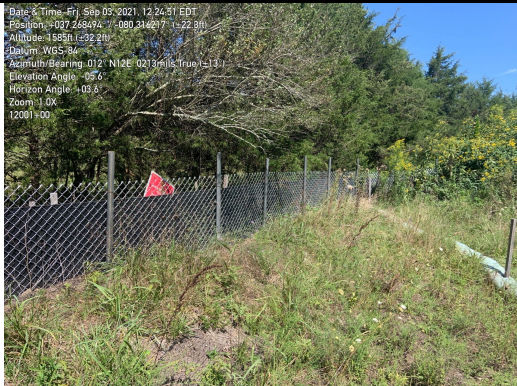
GPS Location		see photo		GPS Location	
Field Station#		12001+00		Field Station#	
Pic 9 Desc.		SSF and signage functional		Pic 10 Desc.	
				Vegetation adequate in sensitive resource area	
<p>Date & Time: Fri, Sep 03, 2021, 12:42:55 EDT Position: +037 267622 / -080 930381 / +23 50m Altitude: 1610ft (+24.8ft) Datum: WGS-84 Azimuth/Bearing: 110° S30E 2005mils True (+10°) Elevation Angle: -03.0° Horizon Angle: -00.0° Zoom: 1.0X 11989+91</p>

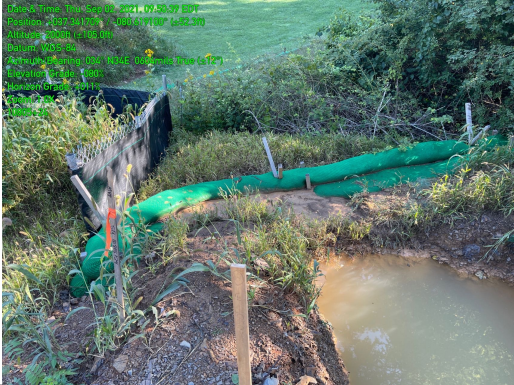
GPS Location	See Photo	GPS Location	See Photo		
Field Station#	10805+24	Field Station#	1085+34		
Pic 3 Desc.	View of soil needing to be removed from CFS.	Pic 4 Desc.	View of Sump pit location and water bar not extended to sump pit.

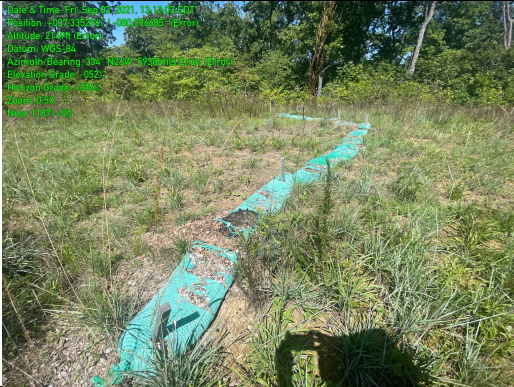
<p> <small> Date & Time: 9/3/2021 12:40:13 Position: +407.235291°N / +408.576697°E (Error) Altitude: 2140ft (Error) Azimuth: 133° S47E Azimuth Bearing: 133° S47E 2344mils Error (Error) Elevation Grade: -021% Horizontal Grade: 301% Zoom: 0.5X Near: 11871+00 </small> </p>			
GPS Location	See Photo	GPS Location	See Photo		
Field Station#	11871+00	Field Station#	11863+65		
Pic 1 Desc.	View looking at the depleted CFS. This sock can and should be removed.	Pic 2 Desc.	View looking at the P-KL2 Pond resource condition. No water and vegetated.

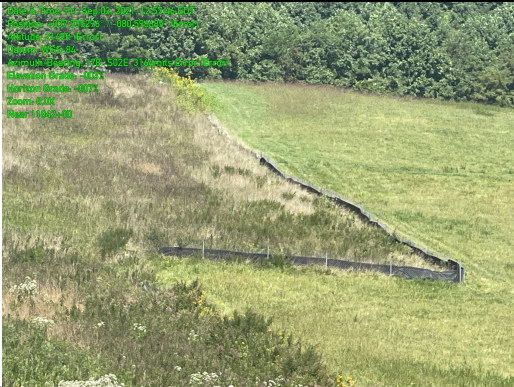
GPS Location	See Photo	GPS Location	See Photo		
Field Station#	11842+00	Field Station#	11832+00		
Pic 3 Desc.	View looking at row vegetation as compared to adjacent pasture vegetation. SSF remains around the atws.	Pic 4 Desc.	View looking at final row condition and PCSM BMPs. Weathered PCSM CFS can be removed.

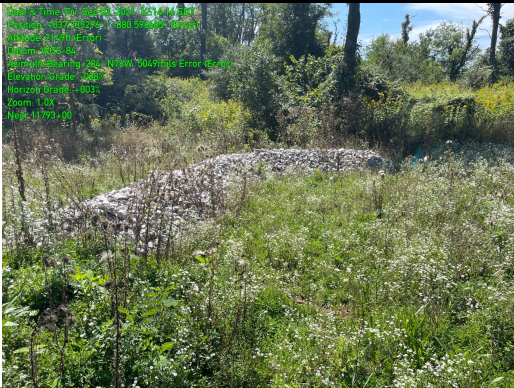
Field Station#	11793+00	Field Station#	11835+00		
Pic 5 Desc.	View looking at permanent water bar and vegetation condition	Pic 6 Desc.	View looking at uniform vegetation. SSF remains along the western LOD.

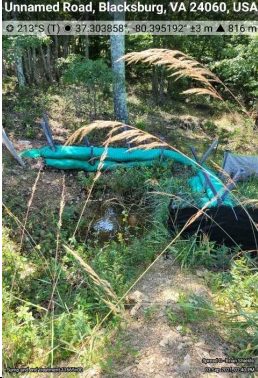
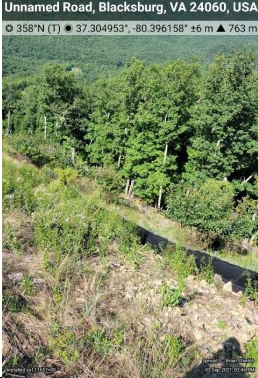
GPS Location	see photo		GPS Location	see photo	
Field Station#	11665+00		Field Station#	11657+00	
Pic 1 Desc.	installed sump and end treatment		Pic 2 Desc.	installed ssf

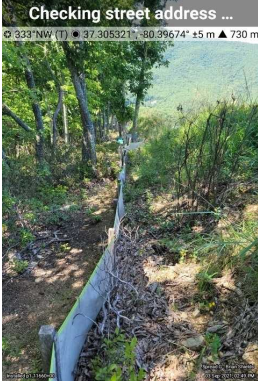
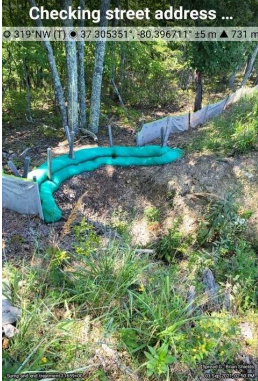
GPS Location	see photo		GPS Location	see photo	
Field Station#	11660+00		Field Station#	11659+00	
Pic 3 Desc.	installed priority one silt fence		Pic 4 Desc.	sump and end treatment

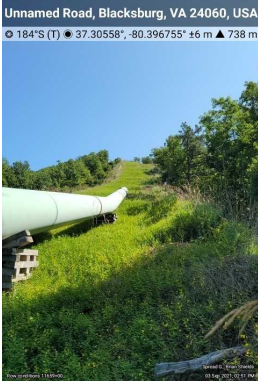
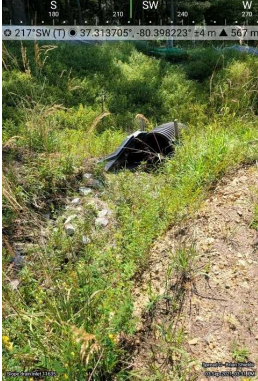
GPS Location	see photo		GPS Location	see photo	
Field Station#	11659+00		Field Station#	11635+00	
Pic 5 Desc.	row conditions		Pic 6 Desc.	Slope drain inlet
