# Visual Site Inspection Report

<b>Project Name</b>	H-600 Pipeline Spread G	<b>AFE</b>	124300137	<b>Spread</b>	H-600 Pipeline Spread G
<b>Contractor</b>	Precision			<b>Report #</b>	28422
<b>Inspector</b>	Clint Sears			<b>Date/Time</b>	9/13/2021 4:20 PM
<b>Permit #</b>	TBD	<b>Inspection Type</b>	VA SWPP	<b>Station Begin</b>	10859+34
<b>State</b>	VA	<b>Inspection Area</b>	Full	<b>Station End</b>	11064+53
<b>County</b>	Giles	<b>Ground</b>	Dry	<b>Temperature (°F)</b>	84.00
<b>Municipality</b>	N/A	<b>Weather</b>	Sunny	<b>Rain Gauge (in)</b>	0.00
				<b>Rain Accumulation Time (days)</b>	1.00

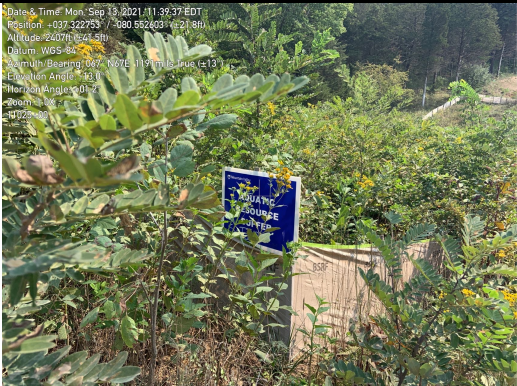
<b>GPS Location</b>	See photo		<b>GPS Location</b>	See photo	
<b>Field Station#</b>	10889+00		<b>Field Station#</b>	10917+60	
<b>Pic 7 Desc.</b>	Silt fence needs redone to allow water to exist the LOD		<b>Pic 8 Desc.</b>	Scouring behind CFS needs maintenance

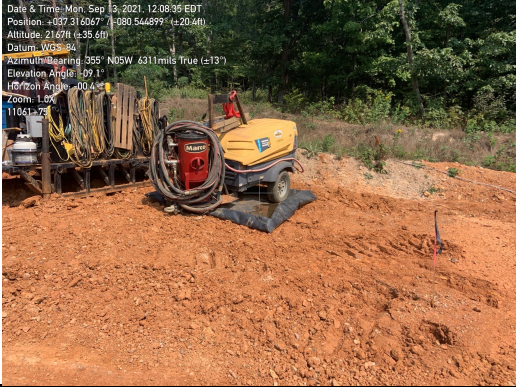
<b>GPS Location</b>	See photo	<b>GPS Location</b>	See photo		
<b>Field Station#</b>	11061+75	<b>Field Station#</b>	11056+00		
<b>Pic 13 Desc.</b>	Containment acceptable	<b>Pic 14 Desc.</b>	Environmental controls acceptable at sensitive resource area		
Insert image here		Insert image here			
<b>GPS Location</b>		<b>GPS Location</b>			
<b>Field Station#</b>		<b>Field Station#</b>			
<b>Pic 15 Desc.</b>		<b>Pic 16 Desc.</b>			
Insert image here		Insert image here			
<b>GPS Location</b>		<b>GPS Location</b>			
<b>Field Station#</b>		<b>Field Station#</b>			
<b>Pic 17 Desc.</b>		<b>Pic 18 Desc.</b>

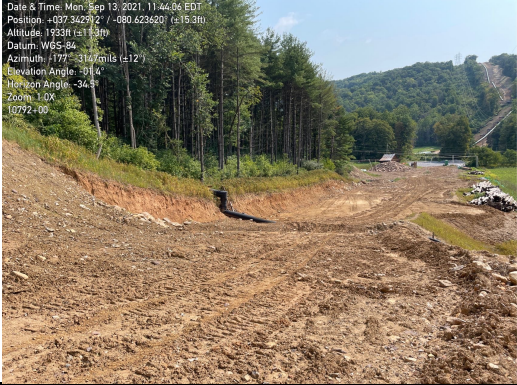
<b>GPS Location</b>	See photo	<b>GPS Location</b>	See photo		
<b>Field Station#</b>	10792+00	<b>Field Station#</b>	10774+00		
<b>Pic 7 Desc.</b>	Clean water diversion berm in place	<b>Pic 8 Desc.</b>	Stream buffer in place		
<p>Date &amp; Time: Mon, Sep 13, 2021, 11:53:10 EDT  Position: +037.348330° / -080.638921° (+22.2ft)  Altitude: 2208ft (+39.4ft)  Datum: WGS-84  Azimuth: 106° (+300mils (+12°))  Elevation Angle: -12.4°  Horizon Angle: -37.7°  Zoom: 1.0X  10748+50</p>

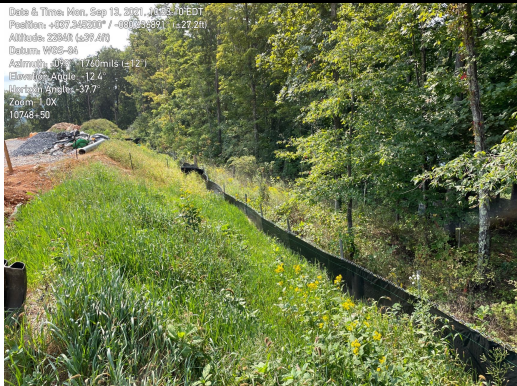
<b>GPS Location</b>	See photo	<b>GPS Location</b>	See photo		
<b>Field Station#</b>	10748+50	<b>Field Station#</b>	10734+00		
<b>Pic 9 Desc.</b>	Supersilt fence perimeter control in place	<b>Pic 10 Desc.</b>	Waterbars in place		
<p>Date &amp; Time: Mon, Sep 13, 2021, 10:32:52 EDT  Position: +037.348888° / -080.643802° (+19.1ft)  Altitude: 2449ft (+26.2ft)  Datum: WGS-84  Azimuth: -69° (+108mils (+12°))  Elevation Angle: 22.44°  Horizon Angle: -30.9°  Zoom: 1.0X  10723+65</p>

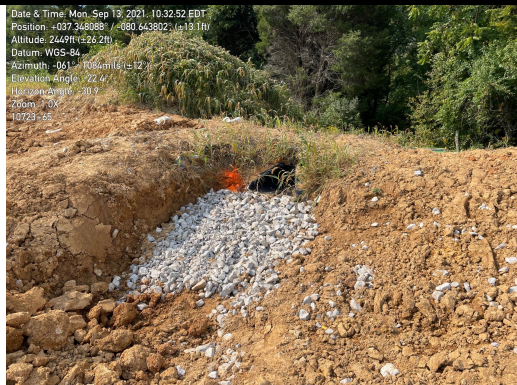
<b>GPS Location</b>	See photo	<b>GPS Location</b>	See photo		
<b>Field Station#</b>	10723+65	<b>Field Station#</b>	10685+00		
<b>Pic 11 Desc.</b>	Stone inlet protection in place	<b>Pic 12 Desc.</b>	CFS triple stack perimeter control in place

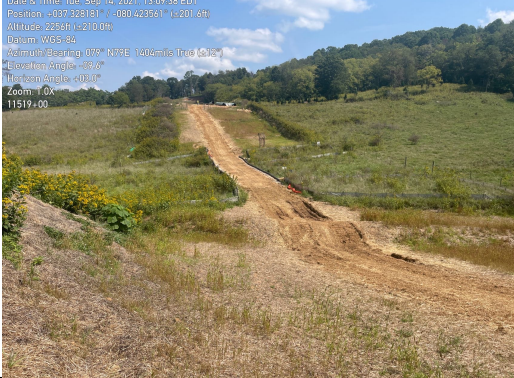
<b>GPS Location</b>	See photo	<b>GPS Location</b>	See photo		
<b>Field Station#</b>	11519+00	<b>Field Station#</b>	11510+00		
<b>Pic 1 Desc.</b>	Stream buffer in place	<b>Pic 2 Desc.</b>	Clean water diversion berm in place		
<p>Date &amp; Time: Tue, Sep 14, 2021, 11:49:23 EDT  Position: +037 222454 / -080 43181 14140.0ft  Altitude: 222454 (+11.1m)  Datum: WGS-84  Azimuth Bearing: 172° S12W 341mils True (+12.1°)  Elevation Angle: +25.7°  Horizon Angle: +05.5°  Zoom: 1.0X  11475+00</p>

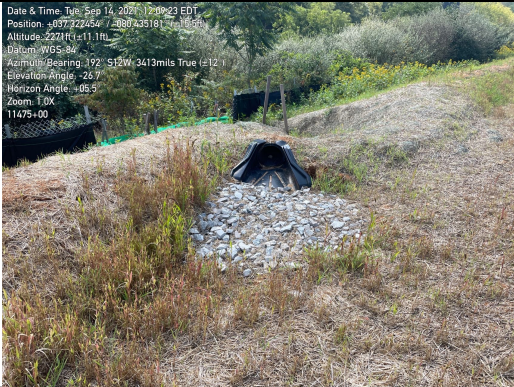
<b>GPS Location</b>	See photo	<b>GPS Location</b>	See photo		
<b>Field Station#</b>	11475+00	<b>Field Station#</b>	11455+00		
<b>Pic 3 Desc.</b>	Stone inlet protection in place	<b>Pic 4 Desc.</b>	P1 silt fence perimeter control in place		
<p>Date &amp; Time: Tue, Sep 14, 2021, 11:40:10 EDT  Position: +037 216517 / -080 443177 14053.1ft  Altitude: 216517 (+10.0m)  Datum: WGS-84  Azimuth Bearing: 088° N08E 130mils True (+12.1°)  Elevation Angle: +04.7°  Horizon Angle: +01.3°  Zoom: 1.0X  11450+00</p>

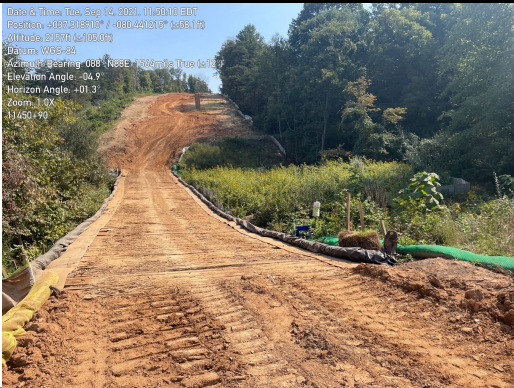
<b>Pic 5 Desc.</b>	Stream buffer in place	<b>Pic 6 Desc.</b>	Seed and hydro mulch has been applied to travel lane

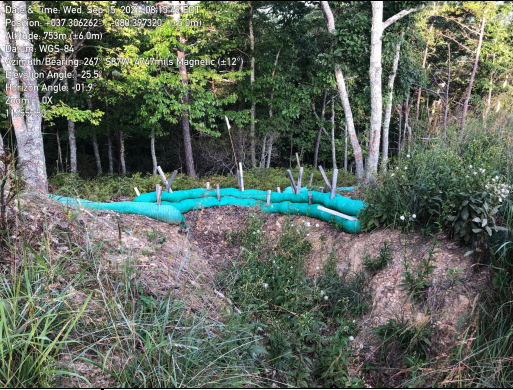
<b>GPS Location</b>	On photo	<b>GPS Location</b>	On photo		
<b>Field Station#</b>	11659+25	<b>Field Station#</b>	11655+50		
<b>Pic 1 Desc.</b>	Example of worn silt fence to be replaced.	<b>Pic 2 Desc.</b>	Sumps and end treatments are functioning as designed.

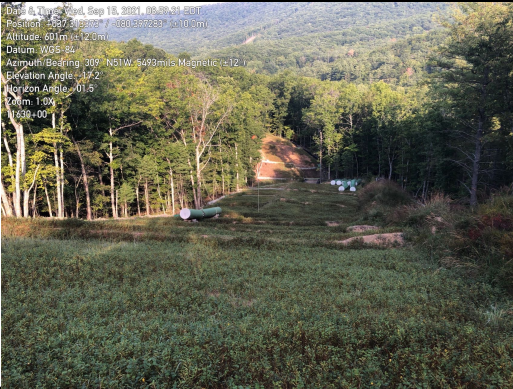
<b>GPS Location</b>	On photo	<b>GPS Location</b>	On photo		
<b>Field Station#</b>	11646+20	<b>Field Station#</b>	11630+00		
<b>Pic 3 Desc.</b>	Silt fence to be tied in correctly to end treatment.	<b>Pic 4 Desc.</b>	Slope stable. ECDs in place.

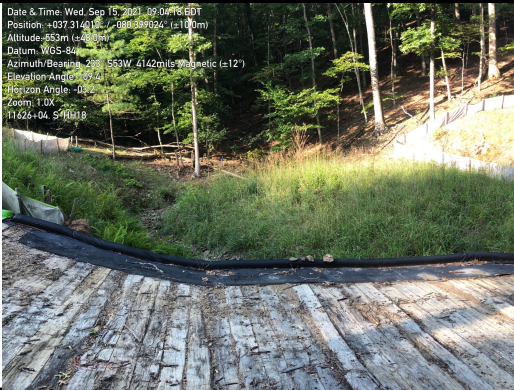
<b>GPS Location</b>	On photo	<b>GPS Location</b>	On photo		
<b>Field Station#</b>	11626+04	<b>Field Station#</b>	11624+00		
<b>Pic 5 Desc.</b>	The S-HH18 crossing is stable.	<b>Pic 6 Desc.</b>	The ROW is stable with ECDs in place.

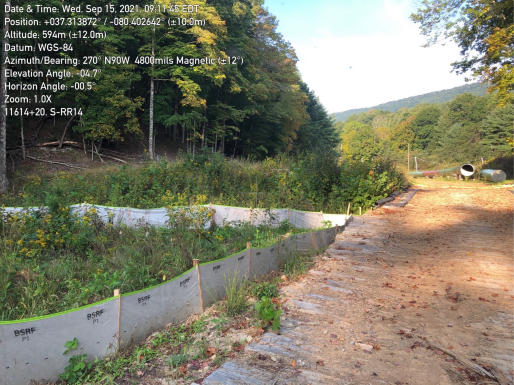
<b>GPS Location</b>	On photo	<b>GPS Location</b>	On photo		
<b>Field Station#</b>	11614+20	<b>Field Station#</b>	11611+00		
<b>Pic 7 Desc.</b>	The S-RR14 crossing is stable. ECDs are in place.		<b>Pic 8 Desc.</b>	Plunge pool in good condition.

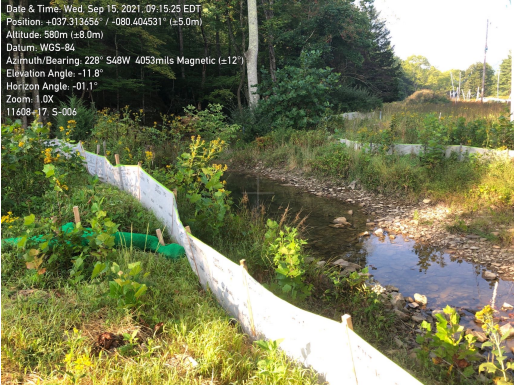
<b>GPS Location</b>	On photo	<b>GPS Location</b>	On photo		
<b>Field Station#</b>	11608+17	<b>Field Station#</b>	11607+00		
<b>Pic 9 Desc.</b>	S-006 crossing stable. ECDs in place.		<b>Pic 10 Desc.</b>	ROW stable. ECDs in place.

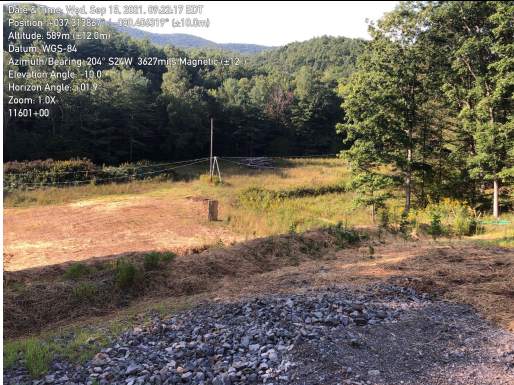
<p style="text-align: center;">Insert image here</p>			
<b>GPS Location</b>	On photo	<b>GPS Location</b>			
<b>Field Station#</b>	11601+00	<b>Field Station#</b>			
<b>Pic 11 Desc.</b>	ROW stable. ECDs in place.		<b>Pic 12 Desc.</b>

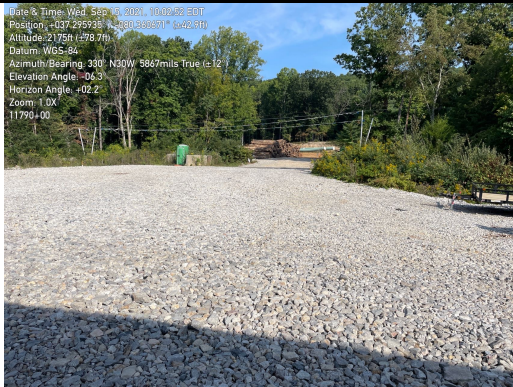
GPS Location				See photo				GPS Location				See photo			
Field Station#				11899+99				Field Station#				11790+00			
Pic 1 Desc.				Silt fence no longer filtering				Pic 2 Desc.				RCE in place

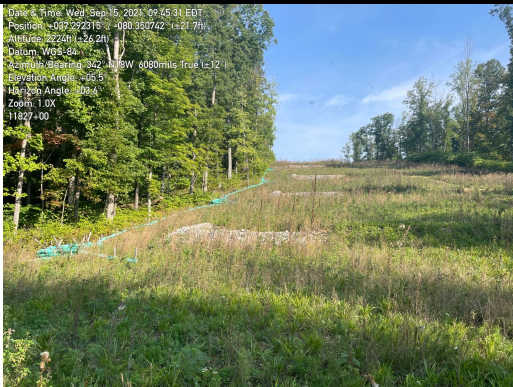
GPS Location				See photo				GPS Location				See photo			
Field Station#				11827+00				Field Station#				11845+00			
Pic 3 Desc.				CFS perimeter control in place				Pic 4 Desc.				Supersilt fence perimeter control in place

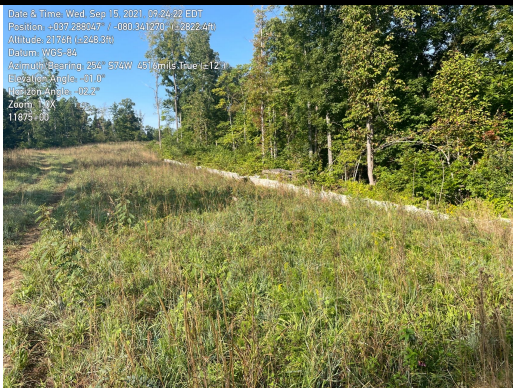
GPS Location				See photo				GPS Location				See photo			
Field Station#				11875+00				Field Station#				11839+00			
Pic 5 Desc.				P1 silt fence perimeter control in place				Pic 6 Desc.				Level spreaders in place

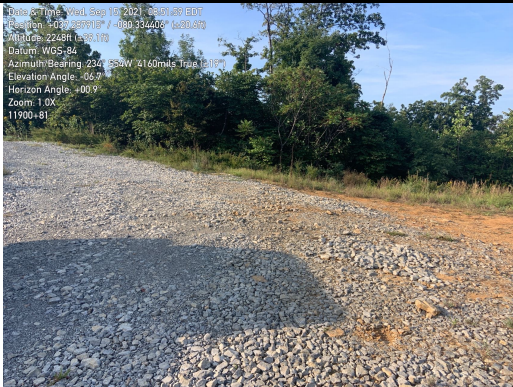
GPS Location		See photo				GPS Location		See photo			
Field Station#		11900+81				Field Station#		11914+00			
Pic 1 Desc.		RCE is in acceptable condition				Pic 2 Desc.		Permanent water bar and level spreader functional			
<p>Date &amp; Time: Wed, Sep 15, 2021, 09:54:55 EDT Position: +037.268346° / -080.321069° (±656.2ft) Altitude: 2245ft (±65.1ft) Datum: WGS-84 Azimuth/Bearing: 234° 25W 4160mils True (±10°) Elevation Angle: -05.7° Horizon Angle: +00.0° Zoom: 1.0X 11985+00</p>

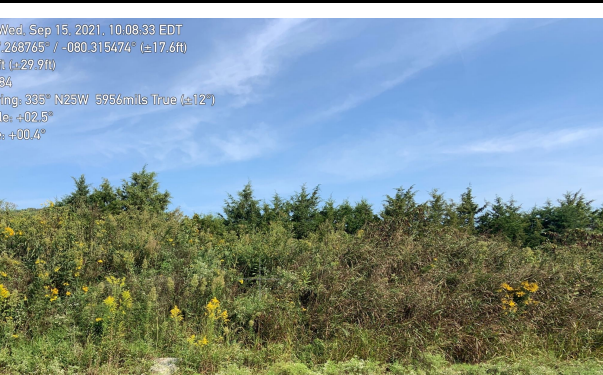
GPS Location		See photo				GPS Location		See photo			
Field Station#		12005+00				Field Station#		11930+00			
Pic 5 Desc.		Topsoil pile vegetation acceptable				Pic 6 Desc.		Erosion control blanket needs installed behind CFS.

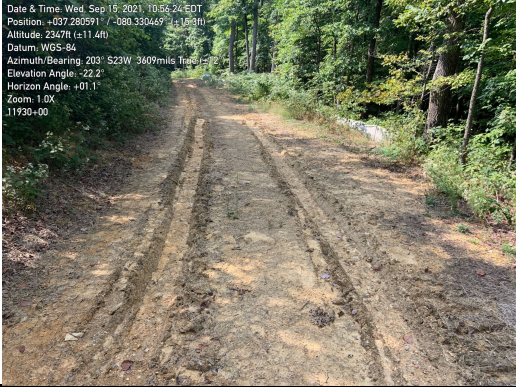
<b>GPS Location</b>	See photo	<b>GPS Location</b>	See photo		
<b>Field Station#</b>	11930+00	<b>Field Station#</b>	11930+00		
<b>Pic 7 Desc.</b>	Vehicle ruts on AR266 need graded	<b>Pic 8 Desc.</b>	Sediment needs clean from throat of water bar		
<small>Date &amp; Time: Wed, Sep 15, 2021, 11:04:54 EDT Position: +037.278547 / -080.322289 (±15.4ft) Altitude: 2250ft (±11.3ft) Datum: WGS-84 Azimuth/Bearing: 309° N51W 4493mils True (±3.7°) Elevation Angle: +22.4° Horizon Angle: +05.4° Zoom: 1.0X 11930+00</small>

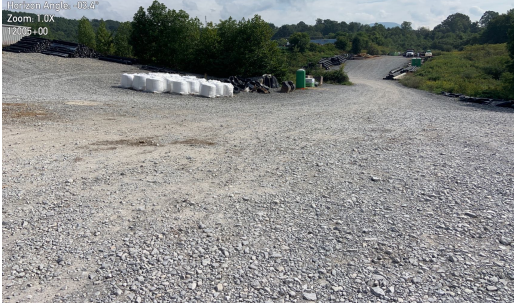
<b>GPS Location</b>	See photo	<b>GPS Location</b>	See photo		
<b>Field Station#</b>	12005+00	<b>Field Station#</b>	12005+00		
<b>Pic 1 Desc.</b>	Rock surface in acceptable condition	<b>Pic 2 Desc.</b>	CFS perimeter controls in place		
<p>Date &amp; Time: Thu, Sep 16, 2021, 11:05:30 EDT  Position: +39°31'19.212" / -88°59'17.172" to 1.6210  Altitude: 1271ft to 1.54ft  Datum: WGS-84  Azimuth Bearing: 180° S89E 8806mils True to 2.1  Elevation Angle: -01.2°  Heading Angle: -01.2°  Zoom: 1.00  12005+00</p>

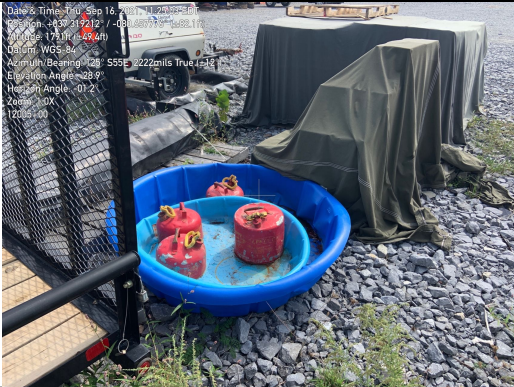
<b>GPS Location</b>	See photo	<b>GPS Location</b>	See photo		
<b>Field Station#</b>	12005+00	<b>Field Station#</b>	12005+00		
<b>Pic 3 Desc.</b>	Secondary containment in place	<b>Pic 4 Desc.</b>	Secondary containment in place		
<p>Date &amp; Time: Thu, Sep 16, 2021, 11:25:41 EDT  Position: +39°31'19.212" / -88°59'17.172" to 1.6210  Altitude: 1271ft to 1.54ft  Datum: WGS-84  Azimuth Bearing: 311° S31W 3335mils True to 1.57  Elevation Angle: -13.4°  Heading Angle: -00.1°  Zoom: 1.00  12005+00</p>

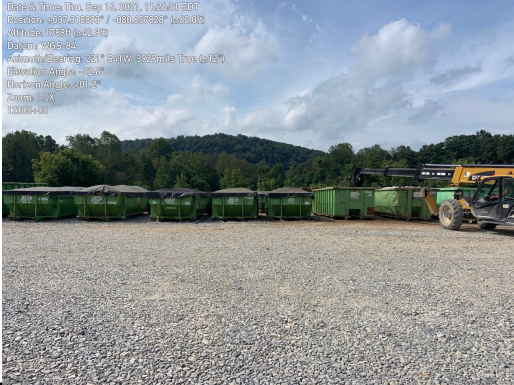
<b>Pic 5 Desc.</b>	Dumpsters in place	<b>Pic 6 Desc.</b>	Secondary containment in place

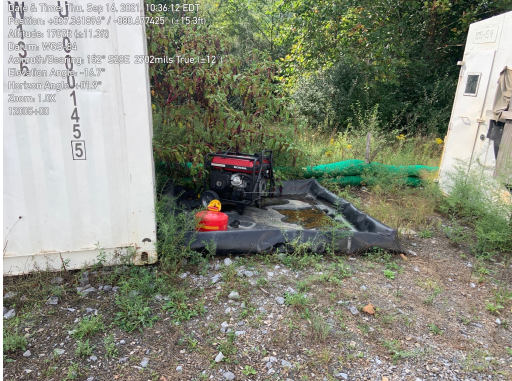
GPS Location	See photo		GPS Location	See photo	
Field Station#	12005+00		Field Station#	12005+00	
Pic 1 Desc.	Secondary containment in place		Pic 2 Desc.	Culvert in place and functional

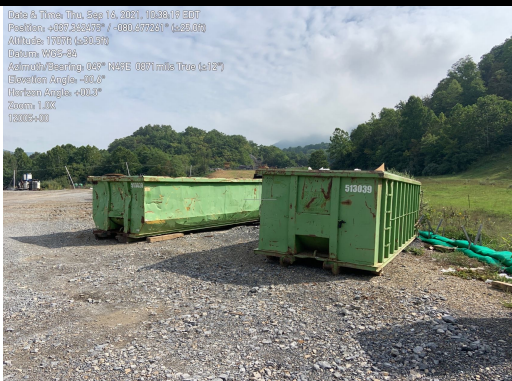
GPS Location	See photo		GPS Location	See photo	
Field Station#	12005+00		Field Station#	12005+00	
Pic 3 Desc.	Dumpsters in place		Pic 4 Desc.	Inspected fuel cell for any visible leaks or spills

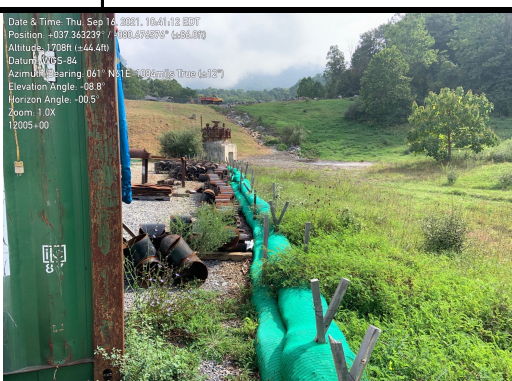
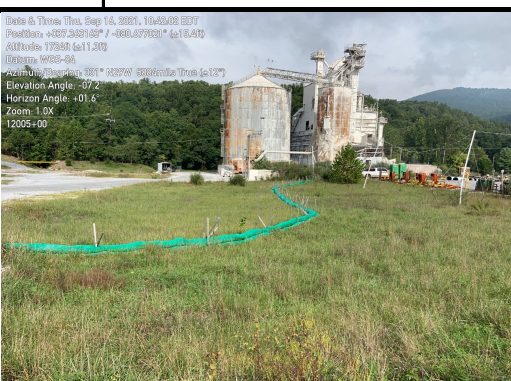
GPS Location	See photo		GPS Location	See photo	
Field Station#	12005+00		Field Station#	12005+00	
Pic 5 Desc.	Triple stacked CFS perimeter controls in place and functional		Pic 6 Desc.	Triple stacked CFS perimeter controls in place and functional

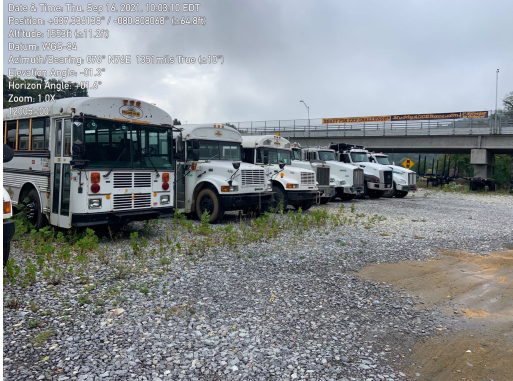
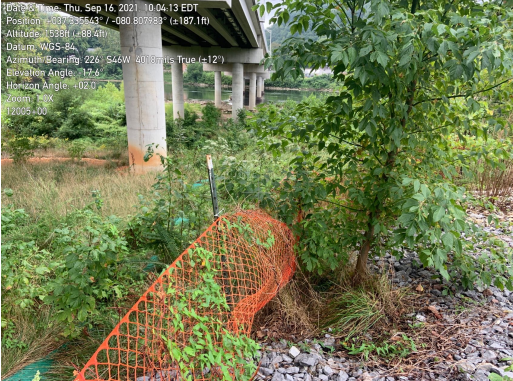
<p>Date &amp; Time: Thu, Sep 16, 2021, 10:04:13 EDT Position: +407.35492° / -80.63092° (+167.10) Altitude: 1538ft (+16.0m) Datum: WGS-84 Azimuth Bearing: 226° 54' 0" 1038mils True (+12°) Elevation Angle: -12.4° Horizon Angle: -02.0° Zoom: 1.0x 12005+00</p>			
<b>GPS Location</b>	See photo	<b>GPS Location</b>	See photo		
<b>Field Station#</b>	12005+00	<b>Field Station#</b>	12005+00		
<b>Pic 1 Desc.</b>	Inspected parked vehicles for any visible spills or leak.	<b>Pic 2 Desc.</b>	Orange safety fence and CFS are acceptable

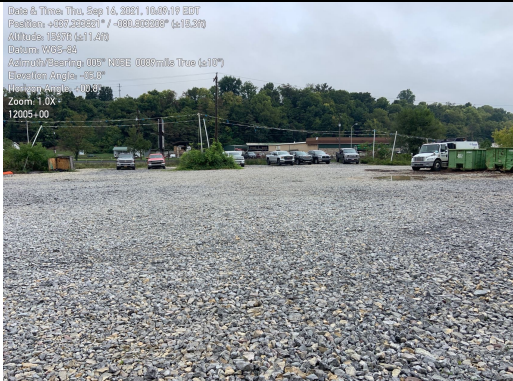
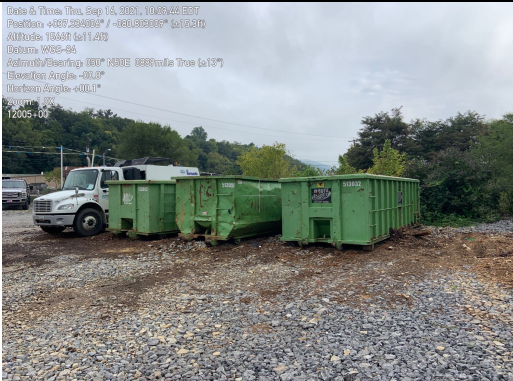
<b>GPS Location</b>	See photo	<b>GPS Location</b>	see photo		
<b>Field Station#</b>	12005+00	<b>Field Station#</b>	12005+00		
<b>Pic 3 Desc.</b>	Rock surface in acceptable condition	<b>Pic 4 Desc.</b>	Dumpsters in place

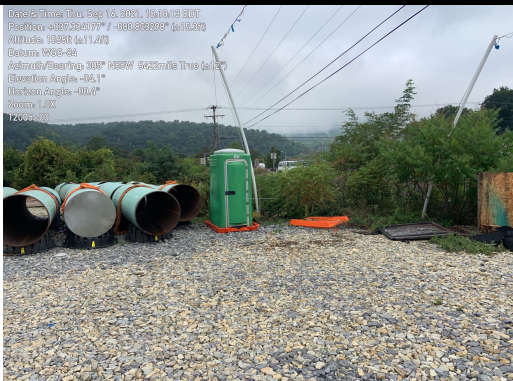
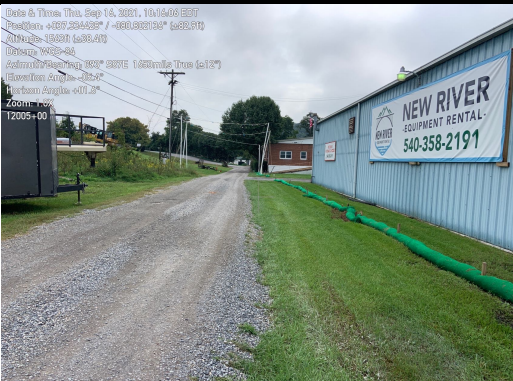
<p>Date &amp; Time: Thu, Sep 16, 2021, 10:10:16 EDT Position: +407.35492° / -80.63092° (+167.10) Altitude: 1538ft (+16.0m) Datum: WGS-84 Azimuth Bearing: 332° 30' 33" 1507mils True (+12°) Elevation Angle: -40.2° Horizon Angle: -02.0° Zoom: 1.0x 12005+00</p>			
<b>GPS Location</b>	see photo	<b>GPS Location</b>	See photo		
<b>Field Station#</b>	12005+00	<b>Field Station#</b>	12005+00		
<b>Pic 5 Desc.</b>	Secondary containment in place	<b>Pic 6 Desc.</b>	CFS perimeter controls in place

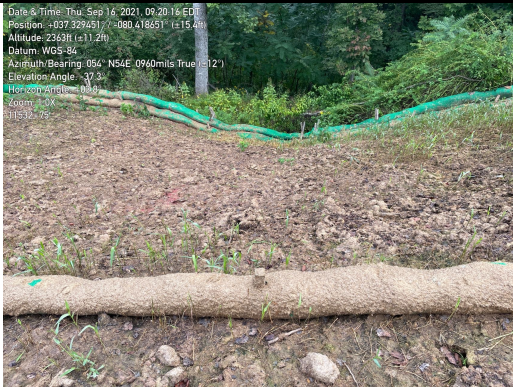
<p>Date &amp; Time: Thu, Sep 16, 2021, 10:34:10 EDT Position: -037.316313° / -080.406485° (-11.1m) Altitude: 2361ft (-13.1m) Datum: WGS 84 Azimuth/Bearing: 122° S08E 3058mils True (-12°) Elevation Angle: -16.7° Horizon Angle: +04.1° Zoom: 1.0x 11599+50</p>			
GPS Location		See photo				GPS Location		See photo							
Field Station#		11532+75				Field Station#		11599+50							
Pic 1 Desc.		Additional controls need installed at low spot				Pic 2 Desc.		RCE in place

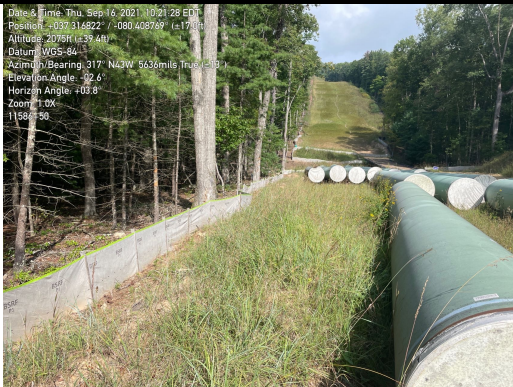
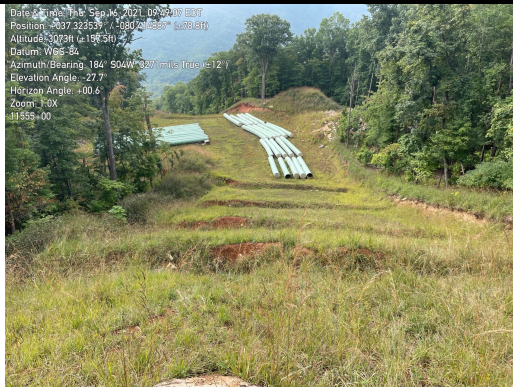
GPS Location		See photo				GPS Location		See photo							
Field Station#		11586+50				Field Station#		11555+00							
Pic 3 Desc.		P1 silt fence perimeter control in place				Pic 4 Desc.		Waterbars in place

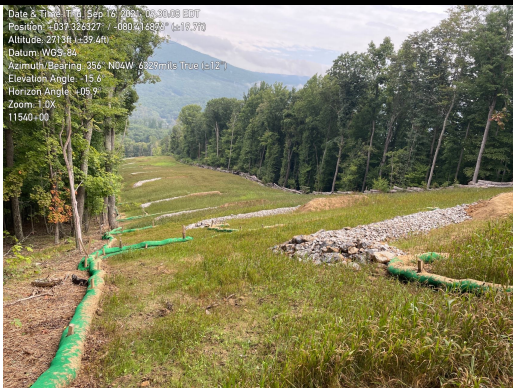
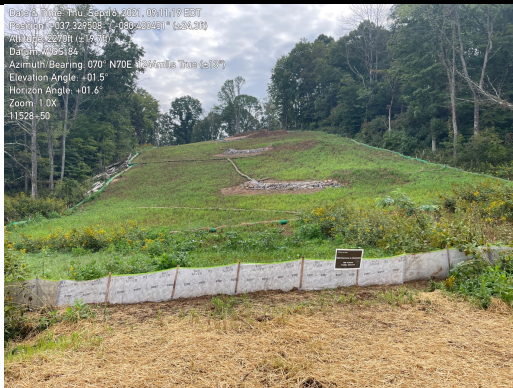
<p>Date &amp; Time: Thu, Sep 16, 2021, 09:19:00 EDT Position: -037.323222° / -080.406485° (-11.1m) Altitude: 2213ft (-13.4m) Datum: WGS 84 Azimuth/Bearing: 070° N70E 3081mils True (-12°) Elevation Angle: +01.5° Horizon Angle: +01.6° Zoom: 1.0x 11528+50</p>			
GPS Location		See photo				GPS Location		See photo							
Field Station#		11540+00				Field Station#		11528+50							
Pic 5 Desc.		Permanent waterbars in place				Pic 6 Desc.		Level spreaders in place

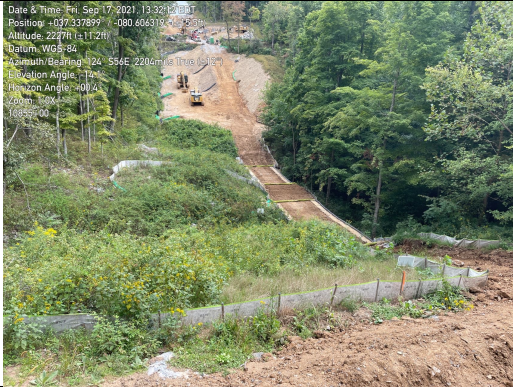
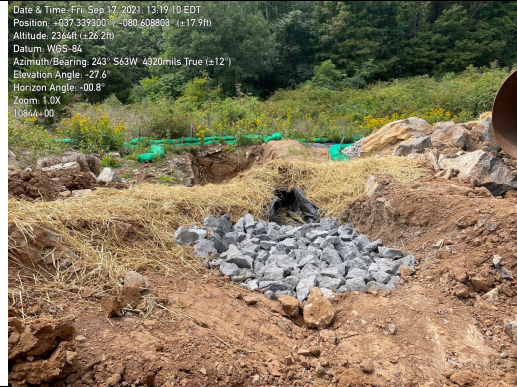
Date & Time: Fri, Sep 17, 2021, 13:32:10 EDT Position: +372.337897° / -880.685119° (±17.7m) Altitude: 2227ft (±11.2m) Datum: WGS-84 Azimuth/Bearing: 124° S54E 220mils True (±12°) Elevation Angle: -12° Horizon Angle: -00.4° Zoom: 1.0X 10855+00				Date & Time: Fri, Sep 17, 2021, 13:19:10 EDT Position: +371.339300° / -880.688803° (±17.7m) Altitude: 2244ft (±12.2m) Datum: WGS-84 Azimuth/Bearing: 243° S63W 4920mils True (±12°) Elevation Angle: -27.6° Horizon Angle: -00.8° Zoom: 1.0X 10844+00											
GPS Location				See photo				GPS Location				See photo			
Field Station#				10855+00				Field Station#				10844+00			
Pic 1 Desc.				Stream buffer in place				Pic 2 Desc.				Stone inlet protection in place

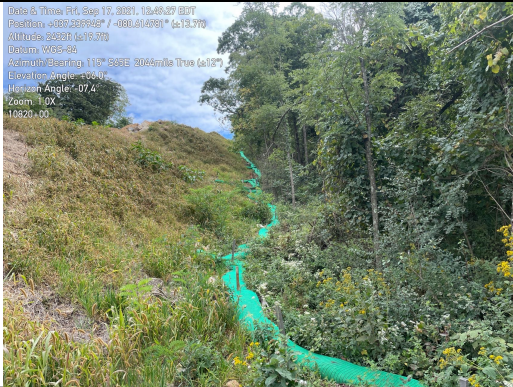
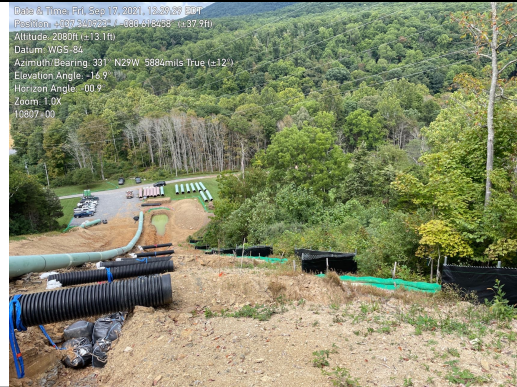
GPS Location				See photo				GPS Location				See photo			
Field Station#				10820+00				Field Station#				10870+00			
Pic 3 Desc.				CFS perimeter control in place				Pic 4 Desc.				End treatments in place

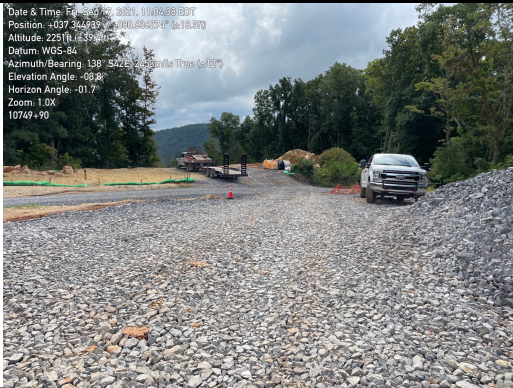
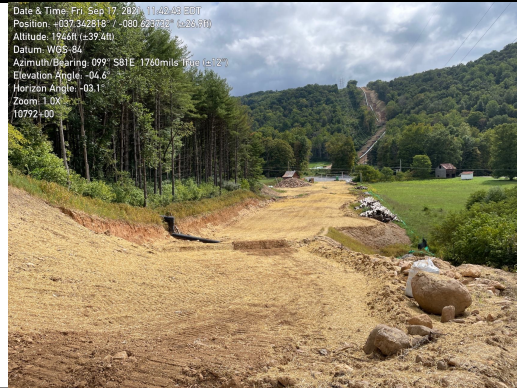
Date & Time: Fri, Sep 17, 2021, 11:06:28 EDT Position: +397.344300° / -886.624874° (±18.8m) Altitude: 2251ft (±13.9m) Datum: WGS-84 Azimuth/Bearing: 138° S42E 2000mils True (±12°) Elevation Angle: -08.8° Horizon Angle: -01.7° Zoom: 1.0X 10749+90				Date & Time: Fri, Sep 17, 2021, 11:06:28 EDT Position: +397.342618° / -880.623397° (±18.8m) Altitude: 1964ft (±39.4ft) Datum: WGS-84 Azimuth/Bearing: 099° S81E 1760mils True (±12°) Elevation Angle: -04.6° Horizon Angle: -03.1° Zoom: 1.0X 10792+00											
GPS Location				See photo				GPS Location				See photo			
Field Station#				10749+90				Field Station#				10792+00			
Pic 5 Desc.				RCE in place				Pic 6 Desc.				Clean water diversion berm in place

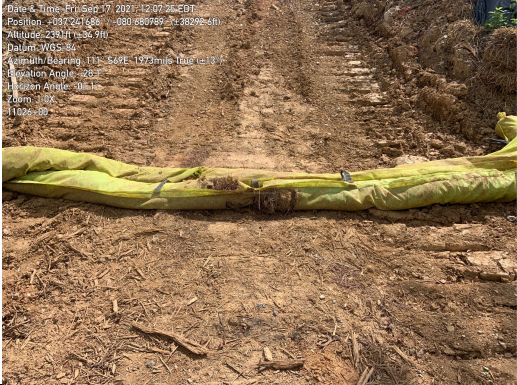
<b>GPS Location</b>	See photo	<b>GPS Location</b>			
<b>Field Station#</b>	11026+00	<b>Field Station#</b>			
<b>Pic 13 Desc.</b>	Straw waddles added to punch list for replacement	<b>Pic 14 Desc.</b>			
Insert image here		Insert image here			
<b>GPS Location</b>		<b>GPS Location</b>			
<b>Field Station#</b>		<b>Field Station#</b>			
<b>Pic 15 Desc.</b>		<b>Pic 16 Desc.</b>			
Insert image here		Insert image here			
<b>GPS Location</b>		<b>GPS Location</b>			
<b>Field Station#</b>		<b>Field Station#</b>			
<b>Pic 17 Desc.</b>		<b>Pic 18 Desc.</b>
