Visual Site Inspection Report

Project Name	H-600 Pipeline Spread G	AFE	124300137	Spread	H-600 Pipeline Spread G
Contractor	Precision			Report #	28117
Inspector	Clint Sears			Date/Time	9/6/2021 10:08 AM
Permit #	TBD	Inspection Type	VA SWPP	Station Begin	12005+00
State	VA	Inspection Area	Full	Station End	12005+00
County	Giles	Ground	Damp	Temperature (°F)	79.00
Municipality	N/A	Weather	Cloudy	Rain Gauge (in)	0.10
				Rain Accumulation Time (days)	1.00

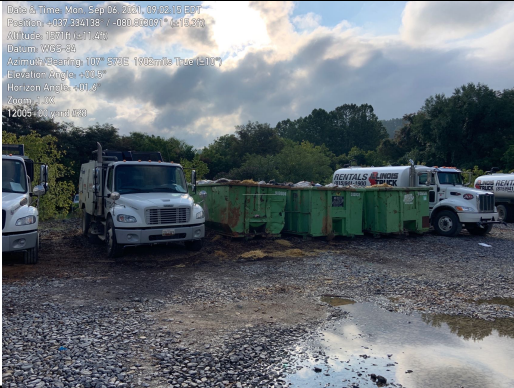
GPS Location	See photo	GPS Location	See photo		
Field Station#	12005+00	Field Station#	12005+00		
Pic 3 Desc.	RCE clean and functional	Pic 4 Desc.	CFS along access road functional

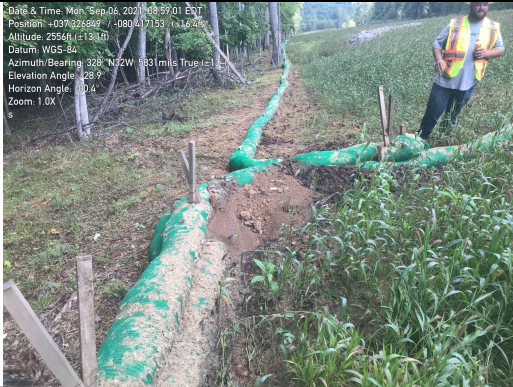
<p>Date & Time: Mon, Sep 06, 2021, 08:22:32 EDT Position: +037.325922° / -080.426381° (-16.4ft) Altitude: 2327ft (-9.5ft) Datum: WGS-84 Azimuth Bearing: 162° S18E 2880mils True (-2.5°) Elevation Angle: -27.5° Horizon Angle: 100.3° Zoom: 1.0X 11528+00</p>			
GPS Location		See photo		GPS Location see photo	
Field Station#		11525+75		Field Station# 11528+00	
Pic 1 Desc.		P1 needs repaired		Pic 2 Desc. Sock undermined

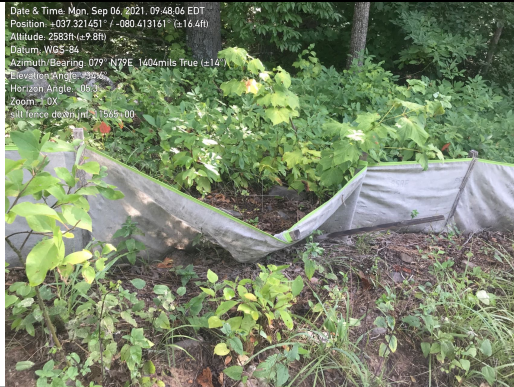
GPS Location		see photo		GPS Location see photo	
Field Station#		11530+00		Field Station# 11565+00	
Pic 3 Desc.		Sock overtopped		Pic 4 Desc. P1 needs a stake

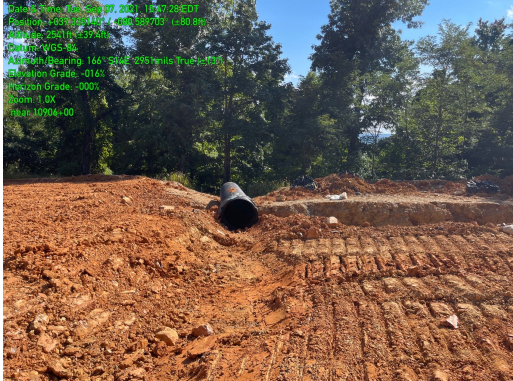
GPS Location	See Photo		GPS Location	See Photo	
Field Station#	10906+00		Field Station#	10864+51	
Pic 3 Desc.	View of ditch relief pipe needing sand bags at inlet to culvert pipe.		Pic 4 Desc.	View of slope drain pipe needing restored to required permit specifications.

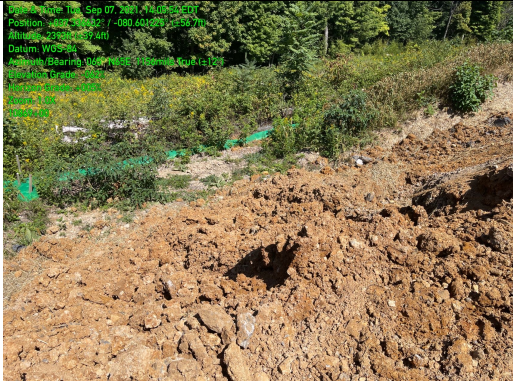
Pic 5 Desc.	View of fill slope stabilization needed after padding and backfill activities.		Pic 6 Desc.	View of CFS overwhelmed with soil from backfilling activities.

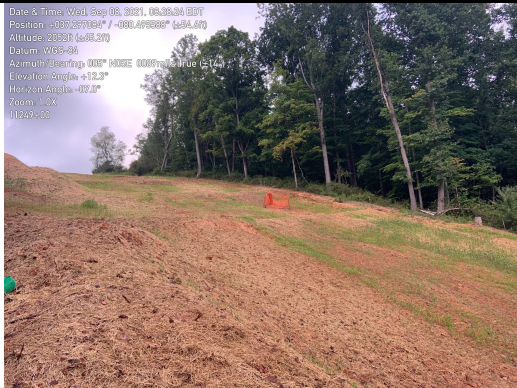
GPS Location	see photo	GPS Location	see photo		
Field Station#	11249+00	Field Station#	11149+00		
Pic 9 Desc.	Temporary stabilization functional	Pic 10 Desc.	Construction materials staged on ROW near AR249

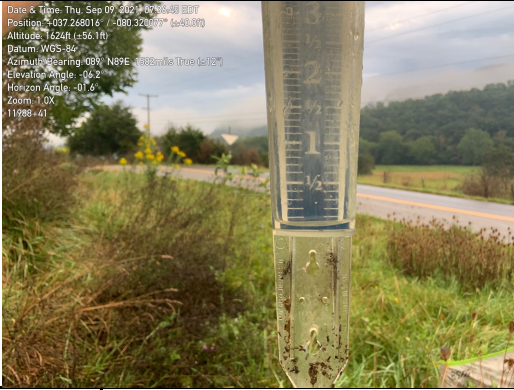
<p>Date & Time: Thu, Sep 09, 2021, 09:16:00 EDT Position: +407.25740° / -88.32946° (±50.0ft) Altitude: 2242ft (±53.1ft) Datum: WGS-84 Azimuth/Bearing: 130° S85E 163mils True (±12°) Elevation Angle: -01.2° Horizon Angle: -01.6° Zoom: 1.0x 11900+81</p>			
GPS Location	See photo	GPS Location	see photo		
Field Station#	11988+41	Field Station#	11900+81		
Pic 1 Desc.	Rain gage at AR266 with .05" inches of rain	Pic 2 Desc.	Level spreader and water bar at AR266.03		
  <p>Date & Time: Thu, Sep 09, 2021, 09:16:11 EDT Position: +407.25740° / -88.32946° (±50.2ft) Altitude: 2242ft (±53.1ft) Datum: WGS-84 Azimuth/Bearing: 130° S85E 163mils True (±12°) Elevation Angle: -01.2° Horizon Angle: -01.6° Zoom: 1.0x 11905+50</p>

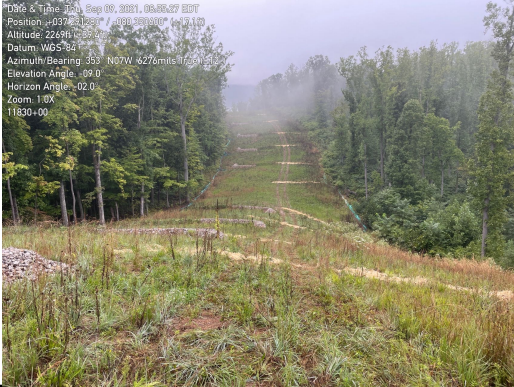
Field Station#	11830+00	Field Station#	11845+00	GPS Location	See photo
Pic 3 Desc.	Permanent waterbars in place	Pic 4 Desc.	Supersilt fence in place	Field Station#	11845+00

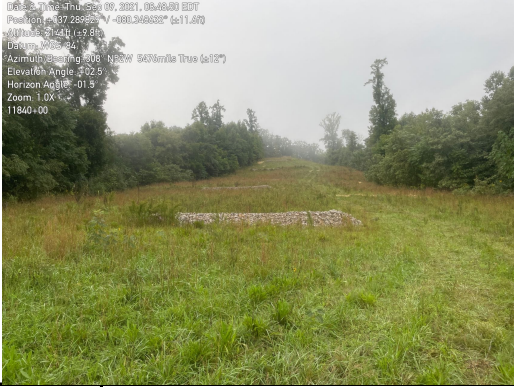
<p>Date & Time: Thu, Sep 09, 2021, 09:10:02 EDT Position: +407.299968° / -80.346497° (±11.8m) Altitude: 2142ft (±20.6ft) Datum: WGS-84 Azimuth/Bearing: 014° N04E 1000mils True (±15°) Elevation Angle: -2.2° Horizon Angle: -01.0° Zoom: 1.0X 11899+99</p>		GPS Location	See photo
Field Station#	11840+00	Field Station#	11899+99	GPS Location	See photo
Pic 5 Desc.	Level spreaders in place	Pic 6 Desc.	RCE in place	Field Station#	11899+99

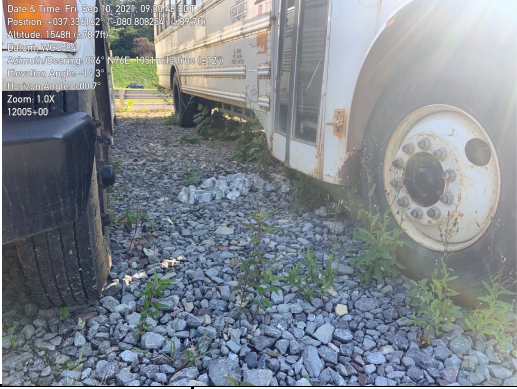
<p>Insert image here</p>			
GPS Location	See photo	GPS Location			
Field Station#	12005+00	Field Station#			
Pic 7 Desc.	Water bottles need pick up from western section of LDY #28	Pic 8 Desc.			
<p>Insert image here</p>		<p>Insert image here</p>			
GPS Location		GPS Location			
Field Station#		Field Station#			
Pic 9 Desc.		Pic 10 Desc.			
<p>Insert image here</p>		<p>Insert image here</p>			
GPS Location		GPS Location			
Field Station#		Field Station#			
Pic 11 Desc.		Pic 12 Desc.

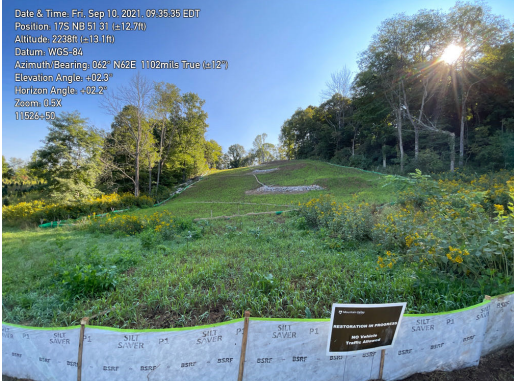
<p>Date & Time: Fri, Sep 10, 2021, 09:37:07 EDT Position: 175 NB 51 31 (+12.20m) Altitude: 2350ft (+19.7m) Datum: WGS-84 Azimuth/Bearing: 033° N83E 1082mils True (+12°) Elevation Angle: +29.2° Horizon Angle: +09.8° Zoom: 0.5X 11529+00</p>		GPS Location	1
Field Station#		11526+50	GPS Location	2	
Pic 1 Desc.		Section of restored RoW showing conditions and controls.	Pic 2 Desc.	Repair grade, apply appropriate seed mixes and install erosion control blanket.

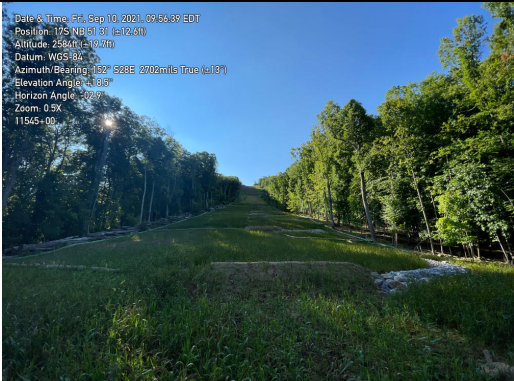
Field Station#		11545+00	GPS Location	4	
Pic 3 Desc.		Section of restored RoW showing conditions and controls.	Pic 4 Desc.	Improper staking in CFS.

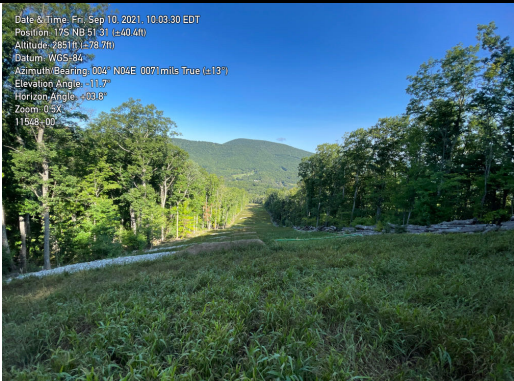
<p>Date & Time: Fri, Sep 10, 2021, 10:21:59 EDT Position: 175 NB 51 30 (+12.45m) Altitude: 2754ft (+17.87m) Datum: WGS-84 Azimuth/Bearing: 338° N22W 6009mils True (+12°) Elevation Angle: +11.4° Horizon Angle: +01.8° Zoom: 0.5X 11560+00</p>		GPS Location	5
Field Station#		11548+00	GPS Location	6	
Pic 5 Desc.		Section of restored RoW showing conditions and controls.	Pic 6 Desc.	Section of RoW showing conditions and controls.
