Visual Site Inspection Report

Project Name	H-600 Pipeline Spread H	AFE	124300138	Spread	H-600 Pipeline Spread H
Contractor	Precision			Report #	25774
Inspector	Jonathan Altizer			Date/Time	7/12/2021 6:30 PM
Permit #	TBD	Inspection Type	VA SWPP	Station Begin	13024+00
State	VA	Inspection Area	Partial	Station End	13141+65
County	Roanoke	Ground	Damp	Temperature (°F)	83.00
Municipality	N/A	Weather	Sunny	Rain Gauge (in)	0.60
				Rain Accumulation Time (days)	2.00

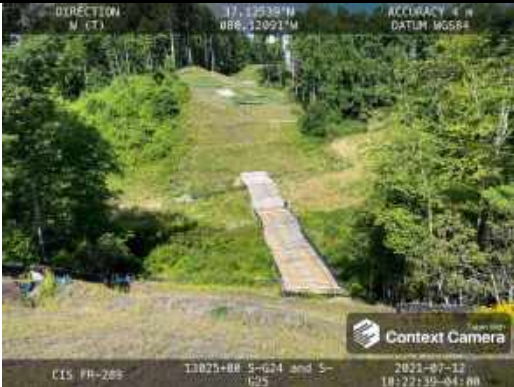
GPS Location	See photo		GPS Location	See photo	
Field Station#	13025+00		Field Station#	13028+00	
Pic 1 Desc.	Stream S-G24 and S-G25 on CIS FR-289		Pic 2 Desc.	Current ROW conditions on CIS FR-289

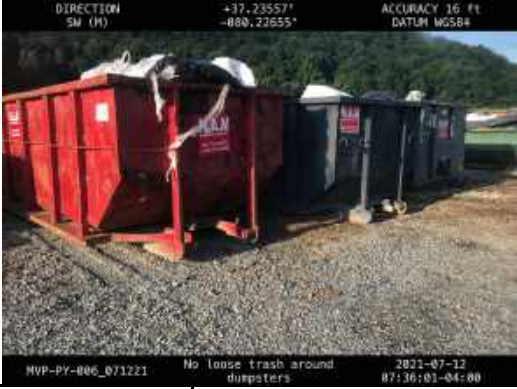
GPS Location	MVP-PY-006 See photo for gps data	GPS Location	MVP-PY-006 See photo for gps data		
Field Station#	+0	Field Station#	+0		
Pic 13 Desc.	No loose trash around dumpsters or in the yard. Looking SW.	Pic 14 Desc.	Blue Bulk Fuel tanks no fuel spills south side of the tanks. Looking NE.

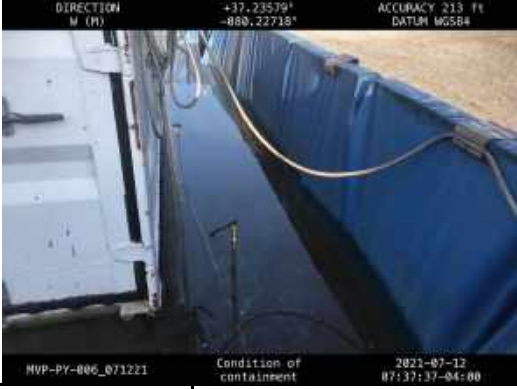
GPS Location	MVP-PY-006 See photo for gps data	GPS Location	MVP-PY-006 See photo for gps data		
Field Station#	+0	Field Station#	+0		
Pic 15 Desc.	Off Road Fuel unit containment holding stormwater. Looking W.	Pic 16 Desc.	Off Road Fuel unit unit condition of internal drip pan. Looking SW.

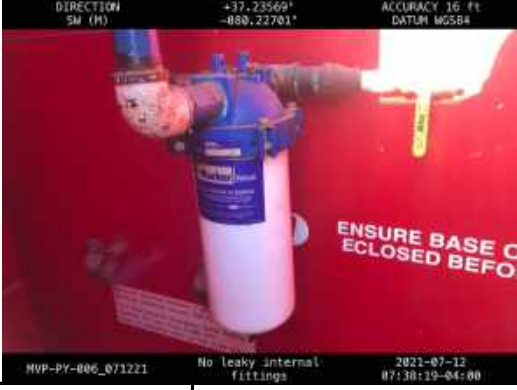
GPS Location	MVP-PY-006 See photo for gps data	GPS Location	MVP-PY-006 See photo for gps data		
Field Station#	+0	Field Station#	+0		
Pic 17 Desc.	Off Road Fuel unit no leaky internal fittings. Looking SW.	Pic 18 Desc.	Condition of posted project documents at the main entrance. Looking W.

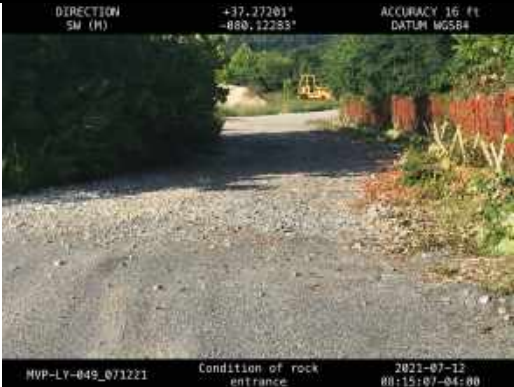
GPS Location	MVP-LY-049 See photo for gps data		GPS Location	MVP-LY-049 See photo for gps data	
Field Station#	+0		Field Station#	+0	
Pic 1 Desc.	Condition of rock entrance on north drive. No sediment on stone. Looking SW.		Pic 2 Desc.	Landowner soil disturbance along triple compost filter sock. No new damage to installed ECD's. Looking SW.

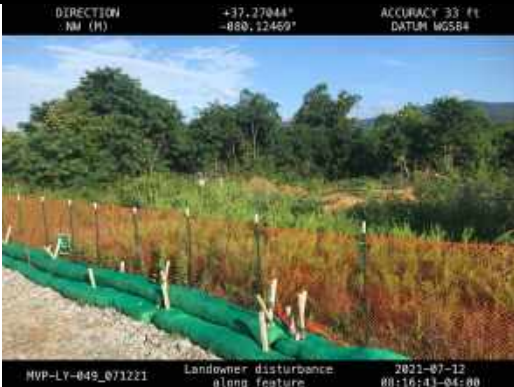
GPS Location	MVP-LY-049 See photo for gps data		GPS Location	MVP-LY-049 See photo for gps data	
Field Station#	+0		Field Station#	+0	
Pic 3 Desc.	Landowner soil disturbance along edge of feature W-CV21A. Area not stabilized. Looking NW.		Pic 4 Desc.	Landowner soil disturbance in 2 locations west of feature W-CV21B. Areas not stabilized. Looking SW.

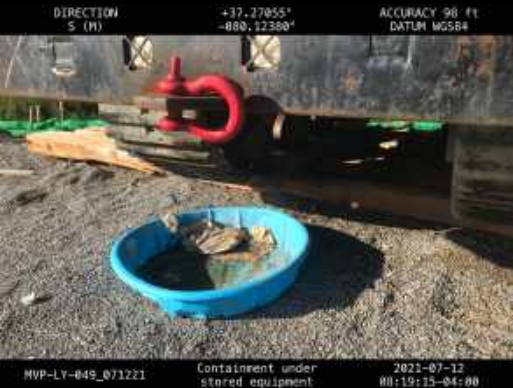
Pic 5 Desc.	Landowner soil disturbance along triple stack compost filter and east of feature W-CV21B. Looking S.		Pic 6 Desc.	Condition of containment under stored equipment. Looking SW.

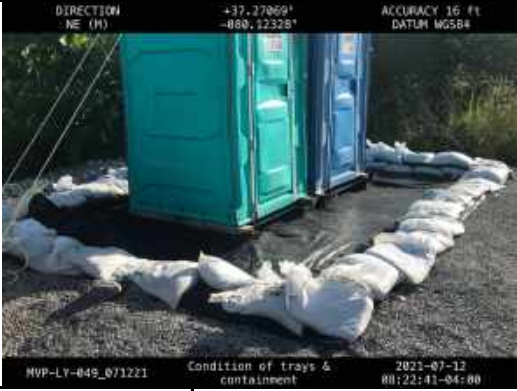
GPS Location	MVP-LY-049 See photo for gps data	GPS Location	MVP-LY-049 See photo for gps data		
Field Station#	+0	Field Station#	+0		
Pic 7 Desc.	Condition of trays and containment under toilets. Looking NE.	Pic 8 Desc.	Condition of temporary trash transfer pit. Most debris has been removed from the pit. Looking W.

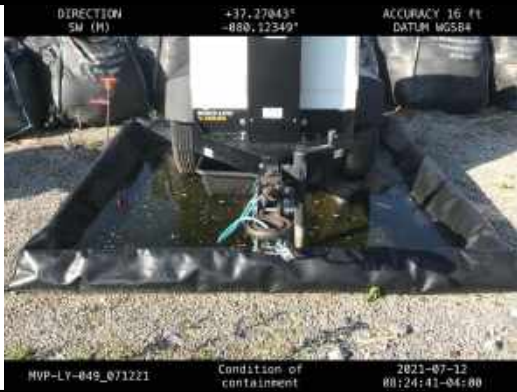
GPS Location	MVP-LY-049 See photo for gps data	GPS Location	MVP-LY-049 See photo for gps data		
Field Station#	+0	Field Station#	+0		
Pic 9 Desc.	Condition of containment under light plant. Holding stormwater. Looking SW.	Pic 10 Desc.	No loose trash around north dumpster or in the yard. Looking N.

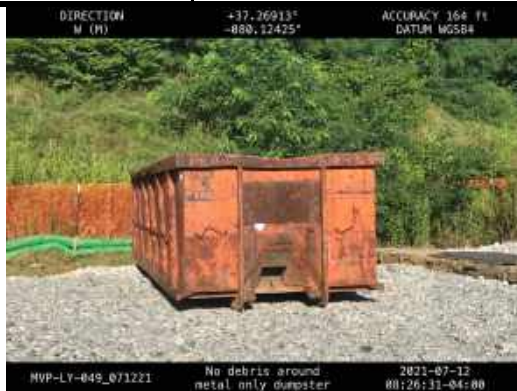
GPS Location	MVP-LY-049 See photo for gps data	GPS Location	MVP-LY-049 See photo for gps data		
Field Station#	+0	Field Station#	+0		
Pic 11 Desc.	No debris around the metal only dumpster. Looking W.	Pic 12 Desc.	Compost filter sock in place around sand pile. Looking SW.

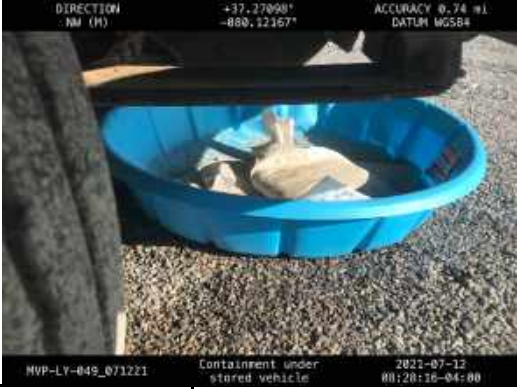
GPS Location	MVP-LY-049 See photo for gps data	GPS Location	MVP-LY-049 See photo for gps data		
Field Station#	+0	Field Station#	+0		
Pic 13 Desc.	Condition of containment under stored vehicle. Looking NW.	Pic 14 Desc.	No fluids or deposits around hazardous waste dumpsters containing swine bones and contaminated soil. Looking SE.

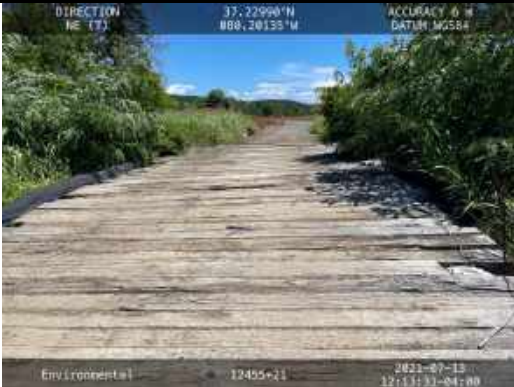
GPS Location	See photo		GPS Location	See photo	
Field Station#	12455+21		Field Station#	12461+81	
Pic 1 Desc.	Stream crossing S-CD12b in acceptable condition		Pic 2 Desc.	Wetland W-KL58 in acceptable condition

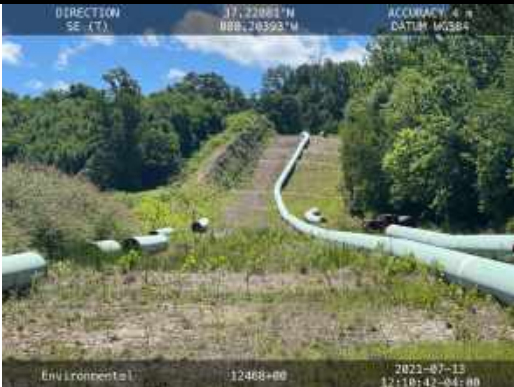
GPS Location	See photo		GPS Location	See photo	
Field Station#	12468+00		Field Station#	12485+00	
Pic 3 Desc.	Stabilized ROW in acceptable condition		Pic 4 Desc.	Stabilized slope in acceptable condition

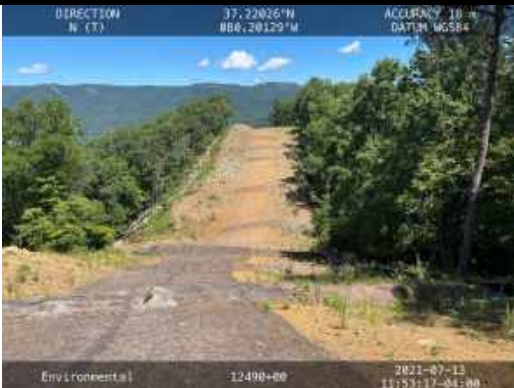
GPS Location	see photo		GPS Location	See photo	
Field Station#	12490+00		Field Station#	12506+00	
Pic 5 Desc.	Stabilized ROW in acceptable condition		Pic 6 Desc.	Stabilized slope in acceptable condition

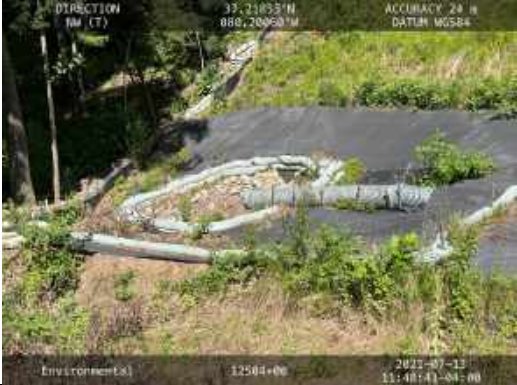
GPS Location	See photo		GPS Location	See photo	
Field Station#	12504+00		Field Station#	12506+00	
Pic 7 Desc.	Clean water crossing pipe outlet in acceptable condition		Pic 8 Desc.	Water bar end treatment needs maintenance performed to fix the fallen CFS

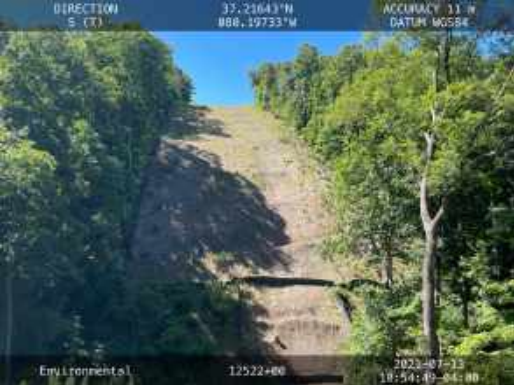
GPS Location	See photo		GPS Location	See photo	
Field Station#	12510+00		Field Station#	12522+00	
Pic 9 Desc.	Stabilized fill slope in acceptable condition		Pic 10 Desc.	Stabilized slope on the GAS of S-EF19

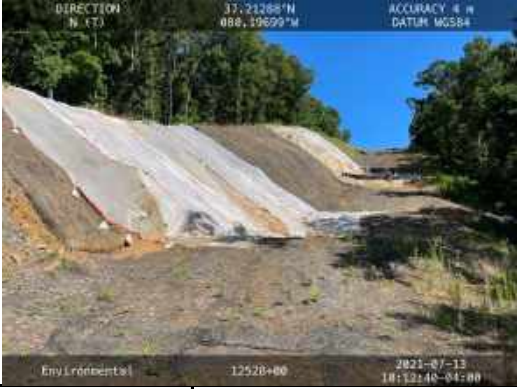
GPS Location	See photo		GPS Location	See photo	
Field Station#	12528+00		Field Station#	12530+00	
Pic 13 Desc.	Plastic covered stabilized spoil pile in acceptable condition		Pic 14 Desc.	Stabilized slope in acceptable condition

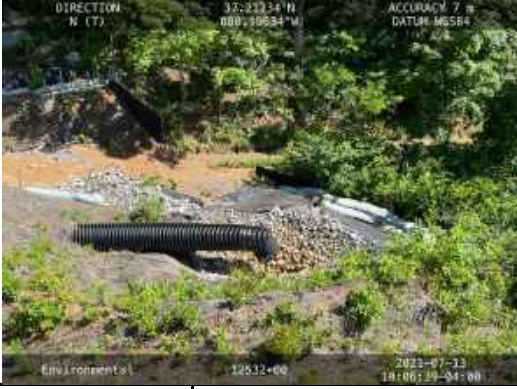
GPS Location	See photo		GPS Location	See photo	
Field Station#	12532+00		Field Station#	12535+00	
Pic 15 Desc.	Clean water crossing pipe outlet in acceptable condition		Pic 16 Desc.	Stabilized ROW in acceptable condition

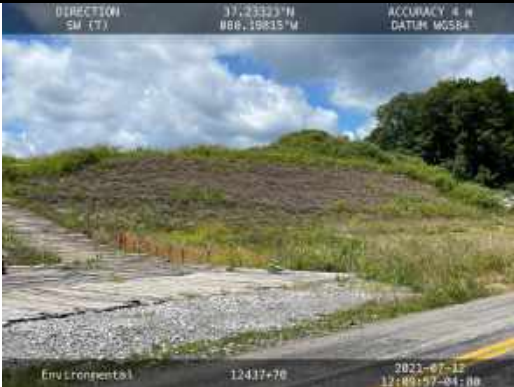
GPS Location	See photo		GPS Location	See photo	
Field Station#	12437+70		Field Station#	12435+50	
Pic 1 Desc.	Stabilized slope in acceptable condition		Pic 2 Desc.	Stream crossing S-NN16 in acceptable condition

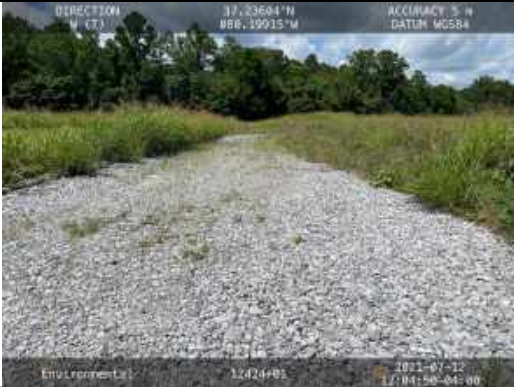
GPS Location	See photo		GPS Location	See photo	
Field Station#	12424+01		Field Station#	12418+00	
Pic 3 Desc.	RCE on access road MVP-MN-279 in acceptable condition		Pic 4 Desc.	Stabilized slope in acceptable condition

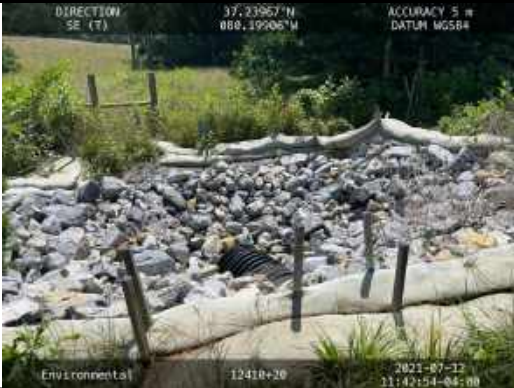
GPS Location	See photo		GPS Location	See photo	
Field Station#	12410+20		Field Station#	12408+86	
Pic 5 Desc.	Clean water crossing pipe outlet in acceptable condition		Pic 6 Desc.	Clean water crossing pipe inlet in acceptable condition

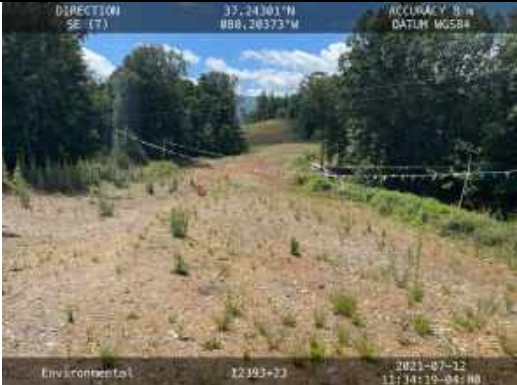
GPS Location	See photo		GPS Location	See photo	
Field Station#	12393+23		Field Station#	12386+00	
Pic 7 Desc.	Stabilized ROW In Acceptable condition		Pic 8 Desc.	Stabilized slope in acceptable condition

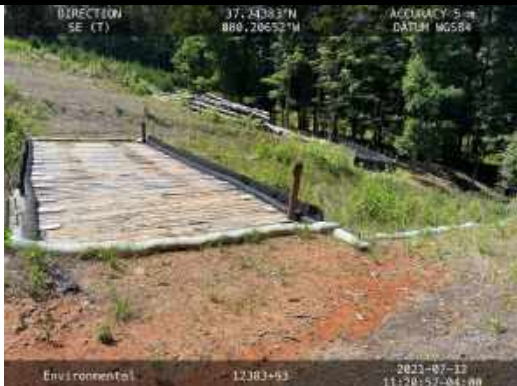
GPS Location	See photo		GPS Location	See photo	
Field Station#	12383+93		Field Station#	12380+76	
Pic 9 Desc.	Clean water crossing in acceptable condition		Pic 10 Desc.	Cannery road crossing in acceptable condition

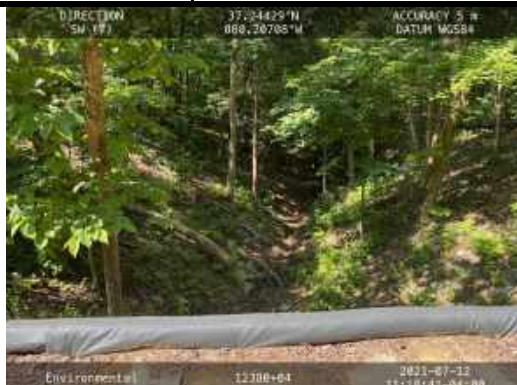
GPS Location	See photo		GPS Location	See photo	
Field Station#	12380+04		Field Station#	12380+04	
Pic 11 Desc.	Down stream of S-NN19 in acceptable condition		Pic 12 Desc.	Bridge and ECDs at stream crossing S-NN19 in acceptable condition

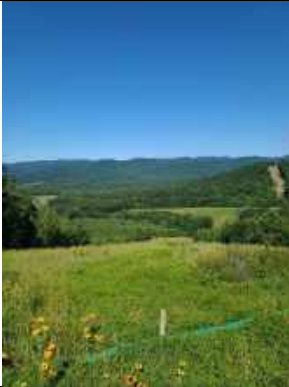
GPS Location	00000	GPS Location	0000		
Field Station#	13436+33	Field Station#	13492+67		
Pic 1 Desc.	Vegetation observation photo. Ecds in place and functioning. No environmental issues observed at the time of inspection.		Pic 2 Desc.	Monitored rock lined channel, ECDs in place at road crossing. No environmental issues observed at the time of inspection.

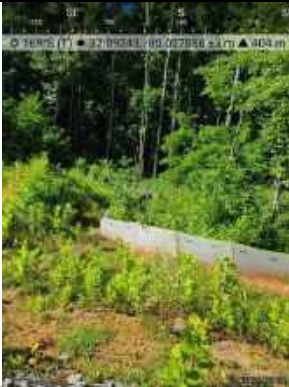
GPS Location	0000	GPS Location	0000		
Field Station#	13415+80	Field Station#	13497+98		
Pic 3 Desc.	Monitored ECDs on row edge , monitored sump pit and end treatment. No issues observed at the time of inspection.		Pic 4 Desc.	Monitored RCE and stream crossing where equipment mats were removed previously during maintenance repairs. No environmental issues observed at the time of inspection.

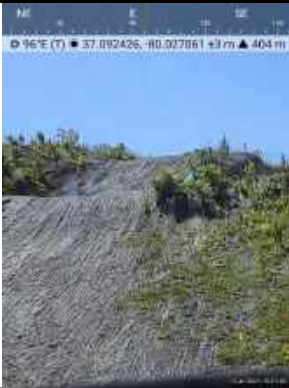
Pic 5 Desc.	Monitored erosion control blanket on hill side above road crossing.no issues observed at the time of inspection.		Pic 6 Desc.	Vegetation observation photo showing good coverage, newly installed ECDs in place and functioning. No environmental issues observed at the time of inspection.

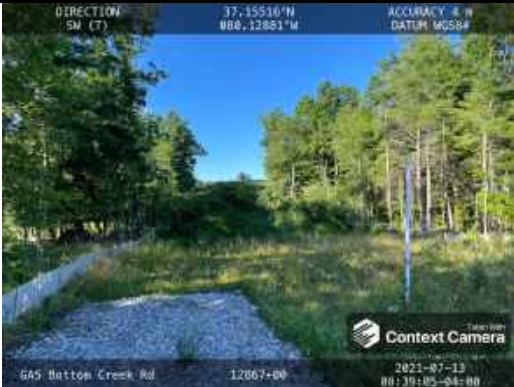
GPS Location	See photo		GPS Location	See photo	
Field Station#	12867+00		Field Station#	12866+00	
Pic 1 Desc.	Current ROW conditions on GAS Bottom Creek Rd		Pic 2 Desc.	Current ROW conditions on CIS Bottom Creek Rd

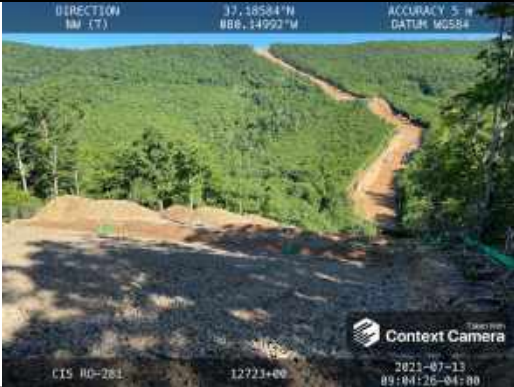
GPS Location	See photo		GPS Location	See photo	
Field Station#	12723+00		Field Station#	12725+00	
Pic 3 Desc.	Current ROW conditions on CIS RO-281. Waterbars curlexed.		Pic 4 Desc.	Current ROW conditions on CIS RO-281

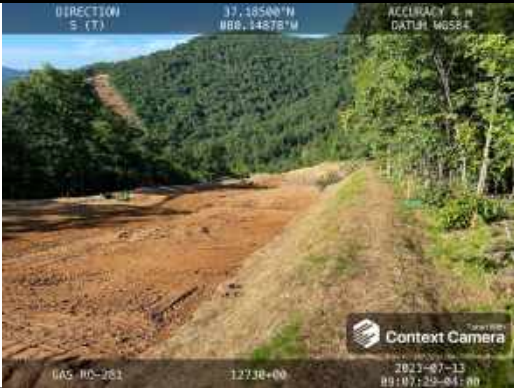
GPS Location	See photo		GPS Location	See photo	
Field Station#	12730+00		Field Station#	12734+50	
Pic 5 Desc.	Current ROW conditions on GAS RO-281. CWD Berm stabilized		Pic 6 Desc.	Current ROW conditions on GAS RO-281. Rock Ditch Crew actively working.

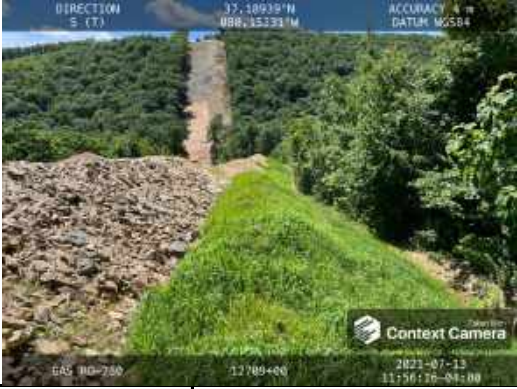
GPS Location	See photo		GPS Location	See photo	
Field Station#	12709+00		Field Station#	12712+00	
Pic 13 Desc.	CWD Berm well stabilized and functional on GAS RO-280		Pic 14 Desc.	Current ROW conditions on GAS RO-282

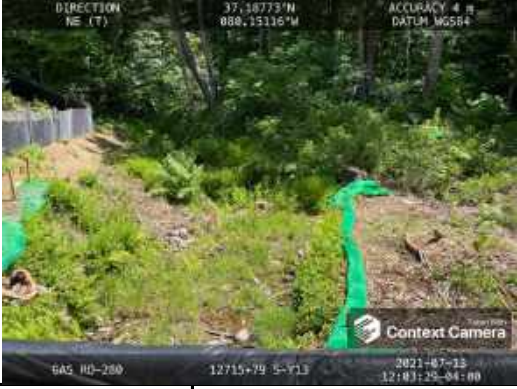
GPS Location	See photo		GPS Location	See photo	
Field Station#	12715+79		Field Station#	12716+23	
Pic 15 Desc.	Stream S-Y13 on GAS RO-280		Pic 16 Desc.	Stream S-Y14 on GAS RO-280

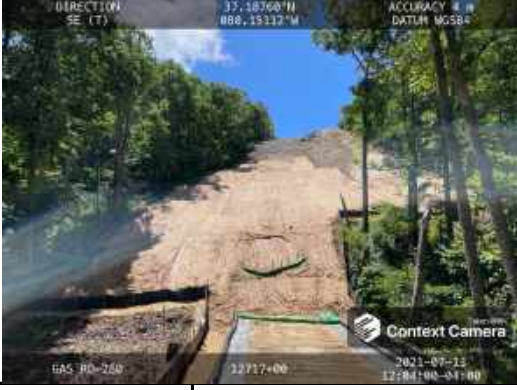
GPS Location	See photo		GPS Location	See photo	
Field Station#	12717+00		Field Station#	12644+00	
Pic 17 Desc.	Current Steep Slope Area condition on GAS S-Y14		Pic 18 Desc.	Current ROW conditions on GAS RO-279.01

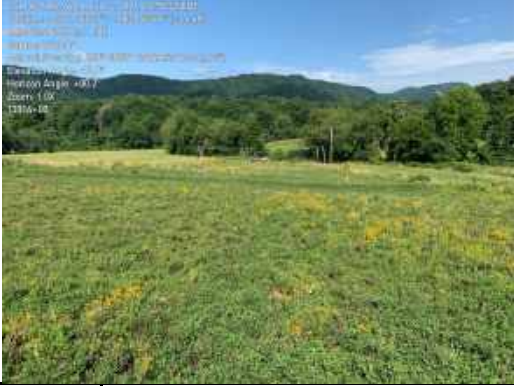
GPS Location	0	GPS Location	0		
Field Station#	13314+00	Field Station#	13309+09		
Pic 1 Desc.	ROW and ECDs in good condition, with good vegetation establishing across LOD.		Pic 2 Desc.	MVP-S-GH7 in good condition

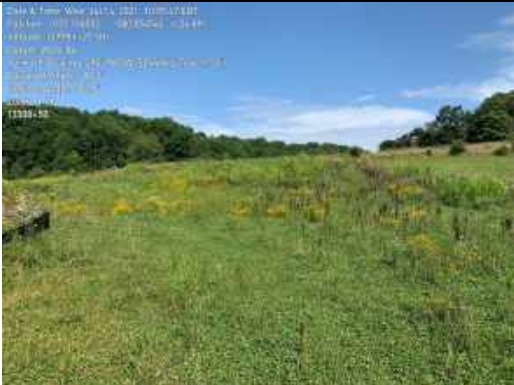
GPS Location	0	GPS Location	0		
Field Station#	13308+50	Field Station#	13260+66		
Pic 3 Desc.	ROW and ECDs in good condition, with good vegetation establishing across LOD.		Pic 4 Desc.	MVP-S-II4 in good condition

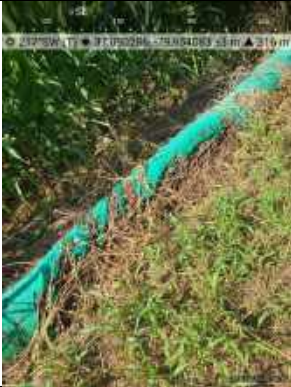
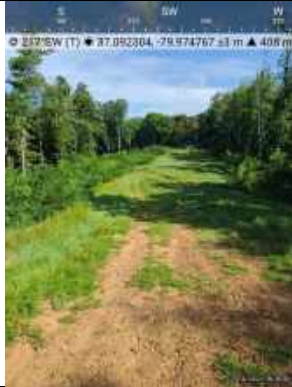
GPS Location	00000		GPS Location	00000	
Field Station#	13650+00		Field Station#	13595+00	
Pic 1 Desc.	CFS requires maintenance due to land owner activities. Documented and added to the punch list for maintenance repairs.		Pic 2 Desc.	Area of row where a land owner has mowed inside the LOD. Documented as non project related activities.

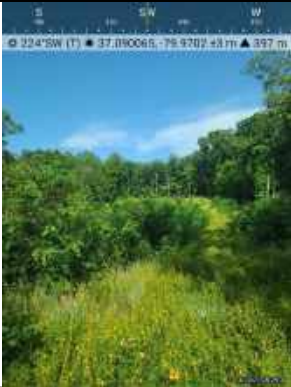
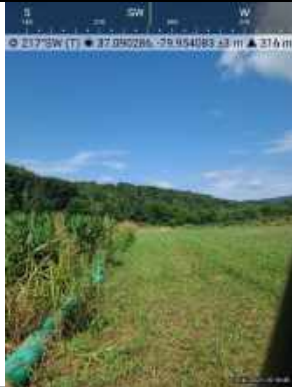
GPS Location	00000		GPS Location	000000	
Field Station#	13613+30		Field Station#	13650+00	
Pic 3 Desc.	Row photo showing vegetation and locust trees inside the LOD . No environmental issues observed at the time of inspection.		Pic 4 Desc.	Photo showing area of row that has been mowed by a land owner with damage done to CFS on edge of row as shown in other photo.

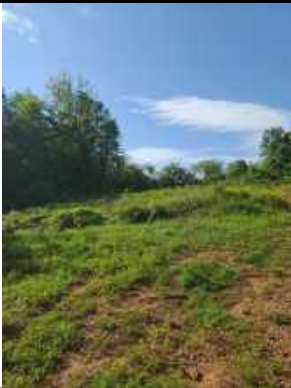
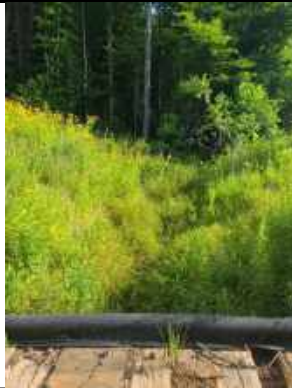
GPS Location	00000		GPS Location	00000	
Field Station#	13600+00		Field Station#	13533+32	
Pic 5 Desc.	Additional photo showing row that has been mowed by a land owner . Documented as non project related activities.		Pic 6 Desc.	Stream observation photo facing upstream during routine inspection today. No issues observed at the time of inspection.

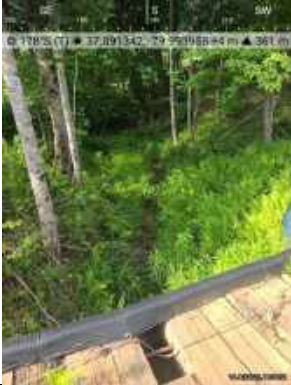
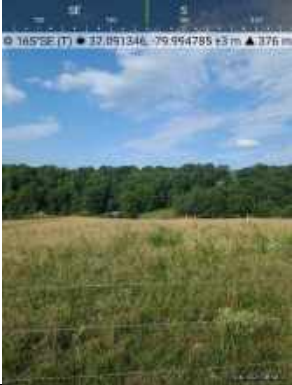
GPS Location	0000	GPS Location	0000		
Field Station#	13533+32	Field Station#	13530+78		
Pic 7 Desc.	Stream observation photo facing downstream during routine inspection today. No issues observed at the time of inspection.		Pic 8 Desc.	Row photo showing vegetation growth. Good coverage noted.	
Insert image here		Insert image here			
GPS Location		GPS Location			
Field Station#		Field Station#			
Pic 9 Desc.		Pic 10 Desc.			
Insert image here		Insert image here			
GPS Location		GPS Location			
Field Station#		Field Station#			
Pic 11 Desc.		Pic 12 Desc.

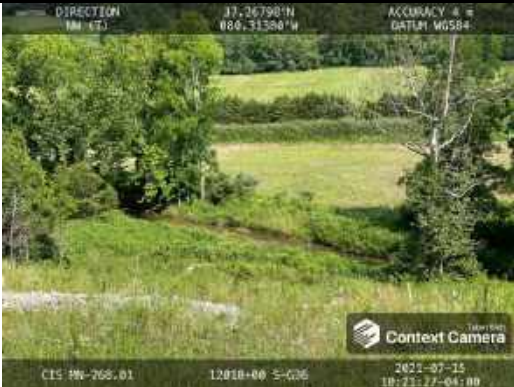
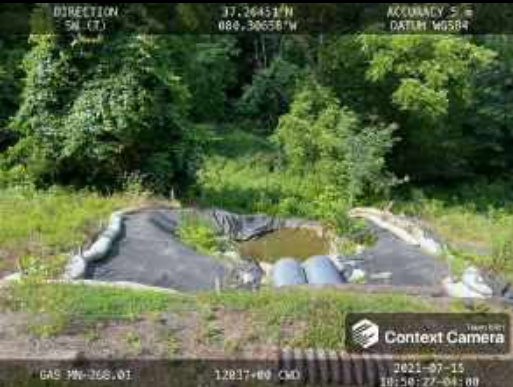
GPS Location	See photo		GPS Location	See photo	
Field Station#	12010+00		Field Station#	12037+00	
Pic 1 Desc.	Stabilized ROW with stream crossing S-G36 in acceptable condition		Pic 2 Desc.	Clean water crossing pipe outlet in acceptable condition

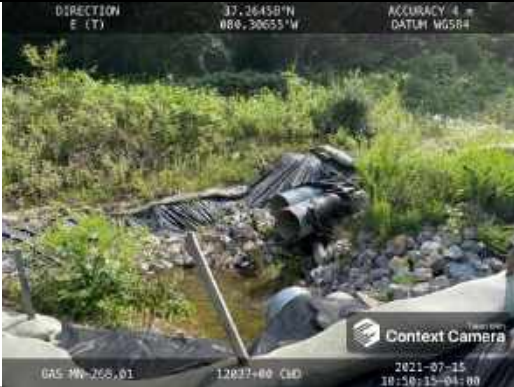
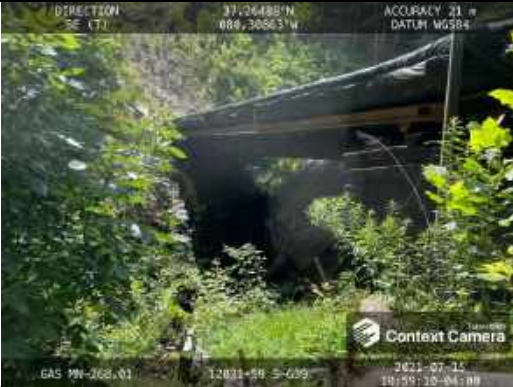
GPS Location	See photo		GPS Location	See photo	
Field Station#	12037+00		Field Station#	12031+59	
Pic 3 Desc.	Clean water crossing pipe inlet in acceptable condition		Pic 4 Desc.	Bridge crossing S-G39 in acceptable condition

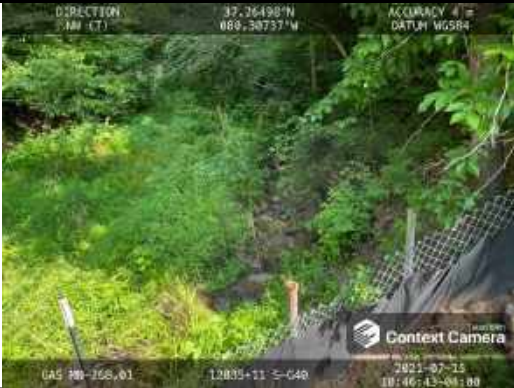
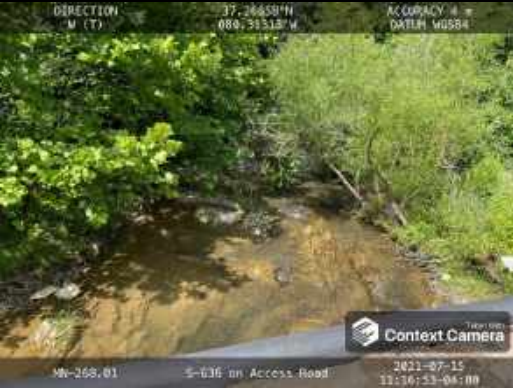
GPS Location	See photo		GPS Location	See photo	
Field Station#	12035+11		Field Station#	12013+97	
Pic 5 Desc.	Stream S-G40 in acceptable condition		Pic 6 Desc.	Stream S-G36 in acceptable condition

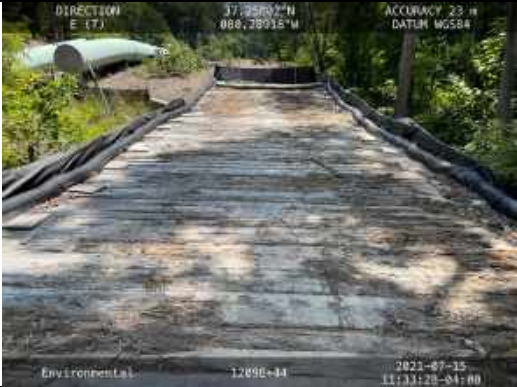
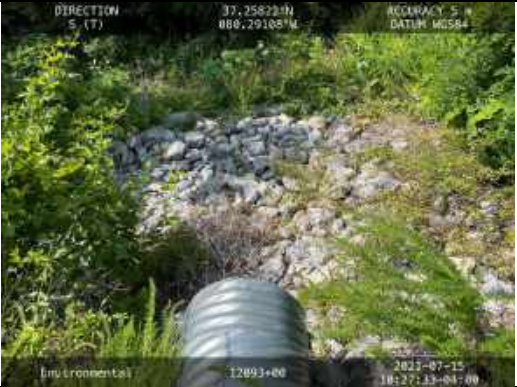
GPS Location	See photo		GPS Location	See photo	
Field Station#	12098+44		Field Station#	12093+00	
Pic 13 Desc.	Stream crossing S-MM13 in acceptable condition		Pic 14 Desc.	Clean water crossing pipe outlet in acceptable

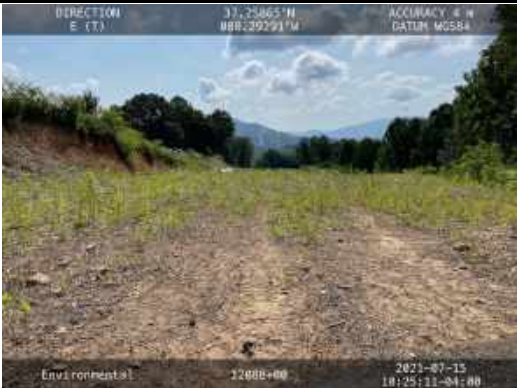
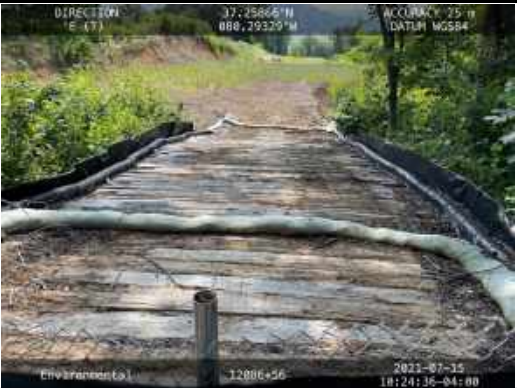
GPS Location	See photo		GPS Location	See photo	
Field Station#	12088+00		Field Station#	12086+55	
Pic 15 Desc.	Stabilized ROW in acceptable condition		Pic 16 Desc.	Because and ECDS at stream crossing S-MM14 in acceptable condition

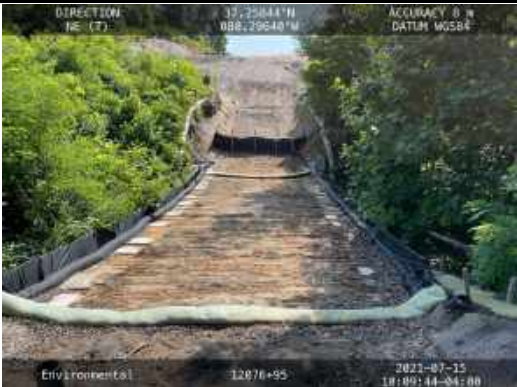
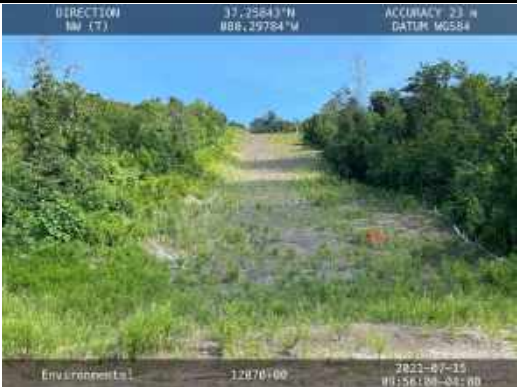
GPS Location	See photo		GPS Location	See photo	
Field Station#	12076+95		Field Station#	12070+00	
Pic 17 Desc.	Bridge and ECDs crossing stream S-MM15 in acceptable condition		Pic 18 Desc.	Stabilized ROW in acceptable condition

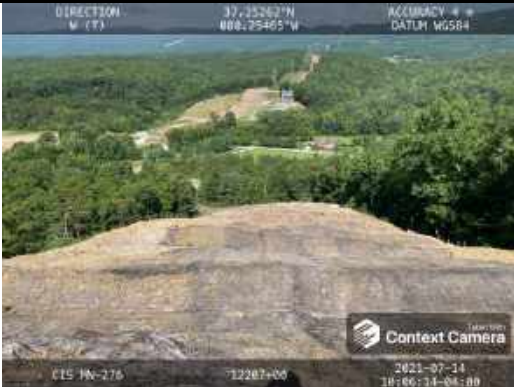
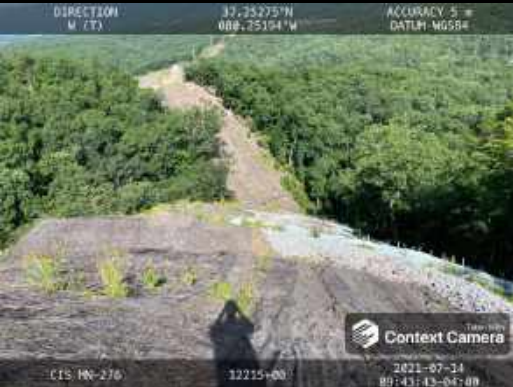
GPS Location	See photo		GPS Location	See photo	
Field Station#	12207+00		Field Station#	12215+00	
Pic 1 Desc.	Stabilized slope in acceptable condition		Pic 2 Desc.	Permanent Waterbars in acceptable condition

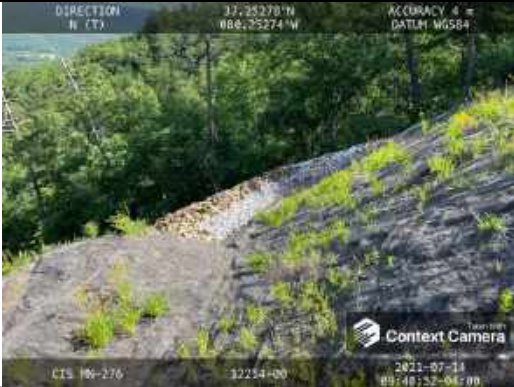
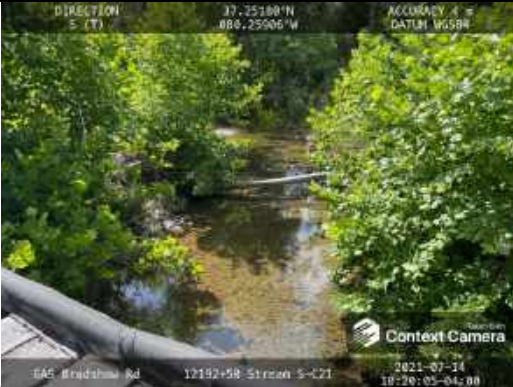
GPS Location	See photo		GPS Location	See photo	
Field Station#	12214+00		Field Station#	12192+50	
Pic 3 Desc.	Permanent rock Weir in acceptable condition		Pic 4 Desc.	Stream crossing S-C21 in acceptable condition

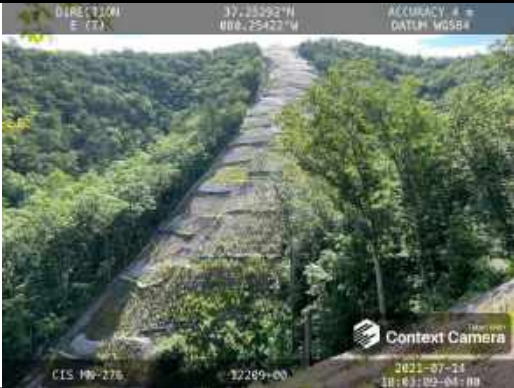
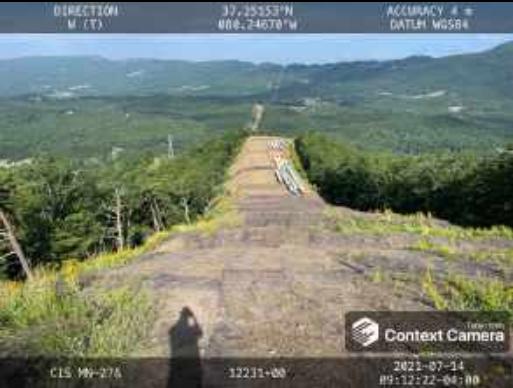
GPS Location	see photo		GPS Location	See photo	
Field Station#	12209+00		Field Station#	12231+00	
Pic 5 Desc.	Stabilized ROW in acceptable condition		Pic 6 Desc.	Stabilized ROW in acceptable condition

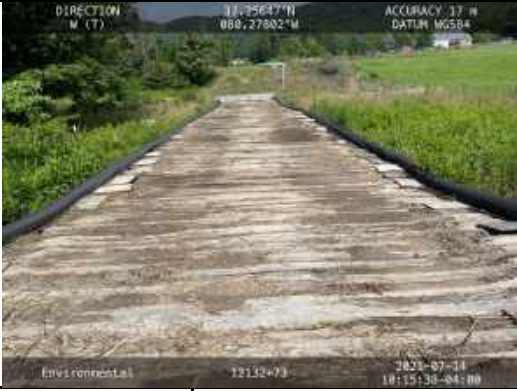
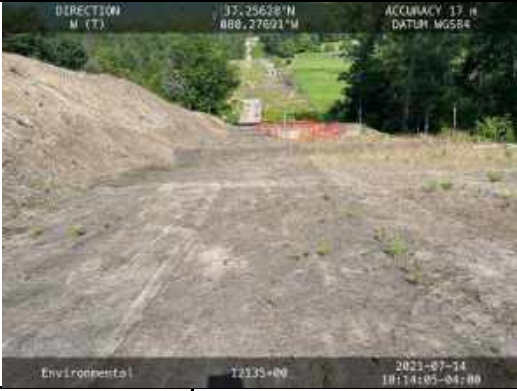
GPS Location	See photo		GPS Location	See photo	
Field Station#	12132+73		Field Station#	12135+00	
Pic 7 Desc.	Bridge and ECDs crossing stream S-C29 in acceptable condition		Pic 8 Desc.	Stabilized ROW in acceptable condition

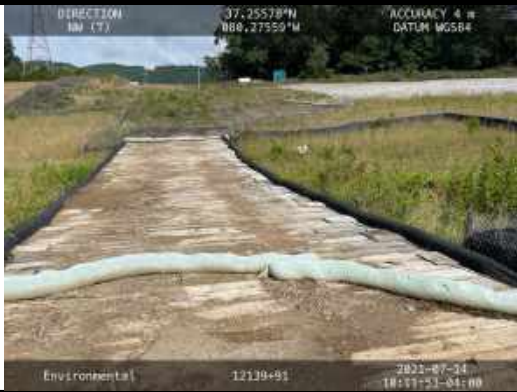
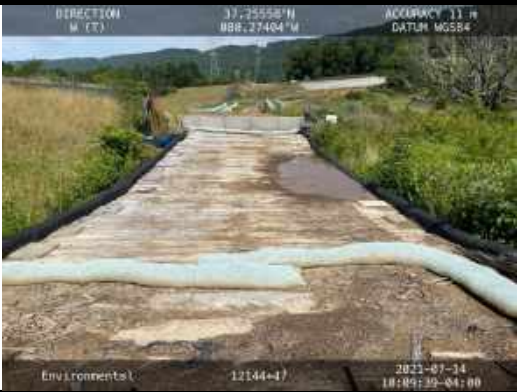
GPS Location	See photo		GPS Location	See photo	
Field Station#	12139+91		Field Station#	12144+47	
Pic 9 Desc.	Wetland W-C6 in acceptable condition		Pic 10 Desc.	Bridge crossing wetland W-C5 in acceptable condition

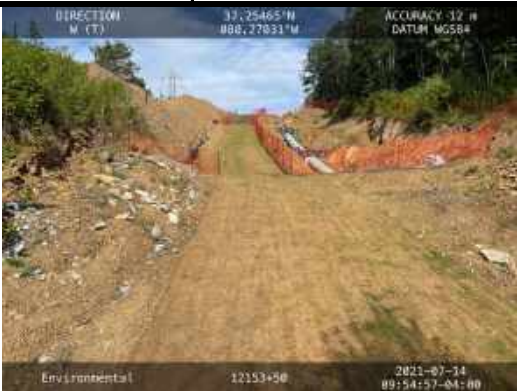
GPS Location	see photo		GPS Location	see photo	
Field Station#	12150+29		Field Station#	12153+50	
Pic 11 Desc.	Drainage feature in acceptable condition		Pic 12 Desc.	Stabilized ROW in acceptable condition

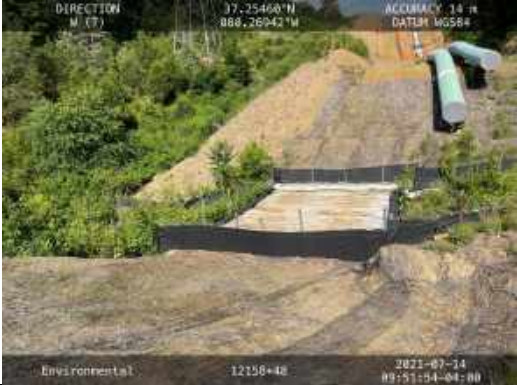
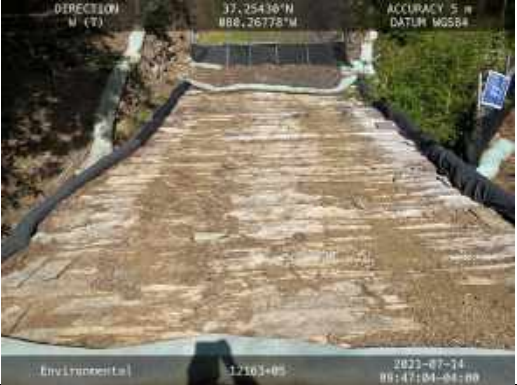
GPS Location	see photo		GPS Location	See photo	
Field Station#	12158+48		Field Station#	12163+05	
Pic 13 Desc.	Clean water crossing in acceptable condition		Pic 14 Desc.	Bridge and ECDs crossing stream S-C25 in acceptable condition

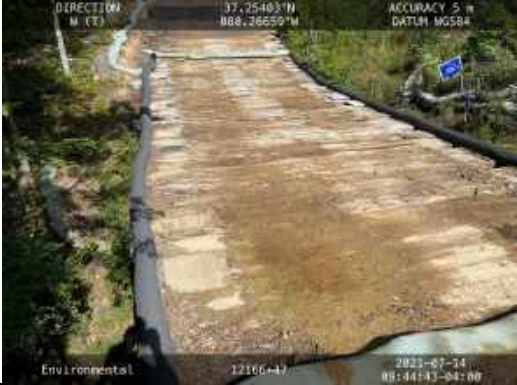
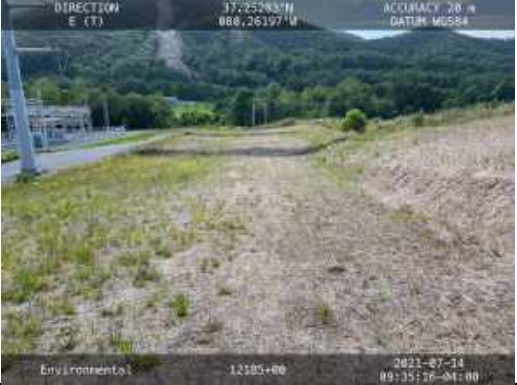
GPS Location	See photo		GPS Location	See photo	
Field Station#	12166+47		Field Station#	12185+00	
Pic 15 Desc.	Bridge and ECDs crossing stream S-C24 in acceptable condition		Pic 16 Desc.	Stabilized ROW in acceptable condition

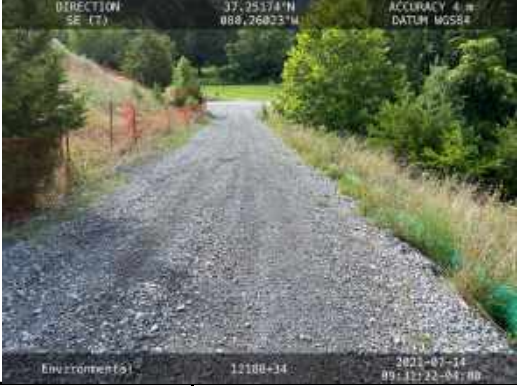
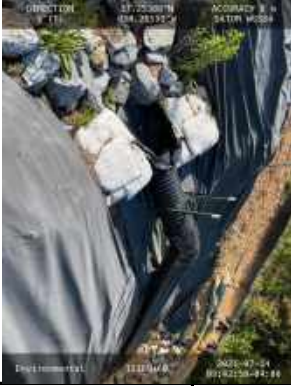
GPS Location	See photo		GPS Location	See photo	
Field Station#	12188+34		Field Station#	12168+60	
Pic 17 Desc.	Access Road MVP-MN-274 in acceptable condition		Pic 18 Desc.	Fill slope drain in acceptable condition

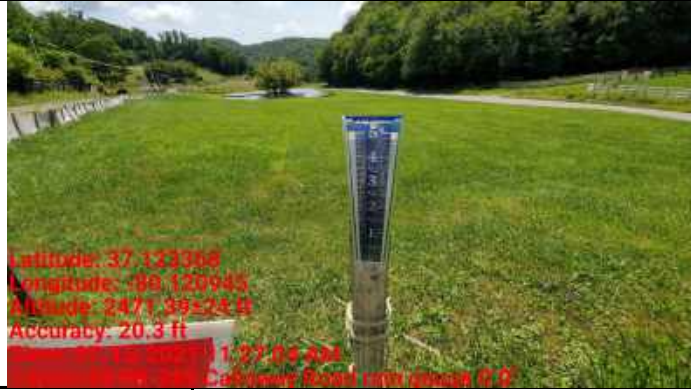
<p>Latitude: 37.123442 Longitude: -80.120355 Elevation: 2615.97±29 ft Accuracy: 30.8 ft Time: 07-15-2021 11:31:11 AM 13012+50 GAS of the BRP</p>			
GPS Location	See pic for GPS location		GPS Location	See pic for GPS location	
Field Station#	13033+59		Field Station#	13017+50	
Pic 1 Desc.	Callaway Road rain gauge. 0.0" total precipitation.		Pic 2 Desc.	GAS of the BRP, wooded portion.

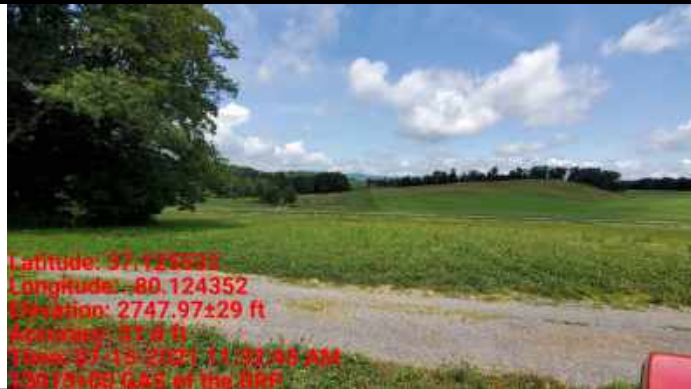
GPS Location	See pic for GPS location		GPS Location	See pic for GPS location	
Field Station#	13015+00		Field Station#	13012+40	
Pic 3 Desc.	GAS of the BRP looking upstream.		Pic 4 Desc.	CIS of the BRP motorway.

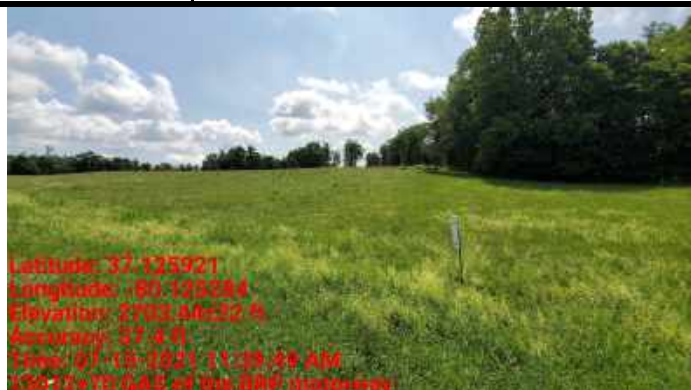
<p>Latitude: 37.128443 Longitude: -80.124658 Elevation: 2435.11±29 ft Accuracy: 34.8 ft Time: 07-15-2021 11:42:45 AM 12996+00 GAS of US-221</p>			
GPS Location	See pic for GPS location		GPS Location	See pic for GPS location	
Field Station#	13012+70		Field Station#	12996+00	
Pic 5 Desc.	GAS of the BRP motorway.		Pic 6 Desc.	GAS of the US-221 road crossing restored portion.

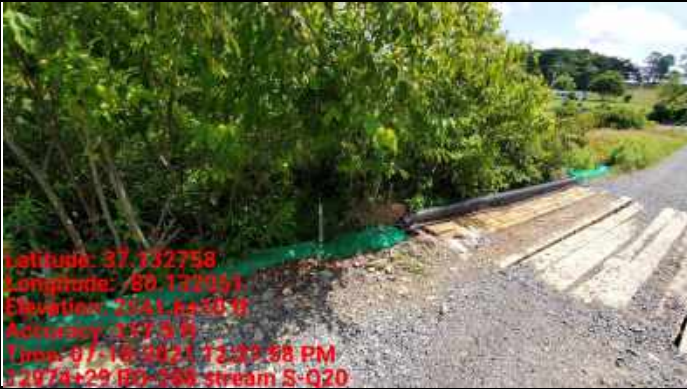
<p>Latitude: 37.13495 Longitude: -80.127994 Elevation: 2600.1±53 ft Accuracy: 32.5 ft Time: 07-15-2021 12:43:07 PM 12956+00 CIS of RO-287</p>		
GPS Location	See pic for GPS location		GPS Location	See pic for GPS location	
Field Station#	12974+29		Field Station#	12956+00	
Pic 13 Desc.	Downstream side of stream S-Q20 on RO-288.		Pic 14 Desc.	Sediment trap on the CIS of RO-287.

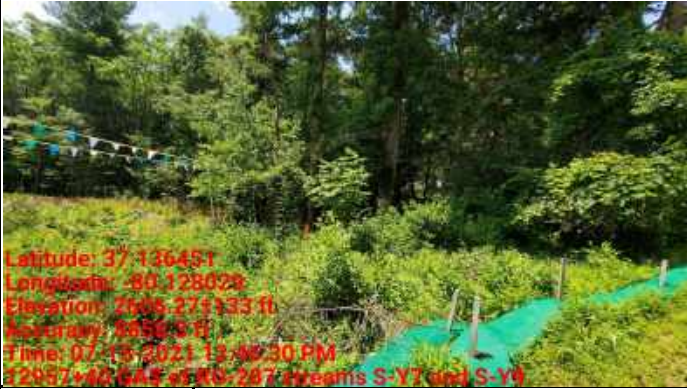
GPS Location	See pic for GPS location		GPS Location	See pic for GPS location	
Field Station#	12957+00		Field Station#	12958+00	
Pic 15 Desc.	Streams S-Y7 and S-Y9 on the GAS of RO-287.		Pic 16 Desc.	Downstream side of streams S-Y7 and S-Y8.

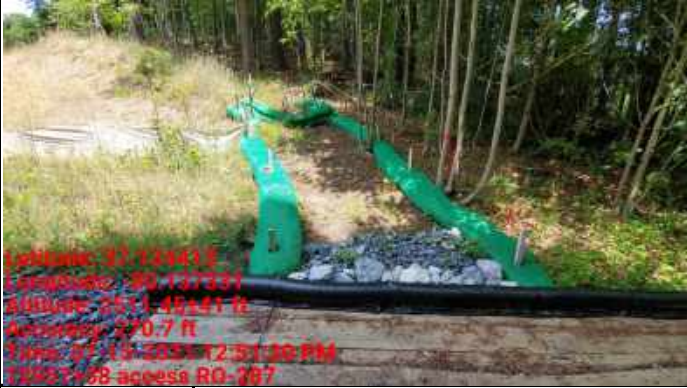
<p>Latitude: 37.145679 Longitude: -80.131282 Elevation: 2456.4±75 ft Accuracy: 40.7 ft Time: 07-15-2021 01:08:30 PM 12915+20 access RO-286</p>		
GPS Location	See pic for GPS location		GPS Location	See pic for GPS location	
Field Station#	12957+38		Field Station#	12915+20	
Pic 17 Desc.	CWDB outlet at RO-288.		Pic 18 Desc.	Access road RO-286.

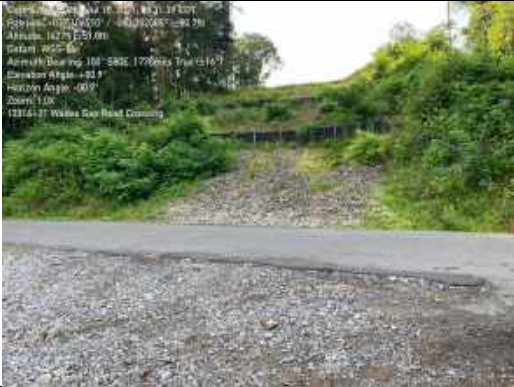
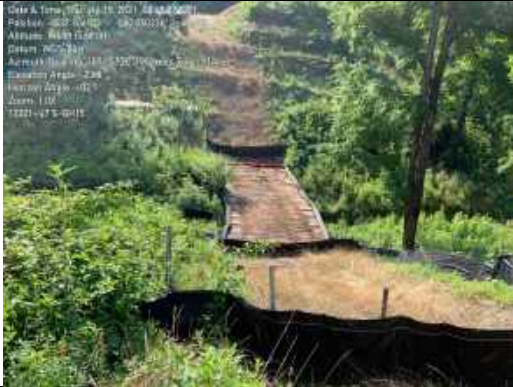
GPS Location	0	GPS Location	0		
Field Station#	13316+21	Field Station#	13321+47		
Pic 1 Desc.	Wades Gap Road Crossing in good condition and RCE in good condition and functioning properly		Pic 2 Desc.	MVP-S-GH15 and corresponding buffer zone in good condition

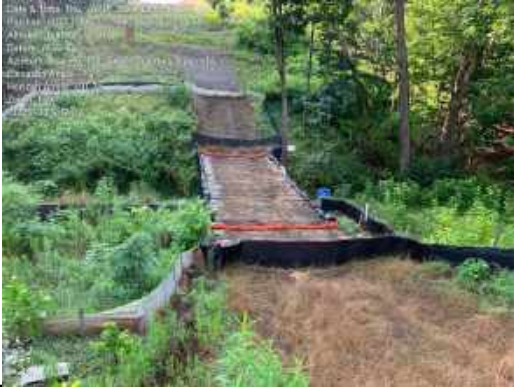
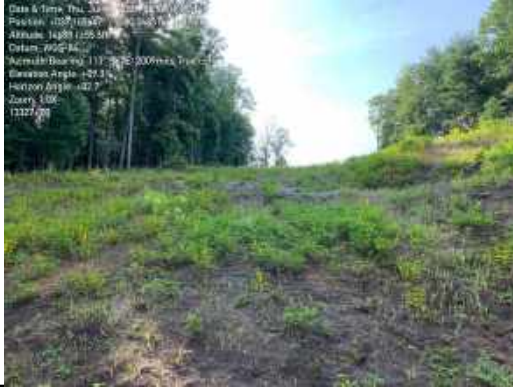
GPS Location	0	GPS Location	0		
Field Station#	13325+30	Field Station#	13327+00		
Pic 3 Desc.	MVP-S-GH14 and corresponding buffer zone in good condition		Pic 4 Desc.	ROW and ECDs in good condition with good vegetation establishing across ROW

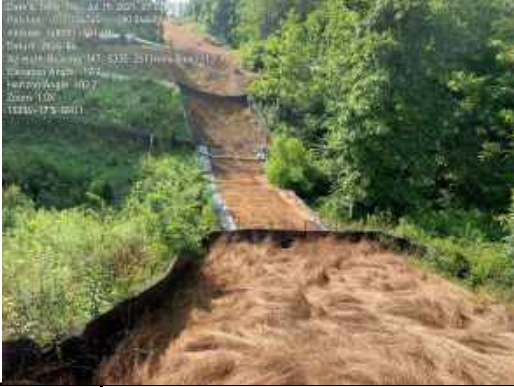
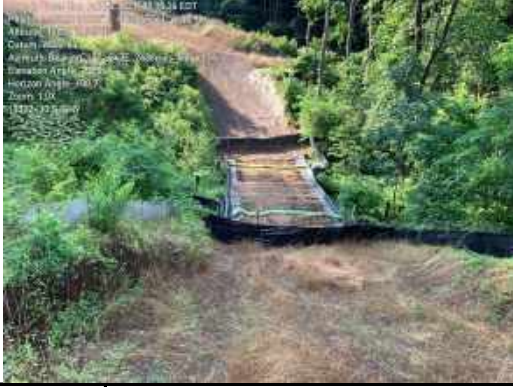
GPS Location	0	GPS Location	0		
Field Station#	13334+17	Field Station#	13337+13		
Pic 5 Desc.	MVP-S-GH11 and corresponding buffer zone in good condition		Pic 6 Desc.	MVP-S-GH9 and corresponding buffer zone in good condition

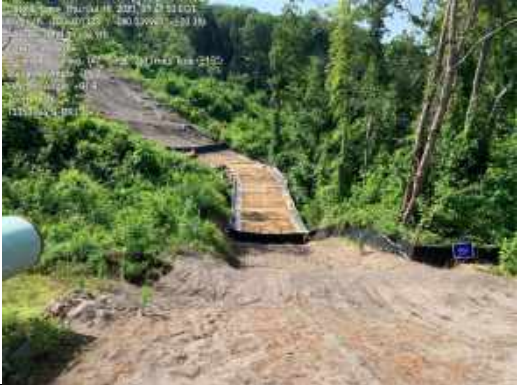
GPS Location	0	GPS Location	0		
Field Station#	13358+64	Field Station#	13366+50		
Pic 13 Desc.	MVP-S-RR11 and corresponding buffer zone in good condition	Pic 14 Desc.	ROW and ECDs in good condition and ROW is stable

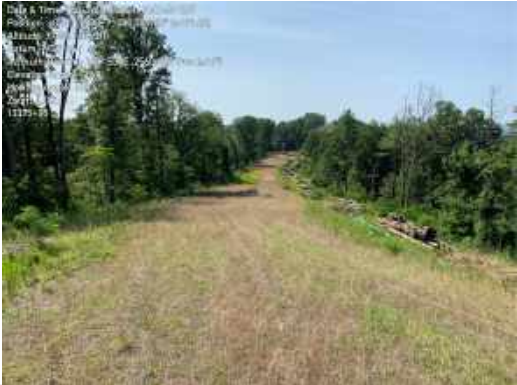
GPS Location	0	GPS Location	0		
Field Station#	13375+25	Field Station#	13413+05		
Pic 15 Desc.	ROW and ECDs in good condition with good vegetation establishing across ROW	Pic 16 Desc.	MVP-S-IJ1 and corresponding buffer zone in good condition

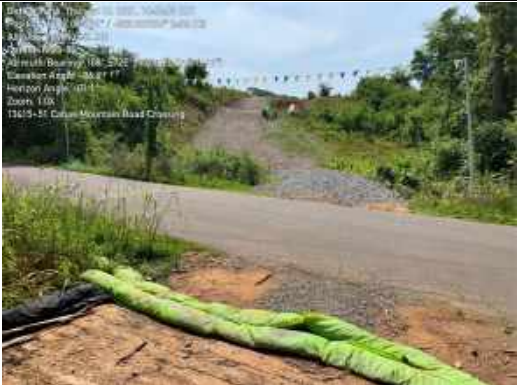
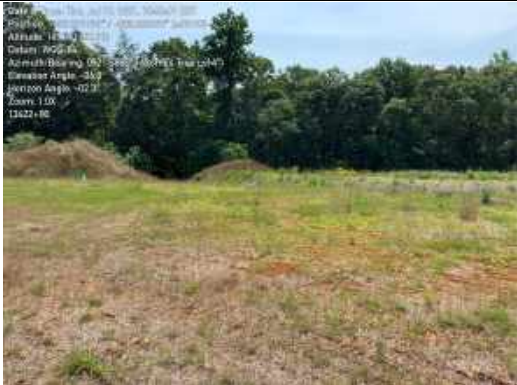
GPS Location	0	GPS Location	0		
Field Station#	13415+51	Field Station#	13422+00		
Pic 17 Desc.	Cahas Mountain Road Crossing in good condition and RCE in good condition and functioning properly	Pic 18 Desc.	ROW and ECDs in good condition with good vegetation establishing across ROW

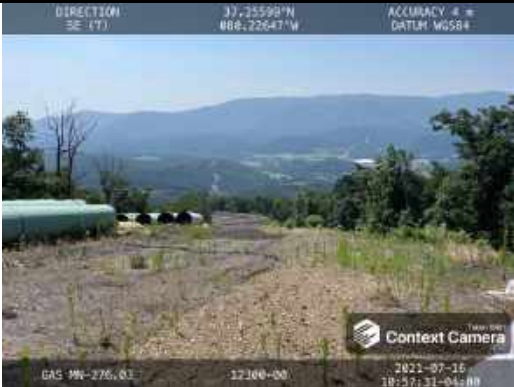
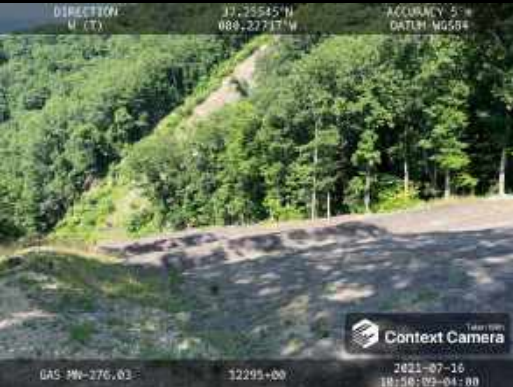
GPS Location	See photo		GPS Location	See photo	
Field Station#	12300+00		Field Station#	12295+00	
Pic 1 Desc.	Stabilized ROW in acceptable condition		Pic 2 Desc.	Stabilized slope in acceptable condition

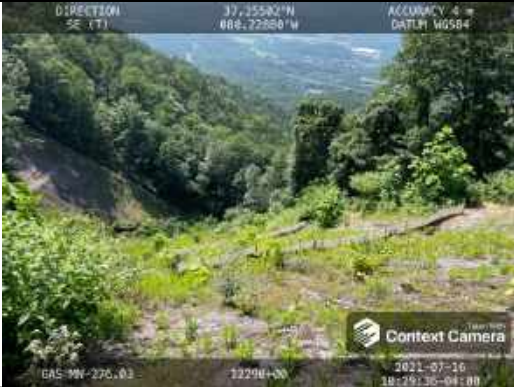
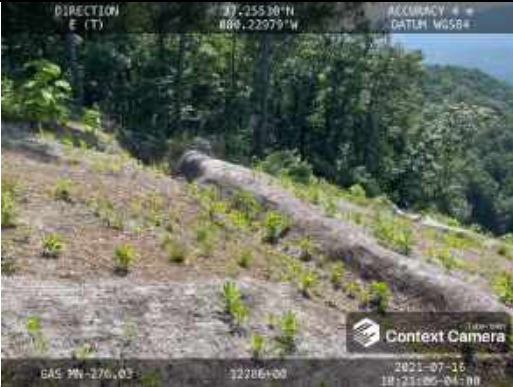
GPS Location	See photo		GPS Location	See photo	
Field Station#	12290+00		Field Station#	12286+00	
Pic 3 Desc.	Stabilized slope in acceptable condition		Pic 4 Desc.	Water bar in acceptable condition
