Visual Site Inspection Report

Project Name	H-600 Pipeline Spread H	AFE	124300138	Spread	H-600 Pipeline Spread H
Contractor	Precision			Report #	25774
Inspector	Jonathan Altizer			Date/Time	7/12/2021 6:30 PM
Permit #	TBD	Inspection Type	VA SWPP	Station Begin	13024+00
State	VA	Inspection Area	Partial	Station End	13141+65
County	Roanoke	Ground	Damp	Temperature (°F)	83.00
Municipality	N/A	Weather	Sunny	Rain Gauge (in)	0.60
				Rain Accumulation Time (days)	2.00

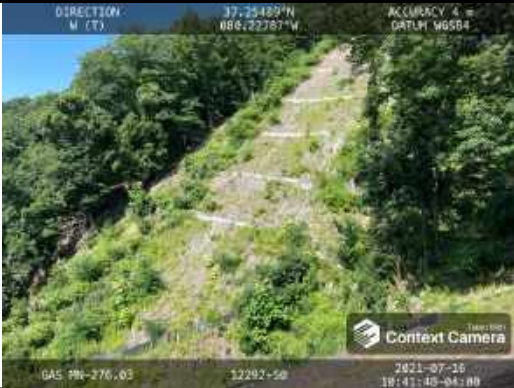
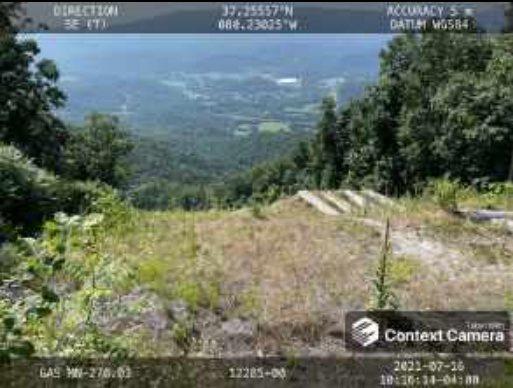
GPS Location	See photo		GPS Location	See photo	
Field Station#	12292+50		Field Station#	12285+00	
Pic 5 Desc.	Stabilized slope in acceptable condition		Pic 6 Desc.	Stabilized slope in acceptable condition

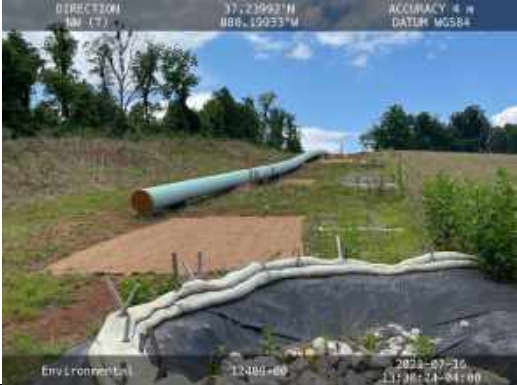
GPS Location	See photo		GPS Location	See photo	
Field Station#	12409+00		Field Station#	12418+00	
Pic 7 Desc.	PPL repaired the rills and stabilized the areas		Pic 8 Desc.	Stabilized slope in acceptable condition

7. Identify all remedial measures that have been taken since the previous inspection was conducted.					
Comments (Reference above questions as appropriate.)					
<p>A SWPPP inspection was performed today between the right-of-way(ROW) crossing on access road MVP-MN-276.03 on Reese Mountain and Highway 11, stations 12284+75 to 12443+75. Included in today's inspection were streams S-0016, S-NN19, and S-NN16. No impacts or any other deficiencies were observed at any of these streams or their corresponding buffer zones. During the inspection there was a few spots of erosion that needs to be fixed and stabilized. These locations were STA#12383+50 and between station numbers 12398+00-12408+00. The rest of the ROW throughout this section remains in acceptable condition. All ECDs were observed to be in good working order. Slope drains, clean water diversion pipes, and their inlets and outlets were in satisfactory condition and functioning properly. PPL had a crew that was in the area working to repair the rilling and stabilize the ROW.</p>

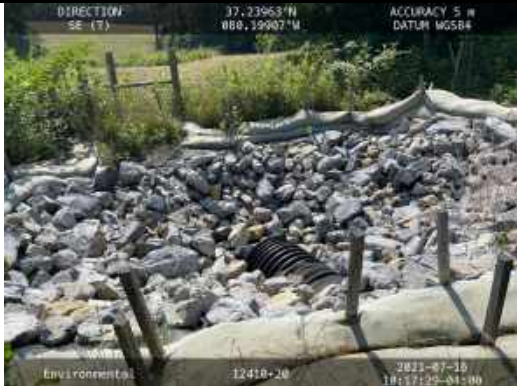
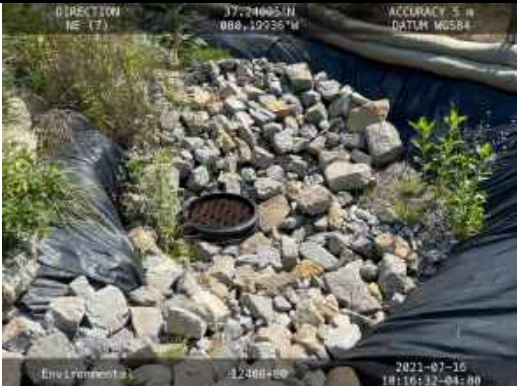
GPS Location	See photo		GPS Location	See photo	
Field Station#	12410+20		Field Station#	12408+80	
Pic 9 Desc.	Clean water crossing outlet in acceptable condition		Pic 10 Desc.	Clean water crossing pipe inlet in acceptable condition

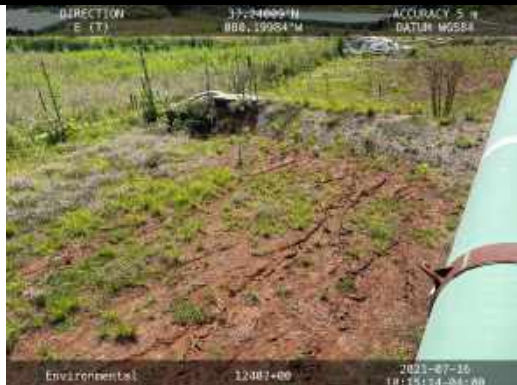
GPS Location	See photo		GPS Location	See photo	
Field Station#	12407+00		Field Station#	12393+22	
Pic 11 Desc.	Rilling within the temporary stabilized ROW		Pic 12 Desc.	Stabilized ROW in acceptable condition

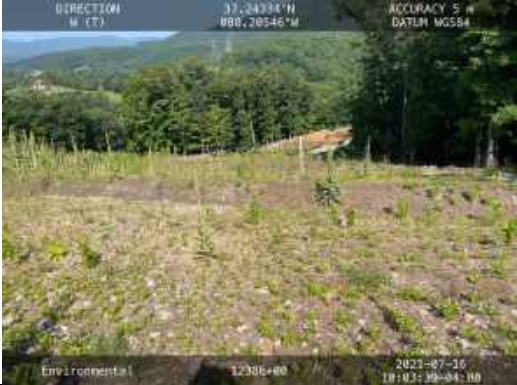
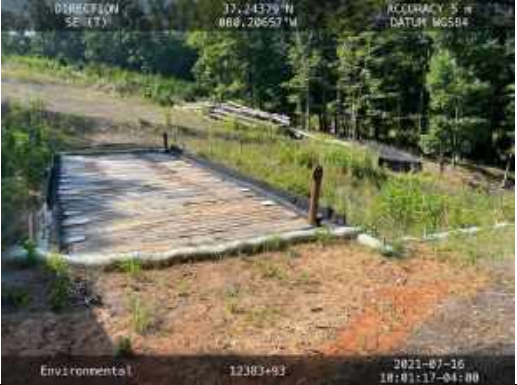
GPS Location	see photo		GPS Location	See photo	
Field Station#	12386+00		Field Station#	12383+93	
Pic 13 Desc.	Stabilized ROW in acceptable condition		Pic 14 Desc.	Clean water crossing in acceptable condition

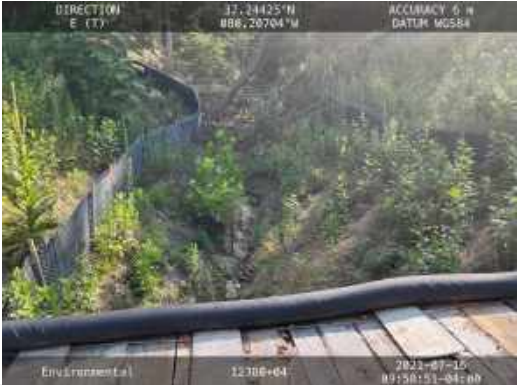
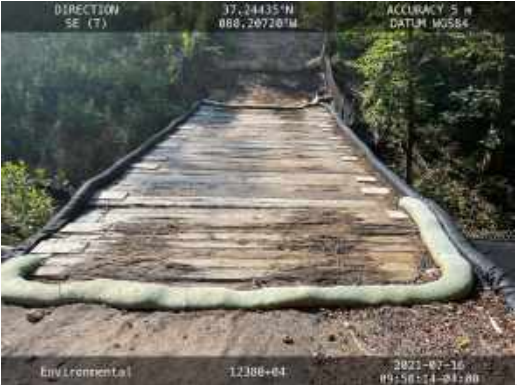
GPS Location	See photo		GPS Location	See photo	
Field Station#	12380+04		Field Station#	12380+04	
Pic 15 Desc.	Stream crossing S-NN19 in acceptable condition		Pic 16 Desc.	Bridge and ECDs at stream crossing S-NN19 in acceptable condition

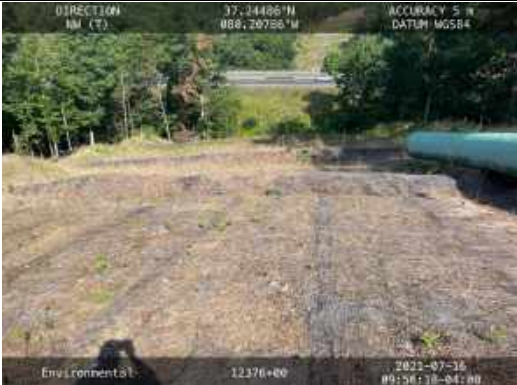
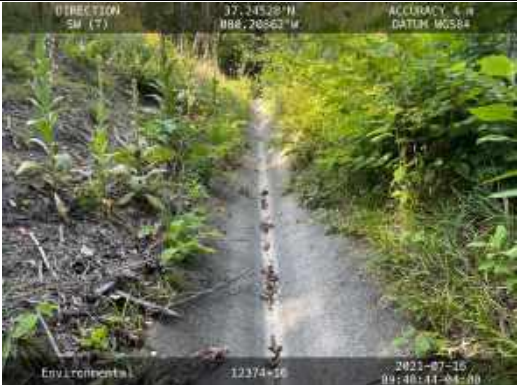
GPS Location	See photo		GPS Location	See photo	
Field Station#	12376+00		Field Station#	12374+16	
Pic 17 Desc.	Stabilized slope in acceptable condition		Pic 18 Desc.	Stream crossing S-OO16 in acceptable condition

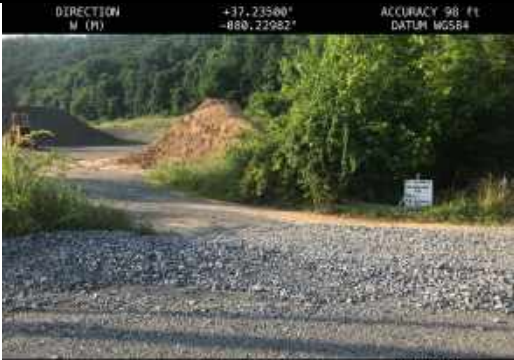
GPS Location	MVP-PY-006 See photo for gps data	GPS Location	MVP-PY-006 See photo for gps data		
Field Station#	+0	Field Station#	+0		
Pic 1 Desc.	Condition of spoil pile adjacent to LOD on VDOT property. Not stabilized. Looking S.	Pic 2 Desc.	Condition of triple stack compost filter sock and signage at feature W-008. Over grown with vegetation. Looking E.

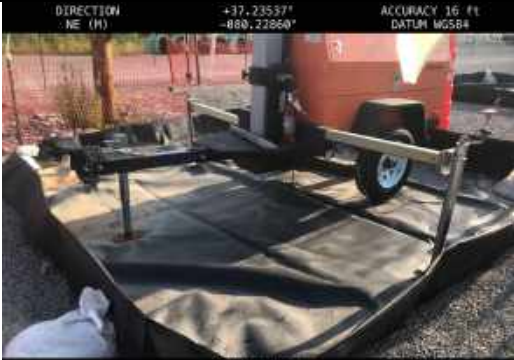
GPS Location	MVP-PY-006 See photo for gps data	GPS Location	MVP-PY-006 See photo for gps data		
Field Station#	+0	Field Station#	+0		
Pic 3 Desc.	Condition of containment under light plant. Free of stormwater. Looking NE.	Pic 4 Desc.	Secondary containment on site and in place for tankers offloading fuel. Looking W.

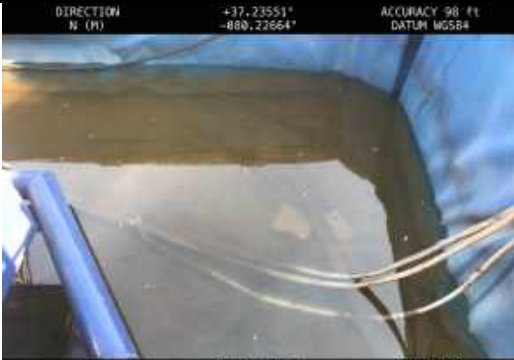
Pic 5 Desc.	Blue Bulk Fuel tanks holding stormwater. Looking N.	Pic 6 Desc.	Blue Bulk Fuel tanks no leaky internal fittings. Looking W.

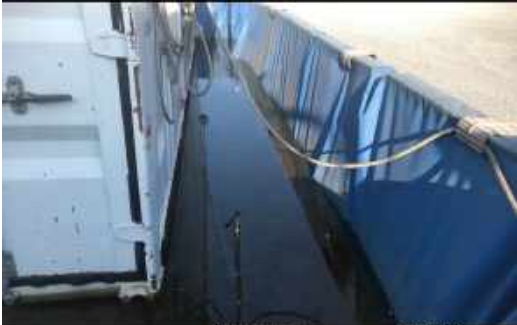
MVP-PY-006_071621 Condition of containment 2021-07-16 00:00:52-04:00		DIRECTION N (M) +37.23562° -880.22681° ACCURACY 16 ft DATUM WGS84

MVP-PY-006_071621 No leaky internal fittings 2021-07-16 00:09:27-04:00			
GPS Location	MVP-PY-006 See photo for gps data		GPS Location	MVP-PY-006 See photo for gps data	
Field Station#	+0		Field Station#	+0	
Pic 7 Desc.	Off Road Fuel unit containment holding stormwater. Looking W.		Pic 8 Desc.	Off Road Fuel unit no leaky internal fittings. Looking NW.	
DIRECTION N (M) +37.23563° -880.22685° ACCURACY 16 ft DATUM WGS84

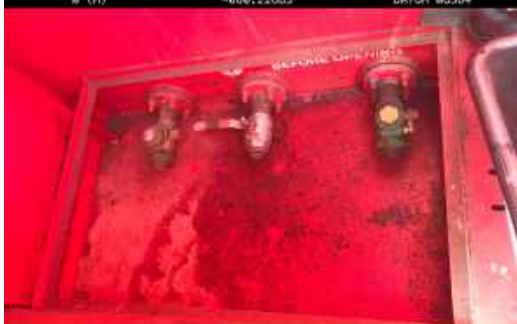
MVP-PY-006_071621 Condition of internal drip pan 2021-07-16 00:09:32-04:00		DIRECTION N (M) +37.23563° -880.22692° ACCURACY 16 ft DATUM WGS84

GPS Location	MVP-PY-006 See photo for gps data		GPS Location	MVP-PY-006 See photo for gps data	
Field Station#	+0		Field Station#	+0	
Pic 9 Desc.	Off Road Fuel unit condition of internal drip pan. Free of fluids. Looking W.		Pic 10 Desc.	Blue Bulk Fuel tanks no leaky fittings or nozzles. Looking N.	
DIRECTION SE (M) +37.23560° -880.22675° ACCURACY 16 ft DATUM WGS84

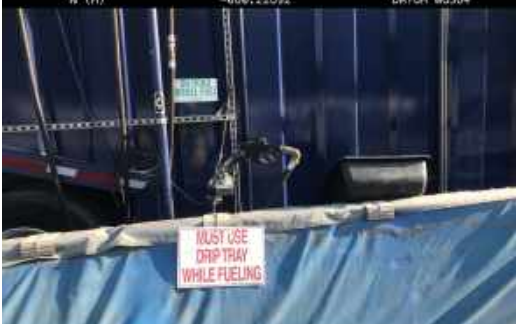
MVP-PY-006_071621 No leaky fittings or nozzles 2021-07-16 00:10:29-04:00

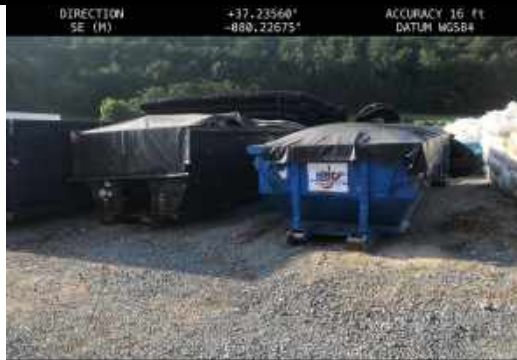
MVP-PY-006_071621 No fluids around hazardous waste dump. 2021-07-16 00:11:20-04:00		DIRECTION SW (M) +37.23555° -880.22645° ACCURACY 33 ft DATUM WGS84

MVP-PY-006_071621 No loose trash around dumpsters 2021-07-16 00:11:57-04:00			
GPS Location	MVP-PY-006 See photo for gps data		GPS Location	MVP-PY-006 See photo for gps data	
Field Station#	+0		Field Station#	+0	
Pic 11 Desc.	No fluids or deposits around hazardous waste dumpsters. Looking SE.		Pic 12 Desc.	No loose trash around dumpsters. Looking SW.

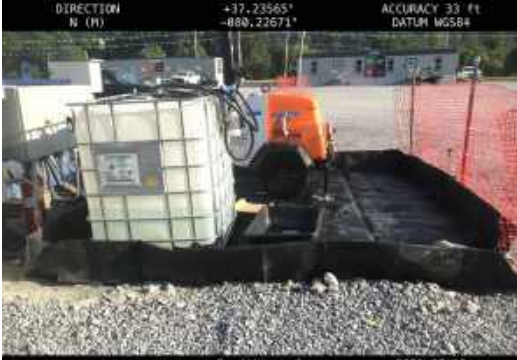
<p>DIRECTION N (M) +37.23565° -880.22671° ACCURACY 33 ft DATUM WGS84</p> <p>MVP-PY-006_071621 Condition of containment 2021-07-16 00:11:36-04:00</p>

<p>DIRECTION NM (M) +37.23476° -880.22573° ACCURACY 16 ft DATUM WGS84</p> <p>MVP-PY-049_071621 Condition of CFS along east LOD 2021-07-16 00:14:32-04:00</p>			
GPS Location	MVP-PY-006 See photo for gps data		GPS Location	MVP-PY-006 See photo for gps data	
Field Station#	+0		Field Station#	+0	
Pic 13 Desc.	Condition of containment under DEF container and light plant. Free of stormwater. Looking N.		Pic 14 Desc.	Condition of triple stack compost filter sock along east LOD. Looking N.

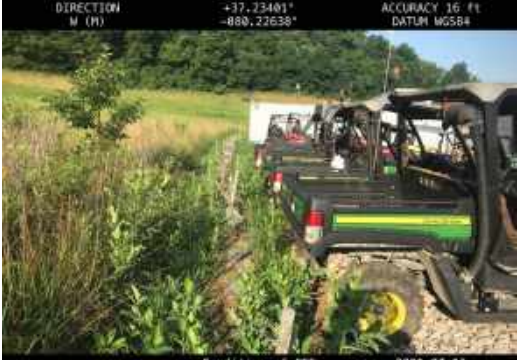
<p>DIRECTION M (M) +37.23401° -880.22638° ACCURACY 16 ft DATUM WGS84</p> <p>MVP-PY-006_071621 Condition of CFS along south LOD 2021-07-16 00:15:58-04:00</p>

GPS Location	MVP-PY-006 See photo for gps data		GPS Location	MVP-PY-006 See photo for gps data	
Field Station#	+0		Field Station#	+0	
Pic 15 Desc.	Condition of triple stack compost filter sock along south LOD. Over grown with vegetation. Looking W.		Pic 16 Desc.	Condition of containment under hazardous waste dumpsters. Free of stormwater. Looking E.

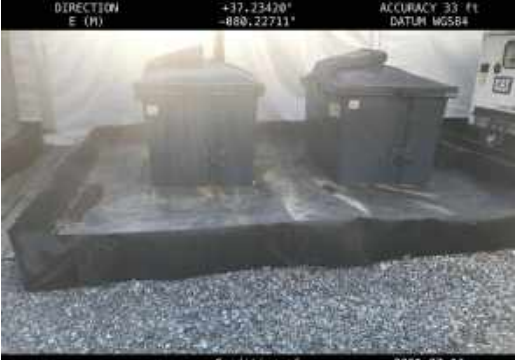
<p>DIRECTION E (M) +37.23420° -880.22711° ACCURACY 33 ft DATUM WGS84</p> <p>MVP-PY-006_071621 Condition of containment 2021-07-16 00:17:27-04:00</p>

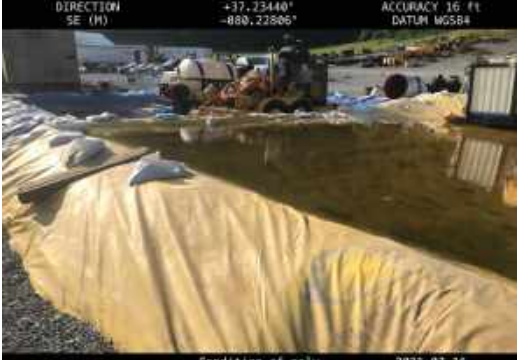
<p>DIRECTION SE (M) +37.23440° -880.22806° ACCURACY 16 ft DATUM WGS84</p> <p>MVP-PY-006_071621 Condition of poly lined containments 2021-07-16 00:31:54-04:00</p>

<p>DIRECTION N (M) +37.23462° -880.22803° ACCURACY 16 ft DATUM WGS84</p> <p>MVP-PY-006_071621 Condition of trays & containment 2021-07-16 00:32:48-04:00</p>			
GPS Location	MVP-PY-006 See photo for gps data		GPS Location	MVP-PY-006 See photo for gps data	
Field Station#	+0		Field Station#	+0	
Pic 17 Desc.	Condition of poly lined rock berm containment. Holding stormwater. Looking SE.		Pic 18 Desc.	Condition of trays and containment under toilets. Looking N.

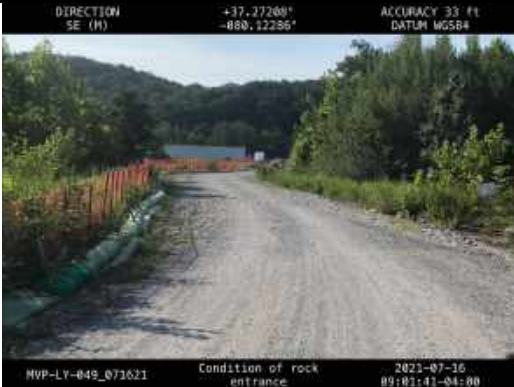
<p>DIRECTION SE (H) +37.27288° -880.12298° ACCURACY 33 ft DATUM WGS84 MVP-LY-049_071621 Condition of rock entrance 2021-07-16 09:03:41-04:00</p>

<p>DIRECTION SW (H) +37.27092° -880.12211° ACCURACY 16 ft DATUM WGS84 MVP-LY-049_071621 Condition of containment 2021-07-16 09:05:00-04:00</p>			
GPS Location	MVP-LY-049 See photo for gps data		GPS Location	MVP-LY-049 See photo for gps data	
Field Station#	+0		Field Station#	+0	
Pic 1 Desc.	Condition of rock entrance. No sediment on stone surface. Looking SE.		Pic 2 Desc.	Condition of containment under light plant. Free of stormwater. Looking SW.

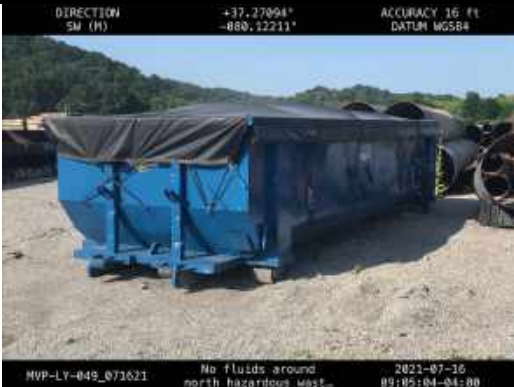
<p>DIRECTION SW (H) +37.27094° -880.12211° ACCURACY 16 ft DATUM WGS84 MVP-LY-049_071621 No fluids around north hazardous waste 2021-07-16 09:05:04-04:00</p>

GPS Location	MVP-LY-049 See photo for gps data		GPS Location	MVP-LY-049 See photo for gps data	
Field Station#	+0		Field Station#	+0	
Pic 3 Desc.	No fluids or deposits around north hazardous waste dumpster. Looking SW.		Pic 4 Desc.	Condition of triple stack compost filter sock and safety fence along north LOD. Over grown with vegetation. Looking NE.

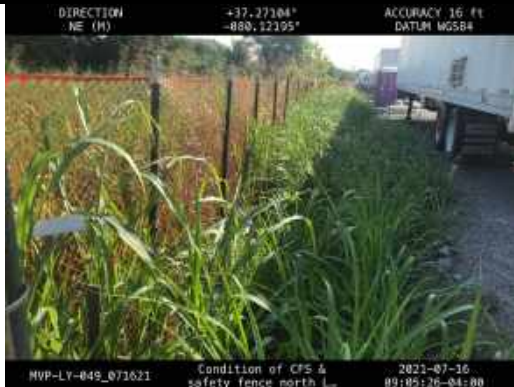
<p>DIRECTION NE (H) +37.27104° -880.12195° ACCURACY 16 ft DATUM WGS84 MVP-LY-049_071621 Condition of CFS & safety fence north L 2021-07-16 09:05:26-04:00</p>

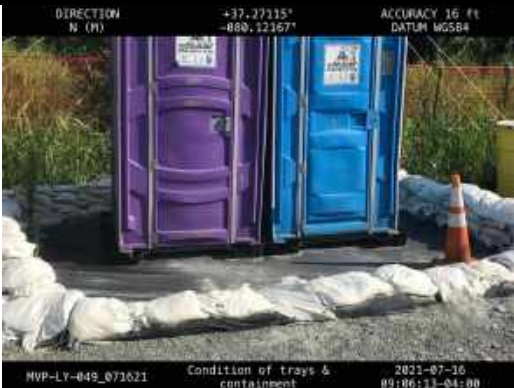
<p>DIRECTION N (H) +37.27115° -880.12157° ACCURACY 16 ft DATUM WGS84 MVP-LY-049_071621 Condition of trays & containment 2021-07-16 09:06:11-04:00</p>

<p>DIRECTION N (H) +37.27114° -880.12150° ACCURACY 16 ft DATUM WGS84 MVP-LY-049_071621 Condition of containment 2021-07-16 09:06:23-04:00</p>			
GPS Location	MVP-LY-049 See photo for gps data		GPS Location	MVP-LY-049 See photo for gps data	
Field Station#	+0		Field Station#	+0	
Pic 5 Desc.	Condition of trays and containment under toilets. Looking N.		Pic 6 Desc.	Condition of containment under generator. Free of fluids. Looking N.

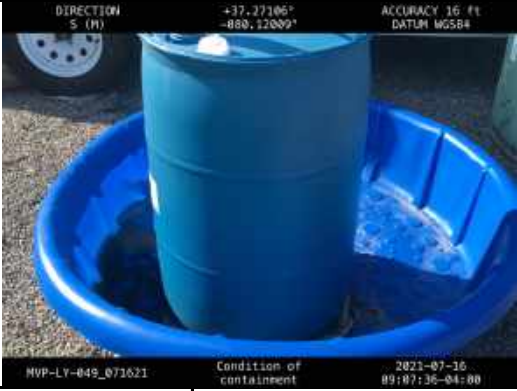
<p>DIRECTION S (M) +37.27106° -880.12009° ACCURACY 16 ft DATUM WGS84 MVP-LY-049_071621 Condition of containment 2021-07-16 09:07:36-04:00</p>		  <p>DIRECTION W (M) +37.27078° -880.11998° ACCURACY 33 ft DATUM WGS84 MVP-LY-049_071621 Condition of CFS & safety fence south L 2021-07-16 09:00:13-04:00</p>			
GPS Location	MVP-LY-049 See photo for gps data		GPS Location	MVP-LY-049 See photo for gps data	
Field Station#	+0		Field Station#	+0	
Pic 7 Desc.	Condition of containment under barrel of toilet chemical. Looking S.		Pic 8 Desc.	Condition of triple stack compost filter sock and safety fence along south LOD. Over grown with vegetation. Looking W.	
  <p>DIRECTION S (M) +37.27004° -880.12270° ACCURACY 33 ft DATUM WGS84 MVP-LY-049_071621 Containment under stored trailer 2021-07-16 09:10:42-04:00</p>

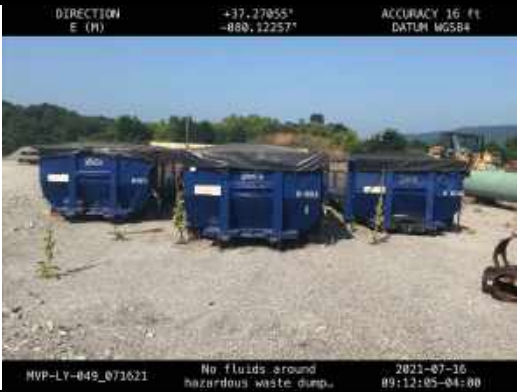
<p>DIRECTION E (M) +37.27055° -880.12257° ACCURACY 16 ft DATUM WGS84 MVP-LY-049_071621 No fluids around hazardous waste dump 2021-07-16 09:12:05-04:00</p>

GPS Location	MVP-LY-049 See photo for gps data		GPS Location	MVP-LY-049 See photo for gps data	
Field Station#	+0		Field Station#	+0	
Pic 9 Desc.	Condition of containment under stored trailer. Looking S.		Pic 10 Desc.	No fluids or deposits around hazardous waste dumpsters. Noted 11 trap straps are missing. Looking W.	
  <p>DIRECTION W (M) +37.27041° -880.12349° ACCURACY 33 ft DATUM WGS84 MVP-LY-049_071621 Condition of temporary trash tran 2021-07-16 09:13:02-04:00</p>		  <p>DIRECTION SW (M) +37.27059° -880.12354° ACCURACY 16 ft DATUM WGS84 MVP-LY-049_071621 No loose trash around north dumpster 2021-07-16 09:13:14-04:00</p>			
GPS Location	MVP-LY-049 See photo for gps data		GPS Location	MVP-LY-049 See photo for gps data	
Field Station#	+0		Field Station#	+0	
Pic 11 Desc.	Condition of temporary trash transfer pit. Debris inside boundary of pit. Looking W.		Pic 12 Desc.	No loose trash around north dumpster or in the yard. Looking NW.

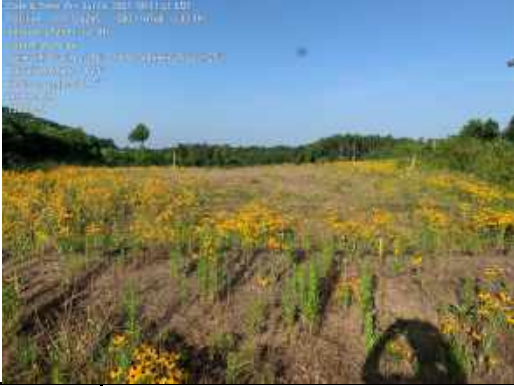
GPS Location	0	GPS Location	0		
Field Station#	13033+59	Field Station#	13030+00		
Pic 1 Desc.	ROW and ECDs in good condition, with good vegetation established across ROW	Pic 2 Desc.	ROW and ECDs in good condition, with good vegetation established across ROW

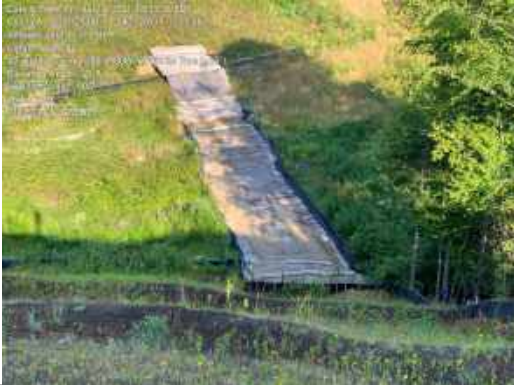
GPS Location	0	GPS Location	0		
Field Station#	13024+06	Field Station#	13039+00		
Pic 3 Desc.	MVP-S-G24 and S-G25 in good condition	Pic 4 Desc.	ROW and ECDs in good condition, with good vegetation established across ROW

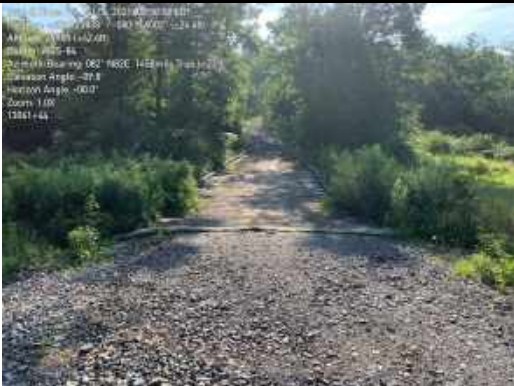
GPS Location	0	GPS Location	0		
Field Station#	13061+44	Field Station#	13061+00		
Pic 5 Desc.	MVP-FR-290 and equipment bridge in good condition	Pic 6 Desc.	ROW and ECDs in good condition, with good vegetation established across ROW

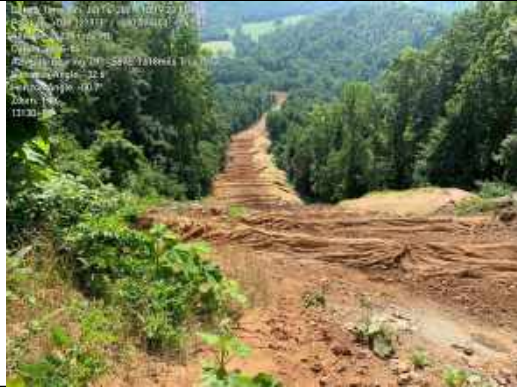
GPS Location	0	GPS Location	0		
Field Station#	13130+00	Field Station#	13131+00		
Pic 11 Desc.	ROW and ECDs in good condition and stable	Pic 12 Desc.	Slope drains in good condition
