Visual Site Inspection Report

Project Name	H-600 Pipeline Spread H	AFE	124300138	Spread	H-600 Pipeline Spread H
Contractor	Precision			Report #	26088
Inspector	Jonathan Altizer			Date/Time	7/19/2021 6:48 PM
Permit #	TBD	Inspection Type	VA SWPP	Station Begin	12638+00
State	VA	Inspection Area	Partial	Station End	12868+00
County	Roanoke	Ground	Damp	Temperature (°F)	75.00
Municipality	N/A	Weather	Cloudy	Rain Gauge (in)	0.00
				Rain Accumulation Time (days)	2.00

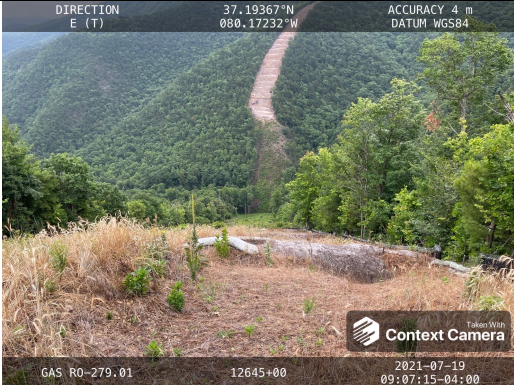
GPS Location	See photo		GPS Location	See photo	
Field Station#	12645+00		Field Station#	12675+00	
Pic 1 Desc.	Current ROW conditions on GAS RO-279.01		Pic 2 Desc.	Current ROW conditions on CIS Honeysuckle Road

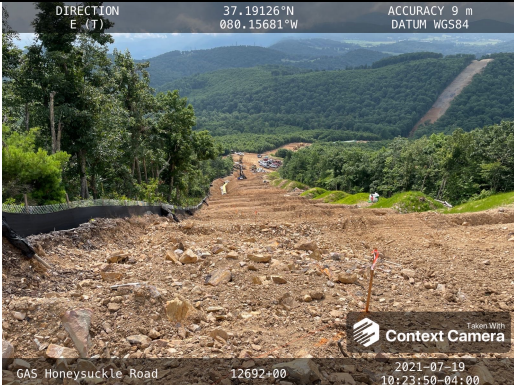
GPS Location	See photo		GPS Location	See photo	
Field Station#	12692+00		Field Station#	12703+00	
Pic 3 Desc.	Current ROW conditions on GAS Honeysuckle road		Pic 4 Desc.	Broad Based Dips have been installed on RO-280

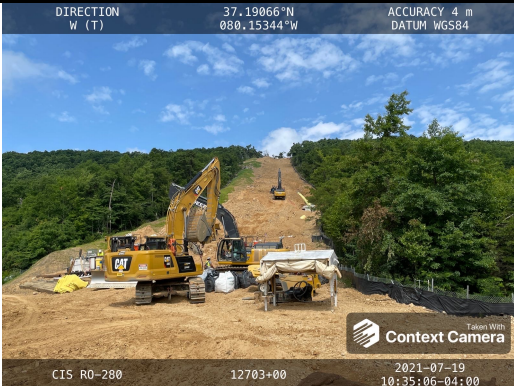
GPS Location	See photo		GPS Location	See photo	
Field Station#	12703+00		Field Station#	12709+00	
Pic 5 Desc.	Tie in crews actively working on trench breakers on CIS of RO-280		Pic 6 Desc.	Steep Slope Area at Streams S-Y13 and S-Y14

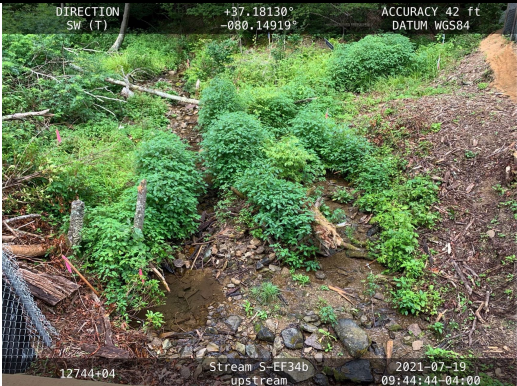
GPS Location	See photo		GPS Location	See photo	
Field Station#	12744+04		Field Station#	12744+04	
Pic 9 Desc.	Stream S-EF34B on GAS RO-281		Pic 10 Desc.	Stream S-EF34B on GAS RO-281

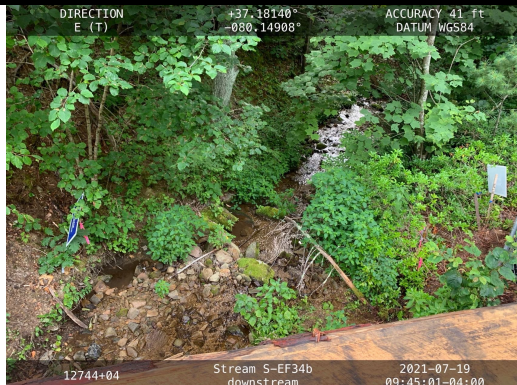
GPS Location	See photo		GPS Location	See photo	
Field Station#	12744+04		Field Station#	12744+00	
Pic 11 Desc.	Stream S-EF34B on GAS RO-281		Pic 12 Desc.	Buffer Space at Stream S-EF34B on GAS RO-281

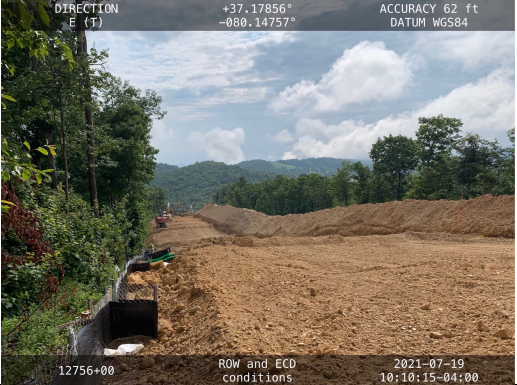
GPS Location	See photo		GPS Location	See photo	
Field Station#	12754+00		Field Station#	12756+00	
Pic 13 Desc.	Fill Slope stabilized and slope drains functional		Pic 14 Desc.	Current ROW conditions on CIS RO-282

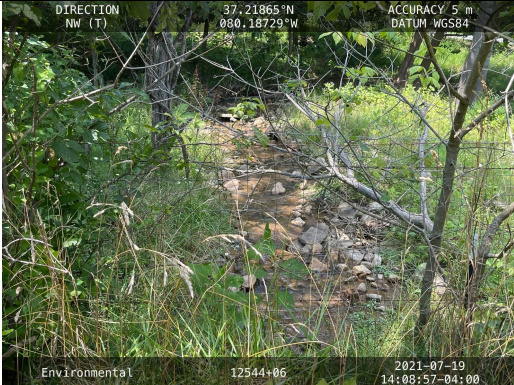
GPS Location	See photo		GPS Location	See photo	
Field Station#	12544+06		Field Station#	12544+06	
Pic 1 Desc.	Down stream of S-KL32 in acceptable condition		Pic 2 Desc.	Down stream of S-EF20b in acceptable condition

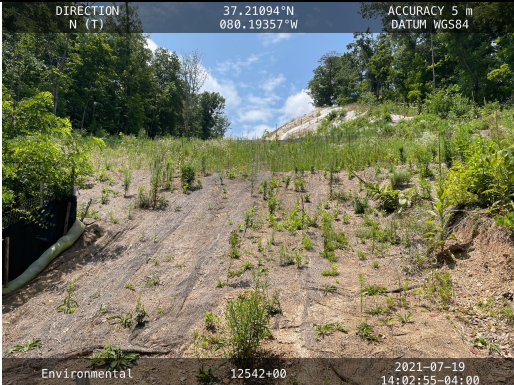
GPS Location	see photo		GPS Location	See photo	
Field Station#	12542+00		Field Station#	12544+10	
Pic 3 Desc.	Stabilized Slope in acceptable condition		Pic 4 Desc.	Wetland W-EF5 in acceptable condition

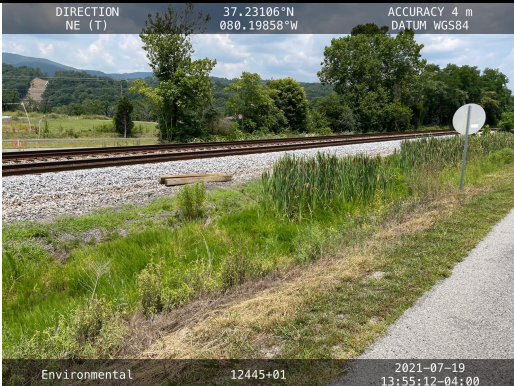
GPS Location	See photo		GPS Location	See photo	
Field Station#	12444+01		Field Station#	12455+21	
Pic 5 Desc.	Stream crossing S-I1 in acceptable condition		Pic 6 Desc.	Bridge and ECDs crossing stream S-CD12b in acceptable condition

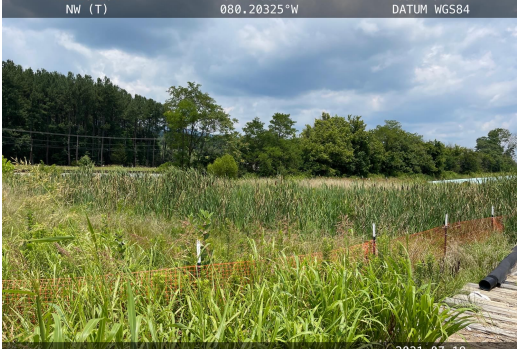
Environmental 12461+81 2021-07-19 13:50:59-04:00		Environmental 12467+00 2021-07-19 13:50:09-04:00			
GPS Location	See photo		GPS Location	See photo	
Field Station#	12461+81		Field Station#	12467+00	
Pic 7 Desc.	Wetland W-KL58 in acceptable condition		Pic 8 Desc.	Stabilized ROW in acceptable condition	
DIRECTION SE (T) 37.22366°N 080.20211°W ACCURACY 5 m DATUM WGS84

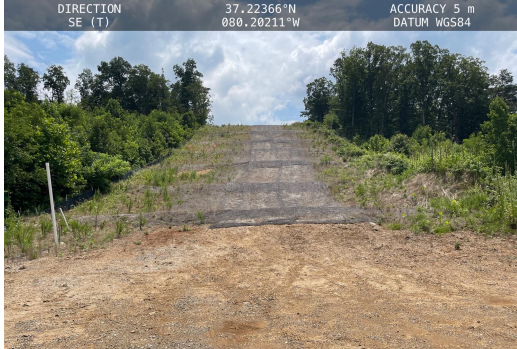
Environmental 12485+00 2021-07-19 13:17:50-04:00		Environmental 12498+00 2021-07-19 13:05:27-04:00			
GPS Location	See photo		GPS Location	See photo	
Field Station#	12485+00		Field Station#	12498+00	
Pic 9 Desc.	Stabilized slope in acceptable condition		Pic 10 Desc.	Stabilized ROW In Acceptable condition

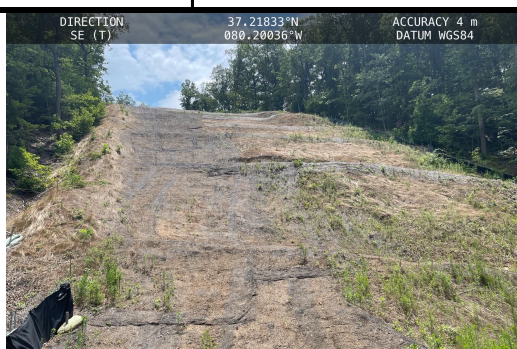
Environmental 12506+00 2021-07-19 13:01:36-04:00		Environmental 12504+00 2021-07-19 13:01:08-04:00			
GPS Location	See photo		GPS Location	See photo	
Field Station#	12506+00		Field Station#	12504+00	
Pic 11 Desc.	Stabilized slope in acceptable condition		Pic 12 Desc.	Clean water crossing pipe outlet in acceptable condition

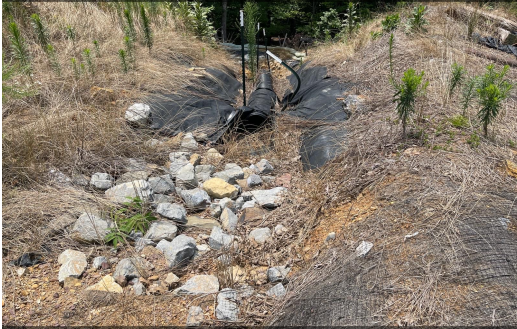
Environmental 12510+00 2021-07-19 12:46:39-04:00	
GPS Location	See photo		GPS Location	See photo	
Field Station#	12508+00		Field Station#	12510+00	
Pic 13 Desc.	Fill slope drain in acceptable condition		Pic 14 Desc.	Stabilized ROW in acceptable condition	
DIRECTION N (T) 37.21603°N 080.19747°W ACCURACY 4 m DATUM WGS84

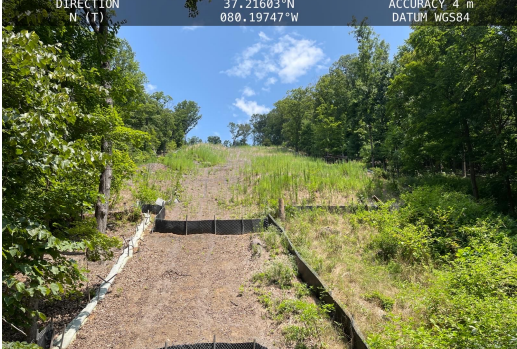
Environmental 12519+41 2021-07-19 12:17:07-04:00	
GPS Location	See photo		GPS Location	See photo	
Field Station#	12517+00		Field Station#	12519+41	
Pic 15 Desc.	Stabilized slope in acceptable condition		Pic 16 Desc.	Bridge and ECDs crossing stream S-EF19 in acceptable condition

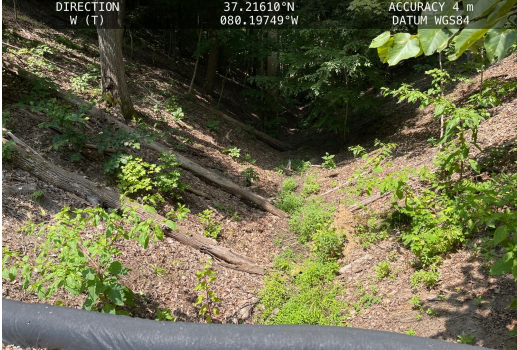
Environmental 12521+00 2021-07-19 12:11:01-04:00	
GPS Location	See photo		GPS Location	See photo	
Field Station#	12519+41		Field Station#	12521+00	
Pic 17 Desc.	S-EF19 down stream in acceptable condition		Pic 18 Desc.	Stabilized slope in acceptable condition

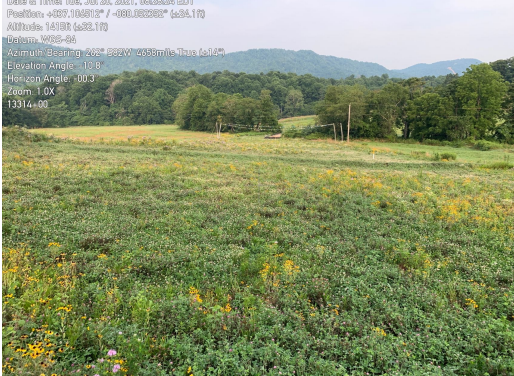
GPS Location	0	GPS Location	0		
Field Station#	13314+00	Field Station#	13309+09		
Pic 1 Desc.	ROW and ECDs in good condition, with good vegetation establishing across LOD.		Pic 2 Desc.	MVP-S-GH7 and corresponding buffer zone in good condition.	
<p>Date & Time: Tue, Jul 20, 2021, 08:58:20 EDT Position: +037.115561° / -080.059973° (±15.5ft) Altitude: 1452ft (±11.1ft) Datum: WGS-84 Azimuth/Bearing: 259° S76W 4587mils True (±16°) Elevation Angle: -05.5° Horizon Angle: -02.1° Zoom: 1.0x 13260+66 S-II4</p>

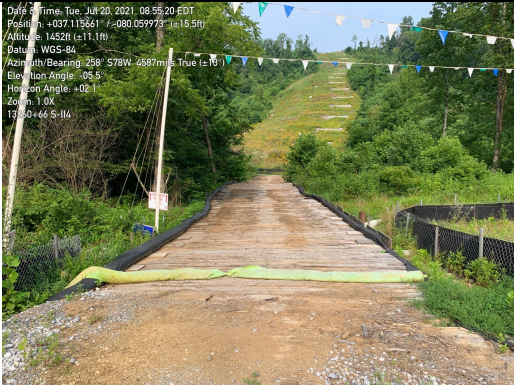
GPS Location	0	GPS Location	0		
Field Station#	13260+66	Field Station#	13259+00		
Pic 3 Desc.	MVP-S-II4 and corresponding buffer zone in good condition.		Pic 4 Desc.	ROW and ECDs in good condition, with good vegetation establishing across LOD.	
<p>Date & Time: Tue, Jul 20, 2021, 09:20:01 EDT Position: +037.118509° / -080.060959° (±16.4ft) Altitude: 1429ft (±10.7ft) Datum: WGS-84 Azimuth/Bearing: 258° S76W 4587mils True (±16°) Elevation Angle: -05.2° Horizon Angle: -05.8° Zoom: 1.0x 13253+00</p>

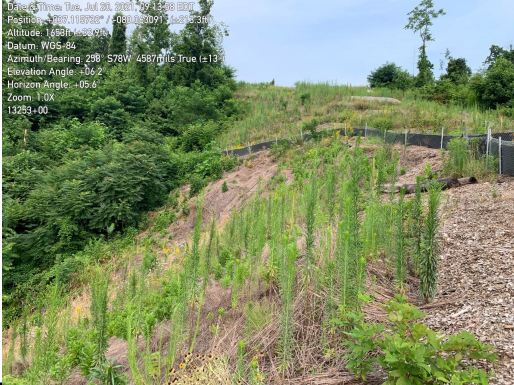
GPS Location	0	GPS Location	0		
Field Station#	13253+00	Field Station#	13249+00		
Pic 5 Desc.	Slip observed to be stable, no notable changes, vegetation establishing.		Pic 6 Desc.	ROW and ECDs in good condition, with good vegetation establishing across LOD.

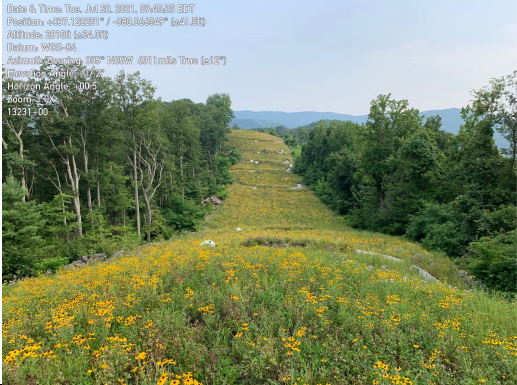
GPS Location	0	GPS Location	0		
Field Station#	13231+00	Field Station#	13217+00		
Pic 7 Desc.	ROW and ECDs in good condition, with good vegetation establishing across LOD.		Pic 8 Desc.	ROW and ECDs in good condition, with good vegetation establishing across LOD.	
<small>Date & Time: Tue, Jul 20, 2021, 10:17:55 EDT Position: +037.122584° / -080.070045° (±0.10) Altitude: 1867ft (±11.10) Datum: WGS-84 Azimuth/Bearing: 082° N82E 1458mils True (±12°) Elevation Angle: -02.2° Horizon Angle: -01.3° Zoom: 1.0X 13210+80</small>

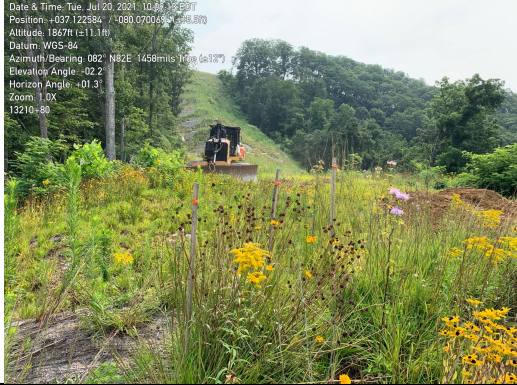
GPS Location	0	GPS Location	0		
Field Station#	13210+80	Field Station#	13209+75		
Pic 9 Desc.	Clearing and grading crew removing vegetation, stockpiling dirt, and installing BMPs		Pic 10 Desc.	Crew stockpiled and stabilized soil removed from ROW.	
<small>Date & Time: Tue, Jul 20, 2021, 10:23:51 EDT Position: +037.122855° / -080.071083° (±0.10) Altitude: 1766ft (±53.20) Datum: WGS-84 Azimuth/Bearing: 268° N76W 5049mils True (±12°) Elevation Angle: -23.4° Horizon Angle: -00.5° Zoom: 1.0X 13207+00</small>

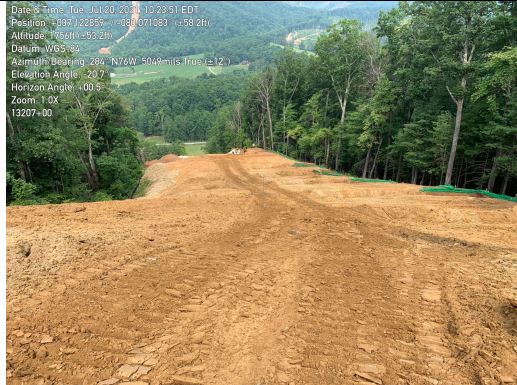
GPS Location	0	GPS Location	0		
Field Station#	13207+00	Field Station#	13196+79		
Pic 11 Desc.	ROW cleared and BMPs installed		Pic 12 Desc.	MVP-S-II4 and corresponding buffer zone in good condition.

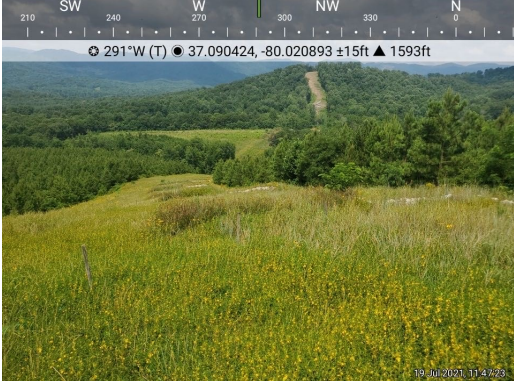
GPS Location	0	GPS Location	0		
Field Station#	13435+00	Field Station#	13442+00		
Pic 1 Desc.	Permanent vegetation	Pic 2 Desc.	Sideslope stabilization

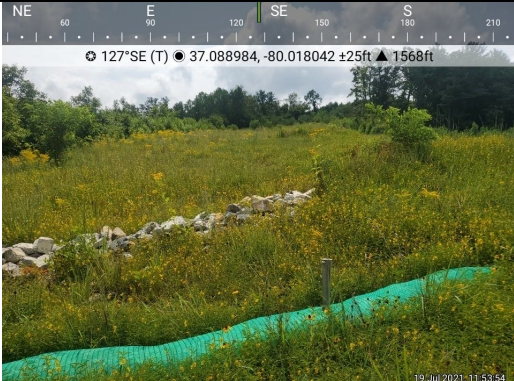
GPS Location	0	GPS Location	0		
Field Station#	13448+00	Field Station#	13450+00		
Pic 3 Desc.	Waterbar outlet protection	Pic 4 Desc.	Perimeter CFS

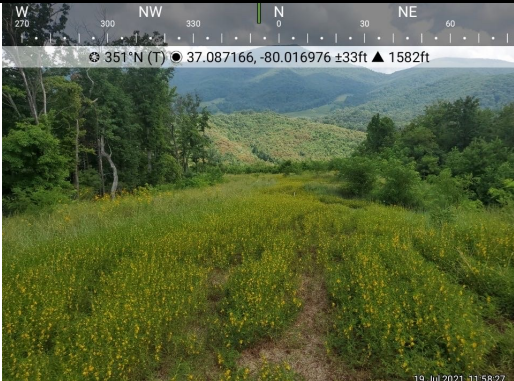
GPS Location	0	GPS Location	0		
Field Station#	13455+00	Field Station#	13475+00		
Pic 5 Desc.	Permanent vegetation	Pic 6 Desc.	Sideslope stabilization

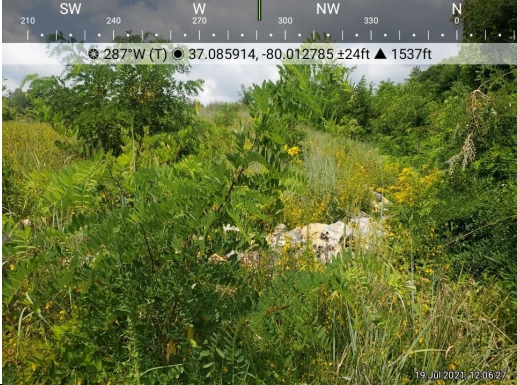
GPS Location	0	GPS Location	0		
Field Station#	13478+00	Field Station#	13480+00		
Pic 7 Desc.	Rock filter	Pic 8 Desc.	Perimeter CFS

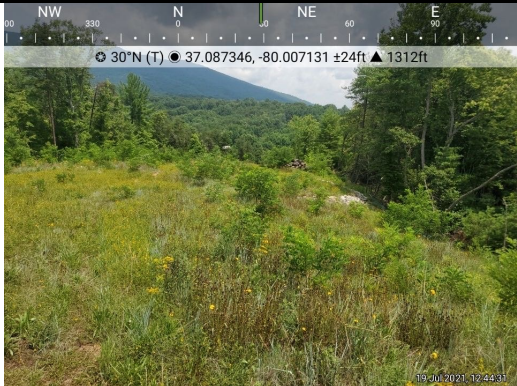
GPS Location	0	GPS Location	0		
Field Station#	13486+00	Field Station#	13485+00		
Pic 9 Desc.	Sideslope vegetation	Pic 10 Desc.	Permanent vegetation

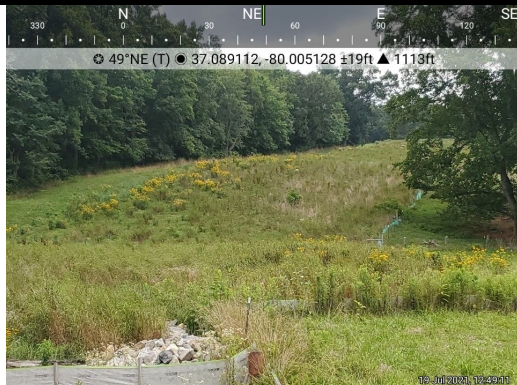
GPS Location	0	GPS Location	0		
Field Station#	13498+50	Field Station#	13490+00		
Pic 11 Desc.	GAS Cahas Mtn Rd #2 Permanent vegetation	Pic 12 Desc.	CIS Cahas Mtn Rd #2 Permanent vegetation

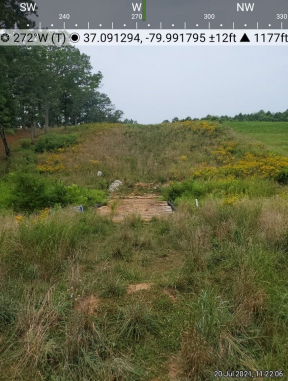
GPS Location	0	GPS Location	0		
Field Station#	13539+50	Field Station#	13543+50		
Pic 1 Desc.	S-II7 Permanent vegetation	Pic 2 Desc.	GAS S-II9 Vegetation

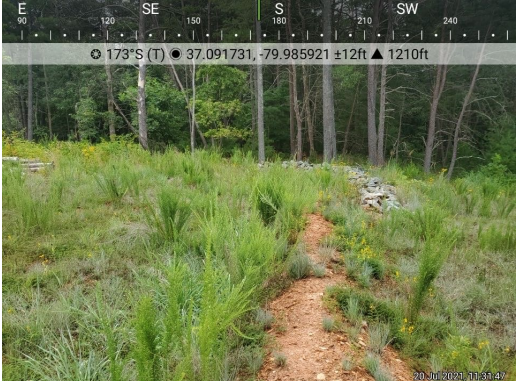
GPS Location	0	GPS Location	0		
Field Station#	13553+00	Field Station#	13557+00		
Pic 3 Desc.	Waterbar outlet protection	Pic 4 Desc.	Sideslope stabilization

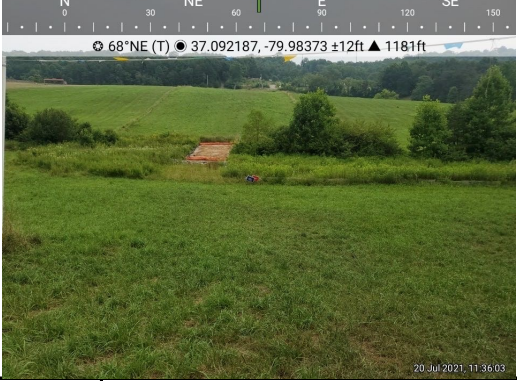
GPS Location	0	GPS Location	0		
Field Station#	13564+00	Field Station#	13579+50		
Pic 5 Desc.	W-GH2 Vegetation	Pic 6 Desc.	GAS S-II9 Vegetation

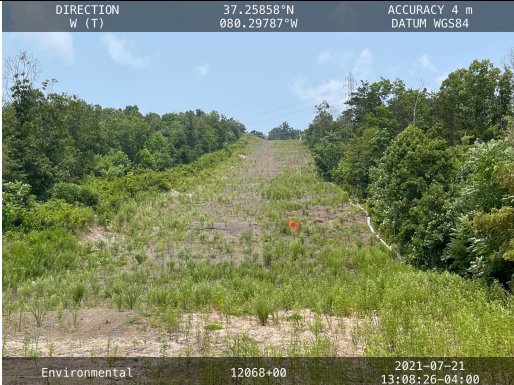
GPS Location	See photo		GPS Location	See photo	
Field Station#	12068+00		Field Station#	12073+00	
Pic 1 Desc.	Stabilized slope in acceptable condition		Pic 2 Desc.	Stabilized ROW in acceptable condition

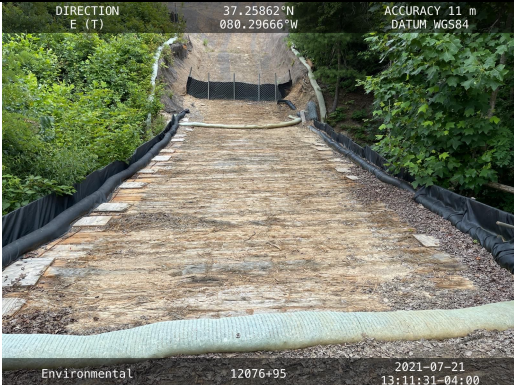
GPS Location	See photo		GPS Location	See photo	
Field Station#	12076+95		Field Station#	12086+56	
Pic 3 Desc.	Bridge and ECDs crossing stream S-MM15 in acceptable condition		Pic 4 Desc.	Bridge and ECDs at stream crossing S-MM14 in acceptable condition

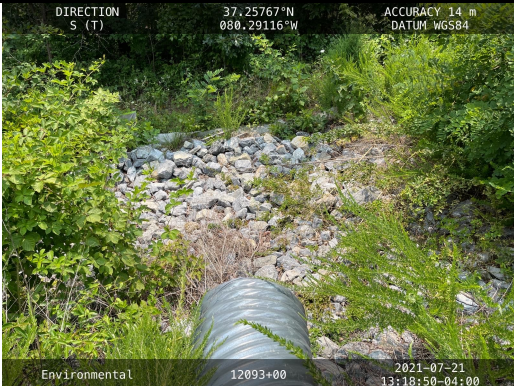
GPS Location	See photo		GPS Location	See photo	
Field Station#	12093+00		Field Station#	12093+50	
Pic 5 Desc.	Clean water crossing pipe outlet in acceptable condition		Pic 6 Desc.	Stabilized ROW in acceptable condition

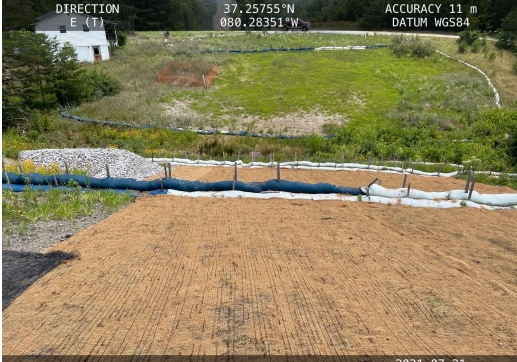
<p>DIRECTION: E (T) 37.25755°N 080.28351°W ACCURACY 11 m DATUM WGS84</p> <p>Environmental 12117+00 2021-07-21 13:39:00-04:00</p>

<p>DIRECTION: SE (T) 37.26732°N 080.31307°W ACCURACY 6 m DATUM WGS84</p> <p>Environmental 12015+84 2021-07-21 14:19:42-04:00</p>			
GPS Location	See photo		GPS Location	See photo	
Field Station#	12117+00		Field Station#	12015+84	
Pic 13 Desc.	Stabilized ROW in acceptable condition		Pic 14 Desc.	Bridge and ECDs at stream crossing S-G38 in acceptable condition

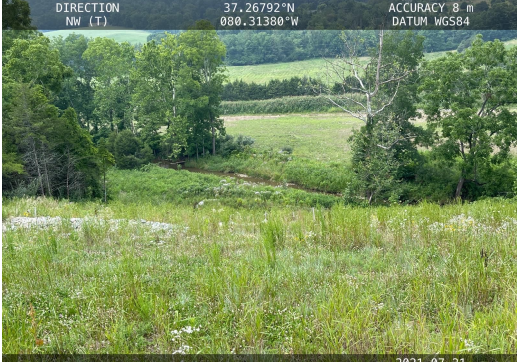
<p>DIRECTION: NW (T) 37.26792°N 080.31380°W ACCURACY 8 m DATUM WGS84</p> <p>Environmental 12010+00 2021-07-21 14:21:26-04:00</p>

Pic 15 Desc.	Stabilized ROW in acceptable condition		Pic 16 Desc.	Bridge and ECDs crossing stream S-G36 in acceptable condition

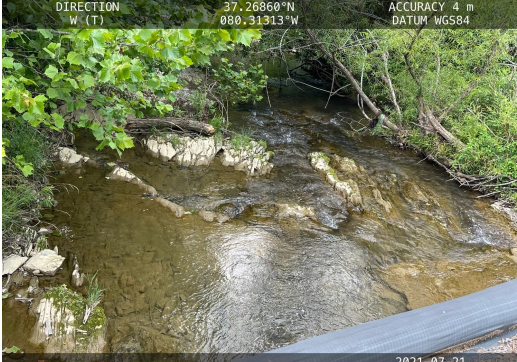
<p>DIRECTION: W (T) 37.26860°N 080.31313°W ACCURACY 4 m DATUM WGS84</p> <p>Environmental 12013+97 2021-07-21 14:29:56-04:00</p>

<p>DIRECTION: NW (T) 37.26913°N 080.31292°W ACCURACY 8 m DATUM WGS84</p> <p>Environmental 12013+97 2021-07-21 14:31:18-04:00</p>			
GPS Location	See photo		GPS Location	See photo	
Field Station#	12013+97		Field Station#	12013+97	
Pic 17 Desc.	Down stream of S-G36 in acceptable condition		Pic 18 Desc.	Access Road MVP-MN-268.1 in acceptable condition

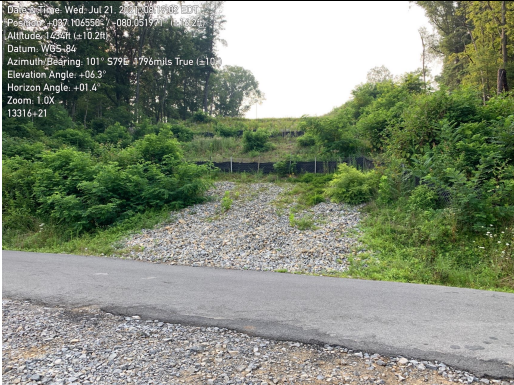
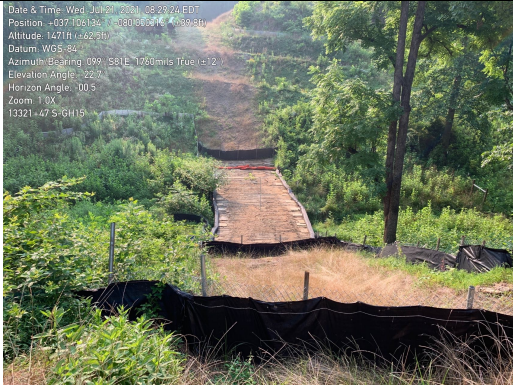
GPS Location	0	GPS Location	0	Field Station#	13316+21
Field Station#	13316+21	Field Station#	13321+47	Pic 1 Desc.	Wades Gap Road Crossing in good condition, RCE in good condition and functioning properly
Pic 1 Desc.	Wades Gap Road Crossing in good condition, RCE in good condition and functioning properly

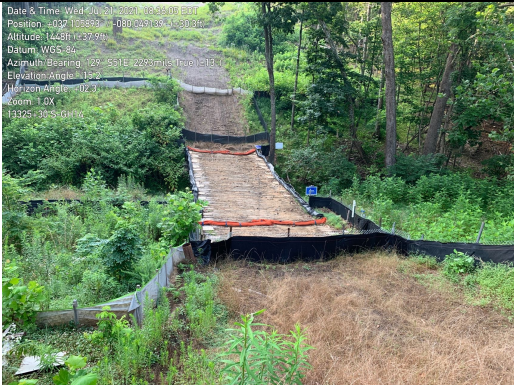
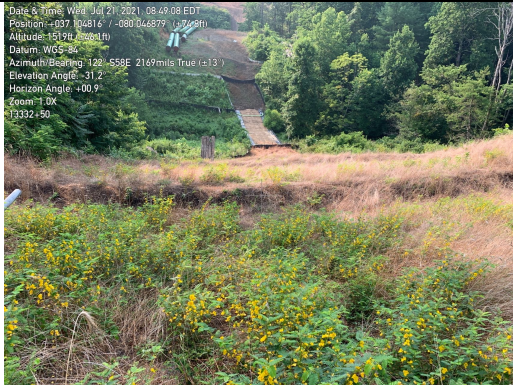
GPS Location	0	GPS Location	0	Field Station#	13325+30
Field Station#	13325+30	Field Station#	13332+50	Pic 3 Desc.	MVP-S-GH14 and corresponding buffer zone in good condition
Pic 3 Desc.	MVP-S-GH14 and corresponding buffer zone in good condition

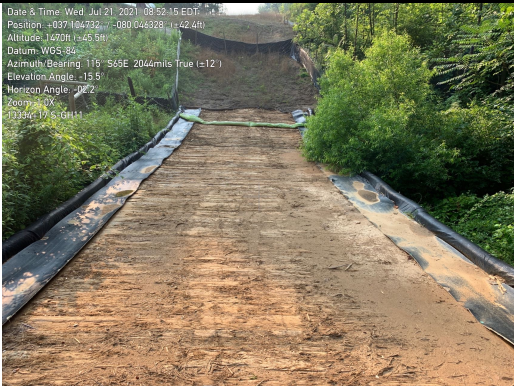
GPS Location	0	GPS Location	0	Field Station#	13334+17
Field Station#	13334+17	Field Station#	13337+14	Pic 5 Desc.	MVP-S-GH11 and corresponding buffer zone in good condition
Pic 5 Desc.	MVP-S-GH11 and corresponding buffer zone in good condition				
			Pic 6 Desc. MVP-S-GH9 and corresponding buffer zone in good condition

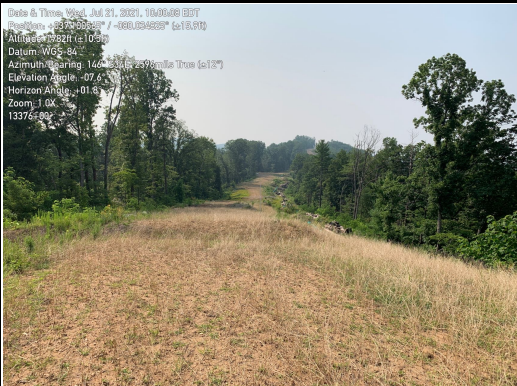
GPS Location 0						GPS Location 0					
Field Station# 13376+00						Field Station# 13403+10					
Pic 15 Desc. ROW and ECDs in good condition with good vegetation establishing across ROW						Pic 16 Desc. ROW and ECDs in good condition with good vegetation establishing across ROW

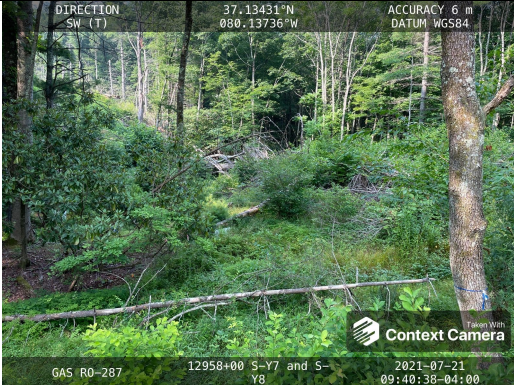
GPS Location	See photo		GPS Location	See photo	
Field Station#	12958+00		Field Station#	12956+75	
Pic 1 Desc.	Streams S-Y7 and S-Y8 on GAS RO-287		Pic 2 Desc.	Landowner spring box is undisturbed

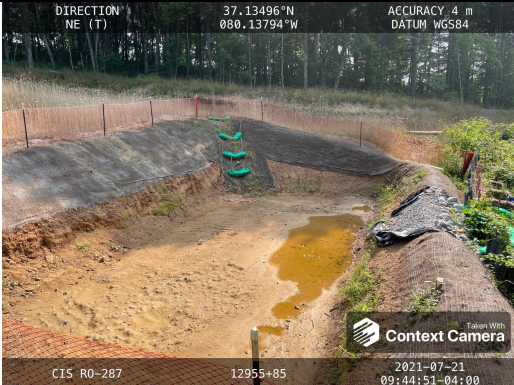
GPS Location	See photo		GPS Location	See photo	
Field Station#	12955+85		Field Station#	12949+00	
Pic 3 Desc.	Functional Sediment Trap on CIS of RO-287		Pic 4 Desc.	Current ROW conditions on CIS RO-287. Vegetation growing

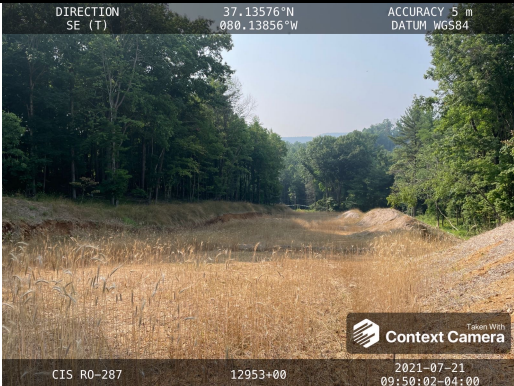
GPS Location	See photo		GPS Location	See photo	
Field Station#	12953+00		Field Station#	12915+00	
Pic 5 Desc.	Current ROW conditions on CIS RO-287		Pic 6 Desc.	Current ROW conditions on CIS RO-286

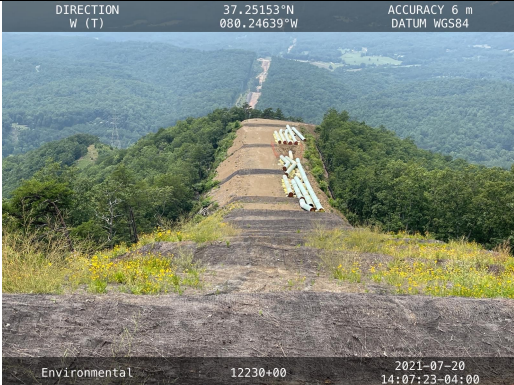
GPS Location	see photo		GPS Location	see photo	
Field Station#	12230+00		Field Station#	12237+00	
Pic 1 Desc.	Stabilized ROW in acceptable condition		Pic 2 Desc.	Stabilized ROW in acceptable condition

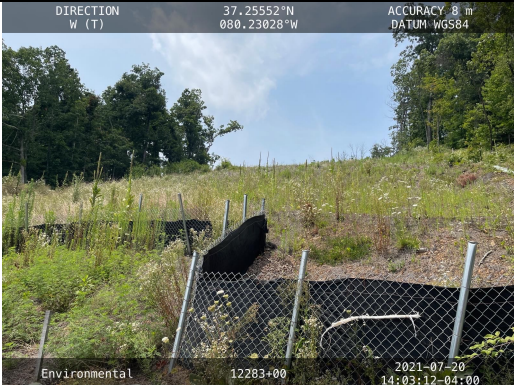
GPS Location	See photo		GPS Location	See photo	
Field Station#	12283+00		Field Station#	12135+00	
Pic 3 Desc.	Stabilized slope in acceptable condition		Pic 4 Desc.	Stabilized slope in acceptable condition

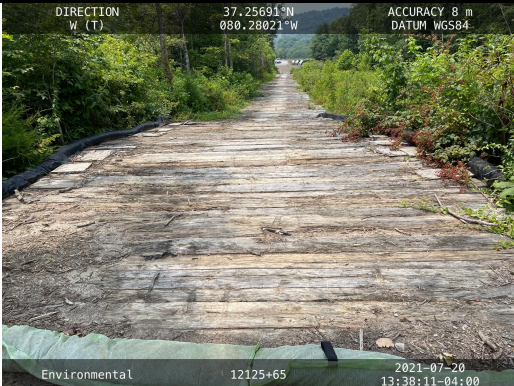
GPS Location	See photo		GPS Location	See photo	
Field Station#	12115+65		Field Station#	12132+73	
Pic 5 Desc.	Bridge and ECDs crossing multiple streams and wetlands in acceptable condition		Pic 6 Desc.	Bridge and ECDs at stream crossing S-C29 in acceptable condition

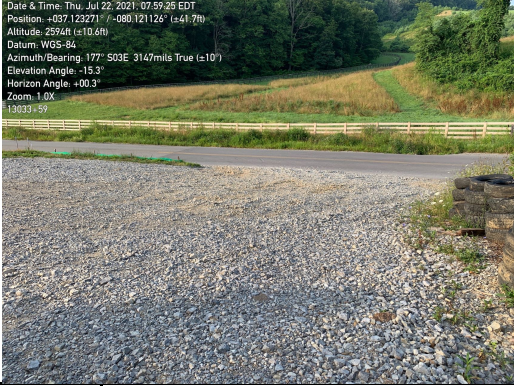
GPS Location	0	GPS Location	0		
Field Station#	13033+59	Field Station#	13033+59		
Pic 1 Desc.	RCE in good condition and functioning properly		Pic 2 Desc.	ROW and ECDs in good condition, with good vegetation established across ROW	
<p>Date & Time: Thu, Jul 22, 2021, 08:05:51 EDT Position: +037.125423 / -080.122910 (±43.7m) Altitude: 2620ft (±13.1m) Datum: WGS-84 Azimuth/Bearing: 274.1584E 4907mils True (±10°) Elevation Angle: -10° Horizon Angle: 00.5° Zoom: 1.0x 13024+06 S-026-025</p>

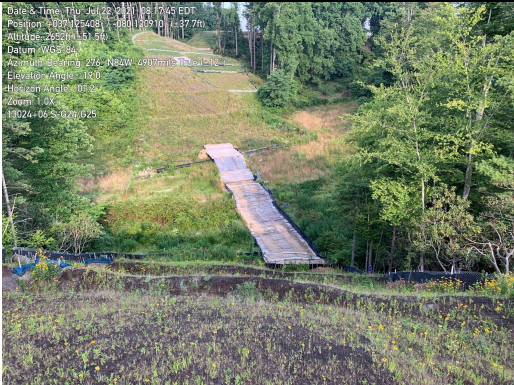
GPS Location	0	GPS Location	0		
Field Station#	13024+06	Field Station#	13042+61		
Pic 3 Desc.	MVP-S-G24/G25 and their corresponding buffer zones in good condition		Pic 4 Desc.	MVP-S-H1 and corresponding buffer zone in good condition	
<p>Date & Time: Thu, Jul 22, 2021, 09:06:07 EDT Position: +037.124937 / -080.111489 (±37.2m) Altitude: 2631ft (±9.4m) Datum: WGS-84 Azimuth/Bearing: 109.571E 1938mils True (±12°) Elevation Angle: -11.7° Horizon Angle: +01.1° Zoom: 1.0x 13061+89 S-026</p>

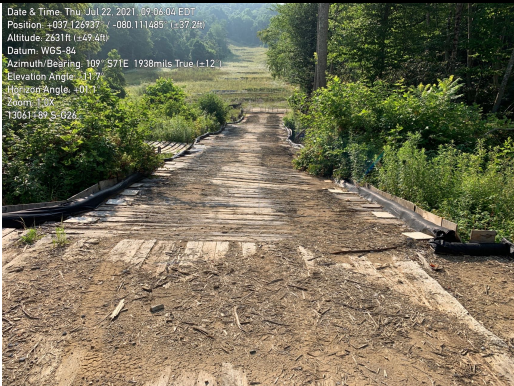
GPS Location	0	GPS Location	0		
Field Station#	13061+89	Field Station#	13062+96		
Pic 5 Desc.	MVP-S-G26 and corresponding buffer zone in good condition		Pic 6 Desc.	MVP-S-G27 and corresponding buffer zone in good condition

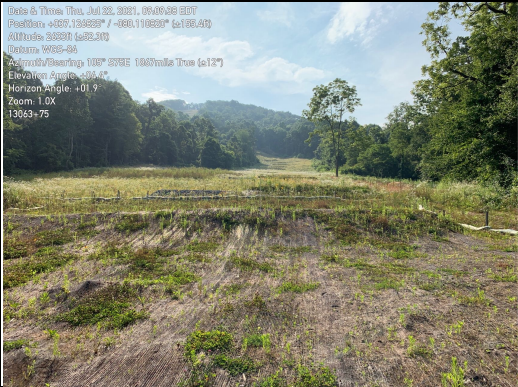
GPS Location	0	GPS Location	0		
Field Station#	13063+75	Field Station#	13072+00		
Pic 7 Desc.	ROW and ECDs in good condition, with good vegetation established across ROW		Pic 8 Desc.	ROW and ECDs in good condition, with good vegetation established across ROW	
<p>Date & Time: Thu, Jul 22, 2021, 09:41:10 EDT Position: +437.12361° / -88.11977° (±15.4m) Altitude: 3330 (±3.1m) Datum: WGS-84 Azimuth/Bearing: 206° 45'W 1926mils True (±12°) Elevation Angle: +09.7° Horizon Angle: +00.9° Zoom: 1.0X 13061+44</p>

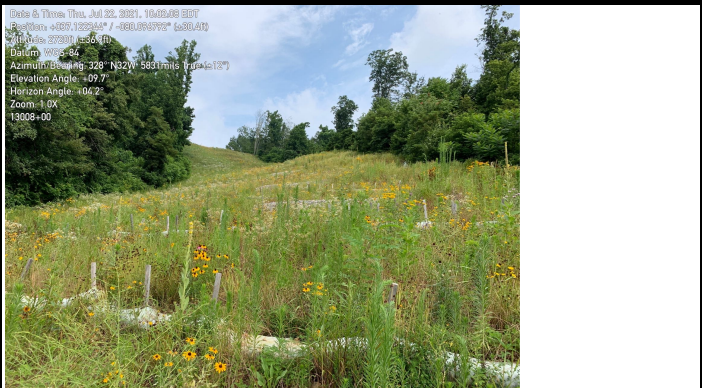
<p>Date & Time: Thu, Jul 22, 2021, 10:00:48 EDT Position: +437.12361° / -88.11977° (±15.4m) Altitude: 3330 (±3.1m) Datum: WGS-84 Azimuth/Bearing: 328° 13'W 5831mils True (±12°) Elevation Angle: +09.7° Horizon Angle: +04.2° Zoom: 1.0X 13008+00</p>

GPS Location	0	GPS Location	0		
Field Station#	13061+44	Field Station#	13008+00		
Pic 9 Desc.	72 hour maintenance item, repair holes in P1 along access road MVP-FR-290		Pic 10 Desc.	ROW and ECDs in good condition, with good vegetation established across ROW	
<p>Date & Time: Thu, Jul 22, 2021, 10:09:11 EDT Position: +437.12193° / -88.09970° (±14.9m) Altitude: 3330 (±3.1m) Datum: WGS-84 Azimuth/Bearing: 112° 58'E 1931mils True (±12°) Elevation Angle: +11.0° Horizon Angle: +02.9° Zoom: 1.0X 13115+97</p>

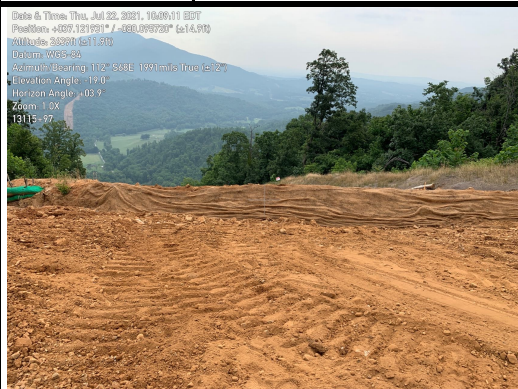
GPS Location	0	GPS Location	0		
Field Station#	13115+97	Field Station#	13115+97		
Pic 11 Desc.	ROW and ECDs in good condition, ROW is stable		Pic 12 Desc.	72 hour maintenance item, repair holes and tears in Sock along access road MVP-FR-291

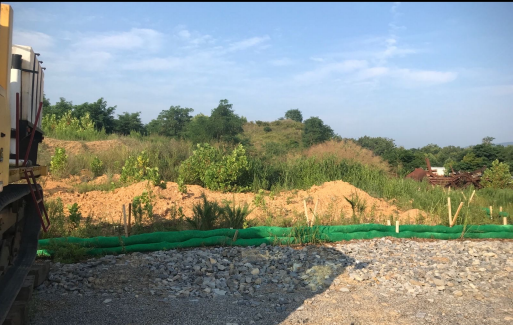
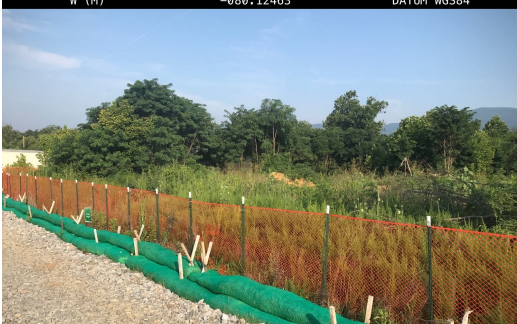
MVP-LY-049_072221 Containment under stored equipment 2021-07-22 08:37:20-04:00		MVP-LY-049_072221 Landowner disturbance along CFS 2021-07-22 08:37:30-04:00			
GPS Location	MVP-LY-049 See photo for gps data		GPS Location	MVP-LY-049 See photo for gps data	
Field Station#	+0		Field Station#	+0	
Pic 13 Desc.	Condition of containment under stored equipment. Looking SW.		Pic 14 Desc.	Landowner soil disturbance along triple stack compost filter sock. Area not stabilized. Looking W.	
DIRECTION W (M) +37.27048° -080.12463° ACCURACY 16 ft DATUM WGS84

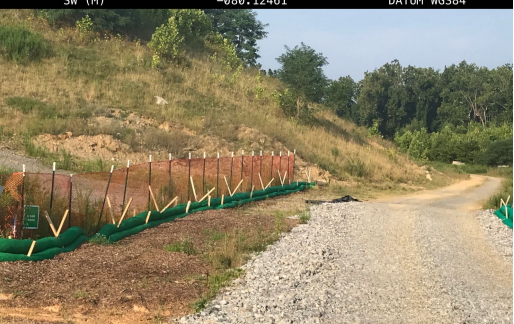
MVP-LY-049_072221 Landowner disturbance along feature 2021-07-22 08:38:10-04:00		MVP-LY-049_072221 Landowner disturbance west of feature 2021-07-22 08:38:23-04:00

GPS Location	MVP-LY-049 See photo for gps data		GPS Location	MVP-LY-049 See photo for gps data	
Field Station#	+0		Field Station#	+0	
Pic 15 Desc.	Landowner soil disturbance along edge of feature W-CV21A. Area not stabilized. Looking NW.		Pic 16 Desc.	Landowner soil disturbance in 2 areas west of feature W-CV21B. Areas not stabilized. Looking SW.	
DIRECTION S (M) +37.27040° -080.12465° ACCURACY 16 ft DATUM WGS84

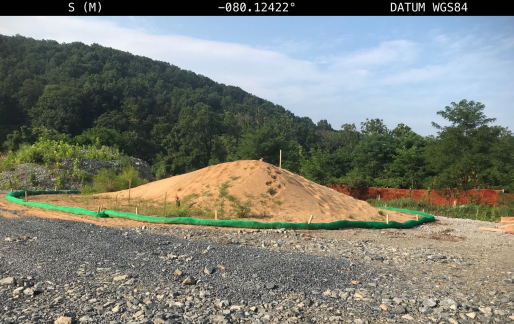
MVP-LY-049_072221 Landowner disturbance along CFS & feature 2021-07-22 08:38:37-04:00		MVP-LY-049_072221 CFS in place around sand pile 2021-07-22 08:40:12-04:00			
GPS Location	MVP-LY-049 See photo for gps data		GPS Location	MVP-LY-049 See photo for gps data	
Field Station#	+0		Field Station#	+0	
Pic 17 Desc.	Landowner soil disturbance along triple stack compost filter sock and east of feature W-CV21B. Area not stabilized. Looking S.		Pic 18 Desc.	Compost filter sock in place around sand pile. Looking S.

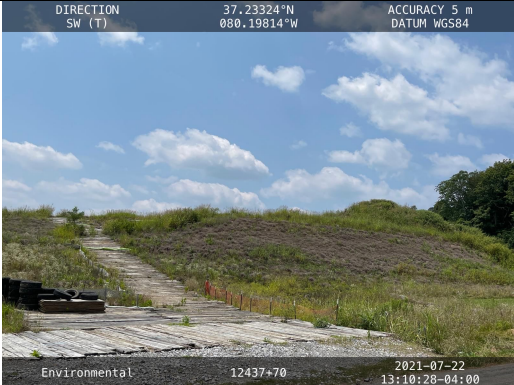
GPS Location	See photo		GPS Location	See photo	
Field Station#	12437+70		Field Station#	12435+50	
Pic 1 Desc.	Stabilized slope in acceptable condition		Pic 2 Desc.	Stream crossing S-NN16 in acceptable condition

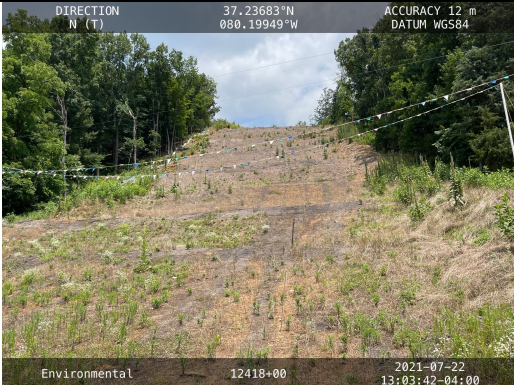
GPS Location	See photo		GPS Location	See photo	
Field Station#	12418+00		Field Station#	12410+20	
Pic 3 Desc.	Stabilized slope in acceptable condition		Pic 4 Desc.	Clean water crossing pipe outlet in acceptable condition

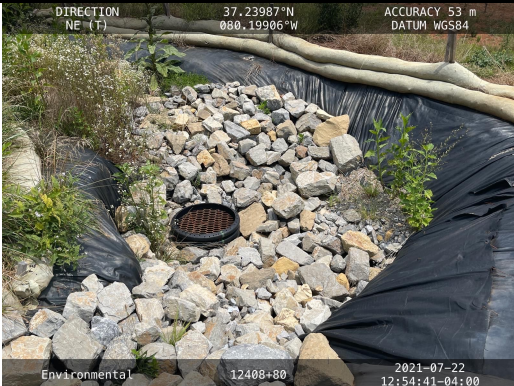
GPS Location	See photo		GPS Location	See photo	
Field Station#	12408+80		Field Station#	12402+00	
Pic 5 Desc.	Clean water crossing pipe inlet in acceptable condition		Pic 6 Desc.	Stabilized Row in acceptable condition

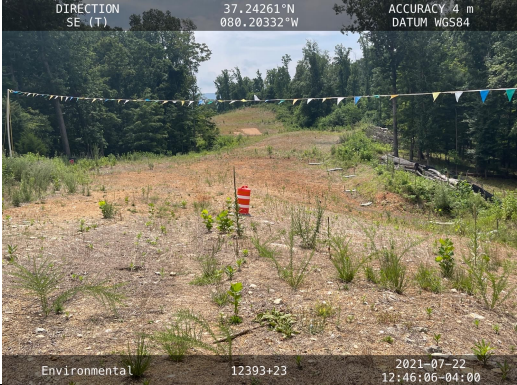
GPS Location	See photo		GPS Location	See photo	
Field Station#	12393+23		Field Station#	12383+93	
Pic 7 Desc.	Stabilized Row in acceptable condition		Pic 8 Desc.	Clean water crossing in acceptable condition

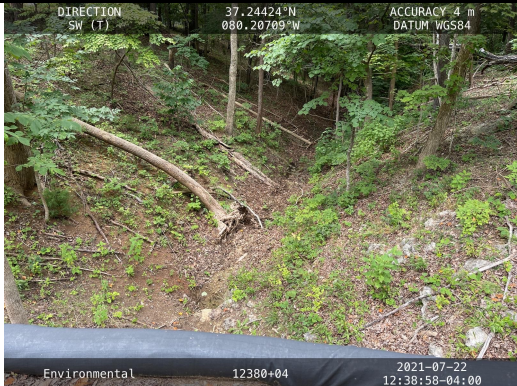
GPS Location	See photo		GPS Location	See photo	
Field Station#	12380+04		Field Station#	12374+16	
Pic 9 Desc.	Down stream of S-NN19 in acceptable condition		Pic 10 Desc.	Stream crossing S-OO16 in acceptable condition

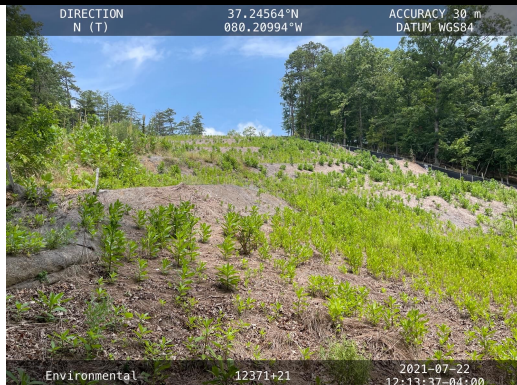
GPS Location	See photo		GPS Location	See photo	
Field Station#	12371+21		Field Station#	12361+02	
Pic 11 Desc.	Stabilized slope in acceptable condition		Pic 12 Desc.	Stabilized Row in acceptable condition

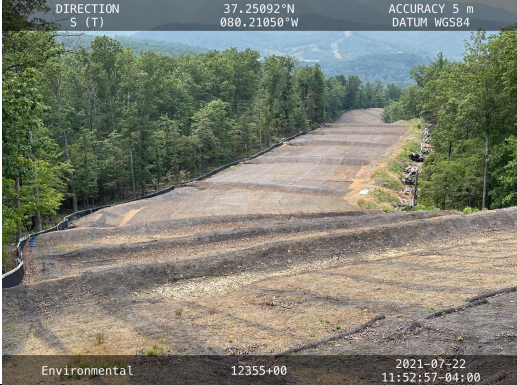
GPS Location	See photo		GPS Location	See photo	
Field Station#	12355+00		Field Station#	12332+00	
Pic 13 Desc.	Stabilized Row in acceptable condition		Pic 14 Desc.	Fill slope drain in acceptable condition

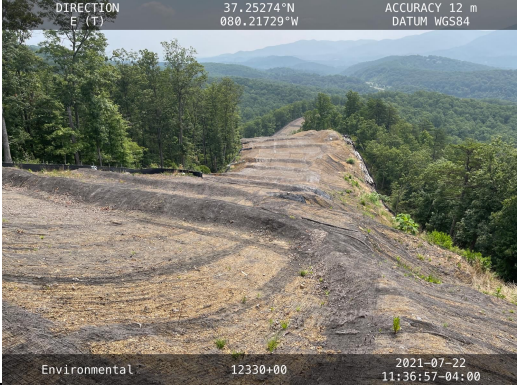
GPS Location	See photo		GPS Location	See photo	
Field Station#	12330+00		Field Station#	12310+00	
Pic 15 Desc.	Stabilized Row in acceptable condition		Pic 16 Desc.	Stabilized Row in acceptable condition

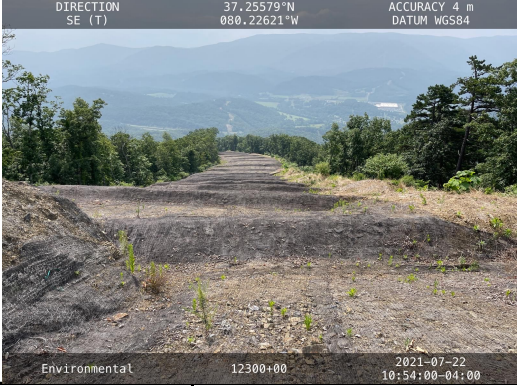
GPS Location	See photo		GPS Location	See photo	
Field Station#	12300+00		Field Station#	12299+24	
Pic 17 Desc.	Stabilized Row in acceptable condition		Pic 18 Desc.	Stabilized access Road in acceptable condition

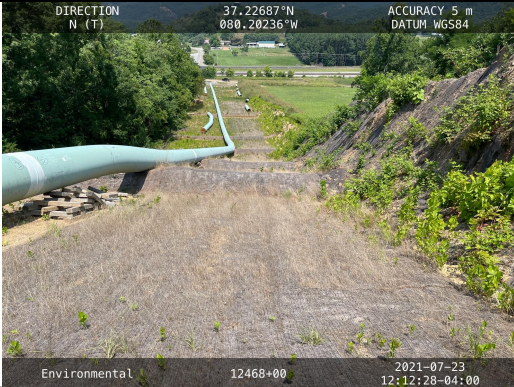
GPS Location	See photo		GPS Location	See photo	
Field Station#	12468+00		Field Station#	12474+00	
Pic 3 Desc.	Stabilized Row in acceptable condition		Pic 4 Desc.	Clean water crossing in acceptable condition

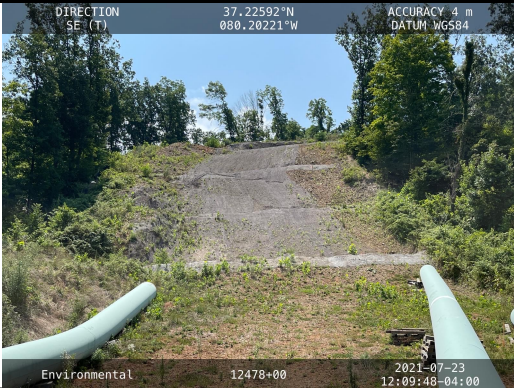
GPS Location	See photo		GPS Location	See photo	
Field Station#	12478+00		Field Station#	12482+67	
Pic 5 Desc.	Stabilized slope in acceptable condition		Pic 6 Desc.	Access Road MVP-MLV-AR-28 in acceptable condition

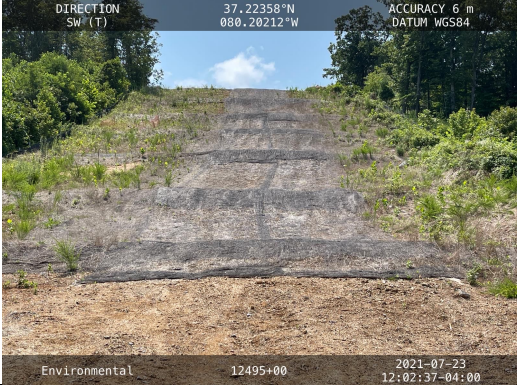
GPS Location	See photo		GPS Location	see photo	
Field Station#	12485+00		Field Station#	12544+06	
Pic 7 Desc.	Stabilized slope in acceptable condition		Pic 8 Desc.	Stream crossing S-KL32 in acceptable condition

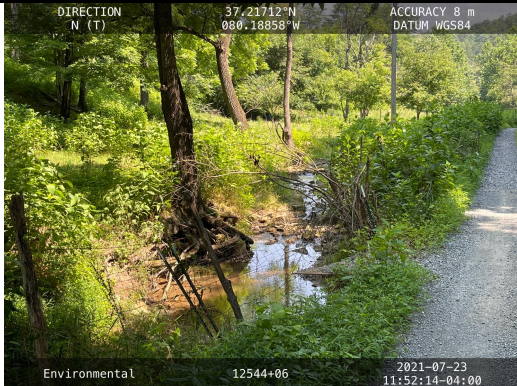
GPS Location	See photo		GPS Location	See photo	
Field Station#	12544+06		Field Station#	12538+00	
Pic 9 Desc.	Stream crossing S-EF20b in acceptable condition		Pic 10 Desc.	Stabilized row in acceptable condition

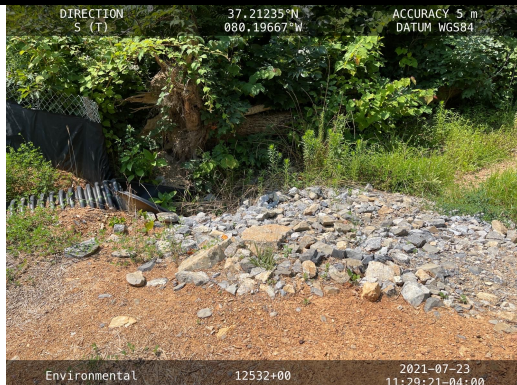
GPS Location	see photo		GPS Location	See photo	
Field Station#	12532+00		Field Station#	12532+00	
Pic 11 Desc.	Clean water crossing pipe inlet in acceptable condition		Pic 12 Desc.	Clean water crossing pipe outlet in acceptable condition

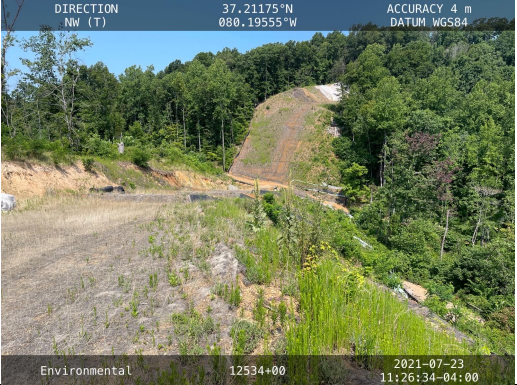
GPS Location	See photo		GPS Location	See photo	
Field Station#	12528+00		Field Station#	12534+00	
Pic 13 Desc.	Plastic covered spoil pile in acceptable condition		Pic 14 Desc.	Stabilized Row in acceptable condition

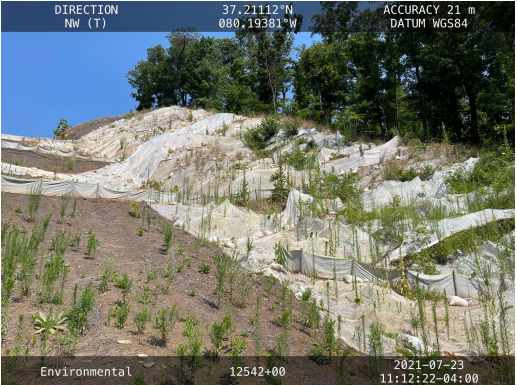
GPS Location	See photo		GPS Location	See photo	
Field Station#	12536+24		Field Station#	12542+00	
Pic 15 Desc.	Slope drain pipe in acceptable condition		Pic 16 Desc.	Plastic covered spoil pile in acceptable condition

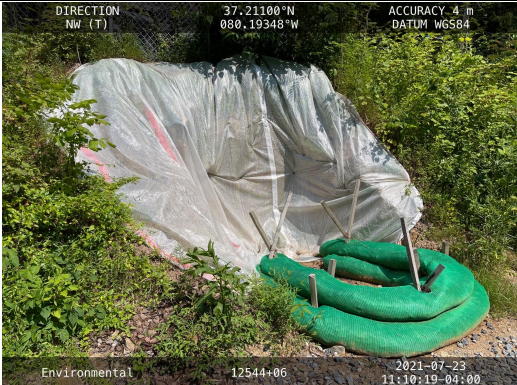
GPS Location	See photo		GPS Location	See photo	
Field Station#	12544+06		Field Station#	12544+10	
Pic 17 Desc.	Stabilized cut bank in acceptable condition		Pic 18 Desc.	Wetland W-EF5 in acceptable condition

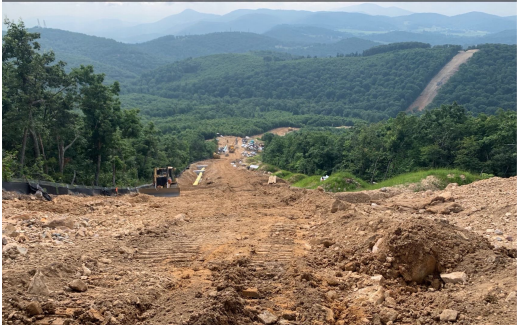
12692+00 ROW condition 2021-07-23 10:15:00-04:00		DIRECTION SE (T) +37.18763° -080.15111° ACCURACY 15 ft DATUM WGS84

12716+50 ROW and ECD conditions 2021-07-23 11:04:13-04:00			
GPS Location	See photo		GPS Location	See photo	
Field Station#	12692+00		Field Station#	12716+50	
Pic 13 Desc.	Current ROW conditions on GAS Honeysuckle Road		Pic 14 Desc.	Current ROW conditions on GAS S-Y13 and S-Y14	
DIRECTION SW (T) +37.18496° -080.14859° ACCURACY 177 ft DATUM WGS84

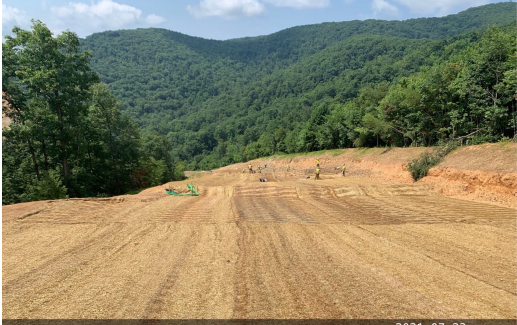
12729+00 Installing ECB 2021-07-23 11:28:57-04:00		DIRECTION E (T) +37.18770° -080.15116° ACCURACY 341 ft DATUM WGS84

12715+80 S-Y13 downstream 2021-07-23 10:51:49-04:00			
GPS Location	See photo		GPS Location	See photo	
Field Station#	12729+00		Field Station#	12715+80	
Pic 15 Desc.	PPL Environmental Crew placing installing ECB		Pic 16 Desc.	Downstream of S-Y13

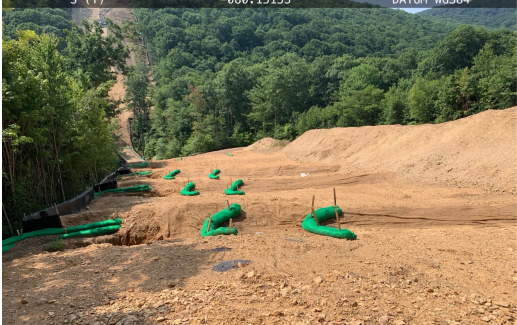
12712+00 ROW condition 2021-07-23 10:47:50-04:00		DIRECTION S (T) +37.18756° -080.15115° ACCURACY 48 ft DATUM WGS84

12716+20 Bridge over S-Y14 2021-07-23 10:54:45-04:00			
GPS Location	See photo		GPS Location	See photo	
Field Station#	12712+00		Field Station#	12716+20	
Pic 17 Desc.	Current ROW conditions on CIS S-EF34B		Pic 18 Desc.	Equipment Bridge over S-Y14
