# Visual Site Inspection Report

<b>Project Name</b>	H-600 Pipeline Spread H	<b>AFE</b>	124300138	<b>Spread</b>	H-600 Pipeline Spread H
<b>Contractor</b>	Precision			<b>Report #</b>	26368
<b>Inspector</b>	Logan Box			<b>Date/Time</b>	7/26/2021 3:12 PM
<b>Permit #</b>	TBD	<b>Inspection Type</b>	VA SWPP	<b>Station Begin</b>	13525+99
<b>State</b>	VA	<b>Inspection Area</b>	Partial	<b>Station End</b>	13670+00
<b>County</b>	Franklin	<b>Ground</b>	Dry	<b>Temperature (°F)</b>	90.00
<b>Municipality</b>	N/A	<b>Weather</b>	Light Rain	<b>Rain Gauge (in)</b>	0.00
				<b>Rain Accumulation Time (days)</b>	0.00

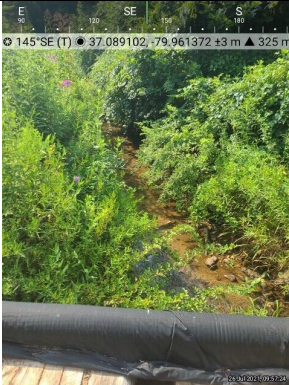
<b>GPS Location</b>	00000	<b>GPS Location</b>	00000		
<b>Field Station#</b>	13643+53	<b>Field Station#</b>	13656+60		
<b>Pic 1 Desc.</b>	Stream observation photo facing downstream during routine inspection today. No issues observed at the time of inspection.		<b>Pic 2 Desc.</b>	Monitored ECDs along row edge . All up to date and functioning properly at the time of inspection.

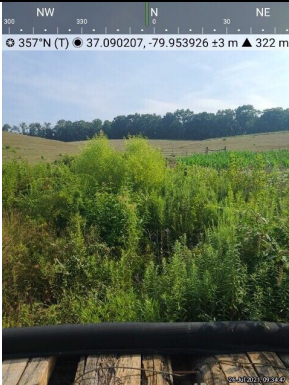
<b>GPS Location</b>	00000	<b>GPS Location</b>	00000		
<b>Field Station#</b>	13666+27	<b>Field Station#</b>	13643+30		
<b>Pic 3 Desc.</b>	Stream observation photo facing upstream during routine inspection today. No issues observed at the time of inspection.		<b>Pic 4 Desc.</b>	Vegetation observation photo up row from stream crossing showing good stabilization.

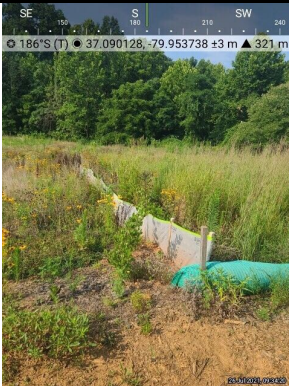
<b>Field Station#</b>	13666+75	<b>Field Station#</b>	13643+53		
<b>Pic 5 Desc.</b>	Monitored ECDs at stream buffer. No environmental issues observed at the time of inspection.		<b>Pic 6 Desc.</b>	Stream observation photo facing upstream during routine inspection today. No issues observed at the time of inspection.

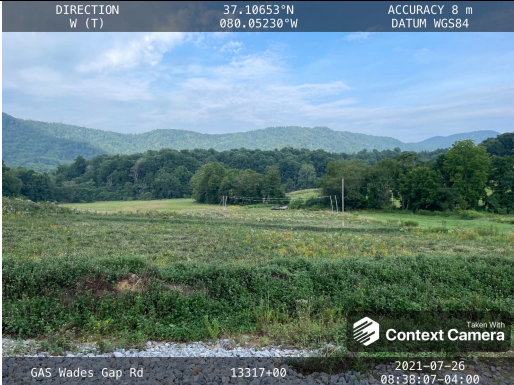
<p>DIRECTION W (T) 37.10653°N 080.05230°W ACCURACY 8 m DATUM WGS84</p> <p>GAS Wades Gap Rd 13317+00 2021-07-26 08:38:07-04:00</p>

<p>DIRECTION NE (T) 37.10661°N 080.05442°W ACCURACY 5 m DATUM WGS84</p> <p>CIS Wades Gap Rd 13309+09 S-GH7 upstream 2021-07-26 08:43:19-04:00</p>			
<b>GPS Location</b>	See photo		<b>GPS Location</b>	See photo	
<b>Field Station#</b>	13317+00		<b>Field Station#</b>	13309+09	
<b>Pic 1 Desc.</b>	Current ROW conditions on CIS of Wade's Gap Road		<b>Pic 2 Desc.</b>	Stream S-GH7 flowing free and clear of sediment

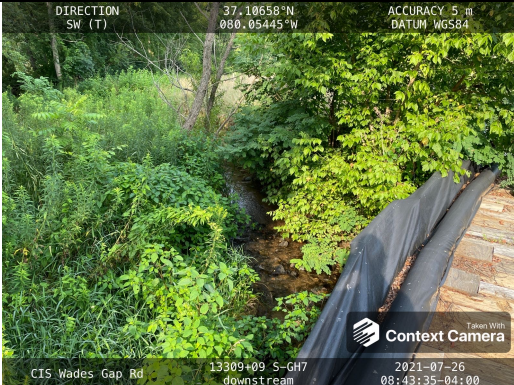
<p>DIRECTION SW (T) 37.10658°N 080.05445°W ACCURACY 5 m DATUM WGS84</p> <p>CIS Wades Gap Rd 13309+09 S-GH7 downstream 2021-07-26 08:43:35-04:00</p>

<b>GPS Location</b>	See photo		<b>GPS Location</b>	See photo	
<b>Field Station#</b>	13309+09		<b>Field Station#</b>	13274+00	
<b>Pic 3 Desc.</b>	Stream S-GH7 flowing free and clear of sediment		<b>Pic 4 Desc.</b>	Current ROW conditions on GAS of FR-293.01. Area well vegetated and stabilized

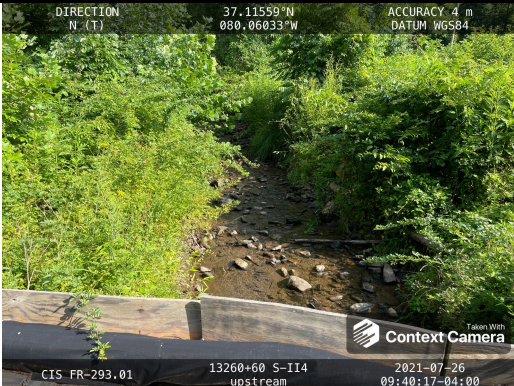
<p>DIRECTION N (T) 37.11559°N 080.06033°W ACCURACY 4 m DATUM WGS84</p> <p>CIS FR-293.01 13260+60 S-II4 upstream 2021-07-26 09:40:17-04:00</p>

<p>DIRECTION S (T) 37.11562°N 080.06033°W ACCURACY 4 m DATUM WGS84</p> <p>CIS FR-293.01 13260+60 S-II4 downstream 2021-07-26 09:40:29-04:00</p>			
<b>GPS Location</b>	See photo		<b>GPS Location</b>	See photo	
<b>Field Station#</b>	13260+60		<b>Field Station#</b>	13260+60	
<b>Pic 5 Desc.</b>	Stream S-II4 flowing free and clear of sediment		<b>Pic 6 Desc.</b>	Stream S-II4 flowing free and clear of sediment

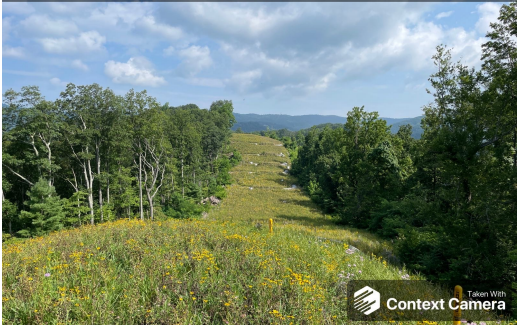
GAS Dillons Mill Rd 13220+00 2021-07-26 10:30:17-04:00			
<b>GPS Location</b>	See photo		<b>GPS Location</b>	See photo	
<b>Field Station#</b>	13230+00		<b>Field Station#</b>	13220+00	
<b>Pic 7 Desc.</b>	Current ROW conditions on CIS of FR-293.01		<b>Pic 8 Desc.</b>	Current ROW conditions on GAS Dillons Mill.	
DIRECTION W (T) 37.12267°N 080.07031°W ACCURACY 4 m DATUM WGS84

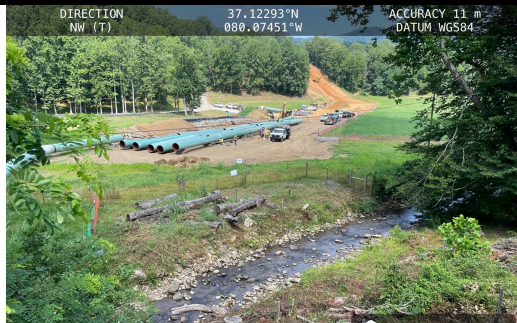
CIS Dillons Mill Rd 13197+00 S-D8 2021-07-26 11:20:21-04:00		DIRECTION NW (T) 37.12221°N 080.07601°W ACCURACY 15 m DATUM WGS84

MLV-29 13196+31 S-D10 2021-07-26 11:29:38-04:00			
<b>GPS Location</b>	See photo		<b>GPS Location</b>	See photo	
<b>Field Station#</b>	13197+00		<b>Field Station#</b>	13196+31	
<b>Pic 11 Desc.</b>	Stream S-D8 flowing free and clear of sediment		<b>Pic 12 Desc.</b>	Stream S-D10 crossing on MLV-29

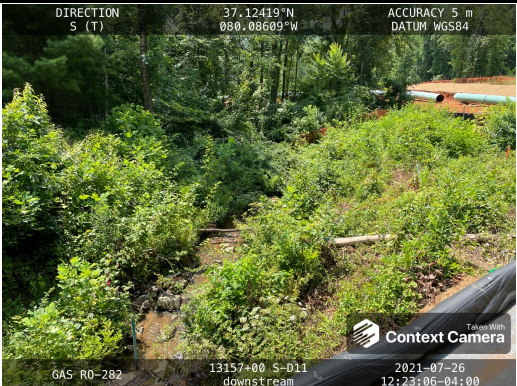
<b>GPS Location</b>	See photo		<b>GPS Location</b>	See photo	
<b>Field Station#</b>	13157+00		<b>Field Station#</b>	13157+00	
<b>Pic 15 Desc.</b>	Stream S-D11 flowing free and clear of sediment		<b>Pic 16 Desc.</b>	Stream S-D11 flowing free and clear of sediment

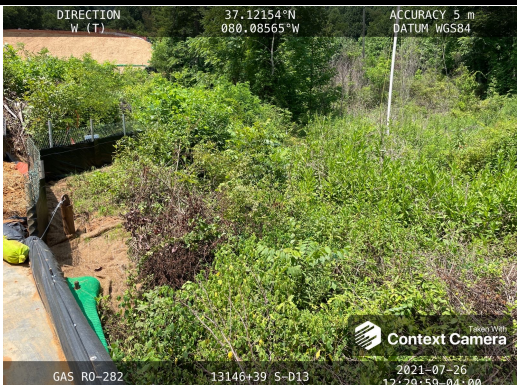
<b>GPS Location</b>	See photo		<b>GPS Location</b>	See photo	
<b>Field Station#</b>	13146+56		<b>Field Station#</b>	13146+39	
<b>Pic 17 Desc.</b>	Stream S-D12 flowing free and clear of sediment		<b>Pic 18 Desc.</b>	Stream S-D13 and buffer area

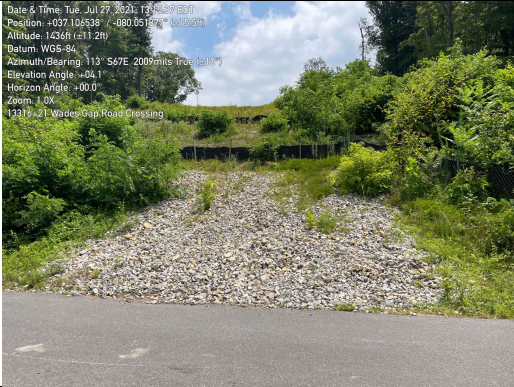
<b>GPS Location</b>	0	<b>GPS Location</b>	0		
<b>Field Station#</b>	13316+21	<b>Field Station#</b>	13337+13		
<b>Pic 1 Desc.</b>	Wades Gap Road Crossing in good condition, RCE in good condition and functioning properly		<b>Pic 2 Desc.</b>	MVP-S-GH9 and corresponding buffer zone in good condition

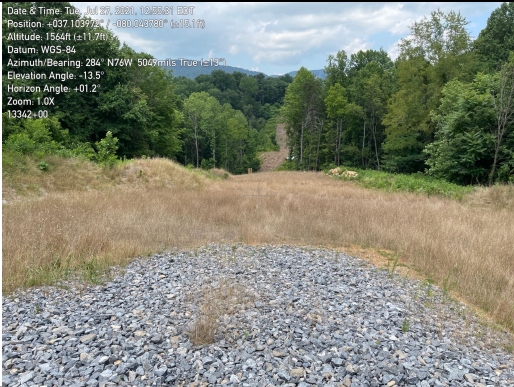
<b>GPS Location</b>	0	<b>GPS Location</b>	0		
<b>Field Station#</b>	13342+00	<b>Field Station#</b>	13358+64		
<b>Pic 3 Desc.</b>	ROW and ECDs in good condition, with good vegetation established across ROW		<b>Pic 4 Desc.</b>	MVP-S-RR11 and corresponding buffer zone in good condition	
<p>Date &amp; Time: Tue Jul 27, 2021 11:43:02 EDT  Position: +037.105947 / -080.031347 (+11.4m)  Altitude: 1640ft (+11.3m)  Datum: WGS-84  Azimuth/Bearing: 279° N81W 4940mils True (+12)  Elevation Angle: -16.2°  Horizon Angle: +02.2°  Zoom: 1.0X  13365+00</p>

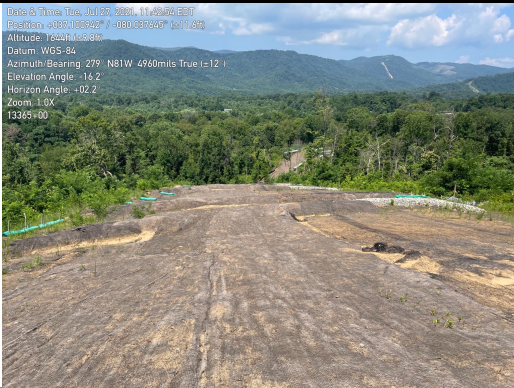
<b>GPS Location</b>	0	<b>GPS Location</b>	0		
<b>Field Station#</b>	13365+00	<b>Field Station#</b>	13368+50		
<b>Pic 5 Desc.</b>	ROW and ECDs in good condition, ROW is stable		<b>Pic 6 Desc.</b>	ROW and ECDs in good condition, ROW is stable

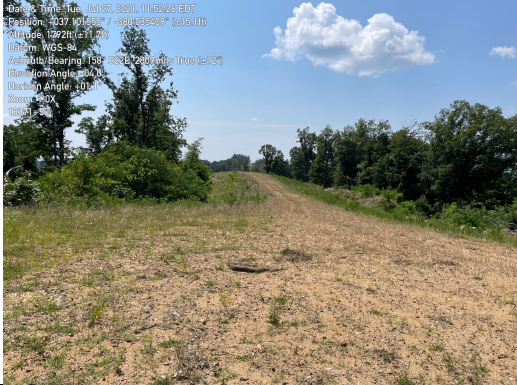
<b>GPS Location</b>	0	<b>GPS Location</b>	0		
<b>Field Station#</b>	13370+50	<b>Field Station#</b>	13371+50		
<b>Pic 7 Desc.</b>	P1 needs repaired - 72hr maintenance item	<b>Pic 8 Desc.</b>	ROW and ECDs in good condition, With Vegetation established, temporary stabilization of travel lane beginning to seed and turn

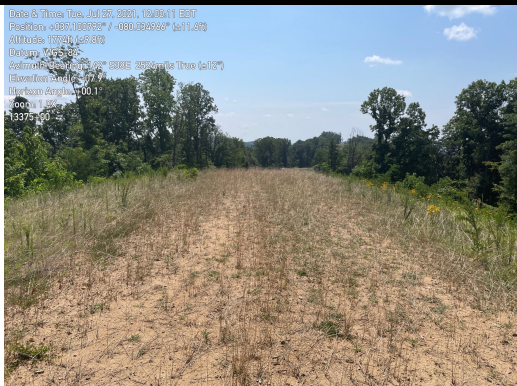
<b>GPS Location</b>	0	<b>GPS Location</b>	0		
<b>Field Station#</b>	13375+00	<b>Field Station#</b>	13377+00		
<b>Pic 9 Desc.</b>	ROW and ECDs in good condition, With Vegetation established, temporary stabilization of travel lane beginning to seed and turn	<b>Pic 10 Desc.</b>	ROW and ECDs in good condition, With Vegetation established, temporary stabilization of travel lane beginning to seed and turn

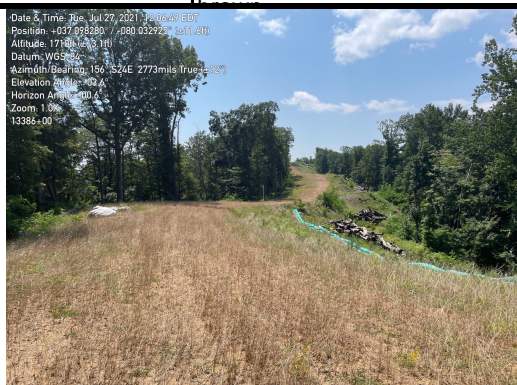
<b>Pic 11 Desc.</b>	ROW and ECDs in good condition, With Vegetation established, temporary stabilization of travel lane beginning to seed and turn	<b>Pic 12 Desc.</b>	ROW and ECDs in good condition, With Vegetation established, temporary stabilization of travel lane beginning to seed and turn

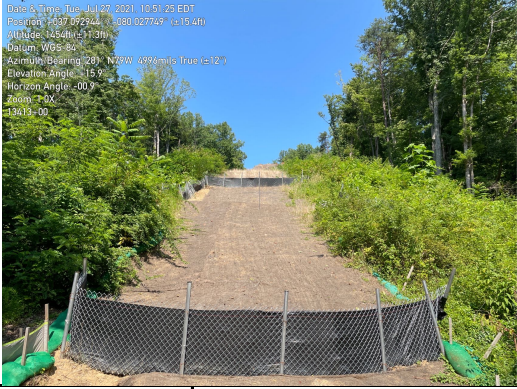
<b>GPS Location</b>	0	<b>GPS Location</b>	0		
<b>Field Station#</b>	13413+00	<b>Field Station#</b>	13413+05		
<b>Pic 13 Desc.</b>	ROW and ECDs in good condition, ROW is stable		<b>Pic 14 Desc.</b>	MVP-S-IJ1 and corresponding buffer zone in good condition	
<p>Date &amp; Time: Tue, Jul 27, 2021, 10:48:44 EDT  Position: +037.072452° / +080.027170° (+15.44h)  Altitude: 1340ft (+11.3ft)  Datum: WGS-84  Azimuth Bearing: 320° N40W 588mils True (+14°)  Elevation Angle: +07.7°  Horizon Angle: +00.8°  Zoom: 1.0X  13415-51 Cahas Mountain Road Crossing</p>

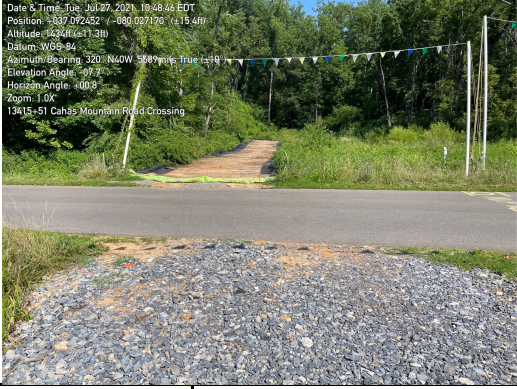
<b>GPS Location</b>	0	<b>GPS Location</b>	0		
<b>Field Station#</b>	13415+51	<b>Field Station#</b>	13416+50		
<b>Pic 15 Desc.</b>	Cahas Mountain Road Crossing in good condition and RCE in good condition and functioning properly		<b>Pic 16 Desc.</b>	ROW and ECDs in good condition, ROW is stable	
<p>Date &amp; Time: Tue, Jul 27, 2021, 10:44:40 EDT  Position: +037.073330° / +080.025550° (+15.44h)  Altitude: 1518ft (+15.4ft)  Datum: WGS-84  Azimuth Bearing: 108° S01E 300mils True (+12°)  Elevation Angle: +15.2°  Horizon Angle: +01.7°  Zoom: 1.0X  13422+00</p>

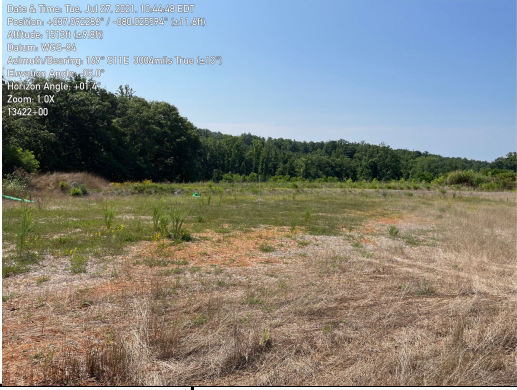
<b>Pic 17 Desc.</b>	ROW and ECDs in good condition, With Vegetation established across ROW		<b>Pic 18 Desc.</b>	RCE in good condition and functioning properly

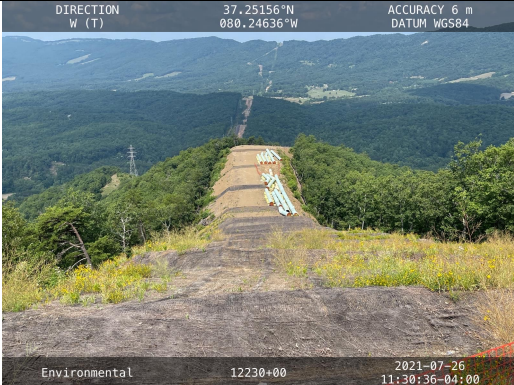
<b>GPS Location</b>	See photo		<b>GPS Location</b>	See photo	
<b>Field Station#</b>	12230+00		<b>Field Station#</b>	12236+00	
<b>Pic 1 Desc.</b>	Stabilized slope in acceptable condition		<b>Pic 2 Desc.</b>	Stabilized slope in acceptable condition

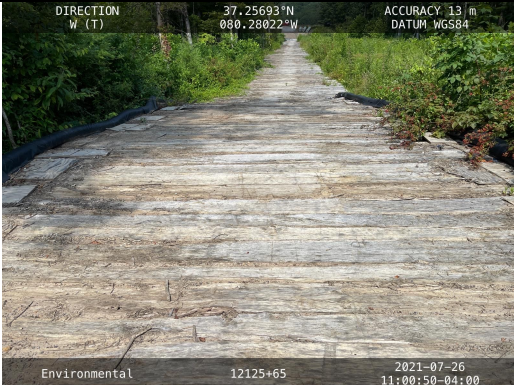
<b>GPS Location</b>	See photo		<b>GPS Location</b>	See photo	
<b>Field Station#</b>	12125+65		<b>Field Station#</b>	12132+73	
<b>Pic 3 Desc.</b>	Bridge and timber mat travel lane crossing multiple streams in acceptable condition		<b>Pic 4 Desc.</b>	Bridge and ECDs crossing S-C29 in acceptable condition

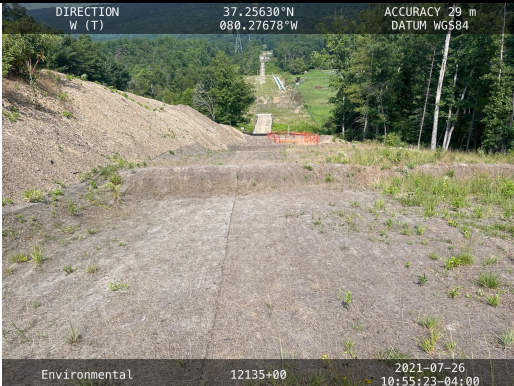
<b>GPS Location</b>	See photo		<b>GPS Location</b>	See photo	
<b>Field Station#</b>	12135+00		<b>Field Station#</b>	12139+91	
<b>Pic 5 Desc.</b>	Stabilized slope in acceptable condition		<b>Pic 6 Desc.</b>	Wetland W-C5 in acceptable condition

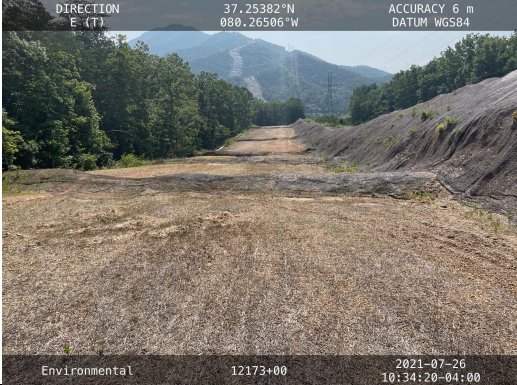
<b>GPS Location</b>	See photo		<b>GPS Location</b>	See photo	
<b>Field Station#</b>	12173+00		<b>Field Station#</b>	12166+47	
<b>Pic 7 Desc.</b>	Stabilized ROW in acceptable condition		<b>Pic 8 Desc.</b>	Bridge and ECDs crossing stream S-C24 in acceptable condition

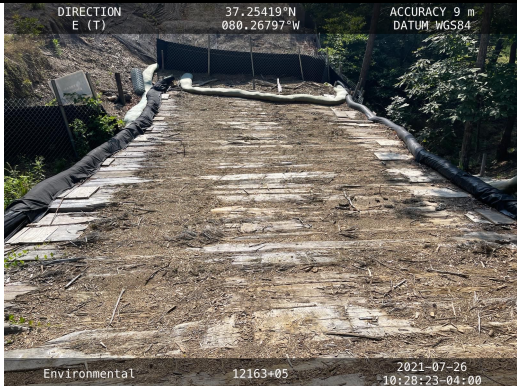
<b>GPS Location</b>	See photo		<b>GPS Location</b>	See photo	
<b>Field Station#</b>	12163+05		<b>Field Station#</b>	12159+00	
<b>Pic 9 Desc.</b>	Stream crossing S-C25 in acceptable condition		<b>Pic 10 Desc.</b>	Fill slope drain in acceptable condition

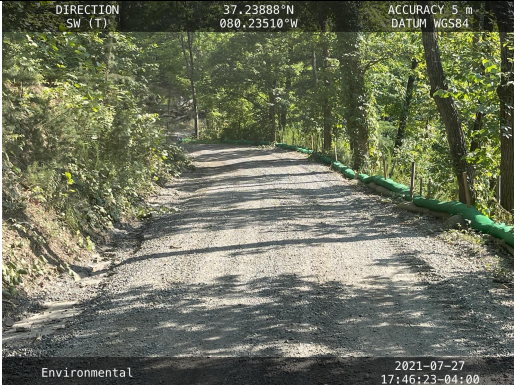
<b>GPS Location</b>	See photo		<b>GPS Location</b>	See photo	
<b>Field Station#</b>	12234+50		<b>Field Station#</b>	12234+50	
<b>Pic 1 Desc.</b>	Access Road MVP-MN-276.03 in acceptable condition		<b>Pic 2 Desc.</b>	Access Road MVP-MN-276.03 in acceptable condition

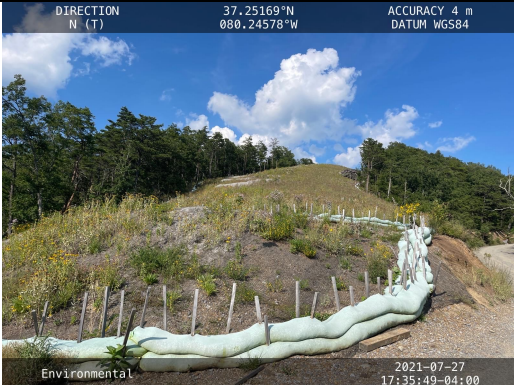
<b>GPS Location</b>	See photo		<b>GPS Location</b>	See photo	
<b>Field Station#</b>	12236+00		<b>Field Station#</b>	12232+00	
<b>Pic 3 Desc.</b>	Stabilized ROW in acceptable condition		<b>Pic 4 Desc.</b>	ROW with open travel lane

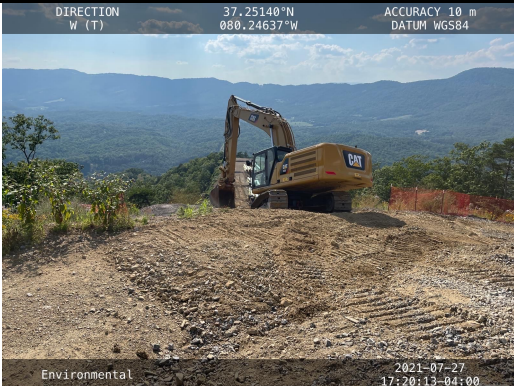
<b>GPS Location</b>	See photo		<b>GPS Location</b>	See photo	
<b>Field Station#</b>	12234+00		<b>Field Station#</b>	12233+00	
<b>Pic 5 Desc.</b>	Excavator reinstalling waterbars		<b>Pic 6 Desc.</b>	Dozer pushing water bar materials into place for excavator to pack in.

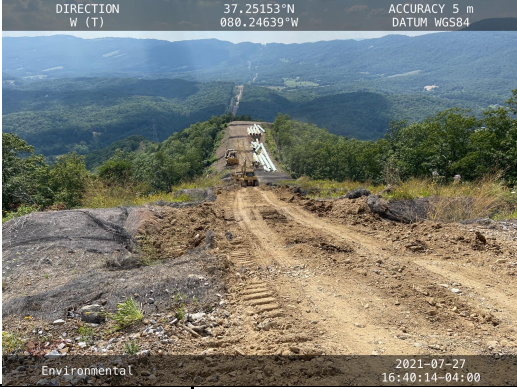
<b>GPS Location</b>	See photo	<b>GPS Location</b>	See photo		
<b>Field Station#</b>	12228+00	<b>Field Station#</b>	12234+50		
<b>Pic 7 Desc.</b>	Dozer and excavator working their way up the slope reinstalling waterbars	<b>Pic 8 Desc.</b>	Three of four side booms staged for assembly		
Insert image here		Insert image here			
<b>GPS Location</b>		<b>GPS Location</b>			
<b>Field Station#</b>		<b>Field Station#</b>			
<b>Pic 9 Desc.</b>		<b>Pic 10 Desc.</b>			
Insert image here		Insert image here			
<b>GPS Location</b>		<b>GPS Location</b>			
<b>Field Station#</b>		<b>Field Station#</b>			
<b>Pic 11 Desc.</b>		<b>Pic 12 Desc.</b>

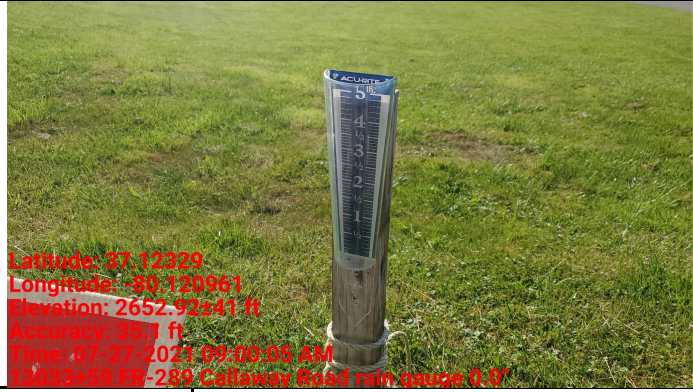
<p>Latitude: 37.12329 Longitude: -80.120961 Elevation: 2652.92±41 ft Accuracy: 35.1 ft Time: 07-27-2021 09:10:05 AM 13033+59 BR-289 Callaway Road rain gauge 0.0"</p>

<p>Latitude: 37.125383 Longitude: -80.121578 Elevation: 2661.94±22 ft Accuracy: 19.0 ft Time: 07-27-2021 09:14:19 AM 13024+00 GAS of the BRP</p>		<b>GPS Location</b>	See pic for GPS location
<b>Field Station#</b>	13033+59	<b>Field Station#</b>	13024+00	<b>Field Station#</b>	13024+00
<b>Pic 1 Desc.</b>	Callaway Road rain gauge 0.0" total precipitation	<b>Pic 2 Desc.</b>	Mat bridge over CWDP and temporary stabilization.	<b>Pic 3 Desc.</b>

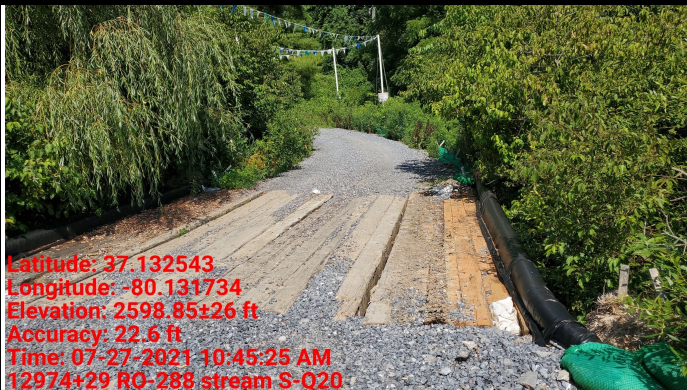
<p>Latitude: 37.132543 Longitude: -80.131734 Elevation: 2598.85±26 ft Accuracy: 22.6 ft Time: 07-27-2021 10:45:25 AM 12974+29 RO-288 stream S-Q20</p>

<b>GPS Location</b>	See pic for GPS location		<b>GPS Location</b>	See pic for GPS location	
<b>Field Station#</b>	12974+29		<b>Field Station#</b>	12957+38	
<b>Pic 9 Desc.</b>	Stream crossing S-Q20 on RO-288.		<b>Pic 10 Desc.</b>	Punch list maintenance issue. Porta-John's removed and now needs P1 installed across the gap. Completed

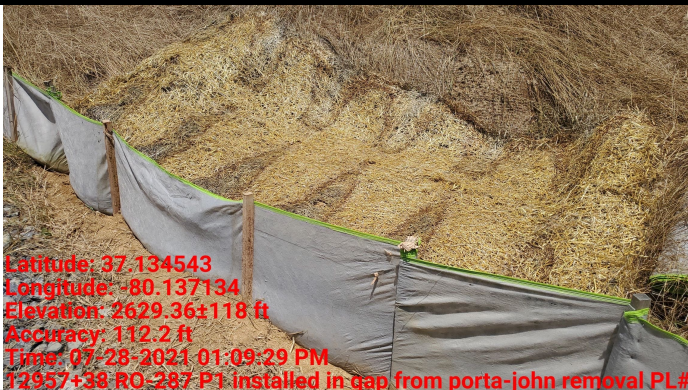
<p>Latitude: 37.134543 Longitude: -80.137134 Elevation: 2629.36±118 ft Accuracy: 112.2 ft Time: 07-28-2021 01:09:29 PM 12957+38 RO-287 P1 installed in gap from porta-john removal PL#</p>

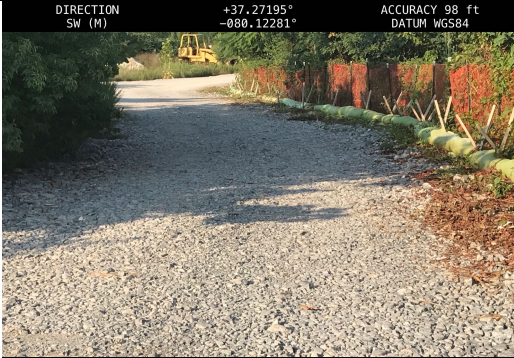
<p>DIRECTION SW (M) +37.27195° -080.12281° ACCURACY 98 ft DATUM WGS84</p> <p>MVP-LY-049_072821 Condition of rock entrance 2021-07-28 08:12:30-04:00</p>

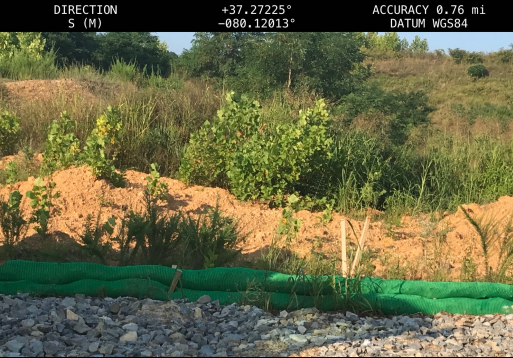
<p>DIRECTION S (M) +37.27225° -080.12013° ACCURACY 0.76 m1 DATUM WGS84</p> <p>MVP-LY-049_072821 Landowner disturbance along CFS 2021-07-28 08:21:09-04:00</p>			
<b>GPS Location</b>	MVP-LY-049 See photo for gps data		<b>GPS Location</b>	MVP-LY-049 See photo for gps data	
<b>Field Station#</b>	+0		<b>Field Station#</b>	+0	
<b>Pic 1 Desc.</b>	Condition of rock entrance on north drive. No sediment on stone. Looking SW.		<b>Pic 2 Desc.</b>	Landowner soil disturbance along triple compost filter sock. No new damage to installed ECD's. Looking SW.

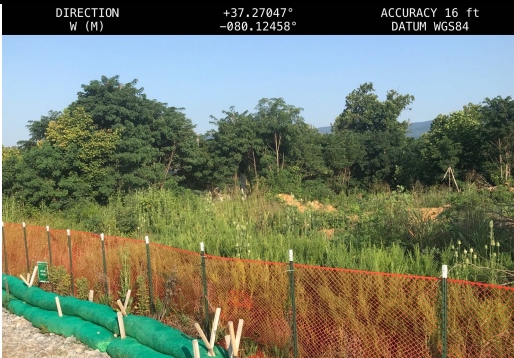
<p>DIRECTION W (M) +37.27047° -080.12458° ACCURACY 16 ft DATUM WGS84</p> <p>MVP-LY-049_072821 Landowner disturbance along feature 2021-07-28 08:22:48-04:00</p>

<b>GPS Location</b>	MVP-LY-049 See photo for gps data		<b>GPS Location</b>	MVP-LY-049 See photo for gps data	
<b>Field Station#</b>	+0		<b>Field Station#</b>	+0	
<b>Pic 3 Desc.</b>	Landowner soil disturbance along edge of feature W-CV21A. Area not stabilized. Looking NW.		<b>Pic 4 Desc.</b>	Landowner soil disturbance in 2 locations west of feature W-CV21B. Areas not stabilized. Looking SW.

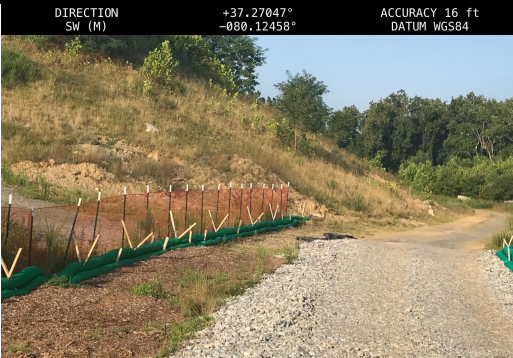
<p>DIRECTION SW (M) +37.27047° -080.12458° ACCURACY 16 ft DATUM WGS84</p> <p>MVP-LY-049_072821 Landowner disturbance west of feature 2021-07-28 08:22:52-04:00</p>

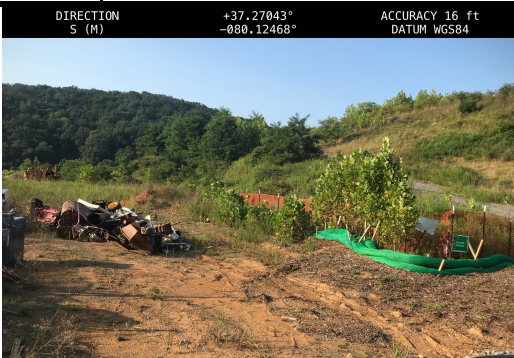
<p>DIRECTION S (M) +37.27043° -080.12468° ACCURACY 16 ft DATUM WGS84</p> <p>MVP-LY-049_072821 Landowner disturbance along CFS &amp; feature 2021-07-28 08:23:13-04:00</p>

<p>DIRECTION S (M) +37.27063° -080.12382° ACCURACY 33 ft DATUM WGS84</p> <p>MVP-LY-049_072821 Containment under stored equipment 2021-07-28 08:24:19-04:00</p>			
<b>GPS Location</b>	MVP-LY-049 See photo for gps data		<b>GPS Location</b>	MVP-LY-049 See photo for gps data	
<b>Field Station#</b>	+0		<b>Field Station#</b>	+0	
<b>Pic 5 Desc.</b>	Landowner soil disturbance along triple compost filter sock and east of feature W-CV21B. Area not stabilized. Looking S.		<b>Pic 6 Desc.</b>	Condition of containment under stored equipment. Looking SW.

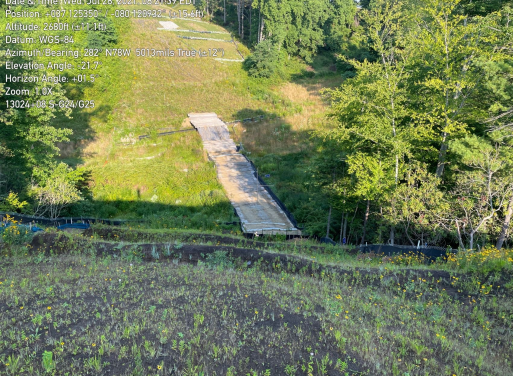
<b>GPS Location</b>	0	<b>GPS Location</b>	0		
<b>Field Station#</b>	13033+50	<b>Field Station#</b>	13025+08		
<b>Pic 1 Desc.</b>	ROW and ECDs in good condition, with good vegetation established across ROW		<b>Pic 2 Desc.</b>	MVP-S-G24/G25 and their corresponding buffer zones in good condition

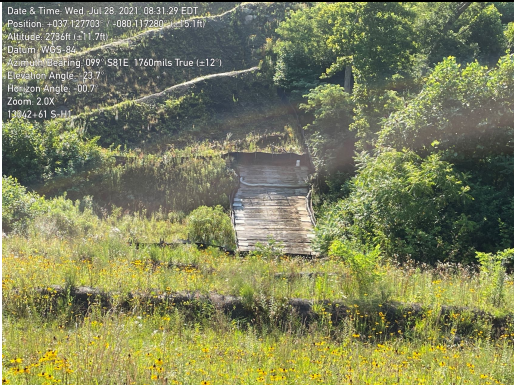
<b>GPS Location</b>	0	<b>GPS Location</b>	0		
<b>Field Station#</b>	13042+61	<b>Field Station#</b>	13061+89		
<b>Pic 3 Desc.</b>	MVP-S-H1 and corresponding buffer zone in good condition		<b>Pic 4 Desc.</b>	MVP-S-G26 and corresponding buffer zone in good condition	
<p>Date &amp; Time: Wed Jul 28, 2021, 09:46:29 EDT  Position: +037.126407 / -080.110307 (-5.15.1in)  Altitude: 2628ft (+11.2in)  Datum: WGS-84  Azimuth/Bearing: 112° S48E 1991mils True (+12.1)  Elevation Angle: +06.9°  Horizon Angle: +01.6°  Zoom: 1.0X  13062+96 S-027</p>

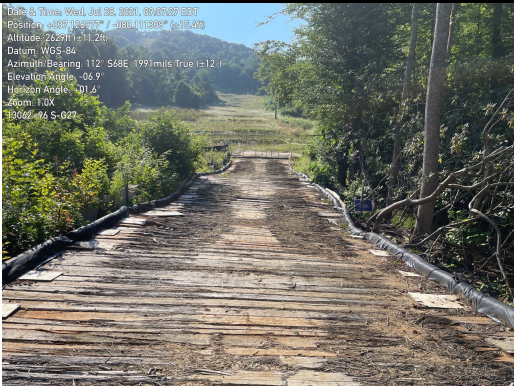
<b>GPS Location</b>	0	<b>GPS Location</b>	0		
<b>Field Station#</b>	13062+96	<b>Field Station#</b>	13064+00		
<b>Pic 5 Desc.</b>	MVP-S-G27 and corresponding buffer zone in good condition		<b>Pic 6 Desc.</b>	ROW and ECDs in good condition, with good vegetation established across ROW

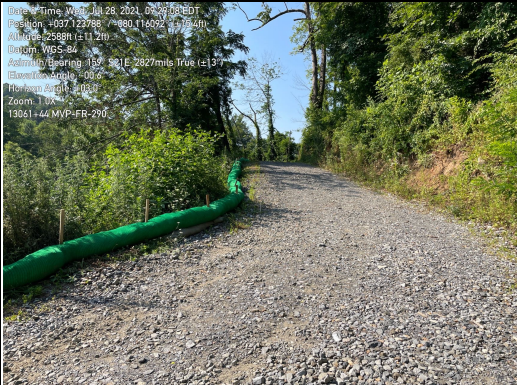
GPS Location		0				GPS Location		0			
Field Station#		13061+44				Field Station#		13033+59			
Pic 7 Desc.		New compost filter sock was placed along MVP-FR-290				Pic 8 Desc.		RCE in good condition and functioning properly			
<p>Date &amp; Time: Wed, Jul 28, 2021, 09:53:32 EDT Position: +037.123388° / -080.092788° (±11.6ft) Altitude: 2715ft (±11.7ft) Datum: WGS-84 Azimuth/Bearing: 325° N35W 5726mils True (±12°) Elevation Angle: +07.5° Horizon Angle: +02.0° Zoom: 1.0X 13113+50</p>

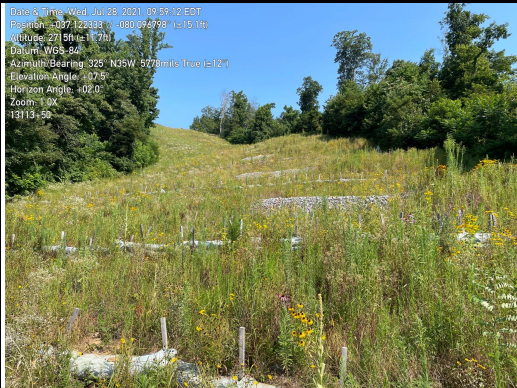
GPS Location		0				GPS Location		0			
Field Station#		13113+50				Field Station#		13141+53			
Pic 9 Desc.		ROW and ECDs in good condition, with good vegetation established across ROW				Pic 10 Desc.		Sock needs repaired along MVP-FR-292, 72 hour maintenance item. Was addressed and sock repaired prior to finishing inspection			
<p>Date &amp; Time: Wed, Jul 28, 2021, 11:33:52 EDT Position: +037.120435° / -080.088321° (±15.1ft) Altitude: 1634ft (±11.7ft) Datum: WGS-84 Azimuth/Bearing: 318° N42W 5693mils True (±12°) Elevation Angle: +02.1° Horizon Angle: +00.3° Zoom: 1.0X 13141+53 S-D14</p>

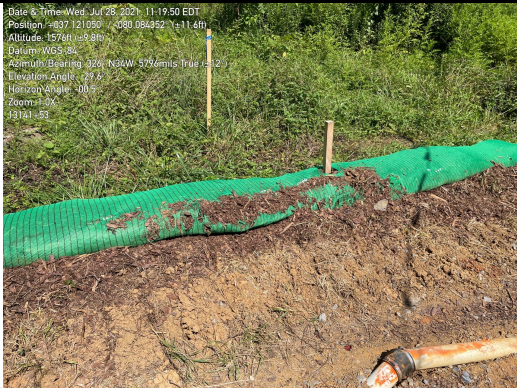
E&S BMPs	Compliance Level	Corrective Action	Corrective Time Frame	Date Repaired
Compost Filter Berm	Acceptable			
Compost Filter Sock	Communication	Sock needs repaired -72hr item		7/28/2021
Equipment Bridge	Acceptable			
Erosion Control Blanket	Acceptable			
Rock Construction Entrance	Acceptable			
Silt Fence (Filter Fabric Fence)	Acceptable			
Silt Fence (Reinforced Filter Fabric Fence)	Acceptable			
Housekeeping	Communication	Trash needs picked up - 72hr item		7/28/2021
Waterbar	Acceptable

<b>A/E</b>	124300138	<b>Date/Time</b>	7/28/2021 4:02 PM	<b>Report #</b>	26489
<b>6. PCSM BMPs</b> (List BMPs and note if installed and maintained as per the plan. If corrective action is needed, a picture is required.)					
<b>PCSM BMPs</b>	<b>Compliance Level</b>	<b>Corrective Action</b>	<b>Corrective Time Frame</b>	<b>Date Repaired</b>	
Level Spreader	Acceptable				
Other	Acceptable	Permanent waterbar			
<b>7. Identify all remedial measures that have been taken since the previous inspection was conducted.</b>					
<b>Comments</b> (Reference above questions as appropriate.)					
<p>A SWPPP Inspection was performed from Station 13024+00 to Station 13141+65. Stream Crossings included in the inspection were S-G24, S-G25, S-H1, S-G26, S-G27, S-RR18, S-RR16, S-EF17, S-D17 and S-D14. There were no issues or impacts observed at stream crossings or corresponding buffer zones. Access roads FR-289, FR-290, FR-291, and FR-292 were inspected. Two 72 hour maintenance items (repair filter sock &amp; clean up and remove trash) were noted at access 291. ROW was stable throughout this inspection area. All other ECDs were in satisfactory condition and functioning properly. Rock Construction Entrances were in good condition.</p> <p>An E&amp;S Crew arrived at 292 and resolved the two maintenance items.</p>

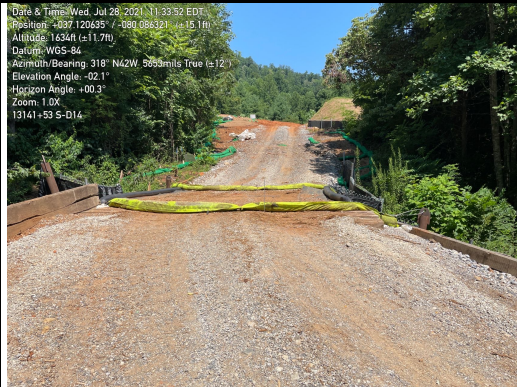
Field Station#		13141+53				Field Station#		13141+53			
Pic 11 Desc.		MVP-S-D14 and corresponding buffer zone in good condition				Pic 12 Desc.		Trash needs cleaned up and removed from site

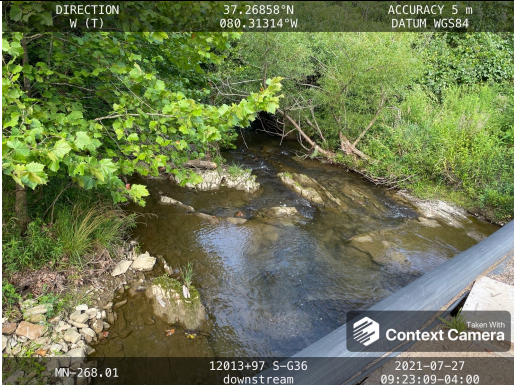
<p>DIRECTION W (T) 37.26858°N 080.31314°W ACCURACY 5 m DATUM WGS84</p> <p>MN-268.01 12013+97 S-G36 downstream 2021-07-27 09:23:09-04:00</p>

<p>DIRECTION SE (T) 37.26714°N 080.31289°W ACCURACY 4 m DATUM WGS84</p> <p>MN-268.01 12015+84 S-G38 crossing 2021-07-27 09:35:50-04:00</p>	
<b>GPS Location</b>	See photo		<b>GPS Location</b>	See photo	
<b>Field Station#</b>	12013+97		<b>Field Station#</b>	12015+84	
<b>Pic 1 Desc.</b>	Stream S-G36 flowing free and clear of sediment		<b>Pic 2 Desc.</b>	Equipment Bridge over Stream S-G38

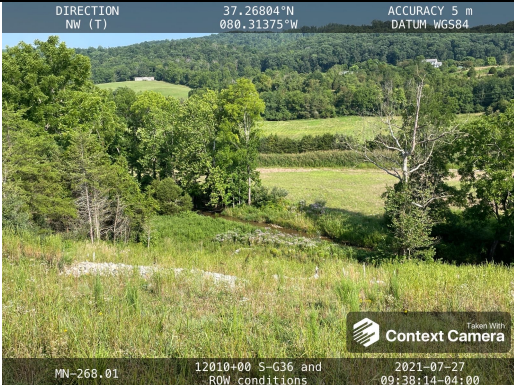
<p>DIRECTION NW (T) 37.26804°N 080.31375°W ACCURACY 5 m DATUM WGS84</p> <p>MN-268.01 12010+00 S-G36 and ROW conditions 2021-07-27 09:38:14-04:00</p>

<b>GPS Location</b>	See photo		<b>GPS Location</b>	See photo	
<b>Field Station#</b>	12010+00		<b>Field Station#</b>	12013+00	
<b>Pic 3 Desc.</b>	Stream S-G36 and current ROW conditions		<b>Pic 4 Desc.</b>	Current ROW conditions on GAS MN-268.01

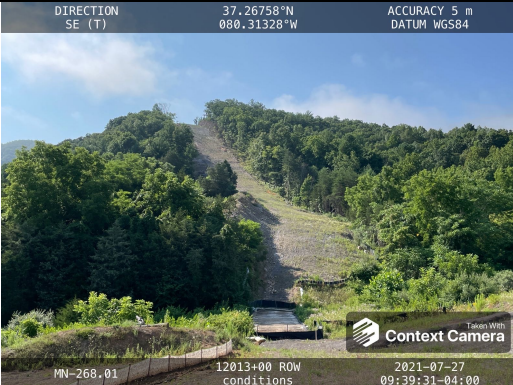
<p>DIRECTION SE (T) 37.26758°N 080.31328°W ACCURACY 5 m DATUM WGS84</p> <p>MN-268.01 12013+00 ROW conditions 2021-07-27 09:39:31-04:00</p>

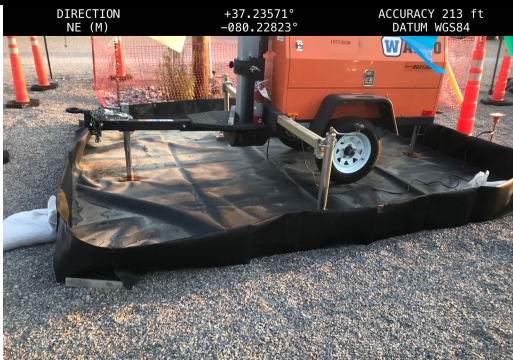
MVP-PY-006_072821 Condition of containment 2021-07-28 07:13:51-04:00		MVP-PY-006_072821 Condition of signage & CFS at feature 2021-07-28 07:14:34-04:00			
GPS Location	MVP-PY-006 See photo for gps data		GPS Location	MVP-PY-006 See photo for gps data	
Field Station#	+0		Field Station#	+0	
Pic 1 Desc.	Condition of containment under light plant. Free of stormwater. Looking NE.		Pic 2 Desc.	Condition of signage and compost filter sock at feature W-008. Over grown with vegetation. Looking NE.

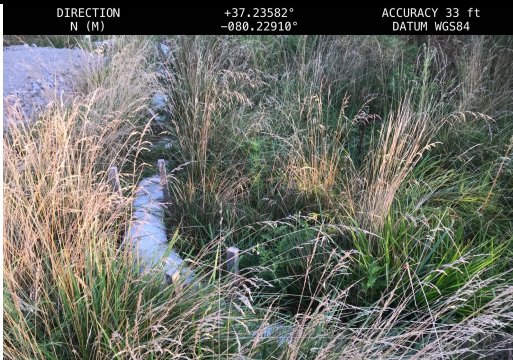
MVP-PY-006_072821 Condition of CFS along LOD 2021-07-28 07:15:20-04:00		MVP-PY-006_072821 Condition of trays & containment 2021-07-28 07:16:57-04:00			
GPS Location	MVP-PY-006 See photo for gps data		GPS Location	MVP-PY-006 See photo for gps data	
Field Station#	+0		Field Station#	+0	
Pic 3 Desc.	Condition of compost filter sock along north LOD. Over grown with vegetation. Looking N		Pic 4 Desc.	Condition of trays and containment under toilets. Looking SW.

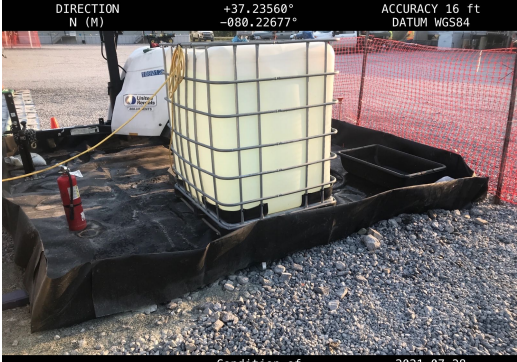
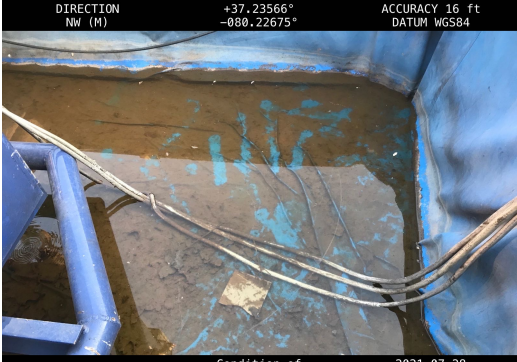
<p>DIRECTION N (M) +37.23560° -080.22677° ACCURACY 16 ft DATUM WGS84</p> <p>MVP-PY-006_072821 Condition of containment 2021-07-28 07:22:39-04:00</p>

<p>DIRECTION NW (M) +37.23566° -080.22675° ACCURACY 16 ft DATUM WGS84</p> <p>MVP-PY-006_072821 Condition of containment 2021-07-28 07:22:53-04:00</p>			
<b>GPS Location</b>	MVP-PY-006 See photo for gps data	<b>GPS Location</b>	MVP-PY-006 See photo for gps data		
<b>Field Station#</b>	+0	<b>Field Station#</b>	+0		
<b>Pic 7 Desc.</b>	Condition of containment under DEF container. Free of fluids. Looking N.	<b>Pic 8 Desc.</b>	Blue Bulk Fuel tanks containment holding stormwater with sheen. Looking NW.

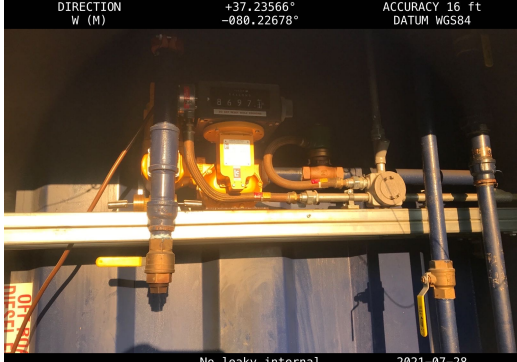
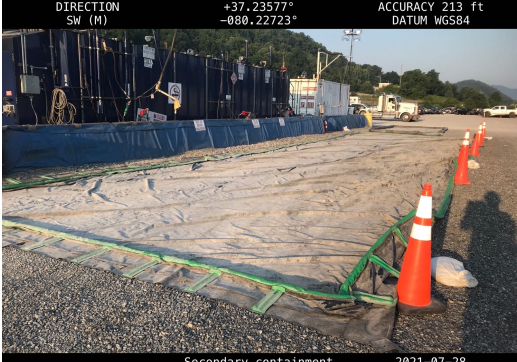
<p>DIRECTION W (M) +37.23566° -080.22678° ACCURACY 16 ft DATUM WGS84</p> <p>MVP-PY-006_072821 No leaky internal fittings 2021-07-28 07:23:18-04:00</p>

<p>DIRECTION SW (M) +37.23577° -080.22723° ACCURACY 213 ft DATUM WGS84</p> <p>MVP-PY-006_072821 Secondary containment on site for tankers 2021-07-28 07:23:52-04:00</p>

<b>GPS Location</b>	MVP-PY-006 See photo for gps data	<b>GPS Location</b>	MVP-PY-006 See photo for gps data		
<b>Field Station#</b>	+0	<b>Field Station#</b>	+0		
<b>Pic 9 Desc.</b>	Blue Bulk Fuel tanks no leaky internal fittings. Looking W.	<b>Pic 10 Desc.</b>	Both secondary containments on site and in place for tankers offloading fuel. Looking SW.

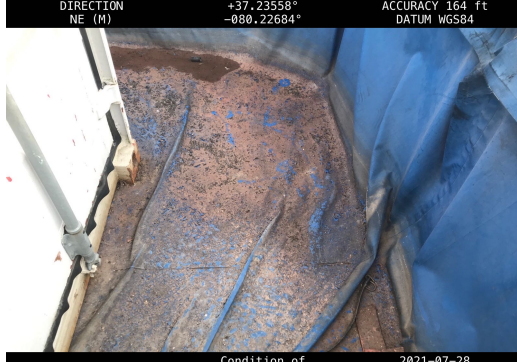
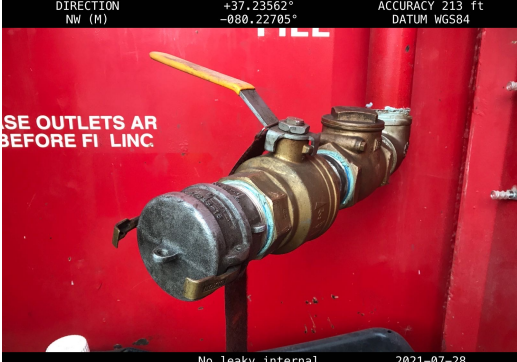
<p>DIRECTION NE (M) +37.23558° -080.22684° ACCURACY 164 ft DATUM WGS84</p> <p>MVP-PY-006_072821 Condition of containment 2021-07-28 07:25:07-04:00</p>

<p>DIRECTION NW (M) +37.23562° -080.22705° ACCURACY 213 ft DATUM WGS84</p> <p>MVP-PY-006_072821 No leaky internal fittings 2021-07-28 07:25:29-04:00</p>			
<b>GPS Location</b>	MVP-PY-006 See photo for gps data	<b>GPS Location</b>	MVP-PY-006 See photo for gps data		
<b>Field Station#</b>	+0	<b>Field Station#</b>	+0		
<b>Pic 11 Desc.</b>	Off Road Fuel unit containment free of stormwater. Looking NE.	<b>Pic 12 Desc.</b>	Off Road Fuel unit no leaky internal fittings. Looking NW.

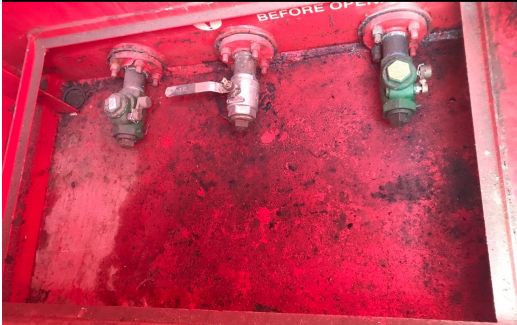
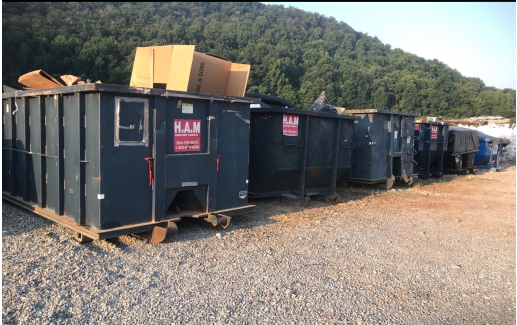
MVP-PY-006_072821 Condition of internal drip pan 2021-07-28 07:25:35-04:00		DIRECTION SW (M) +37.23561° -080.22674° ACCURACY 164 ft DATUM WGS84

MVP-PY-006_072821 No loose trash around dumpsters 2021-07-28 07:26:56-04:00			
<b>GPS Location</b>	MVP-PY-006 See photo for gps data		<b>GPS Location</b>	MVP-PY-006 See photo for gps data	
<b>Field Station#</b>	+0		<b>Field Station#</b>	+0	
<b>Pic 13 Desc.</b>	Off Road Fuel unit condition of internal drip pan. Free of fluids. Looking SW.		<b>Pic 14 Desc.</b>	No loose trash around dumpsters or in the yard. Looking SW.	
DIRECTION SW (M) +37.23549° -080.22668° ACCURACY 33 ft DATUM WGS84

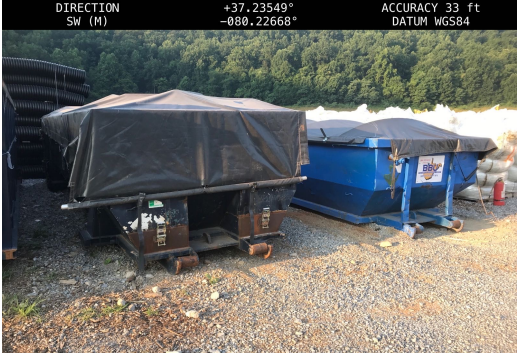
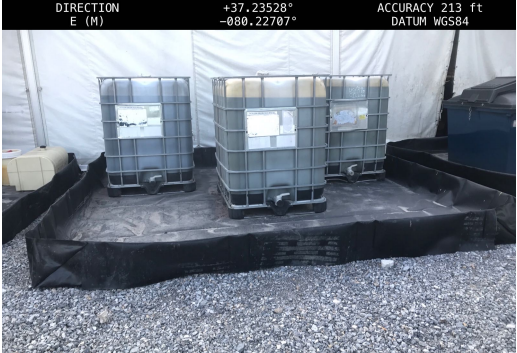
MVP-PY-006_072821 No fluids around hazardous waste dump... 2021-07-28 07:27:14-04:00		DIRECTION E (M) +37.23528° -080.22707° ACCURACY 213 ft DATUM WGS84

MVP-PY-006_072821 Condition of containment under us... 2021-07-28 07:32:06-04:00

<b>GPS Location</b>	MVP-PY-006 See photo for gps data		<b>GPS Location</b>	MVP-PY-006 See photo for gps data	
<b>Field Station#</b>	+0		<b>Field Station#</b>	+0	
<b>Pic 15 Desc.</b>	No fluids or deposits around hazardous waste dumpsters. Looking SW.		<b>Pic 16 Desc.</b>	Condition of containment under used oil containers. Free of stormwater and fluids. Looking E.	
DIRECTION SE (M) +37.23421° -080.22711° ACCURACY 16 ft DATUM WGS84

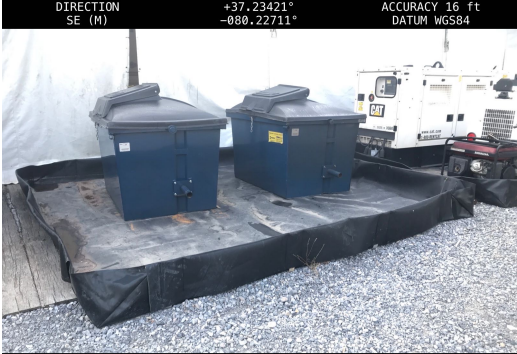
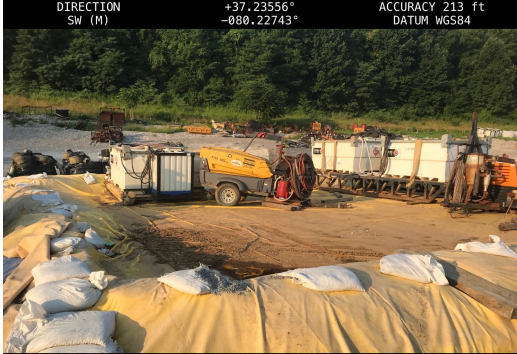
MVP-PY-006_072821 Condition of containment 2021-07-28 07:32:12-04:00		DIRECTION SW (M) +37.23556° -080.22743° ACCURACY 213 ft DATUM WGS84

MVP-PY-006_072821 Condition of poly lined containments 2021-07-28 07:33:50-04:00			
<b>GPS Location</b>	MVP-PY-006 See photo for gps data		<b>GPS Location</b>	MVP-PY-006 See photo for gps data	
<b>Field Station#</b>	+0		<b>Field Station#</b>	+0	
<b>Pic 17 Desc.</b>	Condition of containment under the hazardous waste dumpsters. Free of stormwater and fluids. Looking SE.		<b>Pic 18 Desc.</b>	Condition of poly lined rock berm containments. Free of stormwater. Looking SW.

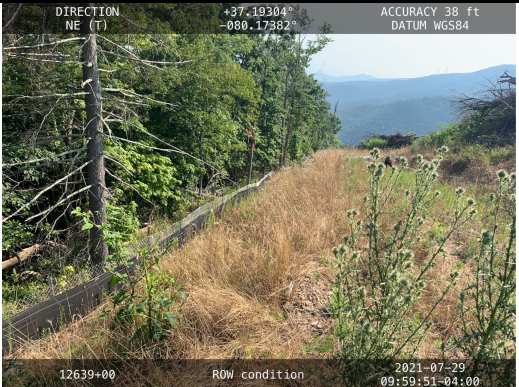
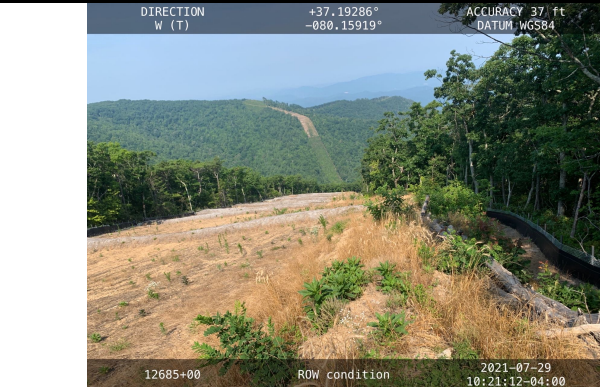
GPS Location	See photo for gps location data.		GPS Location	See photo for gps location data.	
Field Station#	12639+00		Field Station#	12685+00	
Pic 1 Desc.	Photo shows the ROW and ECD conditions.		Pic 2 Desc.	Photo shows the ROW and ECD conditions

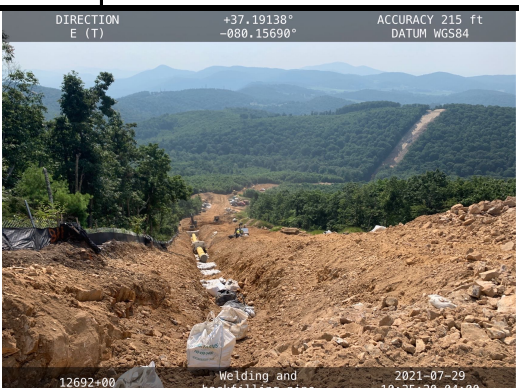
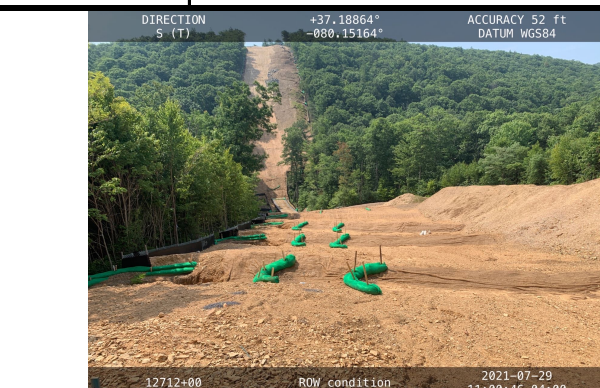
GPS Location	See photo for gps location data.		GPS Location	See photo for gps location data.	
Field Station#	12692+00		Field Station#	12712+00	
Pic 3 Desc.	Photo shows the contractor welding and backfilling		Pic 4 Desc.	Photo shows the ROW and ECD conditions

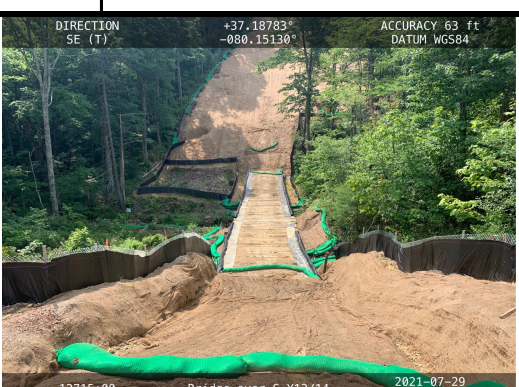
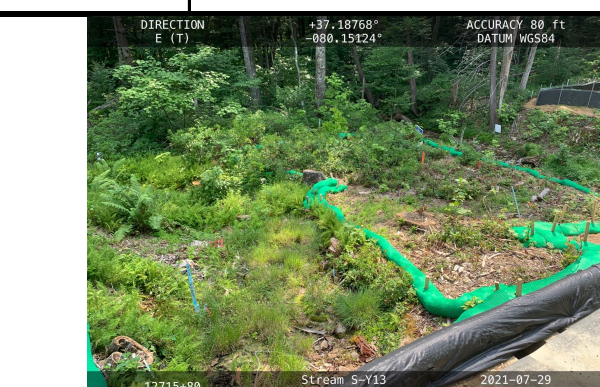
GPS Location	See photo for gps location data.		GPS Location	See photo for gps location data.	
Field Station#	12715+00		Field Station#	12715+80	
Pic 5 Desc.	Photo shows the bridge over streams S-Y13 and S-Y14		Pic 6 Desc.	Photo shows stream S-Y13 downstream from the bridge

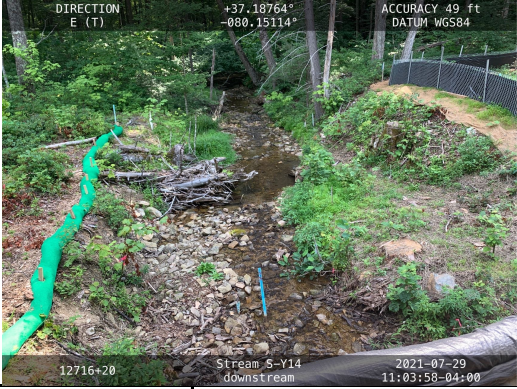
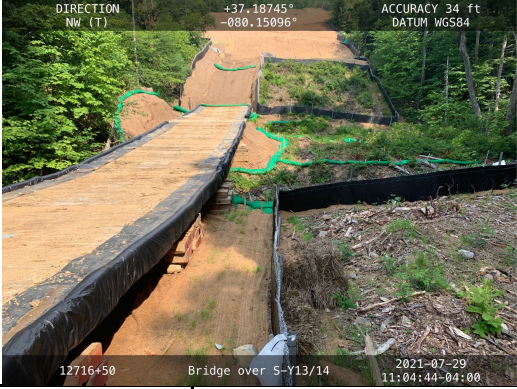
<b>GPS Location</b>	See photo for gps location data.		<b>GPS Location</b>	See photo for gps location data.	
<b>Field Station#</b>	12716+20		<b>Field Station#</b>	12716+50	
<b>Pic 7 Desc.</b>	Photo shows stream S-Y14 downstream from the bridge		<b>Pic 8 Desc.</b>	Photo shows the bridge over streams S-Y13 and S-Y14

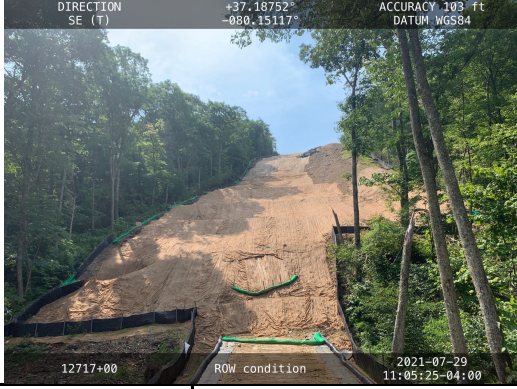
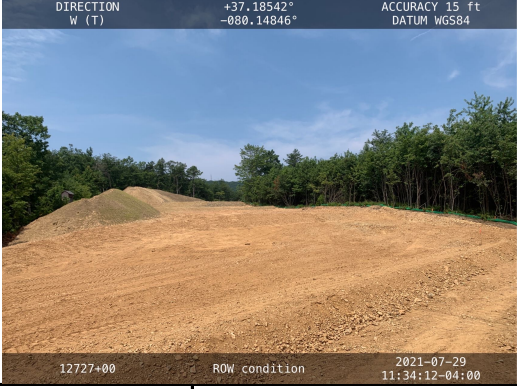
<b>GPS Location</b>	See photo for gps location data.		<b>GPS Location</b>	See photo for gps location data.	
<b>Field Station#</b>	12717+00		<b>Field Station#</b>	12727+00	
<b>Pic 9 Desc.</b>	Photo shows the ROW and ECD conditions		<b>Pic 10 Desc.</b>	Photo shows the ROW condition

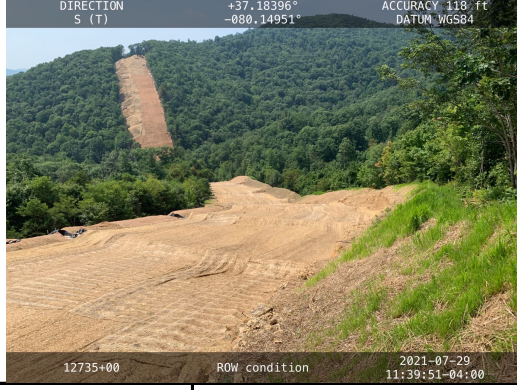
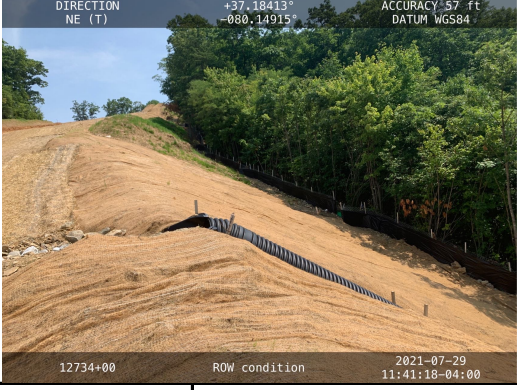
<b>GPS Location</b>	See photo for gps location data.		<b>GPS Location</b>	See photo for gps location data.	
<b>Field Station#</b>	12735+00		<b>Field Station#</b>	12734+00	
<b>Pic 11 Desc.</b>	Photo shows the ROW and ECD conditions		<b>Pic 12 Desc.</b>	Photo shows the stabilized fill slopes and slope drains

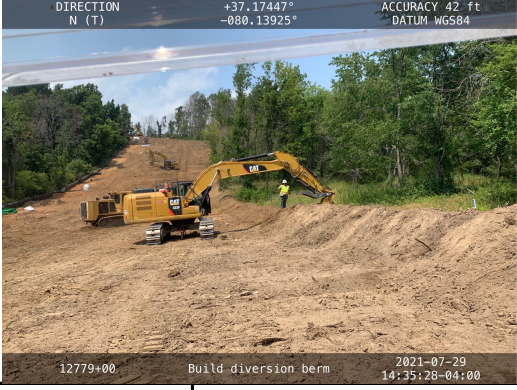
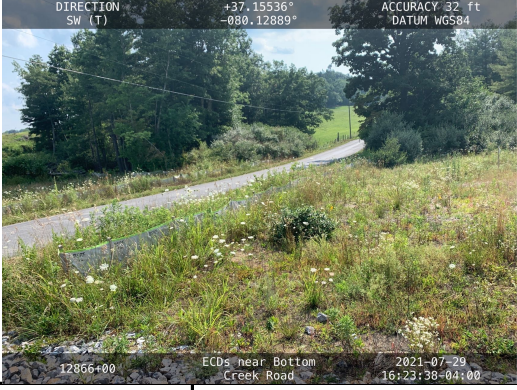
<b>GPS Location</b>	See photo for gps location data.		<b>GPS Location</b>	See photo for gps location data.	
<b>Field Station#</b>	12779+00		<b>Field Station#</b>	12866+00	
<b>Pic 17 Desc.</b>	Photo shows the contractor installing a diversion berm		<b>Pic 18 Desc.</b>	Photo shows the ECDs near Bottom Creek Road

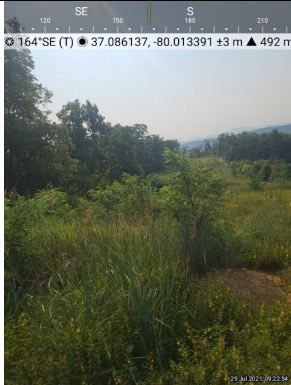
<b>GPS Location</b>	0000	<b>GPS Location</b>	0000		
<b>Field Station#</b>	13450+00	<b>Field Station#</b>	13462+00		
<b>Pic 1 Desc.</b>	Vegetation observation photo showing good coverage throughout.		<b>Pic 2 Desc.</b>	Row photo showing locust trees growing inside the LOD . No environmental issues observed at the time of inspection.

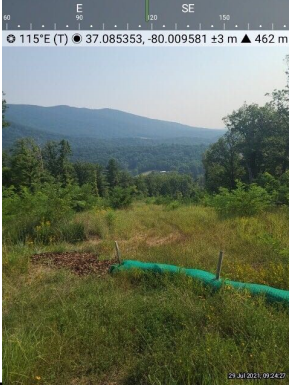
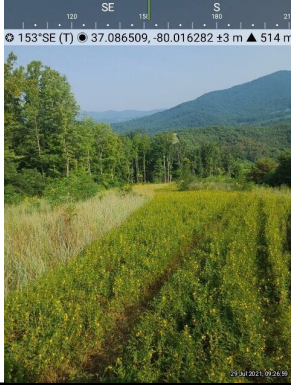
<b>GPS Location</b>	00000	<b>GPS Location</b>	00000		
<b>Field Station#</b>	13476+78	<b>Field Station#</b>	13450+00		
<b>Pic 5 Desc.</b>	Monitored recently repaired ECDs while inspecting row conditions. No environmental issues observed at the time of inspection.		<b>Pic 6 Desc.</b>	Vegetation observation photo showing good coverage throughout.
