# Visual Site Inspection Report

<b>Project Name</b>	H-600 Pipeline Spread H	<b>AFE</b>	124300138	<b>Spread</b>	H-600 Pipeline Spread H
<b>Contractor</b>	Precision			<b>Report #</b>	26368
<b>Inspector</b>	Logan Box			<b>Date/Time</b>	7/26/2021 3:12 PM
<b>Permit #</b>	TBD	<b>Inspection Type</b>	VA SWPP	<b>Station Begin</b>	13525+99
<b>State</b>	VA	<b>Inspection Area</b>	Partial	<b>Station End</b>	13670+00
<b>County</b>	Franklin	<b>Ground</b>	Dry	<b>Temperature (°F)</b>	90.00
<b>Municipality</b>	N/A	<b>Weather</b>	Light Rain	<b>Rain Gauge (in)</b>	0.00
				<b>Rain Accumulation Time (days)</b>	0.00

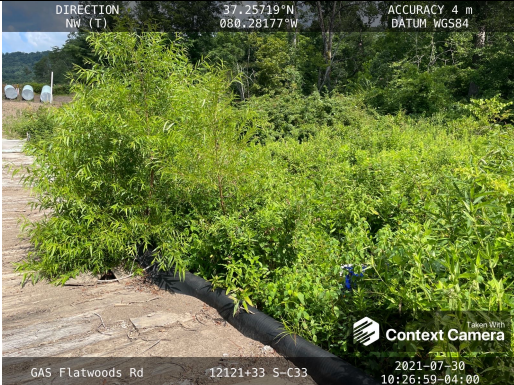
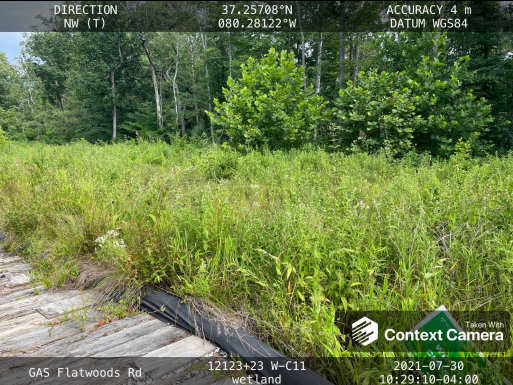
<b>GPS Location</b>	See photo		<b>GPS Location</b>	See photo	
<b>Field Station#</b>	12121+33		<b>Field Station#</b>	12123+23	
<b>Pic 1 Desc.</b>	Stream S-C33 on GAS Flatwoods Road		<b>Pic 2 Desc.</b>	Wetland W-C11 on GAS Flatwoods Road

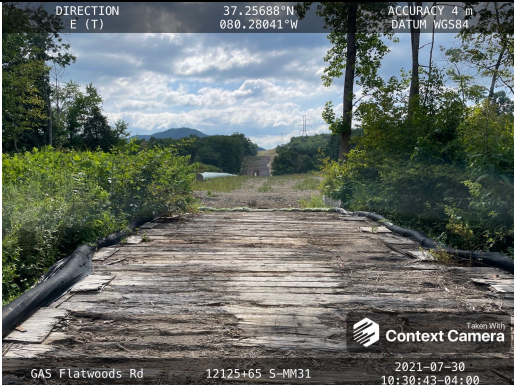
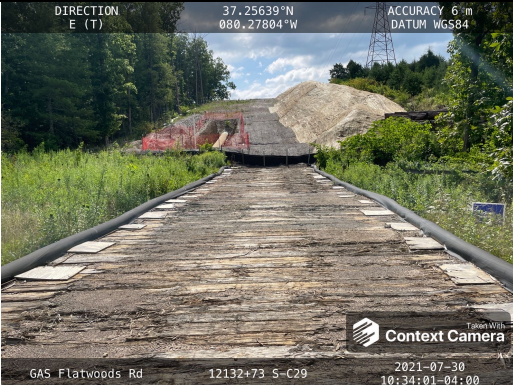
<b>GPS Location</b>	See photo		<b>GPS Location</b>	See photo	
<b>Field Station#</b>	12125+65		<b>Field Station#</b>	12132+73	
<b>Pic 3 Desc.</b>	Equipment Bridge over Stream S-MM31		<b>Pic 4 Desc.</b>	Equipment Bridge over S-C29

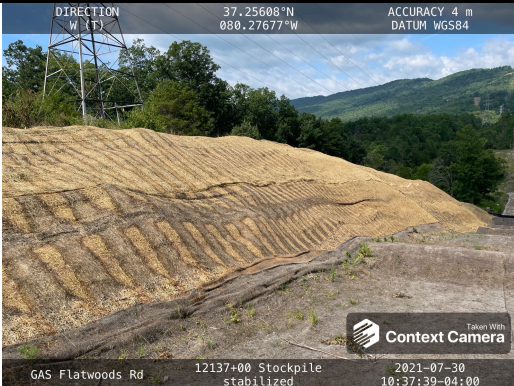
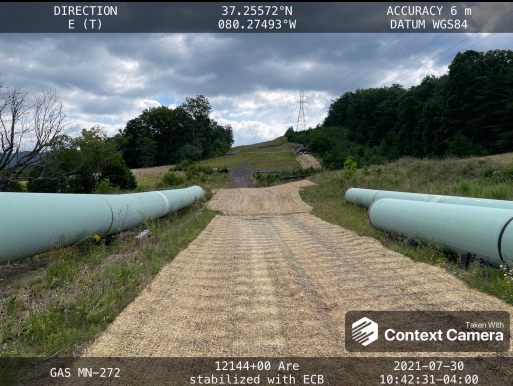
<b>GPS Location</b>	See photo		<b>GPS Location</b>	See photo	
<b>Field Station#</b>	12137+00		<b>Field Station#</b>	12144+00	
<b>Pic 5 Desc.</b>	Stockpile has been stabilized since last inspection		<b>Pic 6 Desc.</b>	Area has been stabilized with ECB

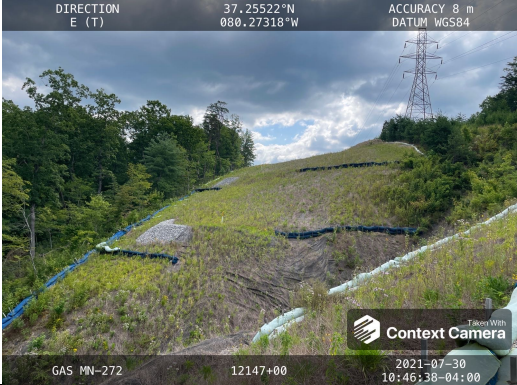
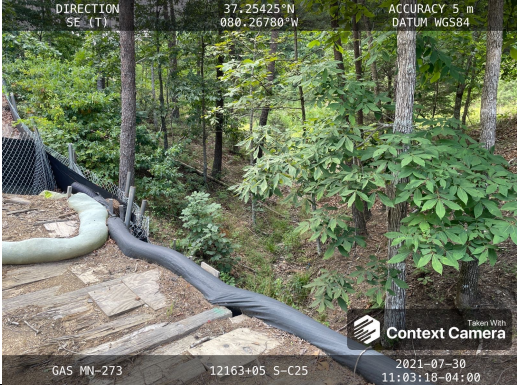
<b>GPS Location</b>	See photo		<b>GPS Location</b>	See photo	
<b>Field Station#</b>	12147+00		<b>Field Station#</b>	12163+05	
<b>Pic 7 Desc.</b>	Current ROW conditions on GAS MN-272. Permanent Slope Breaker and Level Spreader functional		<b>Pic 8 Desc.</b>	Downstream photo of Stream S-C25

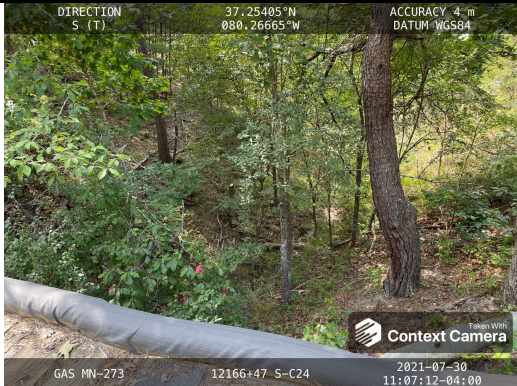
<b>GPS Location</b>	See photo		<b>GPS Location</b>	See photo	
<b>Field Station#</b>	12166+47		<b>Field Station#</b>	12173+00	
<b>Pic 9 Desc.</b>	Downstream photo of Stream S-C24		<b>Pic 10 Desc.</b>	Current ROW conditions. Waterbars are functional and stockpiles stabilized.

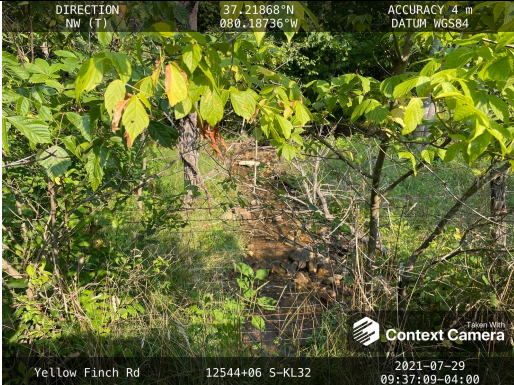
<b>GPS Location</b>	See photo		<b>GPS Location</b>	See photo	
<b>Field Station#</b>	12544+06		<b>Field Station#</b>	12544+06	
<b>Pic 1 Desc.</b>	Stream S-KL32 on Yellow Finch Road		<b>Pic 2 Desc.</b>	Stream S-EF20B on Yellow Finch Road

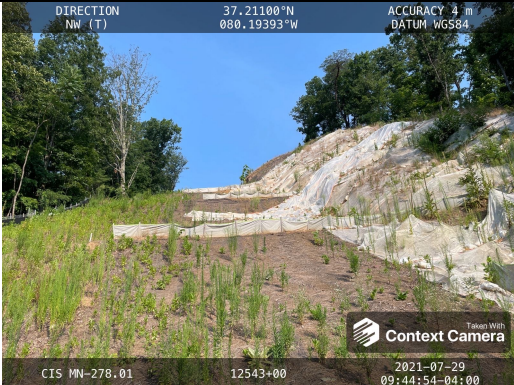
<b>GPS Location</b>	See photo		<b>GPS Location</b>	See photo	
<b>Field Station#</b>	12543+00		<b>Field Station#</b>	12537+00	
<b>Pic 3 Desc.</b>	Current ROW conditions on CIS MN-278.01. Stockpile stabilized with visqueen		<b>Pic 4 Desc.</b>	Current ROW conditions on CIS MN-278.01. Fill Slope stabilized

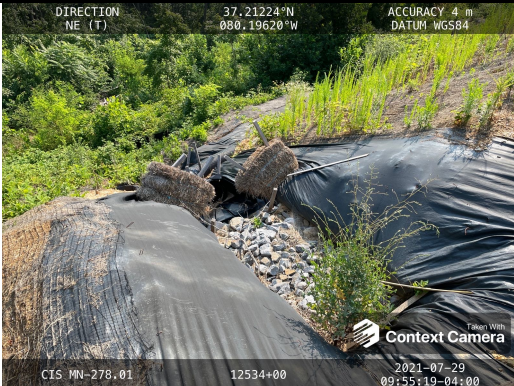
<b>GPS Location</b>	See photo		<b>GPS Location</b>	See photo	
<b>Field Station#</b>	12534+00		<b>Field Station#</b>	12529+00	
<b>Pic 5 Desc.</b>	Slope Drain Inlet is functional		<b>Pic 6 Desc.</b>	Sump pit is functional

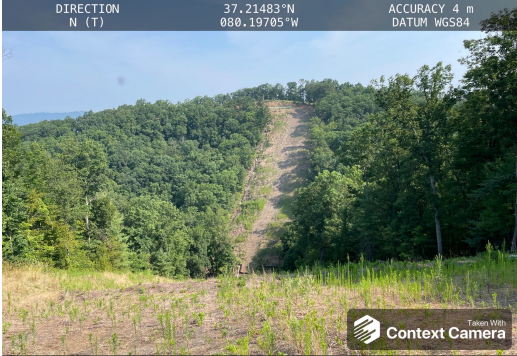
CIS MN-278.01 12519+41 S-EF19 2021-07-29 10:25:06-04:00			
<b>GPS Location</b>	See photo		<b>GPS Location</b>	See photo	
<b>Field Station#</b>	12525+00		<b>Field Station#</b>	12519+41	
<b>Pic 7 Desc.</b>	Current ROW conditions in the area of S-EF19		<b>Pic 8 Desc.</b>	Downstream of S-EF19	
DIRECTION N (T) 37.21600°N 080.19749°W ACCURACY 4 m DATUM WGS84

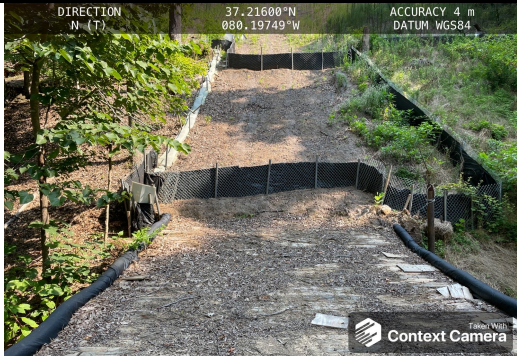
<b>Pic 9 Desc.</b>	Equipment Bridge and ECDs over S-EF19		<b>Pic 10 Desc.</b>	Current ROW conditions on GAS S-EF19	
DIRECTION SW (T) 37.21747°N 080.19723°W ACCURACY 5 m DATUM WGS84

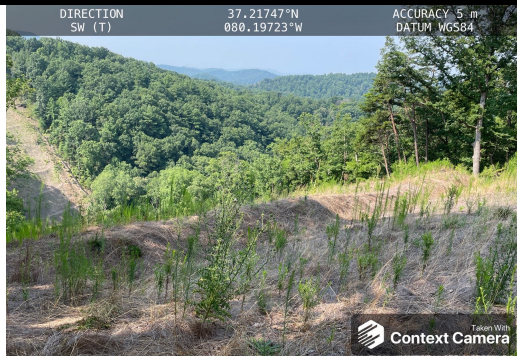
CIS MN-278.01 12514+00 2021-07-29 10:40:10-04:00			
<b>GPS Location</b>	See photo		<b>GPS Location</b>	See photo	
<b>Field Station#</b>	12515+00		<b>Field Station#</b>	12514+00	
<b>Pic 11 Desc.</b>	Waterbar is functional		<b>Pic 12 Desc.</b>	Current ROW conditions on CIS MN-278.01

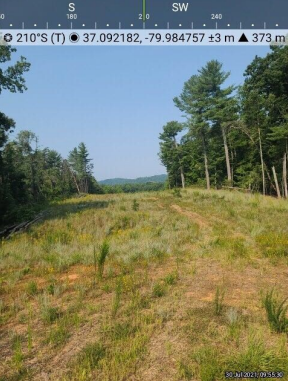
<b>GPS Location</b>	00000	<b>GPS Location</b>	00000		
<b>Field Station#</b>	13561+00	<b>Field Station#</b>	13551+34		
<b>Pic 1 Desc.</b>	Vegetation observation photo . No environmental issues observed at the time of inspection.		<b>Pic 2 Desc.</b>	Stream observation photo facing upstream during routine inspection today. No environmental issues observed at the time of inspection.

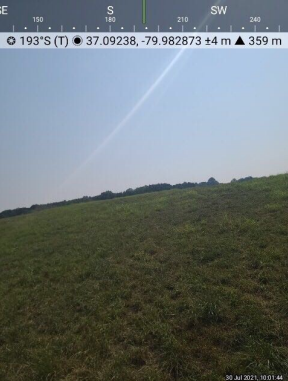
<b>GPS Location</b>	00000	<b>GPS Location</b>	00000		
<b>Field Station#</b>	13570+00	<b>Field Station#</b>	13581+70		
<b>Pic 3 Desc.</b>	Vegetation observation photo showing good coverage in permanent area of row.		<b>Pic 4 Desc.</b>	Row photo showing locust trees growing inside the LOD. Good stabilization observed.

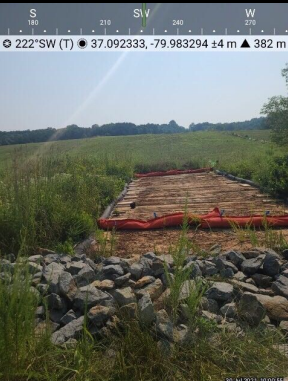
<b>Pic 5 Desc.</b>	Monitored equipment bridge and protection. No environmental issues observed at the time of inspection.		<b>Pic 6 Desc.</b>	Stream observation photo facing downstream during routine inspection today. No environmental issues observed at the time of inspection.

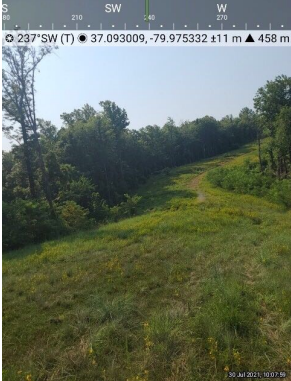
<div style="text-align: center;">Insert image here</div>			
<b>GPS Location</b>	00000	<b>GPS Location</b>			
<b>Field Station#</b>	13590+00	<b>Field Station#</b>			
<b>Pic 7 Desc.</b>	Row photo showing vegetation coverage in permanent area.	<b>Pic 8 Desc.</b>			
<div style="text-align: center;">Insert image here</div>		<div style="text-align: center;">Insert image here</div>			
<b>GPS Location</b>		<b>GPS Location</b>			
<b>Field Station#</b>		<b>Field Station#</b>			
<b>Pic 9 Desc.</b>		<b>Pic 10 Desc.</b>			
<div style="text-align: center;">Insert image here</div>		<div style="text-align: center;">Insert image here</div>			
<b>GPS Location</b>		<b>GPS Location</b>			
<b>Field Station#</b>		<b>Field Station#</b>			
<b>Pic 11 Desc.</b>		<b>Pic 12 Desc.</b>

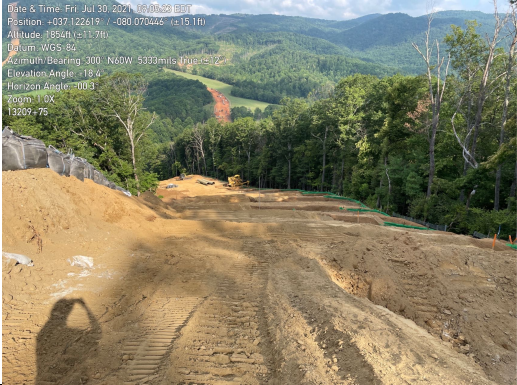
<p>Date &amp; Time: Fri Jul 30 2021 11:11:56 EDT Position: +037 122961 / -080 070416 (+15 1h) Altitude: 1854ft (+117h) Datum: WGS-84 Azimuth/Bearing: 300° N60W 5333mils True (+12) Elevation Angle: +18.2 Horizon Angle: +00.3 Zoom: 1.0X 13211+00</p>			
<b>GPS Location</b>	0	<b>GPS Location</b>	0		
<b>Field Station#</b>	13209+75	<b>Field Station#</b>	13211+00		
<b>Pic 13 Desc.</b>	ROW and ECDs in good condition, ROW is stable		<b>Pic 14 Desc.</b>	ROW and ECDs in good condition, With good vegetation established across ROW

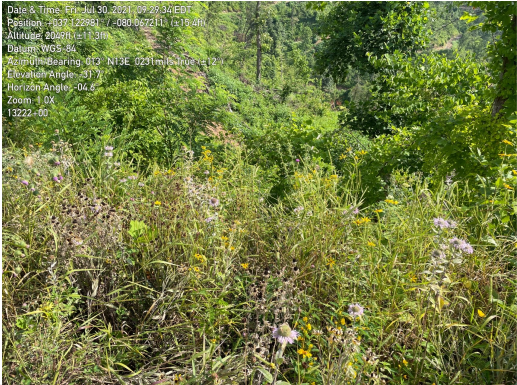
<b>GPS Location</b>	0	<b>GPS Location</b>	0		
<b>Field Station#</b>	13222+00	<b>Field Station#</b>	13253+00		
<b>Pic 15 Desc.</b>	Slip observed to be stable, no notable changes, vegetation establishing.		<b>Pic 16 Desc.</b>	Slip observed to be stable, no notable changes, vegetation establishing.

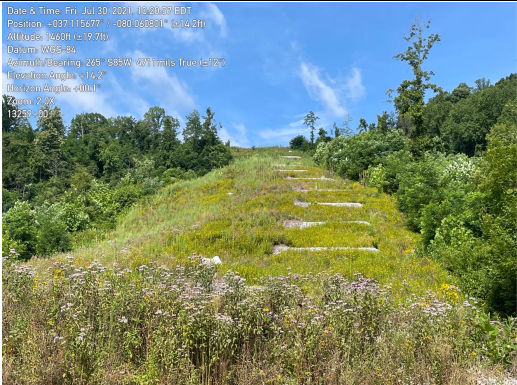
<b>Pic 17 Desc.</b>	ROW and ECDs in good condition, With good vegetation established across ROW		<b>Pic 18 Desc.</b>	MVP-S-GH7 and corresponding buffer zone in good condition
