Visual Site Inspection Report

Project Name	H-600 Pipeline Spread H	AFE	124300138	Spread	H-600 Pipeline Spread H
Contractor	Precision			Report #	26667
Inspector	Bryan Cole			Date/Time	8/2/2021 5:12 PM
Permit #	TBD	Inspection Type	VA SWPP	Station Begin	13316+21
State	VA	Inspection Area	Partial	Station End	13422+00
County	Franklin	Ground	Dry	Temperature (°F)	78.00
Municipality	N/A	Weather	Sunny	Rain Gauge (in)	0.20
				Rain Accumulation Time (days)	0.00

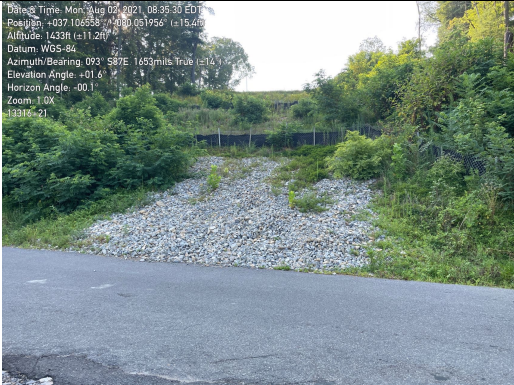
GPS Location	0	GPS Location	0		
Field Station#	13316+21	Field Station#	13321+47		
Pic 1 Desc.	Wades Gap Road Crossing and RCE in good condition and functioning properly		Pic 2 Desc.	MVP-S-GH15 and Corresponding buffer zone in good condition

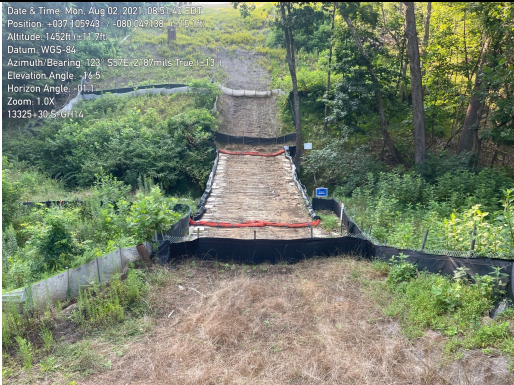
GPS Location	0	GPS Location	0		
Field Station#	13325+30	Field Station#	13334+17		
Pic 3 Desc.	MVP-S-GH14 and Corresponding buffer zone in good condition		Pic 4 Desc.	MVP-S-GH11 and Corresponding buffer zone in good condition

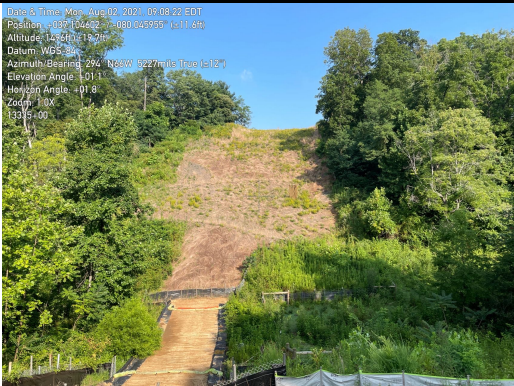
GPS Location	0	GPS Location	0		
Field Station#	13335+00	Field Station#	13337+13		
Pic 5 Desc.	ROW and ECDs in good condition, with good vegetation established across ROW		Pic 6 Desc.	MVP-S-GH9 and Corresponding buffer zone in good condition

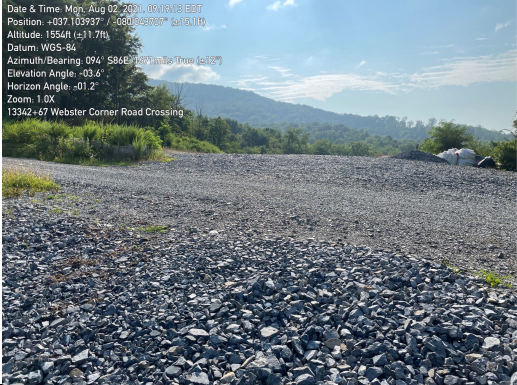
GPS Location	0	GPS Location	0		
Field Station#	13342+67	Field Station#	13344+50		
Pic 7 Desc.	Webster Corner Road Crossing in good condition and RCE in good condition and functioning properly		Pic 8 Desc.	ROW and ECDs in good condition, ROW is stable	
<p>Date & Time: Mon, Aug 02, 2021, 09:47:00 EDT Position: +037.102817° / -080.03978° (±11.81) Altitude: 1464ft (±11.7ft) Datum: WGS-84 Azimuth/Bearing: 104° S39E 2507mils True (±12°) Elevation Angle: +11.7° Horizon Angle: +00.9° Zoom: 1.0X 13352+23 S-RR09</p>  		<p>Date & Time: Mon, Aug 02, 2021, 09:51:55 EDT Position: +037.101243° / -080.03978° (±11.81) Altitude: 1491ft (±11.7ft) Datum: WGS-84 Azimuth/Bearing: 109° S41E 2471mils True (±12°) Elevation Angle: +10.0° Horizon Angle: +01.1° Zoom: 1.0X 13358+64 S-RR11</p>

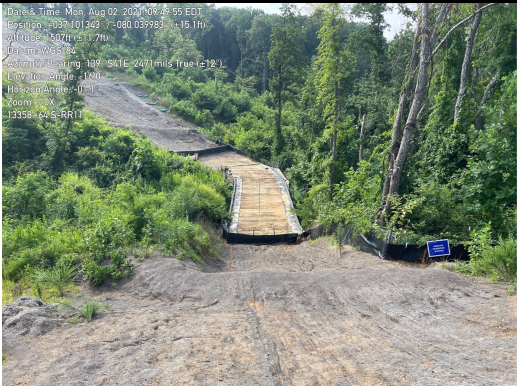
GPS Location	0	GPS Location	0		
Field Station#	13352+23	Field Station#	13358+64		
Pic 9 Desc.	MVP-S-RR09 and Corresponding buffer zone in good condition		Pic 10 Desc.	MVP-S-GH15 and Corresponding buffer zone in good condition	
<p>Date & Time: Mon, Aug 02, 2021, 10:05:10 EDT Position: +037.100920° / -080.03978° (±11.81) Altitude: 1437ft (±11.8ft) Datum: WGS-84 Azimuth/Bearing: 270° N07W 0330mils True (±12°) Elevation Angle: +02.5° Horizon Angle: +01.1° Zoom: 1.0X 13365+30</p>

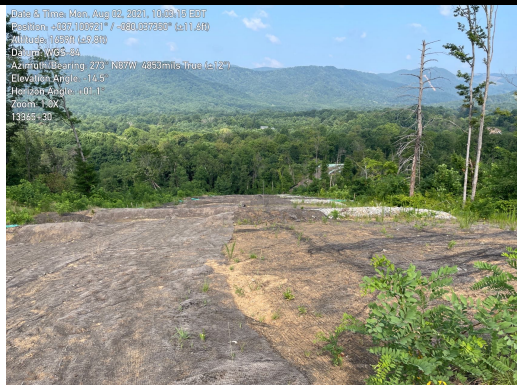
GPS Location	0	GPS Location	0		
Field Station#	13365+30	Field Station#	13365+30		
Pic 11 Desc.	ROW and ECDs in good condition, ROW is stable		Pic 12 Desc.	ROW and ECDs in good condition, ROW is stable

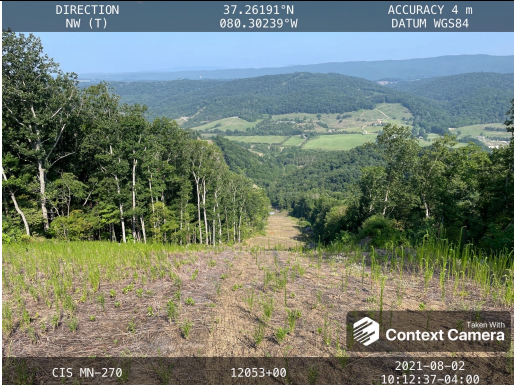
GPS Location	See photo		GPS Location	See photo	
Field Station#	12053+00		Field Station#	12047+00	
Pic 1 Desc.	Current ROW conditions on CIS MN-270		Pic 2 Desc.	Functional waterbar on GAS MN-268.01

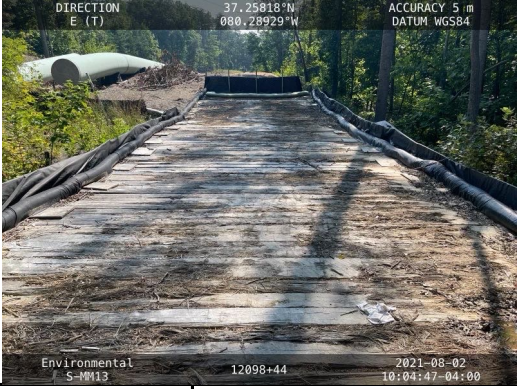
GPS Location	See photo		GPS Location	See photo	
Field Station#	12098+44		Field Station#	12112+13	
Pic 15 Desc.	Equipment bridge over Stream S-MM13		Pic 16 Desc.	Equipment bridge over Stream S-F16A/B

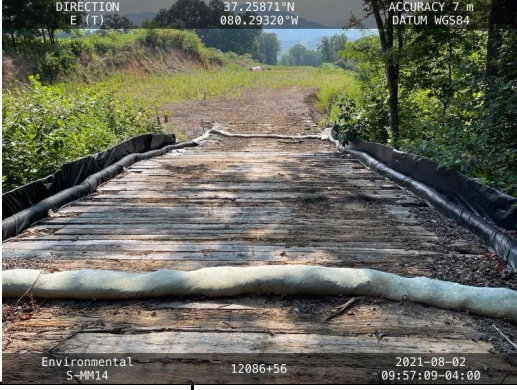
GPS Location	See photo		GPS Location	See photo	
Field Station#	12086+56		Field Station#	12101+57	
Pic 17 Desc.	Equipment bridge over Stream S-MM14		Pic 18 Desc.	Equipment bridge over Stream S-MM11

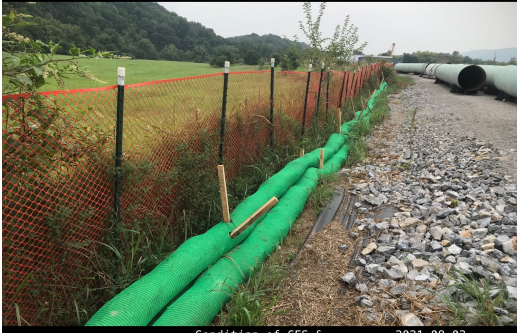
MVP-LY-049_080321 Condition of CFS & safety fence LOD 2021-08-03 09:01:20-04:00		MVP-LY-049_080321 Restoration supplies under cover 2021-08-03 09:05:13-04:00			
GPS Location	MVP-LY-049 See photo for gps data		GPS Location	MVP-LY-049 See photo for gps data	
Field Station#	+0		Field Station#	+0	
Pic 7 Desc.	Condition of triple stack compost filter sock and safety fence along south LOD. Looking SW.		Pic 8 Desc.	Restoration supplies under cover. Looking S.	
DIRECTION W (M) +37.26918° -080.12375° ACCURACY 33 ft DATUM WGS84		DIRECTION NW (M) +37.26980° -080.12437° ACCURACY 33 ft DATUM WGS84

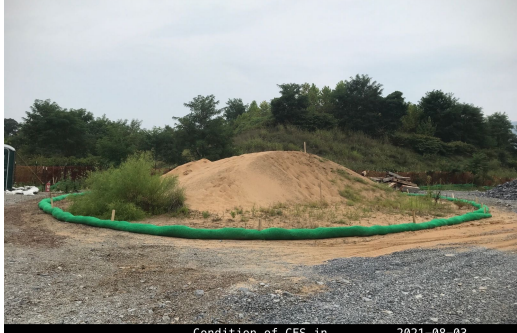
MVP-LY-049_080321 Condition of CFS in place around sand pile. 2021-08-03 09:09:59-04:00		MVP-LY-049_080321 No debris around metal only dumpster 2021-08-03 09:11:34-04:00

GPS Location	MVP-LY-049 See photo for gps data		GPS Location	MVP-LY-049 See photo for gps data	
Field Station#	+0		Field Station#	+0	
Pic 9 Desc.	Compost filter sock in place around sand pile. Looking W.		Pic 10 Desc.	No debris around hazardous metal only dumpster. Looking NW.	
DIRECTION E (M) +37.27059° -080.12257° ACCURACY 16 ft DATUM WGS84		DIRECTION S (M) +37.27066° -080.12392° ACCURACY 98 ft DATUM WGS84

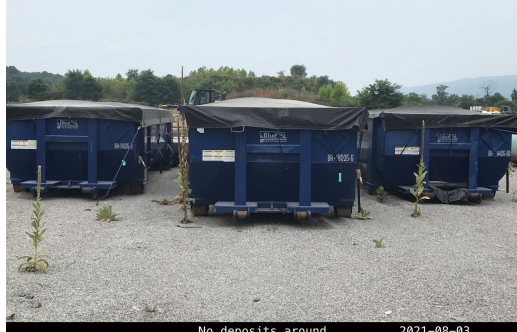
MVP-LY-049_080321 No deposits around hazardous waste dump... 2021-08-03 09:15:51-04:00		MVP-LY-049_080321 Landowner disturbance along CFS 2021-08-03 09:18:18-04:00			
GPS Location	MVP-LY-049 See photo for gps data		GPS Location	MVP-LY-049 See photo for gps data	
Field Station#	+0		Field Station#	+0	
Pic 11 Desc.	No fluids or deposits around hazardous waste dumpsters containing swine bones and contaminated soil. Looking E.		Pic 12 Desc.	Landowner soil disturbance along compost filter sock. Area not stabilized. Looking S.

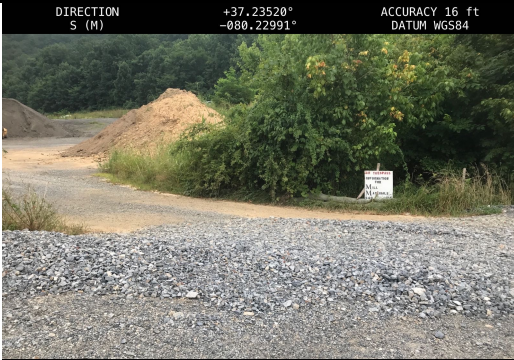
<p>DIRECTION S (M) +37.23520° -080.22991° ACCURACY 16 ft DATUM WGS84</p> <p>MVP-PY-006_080321 Condition of spoil pile adjacent to LOD 2021-08-03 07:30:26-04:00</p>

<p>DIRECTION SE (M) +37.23440° -080.22808° ACCURACY 33 ft DATUM WGS84</p> <p>MVP-PY-006_080321 Condition of poly lined containments 2021-08-03 07:35:02-04:00</p>			
GPS Location	MVP-PY-006 See photo for gps data		GPS Location	MVP-PY-006 See photo for gps data	
Field Station#	+0		Field Station#	+0	
Pic 1 Desc.	Condition of spoil pile adjacent to LOD. Area not stabilized. Looking S.		Pic 2 Desc.	Condition of poly lined rock berm containments. Free of stormwater and fluids. Looking SE.

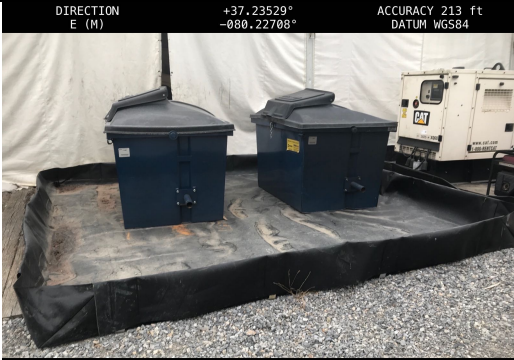
<p>DIRECTION E (M) +37.23529° -080.22708° ACCURACY 213 ft DATUM WGS84</p> <p>MVP-PY-006_080321 Condition of containment 2021-08-03 08:02:35-04:00</p>

GPS Location	MVP-PY-006 See photo for gps data		GPS Location	MVP-PY-006 See photo for gps data	
Field Station#	+0		Field Station#	+0	
Pic 3 Desc.	Condition of containment under hazardous waste dumpsters. Free of stormwater and fluids. Looking E.		Pic 4 Desc.	Condition of containment under used oil containers. Free of stormwater and fluids. Looking NE.

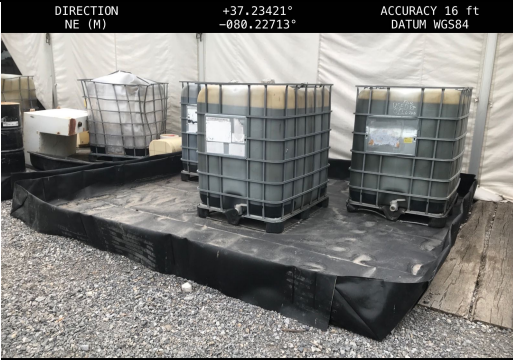
<p>DIRECTION NE (M) +37.23421° -080.22713° ACCURACY 16 ft DATUM WGS84</p> <p>MVP-PY-006_080321 Condition of containment 2021-08-03 08:02:36-04:00</p>

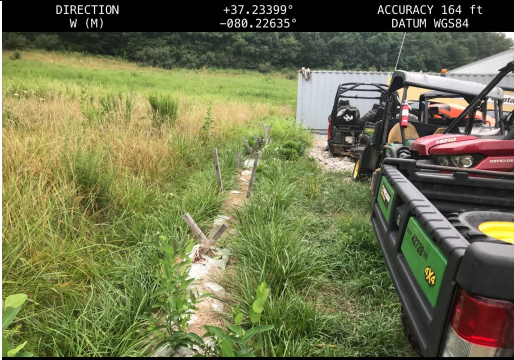
<p>DIRECTION W (M) +37.23399° -080.22635° ACCURACY 164 ft DATUM WGS84</p> <p>MVP-PY-006_080321 Condition of CFS along south LOD 2021-08-03 08:04:52-04:00</p>

<p>DIRECTION S (M) +37.23565° -080.22722° ACCURACY 0.61 m1 DATUM WGS84</p> <p>MVP-PY-006_080321 Condition of CFS along east LOD 2021-08-03 08:06:43-04:00</p>			
GPS Location	MVP-PY-006 See photo for gps data		GPS Location	MVP-PY-006 See photo for gps data	
Field Station#	+0		Field Station#	+0	
Pic 5 Desc.	Condition of triple stack compost filter sock along south LOD. Looking W.		Pic 6 Desc.	Condition of triple stack compost filter sock along east LOD. Looking S.

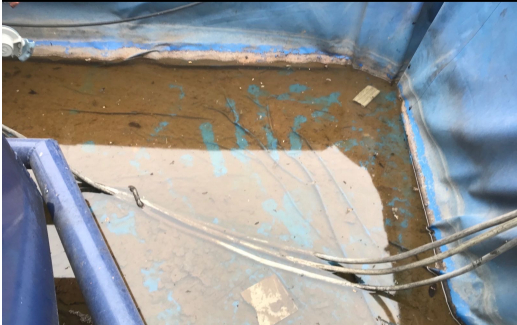
MVP-PY-006_080321 Both secondary containments on site... 2021-08-03 08:08:21-04:00		MVP-PY-006_080321 Condition of containment 2021-08-03 08:08:41-04:00			
GPS Location	MVP-PY-006 See photo for gps data		GPS Location	MVP-PY-006 See photo for gps data	
Field Station#	+0		Field Station#	+0	
Pic 7 Desc.	Blue Bulk Fuel tanks both secondary containments on site and in place for tankers offloading fuel. Looking W.		Pic 8 Desc.	Blue Bulk Fuel tanks containment holding stormwater. Looking NE.	
DIRECTION NW (M) +37.23562° -080.22682° ACCURACY 16 ft DATUM WGS84

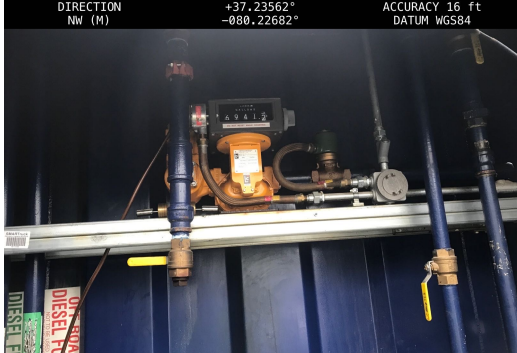
GPS Location	MVP-PY-006 See photo for gps data		GPS Location	MVP-PY-006 See photo for gps data	
Field Station#	+0		Field Station#	+0	
Pic 9 Desc.	Blue Bulk Fuel tanks no leaky internal fittings. Looking NW.		Pic 10 Desc.	Blue Bulk Fuel tanks no leaky fittings or nozzles. Looking S.	
DIRECTION N (M) +37.23572° -080.22723° ACCURACY 213 ft DATUM WGS84

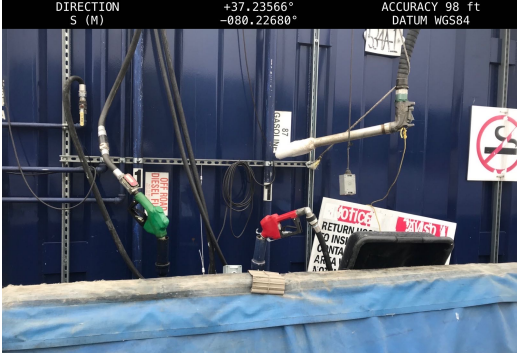
MVP-PY-006_080321 No leaky internal fittings 2021-08-03 08:08:57-04:00		MVP-PY-006_080321 No leaky fittings or nozzles 2021-08-03 08:09:30-04:00

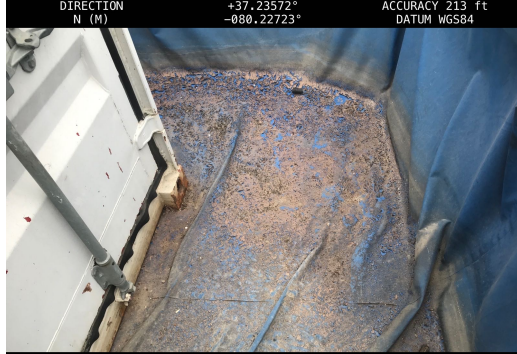
MVP-PY-006_080321 Condition of containment 2021-08-03 08:10:08-04:00		MVP-PY-006_080321 No leaky internal fittings 2021-08-03 08:10:25-04:00			
GPS Location	MVP-PY-006 See photo for gps data		GPS Location	MVP-PY-006 See photo for gps data	
Field Station#	+0		Field Station#	+0	
Pic 11 Desc.	Off Road Fuel unit condition of containment. Free of stormwater. Looking N.		Pic 12 Desc.	Off Road Fuel unit no leaky internal fittings. Looking W.

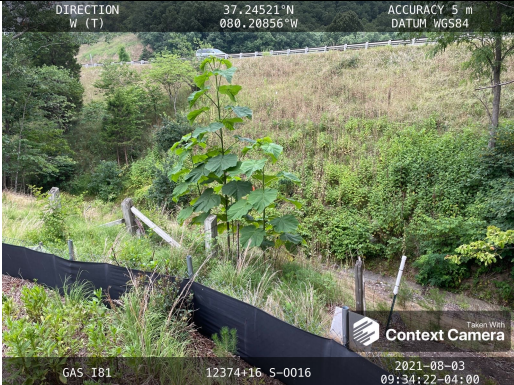
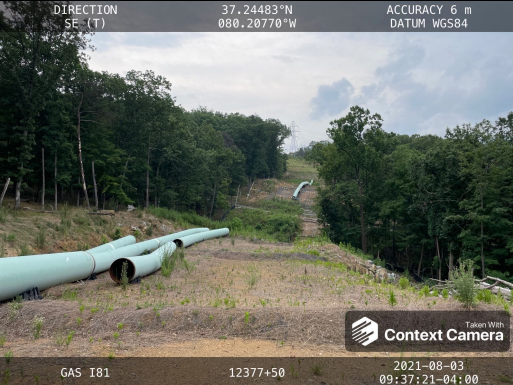
GPS Location	See photo		GPS Location	See photo	
Field Station#	12374+16		Field Station#	12377+50	
Pic 1 Desc.	Stream S-0016 in good condition. No water currently flowing.		Pic 2 Desc.	Current ROW conditions. Waterbars functional. Fill Slope stabilized.

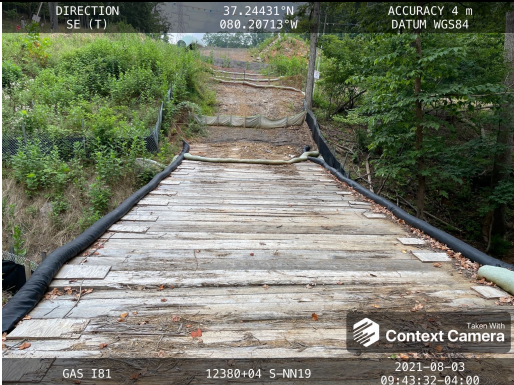
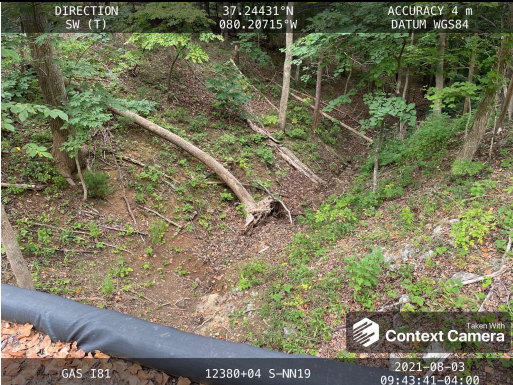
GPS Location	See photo		GPS Location	See photo	
Field Station#	12380+04		Field Station#	12380+04	
Pic 3 Desc.	Equipment Bridge over Stream S-NN19		Pic 4 Desc.	Stream S-NN19 in good condition. No water currently flowing.

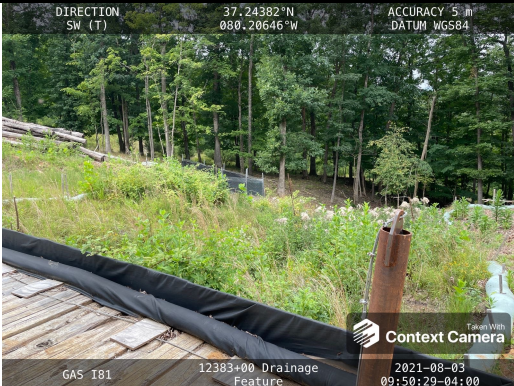
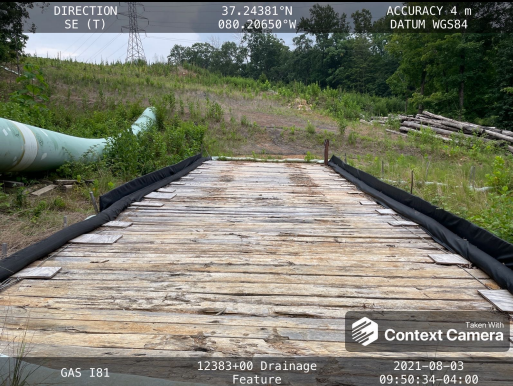
GPS Location	See photo		GPS Location	See photo	
Field Station#	12383+00		Field Station#	12383+00	
Pic 5 Desc.	Drainage feature in good condition. Area stable and no sediment observed.		Pic 6 Desc.	Equipment bridge over drainage feature in good condition.

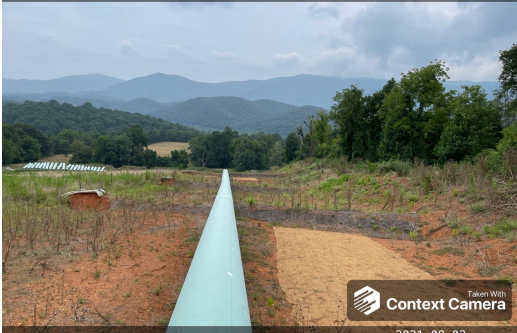
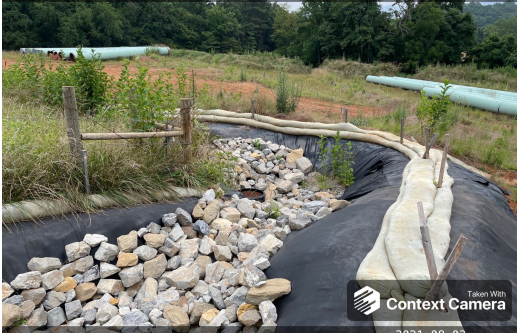
CIS MLV-27 12409+00 CWD Inlet 2021-08-03 10:18:05-04:00			
GPS Location	See photo		GPS Location	See photo	
Field Station#	12403+00		Field Station#	12409+00	
Pic 7 Desc.	Current ROW conditions. Area stable.		Pic 8 Desc.	Clean Water Diversion Inlet free of sediment	
DIRECTION N (T) 37.23982°N 080.19924°W ACCURACY 4 m DATUM WGS84

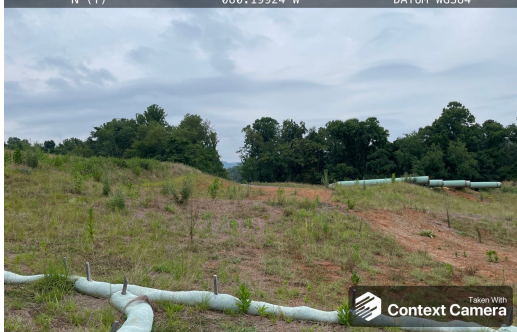
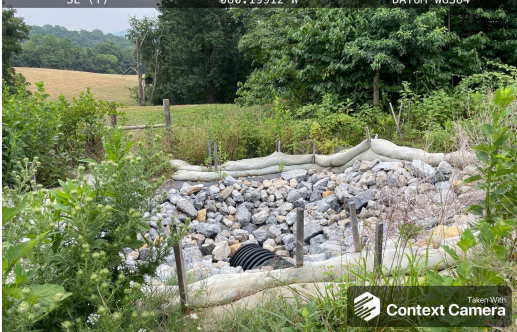
GAS MLV-27 12409+40 CWD Outlet 2021-08-03 10:19:35-04:00			
GPS Location	See photo		GPS Location	See photo	
Field Station#	12409+40		Field Station#	12409+40	
Pic 9 Desc.	Current ROW conditions. Area is stable		Pic 10 Desc.	Clean Water Diversion outlet is functional

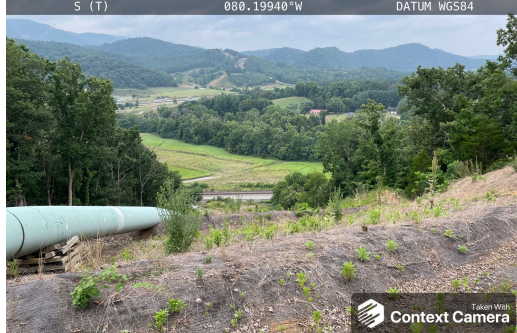
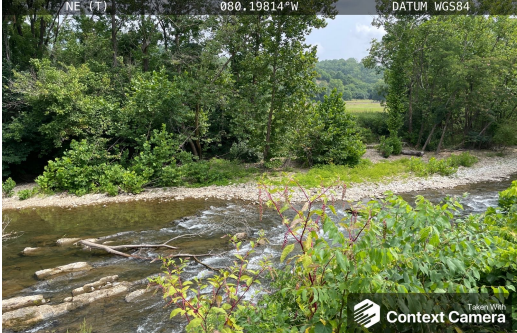
CIS HWY 11 12435+16 S-N16 2021-08-03 11:26:13-04:00			
GPS Location	See photo		GPS Location	See photo	
Field Station#	12417+00		Field Station#	12435+16	
Pic 11 Desc.	Current ROW conditions. Waterbars are functional.		Pic 12 Desc.	Stream S-NN16 flowing free and clear of sediment

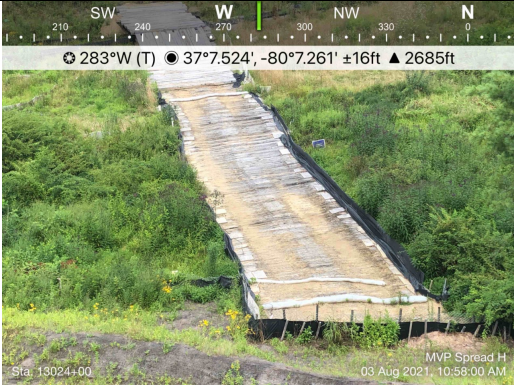
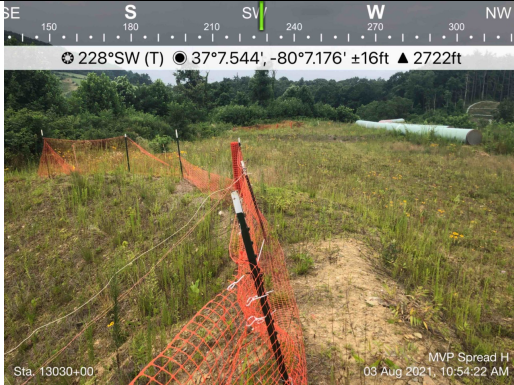
GPS Location	See Photo Watermark		GPS Location	See Photo Watermark	
Field Station#	13024+00		Field Station#	13030+00	
Pic 1 Desc.	Equipment bridge, perimeter controls and resource buffer zone at S-G24 & S-G25 are in good condition. No maintenance needed.		Pic 2 Desc.	Safety fencing around exposed pipe pit and temporarily stabilized ROW are in good condition. No maintenance needed.

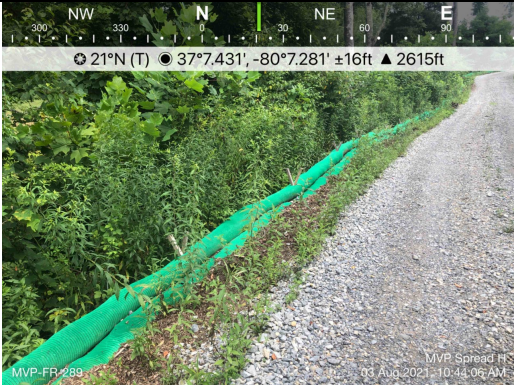
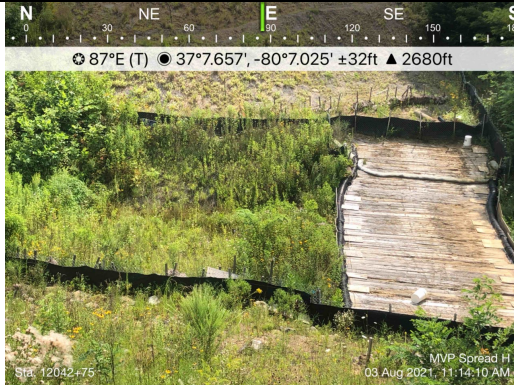
GPS Location	See Photo Watermark		GPS Location	See Photo Watermark	
Field Station#	13032+00		Field Station#	12042+75	
Pic 3 Desc.	MVP-FR-289 controls and roadway are in good condition. No maintenance needed.		Pic 4 Desc.	Stream S-H1 equipment bridge, perimeter controls, and vegetation are in good condition. No maintenance needed.

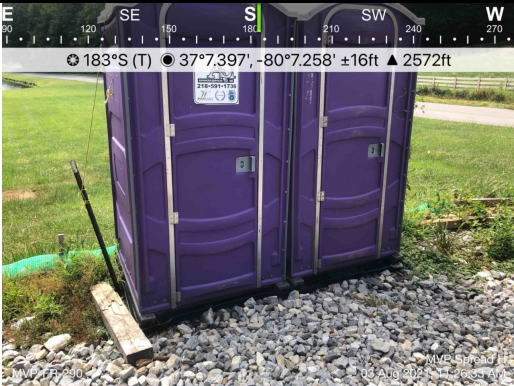
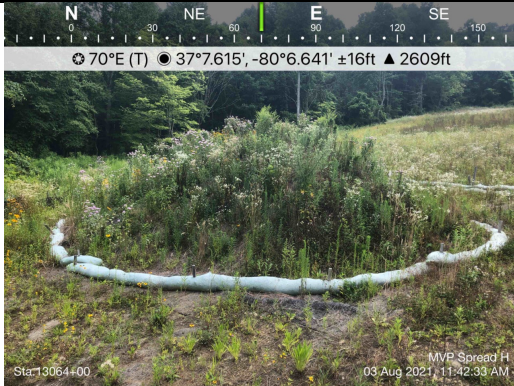
GPS Location	See Photo Watermark		GPS Location	See Photo Watermark	
Field Station#	13032+00		Field Station#	13064+00

Pic 5 Desc.	Portable toilets at FR-289/FR-290 entrance point are clean and within secondary containment. No maintenance needed.		Pic 6 Desc.	Temporary stockpile well vegetated and surrounded with CFS. No maintenance needed.

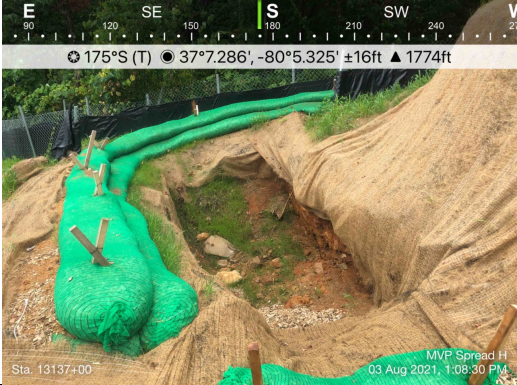
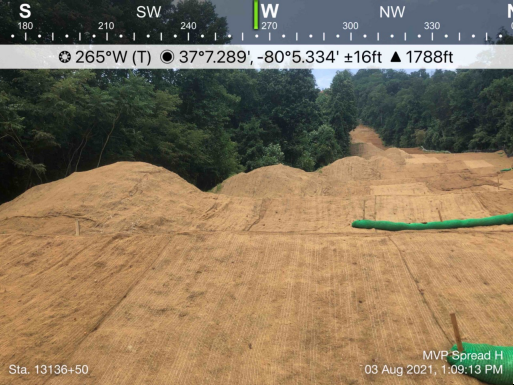
GPS Location	See Photo Watermark		GPS Location	See Photo Watermark	
Field Station#	13137+00		Field Station#	13136+50	
Pic 13 Desc.	Waterbar sump pit is dry and CFS is in good condition. No maintenance needed.		Pic 14 Desc.	ROW stabilized with erosion control matting. No signs of accelerated erosion were observed.

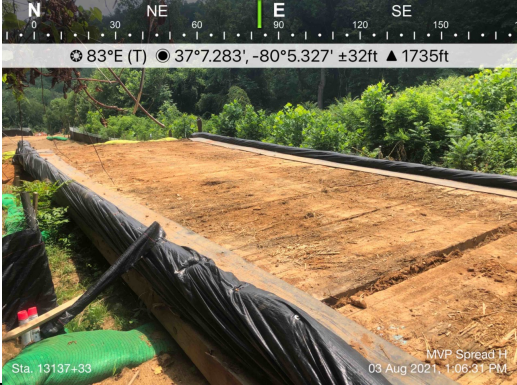
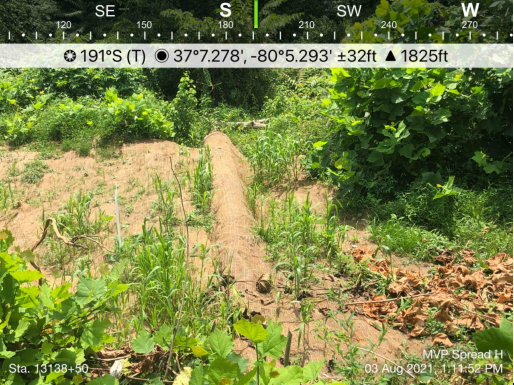
GPS Location	See Photo Watermark		GPS Location	See Photo Watermark	
Field Station#	13137+33		Field Station#	13138+50	
Pic 15 Desc.	Equipment bridge at S-D14 is in good condition. No maintenance needed.		Pic 16 Desc.	Wetland Habitat Log remains stable and in good condition. Vegetation is germinating despite dry conditions.

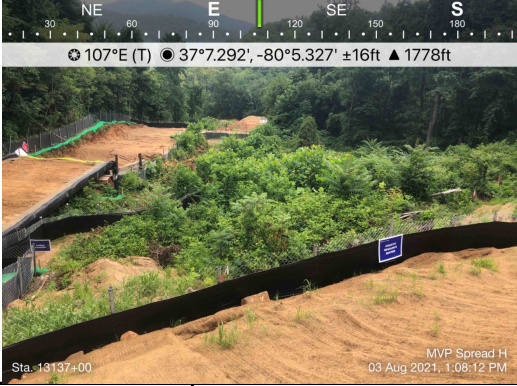
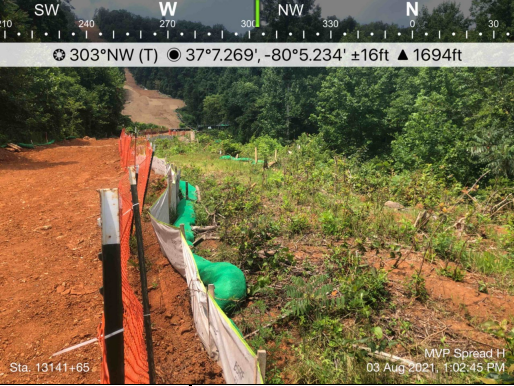
GPS Location	See Photo Watermark		GPS Location	See Photo Watermark	
Field Station#	13137+00		Field Station#	13141+65	
Pic 17 Desc.	Temporary ROW stabilized with erosion control matting, SSF is installed, and the resource buffer area is in good condition.		Pic 18 Desc.	Undisturbed side-slope area adjacent to established travel lane. Safety fence and perimeter E&S controls are in good condition.

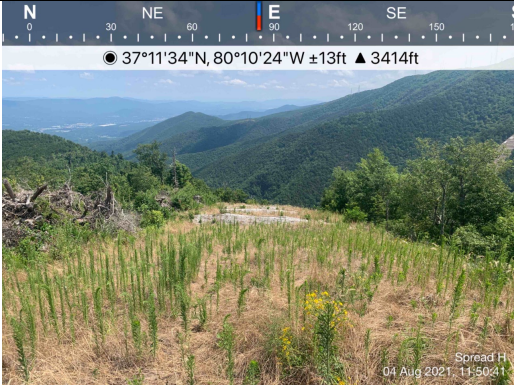
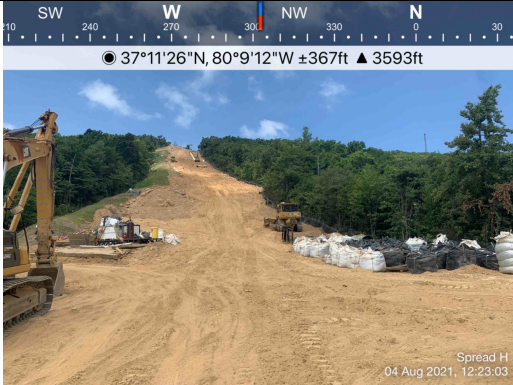
GPS Location	See Photograph		GPS Location	See Photograph	
Field Station#	12638+00		Field Station#	12693+00	
Pic 1 Desc.	The ROW between 12638+00 and Honeysuckle Rd. is inactive and stabilized with all controls in acceptable condition.		Pic 2 Desc.	Trenching and pipe installation is ongoing from Honeysuckle Rd. to S-Y13. All controls are in place and in acceptable condition.

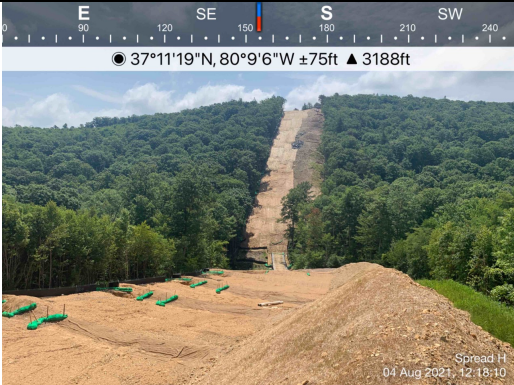
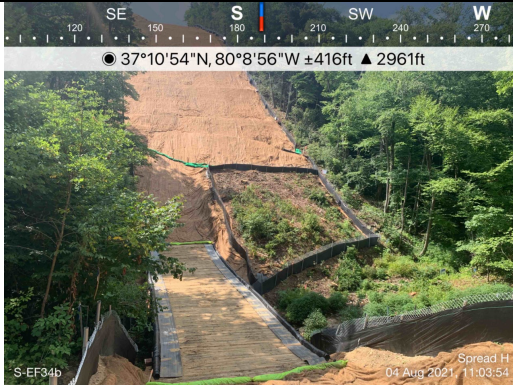
GPS Location	See Photograph		GPS Location	See Photograph	
Field Station#	12703+50		Field Station#	12730+00	
Pic 3 Desc.	Areas between Honeysuckle Rd. and S-Y13 that are not being trenched are stabilized with ECB and straw.		Pic 4 Desc.	The bridge crossing at S-EF34b is in acceptable condition.

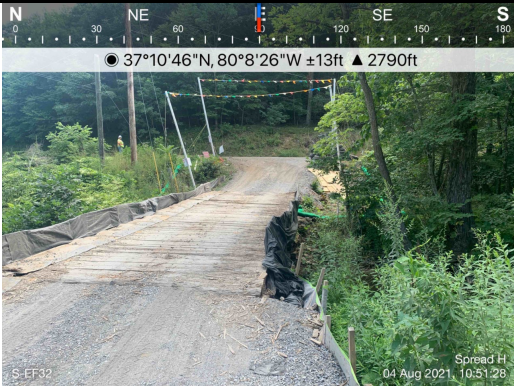
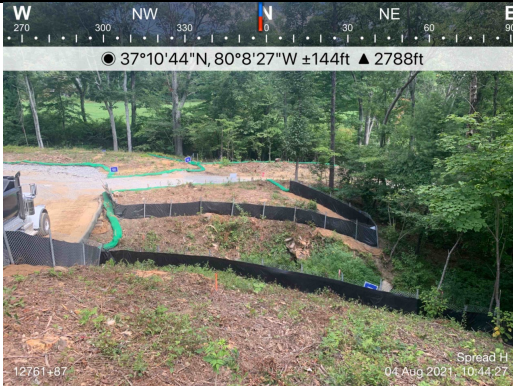
GPS Location	See photograph		GPS Location	See Photograph	
Field Station#	12761+00		Field Station#	12761+87	
Pic 5 Desc.	The bridge crossing and stream buffer controls at S-EF32 are in acceptable condition.		Pic 6 Desc.	The bridge crossing and stream buffer controls at S-EF33 are in acceptable condition.

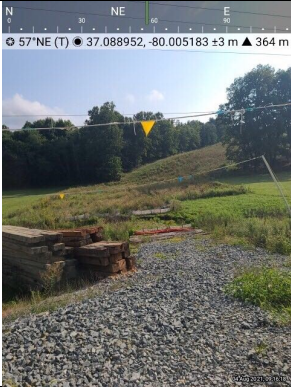
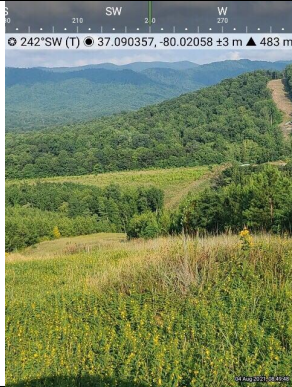
GPS Location	00000	GPS Location	0000		
Field Station#	13497+00	Field Station#	13436+44		
Pic 1 Desc.	Monitored stream crossing at CAHAS#2 where mats were removed , inspected ECDs on stream bank. No environmental issues observed at the time of inspection.		Pic 2 Desc.	Vegetation observation photo showing good coverage in permanent area.

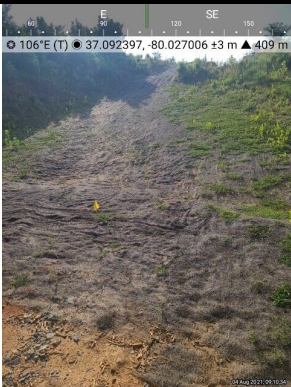
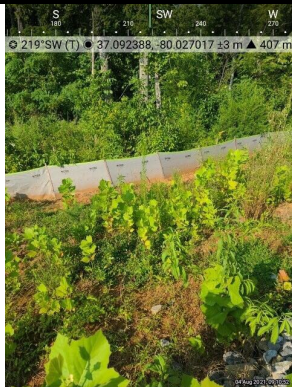
GPS Location	0000	GPS Location	0000		
Field Station#	13417+00	Field Station#	13415+90		
Pic 3 Desc.	Monitored erosion control blanket on hill side. Hill side stabilized, no environmental issues observed at the time of inspection.		Pic 4 Desc.	Observed P1 along the edge of row. No environmental issues observed at the time of inspection.

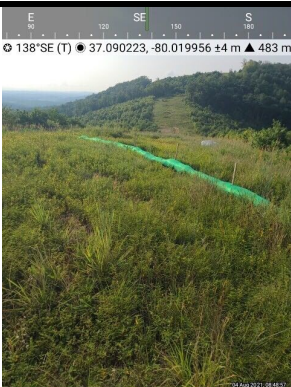
GPS Location	0000	GPS Location	0000		
Field Station#	13439+00	Field Station#	13416+10		
Pic 5 Desc.	Observed ECDs throughout, all up to date and functioning.		Pic 6 Desc.	Monitored ECDs and sump pit , good stabilization noted. No environmental issues observed at the time of inspection.

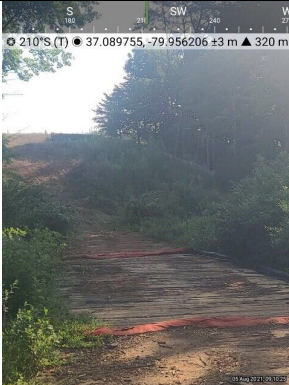
GPS Location	00000	GPS Location	00000		
Field Station#	13658+90	Field Station#	13574+98		
Pic 1 Desc.	Monitored equipment bridges and protection along with ECDs , no environmental issues observed at the time of inspection.		Pic 2 Desc.	Row photo in permanent area showing good coverage.

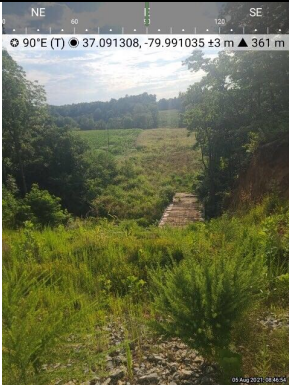
GPS Location	00000	GPS Location	00000		
Field Station#	13541+98	Field Station#	13539+00		
Pic 3 Desc.	Row photo on hill side above stream crossing showing showing good stabilization. No issues observed at the time of inspection.		Pic 4 Desc.	Vegetation observation photo showing good coverage in permanent area.

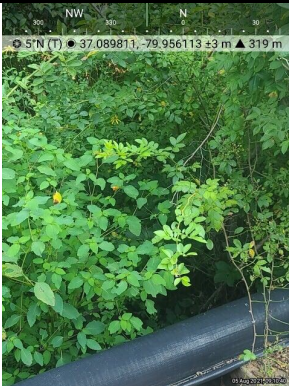
GPS Location	00000	GPS Location	00000		
Field Station#	13659+03	Field Station#	13659+03		
Pic 5 Desc.	Stream observation photo facing upstream during routine inspection today. No issues observed at the time of inspection.		Pic 6 Desc.	Stream observation photo facing downstream during routine inspection today. No issues observed at the time of inspection.

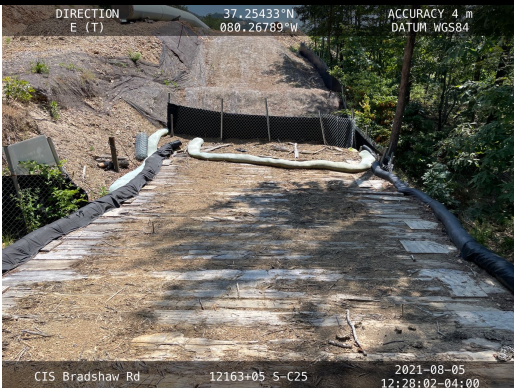
GPS Location	See photo		GPS Location	See photo	
Field Station#	12163+05		Field Station#	12157+00	
Pic 5 Desc.	Equipment Bridge and ECDs over Stream S-C25		Pic 6 Desc.	Drainage Feature is functional and undisturbed

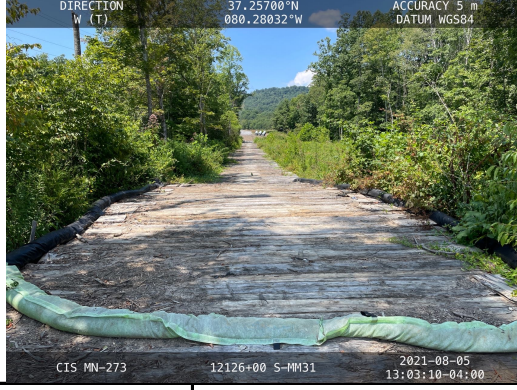
GPS Location	See photo		GPS Location	See photo	
Field Station#	12126+00		Field Station#	12163+05	
Pic 11 Desc.	Equipment Bridge over Stream S-MM31		Pic 12 Desc.	Downstream photo of Stream S-C25

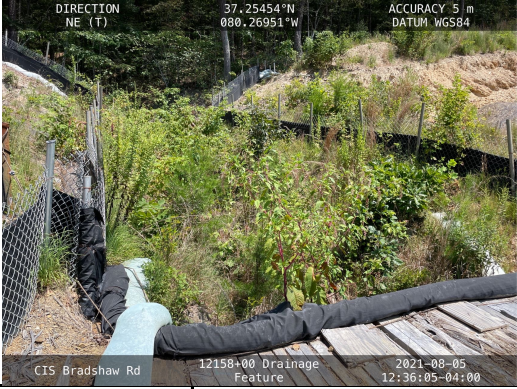
GPS Location	See photo		GPS Location	See photo	
Field Station#	12158+00		Field Station#	12196+24	
Pic 13 Desc.	Functional Drainage Feature. Area is stable and undisturbed.		Pic 14 Desc.	Photo of Stream S-0011

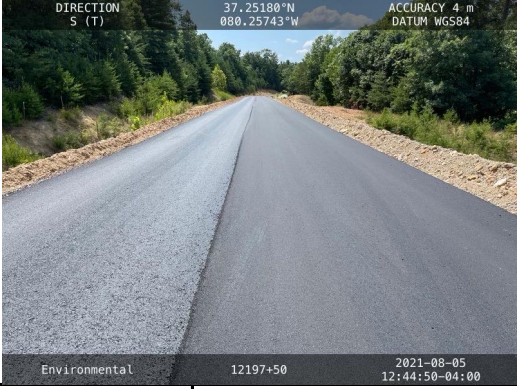
GPS Location	See photo		GPS Location	See photo	
Field Station#	12197+50		Field Station#	12192+50	
Pic 15 Desc.	Non-project related construction activity.		Pic 16 Desc.	Downstream photo of Stream S-C21

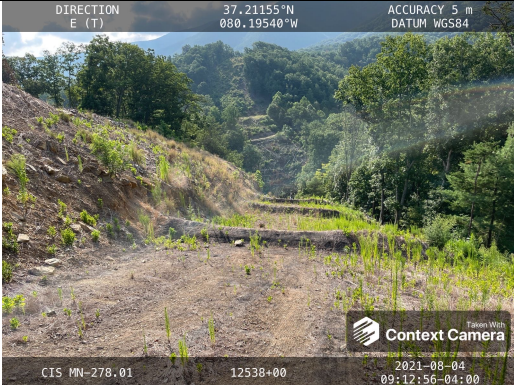
GPS Location	See photo		GPS Location	See photo	
Field Station#	12538+00		Field Station#	12538+00	
Pic 1 Desc.	Current ROW conditions. Waterbars are functional		Pic 2 Desc.	Current ROW conditions. ROW is stable

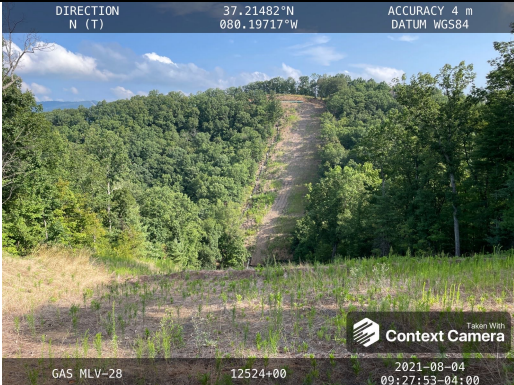
GPS Location	See photo		GPS Location	See photo	
Field Station#	12524+00		Field Station#	12521+50	
Pic 3 Desc.	Current ROW conditions. ROW is stable.		Pic 4 Desc.	Buffer Space at S-EF19 well stabilized and undisturbed

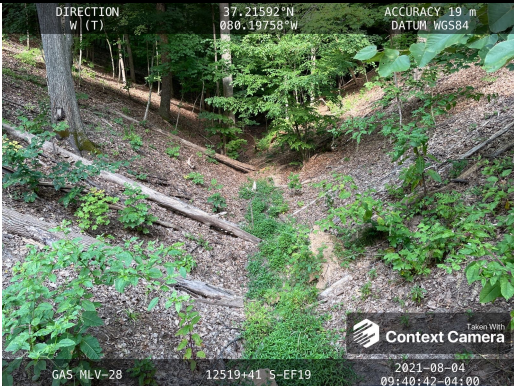
GPS Location	See photo		GPS Location	See photo	
Field Station#	12519+41		Field Station#	12519+41	
Pic 5 Desc.	Downstream of Stream S-EF19		Pic 6 Desc.	Equipment Bridge over Stream S-EF19

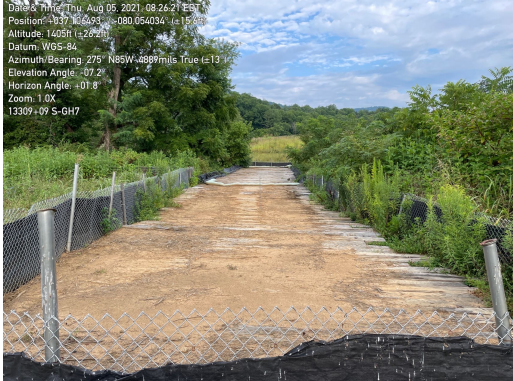
</div></div>			
GPS Location	0		GPS Location	0	
Field Station#	13309+09		Field Station#	13308+00	
Pic 1 Desc.	MVP-S-GH7 and Corresponding buffer zone in good condition		Pic 2 Desc.	ROW and ECDs in good condition, with good vegetation established across ROW	
<div><div><div>Date & Time: Thu, Aug 05, 2021, 09:16:53 EDT Position: +037.1154317, -080.060042° (+11.247) Altitude: 1423ft (+3.11m) Datum: WGS-84 Azimuth/Bearing: 259° NSW, 480mils True (+13.1°) Elevation Angle: -01.3° Horizon Angle: +01.4° Zoom: 1.0X 13398+00</div>

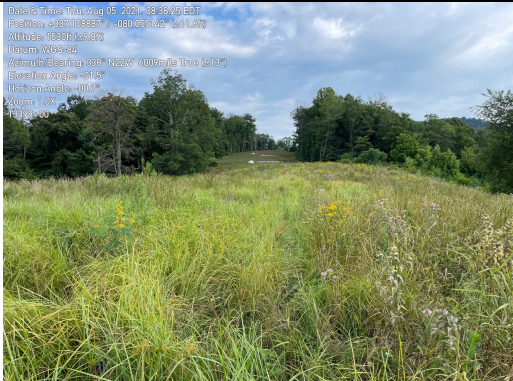
GPS Location	0		GPS Location	0	
Field Station#	13398+00		Field Station#	13260+66	
Pic 3 Desc.	ROW and ECDs in good condition, with good vegetation established across ROW		Pic 4 Desc.	MVP-S-II4 and Corresponding buffer zone in good condition	
<div><div><div>Date & Time: Thu, Aug 05, 2021, 09:16:53 EDT Position: +037.1154317, -080.060042° (+11.247) Altitude: 1423ft (+3.11m) Datum: WGS-84 Azimuth/Bearing: 270° SSW, 490mils True (+13.1°) Elevation Angle: -11.0° Horizon Angle: +01.4° Zoom: 1.0X 13259+00</div>

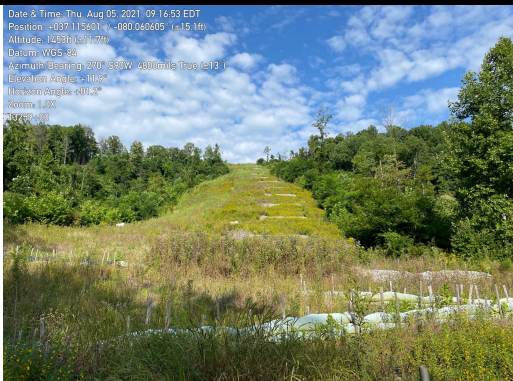
</div></div>			
GPS Location	0		GPS Location	0	
Field Station#	13259+00		Field Station#	13253+00	
Pic 5 Desc.	ROW and ECDs in good condition, with good vegetation established across ROW		Pic 6 Desc.	Slip observed to be stable, no notable changes, vegetation establishing.

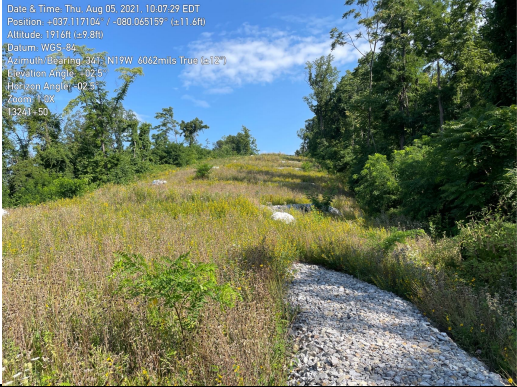
GPS Location		0		GPS Location	
Field Station#		13241+50		Field Station#	
Pic 7 Desc.		ROW and ECDs in good condition, with good vegetation established across ROW		Pic 8 Desc.	
<p>Date & Time: Thu, Aug 05, 2021, 10:41:52 EDT Position: +037.122893 / -080.070872 (+11.6ft) Altitude: 1720ft (+19.7ft) Datum: WGS-84 Azimuth/Bearing: 276° N84W 49.07mils True (+12°) Elevation Angle: -19.6° Horizon Angle: -01.9° Zoom: 1.0X 13208+00</p>

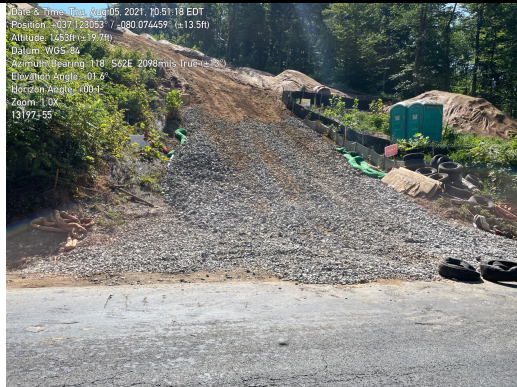
GPS Location		0		GPS Location	
Field Station#		13197+55		Field Station#	
Pic 11 Desc.		RCE in good condition and functioning properly		Pic 12 Desc.	
				MVP-S-D8 and Corresponding buffer zone in good condition

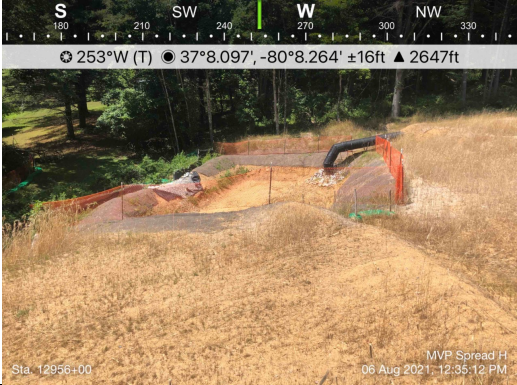
GPS Location	See Picture Watermark		GPS Location	See Picture Watermark	
Field Station#	12956+00		Field Station#	12950+50	
Pic 13 Desc.	Waterbar end treatment train catch basin is in good condition and dry. No maintenance is needed.		Pic 14 Desc.	Inactive ROW and stockpiles are stabilized with erosion control matting and seed/straw. No maintenance needed.

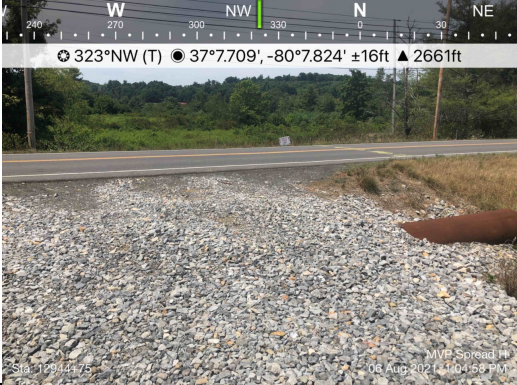
GPS Location	See Picture Watermark		GPS Location	See Picture Watermark	
Field Station#	12944+75		Field Station#	13024+00	
Pic 15 Desc.	Rock construction entrance at GAS Rt. 221 is in good condition, and no signs of tracked material were observed.		Pic 16 Desc.	Equipment bridge and buffer zone at S-G24/G25 is in good condition, and no maintenance is needed.

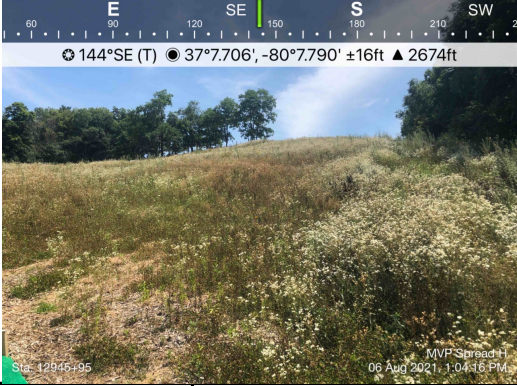
Pic 17 Desc.	ROW on GAS Rt. 221 at Blue Ridge Parkway is stabilized and in good condition.		Pic 18 Desc.	Permanent waterbars and rock level spreaders are in good condition. ROW remains well stabilized and CFS berms installed.

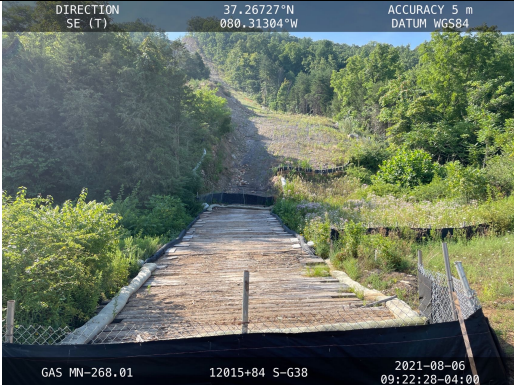
<p>DIRECTION: NW (T) 37.26803°N 080.31377°W ACCURACY 5 m DATUM WGS84</p> <p>CIS MN-268.01 12008+53 S-G36 2021-08-06 09:24:19-04:00</p>			
GPS Location	See photo		GPS Location	See photo	
Field Station#	12015+84		Field Station#	12008+53	
Pic 1 Desc.	Equipment Bridge over Stream S-G38		Pic 2 Desc.	Stream S-G36. ROW is stable.

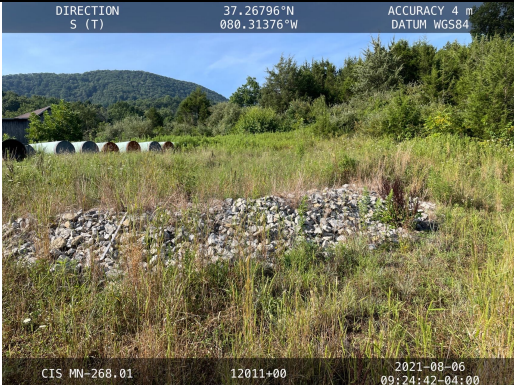
Pic 3 Desc.	Permanent Level spreader is functional		Pic 4 Desc.	Current ROW conditions. ROW is stable. Stockpile stabilized.

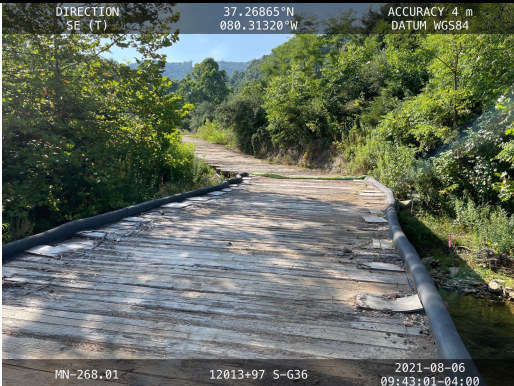
<p>DIRECTION: SW (T) 37.26862°N 080.31316°W ACCURACY 4 m DATUM WGS84</p> <p>MN-268.01 12013+97 S-G36 2021-08-06 09:43:11-04:00</p>			
GPS Location	See photo		GPS Location	See photo	
Field Station#	12013+97		Field Station#	12013+97	
Pic 5 Desc.	Equipment Bridge over Stream S-G36		Pic 6 Desc.	Downstream photo of Stream S-G36.

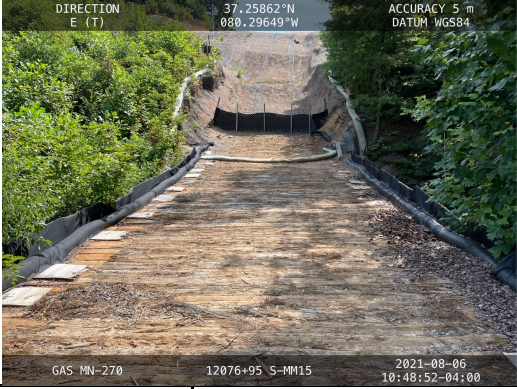
GPS Location	See photo		GPS Location	See photo	
Field Station#	12076+95		Field Station#	12076+95	
Pic 7 Desc.	Equipment Bridge over Stream S-MM15		Pic 8 Desc.	Downstream photo of Stream S-MM15

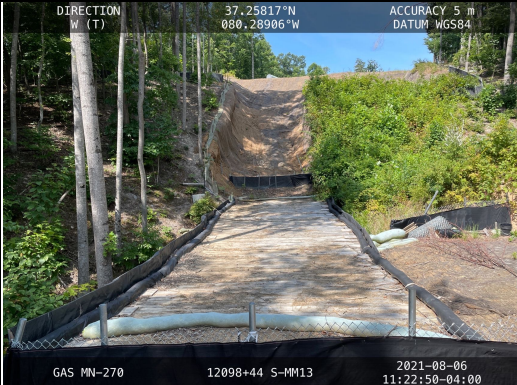
GPS Location	See photo		GPS Location	See photo	
Field Station#	12098+44		Field Station#	12098+44	
Pic 13 Desc.	Equipment Bridge and ECDs over Stream S-MM13		Pic 14 Desc.	Downstream photo of Stream S-MM13

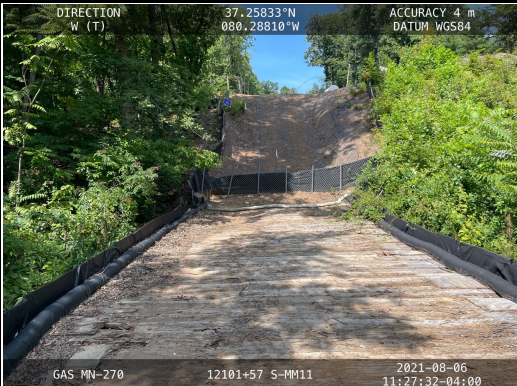
GPS Location	See photo		GPS Location	See photo	
Field Station#	12101+57		Field Station#	12108+41	
Pic 15 Desc.	Equipment Bridge over Stream S-MM11		Pic 16 Desc.	Equipment Bridge over Stream S-F15

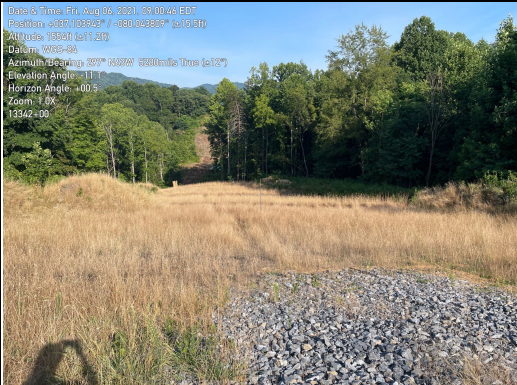
GPS Location			0			
Field Station#			13342+00			
Pic 7 Desc.			ROW and ECDs in good condition, with vegetation established across ROW			
GPS Location			0			
Field Station#			13342+67			
Pic 8 Desc.			Webster Corner Road Crossing in good condition, RCE in good condition and functioning properly			
<p>Date & Time: Fri Aug 06 2021 06:45:49 EDT Position: +037.103893 / -080.045740° (±10.11m) Altitude: 1549ft (±11.7m) Datum: WGS-84 Azimuth/Bearing: 108° S72E 1920mils True (±12°) Elevation Angle: -13.5° Horizon Angle: -02.6° Zoom: 1.0X 13343+50</p>

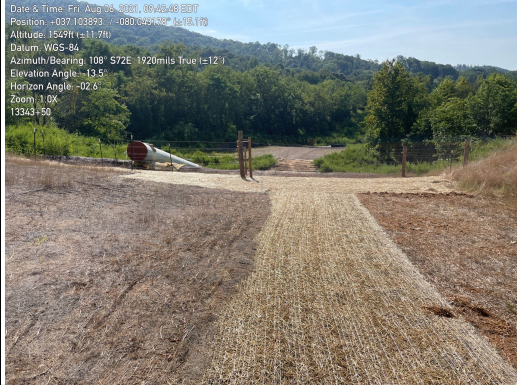
GPS Location			0			
Field Station#			13343+50			
Pic 9 Desc.			ROW and ECDs in good condition, ROW is stable			
GPS Location			0			
Field Station#			13345+00			
Pic 10 Desc.			Equipment bridge in good condition and ROW is stable			
<p>Date & Time: Fri Aug 06 2021 09:46:00 EDT Position: +037.103472 / -080.042456° (±15.51m) Altitude: 1528ft (±11.1m) Datum: WGS-84 Azimuth/Bearing: 195° S15W 3487mils True (±12°) Elevation Angle: -19.2° Horizon Angle: -00.2° Zoom: 1.0X 13345+50</p>

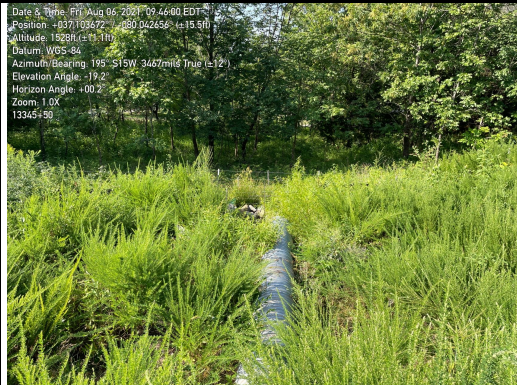
GPS Location			0			
Field Station#			13345+50			
Pic 11 Desc.			Clean water diversion pipe and outlet in good condition			
GPS Location			0			
Field Station#			13348+46

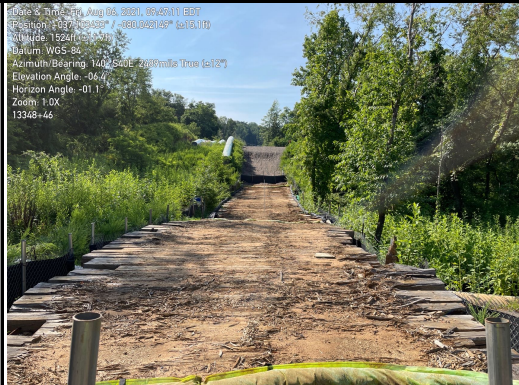
Pic 12 Desc.			MVP-S-RR08 and Corresponding buffer zone in good condition
