Visual Site Inspection Report

Project Name	H-600 Pipeline Spread H	AFE	124300138	Spread	H-600 Pipeline Spread H
Contractor	Precision			Report #	26948
Inspector	Pat Davis			Date/Time	8/9/2021 5:30 PM
Permit #	TBD	Inspection Type	VA SWPP	Station Begin	+0
State	VA	Inspection Area	Partial	Station End	+0
County	Roanoke	Ground	Dry	Temperature (°F)	93.00
Municipality	N/A	Weather	Sunny	Rain Gauge (in)	0.00
				Rain Accumulation Time (days)	0.00

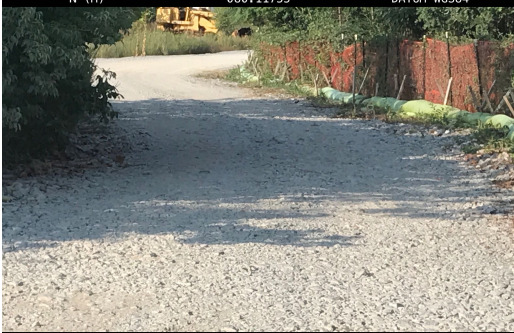
<p>DIRECTION N (M) +37.27478° -080.11755° ACCURACY 1.02 m DATUM WGS84</p> <p>MVP-LY-049_080921 Condition of rock entrance 2021-08-09 08:47:31-04:00</p>

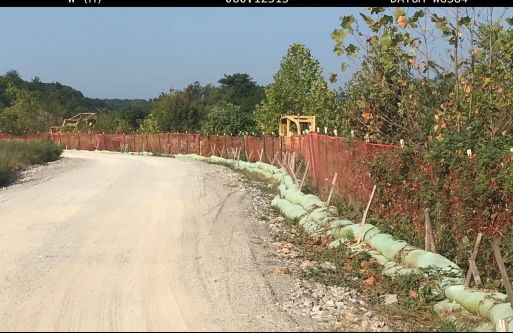
<p>DIRECTION W (M) +37.27153° -080.12315° ACCURACY 16 ft DATUM WGS84</p> <p>MVP-LY-049_080921 Condition of CFS & safety fence north L... 2021-08-09 08:48:24-04:00</p>			
GPS Location	MVP-LY-049 See photo for gps data		GPS Location	MVP-LY-049 See photo for gps data	
Field Station#	+0		Field Station#	+0	
Pic 1 Desc.	Condition of north rock entrance. No sediment on stone. Looking NW.		Pic 2 Desc.	Condition of triple compost filter sock and safety fence along north LOD. Looking W.

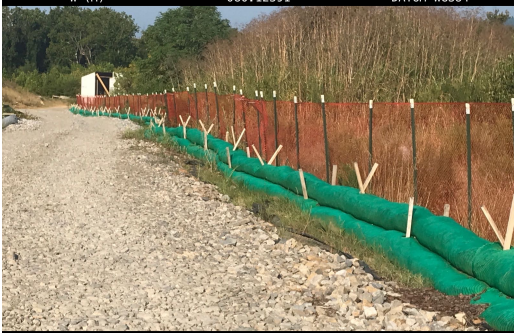
<p>DIRECTION W (M) +37.27067° -080.12391° ACCURACY 16 ft DATUM WGS84</p> <p>MVP-LY-049_080921 Condition of CFS & safety fence north L... 2021-08-09 08:49:06-04:00</p>

GPS Location	MVP-LY-049 See photo for gps data		GPS Location	MVP-LY-049 See photo for gps data	
Field Station#	+0		Field Station#	+0	
Pic 3 Desc.	Condition of triple stack compost filter sock along north LOD. Looking W.		Pic 4 Desc.	Landowner soil disturbance along triple stack compost filter sock. No new damage to installed ECD's. Looking S.

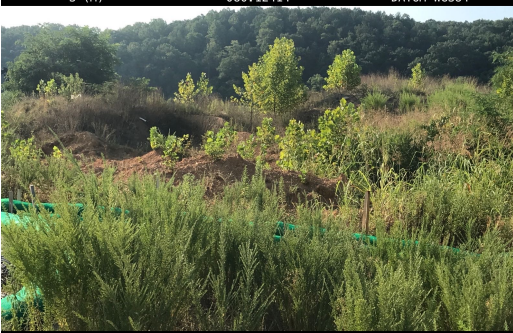
<p>DIRECTION S (M) +37.27059° -080.12414° ACCURACY 16 ft DATUM WGS84</p> <p>MVP-LY-049_080921 Landowner disturbance along CFS 2021-08-09 08:49:23-04:00</p>

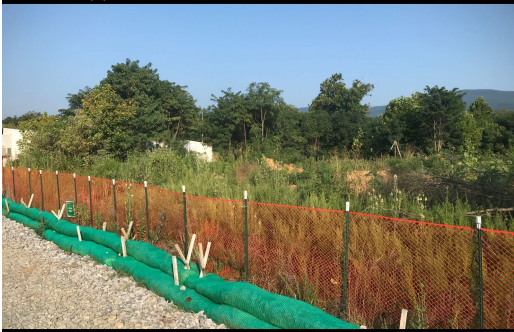
<p>DIRECTION NW (M) +37.27046° -080.12461° ACCURACY 16 ft DATUM WGS84</p> <p>MVP-LY-049_080921 Landowner disturbance along feature 2021-08-09 08:49:50-04:00</p>

<p>DIRECTION SW (M) +37.27046° -080.12462° ACCURACY 16 ft DATUM WGS84</p> <p>MVP-LY-049_080921 Landowner disturbance west of feature 2021-08-09 08:49:54-04:00</p>			
GPS Location	MVP-LY-049 See photo for gps data		GPS Location	MVP-LY-049 See photo for gps data	
Field Station#	+0		Field Station#	+0	
Pic 5 Desc.	Landowner soil disturbance along edge of feature W-CV21A. Area not stabilized. Looking NW.		Pic 6 Desc.	Landowner soil disturbance west of feature W-CV21B. Areas not stabilized. Looking SW.

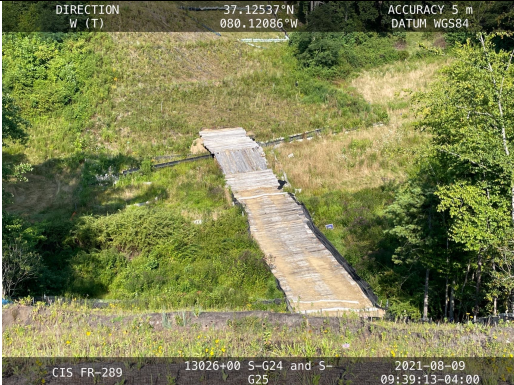
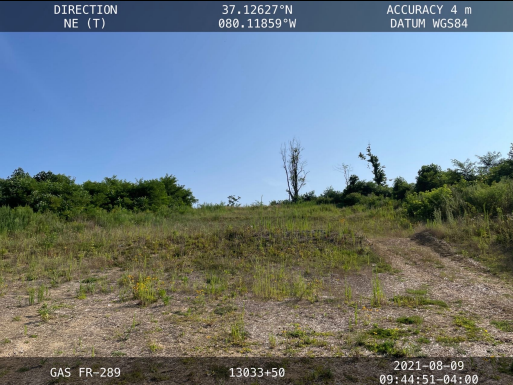
GPS Location	See photo		GPS Location	See photo	
Field Station#	13026+00		Field Station#	13033+50	
Pic 1 Desc.	Stream S-G24 and S-G25 on CIS FR-289		Pic 2 Desc.	Current ROW conditions on GAS FR-289. ROW is stable.

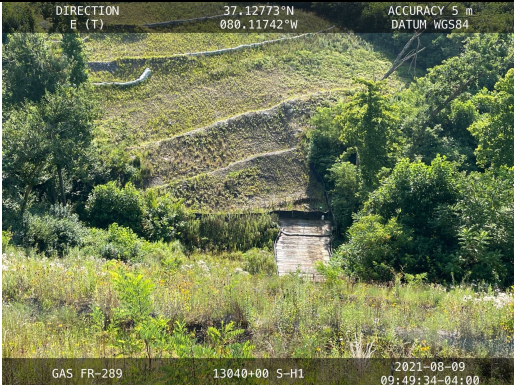
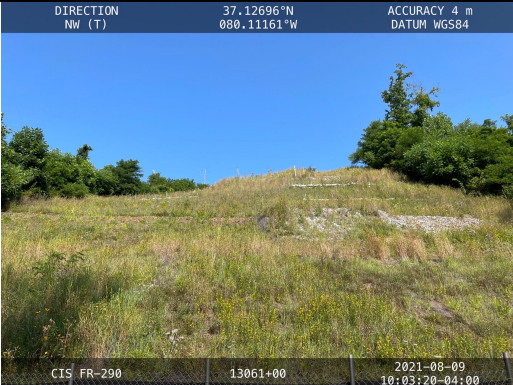
GPS Location	See photo		GPS Location	See photo	
Field Station#	13040+00		Field Station#	13061+00	
Pic 3 Desc.	Stream S-H1 on GAS FR-289		Pic 4 Desc.	Current ROW conditions on CIS FR-290. ROW is stable. Permanent ECDs functional.

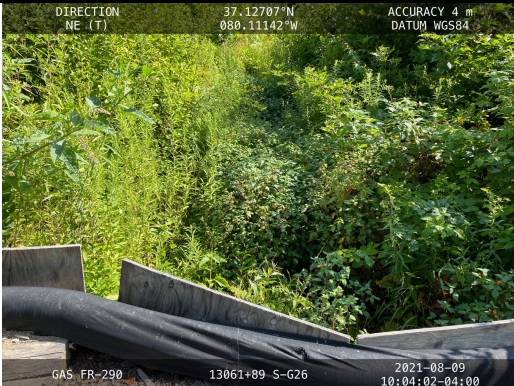
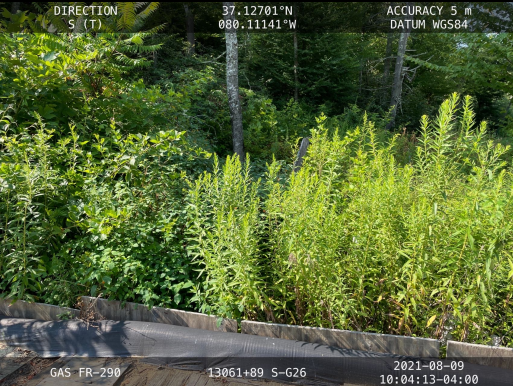
GPS Location	See photo		GPS Location	See photo	
Field Station#	13061+89		Field Station#	13061+89	
Pic 5 Desc.	Upstream photo of Stream S-G26		Pic 6 Desc.	Downstream photo of Stream S-G26

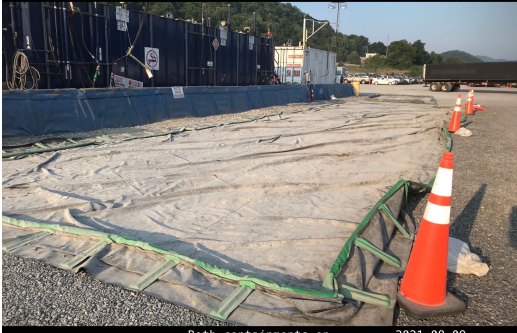
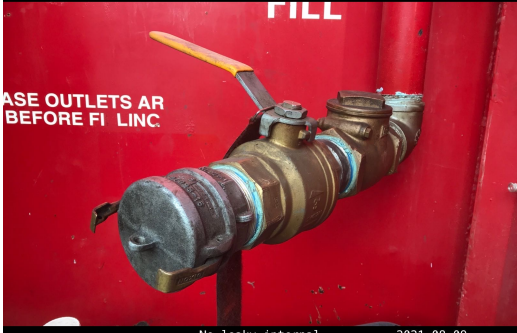
MVP-PY-006_080921 Both containments on site for tankers 2021-08-09 07:51:01-04:00		MVP-PY-006_080921 No leaky internal fittings 2021-08-09 07:52:30-04:00			
GPS Location	MVP-PY-006 See photo for gps data		GPS Location	MVP-PY-006 See photo for gps data	
Field Station#	+0		Field Station#	+0	
Pic 7 Desc.	Both secondary containments on site and in place for tankers offloading fuel. Looking SW.		Pic 8 Desc.	Off Road Fuel unit no leaky internal fittings. Looking W.	
DIRECTION SW (M) +37.23559° -080.22703° ACCURACY 33 ft DATUM WGS84

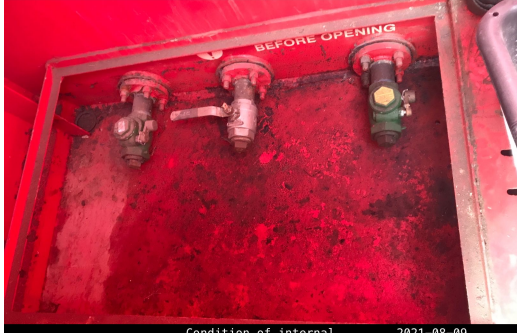
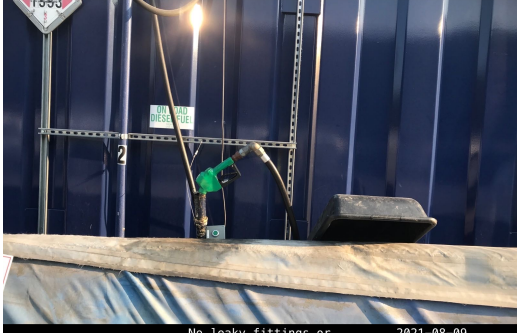
MVP-PY-006_080921 Condition of internal drip pan 2021-08-09 07:52:43-04:00		MVP-PY-006_080921 No leaky fittings or nozzles 2021-08-09 07:53:27-04:00

GPS Location	MVP-PY-006 See photo for gps data		GPS Location	MVP-PY-006 See photo for gps data	
Field Station#	+0		Field Station#	+0	
Pic 9 Desc.	Off Road Fuel unit condition of internal drip pan. Looking SW.		Pic 10 Desc.	Blue Bulk Fuel tanks no leaky fittings or nozzles. Drip pans in place. Looking N.	
DIRECTION S (M) +37.23553° -080.22673° ACCURACY 16 ft DATUM WGS84

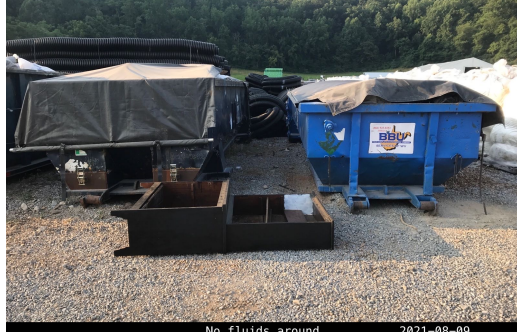
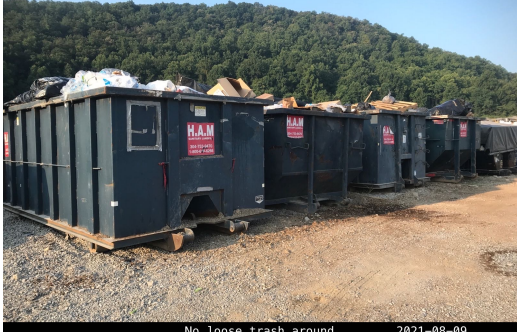
MVP-PY-006_080921 No fluids around hazardous waste dump... 2021-08-09 07:54:00-04:00		MVP-PY-006_080921 No loose trash around dumpsters 2021-08-09 07:54:43-04:00			
GPS Location	MVP-PY-006 See photo for gps data		GPS Location	MVP-PY-006 See photo for gps data	
Field Station#	+0		Field Station#	+0	
Pic 11 Desc.	No fluids or deposits around hazardous waste dumpsters. Looking S.		Pic 12 Desc.	No loose trash around dumpsters and in the yard. Looking SW.

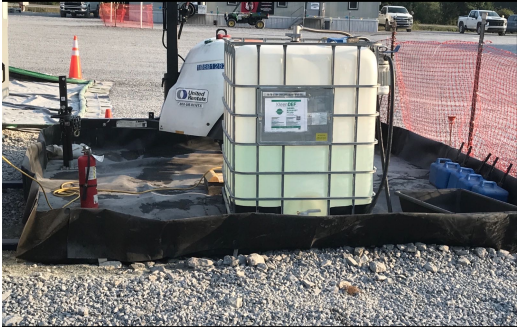
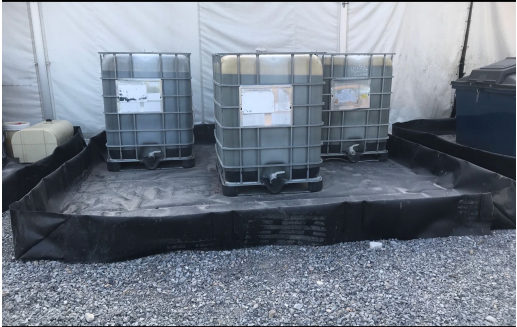
MVP-PY-006_080921 Condition of containment 2021-08-09 07:55:51-04:00		DIRECTION E (M) +37.23549° -080.22710° ACCURACY 213 ft DATUM WGS84

MVP-PY-006_080921 Condition of containment 2021-08-09 07:58:29-04:00			
GPS Location	MVP-PY-006 See photo for gps data		GPS Location	MVP-PY-006 See photo for gps data	
Field Station#	+0		Field Station#	+0	
Pic 13 Desc.	Condition of containment under DEF container. Free of fluids. Looking SE.		Pic 14 Desc.	Condition of containment under used oil containers. Free of fluids. Looking E.	
DIRECTION E (M) +37.23421° -080.22720° ACCURACY 16 ft DATUM WGS84

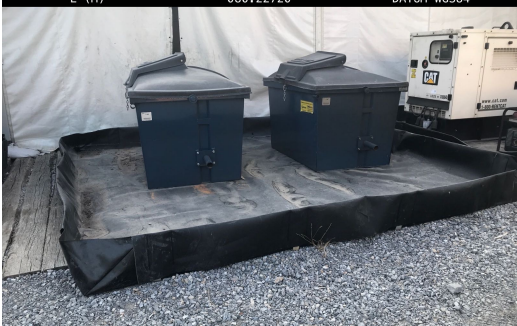
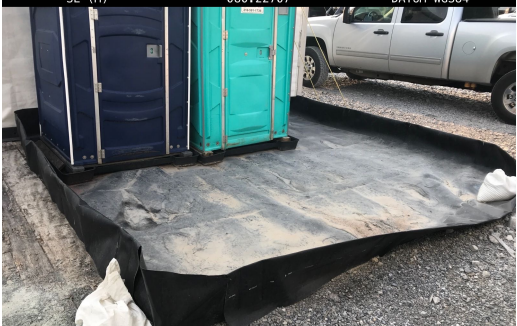
MVP-PY-006_080921 Condition of containment 2021-08-09 07:58:33-04:00		DIRECTION SE (M) +37.23407° -080.22707° ACCURACY 16 ft DATUM WGS84

MVP-PY-006_080921 Condition of trays & containment 2021-08-09 07:58:47-04:00

GPS Location	MVP-PY-006 See photo for gps data		GPS Location	MVP-PY-006 See photo for gps data	
Field Station#	+0		Field Station#	+0	
Pic 15 Desc.	Condition of containment under hazardous waste dumpsters. Free of fluids. Looking E.		Pic 16 Desc.	Condition of trays and containment under toilets. Looking SE.	
DIRECTION SE (M) +37.23445° -080.22844° ACCURACY 164 ft DATUM WGS84

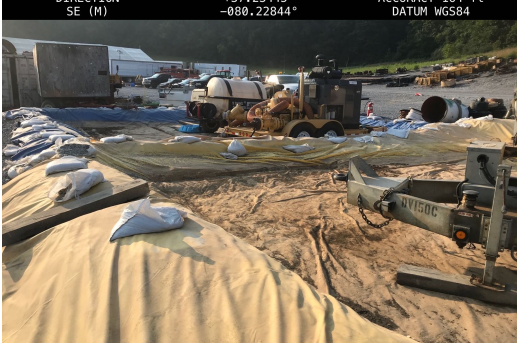
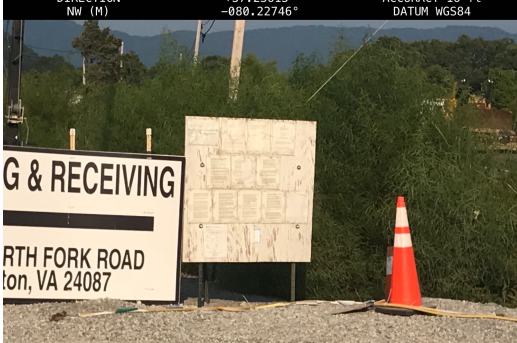
MVP-PY-006_080921 Condition of poly lined containments 2021-08-09 08:00:10-04:00		DIRECTION NW (M) +37.23613° -080.22746° ACCURACY 16 ft DATUM WGS84

MVP-PY-006_080921 Condition of posted project documents 2021-08-09 08:06:52-04:00			
GPS Location	MVP-PY-006 See photo for gps data		GPS Location	MVP-PY-006 See photo for gps data	
Field Station#	+0		Field Station#	+0	
Pic 17 Desc.	Condition of poly lined rock berm containments. Free of stormwater and fluids. Looking SE.		Pic 18 Desc.	Condition of posted project documents at main entrance. Looking NW.

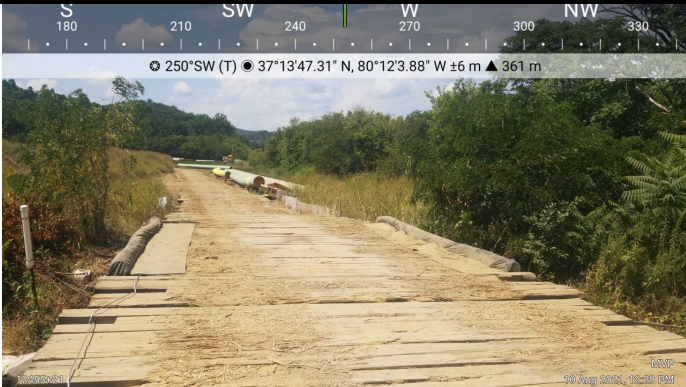
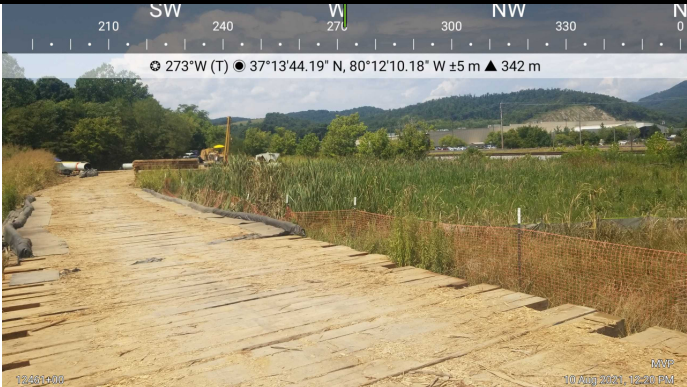
GPS Location	See Above	GPS Location	See Above		
Field Station#	12455+21	Field Station#	12461+00		
Pic 3 Desc.	Overview of Waterbody S-CD12b. ECDs are functional and ROW is stable.	Pic 4 Desc.	Overview of Wetland W-KL58. ECDs are functional and ROW is stable.

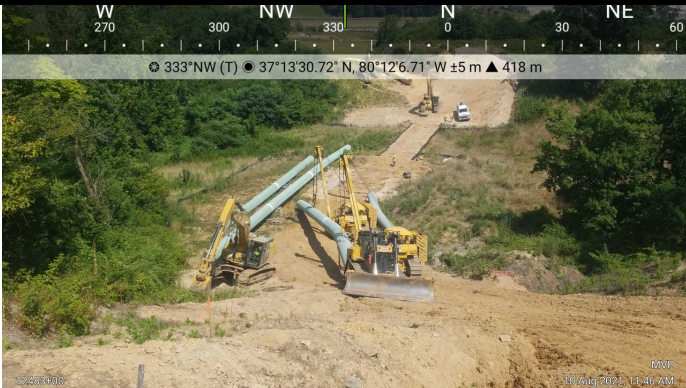
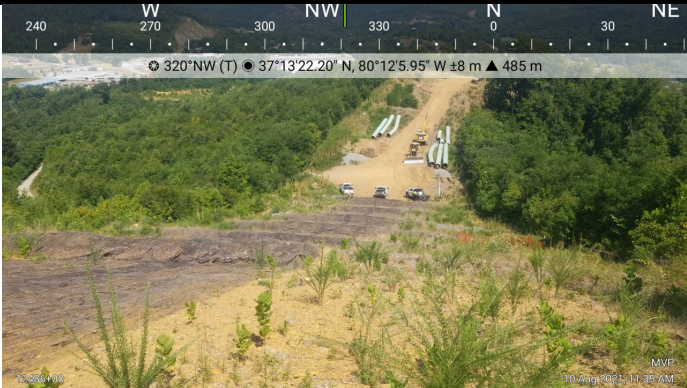
GPS Location	See Above	GPS Location	See Above		
Field Station#	12483+00	Field Station#	12486+00		
Pic 5 Desc.	Composite crew working on stringing pipe. Composite crew is working in environmental compliance.	Pic 6 Desc.	ROW Overview. ECDs are functional and ROW is stable.

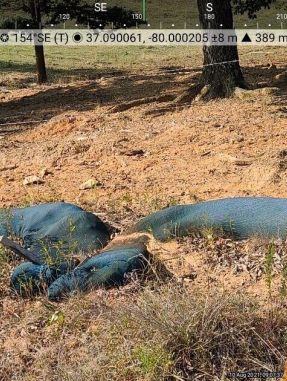
GPS Location	00000	GPS Location	00000		
Field Station#	13511+00	Field Station#	13510+00		
Pic 1 Desc.	Row photo showing vegetation growth . Good permanent coverage noted.		Pic 2 Desc.	CFS over topping with sediment on problem land owner track , recommended adding additional CFS to the area. Documented and added to the punch list.

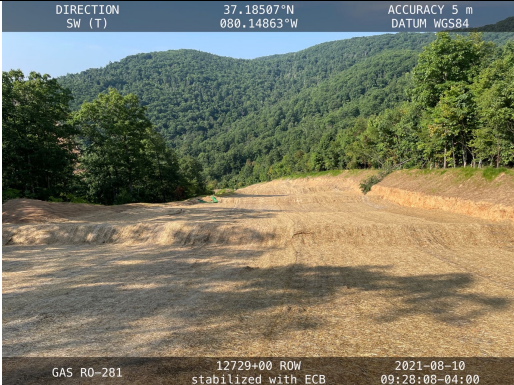
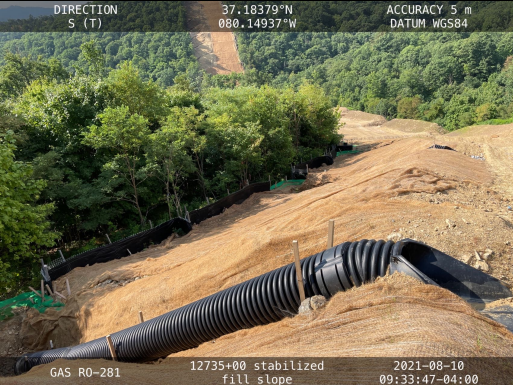
GPS Location	See photo		GPS Location	See photo	
Field Station#	12729+00		Field Station#	12735+00	
Pic 1 Desc.	Current ROW conditions. ROW is stable.		Pic 2 Desc.	Fill Slope is stabilized. Slope drain is functional.

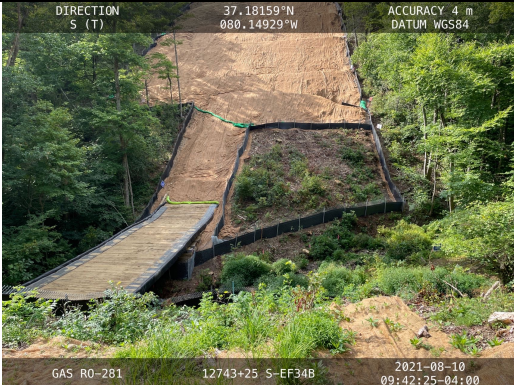
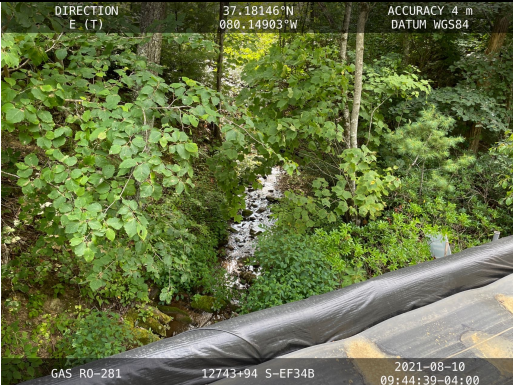
GPS Location	See photo		GPS Location	See photo	
Field Station#	12743+25		Field Station#	12743+94	
Pic 3 Desc.	Stream S-EF34B and corresponding Buffer Area		Pic 4 Desc.	Downstream photo of Stream S-EF34B

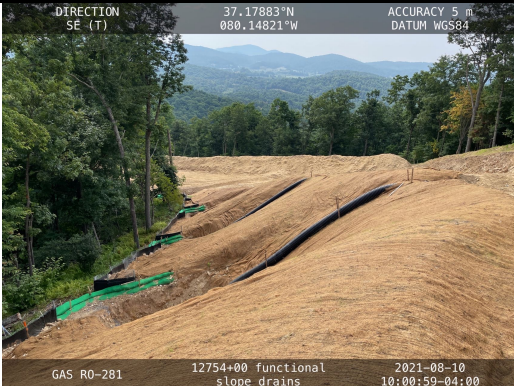
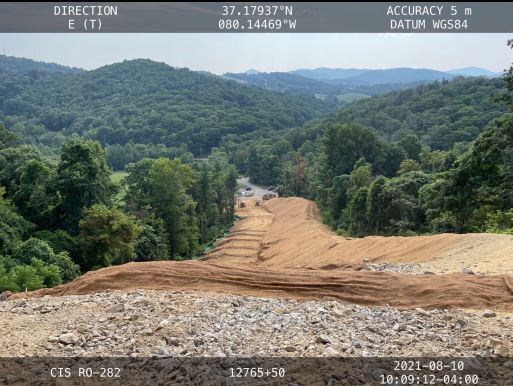
GPS Location	See photo		GPS Location	See photo	
Field Station#	12754+00		Field Station#	12765+50	
Pic 5 Desc.	Fill Slope stabilized. Slope drains are functional.		Pic 6 Desc.	Current ROW conditions. ROW is stable.

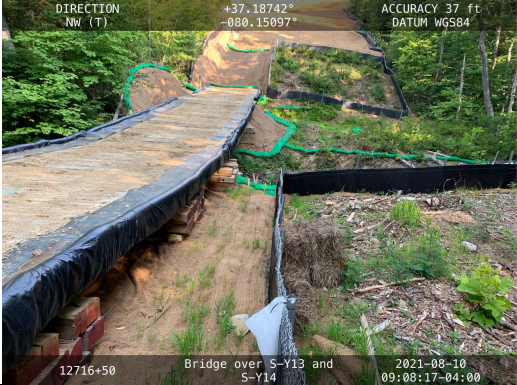
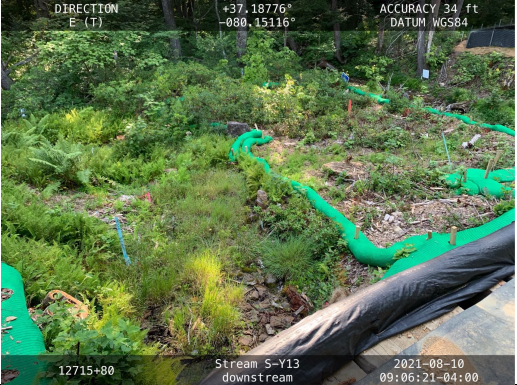
GPS Location	See photo		GPS Location	See photo	
Field Station#	12716+50		Field Station#	12715+80	
Pic 13 Desc.	Equipment Bridge over Streams S-Y13 and S-Y14		Pic 14 Desc.	Downstream photo of Stream S-Y13

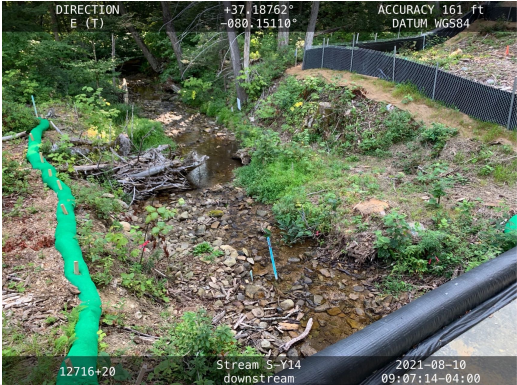
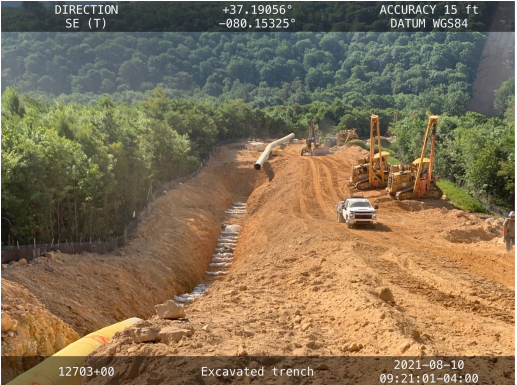
GPS Location	See photo		GPS Location	See photo	
Field Station#	12716+20		Field Station#	12703+00	
Pic 15 Desc.	Downstream photo of Stream S-Y14		Pic 16 Desc.	Tie-in crew actively working on GAS RO-280

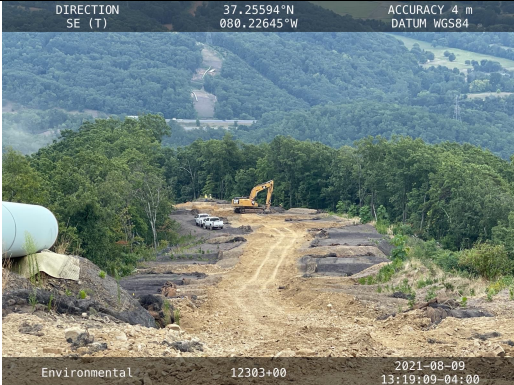
GPS Location	See photo		GPS Location	See photo	
Field Station#	12303+00		Field Station#	12410+20	
Pic 1 Desc.	Environmental crew performing preventative maintenance to the dumps and end treatment		Pic 2 Desc.	Clean water crossing pipe outlet in acceptable condition

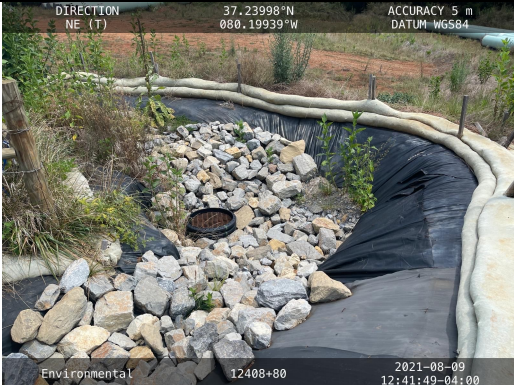
GPS Location	See photo		GPS Location	See photo	
Field Station#	12408+80		Field Station#	12400+00	
Pic 3 Desc.	Clean water crossing pipe inlet in acceptable condition		Pic 4 Desc.	Stabilized ROW in acceptable condition

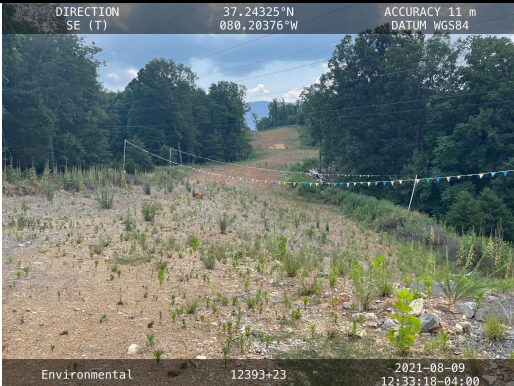
GPS Location	See photo		GPS Location	See photo	
Field Station#	12393+23		Field Station#	12383+93	
Pic 5 Desc.	Stabilized ROW in acceptable condition		Pic 6 Desc.	Clean water crossing in acceptable condition

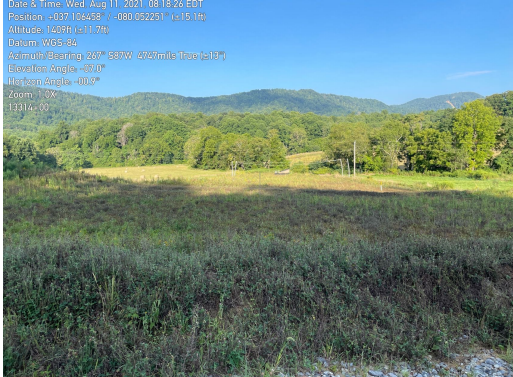
GPS Location		0		GPS Location	
Field Station#		13314+00		Field Station#	
Pic 1 Desc.		ROW and ECDs in good condition with vegetation established across ROW		Pic 2 Desc.	
				MVP-S-GH7 and Corresponding buffer zone in good condition	
<p>Date & Time: Wed Aug 11, 2021 08:32:05 EDT Position: +037 132459 / -080 056972 (+15.14) Altitude: 1424ft (+11.2ft) Datum: WGS-84 Azimuth/Bearing: 267° 58'45" Azimuth True (+12.1) Elevation Angle: -0.22° Horizon Angle: -00.7° Zoom: 1.0X 13262+62 Flanders Road Crossing</p>

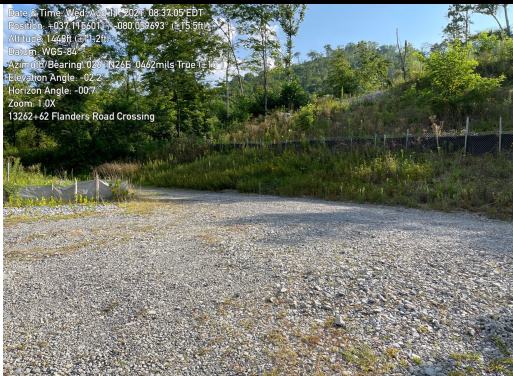
GPS Location		0		GPS Location	
Field Station#		13262+62		Field Station#	
Pic 3 Desc.		Flanders Road Crossing in good condition, RCE in good condition and functioning properly		Pic 4 Desc.	
				MVP-S-II4 and Corresponding buffer zone in good condition	
<p>Date & Time: Wed Aug 11, 2021 08:39:06 EDT Position: +037 132564 / -080 060564 (+15.4ft) Altitude: 1447ft (+11.2ft) Datum: WGS-84 Azimuth/Bearing: 262° S82W 4658mils True (+13.1) Elevation Angle: +12.9° Horizon Angle: +01.9° Zoom: 1.0X 13259+00</p>

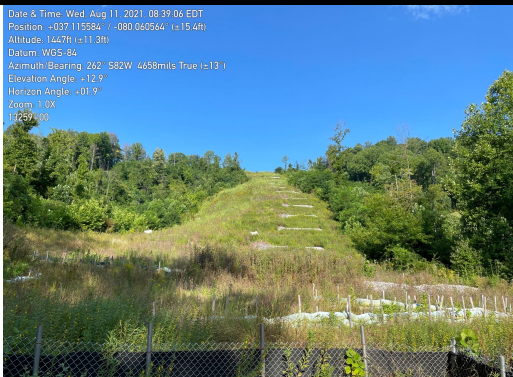
GPS Location		0		GPS Location	
Field Station#		13259+00		Field Station#	
Pic 5 Desc.		ROW and ECDs in good condition with vegetation established across ROW		Pic 6 Desc.

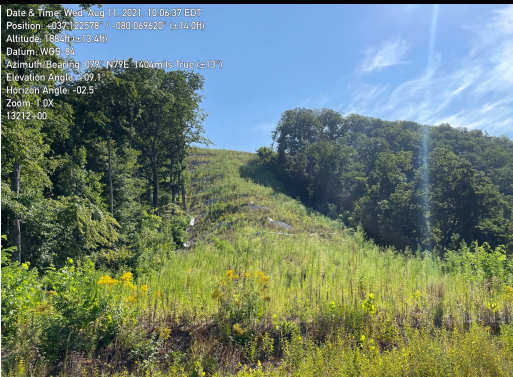
ROW and ECDs in good condition with vegetation established across ROW

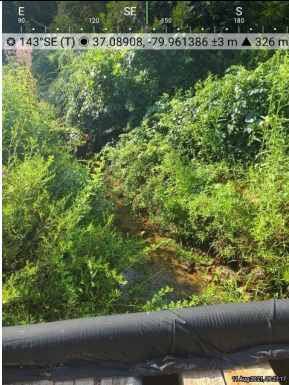
GPS Location	00000	GPS Location	00000		
Field Station#	13643+63	Field Station#	13643+59		
Pic 1 Desc.	Stream observation photo facing downstream during routine inspection today. No environmental issues observed at the time of inspection.		Pic 2 Desc.	Monitored equipment bridge and protection during routine inspection today.

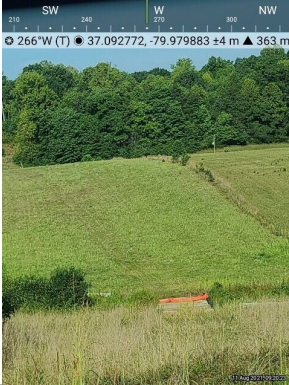
GPS Location	0000	GPS Location	00000		
Field Station#	13574+97	Field Station#	13643+63		
Pic 3 Desc.	Row photo showing good vegetation coverage.		Pic 4 Desc.	Stream observation photo facing upstream during routine inspection today. No issues observed at the time of inspection.

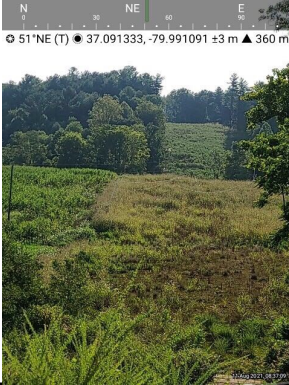
GPS Location	0000	GPS Location	0000		
Field Station#	13541+90	Field Station#	13541+50		
Pic 5 Desc.	Row photo showing good vegetation coverage.		Pic 6 Desc.	Row photo in permanent area showing vegetation with good coverage.

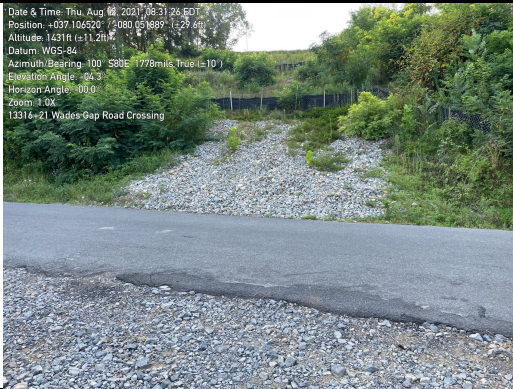
<p>Date & Time: Thu, Aug 12, 2021, 08:39:16 EDT Position: +037 104520 / -080 058697 (+11.2m) Altitude: 1431ft (+11.7m) Datum: WGS-84 Azimuth/Bearing: 231 S51W 4107mils True (+1°) Elevation Angle: +12.1 Horizon Angle: +02.5 Zoom: 1.0X 13317+02 Private Driveway</p>			
GPS Location	0	GPS Location	0		
Field Station#	13316+21	Field Station#	13317+02		
Pic 1 Desc.	Wades Gap Road Crossing in good condition. RCE in good condition and functioning properly		Pic 2 Desc.	Private Driveway in good condition

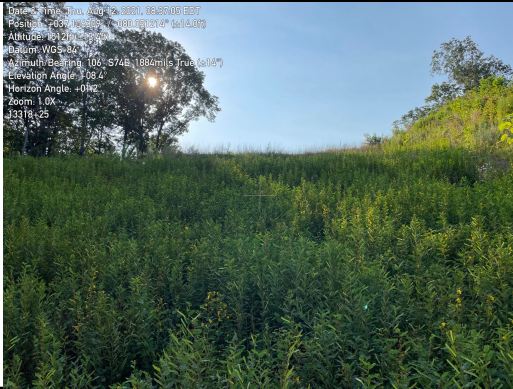
GPS Location	0	GPS Location	0		
Field Station#	13318+25	Field Station#	13321+47		
Pic 3 Desc.	ROW and ECDs in good condition, with vegetation established across ROW		Pic 4 Desc.	MVP-S-GH15 and Corresponding buffer zone in good condition

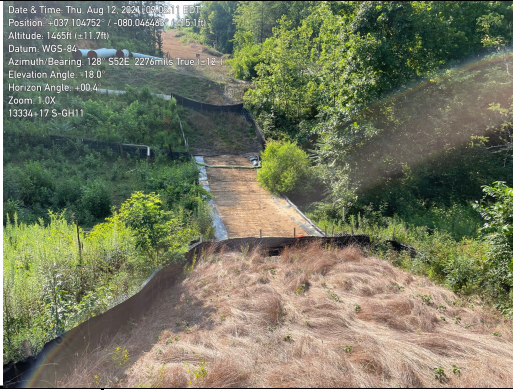
<p>Date & Time: Thu, Aug 12, 2021, 09:05:49 EDT Position: +037 104752 / -080 044587 (+11.5m) Altitude: 1465ft (+11.7m) Datum: WGS-84 Azimuth/Bearing: 130 S52E 2431mils True (+12°) Elevation Angle: +17.4 Horizon Angle: +01.0 Zoom: 1.0X 13337+13 S-GH9</p>			
GPS Location	0	GPS Location	0		
Field Station#	13334+17	Field Station#	13337+13		
Pic 5 Desc.	MVP-S-GH11 and Corresponding buffer zone in good condition		Pic 6 Desc.	MVP-S-GH9 and Corresponding buffer zone in good condition

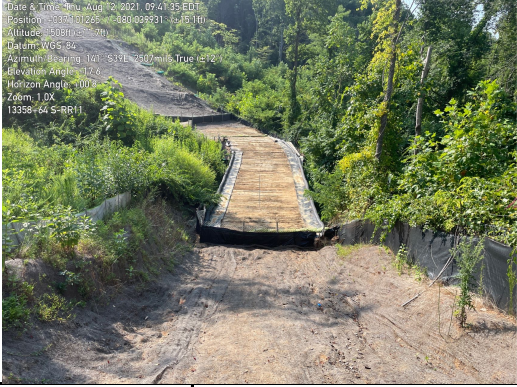
<p> Date & Time: Thu Aug 12, 2021, 10:58:13 EDT Position: -83.74191255° / -880.099331° (-11.16) Altitude: 1508ft (-15.70) Datum: WGS-84 Azimuth/Bearing: 121° S 131° 2007mils True (-12) Elevation Angle: -12.0 Horizon Angle: -100.8 Zoom: 1.0X 13371+50 </p>			
GPS Location	0	GPS Location	0		
Field Station#	13358+64	Field Station#	13371+50		
Pic 13 Desc.	MVP-S-RR11 and Corresponding buffer zone in good condition	Pic 14 Desc.	ROW and ECDs in good condition, ROW is stable

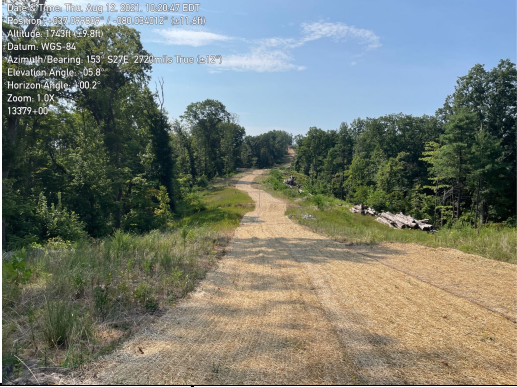
GPS Location	0	GPS Location	0		
Field Station#	13379+00	Field Station#	13403+50		
Pic 15 Desc.	ROW and ECDs in good condition, ROW is stable	Pic 16 Desc.	ROW and ECDs in good condition, with vegetation established across ROW

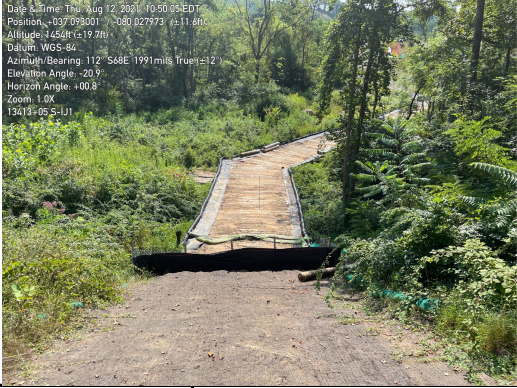
<p> Date & Time: Thu Aug 12, 2021, 10:58:13 EDT Position: -83.74191255° / -880.099331° (-11.16) Altitude: 1450ft (-19.77) Datum: WGS-84 Azimuth/Bearing: 112° S 68° E 1991mils True (-12) Elevation Angle: -20.9 Horizon Angle: -01.9 Zoom: 1.0X 13415+51 Cahas Mountain Road Crossing </p>			
GPS Location	0	GPS Location	0		
Field Station#	13413+05	Field Station#	13415+51		
Pic 17 Desc.	MVP-S-IJ1 and Corresponding buffer zone in good condition	Pic 18 Desc.	Cahas Mountain Road Crossing in good condition, RCE in good condition and functioning properly

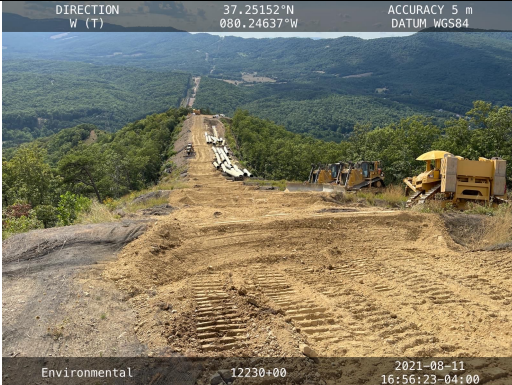
GPS Location	See photo		GPS Location	See photo	
Field Station#	12230+00		Field Station#	12230+00	
Pic 1 Desc.	Waterbars placed back across the travel lane after work was completed for the day.		Pic 2 Desc.	ROW in construction area with waterbars out during working hours.

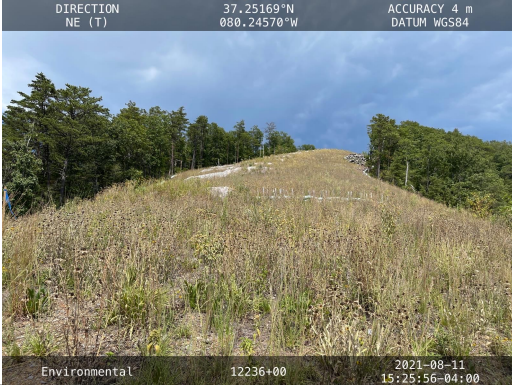
GPS Location	See photo		GPS Location	see photo	
Field Station#	12236+00		Field Station#	12121+00	
Pic 3 Desc.	Stabilized ROW in acceptable condition		Pic 4 Desc.	Timber May travel lane crossing multiple wetland and streams in acceptable condition

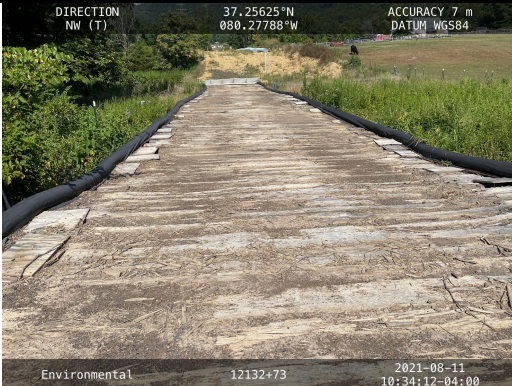
GPS Location	See photo		GPS Location	See photo	
Field Station#	12132+73		Field Station#	12135+00	
Pic 5 Desc.	Bridge and ECDs crossing stream S-C29 in acceptable condition		Pic 6 Desc.	Stabilized slope in acceptable condition

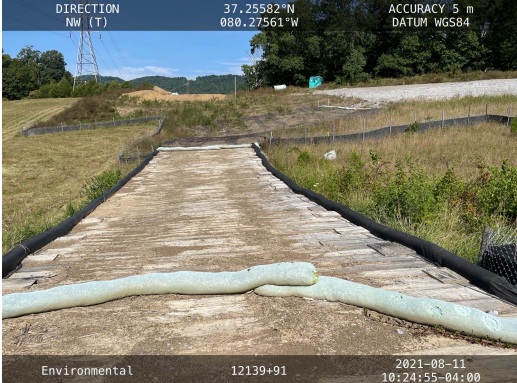
GPS Location	see photo		GPS Location	See photo	
Field Station#	12139+91		Field Station#	12143+00	
Pic 7 Desc.	Wetland crossing W-C6 in acceptable condition		Pic 8 Desc.	Stabilized ROW In Acceptable condition

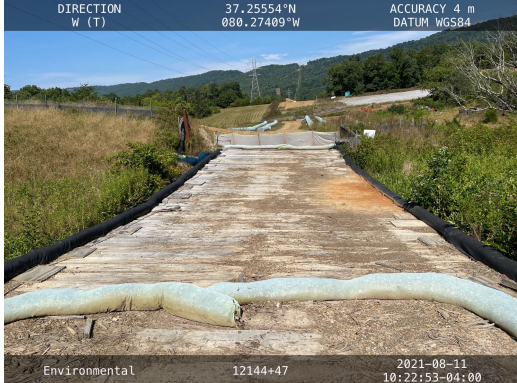
GPS Location	See photo		GPS Location	See photo	
Field Station#	12144+47		Field Station#	12150+95	
Pic 9 Desc.	Wetland crossing W-C5 in acceptable condition		Pic 10 Desc.	Stabilized drainage feature in acceptable condition

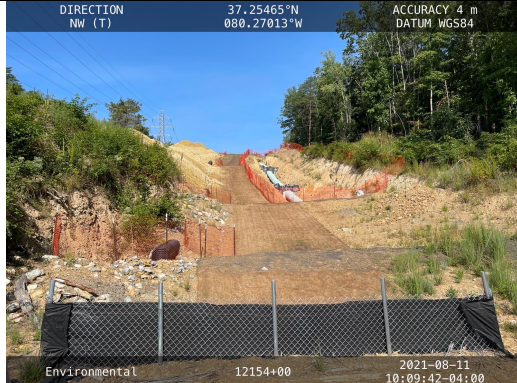
GPS Location	See photo		GPS Location	See photo	
Field Station#	12154+00		Field Station#	12155+00	
Pic 11 Desc.	Stabilized ROW In Acceptable condition		Pic 12 Desc.	End sump drain outlet in acceptable condition

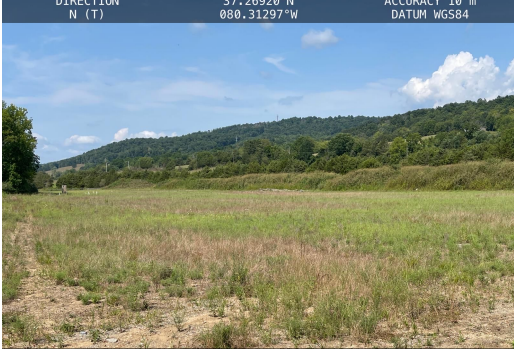
<div> Environmental 12013+97 2021-08-12 11:04:10-04:00 </div> </div>			
GPS Location	See photo		GPS Location	See photo	
Field Station#	12007+00		Field Station#	12014+97	
Pic 1 Desc.	Stabilized Row in acceptable condition		Pic 2 Desc.	Bridge and ECDs crossing stream S-G36 in acceptable condition	
<div> <div> DIRECTION NW (T) 37.26795°N 080.31365°W ACCURACY 7 m DATUM WGS84 </div>

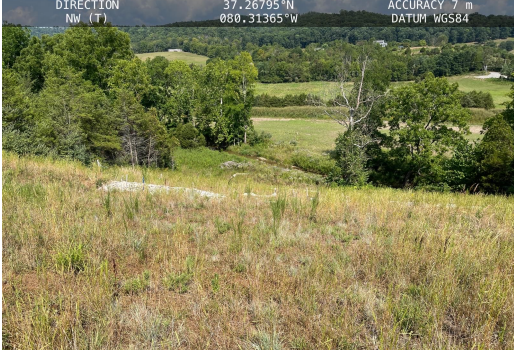
GPS Location	see photo		GPS Location	See photo	
Field Station#	12010+00		Field Station#	12013+00	
Pic 3 Desc.	Stabilized slope in acceptable condition		Pic 4 Desc.	Stabilized Row in acceptable condition	
<div> <div> DIRECTION SE (T) 37.26719°N 080.31308°W ACCURACY 4 m DATUM WGS84 </div>

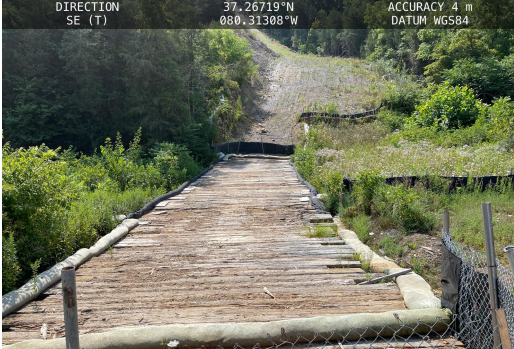
<div> Environmental 12013+97 2021-08-12 10:47:11-04:00 </div> </div>			
GPS Location	See photo		GPS Location	See photo	
Field Station#	12018+50		Field Station#	12013+97	
Pic 5 Desc.	Bridge and ECDs crossing stream S-G38 in acceptable condition		Pic 6 Desc.	Access Road MVP-MN-268 in acceptable condition

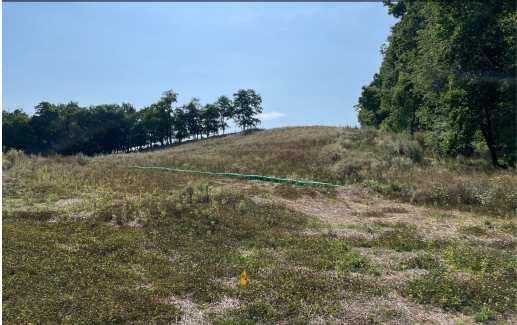
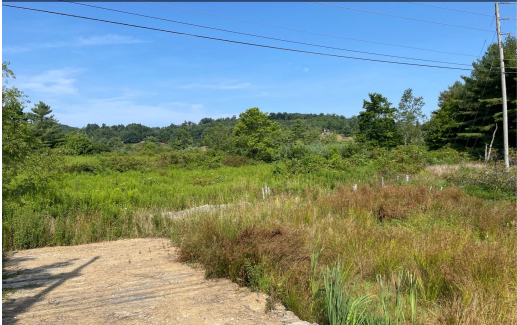
GAS US 221 12996+00 2021-08-12 10:15:16-04:00		CIS US 221 12993+00 2021-08-12 10:16:17-04:00			
GPS Location	See photo		GPS Location	See photo	
Field Station#	12996+00		Field Station#	12993+00	
Pic 7 Desc.	Current ROW conditions. ROW is stable.		Pic 8 Desc.	Current ROW conditions. ROW is stable.	
DIRECTION NW (T) 37.12591°N 080.12539°W ACCURACY 4 m DATUM WGS84		DIRECTION E (T) 37.12542°N 080.12367°W ACCURACY 4 m DATUM WGS84

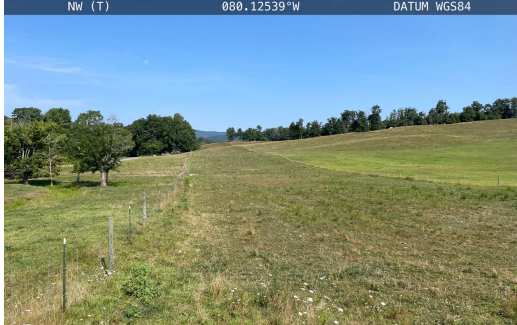
CIS BRP 13012+00 2021-08-12 10:18:42-04:00		GAS BRP 13018+00 2021-08-12 10:33:38-04:00			
GPS Location	See photo		GPS Location	See photo	
Field Station#	13012+00		Field Station#	13018+00	
Pic 9 Desc.	Current ROW conditions. ROW has been restored and is stable.		Pic 10 Desc.	Current ROW conditions. ROW has been restored and is stable.

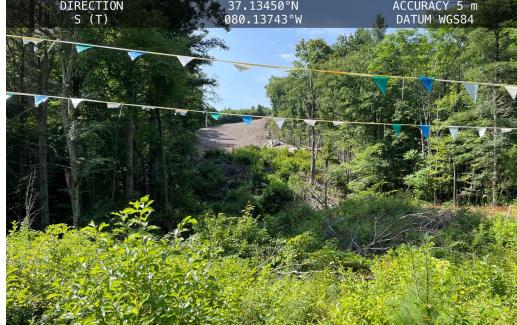
GAS R0-287 12957+50 2021-08-12 10:54:38-04:00		CIS R0-287 12956+93 landowner spring box 2021-08-12 10:55:23-04:00			
GPS Location	See photo		GPS Location	See photo	
Field Station#	12957+50		Field Station#	12956+93	
Pic 11 Desc.	Current ROW conditions. ROW is stable.		Pic 12 Desc.	Landowner spring box remains undisturbed.

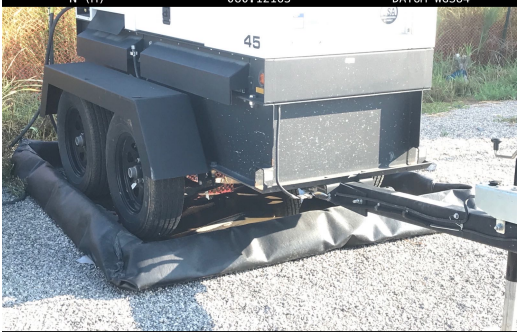
GPS Location	MVP-LY-049 See photo for gps data		GPS Location	MVP-LY-049 See photo for gps data	
Field Station#	+0		Field Station#	+0	
Pic 15 Desc.	Condition of containment under generator holding stormwater. Looking N.		Pic 16 Desc.	Stored supplies in secondary containment. Looking N.	
DIRECTION SW (M) +37.27090° -080.12012° ACCURACY 967 ft DATUM WGS84  				DIRECTION SW (M) +37.27039° -080.12103° ACCURACY 16 ft DATUM WGS84

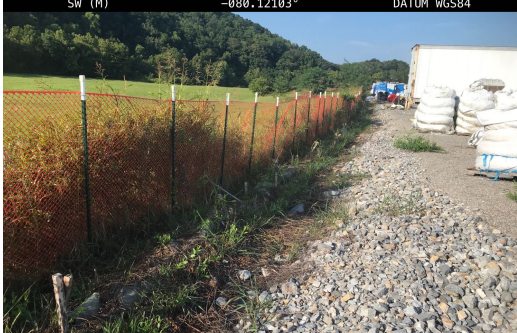
MVP-LY-049_081321 Condition of CFS & safety fence LOD 2021-08-13 08:40:51-04:00				MVP-LY-049_081321 Condition of CFS & safety fence LOD 2021-08-13 08:45:36-04:00	
GPS Location	MVP-LY-049 See photo for gps data		GPS Location	MVP-LY-049 See photo for gps data	
Field Station#	+0		Field Station#	+0	
Pic 17 Desc.	Condition of triple stack compost filter sock and safety fence along south LOD. Looking SW.		Pic 18 Desc.	Condition of triple stack compost filter sock and safety fence along south LOD. Looking W.

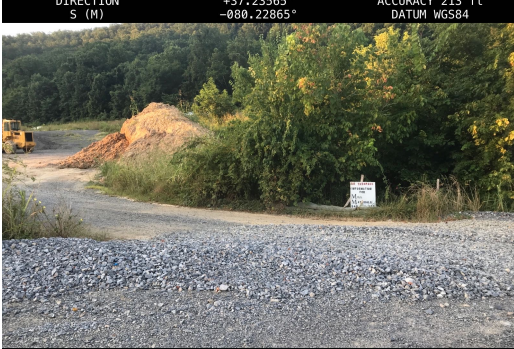
<p>DIRECTION S (M) +37.23565° -080.22865° ACCURACY 213 ft DATUM WGS84</p> <p>MVP-PY-006_081321 Check condition of spoil pile adjacent... 2021-08-13 07:12:17-04:00</p>

<p>DIRECTION SE (M) +37.23548° -080.22671° ACCURACY 33 ft DATUM WGS84</p> <p>MVP-PY-006_081321 No fluids around hazardous waste dump... 2021-08-13 07:20:52-04:00</p>			
GPS Location	MVP-PY-006 See photo for gps data	GPS Location	MVP-PY-006 See photo for gps data		
Field Station#	+0	Field Station#	+0		
Pic 1 Desc.	Check condition of spoil pile adjacent to LOD. Area not stabilized. Looking S.	Pic 2 Desc.	No deposits or fluids around hazardous waste dumpsters. Looking SE.

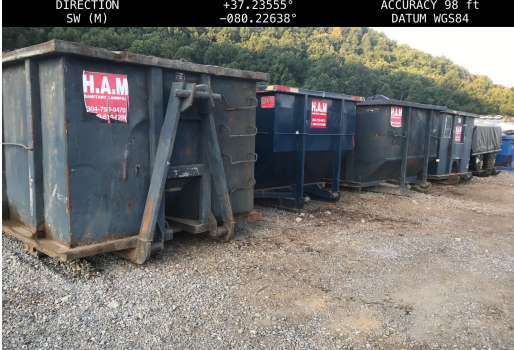
GPS Location	MVP-PY-006 See photo for gps data	GPS Location	MVP-PY-006 See photo for gps data		
Field Station#	+0	Field Station#	+0		
Pic 3 Desc.	No loose trash around dumpsters or in the yard. Looking SW.	Pic 4 Desc.	Blue Bulk Fuel tanks containment holding stormwater. Looking NE.

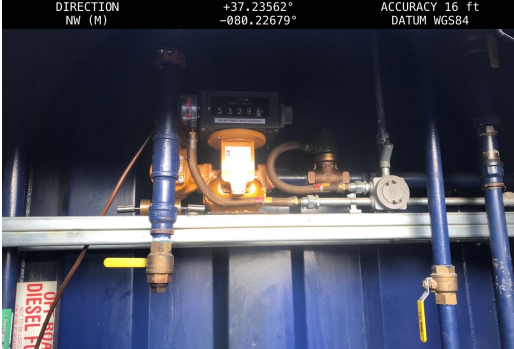
<p>DIRECTION NW (M) +37.23561° -080.22677° ACCURACY 16 ft DATUM WGS84</p> <p>MVP-PY-006_081321 Secondary containment in place for tankers 2021-08-13 07:22:59-04:00</p>			
GPS Location	MVP-PY-006 See photo for gps data	GPS Location	MVP-PY-006 See photo for gps data		
Field Station#	+0	Field Station#	+0		
Pic 5 Desc.	Blue Bulk Fuel tanks no leaky internal fittings. Looking NW.	Pic 6 Desc.	Both secondary containments on site and in place for tankers offloading fuel. Looking NW.

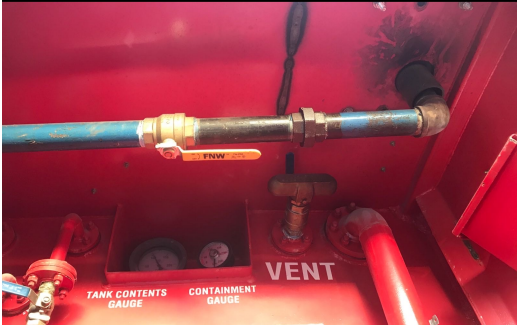
MVP-PY-006_081321 No leaky internal fittings 2021-08-13 07:24:21-04:00		MVP-PY-006_081321 Condition of internal drip pan 2021-08-13 07:24:24-04:00			
GPS Location	MVP-PY-006 See photo for gps data		GPS Location	MVP-PY-006 See photo for gps data	
Field Station#	+0		Field Station#	+0	
Pic 7 Desc.	Off Road Fuel unit no leaky internal fittings. Looking NW.		Pic 8 Desc.	Off Road Fuel unit condition of internal drip pan. Free of fluids. Looking SW.	
DIRECTION NE (M) +37.23554° -080.22691° ACCURACY 16 ft DATUM WGS84

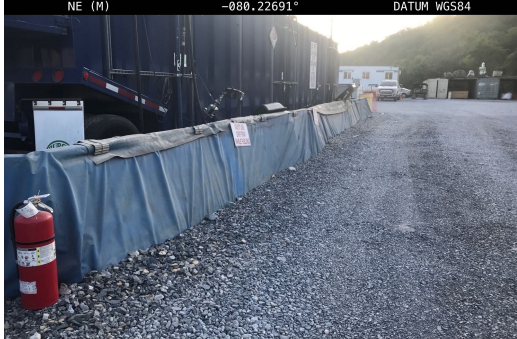
GPS Location	MVP-PY-006 See photo for gps data		GPS Location	MVP-PY-006 See photo for gps data	
Field Station#	+0		Field Station#	+0	
Pic 9 Desc.	Blue Bulk Fuel tanks no fuel spills south of the tanks. Looking NE.		Pic 10 Desc.	Blue Bulk Fuel tanks no leaky fittings or nozzles. Looking NE.	
DIRECTION N (M) +37.23557° -080.22671° ACCURACY 33 ft DATUM WGS84

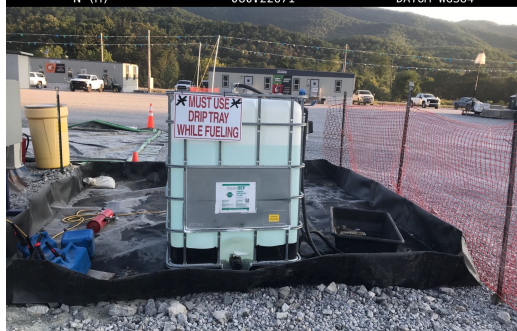
MVP-PY-006_081321 Condition of containment 2021-08-13 07:25:51-04:00		MVP-PY-006_081321 Condition of containment 2021-08-13 07:30:01-04:00			
GPS Location	MVP-PY-006 See photo for gps data		GPS Location	MVP-PY-006 See photo for gps data	
Field Station#	+0		Field Station#	+0	
Pic 11 Desc.	Condition of containment under DEF container. Free of fluids. Looking N.		Pic 12 Desc.	Condition of containment under hazardous waste dumpsters. Free of fluids. Looking SE.

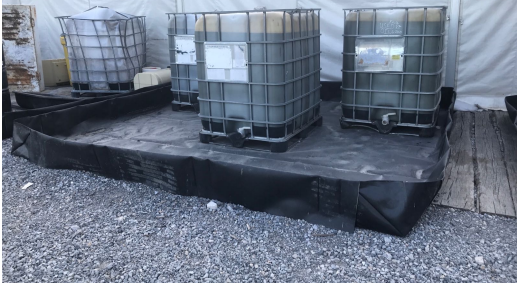
MVP-PY-006_081321 Condition of containment 2021-08-13 07:30:03-04:00		MVP-PY-006_081321 Condition of poly lined containment 2021-08-13 07:37:11-04:00			
GPS Location	MVP-PY-006 See photo for gps data		GPS Location	MVP-PY-006 See photo for gps data	
Field Station#	+0		Field Station#	+0	
Pic 13 Desc.	Condition of containment under used oil containers. Free of fluids. Looking NE.		Pic 14 Desc.	Condition of poly lined rock berm containment. Free of fluids. Looking SE.	
DIRECTION E (M) +37.23440° -080.22804° ACCURACY 16 ft DATUM WGS84		DIRECTION E (M) +37.23554° -080.22869° ACCURACY 98 ft DATUM WGS84

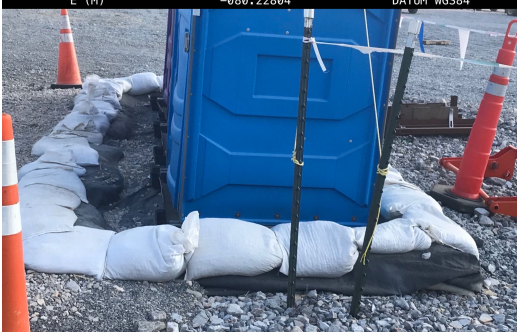
GPS Location	MVP-PY-006 See photo for gps data		GPS Location	MVP-PY-006 See photo for gps data	
Field Station#	+0		Field Station#	+0	
Pic 15 Desc.	Condition of trays and containment under toilets. Looking N.		Pic 16 Desc.	Condition of containment under light plant. Free of fluids. Looking E.	
DIRECTION E (M) +37.23570° -080.22862° ACCURACY 16 ft DATUM WGS84		DIRECTION NW (M) +37.23572° -080.22753° ACCURACY 213 ft DATUM WGS84

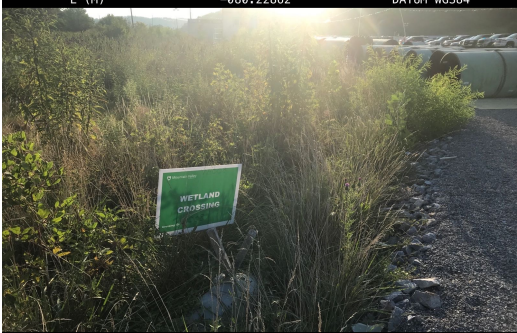
MVP-PY-006_081321 Condition of signage & CFS at feature 2021-08-13 07:45:49-04:00		MVP-PY-006_081321 Condition of posted project documents 2021-08-13 07:50:30-04:00			
GPS Location	MVP-PY-006 See photo for gps data		GPS Location	MVP-PY-006 See photo for gps data	
Field Station#	+0		Field Station#	+0	
Pic 17 Desc.	Condition of triple stack compost filter sock and signage at feature W-008. Over grown with vegetation. Looking E.		Pic 18 Desc.	Condition of posted project documents at main entrance. Looking NW. Looking NW.

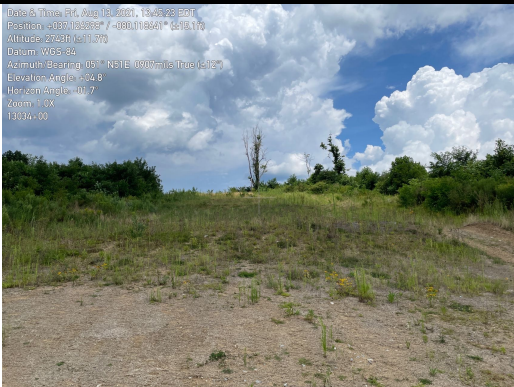
GPS Location	0	GPS Location	0		
Field Station#	13034+00	Field Station#	13033+59		
Pic 3 Desc.	ROW and ECD in good condition, with vegetation established across ROW		Pic 4 Desc.	RCE in good condition and functioning properly	
<p>Date & Time: Fri Aug 13, 2021 13:23:03 EDT Position: +037123241 / +080111519 (+11.6ft) Altitude: 2631ft (+9.8ft) Datum: WGS-84 Azimuth/Bearing: 110° S70E 195mils True (±12°) Elevation Angle: -11.7° Horizon Angle: -00.8° Zoom: 1.0x 13161+89 S-G26</p>

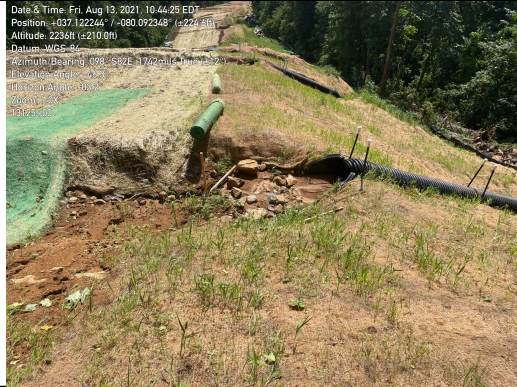
GPS Location 0		GPS Location 0	
Field Station# 13125+00		Field Station# 13126+50	
Pic 11 Desc. Slope drain pipe inlet needs cleaned out - 72hr maintenance item		Pic 12 Desc. ROW and ECD in good condition, ROW is stable

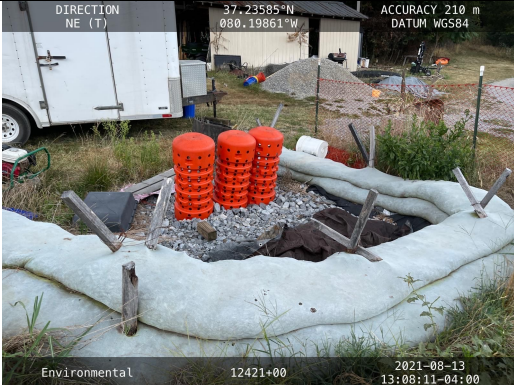
<p>DIRECTION NE (T) 37.23585°N 080.19861°W ACCURACY 210 m DATUM WGS84</p> <p>Environmental 12421+00 2021-08-13 13:08:11-04:00</p>

<p>DIRECTION NE (T) 37.23995°N 080.19939°W ACCURACY 5 m DATUM WGS84</p> <p>Environmental 12408+80 2021-08-13 12:53:02-04:00</p>			
GPS Location	See photo		GPS Location	See photo	
Field Station#	12421+00		Field Station#	12408+80	
Pic 1 Desc.	Clean water crossing inlet in acceptable condition		Pic 2 Desc.	Clean water crossing inlet in acceptable condition

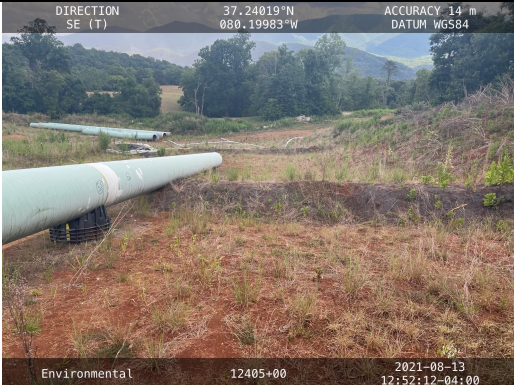
<p>DIRECTION SE (T) 37.24019°N 080.19983°W ACCURACY 14 m DATUM WGS84</p> <p>Environmental 12405+00 2021-08-13 12:52:12-04:00</p>

Pic 3 Desc.	Stabilized ROW In Acceptable condition		Pic 4 Desc.	Stabilized ROW in acceptable condition

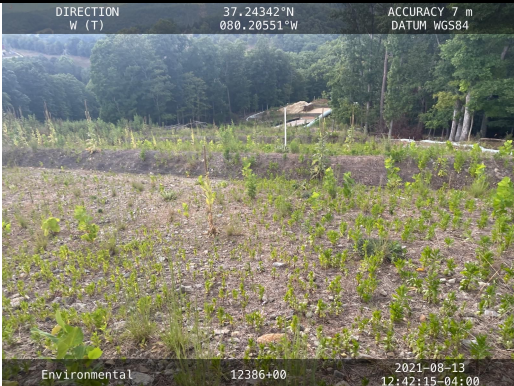
<p>DIRECTION W (T) 37.24342°N 080.20551°W ACCURACY 7 m DATUM WGS84</p> <p>Environmental 12386+00 2021-08-13 12:42:15-04:00</p>

<p>DIRECTION SE (T) 37.24383°N 080.20652°W ACCURACY 5 m DATUM WGS84</p> <p>Environmental 12383+93 2021-08-13 12:34:03-04:00</p>			
GPS Location	See photo		GPS Location	see photo	
Field Station#	12386+00		Field Station#	12383+93	
Pic 5 Desc.	Stabilized ROW In Acceptable condition		Pic 6 Desc.	Clean water crossing in acceptable condition

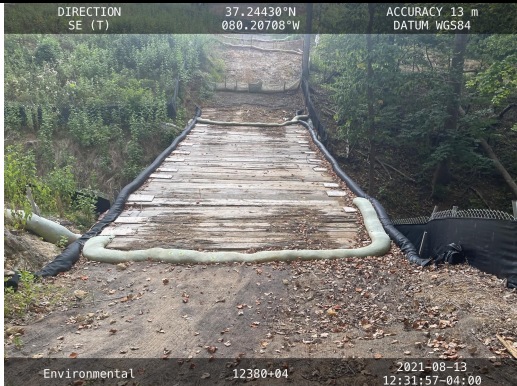
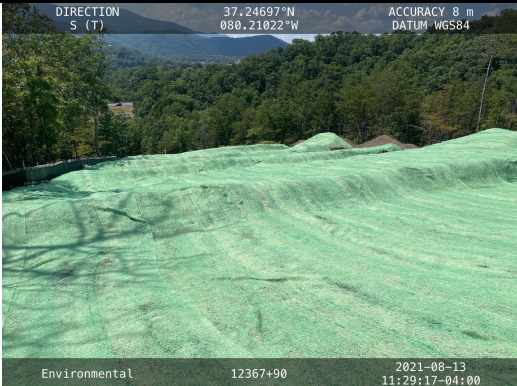
GPS Location	See photo		GPS Location	See photo	
Field Station#	12380+04		Field Station#	12367+90	
Pic 9 Desc.	Bridge and ECDs crossing stream S-NN19 in acceptable condition		Pic 10 Desc.	Stabilized ROW in acceptable condition
