Visual Site Inspection Report

Project Name	H-600 Pipeline Spread H	AFE	124300138	Spread	H-600 Pipeline Spread H
Contractor	Precision			Report #	26948
Inspector	Pat Davis			Date/Time	8/9/2021 5:30 PM
Permit #	TBD	Inspection Type	VA SWPP	Station Begin	+0
State	VA	Inspection Area	Partial	Station End	+0
County	Roanoke	Ground	Dry	Temperature (°F)	93.00
Municipality	N/A	Weather	Sunny	Rain Gauge (in)	0.00
				Rain Accumulation Time (days)	0.00

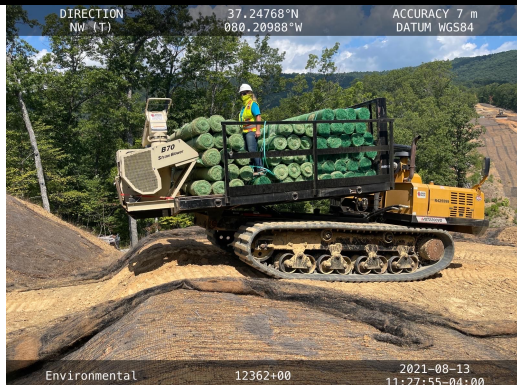
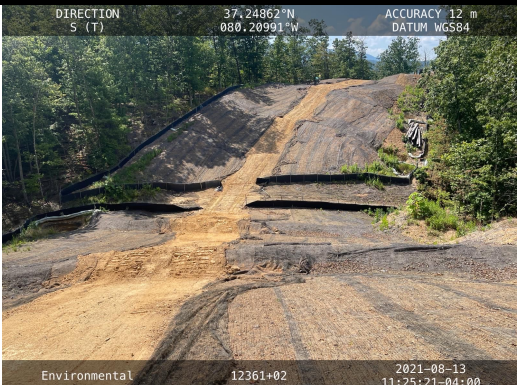
GPS Location	See photo		GPS Location	See photo	
Field Station#	12362+00		Field Station#	12361+02	
Pic 11 Desc.	Marooka carrying curlex for stabilization as the crew works their way out performing maintenance.		Pic 12 Desc.	ROW conditions where crews have been traveling

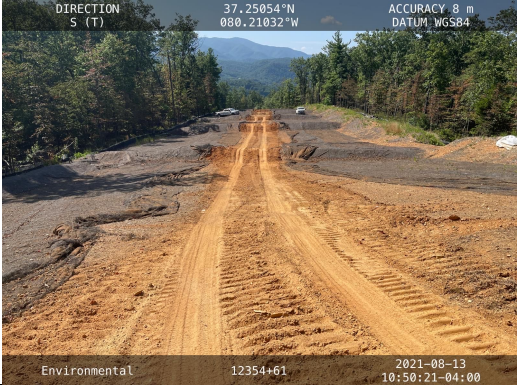
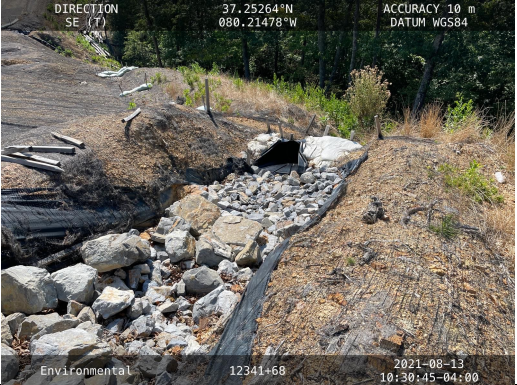
GPS Location	See photo		GPS Location	See photo	
Field Station#	12354+61		Field Station#	12341+68	
Pic 13 Desc.	ROW conditions where crews have been traveling		Pic 14 Desc.	Fill slope drain inlet in acceptable condition

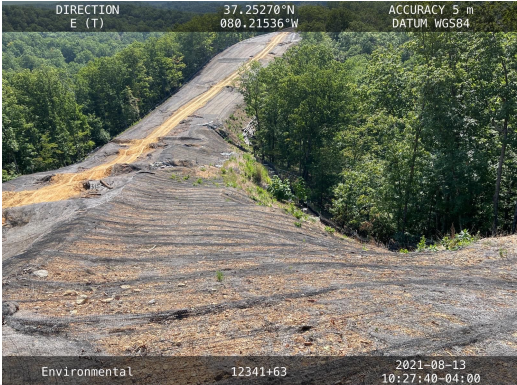
GPS Location	See photo		GPS Location	See photo	
Field Station#	12341+63		Field Station#	12325+00	
Pic 15 Desc.	Stabilized fill slope in acceptable condition		Pic 16 Desc.	Water bar end treatment and sump in acceptable condition
