# Visual Site Inspection Report

<b>Project Name</b>	H-600 Pipeline Spread H	<b>AFE</b>	124300138	<b>Spread</b>	H-600 Pipeline Spread H
<b>Contractor</b>	Precision			<b>Report #</b>	27308
<b>Inspector</b>	Norm Kitchen			<b>Date/Time</b>	8/16/2021 6:00 PM
<b>Permit #</b>	TBD	<b>Inspection Type</b>	VA SWPP	<b>Station Begin</b>	12443+75
<b>State</b>	VA	<b>Inspection Area</b>	Partial	<b>Station End</b>	12544+06
<b>County</b>	Montgomery	<b>Ground</b>	Wet	<b>Temperature (°F)</b>	80.00
<b>Municipality</b>	N/A	<b>Weather</b>	Light Rain	<b>Rain Gauge (in)</b>	0.90
				<b>Rain Accumulation Time (days)</b>	1.00

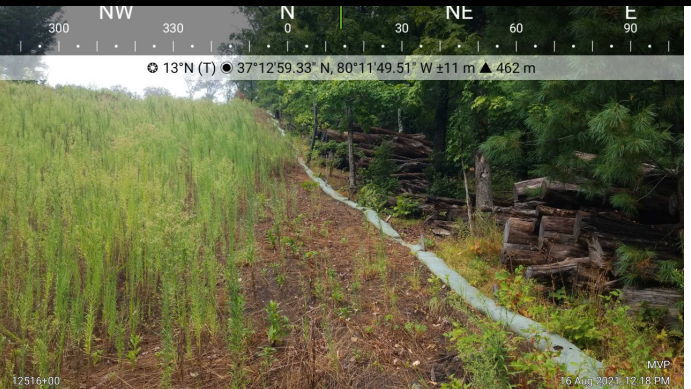
GPS Location	See Above		GPS Location	See Above	
Field Station#	12504+00		Field Station#	12516+00	
Pic 13 Desc.	ROW Overview. ECDs are functional and ROW is stable.		Pic 14 Desc.	ROW Overview. ECDs are functional and ROW is stable.

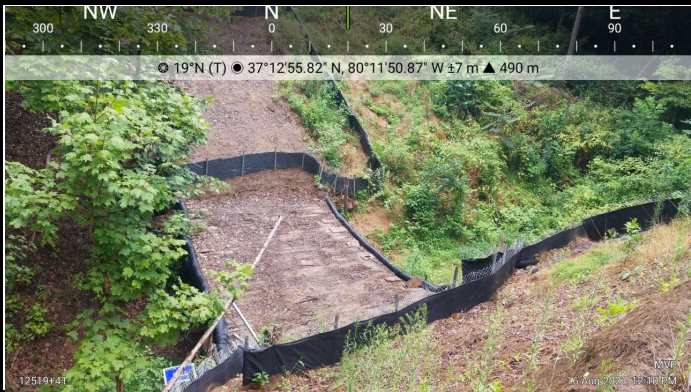
GPS Location	See Above		GPS Location	See Above	
Field Station#	12519+41		Field Station#	12530+00	
Pic 15 Desc.	Overview of Waterbody S-EF19. ECDs are functional and ROW is stable.		Pic 16 Desc.	ROW Overview. Plastic covering spoil pile in acceptable condition.

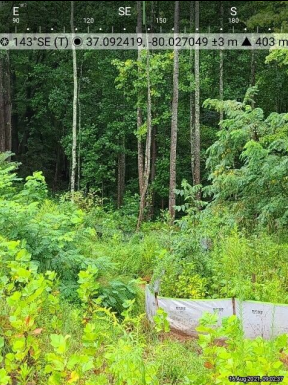
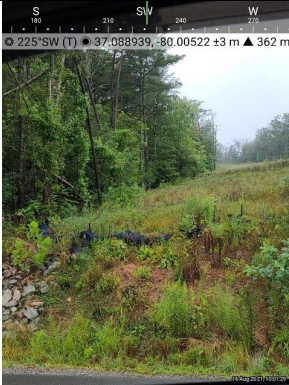
<b>GPS Location</b>	0000	<b>GPS Location</b>	0000		
<b>Field Station#</b>	13416+00	<b>Field Station#</b>	13496+62		
<b>Pic 1 Desc.</b>	Monitored row perimeter ECDs during rain events today. No issues observed at the time of inspection.		<b>Pic 2 Desc.</b>	Row photo showing vegetation, photo taken during rain events today. All ECDs functioning properly.

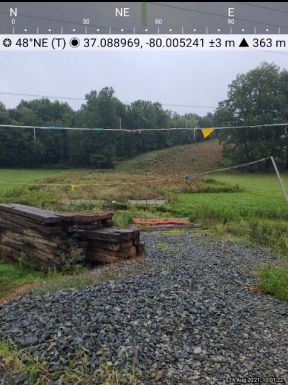
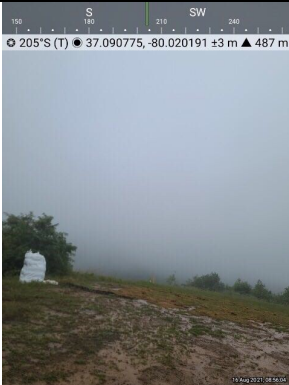
<b>GPS Location</b>	0000	<b>GPS Location</b>	0000		
<b>Field Station#</b>	13497+30	<b>Field Station#</b>	13437+74		
<b>Pic 3 Desc.</b>	Monitored RCEs and stream crossings during rain events today. No environmental issues observed at the time of inspection.		<b>Pic 4 Desc.</b>	Saturated row photo taken during rain events today .

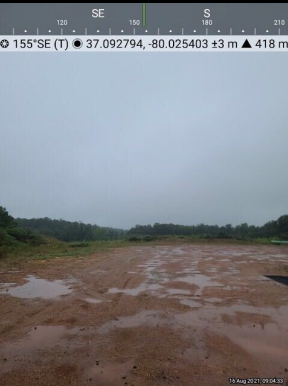
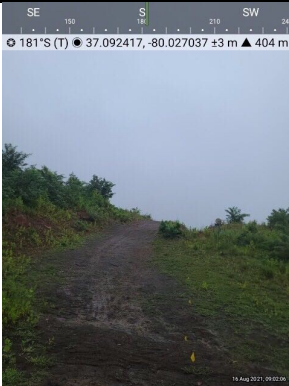
<b>Pic 5 Desc.</b>	Saturated row photo at large work space. No environmental issues observed at the time of inspection.		<b>Pic 6 Desc.</b>	Saturated row photo showing Erosion control blanket on hill side.. no issues observed at the time of inspection during rain events today.

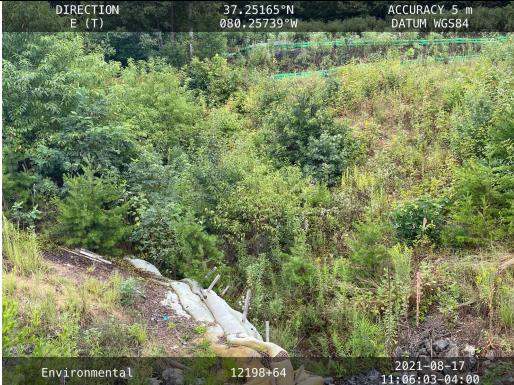
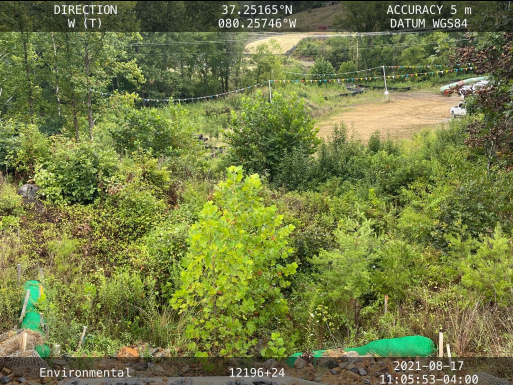
<b>GPS Location</b>	See photo		<b>GPS Location</b>	see photo	
<b>Field Station#</b>	12198+64		<b>Field Station#</b>	12196+24	
<b>Pic 1 Desc.</b>	S-OO11 on the East side of the railroad/road construction in acceptable condition		<b>Pic 2 Desc.</b>	S-OO11 on the West side of the railroad/road construction in acceptable condition

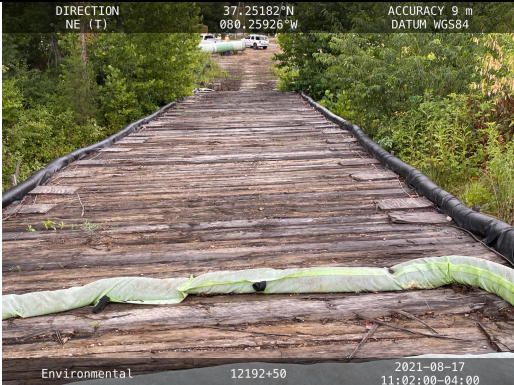
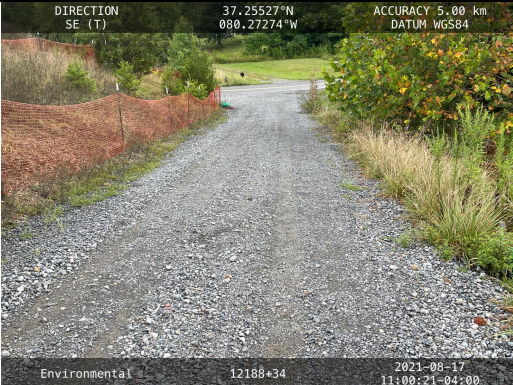
<b>GPS Location</b>	See photo		<b>GPS Location</b>	See photo	
<b>Field Station#</b>	12192+50		<b>Field Station#</b>	12188+34	
<b>Pic 3 Desc.</b>	S-C21 in acceptable condition		<b>Pic 4 Desc.</b>	Access Road MVP-MN-274 in acceptable condition

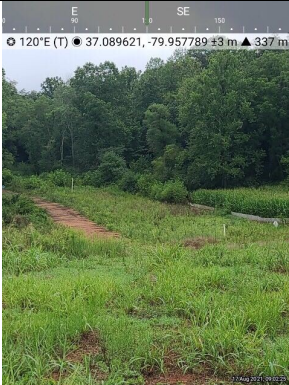
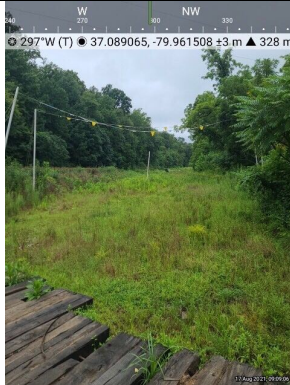
<b>GPS Location</b>	00000	<b>GPS Location</b>	0000		
<b>Field Station#</b>	13655+65	<b>Field Station#</b>	13643+40		
<b>Pic 1 Desc.</b>	Vegetation observation photo showing vegetation growth during light rain events today.		<b>Pic 2 Desc.</b>	Vegetation observation photo taken during continued rain showers. No issues observed at the time of inspection.

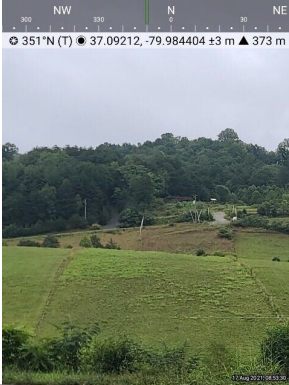
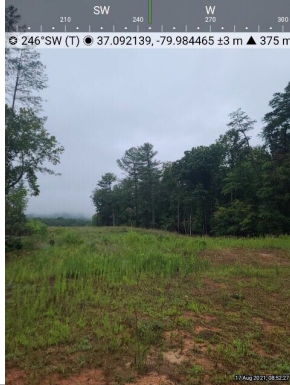
<b>GPS Location</b>	0000	<b>GPS Location</b>	0000		
<b>Field Station#</b>	13562+99	<b>Field Station#</b>	13541+30		
<b>Pic 3 Desc.</b>	Monitored vegetation growth during light rain events today.		<b>Pic 4 Desc.</b>	Row photo showing vegetation and saturated row conditions. No issues observed at the time of inspection.

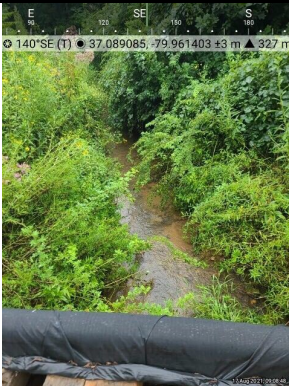
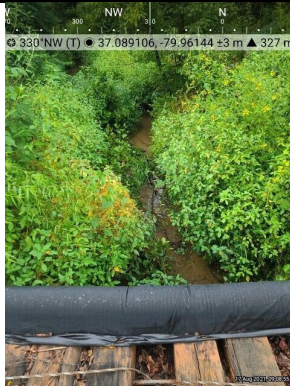
<b>Pic 5 Desc.</b>	Stream observation photo facing downstream during routine inspection today as rain showers continue. No issues observed at the time of inspection.		<b>Pic 6 Desc.</b>	Stream observation photo facing upstream during routine inspection today as rain events continue.

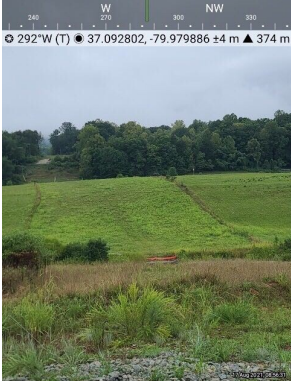
<p>Insert image here</p>		<p>Insert image here</p>	
<b>GPS Location</b>	00000	<b>GPS Location</b>			
<b>Field Station#</b>	13575+07	<b>Field Station#</b>			
<b>Pic 7 Desc.</b>	Monitored row conditions and ECDs at road crossings during continued rain showers. No issues observed at the time of inspection.		<b>Pic 8 Desc.</b>		
<p>Insert image here</p>		<p>Insert image here</p>			
<b>GPS Location</b>		<b>GPS Location</b>			
<b>Field Station#</b>		<b>Field Station#</b>			
<b>Pic 9 Desc.</b>		<b>Pic 10 Desc.</b>			
<p>Insert image here</p>		<p>Insert image here</p>			
<b>GPS Location</b>		<b>GPS Location</b>			
<b>Field Station#</b>		<b>Field Station#</b>			
<b>Pic 11 Desc.</b>		<b>Pic 12 Desc.</b>

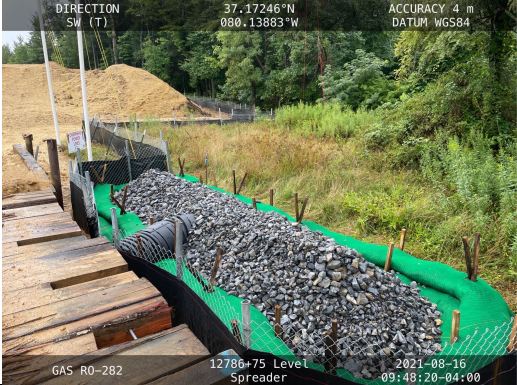
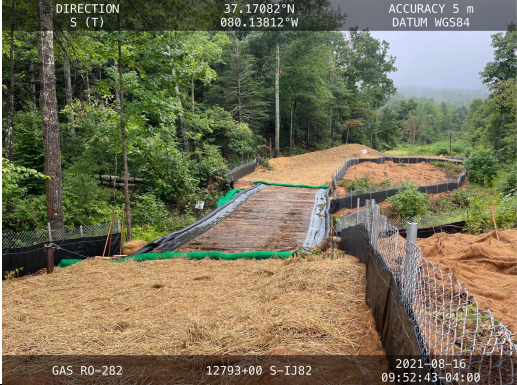
<b>GPS Location</b>	See photo		<b>GPS Location</b>	See photo	
<b>Field Station#</b>	12786+75		<b>Field Station#</b>	12793+00	
<b>Pic 7 Desc.</b>	Level spreader is functional		<b>Pic 8 Desc.</b>	Equipment Bridge over Stream S-IJ82 is maintained.

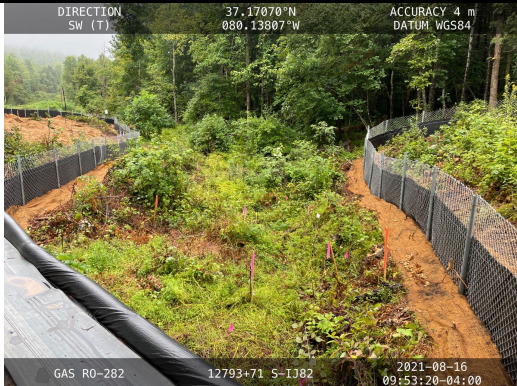
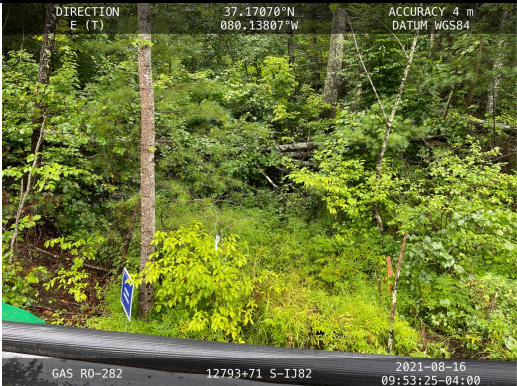
<b>GPS Location</b>	See photo		<b>GPS Location</b>	See photo	
<b>Field Station#</b>	12793+71		<b>Field Station#</b>	12793+71	
<b>Pic 9 Desc.</b>	Downstream at Stream S-IJ82		<b>Pic 10 Desc.</b>	Upstream at Stream S-IJ82

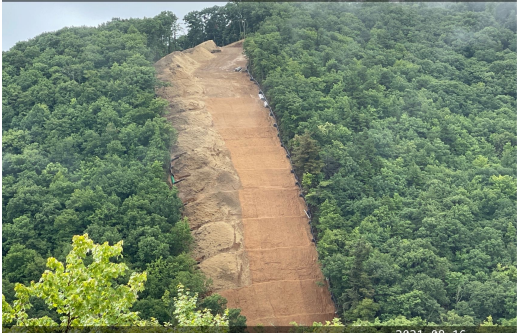
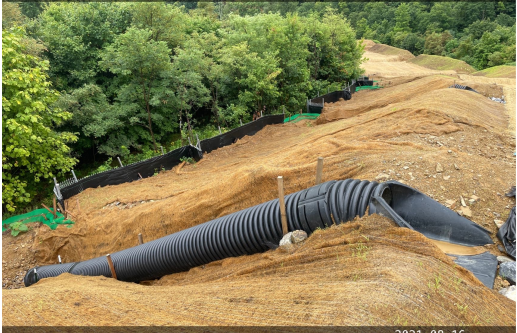
GAS R0-281 12735+00 Slope drain 2021-08-16 10:54:37-04:00			
<b>GPS Location</b>	See photo		<b>GPS Location</b>	See photo	
<b>Field Station#</b>	12746+00		<b>Field Station#</b>	12735+00	
<b>Pic 13 Desc.</b>	Steep Slope area adjacent to S-EF34B is stable.		<b>Pic 14 Desc.</b>	Slope drain is functional	
DIRECTION E (T) 37.19285°N 080.17370°W ACCURACY 5 m DATUM WGS84

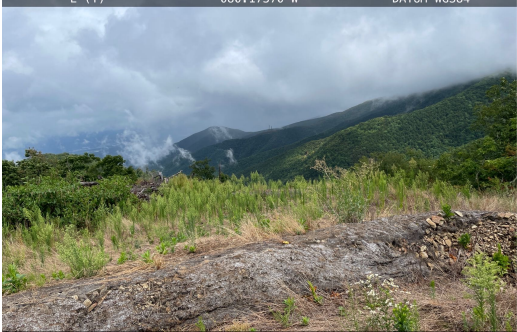
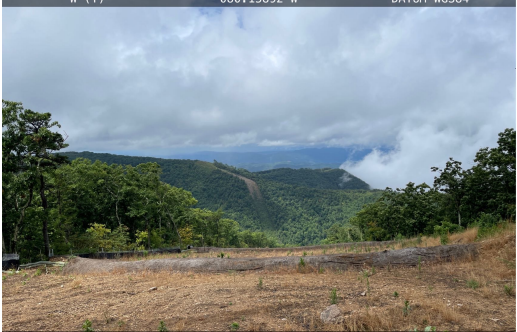
<b>Pic 15 Desc.</b>	Current ROW conditions. ROW is stable.		<b>Pic 16 Desc.</b>	Current ROW conditions. ROW is stable.	
DIRECTION E (T) +37.18762° -080.15116° ACCURACY 193 ft DATUM WGS84

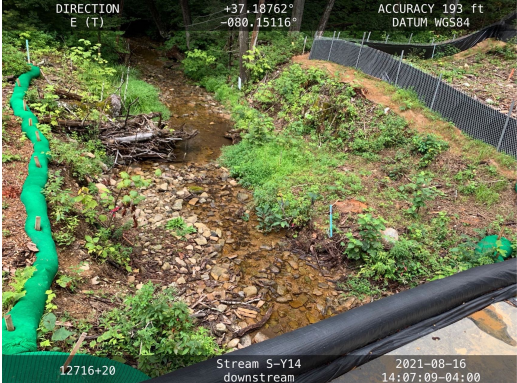
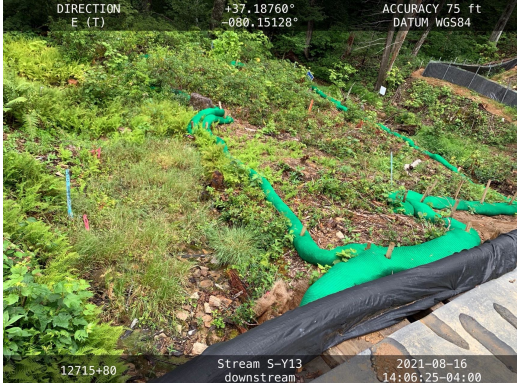
12715+80 Stream S-Y13 downstream 2021-08-16 14:06:25-04:00			
<b>GPS Location</b>	See photo		<b>GPS Location</b>	See photo	
<b>Field Station#</b>	12716+20		<b>Field Station#</b>	12715+80	
<b>Pic 17 Desc.</b>	Downstream of Stream S-Y14		<b>Pic 18 Desc.</b>	Downstream of Stream S-Y13

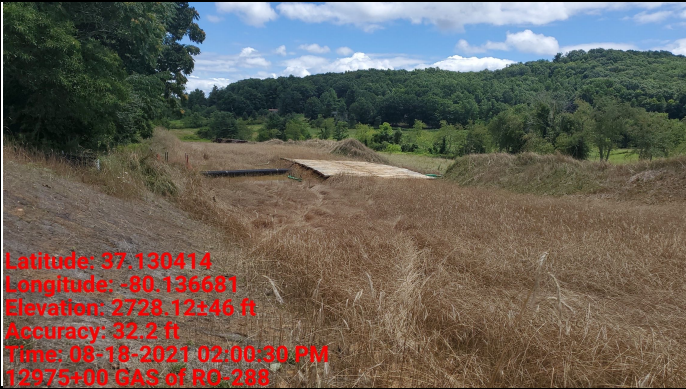
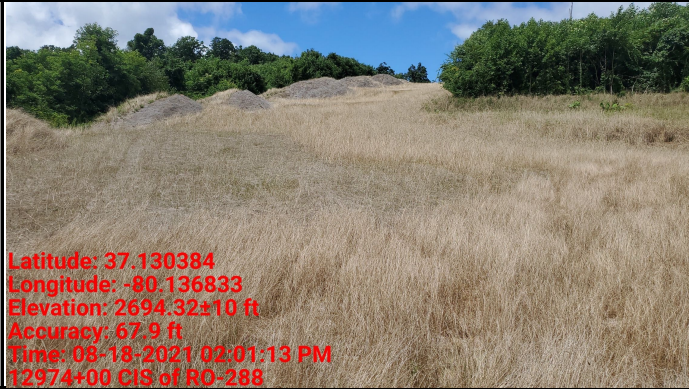
<p>Latitude: 37.130384 Longitude: -80.136833 Elevation: 2694.32±10 ft Accuracy: 67.9 ft Time: 08-18-2021 02:01:13 PM 12974+00 CIS of RO-288</p>		
GPS Location	See pic for GPS location		GPS Location	See pic for GPS location	
Field Station#	12975+00		Field Station#	12974+00	
Pic 13 Desc.	Current conditions of the GAS of RO-288.		Pic 14 Desc.	Current conditions of the CIS of RO-288.

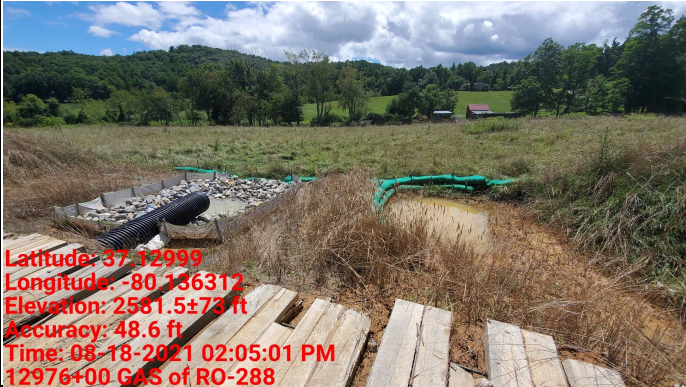
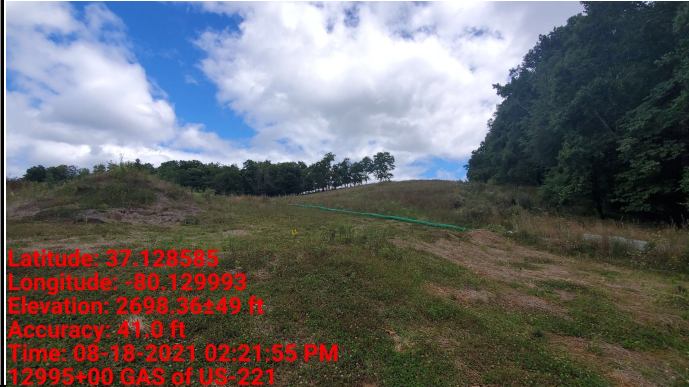
Field Station#	12976+00		Field Station#	12995+00	
Pic 15 Desc.	Plunge pool and sump on the GAS of RO-288.		Pic 16 Desc.	Current conditions of the GAS of US-221

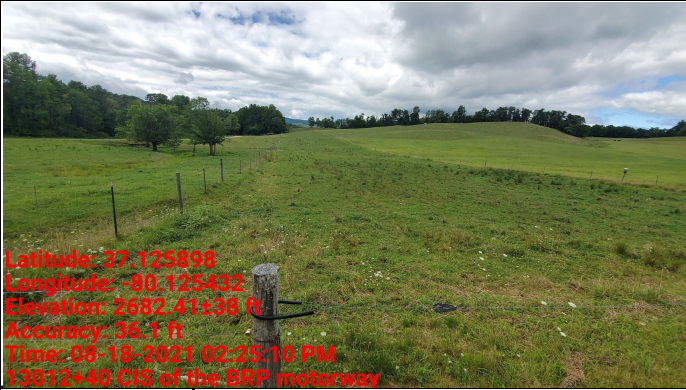
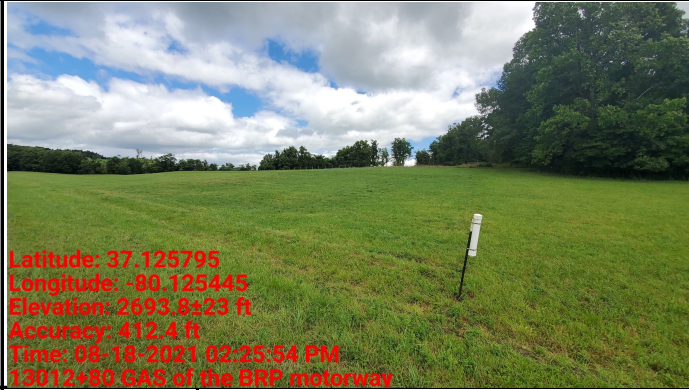
<p>Latitude: 37.125795 Longitude: -80.125445 Elevation: 2693.8±23 ft Accuracy: 412.4 ft Time: 08-18-2021 02:25:54 PM 13012+60 GAS of the BRP motorway</p>		
GPS Location	See pic for GPS location		GPS Location	See pic for GPS location	
Field Station#	13012+40		Field Station#	13012+40	
Pic 17 Desc.	Restored ROW on the CIS of the Blue Ridge Parkway.		Pic 18 Desc.	Restored ROW on the GAS of the Blue Ridge Parkway.

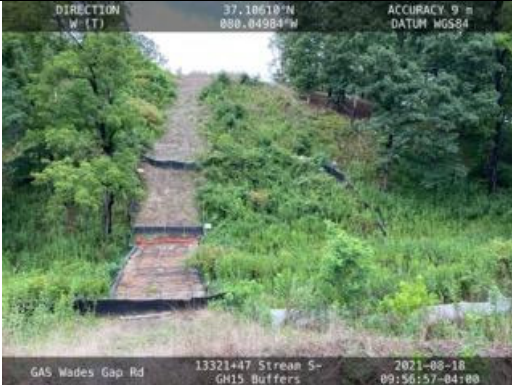
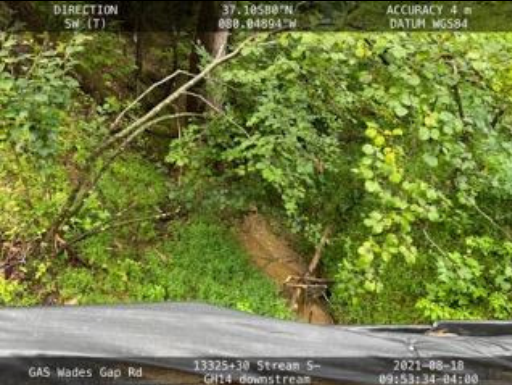
<b>GPS Location</b>	See Above		<b>GPS Location</b>	See Above	
<b>Field Station#</b>	13321+47		<b>Field Station#</b>	13325+30	
<b>Pic 1 Desc.</b>	Overview of Waterbody S-GH15. ECDs are functional and ROW is stable.		<b>Pic 2 Desc.</b>	Waterbody S-GH14. ECDs are functional and ROW is stable.

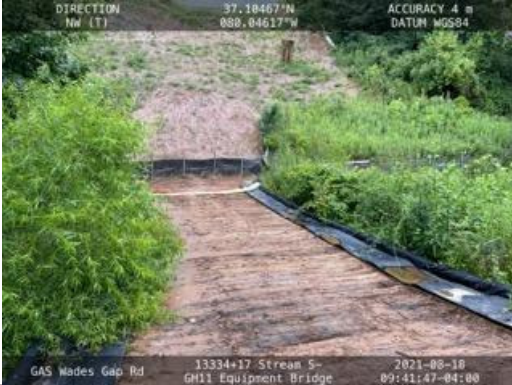
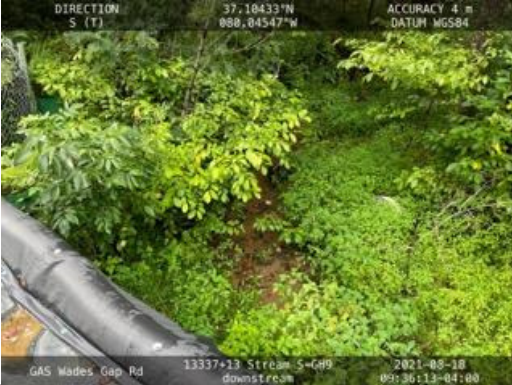
<b>GPS Location</b>	See Above		<b>GPS Location</b>	See Above	
<b>Field Station#</b>	13334+17		<b>Field Station#</b>	13337+13	
<b>Pic 3 Desc.</b>	Overview of Waterbody S-GH11. ECDs are functional and ROW is stable.		<b>Pic 4 Desc.</b>	Waterbody S-GH9. ECDs are functional and ROW is stable.

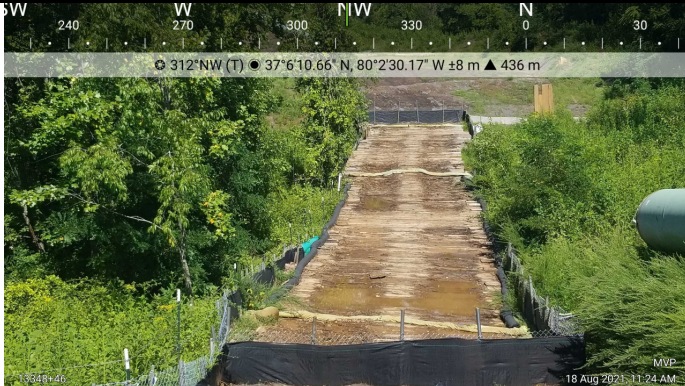
<b>GPS Location</b>	See Above		<b>GPS Location</b>	See Above	
<b>Field Station#</b>	13348+46		<b>Field Station#</b>	13352+23	
<b>Pic 5 Desc.</b>	Overview of Waterbody S-RR08. ECDs are functional and ROW is stable.		<b>Pic 6 Desc.</b>	Overview of Waterbody S-RR09. ECDs are functional and ROW is stable.

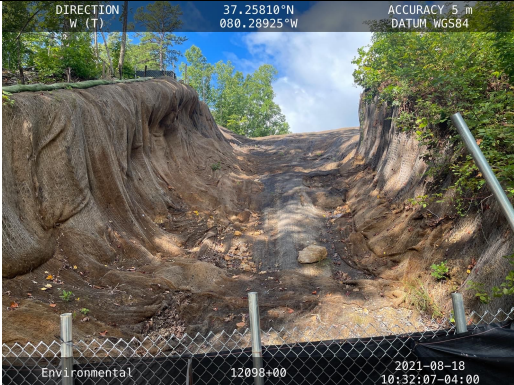
<b>GPS Location</b>	See photo		<b>GPS Location</b>	See photo	
<b>Field Station#</b>	12098+00		<b>Field Station#</b>	12098+44	
<b>Pic 1 Desc.</b>	Stabilized cut bank in acceptable condition		<b>Pic 2 Desc.</b>	Bridge and ECDs crossing stream S-MM13 in acceptable condition

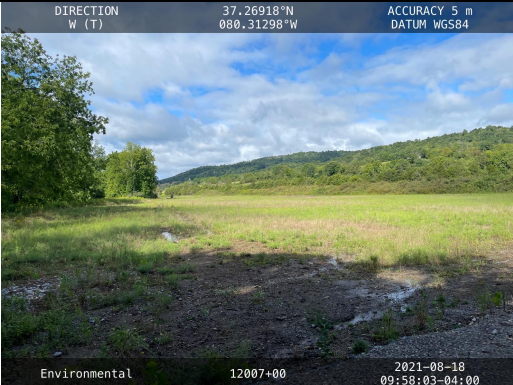
<b>GPS Location</b>	See photo		<b>GPS Location</b>	See photo	
<b>Field Station#</b>	12101+57		<b>Field Station#</b>	12007+00	
<b>Pic 3 Desc.</b>	Bridge and ECDs crossing stream S-MM11 in acceptable condition		<b>Pic 4 Desc.</b>	Stabilized ATWS in acceptable condition

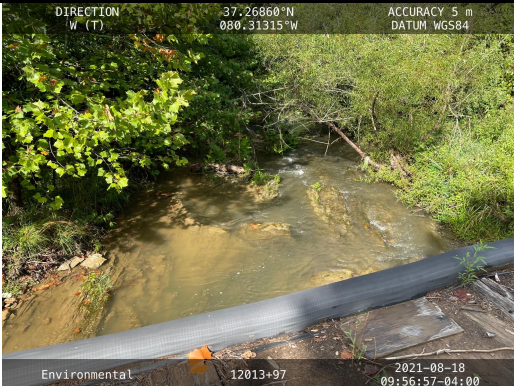
<b>GPS Location</b>	See photo		<b>GPS Location</b>	See photo	
<b>Field Station#</b>	12013+97		<b>Field Station#</b>	12013+97	
<b>Pic 5 Desc.</b>	Down stream of S-G36 in acceptable condition		<b>Pic 6 Desc.</b>	Bridge and ECDs crossing stream S-G36 in acceptable condition

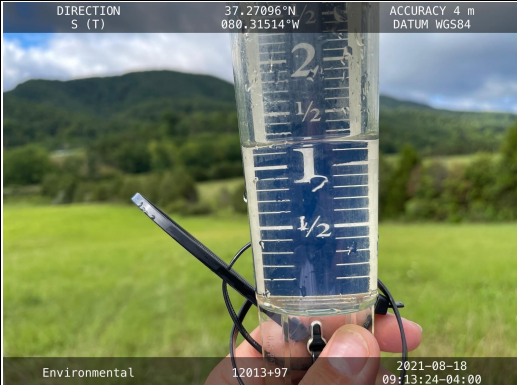
<b>GPS Location</b>	See photo		<b>GPS Location</b>	See photo	
<b>Field Station#</b>	12013+97		<b>Field Station#</b>	12102+75	
<b>Pic 17 Desc.</b>	Catawba rain gauge 1.2"		<b>Pic 18 Desc.</b>	Half acre of rock rain gauge 1"

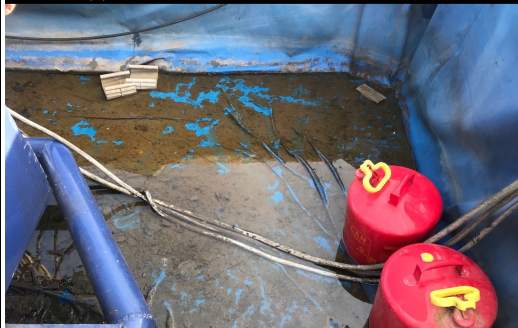
GPS Location	MVP-PY-006 See photo for gps data		GPS Location	MVP-PY-006 See photo for gps data	
Field Station#	+0		Field Station#	+0	
Pic 9 Desc.	Blue Bulk Fuel tanks containment holding stormwater. Looking N.		Pic 10 Desc.	Blue Bulk Fuel tanks no leaky internal fittings. Looking W.	
<div> <div> DIRECTION N (M) +37.23559° -080.22669° </div> <div> ACCURACY 33 ft DATUM WGS84 </div> </div>

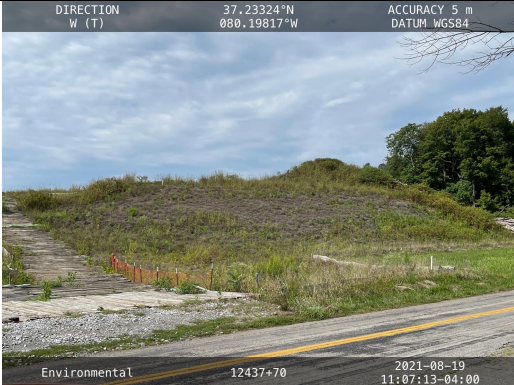
<b>GPS Location</b>	See photo		<b>GPS Location</b>	See photo	
<b>Field Station#</b>	12437+70		<b>Field Station#</b>	12435+50	
<b>Pic 1 Desc.</b>	Stabilized slope in acceptable condition		<b>Pic 2 Desc.</b>	Stream crossing S-NN16 in acceptable condition

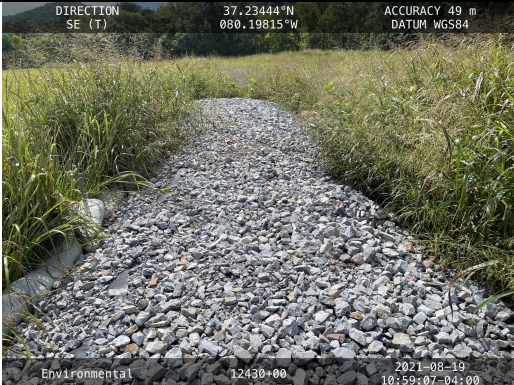
<b>GPS Location</b>	See photo		<b>GPS Location</b>	See photo	
<b>Field Station#</b>	12430+00		<b>Field Station#</b>	12426+00	
<b>Pic 3 Desc.</b>	Clean water crossing outlet rock level spreader.		<b>Pic 4 Desc.</b>	Stabilized ROW in acceptable condition

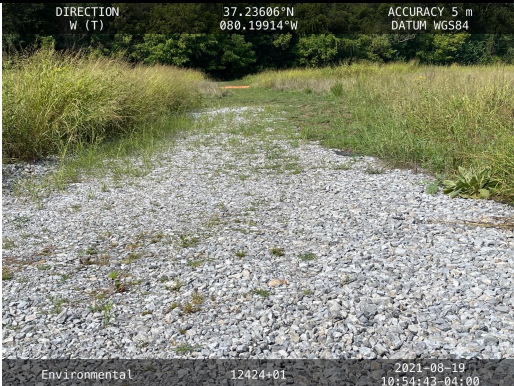
<b>GPS Location</b>	See photo		<b>GPS Location</b>	See photo	
<b>Field Station#</b>	12424+01		<b>Field Station#</b>	12424+01	
<b>Pic 5 Desc.</b>	RCE in acceptable condition		<b>Pic 6 Desc.</b>	Access Road MVP-MN-279 in acceptable condition

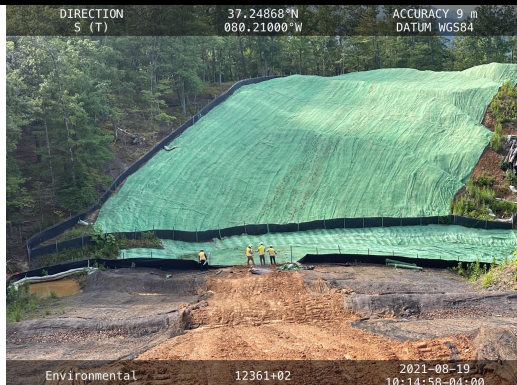
<b>GPS Location</b>	See photo		<b>GPS Location</b>	See photo	
<b>Field Station#</b>	12361+02		<b>Field Station#</b>	12354+61	
<b>Pic 11 Desc.</b>	Crew installing SSF as they work back up the slope with stabilization		<b>Pic 12 Desc.</b>	Excavator installing water bars across travel lane.

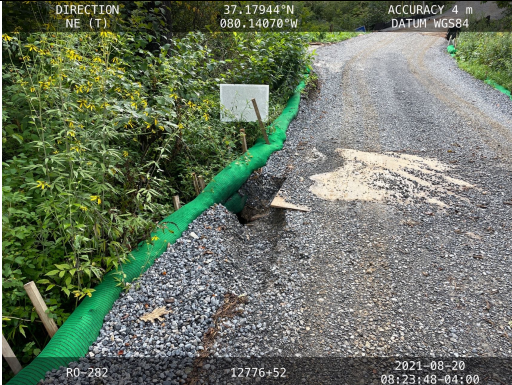
<b>GPS Location</b>	See photo		<b>GPS Location</b>	See photo	
<b>Field Station#</b>	12776+52		<b>Field Station#</b>	12776+53	
<b>Pic 1 Desc.</b>	Gravel has washed from RO-282 and into culvert to W-EF17		<b>Pic 2 Desc.</b>	Gravel has been deposited into Wetland W-EF17

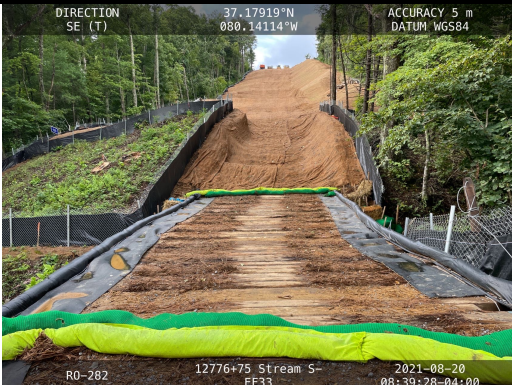
<b>GPS Location</b>	See photo		<b>GPS Location</b>	See photo	
<b>Field Station#</b>	12776+75		<b>Field Station#</b>	12776+75	
<b>Pic 3 Desc.</b>	Equipment Bridge over Stream S-EF33		<b>Pic 4 Desc.</b>	Downstream photo of S-EF33

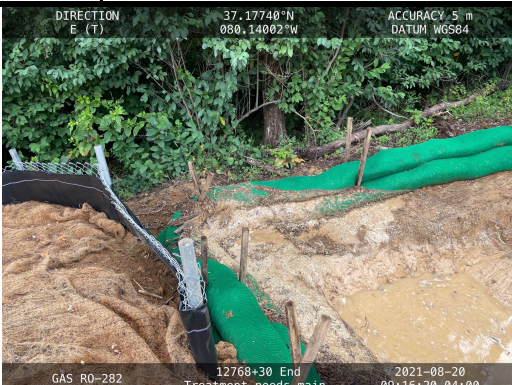
<b>GPS Location</b>	See photo		<b>GPS Location</b>	See photo	
<b>Field Station#</b>	12768+30		<b>Field Station#</b>	12768+30	
<b>Pic 5 Desc.</b>	End treatment has been overwhelmed		<b>Pic 6 Desc.</b>	Sediment off ROW. <5.0 Gallons approx 10' off ROW

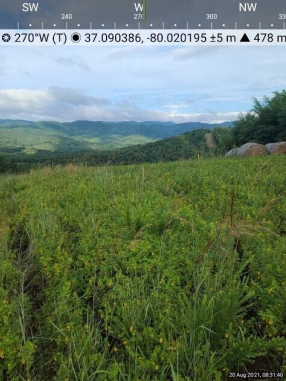
<b>GPS Location</b>	0000	<b>GPS Location</b>	0000		
<b>Field Station#</b>	13437+70	<b>Field Station#</b>	13415+60		
<b>Pic 1 Desc.</b>	Vegetation observation, good coverage noted in permanent area. No issues were observed at the time of inspection.		<b>Pic 2 Desc.</b>	Inspected ECDs at CAHAS#1 crossing. All up to date and functioning properly.

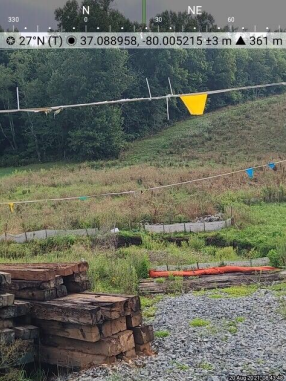
<b>GPS Location</b>	0000	<b>GPS Location</b>	0000		
<b>Field Station#</b>	13497+98	<b>Field Station#</b>	13497+17		
<b>Pic 3 Desc.</b>	After recent rain events throughout the last few days the EI , monitored stream crossings and ECDs , all functioning properly at the time of inspection.		<b>Pic 4 Desc.</b>	Monitored vegetation and ECDs in anode bed location at CAHAS#2 crossing. No environmental issues observed at the time of inspection. Good vegetation noted.

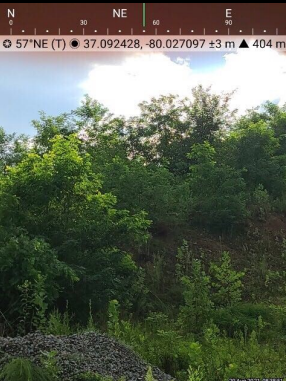
<b>GPS Location</b>	0000	<b>GPS Location</b>	0000		
<b>Field Station#</b>	13416+50	<b>Field Station#</b>	13417+00		
<b>Pic 5 Desc.</b>	Soil pile photo showing stabilization. No issues observed at the time of inspection.		<b>Pic 6 Desc.</b>	Monitored hot spot area after recent rain events. All ECDs functioning properly at the time of inspection.

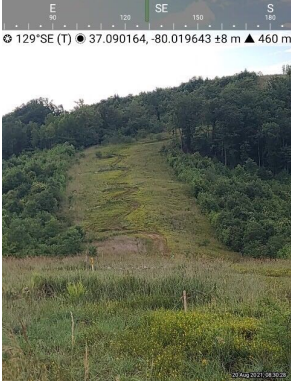
<p>Insert image here</p>		<p>Insert image here</p>	
<b>GPS Location</b>	0000	<b>GPS Location</b>			
<b>Field Station#</b>	13440+00	<b>Field Station#</b>			
<b>Pic 7 Desc.</b>	Row photo taken after rain event showing grass growth and stabilization throughout the row. No issues observed at the time of inspection.	<b>Pic 8 Desc.</b>			
<p>Insert image here</p>		<p>Insert image here</p>			
<b>GPS Location</b>		<b>GPS Location</b>			
<b>Field Station#</b>		<b>Field Station#</b>			
<b>Pic 9 Desc.</b>		<b>Pic 10 Desc.</b>			
<p>Insert image here</p>		<p>Insert image here</p>			
<b>GPS Location</b>		<b>GPS Location</b>			
<b>Field Station#</b>		<b>Field Station#</b>			
<b>Pic 11 Desc.</b>		<b>Pic 12 Desc.</b>

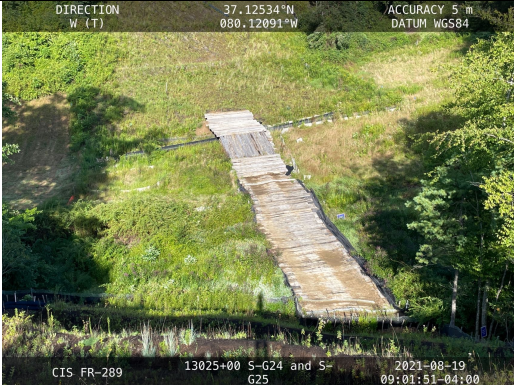
<b>GPS Location</b>	See photo		<b>GPS Location</b>	See photo	
<b>Field Station#</b>	13025+00		<b>Field Station#</b>	13040+00	
<b>Pic 1 Desc.</b>	Streams S-G24 and S-G25		<b>Pic 2 Desc.</b>	Current ROW conditions. ROW is stable.

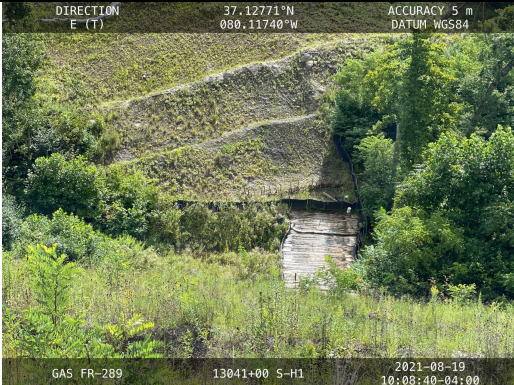
<b>GPS Location</b>	See photo		<b>GPS Location</b>	See photo	
<b>Field Station#</b>	13041+00		<b>Field Station#</b>	13061+00	
<b>Pic 3 Desc.</b>	Equipment Bridge over Stream S-H1		<b>Pic 4 Desc.</b>	Current ROW conditions. ROW is stable.

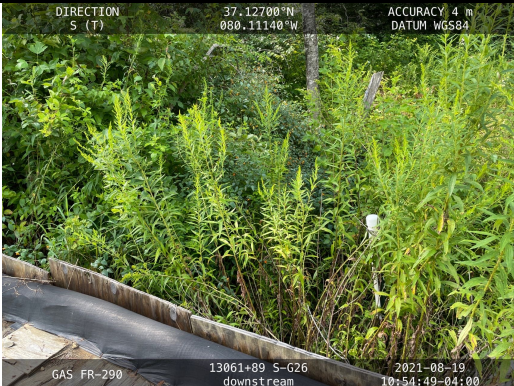
<b>GPS Location</b>	See photo		<b>GPS Location</b>	See photo	
<b>Field Station#</b>	13061+89		<b>Field Station#</b>	13061+89	
<b>Pic 5 Desc.</b>	Downstream photo of Stream S-G26		<b>Pic 6 Desc.</b>	Upstream photo of Stream S-G26

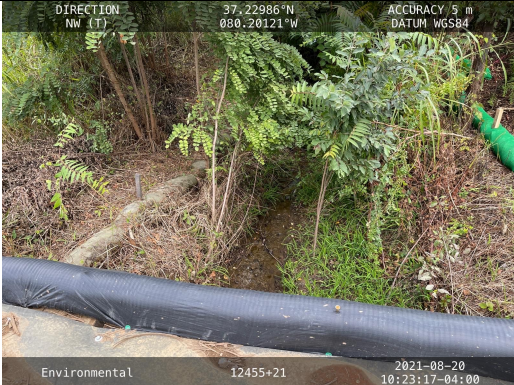
<b>GPS Location</b>	See photo		<b>GPS Location</b>	See photo	
<b>Field Station#</b>	12455+21		<b>Field Station#</b>	12461+81	
<b>Pic 1 Desc.</b>	Down stream of stream crossing S-CD12b in acceptable condition		<b>Pic 2 Desc.</b>	Wetland W-KL58 in acceptable condition

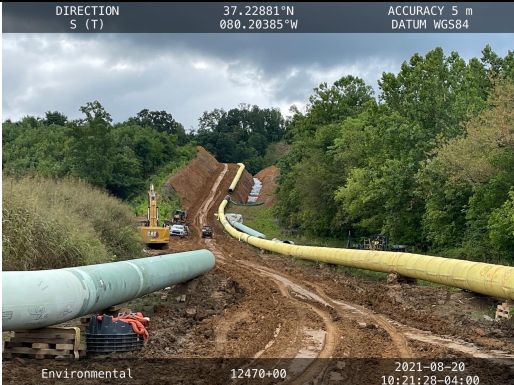
<b>GPS Location</b>	see photo		<b>GPS Location</b>	See photo	
<b>Field Station#</b>	12470+00		<b>Field Station#</b>	12482+67	
<b>Pic 3 Desc.</b>	Crew working in the area, all environmental controls in acceptable condition		<b>Pic 4 Desc.</b>	Access Road MVP-MLV-AR-28 in acceptable condition
