Visual Site Inspection Report

Project Name	H-600 Pipeline Spread H	AFE	124300138	Spread	H-600 Pipeline Spread H
Contractor	Precision			Report #	27607
Inspector	Bryan Cole			Date/Time	8/23/2021 7:19 PM
Permit #	TBD	Inspection Type	VA SWPP	Station Begin	13141+65
State	VA	Inspection Area	Partial	Station End	13316+21
County	Franklin	Ground	Dry	Temperature (°F)	90.00
Municipality	N/A	Weather	Sunny	Rain Gauge (in)	0.00
				Rain Accumulation Time (days)	0.00

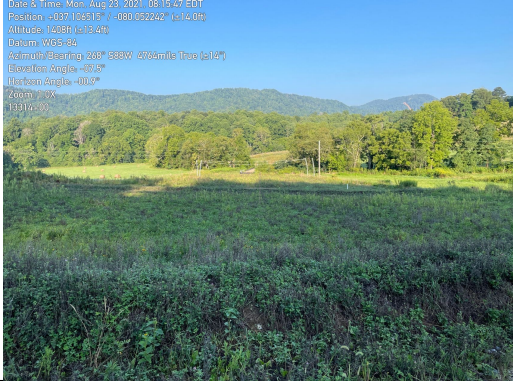
GPS Location		0		GPS Location	
Field Station#		13314+00		Field Station#	
Pic 1 Desc.		ROW and ECDs in good condition with vegetation established across ROW		Pic 2 Desc.	
				SSF support needs repaired - 72hr maintenance item	
<p>Date & Time: Mon, Aug 23, 2021, 08:33:01 EDT Position: +037104511 / -080059707 (±15.4m) Altitude: 13801 (±1.2m) Datum: WGS-84 Azimuth/Bearing: 262° N38° W Azimuth True (±14°) Elevation Angle: -00.6° Horizon Angle: -00.7° Zoom: 1.0X 13309+09 S-GH7</p>

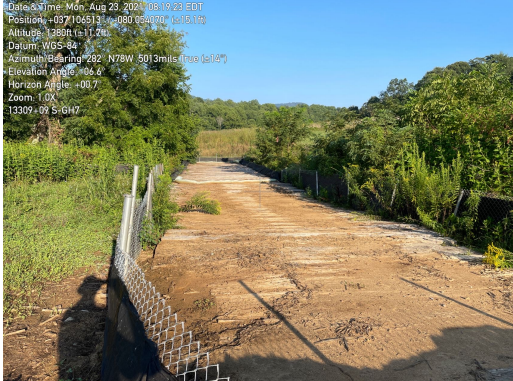
GPS Location		0		GPS Location	
Field Station#		13309+09		Field Station#	
Pic 3 Desc.		MVP-S-GH7 and Corresponding buffer zone in good condition		Pic 4 Desc.	
				Flanders Road Crossing in good condition	
<p>Date & Time: Mon, Aug 23, 2021, 08:38:02 EDT Position: +037115447 / -080059715 (±15.4m) Altitude: 14451 (±1.0m) Datum: WGS-84 Azimuth/Bearing: 263° S83° W Azimuth True (±14°) Elevation Angle: -10.4° Horizon Angle: -01.4° Zoom: 1.0X 13360+66 S-II4</p>

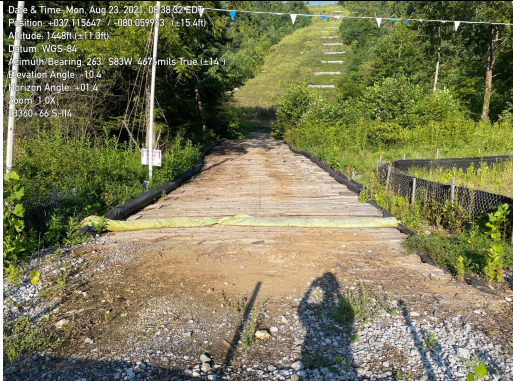
GPS Location		0		GPS Location	
Field Station#		13360+66		Field Station#	
Pic 5 Desc.		MVP-S-II4 and Corresponding buffer zone in good condition		Pic 6 Desc.	
				MVP-S-II4 Downstream and Corresponding buffer zone in good condition

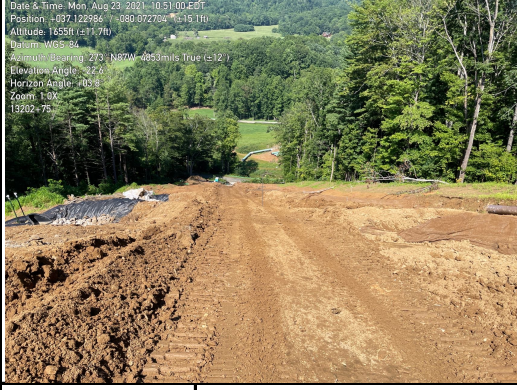
GPS Location 0		GPS Location 0			
Field Station# 13202+75		Field Station# 13302+75			
Pic 11 Desc. Slope drain pipe inlets in good condition		Pic 12 Desc. ROW and ECDs in good condition and stable, waterbars to be put back in prior to leaving for the day

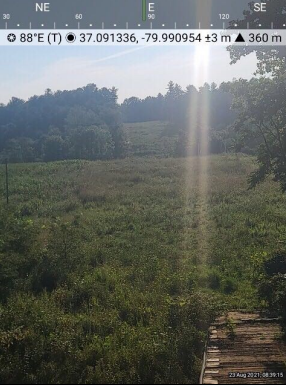
GPS Location	00000	GPS Location	00000		
Field Station#	13543+11	Field Station#	13539+14		
Pic 1 Desc.	Monitored vegetation growth and equipment bridges throughout. No issues observed at the time of inspection.		Pic 2 Desc.	Splash protection on S-II7 requires maintenance , documented and added to the punch list.

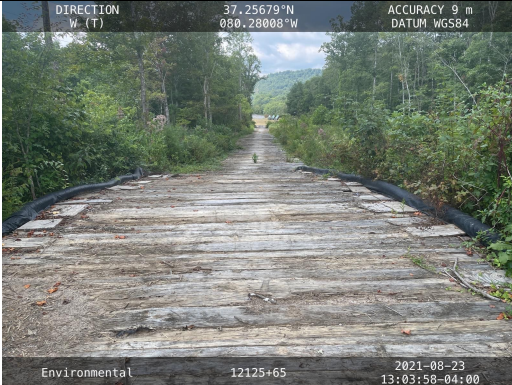
GPS Location	See photo		GPS Location	See photo	
Field Station#	12125+65		Field Station#	12132+73	
Pic 1 Desc.	Bridge and timber mat road in acceptable condition		Pic 2 Desc.	Bridge and ECDs at stream crossing S-C29 in acceptable condition

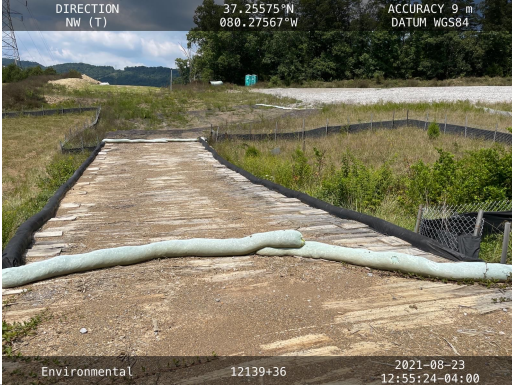
GPS Location	See photo		GPS Location	See photo	
Field Station#	12139+36		Field Station#	12144+47	
Pic 3 Desc.	Wetland crossing W-C6 in acceptable condition		Pic 4 Desc.	Wetland crossing W-C5 in acceptable condition

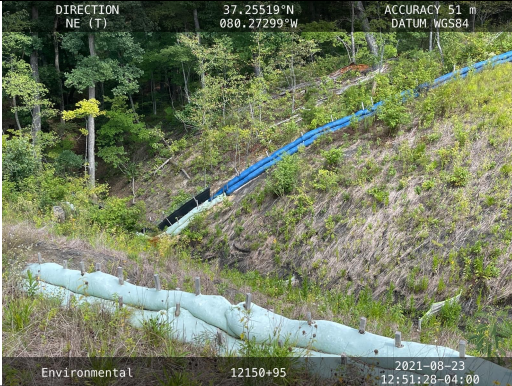
GPS Location	See photo		GPS Location	See photo	
Field Station#	12150+95		Field Station#	12163+05	
Pic 5 Desc.	Stabilized drain in acceptable condition		Pic 6 Desc.	Bridge and ECDs at stream crossing S-C25 in acceptable condition

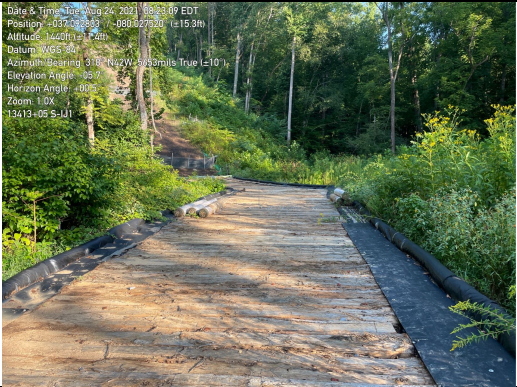
GPS Location	0	GPS Location	0		
Field Station#	13352+23	Field Station#	13413+05		
Pic 13 Desc.	MVP-S-RR09 and Corresponding buffer zone in good condition		Pic 14 Desc.	MVP-S-IJ1 and Corresponding buffer zone in good condition

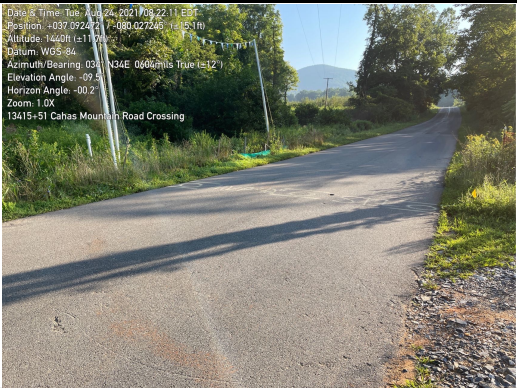
GPS Location	0	GPS Location	0		
Field Station#	13413+05	Field Station#	13415+51		
Pic 15 Desc.	MVP-S-IJ1 Downstream and Corresponding buffer zone in good condition		Pic 16 Desc.	Cahas Mountain Road Crossing in good condition

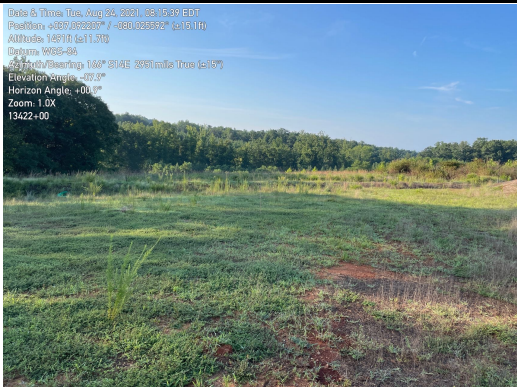
GPS Location	0	GPS Location	0		
Field Station#	13417+50	Field Station#	13422+00		
Pic 17 Desc.	ROW and ECDs in good condition and stable		Pic 18 Desc.	ROW and ECDs in good condition with vegetation established across ROW

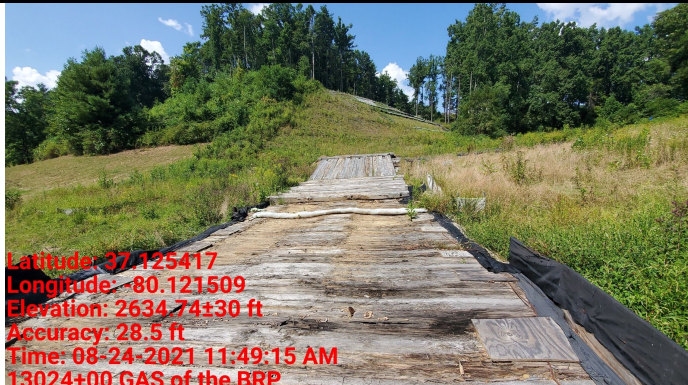
<p>Latitude: 37.125417 Longitude: -80.121509 Elevation: 2634.74±30 ft Accuracy: 28.5 ft Time: 08-24-2021 11:49:15 AM 13024+00 GAS of the BRP</p>

<p>Latitude: 37.125409 Longitude: -80.121727 Elevation: 2539.7±25 ft Accuracy: 20.3 ft Time: 08-24-2021 11:50:59 AM 13023+00 GAS of the BRP CWDP</p>		
GPS Location	See pic for GPS location		GPS Location	See pic for GPS location	
Field Station#	13024+00		Field Station#	13023+00	
Pic 1 Desc.	Current ROW conditions on the CIS of stream S-G24.		Pic 2 Desc.	CWDB and CWDP on the GAS of the BRP property.

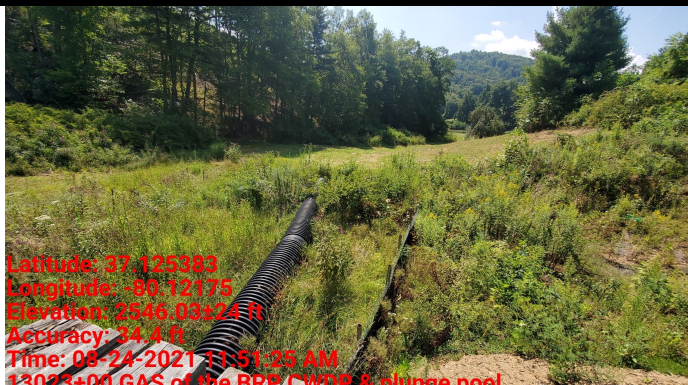
<p>Latitude: 37.125383 Longitude: -80.12175 Elevation: 2546.03±24 ft Accuracy: 24.4 ft Time: 08-24-2021 11:51:25 AM 13023+00 GAS of the BRP CWDP & plunge pool</p>

GPS Location	See pic for GPS location		GPS Location	See pic for GPS location	
Field Station#	13023+00		Field Station#	13017+00	
Pic 3 Desc.	CWDP and plunge pool on the GAS of the BRP property.		Pic 4 Desc.	Current ROW conditions on the GAS of the BRP motorway before the wooded portion.

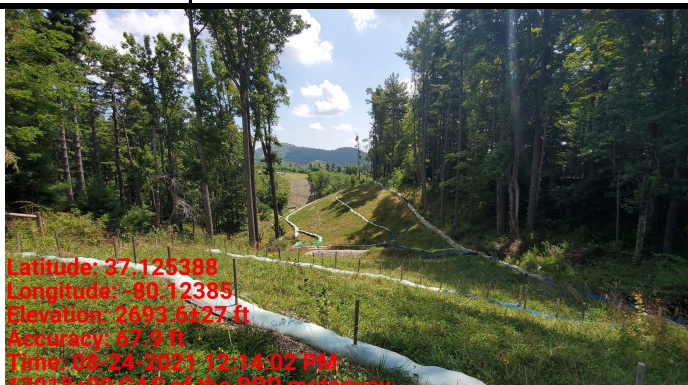
<p>Latitude: 37.125388 Longitude: -80.12385 Elevation: 2693.6±27 ft Accuracy: 67.9 ft Time: 08-24-2021 12:14:02 PM 13018+00 GAS of the BRP motorway</p>

<p>Latitude: 37.125934 Longitude: -80.125404 Elevation: 2639.17±19 ft Accuracy: 14.8 ft Time: 08-24-2021 12:52:17 PM 13012+40 CIS of the BRP motorway</p>		
GPS Location	See pic for GPS location		GPS Location	See pic for GPS location	
Field Station#	13018+00		Field Station#	13012+40	
Pic 5 Desc.	Wooded portion of the BRP on the GAS of the motorway.		Pic 6 Desc.	Current conditions of the ROW on the CIS of BRP motorway.

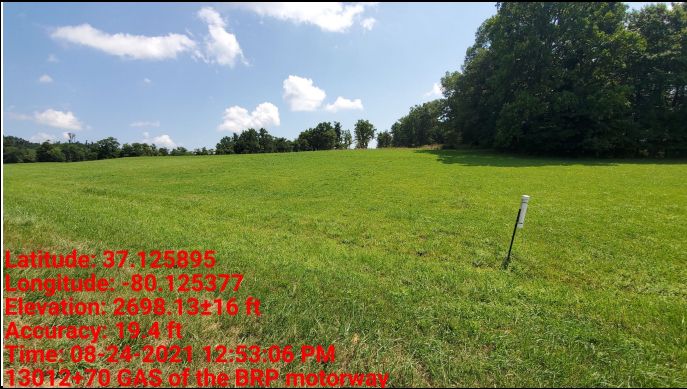
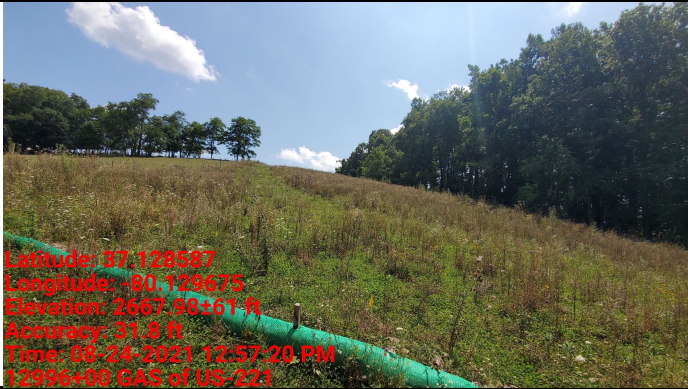
GPS Location	See pic for GPS location		GPS Location	See pic for GPS location	
Field Station#	13012+70		Field Station#	12996+00	
Pic 7 Desc.	Current conditions of the ROW on the GAS of BRP motorway.		Pic 8 Desc.	Restored portion of the ROW on the GAS of US-221.

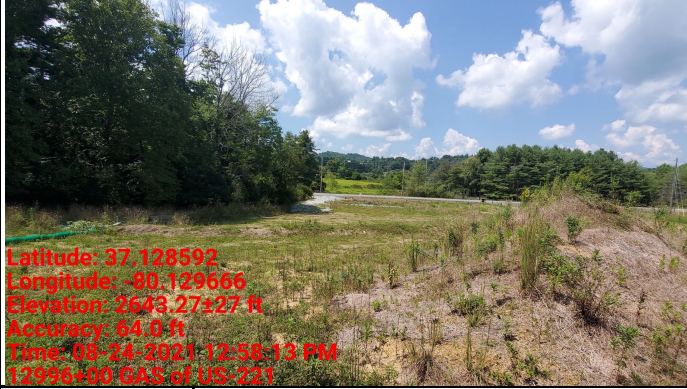
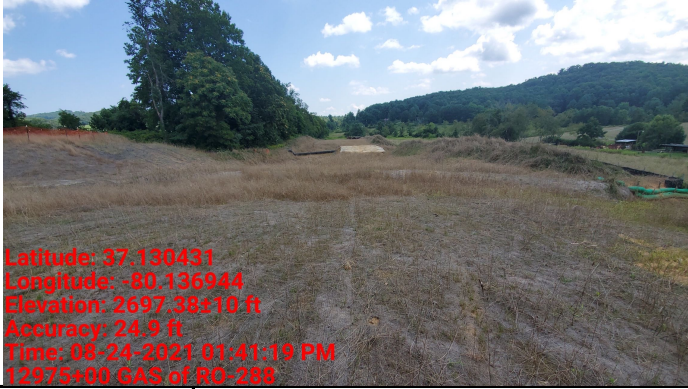
GPS Location	See pic for GPS location		GPS Location	See pic for GPS location	
Field Station#	12996+00		Field Station#	12975+00	
Pic 9 Desc.	Temporary stabilization on the GAS of US-221.		Pic 10 Desc.	Current ROW conditions on the GAS of RO-288.

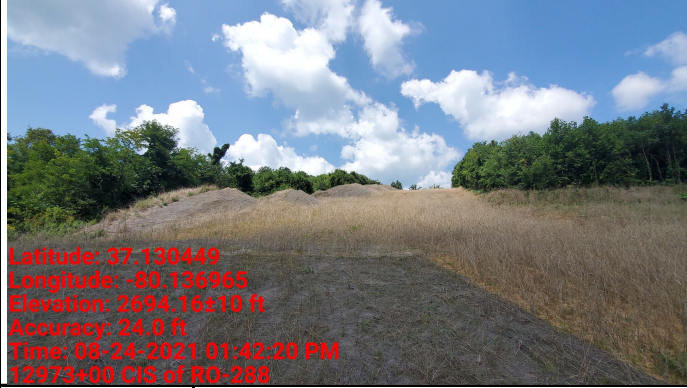
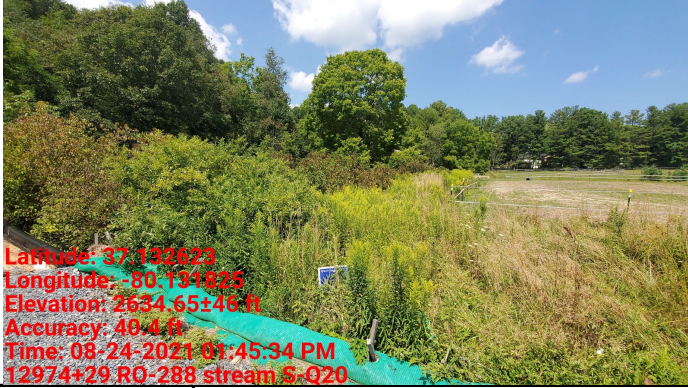
GPS Location	See pic for GPS location		GPS Location	See pic for GPS location	
Field Station#	12973+00		Field Station#	12974+29	
Pic 11 Desc.	Current ROW conditions on the CIS of RO-288.		Pic 12 Desc.	Stream crossing on the access road RO-288.

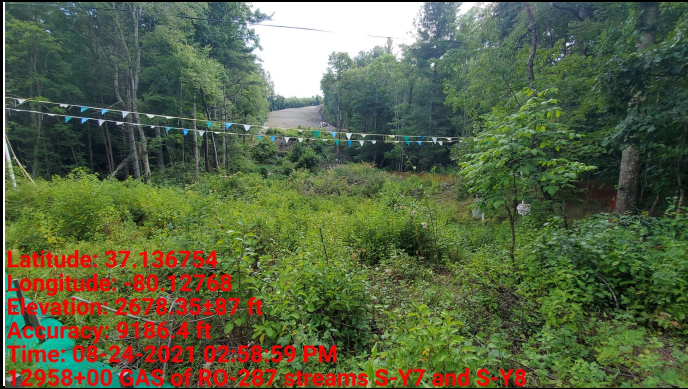
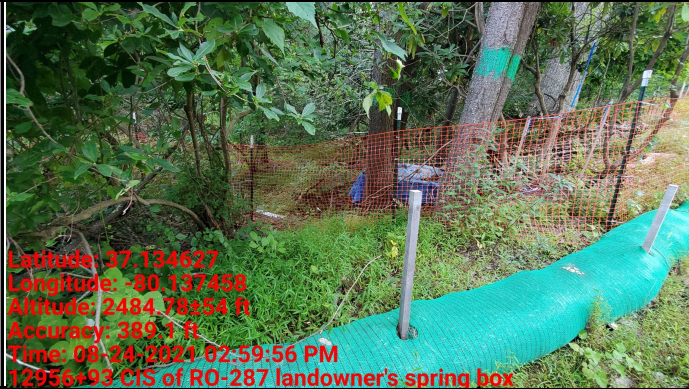
Latitude: 37.136734 Longitude: -80.12749 Elevation: 2679.35±0.7 ft Accuracy: 91.95 ft Time: 08-24-2021 02:58:59 PM 12958+00 GAS of RO-287 streams S-Y7 and S-Y8			Latitude: 37.134627 Longitude: -80.137458 Altitude: 2484.78±0.4 ft Accuracy: 389.1 ft Time: 08-24-2021 02:59:56 PM 12956+93 CIS of RO-287 landowner's spring box		
GPS Location	See pic for GPS location		GPS Location	See pic for GPS location	
Field Station#	12958+00		Field Station#	12956+93	
Pic 13 Desc.	Streams S-Y7 and S-Y8 on the GAS of RO-287.		Pic 14 Desc.	Landowner's spring box at access RO-287.

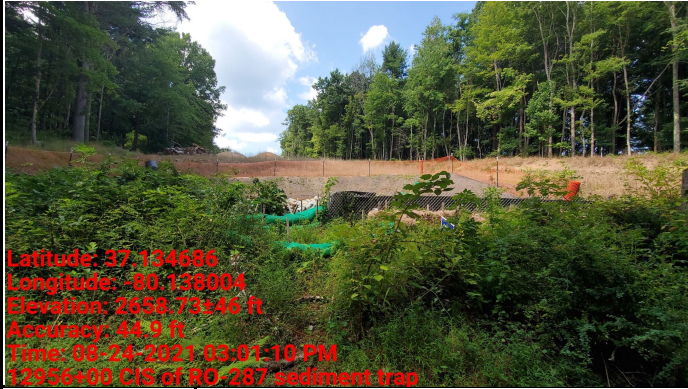
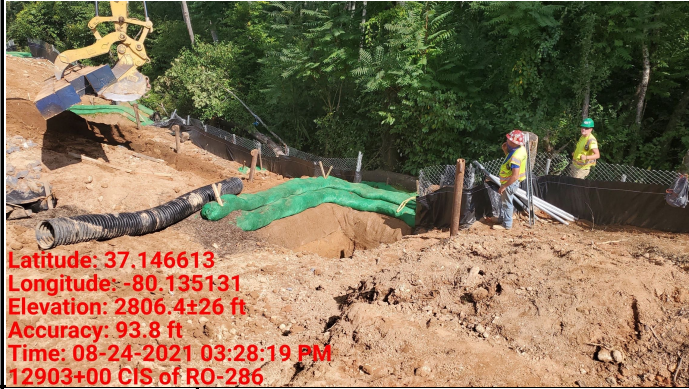
Latitude: 37.134686 Longitude: -80.138004 Elevation: 2658.73±4.6 ft Accuracy: 44.9 ft Time: 08-24-2021 03:01:10 PM 12956+00 CIS of RO-287 sediment trap			Latitude: 37.146613 Longitude: -80.135131 Elevation: 2806.4±26 ft Accuracy: 93.8 ft Time: 08-24-2021 03:28:19 PM 12903+00 CIS of RO-286

GPS Location	See pic for GPS location		GPS Location	See pic for GPS location	
Field Station#	12956+00		Field Station#	12903+00	
Pic 15 Desc.	Sediment trap on the CIS of RO-287.		Pic 16 Desc.	12" CFS end treatments were upgraded to 18" were recently overtopped during rain events.

7. Identify all remedial measures that have been taken since the previous inspection was conducted.					
Performed maintenance to ECD's and BMP's after multiple rain events. Upgraded CFS from 12" to 18" at sumps that were overtopped and caused off ROW silt and sediment deposits. Waterbars were curlexed in the channels before the rain events and replaced with new after each event.					
Comments (Reference above questions as appropriate.)					
Attended the 6:30am Zoom meeting for the MVP inspection staff, followed by the 7:00am Zoom meeting for the construction contractor. Traveled to access road RO-286 and met with environmental crews and security and discussed their plans for the day. Performed the VADEQ SWPPP inspection from station #12868+00 to #13024+00. Rainfall accumulation total from the rain gauge at Callaway Road was 0.0". Included in today's inspection were streams S-KL55, S-IJ12, S-EF44, S-IJ43, S-Z16, S-Z17, S-Y7, S-Y8, S-Y9, S-Q20, and S-KL4, access roads, RO-286, RO-287 and RO-288 and road crossings at US-221 and the BRP motorway. All inactive portions of the ROW has been stabilized with EarthGuard, Curlex ECB, straw mulch, temporary or permanent vegetation. At RO-286, the crews continued to upgrade sump end treatments that were overtopped in the recent rain events. All ECD's and BMP's throughout the inspected area remain in acceptable condition. No maintenance issues or impacts were observed throughout the inspected area today

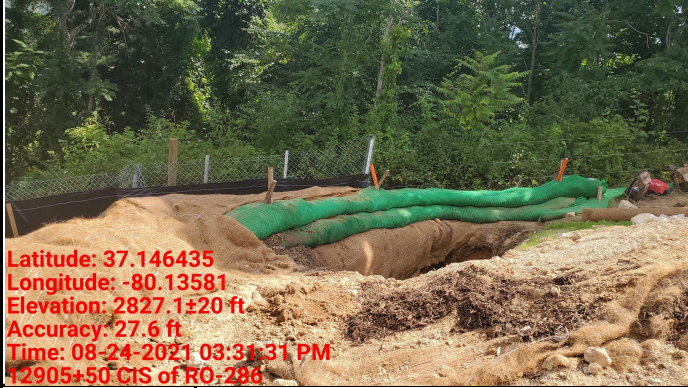
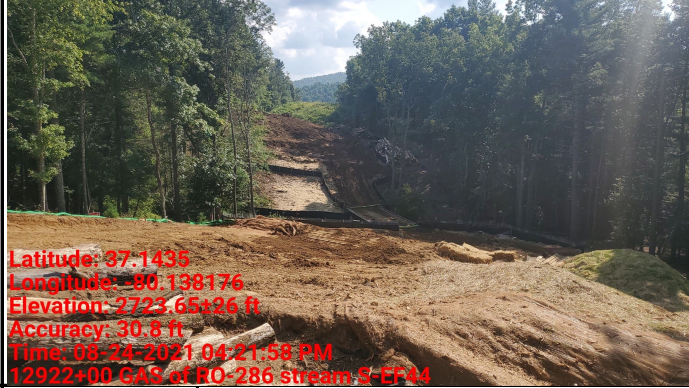
Latitude: 37.146435 Longitude: -80.13581 Elevation: 2827.1±20 ft Accuracy: 27.6 ft Time: 08-24-2021 03:31:31 PM 12905+50 CIS of RO-286			Latitude: 37.1435 Longitude: -80.138176 Elevation: 2723.65±26 ft Accuracy: 30.8 ft Time: 08-24-2021 04:21:58 PM 12922+00 GAS of RO-286 stream S-EF44		
GPS Location	See pic for GPS location		GPS Location	See pic for GPS location	
Field Station#	12905+50		Field Station#	12922+00	
Pic 17 Desc.	12" CFS end treatments were upgraded to 18" were recently overtopped during rain events.		Pic 18 Desc.	Stream crossing S-EF44 on the GAS of RO-286.

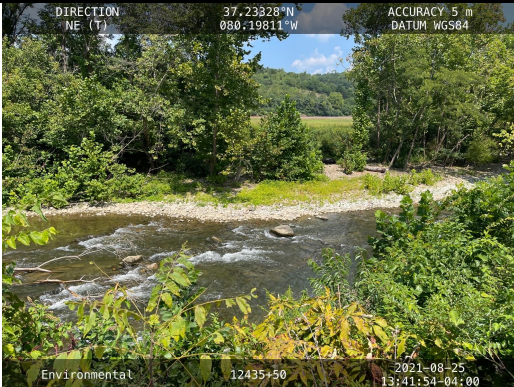
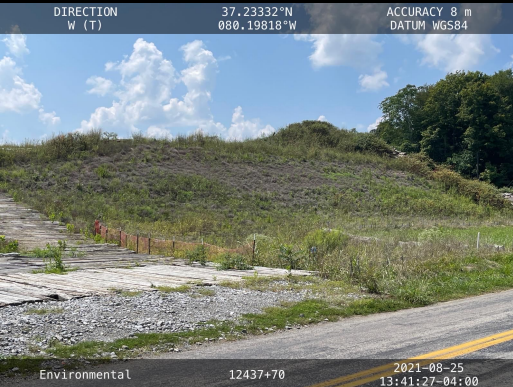
GPS Location	see photo		GPS Location	see photo	
Field Station#	12435+50		Field Station#	12437+70	
Pic 1 Desc.	Stream crossing S-NN16 in acceptable condition		Pic 2 Desc.	Stabilized slope in acceptable condition

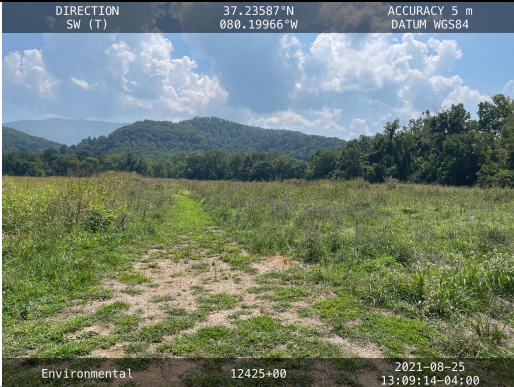
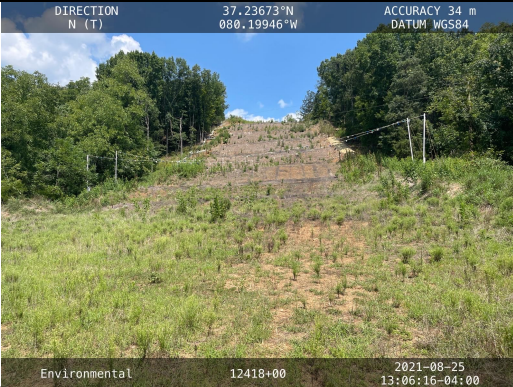
GPS Location	see photo		GPS Location	See photo	
Field Station#	12425+00		Field Station#	12418+00	
Pic 3 Desc.	Stabilized ROW in acceptable condition		Pic 4 Desc.	Stabilized slope in acceptable condition

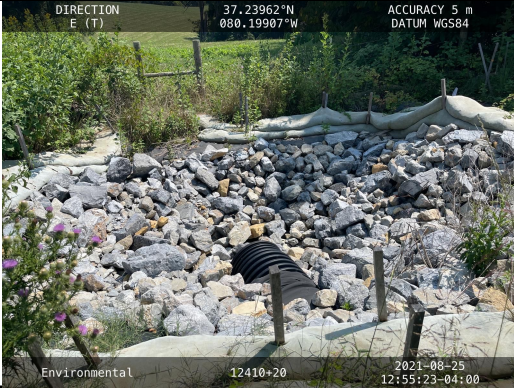
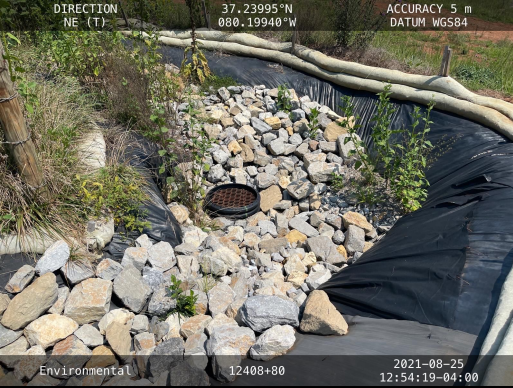
GPS Location	See photo		GPS Location	See photo	
Field Station#	12410+20		Field Station#	12408+80	
Pic 5 Desc.	Clean water crossing pipe outlet in acceptable condition		Pic 6 Desc.	Clean water crossing pipe inlet in acceptable condition

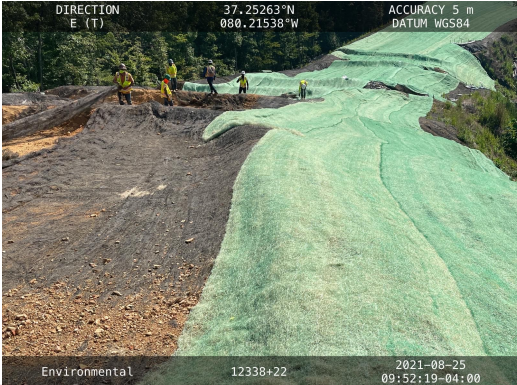
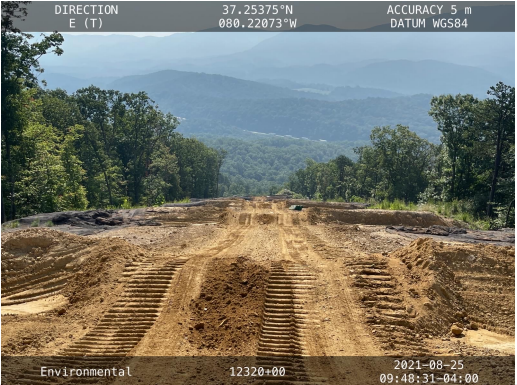
GPS Location	See photo		GPS Location	See photo	
Field Station#	12338+22		Field Station#	12320+00	
Pic 15 Desc.	Environmental crew stabilizing the ROW.		Pic 16 Desc.	ROW conditions acceptable with work being performed

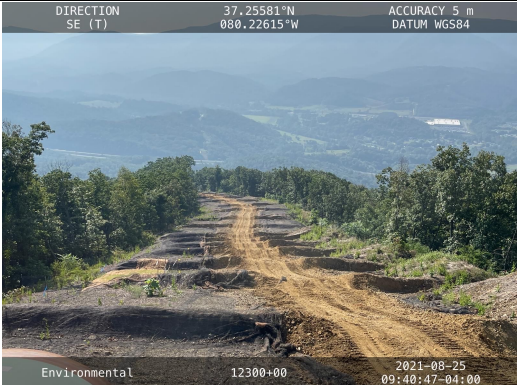
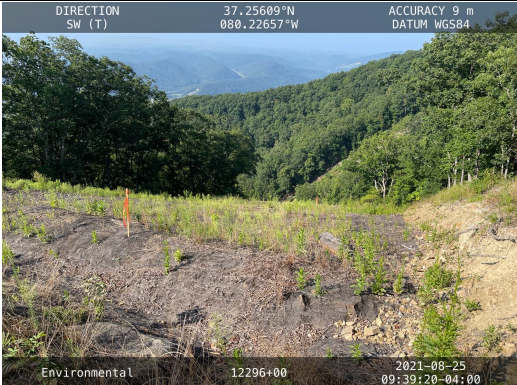
GPS Location	see photo		GPS Location	See photo	
Field Station#	12300+00		Field Station#	12296+00	
Pic 17 Desc.	ROW conditions		Pic 18 Desc.	Stabilized slope in acceptable condition

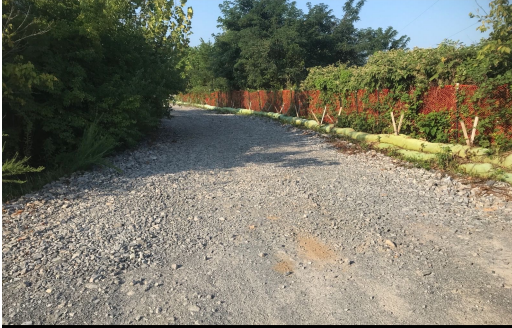
<div> MVP-LY-049_082521 Condition of rock entrance 2021-08-25 08:47:57-04:00 </div>		<div> DIRECTION SW (M) +37.27156° -080.12317° ACCURACY 16 ft DATUM WGS84 </div>

<div> MVP-LY-049_082521 Condition of CFS & safety fence LOD 2021-08-25 08:48:58-04:00 </div>			
GPS Location	MVP-LY-049 See photo for gps data		GPS Location	MVP-LY-049 See photo for gps data	
Field Station#	+0		Field Station#	+0	
Pic 1 Desc.	Condition of north rock entrance. No sediment on stone. Looking SW.		Pic 2 Desc.	Condition of triple stack compost filter sock and safety fence along north LOD. Looking SW.	
<div> DIRECTION N (M) +37.27042° -080.12468° ACCURACY 16 ft DATUM WGS84 </div>

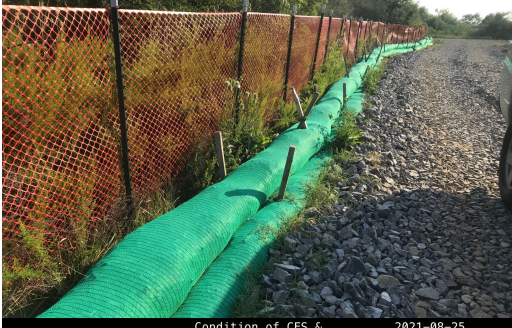
<div> MVP-LY-049_082521 Condition of CFS & safety fence LOD 2021-08-25 08:51:16-04:00 </div>		<div> DIRECTION S (M) +37.27064° -080.12389° ACCURACY 33 ft DATUM WGS84 </div>

GPS Location	MVP-LY-049 See photo for gps data		GPS Location	MVP-LY-049 See photo for gps data	
Field Station#	+0		Field Station#	+0	
Pic 3 Desc.	Condition of triple stack compost filter sock and safety fence along north LOD. Looking NE.		Pic 4 Desc.	Landowner soil disturbance along triple stack compost filter sock. No new damage to installed ECD's. Looking SW.	
<div> DIRECTION NW (M) +37.27042° -080.12465° ACCURACY 16 ft DATUM WGS84 </div>

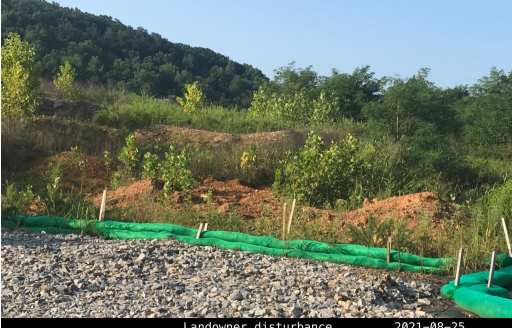
<div> MVP-LY-049_082521 Landowner disturbance along CFS 2021-08-25 08:49:52-04:00 </div>

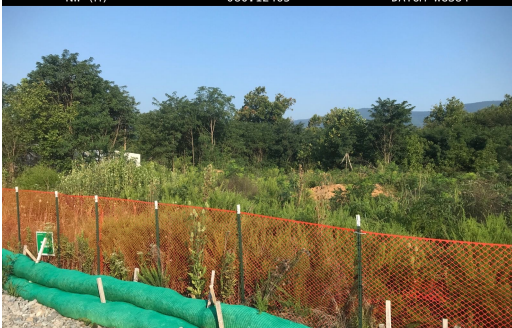
<div> MVP-LY-049_082521 Landowner disturbance along feature 2021-08-25 08:50:38-04:00 </div>		<div> DIRECTION SW (M) +37.27042° -080.12465° ACCURACY 16 ft DATUM WGS84 </div>

<div> MVP-LY-049_082521 Landowner disturbance west of feature 2021-08-25 08:50:46-04:00 </div>			
GPS Location	MVP-LY-049 See photo for gps data		GPS Location	MVP-LY-049 See photo for gps data	
Field Station#	+0		Field Station#	+0	
Pic 5 Desc.	Landowner soil disturbance along edge of feature W-CV21A. Area not stabilized. Looking NW.		Pic 6 Desc.	Landowner soil disturbance west of feature W-CV21B. Areas not stabilized. Looking SW.

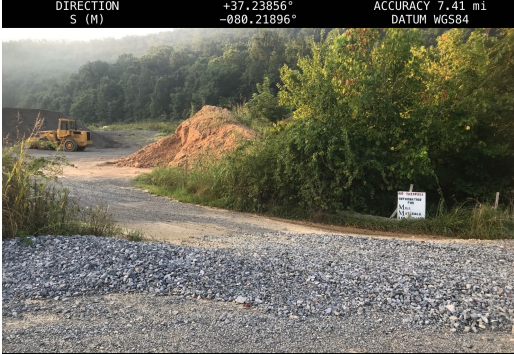
<p>DIRECTION S (M) +37.23856° -080.21896° ACCURACY 7.41 m DATUM WGS84</p> <p>MVP-PY-006_082521 Condition of spoil pile adjacent to LOD 2021-08-25 07:34:36-04:00</p>

<p>DIRECTION SE (M) +37.23572° -080.22952° ACCURACY 541 ft DATUM WGS84</p> <p>MVP-PY-006_082521 Condition of containment 2021-08-25 07:36:35-04:00</p>			
GPS Location	MVP-PY-006 See photo for gps data		GPS Location	MVP-PY-006 See photo for gps data	
Field Station#	+0		Field Station#	+0	
Pic 1 Desc.	Condition of spoil pile adjacent to LOD. Not stabilized. Looking S.		Pic 2 Desc.	Condition of containment under light plant. Free of stormwater. Looking SE.

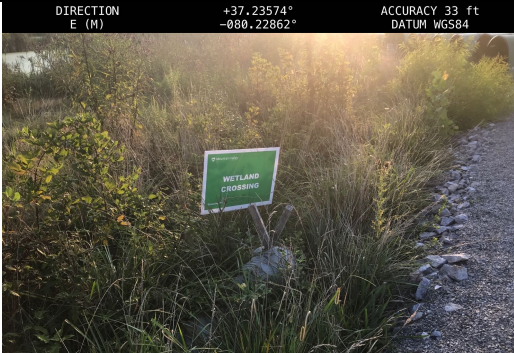
<p>DIRECTION E (M) +37.23574° -080.22862° ACCURACY 33 ft DATUM WGS84</p> <p>MVP-PY-006_082521 Condition of signage & CFS at feature 2021-08-25 07:37:06-04:00</p>

GPS Location	MVP-PY-006 See photo for gps data		GPS Location	MVP-PY-006 See photo for gps data	
Field Station#	+0		Field Station#	+0	
Pic 3 Desc.	Condition of triple stack compost filter sock and signage at feature W-008. Over grown with vegetation. Looking E.		Pic 4 Desc.	Blue Bulk Fuel tanks no fuel spills south of the tanks. Looking W.

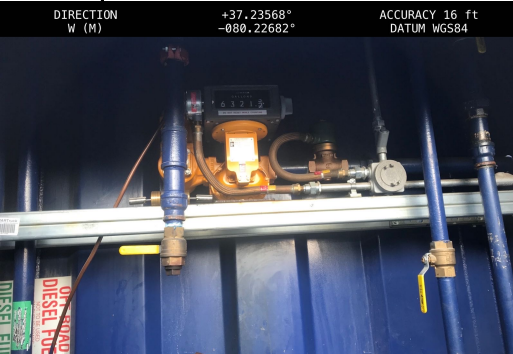
<p>DIRECTION N (M) +37.23560° -080.22687° ACCURACY 98 ft DATUM WGS84</p> <p>MVP-PY-006_082521 Condition of containment 2021-08-25 07:43:01-04:00</p>

<p>DIRECTION W (M) +37.23568° -080.22682° ACCURACY 16 ft DATUM WGS84</p> <p>MVP-PY-006_082521 No leaky internal fittings 2021-08-25 07:43:18-04:00</p>			
GPS Location	MVP-PY-006 See photo for gps data		GPS Location	MVP-PY-006 See photo for gps data	
Field Station#	+0		Field Station#	+0	
Pic 5 Desc.	Blue Bulk Fuel tanks containment holding stormwater. Looking N.		Pic 6 Desc.	Blue Bulk Fuel tanks no leaky internal fittings. Looking W.

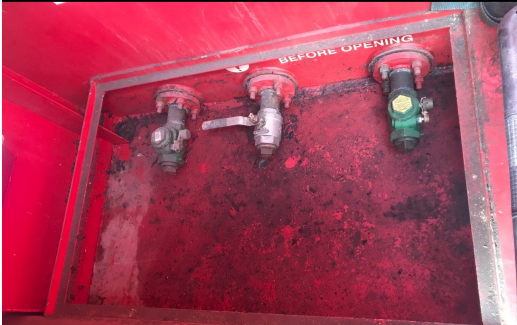
MVP-PY-006_082521 Secondary containment in place for tankers 2021-08-25 07:43:59-04:00		MVP-PY-006_082521 Condition of internal drip pan 2021-08-25 07:46:24-04:00			
GPS Location	MVP-PY-006 See photo for gps data		GPS Location	MVP-PY-006 See photo for gps data	
Field Station#	+0		Field Station#	+0	
Pic 7 Desc.	Blue Bulk Fuel tanks secondary containments for tankers offloading fuel. Looking W.		Pic 8 Desc.	Off Road Fuel unit condition of internal drip pan. Free of fluids. Looking SW.	
DIRECTION W (M) +37.23568° -080.22692° ACCURACY 16 ft DATUM WGS84

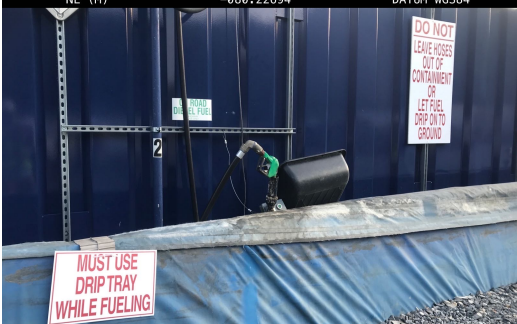
MVP-PY-006_082521 No leaky internal fittings 2021-08-25 07:46:26-04:00		MVP-PY-006_082521 No leaky fittings or nozzles 2021-08-25 07:47:11-04:00

GPS Location	MVP-PY-006 See photo for gps data		GPS Location	MVP-PY-006 See photo for gps data	
Field Station#	+0		Field Station#	+0	
Pic 9 Desc.	Off Road Fuel unit no leaky internal fittings. Looking W.		Pic 10 Desc.	Blue Bulk Fuel tanks no leaky fittings or nozzles. Looking NE.	
DIRECTION SE (M) +37.23558° -080.22681° ACCURACY 16 ft DATUM WGS84

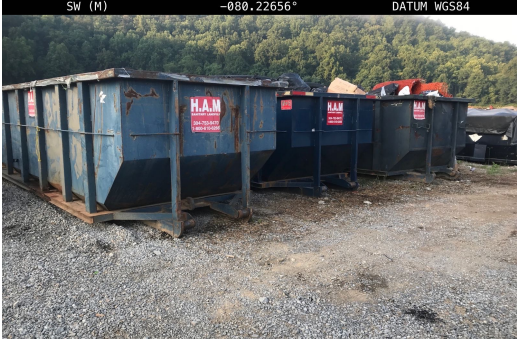
MVP-PY-006_082521 No deposits around hazardous waste dump... 2021-08-25 07:47:24-04:00		MVP-PY-006_082521 No loose trash around dumpsters 2021-08-25 07:49:49-04:00			
GPS Location	MVP-PY-006 See photo for gps data		GPS Location	MVP-PY-006 See photo for gps data	
Field Station#	+0		Field Station#	+0	
Pic 11 Desc.	No deposits or fluids around hazardous waste dumpsters. Looking SE.		Pic 12 Desc.	No loose trash around dumpsters or in the yard. Looking SW.

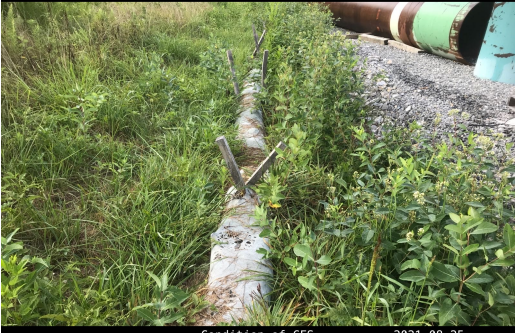
MVP-PY-006_082521 Condition of containment 2021-08-25 07:52:41-04:00		MVP-PY-006_082521 Condition of CFS along LOD 2021-08-25 07:53:17-04:00			
GPS Location	MVP-PY-006 See photo for gps data		GPS Location	MVP-PY-006 See photo for gps data	
Field Station#	+0		Field Station#	+0	
Pic 13 Desc.	Condition of containment under the refrigeration unit. Looking W.		Pic 14 Desc.	Condition of triple stack compost filter sock along east LOD. Looking S.	
DIRECTION SE (M) +37.23445° -080.22750° ACCURACY 164 ft DATUM WGS84

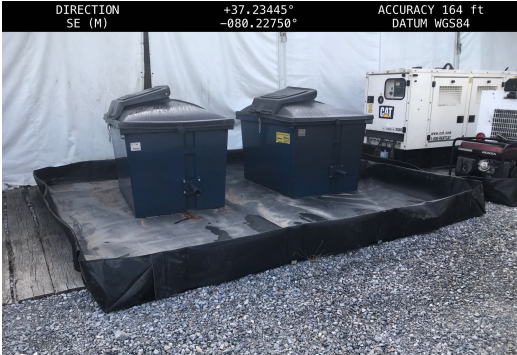
DIRECTION SE (M) +37.23438° -080.22803° ACCURACY 16 ft DATUM WGS84  			
MVP-PY-006_082521 Condition of containment 2021-08-25 07:56:48-04:00		MVP-PY-006_082521 Condition of poly lined containment 2021-08-25 07:58:12-04:00

GPS Location	MVP-PY-006 See photo for gps data		GPS Location	MVP-PY-006 See photo for gps data	
Field Station#	+0		Field Station#	+0	
Pic 15 Desc.	Condition of containment under hazardous waste dumpsters free of stormwater and fluids. Looking SE.		Pic 16 Desc.	Condition of poly lined rock berm containments free of stormwater. Looking SE.	
DIRECTION N (M) +37.23477° -080.22825° ACCURACY 33 ft DATUM WGS84

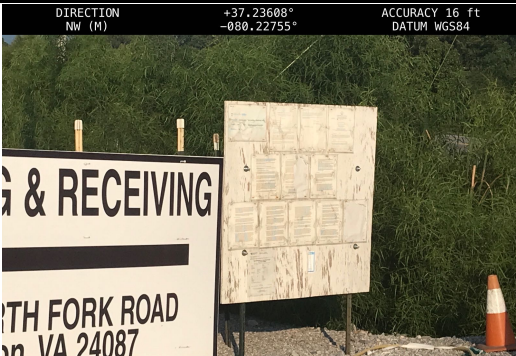
MVP-PY-006_082521 Condition of trays & containment 2021-08-25 07:58:50-04:00		MVP-PY-006_082521 Condition of posted project documents 2021-08-25 08:22:01-04:00			
GPS Location	MVP-PY-006 See photo for gps data		GPS Location	MVP-PY-006 See photo for gps data	
Field Station#	+0		Field Station#	+0	
Pic 17 Desc.	Condition of trays and containment under toilets free of stormwater. Looking N.		Pic 18 Desc.	Condition of posted project documents at the main entrance. Looking NW.

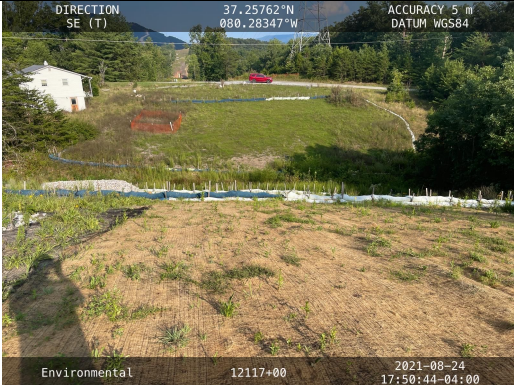
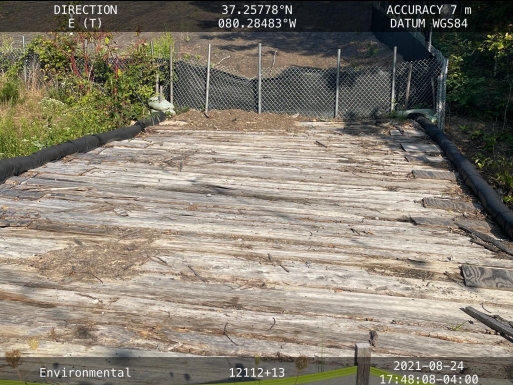
GPS Location	See photo		GPS Location	See photo	
Field Station#	12117+00		Field Station#	12112+13	
Pic 1 Desc.	Stabilized ROW in acceptable condition		Pic 2 Desc.	Bridge and ECDs crossing stream S-F16A/B in acceptable condition

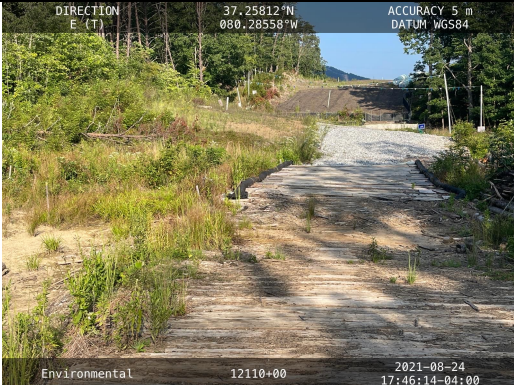
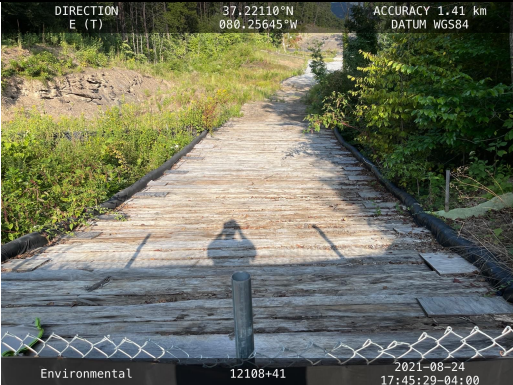
GPS Location	See photo		GPS Location	See photo	
Field Station#	12110+00		Field Station#	12108+41	
Pic 3 Desc.	Clean water crossing in acceptable condition		Pic 4 Desc.	Bridge and ECDs crossing stream S-F15 in acceptable condition

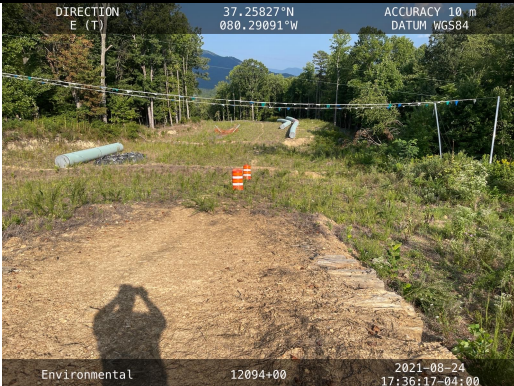
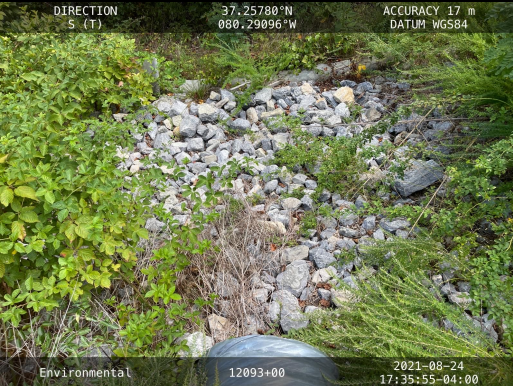
GPS Location	See photo		GPS Location	See photo	
Field Station#	12094+00		Field Station#	12093+00	
Pic 5 Desc.	Stabilized ROW in acceptable condition		Pic 6 Desc.	Clean water crossing pipe outlet in acceptable condition

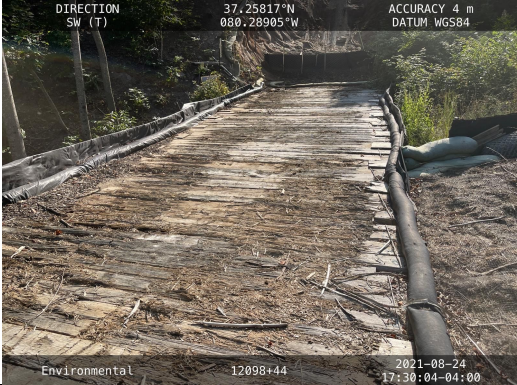
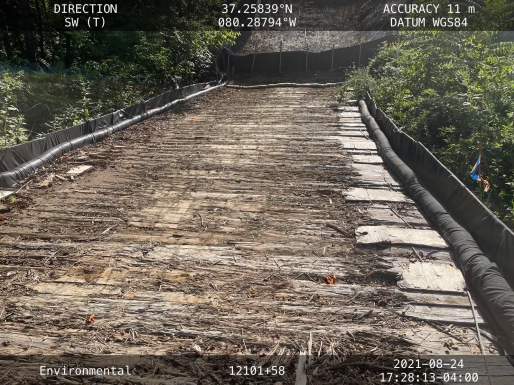
GPS Location	See photo		GPS Location	See photo	
Field Station#	12098+44		Field Station#	12101+58	
Pic 7 Desc.	Bridge and ECDs crossing stream S-MM13 in acceptable condition		Pic 8 Desc.	Bridge and ECDs crossing stream S-MM11 in acceptable condition

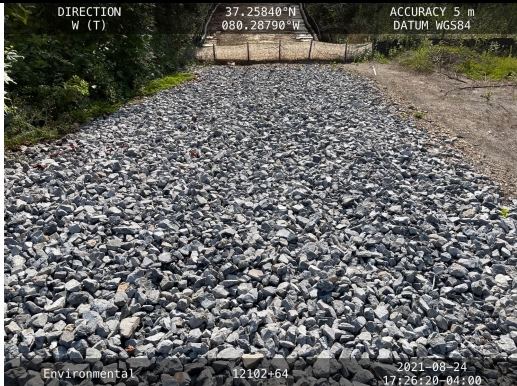
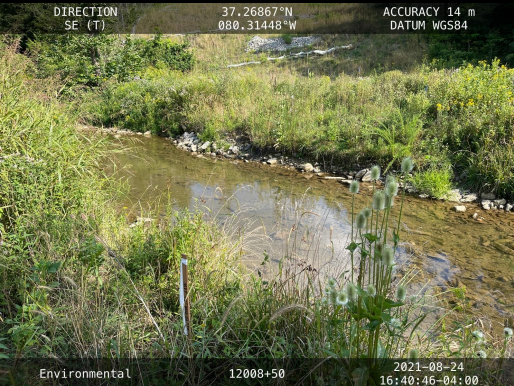
GPS Location	See photo		GPS Location	See photo	
Field Station#	12102+64		Field Station#	12008+50	
Pic 9 Desc.	RCE in acceptable condition		Pic 10 Desc.	S-G36 ROW crossing in acceptable condition

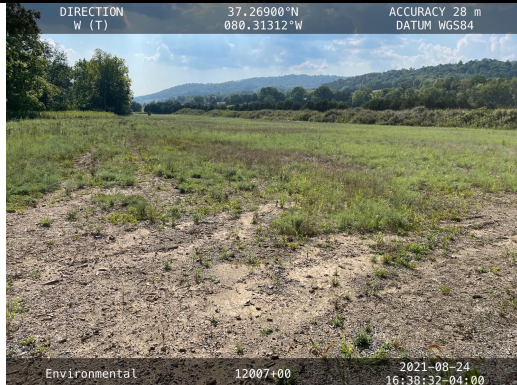
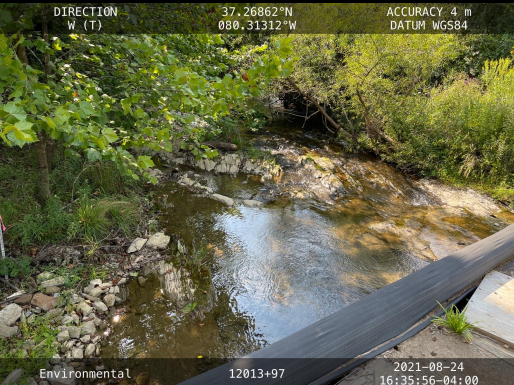
GPS Location	See photo		GPS Location	See photo	
Field Station#	12007+00		Field Station#	12013+97	
Pic 11 Desc.	Stabilized ATWS in acceptable condition		Pic 12 Desc.	Down stream of stream crossing S-G36 in acceptable condition

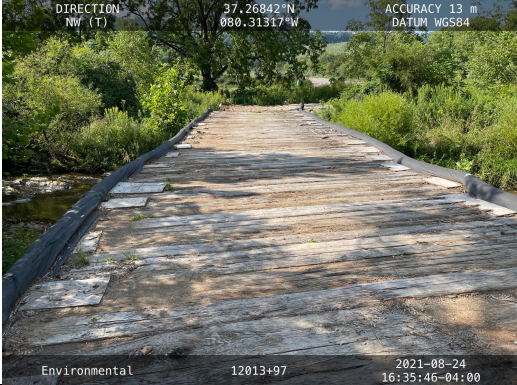
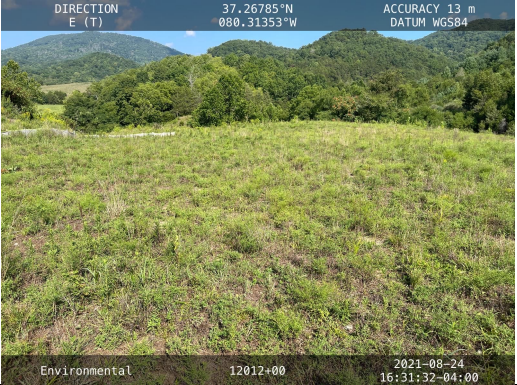
GPS Location	See photo		GPS Location	see photo	
Field Station#	12013+97		Field Station#	12012+00	
Pic 13 Desc.	Bridge and ECDs crossing stream S-G36 in acceptable condition		Pic 14 Desc.	Stabilized ATWS in acceptable condition

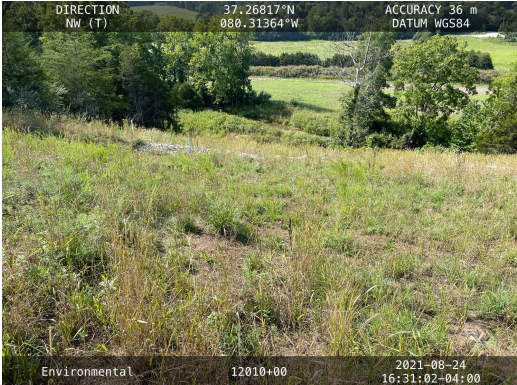
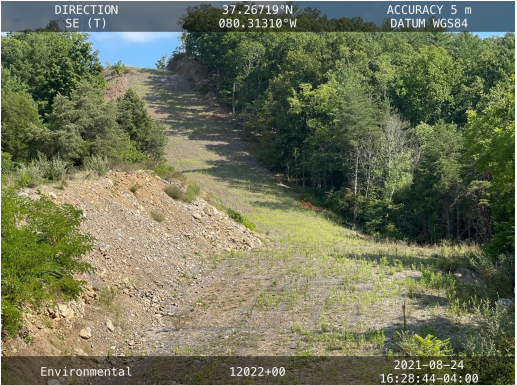
GPS Location	See photo		GPS Location	See photo	
Field Station#	12010+00		Field Station#	12022+00	
Pic 15 Desc.	Stabilized slope in acceptable condition		Pic 16 Desc.	Stabilized slope in acceptable condition

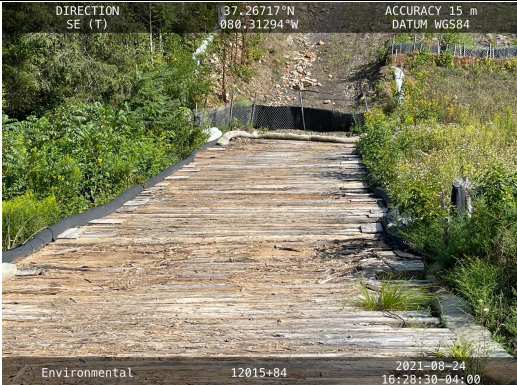
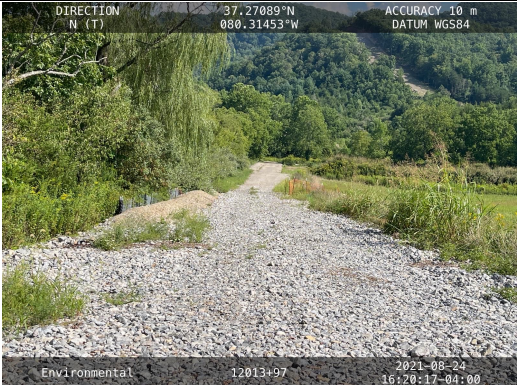
GPS Location	See photo		GPS Location	See photo	
Field Station#	12015+84		Field Station#	12013+97	
Pic 17 Desc.	Bridge and ECDs crossing stream S-G38 in acceptable condition		Pic 18 Desc.	Access Road MVP-MN-268.01 in acceptable condition

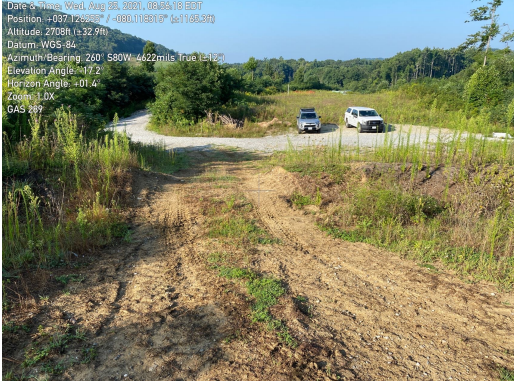
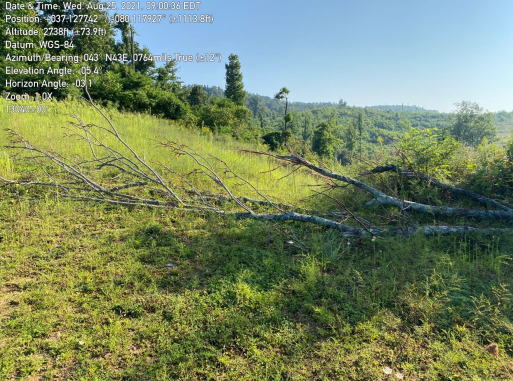
GPS Location	See photo for coordinates.		GPS Location	See photo for coordinates.	
Field Station#	13034+00		Field Station#	13040+00	
Pic 1 Desc.	Waterbar berm cut down for landowner use, two track trail noted.		Pic 2 Desc.	ROW stable, tree limb noted fallen on ROW.

Routine SWPPP inspection covered inspection area from Sta. No. 13024+00 to Sta. No. 13141+65. Permanently restored ROW was stable with good vegetative cover noted. No ROW impacts were noted at resources S-G24, S-G-25, W-ST2, S-H1, S-GH26, S-GH27, S-RR16, W-RR4, S-EF17, W-EF3, S-D14, or S-D17/14 reconnect. No water was noted flowing from S-D14 across access road MVP-FR-292 or in stream channel on ROW at S-D17/14. Perimeter controls were in acceptable condition along the ROW with the exception of the active sediment impact area at approximate Sta. No. 13125+50 where a debris field is being actively cleaned up. Repair was in progress on fill slope above this area and the slope drain was partially installed. Items added to the Punch List in this area include: repair rilling from approximate Sta. No. 13124+00 to Sta. No. 13132+00, clean fill slope drain inlets from approximate Sta. No. 13125+00 to Sta. No. 13127+00, remove sediment accumulation in waterbar throats from approximate Sta. No. 13125+00 to Sta. No. 13132+00, clean sumps from approximate Sta. No. 13126+0-0 to Sta. No. 13132+00.

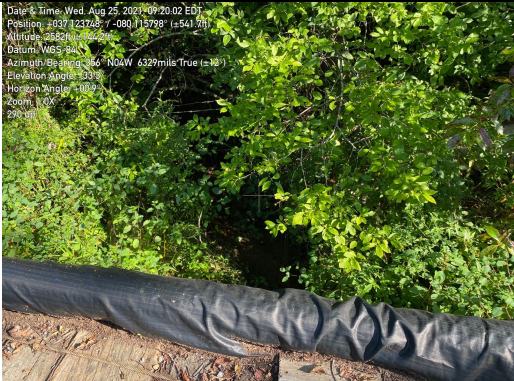
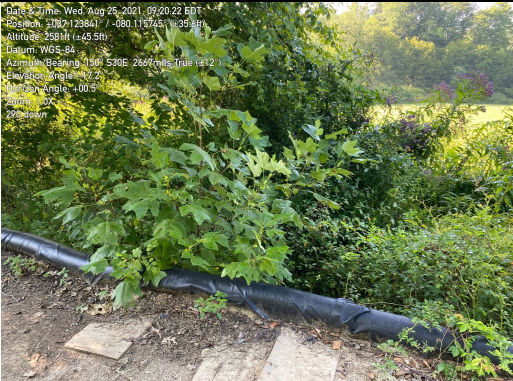
GPS Location	See photo for coordinates.		GPS Location	See photo for coordinates.	
Field Station#	13061+44		Field Station#	13061+44	
Pic 3 Desc.	S-RR16, upstream, water flowing in stream channel along MVP-FR-290, stream banks heavily vegetated.		Pic 4 Desc.	S-RR16, downstream, water flowing in stream channel along MVP-FR-290, stream banks heavily vegetated.

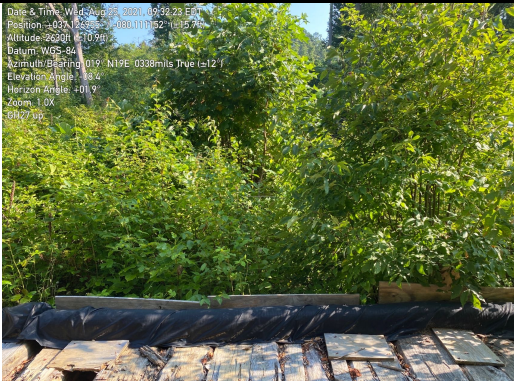
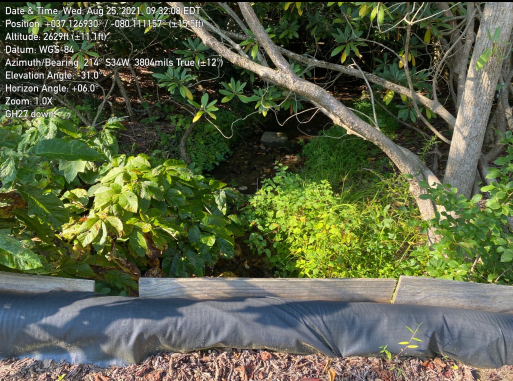
GPS Location	See photo for coordinates.		GPS Location	See photo for coordinates.	
Field Station#	13061+89		Field Station#	13062+96	
Pic 5 Desc.	S-GH27, upstream, thick vegetation noted along stream banks.		Pic 6 Desc.	S-GH27, downstream, water flowing clear, no ROW impacts observed.

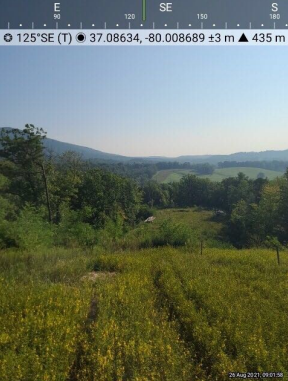
GPS Location	00000	GPS Location	0000		
Field Station#	13480+00	Field Station#	13460+00		
Pic 1 Desc.	Row photo showing vegetation in permanent area of row with good coverage. No environmental issues observed at the time of inspection.	Pic 2 Desc.	Row photo showing vegetation in permanent area of row with good coverage. No environmental issues observed at the time of inspection.

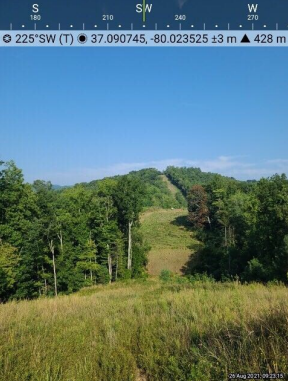
GPS Location	0000	GPS Location	0000		
Field Station#	13425+01	Field Station#	13430+30		
Pic 3 Desc.	Row photo showing vegetation in permanent area of row with good coverage. Monitored ECDs throughout. No environmental issues observed at the time of inspection.	Pic 4 Desc.	Row photo showing vegetation in permanent area of row with good coverage. Monitored ECDs throughout. No environmental issues observed at the time of inspection.

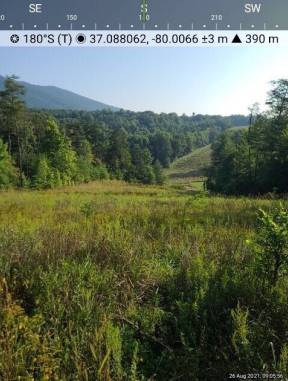
GPS Location	0000	GPS Location	0000		
Field Station#	13490+50	Field Station#	13451+00		
Pic 5 Desc.	Row photo showing vegetation in permanent area of row with good coverage. Monitored ECDs throughout. No environmental issues observed at the time of inspection.	Pic 6 Desc.	Row photo showing vegetation in permanent area of row with good coverage. Monitored ECDs throughout. No environmental issues observed at the time of inspection.

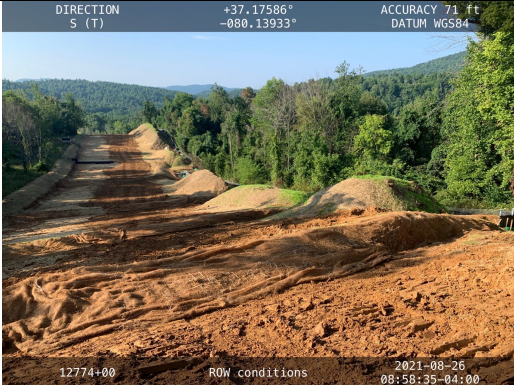
GPS Location	See photo for gps location data.		GPS Location	See photo for gps location data.	
Field Station#	12774+00		Field Station#	12777+60	
Pic 1 Desc.	Photo shows the ROW condition		Pic 2 Desc.	Photo shows the level spreader outlet

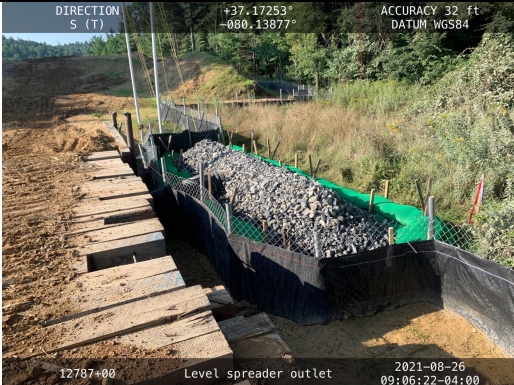
GPS Location	See photo for gps location data.		GPS Location	See photo for gps location data.	
Field Station#	12787+00		Field Station#	12786+50	
Pic 3 Desc.	Photo shows the level spreader outlet		Pic 4 Desc.	Photo shows wetland W-IJ93

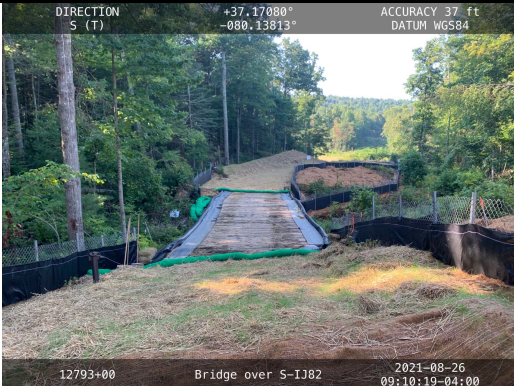
GPS Location	See photo for gps location data.		GPS Location	See photo for gps location data.	
Field Station#	12793+00		Field Station#	12793+30	
Pic 5 Desc.	Photo shows the bridge over stream S-IJ82		Pic 6 Desc.	Photo shows stream S-IJ82 downstream from the bridge
