Visual Site Inspection Report

Project Name	H-600 Pipeline Spread H	AFE	124300138	Spread	H-600 Pipeline Spread H
Contractor	Precision			Report #	27607
Inspector	Bryan Cole			Date/Time	8/23/2021 7:19 PM
Permit #	TBD	Inspection Type	VA SWPP	Station Begin	13141+65
State	VA	Inspection Area	Partial	Station End	13316+21
County	Franklin	Ground	Dry	Temperature (°F)	90.00
Municipality	N/A	Weather	Sunny	Rain Gauge (in)	0.00
				Rain Accumulation Time (days)	0.00

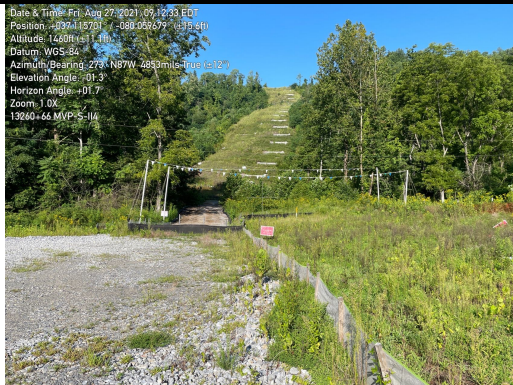
GPS Location				0				GPS Location				0			
Field Station#				13262+62				Field Station#				13260+66			
Pic 3 Desc.				Flanders Road Crossing in good condition				Pic 4 Desc.				MVP-S-II4 and Corresponding buffer zone in good condition			
<p>Date & Time: Fri, Aug 27, 2021, 09:20:00 EDT Position: -037.115559, -080.048714 (-15.1in) Altitude: 1429ft (-11.7in) Datum: WGS-84 Azimuth/Bearing: 273° N87W, 485mils True (-11.7) Elevation Angle: -11.0° Horizon Angle: -00.2° Zoom: 1.0X 13259+00</p>

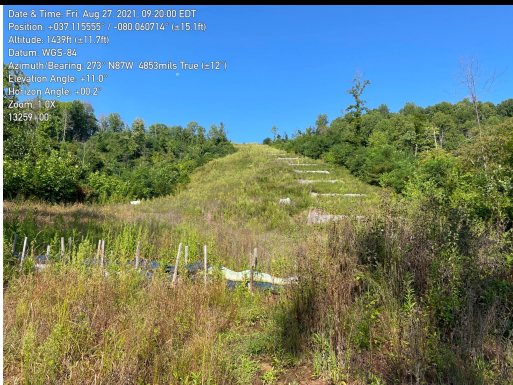
<p>Date & Time: Fri, Aug 27, 2021, 09:26:14 EDT Position: -037.122292, -080.052869 (-15.1in) Altitude: 1434ft (-11.7in) Datum: WGS-84 Azimuth/Bearing: 327° N23W, 599mils True (-11.7) Elevation Angle: -10.9° Horizon Angle: -00.8° Zoom: 1.0X 13196+31 S-D10</p>  							
GPS Location				0				GPS Location				0			
Field Station#				13259+00				Field Station#				13196+31			
Pic 5 Desc.				ROW and ECDs in good condition with vegetation established across ROW				Pic 6 Desc.				MVP-S-D10 and Corresponding buffer zone in good condition

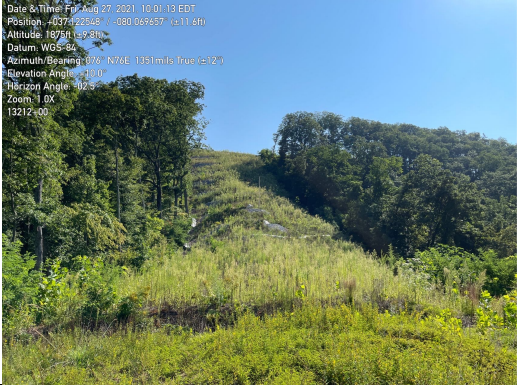
GPS Location	0	GPS Location	0		
Field Station#	13212+00	Field Station#	13210+00		
Pic 7 Desc.	ROW and ECDs in good condition with vegetation established across ROW		Pic 8 Desc.	ROW and ECDs in good condition and stable	
<p>Date & Time: Fri Aug 27, 2021, 10:28:18 EDT Position: +037.122546 / -080.072952 (+11.61m) Altitude: 1856ft (+11.70m) Datum: WGS-84 Azimuth/Bearing: 296 N66W 5262mils True (+12.1) Elevation Angle: +16.8 Horizon Angle: +00.5 Zoom: 1.0X 13202+00</p>

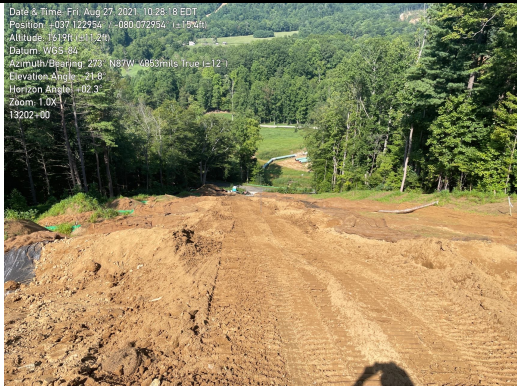
GPS Location	0	GPS Location	0		
Field Station#	13202+00	Field Station#	13198+30		
Pic 9 Desc.	ROW and ECDs in good condition and stable		Pic 10 Desc.	RCE in good condition and functioning properly	
<p>Date & Time: Fri Aug 27, 2021, 10:31:49 EDT Position: +037.122994 / -080.076531 (+11.61m) Altitude: 1465ft (+11.70m) Datum: WGS-84 Azimuth/Bearing: 296 N66W 5262mils True (+12.1) Elevation Angle: +16.8 Horizon Angle: +00.5 Zoom: 1.0X 13196+79 S-08</p>

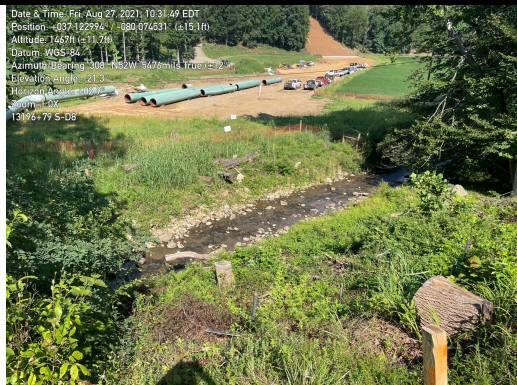
<p>Date & Time: Fri Aug 27, 2021, 10:40:41 EDT Position: +037.124719 / -080.076429 (+11.61m) Altitude: 1465ft (+11.70m) Datum: WGS-84 Azimuth/Bearing: 296 N66W 5262mils True (+12.1) Elevation Angle: +16.8 Horizon Angle: +00.5 Zoom: 1.0X 13188+50</p>  			
GPS Location	0	GPS Location	0		
Field Station#	13196+79	Field Station#	13188+50		
Pic 11 Desc.	MVP-S-D8 and Corresponding buffer zone in good condition		Pic 12 Desc.	ROW and ECDs in good condition and stable

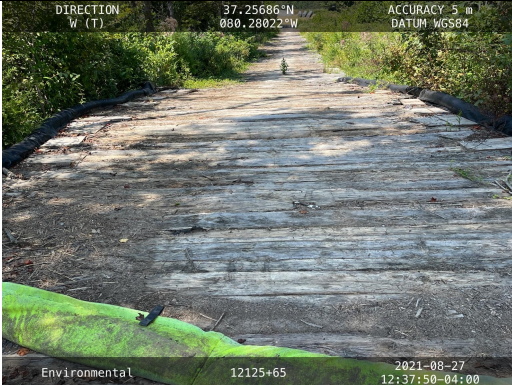
GPS Location	See photo		GPS Location	See photo	
Field Station#	12125+65		Field Station#	12128+00	
Pic 1 Desc.	Bridge and ECDs crossing stream S-MM31 in acceptable condition		Pic 2 Desc.	Stabilized ROW in acceptable condition

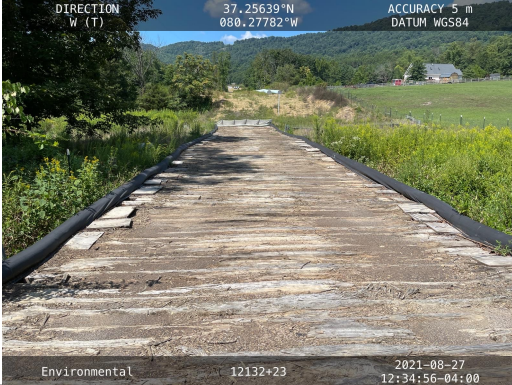
GPS Location	See photo		GPS Location	See photo	
Field Station#	12132+23		Field Station#	12139+91	
Pic 3 Desc.	Bridge and ECDs crossing stream S-C29 in acceptable condition		Pic 4 Desc.	Bridge and ECDs crossing wetland W-C6 in acceptable condition

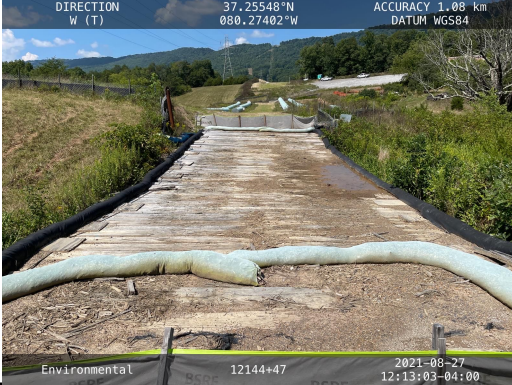
GPS Location	See photo		GPS Location	See photo	
Field Station#	12144+47		Field Station#	12150+95	
Pic 5 Desc.	Bridge and ECDs crossing wetland W-C5 in acceptable condition		Pic 6 Desc.	Stabilized drainage feature in acceptable condition

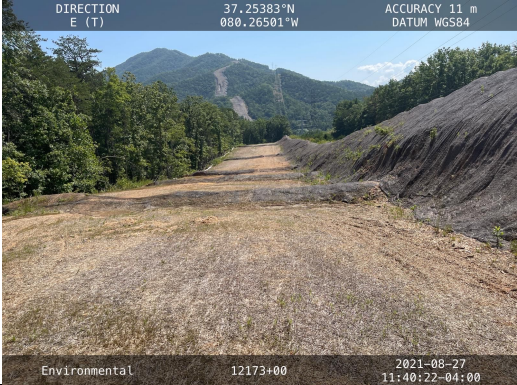
<p>DIRECTION E (T) 37.25383°N 080.26501°W ACCURACY 11 m DATUM WGS84</p> <p>Environmental 12173+00 2021-08-27 11:40:22-04:00</p>

<p>DIRECTION E (T) 37.25364°N 080.26570°W ACCURACY 86 m DATUM WGS84</p> <p>Environmental 12166+47 2021-08-27 11:31:15-04:00</p>			
GPS Location	See photo		GPS Location	See photo	
Field Station#	12173+00		Field Station#	12166+47	
Pic 7 Desc.	Stabilized ROW in acceptable condition		Pic 8 Desc.	Bridge and ECDs crossing stream S-C24 In Acceptable condition

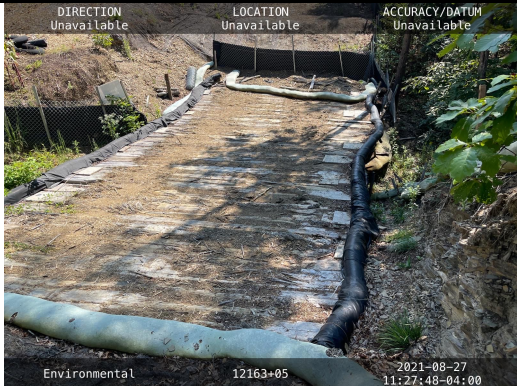
<p>DIRECTION Unavailable LOCATION Unavailable ACCURACY/DATUM Unavailable</p> <p>Environmental 12163+05 2021-08-27 11:27:48-04:00</p>

Pic 9 Desc.	Bridge and ECDs crossing stream S-C25 in acceptable condition		Pic 10 Desc.	Fill slope drain pipe in acceptable condition

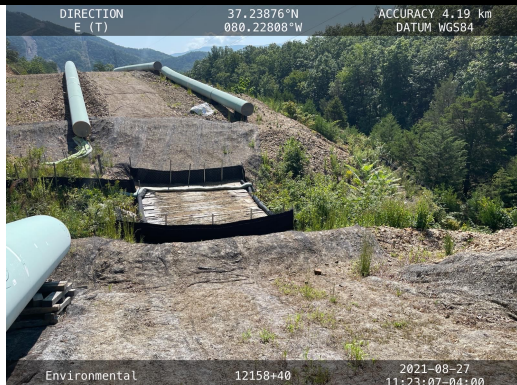
<p>DIRECTION E (T) 37.23876°N 080.22808°W ACCURACY 4.19 km DATUM WGS84</p> <p>Environmental 12158+40 2021-08-27 11:23:07-04:00</p>

<p>DIRECTION E (T) 37.25499°N 080.27115°W ACCURACY 21 m DATUM WGS84</p> <p>Environmental 12154+00 2021-08-27 11:15:10-04:00</p>			
GPS Location	See photo		GPS Location	See photo	
Field Station#	12158+40		Field Station#	12154+00	
Pic 11 Desc.	Clean water crossing in acceptable condition		Pic 12 Desc.	Stabilized ROW in acceptable condition

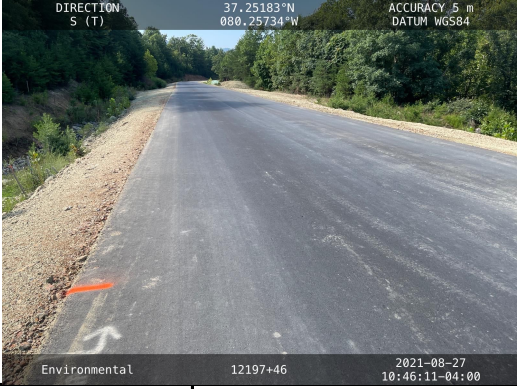
GPS Location	See photo		GPS Location	See photo	
Field Station#	12197+46		Field Station#	12197+50	
Pic 15 Desc.	Newly built road as a replacement for the railroad		Pic 16 Desc.	Stabilized road bank on GAS of newly built road

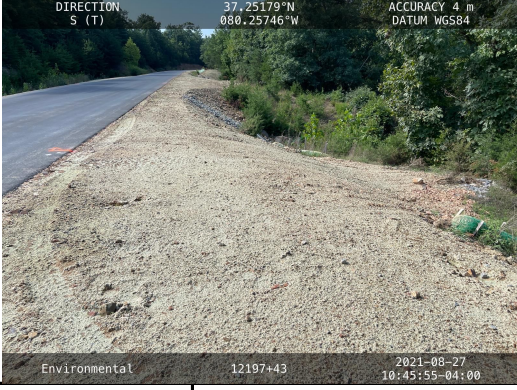
GPS Location	See photo		GPS Location	See photo	
Field Station#	12197+43		Field Station#	12192+50	
Pic 17 Desc.	Stabilized rod bank on CIS of the newly built road		Pic 18 Desc.	Bridge and ECDs crossing stream S-C21 in acceptable condition
