Visual Site Inspection Report

Project Name	H-600 Pipeline Spread H	AFE	124300138	Spread	H-600 Pipeline Spread H
Contractor	Precision			Report #	27870
Inspector	Jonathan Altizer			Date/Time	8/30/2021 3:48 PM
Permit #	TBD	Inspection Type	VA SWPP	Station Begin	12868+00
State	VA	Inspection Area	Partial	Station End	13024+00
County	Roanoke	Ground	Damp	Temperature (°F)	84.00
Municipality	N/A	Weather	Sunny	Rain Gauge (in)	0.10
				Rain Accumulation Time (days)	2.00

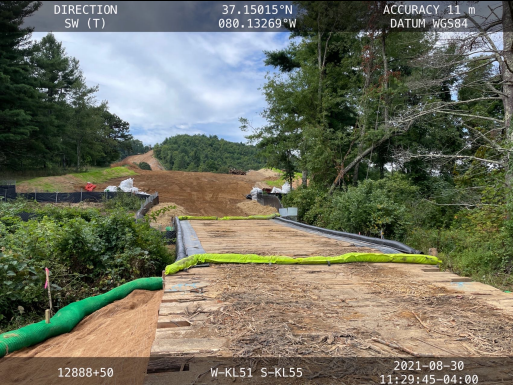
GPS Location	See photo		GPS Location	See photo	
Field Station#	12886+73		Field Station#	12888+50	
Pic 1 Desc.	Equipment bridge over wetland W-KL49		Pic 2 Desc.	Equipment Bridge over Stream S-KL55

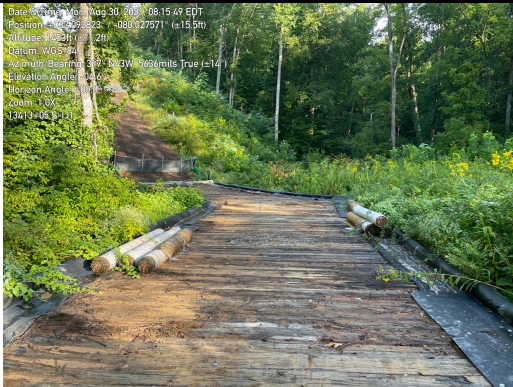
</div></div>									
GPS Location				0		GPS Location				0			
Field Station#				13413+05		Field Station#				13413+05			
Pic 1 Desc.				MVP-S-IJ1 and Corresponding buffer zone in good condition				Pic 2 Desc.				MVP-S-IJ1 Downstream and Corresponding buffer zone in good condition

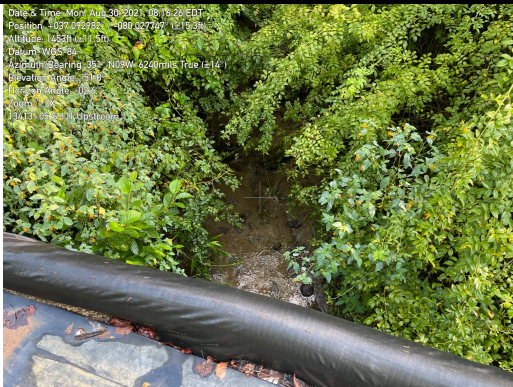
<div><div><div>Date & Time: Mon Aug 30 2021 08:16:26 EDT Position: 43.9139222 / -86.027791 (±15.5m) Altitude: 1424ft (±1.2m) Datum: WGS-84 Azimuth/Bearing: 135° SSW 334mils True (±14°) Elevation Angle: -0.2° Horizon Angle: -0.1° Zoom: 1.0x 13413+05 S-IJ1 Upstream</div>

</div></div>									
GPS Location				0		GPS Location				0			
Field Station#				13413+05		Field Station#				13413+65			
Pic 3 Desc.				MVP-S-IJ1 Upstream and Corresponding buffer zone in good condition				Pic 4 Desc.				MVP-S-IJ2 and Corresponding buffer zone in good condition	
<div><div><div>Date & Time: Mon Aug 30 2021 08:30:37 EDT Position: 43.9139222 / -86.027791 (±15.5m) Altitude: 1439ft (±1.3m) Datum: WGS-84 Azimuth/Bearing: 123° N31W 584mils True (±14°) Elevation Angle: -0.1° Horizon Angle: -0.1° Zoom: 1.0x 13415+19 MVP-S-IJ3</div>

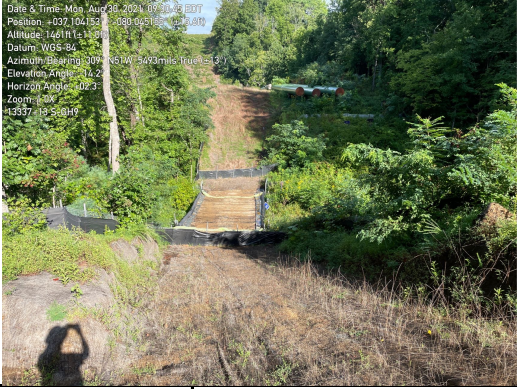
GPS Location	0	GPS Location	0		
Field Station#	13337+13	Field Station#	13348+46		
Pic 13 Desc.	MVP-S-GH9 and Corresponding buffer zone in good condition	Pic 14 Desc.	MVP-S-RR08 and Corresponding buffer zone in good condition		
<p>Date & Time: Mon Aug 30, 2021, 10:56:15 EDT Position: +037.104551 / -080.042208 / +15.480 Altitude: 1520ft (+11.30) Datum: WGS-84 Azimuth/Bearing: 223° S43W 376mils True (+13°) Elevation Angle: +18.2 Horizon Angle: +02.4 Zoom: 1.0X 13348-48-S-RR08 Downstream</p>

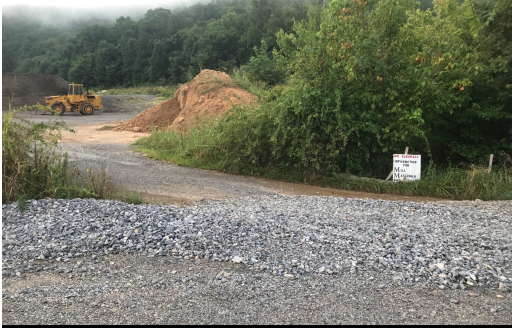
MVP-PY-006_083121 Condition of spoil pile adjacent to LOD 2021-08-31 07:20:19-04:00		DIRECTION N (M) +37.23456° -080.22699° ACCURACY 33 ft DATUM WGS84

MVP-PY-006_083121 Condition of CFS along west LOD 2021-08-31 07:23:14-04:00			
GPS Location	MVP-PY-006 See photo for gps data		GPS Location	MVP-PY-006 See photo for gps data	
Field Station#	+0		Field Station#	+0	
Pic 1 Desc.	Condition of soil pile adjacent to LOD. Soil pile not stabilized. Looking S.		Pic 2 Desc.	Condition of triple stack compost filter sock along west LOD. Over grown with vegetation. Looking N.	
DIRECTION E (M) +37.23406° -080.22640° ACCURACY 16 ft DATUM WGS84

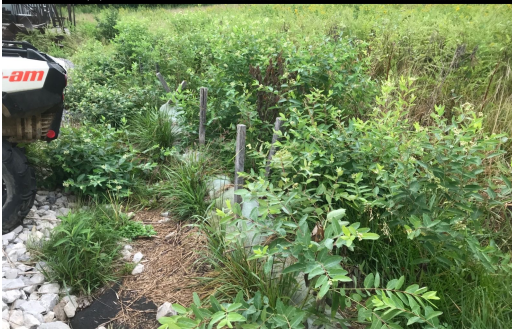
MVP-PY-006_083121 Condition of CFS along south LOD 2021-08-31 07:36:15-04:00		DIRECTION SE (M) +37.23432° -080.22800° ACCURACY 16 ft DATUM WGS84

GPS Location	MVP-PY-006 See photo for gps data		GPS Location	MVP-PY-006 See photo for gps data	
Field Station#	+0		Field Station#	+0	
Pic 3 Desc.	Condition of triple stack compost filter sock along south LOD. Over grown with vegetation. Looking E.		Pic 4 Desc.	Condition of poly lined rock berm containments. Holding stormwater. Looking SE.	
DIRECTION W (M) +37.23467° -080.22751° ACCURACY 16 ft DATUM WGS84

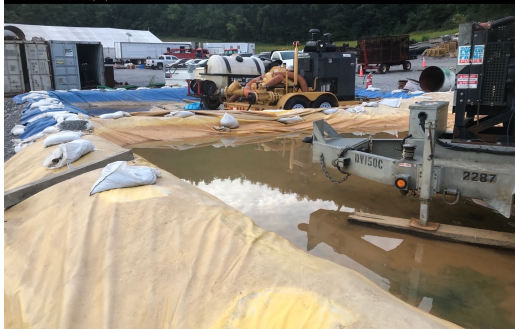
MVP-PY-006_083121 Condition of poly lined containments 2021-08-31 07:25:41-04:00

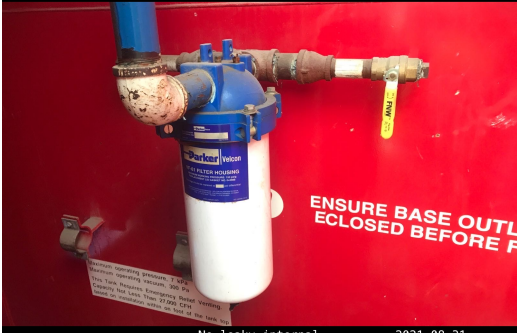
MVP-PY-006_083121 No leaky internal fittings 2021-08-31 07:43:55-04:00		DIRECTION NE (M) +37.23561° -080.22692° ACCURACY 16 ft DATUM WGS84

MVP-PY-006_083121 No fuel spills south of tanks 2021-08-31 07:44:28-04:00			
GPS Location	MVP-PY-006 See photo for gps data		GPS Location	MVP-PY-006 See photo for gps data	
Field Station#	+0		Field Station#	+0	
Pic 13 Desc.	Off Road Fuel unit no leaky internal fittings. Looking NW.		Pic 14 Desc.	Blue Bulk Fuel tanks no fuel spills south of tanks. Looking NE.	
DIRECTION S (M) +37.23557° -080.22675° ACCURACY 16 ft DATUM WGS84

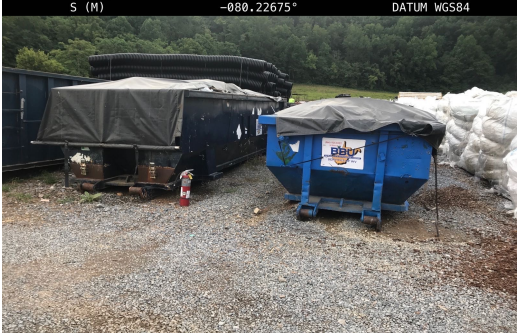
MVP-PY-006_083121 No fluids around hazardous waste dump... 2021-08-31 07:44:54-04:00		DIRECTION SE (M) +37.23554° -080.22672° ACCURACY 16 ft DATUM WGS84

GPS Location	MVP-PY-006 See photo for gps data		GPS Location	MVP-PY-006 See photo for gps data	
Field Station#	+0		Field Station#	+0	
Pic 15 Desc.	No fluids or deposits around hazardous waste dumpsters. Looking S.		Pic 16 Desc.	No loose trash around dumpsters or in the yard. Looking SE.	
DIRECTION SW (M) +37.23583° -080.22756° ACCURACY 33 ft DATUM WGS84

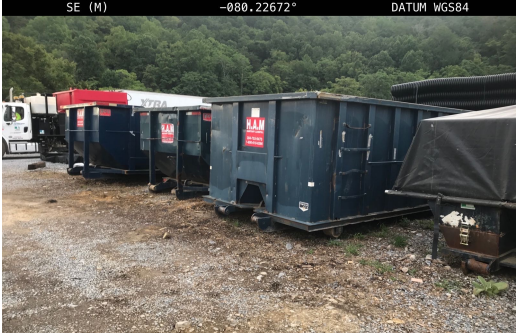
MVP-PY-006_083121 No loose trash around dumpsters 2021-08-31 07:44:59-04:00

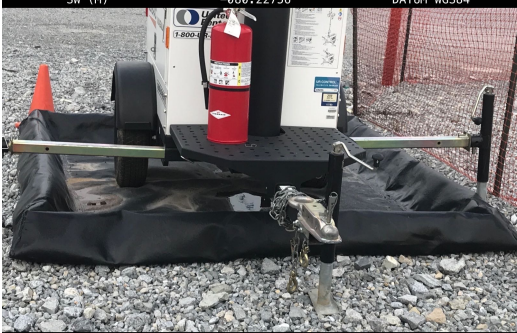
MVP-PY-006_083121 Condition of containment 2021-08-31 07:50:17-04:00		DIRECTION SW (M) +37.23621° -080.22775° ACCURACY 33 ft DATUM WGS84

MVP-PY-006_083121 Condition of posted project documents 2021-08-31 07:50:39-04:00			
GPS Location	MVP-PY-006 See photo for gps data		GPS Location	MVP-PY-006 See photo for gps data	
Field Station#	+0		Field Station#	+0	
Pic 17 Desc.	Condition of containment under light plant. Holding some fluids. Looking SW.		Pic 18 Desc.	Condition of posted project documents at the main entrance. Looking NW.

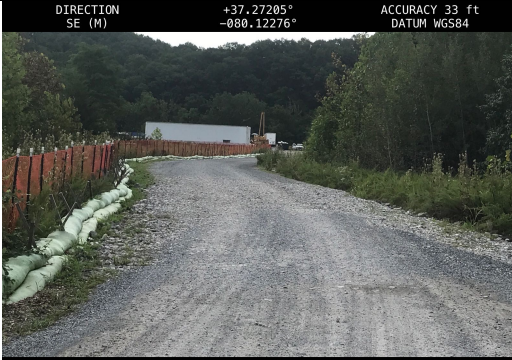
GPS Location	MVP-LY-049 See photo for gps data		GPS Location	MVP-LY-049 See photo for gps data	
Field Station#	+0		Field Station#	+0	
Pic 1 Desc.	Condition of rock entrance on center drive. No sediment on stone. Looking SE.		Pic 2 Desc.	Condition of containment under light plant. Holding some stormwater. Looking SW.

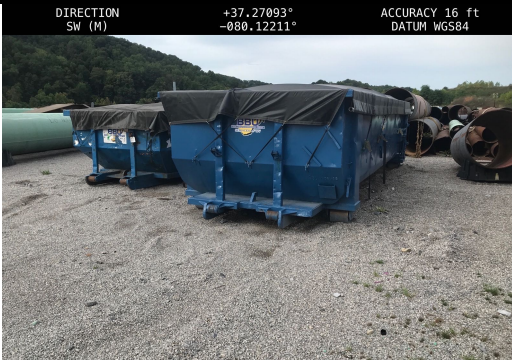
GPS Location	MVP-LY-049 See photo for gps data		GPS Location	MVP-LY-049 See photo for gps data	
Field Station#	+0		Field Station#	+0	
Pic 3 Desc.	No fluids or deposits around hazardous waste dumpsters. Looking SW.		Pic 4 Desc.	Condition of triple stack compost filter sock and safety fence along east side of center drive. Looking N.

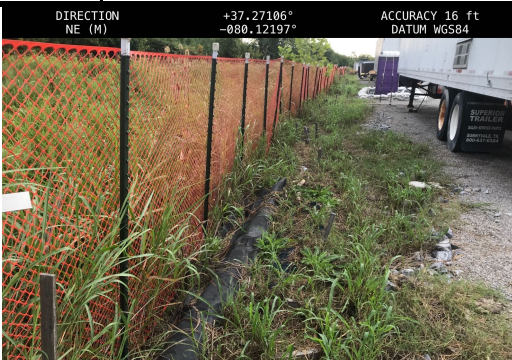
GPS Location	MVP-LY-049 See photo for gps data		GPS Location	MVP-LY-049 See photo for gps data	
Field Station#	+0		Field Station#	+0	
Pic 5 Desc.	Condition of triple stack compost filter sock and safety fence along north LOD. Looking NE.		Pic 6 Desc.	Condition of trays and containment under toilets. Looking N.

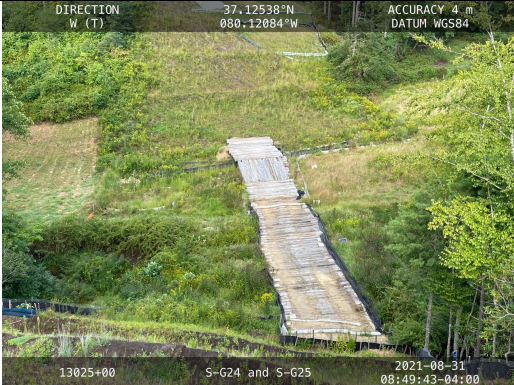
GPS Location	See photo		GPS Location	See photo	
Field Station#	13025+00		Field Station#	13028+00	
Pic 1 Desc.	Equipment Bridge over Streams S-G24 and S-G25		Pic 2 Desc.	Current ROW conditions. ROW is stable.

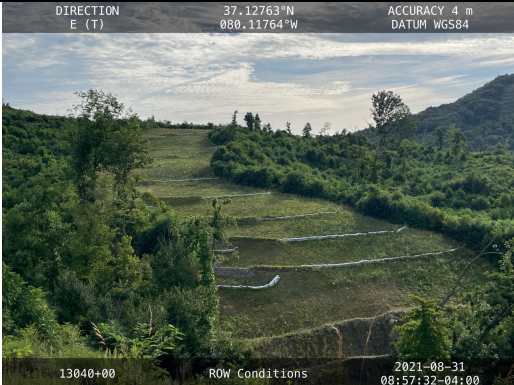
GPS Location	See photo		GPS Location	See photo	
Field Station#	13040+00		Field Station#	13041+00	
Pic 3 Desc.	Current ROW conditions. ROW is stable. Permanent ECDS are functional.		Pic 4 Desc.	Equipment Bridge over Stream S-H1

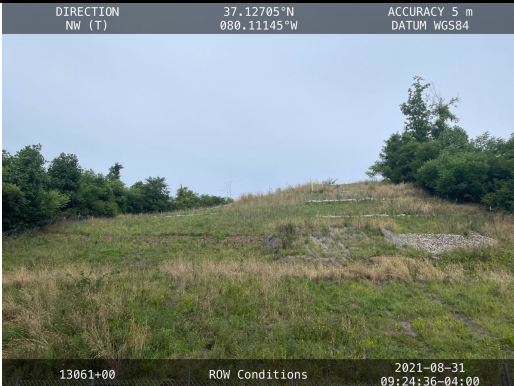
GPS Location	See photo		GPS Location	See photo	
Field Station#	13061+00		Field Station#	13061+89	
Pic 5 Desc.	Current ROW conditions. ROW is stable. Permanent ECDS are functional.		Pic 6 Desc.	Upstream photo of Stream S-G26

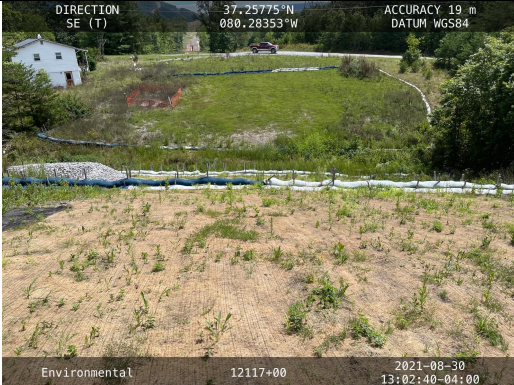
<p>DIRECTION SE (T) 37.25775°N 080.28353°W ACCURACY 19 m DATUM WGS84</p> <p>Environmental 12117+00 2021-08-30 13:02:40-04:00</p>

<p>DIRECTION E (T) 37.25782°N 080.28477°W ACCURACY 10 m DATUM WGS84</p> <p>Environmental 12112+13 2021-08-30 13:00:02-04:00</p>			
GPS Location	See photo		GPS Location	See photo	
Field Station#	12117+00		Field Station#	12112+13	
Pic 1 Desc.	Stabilized Row in acceptable condition		Pic 2 Desc.	Bridge and ECDs crossing stream S-F16A/B in acceptable condition

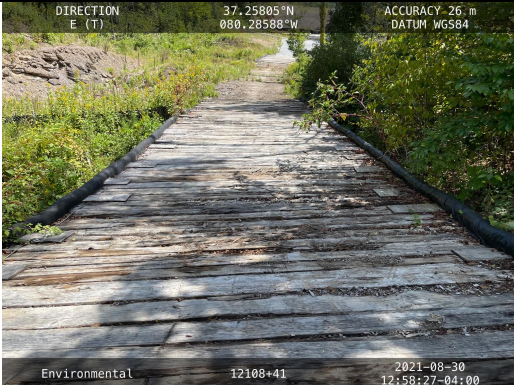
<p>DIRECTION E (T) 37.25805°N 080.28588°W ACCURACY 26 m DATUM WGS84</p> <p>Environmental 12108+41 2021-08-30 12:58:27-04:00</p>

Pic 3 Desc.	Bridge and ECDs at stream crossing S-F15 in acceptable condition		Pic 4 Desc.	Bridge and ECDs crossing stream S-MM11 in acceptable condition

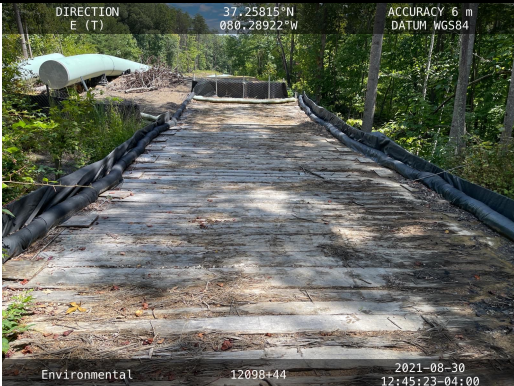
<p>DIRECTION E (T) 37.25815°N 080.28922°W ACCURACY 6 m DATUM WGS84</p> <p>Environmental 12098+44 2021-08-30 12:45:23-04:00</p>

<p>DIRECTION W (T) 37.25825°N 080.28908°W ACCURACY 19 m DATUM WGS84</p> <p>Environmental 12098+00 2021-08-30 12:45:12-04:00</p>			
GPS Location	See photo		GPS Location	See photo	
Field Station#	12098+44		Field Station#	12098+00	
Pic 5 Desc.	Bridge and ECDs at stream crossing S-MM13 in acceptable condition		Pic 6 Desc.	Cut bank in acceptable condition

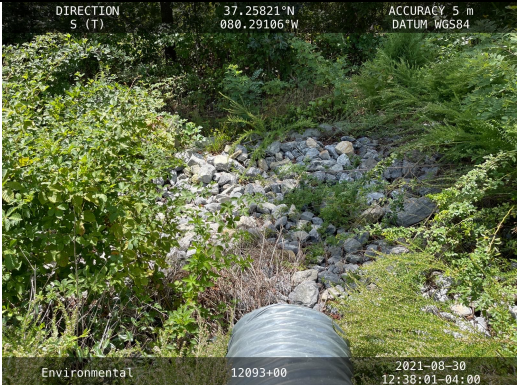
GPS Location	see photo		GPS Location	See photo	
Field Station#	12093+00		Field Station#	12086+55	
Pic 7 Desc.	Clean water crossing pipe outlet in acceptable condition		Pic 8 Desc.	Bridge and ECDs at stream crossing S-MM14 in acceptable condition

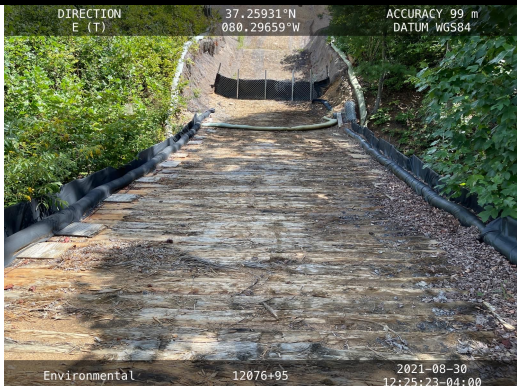
GPS Location	See photo		GPS Location	See photo	
Field Station#	12076+95		Field Station#	12070+00	
Pic 9 Desc.	Bridge and ECDs crossing stream S-MM15 in acceptable condition		Pic 10 Desc.	Stabilized slope in acceptable condition

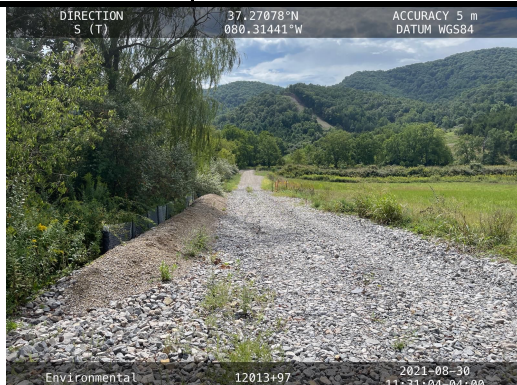
GPS Location	See photo		GPS Location	See photo	
Field Station#	12013+97		Field Station#	12007+00	
Pic 11 Desc.	Access Road MVP-MN-268.01 on acceptable condition		Pic 12 Desc.	Stabilized ATWS in acceptable condition

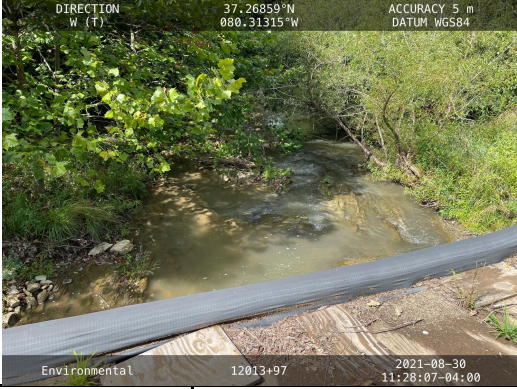
GPS Location	See photo		GPS Location	see photo	
Field Station#	12013+97		Field Station#	12013+97	
Pic 13 Desc.	Down stream of S-G36 in acceptable condition		Pic 14 Desc.	Bridge and ECDs crossing stream S-G36 in acceptable condition

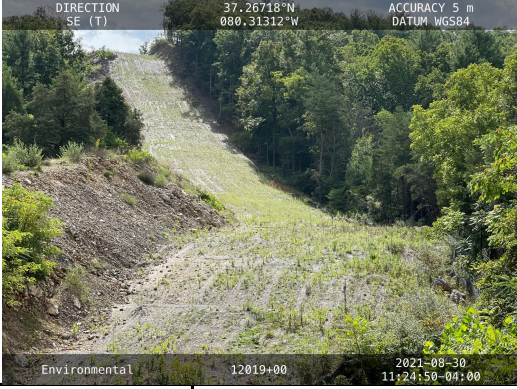
GPS Location	See photo		GPS Location	See photo	
Field Station#	12019+00		Field Station#	12015+84	
Pic 15 Desc.	Stabilized slope in acceptable condition		Pic 16 Desc.	Stream crossing S-G38 in acceptable condition

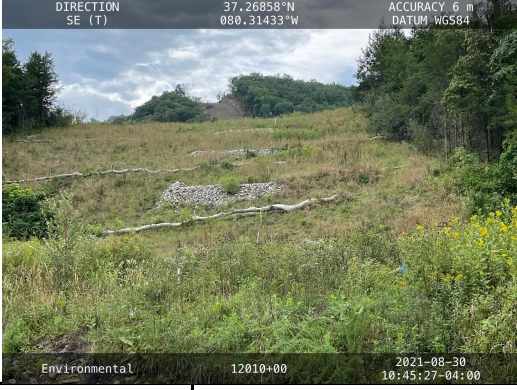
GPS Location	See photo		GPS Location	see photo	
Field Station#	12010+00		Field Station#	12008+50	
Pic 17 Desc.	Stabilized slope in acceptable condition		Pic 18 Desc.	Stream crossing S-G36 in acceptable condition

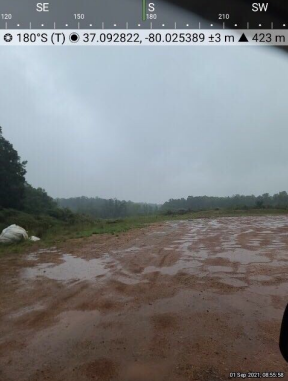
GPS Location	00000	GPS Location	0000		
Field Station#	13420+00	Field Station#	13416+20		
Pic 1 Desc.	Saturated row conditions during light rain events. No environmental issues observed at the time of inspection.		Pic 2 Desc.	Monitored ECDs on hill side during light rain events. No environmental issues observed at the time of inspection.

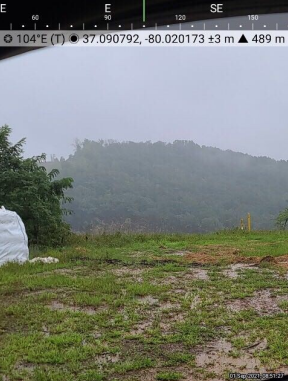
GPS Location	0000	GPS Location	0000		
Field Station#	13437+75	Field Station#	13497+12		
Pic 3 Desc.	Saturated row photo , light rain events throughout the day. No environmental issues observed at the time of inspection.		Pic 4 Desc.	Observed ECDs at stream crossing , all ECDs functioning properly during light rain events.

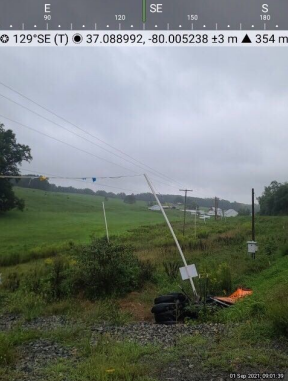
GPS Location	0000	GPS Location	0000		
Field Station#	13497+13	Field Station#	13496+72		
Pic 5 Desc.	Monitored vegetation in anode bed location , photo taken during light rain events.		Pic 6 Desc.	Row photo taken at CAHAS#2 rd crossing during light rain events. Monitored ECDs and rock lined channel. No environmental issues observed at the time of inspection.

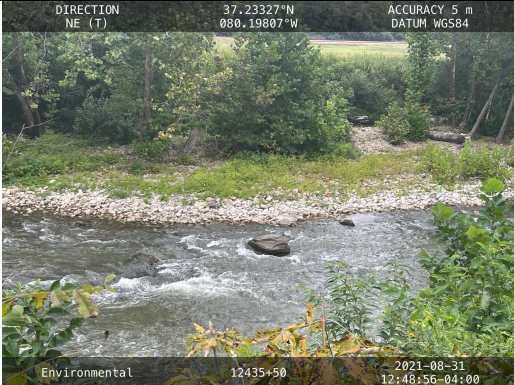
<p>DIRECTION NE (T) 37.23327°N 080.19807°W ACCURACY 5 m DATUM WGS84</p> <p>Environmental 12435+50 2021-08-31 12:48:56-04:00</p>

<p>DIRECTION W (T) 37.23328°N 080.19809°W ACCURACY 8 m DATUM WGS84</p> <p>Environmental 12437+70 2021-08-31 12:48:36-04:00</p>	
GPS Location	See photo		GPS Location	See photo	
Field Station#	12435+50		Field Station#	12437+70	
Pic 1 Desc.	Stream crossing S-NN16 in acceptable condition		Pic 2 Desc.	Stabilized slope in acceptable condition

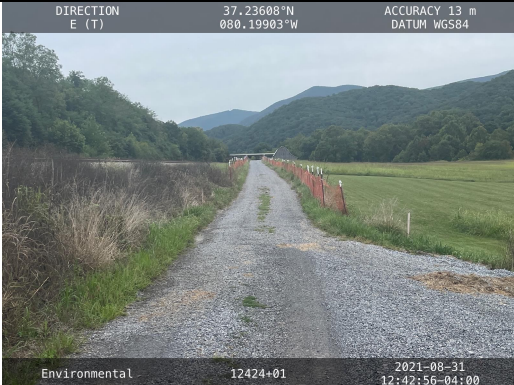
<p>DIRECTION E (T) 37.23608°N 080.19903°W ACCURACY 13 m DATUM WGS84</p> <p>Environmental 12424+01 2021-08-31 12:42:56-04:00</p>

Pic 3 Desc.	Access Road MVP-MN-279 in acceptable condition		Pic 4 Desc.	Stabilized access Road in acceptable condition

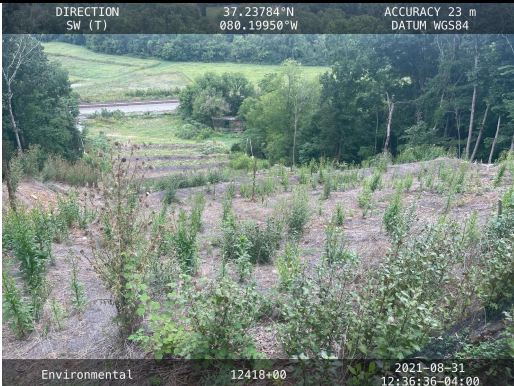
<p>DIRECTION SW (T) 37.23784°N 080.19950°W ACCURACY 23 m DATUM WGS84</p> <p>Environmental 12418+00 2021-08-31 12:36:36-04:00</p>

<p>DIRECTION SE (T) 37.23920°N 080.21005°W ACCURACY 14.4 km DATUM WGS84</p> <p>Environmental 12370+00 2021-08-31 11:29:33-04:00</p>	
GPS Location	See photo		GPS Location	See photo	
Field Station#	12418+00		Field Station#	12370+00	
Pic 5 Desc.	Stabilized slope in acceptable condition		Pic 6 Desc.	Stabilized slope in acceptable condition

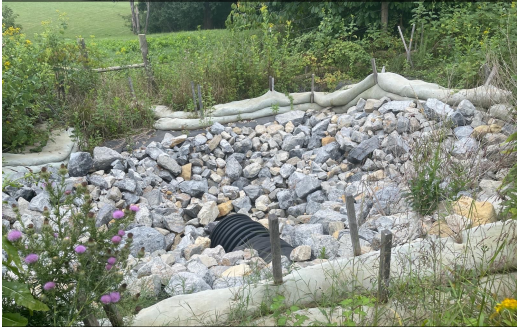
<div>Environmental12408+802021-08-31 12:31:16-04:00</div> </div>	
GPS Location	See photo		GPS Location	See photo	
Field Station#	12410+20		Field Station#	12408+80	
Pic 7 Desc.	Clean water crossing pipe outlet in acceptable condition		Pic 8 Desc.	Clean water crossing pipe inlet in acceptable condition	
<div> <div>DIRECTION SE (T)</div> <div>37.24033°N 080.20033°W</div> <div>ACCURACY 14 m DATUM WGS84</div>

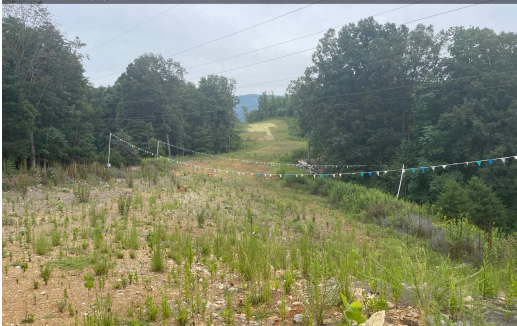
GPS Location	see photo		GPS Location	See photo	
Field Station#	12406+00		Field Station#	12393+23	
Pic 9 Desc.	Stabilized Row in acceptable condition		Pic 10 Desc.	Stabilized Row in acceptable condition	
<div> <div>DIRECTION W (T)</div> <div>37.24347°N 080.20561°W</div> <div>ACCURACY 11 m DATUM WGS84</div>

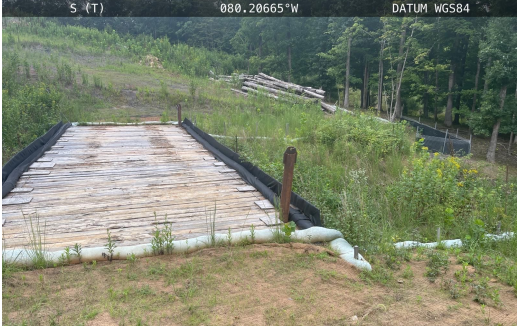
<div>Environmental12383+932021-08-31 12:16:22-04:00</div> </div>	
GPS Location	see photo		GPS Location	See photo	
Field Station#	12386+00		Field Station#	12383+93	
Pic 11 Desc.	Stabilized Row in acceptable condition		Pic 12 Desc.	Clean water crossing in acceptable condition

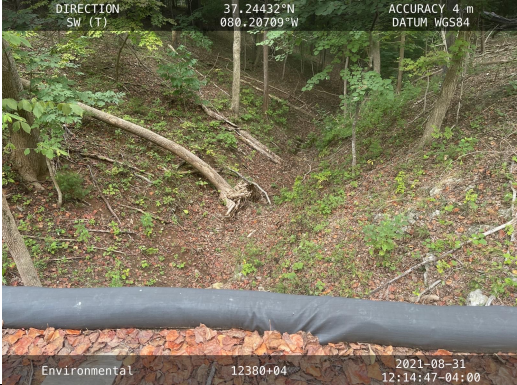
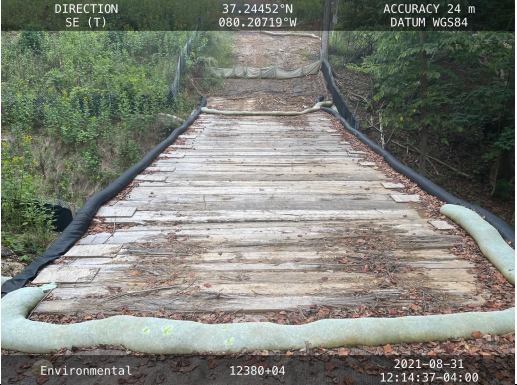
GPS Location	See photo		GPS Location	See photo	
Field Station#	12380+04		Field Station#	12380+04	
Pic 13 Desc.	Down stream of stream crossing S-NN19 in acceptable condition		Pic 14 Desc.	Bridge and ECDs crossing stream S-NN19 in acceptable condition

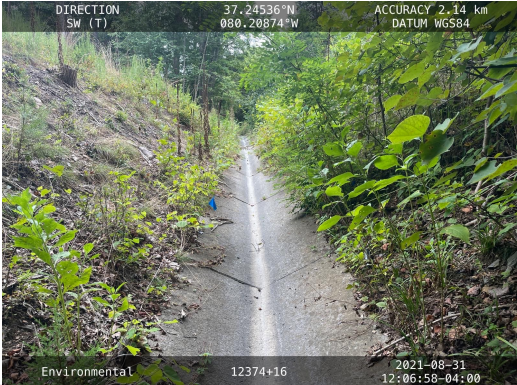
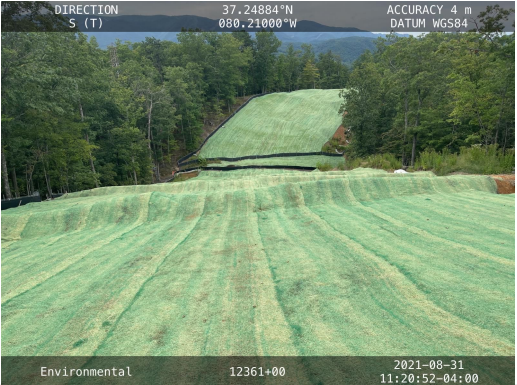
GPS Location	See photo		GPS Location	See photo	
Field Station#	12374+16		Field Station#	12361+00	
Pic 15 Desc.	Stream crossing S-OO16 in acceptable condition		Pic 16 Desc.	Stabilized Row in acceptable condition

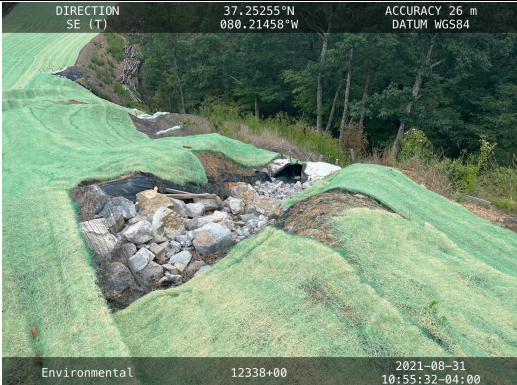
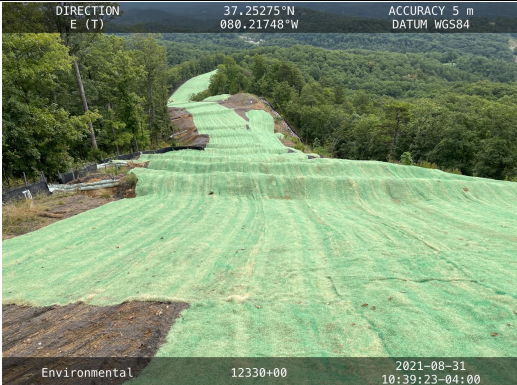
GPS Location	see photo		GPS Location	see photo	
Field Station#	12338+00		Field Station#	12330+00	
Pic 17 Desc.	Fill slope drain in acceptable condition		Pic 18 Desc.	Stabilized Row in acceptable condition

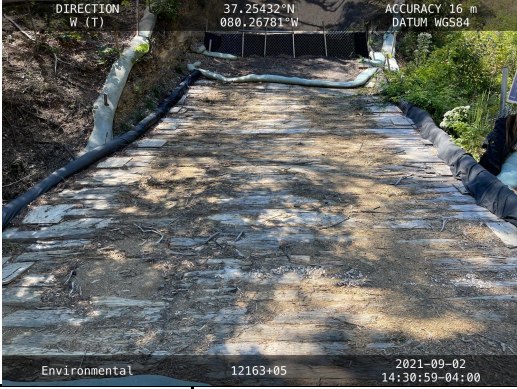
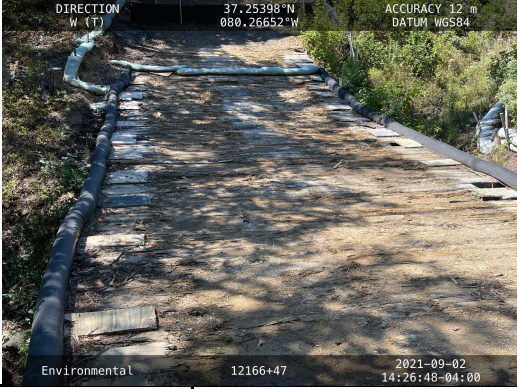
GPS Location	See photo		GPS Location	See photo	
Field Station#	12163+05		Field Station#	12166+47	
Pic 7 Desc.	Bridge and ECDs crossing stream S-C25 in acceptable condition		Pic 8 Desc.	Bridge and ECDs crossing stream S-C24 In Acceptable condition

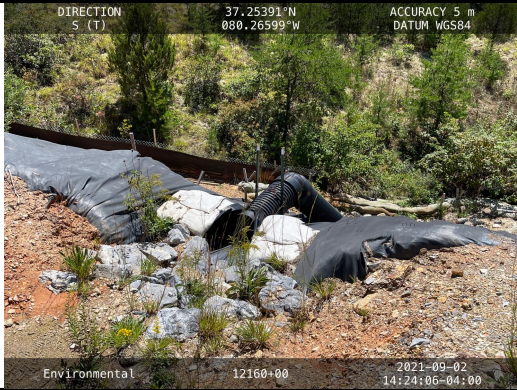
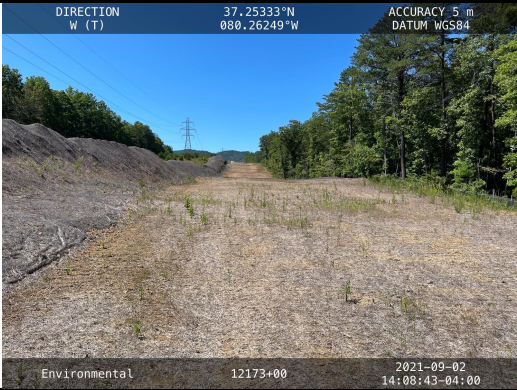
GPS Location	See photo		GPS Location	see photo	
Field Station#	12170+00		Field Station#	12173+00	
Pic 9 Desc.	Fill slope drain in acceptable condition		Pic 10 Desc.	Stabilized Row in acceptable condition

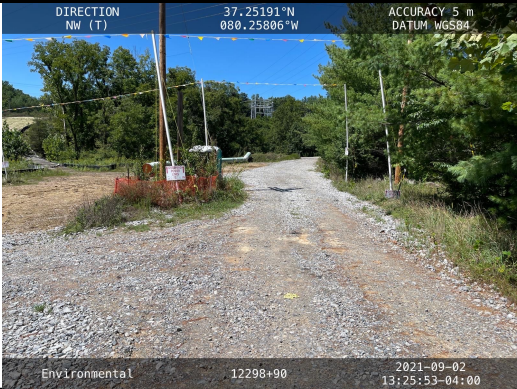
GPS Location	See photo		GPS Location	See photo	
Field Station#	12292+50		Field Station#	12298+90	
Pic 11 Desc.	Bridge and ECDs crossing stream S-C21 in acceptable condition		Pic 12 Desc.	Access Road MVP-MN-275 In Acceptable condition

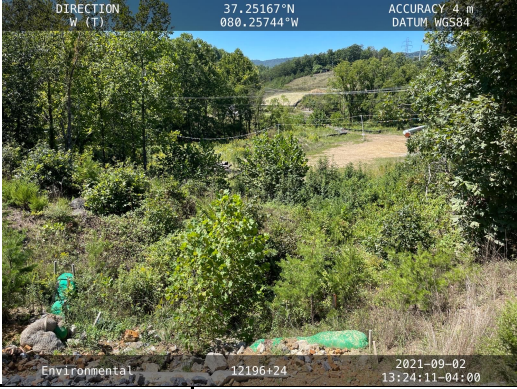
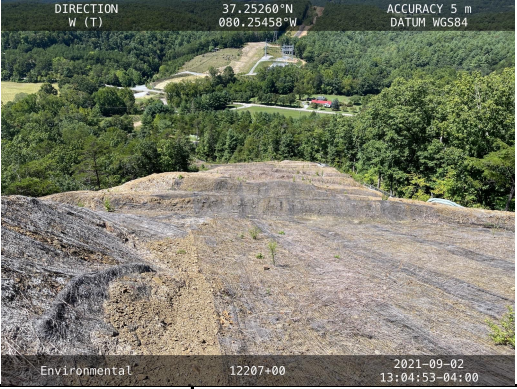
GPS Location	See photo		GPS Location	see photo	
Field Station#	12196+24		Field Station#	12207+00	
Pic 13 Desc.	Stream crossing S-0011 on the CIS of the railroad in acceptable condition		Pic 14 Desc.	Stabilized slope in acceptable condition

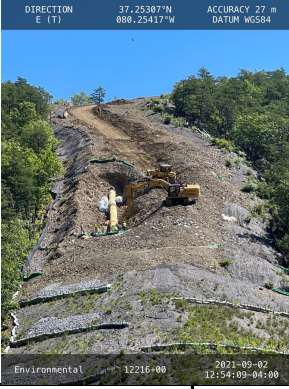
GPS Location	See photo		GPS Location	see photo	
Field Station#	12230+00		Field Station#	12216+00	
Pic 15 Desc.	ROW conditions with travel lane knocked out.		Pic 16 Desc.	Excavator padding and backfilling open ditch

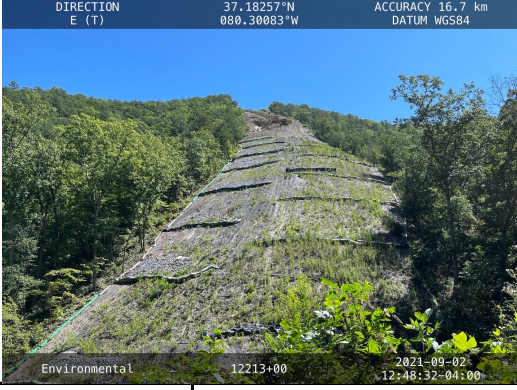
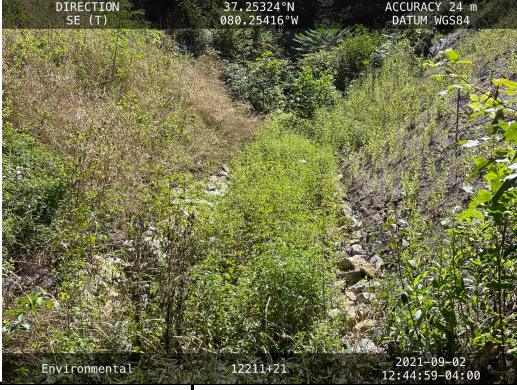
GPS Location	See photo		GPS Location	See photo	
Field Station#	12213+00		Field Station#	12211+21	
Pic 17 Desc.	Stabilized slope in acceptable condition		Pic 18 Desc.	Stabilized drainage feature in acceptable condition

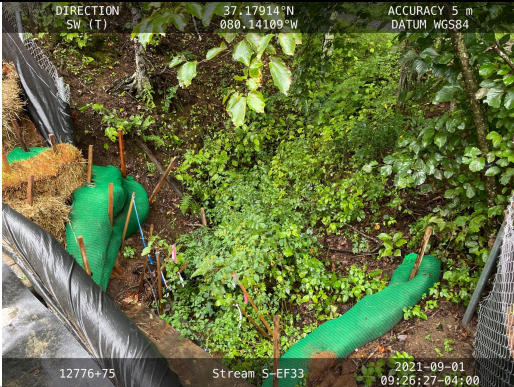
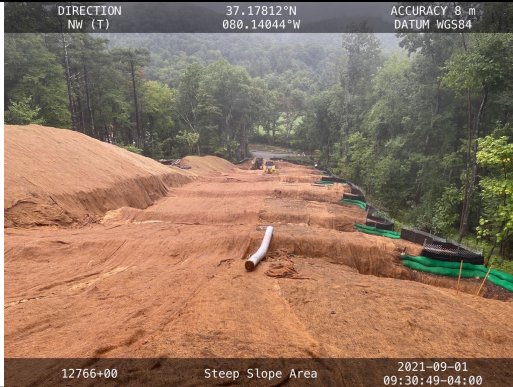
GPS Location	See photo	GPS Location	See photo		
Field Station#	12776+75	Field Station#	12766+00		
Pic 3 Desc.	Upstream photo of Stream S-EF33	Pic 4 Desc.	Current ROW conditions. Steep slope area stabilized with Curlex

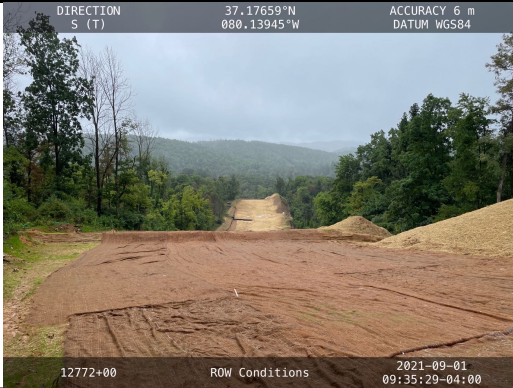
GPS Location	See photo	GPS Location	See photo		
Field Station#	12766+00	Field Station#	12772+00		
Pic 5 Desc.	Functional Sump and End Treatment	Pic 6 Desc.	Current ROW conditions. ROW is stable.

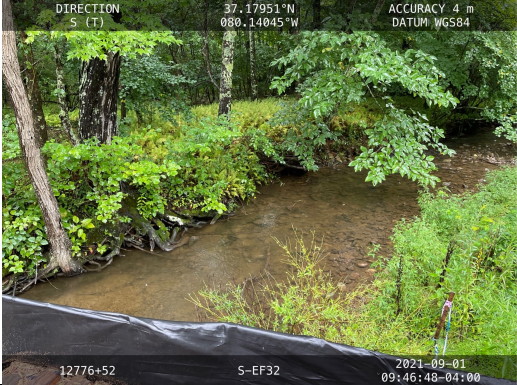
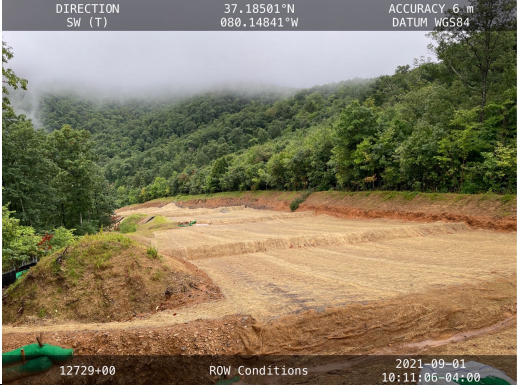
GPS Location	See photo		GPS Location	See photo	
Field Station#	12776+52		Field Station#	12729+00	
Pic 7 Desc.	Downstream photo of Stream S-EF32		Pic 8 Desc.	Current ROW conditions. ROW is stable. Waterbars are functional.

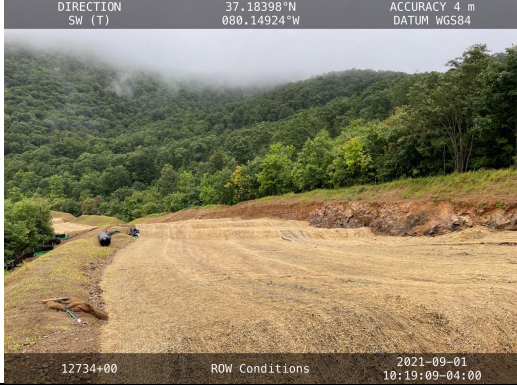
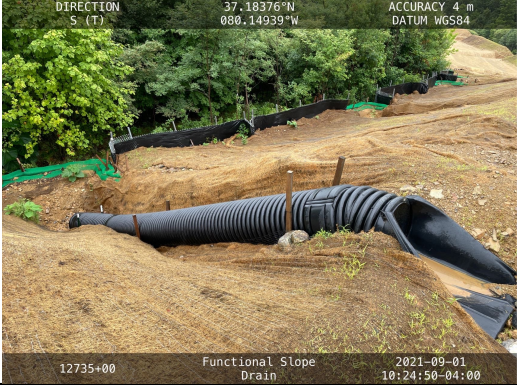
GPS Location	See photo		GPS Location	See photo	
Field Station#	12734+00		Field Station#	12735+00	
Pic 9 Desc.	Current ROW conditions. ROW is stable. Waterbars are functional.		Pic 10 Desc.	Slope Drain is functional

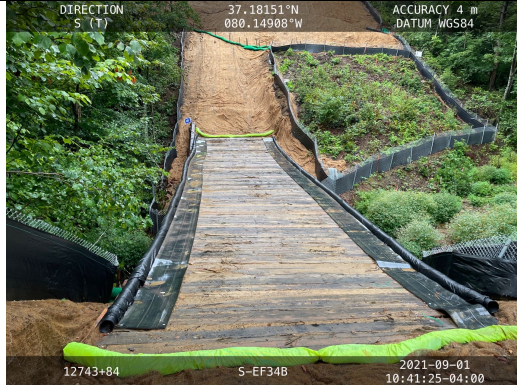
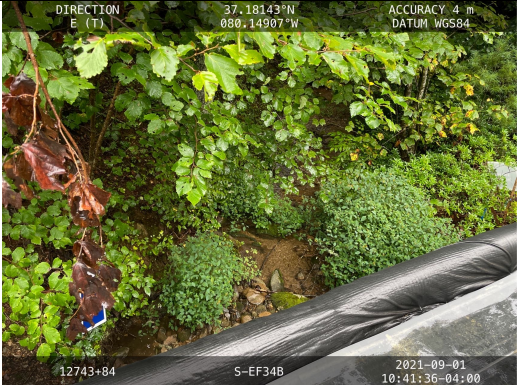
GPS Location	See photo		GPS Location	See photo	
Field Station#	12743+84		Field Station#	12743+84	
Pic 11 Desc.	Equipment Bridge over Stream S-EF34B		Pic 12 Desc.	Downstream photo of Stream S-EF34B

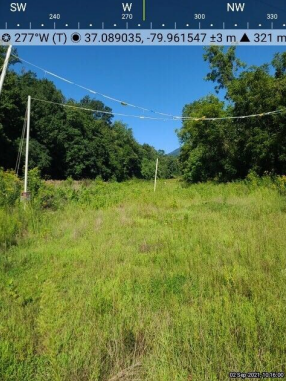
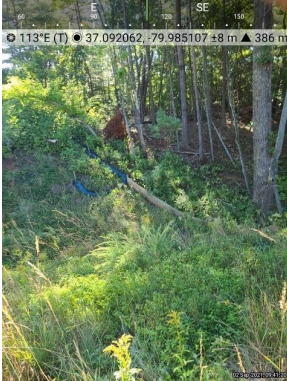
GPS Location	00000	GPS Location	0000		
Field Station#	13643+50	Field Station#	13560+00		
Pic 1 Desc.	Monitored vegetation growth up row from stream crossing. Good coverage noted.		Pic 2 Desc.	Observed ECDs along side of the LOD . All functioning properly at the time of inspection.

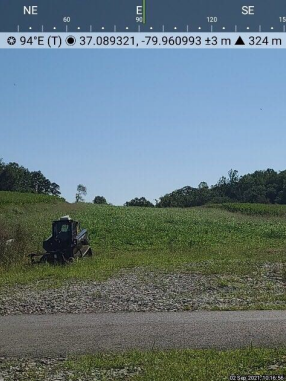
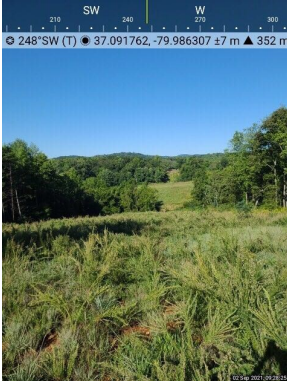
GPS Location	0000	GPS Location	0000		
Field Station#	13644+97	Field Station#	13557+00		
Pic 3 Desc.	Monitored vegetation growth in permanent area of row. Photo showing equipment parked.		Pic 4 Desc.	Vegetation observation photo in permanent area of row.

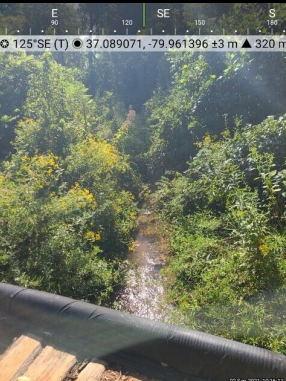
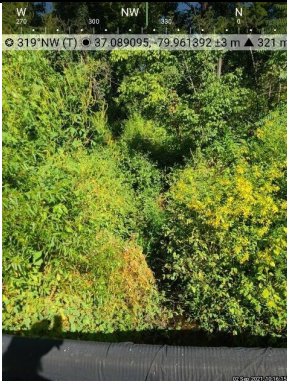
GPS Location	0000	GPS Location	0000		
Field Station#	13643+67	Field Station#	13643+67		
Pic 5 Desc.	Stream observation photo facing downstream during routine inspection today. No issues observed at the time of inspection today after recent rain events.		Pic 6 Desc.	Stream observation photo facing upstream during routine inspection today. No issues observed at the time of inspection.

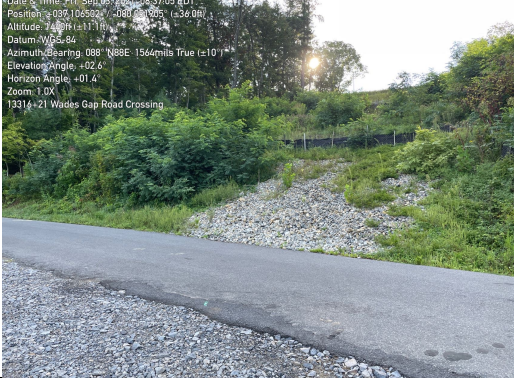
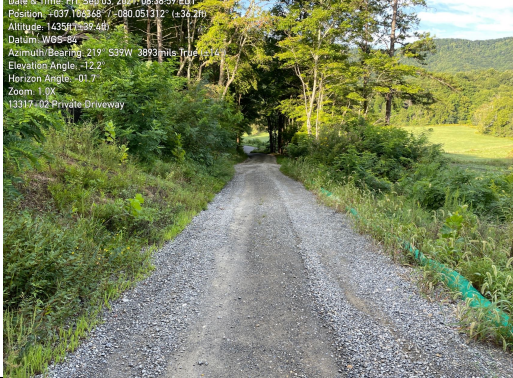
GPS Location	0	GPS Location	0		
Field Station#	13316+21	Field Station#	13317+02		
Pic 1 Desc.	Wades Gap Road Crossing in good condition and RCE in good condition and functioning properly		Pic 2 Desc.	Private Driveway in good condition	
<p>Date & Time: Fri, Sep 03, 2021 08:40:24 EDT Position: +037.106170 / -080.050320 (+38.2m) Altitude: 1500ft (+45.7m) Datum: WGS-84 Azimuth Bearing: 103° S77E 3831mils True (+10°) Elevation Angle: +23.3° Horizon Angle: -00.5° Zoom: 1.0X 13321+47 S-GH15</p>

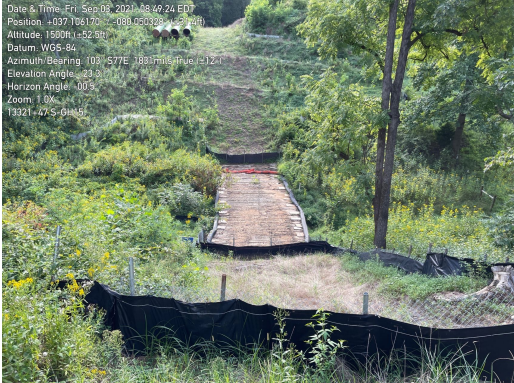
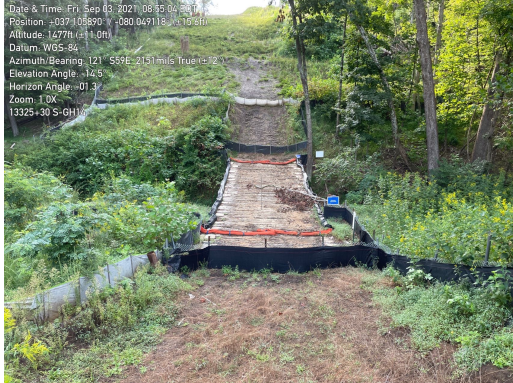
GPS Location	0	GPS Location	0		
Field Station#	13321+47	Field Station#	13325+30		
Pic 3 Desc.	MVP-S-GH15 and Corresponding buffer zone in good condition		Pic 4 Desc.	MVP-S-GH14 and Corresponding buffer zone in good condition	
<p>Date & Time: Fri, Sep 03, 2021 09:01:38 EDT Position: +037.103379 / -080.047928 (+38.2m) Altitude: 1523ft (+46.3m) Datum: WGS-84 Azimuth Bearing: 101° N55W 5561mils True (+10°) Elevation Angle: +13.0° Horizon Angle: -02.3° Zoom: 1.0X 13330+00</p>

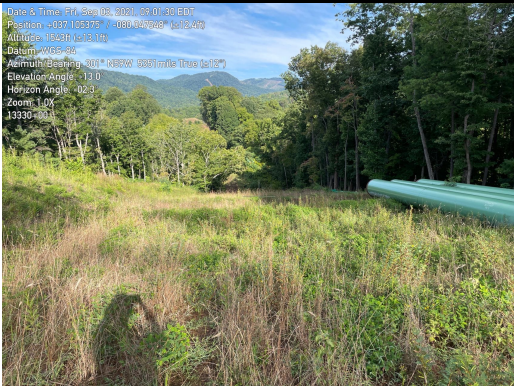
GPS Location	0	GPS Location	0		
Field Station#	13330+00	Field Station#	13334+17		
Pic 5 Desc.	ROW and ECDs in good condition with vegetation established across ROW		Pic 6 Desc.	MVP-S-GH11 and Corresponding buffer zone in good condition

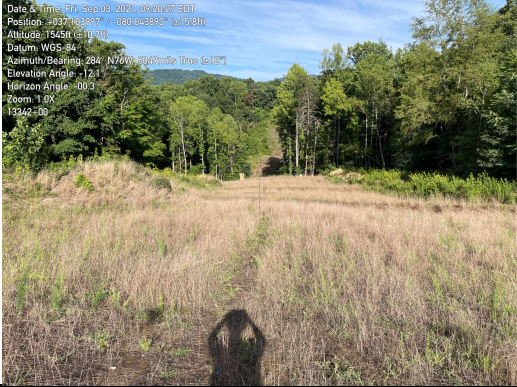
GPS Location	0	GPS Location	0		
Field Station#	13342+00	Field Station#	13342+67		
Pic 7 Desc.	ROW and ECDs in good condition with vegetation established across ROW		Pic 8 Desc.	Webster Corner Road Crossing in good condition and RCE is in good condition and functioning properly	
<p>Date & Time: Fri Sep 03 2021 09:24:47 EDT Position: +037.104072, +080.042468 (+12.11) Altitude: 1520ft (+11.7m) Datum: WGS-84 Azimuth/Bearing: 187° S07W 3324mils True (+12°) Elevation Angle: -20.0° Horizon Angle: +01.7° Zoom: 1.0X 13345+50</p>

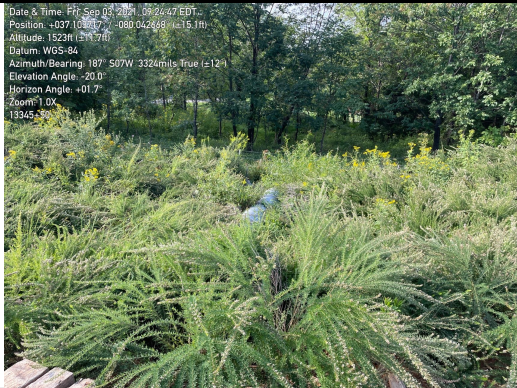
GPS Location	0	GPS Location	0		
Field Station#	13345+50	Field Station#	13348+46		
Pic 9 Desc.	Clean water diversion pipe in good condition		Pic 10 Desc.	MVP-S-RR08 and Corresponding buffer zone in good condition	
<p>Date & Time: Fri Sep 03 2021 09:27:57 EDT Position: +037.102882, +080.041238 (+12.11) Altitude: 1482ft (+11.7m) Datum: WGS-84 Azimuth/Bearing: 163° S37E 2542mils True (+12°) Elevation Angle: -11.7° Horizon Angle: +00.2° Zoom: 1.0X 13352+23 S-RR02</p>

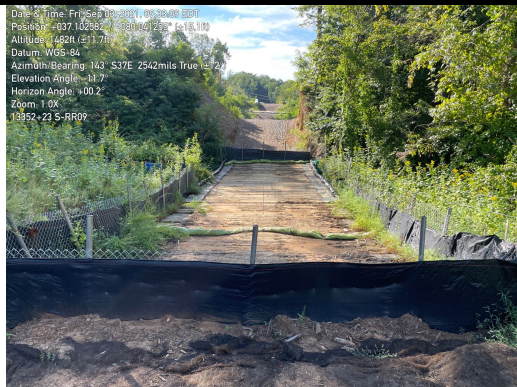
GPS Location	0	GPS Location	0		
Field Station#	13352+23	Field Station#	13355+33		
Pic 11 Desc.	MVP-S-RR08 and Corresponding buffer zone in good condition		Pic 12 Desc.	Gun Club Road in good condition

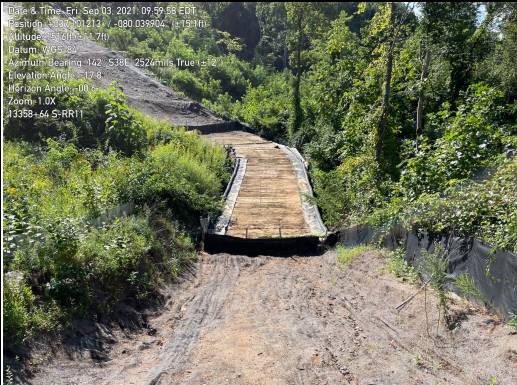
GPS Location		0		GPS Location		0					
Field Station#		13358+64		Field Station#		13370+00					
Pic 13 Desc.		MVP-S-RR11 and Corresponding buffer zone in good condition				Pic 14 Desc.		ROW and ECDs in good condition and stable			
<p>Date & Time: Fri, Sep 03, 2021, 10:47:10 EDT Position: +43.024448 / -69.024448 / +11.8ft Altitude: 1501ft (+2.1ft) Datum: WGS-84 Azimuth/Bearing: 108.5142 / 199mils True (+13.1) Elevation Angle: -00.4 Horizon Angle: -00.4 Zoom: 1.0X 13387+65</p>

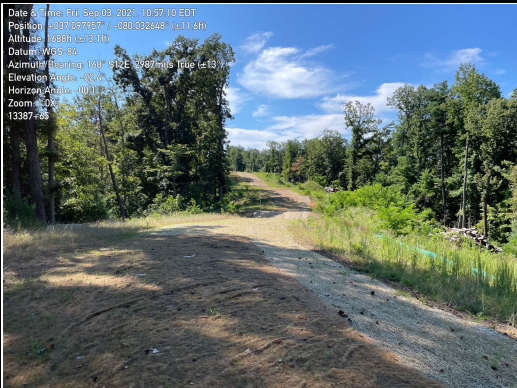
GPS Location		0		GPS Location		0					
Field Station#		13387+65		Field Station#		13403+50					
Pic 15 Desc.		ROW and ECDs in good condition and stable				Pic 16 Desc.		ROW and ECDs in good condition and stable			
<p>Date & Time: Fri, Sep 03, 2021, 11:34:39 EDT Position: +43.010933 / -69.028131 / +14.0ft Altitude: 1457ft (+3.4ft) Datum: WGS-84 Azimuth/Bearing: 112.5885 / 199mils True (+12.1) Elevation Angle: +21.1 Horizon Angle: -00.4 Zoom: 1.0X 13413+05</p>

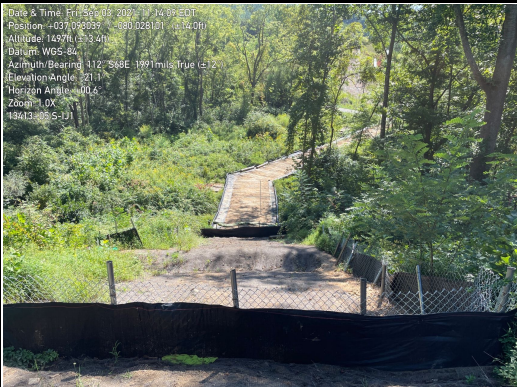
GPS Location		0		GPS Location		0					
Field Station#		13413+05		Field Station#		13415+51					
Pic 17 Desc.		MVP-S-IJ1 and Corresponding buffer zone in good condition				Pic 18 Desc.		RCE in good condition and functioning properly

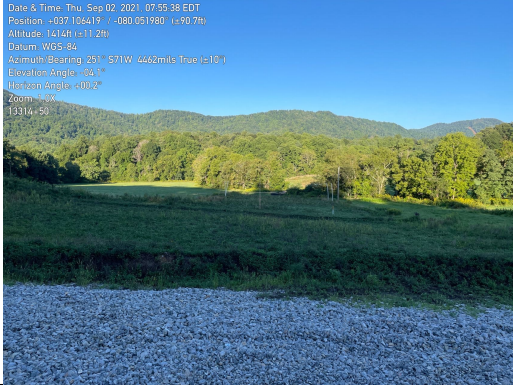
GPS Location				0				GPS Location				0			
Field Station#				13314+50				Field Station#				13262+62			
Pic 1 Desc.				ROW and ECDs in good condition and vegetation established across ROW				Pic 2 Desc.				Flanders Road Crossing in good condition			
<p>Date & Time: Thu, Sep 02, 2021, 08:22:35 EDT Position: +037 115651 / -080 059959 (+15.6m) Altitude: 1445ft (+15.6m) Datum: WGS-84 Azimuth/Bearing: 252° 58'20W 4458mils True (+13.1) Elevation Angle: +04.6° Horizon Angle: +02.0° Zoom: 1.0x 13260+66 S-II4</p>

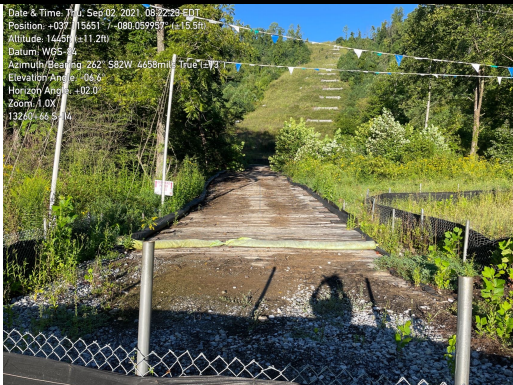
GPS Location				0				GPS Location				0			
Field Station#				13260+66				Field Station#				13259+00			
Pic 3 Desc.				MVP-S-II4 and Corresponding buffer in good condition				Pic 4 Desc.				ROW and ECDs in good condition and vegetation established across ROW			
<p>Date & Time: Thu, Sep 02, 2021, 08:34:50 EDT Position: +037 115245 / -080 063096 (+11.6ft) Altitude: 1322ft (+13.1ft) Datum: WGS-84 Azimuth/Bearing: 273° 14'57W 4853mils True (+13.1) Elevation Angle: +08.4° Horizon Angle: +06.5° Zoom: 1.0x 13253+00</p>

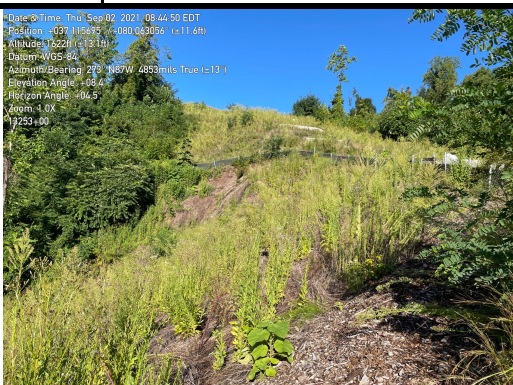
GPS Location				0				GPS Location				0			
Field Station#				13253+00				Field Station#				13249+00			
Pic 5 Desc.				Slip observed to be stable, no notable changes, vegetation established				Pic 6 Desc.				ROW and ECDs in good condition and vegetation established across ROW

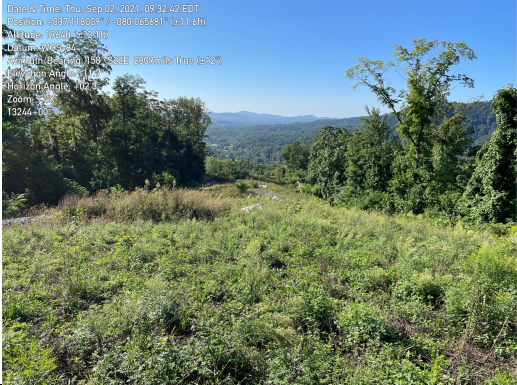
GPS Location 0		GPS Location 0			
Field Station# 13244+00		Field Station# 13229+00			
Pic 7 Desc. ROW and ECDs in good condition and vegetation established across ROW		Pic 8 Desc. ROW and ECDs in good condition and vegetation established across ROW			
<p>Date & Time: Thu, Sep 02, 2021 09:57:07 EDT Position: +037.1223607, -080.0712961 (+11.6ft) Altitude: 1763ft (+9.7ft) Datum: WGS 84 Azimuth Bearing: 369° N11W 6204mils True (+12°) Elevation Angle: +19.6° Horizon Angle: +02.1° Zoom: 10X 13209+50</p>

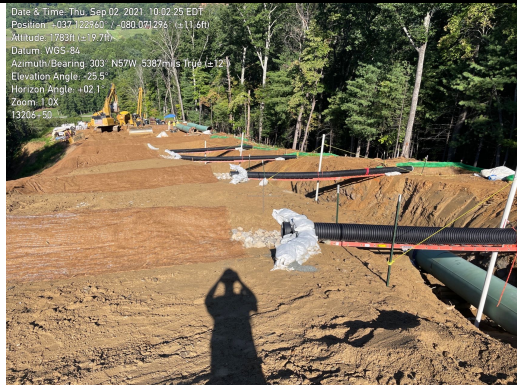
GPS Location 0		GPS Location 0			
Field Station# 13206+50		Field Station# 13200+00			
Pic 11 Desc. Temporary waterbar pipes put in over trench prior to hurricane, worked as designed and in good condition		Pic 12 Desc. ROW and ECDs in good condition and ROW is stable

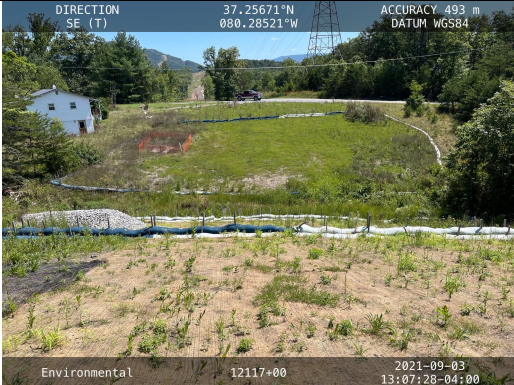
GPS Location	See photo		GPS Location	See photo	
Field Station#	12117+00		Field Station#	12112+13	
Pic 1 Desc.	Stabilized Row in acceptable condition		Pic 2 Desc.	Bridge and ECDs crossing stream S-F16A/B in acceptable condition

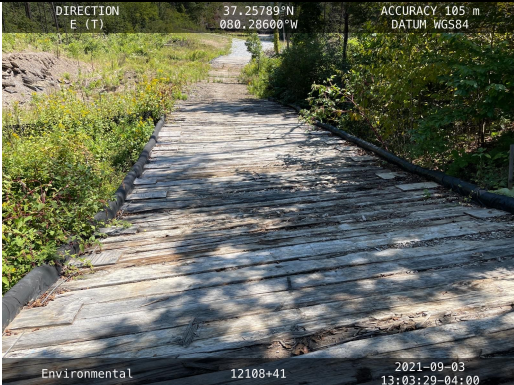
GPS Location	See photo		GPS Location	See photo	
Field Station#	12108+41		Field Station#	12101+57	
Pic 3 Desc.	Bridge and ECDs crossing stream S-F15 in acceptable condition		Pic 4 Desc.	Bridge and ECDs crossing stream S-MM11 in acceptable condition

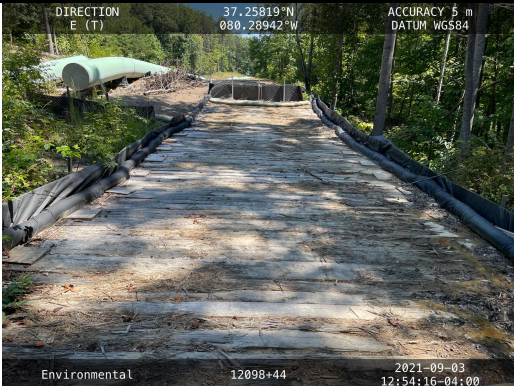
GPS Location	See photo		GPS Location	See photo	
Field Station#	12098+44		Field Station#	12098+00	
Pic 5 Desc.	Bridge and ECDs crossing stream S-MM13 in acceptable condition		Pic 6 Desc.	Stabilized cut bank in acceptable condition

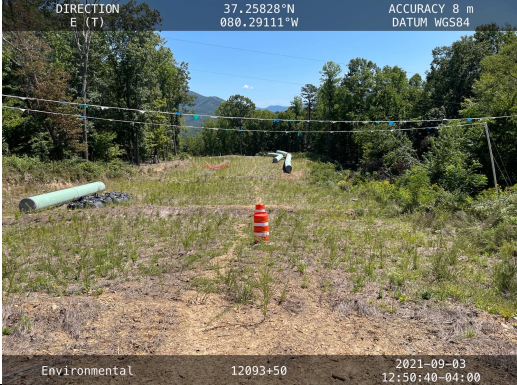
GPS Location	See photo		GPS Location	See photo	
Field Station#	12093+50		Field Station#	12093+00	
Pic 7 Desc.	Stabilized ROW in acceptable condition		Pic 8 Desc.	Clean water crossing pipe outlet in acceptable condition

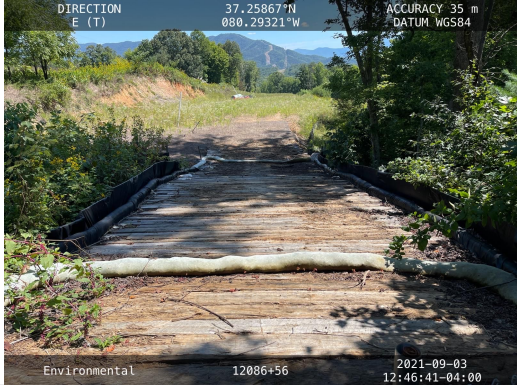
GPS Location	See photo		GPS Location	See photo	
Field Station#	12086+56		Field Station#	12088+50	
Pic 9 Desc.	Bridge and ECDs crossing stream S-MM14 in acceptable condition		Pic 10 Desc.	Stabilized Row in acceptable condition
