Visual Site Inspection Report

Project Name	H-600 Pipeline Spread H	AFE	124300138	Spread	H-600 Pipeline Spread H
Contractor	Precision			Report #	27870
Inspector	Jonathan Altizer			Date/Time	8/30/2021 3:48 PM
Permit #	TBD	Inspection Type	VA SWPP	Station Begin	12868+00
State	VA	Inspection Area	Partial	Station End	13024+00
County	Roanoke	Ground	Damp	Temperature (°F)	84.00
Municipality	N/A	Weather	Sunny	Rain Gauge (in)	0.10
				Rain Accumulation Time (days)	2.00

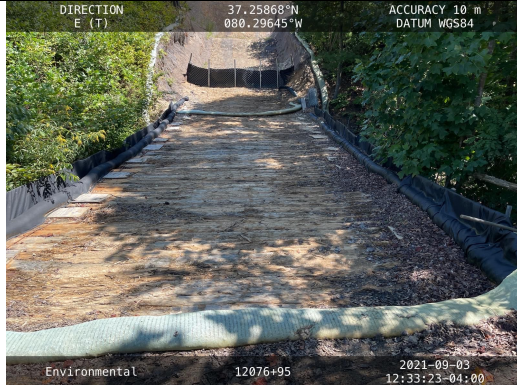
GPS Location	See photo		GPS Location	See photo	
Field Station#	12076+95		Field Station#	12074+00	
Pic 11 Desc.	Bridge and ECDs crossing stream S-MM15 in acceptable condition		Pic 12 Desc.	Stabilized Row in acceptable condition

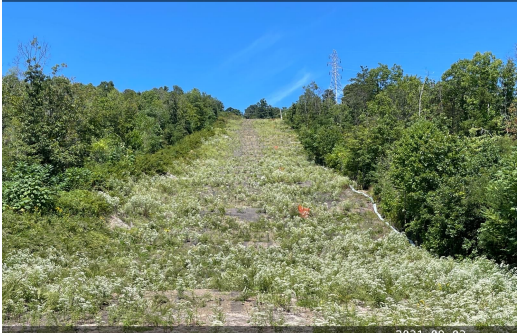
Environmental 12013+97 2021-09-03 11:43:40-04:00			
GPS Location	See photo		GPS Location	See photo	
Field Station#	12069+00		Field Station#	12013+97	
Pic 13 Desc.	Stabilized slope in acceptable condition		Pic 14 Desc.	Access Road MVP-MN-268.01 in acceptable condition	
DIRECTION NE (T) 37.26873°N 080.31524°W ACCURACY 5 m DATUM WGS84

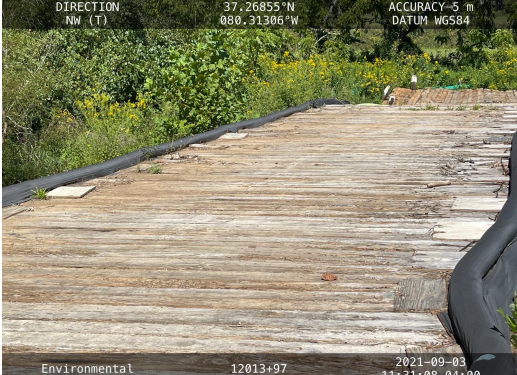
Environmental 12008+50 2021-09-03 11:34:46-04:00			
GPS Location	See photo		GPS Location	See photo	
Field Station#	12005+00		Field Station#	12008+50	
Pic 15 Desc.	Stabilized Row in acceptable condition		Pic 16 Desc.	Stream crossing S-G36 in acceptable condition

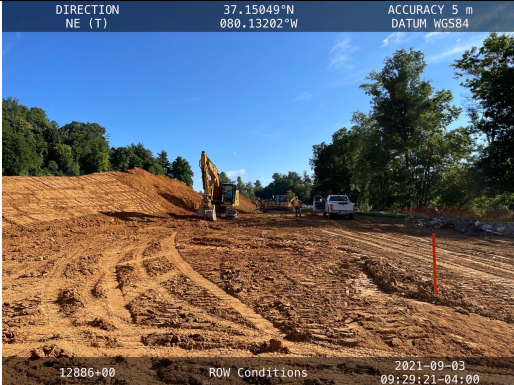
GPS Location	See photo		GPS Location	See photo	
Field Station#	12886+00		Field Station#	12886+75	
Pic 1 Desc.	Current ROW conditions. Grade Crew actively working. ROW is stable.		Pic 2 Desc.	Equipment Bridge over W-KL49 well maintained.

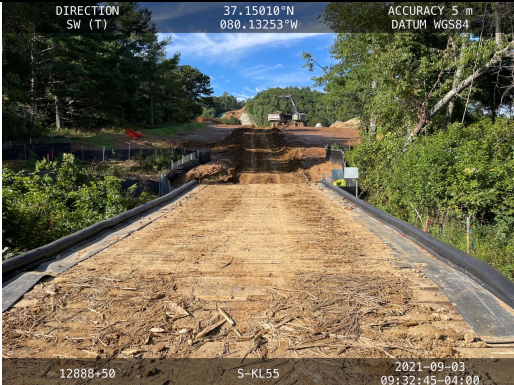
GPS Location	See photo		GPS Location	See photo	
Field Station#	12888+50		Field Station#	12888+50	
Pic 3 Desc.	Equipment Bridge over Stream S-KL55 is well maintained.		Pic 4 Desc.	Downstream photo of Stream S-KL55

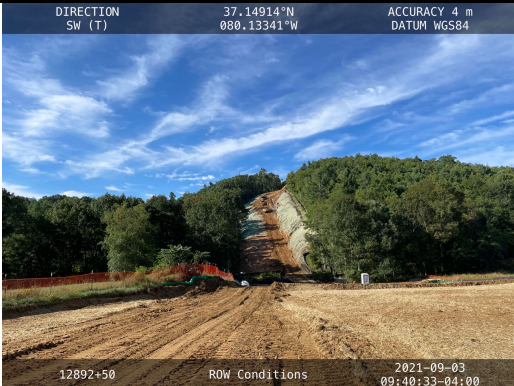
GPS Location	See photo		GPS Location	See photo	
Field Station#	12892+50		Field Station#	12895+92	
Pic 5 Desc.	Current ROW conditions. ROW is stable.		Pic 6 Desc.	Downstream photo of Stream S-IJ12

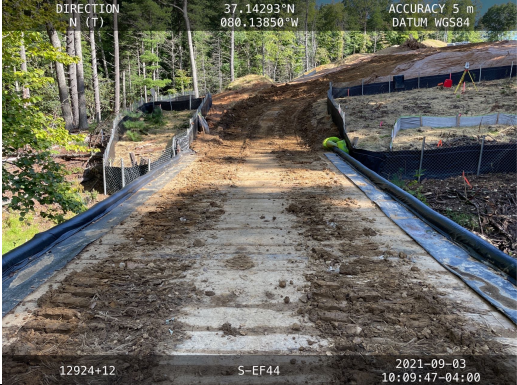
GPS Location	See photo		GPS Location	See photo	
Field Station#	12924+12		Field Station#	12924+12	
Pic 7 Desc.	Equipment Bridge over Stream S-EF44		Pic 8 Desc.	Downstream photo of Stream S-EF44

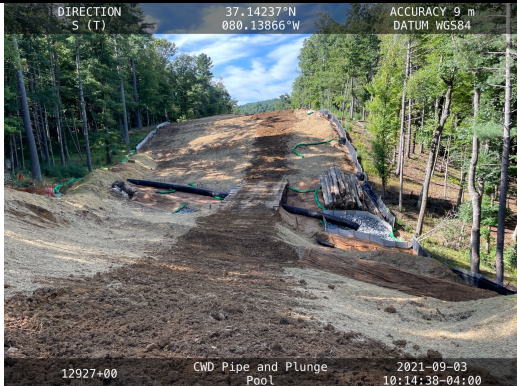
GPS Location	See photo		GPS Location	See photo	
Field Station#	12927+00		Field Station#	12958+00	
Pic 9 Desc.	CWD Pipe and Plunge Pool are functional		Pic 10 Desc.	Stream S-Y8 flowing free and clear of sediment.

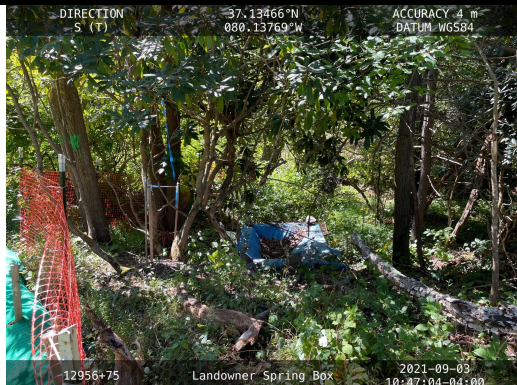
GPS Location	See photo		GPS Location	See photo	
Field Station#	12956+75		Field Station#	12957+38	
Pic 11 Desc.	Landowner Spring Box is undisturbed		Pic 12 Desc.	Downstream photo of Stream S-Z17

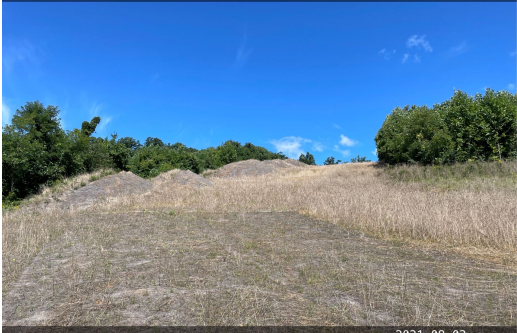
12973+00 ROW Conditions 2021-09-03 11:27:10-04:00		12976+00 CWD Pipe and Plunge Pool 2021-09-03 11:26:08-04:00			
GPS Location	See photo		GPS Location	See photo	
Field Station#	12973+00		Field Station#	12976+00	
Pic 13 Desc.	Current ROW conditions. ROW is stable.		Pic 14 Desc.	CWD Pipe is functional. ROW is stable.	
DIRECTION SW (T) 37.12994°N 080.13628°W ACCURACY 5 m DATUM WGS84

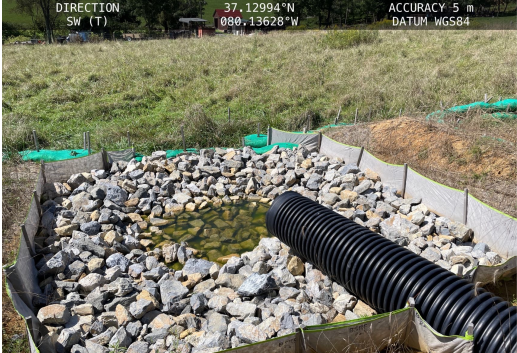
12976+00 CWD Plunge Pool 2021-09-03 11:28:54-04:00		12995+00 ROW Conditions 2021-09-03 11:54:08-04:00			
GPS Location	See photo		GPS Location	See photo	
Field Station#	12976+00		Field Station#	12995+00	
Pic 15 Desc.	CWD Plunge Pool is functional and maintained.		Pic 16 Desc.	Current ROW conditions. ROW is stable.

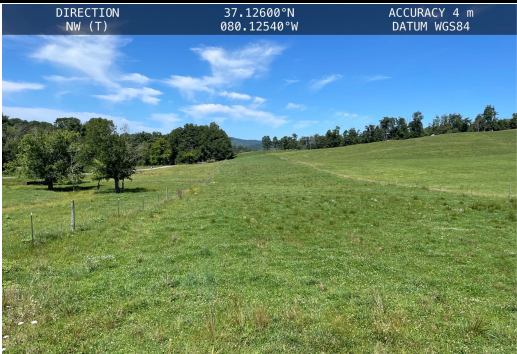
13012+00 ROW Conditions 2021-09-03 11:57:54-04:00		13018+00 ROW Conditions 2021-09-03 12:25:03-04:00			
GPS Location	See photo		GPS Location	See photo	
Field Station#	13012+00		Field Station#	13018+00	
Pic 17 Desc.	Current ROW conditions. ROW is stable.		Pic 18 Desc.	Current ROW conditions. ROW is stable.
