Visual Site Inspection Report

| Project Name | H-600 Pipeline Spread H | AFE | 124300138 | Spread | H-600 Pipeline Spread H |
| Permit # | TBD | Inspection Type | VA SWPP | Station Begin | +0 |

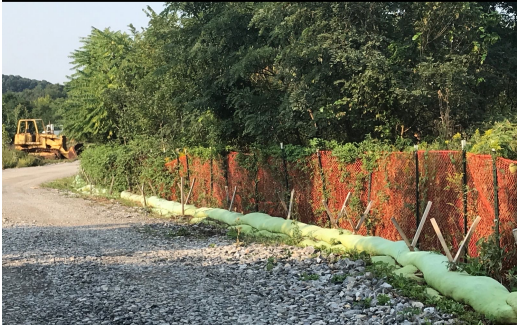
| MVP-LY-049_091321 Condition of CFS & safety fence 2021-09-13 09:05:13-04:00 | | MVP-LY-049_091321 Condition of CFS & safety fence 2021-09-13 09:06:10-04:00 | | | |
| Pic 7 Desc. | Condition of triple compost filter sock and safety fence along north LOD. Looking NW. | | Pic 8 Desc. | Condition of triple stack compost filter sock and safety fence along north LOD. Looking W. | |

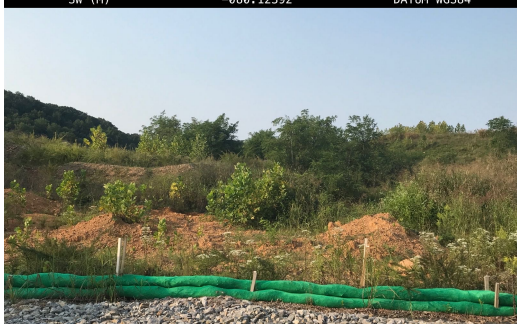
| MVP-LY-049_091321 Landowner soil disturbance along CFS 2021-09-13 09:06:56-04:00 | | MVP-LY-049_091321 Landowner disturbance along feature 2021-09-13 09:07:33-04:00 | | | |
| Pic 9 Desc. | Landowner soil disturbance along triple stack compost filter sock. No new damage to installed ECD's. Looking SW. | | Pic 10 Desc. | Landowner soil disturbance along feature W-CV21A. Area not stabilized. Looking NW. | |

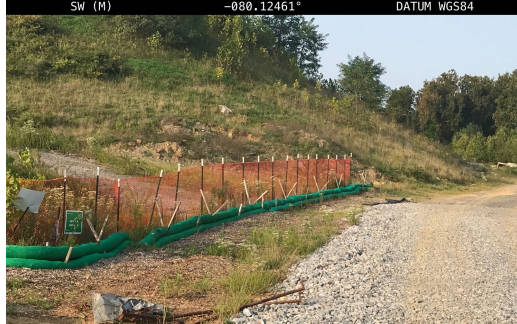
| MVP-LY-049_091321 Landowner disturbance west of feature 2021-09-13 09:08:00-04:00 | | MVP-LY-049_091321 Landowner disturbance & debris along CFS 2021-09-13 09:08:08-04:00 | | | |

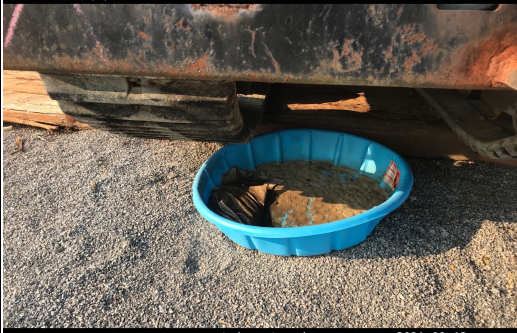
| MVP-LY-049_091321 | | containment under stored equipment | | 2021-09-13 09:09:12-04:00 | |
| Pic 13 Desc. | | Condition of containment under stored equipment. Looking SW. | | | |

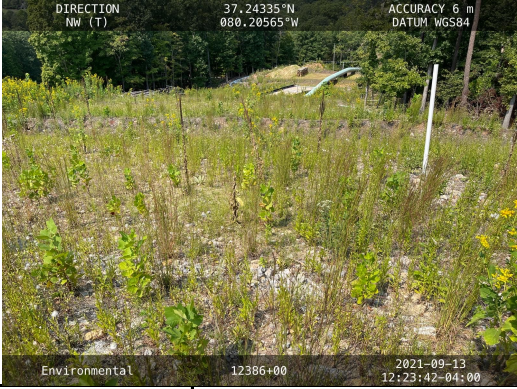
| Field Station# | 12386+00 | | Field Station# | 12383+93 | |

| Pic 7 Desc. | Stabilized Row in acceptable condition | | Pic 8 Desc. | Clean water crossing in acceptable condition | |

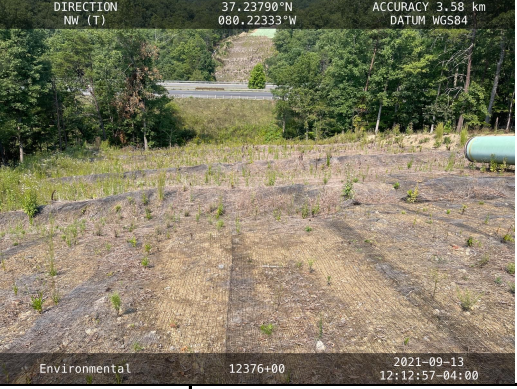
| Field Station# | 12380+04 | | Field Station# | 12376+00 | |

| Pic 9 Desc. | Bridge and ECDs crossing stream S-NN19 in acceptable condition | | Pic 10 Desc. | Stabilized Row in acceptable condition | |

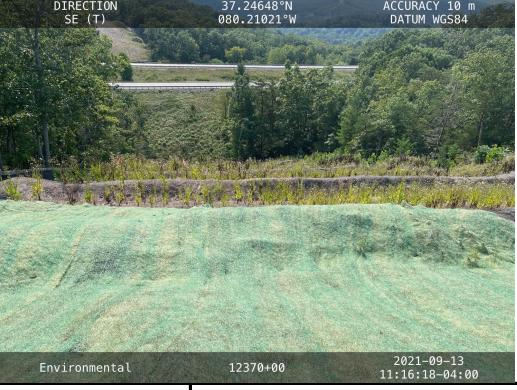
| Field Station# | 12374+16 | | Field Station# | 12370+00 | |

| Pic 11 Desc. | Stream crossing S-0016 in acceptable condition | | Pic 12 Desc. | Stabilized Row in acceptable condition | |

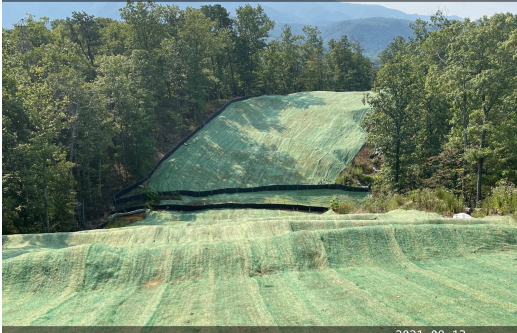
| Field Station# | 12361+03 | | Field Station# | 12340+00 | |

| Pic 13 Desc. | Stabilized Row in acceptable condition | | Pic 14 Desc. | Stabilized Row in acceptable condition | |

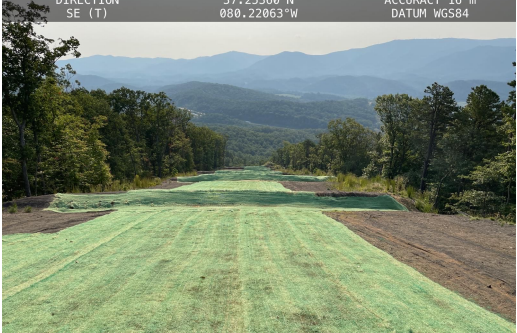
| Field Station# | 12331+50 | | Field Station# | 12308+00 | |

| Pic 15 Desc. | Fill slope drain in acceptable condition | | Pic 16 Desc. | Stabilized Row in acceptable condition | |

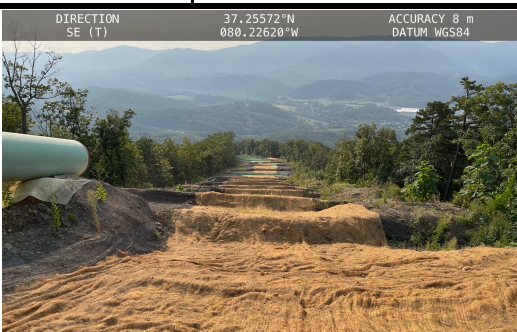
| Field Station# | 12300+00 | | Field Station# | 12299+24 | |

| Pic 17 Desc. | Stabilized Row in acceptable condition | | Pic 18 Desc. | Stabilized access Road in acceptable condition | |

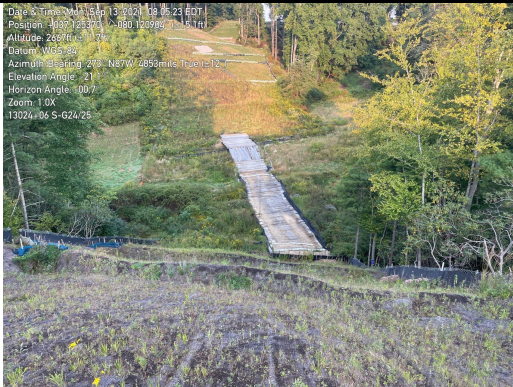
| AFE | | 124300138 | | Date/Time | | 9/13/2021 6:23 PM | | Report # | | | |
|---|--|---|--|---|--|---|--|---|--|---|--|
| Field Station# | | | | 13024+06 | | Field Station# | | | | 13039+00 | |

| AFE | | 124300138 | | Date/Time | | 9/13/2021 6:23 PM | | Report # | | | |
|---|--|---|--|---|--|---|--|---|--|---|--|
| Pic 1 Desc. | | | | MVP-S-G24/25 and Corresponding buffer zone in good condition | | Pic 2 Desc. | | | | ROW and ECDs in good condition with good vegetation established across ROW | |

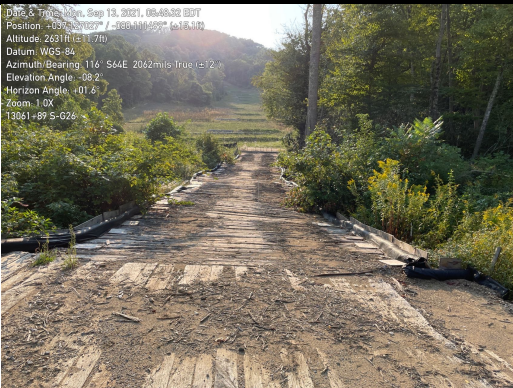
| AFE | | 124300138 | | Date/Time | | 9/13/2021 6:23 PM | | Report # | | | |
|---|--|---|--|---|--|---|--|---|--|---|--|
| Field Station# | | | | 13061+44 | | Field Station# | | | | 13061+89 | |

| AFE | | 124300138 | | Date/Time | | 9/13/2021 6:23 PM | | Report # | | | |
|---|--|---|--|---|--|---|--|---|--|---|--|
| Pic 5 Desc. | | | | P1 along access road 290 needs replaced - 72hr maintenance item | | Pic 6 Desc. | | | | MVP-S-G26 and Corresponding buffer zone in good condition | |

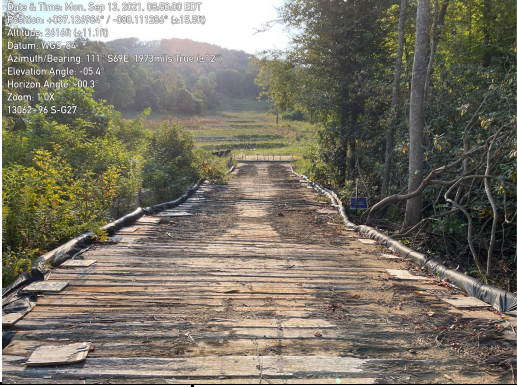
| AFE | 124300138 | Date/Time | 9/13/2021 6:23 PM | Report # | |
|---|---|---|---|---|--|
| Field Station# 13062+96 | | Field Station# 13064+00 | | | |

| AFE | 124300138 | Date/Time | 9/13/2021 6:23 PM | Report # | |
|---|---|---|---|---|--|
| Pic 7 Desc. MVP-S-G27 and Corresponding buffer zone in good condition | | Pic 8 Desc. ROW and ECDs in good condition with good vegetation established across ROW | | | |

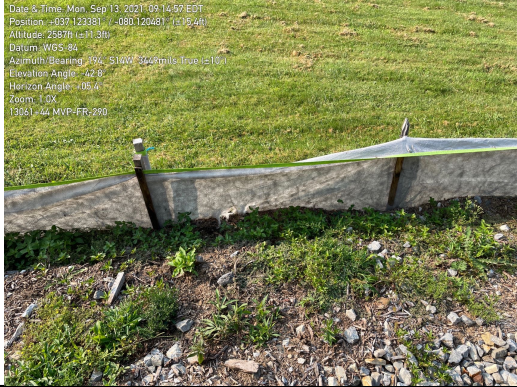
| AFE | 124300138 | Date/Time | 9/13/2021 6:23 PM | Report # | |
|---|---|---|---|---|--|
| Field Station# 13061+44 | | Field Station# 13119+00 | | | |

| AFE | 124300138 | Date/Time | 9/13/2021 6:23 PM | Report # | |
|---|---|---|---|---|--|
| Pic 9 Desc. P1 needs repaired/Replaced along access road 290 | | Pic 10 Desc. ROW and ECDs in good condition and stable | | | |

| E&S BMPs | Compliance Level | Corrective Action | Corrective Time Frame | Date Repaired |
|---|---|---|---|---|
| Silt Fence (Reinforce Filter Fence) | Communication | Repair/Replace P1 - 72hr item | | 9/13/2021 |

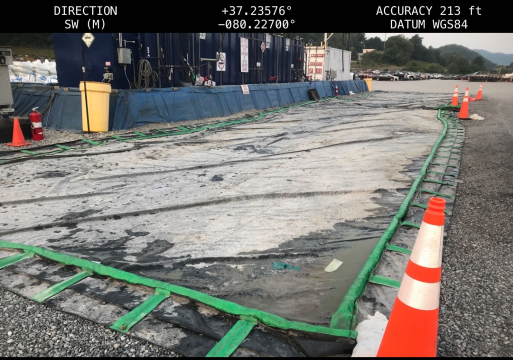
| <p>DIRECTION SE (M) +37.23554° -080.22868° ACCURACY 16 ft DATUM WGS84</p> <p>MVP-PY-006_091321 Condition of containment 2021-09-13 07:17:09-04:00</p> | | <p>DIRECTION SW (M) +37.23576° -080.22700° ACCURACY 213 ft DATUM WGS84</p> <p>MVP-PY-006_091321 Secondary containment in place for tankers 2021-09-13 07:19:48-04:00</p> | | | |
| Pic 5 Desc. | Condition of containment under light plant. Free of stormwater. Looking SE. | | Pic 6 Desc. | Blue Bulk Fuel tanks Secondary containments in place for tankers offloading fuel. Looking SW. | |

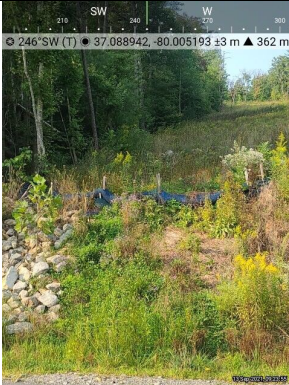
| Field Station# | 13496+62 | Field Station# | 13437+75 | | |

| Pic 1 Desc. | Monitored rock lined channel and ECDs at CAHAS #2 road crossing with no environmental issues observed at the time of inspection. | | Pic 2 Desc. | Photo showing land owner activities inside work space. Monitored equipment for leaks. No environmental issues observed at the time of inspection. | |

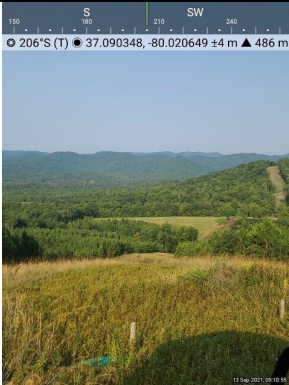
| Field Station# | 13436+33 | Field Station# | 13440+00 | | |

| Pic 3 Desc. | Vegetation observation photo showing good coverage in restored area. | | Pic 4 Desc. | Row photo showing vegetation . Good coverage in restored section of row. | |

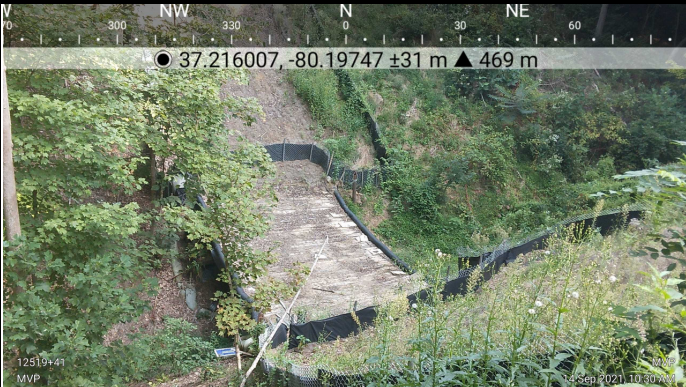
| Field Station# | 12519+41 | | Field Station# | 12520+50 | |

| Pic 13 Desc. | Overview of Waterbody S-EF19. ECDs are functional and ROW is stable. | | Pic 14 Desc. | ROW Overview. ECDs are functional and ROW is stable. | |

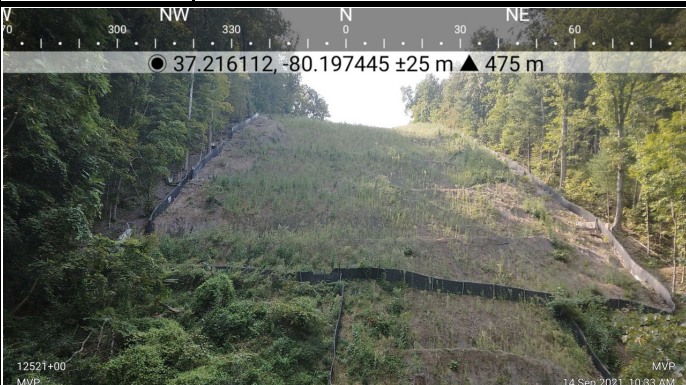
| Field Station# | 12521+00 | | Field Station# | 12530+00 | |

| Pic 15 Desc. | ROW Overview. ECDs are functional and ROW is stable. | | Pic 16 Desc. | ROW Overview. ECDs are functional and ROW is stable. | |

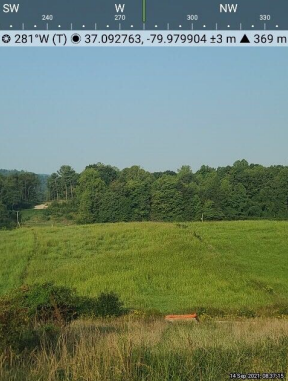
| Pic 1 Desc. | Monitored equipment bridge and protection, all ECDs in place at stream crossing. No environmental issues observed at the time of inspection. | | Pic 2 Desc. | Row photo above stream crossing at House Rock rd. No environmental issues observed at the time of inspection. | |

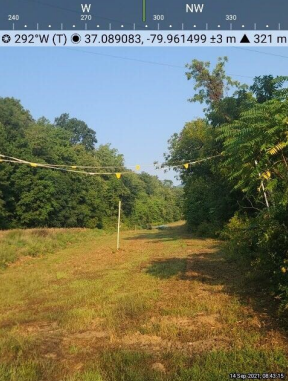
| Pic 3 Desc. | Vegetation observation photo in restored area of row. Good coverage noted. | | Pic 4 Desc. | Stream observation photo facing downstream during routine inspection today. No environmental issues observed at the time of inspection. | |

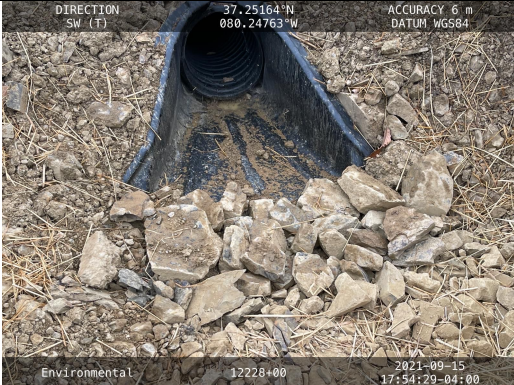
| Pic 1 Desc. | Rock inlet needs checked to make sure rock size is big enough to satisfy the specs. | | Pic 2 Desc. | Bare ground around fill slope drains need stabilized | |

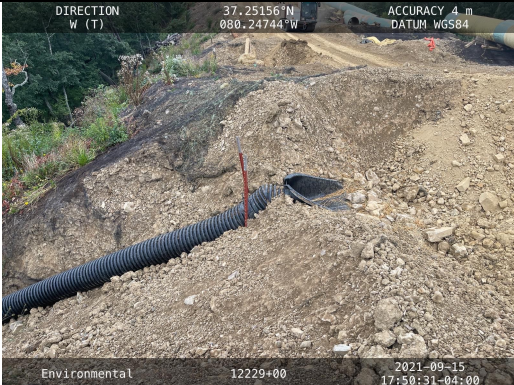
| Pic 3 Desc. | Berm around inlet needs to be built higher than the inlet and compacted. | | Pic 4 Desc. | Bridge and ECDs crossing stream S-C29 in acceptable condition | |

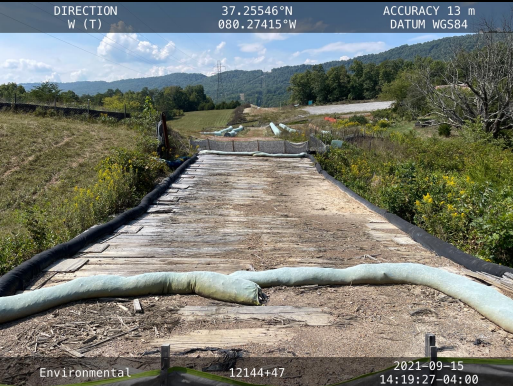
| Pic 5 Desc. | Wetland W-C6 in acceptable condition | | Pic 6 Desc. | Bridge and ECDs at wetland W-C5 in acceptable condition | |

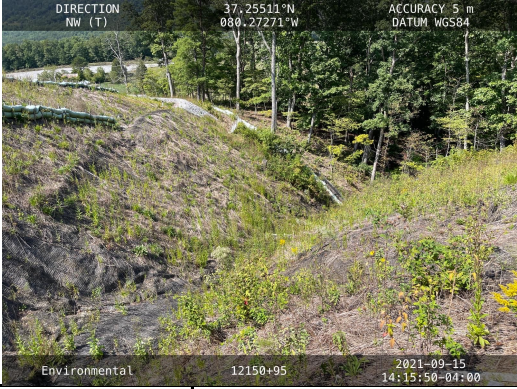
| Pic 7 Desc. | Stabilized drainage feature in acceptable condition | | Pic 8 Desc. | Bridge and ECDs crossing stream S-C25 In Acceptable condition | |

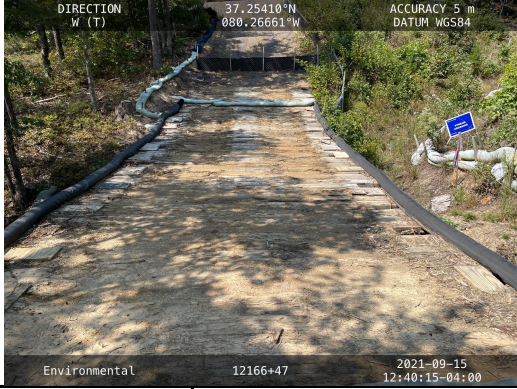
| Pic 9 Desc. | Bridge and ECDs crossing stream S-C24 in acceptable condition | | Pic 10 Desc. | Fill slope drain inlet in acceptable condition | |

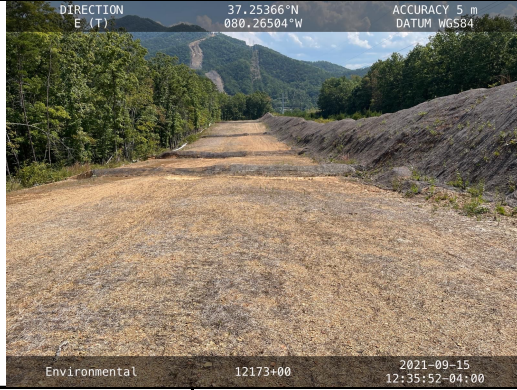
| Pic 11 Desc. | Stabilized ROW in acceptable condition | | Pic 12 Desc. | Down stream of S-C21 in acceptable condition | |

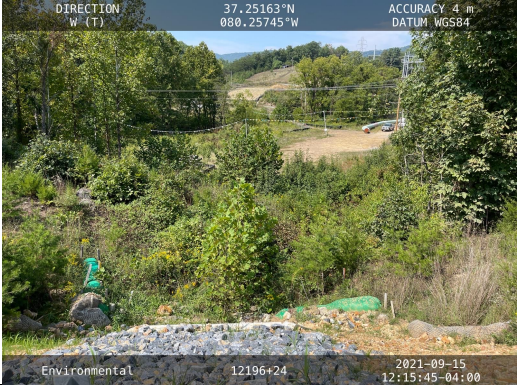
| Pic 13 Desc. | Stream crossing S-0011 on the CIS of the newly built road in acceptable condition | | Pic 14 Desc. | Stream crossing S-0011 on the GAS of the newly built access road | |

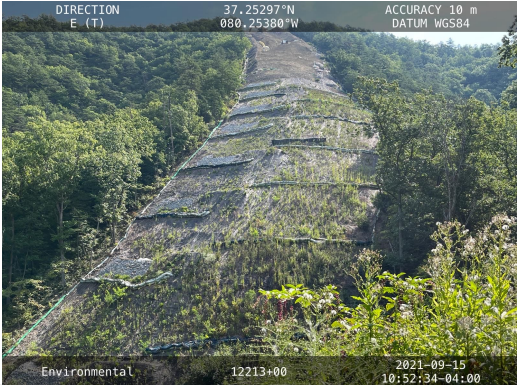
| Pic 15 Desc. | Stabilized ROW in acceptable condition | | Pic 16 Desc. | Stabilized drainage feature in acceptable condition | |

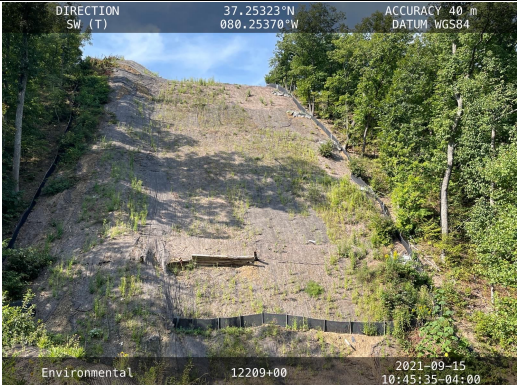
| Pic 17 Desc. | Stabilized slope in acceptable condition | | Pic 18 Desc. | Tie in crew winched down digging and relaying ditch dirt. | |

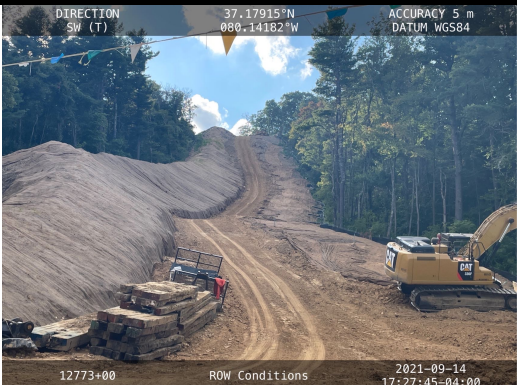
| Pic 11 Desc. | Current ROW conditions. ROW is stable. Engineering working in area | | Pic 12 Desc. | Current ROW conditions. ROW is stable. Waterbars have not yet been reinstalled | |

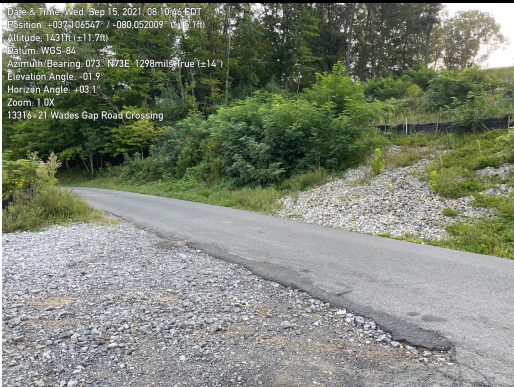
| Pic 1 Desc. | Wades Gap Road Crossing in good condition and RCE in good condition and functioning properly | | Pic 2 Desc. | ROW and ECDs in good condition with good vegetation established across ROW | |

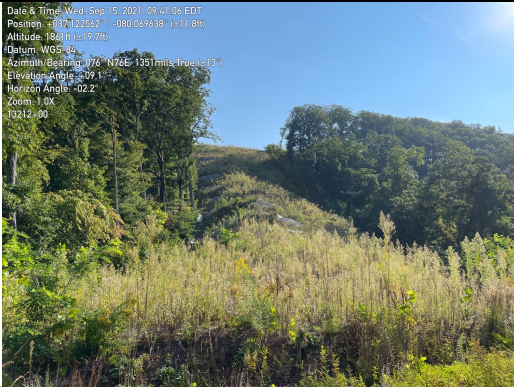
| Pic 3 Desc. | ROW and ECDs in good condition with good vegetation established across ROW | | Pic 4 Desc. | Slope drain pipe and inlet in good condition | |

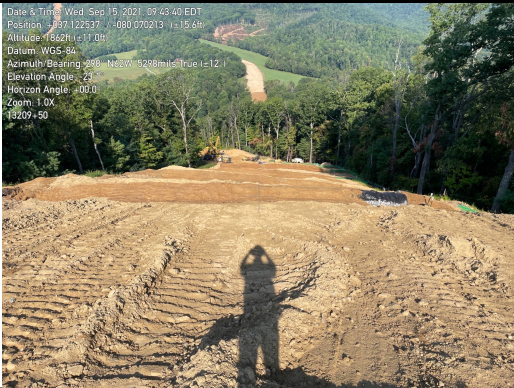
| Pic 5 Desc. | ROW and ECDs in good condition and stable | | Pic 6 Desc. | Dillons Mill Road Crossing in good condition | |

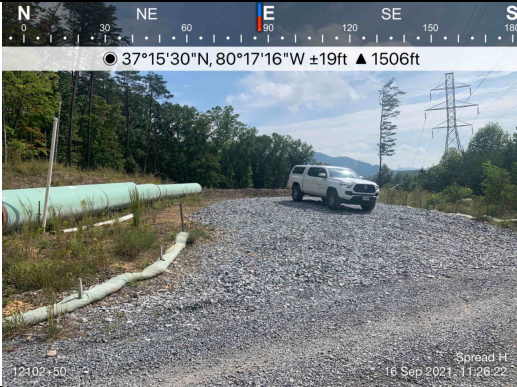
| Pic 13 Desc. | The rock construction entrance and access road | | Pic 14 Desc. | Waterbars are in acceptable condition. | |

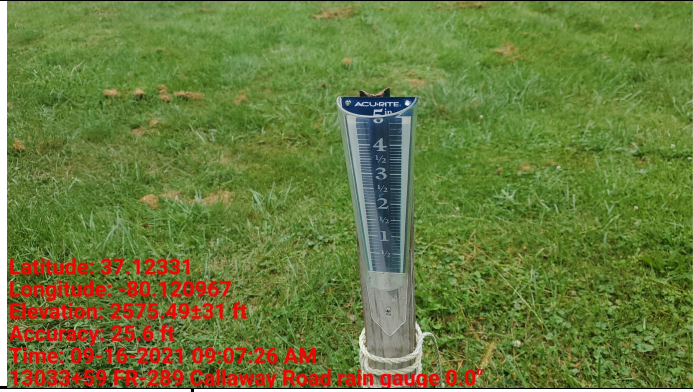
| Pic 1 Desc. | 0.0" total precipitation accumulation at Callaway Road. | | Pic 2 Desc. | GAS of the BRP motorway. | |

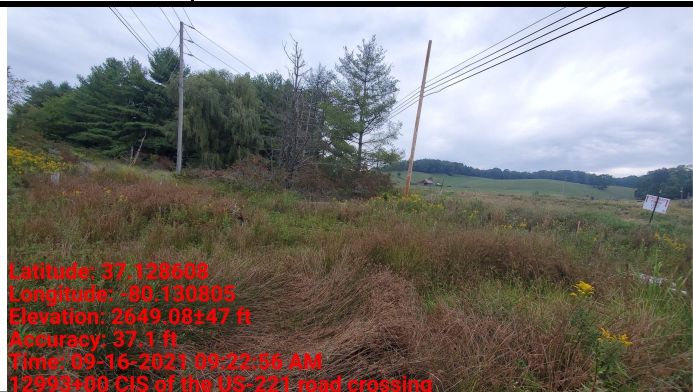
| <p>Latitude: 37.128608 Longitude: -80.130805 Elevation: 2649.08±47 ft Accuracy: 37.1 ft Time: 09-16-2021 09:22:56 AM 12993+00 CIS of the US-221 road crossing</p> | | | <p>Latitude: 37.131548 Longitude: -80.137503 Altitude: 2788.46±28 ft Accuracy: 19.4 ft Time: 09-16-2021 09:40:47 AM 12969+00 CIS of RO-288</p> | | |

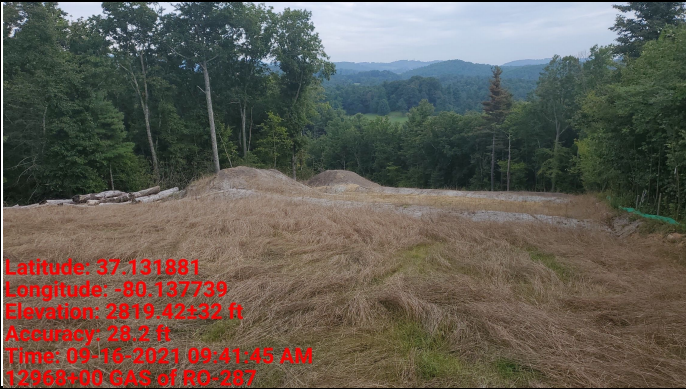
| Field Station# | 12968+00 | | Field Station# | 12964+00 | |

| <p>Latitude: 37.131881 Longitude: -80.137739 Elevation: 2519.42±32 ft Accuracy: 25.2 ft Time: 09-16-2021 09:41:45 AM 12968+00 GAS of RO-287</p> | | | <p>Latitude: 37.132395 Longitude: -80.137149 Elevation: 2715.39±34 ft Accuracy: 27.9 ft Time: 09-16-2021 09:42:12 AM 12964+00 GAS of RO-287</p> | | |
| Pic 7 Desc. | GAS of RO-287. | | Pic 8 Desc. | GAS of RO-287. | |

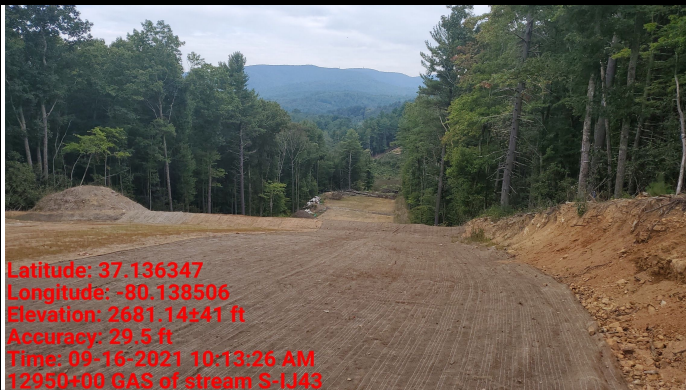
| Field Station# | 12950+00 | | Field Station# | 12957+50 | |

| <p>Latitude: 37.136347 Longitude: -80.138506 Elevation: 2681.14±41 ft Accuracy: 29.5 ft Time: 09-16-2021 10:13:26 AM 12950+00 GAS of stream S-IJ43</p> | | | <p>Latitude: 37.1346 Longitude: -80.137544 Elevation: 2607.09±54 ft Accuracy: 492.1 ft Time: 09-16-2021 10:21:31 AM 12957+50 GAS of RO-287 streams S-Y7 and S-Y8</p> | | |
| Pic 9 Desc. | CIS of RO-287. | | Pic 10 Desc. | Streams S-Y7 and S-Y8 on the downstream side of the ROW. | |

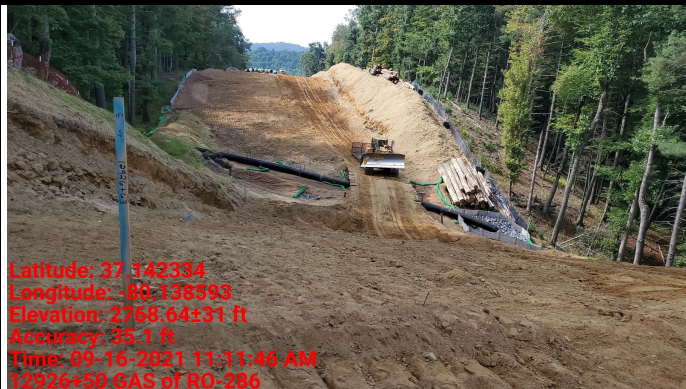
| <p>Latitude: 37.142334 Longitude: -80.138593 Elevation: 2758.64±31 ft Accuracy: 35.1 ft Time: 09-16-2021 11:11:48 AM 12926+50 GAS of RO-286</p> | | | <p>Latitude: 37.14278 Longitude: -80.138526 Elevation: 2675.49±36 ft Accuracy: 109.6 ft Time: 09-16-2021 11:13:47 AM 12925+50 GAS of RO-286 stream S-EF44</p> | | |
| Pic 11 Desc. | Current ROW conditions on the GAS of RO-286. | | Pic 12 Desc. | Stream crossing S-EF44. | |

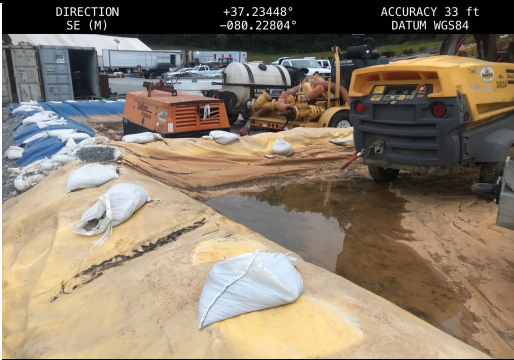
| <p>DIRECTION SE (M) +37.23448° -080.22804° ACCURACY 33 ft DATUM WGS84</p> <p>MVP-PY-006_091721 Condition of poly lined containments 2021-09-17 07:30:21-04:00</p> | | <p>DIRECTION NE (M) +37.23481° -080.22803° ACCURACY 33 ft DATUM WGS84</p> <p>MVP-PY-006_091721 Condition of trays & containment 2021-09-17 07:30:59-04:00</p> | | | |
| Pic 1 Desc. | Condition of poly lined rock berm containments. Holding stormwater. Looking SE. | | Pic 2 Desc. | Condition of trays and containment under toilets. Free of fluids. Looking NE. | |

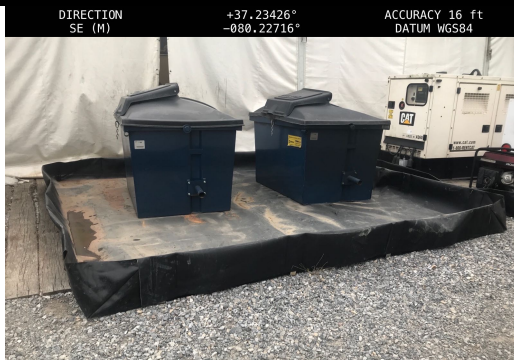
| <p>DIRECTION SE (M) +37.23449° -080.22815° ACCURACY 33 ft DATUM WGS84</p> <p>MVP-PY-006_091721 No fluids around hazardous waste dump... 2021-09-17 07:31:28-04:00</p> | | <p>DIRECTION SE (M) +37.23426° -080.22716° ACCURACY 16 ft DATUM WGS84</p> <p>MVP-PY-006_091721 Condition of containment 2021-09-17 07:33:41-04:00</p> | | | |
| Pic 3 Desc. | No fluids or deposits around hazardous waste dumpsters stored in the yard. Looking SE. | | Pic 4 Desc. | Condition of containment under hazardous waste dumpsters. Free of fluids. Looking SE. | |

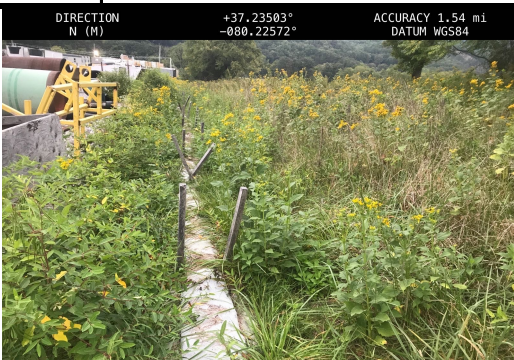
| <p>DIRECTION N (M) +37.23503° -080.22572° ACCURACY 1.54 mi DATUM WGS84</p> <p>MVP-PY-006_091721 Condition of CFS along east LOD 2021-09-17 07:35:35-04:00</p> | | <p>DIRECTION SE (M) +37.23539° -080.22624° ACCURACY 33 ft DATUM WGS84</p> <p>MVP-PY-006_091721 Condition of containment 2021-09-17 07:36:52-04:00</p> | | | |
| Pic 5 Desc. | Condition of triple stack compost filter sock along east LOD. Over grown with vegetation. Looking N. | | Pic 6 Desc. | Condition of containment under refrigeration unit. Looking NW. | |

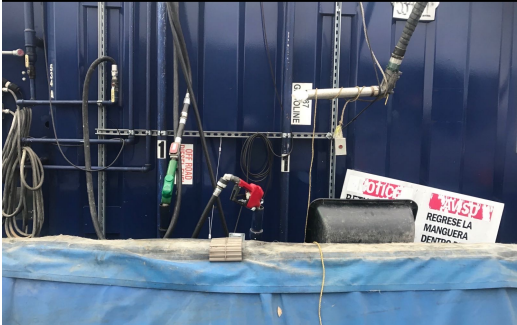
| MVP-PY-006_091721 No leaky fittings or nozzles. 2021-09-17 07:42:36-04:00 | | MVP-PY-006_091721 Condition of containment. 2021-09-17 07:43:15-04:00 | | | |
| Pic 13 Desc. | Blue Bulk Fuel tanks no leaky fittings or nozzles. Looking S. | | Pic 14 Desc. | Off Road Fuel unit containment free of stormwater. Looking SW. | |

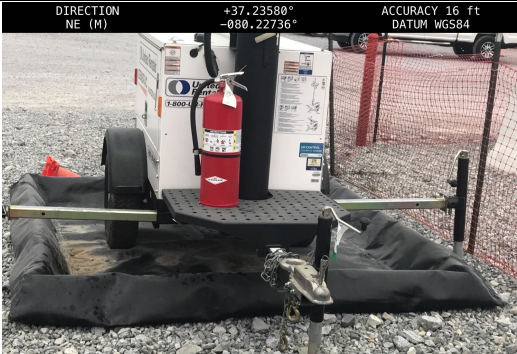
| MVP-PY-006_091721 Condition of containment. 2021-09-17 07:47:27-04:00 | | MVP-PY-006_091721 Condition of post project documents. 2021-09-17 07:47:48-04:00 | | | |
| Pic 17 Desc. | Condition of containment under light plant. Free of fluids. Looking NE. | | Pic 18 Desc. | Condition of posted project documents at the main entrance. Looking NW. | |

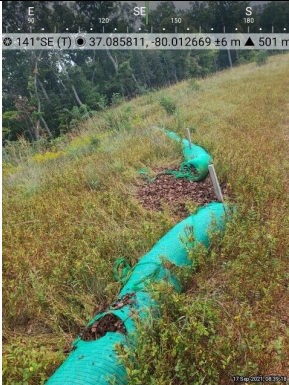
| Field Station# | 13473+90 | Field Station# | 13426+25 | | |

| Pic 1 Desc. | CFS requires maintenance due to wildlife damages, documented and added to the punch list. | Pic 2 Desc. | Row photo showing vegetation at stream crossing, no environmental issues observed at the time of inspection. | | |

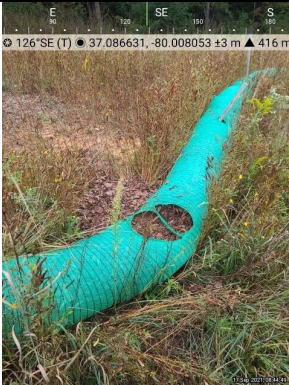
| Field Station# | 13484+00 | Field Station# | 13454+32 | | |

| Pic 3 Desc. | CFS requires maintenance due to wildlife damages, documented and added to the punch list. | Pic 4 Desc. | Row photo showing good coverage. | | |

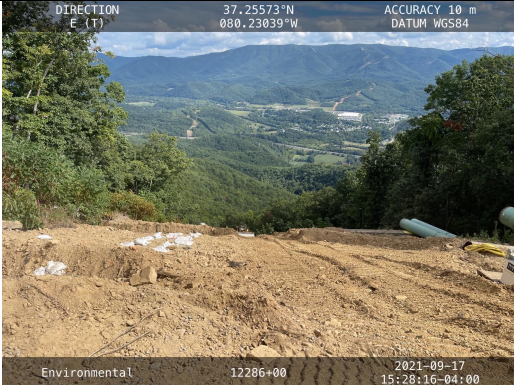
| Field Station# | 12286+00 | | Field Station# | 12421+00 | |

| Pic 1 Desc. | Crew winched down continuing with drinking for blasting. | | Pic 2 Desc. | Clean water crossing pipe inlet in acceptable condition | |

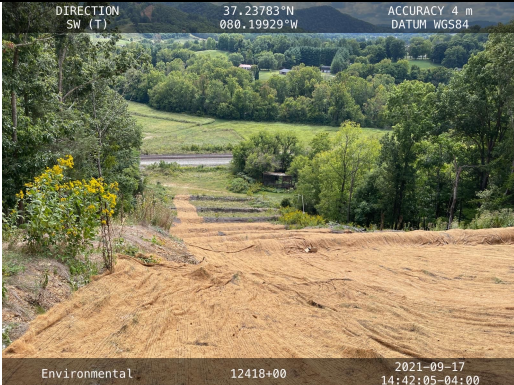
| Field Station# | 12418+00 | | Field Station# | 12410+20 | |

| Pic 3 Desc. | Stabilized slope in acceptable condition | | Pic 4 Desc. | Clean water crossing pipe outlet in acceptable condition | |

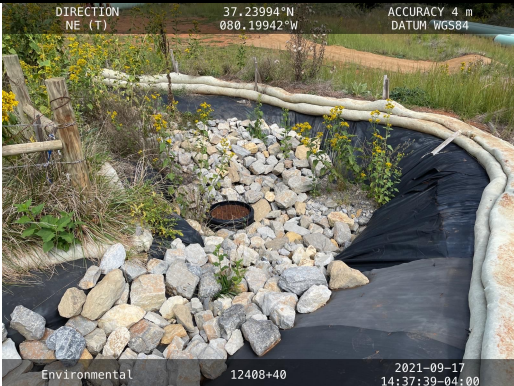
| Field Station# | 12408+40 | | Field Station# | 12400+00 | |

| Pic 5 Desc. | Clean water crossing pipe inlet in acceptable condition | | Pic 6 Desc. | Stabilized ROW in acceptable condition | |

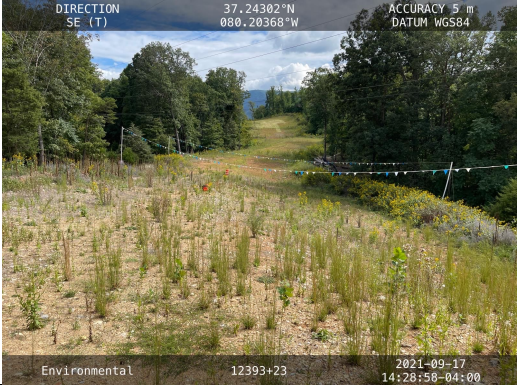
| Field Station# | 12393+23 | | Field Station# | 12386+50 | |

| Pic 7 Desc. | Stabilized ROW in acceptable condition | | Pic 8 Desc. | Stabilized ROW in acceptable condition | |

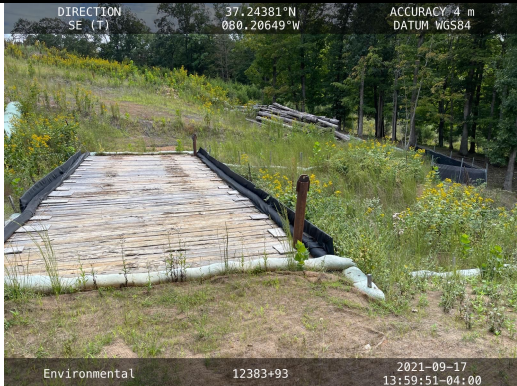
| Field Station# | 12383+93 | | Field Station# | 12380+04 | |

| Pic 9 Desc. | Clean water crossing in acceptable condition | | Pic 10 Desc. | Bridge and ECDs crossing stream S-NN19 in acceptable condition | |

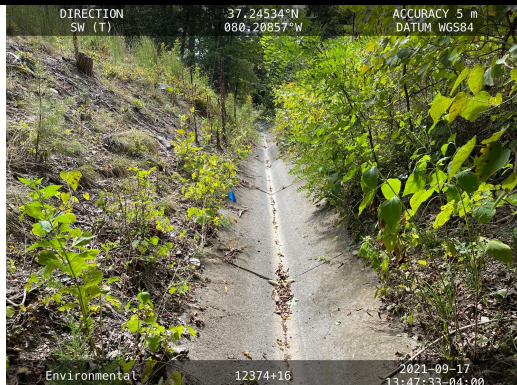
| Field Station# | 12374+16 | | Field Station# | 12376+00 | |

| Pic 11 Desc. | Stream crossing S-0016 in acceptable condition | | Pic 12 Desc. | Stabilized ROW in acceptable condition | |

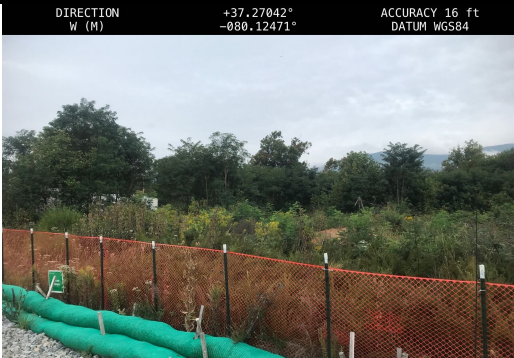
| <p>DIRECTION W (M) +37.27042° -080.12471° ACCURACY 16 ft DATUM WGS84</p> <p>MVP-LY-049_091721 Landowner disturbance along feature 2021-09-17 08:30:43-04:00</p> | | <p>DIRECTION SW (M) +37.27041° -080.12471° ACCURACY 16 ft DATUM WGS84</p> <p>MVP-LY-049_091721 Landowner disturbance west of feature 2021-09-17 08:30:49-04:00</p> | | | |
| Pic 3 Desc. | Landowner soil disturbance along feature W-CV21A. Area not stabilized. Looking NW. | | Pic 4 Desc. | Landowner soil disturbance west of feature W-CV21B. Both areas not stabilized. Looking SW. | |

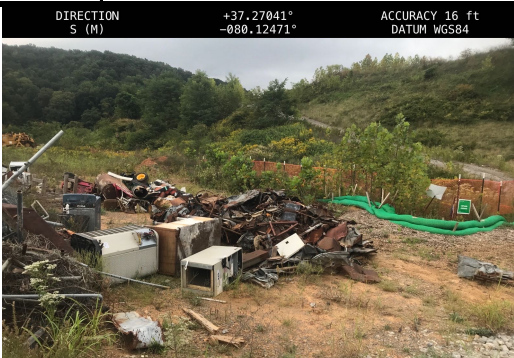
| <p>DIRECTION S (M) +37.27041° -080.12471° ACCURACY 16 ft DATUM WGS84</p> <p>MVP-LY-049_091721 Landowner disturbance & debris along CFS 2021-09-17 08:30:54-04:00</p> | | <p>DIRECTION S (M) +37.27053° -080.12385° ACCURACY 16 ft DATUM WGS84</p> <p>MVP-LY-049_091721 Containment under stored equipment 2021-09-17 08:32:19-04:00</p> | | | |
| Pic 5 Desc. | Landowner soil disturbance along triple stack compost filter sock and debris piled east of feature W-CV21B. Looking S. | | Pic 6 Desc. | Condition of containment under stored equipment. Looking S. | |

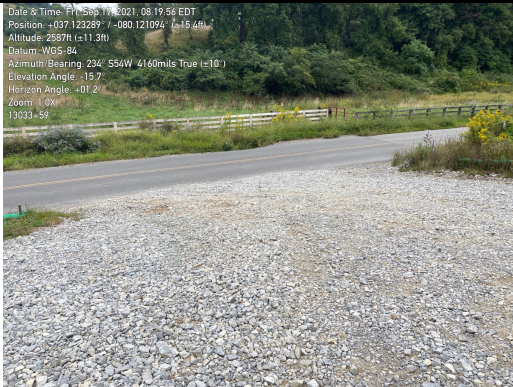
| AFE | | 124300138 | | Date/Time | | 9/17/2021 5:50 PM | | Report # | | | | | | | |
|---|--|---|--|---|--|---|--|---|--|--|--|---|--|--|--|
| Pic 1 Desc. | | | | RCE in good condition and functioning properly | | | | Pic 2 Desc. | | | | ROW and ECDs in good condition with good vegetation established across ROW | | | |

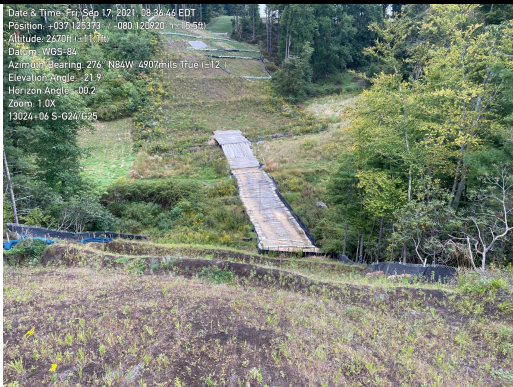
| AFE | | 124300138 | | Date/Time | | 9/17/2021 5:50 PM | | Report # | | | | | | | |
|---|--|---|--|---|--|---|--|---|--|--|--|---|--|--|--|
| Pic 3 Desc. | | | | MVP-S-G24/G25 and Corresponding buffer zone in good condition | | | | Pic 4 Desc. | | | | ROW and ECDs in good condition with good vegetation established across ROW | | | |

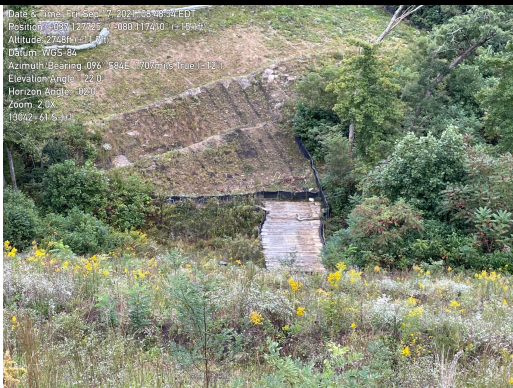
| AFE | | 124300138 | | Date/Time | | 9/17/2021 5:50 PM | | Report # | | | | | | | |
|---|--|---|--|---|--|---|--|---|--|--|--|---|--|--|--|
| Pic 5 Desc. | | | | MVP-S-H1 and Corresponding buffer zone in good condition | | | | Pic 6 Desc. | | | | Equipment bridge in good condition | | | |
