# Visual Site Inspection Report

<b>Project Name</b>	H-600 Pipeline Spread H	<b>AFE</b>	124300138	<b>Spread</b>	H-600 Pipeline Spread H
<b>Contractor</b>	Precision			<b>Report #</b>	28156
<b>Inspector</b>	Pat Davis			<b>Date/Time</b>	9/7/2021 6:30 PM
<b>Permit #</b>	TBD	<b>Inspection Type</b>	VA SWPP	<b>Station Begin</b>	+0
<b>State</b>	VA	<b>Inspection Area</b>	Partial	<b>Station End</b>	+0
<b>County</b>	Montgomery	<b>Ground</b>	Dry	<b>Temperature (°F)</b>	65.00
<b>Municipality</b>	N/A	<b>Weather</b>	Sunny	<b>Rain Gauge (in)</b>	0.00
				<b>Rain Accumulation Time (days)</b>	0.00

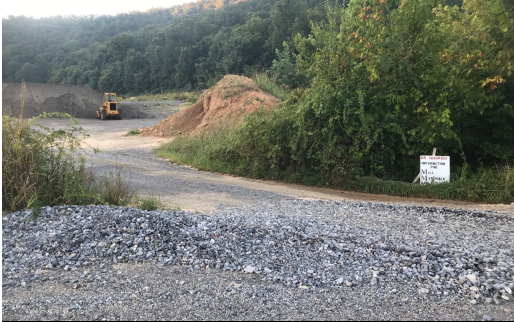
<b>GPS Location</b>	MVP-PY-006 See photo for gps data	<b>GPS Location</b>	MVP-PY-006 See photo for gps data		
<b>Field Station#</b>	+0	<b>Field Station#</b>	+0		
<b>Pic 1 Desc.</b>	Condition of soil pile adjacent to LOD. Soil pile not stabilized. Looking SE.	<b>Pic 2 Desc.</b>	Thin layer of sediment tracked across west entrance from soil pile. Pile not stabilized. Looking SW.

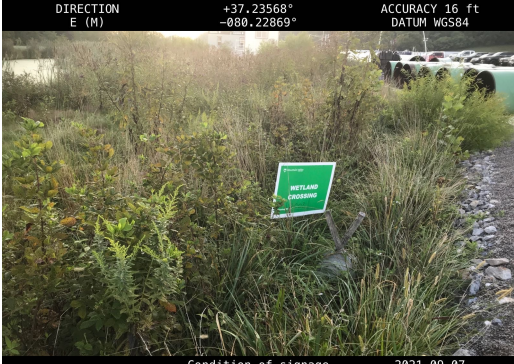
<b>GPS Location</b>	MVP-PY-006 See photo for gps data	<b>GPS Location</b>	MVP-PY-006 See photo for gps data		
<b>Field Station#</b>	+0	<b>Field Station#</b>	+0		
<b>Pic 3 Desc.</b>	Condition of triple stack compost filter sock and signage at feature W-008. Over grown with vegetation. Looking E.	<b>Pic 4 Desc.</b>	Condition of secondary containment under light plant. Holding some fluids. Looking SE.

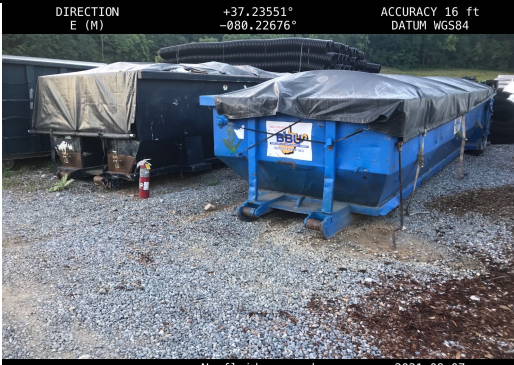
<b>GPS Location</b>	MVP-PY-006 See photo for gps data	<b>GPS Location</b>	MVP-PY-006 See photo for gps data		
<b>Field Station#</b>	+0	<b>Field Station#</b>	+0		
<b>Pic 5 Desc.</b>	No fluids or deposits around hazardous waste dumpsters. Looking SE.	<b>Pic 6 Desc.</b>	No loose trash around dumpsters or in the yard. Looking SE.

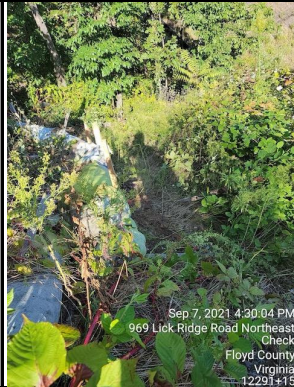
Placeholder image here	
GPS Location	See Above	GPS Location	See Above		
Field Station#	12291+15	Field Station#	12291+15		
Pic 7 Desc.	Punchlist Item: repair triple stack compost filter sock.	Pic 8 Desc.	Punchlist Item: triple stack compost filter sock repaired.

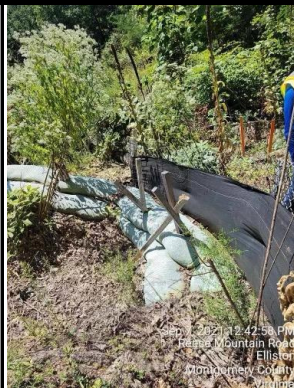
Placeholder image here	
GPS Location	See Above	GPS Location	See Above		
Field Station#	12291+75	Field Station#	12291+75		
Pic 9 Desc.	Punchlist Item: Repair Super Silt Fence.	Pic 10 Desc.	Punchlist Item: Super Silt Fence repaired.		
GPS Location	See Above	GPS Location	See Above		
Field Station#	12335+00	Field Station#	12360+00		
Pic 11 Desc.	ROW Overview. ECDs are functional and ROW is stable.	Pic 12 Desc.	ROW Overview. ECDs are functional and ROW is stable.

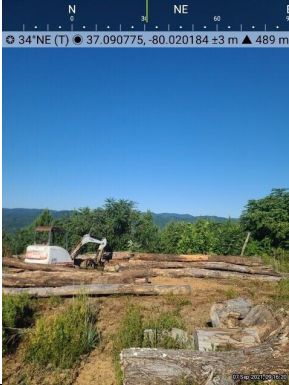
<b>GPS Location</b>	00000	<b>GPS Location</b>	00000		
<b>Field Station#</b>	13437+75	<b>Field Station#</b>	13436+40		
<b>Pic 1 Desc.</b>	Photo showing land owner activities on row , land owner has been removing pile of logs with equipment.		<b>Pic 2 Desc.</b>	Vegetation observation photo showing good coverage in permanent area of row.

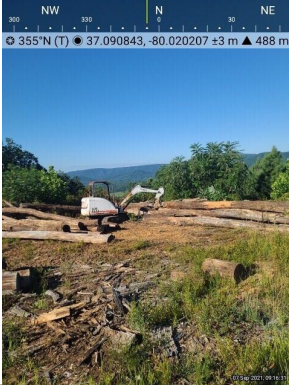
<b>GPS Location</b>	00000	<b>GPS Location</b>	00000		
<b>Field Station#</b>	13437+75	<b>Field Station#</b>	13460+00		
<b>Pic 3 Desc.</b>	Photo showing land owner activities on row , land owner has been removing pile of logs with equipment.		<b>Pic 4 Desc.</b>	Photo showing permanent vegetation growth. Good coverage noted.

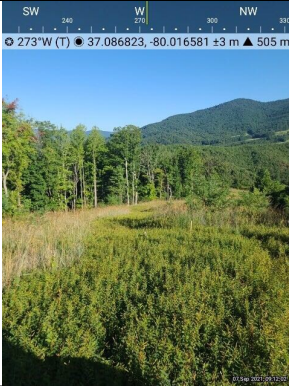
<b>Pic 5 Desc.</b>	Permanent vegetation photo showing good coverage.		<b>Pic 6 Desc.</b>	Monitored ECDs throughout the row while checking row conditions. No environmental issues observed at the time of inspection.

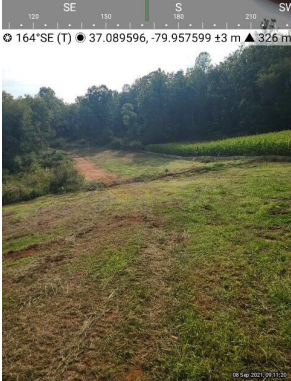
<b>GPS Location</b>	0000	<b>GPS Location</b>	0000		
<b>Field Station#</b>	13655+00	<b>Field Station#</b>	13600+00		
<b>Pic 1 Desc.</b>	Observed area recently mowed by the contractor. No environmental issues observed at the time of inspection.		<b>Pic 2 Desc.</b>	Photo showing vegetation and locust trees inside the LOD in restored section of row.

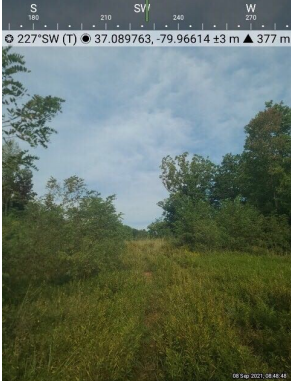
<b>GPS Location</b>	00000	<b>GPS Location</b>	00000		
<b>Field Station#</b>	13610+00	<b>Field Station#</b>	13605+12		
<b>Pic 3 Desc.</b>	Locust tree observation inside the LOD. Photo showing good vegetation coverage.		<b>Pic 4 Desc.</b>	Row photo showing vegetation. No environmental issues observed at the time of inspection.

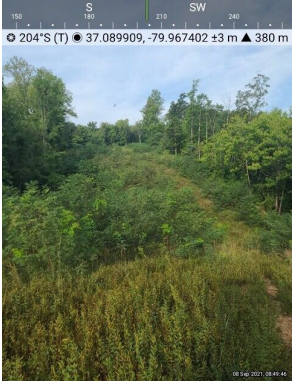
<b>Pic 5 Desc.</b>	Locust tree observation inside the LOD. Photo showing good vegetation coverage.		<b>Pic 6 Desc.</b>	Locust tree observation inside the LOD. Photo showing good vegetation coverage.

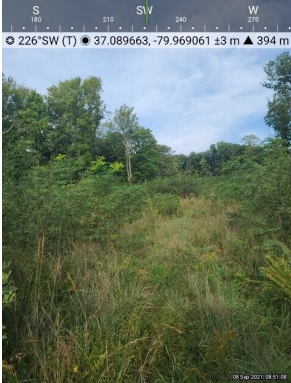
<b>GPS Location</b>	0000	<b>GPS Location</b>	0000		
<b>Field Station#</b>	13626+10	<b>Field Station#</b>	13642+30		
<b>Pic 7 Desc.</b>	Locust tree observation inside the LOD. Photo showing good vegetation coverage.		<b>Pic 8 Desc.</b>	Observed area recently mowed by the contractor. No environmental issues observed at the time of inspection.	
Insert image here		Insert image here			
<b>GPS Location</b>		<b>GPS Location</b>			
<b>Field Station#</b>		<b>Field Station#</b>			
<b>Pic 9 Desc.</b>			<b>Pic 10 Desc.</b>		
Insert image here		Insert image here			
<b>GPS Location</b>		<b>GPS Location</b>			
<b>Field Station#</b>		<b>Field Station#</b>			
<b>Pic 11 Desc.</b>			<b>Pic 12 Desc.</b>

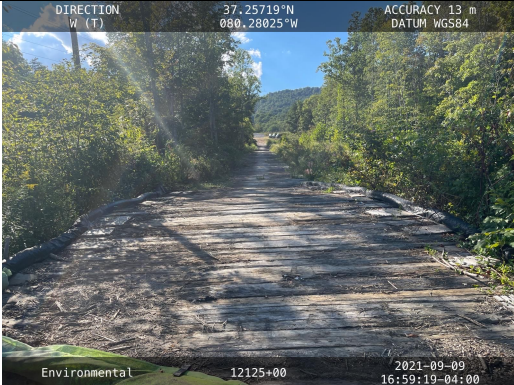
<p>DIRECTION W (T) 37.25719°N 080.28025°W ACCURACY 13 m DATUM WGS84</p> <p>Environmental 12125+00 2021-09-09 16:59:19-04:00</p>

<p>DIRECTION W (T) 37.25638°N 080.27789°W ACCURACY 4 m DATUM WGS84</p> <p>Environmental 12132+73 2021-09-09 16:56:17-04:00</p>			
<b>GPS Location</b>	See photo		<b>GPS Location</b>	See photo	
<b>Field Station#</b>	12125+00		<b>Field Station#</b>	12132+73	
<b>Pic 1 Desc.</b>	Timber mat road crossing multiple streams and wetlands in acceptable condition		<b>Pic 2 Desc.</b>	Bridge and ECDs crossing stream S-C29 in acceptable condition

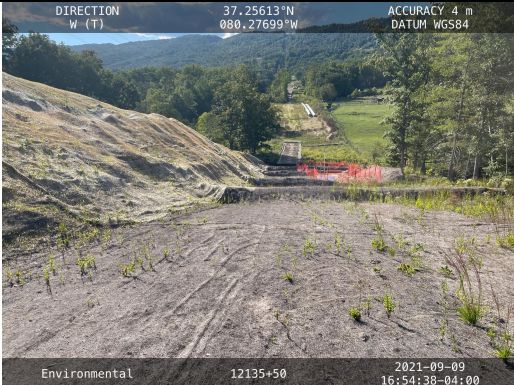
<p>DIRECTION W (T) 37.25613°N 080.27699°W ACCURACY 4 m DATUM WGS84</p> <p>Environmental 12135+50 2021-09-09 16:54:38-04:00</p>

<b>GPS Location</b>	See photo		<b>GPS Location</b>	See photo	
<b>Field Station#</b>	12135+50		<b>Field Station#</b>	12144+47	
<b>Pic 3 Desc.</b>	Stabilized ROW in acceptable condition		<b>Pic 4 Desc.</b>	Bridge and ECDs crossing wetland W-C5 in acceptable condition

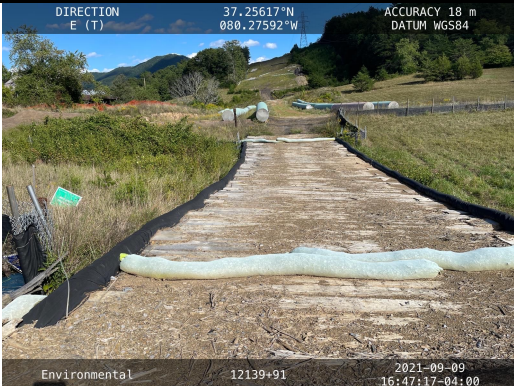
<p>DIRECTION E (T) 37.25304°N 080.26186°W ACCURACY 18 m DATUM WGS84</p> <p>Environmental 12184+00 2021-09-09 15:53:51-04:00</p>			
<b>GPS Location</b>	See photo		<b>GPS Location</b>	See photo	
<b>Field Station#</b>	12139+91		<b>Field Station#</b>	12184+00	
<b>Pic 5 Desc.</b>	Bridge and ECDs crossing wetland W-C6 in acceptable condition		<b>Pic 6 Desc.</b>	Stabilized ROW in acceptable condition

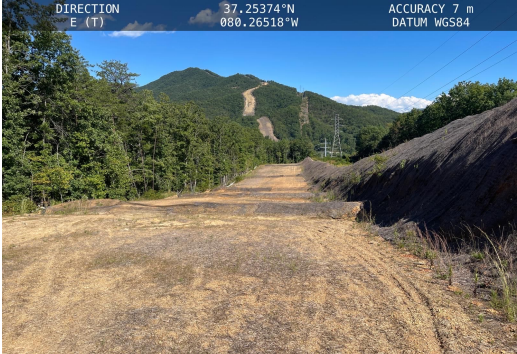
Environmental 12166+47 2021-09-09 15:42:14-04:00	
<b>GPS Location</b>	See photo		<b>GPS Location</b>	See photo	
<b>Field Station#</b>	12173+00		<b>Field Station#</b>	12166+47	
<b>Pic 7 Desc.</b>	Stabilized ROW in acceptable condition		<b>Pic 8 Desc.</b>	Bridge and ECDs crossing stream S-C24 in acceptable condition	
DIRECTION E (T) 37.25427°N 080.26792°W ACCURACY 5 m DATUM WGS84

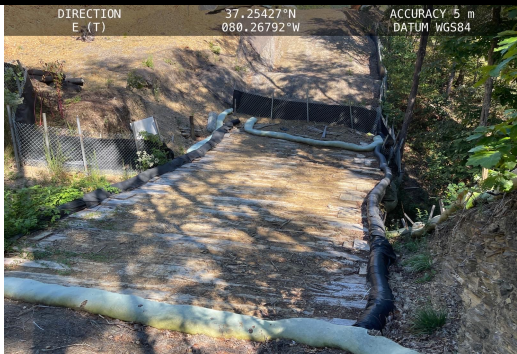
<b>Pic 9 Desc.</b>	Bridge and ECDs crossing stream S-C25 in acceptable condition		<b>Pic 10 Desc.</b>	Fill slope drain in acceptable condition	
DIRECTION SE (T) 37.25456°N 080.26960°W ACCURACY 7 m DATUM WGS84

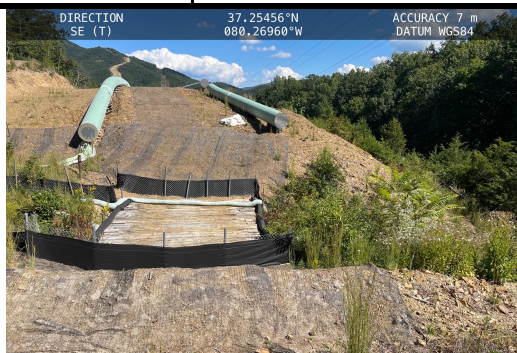
Environmental 12154+00 2021-09-09 15:25:00-04:00	
<b>GPS Location</b>	See photo		<b>GPS Location</b>	See photo	
<b>Field Station#</b>	12158+40		<b>Field Station#</b>	12154+00	
<b>Pic 11 Desc.</b>	Clean water crossing in acceptable condition		<b>Pic 12 Desc.</b>	Stabilized ROW In Acceptable condition

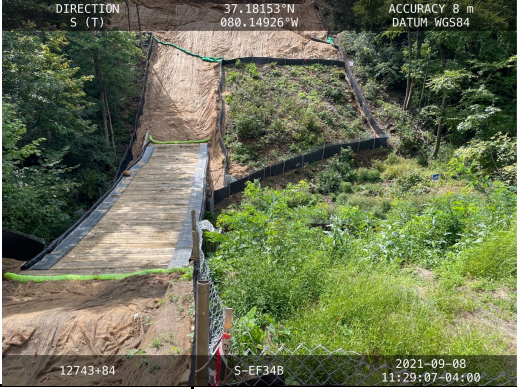
<p>DIRECTION NW (T) 37.18161°N 080.14916°W ACCURACY 5 m DATUM WGS84</p> <p>12743+00 ROW Conditions 2021-09-08 11:31:49-04:00</p>			
<b>GPS Location</b>	See photo		<b>GPS Location</b>	See photo	
<b>Field Station#</b>	12743+84		<b>Field Station#</b>	12743+00	
<b>Pic 13 Desc.</b>	Overview of Stream S-EF34B. ECDs are maintained and functional.		<b>Pic 14 Desc.</b>	Current ROW conditions. Steep slope area adjacent to Stream S-EF34B stabilized with curlex.

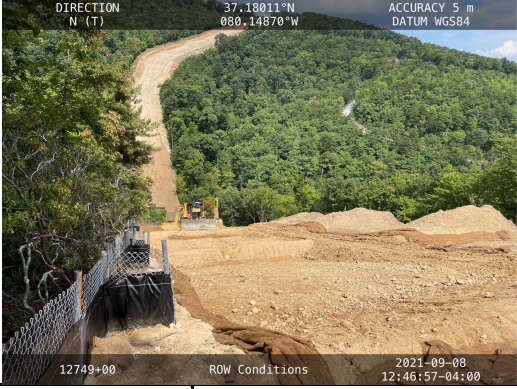
<b>GPS Location</b>	See photo		<b>GPS Location</b>	See photo	
<b>Field Station#</b>	12749+00		<b>Field Station#</b>	12776+75	
<b>Pic 15 Desc.</b>	Travel lane opened up to allow tie in crew to work on steep slope area adjacent to S-EF34B		<b>Pic 16 Desc.</b>	Downstream photo of Stream S-EF33

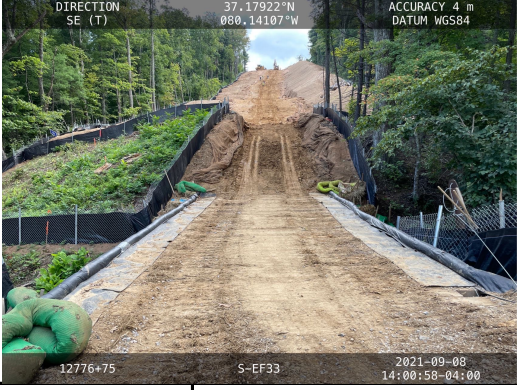
<p>DIRECTION S (T) 37.18159°N 080.14913°W ACCURACY 6 m DATUM WGS84</p> <p>12743+00 2021-09-08 17:14:50-04:00</p>			
<b>GPS Location</b>	See photo		<b>GPS Location</b>	See photo	
<b>Field Station#</b>	12776+75		<b>Field Station#</b>	12743+00	
<b>Pic 17 Desc.</b>	Equipment Bridge over Stream S-EF33		<b>Pic 18 Desc.</b>	Tie in Crew installing temporary trench breakers at the end of the day

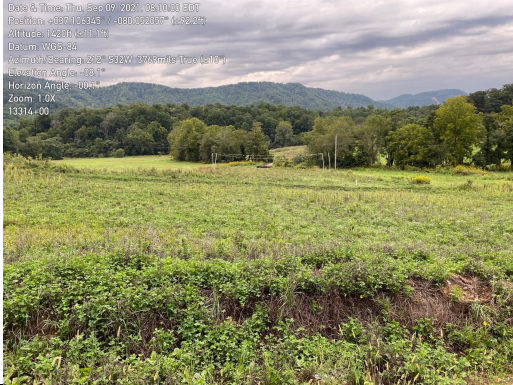
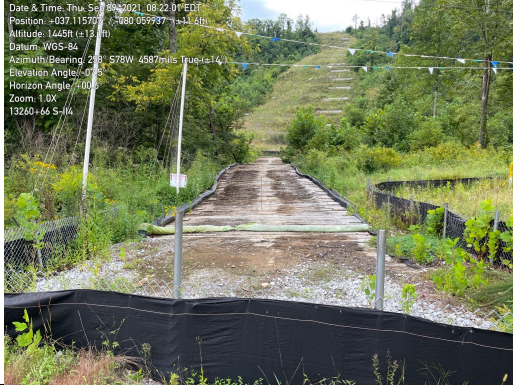
GPS Location				0				GPS Location				0			
Field Station#				13314+00				Field Station#				13260+66			
Pic 1 Desc.				ROW and ECDs in good condition with good vegetation established across ROW				Pic 2 Desc.				MVP-S-II4 and Corresponding buffer zone in good condition

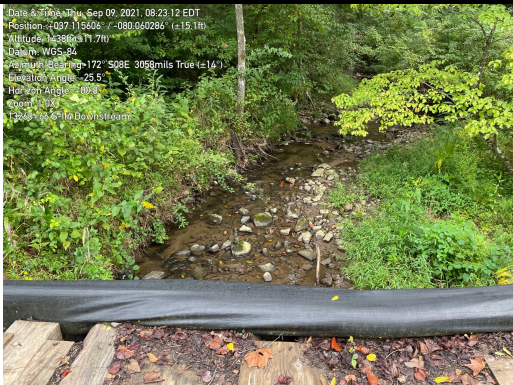
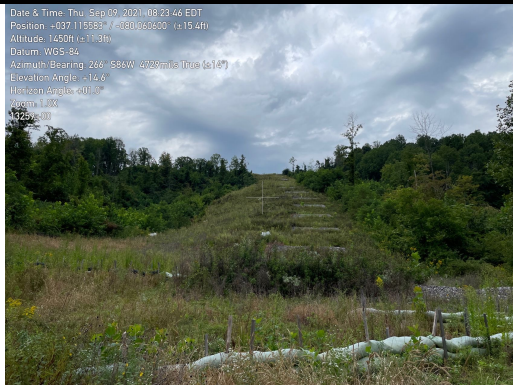
GPS Location				0				GPS Location				0			
Field Station#				13260+66				Field Station#				13259+00			
Pic 3 Desc.				MVP-S-II4 Downstream and Corresponding buffer zone in good condition				Pic 4 Desc.				ROW and ECDs in good condition with good vegetation established across ROW

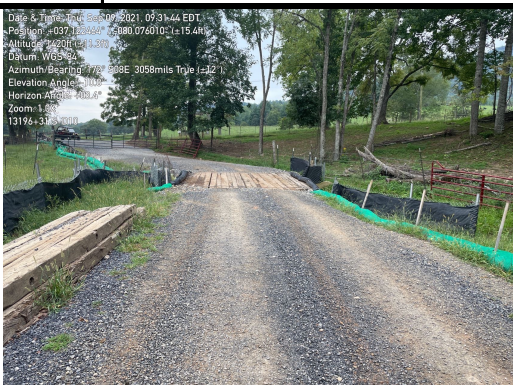
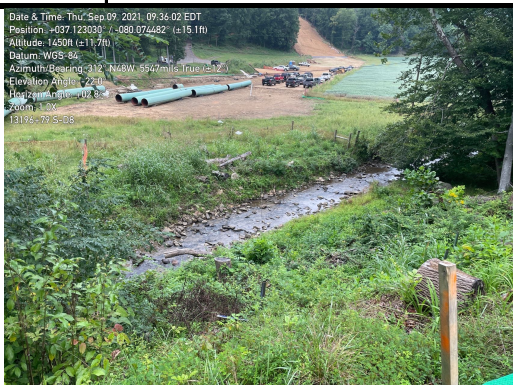
GPS Location				0				GPS Location				0			
Field Station#				13196+31				Field Station#				13196+79			
Pic 5 Desc.				MVP-S-D10 and Corresponding buffer zone in good condition				Pic 6 Desc.				MVP-S-D8 and Corresponding buffer zone in good condition

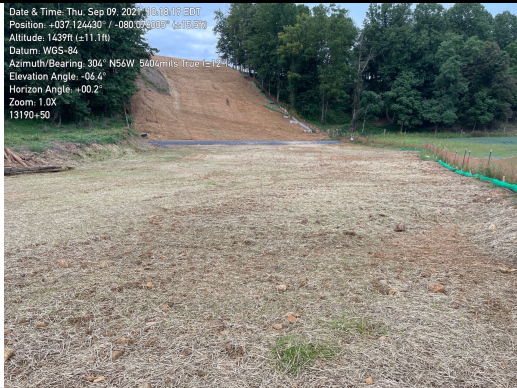
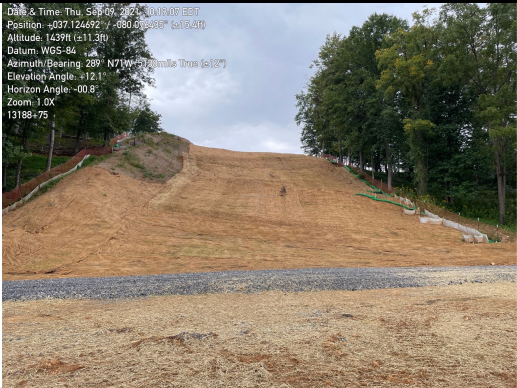
<b>GPS Location</b>	0	<b>GPS Location</b>	0		
<b>Field Station#</b>	13190+50	<b>Field Station#</b>	13188+75		
<b>Pic 9 Desc.</b>	ROW and ECDs in good condition and stable		<b>Pic 10 Desc.</b>	ROW and ECDs in good condition and stable	
<p>Date &amp; Time: Thu, Sep 09, 2021, 10:25:24 EDT  Position: +037.133985 / -080.078317 (+19.1ft)  Altitude: 1538ft (+11.1ft)  Datum: WGS-84  Azimuth/Bearing: 207° N20W 520mils True (+12.1°)  Elevation Angle: +08.2°  Horizon Angle: +00.0°  Zoom: 1.0X  13184+00</p>

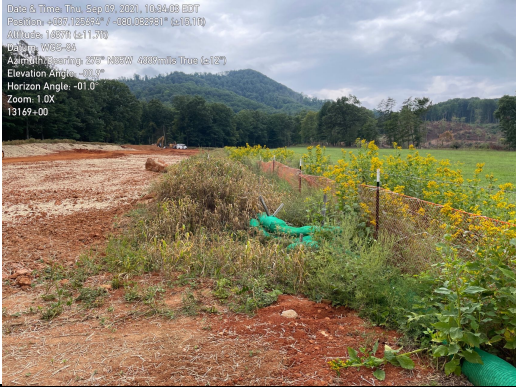
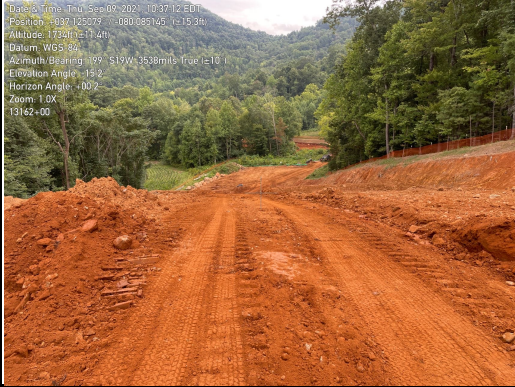
<b>GPS Location</b> 0		<b>GPS Location</b> 0			
<b>Field Station#</b> 13169+00		<b>Field Station#</b> 13162+00			
<b>Pic 13 Desc.</b> Clean water diversion berm in good condition with good vegetation		<b>Pic 14 Desc.</b> ROW and ECDs in good condition and stable			
<p>Date &amp; Time: Thu, Sep 09, 2021, 10:37:21 EDT  Position: +037.125051° / -080.035077° (±15.4m)  Altitude: 13162 (±11.2m)  Datum: WGS-84  Azimuth/Bearing: 189° S39W 334mils True (±10°)  Elevation Angle: +26.1°  Horizon Angle: +07.3°  Zoom: 1.0X  13162+00</p>

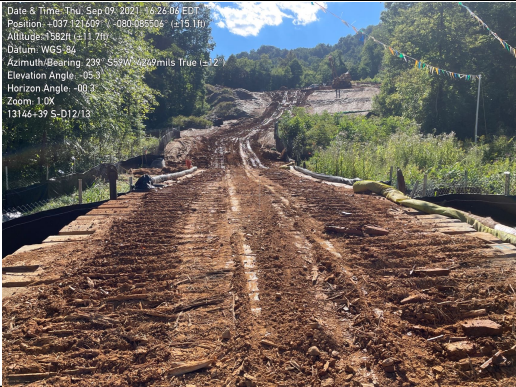
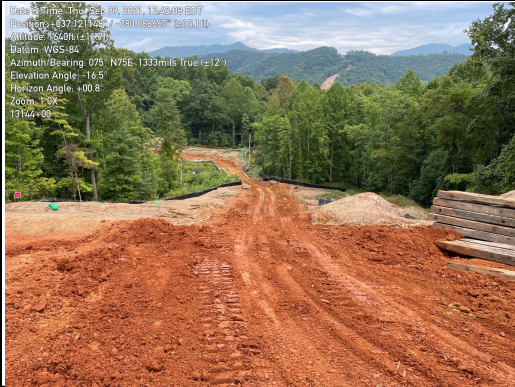
<b>Pic 17 Desc.</b> MVP-S-D12/D13 and Corresponding buffer zone in good condition		<b>Pic 18 Desc.</b> ROW and ECDs in good condition and stable

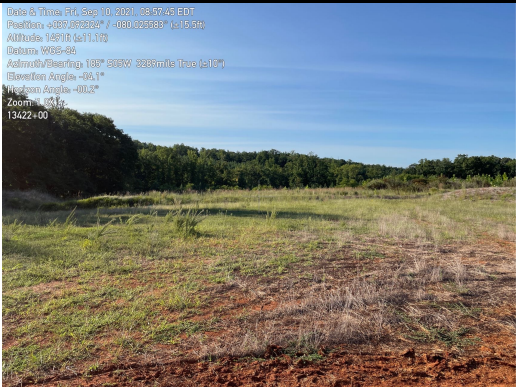
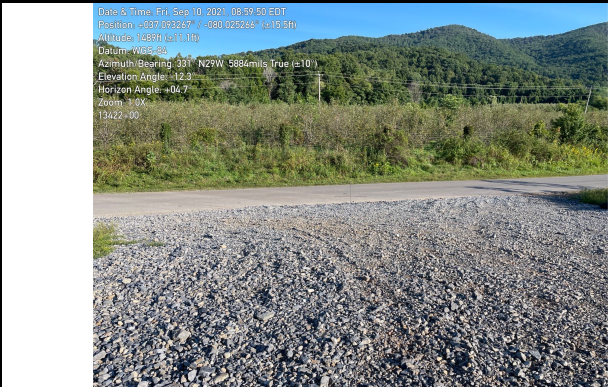
<p>Date &amp; Time: Fri, Sep 10, 2021, 08:39:50 EDT Position: +037.092422, -080.024993 (+15.4m) Altitude: 1439ft (+11.3ft) Datum: WGS-84 Azimuth/Bearing: 331° N29° 588mils True (+10°) Elevation Angle: -12.3° Horizon Angle: -04.7° Zoom: 1.0X 13422+00</p>	
GPS Location	0	GPS Location	0		
Field Station#	13422+00	Field Station#	13422+00		
Pic 1 Desc.	ROW and ECDs in good condition with good vegetation established across ROW		Pic 2 Desc.	RCE in good condition and functioning properly

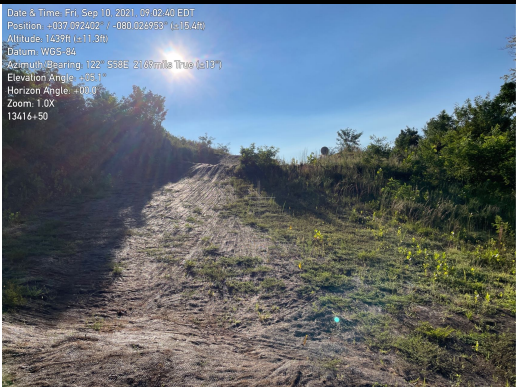
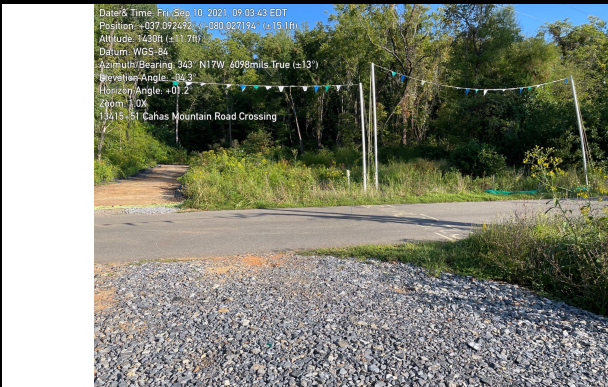
GPS Location	0	GPS Location	0		
Field Station#	13416+50	Field Station#	13415+51		
Pic 3 Desc.	ROW and ECDs in good condition and stable		Pic 4 Desc.	Cahas Mountain Road Crossing in good condition and RCE in good condition

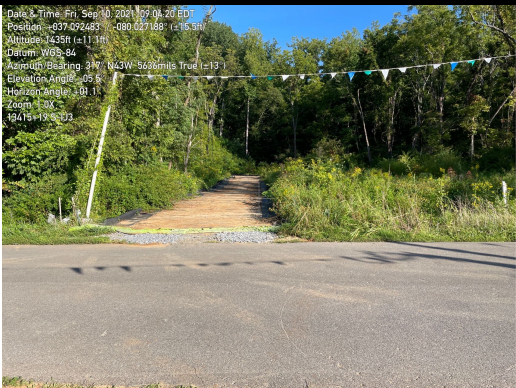
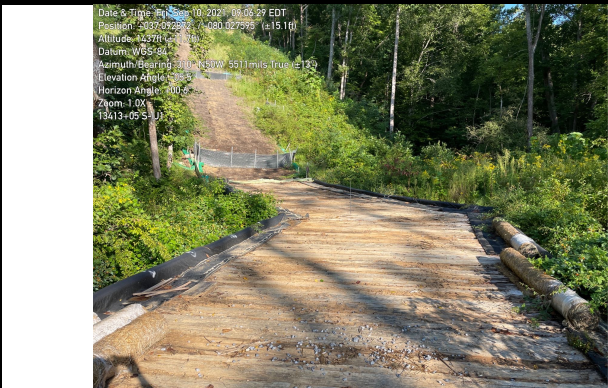
<p>Date &amp; Time: Fri, Sep 10, 2021, 09:05:29 EDT Position: +037.092422, -080.024993 (+15.4m) Altitude: 1439ft (+11.3ft) Datum: WGS-84 Azimuth/Bearing: 310° N37° 551mils True (+13°) Elevation Angle: -05.5° Horizon Angle: -00.5° Zoom: 1.0X 13413+05</p>	
GPS Location	0	GPS Location	0		
Field Station#	13415+19	Field Station#	13413+05		
Pic 5 Desc.	MVP-S-IJ3 and Corresponding buffer zone in good condition		Pic 6 Desc.	MVP-S-IJ1 and Corresponding buffer zone in good condition

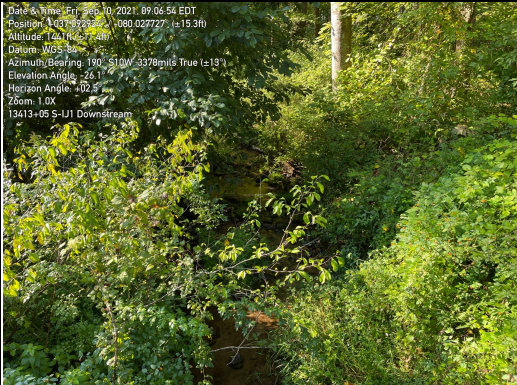
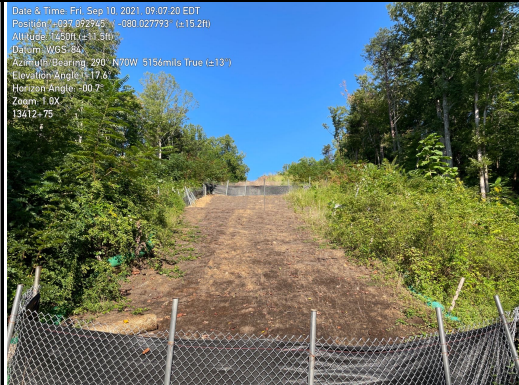
</div>					
GPS Location		0		GPS Location		0	
Field Station#		13413+05		Field Station#		13412+75	
Pic 7 Desc.		MVP-S-IJ1 Downstream and Corresponding buffer zone in good condition		Pic 8 Desc.		ROW and ECDs in good condition and stable	
<div><div>Date &amp; Time: Fri, Sep 10, 2021, 09:18:00 EDT Position: +037.1439297 / -080.040467 (±15.3ft) Altitude: 1552ft (±1.7ft) Datum: WGS-84 Azimuth/Bearing: 244° S44W 4338mils True (±13°) Elevation Angle: -11.8° Horizon Angle: -00.8° Zoom: 1.0X 13342+67 Webster Corner Road Crossing</div>

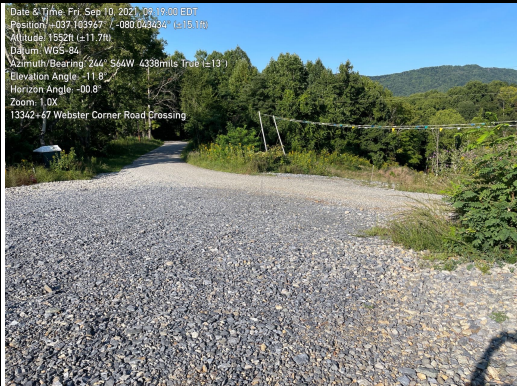
GPS Location		0		GPS Location		0	
Field Station#		13342+67		Field Station#		13342+00	
Pic 9 Desc.		Webster Corner Road Crossing in good condition		Pic 10 Desc.		ROW and ECDs in good condition with good vegetation established across ROW	
<div><div>Date &amp; Time: Fri, Sep 10, 2021, 09:22:00 EDT Position: +037.104134 / -080.044885 (±15.1ft) Altitude: 1491ft (±1.7ft) Datum: WGS-84 Azimuth/Bearing: 191° S11W 3396mils True (±13°) Elevation Angle: -20.1° Horizon Angle: -00.4° Zoom: 1.0X 13337+13 S-GH9</div>

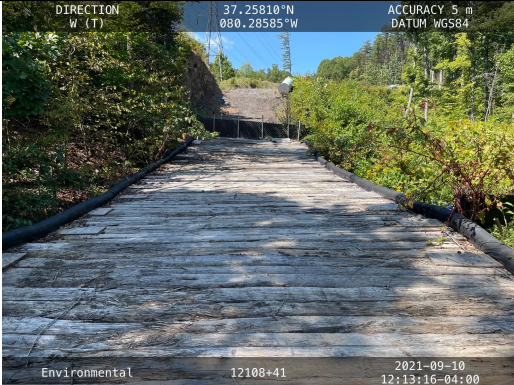
<b>GPS Location</b>	See photo		<b>GPS Location</b>	See photo	
<b>Field Station#</b>	12108+41		<b>Field Station#</b>	12110+00	
<b>Pic 1 Desc.</b>	Bridge and ECDs crossing stream S-F15 in acceptable condition		<b>Pic 2 Desc.</b>	Clean water crossing in acceptable condition

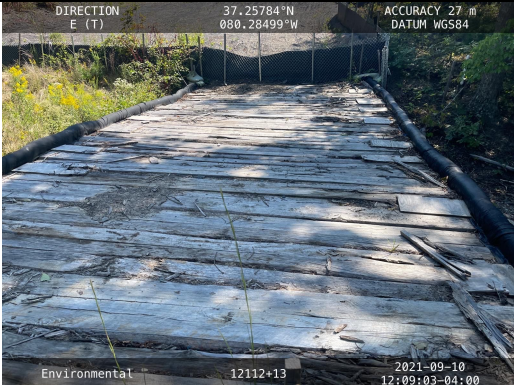
<b>GPS Location</b>	See photo		<b>GPS Location</b>	See photo	
<b>Field Station#</b>	12112+13		<b>Field Station#</b>	12117+00	
<b>Pic 3 Desc.</b>	Bridge and ECDs crossing stream S-F16A/B in acceptable condition		<b>Pic 4 Desc.</b>	Stabilized row in acceptable condition

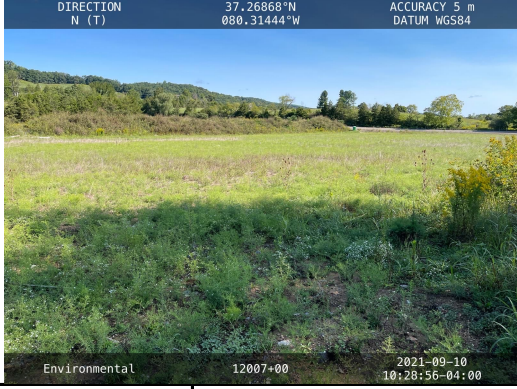
<b>GPS Location</b>	See photo		<b>GPS Location</b>	See photo	
<b>Field Station#</b>	12007+00		<b>Field Station#</b>	12008+50	
<b>Pic 9 Desc.</b>	Stabilized ROW in acceptable condition		<b>Pic 10 Desc.</b>	Stream crossing S-G36 in acceptable condition

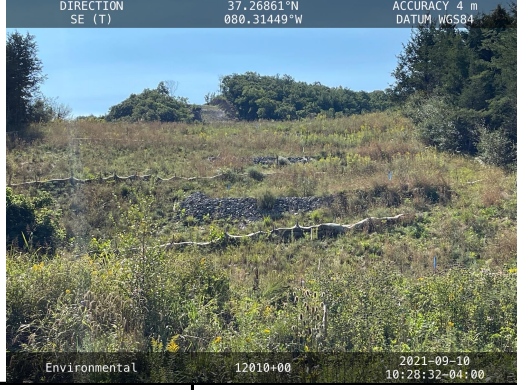
<b>GPS Location</b>	See photo		<b>GPS Location</b>	See photo	
<b>Field Station#</b>	12010+00		<b>Field Station#</b>	12013+97	
<b>Pic 11 Desc.</b>	Stabilized row in acceptable condition		<b>Pic 12 Desc.</b>	Bridge and ECDs crossing stream S-G36 along access road MVP-MN-268.01 in acceptable condition

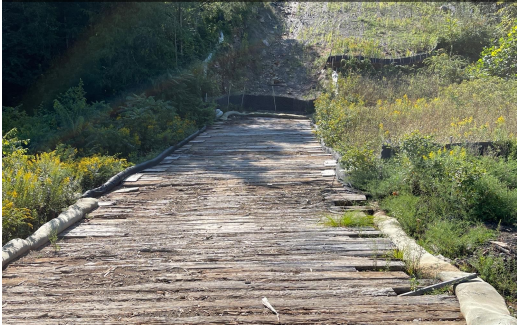
Environmental 12015+84 2021-09-10 10:07:54-04:00				DIRECTION SE (T) 37.26487°N 080.30705°W ACCURACY 5 m DATUM WGS84

Environmental 12040+00 2021-09-10 09:49:54-04:00	
<b>GPS Location</b>	See photo		<b>GPS Location</b>	See photo	
<b>Field Station#</b>	12015+84		<b>Field Station#</b>	1240+00	
<b>Pic 13 Desc.</b>	Bridge and ECDs crossing stream S-G38 in acceptable condition		<b>Pic 14 Desc.</b>	Stabilized slope in acceptable condition	
DIRECTION SE (T) 37.26492°N 080.30716°W ACCURACY 4 m DATUM WGS84

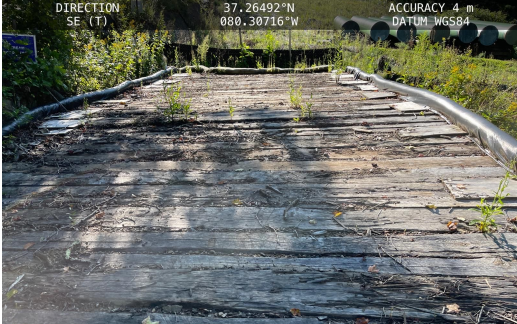
Environmental 12035+75 2021-09-10 09:49:28-04:00				DIRECTION W (T) 37.26482°N 080.30744°W ACCURACY 25 m DATUM WGS84

<b>Field Station#</b>	12035+75		<b>Field Station#</b>	1203+11	
<b>Pic 15 Desc.</b>	Bridge and ECDs crossing stream S-PP23 in acceptable condition		<b>Pic 16 Desc.</b>	Bridge and ECDs at stream S-G340 in acceptable condition	
DIRECTION W (T) 37.26495°N 080.30861°W ACCURACY 4 m DATUM WGS84

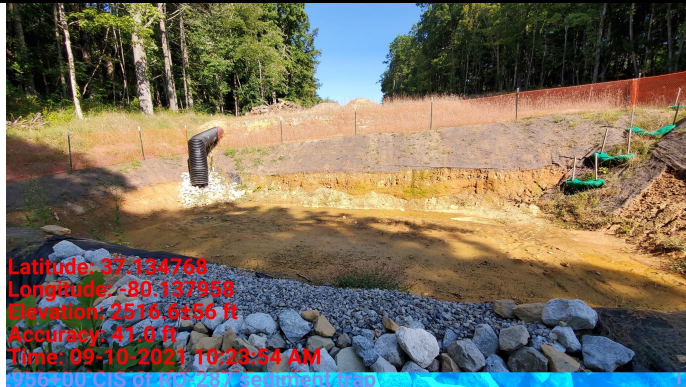
<p>Latitude: 37.134768 Longitude: -80.137958 Elevation: 2516.6±56 ft Accuracy: 41.8 ft Time: 09-10-2021 10:23:34 AM 12956+00 CIS of RO-287 large sediment trap</p>		  <p>Latitude: 37.134759 Longitude: -80.138337 Altitude: 2445.41±52 ft Accuracy: 299.4 ft Time: 09-10-2021 10:25:13 AM 12956+50 CIS of RO-287 streams S-Y7 and S-Y9</p>			
<b>GPS Location</b>	See pic for GPS location.		<b>GPS Location</b>	See pic for GPS location.	
<b>Field Station#</b>	12956+00		<b>Field Station#</b>	12956+50	
<b>Pic 11 Desc.</b>	Large sediment trap on the CIS of RO-287.		<b>Pic 12 Desc.</b>	Streams S-Y7 and S-Y9 on the upstream side of the ROW crossing.
