# Visual Site Inspection Report

<b>Project Name</b>	H-600 Pipeline Spread I	<b>AFE</b>	124300139	<b>Spread</b>	H-600 Pipeline Spread I
<b>Contractor</b>	Precision			<b>Report #</b>	25989
<b>Inspector</b>	Ben Davenport			<b>Date/Time</b>	7/19/2021 11:34 AM
<b>Permit #</b>	TBD	<b>Inspection Type</b>	VA SWPP	<b>Station Begin</b>	14694+77
<b>State</b>	VA	<b>Inspection Area</b>	Partial	<b>Station End</b>	14802+19
<b>County</b>	Franklin	<b>Ground</b>	Damp	<b>Temperature (°F)</b>	82.00
<b>Municipality</b>	N/A	<b>Weather</b>	Light Rain	<b>Rain Gauge (in)</b>	0.10
				<b>Rain Accumulation Time (days)</b>	1.00

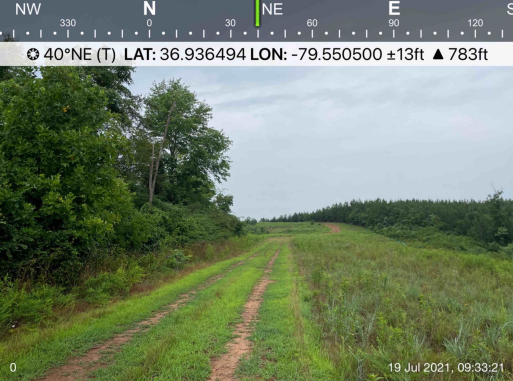
<b>GPS Location</b>	See photo		<b>GPS Location</b>	See photo	
<b>Field Station#</b>	15260+00		<b>Field Station#</b>	15230+00	
<b>Pic 1 Desc.</b>	Vegetation continues to fill in throughout this section of ROW.		<b>Pic 2 Desc.</b>	Vegetation continues to fill in throughout this section of ROW.

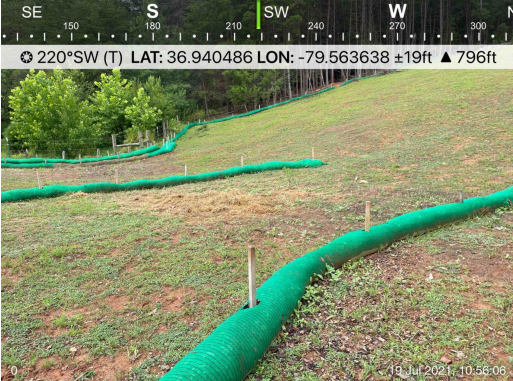
<b>GPS Location</b>	See photo		<b>GPS Location</b>	See photo	
<b>Field Station#</b>	15209+00		<b>Field Station#</b>	15195+00	
<b>Pic 3 Desc.</b>	Vegetation continues to fill in throughout this section of ROW.		<b>Pic 4 Desc.</b>	Drainage ECDs are in good condition and functioning.

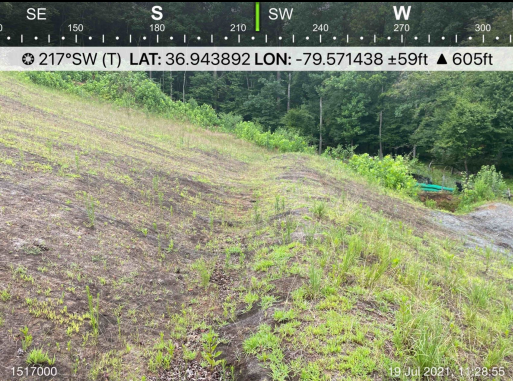
<b>GPS Location</b>	See photo		<b>GPS Location</b>	See photo	
<b>Field Station#</b>	15170+00		<b>Field Station#</b>	15170+00	
<b>Pic 5 Desc.</b>	Slope drain functioning as intended.		<b>Pic 6 Desc.</b>	Waterbars are in good condition throughout this section.

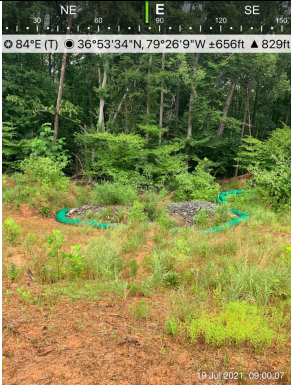
<b>GPS Location</b>	O	<b>GPS Location</b>	O		
<b>Field Station#</b>	15630+00	<b>Field Station#</b>	15590+00		
<b>Pic 1 Desc.</b>	Observing temporary stabilization,CWD outlet and ECD's.	<b>Pic 2 Desc.</b>	Observing temporary stabilization and water bars

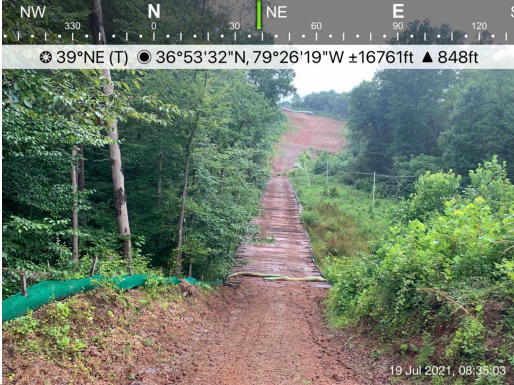
<b>GPS Location</b>	O	<b>GPS Location</b>	O		
<b>Field Station#</b>	15597+99	<b>Field Station#</b>	15619+00		
<b>Pic 3 Desc.</b>	Observing temporary stabilization,buffer, equipment crossing and ECD's	<b>Pic 4 Desc.</b>	Observing P1 that requires maintenance

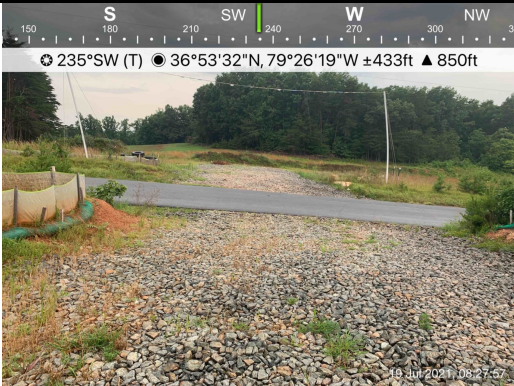
<b>GPS Location</b>	O	<b>GPS Location</b>	O		
<b>Field Station#</b>	15619+48	<b>Field Station#</b>	15619+70		
<b>Pic 5 Desc.</b>	Observing road crossing and RCE's	<b>Pic 6 Desc.</b>	Observing P1 that requires maintenance

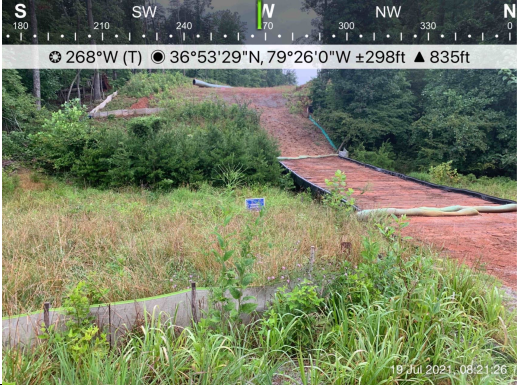
<b>GPS Location</b>	O	<b>GPS Location</b>	O		
<b>Field Station#</b>	15636+45	<b>Field Station#</b>	15646+00		
<b>Pic 7 Desc.</b>	Observing temporary stabilization, signage, buffer, equipment crossing and ECD's		<b>Pic 8 Desc.</b>	Observing temporary stabilization, sump and end treatment.	
Insert image here		Insert image here			
<b>GPS Location</b>		<b>GPS Location</b>			
<b>Field Station#</b>		<b>Field Station#</b>			
<b>Pic 9 Desc.</b>		<b>Pic 10 Desc.</b>			
Insert image here		Insert image here			
<b>GPS Location</b>		<b>GPS Location</b>			
<b>Field Station#</b>		<b>Field Station#</b>			
<b>Pic 11 Desc.</b>		<b>Pic 12 Desc.</b>

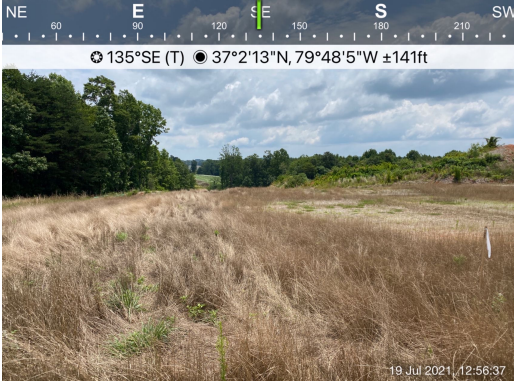
<b>GPS Location</b>	0	<b>GPS Location</b>	0		
<b>Field Station#</b>	14349+00	<b>Field Station#</b>	14391+50		
<b>Pic 3 Desc.</b>	Approximately 14349+00. Overview of ROW.	<b>Pic 4 Desc.</b>	Approximately 14391+50. Overview of stream crossing, equipment bridge and ECDs at stream S-A41.

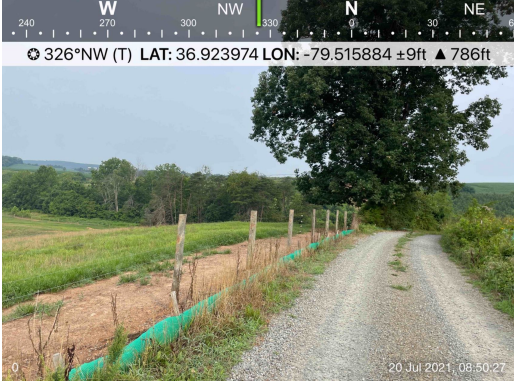
<b>GPS Location</b>	See photo		<b>GPS Location</b>	See photo	
<b>Field Station#</b>	15350+00		<b>Field Station#</b>	15346+87	
<b>Pic 1 Desc.</b>	MVP-PI-332 remains in good condition with controls in place.		<b>Pic 2 Desc.</b>	Equipment bridge ECDs are in good condition and functioning.

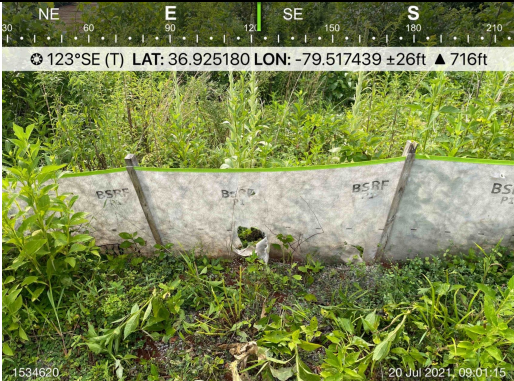
<b>GPS Location</b>	See photo		<b>GPS Location</b>	See photo	
<b>Field Station#</b>	15346+20		<b>Field Station#</b>	15338+00	
<b>Pic 3 Desc.</b>	P1 has been damaged along stream buffer and needs to be replaced.		<b>Pic 4 Desc.</b>	CWD is in good condition and functioning as intended.

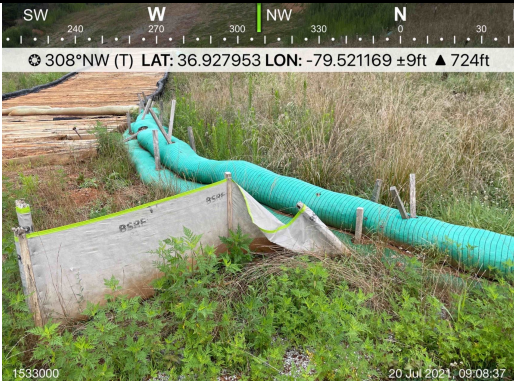
<b>GPS Location</b>	See photo		<b>GPS Location</b>	See photo	
<b>Field Station#</b>	15330+00		<b>Field Station#</b>	15323+24	
<b>Pic 5 Desc.</b>	P1 needs to be restaked at this location.		<b>Pic 6 Desc.</b>	RCEs are in good condition at all road crossings.

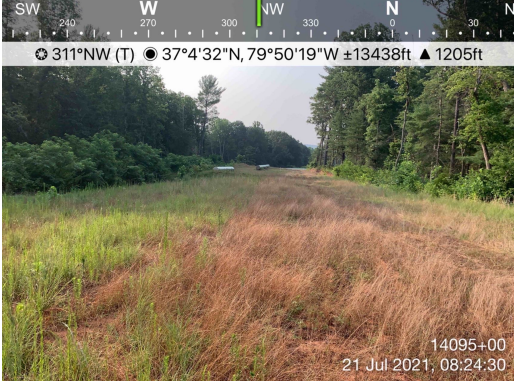
<b>GPS Location</b>	0	<b>GPS Location</b>	0		
<b>Field Station#</b>	14095+00	<b>Field Station#</b>	14109+00		
<b>Pic 1 Desc.</b>	Temporary vegetative stabilization in acceptable condition	<b>Pic 2 Desc.</b>	Waterbar end treatment in acceptable condition

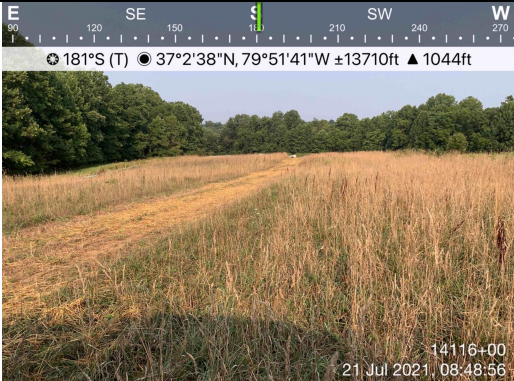
<b>GPS Location</b>	0	<b>GPS Location</b>	0		
<b>Field Station#</b>	14116+00	<b>Field Station#</b>	14124+00		
<b>Pic 3 Desc.</b>	Permanent vegetative stabilization in acceptable condition	<b>Pic 4 Desc.</b>	Perimeter CFS in acceptable condition

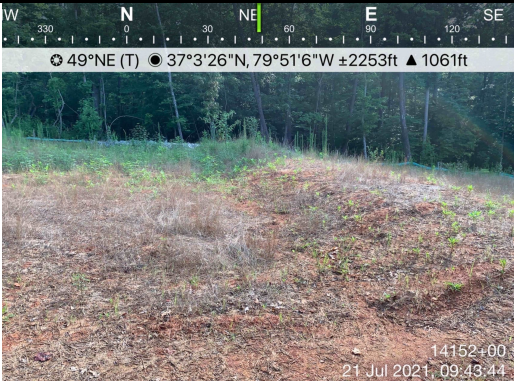
<b>GPS Location</b>	0	<b>GPS Location</b>	0		
<b>Field Station#</b>	14152+00	<b>Field Station#</b>	14158+00		
<b>Pic 5 Desc.</b>	Waterbar in acceptable condition	<b>Pic 6 Desc.</b>	P1 silt fence in acceptable condition

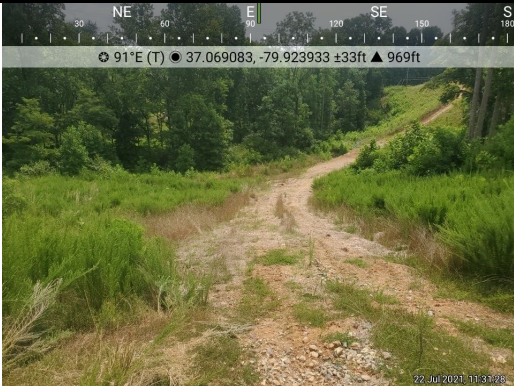
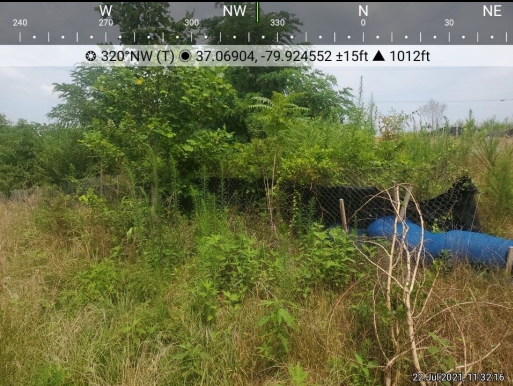
<b>GPS Location</b>	0	<b>GPS Location</b>	0		
<b>Field Station#</b>	13813+00	<b>Field Station#</b>	13811+00		
<b>Pic 5 Desc.</b>	GAS Brick Church Rd vegetation	<b>Pic 6 Desc.</b>	CIS Brick Church Rd SSF

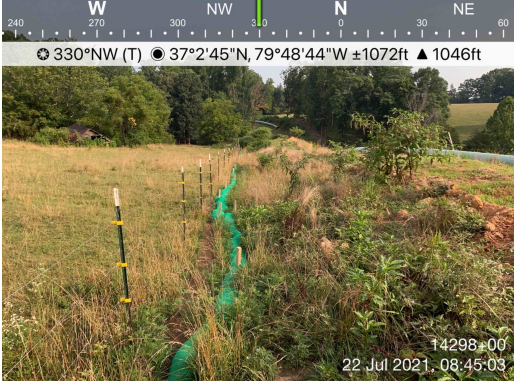
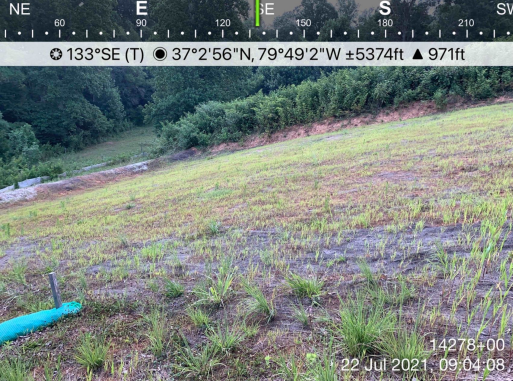
<b>GPS Location</b>	0	<b>GPS Location</b>	0		
<b>Field Station#</b>	14298+00	<b>Field Station#</b>	14278+00		
<b>Pic 1 Desc.</b>	Perimeter CFS in acceptable condition	<b>Pic 2 Desc.</b>	Temporary vegetative stabilization in acceptable condition

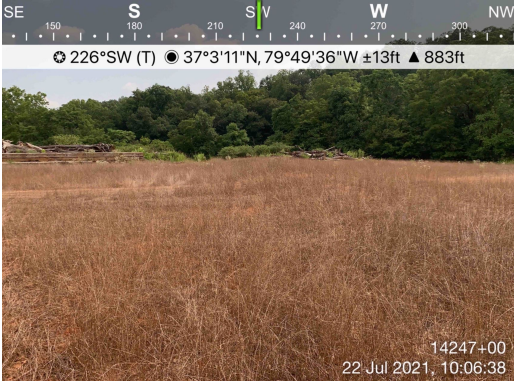
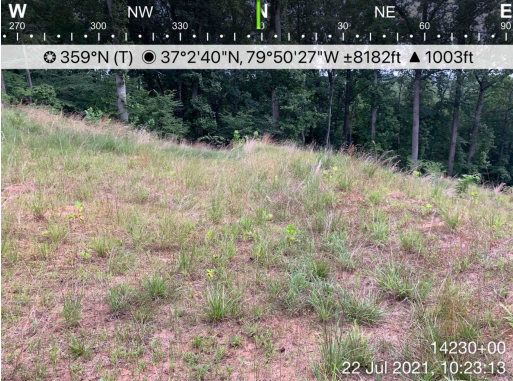
<b>GPS Location</b>	0	<b>GPS Location</b>	0		
<b>Field Station#</b>	14247+00	<b>Field Station#</b>	14230+00		
<b>Pic 3 Desc.</b>	Temporary vegetative stabilization in acceptable condition	<b>Pic 4 Desc.</b>	Waterbar in acceptable condition

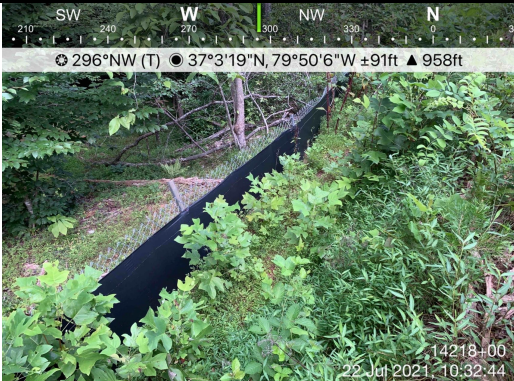
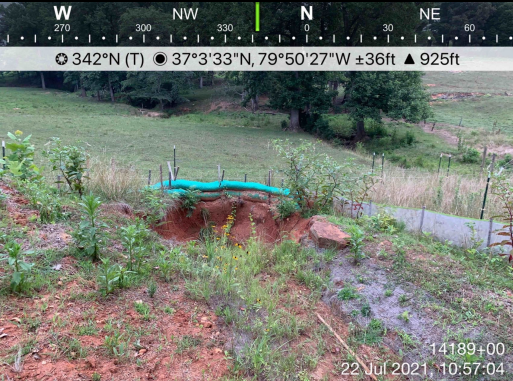
<b>GPS Location</b>	0	<b>GPS Location</b>	0		
<b>Field Station#</b>	14218+00	<b>Field Station#</b>	14189+00		
<b>Pic 5 Desc.</b>	Super silt fence in acceptable condition	<b>Pic 6 Desc.</b>	Waterbar end treatment and P1 silt fence in acceptable condition

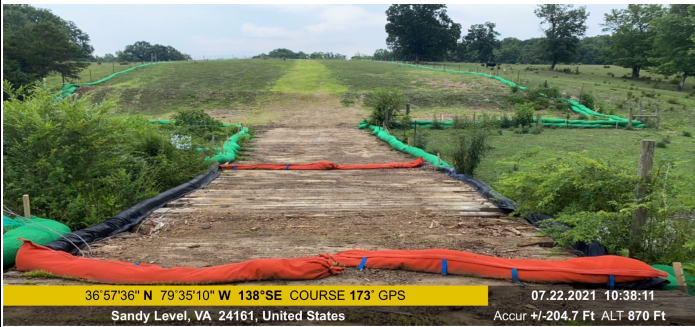
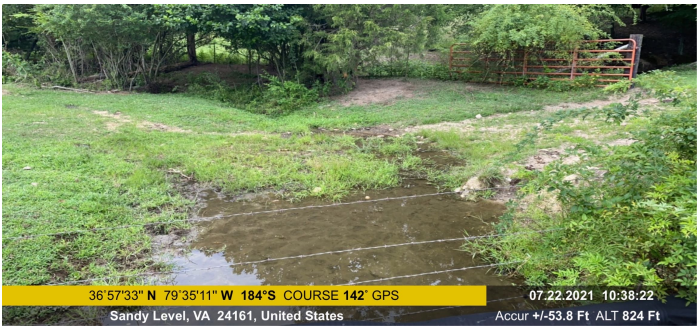
GPS Location	3	GPS Location	4		
Field Station#	15092+95	Field Station#	15092+95		
Pic 3 Desc.	Equipment bridge and surrounding ECDs in place and functional at stream crossing and resource buffer		Pic 4 Desc.	Downstream view of S-G9 at ROW crossing

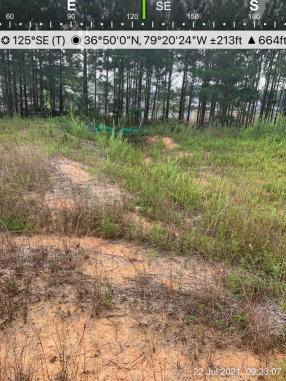
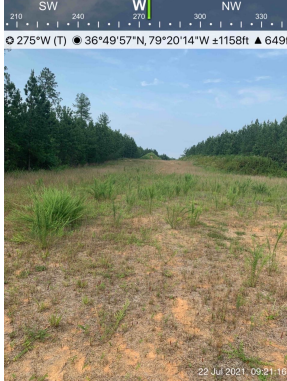
<b>GPS Location</b>	O	<b>GPS Location</b>	O		
<b>Field Station#</b>	8+00	<b>Field Station#</b>	10+00		
<b>Pic 1 Desc.</b>	Observing temporary stabilization and water bar.		<b>Pic 2 Desc.</b>	Observing temporary stabilization

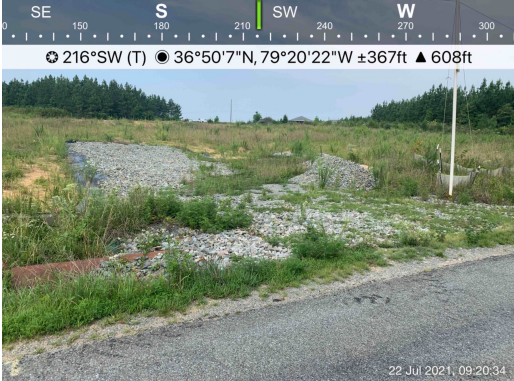
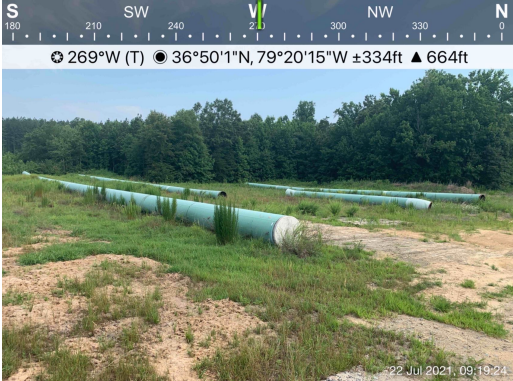
<b>GPS Location</b>	O	<b>GPS Location</b>	O		
<b>Field Station#</b>	13+77	<b>Field Station#</b>	21+00		
<b>Pic 3 Desc.</b>	Observing RCE, temporary stabilization and ECD's		<b>Pic 4 Desc.</b>	Observing temporary stabilization	
Insert image here			Insert image here		
<b>GPS Location</b>		<b>GPS Location</b>			
<b>Field Station#</b>		<b>Field Station#</b>			
<b>Pic 5 Desc.</b>			<b>Pic 6 Desc.</b>

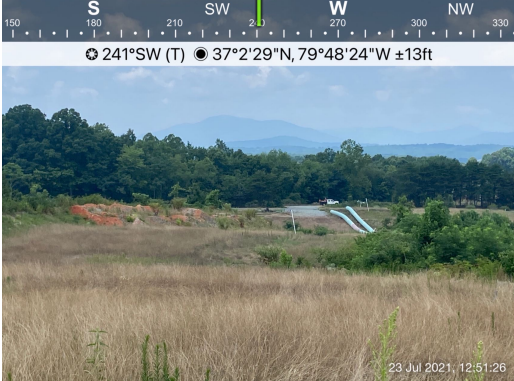
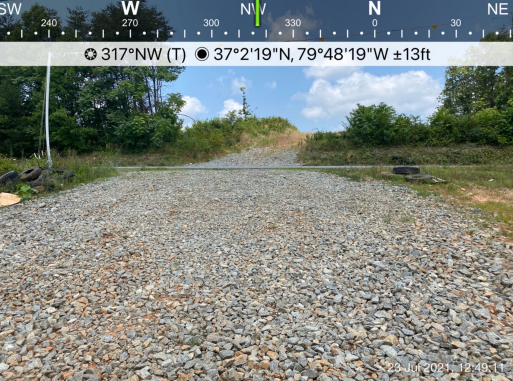
<b>GPS Location</b>	0	<b>GPS Location</b>	0		
<b>Field Station#</b>	14318+00	<b>Field Station#</b>	14333+00		
<b>Pic 1 Desc.</b>	Approximately 14318+00. Overview of ROW.	<b>Pic 2 Desc.</b>	Approximately 14333+00. Overview of road crossing and RCEs.

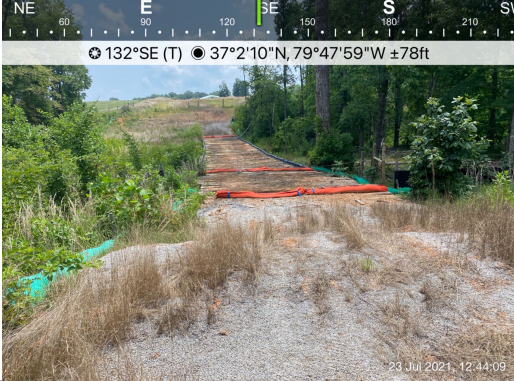
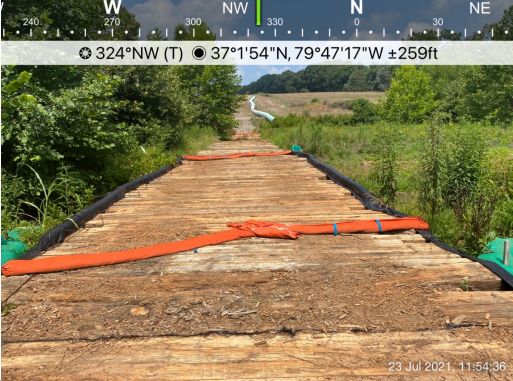
<b>GPS Location</b>	0	<b>GPS Location</b>	0		
<b>Field Station#</b>	14353+53	<b>Field Station#</b>	14391+50		
<b>Pic 3 Desc.</b>	Approximately 14353+53. Overview of stream crossing, equipment bridge and ECDs at stream S-A38.	<b>Pic 4 Desc.</b>	Approximately 14391+50. Overview of stream crossing, equipment bridge and ECDs at stream S-A41.

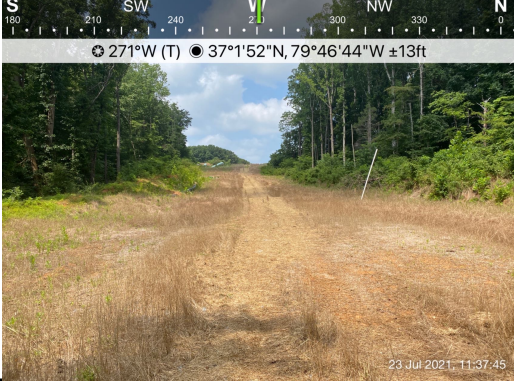
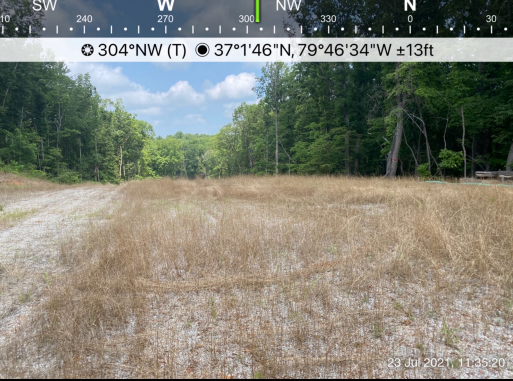
<b>GPS Location</b>	0	<b>GPS Location</b>	0		
<b>Field Station#</b>	14415+00	<b>Field Station#</b>	14428+00		
<b>Pic 5 Desc.</b>	Approximately 14415+00. Overview of ROW.	<b>Pic 6 Desc.</b>	Approximately 14428+00. Overview of ROW.

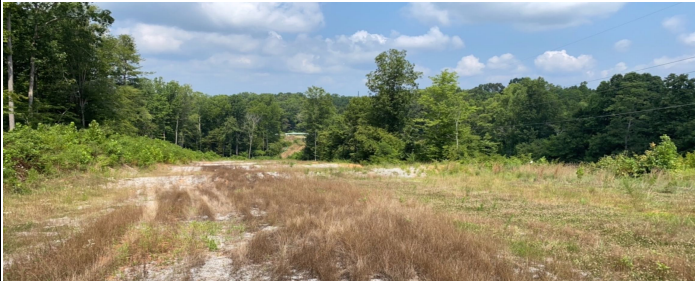
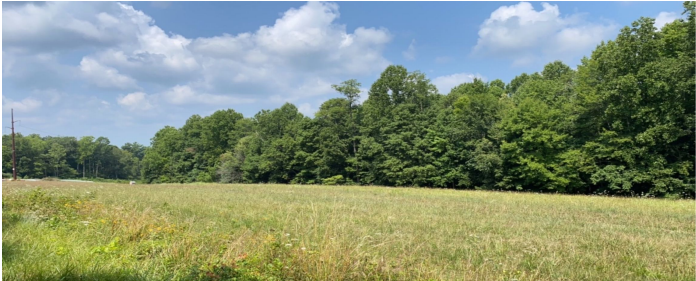
36°58'37" N 79°40'44" W 297°NW COURSE -1' GPS Sorry no results found 07.23.2021 11:51:25 Accur +/-15.4 Ft ALT 941 Ft			36°58'39" N 79°40'35" W 268°W COURSE 155' GPS Sorry no results found 07.23.2021 12:05:32 Accur +/-186.7 Ft ALT 881 Ft		
GPS Location	5		GPS Location	6	
Field Station#	14799+00		Field Station#	14802+00	
Pic 5 Desc.	Temporary stabilization and vegetation along ROW. Much of vegetation dying out.		Pic 6 Desc.	View of extra workspace near MVP-FR-323.

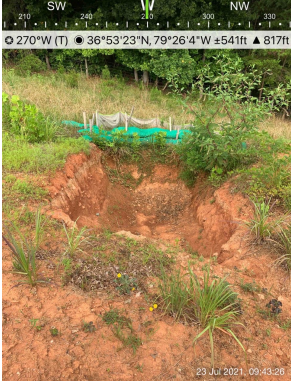
GPS Location	O	GPS Location	O		
Field Station#	15640+00	Field Station#	15616+00		
Pic 1 Desc.	Observing temporary stabilization, sump and end treatment		Pic 2 Desc.	Observing temporary stabilization and water bars

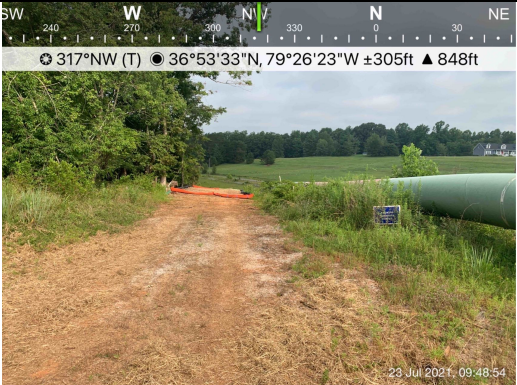
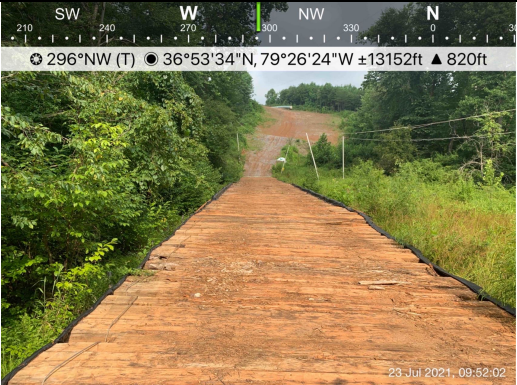
GPS Location	O	GPS Location	O		
Field Station#	15614+94	Field Station#	15597+00		
Pic 3 Desc.	Observing temporary stabilization, signage, buffer, equipment crossing and ECD's		Pic 4 Desc.	Observing equipment crossing

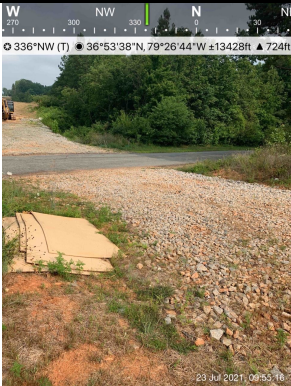
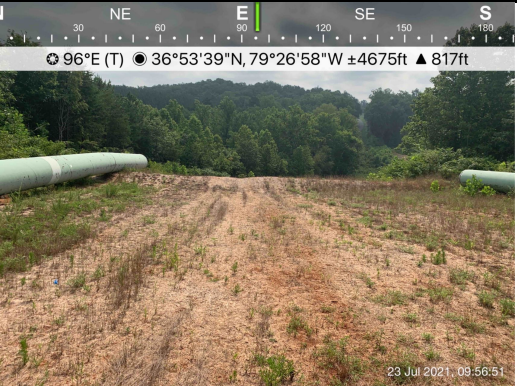
GPS Location	O	GPS Location	O		
Field Station#	15584+23	Field Station#	15590+00		
Pic 5 Desc.	Observing road crossing and RCE's		Pic 6 Desc.	Observing temporary stabilization and water bars

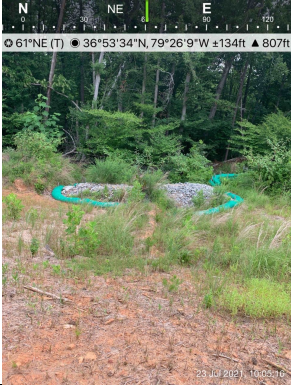
<p>Insert image here</p>		<p>Insert image here</p>	
<b>GPS Location</b>	O	<b>GPS Location</b>			
<b>Field Station#</b>	15630+00	<b>Field Station#</b>			
<b>Pic 7 Desc.</b>	Observing temporary stabilization,CWD outlet and ECD's	<b>Pic 8 Desc.</b>			
<p>Insert image here</p>		<p>Insert image here</p>			
<b>GPS Location</b>		<b>GPS Location</b>			
<b>Field Station#</b>		<b>Field Station#</b>			
<b>Pic 9 Desc.</b>		<b>Pic 10 Desc.</b>			
<p>Insert image here</p>		<p>Insert image here</p>			
<b>GPS Location</b>		<b>GPS Location</b>			
<b>Field Station#</b>		<b>Field Station#</b>			
<b>Pic 11 Desc.</b>		<b>Pic 12 Desc.</b>
