Visual Site Inspection Report

Project Name	H-600 Pipeline Spread I	AFE	124300139	Spread	H-600 Pipeline Spread I
Contractor	Precision			Report #	26291
Inspector	Ben Davenport			Date/Time	7/26/2021 1:59 PM
Permit #	TBD	Inspection Type	VA SWPP	Station Begin	14802+19
State	VA	Inspection Area	Partial	Station End	14928+52
County	Franklin	Ground	Dry	Temperature (°F)	88.00
Municipality	N/A	Weather	Sunny	Rain Gauge (in)	0.00
				Rain Accumulation Time (days)	0.00

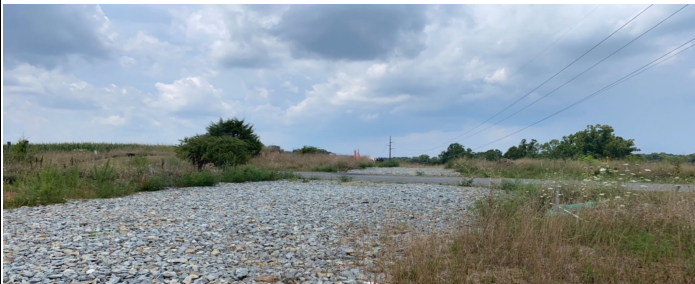
36°58'20" N 79°39'55" W 20°N COURSE 324° GPS 355 Listening Hill Rd, Penhook, VA 24137, United States 07.26.2021 13:07:15 Accur +/-15.4 Ft ALT 992 Ft			36°58'17" N 79°39'36" W 345°N COURSE 346° GPS 1760 Bar Ridge Rd, Penhook, VA 24137, United States 07.26.2021 13:04:21 Accur +/-32.8 Ft ALT 890 Ft		
GPS Location	1		GPS Location	2	
Field Station#	14845+68		Field Station#	14861+31	
Pic 1 Desc.	RCE at Listening Hill Rd in good condition		Pic 2 Desc.	RCE at Bar Ridge Rd in good condition

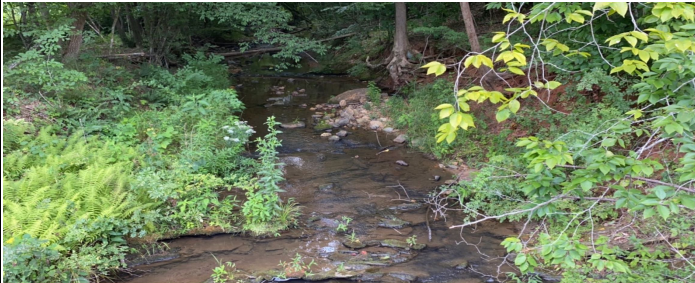
36°58'6" N 79°38'31" W 205°SW COURSE 176° GPS Sorry no results found 07.26.2021 12:42:39 Accur +/-104.9 Ft ALT 768 Ft			36°58'5" N 79°38'22" W 256°W COURSE 182° GPS 07.26.2021 12:38:48 Accur +/-30.4 Ft ALT 820 Ft		
GPS Location	5		GPS Location	6	
Field Station#	14915+96		Field Station#	14923+00	
Pic 5 Desc.	Downstream view of S-G16 at ROW crossing		Pic 6 Desc.	Equipment bridge and surrounding ECDs in place and functional at CWD

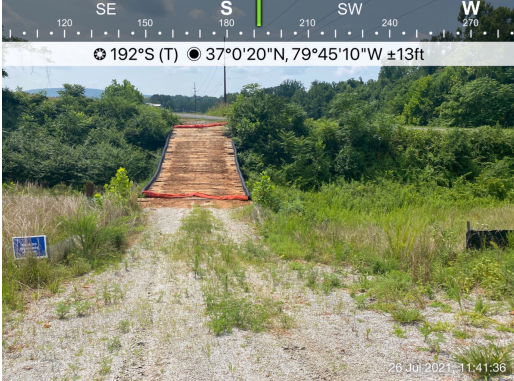
GPS Location	0	GPS Location	0		
Field Station#	14546+33	Field Station#	14537+00		
Pic 1 Desc.	Approximately 14546+33. Overview of stream crossing, equipment bridge and ECDs at stream S-G17.		Pic 2 Desc.	Approximately 14537+00. Overview of ROW.

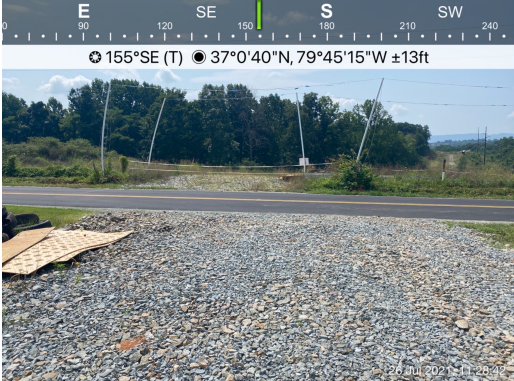
GPS Location	0	GPS Location	0		
Field Station#	14524+50	Field Station#	14520+00		
Pic 3 Desc.	Approximately 14524+50. Overview of road crossing and RCEs.		Pic 4 Desc.	Approximately 14520+00. Overview of ROW.

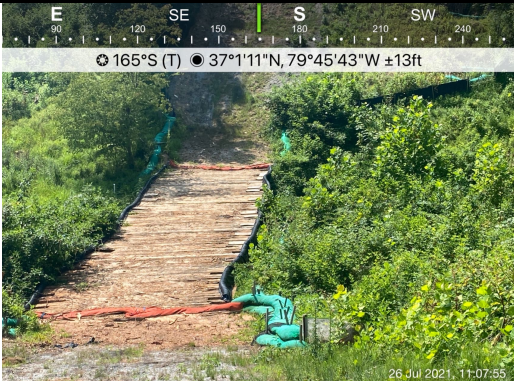
GPS Location	0	GPS Location	0		
Field Station#	14486+60	Field Station#	14484+50		
Pic 5 Desc.	Approximately 14486+60. Overview of stream crossing, equipment bridge and ECDs at stream S-G22.		Pic 6 Desc.	Approximately 14484+50. P-1 requires maintenance. Damaged by livestock.

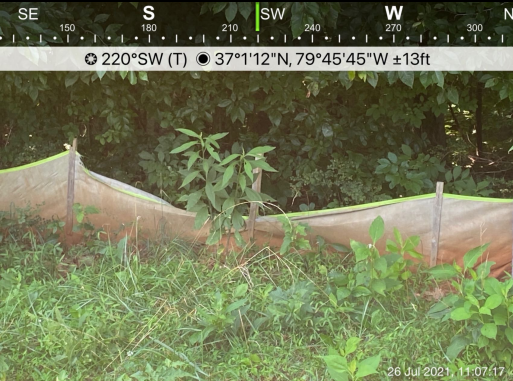
4. E&S BMPs (List BMPs and note if installed and maintained as per the plan. If corrective action is needed, a picture is required.)					
E&S BMPs		Compliance Level	Corrective Action	Corrective Time Frame	Date Repaired
3rd Party Damages		Communication	Repair livestock damage to P-1		
Compost Filter Sock		Acceptable			
Cleanwater Diversion Pipe		Acceptable			
Equipment Bridge		Acceptable			
Rock Construction Entrance		Acceptable			
Sensitive Resource Buffer		Acceptable			
Sensitive Resource Signage		Acceptable			
Silt Fence (Filter Fabric Fence)		Communication	Repair livestock damage		
Silt Fence (Reinforce Filter Fence)		Acceptable

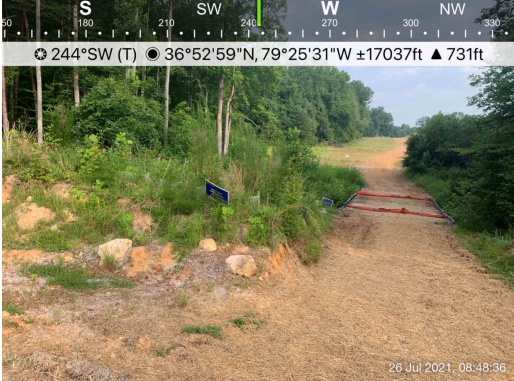
GPS Location	O	GPS Location	O		
Field Station#	15658+43	Field Station#	15677+00		
Pic 1 Desc.	Observing temporary stabilization, signage, buffer, equipment crossing and ECD's	Pic 2 Desc.	Observing CFS that requires maintenance (3rd party damage)

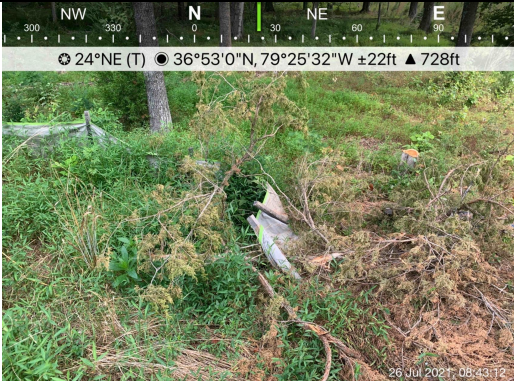
GPS Location	O	GPS Location	O		
Field Station#	15677+00	Field Station#	15677+00		
Pic 3 Desc.	Observing P1 that requires maintenance (3rd party damage)	Pic 4 Desc.	Observing CFS that requires maintenance (3rd party damage)

7. Identify all remedial measures that have been taken since the previous inspection was conducted.					
Comments (Reference above questions as appropriate.)					
Performed SWPPP Inspection on this section. There were issues identified and added to the punch list. The Contractor is working on repairing the identified issues. Other than that there were no issues to report at the time of Inspection.					
Note: It is a condition of National Pollutant Discharge Elimination System and Erosion and Sediment permits that a maintenance program be conducted to provide for the operation and maintenance of all BMPs to be inspected on a weekly basis and after each stormwater event. Please list in the space provided comments to note if repairs or replacement are needed or have been made for BMPs as a result of the inspection. Failure to conduct the required inspection may result in permit suspension or the imposition of civil penalties. If supplemental monitoring is required as part of a permit condition this form may be used to meet those monitoring requirements.

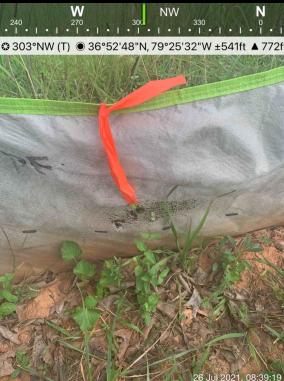
GPS Location	O	GPS Location	O		
Field Station#	15678+57	Field Station#	15690+00		
Pic 5 Desc.	Observing P1 that requires maintenance	Pic 6 Desc.	Observing temporary stabilization, erosion control blanket, CFS checks and water bar

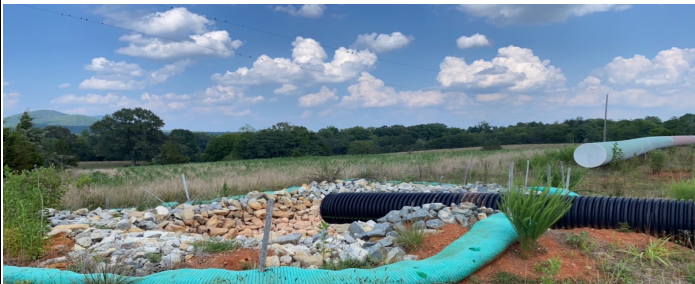
36°57'55" N 79°37'10" W 182°S COURSE 91' GPS 19009-19099 Snow Creek Rd, Penhook, VA 24137, United States Accur +/-15.5 Ft ALT 944 Ft			36°57'55" N 79°37'14" W 334°NW COURSE 324' GPS 19009-19099 Snow Creek Rd, Penhook, VA 24137, United States Accur +/-15.4 Ft ALT 963 Ft		
GPS Location	1	GPS Location	2		
Field Station#	14983+00	Field Station#	14980+00		
Pic 1 Desc.	CWD pipe and plunge pool performing intended functions		Pic 2 Desc.	Spoil pile stabilized and vegetated in extra workspace

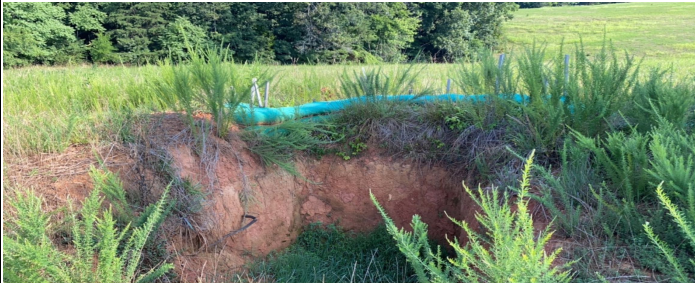
36°57'49" N 79°35'39" W 348°N COURSE 319' GPS 1923-2165 Armstrong Rd, Penhook, VA 24137, United States Accur +/-15.4 Ft ALT 920 Ft			36°57'47" N 79°35'38" W 339°NW COURSE 216' GPS 1923-2165 Armstrong Rd, Penhook, VA 24137, United States Accur +/-15.4 Ft ALT 936 Ft		
GPS Location	5	GPS Location	6		
Field Station#	15059+00	Field Station#	15061+50		
Pic 5 Desc.	Sump pit and CFS end treatment in place and functional		Pic 6 Desc.	Spoil pile stabilized and vegetated in extra workspace

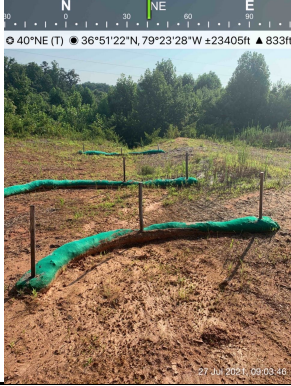
GPS Location	O	GPS Location	O		
Field Station#	15827+00	Field Station#	15858+00		
Pic 1 Desc.	Observing P1 that requires maintenance	Pic 2 Desc.	Observing temporary stabilization, water bar and CFS checks.

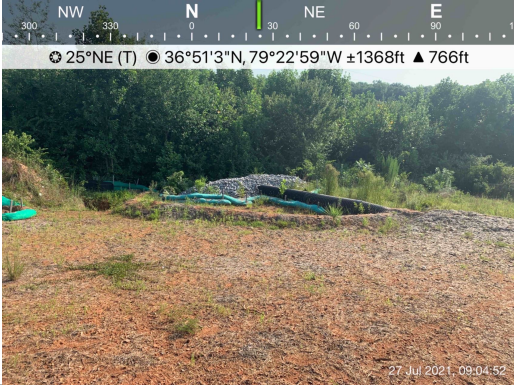
GPS Location	O	GPS Location	O		
Field Station#	15866+00	Field Station#	15878+08		
Pic 3 Desc.	Observing temporary stabilization, CWD outlet and ECD's	Pic 4 Desc.	Observing temporary stabilization, signage, buffer, equipment crossing and ECD's

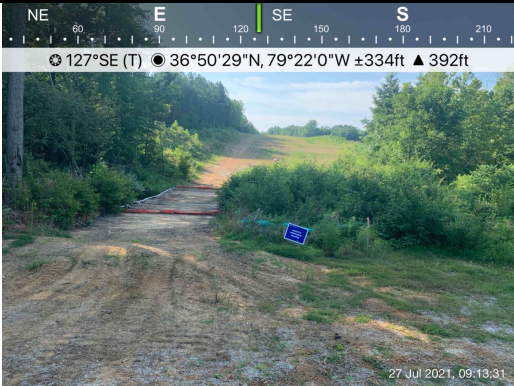
GPS Location	O	GPS Location	O		
Field Station#	15923+62	Field Station#	15934+00		
Pic 5 Desc.	Observing temporary stabilization, signage, buffer, equipment crossing and ECD's	Pic 6 Desc.	Observing temporary stabilization, CWD outlet and ECD's

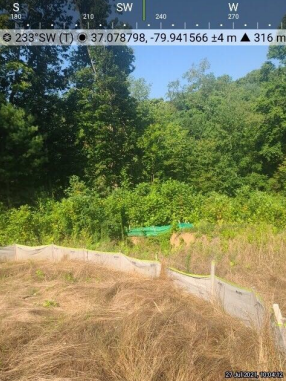
GPS Location	0000		GPS Location	0000	
Field Station#	13728+90		Field Station#	13687+40	
Pic 1 Desc.	Monitored ECDs and end treatment at sump pit, all ECDs functioning properly at the time of inspection.		Pic 2 Desc.	P1 requires maintenance due to broken stake, documented and added to the punch list for repair.

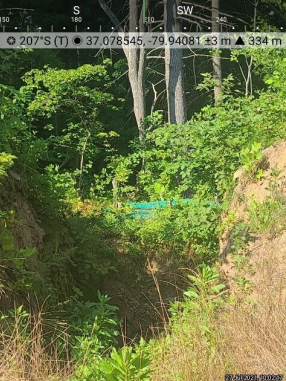
GPS Location	0000		GPS Location	00000	
Field Station#	13730+00		Field Station#	13728+23	
Pic 3 Desc.	Monitored sump pit and end treatment, all ECDs functioning properly at the time of inspection.		Pic 4 Desc.	Monitored stabilization on hill sides above stream crossing S-

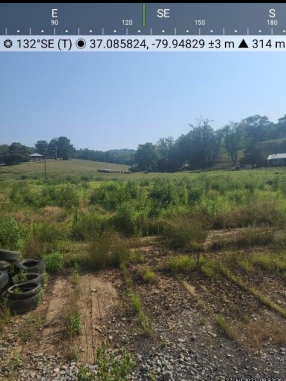
GPS Location	00000		GPS Location	00000	
Field Station#	13692+41		Field Station#	13683+91	
Pic 5 Desc.	Vegetation observation photo in work space and wetland area with ECDs in place and functioning at the time of inspection.		Pic 6 Desc.	Row photo showing vegetation and equipment mats in place in low lying area.

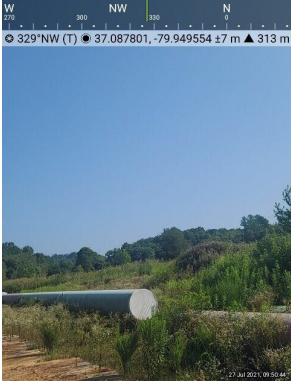
<p>GPS data: 329°NW (T) • 37.087801, -79.949554 ±7 m ▲ 313 m</p>		<p>Insert image here</p>			
GPS Location	0000	GPS Location			
Field Station#	13680+90	Field Station#			
Pic 7 Desc.	Photo showing above ground pipe and spoil piles stabilized. No issues observed at the time of inspection.		Pic 8 Desc.		
<p>Insert image here</p>		<p>Insert image here</p>			
GPS Location		GPS Location			
Field Station#		Field Station#			
Pic 9 Desc.		Pic 10 Desc.			
<p>Insert image here</p>		<p>Insert image here</p>			
GPS Location		GPS Location			
Field Station#		Field Station#			
Pic 11 Desc.		Pic 12 Desc.

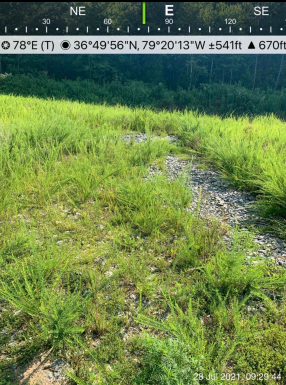
GPS Location	O	GPS Location	O		
Field Station#	22+00	Field Station#	14+00		
Pic 3 Desc.	Observing temporary stabilization	Pic 4 Desc.	Observing temporary stabilization and RCE		
Insert image here			Insert image here		
GPS Location		GPS Location			
Field Station#		Field Station#			
Pic 5 Desc.		Pic 6 Desc.

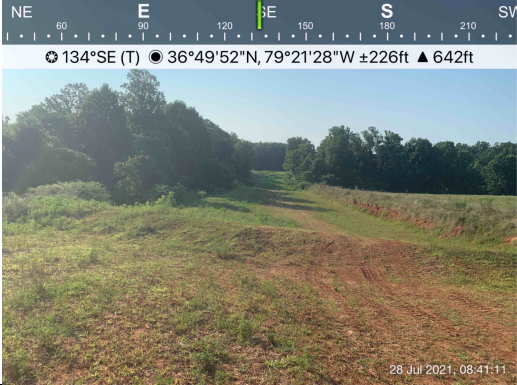
GPS Location	O	GPS Location			
Field Station#	15970+00	Field Station#			
Pic 7 Desc.	Observing temporary stabilization and water bar	Pic 8 Desc.			
Insert image here		Insert image here			
GPS Location		GPS Location			
Field Station#		Field Station#			
Pic 9 Desc.		Pic 10 Desc.			
Insert image here		Insert image here			
GPS Location		GPS Location			
Field Station#		Field Station#			
Pic 11 Desc.		Pic 12 Desc.

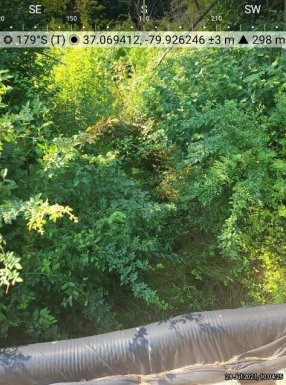
GPS Location	00000	GPS Location	0000		
Field Station#	13805+70	Field Station#	13758+60		
Pic 1 Desc.	Stream observation photo facing downstream during routine inspection today. No environmental issues observed at the time of inspection.	Pic 2 Desc.	Row photo showing millet growing where recently seeded during work activities.

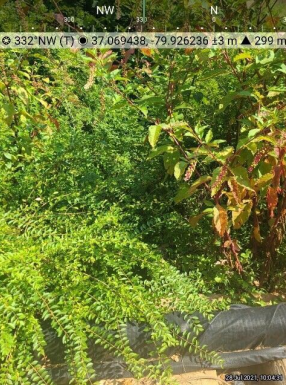
GPS Location	0000	GPS Location	0000		
Field Station#	13805+70	Field Station#	13805+58		
Pic 3 Desc.	Stream observation photo facing upstream during routine inspection today. No environmental issues observed at the time of inspection.	Pic 4 Desc.	ECDs and stabilization on hill side observed and functioning properly. No issues observed at the time of inspection.

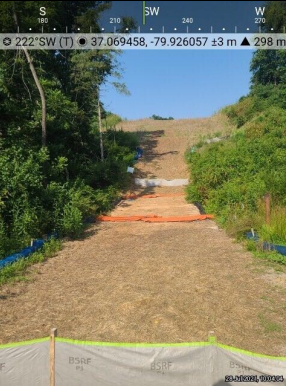
GPS Location	00000	GPS Location	00000		
Field Station#	13806+00	Field Station#	13850+00		
Pic 5 Desc.	Monitored ECDs and equipment bridge at stream crossing. No issues observed at the time of inspection.	Pic 6 Desc.	Row photo showing travel lane stabilization, good vegetation on row was observed.

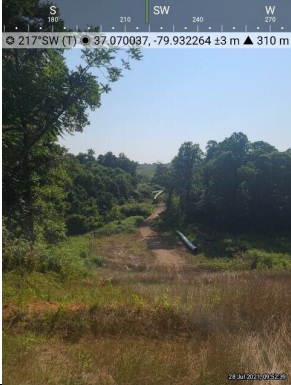
<p>ert image here</p> <p>Insert image here</p>			
GPS Location	00000	GPS Location			
Field Station#	13749+50	Field Station#			
Pic 7 Desc.	Row photo showing stabilization on hill side above stream crossing. No environmental issues observed at the time of inspection.		Pic 8 Desc.		
<p>Insert image here</p>		<p>Insert image here</p>			
GPS Location		GPS Location			
Field Station#		Field Station#			
Pic 9 Desc.		Pic 10 Desc.			
<p>Insert image here</p>		<p>Insert image here</p>			
GPS Location		GPS Location			
Field Station#		Field Station#			
Pic 11 Desc.		Pic 12 Desc.

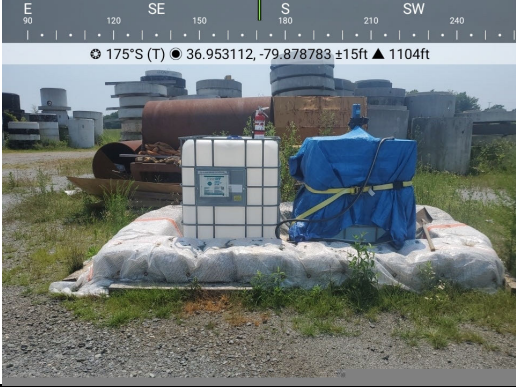
GPS Location	0	GPS Location	0		
Field Station#	0+00	Field Station#	0+00		
Pic 7 Desc.	ANC-006 Secondary containment	Pic 8 Desc.	ANC-006 Stormwater drain inlet protection		
Insert image here		Insert image here			
GPS Location		GPS Location			
Field Station#		Field Station#			
Pic 9 Desc.		Pic 10 Desc.			
Insert image here		Insert image here			
GPS Location		GPS Location			
Field Station#		Field Station#			
Pic 11 Desc.		Pic 12 Desc.

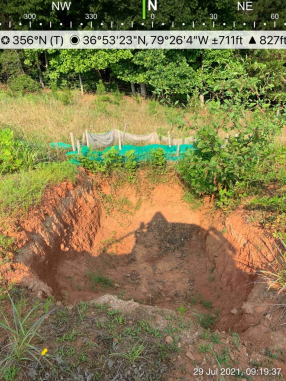
GPS Location	O	GPS Location	O		
Field Station#	15640+00	Field Station#	15636+45		
Pic 1 Desc.	Observing temporary stabilization, sump and end treatment	Pic 2 Desc.	Observing temporary stabilization, signage, buffer, equipment crossing and ECD's

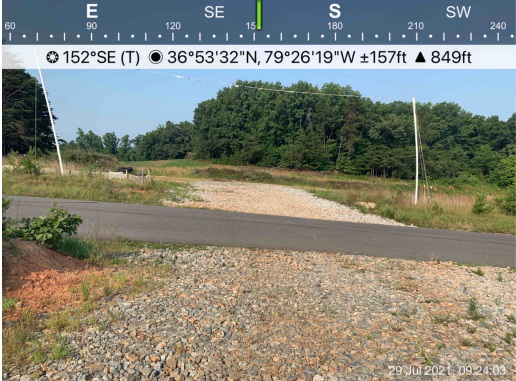
GPS Location	O	GPS Location	O		
Field Station#	15619+48	Field Station#	15598+00		
Pic 3 Desc.	Observing road crossing and RCE's	Pic 4 Desc.	Observing temporary stabilization, signage, buffer, equipment crossing and ECD's

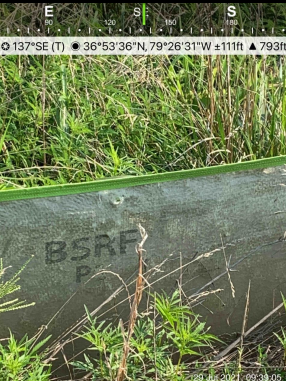
GPS Location	O	GPS Location	O		
Field Station#	15610+00	Field Station#	15610+00		
Pic 5 Desc.	Observing P1 that required maintenance	Pic 6 Desc.	Observing P1 that received maintenance

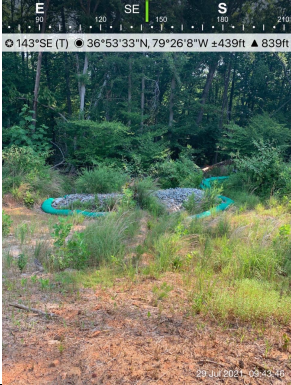
<div style="text-align: center;">Insert image here</div>			
GPS Location	O	GPS Location			
Field Station#	15632+00	Field Station#			
Pic 7 Desc.	Observing temporary stabilization,CWD outlet and ECD's	Pic 8 Desc.			
Insert image here		Insert image here			
GPS Location		GPS Location			
Field Station#		Field Station#			
Pic 9 Desc.		Pic 10 Desc.			
Insert image here		Insert image here			
GPS Location		GPS Location			
Field Station#		Field Station#			
Pic 11 Desc.		Pic 12 Desc.

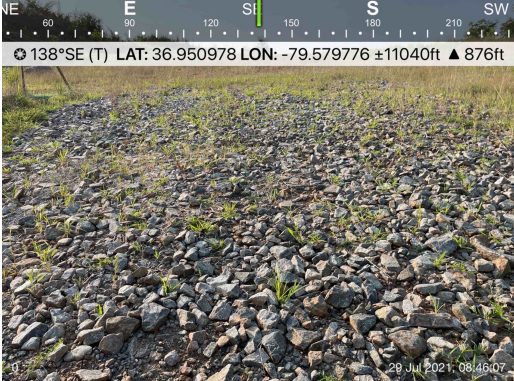
GPS Location	See photo		GPS Location	See photo	
Field Station#	15142+66		Field Station#	15150+00	
Pic 1 Desc.	RCE is in good condition at Rockcreek Rd.		Pic 2 Desc.	Perimeter CFS is in good condition throughout this section.

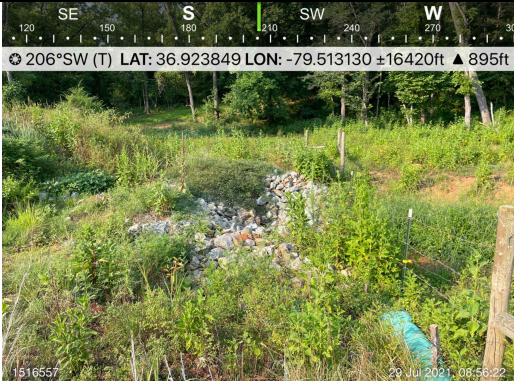
GPS Location	See photo		GPS Location	See photo	
Field Station#	15165+57		Field Station#	15166+00	
Pic 3 Desc.	Rock inlet is in good condition		Pic 4 Desc.	Rock outlet is in good condition.

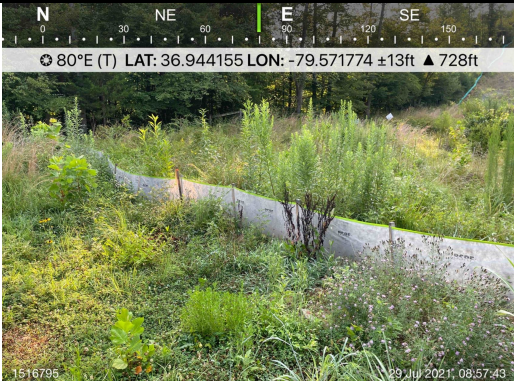
GPS Location	See photo		GPS Location	See photo	
Field Station#	15167+95		Field Station#	15167+95	
Pic 5 Desc.	P1 is in good condition at this stream buffer.		Pic 6 Desc.	Equipment bridge ECDs are in place and functioning.

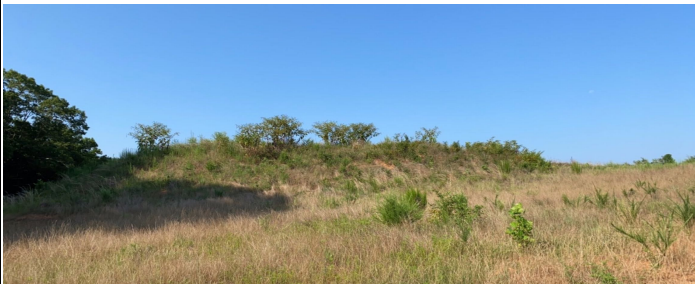
36°57'45" N 79°35'31" W 227°SW COURSE 118' GPS 1918-2164 Armstrong Rd, Penhook, VA 24137, United States 07.28.2021 09:50:29 Accur +/-48.1 Ft ALT 0 Ft			36°57'44" N 79°35'28" W 194°S COURSE -1' GPS 1918-2164 Armstrong Rd, Penhook, VA 24137, United States 07.28.2021 09:52:03 Accur +/-15.4 Ft ALT 920 Ft		
GPS Location	1	GPS Location	2		
Field Station#	15068+00	Field Station#	15070+50		
Pic 1 Desc.	Spoil pile stabilized and vegetated		Pic 2 Desc.	Plunge pool performing intended function

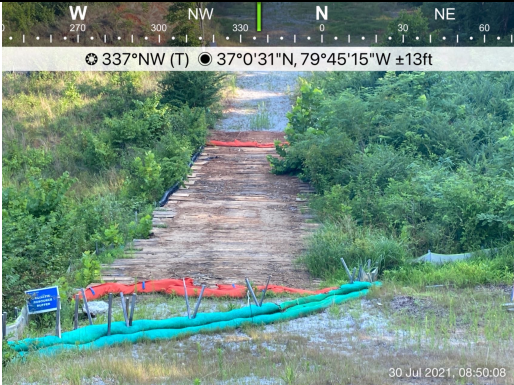
GPS Location	0	GPS Location	0		
Field Station#	14531+58	Field Station#	14524+60		
Pic 3 Desc.	Approximately 14531+58. Overview of stream crossing, equipment bridge and ECDs at stream S-G18.		Pic 4 Desc.	Approximately 14524+60. Overview of road crossing and RCEs.

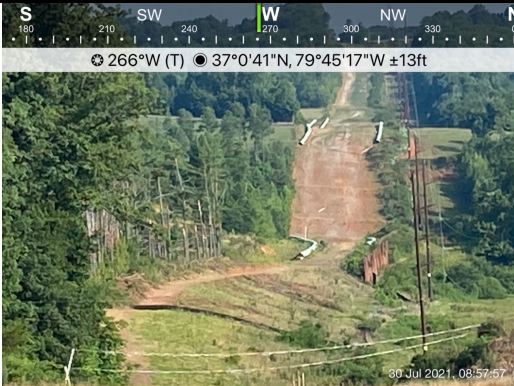
GPS Location	0	GPS Location	0		
Field Station#	14510+00	Field Station#	14486+60		
Pic 5 Desc.	Approximately 14510+00. Overview of ROW.		Pic 6 Desc.	Approximately 14486+60. Overview of stream crossing, equipment bridge and ECDs at stream S-G22.
