Visual Site Inspection Report

| Project Name | H-600 Pipeline Spread I | AFE | 124300139 | Spread | H-600 Pipeline Spread I |

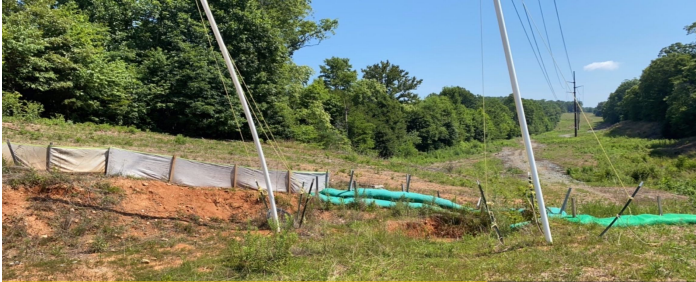
| GPS Location | 1 | | GPS Location | 2 | |

| Pic 1 Desc. | Contractor replaced P1 silt fence per punch list item. | | Pic 2 Desc. | ROW stabilized and vegetated in final cleanup area. Noticeable use of travel lane. | |

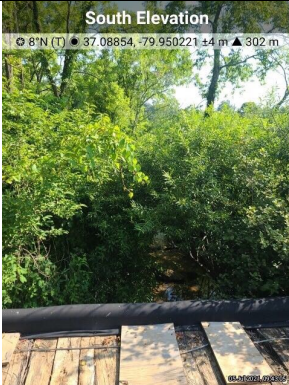
| Field Station# | 13678+71 | Field Station# | 13683+64 | | |

| Pic 1 Desc. | Stream observation photo facing upstream during routine inspection today. No issues observed at the time of inspection. | | Pic 2 Desc. | Monitored stabilization on spoil piles. Good coverage noted, no environmental issues observed at the time of inspection. | |

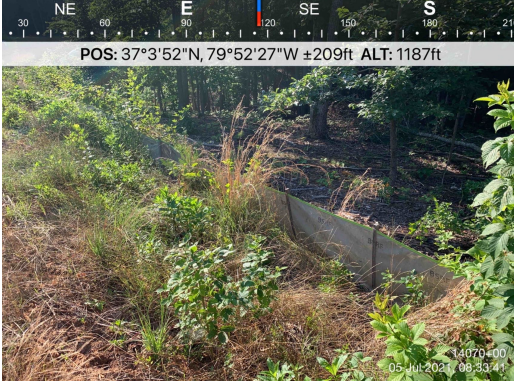
| Field Station# | 14070+00 | Field Station# | 14115+00 | | |

| Pic 1 Desc. | P1 silt fence in acceptable condition | Pic 2 Desc. | Perimeter CFS in acceptable condition | | |

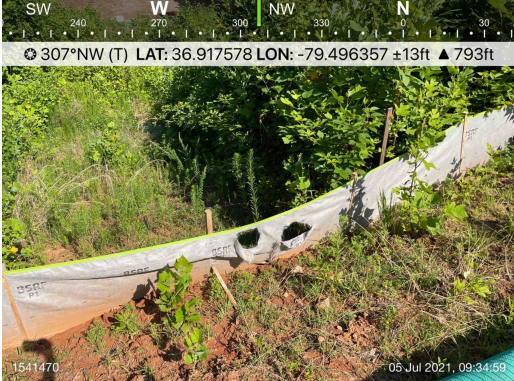
| Field Station# | 15414+70 | | Field Station# | 15414+70 | |

| E&S BMPs | Compliance Level | Corrective Action | Corrective Time Frame | Date Repaired |
|---|---|---|---|---|
| Silt Fence (Filter Fabric Fence) | Communication | P1 has been damaged by livestock | Addressed | 7/5/2021 |

| Pic 1 Desc. | P1 has been damaged by livestock and needs to be replaced. | | Pic 2 Desc. | Environmental crew has corrected this issue. | |

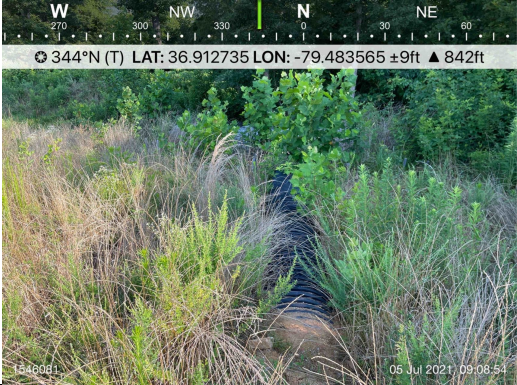
| Field Station# | 15460+81 | | Field Station# | 15457+00 | |

| Pic 7 Desc. | CWD is functioning as intended. | | Pic 8 Desc. | Drainage ECDs are in good condition with no evidence of sedimentation from 3rd party disturbance. | |

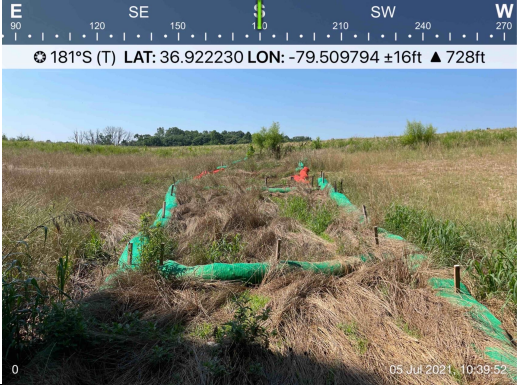
| Field Station# | 15375+00 | Field Station# | | | |

| Pic 13 Desc. | Drainage ECDs are in good condition. | Pic 14 Desc. | | | |

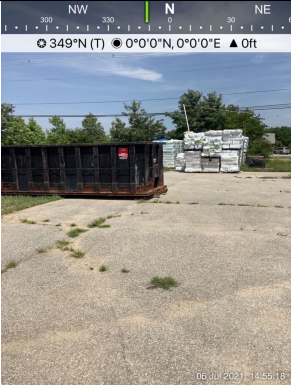
| Pic 1 Desc. | LY-048 Housekeeping & waste management | | Pic 2 Desc. | LY-048 Equipment staging | |

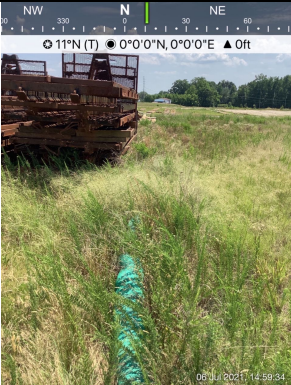
| Pic 3 Desc. | LY-048 CFS West Perimeter | | Pic 4 Desc. | LY-048 Timber mats | |

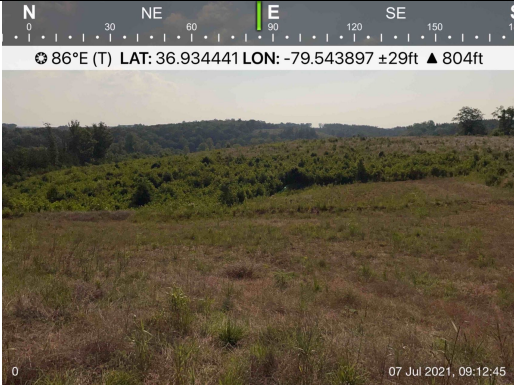
| Field Station# | 15260+00 | | Field Station# | 15235+00 | |

| Pic 1 Desc. | Vegetation continues to fill in throughout this section. | | Pic 2 Desc. | Vegetation continues to fill in throughout this section. | |

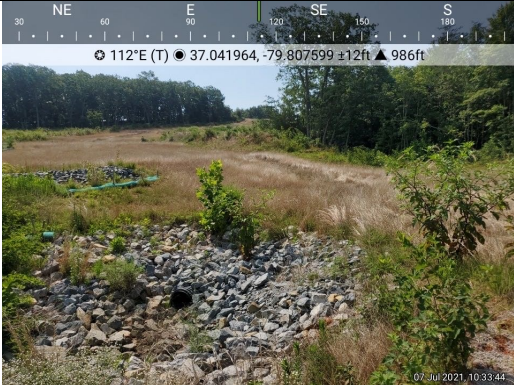
| Field Station# | 14320+00 | Field Station# | 14320+00 | | |

| Pic 1 Desc. | Plunge pool | Pic 2 Desc. | Clean water diversion inlet | | |

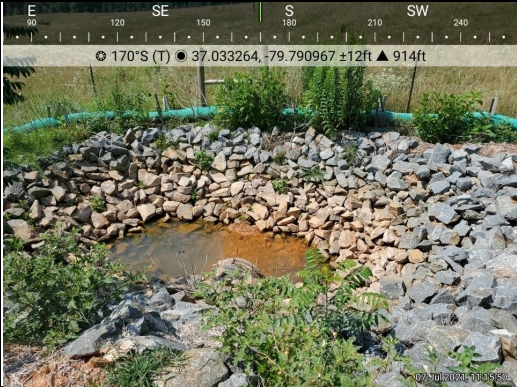
| Field Station# 14382+00 | | Field Station# 14391+60 | | | |

| Pic 7 Desc. Plunge pool | | Pic 8 Desc. S-A41 Bridge & buffer | | | |

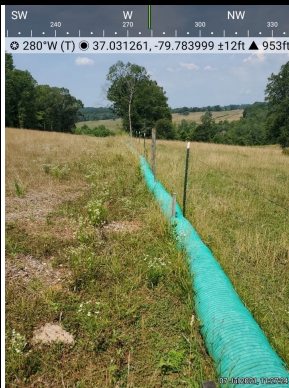
| Field Station# 14405+00 | | Field Station# 14432+00 | | | |

| Pic 9 Desc. Perimeter CFS | | Pic 10 Desc. Waterbar conduit inlet | | | |

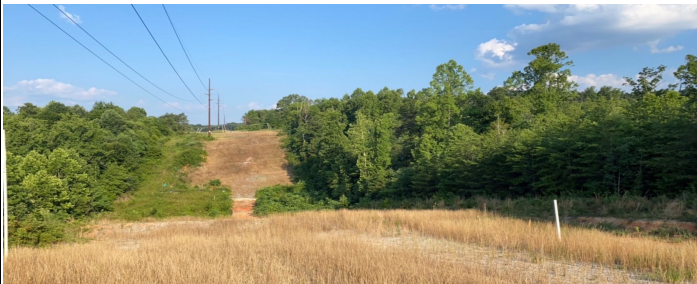
| Pic 1 Desc. | ROW stabilized in temporary area. Temporary vegetation beginning to die out. | | Pic 2 Desc. | Perimeter SSF and CFS triple stacks in good condition. Temporary vegetation beginning to die out along ROW. | |

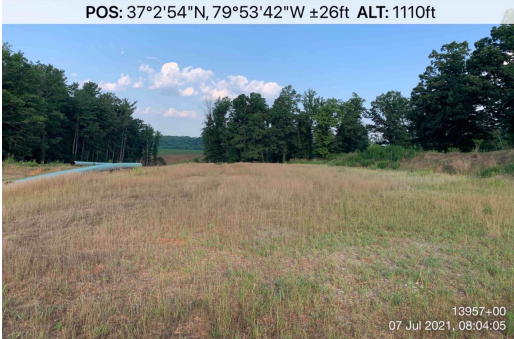
| Field Station# 13957+00 | | Field Station# 13943+00 | | GPS Location 0 | |

| Pic 1 Desc. Temporary vegetative stabilization in acceptable condition | | Pic 2 Desc. Clean water diversion plunge pool in acceptable condition | | Field Station# 13943+00 | |

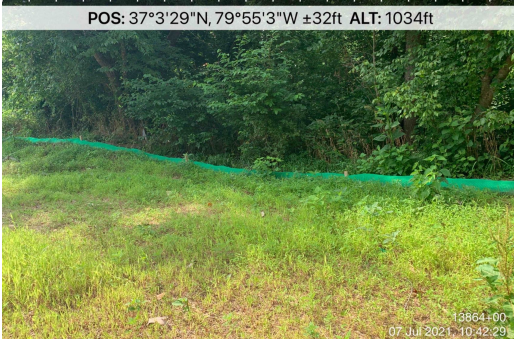
| Field Station# 13864+00 | | Field Station# 13854+00 | | GPS Location 0 | |

| Pic 5 Desc. Perimeter CFS in acceptable condition | | Pic 6 Desc. P1 silt fence and waterbar end treatment in acceptable condition | | Field Station# 13854+00 | |

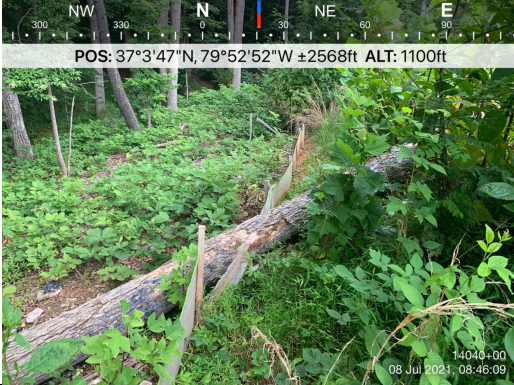
| Field Station# | 14040+00 | Field Station# | 14040+00 | | |

| Pic 1 Desc. | P1 silt fence damaged by a fallen tree, contractor addressed it immediately | | Pic 2 Desc. | P1 silt fence after repair | |

| Silt Fence (Reinforce Filter Fence) | Communication | Tree removed, silt fence repaired | Immediate | 7/8/2021 | |

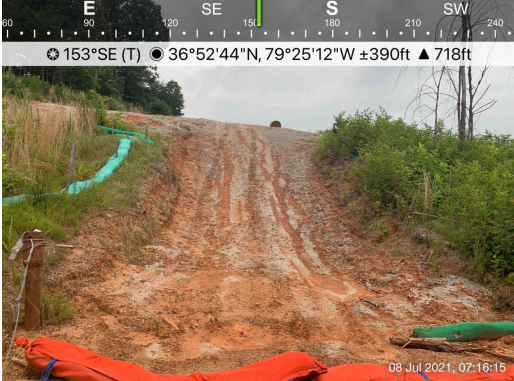
| Field Station# | 15701+00 | Field Station# | 15672+00 | | |

| Pic 1 Desc. | Observing location that requires additional stabilization. | Pic 2 Desc. | Observing CFS that requires maintenance | | |

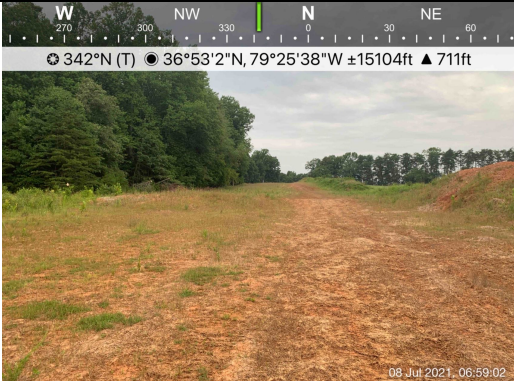
| Field Station# | 15655+00 | Field Station# | 15671+93 | | |

| Pic 3 Desc. | Observing temporary stabilization and water bars | Pic 4 Desc. | Observing temporary stabilization, signage, buffer, equipment crossing and ECD's | | |

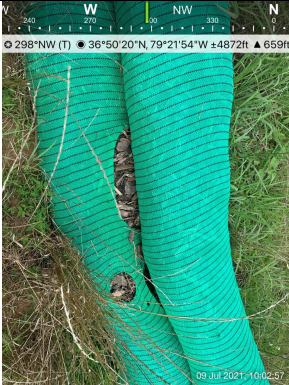
| Field Station# | 15930+00 | Field Station# | 15930+00 | | |

| Pic 1 Desc. | Observing CFS that required maintenance. | Pic 2 Desc. | Observing CFS that received maintenance | | |

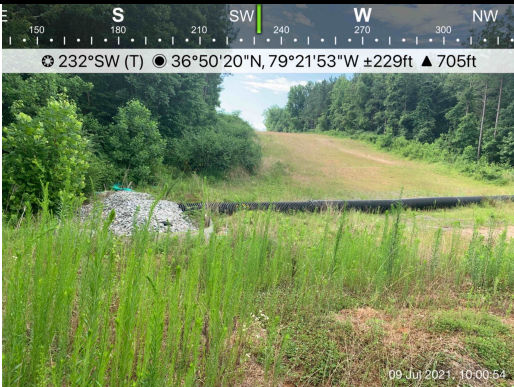
| Field Station# | 15934+00 | Field Station# | 15878+08 | | |

| Pic 3 Desc. | Observing temporary stabilization, CWD outlet and ECD's | Pic 4 Desc. | Observing temporary stabilization, signage, buffer, equipment crossing and ECD's | | |

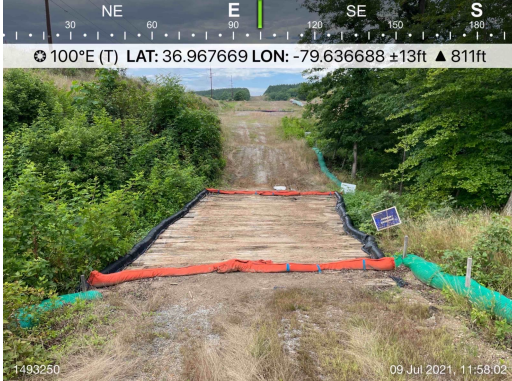
| Field Station# | 14932+89 | Field Station# | 14937+50 | | |

| Pic 1 Desc. | Equipment bridge and surrounding ECDs in place and functional | | Pic 2 Desc. | CWD pipe and outlet performing intended functions | |

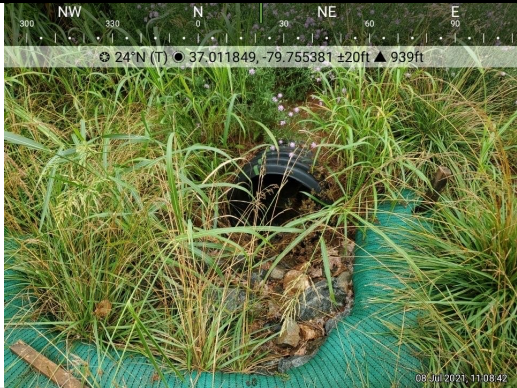
| Pic 7 Desc. | CIS S-G20 Mulching | Pic 8 Desc. | Travel lane stabilization | | |

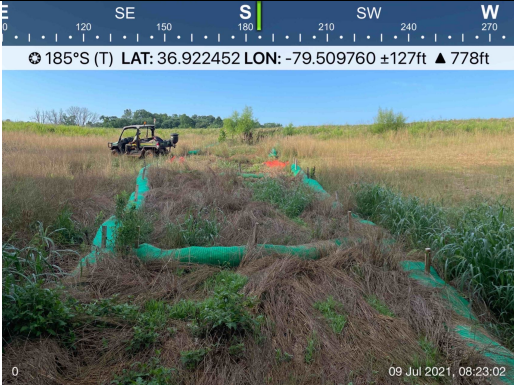
| Field Station# | 15375+00 | Field Station# | 15384+74 | | |

| Pic 1 Desc. | Drainage ECDs are in good condition and functioning. | Pic 2 Desc. | Equipment bridge ECDs are in good condition. | | |

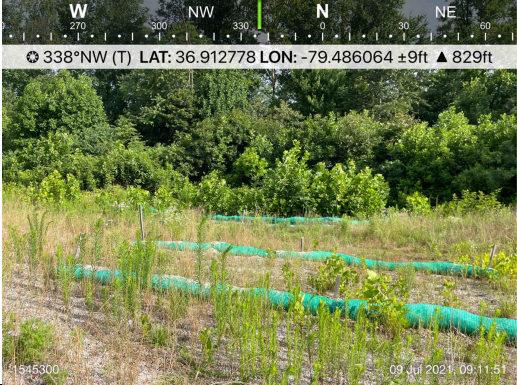
| Field Station# | 15453+00 | | Field Station# | 15457+00 | |

| Pic 7 Desc. | CWD is in good condition with no evidence of sedimentation from 3rd party disturbance. | | Pic 8 Desc. | Drainage is in good condition with no evidence of sedimentation. | |

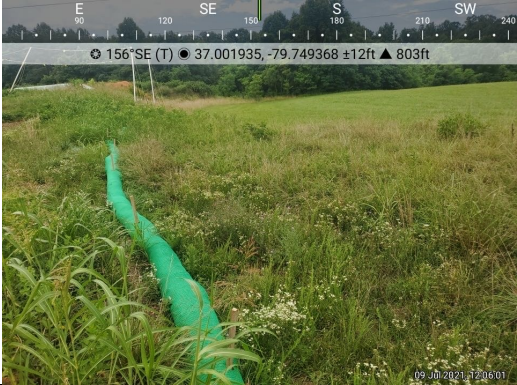
| Field Station# | 14563+00 | Field Station# | 14632+00 | | |

| Pic 7 Desc. | Perimeter CFS @ dry swale | Pic 8 Desc. | Permanent vegetation | | |

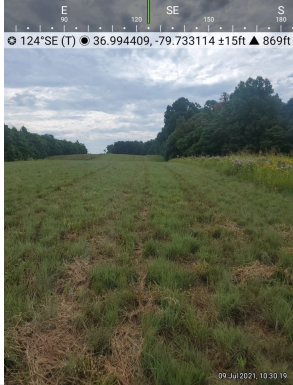
| Field Station# | 14619+00 | Field Station# | 14617+00 | | |

| Pic 9 Desc. | Permanent vegetation | Pic 10 Desc. | GAS MVP-FR-319.01 Perimeter CFS | | |
