Visual Site Inspection Report

Project Name	H-600 Pipeline Spread I	AFE	124300139	Spread	H-600 Pipeline Spread I
Contractor	Precision			Report #	26665
Inspector	John White			Date/Time	8/2/2021 10:44 AM
Permit #	TBD	Inspection Type	VA SWPP	Station Begin	15772+27
State	VA	Inspection Area	Full	Station End	15947+64
County	Pittsylvania	Ground	Dry	Temperature (°F)	75.00
Municipality	Chatham	Weather	Sunny	Rain Gauge (in)	0.20
				Rain Accumulation Time (days)	6.00

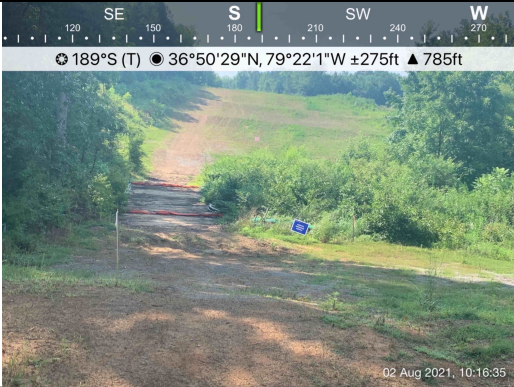
GPS Location	O	GPS Location	O		
Field Station#	15930+00	Field Station#	15934+00		
Pic 1 Desc.	Observing temporary stabilization and ECD's	Pic 2 Desc.	Observing temporary stabilization, CWD outlet and ECD's

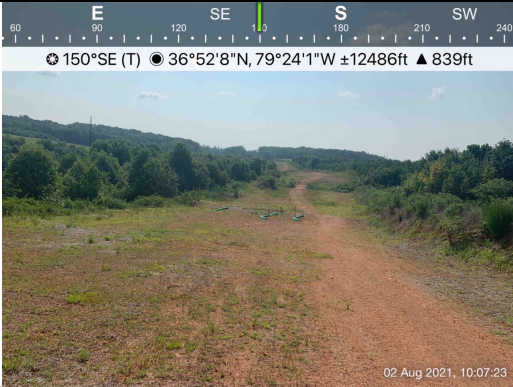
GPS Location	O	GPS Location	O		
Field Station#	15923+62	Field Station#	15860+00		
Pic 3 Desc.	Observing temporary stabilization, signage, buffer, equipment crossing and ECD's	Pic 4 Desc.	Observing temporary stabilization, water bar and CFS checks

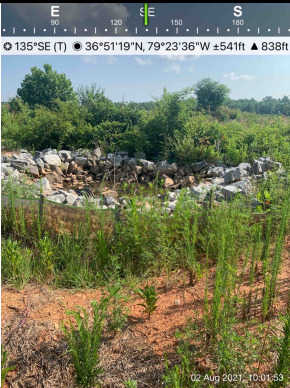
GPS Location	O	GPS Location	O		
Field Station#	15825+00	Field Station#	15790+00		
Pic 5 Desc.	Observing temporary stabilization, plunge pool and ECD's	Pic 6 Desc.	Observing sump and end treatment

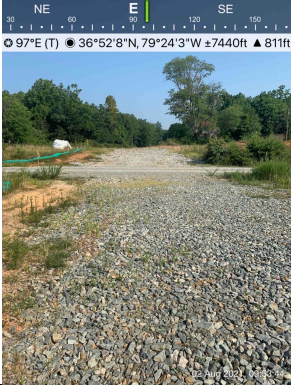
GPS Location	O	GPS Location	O		
Field Station#	15772+27	Field Station#	15781+22		
Pic 7 Desc.	Observing RCE's, temporary stabilization and ECD's	Pic 8 Desc.	Observing temporary stabilization, signage, buffer, equipment crossing and ECD's		
Insert image here		Insert image here			
GPS Location		GPS Location			
Field Station#		Field Station#			
Pic 9 Desc.		Pic 10 Desc.			
Insert image here		Insert image here			
GPS Location		GPS Location			
Field Station#		Field Station#			
Pic 11 Desc.		Pic 12 Desc.

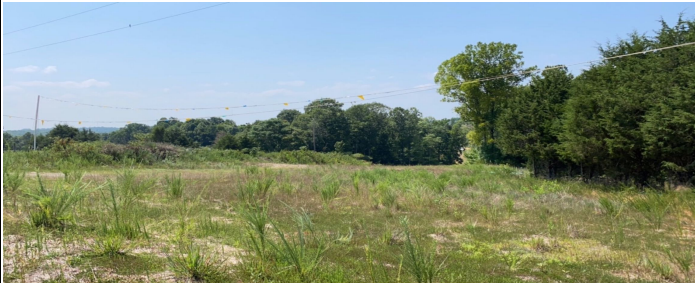
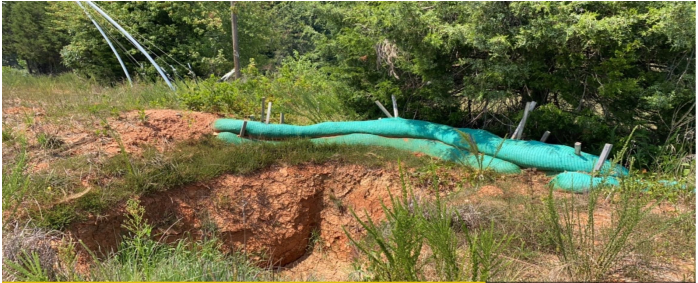
36°57'48" N 79°35'38" W 245°SW COURSE 239° GPS 1923-2165 Armstrong Rd, Penhook, VA 24137, United States 08.02.2021 14:56:05 Accur +/-15.5 Ft ALT 931 Ft			36°57'48" N 79°35'37" W 289°W COURSE 320° GPS 1923-2165 Armstrong Rd, Penhook, VA 24137, United States 08.02.2021 14:55:51 Accur +/-15.4 Ft ALT 927 Ft		
GPS Location	5		GPS Location	6	
Field Station#	15058+00		Field Station#	15060+00	
Pic 5 Desc.	Picture of temporary stabilization and vegetation along ROW		Pic 6 Desc.	Sump pit and CFS end treatment performing intended functions

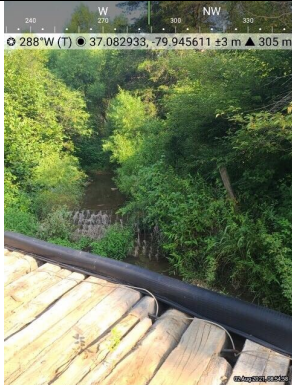
GPS Location	00000	GPS Location	00000		
Field Station#	13742+10	Field Station#	13704+90		
Pic 1 Desc.	P1 requires maintenance due to being weathered and torn. Awaiting avian survey. Item was documented and will be added to the punch list for repair.		Pic 2 Desc.	Stream observation photo facing upstream during routine inspection today. No issues observed at the time of inspection.

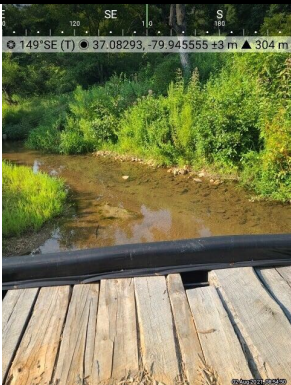
GPS Location	0000	GPS Location	00000		
Field Station#	13704+90	Field Station#	13726+80		
Pic 3 Desc.	Stream observation photo facing downstream during routine inspection today. No issues observed at the time of inspection.		Pic 4 Desc.	Vegetation photo showing temporary grasses with some new growth beginning to come up .

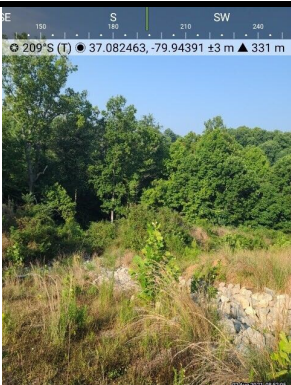
GPS Location	0000	GPS Location	0000		
Field Station#	13709+00	Field Station#	13720+00		
Pic 5 Desc.	Monitored rock lined channels and ECDs throughout. No environmental issues observed at the time of inspection.		Pic 6 Desc.	Vegetation observation photo showing good stabilization.

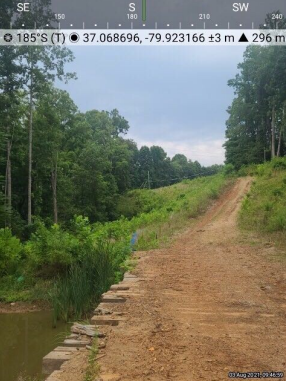
GPS Location	00000	GPS Location	00000		
Field Station#	13817+00	Field Station#	13803+90		
Pic 1 Desc.	Row photo showing vegetation and stabilization on hill side, monitored all ECDs in the area with no environmental issues observed at the time of inspection.		Pic 2 Desc.	Vegetation/stabilization observation. No environmental issues observed at the time of inspection.

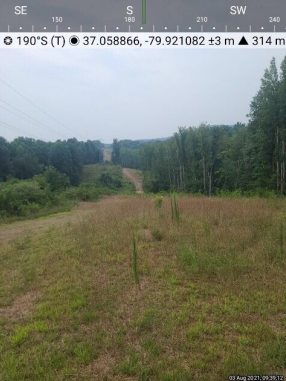
GPS Location	0000	GPS Location	00000		
Field Station#	13853+30	Field Station#	13805+69		
Pic 3 Desc.	Vegetation observation photo up row from stream crossing showing good coverage.		Pic 4 Desc.	ECDs monitored and equipment bridge inspected. No environmental issues observed at the time of inspection.

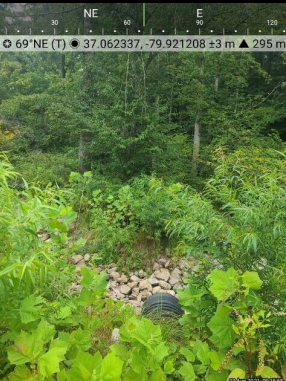
GPS Location	0000	GPS Location	0000		
Field Station#	13840+00	Field Station#	13794+57		
Pic 5 Desc.	Observed clean water diversion and and plunge pool. No environmental issues observed at the time of inspection.		Pic 6 Desc.	Monitored equipment bridge and protection, good stabilization on both sides of stream crossing. No environmental issues observed at the time of inspection.

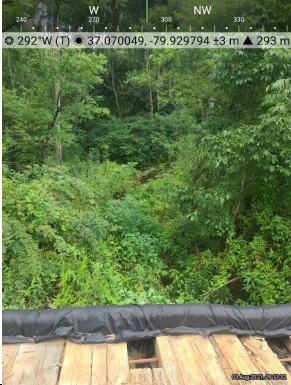
<p>GPS data: 292°W (T) • 37.070049, -79.929794 ±3 m ▲ 293 m</p>		<p>Insert image here</p>			
GPS Location	0000	GPS Location			
Field Station#	13794+57	Field Station#			
Pic 7 Desc.	Stream observation photo facing downstream during routine inspection today. No environmental issues observed at the time of inspection.		Pic 8 Desc.		
<p>Insert image here</p>		<p>Insert image here</p>			
GPS Location		GPS Location			
Field Station#		Field Station#			
Pic 9 Desc.		Pic 10 Desc.			
<p>Insert image here</p>		<p>Insert image here</p>			
GPS Location		GPS Location			
Field Station#		Field Station#			
Pic 11 Desc.		Pic 12 Desc.

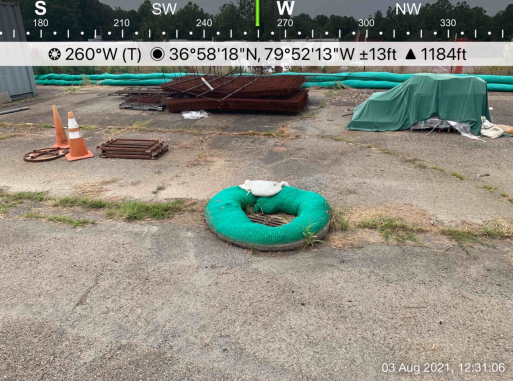
GPS Location	000000000000	GPS Location	000000000000		
Field Station#	0000+00	Field Station#	0000+00		
Pic 1 Desc.	Perimeter ECD's on north end of LY-46 in good condition	Pic 2 Desc.	Inlet protection for catch basin on north end of LY-046 in good condition.

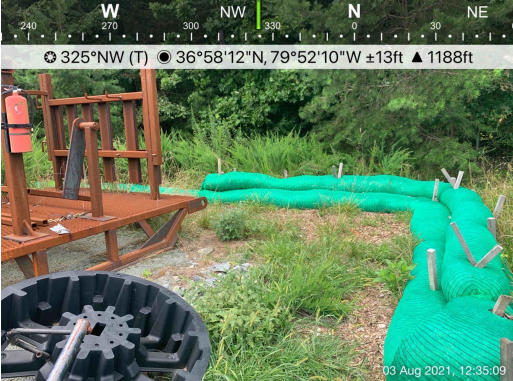
GPS Location	000000000000	GPS Location	000000000000		
Field Station#	0000+00	Field Station#	0000+00		
Pic 3 Desc.	Secondary containment structure for fuel cell in good condition.	Pic 4 Desc.	Perimeter ECD's on northwest corner of LY-045 in good condition

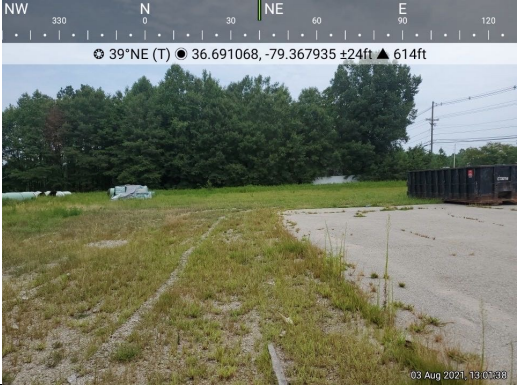
GPS Location	0	GPS Location	0		
Field Station#	0+00	Field Station#	0+00		
Pic 7 Desc.	LY-048 Temporary vegetation	Pic 8 Desc.	LY-048 South perimeter CFS		
Insert image here		Insert image here			
GPS Location		GPS Location			
Field Station#		Field Station#			
Pic 9 Desc.		Pic 10 Desc.			
Insert image here		Insert image here			
GPS Location		GPS Location			
Field Station#		Field Station#			
Pic 11 Desc.		Pic 12 Desc.

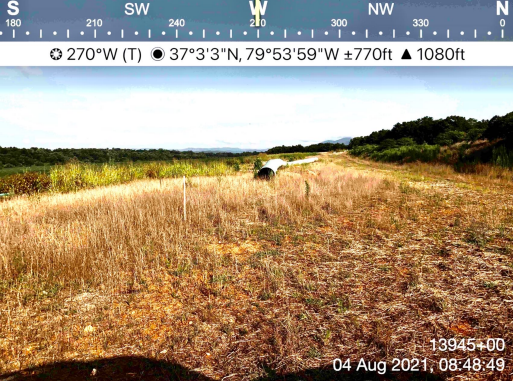
GPS Location	0	GPS Location	0		
Field Station#	13949+70	Field Station#	13945+00		
Pic 1 Desc.	Geotech fabric and sideboard are detached from equipment bridge		Pic 2 Desc.	Temporary vegetative stabilization in acceptable condition

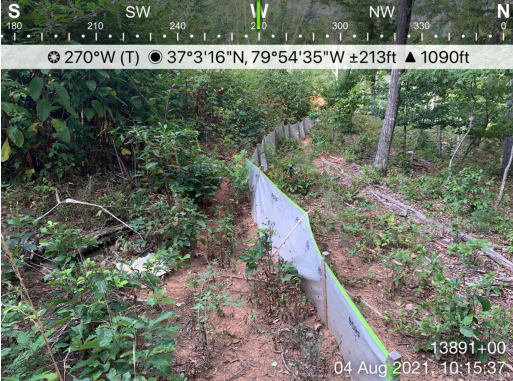
GPS Location	0	GPS Location	0		
Field Station#	13904+00	Field Station#	13891+00		
Pic 3 Desc.	Hole in P1 silt fence at ground line, damaged by wildlife		Pic 4 Desc.	P1 silt fence has a broken stake, damaged by wildlife

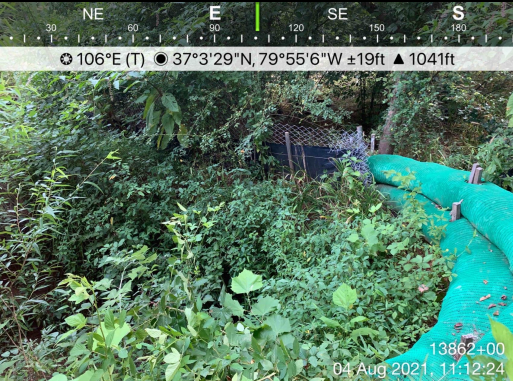
GPS Location	0	GPS Location	0		
Field Station#	13862+00	Field Station#	13862+00		
Pic 5 Desc.	Waterbar in acceptable condition		Pic 6 Desc.	Waterbar end treatment and super silt fence in acceptable conditions

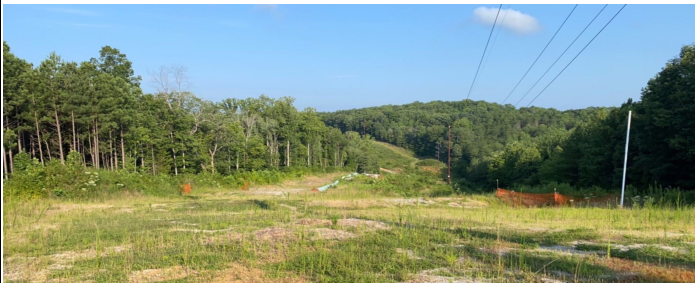
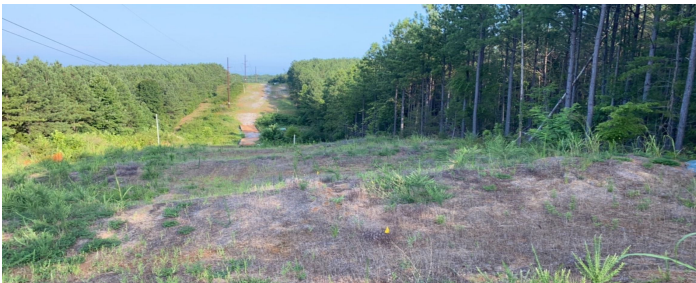
GPS Location	3		GPS Location	4	
Field Station#	14737+00		Field Station#	14754+00	
Pic 3 Desc.	Temporary stabilization and vegetation along ROW. Perimeter controls in place and functional.		Pic 4 Desc.	Temporary stabilization and vegetation along ROW. Perimeter controls in place and functional.

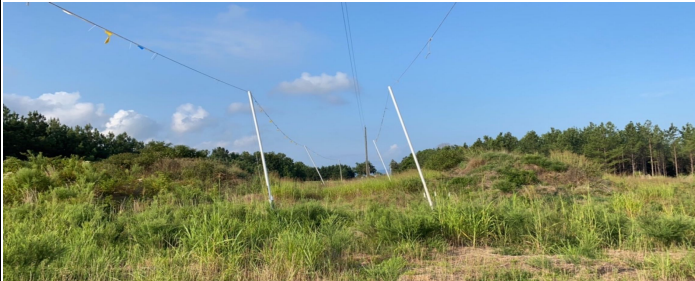
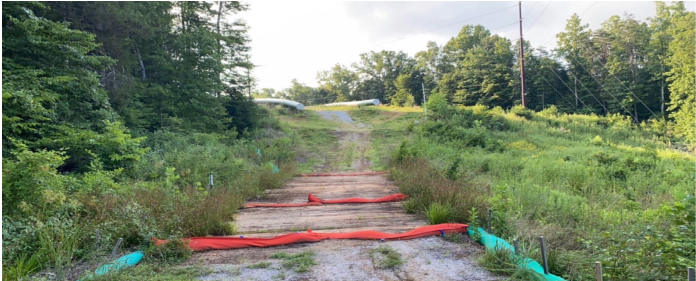
36°59'0" N 79°41'22" W 296°NW COURSE 199° GPS 701-1081 Indian Cave Rd, Union Hall, VA 24176, United States 08.04.2021 08:34:53 Accur +/-18.7 Ft ALT 963 Ft			36°58'45" N 79°41'3" W 272°W COURSE 312° GPS Sorry no results found 08.04.2021 08:25:05 Accur +/-21.4 Ft ALT 864 Ft		
GPS Location	5		GPS Location	6	
Field Station#	14761+28		Field Station#	14782+25	
Pic 5 Desc.	Spoil piles stabilized and vegetated in extra workspace.		Pic 6 Desc.	Equipment bridge and surrounding ECDs in place and functional at stream crossing and resource buffer.

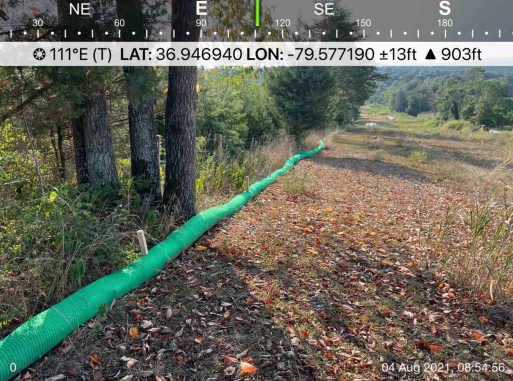
GPS Location	See photo	GPS Location	See photo		
Field Station#	15142+66	Field Station#	15150+00		
Pic 1 Desc.	RCE is in good condition at Rockcreek Rd.	Pic 2 Desc.	Perimeter CFS is in good condition throughout this section of ROW.

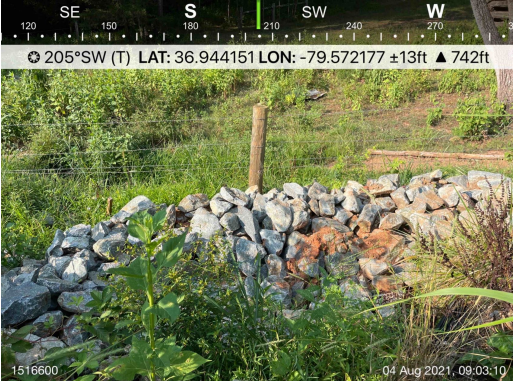
GPS Location	See photo	GPS Location	See photo		
Field Station#	15165+57	Field Station#	15166+00		
Pic 3 Desc.	Rock inlet remains in good condition.	Pic 4 Desc.	Rock outlet remains in good condition.

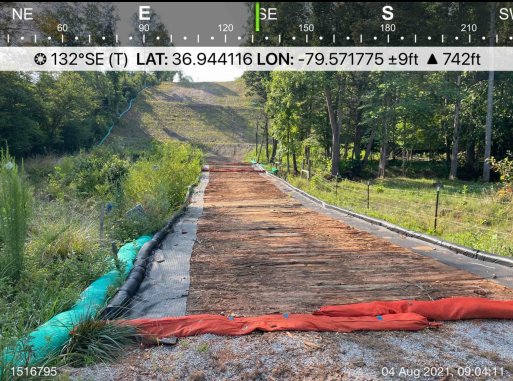
GPS Location	See photo	GPS Location	See photo		
Field Station#	15167+95	Field Station#	15167+95		
Pic 5 Desc.	P1 is in good condition at stream buffer.	Pic 6 Desc.	Equipment bridge ECDs are in place and functioning.

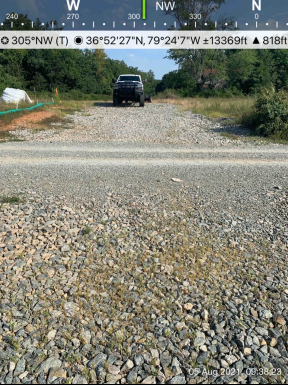
GPS Location	O	GPS Location	O		
Field Station#	15772+27	Field Station#	15762+00		
Pic 1 Desc.	Observing access road and RCE's	Pic 2 Desc.	Observing temporary stabilization and ECD's

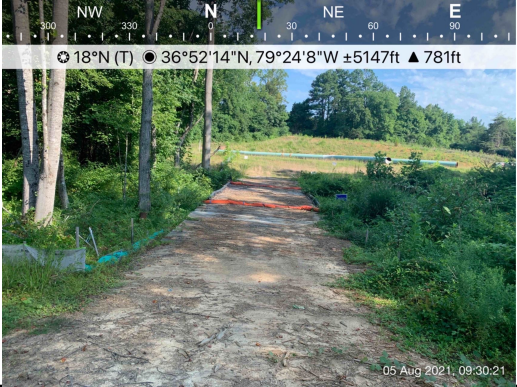
GPS Location	O	GPS Location	O		
Field Station#	15763+80	Field Station#	15770+00		
Pic 3 Desc.	Observing temporary stabilization, equipment crossing, signage, buffer and ECD's	Pic 4 Desc.	Observing temporary stabilization and water bars

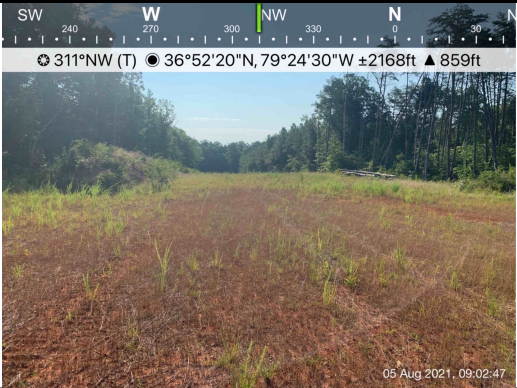
GPS Location	O	GPS Location	O		
Field Station#	15748+00	Field Station#	15744+00		
Pic 5 Desc.	Observing temporary stabilization	Pic 6 Desc.	Observing temporary stabilization and ECD's

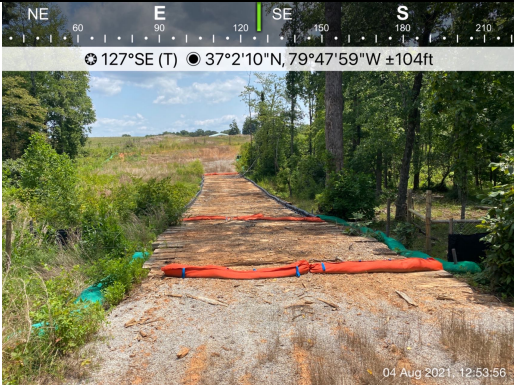
GPS Location	0	GPS Location	0		
Field Station#	14353+53	Field Station#	14391+50		
Pic 3 Desc.	Approximately 14353+53. Overview of stream crossing, equipment bridge and ECDs at stream S-A38.		Pic 4 Desc.	Approximately 14391+50. Overview of stream crossing, equipment bridge and ECDs at stream S-A41.

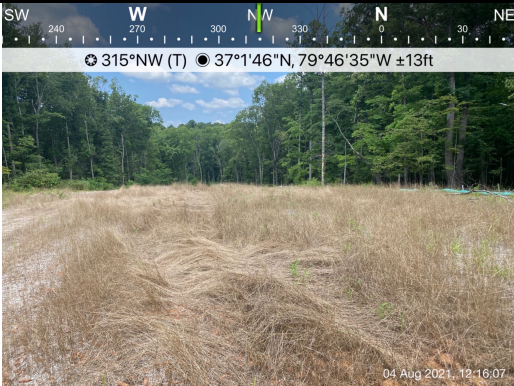
GPS Location	0	GPS Location	0		
Field Station#	14428+00	Field Station#	14451+00		
Pic 5 Desc.	Approximately 14428+00. Overview of ROW.		Pic 6 Desc.	Approximately 14451+00. Overview of ROW.

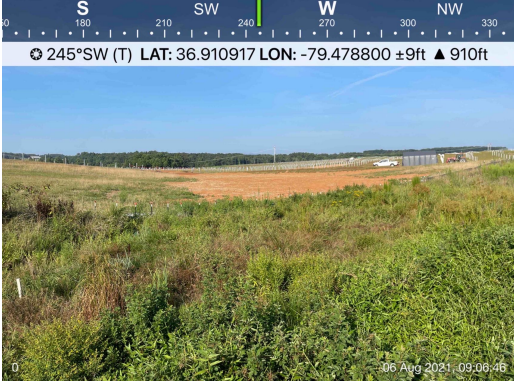
GPS Location	See photo		GPS Location	See photo	
Field Station#	15475+00		Field Station#	15465+00	
Pic 1 Desc.	3rd party rock outlet appears to be in good condition along this drainage.		Pic 2 Desc.	No evidence of sedimentation from 3rd party outlet.

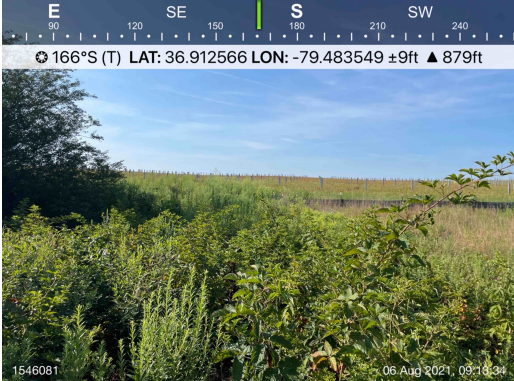
GPS Location	See photo		GPS Location	See photo	
Field Station#	15460+81		Field Station#	15460+81	
Pic 3 Desc.	No evidence of sedimentation from 3rd party outlet into CWD inlet.		Pic 4 Desc.	CWD in good condition and functioning as intended.

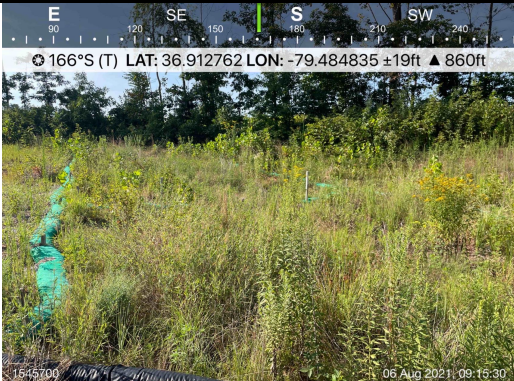
GPS Location	See photo		GPS Location	See photo	
Field Station#	15457+00		Field Station#	15453+00	
Pic 5 Desc.	No evidence of sedimentation in drainage feature.		Pic 6 Desc.	CWD functioning as intended.

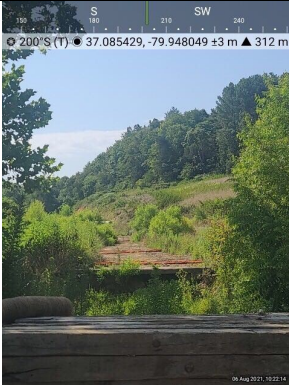
GPS Location	00000	GPS Location	00000		
Field Station#	13692+64	Field Station#	13743+97		
Pic 1 Desc.	Monitored stream crossing where mats were removed during maintenance, erosion control blanket in place and functioning properly.		Pic 2 Desc.	Monitored RCEs and ECDs at road crossing. No issues observed at the time of inspection.

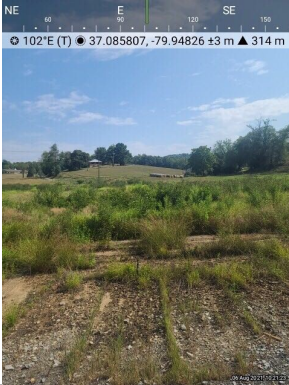
GPS Location	00000	GPS Location	00000		
Field Station#	13691+70	Field Station#	13689+20		
Pic 3 Desc.	Vegetation observation inside work space and wetland area. Good coverage noted.		Pic 4 Desc.	Photo showing stabilization on spoil piles with good vegetation coverage.

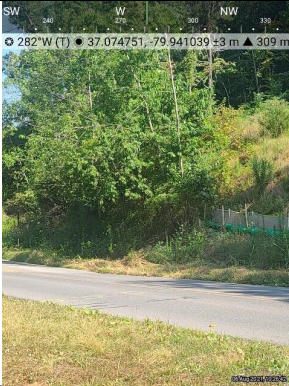
GPS Location	000000	GPS Location	00000		
Field Station#	13748+00	Field Station#	13690+60		
Pic 5 Desc.	Photo showing where county workers mowed at road crossing close to ECDs. All ECDs in place and functioning at the time of inspection.		Pic 6 Desc.	Monitored P1 at row boundary, no environmental issues observed at the time of inspection.

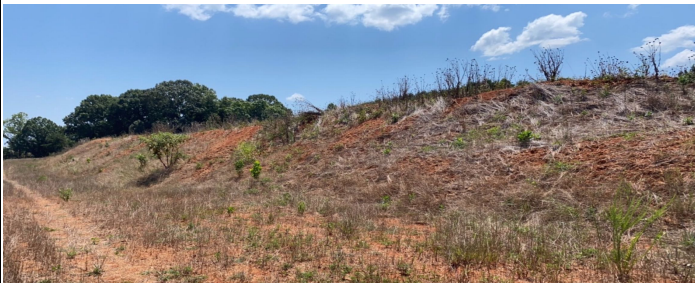
Pic 3 Desc.	Spoil pile stabilized but vegetation dying out		Pic 4 Desc.	Equipment bridge and surrounding ECDs in place and functional at stream crossing and resource buffer

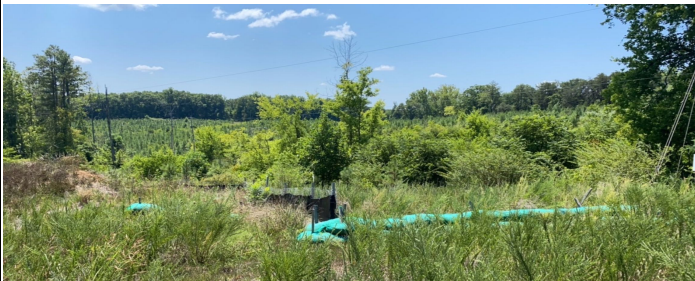
36°57'52" N 79°36'52" W 157°SE COURSE 195° GPS Penhook, VA 24137, United States 08.05.2021 12:56:30 Accur +/-27.6 Ft ALT 919 Ft			36°57'55" N 79°36'41" W 222°SW COURSE 322° GPS Penhook, VA 24137, United States 08.05.2021 13:01:12 Accur +/-45.7 Ft ALT 923 Ft		
GPS Location	5		GPS Location	6	
Field Station#	15002+00		Field Station#	15009+00	
Pic 5 Desc.	Perimeter CFS and SSF in good condition		Pic 6 Desc.	Temporary stabilization and vegetation along ROW

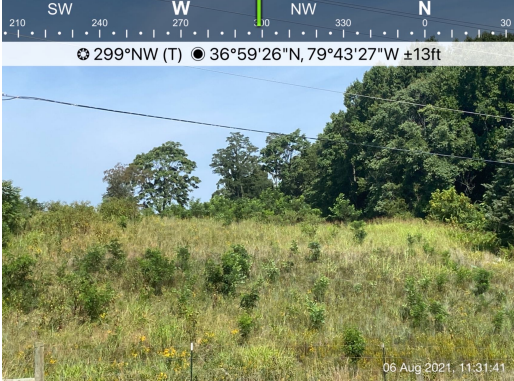
GPS Location	0	GPS Location	0		
Field Station#	14646+00	Field Station#	14603+00		
Pic 1 Desc.	Approximately 14646+00. Overview of ROW.	Pic 2 Desc.	Approximately 14603+00. Overview of ROW.

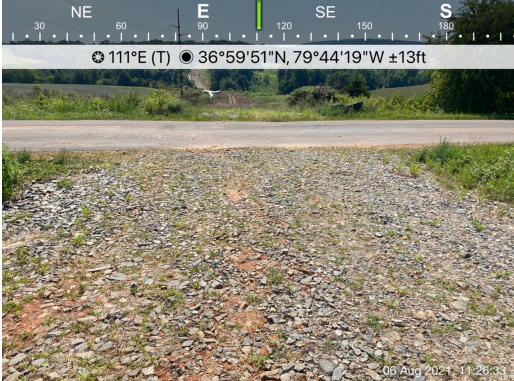
GPS Location	0	GPS Location	0		
Field Station#	14599+25	Field Station#	14575+00		
Pic 3 Desc.	Approximately 14599+25. Overview of road crossing and RCEs.	Pic 4 Desc.	Approximately 14575+00. Overview of ROW.

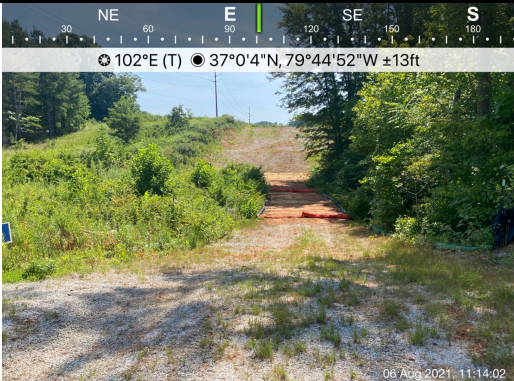
GPS Location	0	GPS Location	0		
Field Station#	14568+10	Field Station#	14549+00		
Pic 5 Desc.	Approximately 14568+10. Overview of stream crossing, equipment bridge and ECDs at stream S-E18.	Pic 6 Desc.	Approximately 14549+00. Overview of ROW.
