# Visual Site Inspection Report

<b>Project Name</b>	H-600 Pipeline Spread I	<b>AFE</b>	124300139	<b>Spread</b>	H-600 Pipeline Spread I
<b>Contractor</b>	Precision			<b>Report #</b>	26955
<b>Inspector</b>	John White			<b>Date/Time</b>	8/9/2021 10:39 AM
<b>Permit #</b>	TBD	<b>Inspection Type</b>	VA SWPP	<b>Station Begin</b>	15947+64
<b>State</b>	VA	<b>Inspection Area</b>	Full	<b>Station End</b>	16027+46
<b>County</b>	Pittsylvania	<b>Ground</b>	Dry	<b>Temperature (°F)</b>	80.00
<b>Municipality</b>	Chatham	<b>Weather</b>	Sunny	<b>Rain Gauge (in)</b>	0.60
				<b>Rain Accumulation Time (days)</b>	6.00

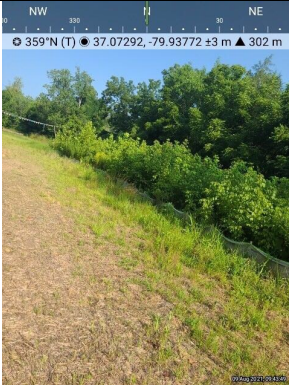
<b>GPS Location</b>	0000	<b>GPS Location</b>	0000		
<b>Field Station#</b>	13760+00	<b>Field Station#</b>	13833+00		
<b>Pic 1 Desc.</b>	Observed ECDs along row boundary during routine inspection today. No issues observed at the time of inspection.		<b>Pic 2 Desc.</b>	Row photo showing stabilization on hill side above stream crossing. No environmental issues observed at the time of inspection.

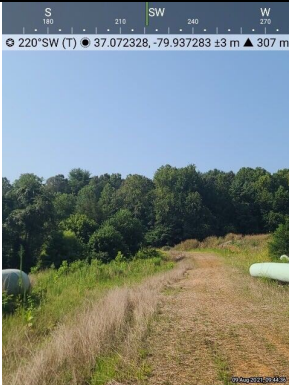
<b>GPS Location</b>	0000	<b>GPS Location</b>	00000		
<b>Field Station#</b>	13765+40	<b>Field Station#</b>	13770+69		
<b>Pic 3 Desc.</b>	Row photo showing stabilization and vegetation.		<b>Pic 4 Desc.</b>	Monitored equipment bridge and ECDs at S-MM42 crossing. No environmental issues observed at the time of inspection.

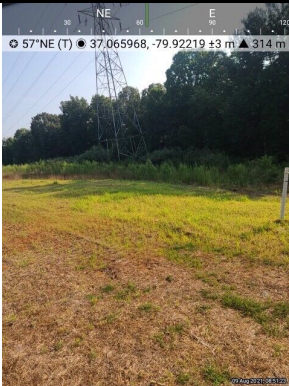
<b>Pic 5 Desc.</b>	Observed vegetation growth at location where anode work was previously done. Good growth observed.		<b>Pic 6 Desc.</b>	Monitored ECDs along stream S-EF7, all up to date and functioning at the time of inspection.

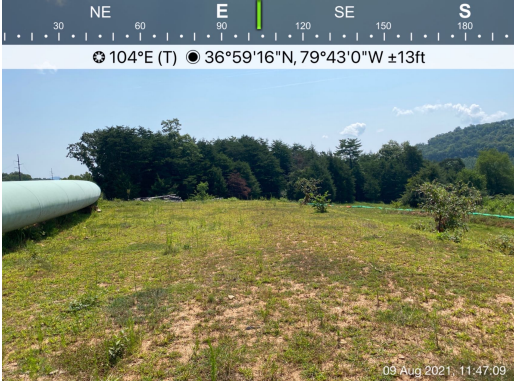
<b>GPS Location</b>	0	<b>GPS Location</b>	0		
<b>Field Station#</b>	14576+00	<b>Field Station#</b>	14673+10		
<b>Pic 3 Desc.</b>	Approximately 14676+00. Overview of ROW.	<b>Pic 4 Desc.</b>	Approximately 14673+10. Overview of stream crossing, equipment bridge and ECDs at stream S-H37.

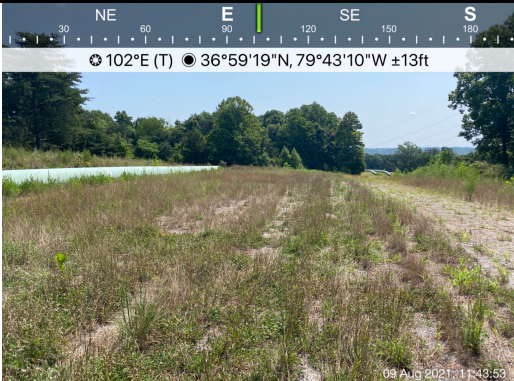
<b>GPS Location</b>	0	<b>GPS Location</b>	0		
<b>Field Station#</b>	14666+00	<b>Field Station#</b>	14653+00		
<b>Pic 5 Desc.</b>	Approximately 14666+00. Overview of ROW.	<b>Pic 6 Desc.</b>	Approximately 14653+00. Overview of ROW.

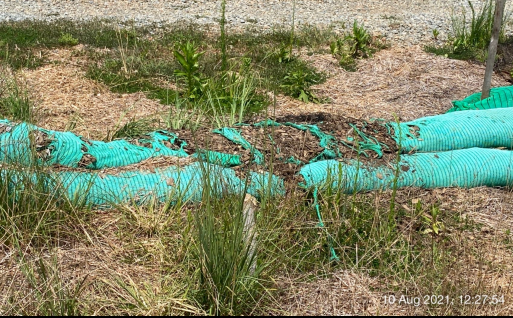
<b>GPS Location</b>	0	<b>GPS Location</b>	0	<b>GPS Location</b>	0
<b>Field Station#</b>	14347+00	<b>Field Station#</b>	14333+50	<b>Field Station#</b>	14322+60
<b>Pic 3 Desc.</b>	Approximately 14347+00. Overview of ROW.		<b>Pic 4 Desc.</b>	Approximately 14333+50. Overview of road crossing and RCEs.	
<b>Pic 5 Desc.</b>	Approximately 14327+00. Overview of ROW.		<b>Pic 6 Desc.</b>	Approximately 14322+60. CFS damaged by third party.

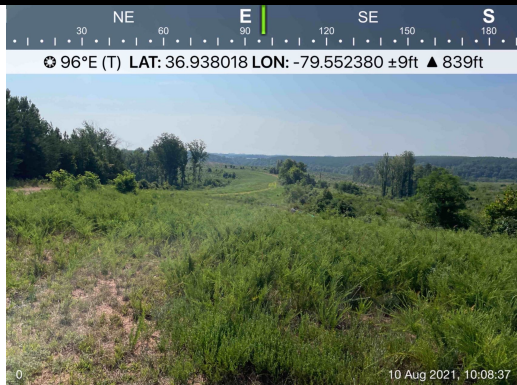
<b>GPS Location</b>	See photo		<b>GPS Location</b>	See photo	
<b>Field Station#</b>	15230+00		<b>Field Station#</b>	15260+00	
<b>Pic 11 Desc.</b>	Vegetation continues to fill in throughout this section of ROW		<b>Pic 12 Desc.</b>	Vegetation continues to fill in throughout this section of ROW

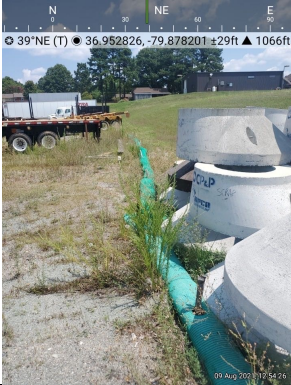
<b>GPS Location</b>	0	<b>GPS Location</b>	0		
<b>Field Station#</b>	0+00	<b>Field Station#</b>	0+00		
<b>Pic 7 Desc.</b>	ANC-006 South perimeter CFS	<b>Pic 8 Desc.</b>	ANC-006 Stormwater drain inlet protection		
Insert image here		Insert image here			
<b>GPS Location</b>		<b>GPS Location</b>			
<b>Field Station#</b>		<b>Field Station#</b>			
<b>Pic 9 Desc.</b>		<b>Pic 10 Desc.</b>			
Insert image here		Insert image here			
<b>GPS Location</b>		<b>GPS Location</b>			
<b>Field Station#</b>		<b>Field Station#</b>			
<b>Pic 11 Desc.</b>		<b>Pic 12 Desc.</b>

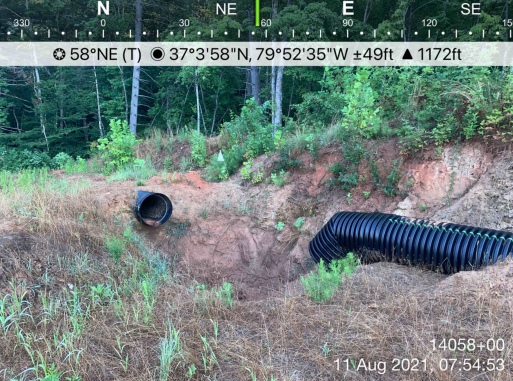
<b>GPS Location</b>	0	<b>GPS Location</b>	0		
<b>Field Station#</b>	14058+00	<b>Field Station#</b>	14058+00		
<b>Pic 1 Desc.</b>	Waterbar end treatment in acceptable condition	<b>Pic 2 Desc.</b>	Sump pit and slope drain pipe in acceptable conditions

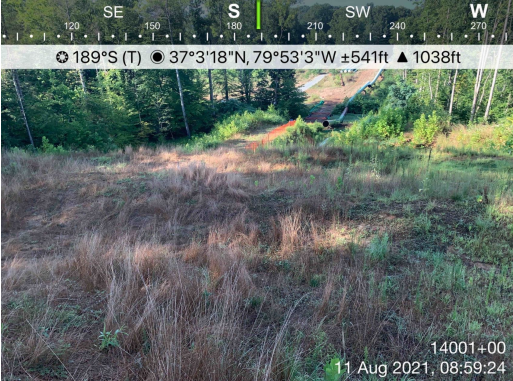
<b>GPS Location</b>	0	<b>GPS Location</b>	0		
<b>Field Station#</b>	14009+20	<b>Field Station#</b>	14001+00		
<b>Pic 3 Desc.</b>	P1 silt fence and equipment bridge in acceptable condition	<b>Pic 4 Desc.</b>	Temporary vegetative stabilization in acceptable condition

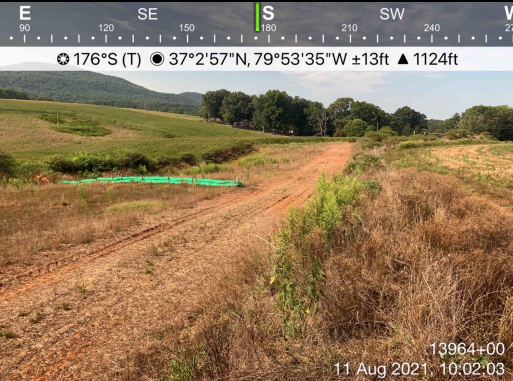
<b>GPS Location</b>	0	<b>GPS Location</b>	0		
<b>Field Station#</b>	14040+00	<b>Field Station#</b>	13964+00		
<b>Pic 5 Desc.</b>	Temporary vegetative stabilization in acceptable condition	<b>Pic 6 Desc.</b>	Clean water diversion berm and CFS in acceptable conditions

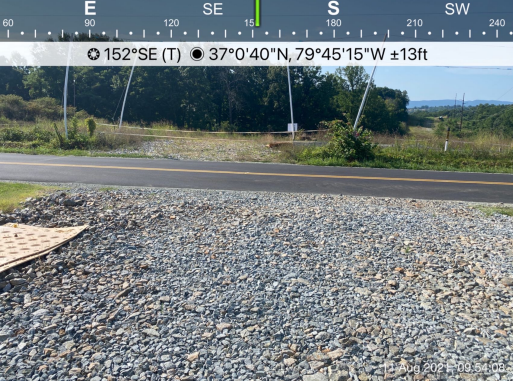
<b>GPS Location</b>	0	<b>GPS Location</b>	0		
<b>Field Station#</b>	14518+00	<b>Field Station#</b>	14524+50		
<b>Pic 1 Desc.</b>	Approximately 14518+00. Overview of ROW.	<b>Pic 2 Desc.</b>	Approximately 14524+50. Overview of road crossing and RCEs.

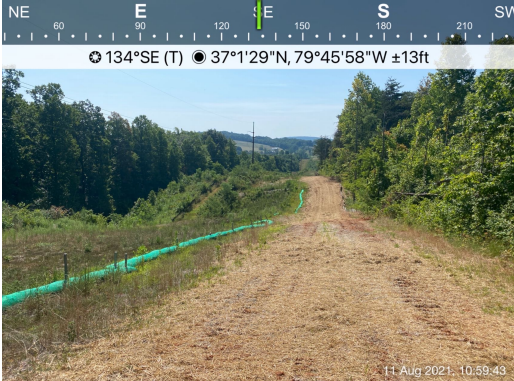
<b>GPS Location</b>	0	<b>GPS Location</b>	0		
<b>Field Station#</b>	14465+00	<b>Field Station#</b>	14486+60		
<b>Pic 3 Desc.</b>	Approximately 14465+00. Overview of ROW.	<b>Pic 4 Desc.</b>	Approximately 14486+60. Overview of stream crossing, equipment bridge and ECDs at stream S-G22.

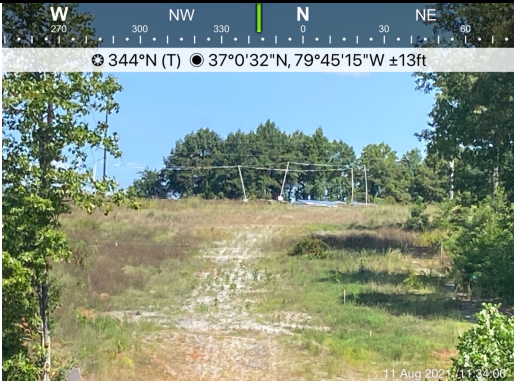
<b>GPS Location</b>	0	<b>GPS Location</b>	0		
<b>Field Station#</b>	14528+00	<b>Field Station#</b>	14542+00		
<b>Pic 5 Desc.</b>	Approximately 14528+00. Overview of ROW.	<b>Pic 6 Desc.</b>	Approximately 14542+00. Overview of ROW.

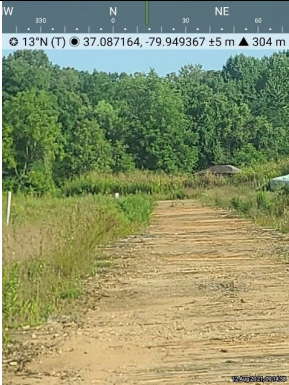
<b>GPS Location</b>	00000	<b>GPS Location</b>	00000		
<b>Field Station#</b>	13681+81	<b>Field Station#</b>	13682+90		
<b>Pic 1 Desc.</b>	Row photo showing equipment mats in place and vegetation. No environmental issues observed at the time of inspection.		<b>Pic 2 Desc.</b>	Monitored LOD perimeter silt fence. No environmental issues observed at the time of inspection.

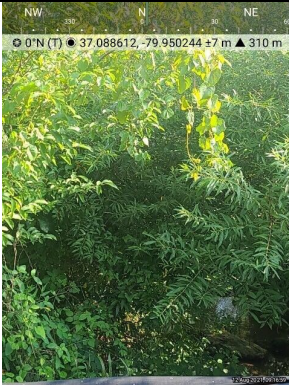
<b>GPS Location</b>	0000	<b>GPS Location</b>	0000		
<b>Field Station#</b>	13678+71	<b>Field Station#</b>	13692+10		
<b>Pic 3 Desc.</b>	Stream observation photo facing upstream during routine inspection today. No issues observed at the time of inspection.		<b>Pic 4 Desc.</b>	Monitored RCE at Grassy Hill road during routine inspection today.

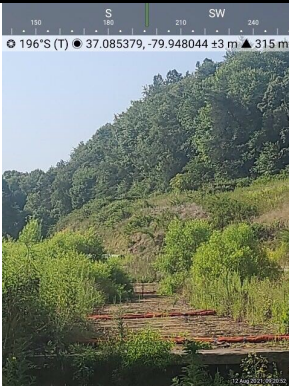
<b>Pic 5 Desc.</b>	Monitored stream crossing S-E28, erosion blanket on banks where mats were previously removed during maintenance repairs was up to date and functioning as intended.		<b>Pic 6 Desc.</b>	Stream observation photo facing downstream during routine inspection today. No issues observed at the time of inspection.

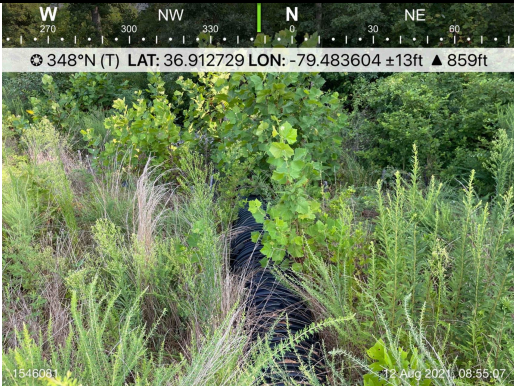
<b>GPS Location</b>	See photo		<b>GPS Location</b>	See photo	
<b>Field Station#</b>	15460+81		<b>Field Station#</b>	15457+00	
<b>Pic 5 Desc.</b>	CWD is functioning as intended.		<b>Pic 6 Desc.</b>	No evidence of sedimentation from 3rd party disturbance into drainage feature.

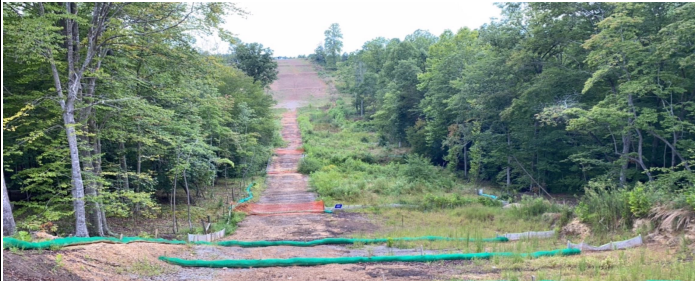
36°57'55" N 79°35'53" W 273°W COURSE 209° GPS Penhook, VA 24137, United States 08.12.2021 14:48:39 Accur +/-62.8 Ft ALT 828 Ft			36°57'52" N 79°35'46" W 292°W COURSE 226° GPS Penhook, VA 24137, United States 08.12.2021 14:46:19 Accur +/-85.9 Ft ALT 0 Ft		
GPS Location	5		GPS Location	6	
Field Station#	15045+50		Field Station#	15053+00	
Pic 5 Desc.	ECDs down slope are in good condition		Pic 6 Desc.	Plunge pool performing intended function

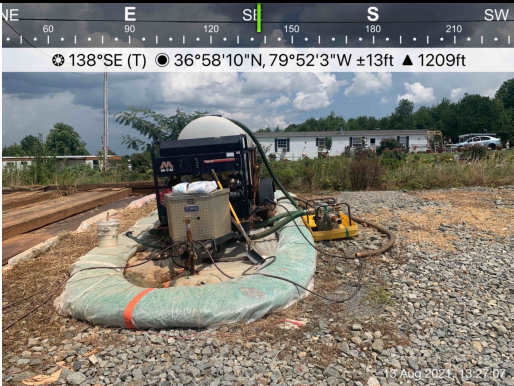
<b>Field Station#</b>	0000+00	<b>Field Station#</b>			
<b>Pic 5 Desc.</b>	Secondary containment structure for wash station at LY-045 in good condition.	<b>Pic 6 Desc.</b>
