Visual Site Inspection Report

Project Name	H-600 Pipeline Spread I		AFE	124300139	Spread	H-600 Pipeline Spread I	
Contractor	Precision				Report #	27186	
Inspector	Ben Davenport				Date/Time	8/16/2021 9:06 AM	
Permit #	TBD	Inspection Type	VA SWPP		Station Begin	14694+77	
State	VA	Inspection Area	Partial		Station End	14802+19	
County	Franklin	Ground	Muddy		Temperature (°F)	81.00	
Municipality	N/A	Weather	Cloudy		Rain Gauge (in)	1.30	
					Rain Accumulation Time (days)	1.00

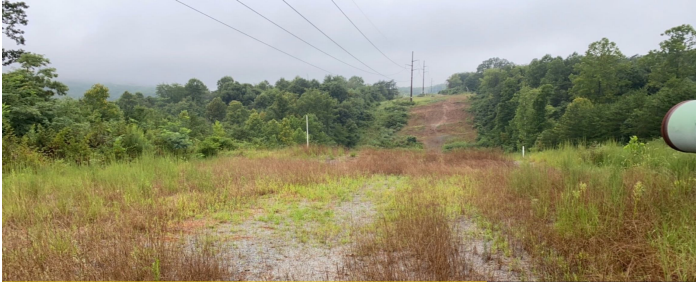
08.16.2021 10:17:48 Accur +/-52.9 Ft ALT 892 Ft			08.16.2021 10:10:06 Accur +/-24.7 Ft ALT 891 Ft		
GPS Location	1		GPS Location	2	
Field Station#	14705+50		Field Station#	14722+60	
Pic 1 Desc.	ROW stabilized and vegetated in temporary area		Pic 2 Desc.	Equipment bridge and surrounding ECDs in place and functional at stream crossing and resource buffer as well as perimeter of ROW

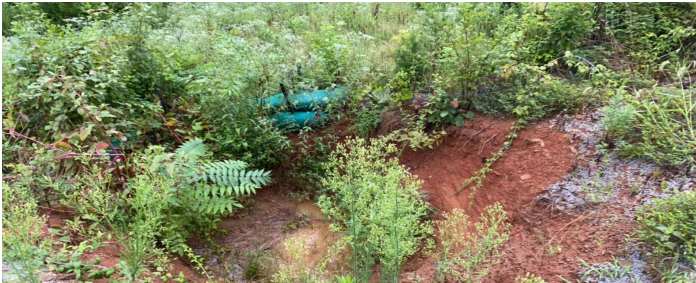
08.16.2021 10:07:04 Accur +/-154.3 Ft ALT 934 Ft			08.16.2021 10:03:52 Accur +/-175.7 Ft ALT 934 Ft		
GPS Location	3		GPS Location	4	
Field Station#	14731+00		Field Station#	14739+00	
Pic 3 Desc.	Sump pit and CFS end treatment in good condition and properly filtering water off ROW		Pic 4 Desc.	ROW stabilized and vegetated in temporary area

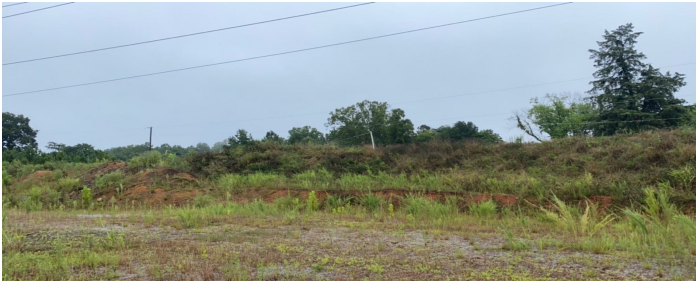
08.16.2021 09:48:51 Accur +/-656.2 Ft ALT 940 Ft			08.16.2021 09:35:50 Accur +/-56.0 Ft ALT 0 Ft		
GPS Location	5		GPS Location	6	
Field Station#	14772+00		Field Station#	14799+00	
Pic 5 Desc.	Temporary diversion berm stabilized and vegetated		Pic 6 Desc.	ROW stabilized and vegetated in temporary area

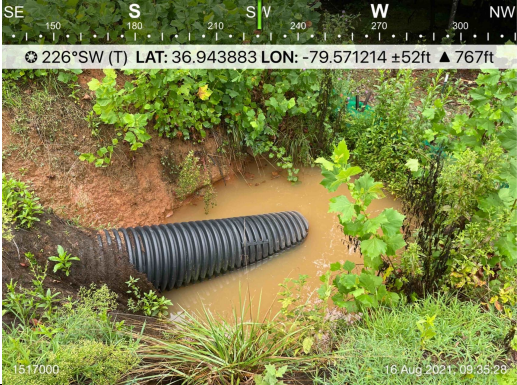
GPS Location	See photo		GPS Location	See photo	
Field Station#	15170+00		Field Station#	15172+00	
Pic 7 Desc.	Slope drain is in good condition and functioning as intended.		Pic 8 Desc.	Waterbars are in good condition and functioning throughout this section.

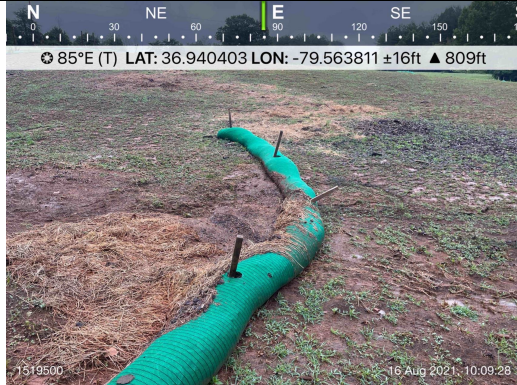
GPS Location	See photo		GPS Location	See photo	
Field Station#	15195+00		Field Station#	15195+00	
Pic 11 Desc.	CFS needs to be maintained and restaked.		Pic 12 Desc.	Environmental crew has corrected this issue.

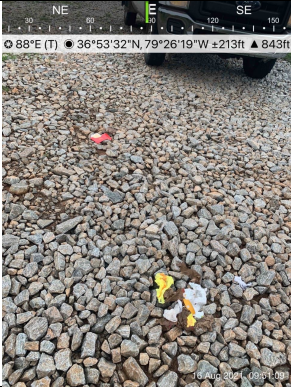
GPS Location	O	GPS Location	O		
Field Station#	15619+48	Field Station#	15619+48		
Pic 1 Desc.	Observing trash that needs to be removed from the RCE (3rd party damage)	Pic 2 Desc.	Observing clean RCE

7. Identify all remedial measures that have been taken since the previous inspection was conducted.					
Comments (Reference above questions as appropriate.)					
Performed SWPPP Inspection on this section. There was one issue identified and repaired by the Contractor (3rd party damage). Checked rain gauges, Anderson Mill #2=.9", Mill Creek =.9", Transco =1.9". Other than that there were no issues to report at the time of Inspection.					
Note: It is a condition of National Pollutant Discharge Elimination System and Erosion and Sediment permits that a maintenance program be conducted to provide for the operation and maintenance of all BMPs to be inspected on a weekly basis and after each stormwater event. Please list in the space provided comments to note if repairs or replacement are needed or have been made for BMPs as a result of the inspection. Failure to conduct the required inspection may result in permit suspension or the imposition of civil penalties. If supplemental monitoring is required as part of a permit condition this form may be used to meet those monitoring requirements.

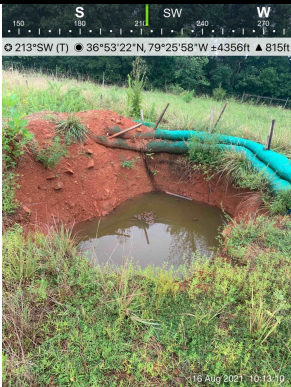
GPS Location	O	GPS Location	O		
Field Station#	15645+00	Field Station#	15632+00		
Pic 3 Desc.	Observing temporary stabilization, sump and end treatment	Pic 4 Desc.	Observing temporary stabilization, CWD outlet and ECD's

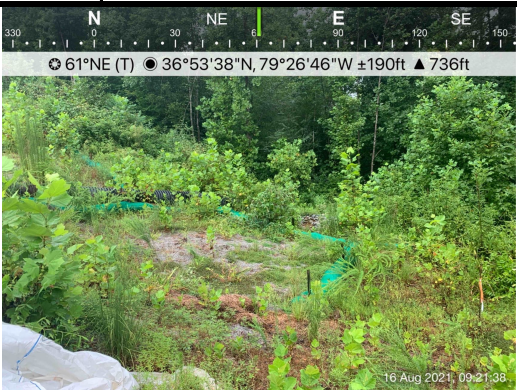
GPS Location	O	GPS Location	O		
Field Station#	15595+00	Field Station#	15595+60		
Pic 5 Desc.	Observing temporary stabilization, CWD outlet and ECD's	Pic 6 Desc.	Observing temporary stabilization, buffer, equipment crossing and ECD's

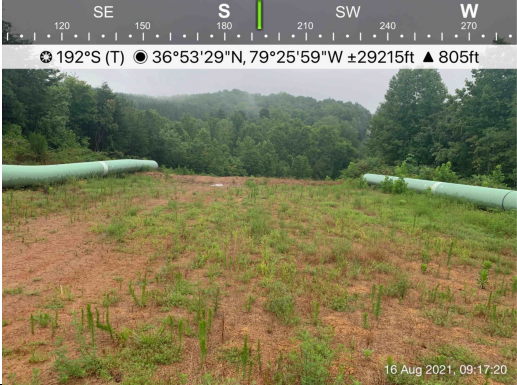
GPS Location	O	GPS Location			
Field Station#	15590+00	Field Station#			
Pic 7 Desc.	Observing temporary stabilization and water bar	Pic 8 Desc.			
Insert image here		Insert image here			
GPS Location		GPS Location			
Field Station#		Field Station#			
Pic 9 Desc.		Pic 10 Desc.			
Insert image here		Insert image here			
GPS Location		GPS Location			
Field Station#		Field Station#			
Pic 11 Desc.		Pic 12 Desc.

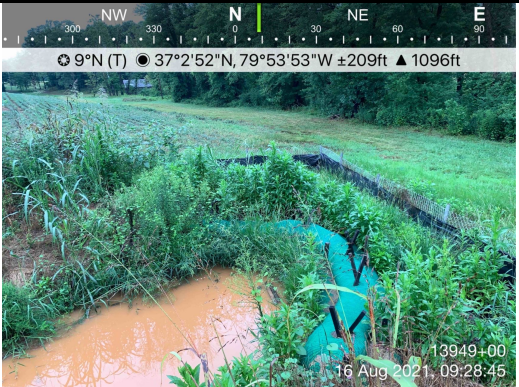
GPS Location	0		GPS Location	0	
Field Station#	13949+00		Field Station#	13943+00	
Pic 1 Desc.	Waterbar end treatment and super silt fence in acceptable conditions		Pic 2 Desc.	Clean water diversion plunge pool in acceptable condition

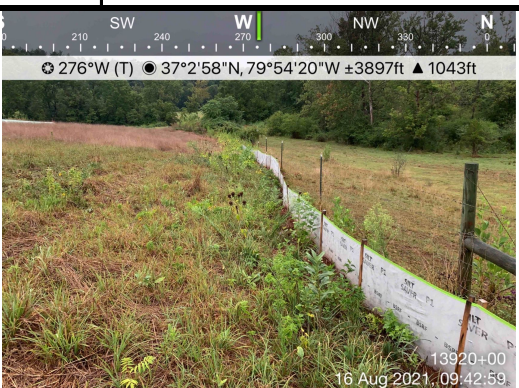
GPS Location	0		GPS Location	0	
Field Station#	13920+00		Field Station#	13893+00	
Pic 3 Desc.	P1 silt fence and permanent vegetative stabilization in acceptable conditions		Pic 4 Desc.	Fabric detached from wire fence on super silt fence, contractor repaired it immediately

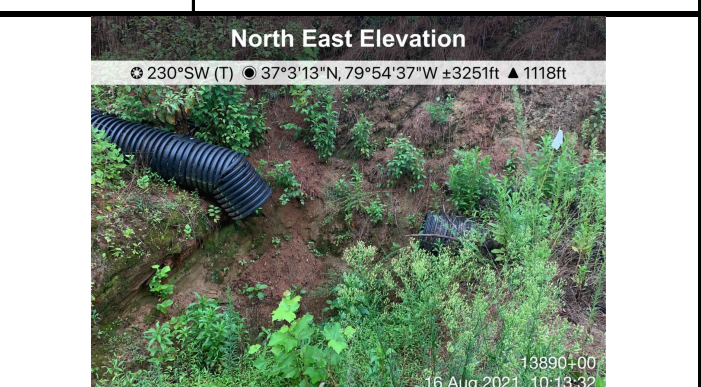
GPS Location	0		GPS Location	0	
Field Station#	13893+00		Field Station#	13890+00	
Pic 5 Desc.	Super silt fence after maintenance		Pic 6 Desc.	Sump pit and slope drain pipe in acceptable conditions

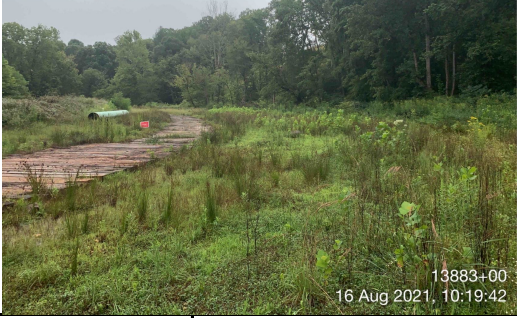
Insert image here			
GPS Location	0	GPS Location			
Field Station#	13883+00	Field Station#			
Pic 7 Desc.	Temporary vegetative stabilization in acceptable condition	Pic 8 Desc.			
Insert image here		Insert image here			
GPS Location		GPS Location			
Field Station#		Field Station#			
Pic 9 Desc.		Pic 10 Desc.			
Insert image here		Insert image here			
GPS Location		GPS Location			
Field Station#		Field Station#			
Pic 11 Desc.		Pic 12 Desc.

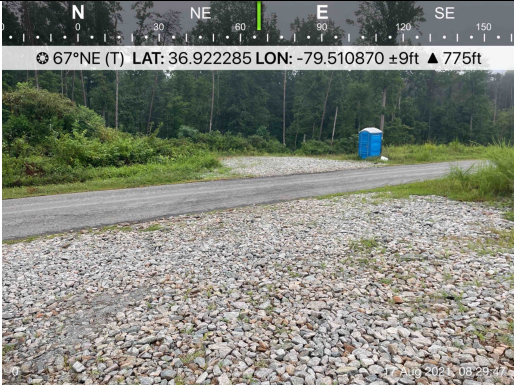
GPS Location	See photo		GPS Location	See photo	
Field Station#	15370+62		Field Station#	15370+00	
Pic 1 Desc.	RCEs are in good condition at all road crossings.		Pic 2 Desc.	Vegetation continues to fill in throughout this section.

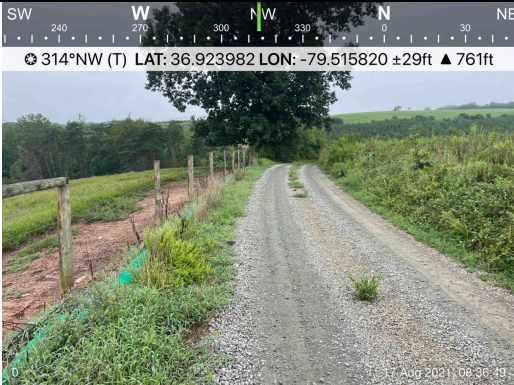
GPS Location	See photo		GPS Location	See photo	
Field Station#	15350+00		Field Station#	15346+90	
Pic 3 Desc.	MVP-PI-332 remains in good condition with controls in place.		Pic 4 Desc.	Equipment bridge ECDs are in place and functioning.

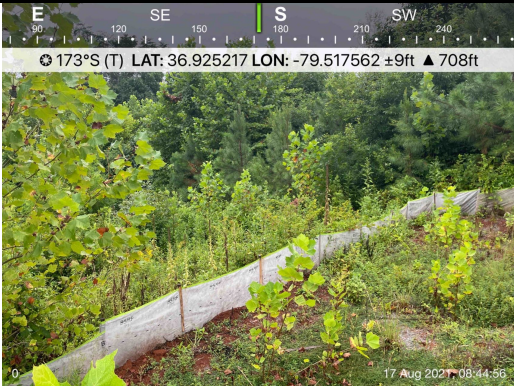
GPS Location	See photo		GPS Location	See photo	
Field Station#	15346+00		Field Station#	15344+13	
Pic 5 Desc.	P1 is in good condition at all stream and wetland buffers.		Pic 6 Desc.	Waterbars are functioning as intended.

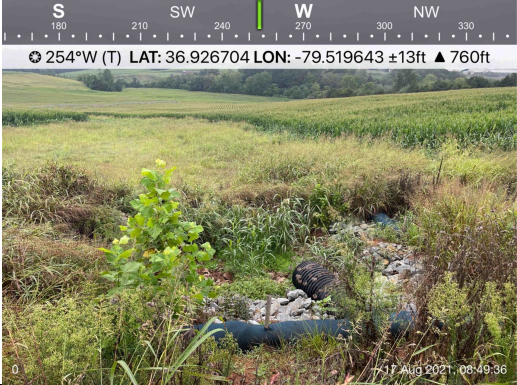
GPS Location	See photo		GPS Location	See photo	
Field Station#	15338+00		Field Station#	15338+00	
Pic 7 Desc.	CWDs are in good condition and functioning.		Pic 8 Desc.	CWD inlets are in good condition.

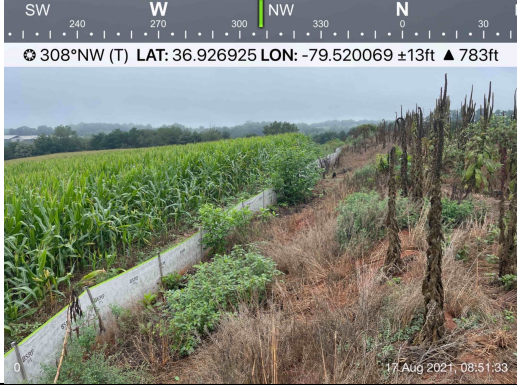
GPS Location	See photo		GPS Location	See photo	
Field Station#	15336+00		Field Station#	15311+78	
Pic 9 Desc.	Perimeter P1 is in good condition.		Pic 10 Desc.	Wetland buffer P1 remains in good condition.

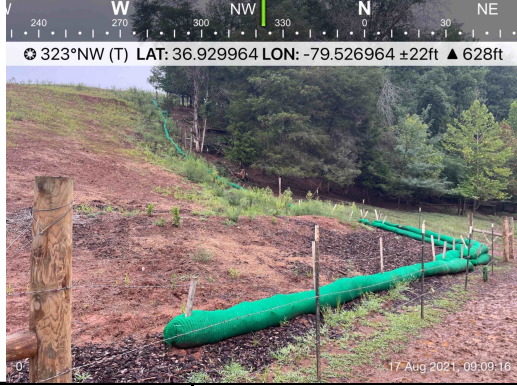
GPS Location	See photo		GPS Location	See photo	
Field Station#	15310+00		Field Station#	15299+00	
Pic 11 Desc.	Perimeter CFS is in good condition throughout this section.		Pic 12 Desc.	CWD is functioning as intended.

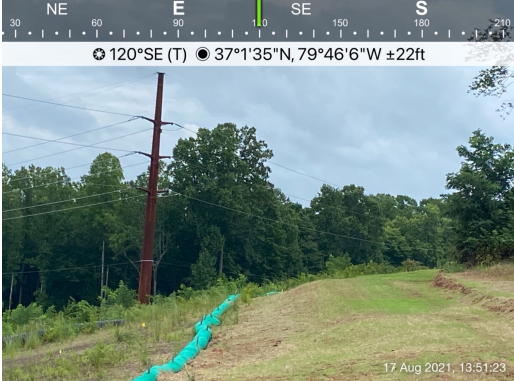
GPS Location	0	GPS Location	0		
Field Station#	14456+50	Field Station#	14518+50		
Pic 1 Desc.	Approximately 14456+50. Overview of ROW.	Pic 2 Desc.	Approximately 14518+50. Overview of ROW.

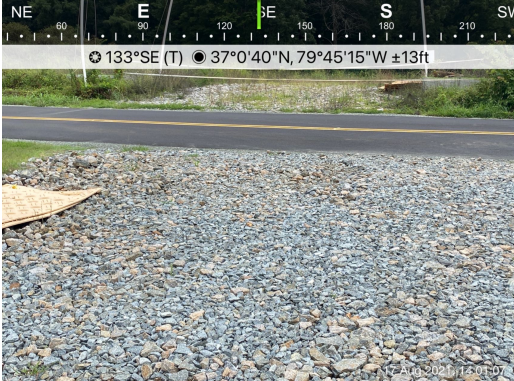
GPS Location	0	GPS Location	0		
Field Station#	14526+00	Field Station#	14530+00		
Pic 3 Desc.	Approximately 14526+00. Overview of road crossing and RCEs.	Pic 4 Desc.	Approximately 14530+00. Overview of ROW.

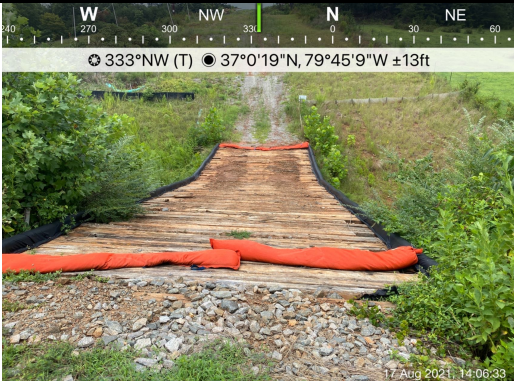
GPS Location	0	GPS Location	0		
Field Station#	14546+33	Field Station#	14542+00		
Pic 5 Desc.	Approximately 14546+33. Overview of stream crossing, equipment bridge and ECDs at stream S-G17.	Pic 6 Desc.	Approximately 14542+00. Overview of ROW.

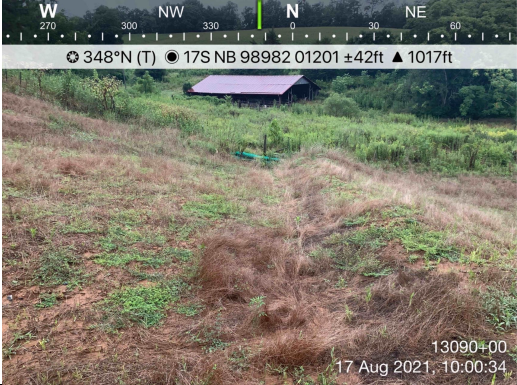
<p>348°N (T) 17S NB 98982 01201 ±42ft ▲ 1017ft</p> <p>13090+00 17 Aug 2021, 10:00:34</p>		  <p>1°N (T) 17S NB 98974 01226 ±213ft ▲ 1011ft</p> <p>13090+00 17 Aug 2021, 10:00:17</p>			
GPS Location	0	GPS Location	0		
Field Station#	13090+00	Field Station#	13090+00		
Pic 7 Desc.	Waterbar in acceptable condition		Pic 8 Desc.	Waterbar end treatment in acceptable condition	
  <p>119°SE (T) 17S NB 98413 00591 ±272ft ▲ 1134ft</p> <p>13063+00 17 Aug 2021, 10:16:39</p>		  <p>117°SE (T) 17S NB 98340 00823 ±236ft ▲ 1145ft</p> <p>13060+00 17 Aug 2021, 10:18:51</p>			
GPS Location	0	GPS Location	0		
Field Station#	13063+00	Field Station#	13060+00		
Pic 9 Desc.	Sump pit in acceptable condition		Pic 10 Desc.	Clean water diversion pipe in acceptable condition

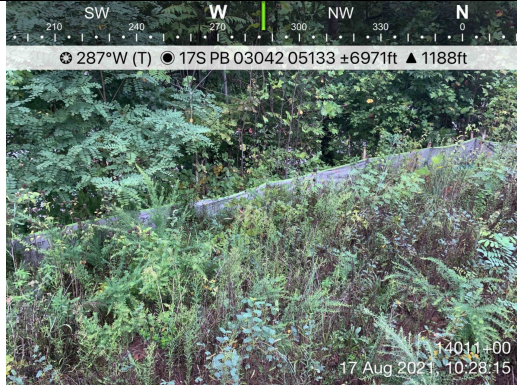
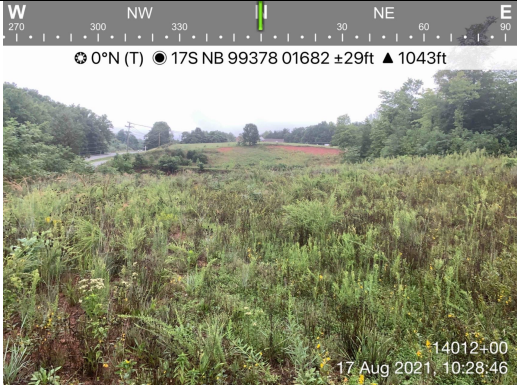
GPS Location	0	GPS Location	0		
Field Station#	14011+00	Field Station#	14012+00		
Pic 11 Desc.	P1 silt fence in acceptable condition		Pic 12 Desc.	Permanent vegetative stabilization in acceptable condition

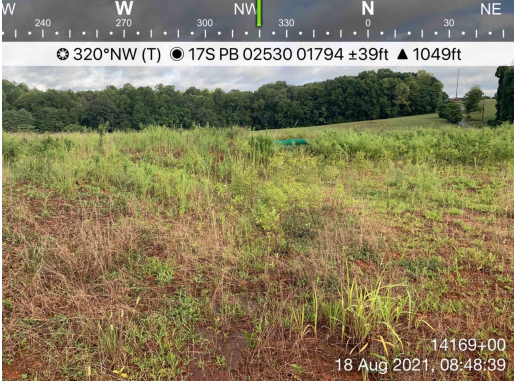
GPS Location	0	GPS Location	0		
Field Station#	14169+00	Field Station#	14169+00		
Pic 1 Desc.	Permanent vegetative stabilization and waterbar in acceptable conditions		Pic 2 Desc.	Waterbar end treatment in acceptable condition

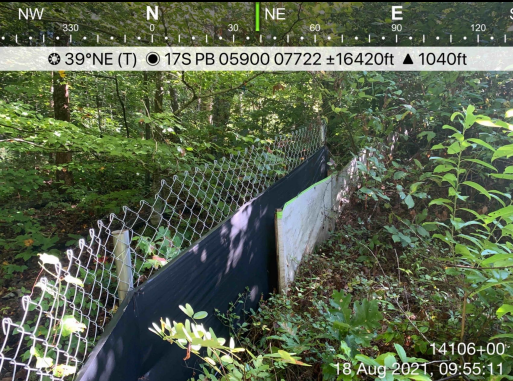
GPS Location	0	GPS Location	0		
Field Station#	14109+00	Field Station#	14106+00		
Pic 5 Desc.	Waterbar end treatment and perimeter CFS in acceptable conditions		Pic 6 Desc.	Super silt fence and P1 silt fence in acceptable conditions

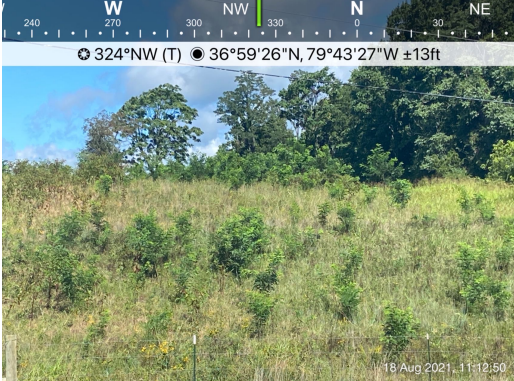
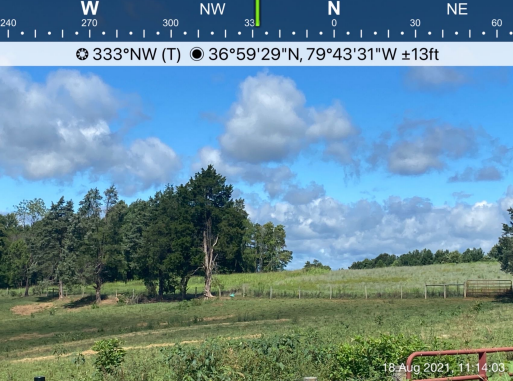
GPS Location	0	GPS Location	0		
Field Station#	14648+00	Field Station#	14642+00		
Pic 1 Desc.	Approximately 14648+00. Overview of ROW.	Pic 2 Desc.	Approximately 14642+00. Overview of ROW.

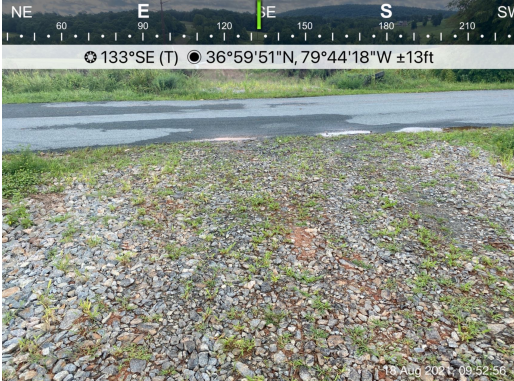
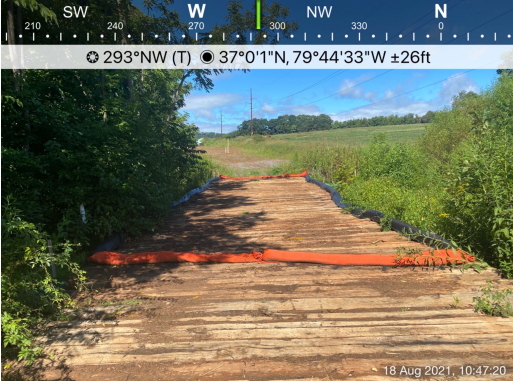
GPS Location	0	GPS Location	0		
Field Station#	14599+25	Field Station#	14582+85		
Pic 3 Desc.	Approximately 14599+25. Overview of road crossing and RCEs.	Pic 4 Desc.	Approximately 14582+85. Overview of stream crossing, equipment bridge and ECDs at stream S-E17.

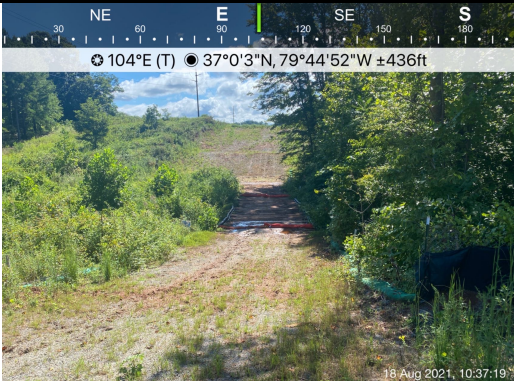
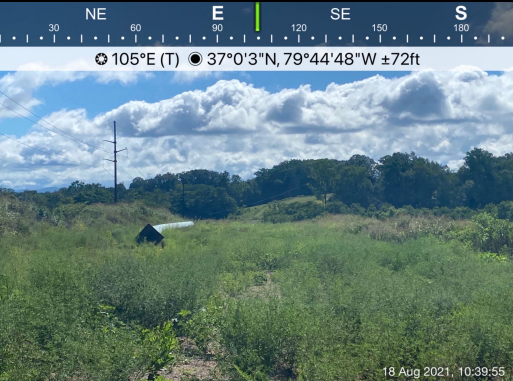
GPS Location	0	GPS Location	0		
Field Station#	14568+10	Field Station#	14575+00		
Pic 5 Desc.	Approximately 14568+10. Overview of stream crossing, equipment bridge and ECDs at stream S-E18.	Pic 6 Desc.	Approximately 14575+00. Overview of ROW.

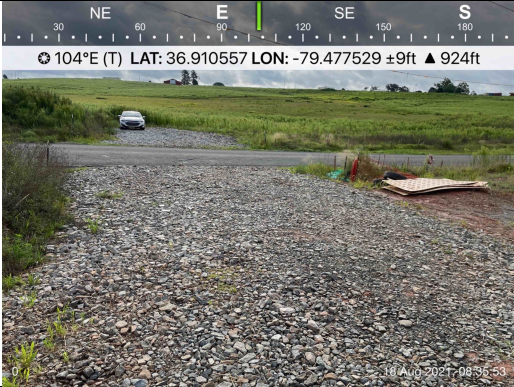
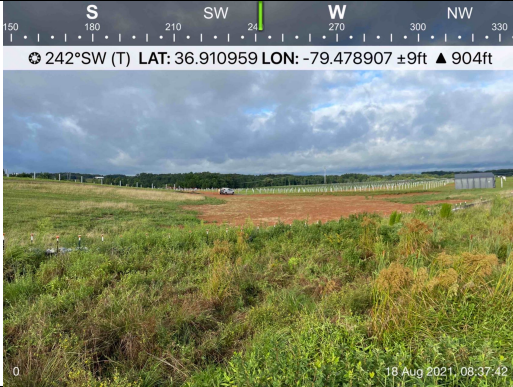
GPS Location	See photo		GPS Location	See photo	
Field Station#	15480+00		Field Station#	15475+00	
Pic 1 Desc.	RCEs are in good condition at all road crossings.		Pic 2 Desc.	Rock outlet appears to be in good condition along this drainage.

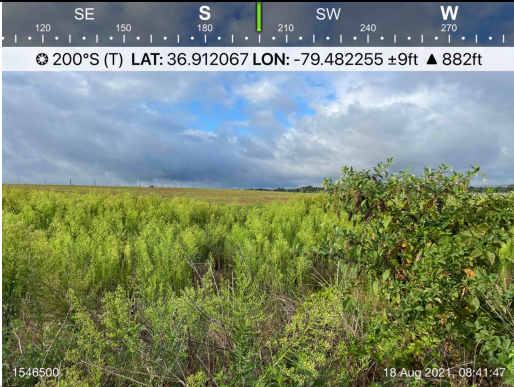
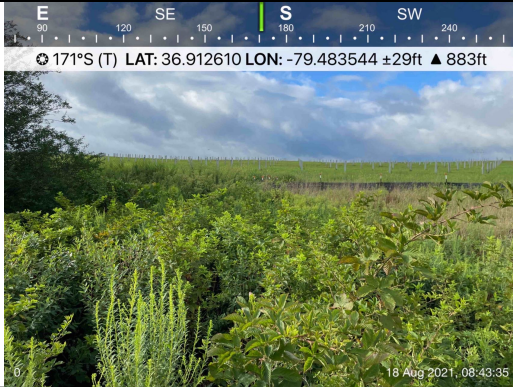
GPS Location	See photo		GPS Location	See photo	
Field Station#	15465+00		Field Station#	15460+81	
Pic 3 Desc.	No evidence of sedimentation from 3rd party disturbance.		Pic 4 Desc.	No evidence of sedimentation from 3rd party rock outlet. CWD is in good condition.

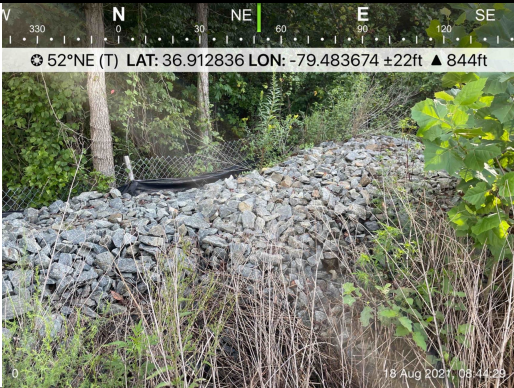
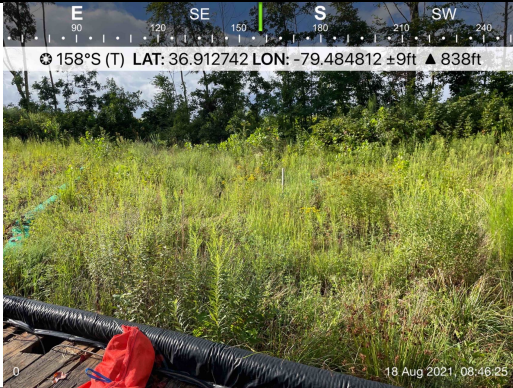
GPS Location	See photo		GPS Location	See photo	
Field Station#	15460+81		Field Station#	15457+00	
Pic 5 Desc.	CWD in good condition. No evidence of sedimentation.		Pic 6 Desc.	Drainage feature is in good condition with no evidence of sedimentation from 3rd party disturbance.

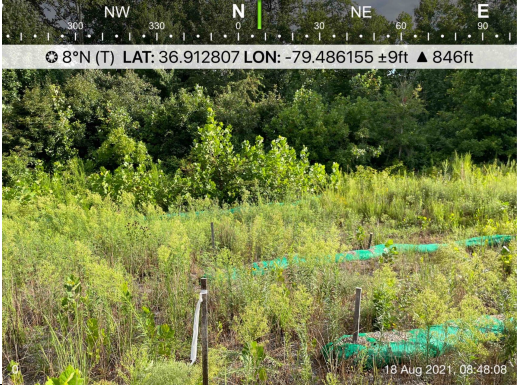
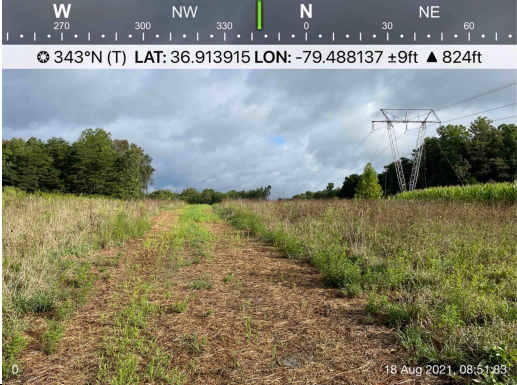
GPS Location	See photo		GPS Location	See photo	
Field Station#	15453+00		Field Station#	15445+00	
Pic 7 Desc.	CWD is in good condition. No evidence of sedimentation from 3rd party disturbance.		Pic 8 Desc.	Vegetation continues to fill in throughout this section of ROW.

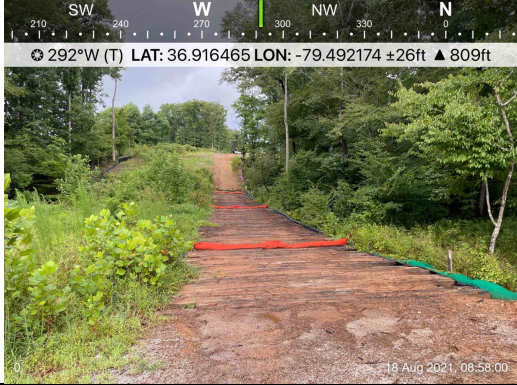
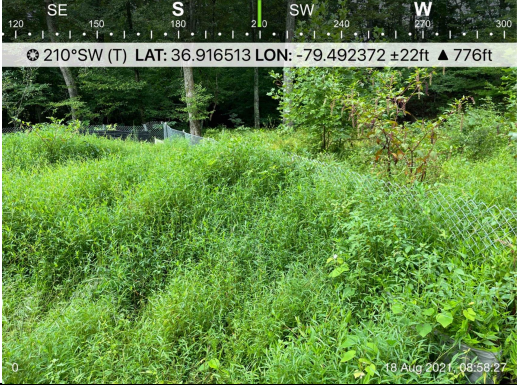
GPS Location	See photo		GPS Location	See photo	
Field Station#	15427+00		Field Station#	15427+30	
Pic 9 Desc.	Equipment bridge ECDs are in place and functioning.		Pic 10 Desc.	Stream buffers remain well vegetated and ECDs are in good condition and functioning.

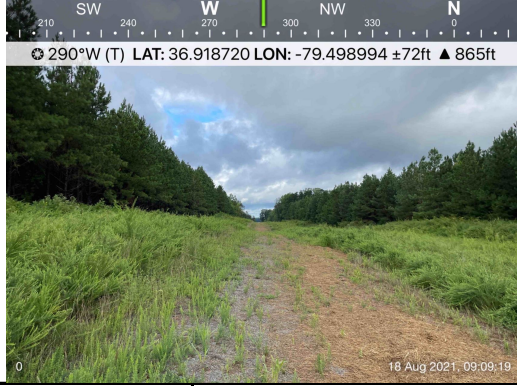
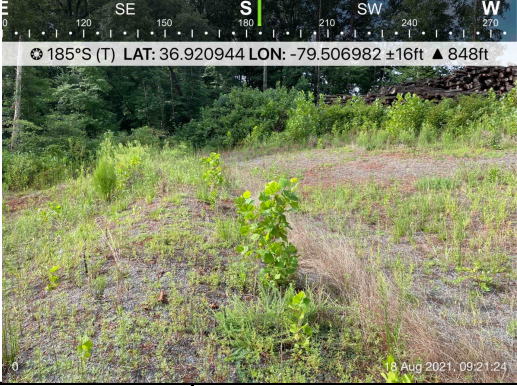
GPS Location	See photo		GPS Location	See photo	
Field Station#	15400+00		Field Station#	15380+00	
Pic 11 Desc.	Vegetation continues to fill in throughout this section.		Pic 12 Desc.	Waterbars are functioning as intended.

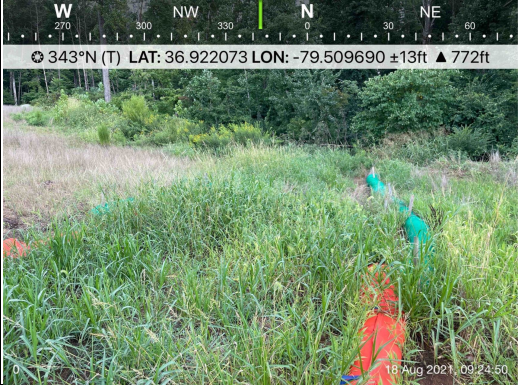
GPS Location	See photo	GPS Location			
Field Station#	15375+00	Field Station#			
Pic 13 Desc.	Drainage ECDs are in good condition and functioning.	Pic 14 Desc.			
Insert image here		Insert image here			
GPS Location		GPS Location			
Field Station#		Field Station#			
Pic 15 Desc.		Pic 16 Desc.			
Insert image here		Insert image here			
GPS Location		GPS Location			
Field Station#		Field Station#			
Pic 17 Desc.		Pic 18 Desc.

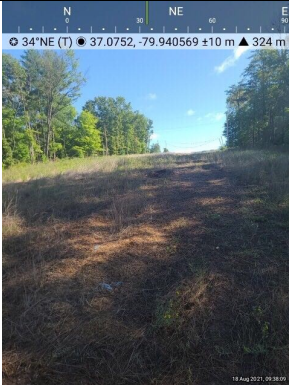
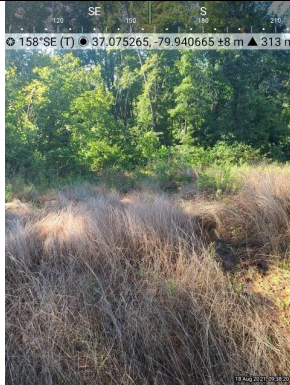
GPS Location	0000	GPS Location	0000		
Field Station#	13746+56	Field Station#	13745+90		
Pic 1 Desc.	Saturated row photo taken while checking row conditions after recent rain events.		Pic 2 Desc.	Vegetation photo taken near sump pit showing good stabilization. No issues observed at the time of inspection.

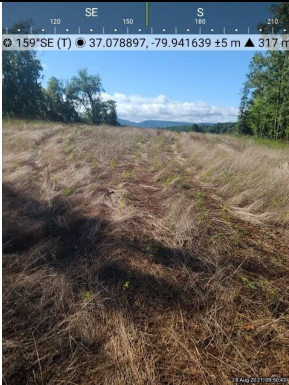
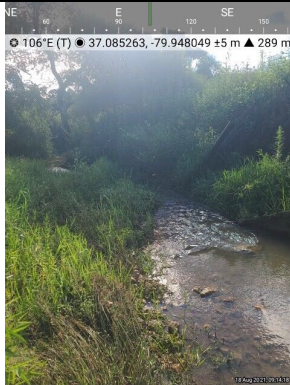
GPS Location	0000	GPS Location	0000		
Field Station#	13738+20	Field Station#	13692+64		
Pic 3 Desc.	Vegetation observation photo taken while monitoring row after recent rain events. No issues noted .		Pic 4 Desc.	Stream observation photo facing downstream during routine inspection today after recent rain events. No environmental issues observed at the time of inspection.

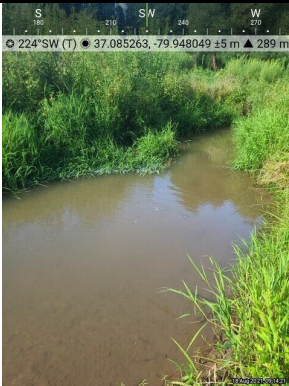
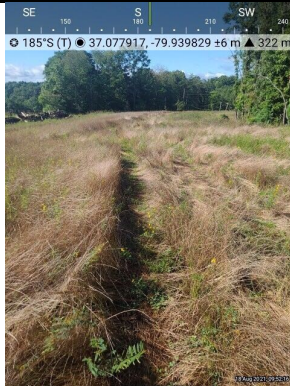
GPS Location	0000	GPS Location	0000		
Field Station#	13692+64	Field Station#	13740+00		
Pic 5 Desc.	Stream observation photo facing upstream during routine inspection today. No issues observed at the time of inspection.		Pic 6 Desc.	Additional vegetation observation photo. Good coverage noted with no environmental issues observed at the time inspection.

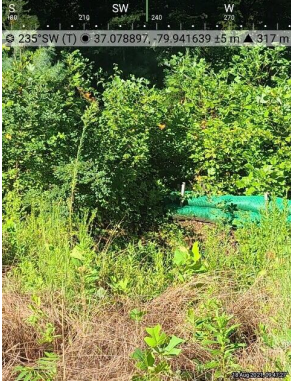
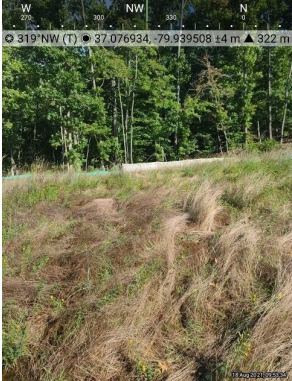
GPS Location	0000	GPS Location	0000		
Field Station#	13730+00	Field Station#	13743+00		
Pic 7 Desc.	Monitored sump pit and end treatment while checking row conditions after recent rain events. No issues observed at the time of inspection.		Pic 8 Desc.	Monitored ECDs along LOD boundary. No issues observed at the time of inspection. Ecds in place and functioning.	
Insert image here		Insert image here			
GPS Location		GPS Location			
Field Station#		Field Station#			
Pic 9 Desc.			Pic 10 Desc.		
Insert image here		Insert image here			
GPS Location		GPS Location			
Field Station#		Field Station#			
Pic 11 Desc.			Pic 12 Desc.

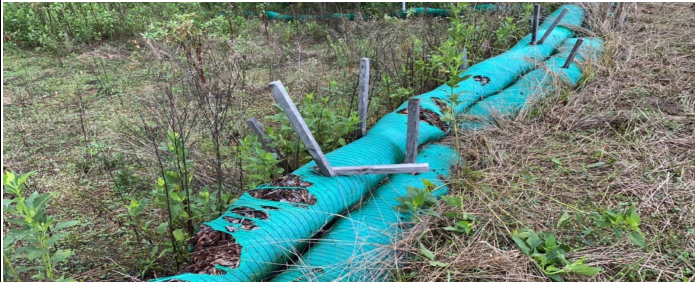
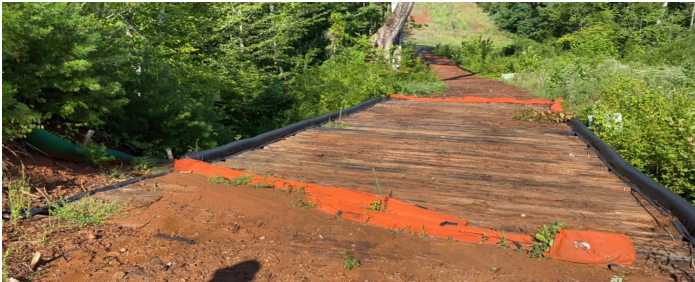
36°57'53" N 79°37'0" W 330°NW COURSE 7° GPS Penhook, VA 24137, United States 08.18.2021 10:03:59 Accur +/-47.0 Ft ALT 927 Ft			36°57'56" N 79°36'17" W 269°W COURSE 295° GPS Sorry no results found 08.18.2021 09:39:04 Accur +/-15.7 Ft ALT 798 Ft		
GPS Location	1	GPS Location	2		
Field Station#	14992+00	Field Station#	15027+97		
Pic 1 Desc.	Routine maintenance. Repair/replace damaged CFS triple stack from cattle damage.		Pic 2 Desc.	Routine maintenance. Sediment accumulation more than half full on bridge wattle.

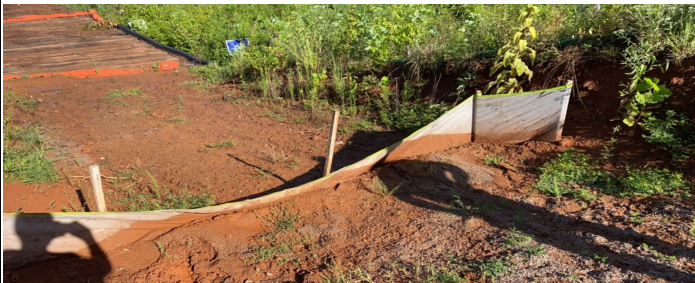
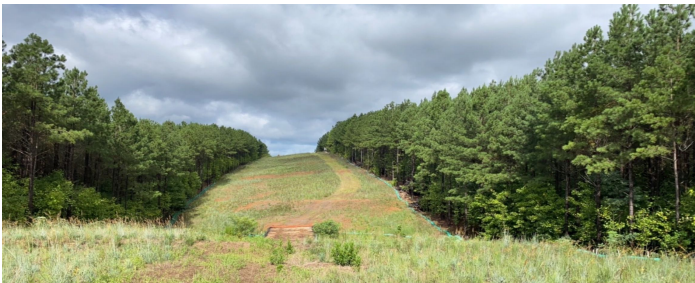
Pic 3 Desc.	Routine maintenance. Replace damaged P1 silt fence more than half full of sediment.		Pic 4 Desc.	View of ROW through final cleanup area. No issues observed.

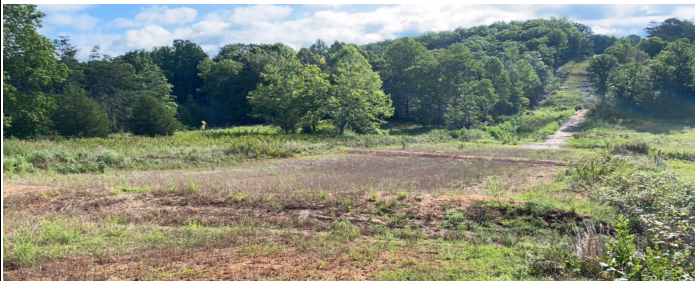
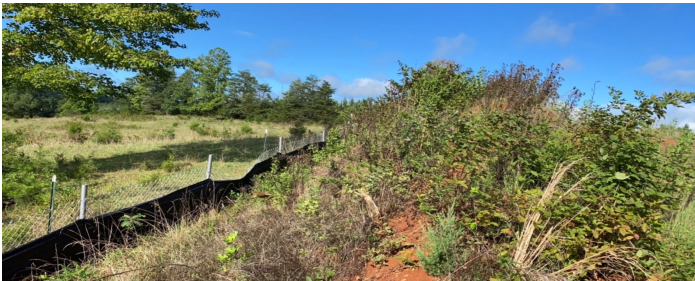
36°57'55" N 79°36'4" W 71°E COURSE 286° GPS Penhook, VA 24137, United States 08.18.2021 09:31:53 Accur +/-29.4 Ft ALT 825 Ft			36°57'55" N 79°36'4" W 151°SE COURSE 177° GPS Penhook, VA 24137, United States 08.18.2021 09:31:49 Accur +/-47.8 Ft ALT 884 Ft		
GPS Location	5	GPS Location	6		
Field Station#	15040+00	Field Station#	15037+00		
Pic 5 Desc.	Water bars performing intended function. ROW stabilized and vegetated in temporary area.		Pic 6 Desc.	Perimeter SSF in place and functional.

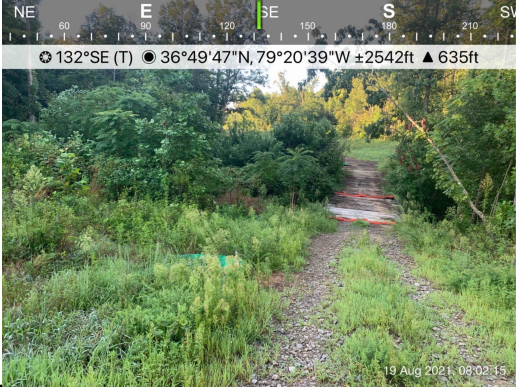
GPS Location	O	GPS Location	O		
Field Station#	12+65	Field Station#	6+00		
Pic 3 Desc.	Observing temporary stabilization, buffer, equipment crossing and ECD's	Pic 4 Desc.	Observing temporary stabilization and access road		
Insert image here		Insert image here			
GPS Location		GPS Location			
Field Station#		Field Station#			
Pic 5 Desc.		Pic 6 Desc.

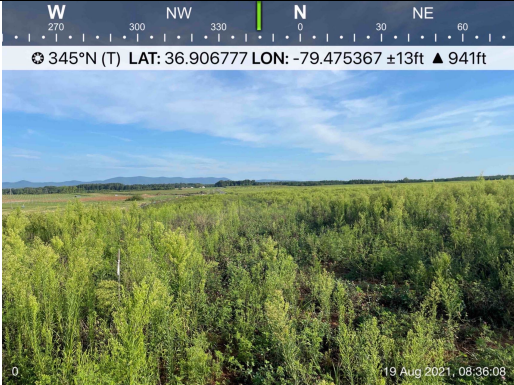
GPS Location	See photo		GPS Location	See photo	
Field Station#	15495+00		Field Station#	15496+70	
Pic 1 Desc.	Vegetation continues to fill in throughout this section.		Pic 2 Desc.	RCEs are in good condition at all road crossings.

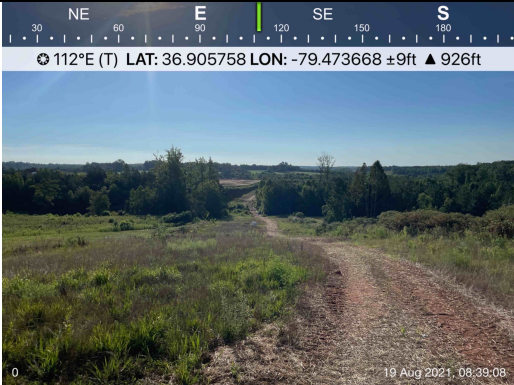
GPS Location	See photo		GPS Location	See photo	
Field Station#	15500+00		Field Station#	15501+00	
Pic 3 Desc.	Vegetation continues to fill in throughout this section.		Pic 4 Desc.	No evidence of sedimentation from 3rd party disturbance.

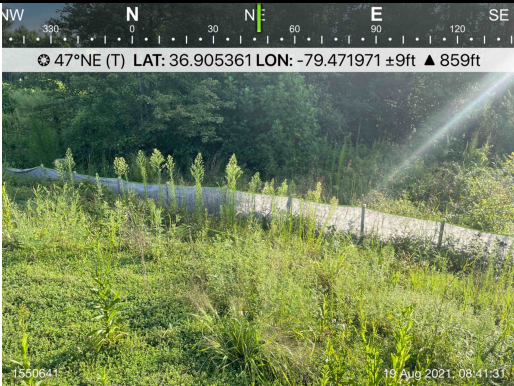
GPS Location	See photo		GPS Location	See photo	
Field Station#	15506+41		Field Station#	15510+00	
Pic 5 Desc.	P1 is in good condition at all stream and wetland crossings.		Pic 6 Desc.	3rd party ECDs appear to be in good condition with no evidence of sedimentation onto MVP ROW.

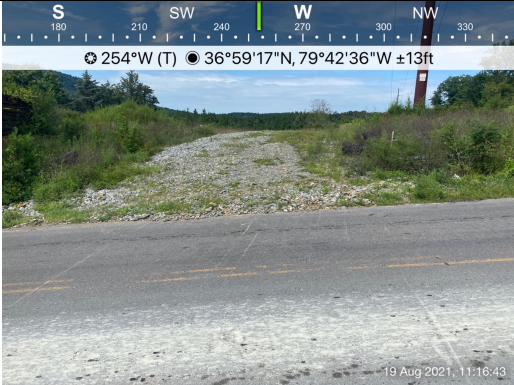
GPS Location	0	GPS Location	0		
Field Station#	14694+30	Field Station#	14689+36		
Pic 1 Desc.	Approximately 14694+30. Overview of road crossing and RCE.		Pic 2 Desc.	Approximately 14689+36. Overview of stream crossing, equipment bridge and ECDs at stream S-H34.

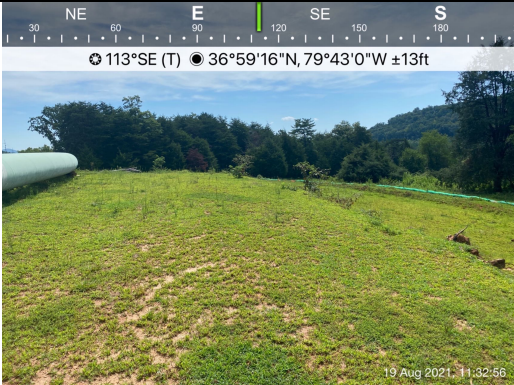
GPS Location	0	GPS Location	0		
Field Station#	14677+00	Field Station#	14660+00		
Pic 3 Desc.	Approximately 14677+00 overview of ROW.		Pic 4 Desc.	Approximately 14660+00. Overview of ROW. Third party atv track's observed on the ROW.

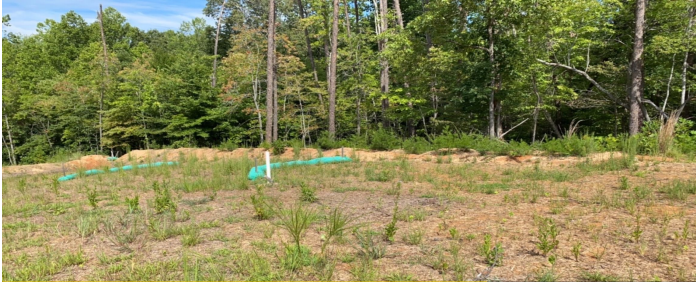
<small>36°57'44" N 79°35'22" W 282°W COURSE 337° GPS Sandy Level, VA 24161, United States</small>			<small>36°57'43" N 79°35'18" W 4°N COURSE 36° GPS Sandy Level, VA 24161, United States</small>		
<small>08.19.2021 10:57:37 Accur +/-94.4 Ft ALT 907 Ft</small>			<small>08.19.2021 10:55:56 Accur +/-25.2 Ft ALT 908 Ft</small>		
GPS Location	1		GPS Location	2	
Field Station#	15075+00		Field Station#	15079+00	
Pic 1 Desc.	CFS check dams performing intended function		Pic 2 Desc.	Plunge pool in good condition

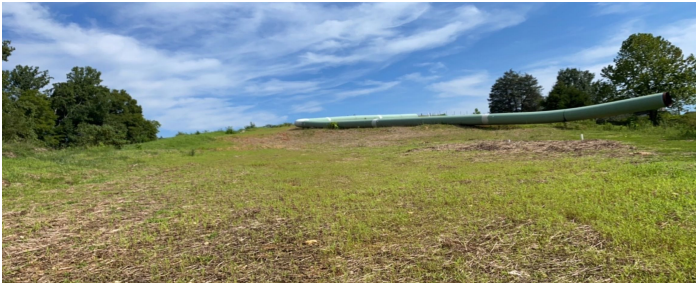
GPS Location	3		GPS Location	4	
Field Station#	15090+50		Field Station#	15098+00	
Pic 3 Desc.	Picture of temporary stabilization and vegetation along ROW		Pic 4 Desc.	Picture of permanent stabilization and vegetation along ROW

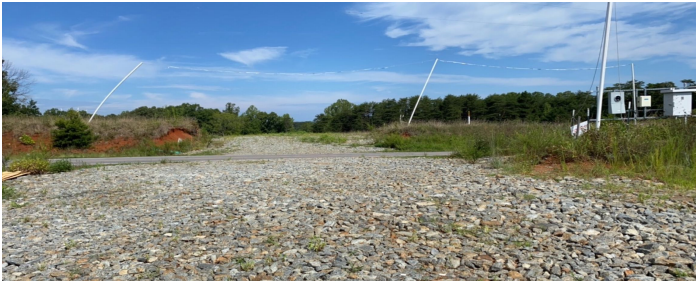
<small>36°57'19" N 79°34'55" W 342°N COURSE 319° GPS 8850-8968 Museville Rd, Sandy Level, VA 24161, United States</small>			<small>36°56'55" N 79°34'44" W 312°NW COURSE 59° GPS 337-521 Rockcreek Rd, Sandy Level, VA 24161, United States</small>		
<small>08.19.2021 10:40:12 Accur +/-23.0 Ft ALT 929 Ft</small>			<small>08.19.2021 10:27:25 Accur +/-74.1 Ft ALT 0 Ft</small>		
GPS Location	5		GPS Location	6	
Field Station#	15113+00		Field Station#	15137+00	
Pic 5 Desc.	RCE at Museville Rd in good condition		Pic 6 Desc.	Sump pit and CFS end treatment in place and functional

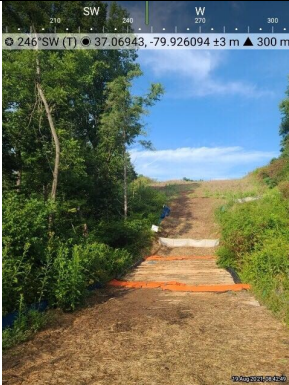
GPS Location	0000	GPS Location	0000		
Field Station#	13805+90	Field Station#	13832+00		
Pic 1 Desc.	Monitored equipment bridge and protection along with all ECDs , no environmental issues observed at the time of inspection.		Pic 2 Desc.	Row photo showing stabilization on hill side. No environmental issues observed at the time of inspection.

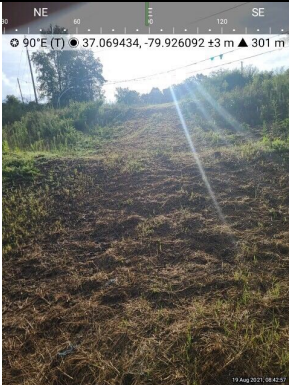
GPS Location	0000	GPS Location	00000		
Field Station#	13806+70	Field Station#	13826+95		
Pic 3 Desc.	Photo showing vegetation and stabilization on hill side above stream crossing. Good coverage. No environmental issues observed at the time of inspection.		Pic 4 Desc.	Vegetation observation while monitoring row conditions. No environmental issues observed at the time of inspection.

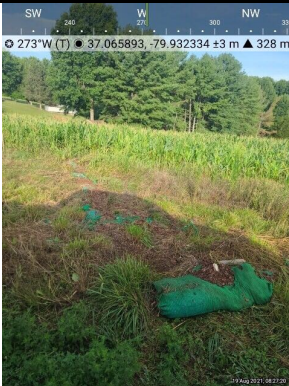
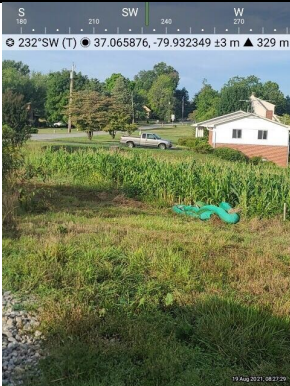
Pic 5 Desc.	Additional photo showing land owner damage to CFS along access rd MVP-FR-300		Pic 6 Desc.	CFS along access rd MVP-FR-300 has been damaged from land owner , documented and sent in to be added to the punch list for maintenance repair.

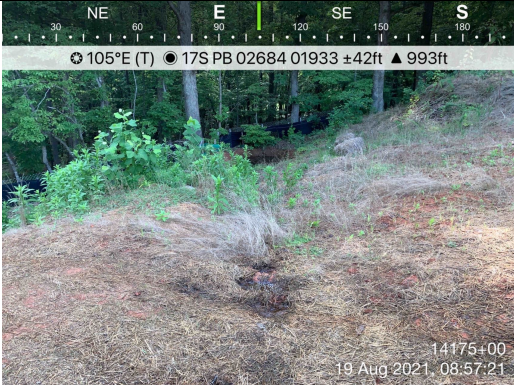
GPS Location	0	GPS Location	0		
Field Station#	14175+00	Field Station#	14175+00		
Pic 1 Desc.	Waterbar in acceptable condition		Pic 2 Desc.	Waterbar end treatment and super silt fence in acceptable conditions

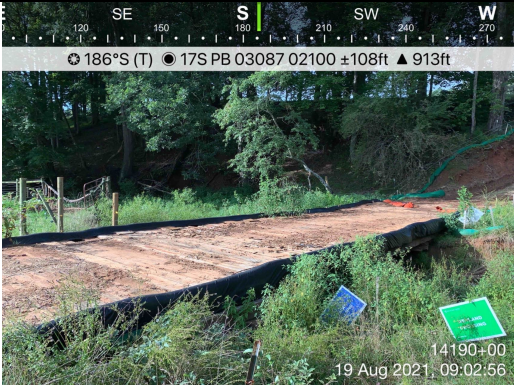
GPS Location	0	GPS Location	0		
Field Station#	14190+00	Field Station#	14190+50		
Pic 3 Desc.	Equipment bridge in acceptable condition		Pic 4 Desc.	P1 silt fence in acceptable condition

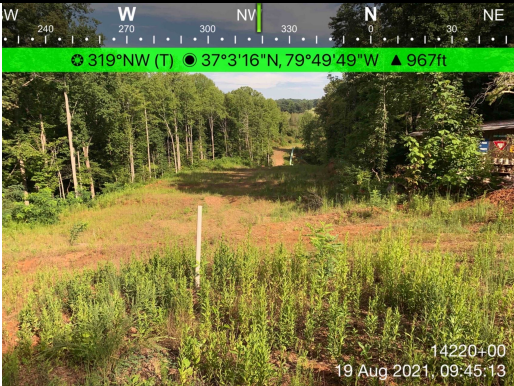
GPS Location	0	GPS Location	0		
Field Station#	14220+00	Field Station#	14203+00		
Pic 5 Desc.	Temporary vegetative stabilization in acceptable condition		Pic 6 Desc.	Temporary vegetative stabilization and perimeter CFS in acceptable conditions

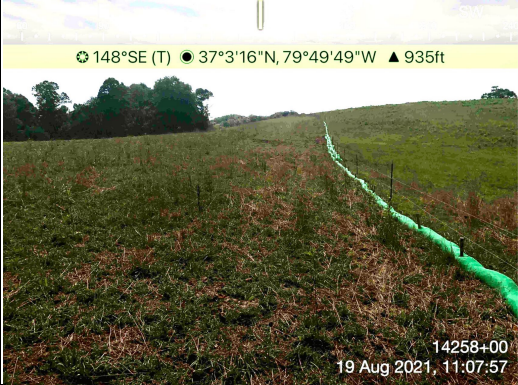
GPS Location	0	GPS Location	0		
Field Station#	14258+00	Field Station#	14289+00		
Pic 7 Desc.	Permanent vegetative stabilization and perimeter CFS in acceptable conditions		Pic 8 Desc.	Clean water diversion plunge pool in acceptable condition	
Insert image here		Insert image here			
GPS Location		GPS Location			
Field Station#		Field Station#			
Pic 9 Desc.		Pic 10 Desc.			
Insert image here		Insert image here			
GPS Location		GPS Location			
Field Station#		Field Station#			
Pic 11 Desc.		Pic 12 Desc.

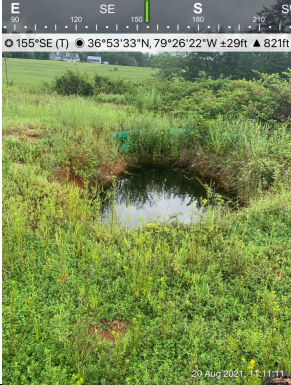
GPS Location	O	GPS Location	O		
Field Station#	15616+00	Field Station#	15619+48		
Pic 7 Desc.	Observing temporary stabilization, sump and end treatment		Pic 8 Desc.	Observing road crossing and RCE's	
Insert image here		Insert image here			
GPS Location		GPS Location			
Field Station#		Field Station#			
Pic 9 Desc.			Pic 10 Desc.		
Insert image here		Insert image here			
GPS Location		GPS Location			
Field Station#		Field Station#			
Pic 11 Desc.			Pic 12 Desc.

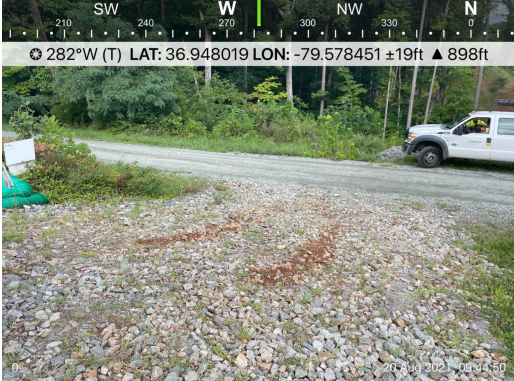
GPS Location	See photo		GPS Location	See photo	
Field Station#	15142+66		Field Station#	15153+00	
Pic 1 Desc.	RCE is in good condition at Rockcreek Rd.		Pic 2 Desc.	Perimeter CFS is in good condition.

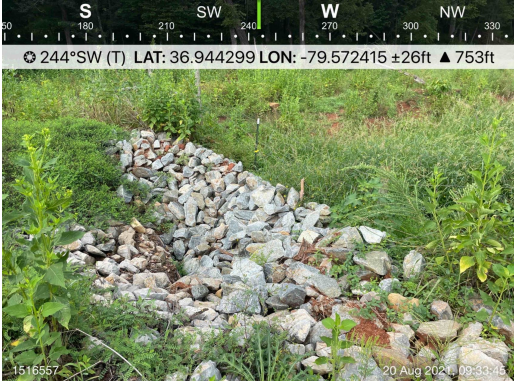
GPS Location	See photo		GPS Location	See photo	
Field Station#	15165+57		Field Station#	15166+00	
Pic 3 Desc.	Rock filter remains in good condition.		Pic 4 Desc.	Rock outlet is in good condition.

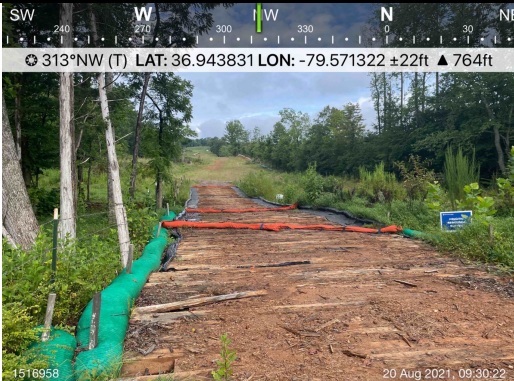
GPS Location	See photo		GPS Location	See photo	
Field Station#	15169+58		Field Station#	15169+58	
Pic 5 Desc.	Equipment bridge ECDs are in place and functioning.		Pic 6 Desc.	P1 is in good condition at stream buffer.

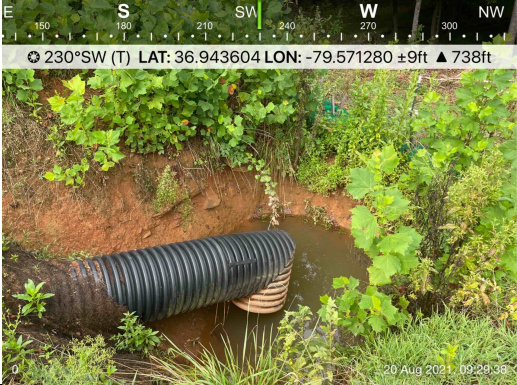
GPS Location	See photo		GPS Location	See photo	
Field Station#	15170+00		Field Station#	15172+00	
Pic 7 Desc.	Slope drain is in good condition and functioning as intended.		Pic 8 Desc.	Waterbars are in good condition throughout this section.

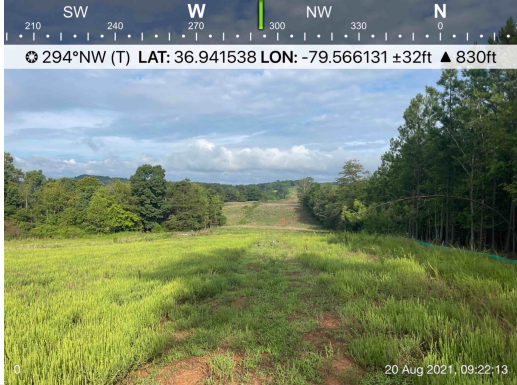
GPS Location	See photo		GPS Location	See photo	
Field Station#	15187+00		Field Station#	15195+00	
Pic 9 Desc.	Vegetation continues to fill in throughout this section.		Pic 10 Desc.	CFS along drainage has been damaged by livestock and needs to be repaired and restaked.

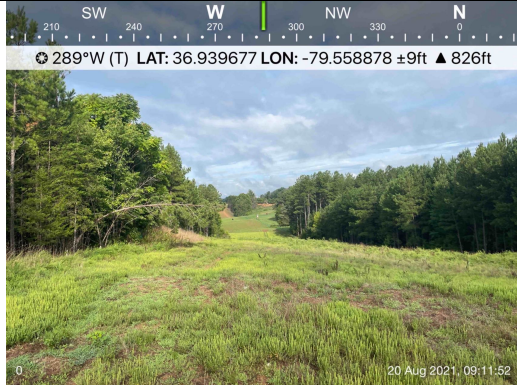
GPS Location	See photo		GPS Location	See photo	
Field Station#	15209+00		Field Station#	15230+00	
Pic 11 Desc.	Vegetation continues to fill in throughout this section.		Pic 12 Desc.	Vegetation continues to fill in throughout this section.

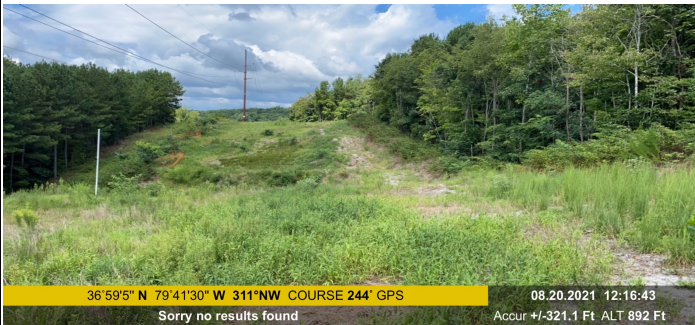
Pic 3 Desc.	Picture of temporary stabilization and vegetation along ROW		Pic 4 Desc.	CFS triple stack at resource buffer in good condition

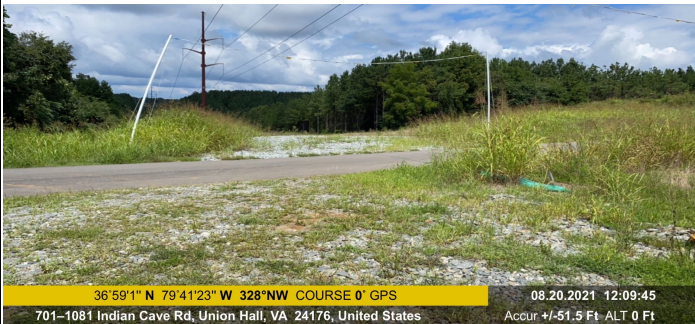
36°59'11" N 79°41'23" W 328°NW COURSE 0' GPS 701-1081 Indian Cave Rd, Union Hall, VA 24176, United States 08.20.2021 12:09:45 Accur +/-51.5 Ft ALT 0 Ft			36°59'9" N 79°41'41" W 102°E COURSE 94' GPS Union Hall, VA 24176, United States 08.20.2021 12:39:43 Accur +/-393.5 Ft ALT 829 Ft		
GPS Location	5		GPS Location	6	
Field Station#	14758+16		Field Station#	14765+00	
Pic 5 Desc.	RCE at Indian Cave Rd in good condition		Pic 6 Desc.	Sump pit and CFS end treatment in place and functional

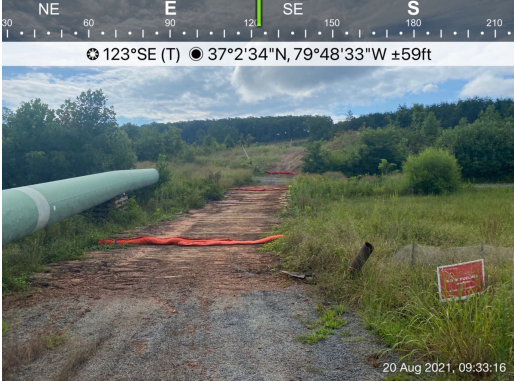
GPS Location	0	GPS Location	0		
Field Station#	14314+79	Field Station#	14333+50		
Pic 1 Desc.	Approximately 14314+79. Overview of stream crossing, equipment bridge and ECDs at stream S-GG4.		Pic 2 Desc.	Approximately 14333+50. Overview of road crossing and RCEs.

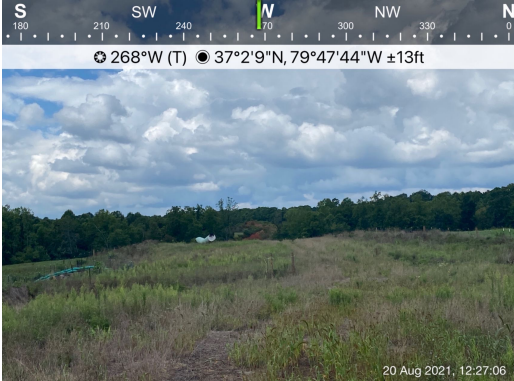
GPS Location	0	GPS Location	0		
Field Station#	14360+00	Field Station#	14391+50		
Pic 3 Desc.	Approximately 14360+00. Overview of ROW.		Pic 4 Desc.	Approximately 14391+50. Overview of stream crossing, equipment bridge and ECDs at stream S-A41.

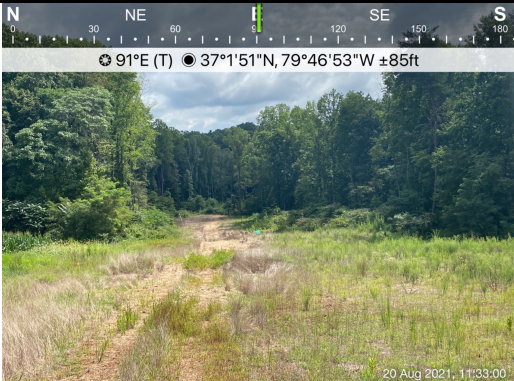
GPS Location	0	GPS Location	0		
Field Station#	14414+00	Field Station#	14451+00		
Pic 5 Desc.	Approximately 14414+00. Overview of ROW.		Pic 6 Desc.	Approximately 14451+00. Overview of ROW.
