Visual Site Inspection Report

Project Name	H-600 Pipeline Spread I	AFE	124300139	Spread	H-600 Pipeline Spread I
Contractor	Precision			Report #	27600
Inspector	John White			Date/Time	8/23/2021 10:49 AM
Permit #	TBD	Inspection Type	VA SWPP	Station Begin	15647+03
State	VA	Inspection Area	Full	Station End	15772+27
County	Pittsylvania	Ground	Dry	Temperature (°F)	85.00
Municipality	Chatham	Weather	Sunny	Rain Gauge (in)	0.50
				Rain Accumulation Time (days)	6.00

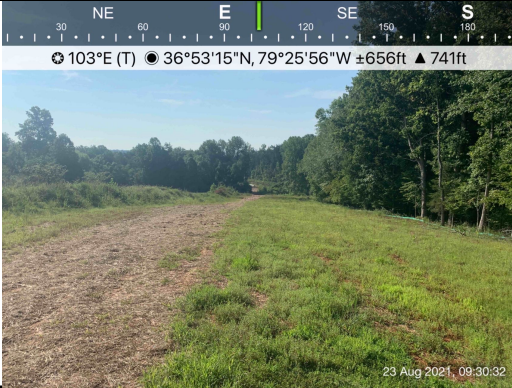
GPS Location	O	GPS Location	O		
Field Station#	15654+00	Field Station#	15671+93		
Pic 5 Desc.	Observing temporary stabilization	Pic 6 Desc.	Observing temporary stabilization, signage, buffer, equipment crossing and ECD's

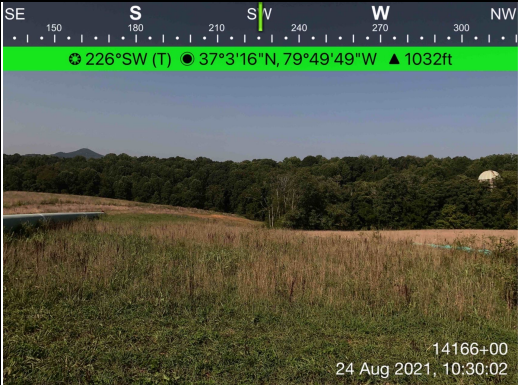
<p>SE 150 S 180 SW 210 W 270 NW 300 226°SW (T) 37°3'16"N, 79°49'49"W ▲ 1032ft 14166+00 24 Aug 2021, 10:30:02</p>

<p>S 180 SW 210 W 270 NW 300 264°W (T) 37°3'16"N, 79°49'49"W ▲ 1019ft 14171+00 24 Aug 2021, 10:28:15</p>			
GPS Location	0	GPS Location	0		
Field Station#	14166+00	Field Station#	14171+00		
Pic 7 Desc.	Permanent vegetative stabilization in acceptable condition		Pic 8 Desc.	Super silt fence in acceptable condition	
Insert image here			Insert image here		
GPS Location		GPS Location			
Field Station#		Field Station#			
Pic 9 Desc.			Pic 10 Desc.		
Insert image here			Insert image here		
GPS Location		GPS Location			
Field Station#		Field Station#			
Pic 11 Desc.			Pic 12 Desc.

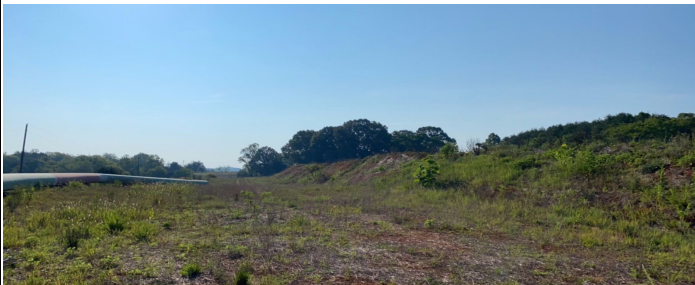
GPS Location	3		GPS Location	4	
Field Station#	14987+00		Field Station#	15052+00	
Pic 3 Desc.	Temporary diversion berm stabilized and vegetated.		Pic 4 Desc.	Plunge pool and perimeter ECDs in place and functional.

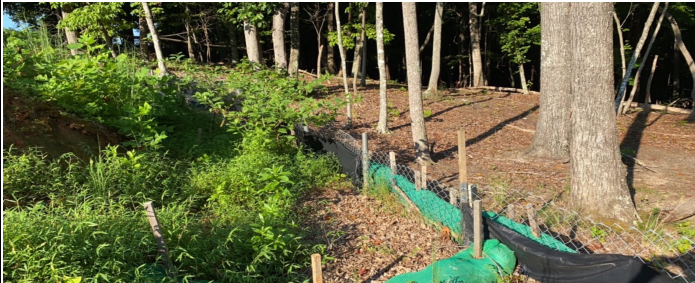
36°57'51" N 79°35'44" W 287°W COURSE 54' GPS 1918-2164 Armstrong Rd, Penhook, VA 24137, United States 08.24.2021 08:51:56 Accur +/-40.1 Ft ALT 887 Ft			36°57'51" N 79°35'44" W 16°N COURSE 278' GPS 1918-2164 Armstrong Rd, Penhook, VA 24137, United States 08.24.2021 08:51:33 Accur +/-116.4 Ft ALT 930 Ft		
GPS Location	5		GPS Location	6	
Field Station#	15057+00		Field Station#	15060+00	
Pic 5 Desc.	CFS J Hook and perimeter SSF performing intended functions.		Pic 6 Desc.	Erosion control blanket in throat of water bar preventing erosion from occurring.

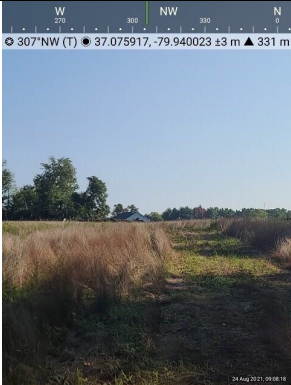
GPS Location	00000		GPS Location	0000	
Field Station#	13737+20		Field Station#	13738+00	
Pic 1 Desc.	Photo showing new vegetation growth . No environmental issues observed at the time of inspection.		Pic 2 Desc.	Monitored ECDs on row edge while checking row conditions throughout today. No issues observed at the time of inspection.

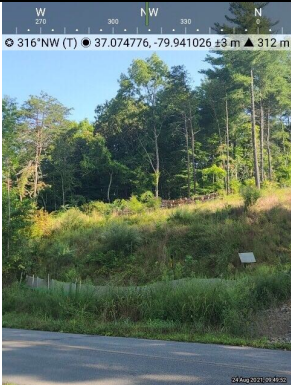
GPS Location	0000		GPS Location	0000	
Field Station#	13748+28		Field Station#	13733+60	
Pic 3 Desc.	ECDs observed at road crossing and photo showing stabilization on banks. No environmental issues observed at the time of inspection.		Pic 4 Desc.	Vegetation observation photo showing some new growth coming up. No environmental issues observed at the time of inspection.

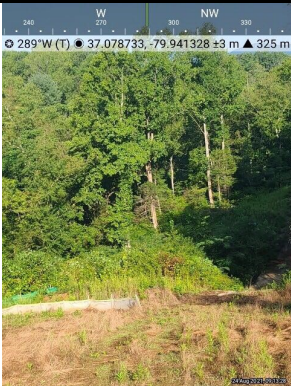
GPS Location	00000		GPS Location	0000	
Field Station#	13729+10		Field Station#	13728+23	
Pic 5 Desc.	Monitored vegetation and ECDs on hill side above stream crossing. No environmental issues observed at the time of inspection.		Pic 6 Desc.	Row photo showing stabilization on both sides of stream crossing with ECDs in place and functioning. No environmental issues observed at the time of inspection.

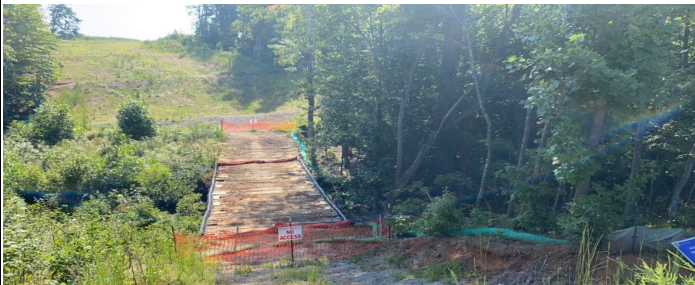
Field Station#	15072+86	Field Station#	15076+00		
Pic 3 Desc.	Equipment bridge and surrounding ECDs in place and functional at stream crossing and resource buffer		Pic 4 Desc.	Sump pit and CFS end treatment performing intended functions

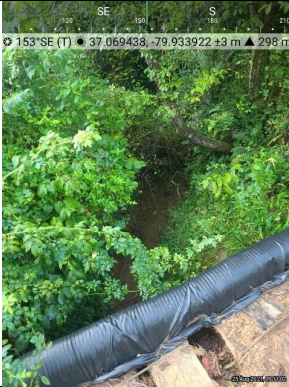
GPS Location	00000	GPS Location	0000		
Field Station#	13781+79	Field Station#	13805+69		
Pic 1 Desc.	Stream observation photo facing downstream during routine inspection today. No issues were observed at the time of inspection.		Pic 2 Desc.	Row photo showing stabilization on both sides of stream crossing. Monitored ECDs. No environmental issues observed at the time of inspection.

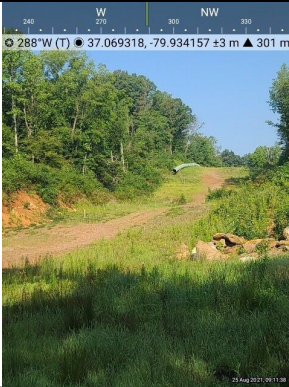
GPS Location	0000	GPS Location	0000		
Field Station#	13780+90	Field Station#	13801+17		
Pic 3 Desc.	Vegetation observation in temporary area of row. Good coverage in area. No environmental issues observed at the time of inspection.		Pic 4 Desc.	Observed sump pits and end treatment while checking row conditions. No issues observed at the time of inspection.

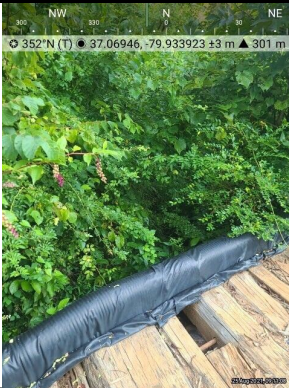
GPS Location	00000	GPS Location	000000		
Field Station#	13781+79	Field Station#	13846+87

Pic 5 Desc.	Stream observation photo facing upstream during routine inspection today. No issues were observed at the time of inspection.		Pic 6 Desc.	Monitored equipment bridges and protection during routine row inspection today. No environmental issues observed at the time of inspection.

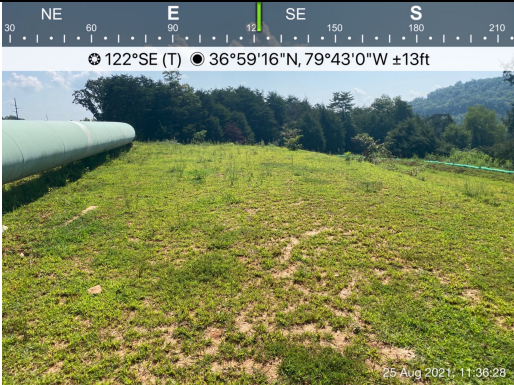
GPS Location	0	GPS Location	0		
Field Station#	14675+00	Field Station#	14673+10		
Pic 3 Desc.	Approximately 14675+00. Overview of ROW.		Pic 4 Desc.	Approximately 14673+10. Overview of stream crossing, equipment bridge and ECDs at stream S-H37.

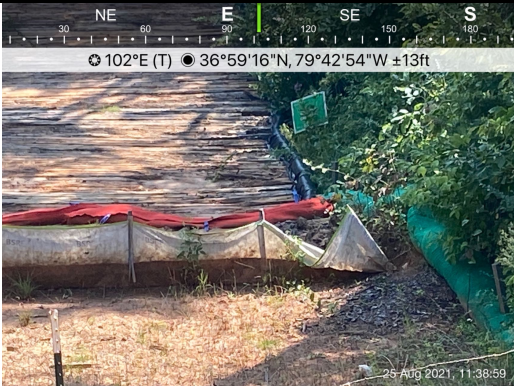
GPS Location	0	GPS Location	0		
Field Station#	14679+75	Field Station#	14653+00		
Pic 5 Desc.	Approximately 14679+75. P-1 across travel lane requires maintenance.		Pic 6 Desc.	Approximately 14653+00. Overview of ROW.

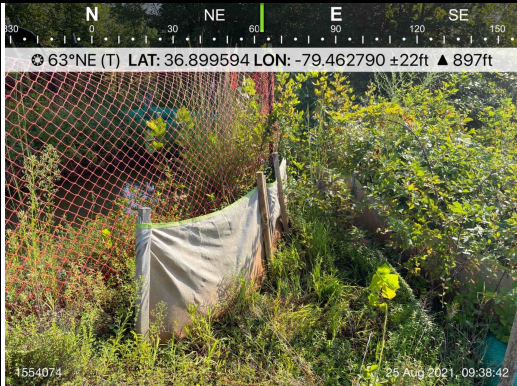
GPS Location	See photo		GPS Location	See photo	
Field Station#	15540+74		Field Station#	15541+00	
Pic 9 Desc.	Environmental crew has corrected this issue.		Pic 10 Desc.	Equipment bridge ECDs are in place and functioning.

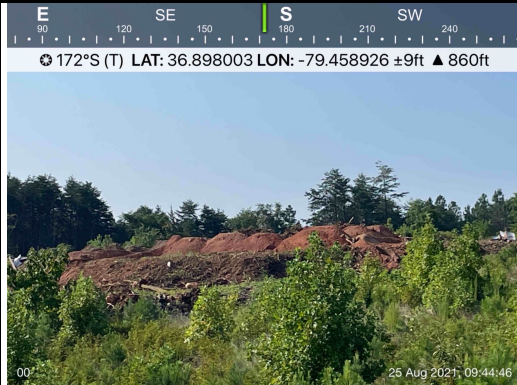
GPS Location	See photo		GPS Location	See photo	
Field Station#	15556+83		Field Station#	15563+57	
Pic 11 Desc.	No evidence of sedimentation from 3rd party disturbance. EI will continue to monitor this issue.		Pic 12 Desc.	Waterbar channel needs to be regraded and stabilized.

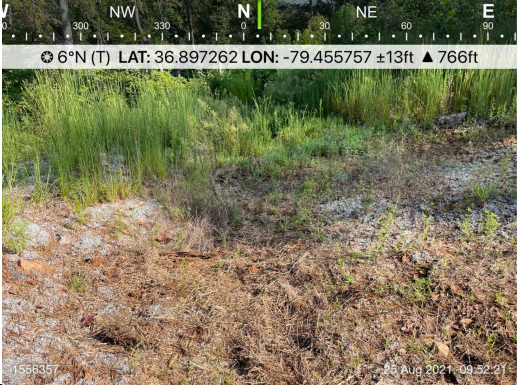
GPS Location	See photo	GPS Location	See photo		
Field Station#	15563+57	Field Station#	15574+00		
Pic 13 Desc.	Environmental crew has corrected this issue.	Pic 14 Desc.	SSF fabric needs to be reattached.

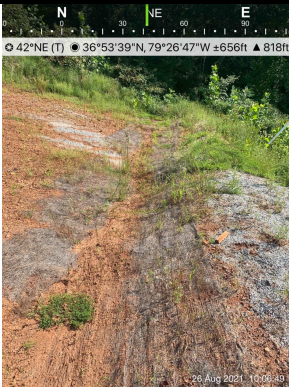
GPS Location	O	GPS Location	O		
Field Station#	15594+00	Field Station#	15592+00		
Pic 3 Desc.	Observing temporary stabilization,water bar and erosion control blanket.	Pic 4 Desc.	Observing temporary stabilization and water bars

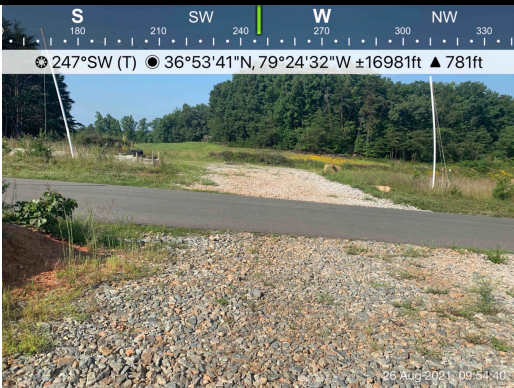
GPS Location	O	GPS Location	O		
Field Station#	15619+48	Field Station#	15636+45		
Pic 5 Desc.	Observing road crossing and RCE's	Pic 6 Desc.	Observing temporary stabilization, signage, buffer, equipment crossing and ECD's

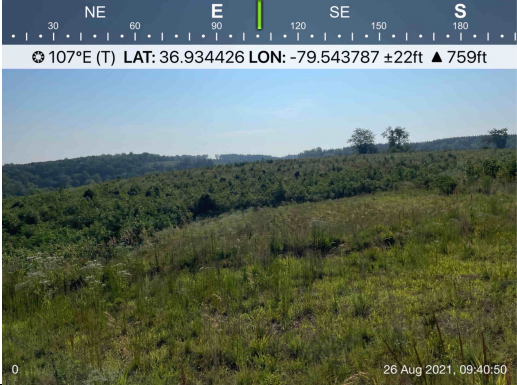
GPS Location	See photo	GPS Location			
Field Station#	15260+00	Field Station#			
Pic 13 Desc.	Vegetation continues to fill in throughout this section.	Pic 14 Desc.			
Insert image here		Insert image here			
GPS Location		GPS Location			
Field Station#		Field Station#			
Pic 15 Desc.		Pic 16 Desc.			
Insert image here		Insert image here			
GPS Location		GPS Location			
Field Station#		Field Station#			
Pic 17 Desc.		Pic 18 Desc.

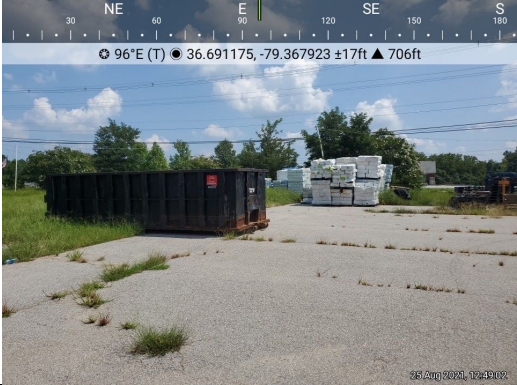
GPS Location	0	GPS Location	0		
Field Station#	0+00	Field Station#	0+00		
Pic 7 Desc.	LY-048 Housekeeping	Pic 8 Desc.	LY-048 Temporary seeding		
Insert image here		Insert image here			
GPS Location		GPS Location			
Field Station#		Field Station#			
Pic 9 Desc.		Pic 10 Desc.			
Insert image here		Insert image here			
GPS Location		GPS Location			
Field Station#		Field Station#			
Pic 11 Desc.		Pic 12 Desc.
