# Visual Site Inspection Report

<b>Project Name</b>	H-600 Pipeline Spread I	<b>AFE</b>	124300139	<b>Spread</b>	H-600 Pipeline Spread I
<b>Contractor</b>	Precision	<b>Report #</b>	27866		
<b>Inspector</b>	Ben Farmer	<b>Date/Time</b>	8/30/2021 2:51 PM		
<b>Permit #</b>	TBD	<b>Inspection Type</b>	VA SWPP	<b>Station Begin</b>	15370+62
<b>State</b>	VA	<b>Inspection Area</b>	Partial	<b>Station End</b>	15480+67
<b>County</b>	Pittsylvania	<b>Ground</b>	Damp	<b>Temperature (°F)</b>	79.00
<b>Municipality</b>	Chatham	<b>Weather</b>	Sunny	<b>Rain Gauge (in)</b>	0.40
				<b>Rain Accumulation Time (days)</b>	0.00

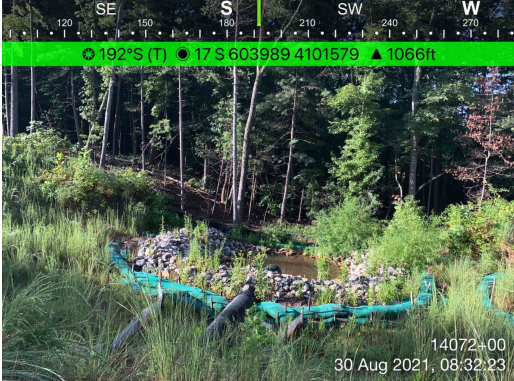
<b>GPS Location</b>	0	<b>GPS Location</b>	0		
<b>Field Station#</b>	14072+00	<b>Field Station#</b>	14074+00		
<b>Pic 1 Desc.</b>	Clean water diversion pipe and plunge pool in acceptable conditions	<b>Pic 2 Desc.</b>	Perimeter CFS and P1 silt fence in acceptable conditions

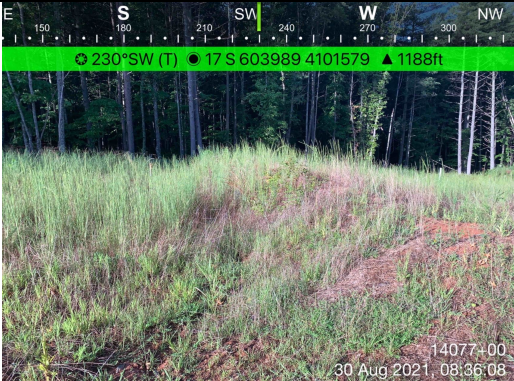
<b>GPS Location</b>	0	<b>GPS Location</b>	0		
<b>Field Station#</b>	14077+00	<b>Field Station#</b>	14077+00		
<b>Pic 3 Desc.</b>	Waterbar in acceptable condition	<b>Pic 4 Desc.</b>	Waterbar end treatment in acceptable condition

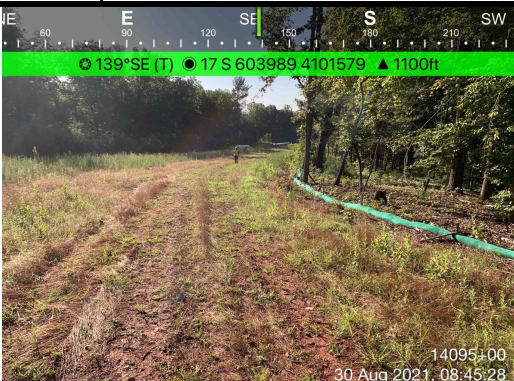
<b>GPS Location</b>	0	<b>GPS Location</b>	0		
<b>Field Station#</b>	14095+00	<b>Field Station#</b>	14112+00		
<b>Pic 5 Desc.</b>	Perimeter CFS and temporary vegetative stabilization in acceptable conditions	<b>Pic 6 Desc.</b>	Permanent vegetative stabilization in acceptable condition

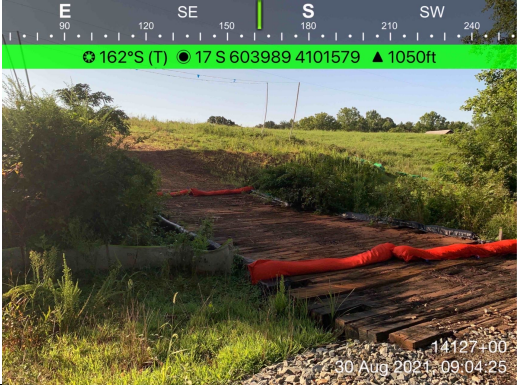
<b>GPS Location</b>	0	<b>GPS Location</b>	0		
<b>Field Station#</b>	14127+00	<b>Field Station#</b>	14153+00		
<b>Pic 7 Desc.</b>	Equipment bridge in acceptable condition		<b>Pic 8 Desc.</b>	Waterbar in acceptable condition

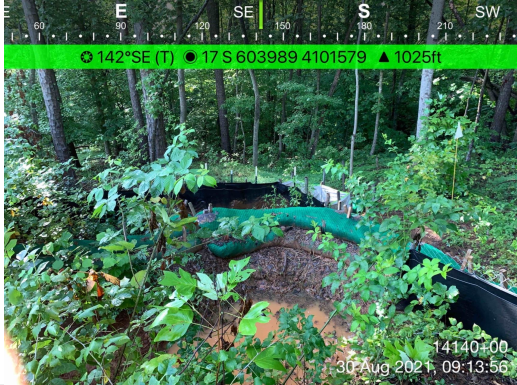
<p style="text-align: center;">Insert image here</p>			
<b>GPS Location</b>	0	<b>GPS Location</b>			
<b>Field Station#</b>	14140+00	<b>Field Station#</b>			
<b>Pic 9 Desc.</b>	Waterbar end treatment in acceptable condition		<b>Pic 10 Desc.</b>		
<p style="text-align: center;">Insert image here</p>			<p style="text-align: center;">Insert image here</p>		
<b>GPS Location</b>		<b>GPS Location</b>			
<b>Field Station#</b>		<b>Field Station#</b>			
<b>Pic 11 Desc.</b>			<b>Pic 12 Desc.</b>

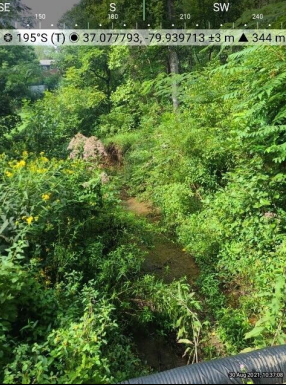
<b>GPS Location</b>	0000	<b>GPS Location</b>	0000		
<b>Field Station#</b>	13728+11	<b>Field Station#</b>	13710+00		
<b>Pic 1 Desc.</b>	Stream observation photo facing downstream during routine inspection today. No issues were observed at the resource crossing today		<b>Pic 2 Desc.</b>	Monitored sump pits and end treatment. No environmental issues observed at the time of inspection.

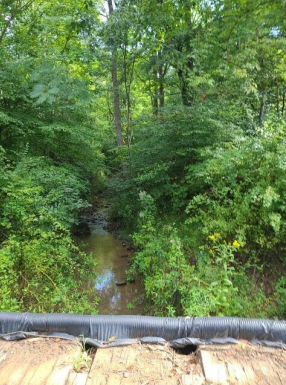
<b>GPS Location</b>	0000	<b>GPS Location</b>	0000		
<b>Field Station#</b>	13728+11	<b>Field Station#</b>	13705+30		
<b>Pic 3 Desc.</b>	Stream observation photo facing upstream during routine inspection today. No issues were observed with the resource at the time of inspection today.		<b>Pic 4 Desc.</b>	Monitored equipment bridge and protection during routine inspection. No issues were observed at the time of inspection.

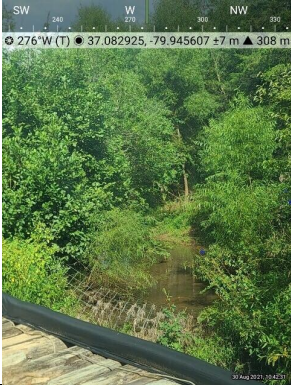
<p>SW 240 W 276 NW 300          276°W (T) 37.082925, -79.945607 ±7 m ▲ 308 m          10 Aug 2021 15:45:51</p>		Insert image here		Insert image here	
<b>GPS Location</b>	00000	<b>GPS Location</b>			
<b>Field Station#</b>	13705+07	<b>Field Station#</b>			
<b>Pic 7 Desc.</b>	Stream observation photo facing upstream during routine inspection today, no issues observed at the time of inspection.		<b>Pic 8 Desc.</b>		
Insert image here		Insert image here			
<b>GPS Location</b>		<b>GPS Location</b>			
<b>Field Station#</b>		<b>Field Station#</b>			
<b>Pic 9 Desc.</b>		<b>Pic 10 Desc.</b>			
Insert image here		Insert image here			
<b>GPS Location</b>		<b>GPS Location</b>			
<b>Field Station#</b>		<b>Field Station#</b>			
<b>Pic 11 Desc.</b>		<b>Pic 12 Desc.</b>

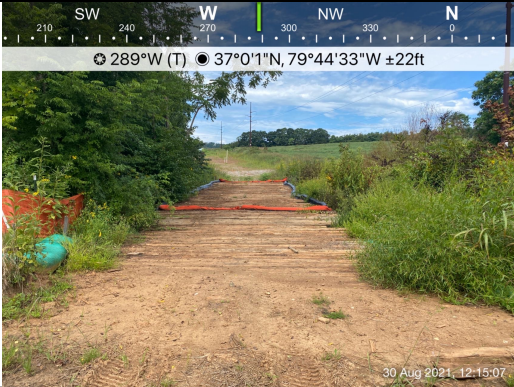
<b>GPS Location</b>	0	<b>GPS Location</b>	0		
<b>Field Station#</b>	14582+85	<b>Field Station#</b>	14546+90		
<b>Pic 3 Desc.</b>	Approximately 14582+85. Overview of stream crossing, equipment bridge and ECDs at stream S-E17.		<b>Pic 4 Desc.</b>	Approximately 14546+90. Third party appears to have mowed and sprayed bank at bar ditch along MVP-ATWS-362.

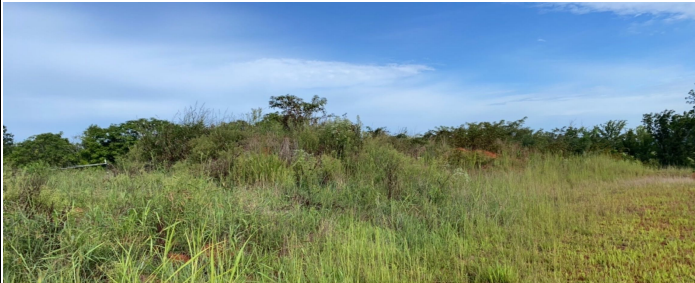
36°57'3" N 79°34'48" W 359°N COURSE 339° GPS Sandy Level, VA 24161, United States 08.31.2021 09:21:26 Accur +/-36.7 Ft ALT 936 Ft			36°56'56" N 79°34'45" W 351°N COURSE 25° GPS 337-521 Rockcreek Rd, Sandy Level, VA 24161, United States 08.31.2021 09:18:09 Accur +/-157.1 Ft ALT 866 Ft		
GPS Location	5		GPS Location	6	
Field Station#	15132+00		Field Station#	15137+00	
Pic 5 Desc.	Temporary diversion berm stabilized and vegetated		Pic 6 Desc.	Picture of temporary stabilization and vegetation along ROW travel lane

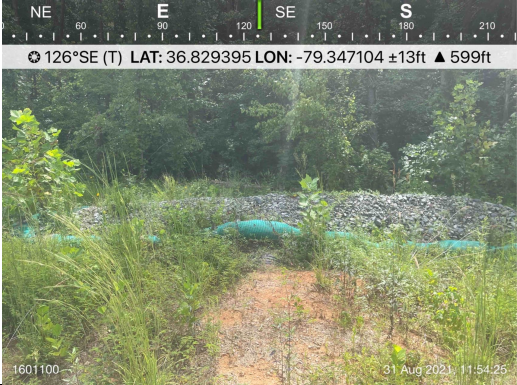
Insert image here			
<b>GPS Location</b>	See photo	<b>GPS Location</b>			
<b>Field Station#</b>	16011+00	<b>Field Station#</b>			
<b>Pic 7 Desc.</b>	CWDs are functioning as intended.	<b>Pic 8 Desc.</b>			
Insert image here		Insert image here			
<b>GPS Location</b>		<b>GPS Location</b>			
<b>Field Station#</b>		<b>Field Station#</b>			
<b>Pic 9 Desc.</b>		<b>Pic 10 Desc.</b>			
Insert image here		Insert image here			
<b>GPS Location</b>		<b>GPS Location</b>			
<b>Field Station#</b>		<b>Field Station#</b>			
<b>Pic 11 Desc.</b>		<b>Pic 12 Desc.</b>

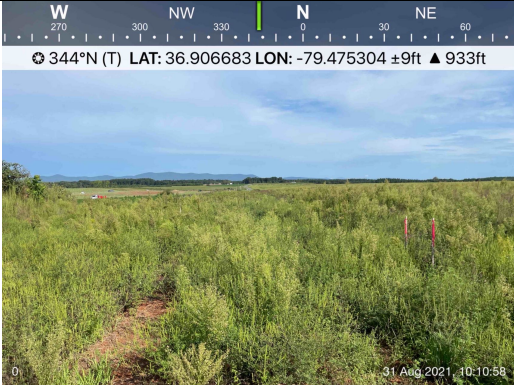
<b>GPS Location</b>	See photo		<b>GPS Location</b>	See photo	
<b>Field Station#</b>	15495+00		<b>Field Station#</b>	15505+00	
<b>Pic 1 Desc.</b>	Vegetation continues to fill in throughout this section.		<b>Pic 2 Desc.</b>	No evidence of sedimentation from 3rd party disturbance.

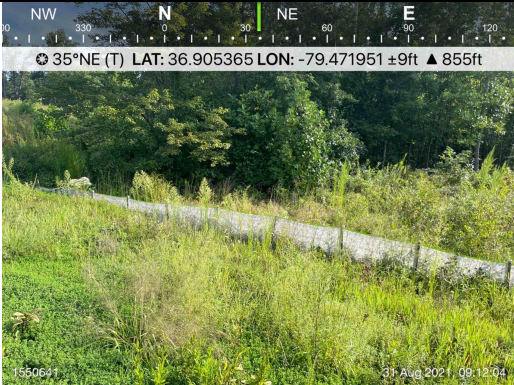
<b>GPS Location</b>	See photo		<b>GPS Location</b>	See photo	
<b>Field Station#</b>	15506+41		<b>Field Station#</b>	15510+00	
<b>Pic 3 Desc.</b>	P1 is in good condition at all stream and wetland crossings.		<b>Pic 4 Desc.</b>	3rd party ECDs appear to be in good condition

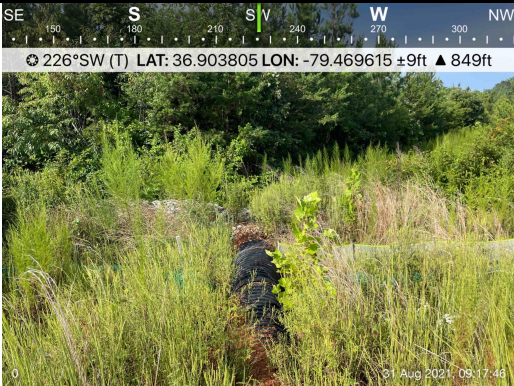
<b>GPS Location</b>	See photo		<b>GPS Location</b>	See photo	
<b>Field Station#</b>	15515+00		<b>Field Station#</b>	15540+00	
<b>Pic 5 Desc.</b>	CWDs are functioning as intended.		<b>Pic 6 Desc.</b>	Equipment bridge ECDs are in place and functioning

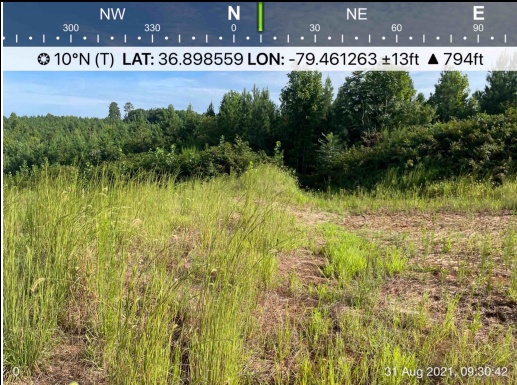
GPS Location	See photo		GPS Location	See photo	
Field Station#	15563+57		Field Station#	15556+83	
Pic 7 Desc.	Waterbars are in good condition and functioning.		Pic 8 Desc.	No evidence of sedimentation from 3rd party disturbance.

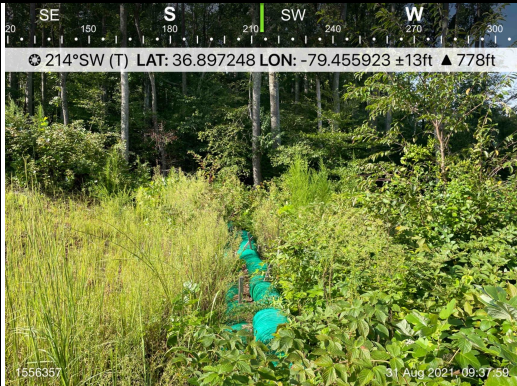
GPS Location	See photo		GPS Location	See photo	
Field Station#	15563+57		Field Station#	15574+87	
Pic 9 Desc.	CFS is in good condition throughout this section.		Pic 10 Desc.	Slope drain is in good condition and functioning.

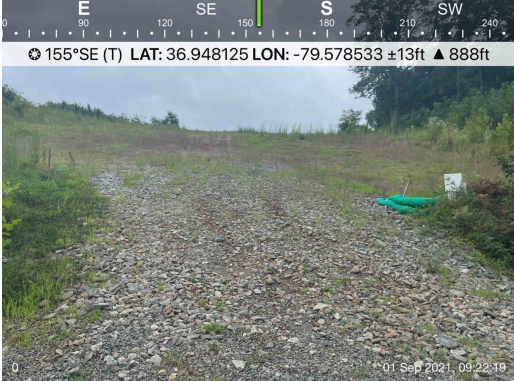
<b>GPS Location</b>	See photo	<b>GPS Location</b>	See photo		
<b>Field Station#</b>	15142+66	<b>Field Station#</b>	15152+00		
<b>Pic 1 Desc.</b>	RCE is in good condition at Rockcreek Rd.	<b>Pic 2 Desc.</b>	Perimeter CFS is in good condition throughout this section.

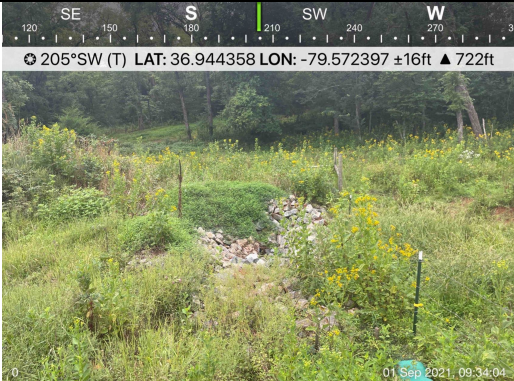
<b>GPS Location</b>	See photo	<b>GPS Location</b>	See photo		
<b>Field Station#</b>	15165+57	<b>Field Station#</b>	15166+00		
<b>Pic 3 Desc.</b>	Rock inlet remains in good condition.	<b>Pic 4 Desc.</b>	Rock outlet remains in good condition.

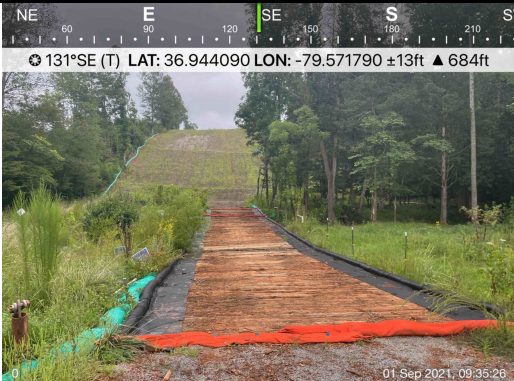
<b>GPS Location</b>	See photo	<b>GPS Location</b>	See photo		
<b>Field Station#</b>	15167+95	<b>Field Station#</b>	15169+58		
<b>Pic 5 Desc.</b>	Equipment bridge ECDs are in place and functioning.	<b>Pic 6 Desc.</b>	P1 is in good condition at stream buffer.

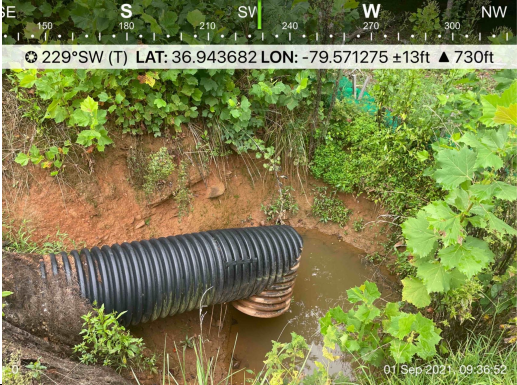
<b>GPS Location</b>	See photo		<b>GPS Location</b>	See photo	
<b>Field Station#</b>	15170+00		<b>Field Station#</b>	15172+00	
<b>Pic 7 Desc.</b>	Slope drain is functioning as intended.		<b>Pic 8 Desc.</b>	Waterbars are in good condition throughout this section.

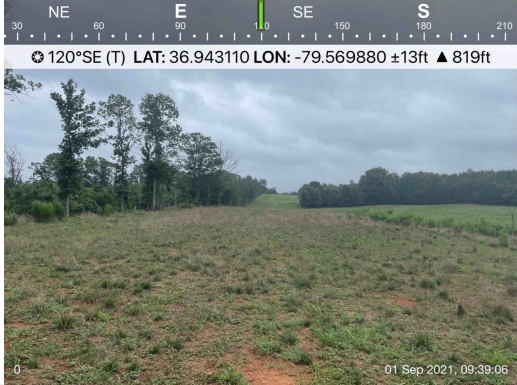
<b>GPS Location</b>	See photo		<b>GPS Location</b>	See photo	
<b>Field Station#</b>	15175+00		<b>Field Station#</b>	15195+00	
<b>Pic 9 Desc.</b>	Vegetation continues to fill in throughout this section.		<b>Pic 10 Desc.</b>	Drainage ECDs are in place and functioning.

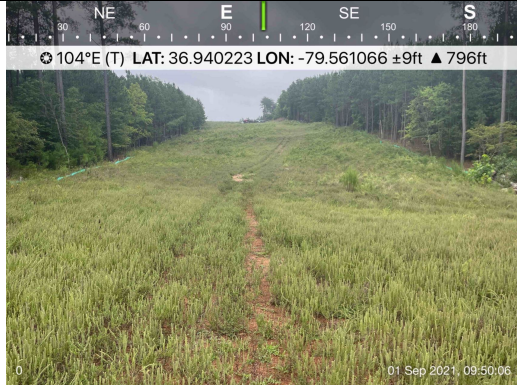
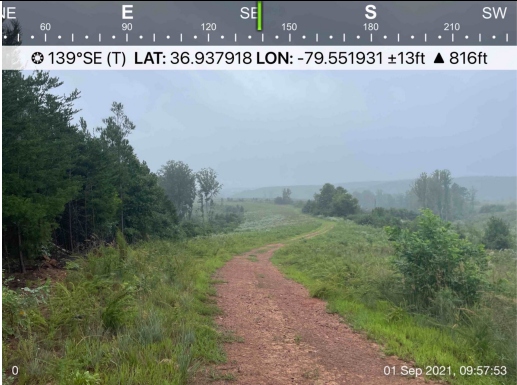
<b>GPS Location</b>	See photo		<b>GPS Location</b>	See photo	
<b>Field Station#</b>	15200+00		<b>Field Station#</b>	15230+00	
<b>Pic 11 Desc.</b>	Vegetation continues to fill in throughout this section.		<b>Pic 12 Desc.</b>	Vegetation continues to fill in throughout this section.

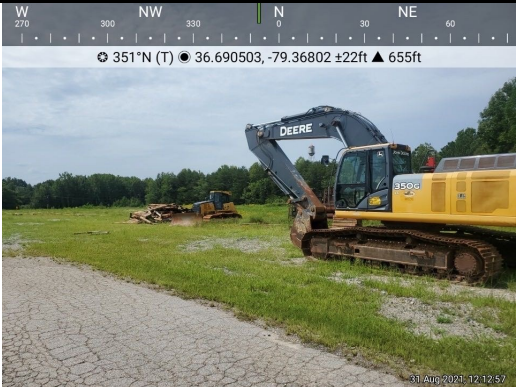
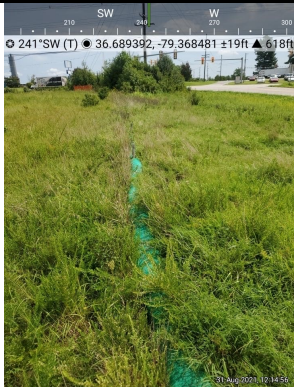
GPS Location	0		GPS Location	0	
Field Station#	0+00		Field Station#	0+00	
Pic 1 Desc.	LY-048 Equipment staging		Pic 2 Desc.	LY-048 South perimeter CFS

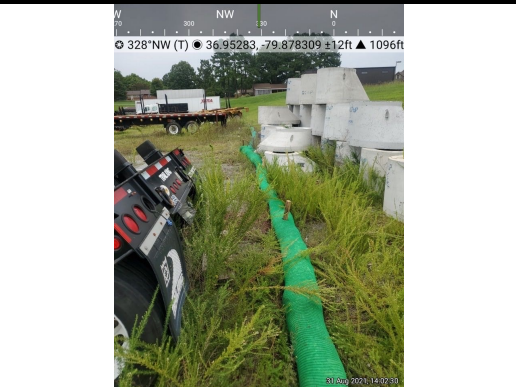
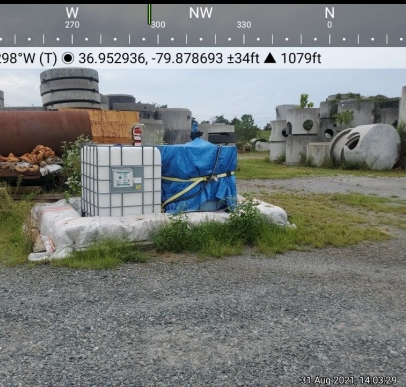
GPS Location	0		GPS Location	0	
Field Station#	0+00		Field Station#	0+00	
Pic 3 Desc.	ANC-006 Southeast perimeter CFS		Pic 4 Desc.	ANC-006 Secondary containment

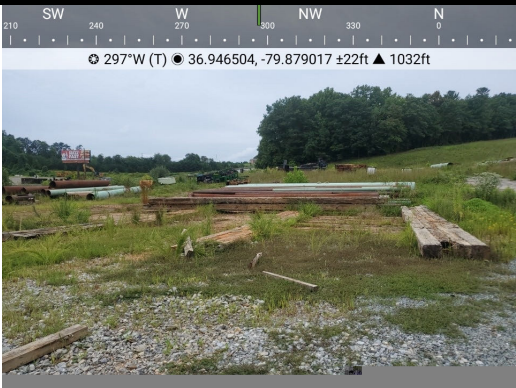
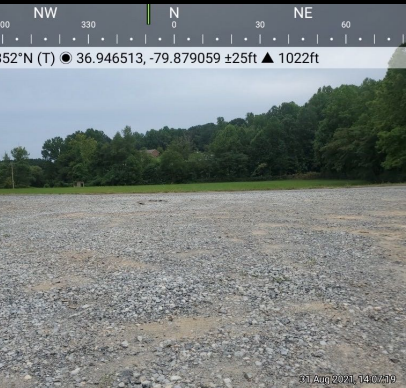
GPS Location	0		GPS Location	0	
Field Station#	0+00		Field Station#	0+00	
Pic 5 Desc.	LY-033 Staging		Pic 6 Desc.	LY-033 Rock Construction Entrance

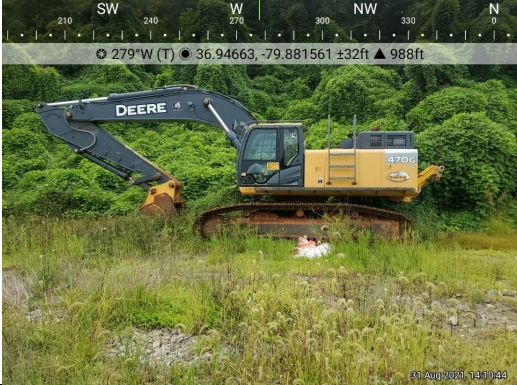
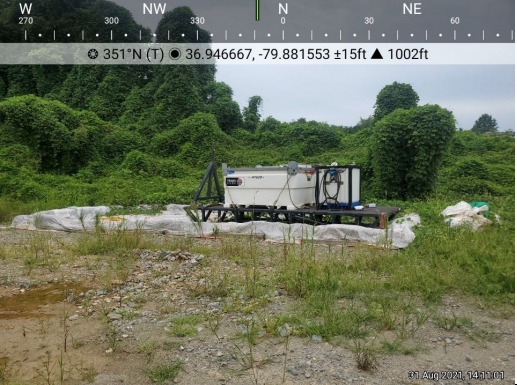
<b>GPS Location</b>	0	<b>GPS Location</b>	0		
<b>Field Station#</b>	0+00	<b>Field Station#</b>	0+00		
<b>Pic 7 Desc.</b>	LY-032 Equipment staging	<b>Pic 8 Desc.</b>	LY-032 Secondary containment		
Insert image here		Insert image here			
<b>GPS Location</b>		<b>GPS Location</b>			
<b>Field Station#</b>		<b>Field Station#</b>			
<b>Pic 9 Desc.</b>		<b>Pic 10 Desc.</b>			
Insert image here		Insert image here			
<b>GPS Location</b>		<b>GPS Location</b>			
<b>Field Station#</b>		<b>Field Station#</b>			
<b>Pic 11 Desc.</b>		<b>Pic 12 Desc.</b>

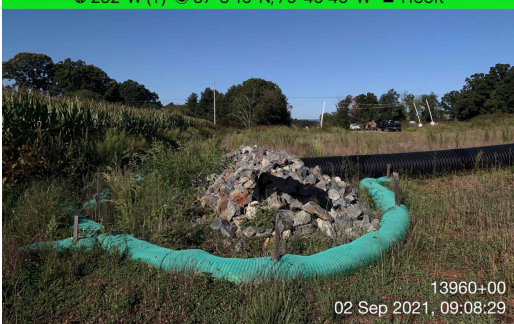
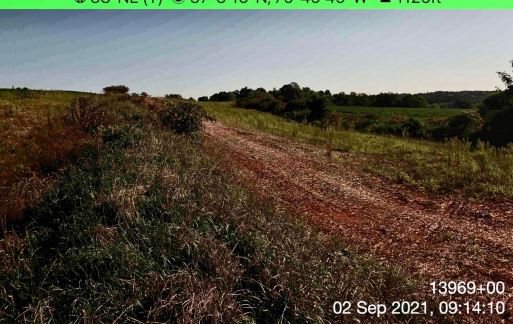
<b>GPS Location</b>	0	<b>GPS Location</b>	0		
<b>Field Station#</b>	13960+00	<b>Field Station#</b>	13969+00		
<b>Pic 1 Desc.</b>	Clean water diversion pipe and CFS in acceptable conditions		<b>Pic 2 Desc.</b>	Clean water diversion berm and temporary vegetative stabilization in acceptable conditions

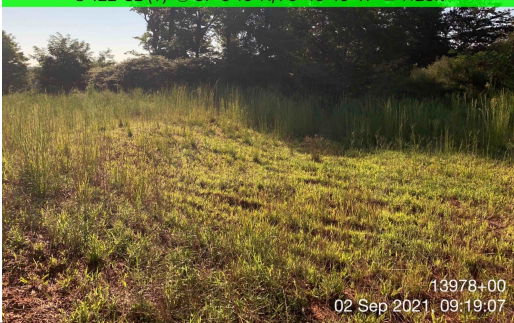
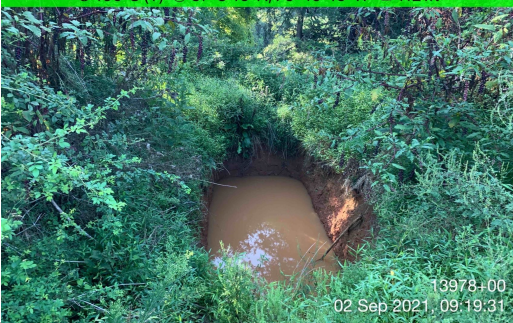
<b>GPS Location</b>	0	<b>GPS Location</b>	0		
<b>Field Station#</b>	13978+00	<b>Field Station#</b>	13978+00		
<b>Pic 3 Desc.</b>	Waterbar and temporary vegetative stabilization in acceptable conditions		<b>Pic 4 Desc.</b>	Waterbar end treatment in acceptable condition

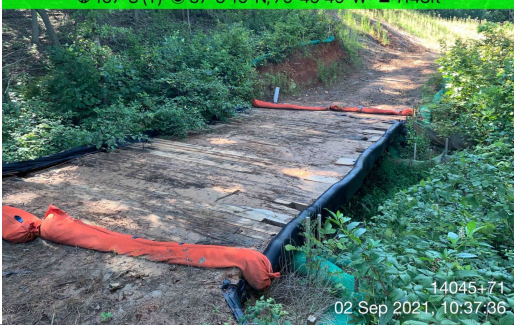
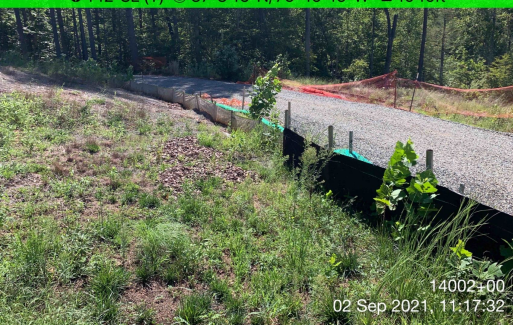
<b>GPS Location</b>	0	<b>GPS Location</b>	0		
<b>Field Station#</b>	14045+71	<b>Field Station#</b>	14002+00		
<b>Pic 5 Desc.</b>	Equipment bridge in acceptable condition		<b>Pic 6 Desc.</b>	Super silt fence and P1 silt fence in acceptable conditions

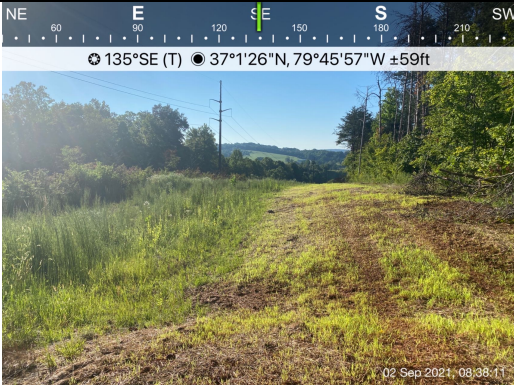
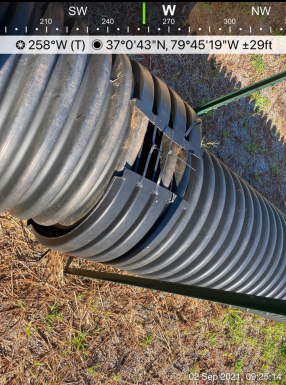
<b>GPS Location</b>	0	<b>GPS Location</b>	0		
<b>Field Station#</b>	14470+00	<b>Field Station#</b>	14520+00		
<b>Pic 3 Desc.</b>	Approximately 14470+00. Overview of ROW.		<b>Pic 4 Desc.</b>	Approximately 14520+00. CWD piping requires maintenance. Displaced by livestock.

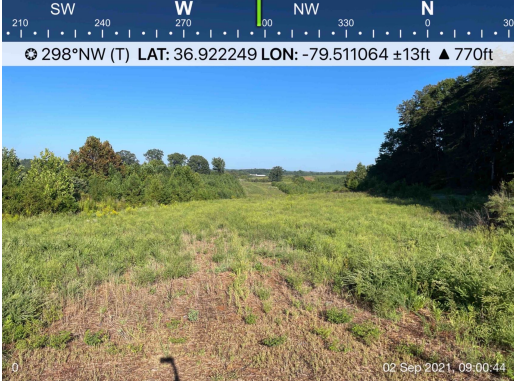
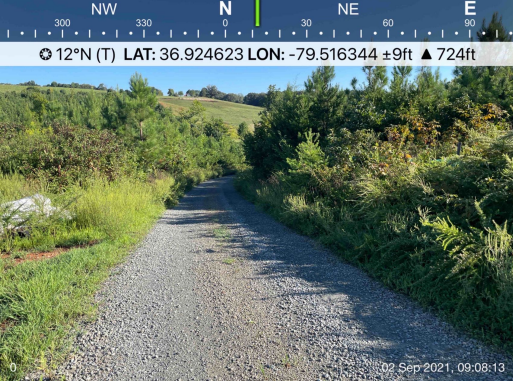
<b>GPS Location</b>	See photo		<b>GPS Location</b>	See photo	
<b>Field Station#</b>	15370+00		<b>Field Station#</b>	15350+00	
<b>Pic 1 Desc.</b>	Vegetation continues to fill in throughout this section.		<b>Pic 2 Desc.</b>	MVP-PI-332 remains in good condition with controls in place.

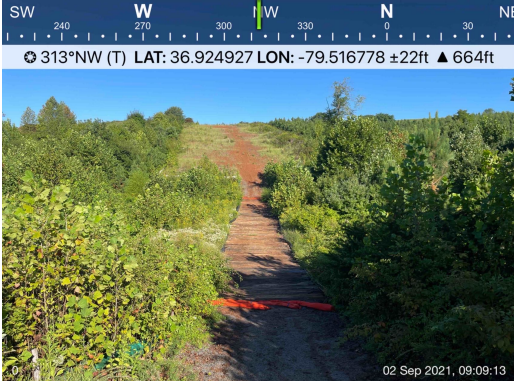
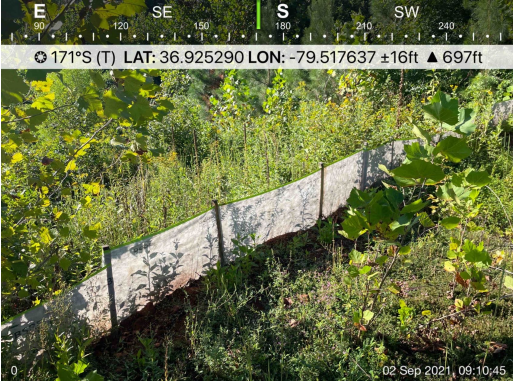
<b>GPS Location</b>	See photo		<b>GPS Location</b>	See photo	
<b>Field Station#</b>	15346+80		<b>Field Station#</b>	15346+60	
<b>Pic 3 Desc.</b>	Equipment bridge ECDs are in good condition and functioning.		<b>Pic 4 Desc.</b>	P1 is in good condition at all stream and wetland buffers.

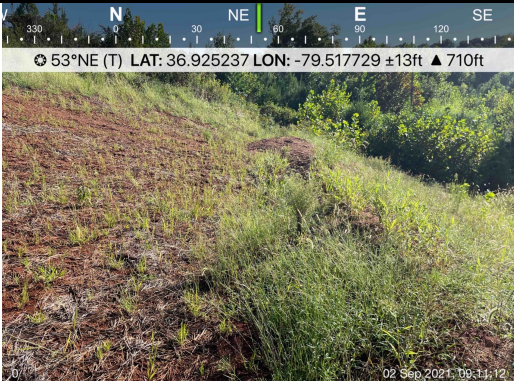
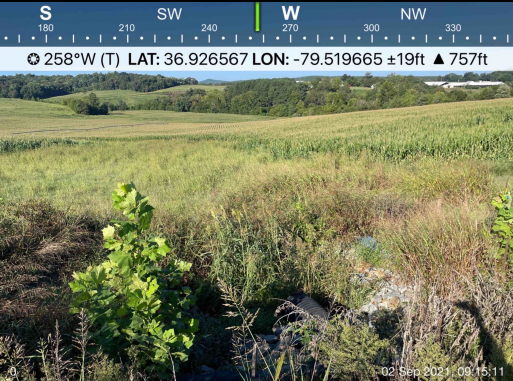
<b>GPS Location</b>	See photo		<b>GPS Location</b>	See photo	
<b>Field Station#</b>	15346+09		<b>Field Station#</b>	15338+00	
<b>Pic 5 Desc.</b>	Waterbars are functioning as intended.		<b>Pic 6 Desc.</b>	CWDs are in good condition.

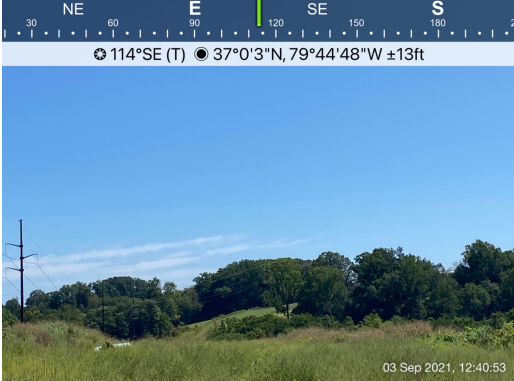
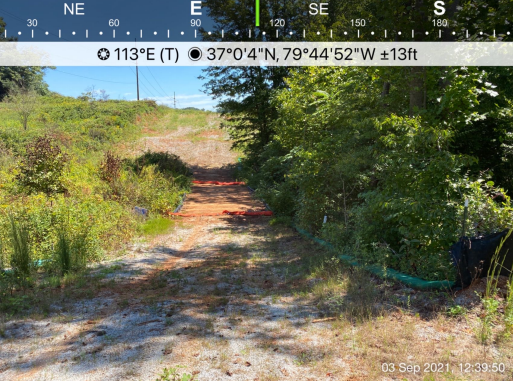
<b>GPS Location</b>	0	<b>GPS Location</b>	0		
<b>Field Station#</b>	14572+00	<b>Field Station#</b>	14568+10		
<b>Pic 1 Desc.</b>	Approximately 14572+00. Overview of ROW.		<b>Pic 2 Desc.</b>	Approximately 14568+10. Overview of stream crossing, equipment bridge and ECDs at stream S-E18.

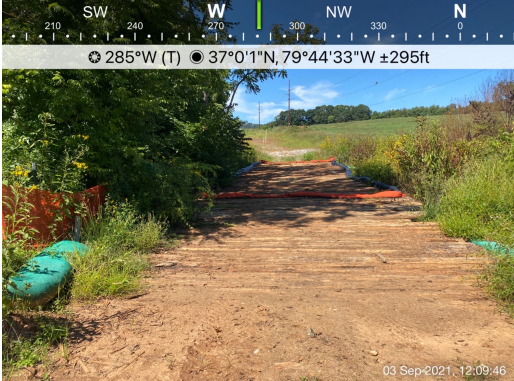
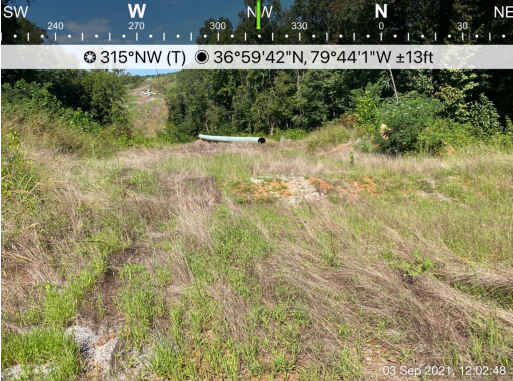
<b>GPS Location</b>	0	<b>GPS Location</b>	0		
<b>Field Station#</b>	14582+85	<b>Field Station#</b>	14615+00		
<b>Pic 3 Desc.</b>	Approximately 14582+85. Overview of stream crossing, equipment bridge and ECDs at stream S-E17.		<b>Pic 4 Desc.</b>	Approximately 14615+00. Overview of ROW.

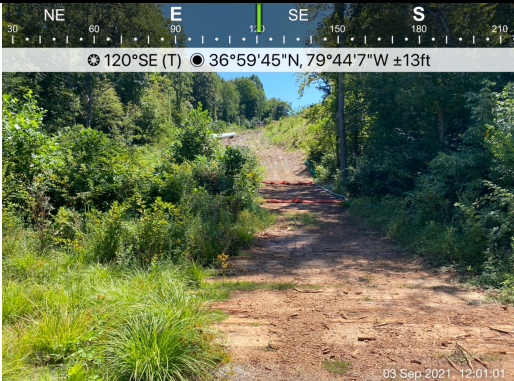
<b>GPS Location</b>	0	<b>GPS Location</b>	0		
<b>Field Station#</b>	14611+25	<b>Field Station#</b>	14599+25		
<b>Pic 5 Desc.</b>	Approximately 14611+25. Overview of stream crossing, equipment bridge and ECDs at stream S-E14.		<b>Pic 6 Desc.</b>	Approximately 14599+25. Overview of road crossing and RCEs.

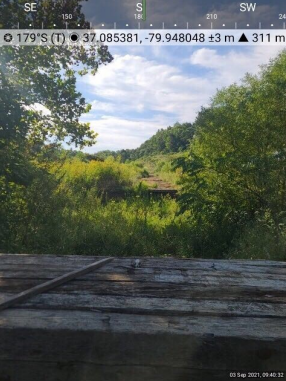
<b>GPS Location</b>	0000	<b>GPS Location</b>	0000		
<b>Field Station#</b>	13692+77	<b>Field Station#</b>	13678+71		
<b>Pic 1 Desc.</b>	Monitored stream crossing , all ECDs in place and good vegetation.		<b>Pic 2 Desc.</b>	Stream observation photo facing upstream during routine inspection today.

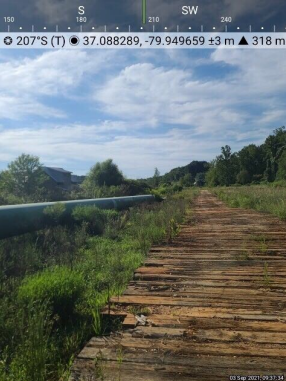
<b>GPS Location</b>	0000	<b>GPS Location</b>	000		
<b>Field Station#</b>	13680+90	<b>Field Station#</b>	13670+00		
<b>Pic 3 Desc.</b>	Row photo showing equipment mats in place and good vegetation coverage. No issues observed at the time of inspection.		<b>Pic 4 Desc.</b>	Vegetation observation photo showing good coverage in permanent area of row.

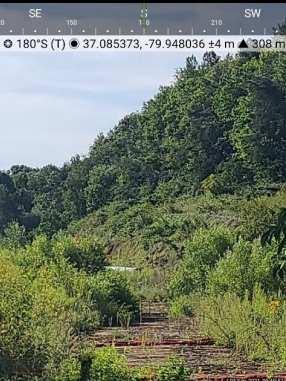
<b>GPS Location</b>	0000	<b>GPS Location</b>	0000		
<b>Field Station#</b>	13692+90	<b>Field Station#</b>	13678+71		
<b>Pic 5 Desc.</b>	Row photo showing vegetation in wetland area and up row from stream crossing. No environmental issues observed at the time of inspection.		<b>Pic 6 Desc.</b>	Stream observation photo facing downstream during routine inspection today. No issues observed at the time of inspection.

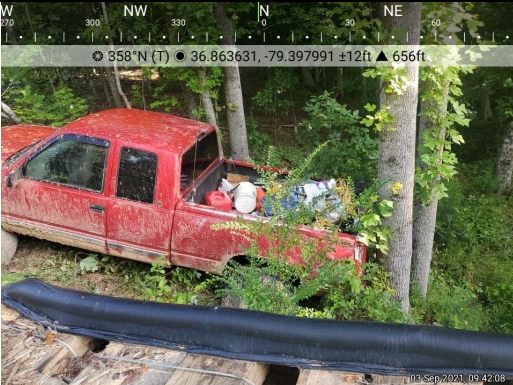
<b>GPS Location</b>	0	<b>GPS Location</b>	0		
<b>Field Station#</b>	15782+00	<b>Field Station#</b>	15795+00		
<b>Pic 3 Desc.</b>	Sump pit		<b>Pic 4 Desc.</b>	CIS S-C1 3rd party vehicle in stream buffer off bridge

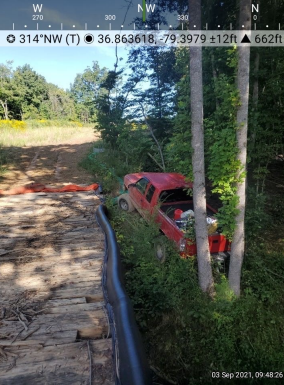
<b>GPS Location</b>	0	<b>GPS Location</b>	0		
<b>Field Station#</b>	15795+00	<b>Field Station#</b>	15798+00		
<b>Pic 5 Desc.</b>	CIS S-C1 3rd party truck off equipment bridge		<b>Pic 6 Desc.</b>	Perimeter CFS

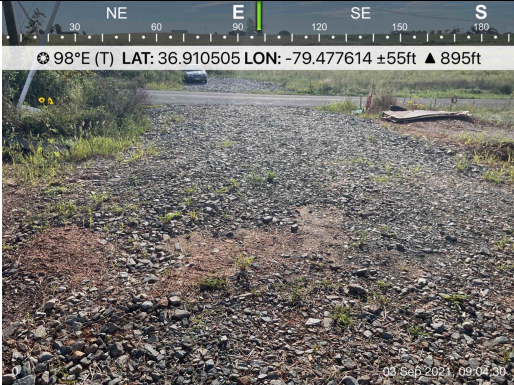
<b>GPS Location</b>	See photo		<b>GPS Location</b>	See photo	
<b>Field Station#</b>	15480+67		<b>Field Station#</b>	15475+00	
<b>Pic 1 Desc.</b>	RCEs are in good condition at all road crossings.		<b>Pic 2 Desc.</b>	3rd party rock outlet appears to be in good condition along this drainage.

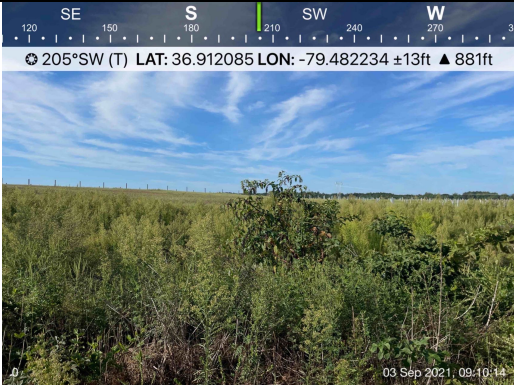
<b>GPS Location</b>	See photo		<b>GPS Location</b>	See photo	
<b>Field Station#</b>	15465+00		<b>Field Station#</b>	15460+81	
<b>Pic 3 Desc.</b>	No evidence of sedimentation from 3rd party rock outlet.		<b>Pic 4 Desc.</b>	No evidence of sedimentation from 3rd party disturbance into CWD inlet.

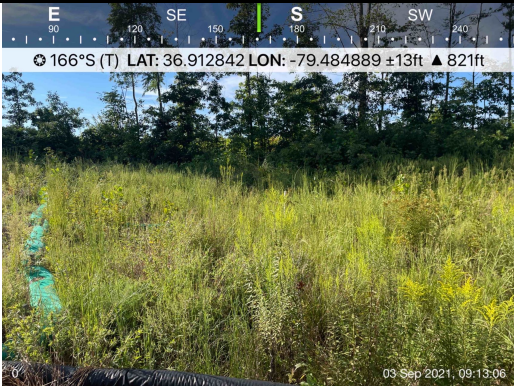
<b>GPS Location</b>	See photo		<b>GPS Location</b>	See photo	
<b>Field Station#</b>	15457+00		<b>Field Station#</b>	15453+00	
<b>Pic 5 Desc.</b>	No evidence of sedimentation in drainage.		<b>Pic 6 Desc.</b>	CWD remains in good condition.

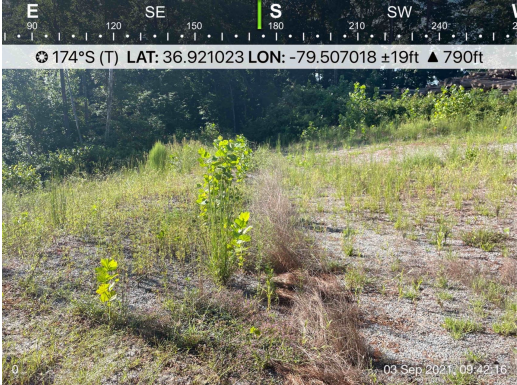
<b>GPS Location</b>	See photo		<b>GPS Location</b>	See photo	
<b>Field Station#</b>	15426+70		<b>Field Station#</b>	15380+50	
<b>Pic 9 Desc.</b>	Equipment bridge ECDs are in place and functioning.		<b>Pic 10 Desc.</b>	Waterbars are in good condition.

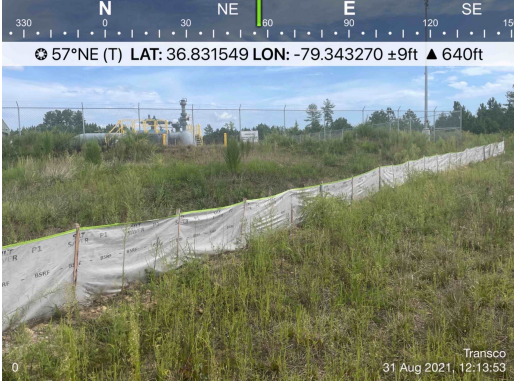
<b>GPS Location</b>	See photo		<b>GPS Location</b>	See photo	
<b>Field Station#</b>	00+00		<b>Field Station#</b>	00+00	
<b>Pic 1 Desc.</b>	P1 is in good condition and functioning.		<b>Pic 2 Desc.</b>	Basin is in good condition and functioning.

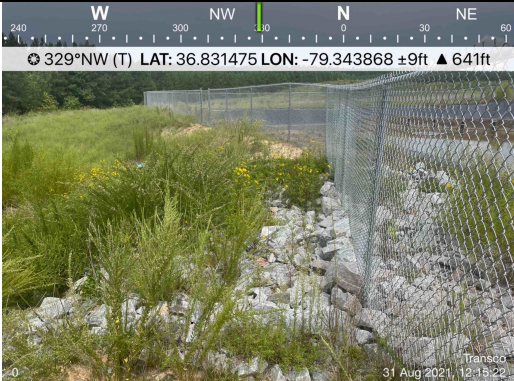
<b>GPS Location</b>	See photo		<b>GPS Location</b>	See photo	
<b>Field Station#</b>	00+00		<b>Field Station#</b>	00+00	
<b>Pic 3 Desc.</b>	Basin outlet is in good condition.		<b>Pic 4 Desc.</b>	Sediment trap is in good condition and functioning

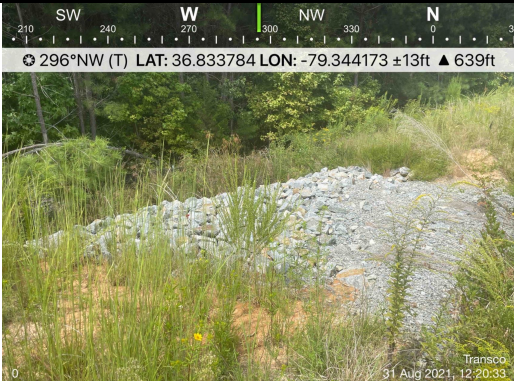
<b>GPS Location</b>	See photo		<b>GPS Location</b>	See photo	
<b>Field Station#</b>	00+00		<b>Field Station#</b>	00+00	
<b>Pic 5 Desc.</b>	Sediment trap outlet remains in good condition.		<b>Pic 6 Desc.</b>	Perimeter SSF is in good condition.
