Visual Site Inspection Report

Project Name	H-600 Pipeline Spread I	AFE	124300139	Spread	H-600 Pipeline Spread I
Contractor	Precision			Report #	28411
Inspector	John White			Date/Time	9/13/2021 10:31 AM
Permit #	TBD	Inspection Type	VA SWPP	Station Begin	15584+23
State	VA	Inspection Area	Full	Station End	15647+03
County	Pittsylvania	Ground	Dry	Temperature (°F)	83.00
Municipality	Chatham	Weather	Sunny	Rain Gauge (in)	0.00
				Rain Accumulation Time (days)	6.00

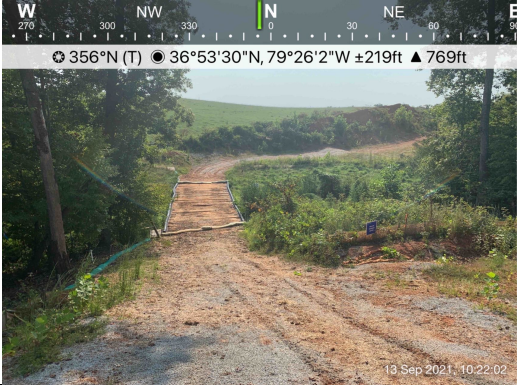
GPS Location	O	GPS Location			
Field Station#	15636+45	Field Station#			
Pic 7 Desc.	Observing temporary stabilization, signage, buffer, equipment crossing and ECD's	Pic 8 Desc.			
Insert image here		Insert image here			
GPS Location		GPS Location			
Field Station#		Field Station#			
Pic 9 Desc.		Pic 10 Desc.			
Insert image here		Insert image here			
GPS Location		GPS Location			
Field Station#		Field Station#			
Pic 11 Desc.		Pic 12 Desc.

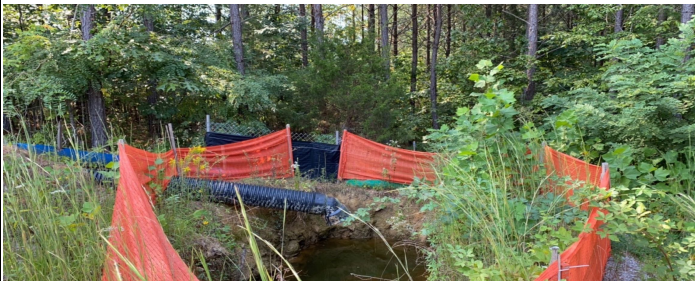
36°58'56" N 79°41'14" W 259°W COURSE 291' GPS 423 Zeigler Ln, Union Hall, VA 24176, United States 09.13.2021 13:02:03 Accur +/-19.0 Ft ALT 908 Ft			36°58'56" N 79°41'14" W 172°S COURSE -1' GPS 423 Zeigler Ln, Union Hall, VA 24176, United States 09.13.2021 13:02:11 Accur +/-21.2 Ft ALT 909 Ft		
GPS Location	3	GPS Location	4		
Field Station#	14766+11	Field Station#	14769+00		
Pic 3 Desc.	Equipment bridge and surrounding ECDs in place and functional at stream crossing and resource buffer		Pic 4 Desc.	Sump pit and CFS end treatment in place and functional

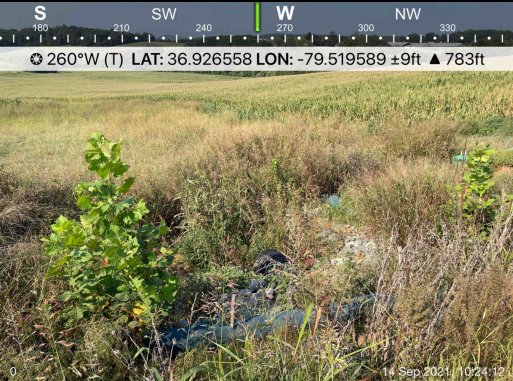
GPS Location	See photo		GPS Location	See photo	
Field Station#	15345+00		Field Station#	15338+00	
Pic 5 Desc.	Waterbars are in good condition and functioning.		Pic 6 Desc.	CWDs are functioning as intended.

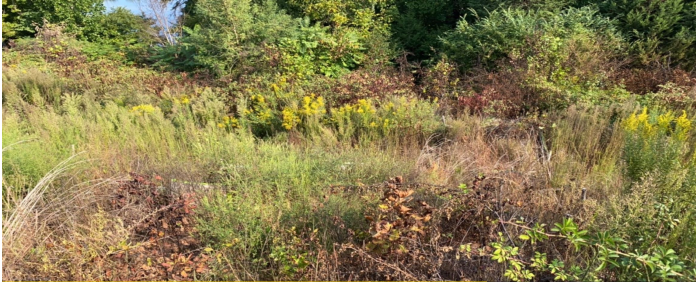
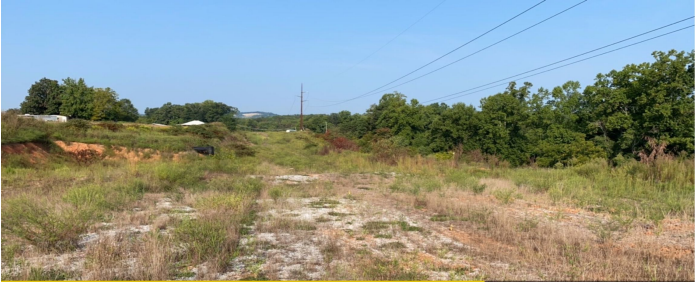
<small>36°58'22" N 79°40'2" W 343°N COURSE 39° GPS 1120 Listening Hill Rd, Penhook, VA 24137, United States 09.14.2021 10:04:55 Accur +/-15.4 Ft ALT 987 Ft</small>			<small>36°58'21" N 79°39'58" W 286°W COURSE 287° GPS 1120 Listening Hill Rd, Penhook, VA 24137, United States 09.14.2021 10:03:29 Accur +/-30.8 Ft ALT 991 Ft</small>		
GPS Location	1		GPS Location	2	
Field Station#	14830+00		Field Station#	14840+00	
Pic 1 Desc.	P1 silt fence in place and functional on slope in temporary area		Pic 2 Desc.	Picture of temporary stabilization and vegetation along ROW

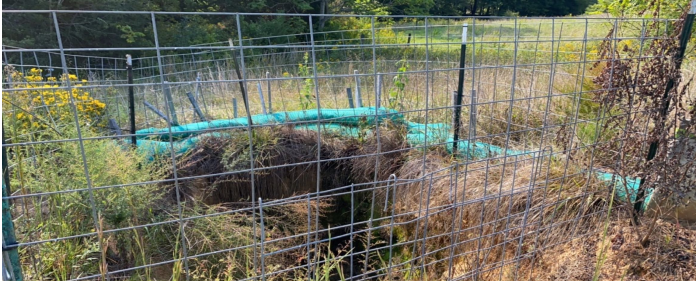
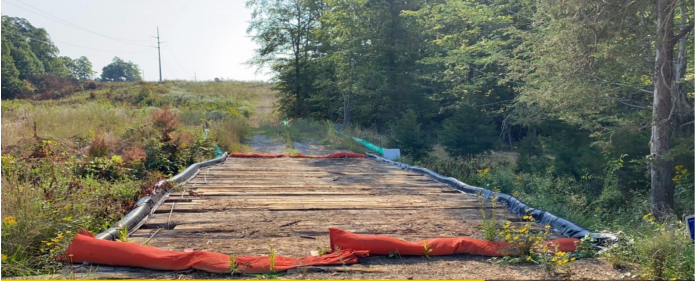
<small>36°58'19" N 79°39'47" W 121°SE COURSE -1° GPS 355 Listening Hill Rd, Penhook, VA 24137, United States 09.14.2021 09:58:43 Accur +/-15.4 Ft ALT 943 Ft</small>			<small>36°58'19" N 79°39'47" W 145°SE COURSE 130° GPS 355 Listening Hill Rd, Penhook, VA 24137, United States 09.14.2021 09:58:58 Accur +/-15.3 Ft ALT 937 Ft</small>		
GPS Location	5		GPS Location	6	
Field Station#	14859+00		Field Station#	14854+75	
Pic 5 Desc.	Sump pit and CFS end treatment performing intended functions		Pic 6 Desc.	Equipment bridge and surrounding ECDs in place and functional at stream crossing and resource buffer

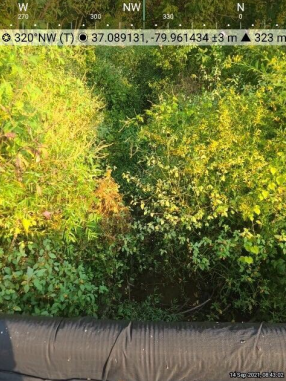
GPS Location	0000	GPS Location	0000		
Field Station#	13678+81	Field Station#	13678+81		
Pic 1 Desc.	Stream observation photo facing downstream during routine inspection today. No issues were observed at the time of inspection.		Pic 2 Desc.	Stream observation photo facing upstream during routine inspection today. No issues observed at the time of inspection.

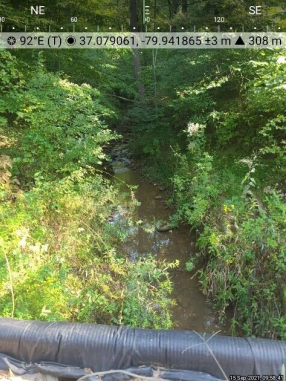
GPS Location	0000	GPS Location	0000		
Field Station#	13728+11	Field Station#	13728+11		
Pic 3 Desc.	Stream observation photo facing upstream, no environmental issues observed at the time of inspection.		Pic 4 Desc.	Stream observation photo facing downstream during routine inspection today. No issues were observed at the time of inspection.

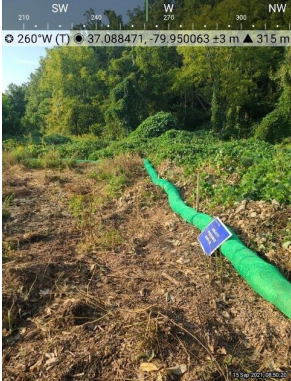
Insert image here		Insert image here	
GPS Location	0000	GPS Location			
Field Station#	13681+60	Field Station#			
Pic 7 Desc.	Monitored recently installed CFS along the LOD and stream buffer. No issues observed at the time of inspection.		Pic 8 Desc.		
Insert image here		Insert image here			
GPS Location		GPS Location			
Field Station#		Field Station#			
Pic 9 Desc.		Pic 10 Desc.			
Insert image here		Insert image here			
GPS Location		GPS Location			
Field Station#		Field Station#			
Pic 11 Desc.		Pic 12 Desc.

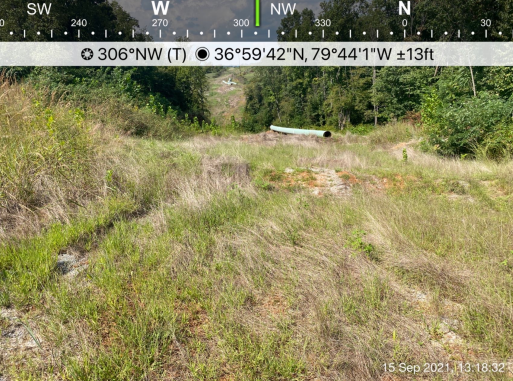
GPS Location	0	GPS Location	0		
Field Station#	14647+00	Field Station#	14615+00		
Pic 1 Desc.	Approximately 14647+00. Overview of ROW.		Pic 2 Desc.	Approximately 14615+00. Overview of ROW.

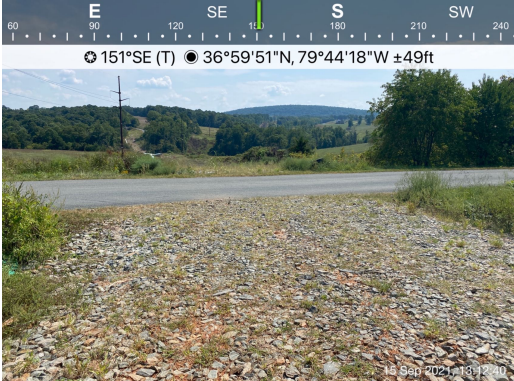
GPS Location	0	GPS Location	0		
Field Station#	14599+25	Field Station#	14582+85		
Pic 3 Desc.	Approximately 14599+25. Overview of road crossing and RCEs.		Pic 4 Desc.	Approximately 14582+85. Overview of stream crossing, equipment bridge and ECDs at stream S-E17.

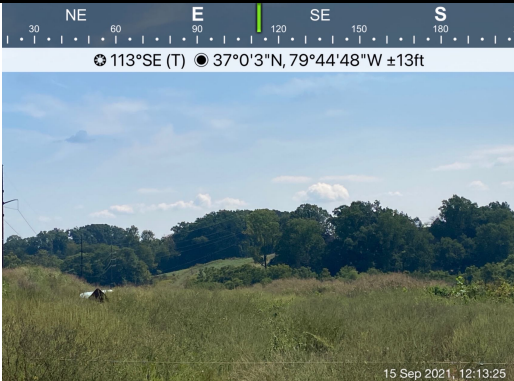
GPS Location	0	GPS Location	0		
Field Station#	14572+00	Field Station#	14549+50		
Pic 5 Desc.	Approximately 14572+00. Overview of ROW.		Pic 6 Desc.	Approximately 14549+50. Overview of ROW.

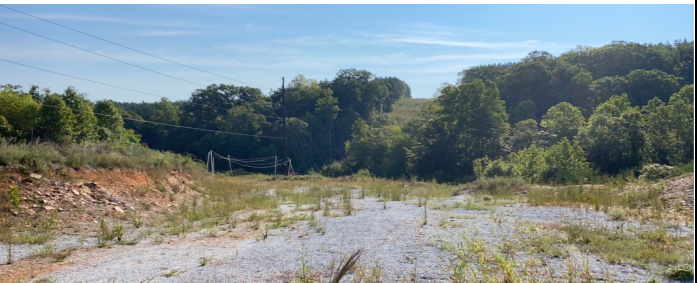
36°58'2" N 79°38'6" W 249°SW COURSE 91° GPS Sorry no results found 09.15.2021 09:41:57 Accur +/-110.8 Ft ALT 824 Ft			36°58'1" N 79°37'56" W 66°NE COURSE 94° GPS Sorry no results found 09.15.2021 09:45:52 Accur +/-125.3 Ft ALT 826 Ft		
GPS Location	3	GPS Location	4		
Field Station#	14939+00	Field Station#	14947+00		
Pic 3 Desc.	CWD pipe in good condition	Pic 4 Desc.	Picture of temporary stabilization and vegetation along ROW

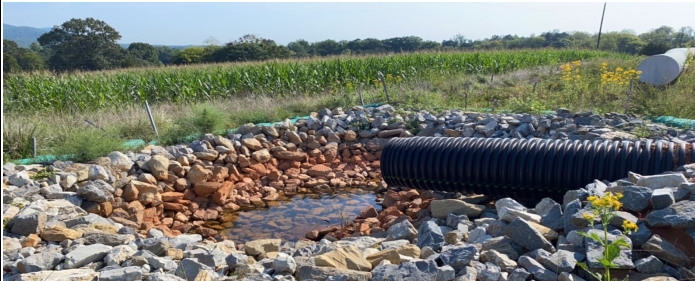
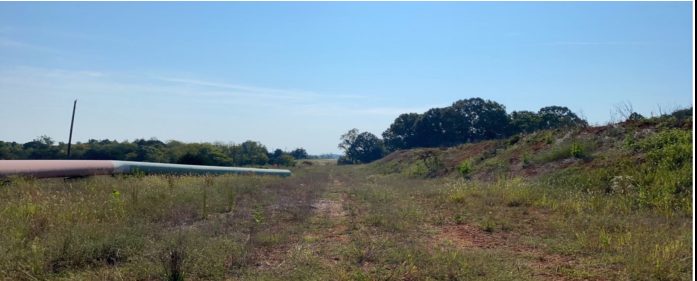
36°57'55" N 79°37'10" W 106°E COURSE 83° GPS 19009-19099 Snow Creek Rd, Penhook, VA 24137, United States 09.15.2021 10:01:49 Accur +/-26.7 Ft ALT 941 Ft			36°57'55" N 79°37'10" W 72°E COURSE 102° GPS 19009-19099 Snow Creek Rd, Penhook, VA 24137, United States 09.15.2021 10:02:16 Accur +/-15.3 Ft ALT 947 Ft		
GPS Location	5	GPS Location	6		
Field Station#	14983+00	Field Station#	14987+00		
Pic 5 Desc.	Plunge pool performing intended function	Pic 6 Desc.	Picture of temporary stabilization and vegetation along ROW

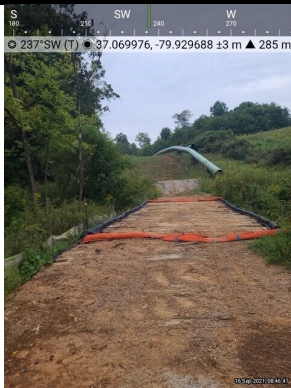
GPS Location	0000	GPS Location	0000		
Field Station#	13840+00	Field Station#	13794+57		
Pic 5 Desc.	Clean water diversion pipe and plunge pool observed. No environmental issues observed at the time of inspection.		Pic 6 Desc.	Monitored equipment bridge and protection. Checked all ECDs at stream crossing during routine inspection today.

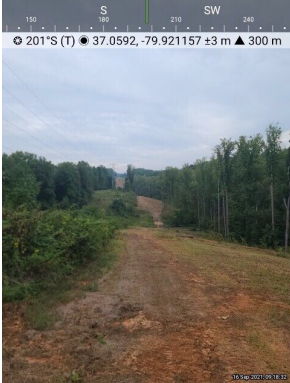
<p>Insert image here</p>		<p>Insert image here</p>	
GPS Location	00000	GPS Location			
Field Station#	13850+00	Field Station#			
Pic 7 Desc.	Row photo showing mowed area in preparation to begin winter stabilization.		Pic 8 Desc.		
<p>Insert image here</p>		<p>Insert image here</p>			
GPS Location		GPS Location			
Field Station#		Field Station#			
Pic 9 Desc.		Pic 10 Desc.			
<p>Insert image here</p>		<p>Insert image here</p>			
GPS Location		GPS Location			
Field Station#		Field Station#			
Pic 11 Desc.		Pic 12 Desc.

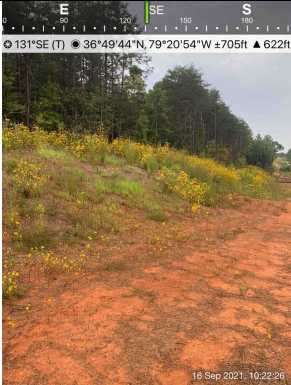
GPS Location	O		GPS Location	O	
Field Station#	16009+00		Field Station#	16007+00	
Pic 1 Desc.	Observing temporary stabilization and CWD berm		Pic 2 Desc.	Observing temporary stabilization, sump and end treatment

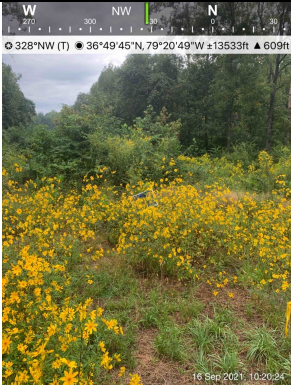
GPS Location	O		GPS Location	O	
Field Station#	16004+00		Field Station#	16010+00	
Pic 3 Desc.	Observing temporary stabilization, signage and buffer		Pic 4 Desc.	Observing temporary stabilization, CWD outlet and ECD's

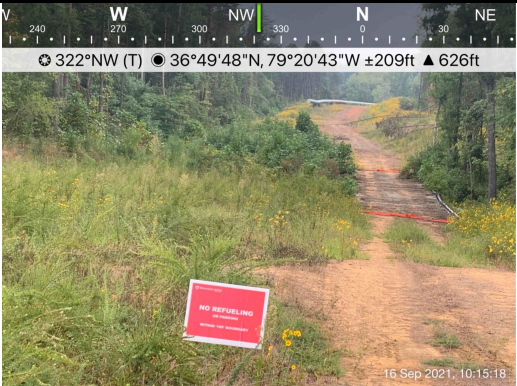
GPS Location	O		GPS Location	O	
Field Station#	16016+36		Field Station#	16022+50	
Pic 5 Desc.	Observing temporary stabilization, signage, buffer, equipment crossing and ECD's		Pic 6 Desc.	Observing temporary stabilization and water bars

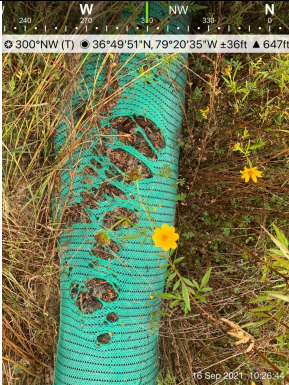
GPS Location	O	GPS Location	O		
Field Station#	4+00	Field Station#	15+00		
Pic 1 Desc.	Observing CFS that requires maintenance.		Pic 2 Desc.	Observing temporary stabilization

7. Identify all remedial measures that have been taken since the previous inspection was conducted.					
Comments (Reference above questions as appropriate.)					
Performed SWPPP Inspection on this line. There was one issue identified and added to the punch list. The Contractor is working on repairing the identified issue. Other than that there were no issues to report at the time of Inspection.					
Note: It is a condition of National Pollutant Discharge Elimination System and Erosion and Sediment permits that a maintenance program be conducted to provide for the operation and maintenance of all BMPs to be inspected on a weekly basis and after each stormwater event. Please list in the space provided comments to note if repairs or replacement are needed or have been made for BMPs as a result of the inspection. Failure to conduct the required inspection may result in permit suspension or the imposition of civil penalties. If supplemental monitoring is required as part of a permit condition this form may be used to meet those monitoring requirements.

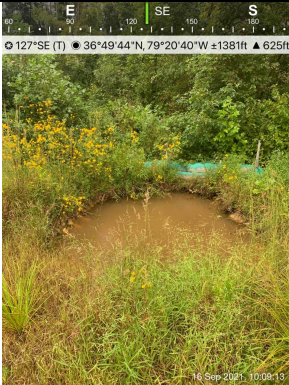
GPS Location	O	GPS Location	O		
Field Station#	13+50	Field Station#	12+65		
Pic 3 Desc.	Observing temporary stabilization, sump and end treatment		Pic 4 Desc.	Observing temporary stabilization, buffer, equipment crossing and ECD's	
Insert image here			Insert image here		
GPS Location		GPS Location			
Field Station#		Field Station#			
Pic 5 Desc.			Pic 6 Desc.

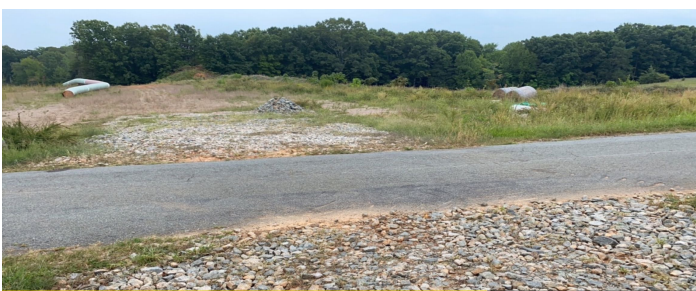
<small>36°57'47" N 79°35'36" W 176°S COURSE 354' GPS 1923-2165 Armstrong Rd, Penhook, VA 24137, United States 09.16.2021 12:09:38 Accur +/-27.4 Ft ALT 929 Ft</small>			<small>36°57'45" N 79°35'33" W 155°SE COURSE 122' GPS 1923-2165 Armstrong Rd, Penhook, VA 24137, United States 09.16.2021 12:11:12 Accur +/-77.7 Ft ALT 928 Ft</small>		
GPS Location	1		GPS Location	2	
Field Station#	15063+85		Field Station#	15067+00	
Pic 1 Desc.	RCE at Armstrong Rd in good condition		Pic 2 Desc.	Temporary diversion berm stabilized and vegetated

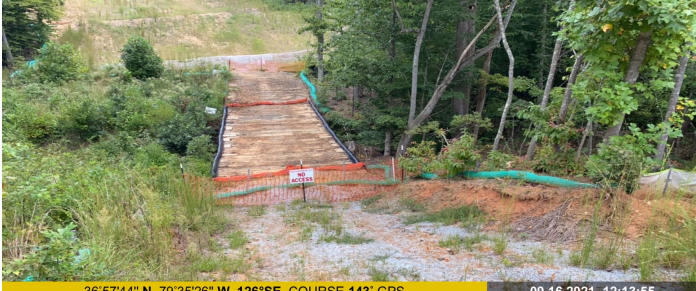
<small>36°57'44" N 79°35'26" W 126°SE COURSE 143' GPS Sandy Level, VA 24161, United States 09.16.2021 12:13:55 Accur +/-15.3 Ft ALT 892 Ft</small>			<small>36°57'44" N 79°35'27" W 107°E COURSE -1' GPS 1918-2164 Armstrong Rd, Penhook, VA 24137, United States 09.16.2021 12:13:35 Accur +/-15.3 Ft ALT 902 Ft</small>		
GPS Location	5		GPS Location	6	
Field Station#	15072+86		Field Station#	15080+00	
Pic 5 Desc.	Equipment bridge and surrounding ECDs in place and functional at stream crossing and resource buffer		Pic 6 Desc.	Picture of temporary stabilization and vegetation along ROW

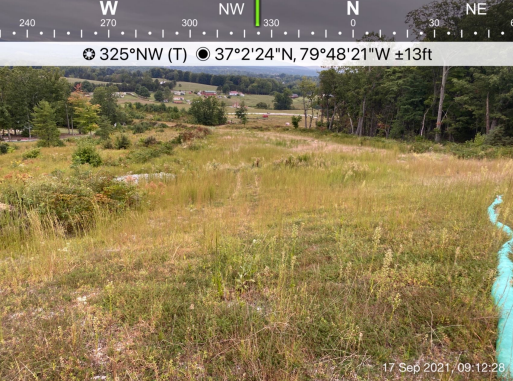
GPS Location	0	GPS Location	0		
Field Station#	14312+00	Field Station#	14326+00		
Pic 1 Desc.	Approximately 14312+00. Overview of road crossing and RCE.		Pic 2 Desc.	Approximately 14326+00. Overview of ROW.

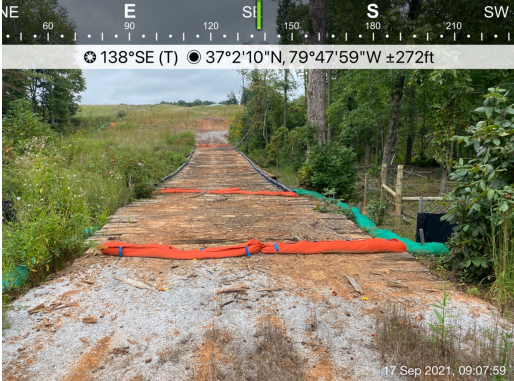
GPS Location	0	GPS Location	0		
Field Station#	14353+53	Field Station#	14391+50		
Pic 3 Desc.	Approximately 14353+53. Overview of stream crossing, equipment bridge and ECDs at stream S-A38.		Pic 4 Desc.	Approximately 14391+50. Overview of stream crossing, equipment bridge and ECDs at stream S-A41.

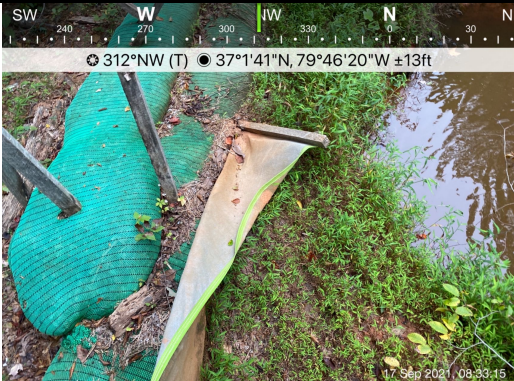
GPS Location	0	GPS Location	0		
Field Station#	14440+75	Field Station#	14452+00		
Pic 5 Desc.	Approximately 14440+00. P-1 requires maintenance.		Pic 6 Desc.	Approximately 14452+00. Overview of ROW.

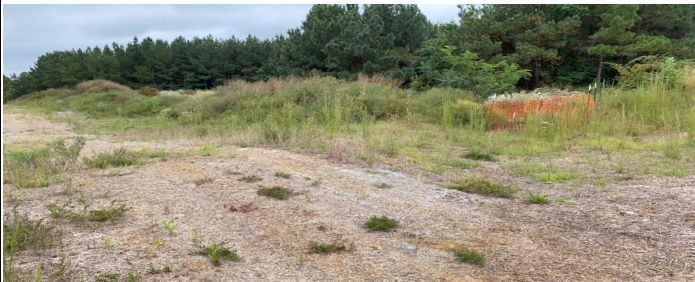
36°58'59" N 79°41'21" W 68°NE COURSE 143° GPS 09.17.2021 08:51:05 Accur +/-15.3 Ft ALT 965 Ft			36°58'58" N 79°41'20" W 147°SE COURSE 135° GPS 09.17.2021 08:51:48 Sorry no results found Accur +/-15.3 Ft ALT 970 Ft		
GPS Location	1	GPS Location	2		
Field Station#	14772+00	Field Station#	14761+28		
Pic 1 Desc.	Water bar performing intended function	Pic 2 Desc.	Temporary diversion berm stabilized and vegetated

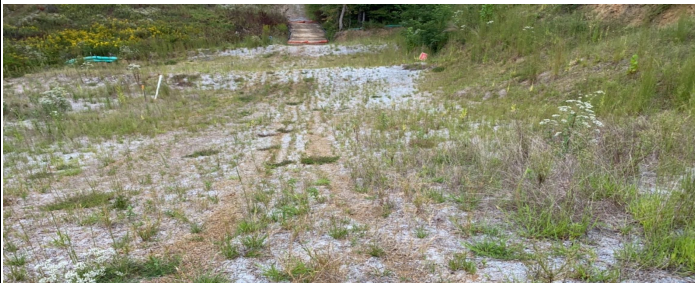
36°59'16" N 79°42'5" W 101°E COURSE 151° GPS 09.17.2021 11:18:40 Union Hall, VA 24176, United States Accur +/-51.9 Ft ALT 912 Ft			36°59'16" N 79°42'5" W 204°SW COURSE -1° GPS 09.17.2021 11:18:52 Union Hall, VA 24176, United States Accur +/-22.3 Ft ALT 912 Ft		
GPS Location	3	GPS Location	4		
Field Station#	14722+00	Field Station#	14721+00		
Pic 3 Desc.	Picture of temporary stabilization and vegetation along ROW	Pic 4 Desc.	Erosion control devices in good condition around stabilized spoil pile

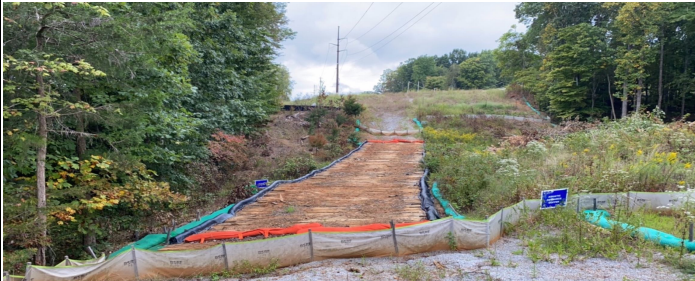
36°59'16" N 79°42'8" W 304°NW COURSE 74° GPS 09.17.2021 11:20:41 Union Hall, VA 24176, United States Accur +/-190.4 Ft ALT 916 Ft			36°59'16" N 79°42'13" W 121°SE COURSE 34° GPS 09.17.2021 11:26:04 Accur +/-64.5 Ft ALT 0 Ft		
GPS Location	5	GPS Location	6		
Field Station#	14716+15	Field Station#	14713+00		
Pic 5 Desc.	Equipment bridge and surrounding ECDs in place and functional at stream crossing and resource buffer	Pic 6 Desc.	Sump pit, CFS end treatment, and perimeter SSF in place and functional
