# Visual Site Inspection Report

<b>Project Name</b>	H-600 Pipeline Spread I	<b>AFE</b>	124300139	<b>Spread</b>	H-600 Pipeline Spread I
<b>Contractor</b>	Precision			<b>Report #</b>	28123
<b>Inspector</b>	Ben Farmer			<b>Date/Time</b>	9/6/2021 3:28 PM
<b>Permit #</b>	TBD	<b>Inspection Type</b>	VA SWPP	<b>Station Begin</b>	15480+67
<b>State</b>	VA	<b>Inspection Area</b>	Partial	<b>Station End</b>	15584+23
<b>County</b>	Pittsylvania	<b>Ground</b>	Damp	<b>Temperature (°F)</b>	76.00
<b>Municipality</b>	Chatham	<b>Weather</b>	Sunny	<b>Rain Gauge (in)</b>	0.00
				<b>Rain Accumulation Time (days)</b>	0.00

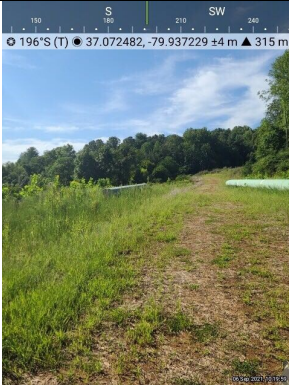
<b>GPS Location</b>	00000	<b>GPS Location</b>	0000		
<b>Field Station#</b>	13764+30	<b>Field Station#</b>	13755+49		
<b>Pic 1 Desc.</b>	Vegetation observation photo showing grass growth . No environmental issues observed at the time of inspection.		<b>Pic 2 Desc.</b>	Stream observation photo facing upstream during routine inspection today No environmental issues observed at the time of inspection.

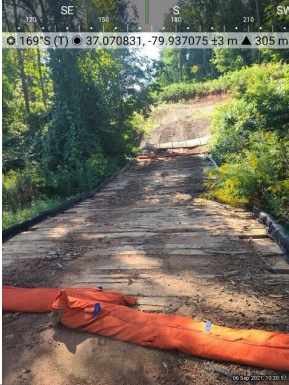
<b>GPS Location</b>	000	<b>GPS Location</b>	0000		
<b>Field Station#</b>	13770+69	<b>Field Station#</b>	13755+49		
<b>Pic 3 Desc.</b>	Monitored equipment bridge and protection over stream crossing. No environmental issues observed at the time of inspection		<b>Pic 4 Desc.</b>	Stream observation photo facing downstream during routine inspection today. No environmental issues observed at the time of inspection.

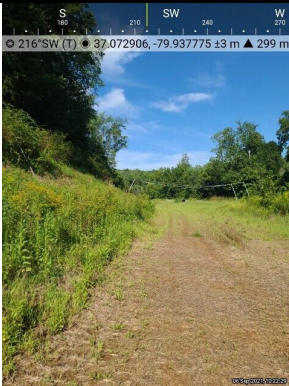
<b>GPS Location</b>	0000	<b>GPS Location</b>	0000		
<b>Field Station#</b>	13760+00	<b>Field Station#</b>	13757+10		
<b>Pic 5 Desc.</b>	Row photo showing vegetation in temporary area, no environmental issues observed at the time of inspection.		<b>Pic 6 Desc.</b>	Vegetation observation photo showing good coverage.

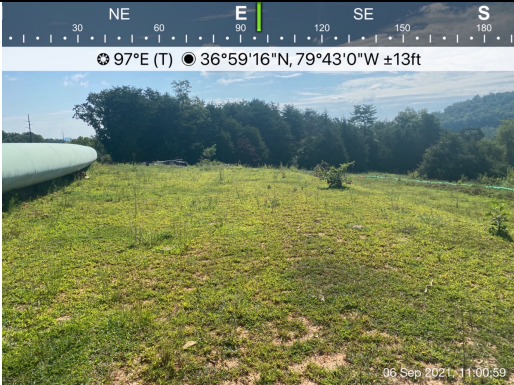
<b>GPS Location</b>	0	<b>GPS Location</b>	0		
<b>Field Station#</b>	14676+00	<b>Field Station#</b>	14673+10		
<b>Pic 3 Desc.</b>	Approximately 14676+00. Overview of ROW.		<b>Pic 4 Desc.</b>	Approximately 14673+10. Overview of stream crossing, equipment bridge and ECDs at stream S-H37.

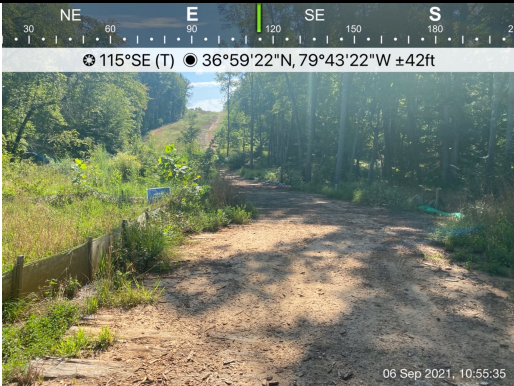
<b>GPS Location</b>	0	<b>GPS Location</b>	0		
<b>Field Station#</b>	14656+90	<b>Field Station#</b>	14652+00		
<b>Pic 5 Desc.</b>	Approximately 14656+90. Overview of stream crossing, equipment bridge and ECDs at stream S-H38.		<b>Pic 6 Desc.</b>	Approximately 14652+00. Overview of ROW.

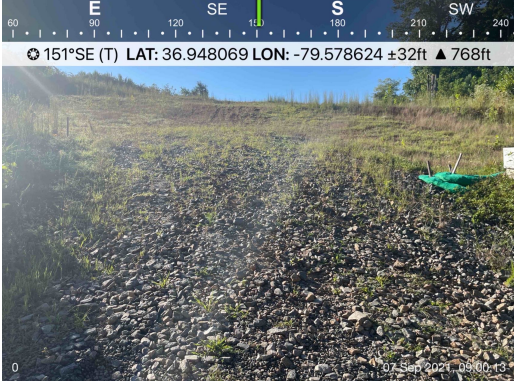
<b>GPS Location</b>	See photo		<b>GPS Location</b>	See photo	
<b>Field Station#</b>	15142+66		<b>Field Station#</b>	15150+00	
<b>Pic 1 Desc.</b>	RCEs are in good condition at all road crossings.		<b>Pic 2 Desc.</b>	Perimeter CFS is in good condition.

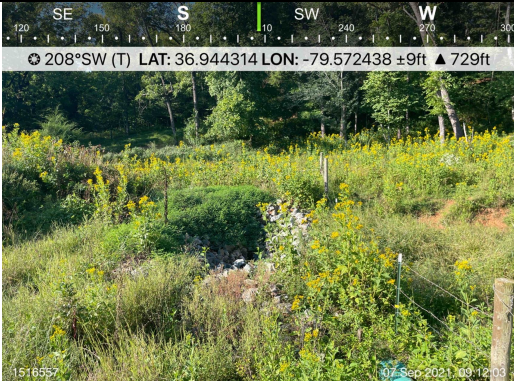
<b>GPS Location</b>	See photo		<b>GPS Location</b>	See photo	
<b>Field Station#</b>	15165+57		<b>Field Station#</b>	15166+00	
<b>Pic 3 Desc.</b>	Rock filter remains in good condition.		<b>Pic 4 Desc.</b>	Rock outlet remains in good condition.

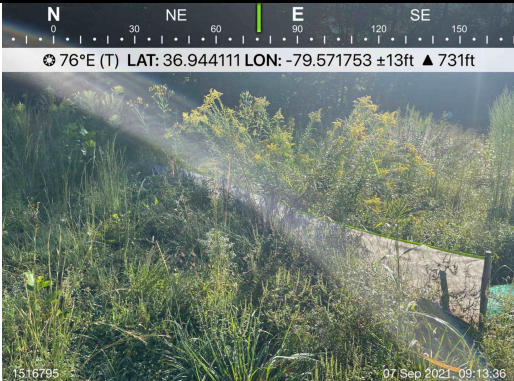
<b>GPS Location</b>	See photo		<b>GPS Location</b>	See photo	
<b>Field Station#</b>	15167+95		<b>Field Station#</b>	15167+95	
<b>Pic 5 Desc.</b>	P1 is in good condition at stream crossing.		<b>Pic 6 Desc.</b>	Equipment bridge ECDs are in good condition and functioning.

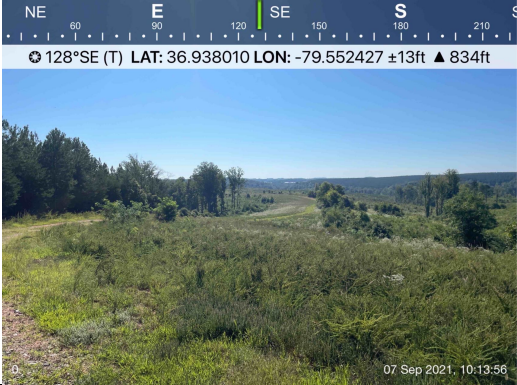
<p>Insert image here</p>			
<b>GPS Location</b>	See photo	<b>GPS Location</b>			
<b>Field Station#</b>	15230+00	<b>Field Station#</b>			
<b>Pic 13 Desc.</b>	Vegetation continues to fill in throughout this section.	<b>Pic 14 Desc.</b>			
<p>Insert image here</p>		<p>Insert image here</p>			
<b>GPS Location</b>		<b>GPS Location</b>			
<b>Field Station#</b>		<b>Field Station#</b>			
<b>Pic 15 Desc.</b>		<b>Pic 16 Desc.</b>			
<p>Insert image here</p>		<p>Insert image here</p>			
<b>GPS Location</b>		<b>GPS Location</b>			
<b>Field Station#</b>		<b>Field Station#</b>			
<b>Pic 17 Desc.</b>		<b>Pic 18 Desc.</b>

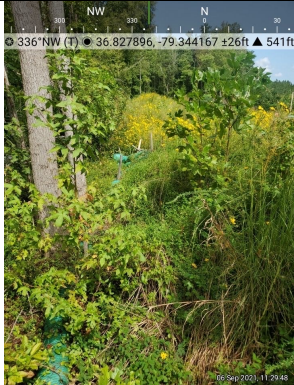
<b>GPS Location</b>	0	<b>GPS Location</b>	0		
<b>Field Station#</b>	7+35	<b>Field Station#</b>	10+00		
<b>Pic 1 Desc.</b>	Temporary vegetation and mat road		<b>Pic 2 Desc.</b>	Perimeter CFS

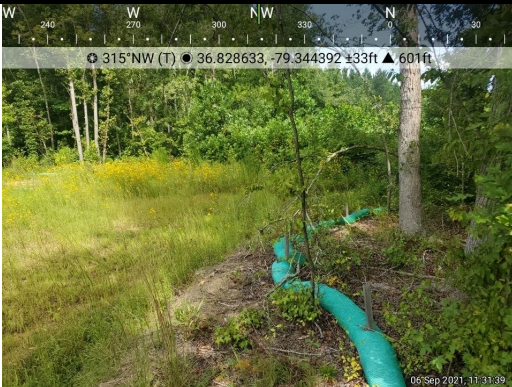
<b>GPS Location</b>	0	<b>GPS Location</b>	0		
<b>Field Station#</b>	11+50	<b>Field Station#</b>	13+50		
<b>Pic 3 Desc.</b>	CIS S-H42 Perimeter CFS & Buffer zone		<b>Pic 4 Desc.</b>	GAS S-H42 Buffer zone

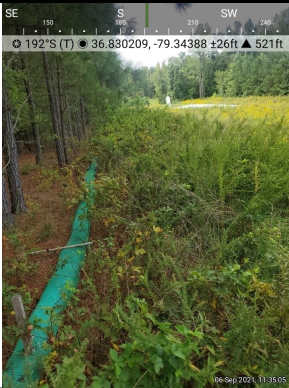
<b>GPS Location</b>	0	<b>GPS Location</b>	0		
<b>Field Station#</b>	16+00	<b>Field Station#</b>	19+00		
<b>Pic 5 Desc.</b>	Perimeter CFS		<b>Pic 6 Desc.</b>	Temporary vegetation

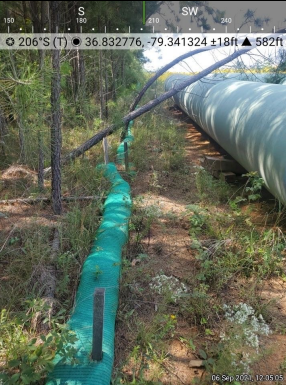
<b>GPS Location</b>	0	<b>GPS Location</b>	0		
<b>Field Station#</b>	2+50	<b>Field Station#</b>	5+00		
<b>Pic 1 Desc.</b>	Temporary vegetation	<b>Pic 2 Desc.</b>	Perimeter CFS

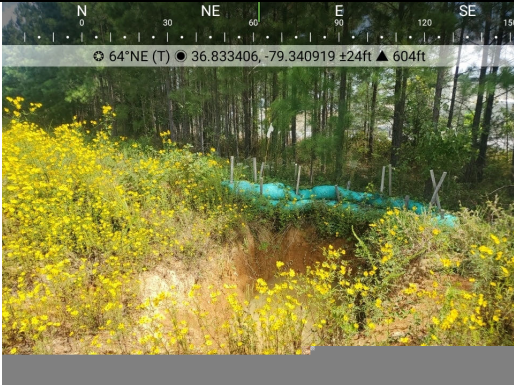
<b>GPS Location</b>	0	<b>GPS Location</b>	0		
<b>Field Station#</b>	8+00	<b>Field Station#</b>	12+75		
<b>Pic 3 Desc.</b>	Sump	<b>Pic 4 Desc.</b>	Temporary vegetation

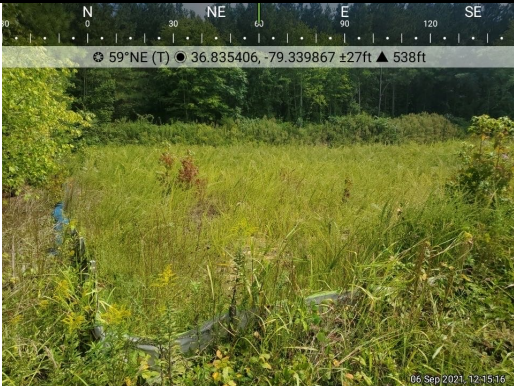
<b>GPS Location</b>	0	<b>GPS Location</b>	0		
<b>Field Station#</b>	14+25	<b>Field Station#</b>	22+00		
<b>Pic 5 Desc.</b>	Perimeter SSF	<b>Pic 6 Desc.</b>	Temporary vegetation

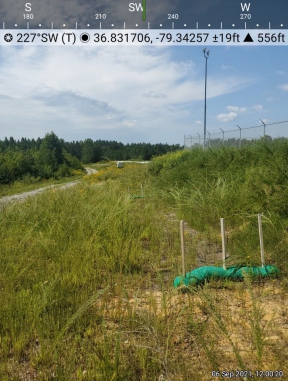
<b>GPS Location</b>	0	<b>GPS Location</b>	0		
<b>Field Station#</b>	16027+00	<b>Field Station#</b>	16026+00		
<b>Pic 1 Desc.</b>	CFS Checks	<b>Pic 2 Desc.</b>	Perimeter CFS

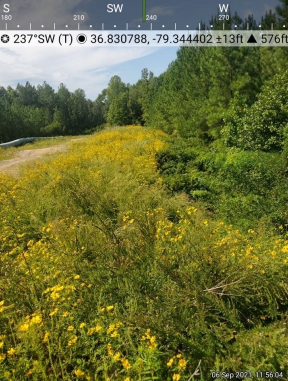
<b>GPS Location</b>	0	<b>GPS Location</b>	0		
<b>Field Station#</b>	16022+00	<b>Field Station#</b>	16020+00		
<b>Pic 3 Desc.</b>	Sideslope temporary vegetation	<b>Pic 4 Desc.</b>	Waterbar checks

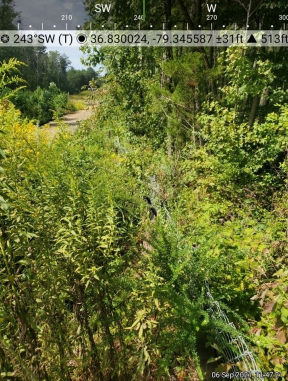
<b>GPS Location</b>	0	<b>GPS Location</b>	0		
<b>Field Station#</b>	16018+00	<b>Field Station#</b>	16018+00		
<b>Pic 5 Desc.</b>	Perimeter Supersilt fence GAS S-H44	<b>Pic 6 Desc.</b>	GAS S-H44 Buffer zone

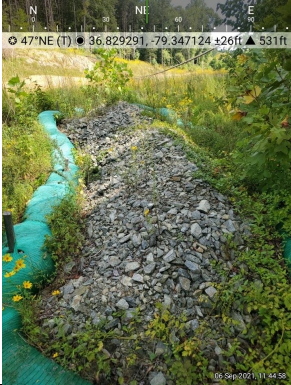
<b>GPS Location</b>	0	<b>GPS Location</b>	0		
<b>Field Station#</b>	16015+00	<b>Field Station#</b>	16015+00		
<b>Pic 7 Desc.</b>	Clean water diversion outlet	<b>Pic 8 Desc.</b>	Clean water diversion inlet

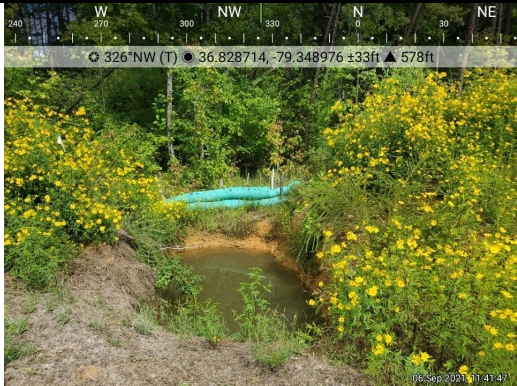
<b>GPS Location</b>	0	<b>GPS Location</b>	0		
<b>Field Station#</b>	16008+00	<b>Field Station#</b>	16005+00		
<b>Pic 9 Desc.</b>	Sump	<b>Pic 10 Desc.</b>	GAS S-EF26 Temporary vegetation		
Insert image here		Insert image here			
<b>GPS Location</b>		<b>GPS Location</b>			
<b>Field Station#</b>		<b>Field Station#</b>			
<b>Pic 11 Desc.</b>		<b>Pic 12 Desc.</b>

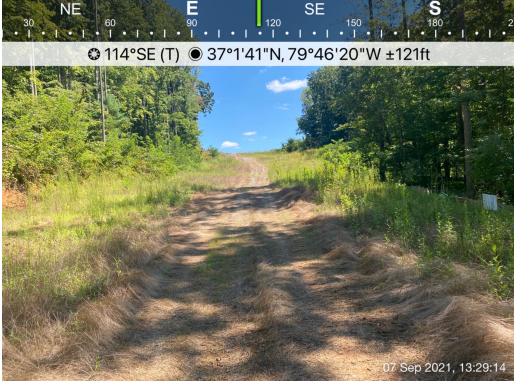
<b>GPS Location</b>	0	<b>GPS Location</b>	0		
<b>Field Station#</b>	14444+00	<b>Field Station#</b>	14415+00		
<b>Pic 1 Desc.</b>	Approximately 14444+00. Overview of ROW.		<b>Pic 2 Desc.</b>	Approximately 14415+00. Overview of ROW.

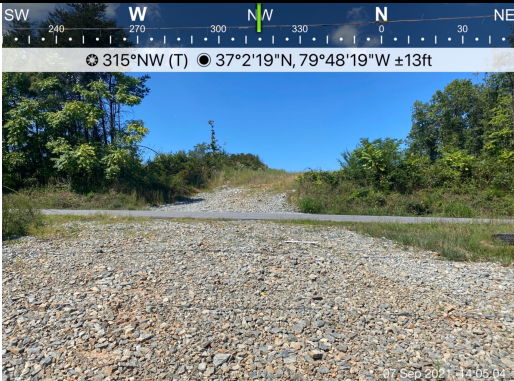
<b>GPS Location</b>	0	<b>GPS Location</b>	0		
<b>Field Station#</b>	14391+50	<b>Field Station#</b>	14346+00		
<b>Pic 3 Desc.</b>	Approximately 14391+50. Overview of stream crossing, equipment bridge and ECDs at stream S-A41.		<b>Pic 4 Desc.</b>	Approximately 14346+00. Overview of ROW.

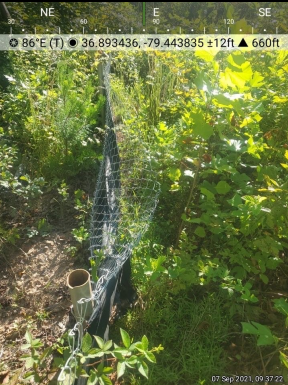
<b>GPS Location</b>	0	<b>GPS Location</b>	0		
<b>Field Station#</b>	15586+00	<b>Field Station#</b>	15590+00		
<b>Pic 1 Desc.</b>	GAS Anderson Mill Rd #1 Vegetation	<b>Pic 2 Desc.</b>	Vegetation

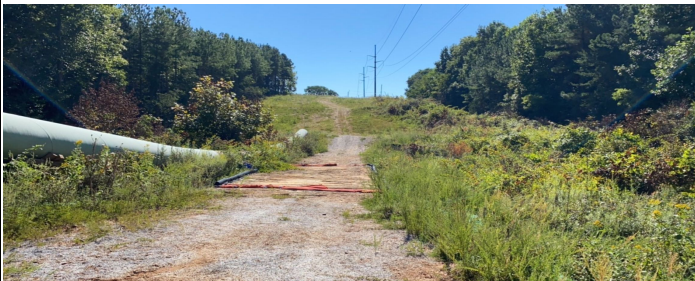
36°59'17" N 79°42'13" W 101°E COURSE 90' GPS Sorry no results found 09.07.2021 10:23:16 Accur +/-69.3 Ft ALT 935 Ft			36°59'17" N 79°42'13" W 83°E COURSE 3' GPS Sorry no results found 09.07.2021 10:30:23 Accur +/-367.2 Ft ALT 934 Ft		
GPS Location	3		GPS Location	4	
Field Station#	14714+99		Field Station#	14727+62	
Pic 3 Desc.	Perimeter controls in place and functional along ROW; no issues observed		Pic 4 Desc.	Equipment bridge and surrounding ECDs in place and functional

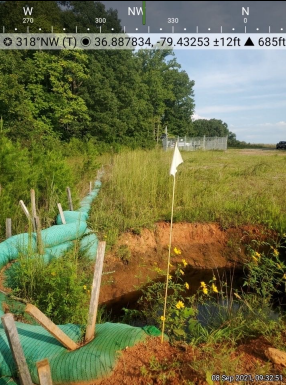
<b>GPS Location</b>	0	<b>GPS Location</b>	0		
<b>Field Station#</b>	15647+50	<b>Field Station#</b>	15655+00		
<b>Pic 1 Desc.</b>	GAS Anderson Mill #3 Vegetation	<b>Pic 2 Desc.</b>	Sump pit

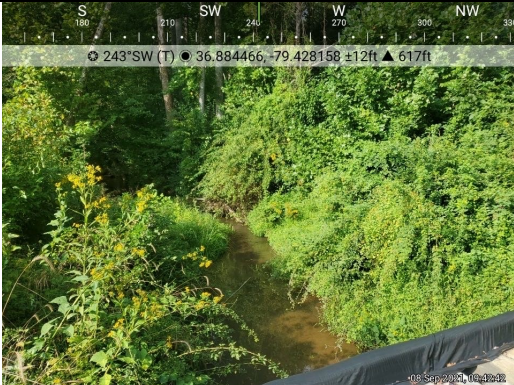
<b>GPS Location</b>	0	<b>GPS Location</b>	0		
<b>Field Station#</b>	15668+25	<b>Field Station#</b>	15678+00		
<b>Pic 3 Desc.</b>	S-Q3 Channel and buffer	<b>Pic 4 Desc.</b>	Clean water diversion outlet

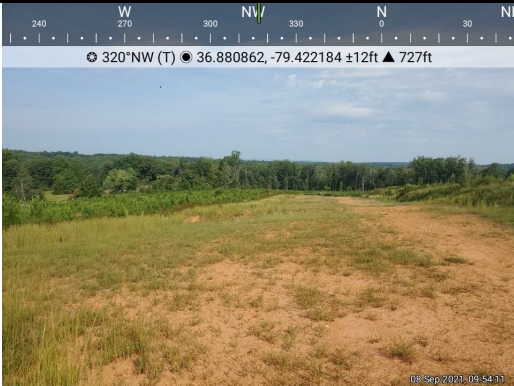
<b>GPS Location</b>	0	<b>GPS Location</b>	0		
<b>Field Station#</b>	15692+00	<b>Field Station#</b>	15696+00		
<b>Pic 5 Desc.</b>	CIS Riddle Rd Vegetation	<b>Pic 6 Desc.</b>	GAS Riddle Rd ATWS Perimeter CFS and sump

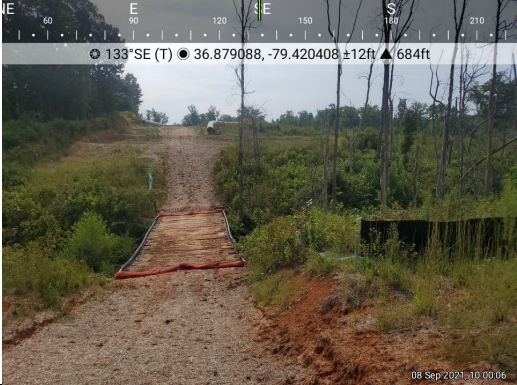
<b>GPS Location</b>	0	<b>GPS Location</b>	0		
<b>Field Station#</b>	15699+50	<b>Field Station#</b>	15707+00		
<b>Pic 7 Desc.</b>	CIS S-B8 Travel lane and buffer	<b>Pic 8 Desc.</b>	Sideslope stabilization

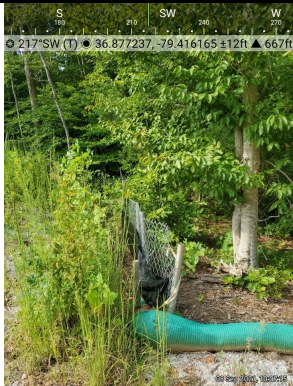
<b>GPS Location</b>	0	<b>GPS Location</b>	0		
<b>Field Station#</b>	15712+00	<b>Field Station#</b>	15726+00		
<b>Pic 9 Desc.</b>	Perimeter ECDs	<b>Pic 10 Desc.</b>	Vegetation

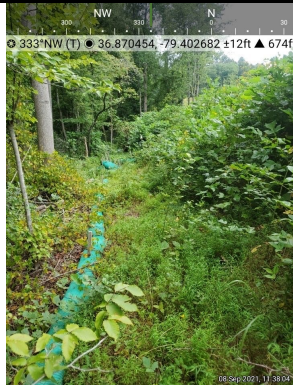
<b>GPS Location</b>	0	<b>GPS Location</b>	0		
<b>Field Station#</b>	15766+00	<b>Field Station#</b>	15767+00		
<b>Pic 11 Desc.</b>	Perimeter CFS	<b>Pic 12 Desc.</b>	CIS Dual Track Rd Vegetation

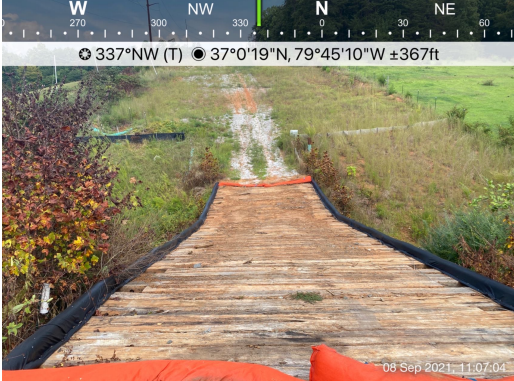
<b>GPS Location</b>	0	<b>GPS Location</b>	0		
<b>Field Station#</b>	14546+33	<b>Field Station#</b>	14531+58		
<b>Pic 1 Desc.</b>	Approximately 14546+33. Overview of stream crossing, equipment bridge and ECDs at stream S-G17.		<b>Pic 2 Desc.</b>	Approximately 14531+58. Overview of stream crossing, equipment bridge and ECDs at stream S-G18.

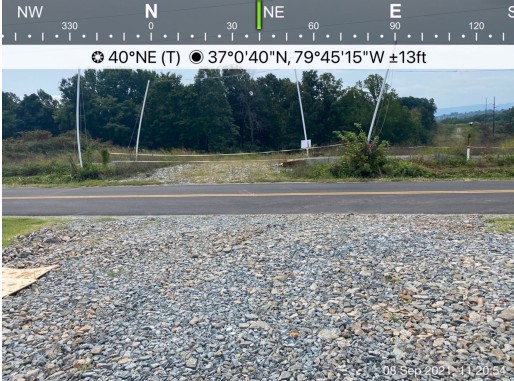
<b>GPS Location</b>	0	<b>GPS Location</b>	0		
<b>Field Station#</b>	14524+50	<b>Field Station#</b>	14496+64		
<b>Pic 3 Desc.</b>	Approximately 14524+50. Overview of road crossing and RCEs.		<b>Pic 4 Desc.</b>	Approximately 14496+64. Overview of stream crossing, equipment bridge and ECDs at stream S-G20.

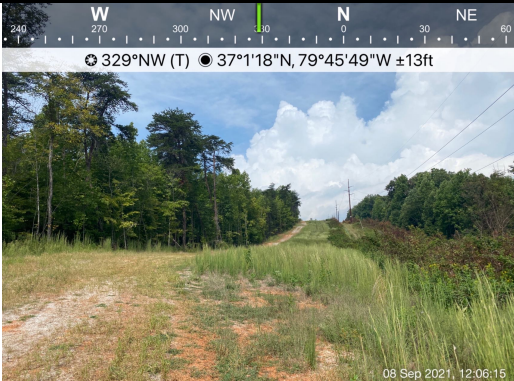
<b>GPS Location</b>	0	<b>GPS Location</b>	0		
<b>Field Station#</b>	14475+00	<b>Field Station#</b>	14457+00		
<b>Pic 5 Desc.</b>	Approximately 14475+00. Overview of ROW.		<b>Pic 6 Desc.</b>	Approximately 14457+00. Overview of ROW.

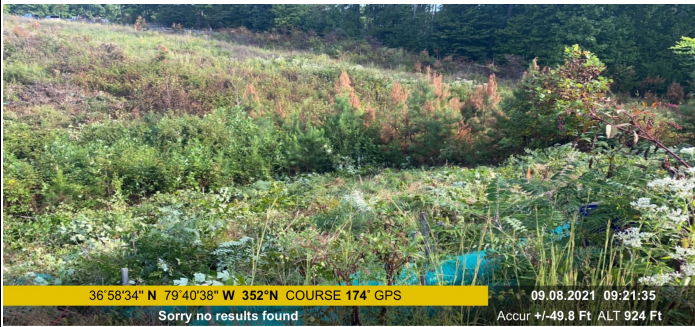
<b>GPS Location</b>	3	<b>GPS Location</b>	4		
<b>Field Station#</b>	14816+07	<b>Field Station#</b>	14819+00		
<b>Pic 3 Desc.</b>	Recently trimmed resource buffer		<b>Pic 4 Desc.</b>	Temporary diversion berm stabilized and vegetated

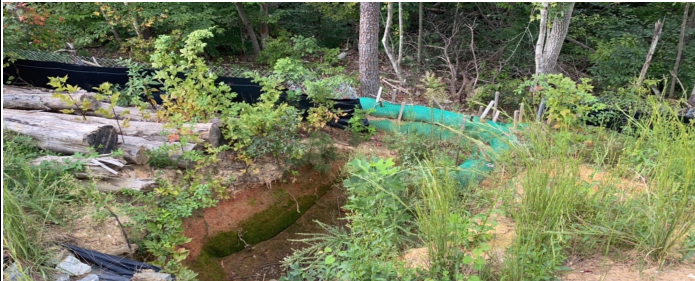
36°57'54" N 79°35'52" W 177°S COURSE 109' GPS Penhook, VA 24137, United States 09.09.2021 09:20:42 Accur +/-15.4 Ft ALT 857 Ft			36°57'51" N 79°35'44" W 334°NW COURSE 20' GPS Penhook, VA 24137, United States 09.09.2021 09:16:17 Accur +/-15.3 Ft ALT 901 Ft		
<b>GPS Location</b>	5	<b>GPS Location</b>	6		
<b>Field Station#</b>	15049+00	<b>Field Station#</b>	15055+88		
<b>Pic 5 Desc.</b>	Sump pit and CFS end treatment performing intended functions; perimeter SSF in good condition	<b>Pic 6 Desc.</b>	Equipment bridge and surrounding ECDs in place and functional at stream crossing and resource buffer

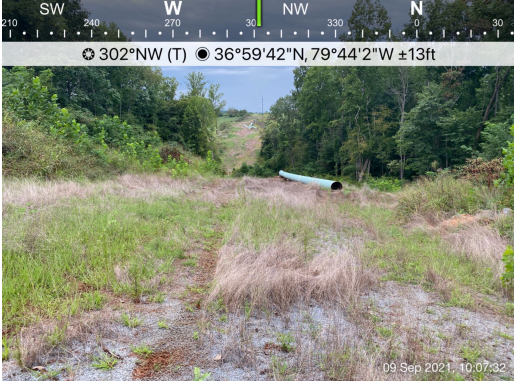
<b>GPS Location</b>	0	<b>GPS Location</b>	0		
<b>Field Station#</b>	14615+00	<b>Field Station#</b>	14611+25		
<b>Pic 1 Desc.</b>	Approximately 14615+00. Overview of ROW.		<b>Pic 2 Desc.</b>	Approximately 14611+25. Overview of stream crossing, equipment bridge and ECDs at stream S-E14.

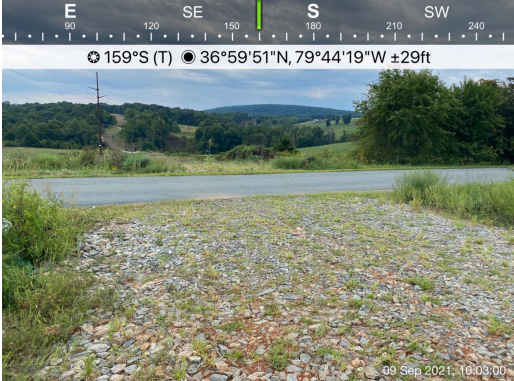
<b>GPS Location</b>	0	<b>GPS Location</b>	0		
<b>Field Station#</b>	14599+00	<b>Field Station#</b>	14582+85		
<b>Pic 3 Desc.</b>	Approximately 14599+00. Overview of road crossing and RCEs.		<b>Pic 4 Desc.</b>	Approximately 14582+85. Overview of stream crossing, equipment bridge and ECDs at stream S-E17.

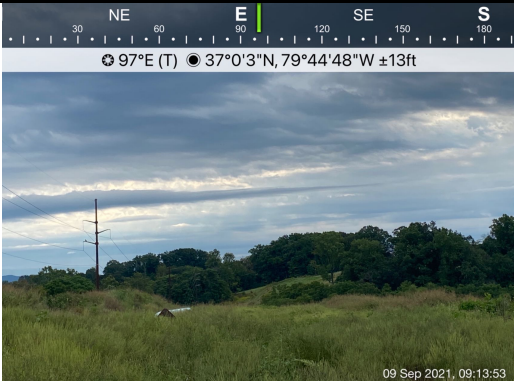
<b>GPS Location</b>	0	<b>GPS Location</b>	0		
<b>Field Station#</b>	14573+00	<b>Field Station#</b>	14547+50		
<b>Pic 5 Desc.</b>	Approximately 14573+00. Overview of ROW.		<b>Pic 6 Desc.</b>	Approximately 14547+50. SSF requires maintenance.

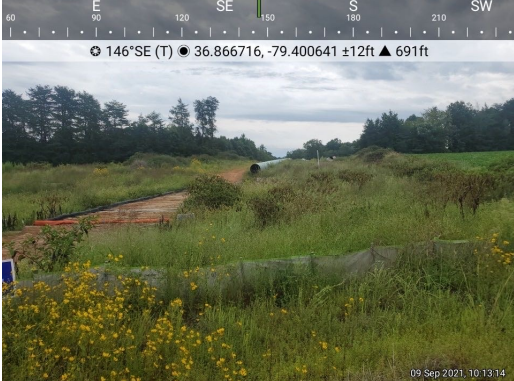
<b>GPS Location</b>	0	<b>GPS Location</b>	0		
<b>Field Station#</b>	15780+75	<b>Field Station#</b>	15785+00		
<b>Pic 1 Desc.</b>	CIS S-KL27 Buffer zone	<b>Pic 2 Desc.</b>	Clean water diversion outlet

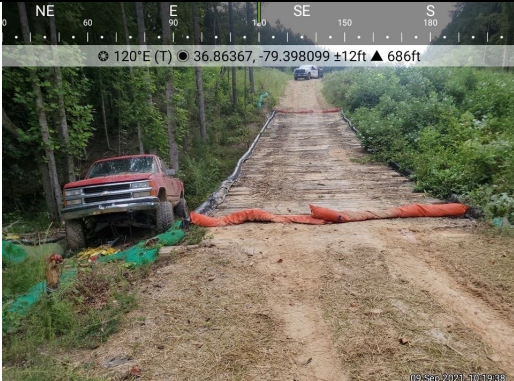
<b>GPS Location</b>	0	<b>GPS Location</b>	0		
<b>Field Station#</b>	15794+50	<b>Field Station#</b>	15794+50		
<b>Pic 3 Desc.</b>	3rd party truck in buffer @ S-C1	<b>Pic 4 Desc.</b>	3rd party truck Retrieval tools and clearing of small trees in buffer of S-C1

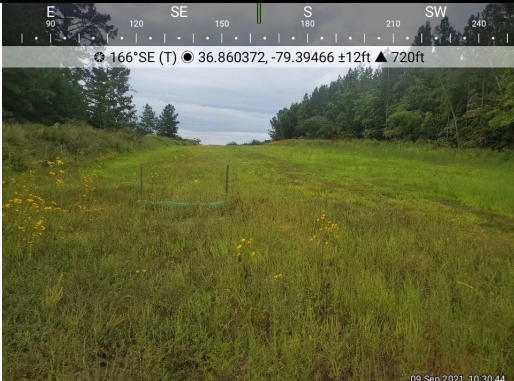
<b>GPS Location</b>	0	<b>GPS Location</b>	0		
<b>Field Station#</b>	15810+00	<b>Field Station#</b>	15824+00		
<b>Pic 5 Desc.</b>	Temporary vegetation	<b>Pic 6 Desc.</b>	Plunge pool outlet

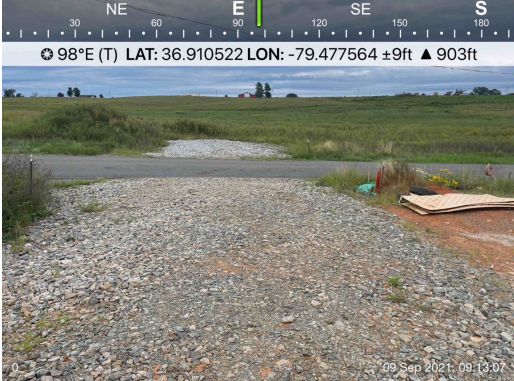
<b>GPS Location</b>	See photo		<b>GPS Location</b>	See photo	
<b>Field Station#</b>	15480+67		<b>Field Station#</b>	15475+00	
<b>Pic 1 Desc.</b>	RCEs are in good condition at all road crossings.		<b>Pic 2 Desc.</b>	3rd party rock outlet appears to be in good condition along this drainage.

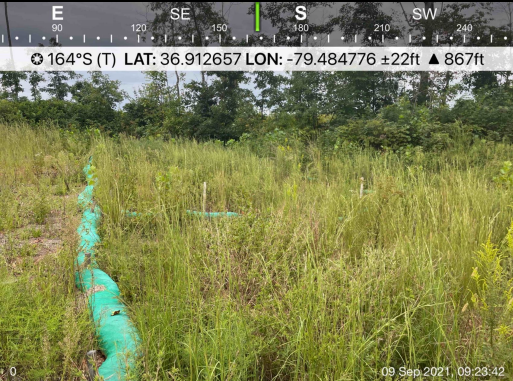
<b>GPS Location</b>	See photo		<b>GPS Location</b>	See photo	
<b>Field Station#</b>	15465+00		<b>Field Station#</b>	15460+81	
<b>Pic 3 Desc.</b>	No evidence of sedimentation from 3rd party disturbance.		<b>Pic 4 Desc.</b>	No evidence of sedimentation from 3rd party disturbance into CWD inlet.

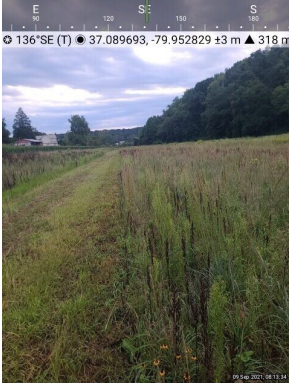
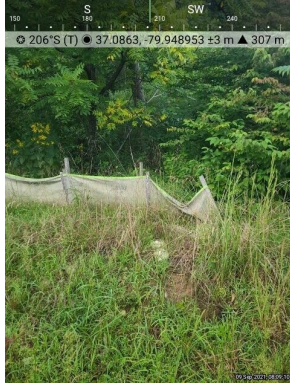
<b>GPS Location</b>	00000	<b>GPS Location</b>	00000		
<b>Field Station#</b>	13670+00	<b>Field Station#</b>	13687+61		
<b>Pic 1 Desc.</b>	Vegetation observation photo showing good coverage in restored area of row .		<b>Pic 2 Desc.</b>	P1 requires maintenance due to broken stake, contractor on site to make repairs.

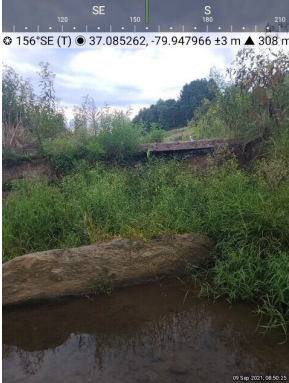
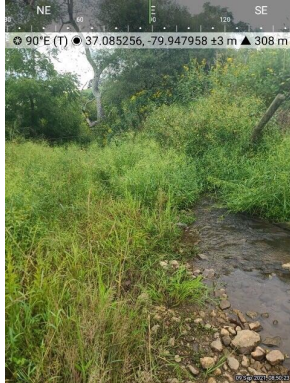
<b>GPS Location</b>	00000	<b>GPS Location</b>	00000		
<b>Field Station#</b>	13692+67	<b>Field Station#</b>	13692+64		
<b>Pic 3 Desc.</b>	Monitored stream crossing where mats were removed in efforts to complete maintenance repairs previously. No environmental issues observed at the time of inspection.		<b>Pic 4 Desc.</b>	Stream observation photo facing downstream during routine inspection today.

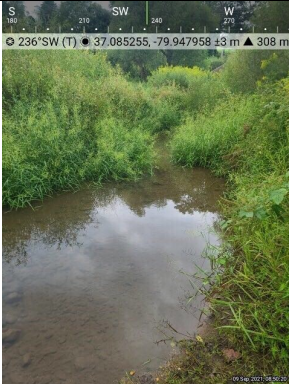
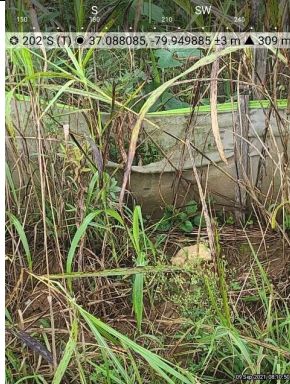
<b>Pic 5 Desc.</b>	Stream observation photo facing upstream during routine inspection today, no environmental issues observed at the time of inspection.		<b>Pic 6 Desc.</b>	P1 requires maintenance due to wildlife damages. Crew on site to make repairs, documented and added to the punch list.

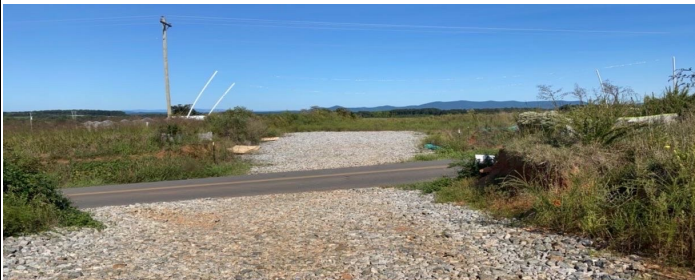
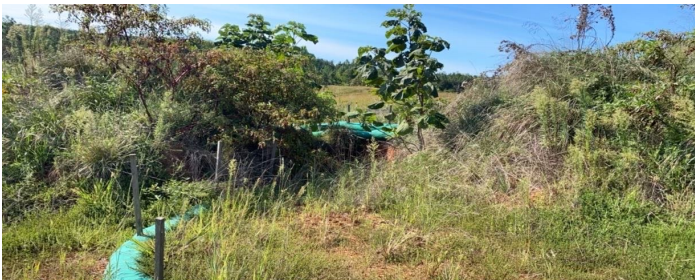
36°54'23" N 79°28'29" W 40°NE COURSE 144° GPS 5300-5698 Climax Rd, Chatham, VA 24531, United States 09.10.2021 10:10:01 Accur +/-48.6 Ft ALT 940 Ft			36°54'20" N 79°28'23" W 203°S COURSE 25° GPS 5300-5698 Climax Rd, Chatham, VA 24531, United States 09.10.2021 10:12:39 Accur +/-43.1 Ft ALT 895 Ft		
GPS Location	See photo		GPS Location	See photo	
Field Station#	15496+70		Field Station#	15505+00	
Pic 1 Desc.	RCEs are in good condition at all road crossings.		Pic 2 Desc.	Waterbar end treatments are in good condition and functioning.

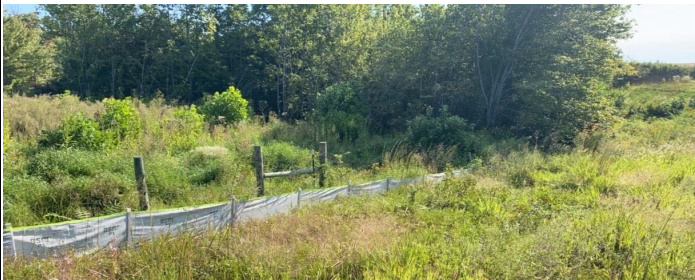
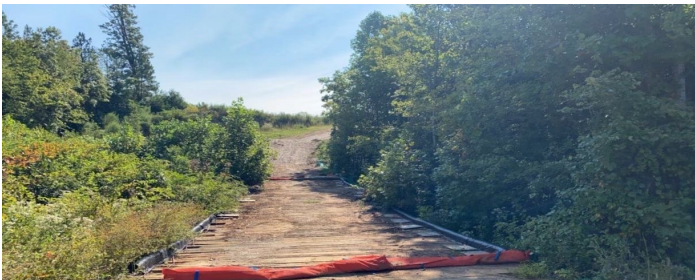
Field Station#	15506+00		Field Station#	15508+02	
Pic 3 Desc.	P1 is in good condition at all stream and wetland buffers.		Pic 4 Desc.	Equipment bridge ECDs are in good condition and functioning.

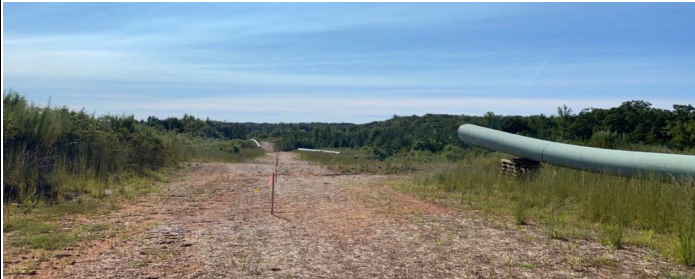
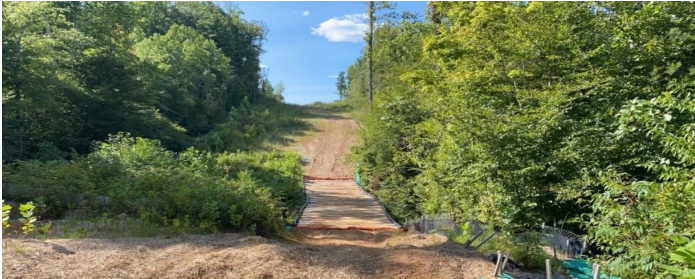
36°54'19" N 79°28'18" W 179°S COURSE 97° GPS Chatham, VA 24531, United States 09.10.2021 10:17:09 Accur +/-242.4 Ft ALT 855 Ft			36°53'44" N 79°27'9" W 258°W COURSE 334° GPS Chatham, VA 24531, United States 09.10.2021 15:45:41 Accur +/-23.2 Ft ALT 776 Ft		
GPS Location	See photo		GPS Location	See photo	
Field Station#	15512+00		Field Station#	15573+54	
Pic 5 Desc.	Vegetation continues to fill in throughout this section.		Pic 6 Desc.	Stream and wetland buffers are in good condition.

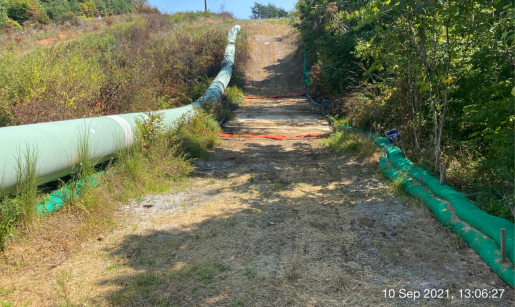
<b>GPS Location</b>	0	<b>GPS Location</b>	0		
<b>Field Station#</b>	14694+50	<b>Field Station#</b>	14689+36		
<b>Pic 1 Desc.</b>	Approximately 14694+50. Overview of road crossing and RCE.		<b>Pic 2 Desc.</b>	Approximately 14689+36. Overview of stream crossing, equipment bridge and ECDs at stream S-H34.

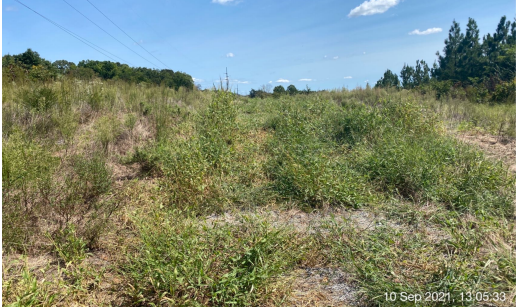
<b>GPS Location</b>	0	<b>GPS Location</b>	0		
<b>Field Station#</b>	14685+00	<b>Field Station#</b>	14680+45		
<b>Pic 3 Desc.</b>	Approximately 14685+00. Overview of ROW.		<b>Pic 4 Desc.</b>	Approximately 14680+45. Overview of stream crossing, equipment bridge and ECDs at stream S-H36.

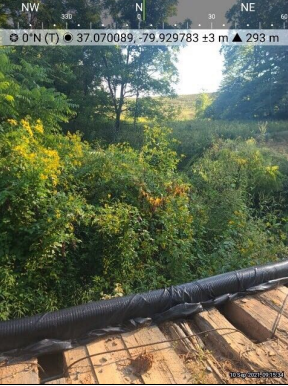
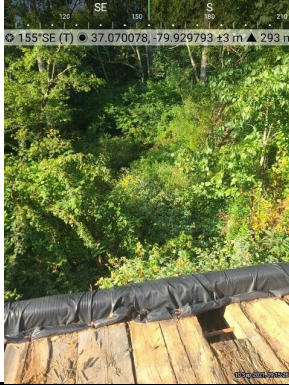
<b>GPS Location</b>	0000	<b>GPS Location</b>	0000		
<b>Field Station#</b>	13794+87	<b>Field Station#</b>	13794+87		
<b>Pic 1 Desc.</b>	Stream observation photo facing downstream during routine inspection today. No issues observed at the time of inspection.		<b>Pic 2 Desc.</b>	Stream observation photo facing upstream during routine inspection today.

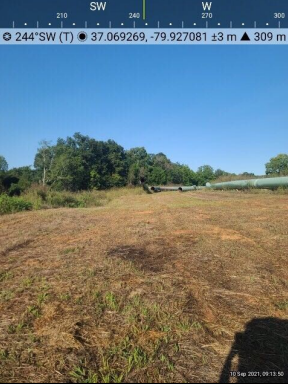
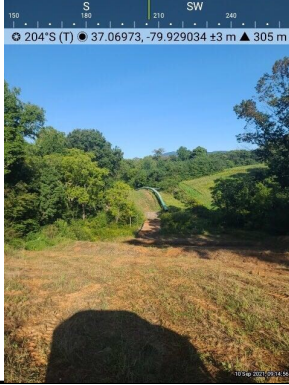
<b>GPS Location</b>	0000	<b>GPS Location</b>	0000		
<b>Field Station#</b>	13801+10	<b>Field Station#</b>	13796+00		
<b>Pic 3 Desc.</b>	Row photo showing mowed row. No environmental issues observed at the time of inspection.		<b>Pic 4 Desc.</b>	Photo showing area recently mowed by the contractor.

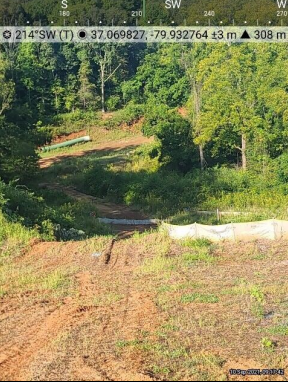
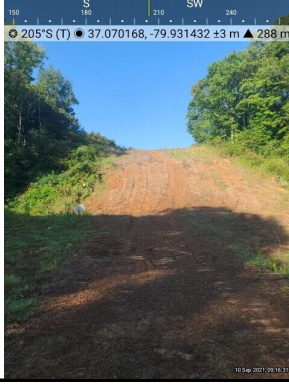
<b>GPS Location</b>	0000	<b>GPS Location</b>	00000		
<b>Field Station#</b>	13784+00	<b>Field Station#</b>	13788+30		
<b>Pic 5 Desc.</b>	ECDs put back in place at stream crossing after recent mowing activities.		<b>Pic 6 Desc.</b>	Photo showing hill side mowed after recent activities to prepare for seeding and mulching.

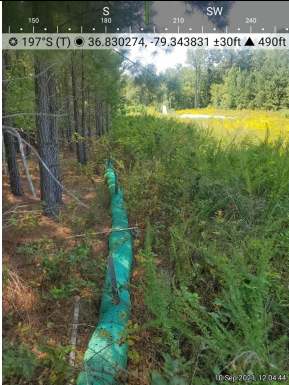
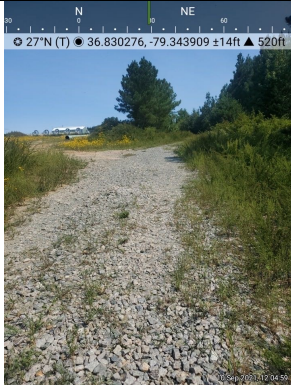
<b>GPS Location</b>	0	<b>GPS Location</b>	0		
<b>Field Station#</b>	18+00	<b>Field Station#</b>	19+00		
<b>Pic 1 Desc.</b>	Perimeter CFS	<b>Pic 2 Desc.</b>	Rock entrance

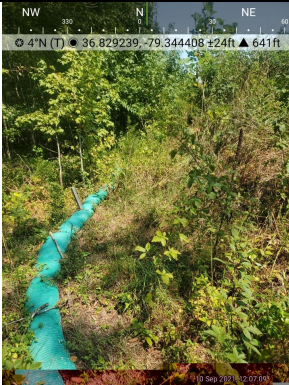
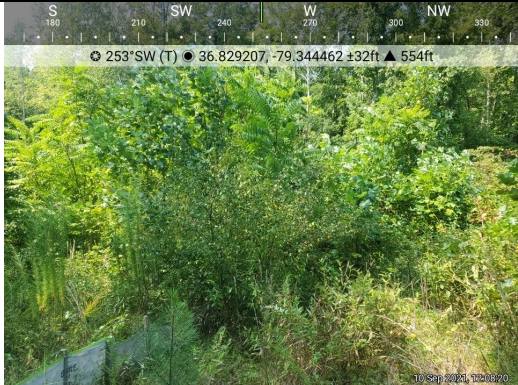
<b>GPS Location</b>	0	<b>GPS Location</b>	0		
<b>Field Station#</b>	14+00	<b>Field Station#</b>	13+25		
<b>Pic 3 Desc.</b>	Perimeter CFS	<b>Pic 4 Desc.</b>	GAS S-H42 Buffer and silt fence

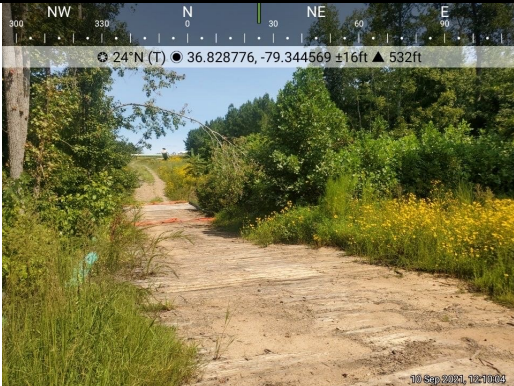
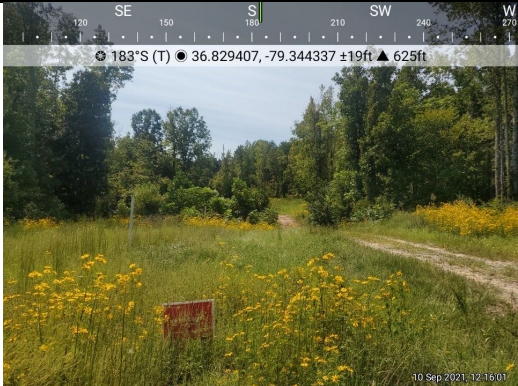
<b>GPS Location</b>	0	<b>GPS Location</b>	0		
<b>Field Station#</b>	12+00	<b>Field Station#</b>	14+50		
<b>Pic 5 Desc.</b>	CIS S-H42 Buffer zone and equipment bridge	<b>Pic 6 Desc.</b>	GAS S-H42 Vegetation

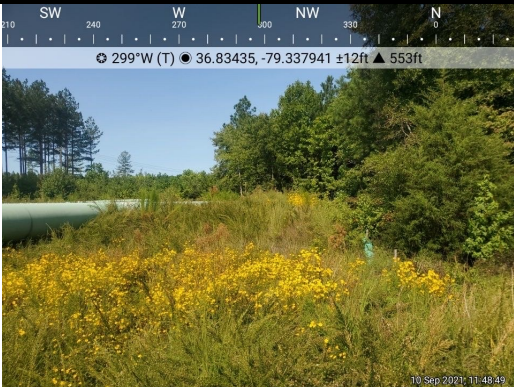
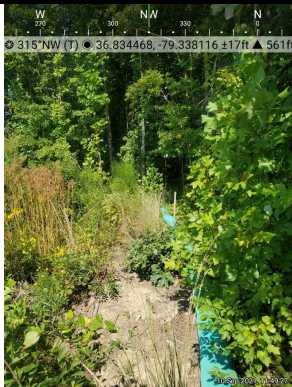
<b>GPS Location</b>	0	<b>GPS Location</b>	0		
<b>Field Station#</b>	20+00	<b>Field Station#</b>	19+50		
<b>Pic 3 Desc.</b>	Temporary vegetation	<b>Pic 4 Desc.</b>	GAS W-IJ21 CFS

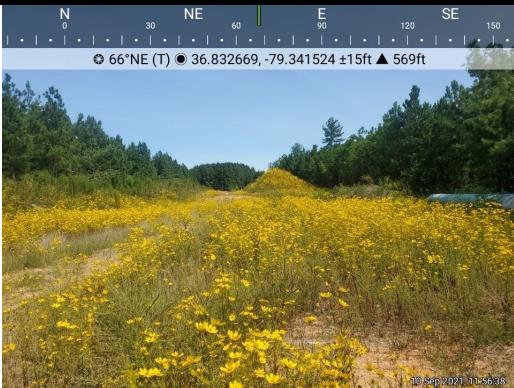
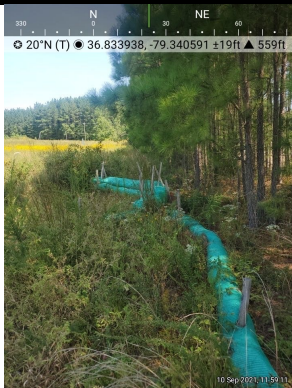
<b>GPS Location</b>	0	<b>GPS Location</b>	0		
<b>Field Station#</b>	1+00	<b>Field Station#</b>	8+00		
<b>Pic 5 Desc.</b>	Temporary vegetation	<b>Pic 6 Desc.</b>	Sump pit & perimeter CFS

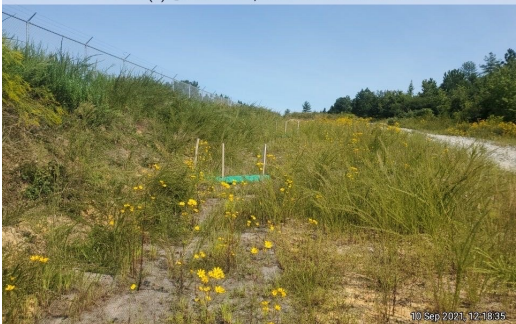
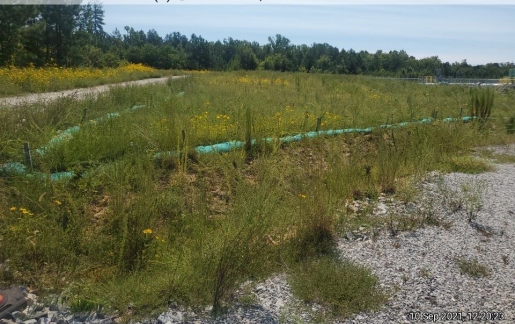
<p>GPS: 158°SE (T) 36.832902, -79.342393 ±13ft ▲ 548ft</p>	
GPS Location	0	GPS Location	0		
Field Station#	0+00	Field Station#	0+00		
Pic 1 Desc.	Transco CFS checks		Pic 2 Desc.	Transco Entrance CFS

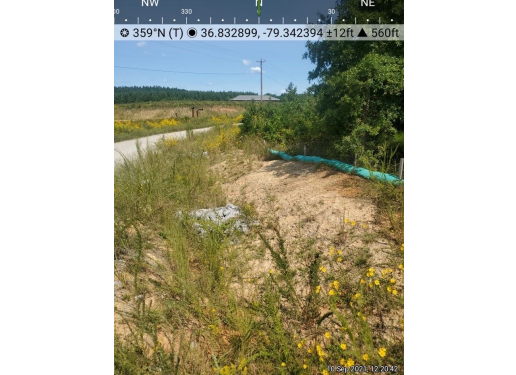
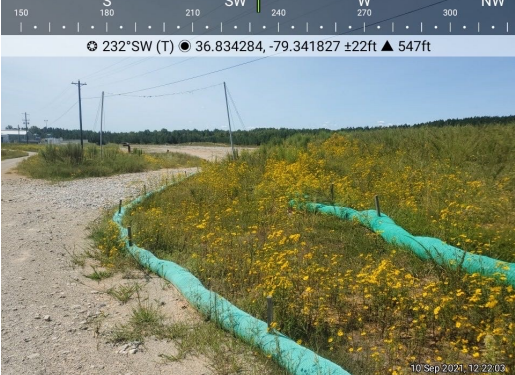
<p>GPS: 232°SW (T) 36.834284, -79.341827 ±22ft ▲ 547ft</p>	
GPS Location	0	GPS Location	0		
Field Station#	0+00	Field Station#	0+00		
Pic 3 Desc.	Transco Rock checks		Pic 4 Desc.	Transco entrance CFS

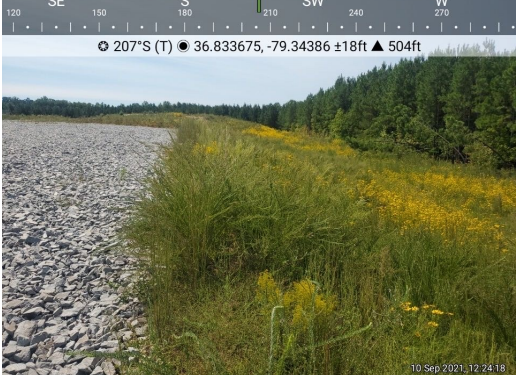
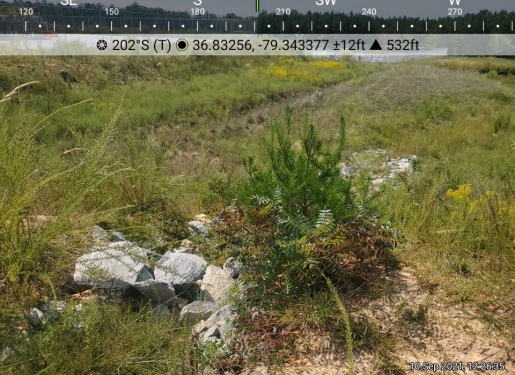
<p>GPS: 202°S (T) 36.83256, -79.343377 ±12ft ▲ 532ft</p>	
GPS Location	0	GPS Location	0		
Field Station#	0+00	Field Station#	0+00		
Pic 5 Desc.	Transco Northwest perimeter vegetation		Pic 6 Desc.	Transco Southwest corner Rock lined outlet

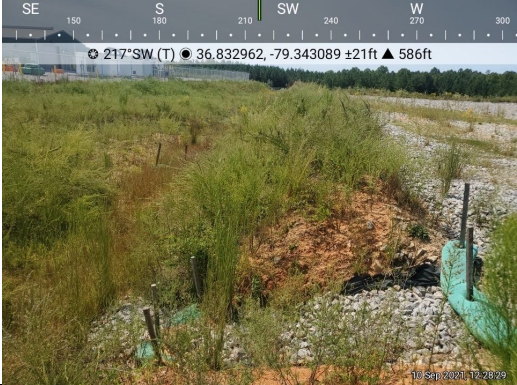
<b>GPS Location</b>	0	<b>GPS Location</b>			
<b>Field Station#</b>	0+00	<b>Field Station#</b>			
<b>Pic 7 Desc.</b>	Transco Rock lined outlet	<b>Pic 8 Desc.</b>			
Insert image here		Insert image here			
<b>GPS Location</b>		<b>GPS Location</b>			
<b>Field Station#</b>		<b>Field Station#</b>			
<b>Pic 9 Desc.</b>		<b>Pic 10 Desc.</b>			
Insert image here		Insert image here			
<b>GPS Location</b>		<b>GPS Location</b>			
<b>Field Station#</b>		<b>Field Station#</b>			
<b>Pic 11 Desc.</b>		<b>Pic 12 Desc.</b>
