Visual Site Inspection Report

Project Name	H-600 Pipeline Spread G	AFE	124300137	Spread	H-600 Pipeline Spread G
Contractor	Precision			Report #	29615
Inspector	Patrick Shields			Date/Time	10/11/2021 5:53 PM
Permit #	TBD	Inspection Type	VA SWPP	Station Begin	10655+00
State	VA	Inspection Area	Full	Station End	10859+34
County	Giles	Ground	Wet	Temperature (°F)	67.00
Municipality	N/A	Weather	Cloudy	Rain Gauge (in)	0.10
				Rain Accumulation Time (days)	1.00

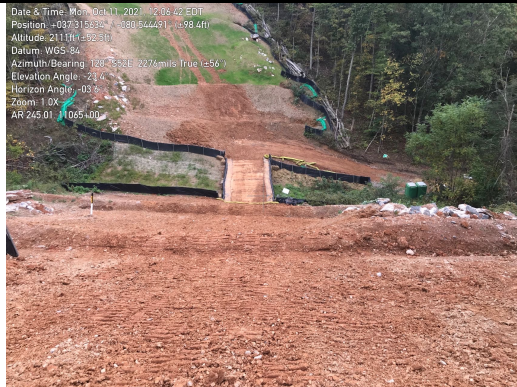
<p>Date & Time: Mon, Oct 11, 2021, 12:06:48 EDT Position: +037.315771° / -080.544838° (+98.4ft) Altitude: 2143ft (+39.4ft) Datum: WGS-84 Azimuth/Bearing: 227° S47W 4036mils True (+44°) Elevation Angle: +24.4° Horizon Angle: +05.2° Zoom: 1.0X sump station 11062+00</p>  			
GPS Location	see photo	GPS Location	see photo		
Field Station#	11065+00	Field Station#	11062+00		
Pic 11 Desc.	AR 245.01	Pic 12 Desc.	Sump

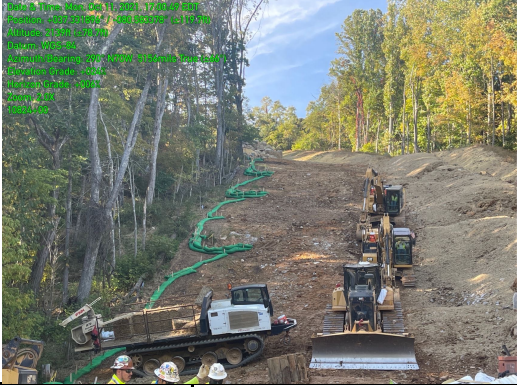
GPS Location	See Photo	GPS Location			
Field Station#	10824+00	Field Station#			
Pic 7 Desc.	View of row conditions and water bars restored at end of day activities.	Pic 8 Desc.			
Insert image here		Insert image here			
GPS Location		GPS Location			
Field Station#		Field Station#			
Pic 9 Desc.		Pic 10 Desc.			
Insert image here		Insert image here			
GPS Location		GPS Location			
Field Station#		Field Station#			
Pic 11 Desc.		Pic 12 Desc.

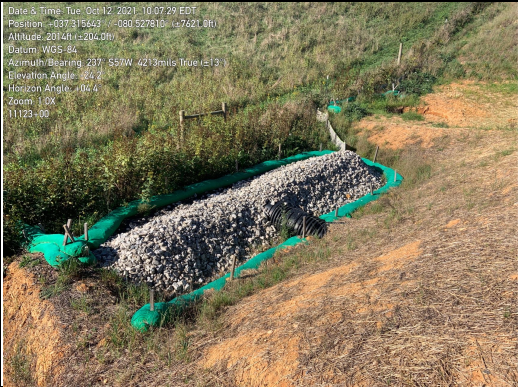
GPS Location	See photo	GPS Location	See photo		
Field Station#	11123+00	Field Station#	11126+00		
Pic 7 Desc.	Level spreader at clean water pipe acceptable		Pic 8 Desc.	Equipment bridge cleaned and acceptable	
<p><small>Date & Time: Tue, Oct 12, 2021, 10:13:02 EDT Position: -937.31643° / -930.51761° (±7421.0ft) Altitude: 2003ft (±2442ft) Datum: WGS-84 Azimuth/Bearing: 079°N (79E) (±404mils True (±12°) Elevation Angle: -04.9° Horizon Angle: -03.8° Zoom: 1.0X 11132+00</small></p>

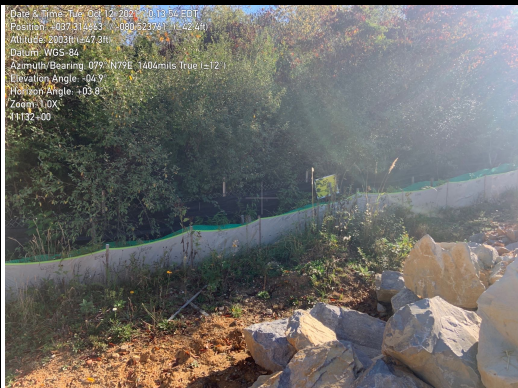
GPS Location	See photo	GPS Location	See photo		
Field Station#	11132+00	Field Station#	11173+45		
Pic 9 Desc.	Sensitive resource signage in place		Pic 10 Desc.	Permanent vegetation adequate	
<p><small>Date & Time: Tue, Oct 12, 2021, 10:51:01 EDT Position: -937.30825° / -930.51348° (±420.6ft) Altitude: 1821ft (±1350.3ft) Datum: WGS-84 Azimuth/Bearing: 100°N (102E) (±003mils True (±12°) Elevation Angle: -04.5° Horizon Angle: -03.7° Zoom: 1.0X 11177+30</small></p>

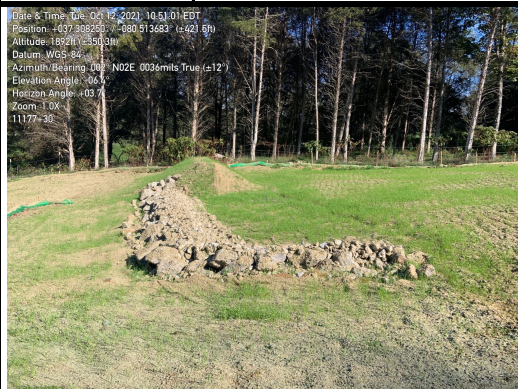
GPS Location	See photo	GPS Location	See photo		
Field Station#	11177+30	Field Station#	11227+00		
Pic 11 Desc.	Permanent water bar and level spreader functional		Pic 12 Desc.	RCE at Winding Way is in acceptable condition

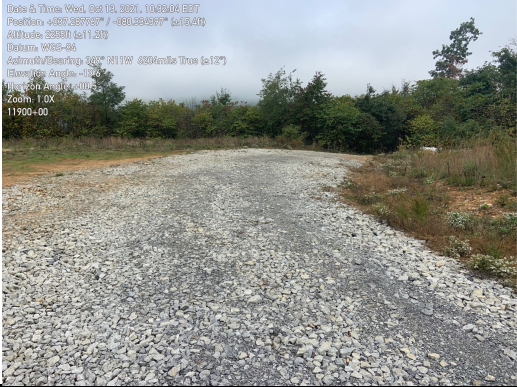
GPS Location		See photo		GPS Location	
Field Station#		11900+00		Field Station#	
Pic 7 Desc.		AR266.03 is in acceptable condition		Pic 8 Desc.	
<p>Date & Time: Wed Oct 13, 2021, 10:59:04 EDT Position: +037.27728° / -080.31997° (±10.3') Altitude: 2280ft (±46.0') Datum: WGS-84 Azimuth/Bearing: 166° S14E 2951mils True (±12°) Elevation Angle: -22.8° Horizon Angle: -00.7° Zoom: 1.0X 11931+00</p>

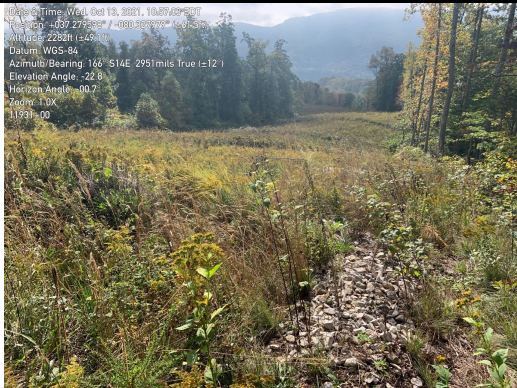
GPS Location		See photo		GPS Location	
Field Station#		11931+00		Field Station#	
Pic 9 Desc.		Permanent water bar and level spreader are acceptable		Pic 10 Desc.	
<p>Date & Time: Wed Oct 13, 2021, 11:38:54 EDT Position: +037.26769° / -080.32058° (±27.7') Altitude: 1623ft (±38.8') Datum: WGS-84 Azimuth/Bearing: 195° S85E 1839mils True (±13°) Elevation Angle: -00.6° Horizon Angle: -01.1° Zoom: 1.0X 11992+16</p>

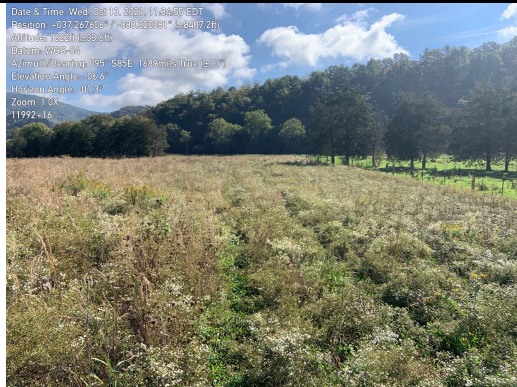
GPS Location		See photo		GPS Location	
Field Station#		11992+16		Field Station#	
Pic 11 Desc.		Vegetation is acceptable		Pic 12 Desc.

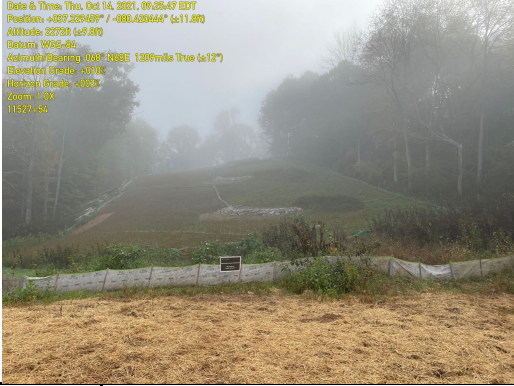
GPS Location	See photo	GPS Location	See photo		
Field Station#	11527+54	Field Station#	11534+00		
Pic 1 Desc.	Proper signage in place	Pic 2 Desc.	CFS controls in place		
<p>Date & Time: Thu, Oct 14, 2021, 09:45:53 EDT Position: +037.328460° / -080.618644° (±11.80) Altitude: 2427ft (±11.80) Datum: WGS-84 Azimuth-Bearing: 143° S106E 2542mils True (±12°) Elevation Grade: +026% Horizon Grade: +003% Zoom: 1.0x 11533+00</p>

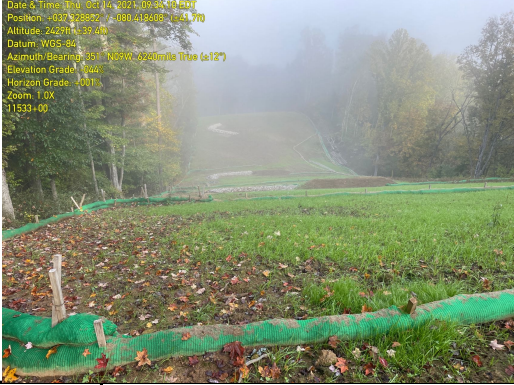
GPS Location	See photo	GPS Location	See photo		
Field Station#	11533+00	Field Station#	11545+00		
Pic 3 Desc.	Waterbars in place	Pic 4 Desc.	CFS end treatments in place		
<p>Date & Time: Thu, Oct 14, 2021, 09:57:18 EDT Position: +037.328460° / -080.618644° (±11.80) Altitude: 2721ft (±9.80) Datum: WGS-84 Azimuth-Bearing: 159° S81E 3283mils True (±12°) Elevation Grade: +029% Horizon Grade: +011% Zoom: 1.0x 11545+00</p>

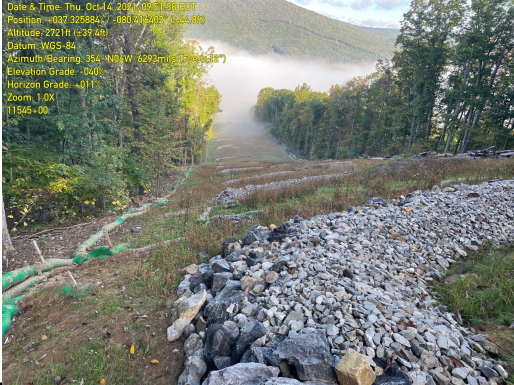
GPS Location	See photo	GPS Location	See photo		
Field Station#	11545+00	Field Station#	11557+00		
Pic 5 Desc.	Level spreaders in place	Pic 6 Desc.	Waterbars in place

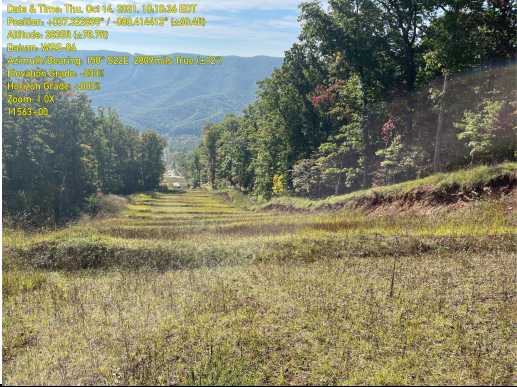
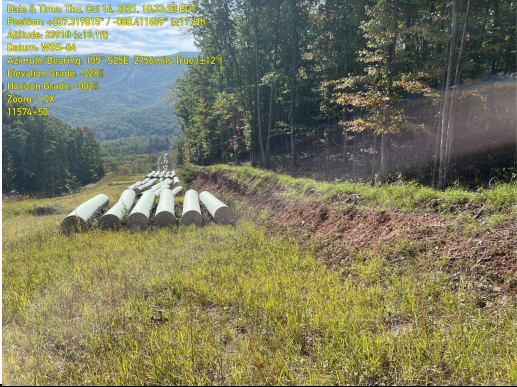
<p>Date & Time: Thu, Oct 14, 2021, 10:33:29 EDT Position: +437.319019° / -060.411699° (s=17.80) Altitude: 2991ft (s=19.10) Datum: WGS-84 Azimuth/Bearing: 100° 00' 00" 270mils True (s=12°) Elevation Grade: -00% Horizon Grade: -00% Zoom: 1.0X 11574+00</p>			
GPS Location	See photo	GPS Location	See photo		
Field Station#	11563+00	Field Station#	11574+50		
Pic 7 Desc.	Waterbars in place	Pic 8 Desc.	Cleanwater diversion berm in place

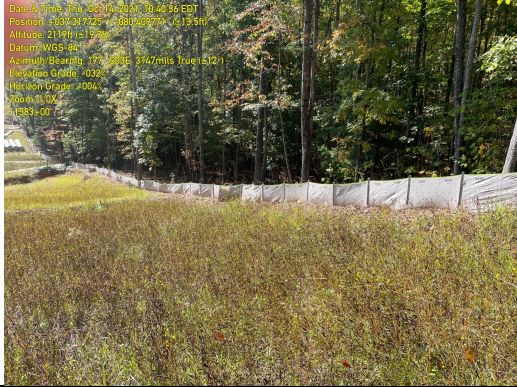
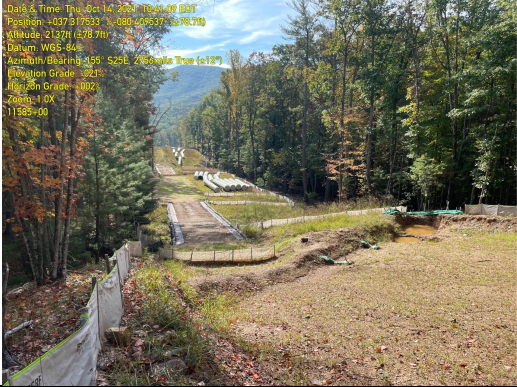
GPS Location	See photo	GPS Location	See photo		
Field Station#	11583+00	Field Station#	11585+00		
Pic 9 Desc.	P1 silt fence perimeter control in place	Pic 10 Desc.	Stream buffer in place

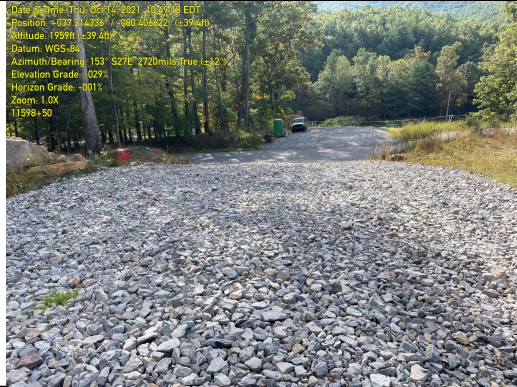
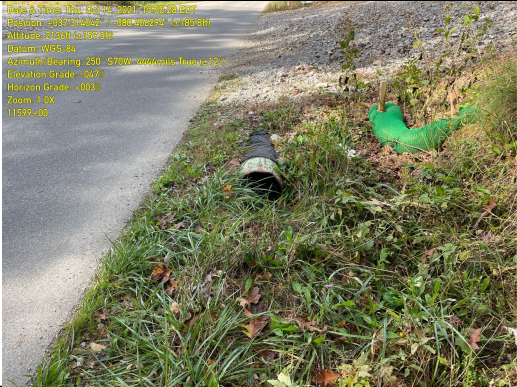
<p>Date & Time: Thu, Oct 14, 2021, 10:53:16 EDT Position: +435.314622° / -060.408322° (s=19.40) Altitude: 2130ft (s=17.90) Datum: WGS-84 Azimuth/Bearing: 250° 53' 0" 270mils True (s=12°) Elevation Grade: -03% Horizon Grade: -00% Zoom: 1.0X 11599+00</p>			
GPS Location	See photo	GPS Location	See photo		
Field Station#	11598+50	Field Station#	11599+00		
Pic 11 Desc.	RCE in place	Pic 12 Desc.	Culvert in place

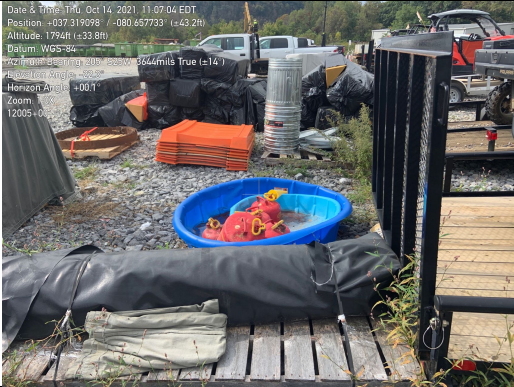
<p>Date & Time Thu, Oct 14, 2021, 11:07:14 EDT Position: +037.319292° / -080.657733° (+43.30) Altitude: 1794ft (+33.8m) Datum: WGS-84 Azimuth/Bearing: 130° 3046mils True (+14°) Elevation Angle: +02.0° Horizon Angle: +00.0° Zoom: 1.0X 12005+00</p>			
GPS Location	See photo	GPS Location	See photo		
Field Station#	12005+00	Field Station#	12005+00		
Pic 1 Desc.	Secondary containment in place	Pic 2 Desc.	Rock surface of the yard is in acceptable condition

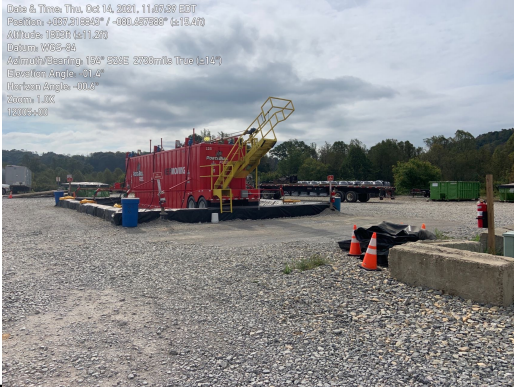
GPS Location	See photo	GPS Location	See photo		
Field Station#	12005+00	Field Station#	12005+00		
Pic 3 Desc.	Secondary containment in place	Pic 4 Desc.	Dumpsters in place

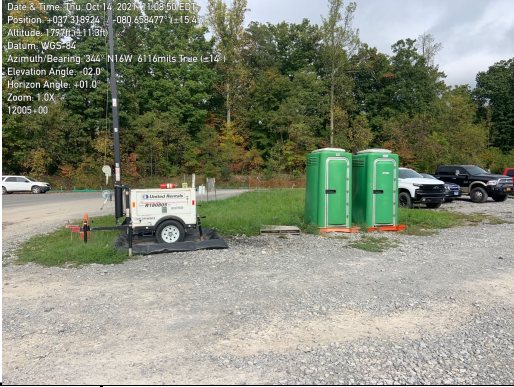
<p>Date & Time Thu, Oct 14, 2021, 11:08:20 EDT Position: +037.319292° / -080.657733° (+43.30) Altitude: 1795ft (+33.8m) Datum: WGS-84 Azimuth/Bearing: 050° N50E 0889mils True (+14°) Elevation Angle: +06.1° Horizon Angle: +00.2° Zoom: 1.0X 12005+00</p>			
GPS Location	See photo	GPS Location	See photo		
Field Station#	12005+00	Field Station#	12005+00		
Pic 5 Desc.	Secondary containment in place	Pic 6 Desc.	CFS perimeter controls in place

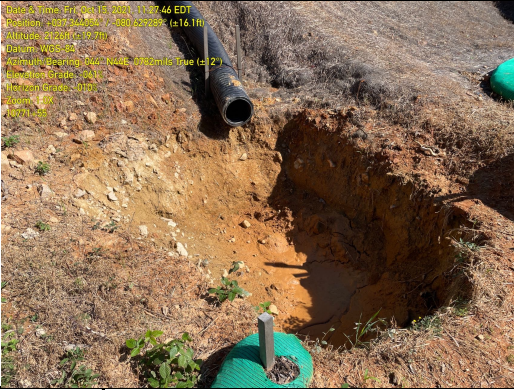
GPS Location	See photo		GPS Location	See photo	
Field Station#	10858+00		Field Station#	10840+00	
Pic 3 Desc.	End treatments in place		Pic 4 Desc.	Waterbars in place	
  <p> Date & Time: Fri, Oct 15, 2021, 11:22:44 EDT Position: 4037.24466° N, -88.130788° W (±13.4ft) Altitude: 2137ft (±19.7ft) Datum: WGS-84 Azimuth/Bearing: 264° S89W 4782mils True (±12°) Elevation Grade: -103% Horizon Grade: -00% Zoom: 1.0X 10840+00 </p>		  <p> Date & Time: Fri, Oct 15, 2021, 11:22:46 EDT Position: 4037.24466° N, -88.130788° W (±16.1ft) Altitude: 2137ft (±19.7ft) Datum: WGS-84 Azimuth/Bearing: 264° S89W 4782mils True (±12°) Elevation Grade: -103% Horizon Grade: -00% Zoom: 1.0X 10840+00 </p>			
GPS Location	See photo		GPS Location	See photo	
Field Station#	10822+00		Field Station#	10792+00	
Pic 5 Desc.	Stone inlet protection in place		Pic 6 Desc.	Level spreader in place

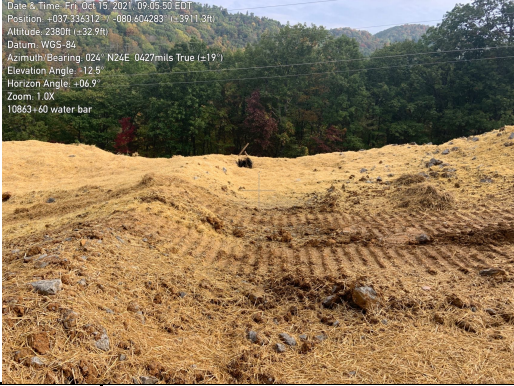
GPS Location		See photo		GPS Location	
Field Station#		10863+60		Field Station#	
Pic 1 Desc.		Water acceptable		Pic 2 Desc.	
				Temporarily stabilized inactive area of Row	
<p>Date & Time: Fri, Oct 15, 2021, 09:52:38 EDT Position: +037.326085° / +80.620058° (+7730.0ft) Altitude: 2237ft (+33.1ft) Datum: WGS-84 Azimuth/Bearing: 258° S78W 4587mils True (+18°) Elevation Angle: -31.4° Horizon Angle: -01.4° Zoom: 1.0X 10887+85</p>

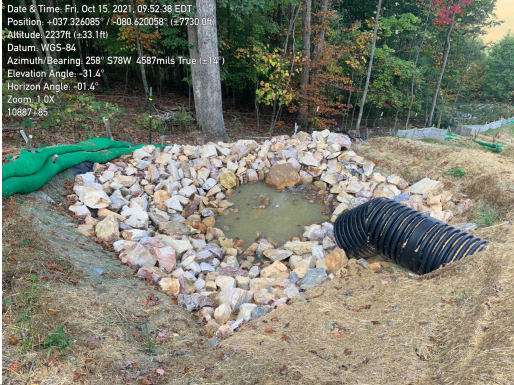
GPS Location		See photo		GPS Location	
Field Station#		10887+85		Field Station#	
Pic 3 Desc.		Clean water diversion pipe and plunge pool acceptable		Pic 4 Desc.	
				P1 silt fence and temporary stabilization acceptable	
<p>Date & Time: Fri, Oct 15, 2021, 10:13:38 EDT Position: +037.332765° / +80.636124° (+8127.2ft) Altitude: 2211ft (+33.3ft) Datum: WGS-84 Azimuth/Bearing: 124° S53E 2204mils True (+21°) Elevation Angle: -27.6° Horizon Angle: -03.4° Zoom: 1.0X 10923+85</p>

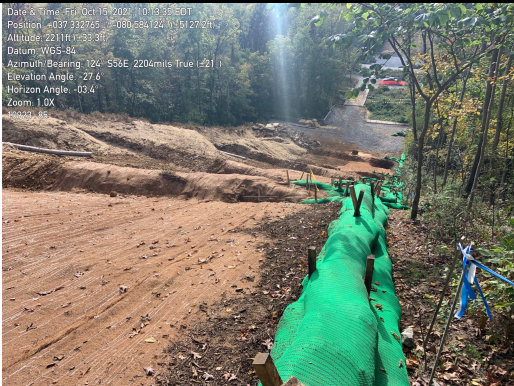
GPS Location		See photo		GPS Location	
Field Station#		10923+85		Field Station#	
Pic 5 Desc.		Erosion control blanket and CFS perimeter controls functional		Pic 6 Desc.

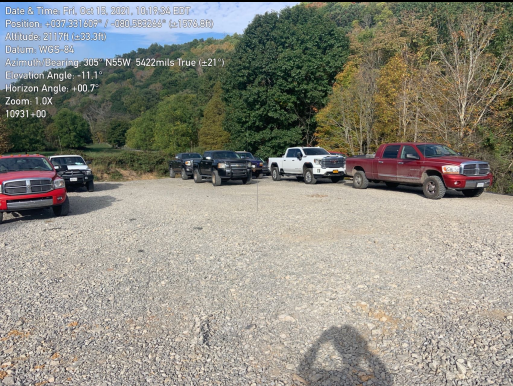
Rock surface of RCE is in acceptable condition
