Visual Site Inspection Report

Project Name	H-600 Pipeline Spread G	AFE	124300137	Spread	H-600 Pipeline Spread G
Contractor	Precision			Report #	29913
Inspector	Patrick Shields			Date/Time	10/18/2021 5:13 PM
Permit #	TBD	Inspection Type	VA SWPP	Station Begin	11254+99
State	VA	Inspection Area	Full	Station End	11524+16
County	Giles	Ground	Dry	Temperature (°F)	63.00
Municipality	N/A	Weather	Sunny	Rain Gauge (in)	0.10
				Rain Accumulation Time (days)	1.00

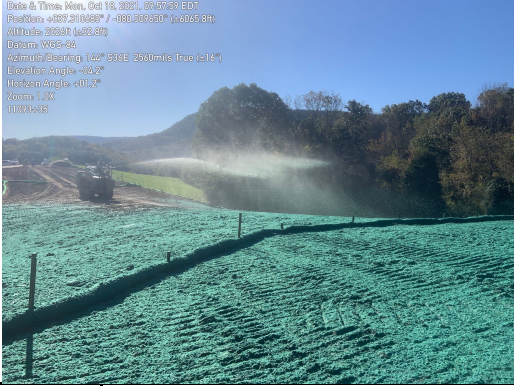
<p>Date & Time: Mon, Oct 18, 2021, 10:08:42 EDT Position: +037.312973 / -080.533724 / 11093+35 Altitude: 1944ft (+36.6ft) Datum: WGS-84 Azimuth/Bearing: 142° 53SE 330mils True (+12°) Elevation Angle: -02.2° Horizon Angle: +01.2° Zoom: 1.0X 11093+35</p>			
GPS Location		See photo		GPS Location	
Field Station#		11093+35		Field Station#	
Pic 1 Desc.		Hydro seeding of restored Row		Pic 2 Desc.

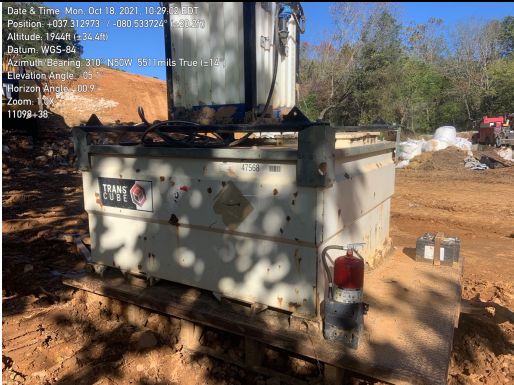
<p>Date & Time: Mon, Oct 18, 2021, 10:39:10 EDT Position: +037.312973 / -080.533724 / 11098+38 Altitude: 1944ft (+36.6ft) Datum: WGS-84 Azimuth/Bearing: 310° N50W 551mils True (+13°) Elevation Angle: -02° Horizon Angle: -00.9° Zoom: 1.0X 11098+38</p>

GPS Location		See photo		GPS Location	
Field Station#		11098+38		Field Station#	
Pic 3 Desc.		Fuel cell #47568 inspected no visible leaks or spills		Pic 4 Desc.

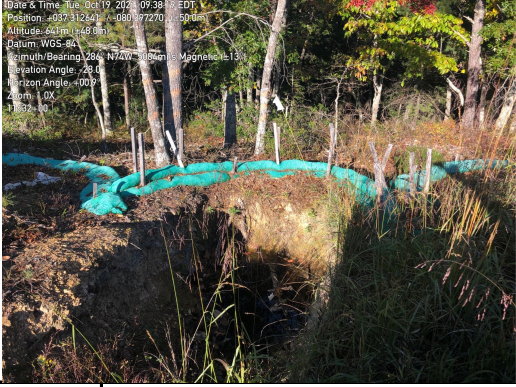
<p>Date & Time: Tue, Oct 19, 2021 09:38:19 EDT Position: 43°37'30.2436"N 72°40'39.5049"W (a30m) Altitude: 846m (2776ft) Datum: WGS-84 Azimuth/Bearing: 08° N24W 208mils Magnetic (-13°) Elevation Angle: -06.2° Horizon Angle: +02.9° Zoom: 1.0x Replace worn P1: 11668+50-11666+25</p>			
GPS Location	On photo	GPS Location	On photo		
Field Station#	11632+00	Field Station#	11629+00		
Pic 5 Desc.	Sumps and end treatments are functional	Pic 6 Desc.	Slope breakers, sumps and end treatments are functioning properly

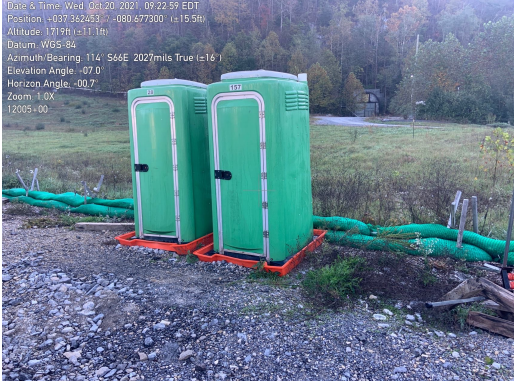
<p>Date & Time: Wed Oct 20, 2021 09:22:59 EDT Position: +037 363386 / -080 677300 (+15.5m) Altitude: 1711ft (+111m) Datum: WGS-84 Azimuth/Bearing: 114 S66E 2027mils True (+16°) Elevation Angle: -07.0 Horizon Angle: -00.7 Zoom: 1.0X 12005+00</p>

<p>Date & Time: Wed Oct 20, 2021 09:24:18 EDT Position: +037 363329 / -080 676810 (+213.3m) Altitude: 1712ft (+102.8m) Datum: WGS-84 Azimuth/Bearing: 103 S77E 1831mils True (+16°) Elevation Angle: -13.8 Horizon Angle: -01.8 Zoom: 1.0X 12005+00</p>			
GPS Location	See photo	GPS Location	See photo		
Field Station#	12005+00	Field Station#	12005+00		
Pic 1 Desc.	Secondary containment in place	Pic 2 Desc.	Culvert in place

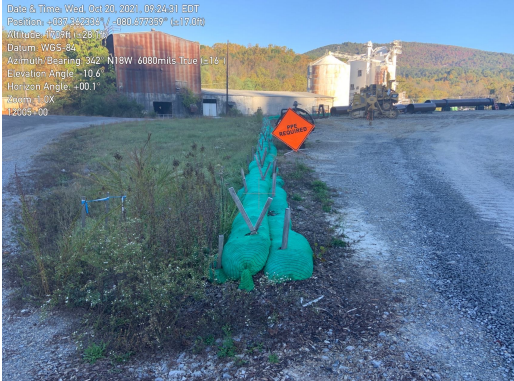
<p>Date & Time: Wed Oct 20, 2021 09:30:51 EDT Position: +037 363386 / -080 676590 (+172.4m) Altitude: 1705ft (+128m) Datum: WGS-84 Azimuth/Bearing: 342 N18W 6880mils True (+16°) Elevation Angle: -10.6 Horizon Angle: -00.1 Zoom: 1.0X 12005+00</p>

GPS Location	See photo	GPS Location	See photo		
Field Station#	12005+00	Field Station#	12005+00		
Pic 3 Desc.	Triple stacked CFS perimeter controls acceptable	Pic 4 Desc.	RCE is maintained and in acceptable condition

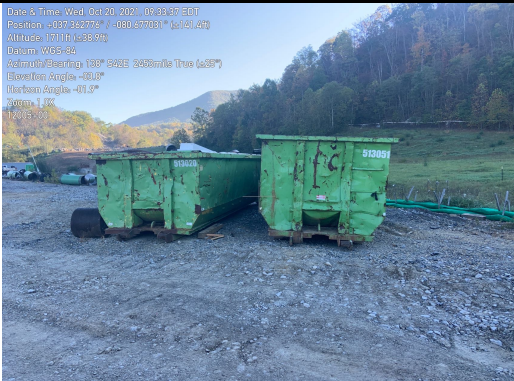
<p>Date & Time: Wed Oct 20, 2021 09:38:38 EDT Position: +037 363772 / -080 670317 (+101.4m) Altitude: 1711ft (+108.2m) Datum: WGS-84 Azimuth/Bearing: 130° S43E 3450mils True (+24°) Elevation Angle: -08.2° Horizon Angle: -01.3° Zoom: 1.0X 12005+00</p>

<p>Date & Time: Wed Oct 20, 2021 09:41:14 EDT Position: +037 363772 / -080 670426 (+105.4m) Altitude: 1710ft (+103.2m) Datum: WGS-84 Azimuth/Bearing: 130° S35E 2756mils True (+24°) Elevation Angle: -12.2° Horizon Angle: -01.1° Zoom: 1.0X 12005+00</p>			
GPS Location	See photo	GPS Location	See photo		
Field Station#	12005+00	Field Station#	12005+00		
Pic 5 Desc.	Dumpsters in place	Pic 6 Desc.	Secondary containment in place

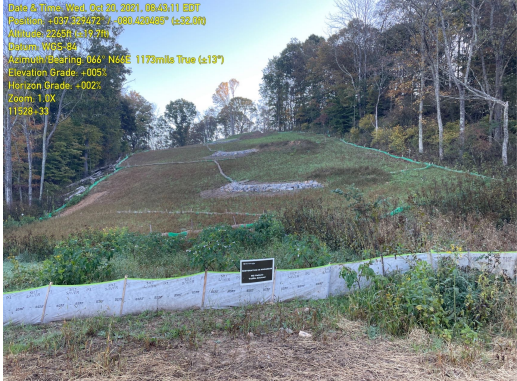
<p><small> Date & Time: Wed, Oct 20, 2021, 08:43:11 EDT Position: +437.329297° / -080.418948° (s47.310) Altitude: 22478 (s39.40) Datum: WGS-84 Azimuth/Bearing: 044° N044° 1173mils True (s13°) Elevation Grade: +005° Horizontal Grade: +002° Zoom: 1.0X 11528+33 </small></p>

<p><small> Date & Time: Wed, Oct 20, 2021, 08:49:02 EDT Position: +437.329297° / -080.418948° (s47.310) Altitude: 22478 (s39.40) Datum: WGS-84 Azimuth/Bearing: 044° N044° 1173mils True (s13°) Elevation Grade: +005° Horizontal Grade: +002° Zoom: 1.0X 11534+00 </small></p>			
GPS Location	See photo		GPS Location	See photo	
Field Station#	11528+33		Field Station#	11534+00	
Pic 1 Desc.	Proper signage in place		Pic 2 Desc.	Temporary CFS waterbars in place

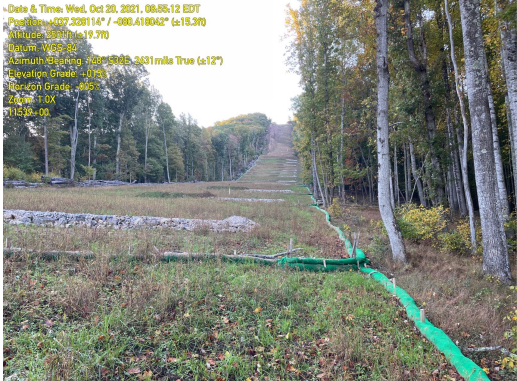
<p><small> Date & Time: Wed, Oct 20, 2021, 09:05:12 EDT Position: +437.328114° / -080.418042° (s15.370) Altitude: 22438 (s36.210) Datum: WGS-84 Azimuth/Bearing: 144° S34E 2831mils True (s12°) Elevation Grade: +005° Horizontal Grade: +005° Zoom: 1.0X 11539+00 </small></p>

GPS Location	See photo		GPS Location	See photo	
Field Station#	11539+00		Field Station#	11545+00	
Pic 3 Desc.	CFS perimeter control in place		Pic 4 Desc.	Level spreaders in place

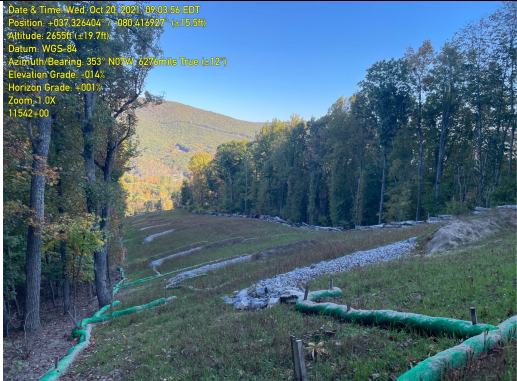
<p><small> Date & Time: Wed, Oct 20, 2021, 09:30:00 EDT Position: +437.326404° / -080.418497° (s41.210) Altitude: 22536 (s39.770) Datum: WGS-84 Azimuth/Bearing: 353° N043° 2834mils True (s12°) Elevation Grade: -014° Horizontal Grade: +001° Zoom: 1.0X 11542+00 </small></p>

<p><small> Date & Time: Wed, Oct 20, 2021, 09:30:00 EDT Position: +437.322819° / -080.414397° (s41.210) Altitude: 22738 (s36.210) Datum: WGS-84 Azimuth/Bearing: 144° S34E 2894mils True (s12°) Elevation Grade: -014° Horizontal Grade: +003° Zoom: 1.0X 11563+00 </small></p>			
GPS Location	See photo		GPS Location	See photo	
Field Station#	11542+00		Field Station#	11563+00	
Pic 5 Desc.	Permanent waterbars in place		Pic 6 Desc.	Waterbars in place

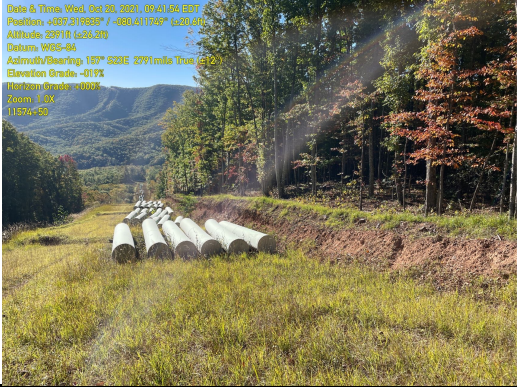
<p>Date & Time: Wed, Oct 20, 2021, 09:43:08 EDT Position: +427.216585° / -880.411596° (-25.44) Altitude: 2391ft (-62.3ft) Datum: WGS-84 Azimuth/Bearing: 180° S20E 2791mils True (-2°) Elevation Grade: -017% Horizon Grade: +003% Zoom: 1.0X 11574+50</p>

<p>Date & Time: Wed, Oct 20, 2021, 09:43:55 EDT Position: +427.216585° / -880.411596° (-25.44) Altitude: 2391ft (-62.3ft) Datum: WGS-84 Azimuth/Bearing: 180° S20E 2791mils True (-2°) Elevation Grade: -017% Horizon Grade: +003% Zoom: 1.0X 11574+50</p>			
GPS Location	See photo	GPS Location	See photo		
Field Station#	11574+50	Field Station#	11584+00		
Pic 7 Desc.	Cleanwater diversion berm in place	Pic 8 Desc.	P1 silt fence perimeter control in place

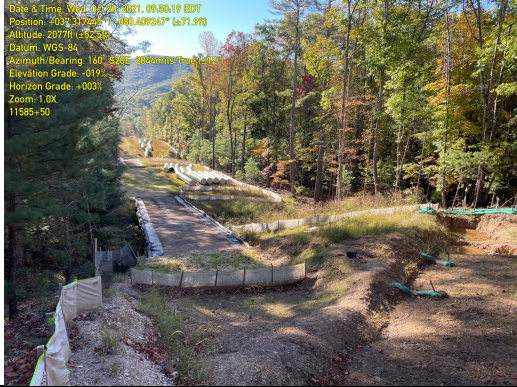
<p>Date & Time: Wed, Oct 20, 2021, 09:50:19 EDT Position: +427.216770° / -880.409247° (-25.44) Altitude: 2377ft (-62.3ft) Datum: WGS-84 Azimuth/Bearing: 160° S20E 2844mils True (-2°) Elevation Grade: -019% Horizon Grade: +003% Zoom: 1.0X 11585+50</p>

GPS Location	See photo	GPS Location	See photo		
Field Station#	11585+50	Field Station#	11592+00		
Pic 9 Desc.	Stream buffer in place	Pic 10 Desc.	P1 silt fence perimeter control in place

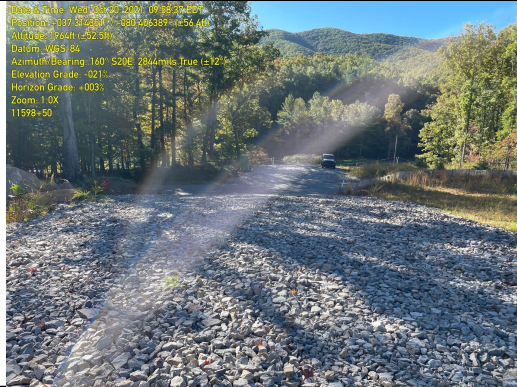
<p>Date & Time: Wed, Oct 20, 2021, 10:00:00 EDT Position: +427.216770° / -880.409247° (-25.44) Altitude: 2377ft (-62.3ft) Datum: WGS-84 Azimuth/Bearing: 160° S20E 2844mils True (-2°) Elevation Grade: -021% Horizon Grade: +003% Zoom: 1.0X 11598+50</p>

<p>Date & Time: Wed, Oct 20, 2021, 10:00:00 EDT Position: +427.216770° / -880.409247° (-25.44) Altitude: 2377ft (-62.3ft) Datum: WGS-84 Azimuth/Bearing: 160° S20E 2844mils True (-2°) Elevation Grade: -021% Horizon Grade: +003% Zoom: 1.0X 11599+00</p>			
GPS Location	See photo	GPS Location	See photo		
Field Station#	11598+50	Field Station#	11599+00		
Pic 11 Desc.	RCE in place	Pic 12 Desc.	Culvert in place

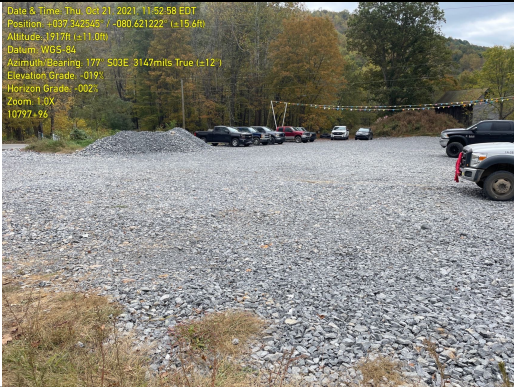
<p>Date & Time: Thu, Oct 21, 2021 11:52:58 EDT Position: -037.342528 / -080.621222 (-15.6M) Altitude: 1917ft (-11.0M) Datum: WGS-84 Azimuth/Bearing: 177 S02E 3147mils True (-12°) Elevation Grade: -01% Horizon Grade: -00% Zoom: 1.8X 10797+96</p>

GPS Location	See photo	GPS Location	See photo		
Field Station#	10797+96	Field Station#	10769+00		
Pic 3 Desc.	RCE in place	Pic 4 Desc.	CFS perimeter control in place

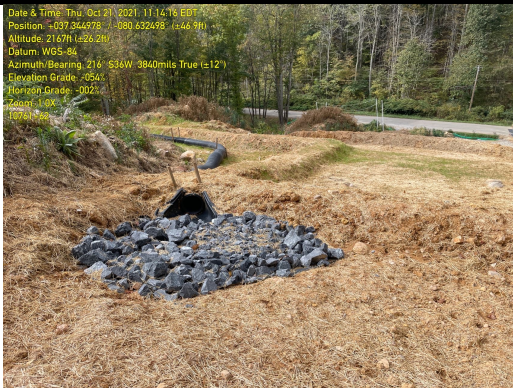
<p>Date & Time: Thu, Oct 21, 2021 11:14:18 EDT Position: -037.344078 / -080.632408 (-13.4M) Altitude: 2167ft (-26.2M) Datum: WGS-84 Azimuth/Bearing: 216 S34W 3840mils True (-12°) Elevation Grade: -05% Horizon Grade: -00% Zoom: 1.8X 10761+62</p>			
GPS Location	See photo	GPS Location	See photo		
Field Station#	10779+85	Field Station#	10761+62		
Pic 5 Desc.	Stream buffer in place	Pic 6 Desc.	Stone inlet protection in place

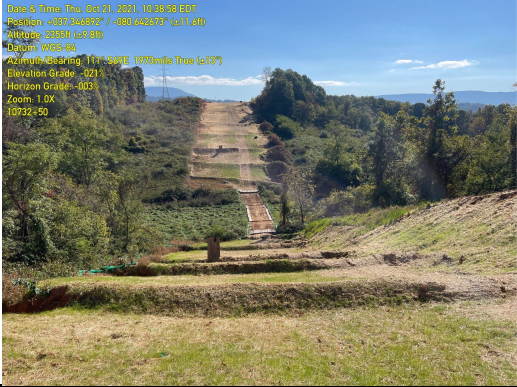
<p>Date & Time: Thu, Oct 21, 2021, 10:26:25 EDT Position: +387.344656° / -880.635817° (-13.140) Altitude: 2272ft (-1177m) Datum: WGS-84 Datum Bearing: 100° 1680E, 1762m (True (-12°) Elevation Grade: -00% Horizon Grade: -00% Zoom: 1.0X 10732+50</p>			
GPS Location	See photo	GPS Location	See photo		
Field Station#	10754+00	Field Station#	10732+50		
Pic 7 Desc.	Waterbars in place	Pic 8 Desc.	Waterbars in place

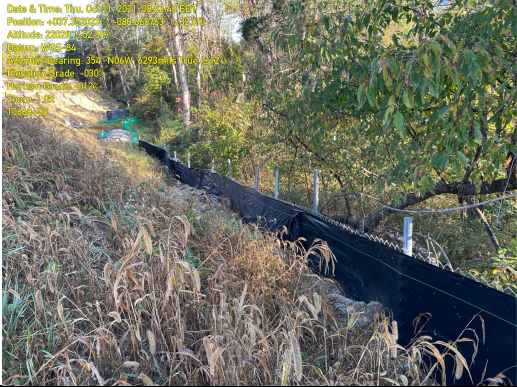
GPS Location	See photo	GPS Location	See photo		
Field Station#	10694+00	Field Station#	10668+00		
Pic 9 Desc.	Cleanwater drainage feature in place	Pic 10 Desc.	Supersilt fence perimeter control in place

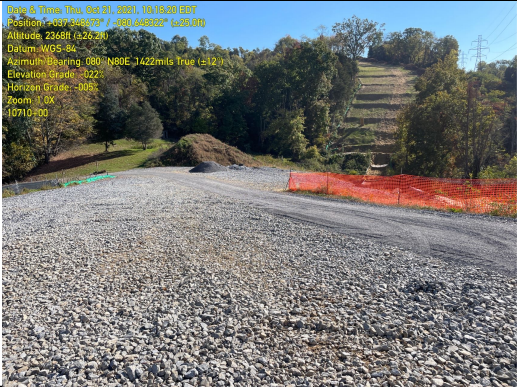
<p>Date & Time: Thu, Oct 21, 2021, 10:28:00 EDT Position: +387.344656° / -880.635817° (-13.140) Altitude: 2272ft (-1177m) Datum: WGS-84 Datum Bearing: 100° 1680E, 1762m (True (-12°) Elevation Grade: -00% Horizon Grade: -00% Zoom: 1.0X 10710+00</p>			
GPS Location	See photo	GPS Location	See photo		
Field Station#	10681+00	Field Station#	10710+00		
Pic 11 Desc.	Cleanwater diversion berm in place	Pic 12 Desc.	RCE in place

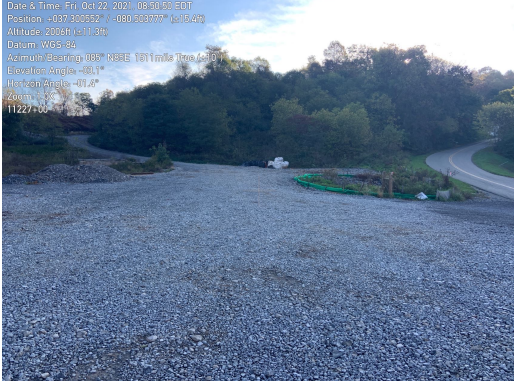
GPS Location	See photo	GPS Location	See photo		
Field Station#	11227+00	Field Station#	11111+85		
Pic 1 Desc.	RCE at Winding Way is acceptable	Pic 2 Desc.	Subsoil being restored

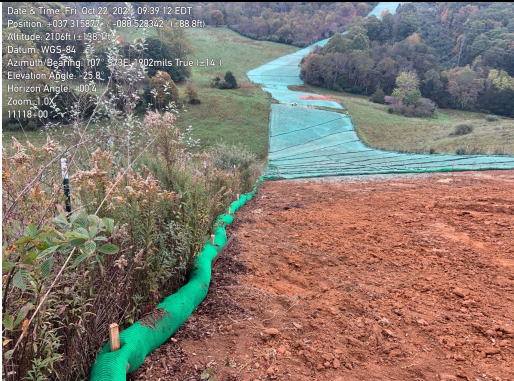
GPS Location	See photo	GPS Location	See photo		
Field Station#	11118+00	Field Station#	11121+00		
Pic 3 Desc.	Perimeter controls and CFS water bars acceptable	Pic 4 Desc.	Daylight drain and outlet protection acceptable

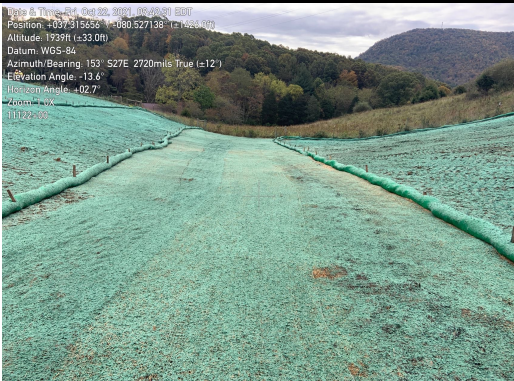
GPS Location	See photo	GPS Location	See photo		
Field Station#	11122+00	Field Station#	11134+00		
Pic 5 Desc.	Erosion control blanket in drainage feature acceptable	Pic 6 Desc.	Permanent water bar and level spreader acceptable

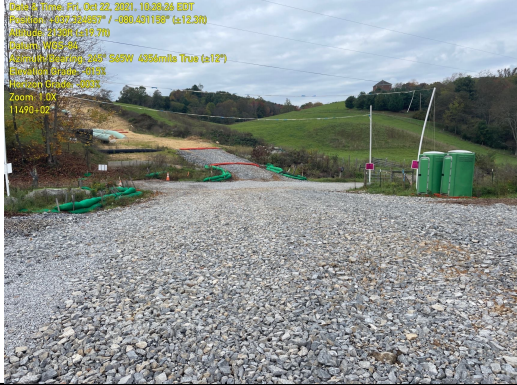
GPS Location		See photo		GPS Location	
Field Station#		11490+02		Field Station#	
Pic 9 Desc.		RCE in place		Pic 10 Desc.	
<p>Date & Time: Fri, Oct 22, 2021, 09:35:44 EDT Position: +037.298287° / -080.475144° (s147.30) Altitude: 2447ft (s420.00) Datum: WGS-84 Azimuth/Bearing: 305° N10W 603ft/mile True (s12°) Elevation Grade: -004% Horizon Grade: +009% Zoom: 1.0X 11317+00</p>

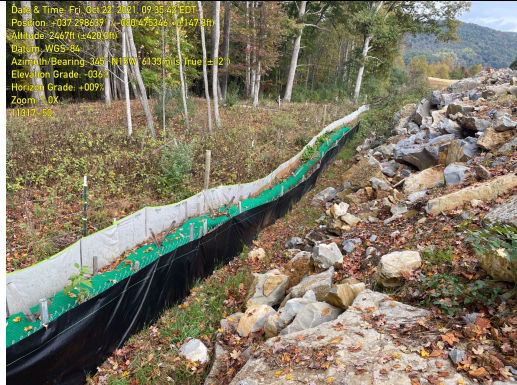
GPS Location		See photo		GPS Location	
Field Station#		11317+50		Field Station#	
Pic 11 Desc.		Karst feature ECDs in place		Pic 12 Desc.
