Visual Site Inspection Report

Project Name	H-600 Pipeline Spread G	AFE	124300137	Spread	H-600 Pipeline Spread G
Contractor	Precision			Report #	30229
Inspector	Clint Sears			Date/Time	10/25/2021 12:49 PM
Permit #	TBD	Inspection Type	VA SWPP	Station Begin	11788+52
State	VA	Inspection Area	Full	Station End	12005+00
County	Montgomery	Ground	Dry	Temperature (°F)	73.00
Municipality	N/A	Weather	Sunny	Rain Gauge (in)	0.00
				Rain Accumulation Time (days)	1.00

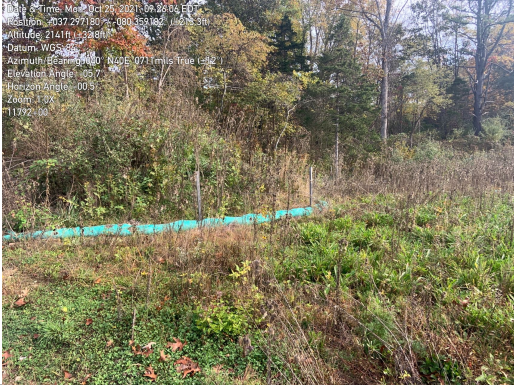
GPS Location		See photo		GPS Location	
Field Station#		11792+00		Field Station#	
Pic 3 Desc.		CFS perimeter controls in place and functional		Pic 4 Desc.

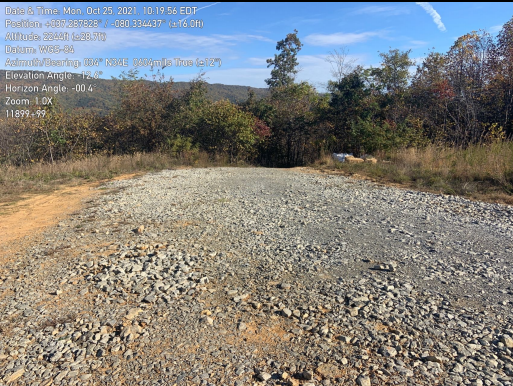
GPS Location		See photo		GPS Location	
Field Station#		11882+50		Field Station#	
Pic 5 Desc.		CFS water bar end treatments and perimeter controls functional		Pic 6 Desc.	
				AR266.03 is in acceptable condition

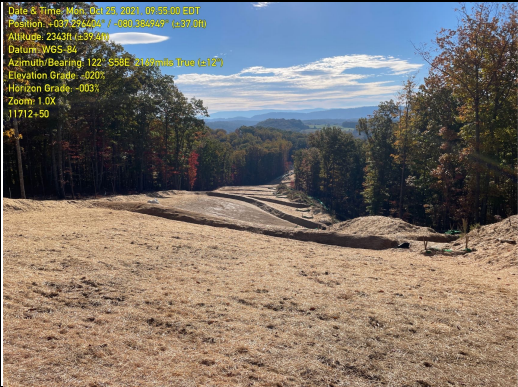
GPS Location	See photo	GPS Location	See photo		
Field Station#	11712+50	Field Station#	11700+00		
Pic 7 Desc.	Waterbars in place	Pic 8 Desc.	CFS perimeter control in place		
<p>Date & Time: Mon, Oct 25, 2021, 09:57:03 EDT Position: +437.300453° / -880.372583° (s37.00) Altitude: 2294ft (s37.00) Datum: WGS-84 Azimuth/Bearing: 105° N 551mils True (s12°) Elevation Grade: -028° Horizon Grade: -005° Zoom: 1.0X 11687+00</p>

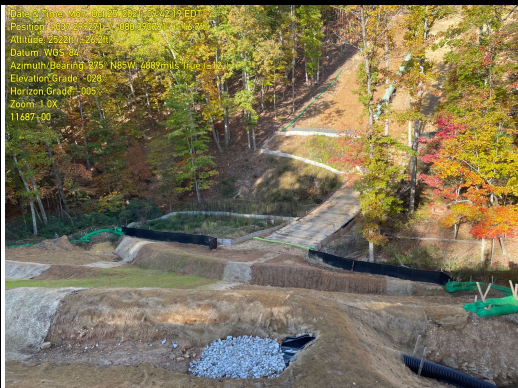
GPS Location	See photo	GPS Location	See photos		
Field Station#	11687+00	Field Station#	11681+50		
Pic 9 Desc.	Stone inlet protection in place	Pic 10 Desc.	CFS perimeter control in place		
<p>Date & Time: Mon, Oct 25, 2021, 09:57:03 EDT Position: +437.300453° / -880.372583° (s37.00) Altitude: 2294ft (s37.00) Datum: WGS-84 Azimuth/Bearing: 180° S 551mils True (s12°) Elevation Grade: -000° Horizon Grade: -000° Zoom: 1.0X 11678+00</p>

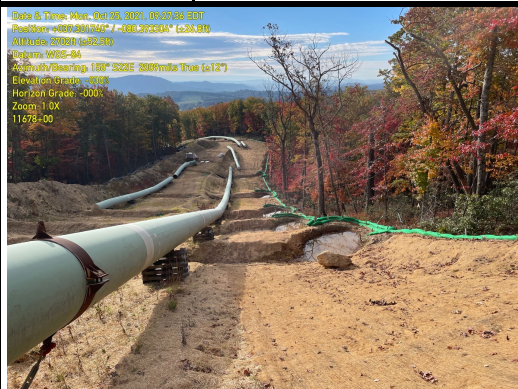
GPS Location	See photo	GPS Location	See photos		
Field Station#	11678+00	Field Station#	11669+00		
Pic 11 Desc.	Waterbars in place	Pic 12 Desc.	P1 silt fence perimeter control in place

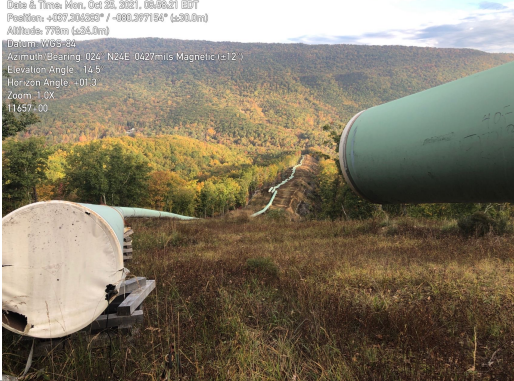
GPS Location		On photo		GPS Location	
Field Station#		11657+00		Field Station#	
Pic 3 Desc.		ROW stable. Slope breakers functional.		Pic 4 Desc.	
				Perimeter ECDs are functional.

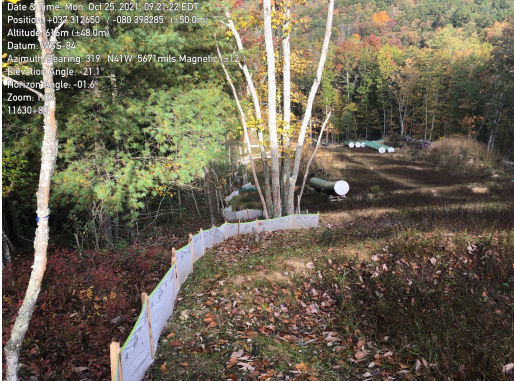
GPS Location		On photo		GPS Location	
Field Station#		11630+00		Field Station#	
Pic 5 Desc.		Perimeter ECDs are functional.		Pic 6 Desc.	
				The S-HH18 crossing is stable with no impact to resource.

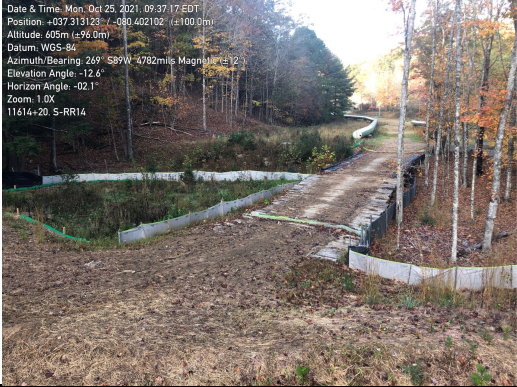
<p><small>Date & Time: Mon, Oct 25, 2021 09:43:55 EDT Position: +037.313531 / -080.404333 (+100.0m) Altitude: 688m (+92.0m) Datum: WGS-84 Azimuth/Bearing: 180° S16W 4378mils Magnitude: +13° Elevation Angle: -28.0° Horizon Angle: -00.4° Zoom: 1.0X 11608+17</small></p>			
GPS Location	On photo	GPS Location	On photo		
Field Station#	11614+20	Field Station#	11608+17		
Pic 7 Desc.	The S-RR14 crossing is stable with ECDs in place.	Pic 8 Desc.	The S-006 crossing is stable.

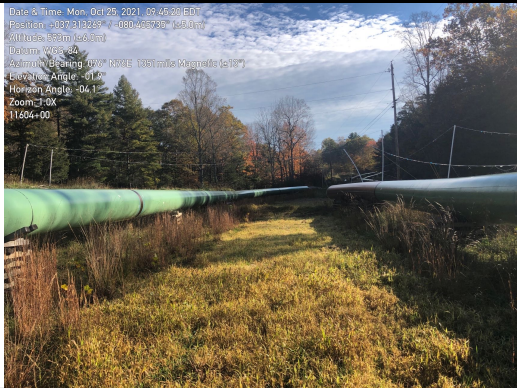
GPS Location	On photo	GPS Location			
Field Station#	11604+00	Field Station#			
Pic 9 Desc.	The ROW is currently stable.	Pic 10 Desc.			
<p style="text-align: center;">Insert image here</p>		<p style="text-align: center;">Insert image here</p>			
GPS Location		GPS Location			
Field Station#		Field Station#			
Pic 11 Desc.		Pic 12 Desc.

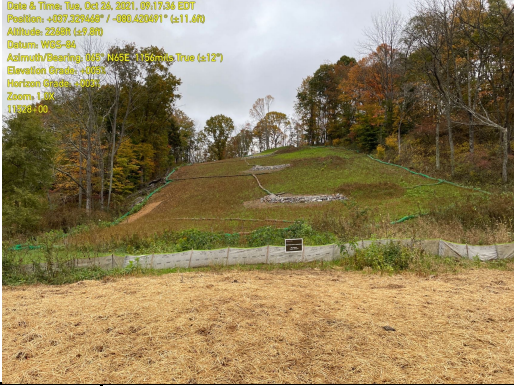
<p>Date & Time: Tue, Oct 26, 2021, 09:22:33 EDT Position: +037.3294407° / -080.4189997° (±11.90) Altitude: 2251R (±9.40) Datum: WGS-84 Azimuth/Bearing: 137° S43E 2436mils True (±12°) Elevation Grade: +010% Horizontal Grade: +011% Zoom: 1.0X 11534+00</p>			
GPS Location	See photo	GPS Location	See photo		
Field Station#	11528+00	Field Station#	11534+00		
Pic 1 Desc.	Proper signage in place	Pic 2 Desc.	Temporary CFS waterbars in place

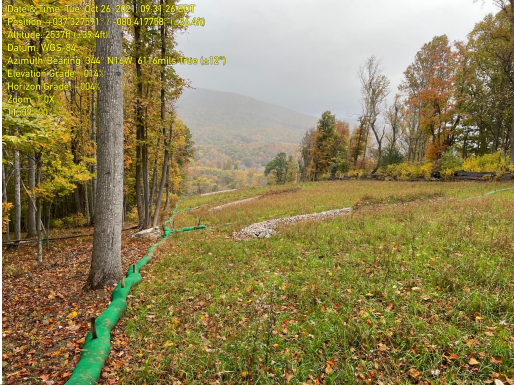
GPS Location	See photo	GPS Location	See photo		
Field Station#	11539+00	Field Station#	11543+00		
Pic 3 Desc.	Level spreaders in place	Pic 4 Desc.	CFS perimeter controls in place

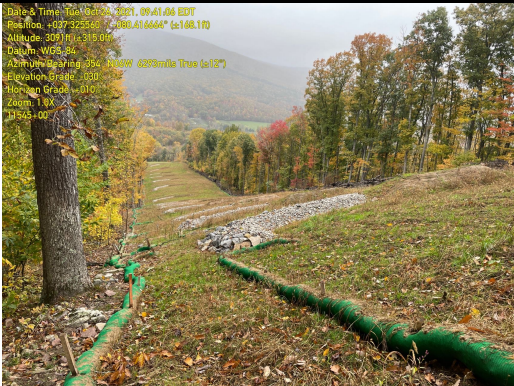
<p>Date & Time: Tue, Oct 26, 2021, 10:00:10 EDT Position: +037.329556° / -080.445597° (±13097.00) Altitude: 2090R (±218.30) Datum: WGS-84 Azimuth/Bearing: 146° S34E 2096mils True (±12°) Elevation Grade: +024% Horizontal Grade: +024% Zoom: 1.0X 11564+00</p>			
GPS Location	See photo	GPS Location	See photo		
Field Station#	11545+00	Field Station#	11564+00		
Pic 5 Desc.	Permanent waterbars in place	Pic 6 Desc.	Waterbars in place

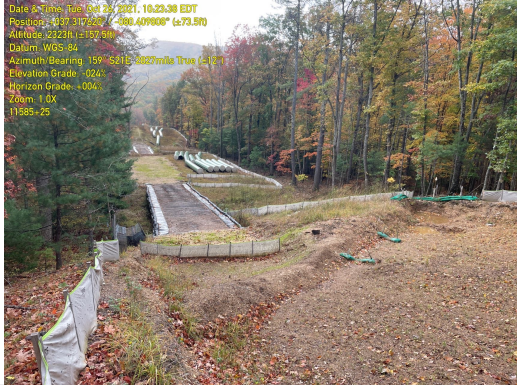
GPS Location	See photo	GPS Location	See photo		
Field Station#	11585+25	Field Station#	11592+00		
Pic 9 Desc.	Stream buffer in place	Pic 10 Desc.	Silt fence perimeter control in place		
<p>Date & Time: Tue, Oct 26, 2021, 11:01:58 EDT Position: +037.314323° / -080.206463° (+42.54) Altitude: 1955ft (+26.2ft) Datum: WGS-84 Azimuth/Bearing: 168° S15E 2933mils True (+12) Elevation Grade: -014% Horizon Grade: +002% Zoom: 1.0X 11598+50</p>

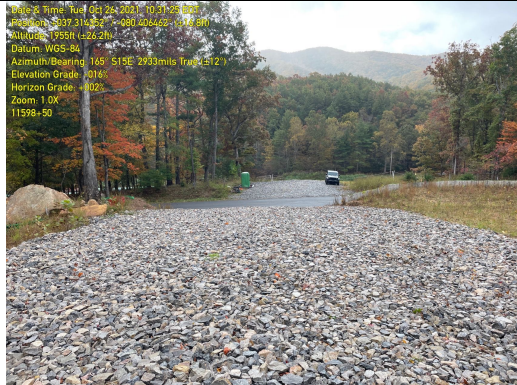
GPS Location	See photo	GPS Location	See photo		
Field Station#	11598+50	Field Station#	11599+00		
Pic 11 Desc.	RCE in place	Pic 12 Desc.	Culvert in place

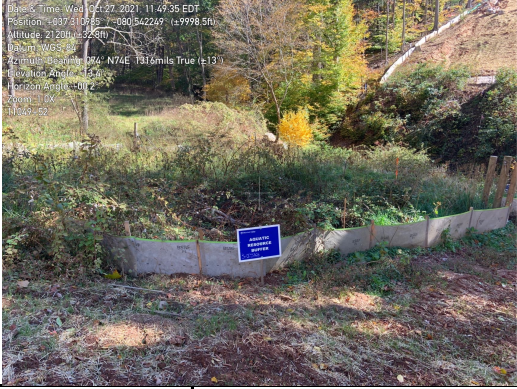
GPS Location	See photo	GPS Location			
Field Station#	11049+52	Field Station#			
Pic 13 Desc.	Signage and buffer are in acceptable condition	Pic 14 Desc.			
Insert image here		Insert image here			
GPS Location		GPS Location			
Field Station#		Field Station#			
Pic 15 Desc.		Pic 16 Desc.			
Insert image here		Insert image here			
GPS Location		GPS Location			
Field Station#		Field Station#			
Pic 17 Desc.		Pic 18 Desc.

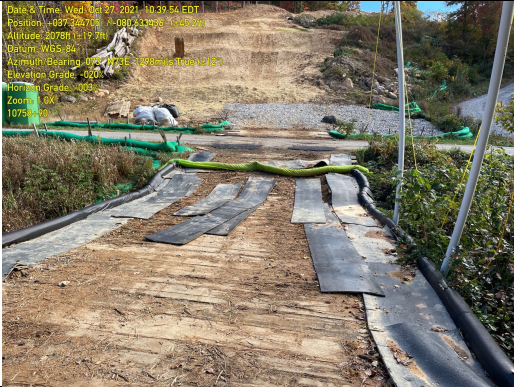
<p>Date & Time: Wed Oct 27, 2021 09:21:38 EDT Position: +037.342717, -80.619887 (+35.3m) Altitude: 2070ft (+12m) Datum: WGS-84 Azimuth Bearing: 116.944E 2062mils True (+12) Elevation Grade: +005 Horizon Grade: +003 Zoom: 1.0X 10679+30</p>		GPS Location	See photo
Field Station#	10758+90	Field Station#	10679+30	GPS Location	See photo
Pic 1 Desc.	Lose mining belt needs removed from bridge	Pic 2 Desc.	Bridge needs cleaned off	GPS Location	See photo

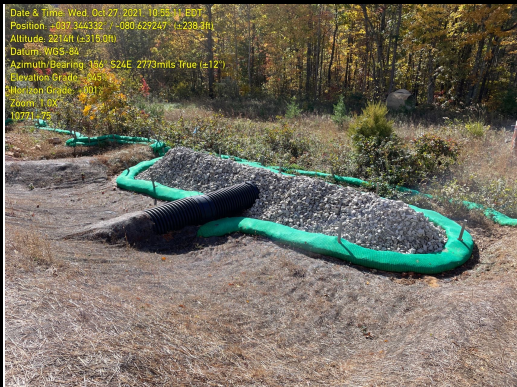
GPS Location	See photo	GPS Location	See photo		
Field Station#	10771+75	Field Station#	10733+00		
Pic 7 Desc.	Cleanwater diversion outlet protection in place	Pic 8 Desc.	Waterbars in place		
<p>Date & Time: Wed, Oct 27, 2021, 09:55:28 EDT Position: +037.348296° / -080.648367° (±15.2ft) Altitude: 2236ft (±13.1ft) Datum: WGS-84 Azimuth/Bearing: 238° S58W 4231mils True (±12°) Elevation Grade: -013% Horizon Grade: +019% Zoom: 1.0X 10708+00</p>

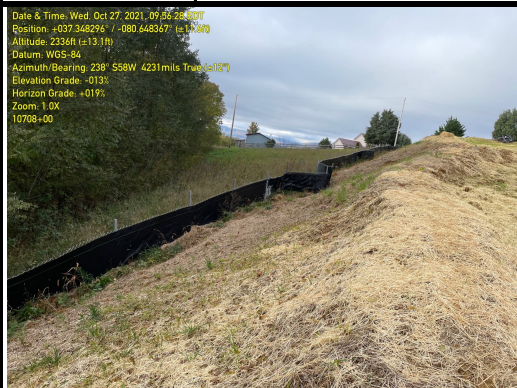
GPS Location	See photo	GPS Location	See photo		
Field Station#	10708+00	Field Station#	10694+00		
Pic 9 Desc.	Supersilt fence perimeter control in place	Pic 10 Desc.	Cleanwater drainage feature in place		
<p>Date & Time: Wed, Oct 27, 2021, 09:28:53 EDT Position: +037.349004° / -080.659238° (±2010.2ft) Altitude: 2154ft (±226.7ft) Datum: WGS-84 Azimuth/Bearing: 118° S45E 2044mils True (±12°) Elevation Grade: -021% Horizon Grade: -018% Zoom: 1.0X 10684+75</p>

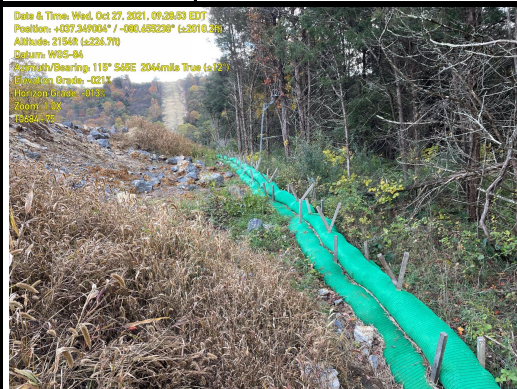
GPS Location	See photo	GPS Location	See photo		
Field Station#	10684+75	Field Station#	10667+25		
Pic 11 Desc.	CFS triple stack perimeter control in place	Pic 12 Desc.	Fill slope stabilized with erosion control blanket

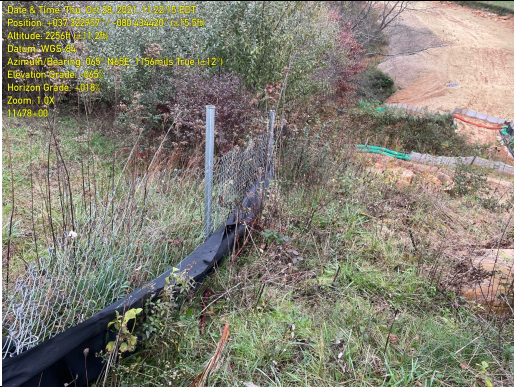
<p>Date & Time: Thu, Oct 28, 2021, 11:11:25 EDT Position: +407.3229417 / -880.4326657 (s14.71) Altitude: 22320 (+13.5m) Datum: WGS-84 Azimuth: Bearing: 000° S00E 010mils True (+12°) Elevation Grade: -029° Horizon Grade: -016° Zoom: 1.0X 11479+15</p>			
GPS Location	See photo	GPS Location	See photo		
Field Station#	11478+00	Field Station#	11479+15		
Pic 1 Desc.	Supersilt fence fabric needs reattached to chain link	Pic 2 Desc.	Equipment bridge needs cleaned off

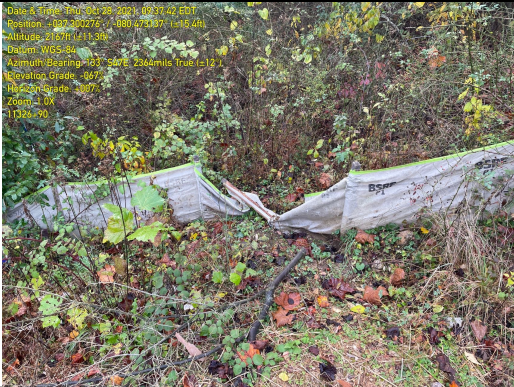
GPS Location	See photo	GPS Location	See photo		
Field Station#	11326+90	Field Station#	11340+00		
Pic 3 Desc.	P1 silt fence damaged by wildlife	Pic 4 Desc.	Erosion control blanket needs properly installed

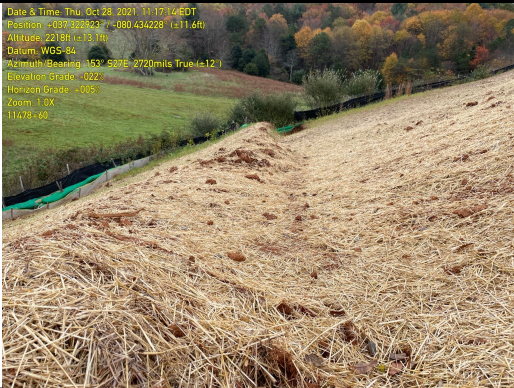
<p>Date & Time: Thu, Oct 28, 2021, 10:38:20 EDT Position: +407.323138804 / -880.4462091 (s14.51) Altitude: 19950 (+26.2m) Datum: WGS-84 Azimuth: Bearing: 177° S01E 3127mils True (+12°) Elevation Grade: -029° Horizon Grade: -016° Zoom: 1.0X 11362+00</p>			
GPS Location	See photo	GPS Location	See photo		
Field Station#	11478+60	Field Station#	11362+00		
Pic 5 Desc.	Waterbar needs built up to specifications through travel lane	Pic 6 Desc.	End treatments in place

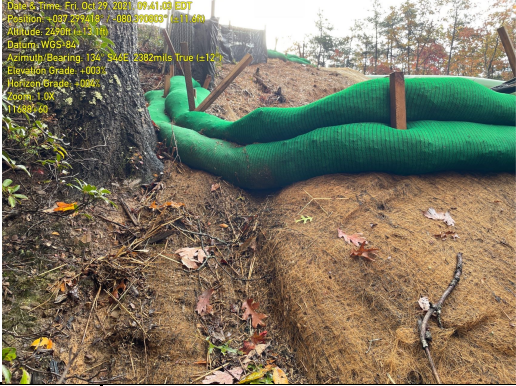
<p>Date & Time: Fri, Oct 29, 2021, 09:42:00 EDT Position: +437.23418° / +400.37000° (±11.9m) Altitude: 2341m (±1.9m) Datum: WGS 84 Azimuth/Bearing: 100° S06E 1278mils True (±12°) Elevation Grade: +011° Horizon Grade: +011° Zoom: 1.0X M: Tabor 1.1"</p>		GPS Location	See photo
Field Station#	11688+60	Field Station#	11711+48	GPS Location	See photo
Pic 1 Desc.	End treatment undermined	Pic 2 Desc.	P1 silt fence undermined	GPS Location	See photo

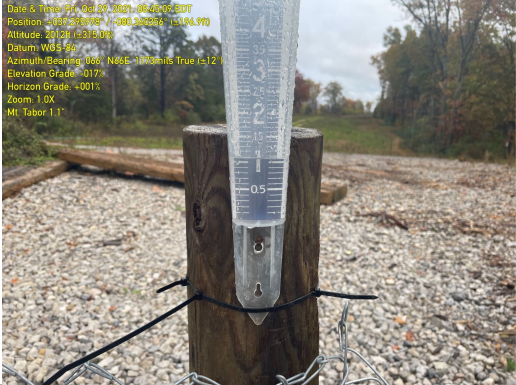
Field Station#	11788+43	Field Station#	11670+00	GPS Location	See photo
Pic 3 Desc.	My. Tabor rain gauge measured 1.1" of rainfall	Pic 4 Desc.	P1 silt fence perimeter control in place	GPS Location	See photo

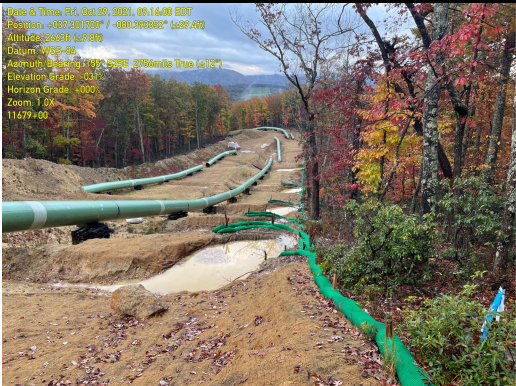
<p>Date & Time: Fri, Oct 29, 2021, 09:45:00 EDT Position: +437.23418° / +400.37000° (±11.9m) Altitude: 2341m (±1.9m) Datum: WGS 84 Azimuth/Bearing: 139° S01E 1278mils True (±12°) Elevation Grade: +000° Horizon Grade: +000° Zoom: 1.0X M: Tabor 1.1"</p>		GPS Location	See photo
Field Station#	11679+00	Field Station#	11683+50	GPS Location	See photo
Pic 5 Desc.	End treatments in place	Pic 6 Desc.	Stone inlet protection in place	GPS Location	See photo

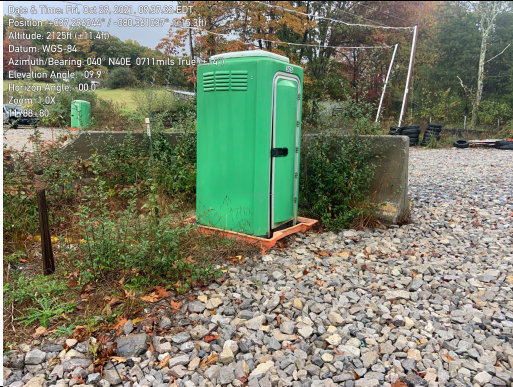
GPS Location	See photo	GPS Location	See photo		
Field Station#	11788+95	Field Station#	11788+80		
Pic 1 Desc.	RCE is maintained and in acceptable condition	Pic 2 Desc.	Secondary containment in place

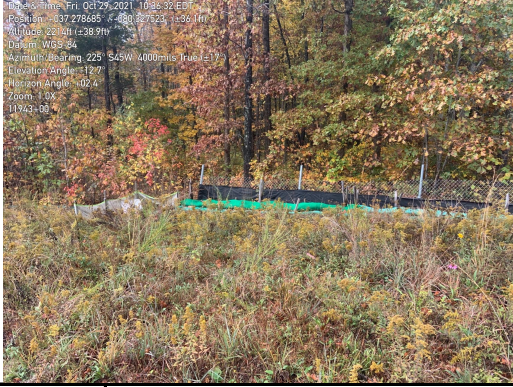
GPS Location	See photo	GPS Location	See photo		
Field Station#	11930+20	Field Station#	11943+00		
Pic 5 Desc.	Permanent vegetation is in acceptable condition	Pic 6 Desc.	Perimeter controls are in acceptable condition

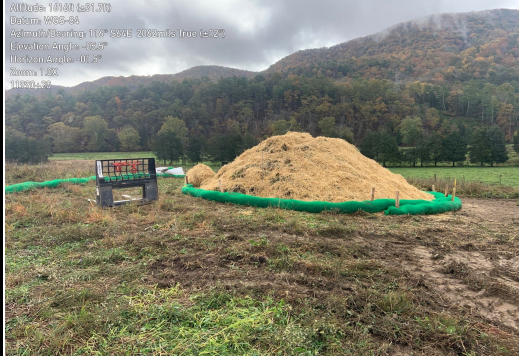
GPS Location	See photo		GPS Location	See photo	
Field Station#	11990+20		Field Station#	12005+00	
Pic 7 Desc.	CFS perimeter controls and stabilization of topsoil acceptable		Pic 8 Desc.	Temporary stabilization of disturbed soils is acceptable	
<p>Date & Time: Fri, Oct 29, 2021, 11:16:59 EDT Position: +40° 27' 7.7" / -80° 32' 51.3" (s18.1°) Altitude: 210.0 ft (s11.4°) Datum: WGS-84 Azimuth/Bearing: 180° 50' 58" (s18.1°) True (s10°) Elevation Angle: -00.3° Horizon Angle: -01.0° Zoom: 1.0X 11930+00</p>

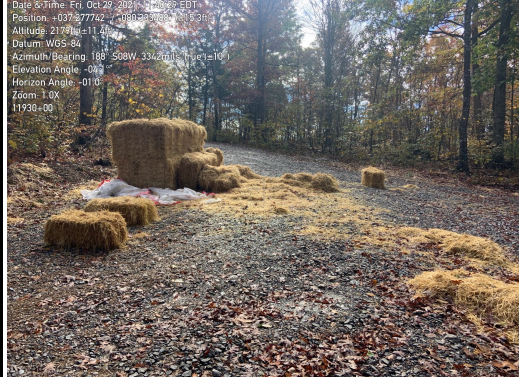
GPS Location	See photo		GPS Location	See photo	
Field Station#	11930+00		Field Station#	11930+00	
Pic 9 Desc.	Straw bales scattered across AR266 added to punch list for removal		Pic 10 Desc.	Damaged P1 silt fence added to the punch list for repair	
<p>Date & Time: Fri, Oct 29, 2021, 11:18:39 EDT Position: +40° 27' 44.9" / -80° 32' 57.0" (s18.1°) Altitude: 203.0 ft (s11.2°) Datum: WGS-84 Azimuth/Bearing: 204° 55' 06" (s18.1°) True (s12°) Elevation Angle: -15.7° Horizon Angle: -06.8° Zoom: 1.0X 11930+00</p>

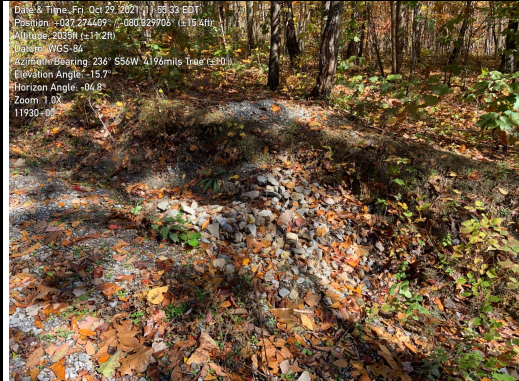
GPS Location	See photo		GPS Location	See photo	
Field Station#	11930+00		Field Station#	11988+41	
Pic 11 Desc.	Rock check dams along AR266 are in acceptable condition		Pic 12 Desc.	Rain gage at Catawba with 1.3" inches of rain
