# Visual Site Inspection Report

<b>Project Name</b>	H-600 Pipeline Spread G	<b>AFE</b>	124300137	<b>Spread</b>	H-600 Pipeline Spread G
<b>Contractor</b>	Precision			<b>Report #</b>	29321
<b>Inspector</b>	Patrick Shields			<b>Date/Time</b>	10/4/2021 4:44 PM
<b>Permit #</b>	TBD	<b>Inspection Type</b>	VA SWPP	<b>Station Begin</b>	11524+16
<b>State</b>	VA	<b>Inspection Area</b>	Full	<b>Station End</b>	11600+01
<b>County</b>	Craig	<b>Ground</b>	Wet	<b>Temperature (°F)</b>	68.00
<b>Municipality</b>	N/A	<b>Weather</b>	Cloudy	<b>Rain Gauge (in)</b>	0.65
				<b>Rain Accumulation Time (days)</b>	1.00

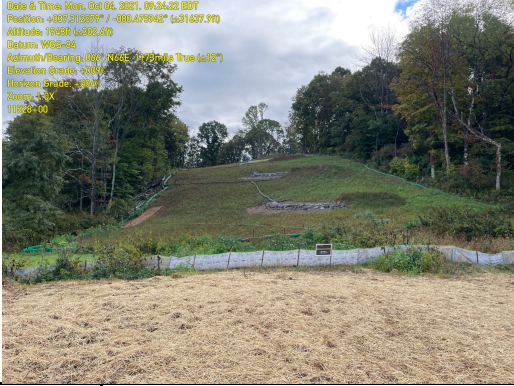
<b>GPS Location</b>	See photo	<b>GPS Location</b>	See photo		
<b>Field Station#</b>	11528+00	<b>Field Station#</b>	11533+00		
<b>Pic 1 Desc.</b>	Proper signage in place	<b>Pic 2 Desc.</b>	Temporary CFS waterbars in place		
<p>Date &amp; Time: Mon, Oct 04, 2021, 09:34:35 EDT  Position: +037.327019° / -080.417717° (s149.210)  Altitude: 2640ft (s19.410)  Datum: WGS-84  Azimuth/Bearing: 160° 50'00" SAGE 2640m True (s12°)  Elevation Grade: -000°  Horizon Grade: -000°  Zoom: 1.0X  11542+00</p>

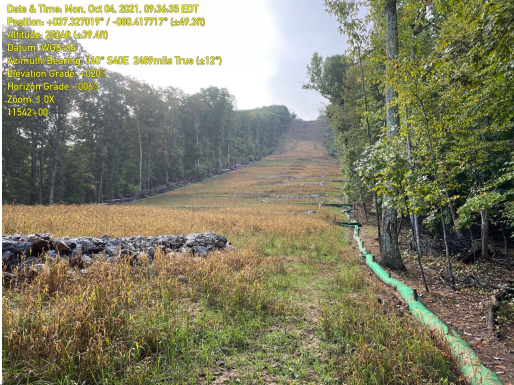
<b>GPS Location</b>	See photo	<b>GPS Location</b>	See photo		
<b>Field Station#</b>	11542+00	<b>Field Station#</b>	11546+00		
<b>Pic 3 Desc.</b>	CFS end treatments in place	<b>Pic 4 Desc.</b>	Level spreaders in place		
<p>Date &amp; Time: Mon, Oct 04, 2021, 10:04:32 EDT  Position: +037.326265° / -080.416765° (s15.110)  Altitude: 2640ft (s11.710)  Datum: WGS-84  Azimuth/Bearing: 161° 51'00" S19E 2642m True (s12°)  Elevation Grade: -025X  Horizon Grade: -015X  Zoom: 1.0X  11546+00</p>

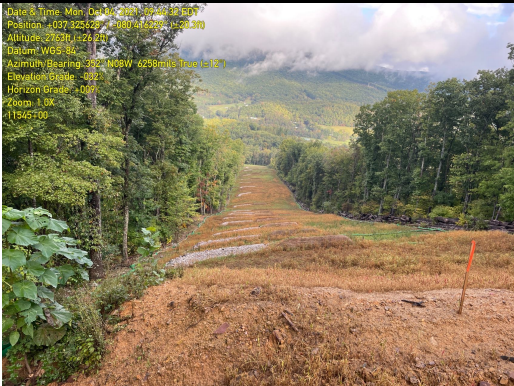
<b>GPS Location</b>	See photo	<b>GPS Location</b>	See photo		
<b>Field Station#</b>	11545+00	<b>Field Station#</b>	11534+00		
<b>Pic 5 Desc.</b>	Permanent waterbars in place	<b>Pic 6 Desc.</b>	End treatment undermined

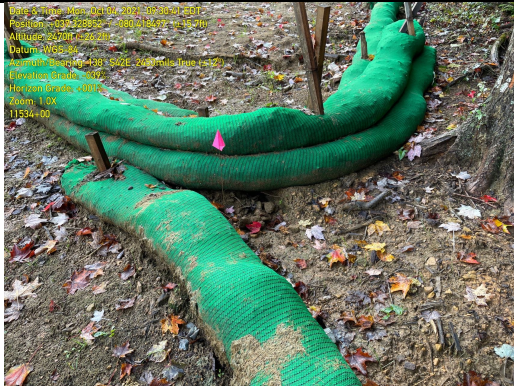
E&S BMPs	Compliance Level	Corrective Action	Corrective Time Frame	Date Repaired
Waterbar End Treatment	Communication	See comments		
Cleanwater Diversion Berm	Acceptable			
Culvert	Acceptable			
Equipment Bridge	Acceptable			
Erosion Control Blanket	Acceptable			
Housekeeping	Acceptable			
Rock Construction Entrance	Acceptable			
Sensitive Resource Buffer	Acceptable			
Silt Fence (Filter Fabric Fence)	Acceptable

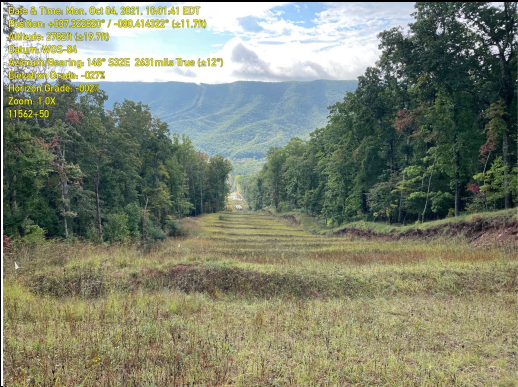
<p>Date &amp; Time: Mon, Oct 04, 2021, 10:09:49 EDT Position: +037.32024° / -80.414271° (±10.5m) Altitude: 2638ft (±16.4m) Datum: WGS-84 Azimuth/Bearing: 187° E50W 3326mils True (±12°) Elevation Grade: -063% Horizon Grade: -063% Zoom: 1.0X 11566+27</p>	
GPS Location	See photo	GPS Location	See photo		
Field Station#	11562+50	Field Station#	11566+27		
Pic 7 Desc.	Waterbars in place	Pic 8 Desc.	Sediment filter logs in place

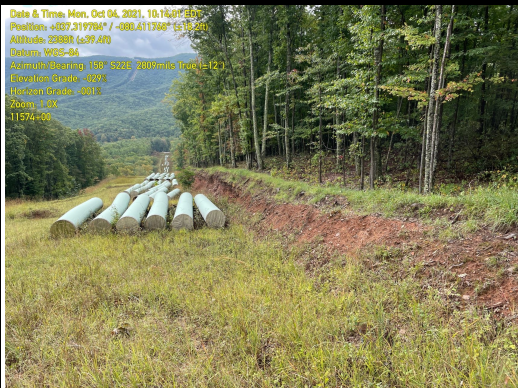
GPS Location	See photo	GPS Location	See photo		
Field Station#	11574+00	Field Station#	11583+00		
Pic 9 Desc.	Cleanwater diversion berm in place	Pic 10 Desc.	P1 silt fence perimeter control in place

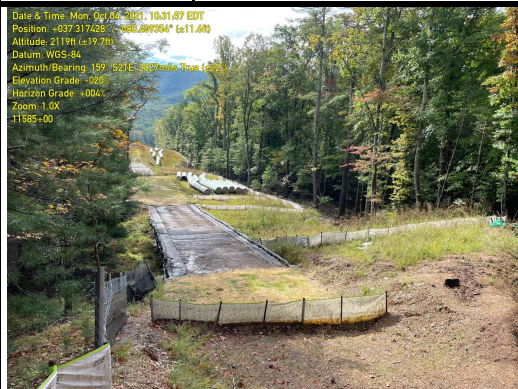
<p>Date &amp; Time: Mon, Oct 04, 2021, 10:49:22 EDT Position: +037.314315° / -80.42551° (±14.0m) Altitude: 1920ft (±13.4m) Datum: WGS-84 Azimuth/Bearing: 142° S18E 2680mils True (±12°) Elevation Grade: -3% Horizon Grade: +003% Zoom: 1.0X 11598+50</p>	
GPS Location	See photo	GPS Location	See photo		
Field Station#	11585+00	Field Station#	11598+50		
Pic 11 Desc.	Stream buffer in place	Pic 12 Desc.	RCE in place

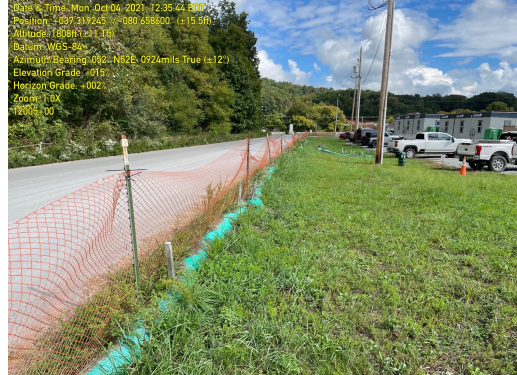
<p>Date &amp; Time: Mon, Oct 04, 2021, 12:35:44 EDT Position: +407.2184197° / -080.658002° (+19.5m) Altitude: 1805ft (+11.1ft) Datum: WGS-84 Azimuth/Bearing: 002° N02° 00' 00"mils True (+12°) Elevation Grade: -001° Horizon Grade: -002° Zoom: 1.0x 12005+00</p>			
GPS Location	See photo		GPS Location	See photo	
Field Station#	12005+00		Field Station#	12005+00	
Pic 1 Desc.	Fuel island is maintained in acceptable condition		Pic 2 Desc.	CFS perimeter control in place

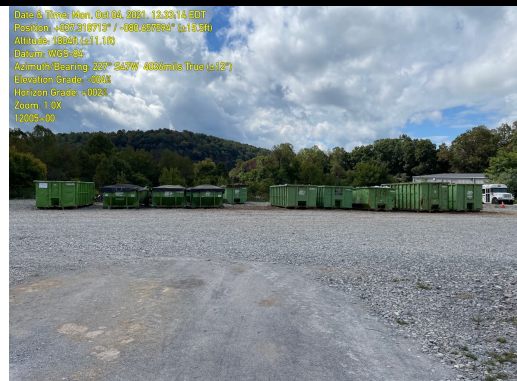
GPS Location	See photo		GPS Location	See photo	
Field Station#	12005+00		Field Station#	12005+00	
Pic 3 Desc.	Secondary containments in place		Pic 4 Desc.	Dumpsters in place

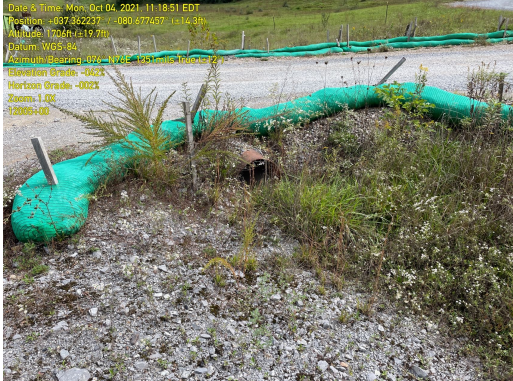
<p>Date &amp; Time: Mon, Oct 04, 2021, 11:25:47 EDT Position: +037.361167° / -080.677294° (±15.3m) Altitude: 1709m (±11.7m) Datum: WGS-84 Azimuth/Heading: 187° S20E 2290miles True (±12°) Elevation Grade: -001% Horizon Grade: -001% Zoom: 1.0X 12005+00</p>			
GPS Location		See photo				GPS Location		See photo							
Field Station#		12005+00				Field Station#		12005+00							
Pic 1 Desc.		Culvert in place				Pic 2 Desc.		Secondary containment in place

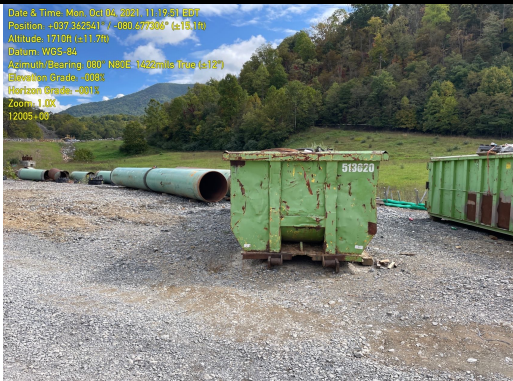
GPS Location		See photo				GPS Location		See photo							
Field Station#		12005+00				Field Station#		12005+00							
Pic 3 Desc.		Dumpsters in place				Pic 4 Desc.		Inspected fuel cel for any visible leaks or spills

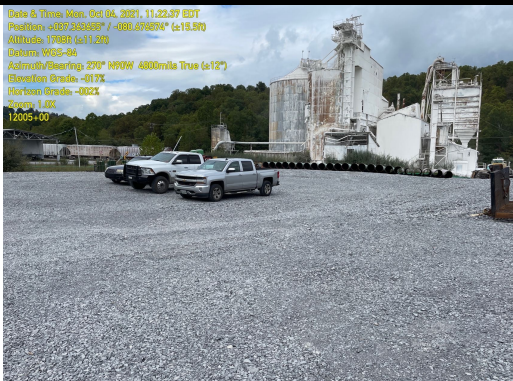
<p>Date &amp; Time: Mon, Oct 04, 2021, 11:26:11 EDT Position: +037.363012° / -080.677084° (±15.3m) Altitude: 1710m (±11.7m) Datum: WGS-84 Azimuth/Heading: 207° S20W 3400miles True (±12°) Elevation Grade: -017% Horizon Grade: -017% Zoom: 1.0X 12005+00</p>			
GPS Location		See photo				GPS Location		See photo							
Field Station#		12005+00				Field Station#		12005+00							
Pic 5 Desc.		Rock surface in acceptable condition				Pic 6 Desc.		CFS triple stack perimeter control in place of

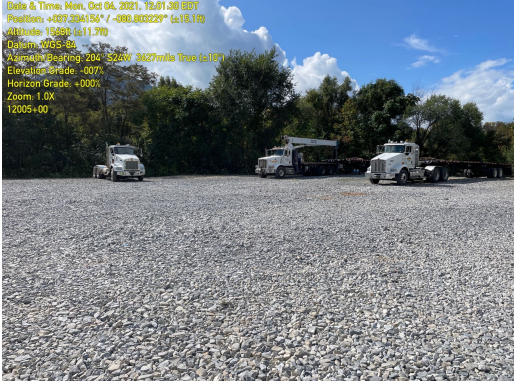
<b>GPS Location</b>		See photo		<b>GPS Location</b>	
<b>Field Station#</b>		12005+00		<b>Field Station#</b>	
<b>Pic 1 Desc.</b>		Rock surface in acceptable condition		<b>Pic 2 Desc.</b>	
				Inspected parked vehicles being stored here for any visible spills or leaks

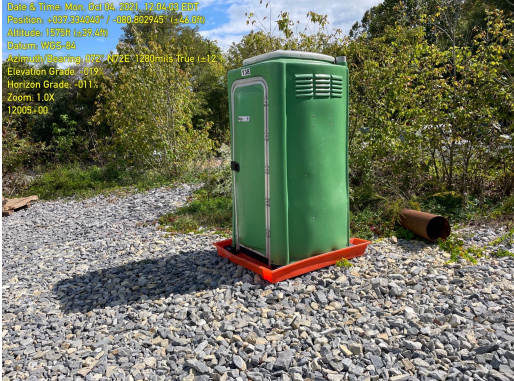
<b>GPS Location</b>		See photo		<b>GPS Location</b>	
<b>Field Station#</b>		12005+00		<b>Field Station#</b>	
<b>Pic 3 Desc.</b>		Secondary containment in place		<b>Pic 4 Desc.</b>	
				Dumpsters in place

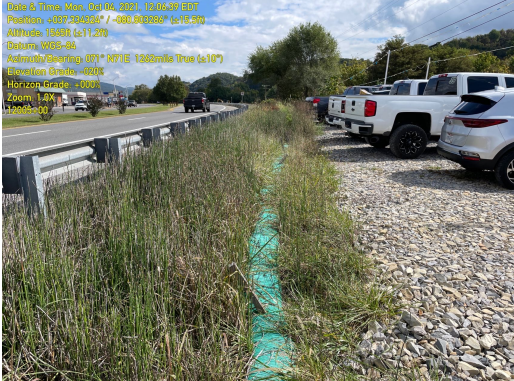
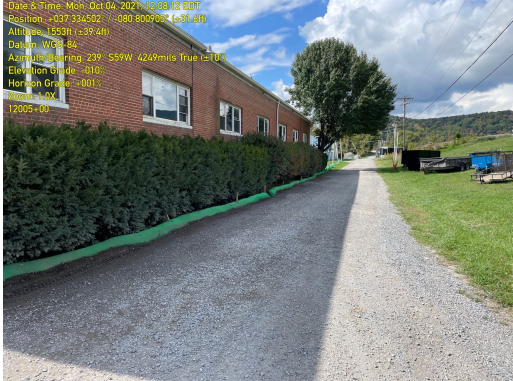
<b>GPS Location</b>		See photo		<b>GPS Location</b>	
<b>Field Station#</b>		12005+00		<b>Field Station#</b>	
<b>Pic 5 Desc.</b>		CFS perimeter control in place		<b>Pic 6 Desc.</b>	
				CFS perimeter control in place

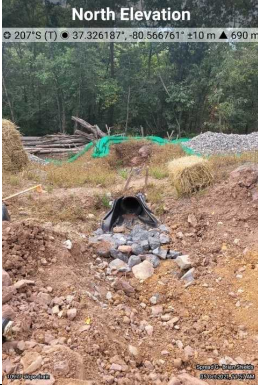
<p>North Elevation 207°S (T) • 37.326187° -80.566761° ±10 m ▲ 690 m</p>			  <p>South East Elevation 320°NW (T) • 37.326255° -80.566781° ±6 m ▲ 696 m</p>	
<b>GPS Location</b>	see photo		<b>GPS Location</b>	see photo	
<b>Field Station#</b>	10977+00		<b>Field Station#</b>	10983+80	
<b>Pic 1 Desc.</b>	installed slope drain		<b>Pic 2 Desc.</b>	excess rock as described above

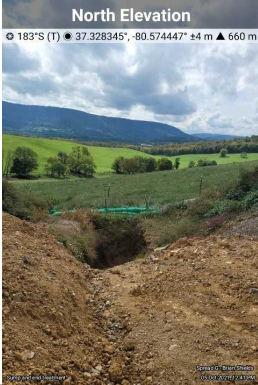
<p>North Elevation 183°S (T) • 37.328345° -80.574447° ±4 m ▲ 660 m</p>			  <p>North East Elevation 219°SW (T) • 37.325882° -80.565591° ±5 m ▲ 698 m</p>	
<b>GPS Location</b>	see photo		<b>GPS Location</b>	see photo	
<b>Field Station#</b>	10948+00		<b>Field Station#</b>	10985+00	
<b>Pic 3 Desc.</b>	sump and end treatment		<b>Pic 4 Desc.</b>	installed level spreader	
	  <p>East Elevation 247°SW (T) • 37.31662° -80.545744° ±6 m ▲ 645 m</p>			  <p>NW 353°N (T) • 37.320053° -80.550316° ±6 m ▲ 653 m</p>

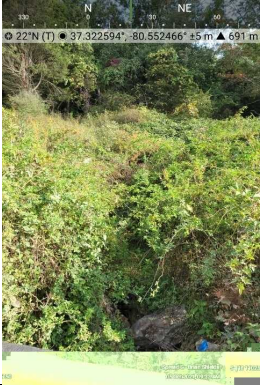
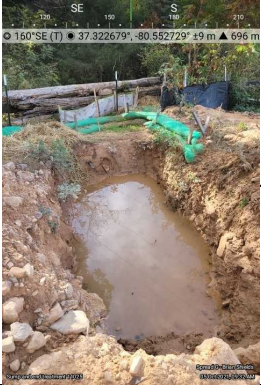
<b>GPS Location</b>	see photo	<b>GPS Location</b>	see photo		
<b>Field Station#</b>	11025+00	<b>Field Station#</b>	11025+00		
<b>Pic 7 Desc.</b>	s-ij16b	<b>Pic 8 Desc.</b>	sump and end treatment		
Insert image here		Insert image here			
<b>GPS Location</b>		<b>GPS Location</b>			
<b>Field Station#</b>		<b>Field Station#</b>			
<b>Pic 9 Desc.</b>		<b>Pic 10 Desc.</b>			
Insert image here		Insert image here			
<b>GPS Location</b>		<b>GPS Location</b>			
<b>Field Station#</b>		<b>Field Station#</b>			
<b>Pic 11 Desc.</b>		<b>Pic 12 Desc.</b>

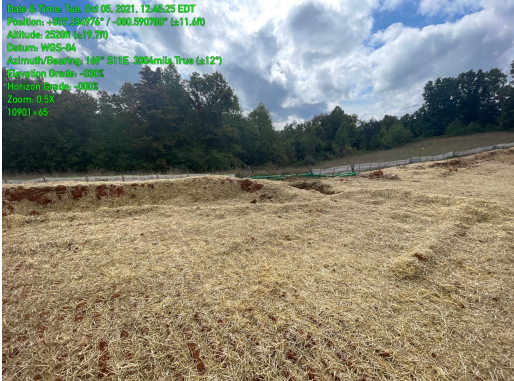
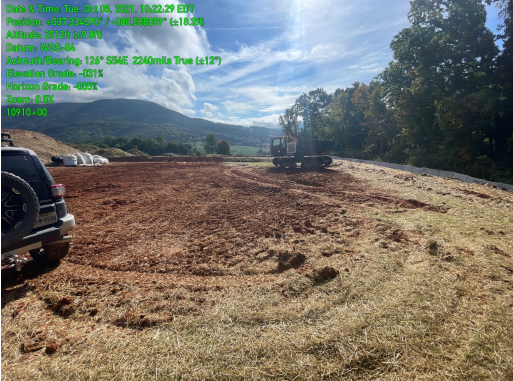
<b>GPS Location</b>	See Photo	<b>GPS Location</b>	See Photo		
<b>Field Station#</b>	10901+65	<b>Field Station#</b>	10910+00		
<b>Pic 3 Desc.</b>	This portion of row will pond water not allowing for drainage to the sump pit.	<b>Pic 4 Desc.</b>	Portion of row requiring temporary stabilization.

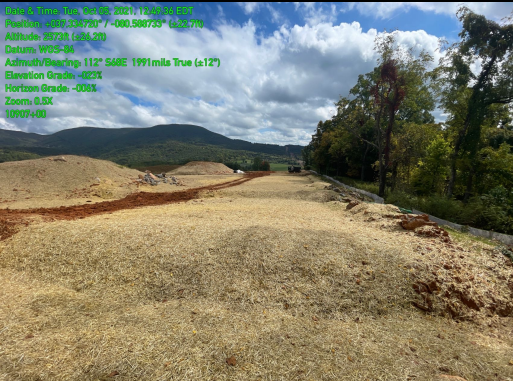
<b>GPS Location</b>	See Photo	<b>GPS Location</b>	See Photo		
<b>Field Station#</b>	10920+45	<b>Field Station#</b>	10907+00		
<b>Pic 5 Desc.</b>	View of gap between P1 and CFS end treatment.	<b>Pic 6 Desc.</b>	View of temporary stabilization of row and current conditions.

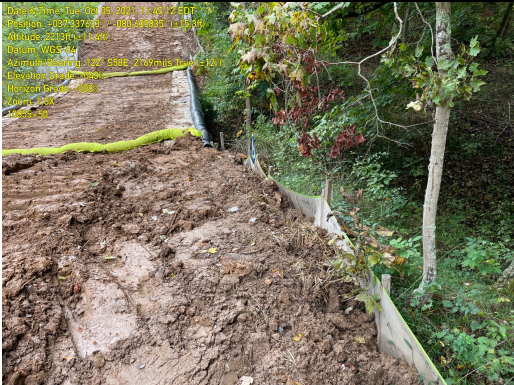
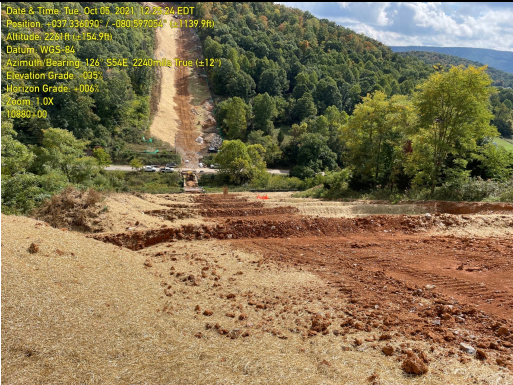
<b>GPS Location</b>	See photo	<b>GPS Location</b>	See photo		
<b>Field Station#</b>	10855+50	<b>Field Station#</b>	10880+00		
<b>Pic 3 Desc.</b>	P1 silt fence overwhelmed	<b>Pic 4 Desc.</b>	Waterbars in place

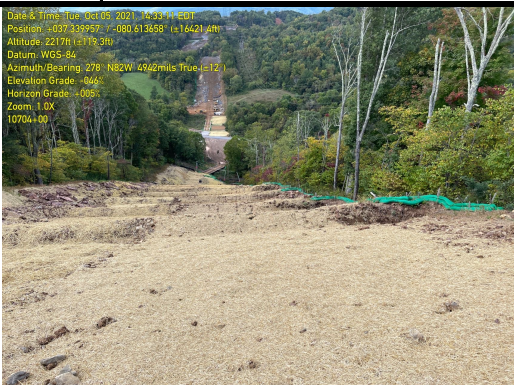
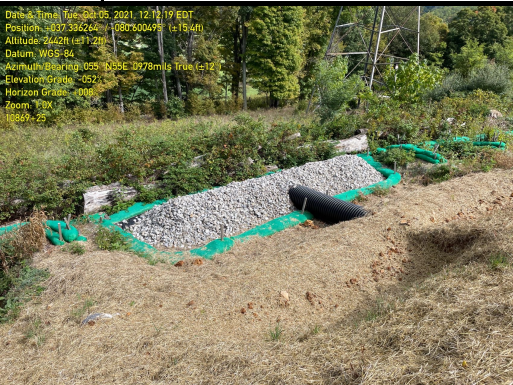
<b>GPS Location</b>	See photo	<b>GPS Location</b>	See photo		
<b>Field Station#</b>	10704+00	<b>Field Station#</b>	10869+25		
<b>Pic 5 Desc.</b>	End treatments in place	<b>Pic 6 Desc.</b>	Cleanwater outlet protection in place

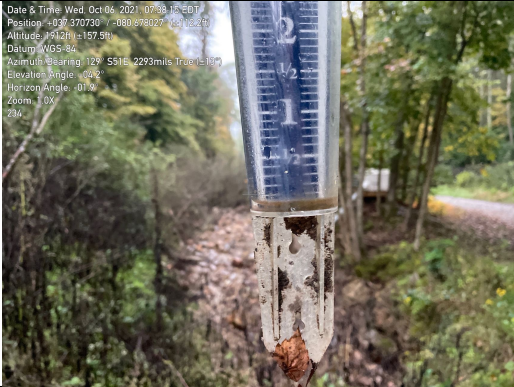
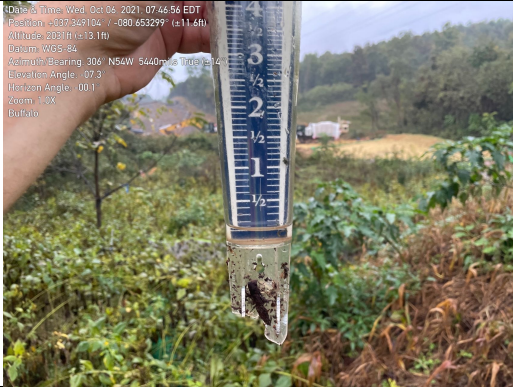
<b>GPS Location</b>	See photo	<b>GPS Location</b>	See photo		
<b>Field Station#</b>	10510+78	<b>Field Station#</b>	10695+77		
<b>Pic 1 Desc.</b>	AR 234 rain gauge	<b>Pic 2 Desc.</b>	Buffalo anklets rain gauge		
<p>Date &amp; Time: Wed, Oct 06, 2021 07:18:30 EDT  Position: +037.381535 / -080.501315 (+15.5h)  Altitude: 2078ft (+11.1h)  Datum: WGS 84  Azimuth/Bearing: 107+ N99E 1004mils true (+12h)  Elevation Angle: +49.3  Horizon Angle: -02.3  Zoom: 1.0x  11227+50</p>

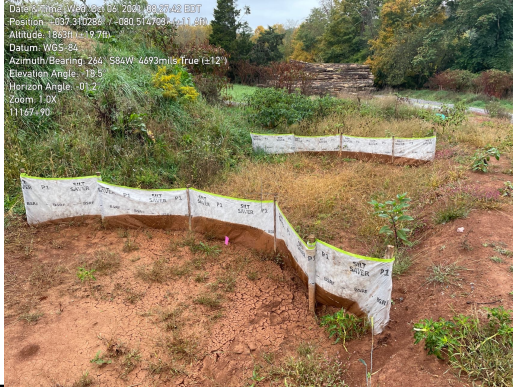
<b>GPS Location</b>	See photo	<b>GPS Location</b>	See photo		
<b>Field Station#</b>	11227+50	<b>Field Station#</b>	11167+90		
<b>Pic 3 Desc.</b>	Housekeeping trash needs removed	<b>Pic 4 Desc.</b>	P1 needs replaced		
<p>Date &amp; Time: Wed, Oct 06, 2021 08:04:14 EDT  Position: +037.297122 / -080.454377 (+13.07h)  Altitude: 2128ft (+13.07h)  Datum: WGS 84  Azimuth/Bearing: 120 S40E 2133mils true (+12.1h)  Elevation Angle: -13.7  Horizon Angle: -02.1  Zoom: 1.0x  11248+50</p>

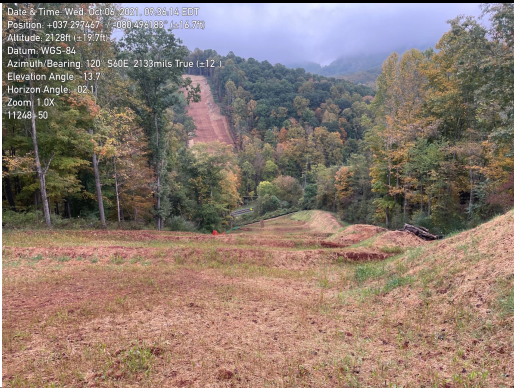
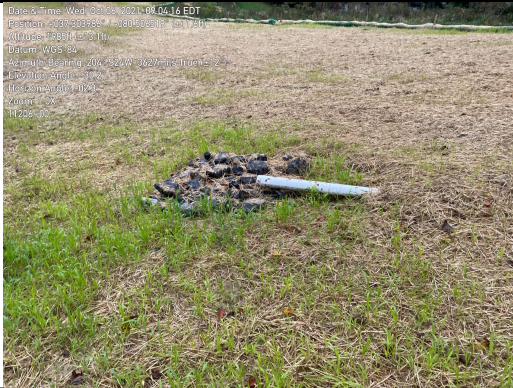
<b>GPS Location</b>	See photo	<b>GPS Location</b>	See photo		
<b>Field Station#</b>	11248+50	<b>Field Station#</b>	11206+00		
<b>Pic 5 Desc.</b>	Waterbars in place	<b>Pic 6 Desc.</b>	Day light drain in place

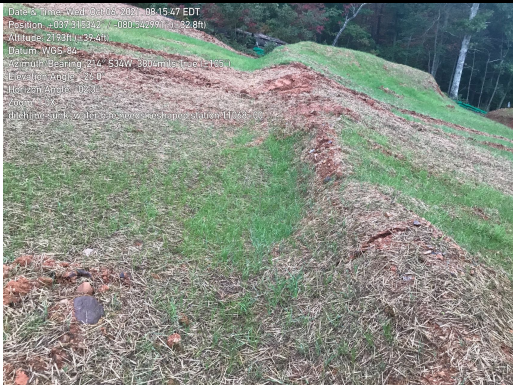
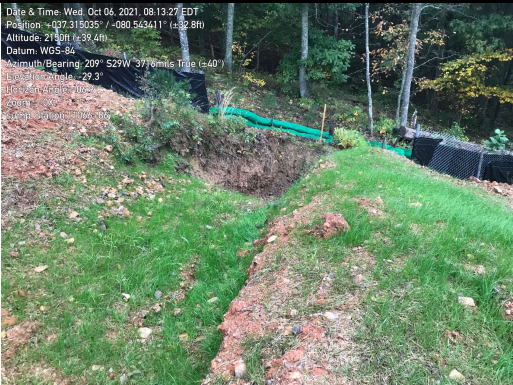
<p>Date &amp; Time: Wed, Oct 06, 2021, 08:13:27 EDT Position: +037.315035° / -080.543411° (±32.8ft) Altitude: 2133ft (±32.4ft) Datum: WGS-84 Azimuth/Bearing: 209° S29W 3716mils True (±40°) Elevation Angle: -29.3° Horizon Angle: -02.3° Zoom: 1.0X Pic station 11066+86</p>		
GPS Location	See photo		GPS Location	see photo	
Field Station#	11068+50		Field Station#	11066+86	
Pic 1 Desc.	Water bar on PL		Pic 2 Desc.	Sump

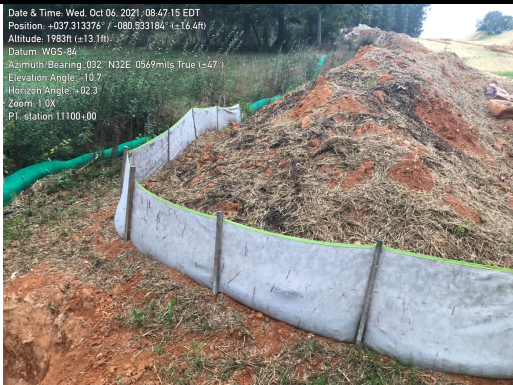
GPS Location	see photo		GPS Location	see photo	
Field Station#	11100+00		Field Station#	11110+00	
Pic 3 Desc.	P1		Pic 4 Desc.	Slope drain

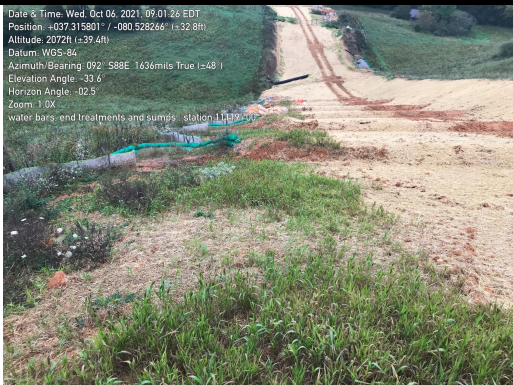
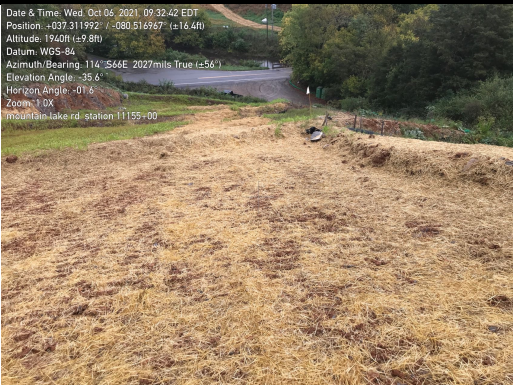
<p>Date &amp; Time: Wed, Oct 06, 2021, 09:32:42 EDT Position: +037.311992° / -080.516967° (±16.4ft) Altitude: 1940ft (±9.8ft) Datum: WGS-84 Azimuth/Bearing: 114° S46E 2027mils True (±56°) Elevation Angle: -35.6° Horizon Angle: -07.6° Zoom: 1.0X Pic station 11155+00</p>		
GPS Location	see photo		GPS Location	see photo	
Field Station#	1119+00		Field Station#	11155+00	
Pic 5 Desc.	Water bars, end treatments and sumps		Pic 6 Desc.	Mountain Lake rd

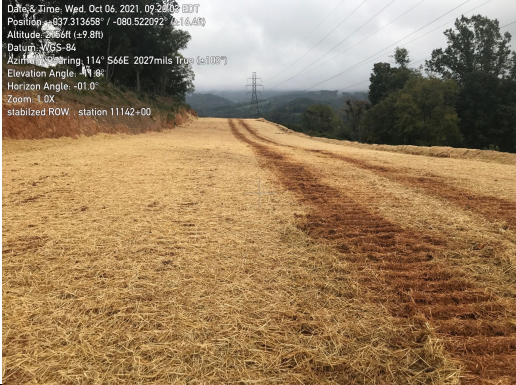
<p>Date &amp; Time: Wed, Oct 06, 2021, 09:24:09 EDT  Position: +037 313658° / -080 522092° (±16.4ft)  Altitude: 2066ft (±9.8ft)  Datum: WGS-84  Azimuth/Bearing: 114° S66E 2027mils True (±0.7°)  Elevation Angle: -31.0°  Horizon Angle: -01.0°  Zoom: 1.0X  stabilized ROW - station 11142+00</p>

<p>Date &amp; Time: Wed, Oct 06, 2021, 09:25:29 EDT  Position: +037 312823° / -080 519555° (±16.4ft)  Altitude: 2116ft (±9.8ft)  Datum: WGS-84  Azimuth/Bearing: 183° S03W 3253mils True (±0.1°)  Elevation Angle: -25.0°  Horizon Angle: -00.2°  Zoom: 1.0X  slope drain - station 11147+00</p>			
<b>GPS Location</b>	See photo	<b>GPS Location</b>	see photo		
<b>Field Station#</b>	11142+00	<b>Field Station#</b>	11147+00		
<b>Pic 7 Desc.</b>	Stabilized ROW	<b>Pic 8 Desc.</b>	Slope Drain

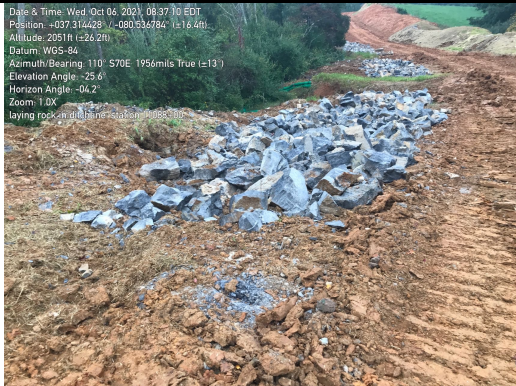
<p>Date &amp; Time: Wed, Oct 06, 2021, 08:37:10 EDT  Position: +037 314428° / -080 536784° (±16.4ft)  Altitude: 2051ft (±26.2ft)  Datum: WGS-84  Azimuth/Bearing: 110° S70E 1956mils True (±1.3°)  Elevation Angle: -25.6°  Horizon Angle: -04.2°  Zoom: 1.0X  laying rock in ditch line - station 11088+00</p>		<div style="text-align: center;">Insert image here</div>

<b>GPS Location</b>	See photo	<b>GPS Location</b>			
<b>Field Station#</b>	11088+00	<b>Field Station#</b>			
<b>Pic 9 Desc.</b>	Rock in ditch line	<b>Pic 10 Desc.</b>			
<div style="text-align: center;">Insert image here</div>		<div style="text-align: center;">Insert image here</div>			
<b>GPS Location</b>		<b>GPS Location</b>			
<b>Field Station#</b>		<b>Field Station#</b>			
<b>Pic 11 Desc.</b>		<b>Pic 12 Desc.</b>

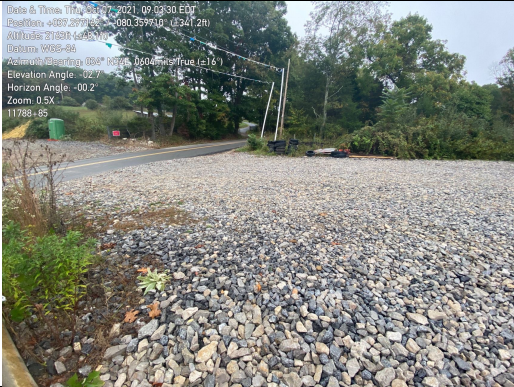
<b>GPS Location</b>	See photo	<b>GPS Location</b>	See Photo		
<b>Field Station#</b>	11788+85	<b>Field Station#</b>	11792+07		
<b>Pic 1 Desc.</b>	RCE in acceptable condition	<b>Pic 2 Desc.</b>	Two track stabilized

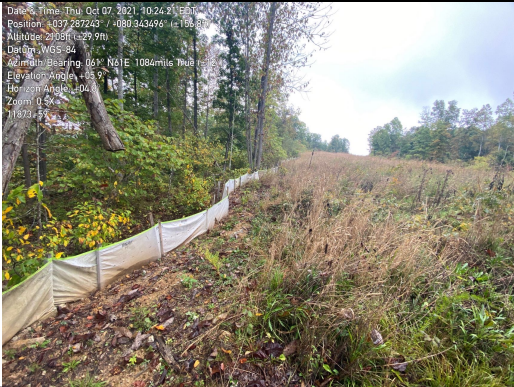
<b>GPS Location</b>	See Photo	<b>GPS Location</b>	See Photo		
<b>Field Station#</b>	11873+59	<b>Field Station#</b>	11865+90		
<b>Pic 3 Desc.</b>	Perimeter controls in place	<b>Pic 4 Desc.</b>	Controls in place

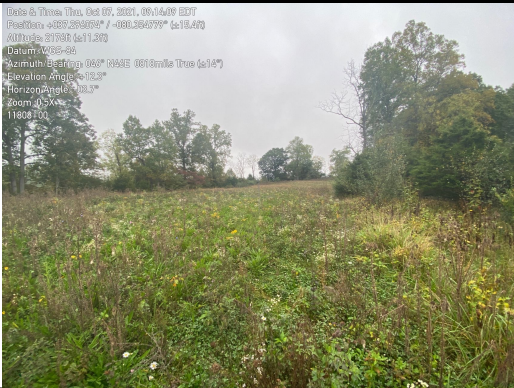
<b>GPS Location</b>	See Photo	<b>GPS Location</b>	See photo		
<b>Field Station#</b>	11808+00	<b>Field Station#</b>	11899+99		
<b>Pic 5 Desc.</b>	Vegetation	<b>Pic 6 Desc.</b>	Access road in good condition

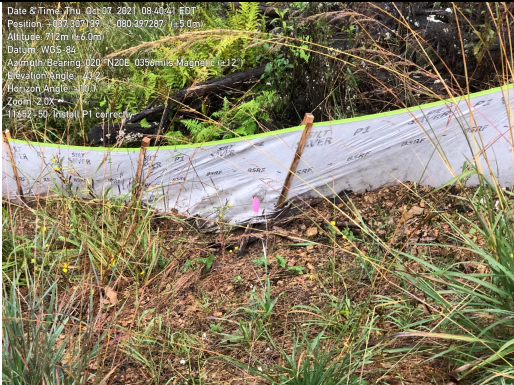
<b>GPS Location</b>		On photo		<b>GPS Location</b>	
<b>Field Station#</b>		11652+50		<b>Field Station#</b>	
<b>Pic 3 Desc.</b>		Communication. Install P1 correctly		<b>Pic 4 Desc.</b>

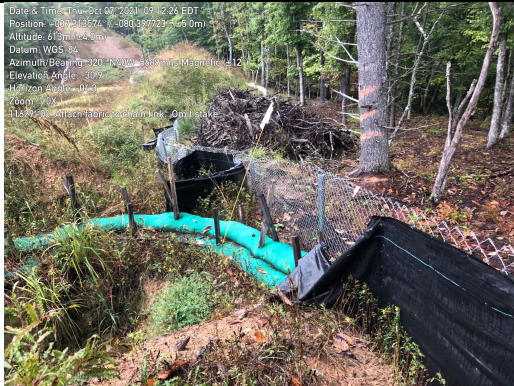
<b>GPS Location</b>		On photo		<b>GPS Location</b>	
<b>Field Station#</b>		11632+75		<b>Field Station#</b>	
<b>Pic 5 Desc.</b>		Communication. Re-attach SSF fabric		<b>Pic 6 Desc.</b>	
				Communication. Attach SSF fabric to chain link and eliminate stake

E&S BMPs	Compliance Level	Corrective Action	Corrective Time Frame	Date Repaired
Cleanwater Diversion Berm	Acceptable			
Cleanwater Diversion Pipe	Acceptable			
Compost Filter Sock	Acceptable			
Equipment Bridge	Acceptable			
Rock Construction Entrance	Acceptable			
Sensitive Resource Buffer	Acceptable			
Silt Fence (Filter Fabric Fence)	Communication	Worn P1 to be replaced		
Silt Fence (Reinforce Filter Fence)	Communication	Fabric re-attached to chain link		
Waterbar End Treatment	Acceptable

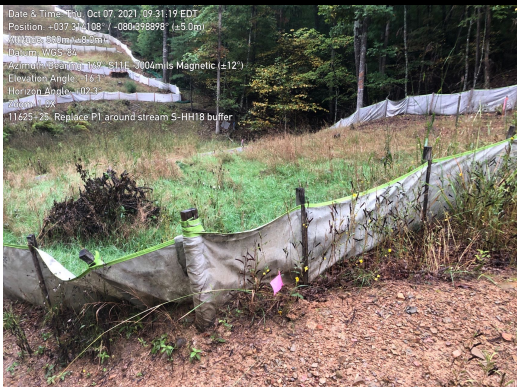
<p>Date &amp; Time: Thu, Oct 07, 2021 09:31:19 EDT  Position: +037.319919° / -080.398519° (+10.0m)  Altitude: 611m (+12.0m)  Datum: WGS-84  Azimuth/Bearing: 116° N (116° Magnetic (+12°))  Elevation Angle: +05.2°  Horizon Angle: +02.1°  Zoom: 1.0X  11625+25: Replace P1 around stream S-HH18 buffer</p>

<b>Field Station#</b>		11626+40		<b>Field Station#</b>	
<b>Pic 11 Desc.</b>		Communication. Extend P1 upslope and key into earthen bank		<b>Pic 12 Desc.</b>	
		Communication. Replace worn P1 around perimeter of S-HH18 buffer

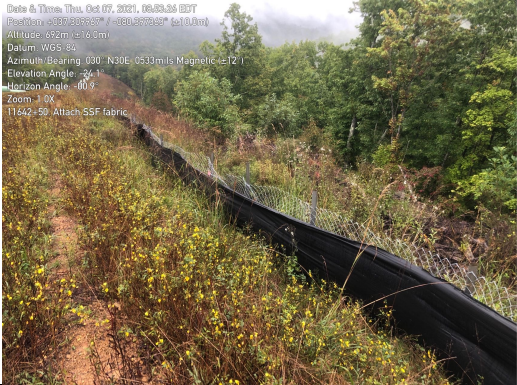
<small>Date &amp; Time: Thu Oct 07, 2021, 08:58:58 EDT  Position: 43.0733333° N, -88.0733333° W, 10.0 ft  Altitude: 692m (+16.0m)  Datum: WGS 84  Azimuth Bearing: 000° N30E-0533mils Magnetic (+12°)  Elevation Angle: 36.1°  Horizon Angle: -00.0°  Zoom: 1.0X  11642+50 Attach SSF fabric.</small>					
<b>GPS Location</b>	On photo	<b>GPS Location</b>			
<b>Field Station#</b>	11642+50	<b>Field Station#</b>			
<b>Pic 13 Desc.</b>	Communication. Re-attach SSF fabric	<b>Pic 14 Desc.</b>			
Insert image here		Insert image here			
<b>GPS Location</b>		<b>GPS Location</b>			
<b>Field Station#</b>		<b>Field Station#</b>			
<b>Pic 15 Desc.</b>		<b>Pic 16 Desc.</b>			
Insert image here		Insert image here			
<b>GPS Location</b>		<b>GPS Location</b>			
<b>Field Station#</b>		<b>Field Station#</b>			
<b>Pic 17 Desc.</b>		<b>Pic 18 Desc.</b>

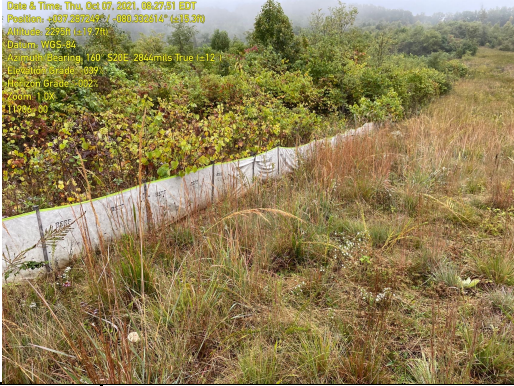
<b>GPS Location</b>	See photo	<b>GPS Location</b>	See photo		
<b>Field Station#</b>	11906+00	<b>Field Station#</b>	11925+00		
<b>Pic 1 Desc.</b>	Silt fence perimeter control in place	<b>Pic 2 Desc.</b>	Level spreader in place		
<p>Date &amp; Time: Thu, Oct 07, 2021, 09:01:20 EDT  Position: +407.272272° / -900.331030° (±30.20)  Altitude: 22524 (±9.80)  Datum: WGS-84  Azimuth/Bearing: 290° N26W 539mils True (±12°)  Elevation Grade: -031X  Horizon Grade: +000X  Zoom: 1.0X  20/266</p>

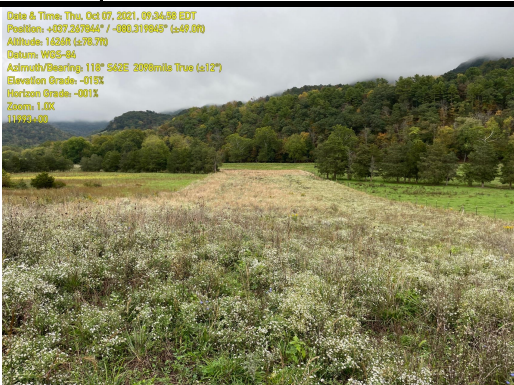
<b>GPS Location</b>	See photo	<b>GPS Location</b>	See photo		
<b>Field Station#</b>	11993+00	<b>Field Station#</b>	11988+96		
<b>Pic 5 Desc.</b>	Good vegetation on ROW	<b>Pic 6 Desc.</b>	Catawba rain gauge measured trace amounts of rainfall

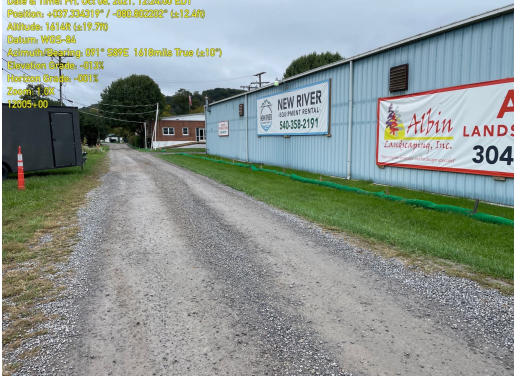
<b>GPS Location</b>	See photo	<b>GPS Location</b>	See photo		
<b>Field Station#</b>	12005+00	<b>Field Station#</b>	12005+00		
<b>Pic 1 Desc.</b>	CFS perimeter control in place	<b>Pic 2 Desc.</b>	Secondary containment in place		
<p>Date &amp; Time Fri, Oct 08, 2021, 12:21:49 EDT  Position: +4297.334057° / -900.802114° (±15.1ft)  Altitude: 1537ft (±11.3ft)  Datum: WGS-84  Azimuth/Heading: 092° 589ft 1490mils True (±10°)  Elevation Grade: -000%  Horizon Grade: -000%  Zoom: 1.0x  12005+00</p>

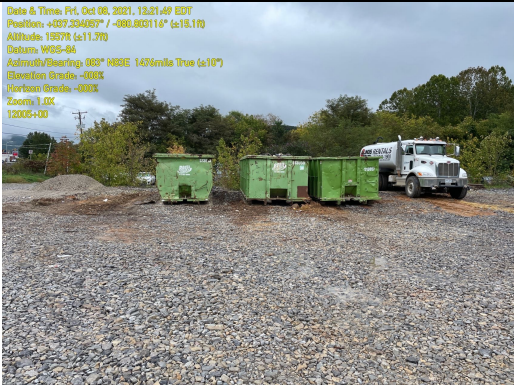
<b>GPS Location</b>	See photo	<b>GPS Location</b>	See photo		
<b>Field Station#</b>	12005+00	<b>Field Station#</b>	12005+00		
<b>Pic 3 Desc.</b>	Dumpsters in place	<b>Pic 4 Desc.</b>	No visible leaks or spills at time of inspection		
<p>Date &amp; Time Fri, Oct 08, 2021, 12:22:30 EDT  Position: +4297.334914° / -900.802197° (±15.4ft)  Altitude: 1549ft (±11.3ft)  Datum: WGS-84  Azimuth/Heading: 352° 509ft 6311mils True (±10°)  Elevation Grade: -002%  Horizon Grade: +002%  Zoom: 1.0x  12005+00</p>

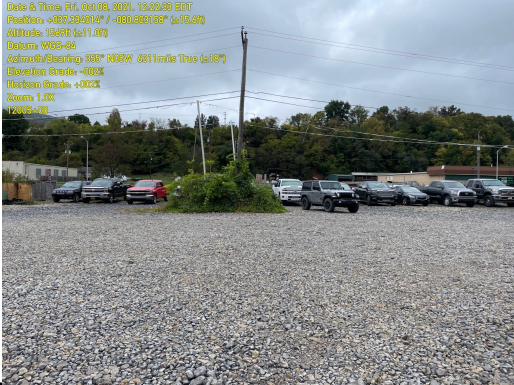
<b>Pic 5 Desc.</b>	Rock surface of yard is in acceptable condition	<b>Pic 6 Desc.</b>	RCE is in place.

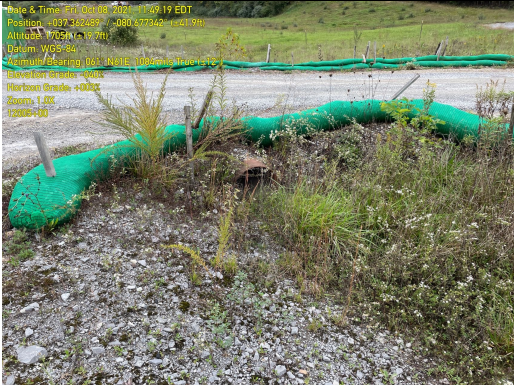
<b>GPS Location</b>	See photo	<b>GPS Location</b>	See photo		
<b>Field Station#</b>	12005+00	<b>Field Station#</b>	12005+00		
<b>Pic 1 Desc.</b>	Culvert in place	<b>Pic 2 Desc.</b>	CFS perimeter control in place

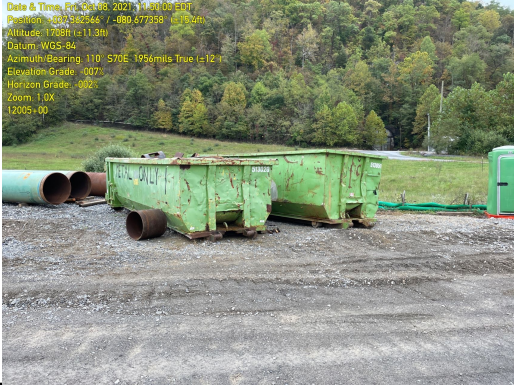
<b>GPS Location</b>	See photo	<b>GPS Location</b>	See photo		
<b>Field Station#</b>	12005+00	<b>Field Station#</b>	12005+00		
<b>Pic 3 Desc.</b>	Dumpsters in place	<b>Pic 4 Desc.</b>	Secondary containment in place

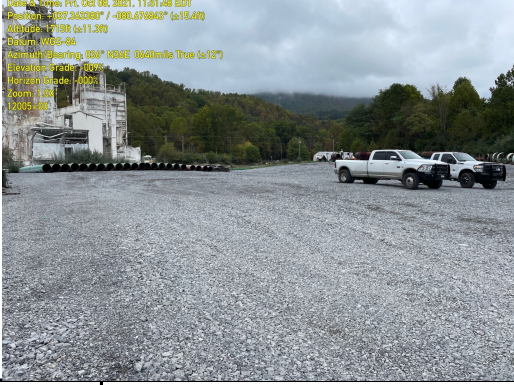
<b>GPS Location</b>	See photo	<b>GPS Location</b>	See photo		
<b>Field Station#</b>	12005+00	<b>Field Station#</b>	12005+00		
<b>Pic 5 Desc.</b>	Rock surface in acceptable condition	<b>Pic 6 Desc.</b>	CFS perimeter control in place

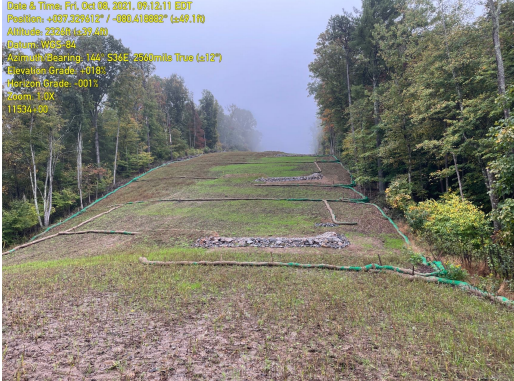
<b>GPS Location</b>	See photo		<b>GPS Location</b>	See photo	
<b>Field Station#</b>	11534+00		<b>Field Station#</b>	11540+00	
<b>Pic 1 Desc.</b>	CFS controls in place		<b>Pic 2 Desc.</b>	Level spreaders in place

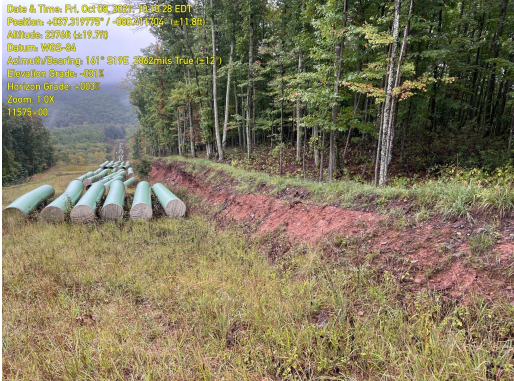
<b>GPS Location</b>	See photo		<b>GPS Location</b>	See photo	
<b>Field Station#</b>	11575+00		<b>Field Station#</b>	11587+00	
<b>Pic 3 Desc.</b>	Cleanwater diversion berm in place		<b>Pic 4 Desc.</b>	P1 silt fence perimeter control in place

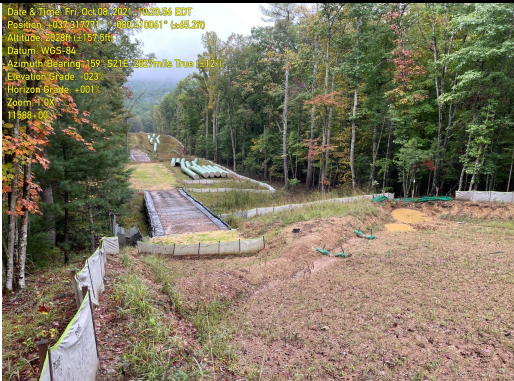
<b>GPS Location</b>	See photo		<b>GPS Location</b>	See photo	
<b>Field Station#</b>	11588+00		<b>Field Station#</b>	11598+50	
<b>Pic 5 Desc.</b>	Stream buffer in place		<b>Pic 6 Desc.</b>	RCE in place
