Visual Site Inspection Report

Project Name	H-600 Pipeline Spread G	AFE	124300137	Spread	H-600 Pipeline Spread G
Contractor	Precision			Report #	31452
Inspector	David Schoolcraft			Date/Time	11/22/2021 12:21 PM
Permit #	TBD	Inspection Type	VA SWPP	Station Begin	11254+99
State	VA	Inspection Area	Full	Station End	11353+67
County	Giles	Ground	Damp	Temperature (°F)	45.00
Municipality	N/A	Weather	Sunny	Rain Gauge (in)	0.00
				Rain Accumulation Time (days)	1.00

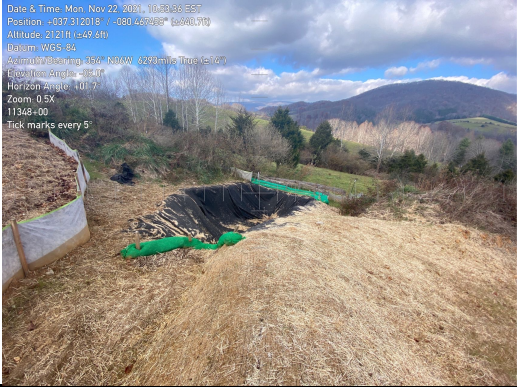
GPS Location	See Photo	GPS Location	See Photo		
Field Station#	11348+00	Field Station#	11351+30		
Pic 7 Desc.	Sump Karst Protection	Pic 8 Desc.	Sump Karst Protection		
<small> Date & Time: Mon Nov 22 2021 10:58:55 EST Position: +037.315847 / -080.427206 / 11352.91ft Altitude: 1997ft (+176.9ft) Datum: WGS-84 Azimuth/Bearing: 106° S74E 1884mils True (±12°) Elevation Angle: -01.4° Horizon Angle: -03.5° Zoom: 0.5X S-NN11 11352+97 Tick marks every 5' </small>

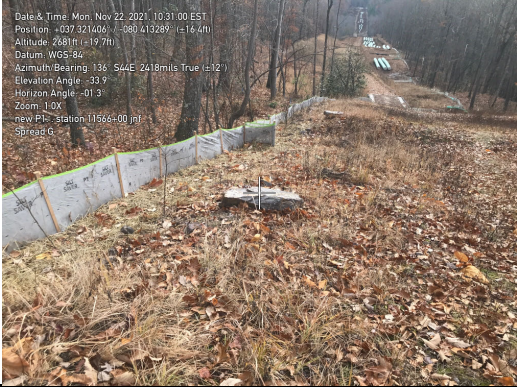
GPS Location	See photo		GPS Location	see photo	
Field Station#	11566+00		Field Station#	11568+00	
Pic 13 Desc.	New P1		Pic 14 Desc.	S-PP 20	
<p>Date & Time: Mon, Nov 22, 2021, 10:35:05 EST Position: +037.3207697 / -080.412638 (E=16.4ft) Altitude: 2843ft (+26.2ft) Datum: WGS-84 Azimuth/Bearing: 124 S56E 2204mils True (±12°) Elevation Angle: -15.1° Horizon Angle: -02.3° Zoom: 1.0X stabilized soil stock piles station 11570+00 .jnt Spread G</p>

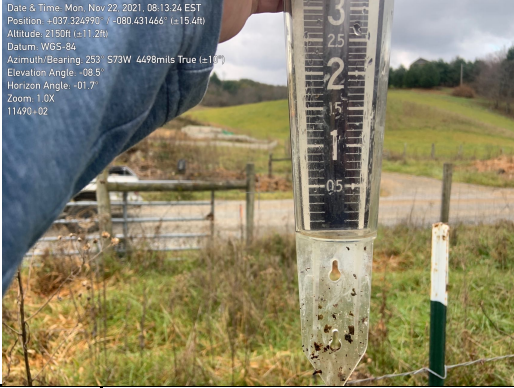
<p>Date & Time: Mon, Nov 22, 2021, 09:11:55 EST Position: +037.324996° / +080.431466° (+15.4ft) Altitude: 2150ft (+11.2m) Datum: WGS-84 Azimuth/Bearing: 331° N29W 5882mils True (±13°) Elevation Angle: -29.9° Horizon Angle: -00.1° Zoom: 1.0X 11481+55</p>			
GPS Location	See photo	GPS Location	See photo		
Field Station#	11490+02	Field Station#	11481+55		
Pic 1 Desc.	Rain gage at Stevers Gap with trace amount of rain	Pic 2 Desc.	Stone inlet protection, slope drain pipe and sump pit are functional

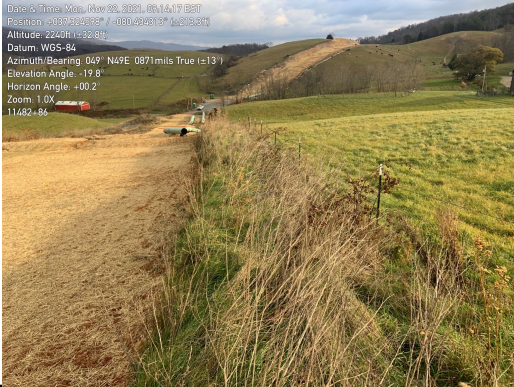
GPS Location	See photo	GPS Location	See photo		
Field Station#	11482+86	Field Station#	11487+24		
Pic 3 Desc.	Clean water diversion berm is in acceptable condition	Pic 4 Desc.	Clean water diversion pipe and outlet protection are acceptable

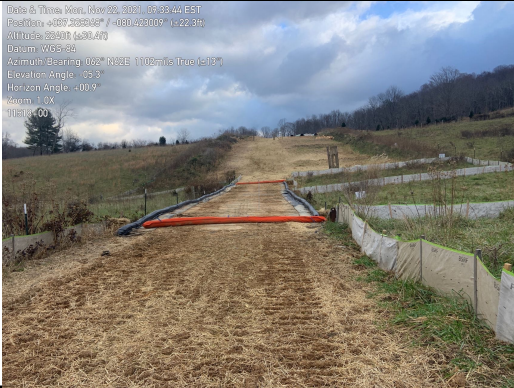
<p>Date & Time: Mon, Nov 22, 2021, 09:37:12 EST Position: +037.324996° / +080.431466° (+15.4ft) Altitude: 2240ft (+132.6ft) Datum: WGS-84 Azimuth/Bearing: 268° S88W 4764mils True (±13°) Elevation Angle: -15.7° Horizon Angle: +03.8° Zoom: 1.0X 11521+54</p>			
GPS Location	See photo	GPS Location	See photo		
Field Station#	11518+00	Field Station#	11521+54		
Pic 5 Desc.	Equipment bridge is maintained in acceptable condition	Pic 6 Desc.	Water bars are in place

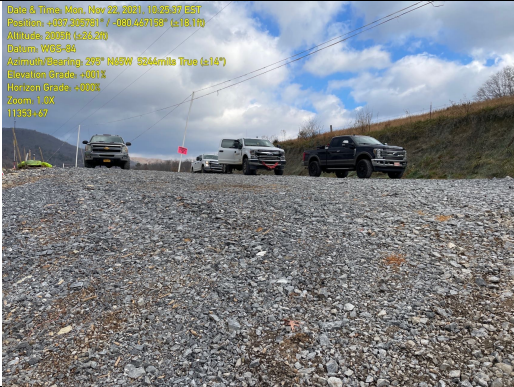
GPS Location	See photo	GPS Location	See photo		
Field Station#	11353+67	Field Station#	11361+00		
Pic 1 Desc.	RCE in place	Pic 2 Desc.	Erosion control blanket in place		
<p> <small> Date & Time Mon, Nov 22, 2021, 10:19:10 EST Position: +037.200791° / -080.666686° (±18.170) Altitude: 1962ft (±11.70) Datum: WGS-84 Azimuth/Bearing: 204° S24W 3627mils True (±12°) Elevation Grade: -019° Horizon Grade: +001° Zoom: 1.0X 11360+50 </small> </p>

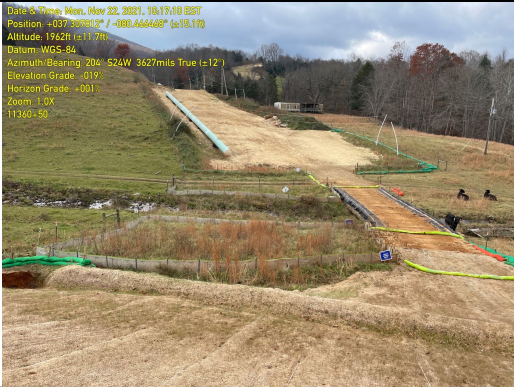
GPS Location	See photo	GPS Location	See photo		
Field Station#	11360+50	Field Station#	11362+00		
Pic 3 Desc.	Stream buffer in place	Pic 4 Desc.	End treatments in place		
<p> <small> Date & Time Mon, Nov 22, 2021, 09:41:25 EST Position: +037.210097° / -080.655597° (±12.40) Altitude: 2210ft (±13.10) Datum: WGS-84 Azimuth/Bearing: 033° N00E 5557mils True (±12°) Elevation Grade: +011% Horizon Grade: +000% Zoom: 1.0X 11411+00 </small> </p>

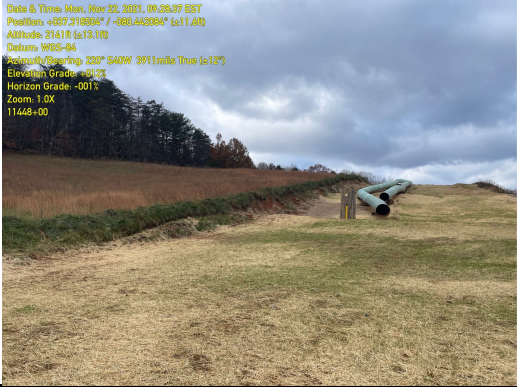
GPS Location	See photo	GPS Location	See photo		
Field Station#	11448+00	Field Station#	11456+50		
Pic 7 Desc.	Cleanwater diversion berm in place	Pic 8 Desc.	Stone inlet protection in place		
<p>Date & Time: Mon, Nov 22, 2021, 09:17:53 EST Position: +037.316412° / -080.442504° (±12.10) Altitude: 2270ft (±46.20) Datum: WGS-84 Azimuth/Bearing: 304° M45°W 6120mils True (±12°) Elevation Grade: +01% Horizon Grade: -001% Zoom: 1.0X 11463+00</p>

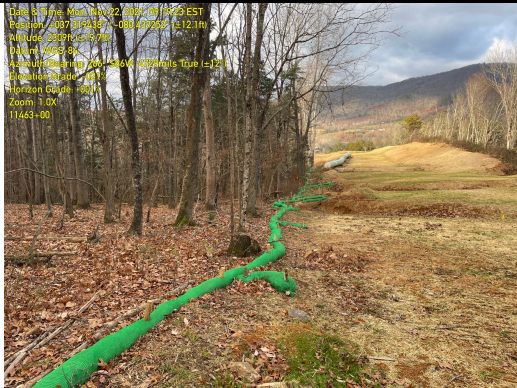
GPS Location	See photo	GPS Location	See photo		
Field Station#	11463+00	Field Station#	11468+00		
Pic 9 Desc.	CFS perimeter control in place	Pic 10 Desc.	Triple protection ECDs in place at karst feature		
<p>Date & Time: Mon, Nov 22, 2021, 09:14:45 EST Position: +037.313082° / -080.440604° (±11.40) Altitude: 21631ft (±9.80) Datum: WGS-84 Azimuth/Bearing: 285° S80°W 5899mils True (±12°) Elevation Grade: +090% Horizon Grade: -001% Zoom: 1.0X 11452+00</p>

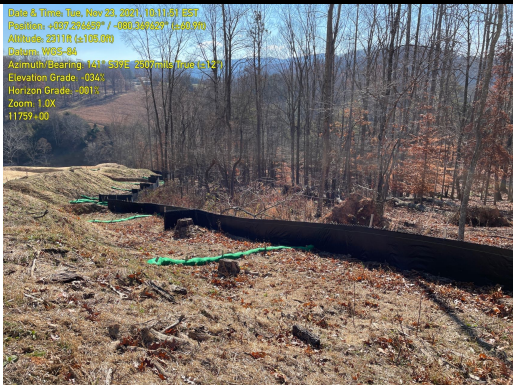
GPS Location				See photo				GPS Location				See photo			
Field Station#				11759+00				Field Station#				11749+50			
Pic 3 Desc.				Supersilt fence perimeter control in place				Pic 4 Desc.				End treatments in place

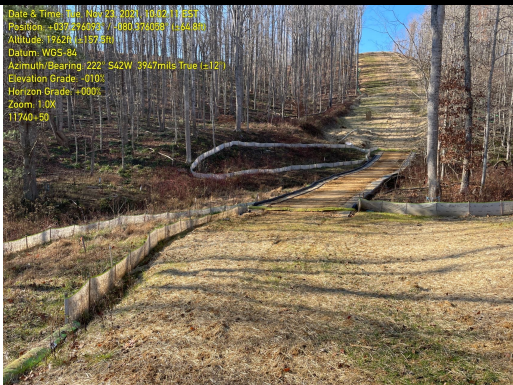
GPS Location				See photo				GPS Location				See photo			
Field Station#				11740+50				Field Station#				11720+00			
Pic 5 Desc.				Stream buffer in place				Pic 6 Desc.				Triple stack CFS perimeter control in place

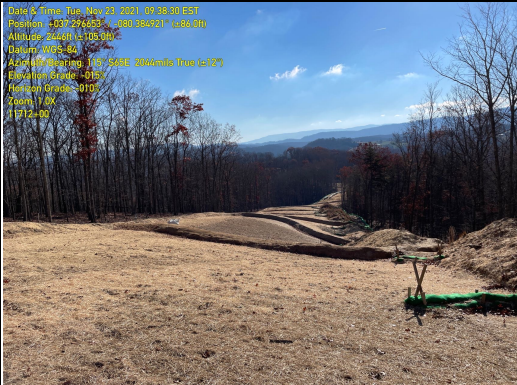
GPS Location			See photo			
Field Station#			11712+00			
Pic 7 Desc.			Waterbars in place			
GPS Location			See photo			
Field Station#			11689+15			
Pic 8 Desc.			Stone inlet protection in place			
<p>Date & Time Tue Nov 23 2021 09:55:20 EST Position +38°29'46.83" / -88°38'43.1" (-88.64) Altitude 3377ft (-88.64) Datum WGS-84 Azimuth/Bearing 137° 53SE 330mils True (±12°) Elevation Grade -000° Horizontal Grade -000° Zoom 1.0X 11688+50</p>

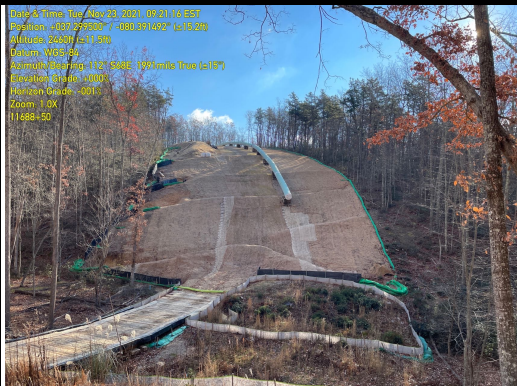
GPS Location			See photo			
Field Station#			11688+50			
Pic 9 Desc.			Erosion control blanket in place			
GPS Location			See photo			
Field Station#			11687+40			
Pic 10 Desc.			Stream buffer in place			
<p>Date & Time Tue Nov 23 2021 09:55:20 EST Position +38°29'46.83" / -88°38'43.1" (-88.64) Altitude 3377ft (-88.64) Datum WGS-84 Azimuth/Bearing 137° 53SE 330mils True (±12°) Elevation Grade -000° Horizontal Grade -000° Zoom 1.0X 11678+00</p>

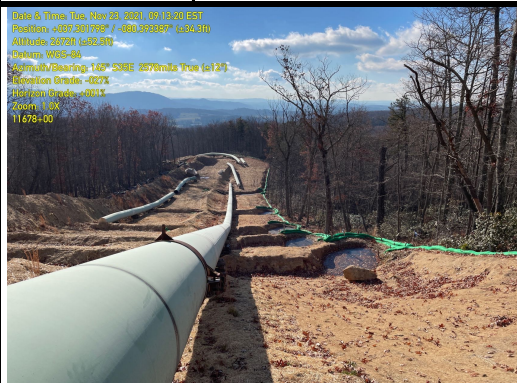
GPS Location			See photo			
Field Station#			11678+00			
Pic 11 Desc.			End treatments in place			
GPS Location			See photo			
Field Station#			11670+00			
Pic 12 Desc.			P1 silt fence perimeter control in place

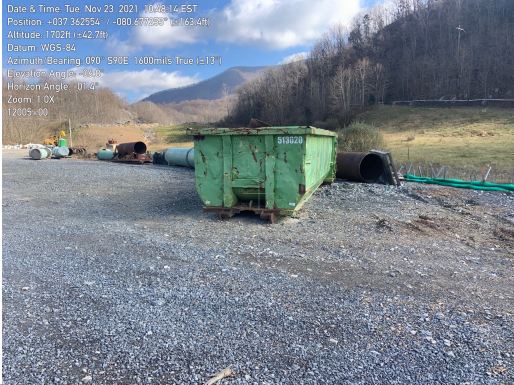
GPS Location	See photo	GPS Location	See photo		
Field Station#	12005+00	Field Station#	12005+00		
Pic 3 Desc.	Dumpsters in place	Pic 4 Desc.	Secondary containment in place

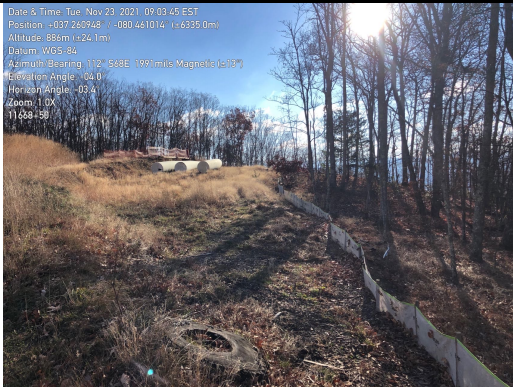
GPS Location	On photo		GPS Location	On photo			
Field Station#	11668+50		Field Station#	11665+00			
Pic 1 Desc.	ROW stable at top of Brush Mountain by FS188. ECDs acceptable.		Pic 2 Desc.	Slope breakers are effectively controlling stormwater runoff.			
<div><div><div>Date & Time: Tue Nov 23, 2021, 09:38:22 EST Position: +037.288901° / -089.412830° (+1412.0m) Altitude: 651m (+12.0m) Datum: WGS-84 Azimuth/Bearing: 002.003E 003.0mils Magnetic (+15°) Elevation Angle: -18.0 Horizon Angle: -03.9 Zoom: 2.2X 11634+00</div><div>

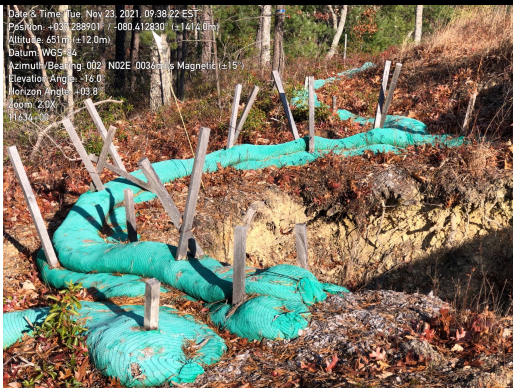
Pic 5 Desc.	Sumps and end treatments are functional.		Pic 6 Desc.	Perimeter ECDs are functional.

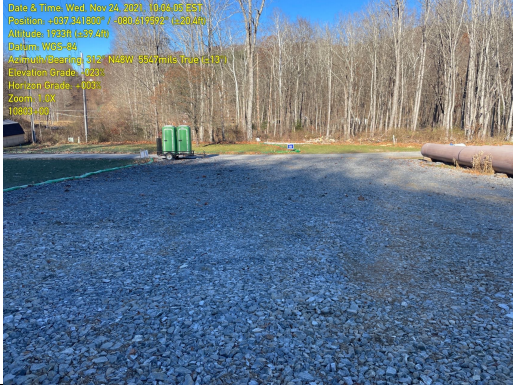
<p>Date & Time: Wed, Nov 24, 2021, 1:47:48 EST Position: +007.340288° / -080.615897° (-11.40) Altitude: 2231 (±11.25) Datum: WGS 84 Azimuth Bearing: 018° N18E 0320mils True (±12°) Elevation Grade: -074% Horizon Grade: +007% Zoom: 1.0X 10808+16</p>		
GPS Location	See photo		GPS Location	See photo	
Field Station#	10803+00		Field Station#	10808+16	
Pic 1 Desc.	RCE in place		Pic 2 Desc.	Stone inlet protection in place

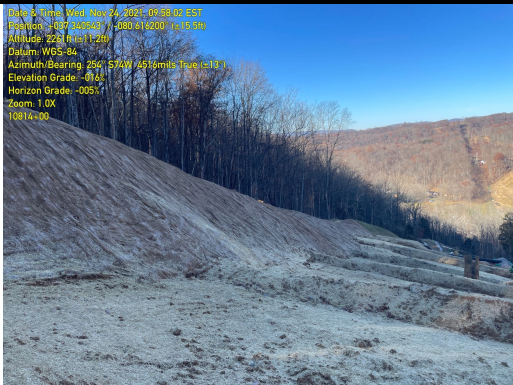
GPS Location	See photo		GPS Location	See photo	
Field Station#	10814+00		Field Station#	10815+50	
Pic 3 Desc.	Waterbars in place		Pic 4 Desc.	Cleanwater diversion outlet protection in place

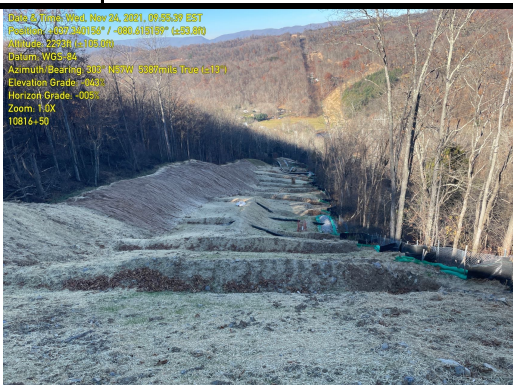
<p>Date & Time: Wed, Nov 24, 2021, 1:52:40 EST Position: +007.340288° / -080.615897° (-11.40) Altitude: 2231 (±11.25) Datum: WGS 84 Azimuth Bearing: 018° N18E 0320mils True (±12°) Elevation Grade: -074% Horizon Grade: +007% Zoom: 1.0X 10818+85</p>		
GPS Location	See photo		GPS Location	See photo	
Field Station#	10816+50		Field Station#	10818+85	
Pic 5 Desc.	Erosion control blanket in place		Pic 6 Desc.	Supersilt fence perimeter control in place

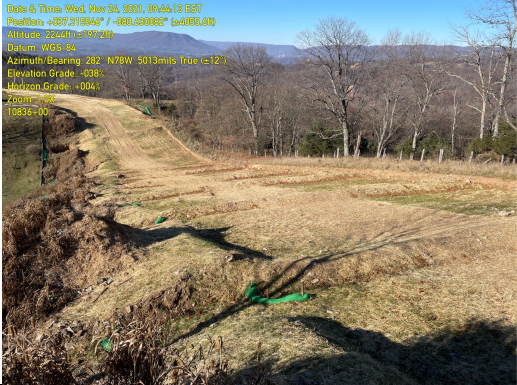
<p>Date & Time: Wed, Nov 24, 2021, 09:44:53 EST Position: +437.340212° / -680.426924° (s=464M) Altitude: 2525ft (770.2M) Datum: WGS 84 Azimuth/Bearing: 137° S42E 04.6mils True (±12°) Elevation Grade: -00° Horizon Grade: -00% Zoom: 1.0X 10840+20</p>			
GPS Location	See photo	GPS Location	See photo		
Field Station#	10836+00	Field Station#	10840+20		
Pic 7 Desc.	Waterbars in place	Pic 8 Desc.	Daylight drain in place

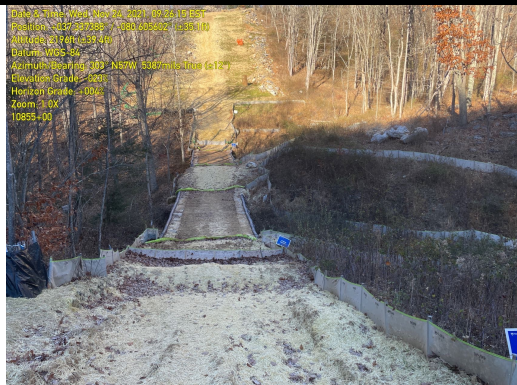
<p>Date & Time: Wed, Nov 24, 2021, 10:25:10 EST Position: +437.352544° / -680.435584° (s=524M) Altitude: 2124ft (647.0M) Datum: WGS 84 Azimuth/Bearing: 183° NSW 50.66mils True (±12°) Elevation Grade: -00% Horizon Grade: -00% Zoom: 1.0X 10858+00</p>			
GPS Location	See photo	GPS Location	See photo		
Field Station#	10855+00	Field Station#	10858+00		
Pic 11 Desc.	Stream buffer in place	Pic 12 Desc.	End treatments in place

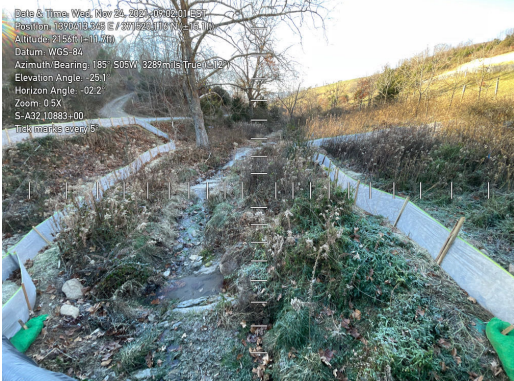
GPS Location	1	GPS Location	2		
Field Station#	10883+00	Field Station#	10927+75		
Pic 1 Desc.	S-A32 and controls.	Pic 2 Desc.	S-Y3 and controls.

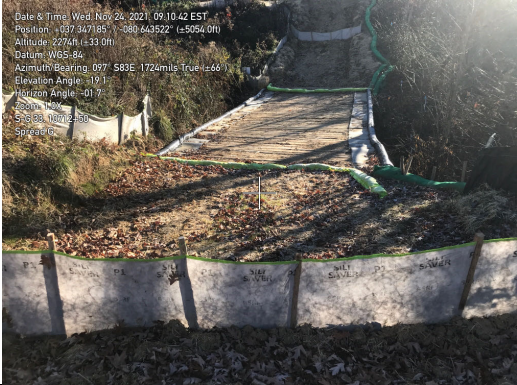
<p>Date & Time: Wed Nov 24, 2021 09:16:51 EST Position: +037 348518 / -080 649529 (+516.4ft) Altitude: 2237ft (+9.0m) Datum: WGS-84 Azimuth/Bearing: 279° 08'W 4960mils True (+12°) Elevation Angle: -24.0° Horizon Angle: -01.0° Zoom: 1.0X water bar sump 10706+00 Spread: 6</p>			
GPS Location	See photo	GPS Location	see photo		
Field Station#	10712+50	Field Station#	10706+00		
Pic 7 Desc.	S-G 33	Pic 8 Desc.	Water bar sump

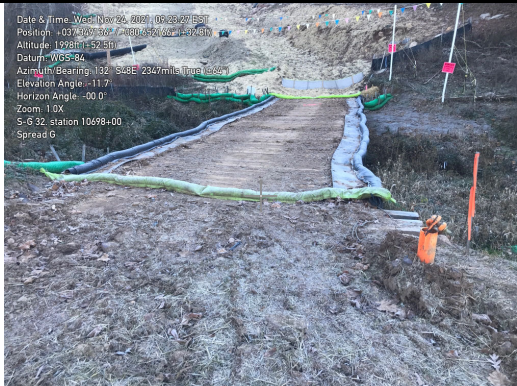
GPS Location	see photo	GPS Location			
Field Station#	10698+00	Field Station#			
Pic 9 Desc.	S-G 32	Pic 10 Desc.			
Insert image here		Insert image here			
GPS Location		GPS Location			
Field Station#		Field Station#			
Pic 11 Desc.		Pic 12 Desc.

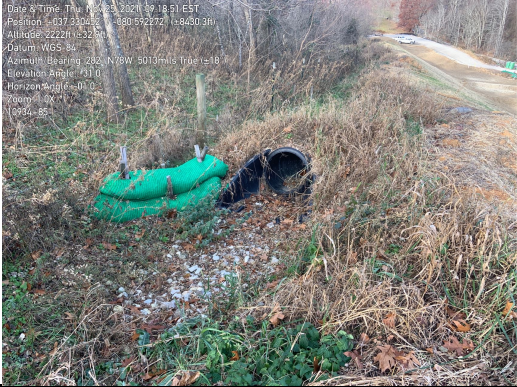
GPS Location	See photo	GPS Location			
Field Station#	10934+85	Field Station#			
Pic 7 Desc.	Clean water diversion inlet is in acceptable condition	Pic 8 Desc.			
Insert image here		Insert image here			
GPS Location		GPS Location			
Field Station#		Field Station#			
Pic 9 Desc.		Pic 10 Desc.			
Insert image here		Insert image here			
GPS Location		GPS Location			
Field Station#		Field Station#			
Pic 11 Desc.		Pic 12 Desc.

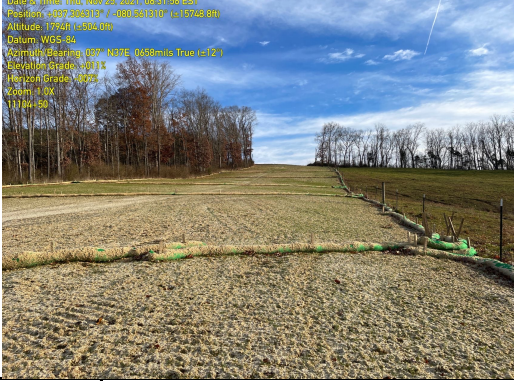
GPS Location	See photo	GPS Location	See photo		
Field Station#	11104+50	Field Station#	11112+00		
Pic 1 Desc.	CFS perimeter control in place	Pic 2 Desc.	CFS triple stack perimeter control in place		
<p>Date & Time: Thu, Nov 25, 2021, 09:45:25 EST Position: +407.210259° / -080.824317° (±1.0m) Altitude: 19718 (±9.7m) Datum: WGS-84 Azimuth/Bearing: 272° MAGN 1000mils True (±12°) Elevation Grade: +01% Horizon Grade: +00% Zoom: 1.0x 11120+00</p>

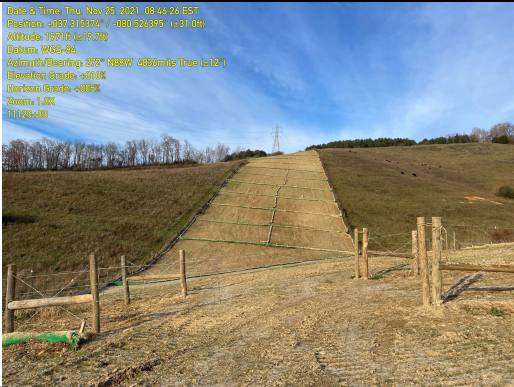
GPS Location	See photo	GPS Location	See photo		
Field Station#	11120+00	Field Station#	11134+00		
Pic 3 Desc.	CFS temporary waterbars in place	Pic 4 Desc.	Permanent waterbars in place		
<p>Date & Time: Thu, Nov 25, 2021, 09:49:47 EST Position: +407.210259° / -080.819397° (±1.1m) Altitude: 20517 (±9.7m) Datum: WGS-84 Azimuth/Bearing: 133° MAGN 1000mils True (±12°) Elevation Grade: -01% Horizon Grade: +00% Zoom: 1.0x 11148+00</p>

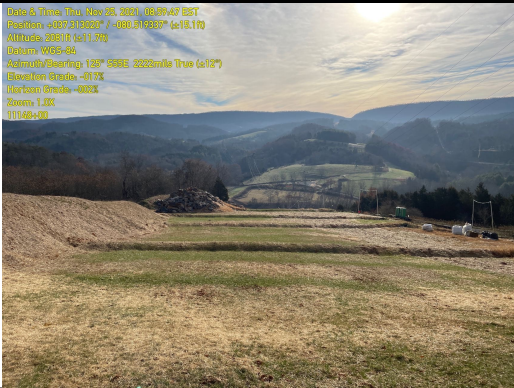
GPS Location	See photo	GPS Location	See photo		
Field Station#	11148+00	Field Station#	11149+25		
Pic 5 Desc.	Waterbars in place	Pic 6 Desc.	Stone inlet protection in place

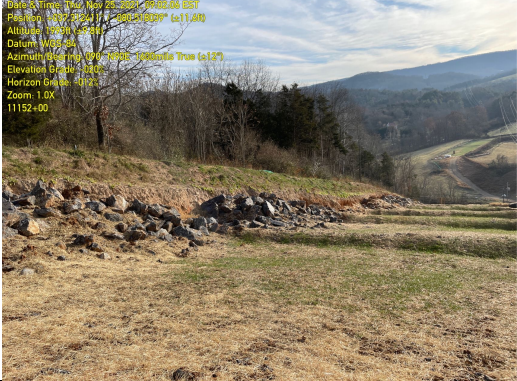
GPS Location	See photo	GPS Location	See photo		
Field Station#	11152+00	Field Station#	11163+00		
Pic 7 Desc.	Cleanwater diversion berm in place	Pic 8 Desc.	P1 silt fence perimeter control in place		
<p>Date & Time: Thu, Nov 25, 2021, 09:16:31 EST Position: +437.210343° / -880.914312° (s11.40) Altitude: 1844ft (s13.10) Datum: WGS-84 Azimuth/Bearing: 212° S32W 3760mils True (s12°) Elevation Grade: -001X Horizon Grade: -000X Zoom: 1.0X 11168+00</p>

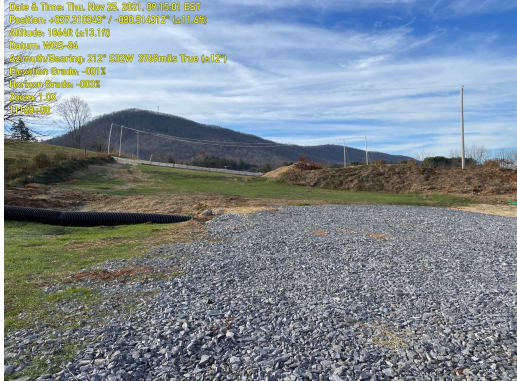
GPS Location	See photo	GPS Location	See photo		
Field Station#	11168+00	Field Station#	11167+50		
Pic 9 Desc.	RCE in place	Pic 10 Desc.	Cleanwater diversion outlet protection in place		
<p>Date & Time: Thu, Nov 25, 2021, 09:17:49 EST Position: +437.208326° / -880.913388° (s11.40) Altitude: 1937ft (s13.10) Datum: WGS-84 Azimuth/Bearing: 300° N57W 5000mils True (s12°) Elevation Grade: -010X Horizon Grade: +000X Zoom: 1.0X 11178+00</p>

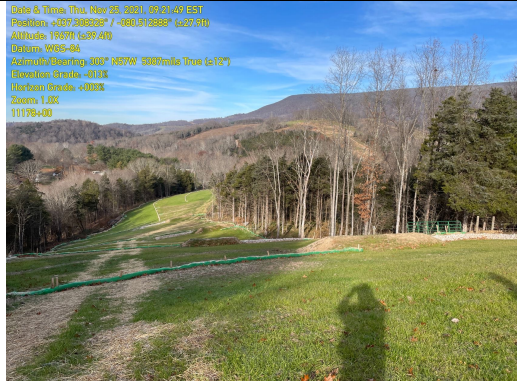
GPS Location	See photo	GPS Location	See photo		
Field Station#	11178+00	Field Station#	11184+15		
Pic 11 Desc.	Level spreaders in place	Pic 12 Desc.	Daylight drain in place

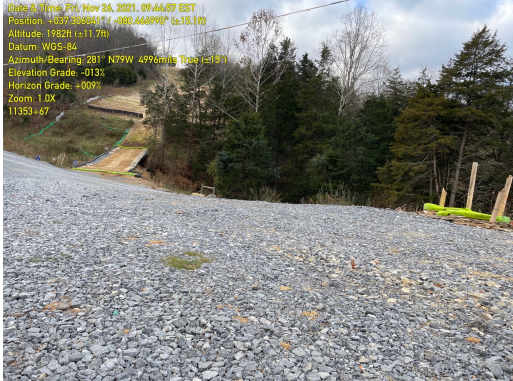
GPS Location		See photo		GPS Location		See photo
Field Station#		11353+67		Field Station#		11362+00
Pic 1 Desc.		RCE in place		Pic 2 Desc.		Erosion control blanket in place

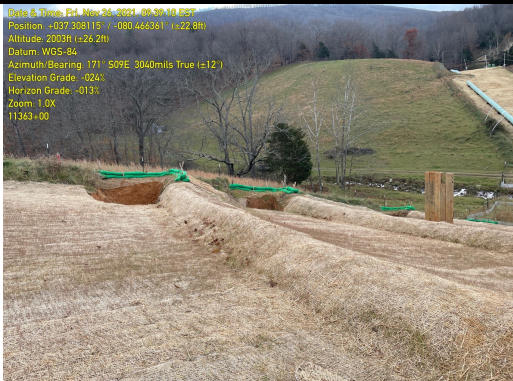
GPS Location		See photo		GPS Location		See photo
Field Station#		11363+00		Field Station#		11398+00
Pic 3 Desc.		End treatments in place		Pic 4 Desc.		Permanent waterbar in place

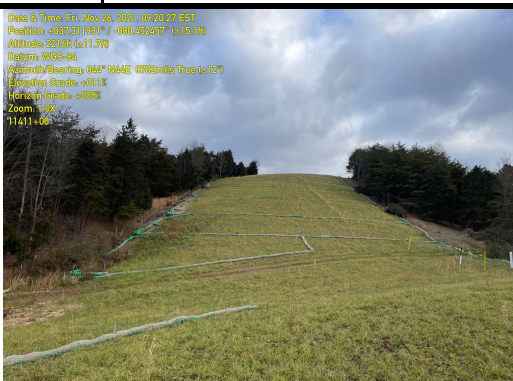
GPS Location		See photo		GPS Location		See photo
Field Station#		11411+00		Field Station#		11438+00
Pic 5 Desc.		CFS temporary waterbars in place		Pic 6 Desc.		CFS triple stack perimeter control in place

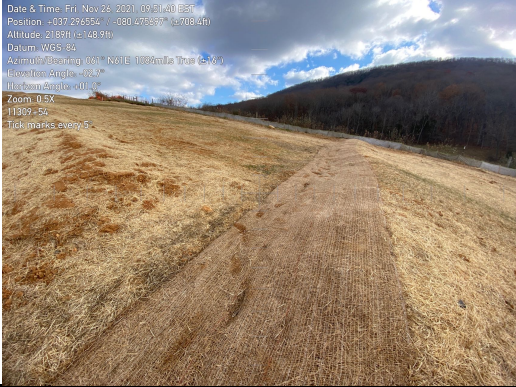
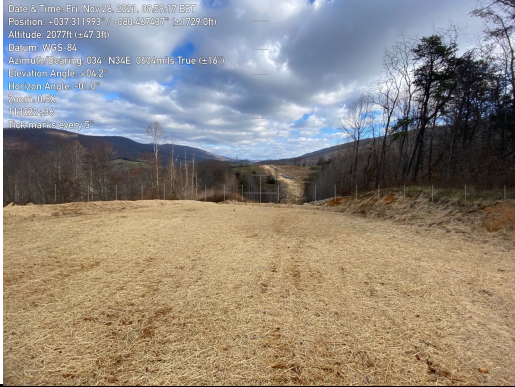
<p><small>Date & Time: Fri, Nov 26, 2021 09:50:43 EST Position: +037 311993, -080 432657 12729.0ft Altitude: 2077ft (+47.3ft) Datum: WGS 84 Azimuth: Bearing: 034 N34E 030mils True (+18.0) Horizontal Angle: 00.2° Pitch Angle: -01.2° Zoom: 0.5X 11322+36 Tick marks every 5'</small></p>			
GPS Location	See Photo	GPS Location	See photo		
Field Station#	11309+54	Field Station#	11322+36		
Pic 7 Desc.	Photo showing repaired waterbar and stabilization from deficiency of last SWPPP		Pic 8 Desc.	Photo showing stabilization	
Insert image here		Insert image here

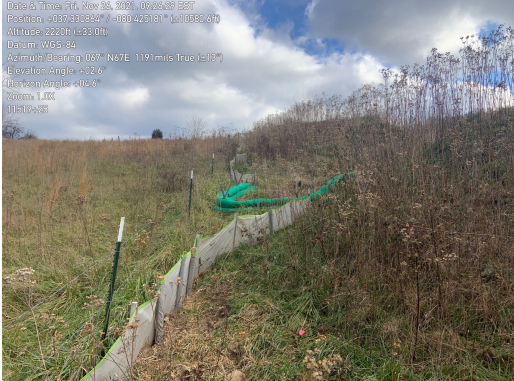
GPS Location	See photo	GPS Location	See photo		
Field Station#	11519+25	Field Station#	11512+50		
Pic 1 Desc.	P1 silt fence and CFS perimeter controls in place	Pic 2 Desc.	Equipment bridge is maintained in acceptable condition		
<p>Date & Time: Fri, Nov 26, 2021, 09:14:01 EST Position: +437.32979° / -880.42672° (+7616ft) Altitude: 2230ft (+22.9ft) Datum: WGS-84 Azimuth/Bearing: 124° 554E 2204mils True (±17°) Elevation Angle: -10.7° Horizon Angle: -01.6° Zoom: 1.0x 11490+02</p>

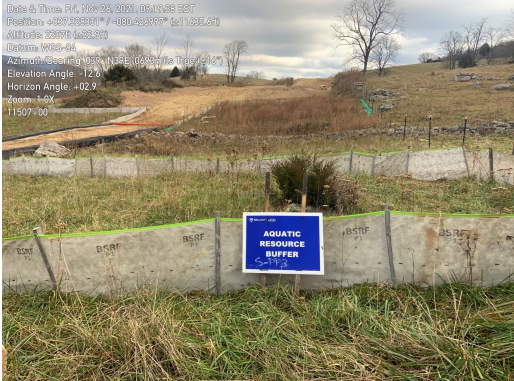
GPS Location	See photo	GPS Location	See photo		
Field Station#	11507+00	Field Station#	11500+35		
Pic 3 Desc.	Sensitive resource signage functional	Pic 4 Desc.	Temporary construction berm is in place		
<p>Date & Time: Fri, Nov 26, 2021, 09:00:00 EST Position: +437.32979° / -880.42672° (+7616ft) Altitude: 2152ft (+11.1ft) Datum: WGS-84 Azimuth/Bearing: 210° 507W 3303mils True (±10°) Elevation Angle: -08.5° Horizon Angle: -00.4° Zoom: 1.0x 11490+02</p>

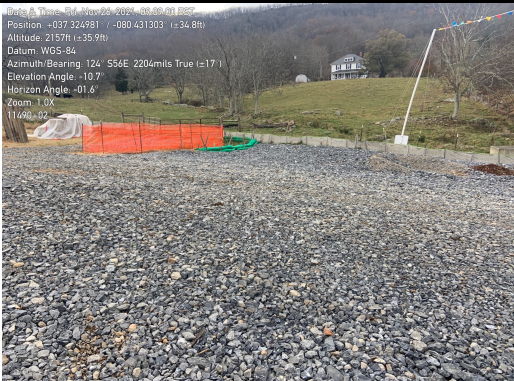
GPS Location	See photo	GPS Location	See photo		
Field Station#	11490+02	Field Station#	11490+02		
Pic 5 Desc.	RCE at Stevers Gap is in acceptable condition	Pic 6 Desc.	Rain gage at Stevers Gap with trace amount of precipitation
