Visual Site Inspection Report

Project Name	H-600 Pipeline Spread G	AFE	124300137	Spread	H-600 Pipeline Spread G
Contractor	Precision			Report #	31681
Inspector	Patrick Shields			Date/Time	11/29/2021 10:32 AM
Permit #	TBD	Inspection Type	VA SWPP	Station Begin	11670+00
State	VA	Inspection Area	Full	Station End	11788+52
County	Montgomery	Ground	Frozen	Temperature (°F)	34.00
Municipality	N/A	Weather	Cloudy	Rain Gauge (in)	0.00
				Rain Accumulation Time (days)	1.00

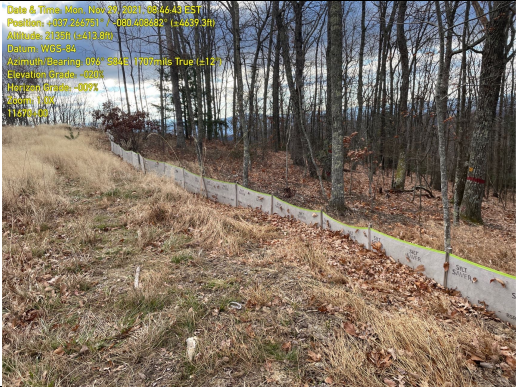
GPS Location	See photo	GPS Location	See photo		
Field Station#	11670+00	Field Station#	11679+00		
Pic 1 Desc.	P1 silt fence perimeter control in place	Pic 2 Desc.	End treatments in place		
<p>Date & Time Mon Nov 29 2021 08:57:24 EST Position: +037.3017237° / +080.591334° (+23.118) Altitude: 2530ft (+77.2m) Datum: WGS 84 Azimuth/Bearing: 157° 52'45" (+2773mils True (+12°)) Elevation Grade: +000ft Horizon Grade: +001ft Zoom: 1.0x 11687+00</p>

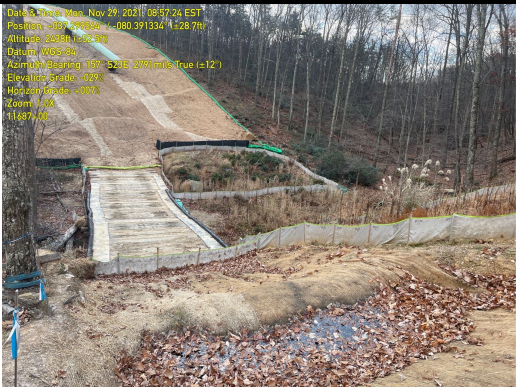
GPS Location	See photo	GPS Location	See photo		
Field Station#	11687+00	Field Station#	11689+00		
Pic 3 Desc.	Stream buffer in place	Pic 4 Desc.	Erosion control blanket in place		
<p>Date & Time Mon Nov 29 2021 08:58:52 EST Position: +037.3017237° / +080.591334° (+23.118) Altitude: 2530ft (+77.2m) Datum: WGS 84 Azimuth/Bearing: 009° 00' 00" (+0.00mils True (+12°)) Elevation Grade: +000ft Horizon Grade: +001ft Zoom: 1.0x 11688+00</p>

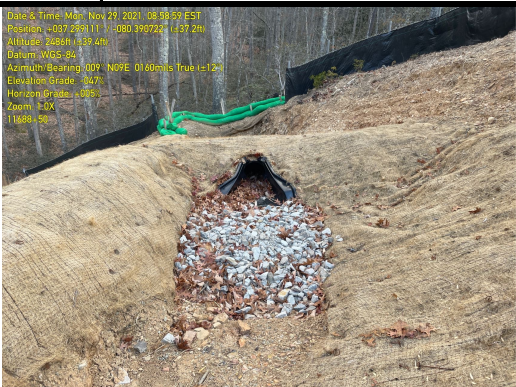
GPS Location	See photo	GPS Location	See photo		
Field Station#	11688+50	Field Station#	11704+50		
Pic 5 Desc.	Stone inlet protection in place	Pic 6 Desc.	Sediment filter logs in place

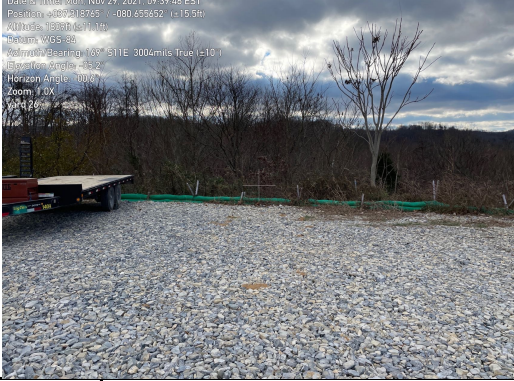
GPS Location	See photo	GPS Location	See photo		
Field Station#	12005+00	Field Station#	12005+00		
Pic 1 Desc.	CFS functional	Pic 2 Desc.	RCE functional		
<p>Date & Time: Mon, Nov 29, 2021, 07:39:46 EST Position: +387213785° / +080 455652° (+15.5ft) Altitude: 1753ft (+11.1ft) Datum: WGS-84 Azimuth Bearing: 055° N54E 0996mils True (+10°) Elevation Angle: +14.0° Horizon Angle: -01.3° Zoom: 1.0X yard 26</p>

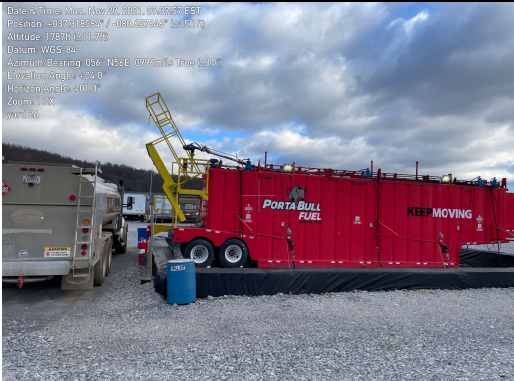
GPS Location	See photo	GPS Location	See photo		
Field Station#	12005+00	Field Station#	12005+00		
Pic 3 Desc.	Secondary containment in place	Pic 4 Desc.	Secondary containment in place		
<p>Date & Time: Mon, Nov 29, 2021, 07:39:46 EST Position: +387213785° / +080 455652° (+15.5ft) Altitude: 1753ft (+11.1ft) Datum: WGS-84 Azimuth Bearing: 074° N55° S16mils True (+10°) Elevation Angle: -06.6° Horizon Angle: -01.0° Zoom: 1.0X yard 26</p>

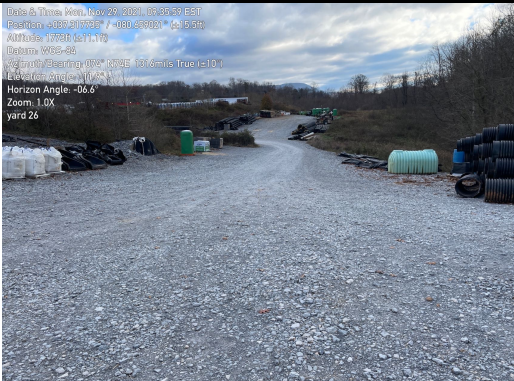
GPS Location	See photo	GPS Location	See photo		
Field Station#	12005+00	Field Station#	12005+00		
Pic 5 Desc.	Housekeeping in good order	Pic 6 Desc.	Perimeter controls in place

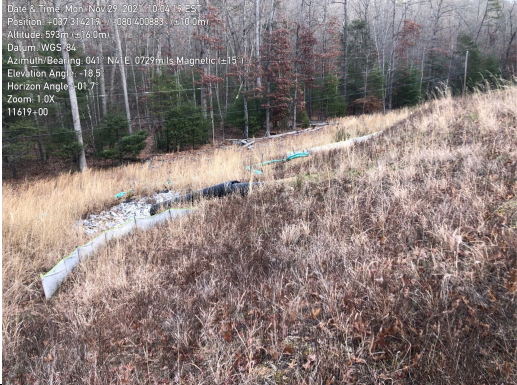
GPS Location	On photo	GPS Location	On photo		
Field Station#	11619+00	Field Station#	11614+20		
Pic 7 Desc.	Perimeter ECDs are in place. ROW is stable.	Pic 8 Desc.	S-RR14 crossing is stable.

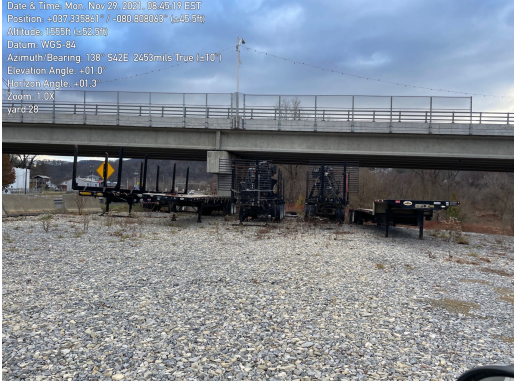
GPS Location	See photo	GPS Location	See photo		
Field Station#	12005+00	Field Station#	12005+00		
Pic 1 Desc.	Housekeeping functional	Pic 2 Desc.	Perimeter controls in place are		
<p>Date & Time: Mon, Nov 29, 2021, 10:44:49 EST Position: 40°13'33.93" N, -80°30'00.00" W, 40.22 ft Altitude: 1550 ft (472.49 m) Datum: WGS 84 Azimuth/Bearing: 112.532E, 3009mils True (±10.1) Elevation Angle: +02.4 Horizon Angle: -01.5 Zoom: 1.0X yard 28</p>

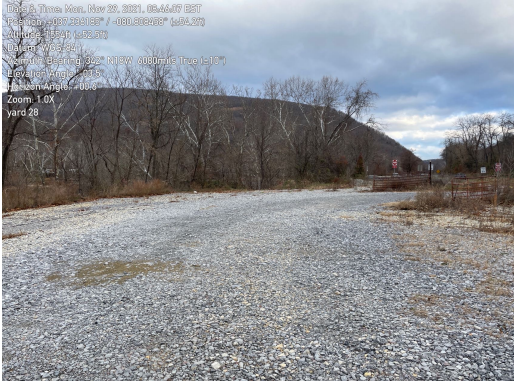
GPS Location	See photo	GPS Location	See photo		
Field Station#	12005+00	Field Station#	12005+00		
Pic 3 Desc.	RCE functional	Pic 4 Desc.	CFS perimeter controls functional		
<p>Date & Time: Mon, Nov 29, 2021, 10:46:08 EST Position: 40°13'33.93" N, -80°30'00.00" W, 40.22 ft Altitude: 1550 ft (472.49 m) Datum: WGS 84 Azimuth/Bearing: 112.532E, 3009mils True (±10.1) Elevation Angle: +02.4 Horizon Angle: -01.5 Zoom: 1.0X yard 28</p>

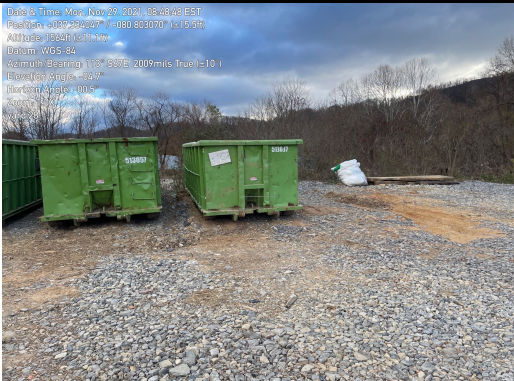
GPS Location	See photo	GPS Location	See photo		
Field Station#	12005+00	Field Station#	12005+00		
Pic 5 Desc.	Housekeeping functional	Pic 6 Desc.	RCE functional

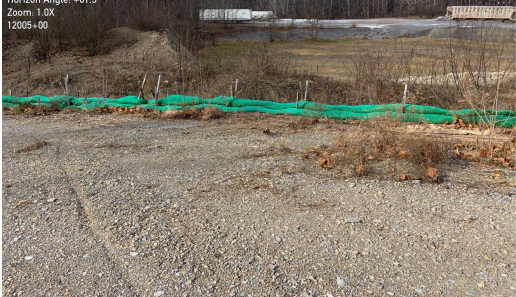
GPS Location	See photo	GPS Location	See photo		
Field Station#	12005+00	Field Station#	12005+00		
Pic 1 Desc.	Triple stacked CFS perimeter controls in place	Pic 2 Desc.	Culvert in place		
<p>Date & Time: Mon, Nov 29, 2021, 10:45:08 EST Position: +037.362264 / -080.677490 (-1213.3m) Altitude: 17006 ft (-52.8m) Datum: WGS-84 Azimuth/Bearing: 151 S29E 2684m True (±13) Elevation Angle: -05.5° Horizon Angle: -01.9° Zoom: 1.0X 12005+00</p>

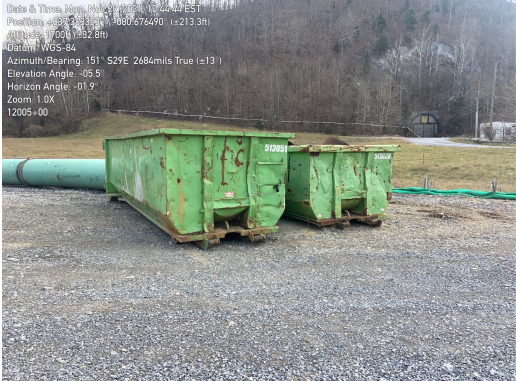
GPS Location	See photo	GPS Location	See photo		
Field Station#	12005+00	Field Station#	12005+00		
Pic 3 Desc.	Dumpsters in place	Pic 4 Desc.	Secondary containment in place		
<p>Date & Time: Mon, Nov 29, 2021, 10:45:08 EST Position: +037.362264 / -080.677337 (-12327) Altitude: 17097 ft (-17.2m) Datum: WGS-84 Azimuth/Bearing: 075 N19E 1404 m True (±13) Elevation Angle: -05.0° Horizon Angle: +01.9° Zoom: 1.0X 12005+00</p>

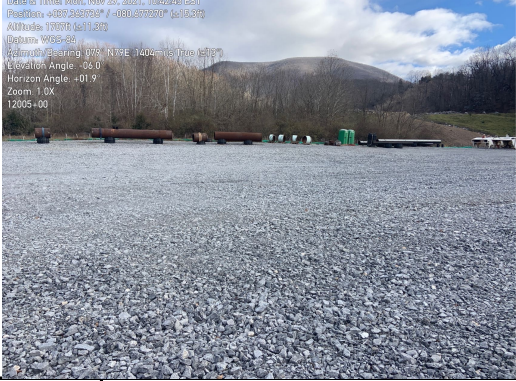
GPS Location	See photo	GPS Location	See photo		
Field Station#	12005+00	Field Station#	12005+00		
Pic 5 Desc.	Rock surface of the RCE is maintained in acceptable condition	Pic 6 Desc.	Triple stacked CFS perimeter controls in place

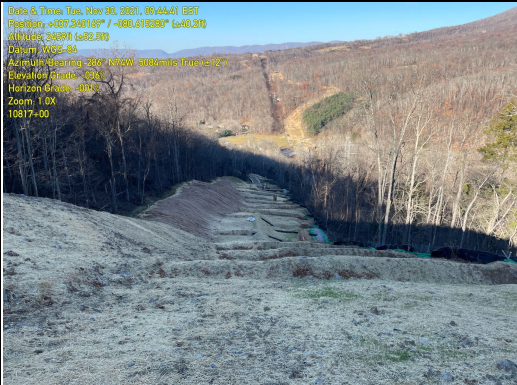
GPS Location	See photo	GPS Location	See photo		
Field Station#	10817+00	Field Station#	10812+00		
Pic 7 Desc.	Waterbars in place	Pic 8 Desc.	Erosion control blanket in place

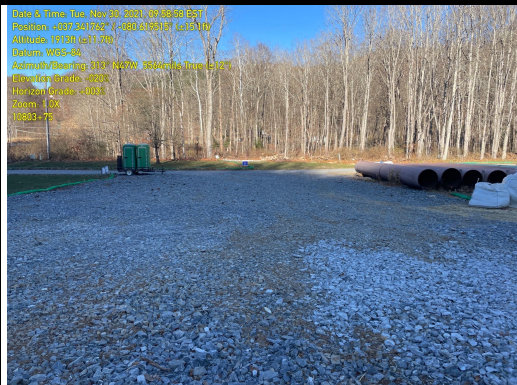
<div>Insert image here</div>			
GPS Location	See photo	GPS Location			
Field Station#	10803+75	Field Station#			
Pic 11 Desc.	RCE in place	Pic 12 Desc.

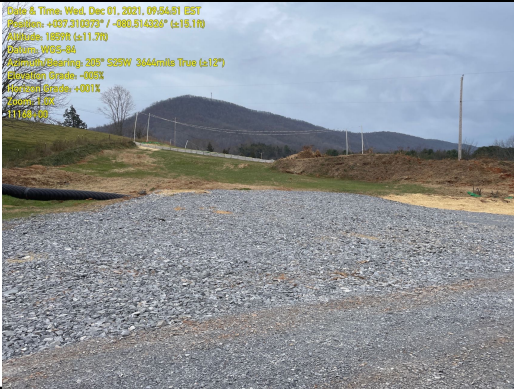
<p>Date & Time: Wed, Dec 01, 2021, 09:54:51 EST Position: +027.310792° / -080.514326° (±15.110) Altitude: 1899ft (±39.40) Datum: WGS-84 Azimuth/Bearing: 209° 529W 344mils True (±12°) Elevation Grade: +00% Horizontal Grade: +00% Zoom: 1.0x 11168+00</p>

GPS Location	See photo	GPS Location	See photo		
Field Station#	11168+00	Field Station#	11167+00		
Pic 3 Desc.	RCE in place	Pic 4 Desc.	Cleanwater diversion outlet protection in place

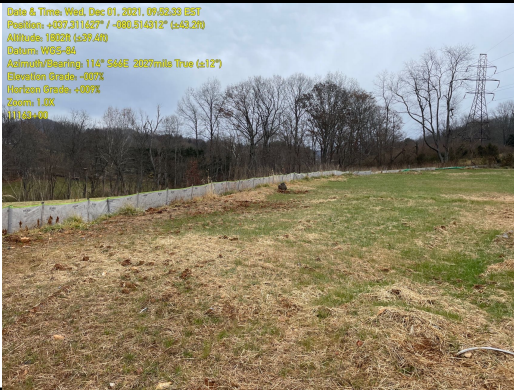
<p>Date & Time: Wed, Dec 01, 2021, 09:52:53 EST Position: +027.311627° / -080.514312° (±15.110) Altitude: 1820ft (±39.40) Datum: WGS-84 Azimuth/Bearing: 114° 541E 202mils True (±12°) Elevation Grade: +00% Horizontal Grade: +00% Zoom: 1.0x 11163+00</p>

<p>Date & Time: Wed, Dec 01, 2021, 09:41:15 EST Position: +027.312619° / -080.518882° (±15.110) Altitude: 2055ft (±11.10) Datum: WGS-84 Azimuth/Bearing: 173° 507E 307mils True (±12°) Elevation Grade: +02% Horizontal Grade: +00% Zoom: 1.0x 11149+50</p>			
GPS Location	See photo	GPS Location	See photo		
Field Station#	11163+00	Field Station#	11149+50		
Pic 5 Desc.	P1 silt fence perimeter control in place	Pic 6 Desc.	Stone inlet protection in place

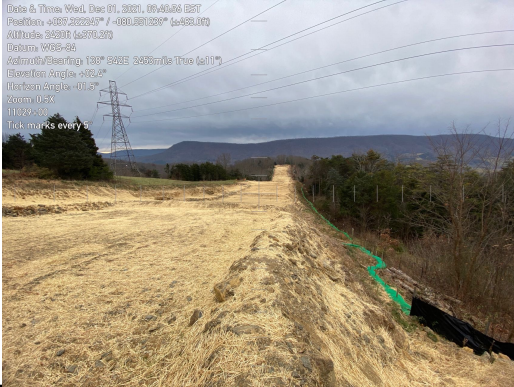
GPS Location	See Photo	GPS Location	See Photo		
Field Station#	11050+14	Field Station#	11084+50		
Pic 5 Desc.	Over View of S-IJ16B	Pic 6 Desc.	Restoration and CFS water bars

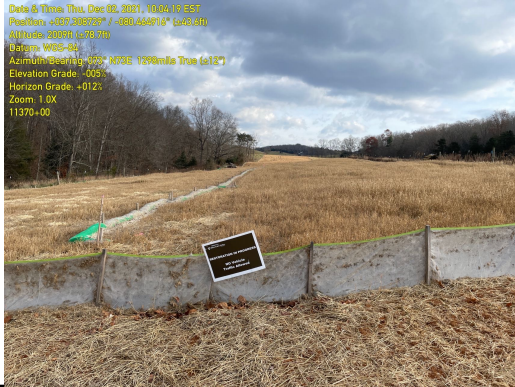
GPS Location	See photo	GPS Location	See photo		
Field Station#	11363+00	Field Station#	11370+00		
Pic 3 Desc.	End treatments in place	Pic 4 Desc.	Proper signage in place

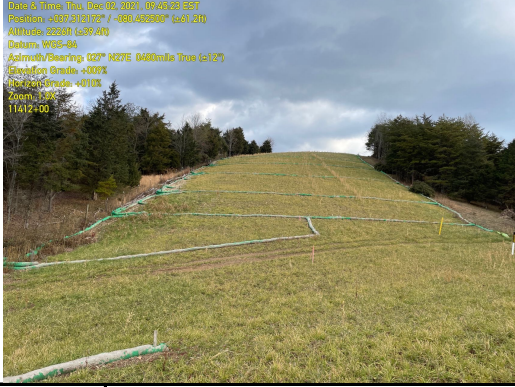
GPS Location	See photo	GPS Location	See photo		
Field Station#	11396+00	Field Station#	11412+00		
Pic 5 Desc.	Level spreader in place	Pic 6 Desc.	CFS waterbars in place

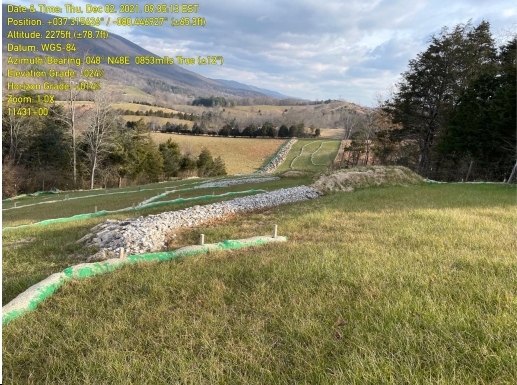
<p>Date & Time: Thu, Dec 02, 2021, 09:35:24 EST Position: +037.314524° / -080.440889° (s=18.970) Altitude: 2275ft (s=78.70) Datum: WGS-84 Azimuth/Bearing: 260° S80W Azimuth/True (s=12°) Elevation Grade: +032° Horizon Grade: +000° Zoom: 1.0X 11431+00</p>

GPS Location	See photo	GPS Location	See photo		
Field Station#	11431+00	Field Station#	11447+00		
Pic 7 Desc.	Permanent waterbar in place	Pic 8 Desc.	Cleanwater diversion berm in place		
<p>Date & Time: Thu, Dec 02, 2021, 09:19:49 EST Position: +037.314440° / -080.440889° (s=18.970) Altitude: 2259ft (s=74.34) Datum: WGS-84 Azimuth/Bearing: 260° S80W Azimuth/True (s=12°) Elevation Grade: +032° Horizon Grade: +000° Zoom: 1.0X 11452+00</p>

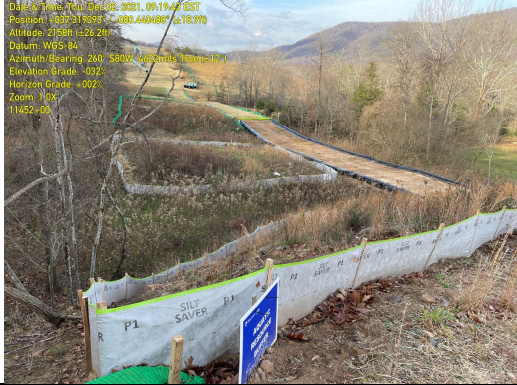
<p>Date & Time: Thu, Dec 02, 2021, 09:18:14 EST Position: +037.314440° / -080.439729° (s=12.00) Altitude: 2259ft (s=74.34) Datum: WGS-84 Azimuth/Bearing: 260° S80W Azimuth/True (s=12°) Elevation Grade: +032° Horizon Grade: +000° Zoom: 1.0X 11455+00</p>

GPS Location	See photo	GPS Location	See photo		
Field Station#	11452+00	Field Station#	11455+00		
Pic 9 Desc.	Stream buffer in place	Pic 10 Desc.	Stone inlet protection in place		
<p>Date & Time: Thu, Dec 02, 2021, 09:15:29 EST Position: +037.314524° / -080.437395° (s=18.970) Altitude: 2284ft (s=71.76) Datum: WGS-84 Azimuth/Bearing: 260° S80W Azimuth/True (s=12°) Elevation Grade: +032° Horizon Grade: +000° Zoom: 1.0X 11460+00</p>

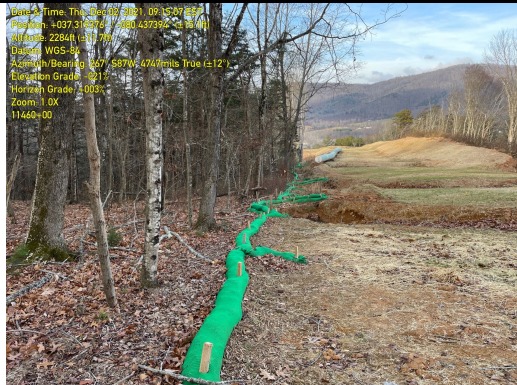
<p>Date & Time: Thu, Dec 02, 2021, 09:15:29 EST Position: +037.314524° / -080.437395° (s=18.970) Altitude: 2284ft (s=71.76) Datum: WGS-84 Azimuth/Bearing: 260° S80W Azimuth/True (s=12°) Elevation Grade: +032° Horizon Grade: +000° Zoom: 1.0X 11468+00</p>

GPS Location	See photo	GPS Location	See photo		
Field Station#	11460+00	Field Station#	11468+00		
Pic 11 Desc.	CFS perimeter control in place	Pic 12 Desc.	Triple protection ECDs in place at karst feature

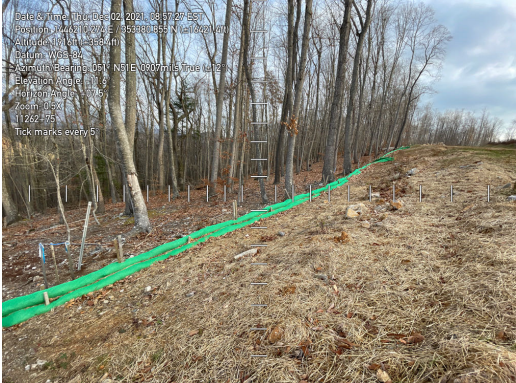
<p>Date & Time Thu Dec 02, 2021, 05:37:29 EST Position 11262+75 N 11262+75 W 11262+75 Altitude 742.41 ft (226.10 m) Datum WGS 84 Azimuth Bearing 124° 58' 43" 203mils True (12) Elevation Angle -12.3° Horizon Angle -13.5° Zoom 0.5X 11262+75 Tick marks every 5'</p>

GPS Location	3	GPS Location	4		
Field Station#	11262+75	Field Station#	11281+00		
Pic 3 Desc.	Perimeter controls functional.	Pic 4 Desc.	Waterbar end treatment.

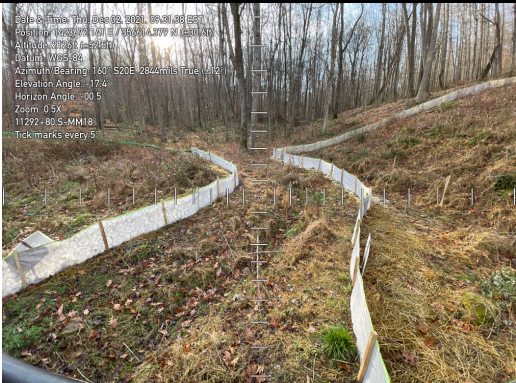
<p>Date & Time Thu Dec 02, 2021, 05:37:29 EST Position 11292+80 N 11292+80 W 11292+80 Altitude 742.41 ft (226.10 m) Datum WGS 84 Azimuth Bearing 124° 58' 43" 203mils True (12) Elevation Angle -12.3° Horizon Angle -13.5° Zoom 0.5X 11292+80 S-MM18 Tick marks every 5'</p>

<p>Date & Time Thu Dec 02, 2021, 05:37:29 EST Position 11327+85 N 11327+85 W 11327+85 Altitude 742.41 ft (226.10 m) Datum WGS 84 Azimuth Bearing 124° 58' 43" 203mils True (12) Elevation Angle -12.3° Horizon Angle -13.5° Zoom 0.5X 11327+85 S-NN12 Tick marks every 5'</p>			
GPS Location	5	GPS Location	6		
Field Station#	11292+80	Field Station#	11327+85		
Pic 5 Desc.	S-MM18 and controls.	Pic 6 Desc.	S-NN12 and controls.

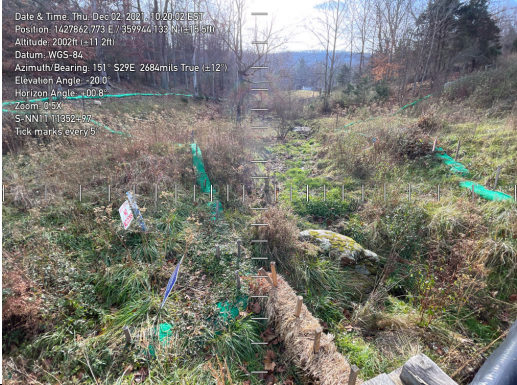
Insert image here	
GPS Location	7	GPS Location			
Field Station#	11352+97	Field Station#			
Pic 7 Desc.	S-NN11 and controls.	Pic 8 Desc.			
Insert image here		Insert image here			
GPS Location		GPS Location			
Field Station#		Field Station#			
Pic 9 Desc.		Pic 10 Desc.			
Insert image here		Insert image here			
GPS Location		GPS Location			
Field Station#		Field Station#			
Pic 11 Desc.		Pic 12 Desc.

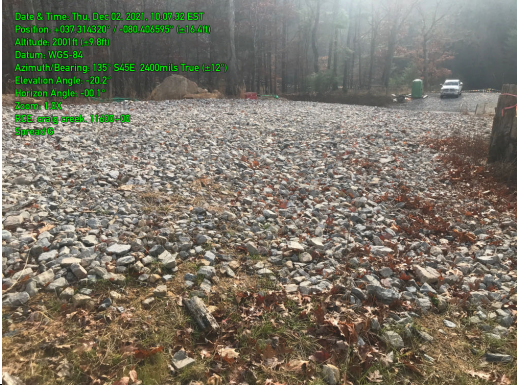
<p>Insert image here</p>			
GPS Location	See photo	GPS Location			
Field Station#	11600+01	Field Station#			
Pic 13 Desc.	RCE at Craig Creek	Pic 14 Desc.			
<p>Insert image here</p>		<p>Insert image here</p>			
GPS Location		GPS Location			
Field Station#		Field Station#			
Pic 15 Desc.		Pic 16 Desc.			
<p>Insert image here</p>		<p>Insert image here</p>			
GPS Location		GPS Location			
Field Station#		Field Station#			
Pic 17 Desc.		Pic 18 Desc.

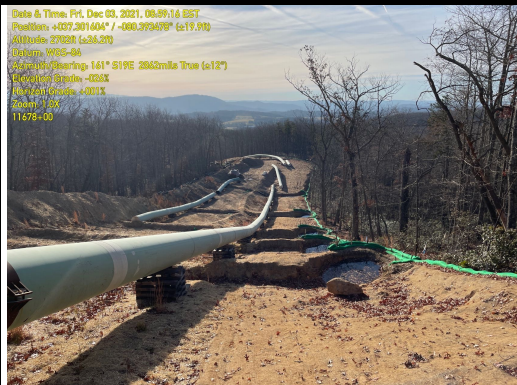
<p>Date & Time: Fri, Dec 03, 2021, 07:52:14 EST Position: +43° 27'05" / -88° 38'58" (±15.40) Altitude: 2700ft (±26.30) Datum: WGS-84 Magnetic Bearing: 210° NMMW 1066mils True (±12°) Horizontal Grade: +00% Horizontal Grade: +00% Zoom: 1.0X 11670+00</p>  			
GPS Location		See photo		GPS Location		See photo
Field Station#		11678+00		Field Station#		11670+00
Pic 11 Desc.		End treatments in place		Pic 12 Desc.		P1 silt fence perimeter control in place

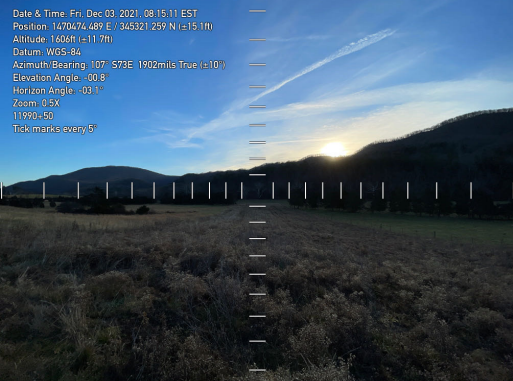
<p>Date & Time: Fri, Dec 03, 2021, 08:15:11 EST Position: 1670474.489 E / 345321.259 N (±15.1m) Altitude: 1606ft (±11.7m) Datum: WGS-84 Azimuth/Bearing: 107° S73E 1902mils True (±10°) Elevation Angle: -00.8° Horizon Angle: -03.1° Zoom: 0.5X 11990+50 Tick marks every 5'</p>			
GPS Location 1		GPS Location 2			
Field Station# 12005+00		Field Station# 11990+50			
Pic 1 Desc. Section of RoW showing conditions and controls.		Pic 2 Desc. Section of RoW showing conditions and controls.

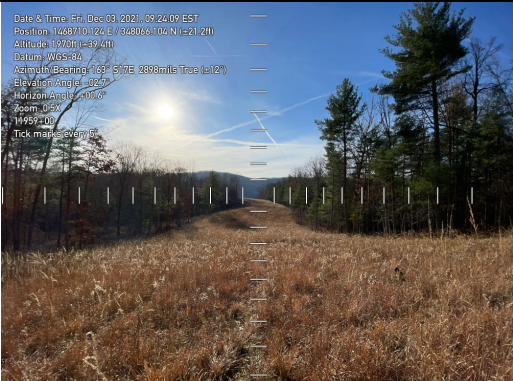
GPS Location 3		GPS Location 4			
Field Station# 11978+85		Field Station# 11959+00			
Pic 3 Desc. Karst protection functional.		Pic 4 Desc. Section of RoW showing conditions and controls.

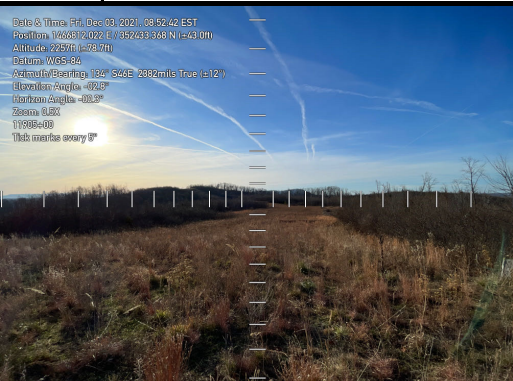
<p>Date & Time: Fri, Dec 03, 2021, 08:52:42 EST Position: 1648312.022 E / 345243.368 N (±43.0m) Altitude: 2297ft (±38.7m) Datum: WGS-84 Azimuth/Bearing: 124° S46E 3892mils True (±12°) Elevation Angle: -02.8° Horizon Angle: -03.5° Zoom: 0.5X 11905+00 Tick marks every 5'</p>			
GPS Location 5		GPS Location 6			
Field Station# 11948+00		Field Station# 11905+00			
Pic 5 Desc. Section of RoW showing conditions and controls.		Pic 6 Desc. Section of RoW showing conditions and controls.

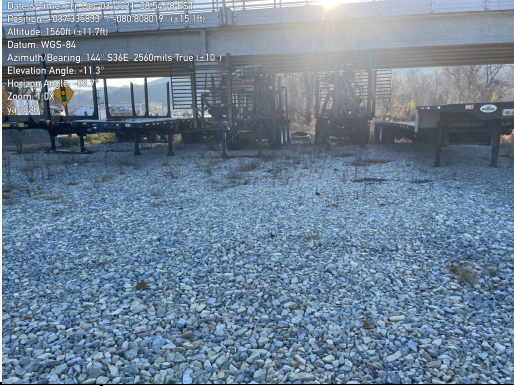
<p>Date & Time: Fri, Dec 03, 2021, 08:55:26 EST Position: +037 334545 / -080 809958 (±11.4ft) Altitude: 1561ft (±11.7ft) Datum: WGS-84 Azimuth/Bearing: 220.540W 3813mils True (±10.1) Elevation Angle: -13.5° Horizon Angle: -00.2° Zoom: 1.0X yard 28</p>			
GPS Location	See photo	GPS Location	See photo		
Field Station#	12005+00	Field Station#	12005+00		
Pic 1 Desc.	RCE functional	Pic 2 Desc.	CFS perimeter controls functional

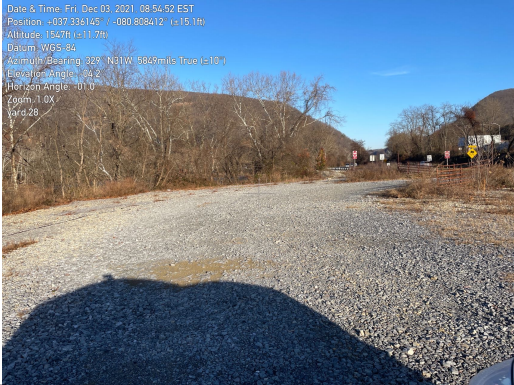
GPS Location	See photo	GPS Location	See photo		
Field Station#	12005+00	Field Station#	12005+00		
Pic 3 Desc.	RCE functional	Pic 4 Desc.	CFS perimeter controls functional

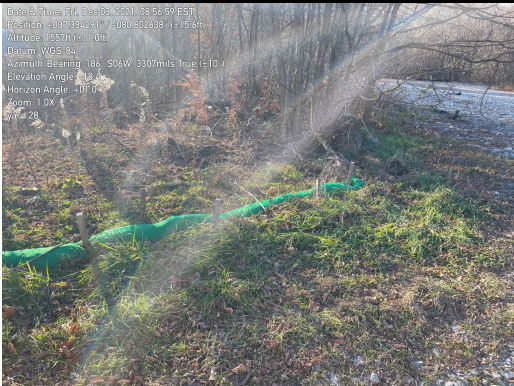
<p>Date & Time: Fri, Dec 03, 2021, 08:57:21 EST Position: +037 334118 / -080 803048 (±15.3ft) Altitude: 1567ft (±11.1ft) Datum: WGS-84 Azimuth/Bearing: 135.545E 2400mils True (±10.1) Elevation Angle: -01.9° Horizon Angle: -01.2° Zoom: 1.0X yard 28</p>			
GPS Location	See photo	GPS Location	See photo		
Field Station#	12005+00	Field Station#	12005+00		
Pic 5 Desc.	CFS perimeter controls functional	Pic 6 Desc.	Waste management functional

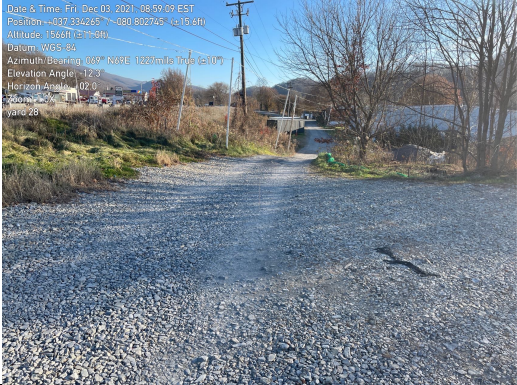
GPS Location	See photo	GPS Location			
Field Station#	12005+00	Field Station#			
Pic 7 Desc.	RCE functional	Pic 8 Desc.			
Insert image here		Insert image here			
GPS Location		GPS Location			
Field Station#		Field Station#			
Pic 9 Desc.		Pic 10 Desc.			
Insert image here		Insert image here			
GPS Location		GPS Location			
Field Station#		Field Station#			
Pic 11 Desc.		Pic 12 Desc.

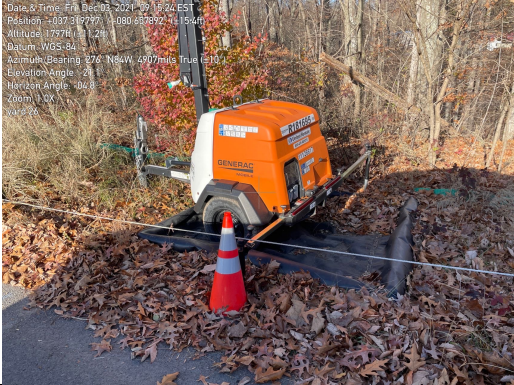
GPS Location	See photo		GPS Location	See photo	
Field Station#	12005+00		Field Station#	12005+00	
Pic 1 Desc.	Secondary containment functional		Pic 2 Desc.	CFS perimeter controls functional

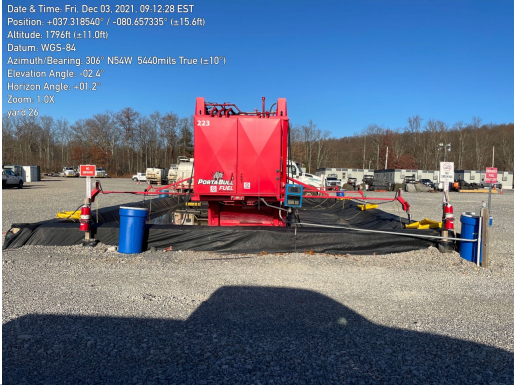
GPS Location	See photo		GPS Location	See photo	
Field Station#	12005+00		Field Station#	12005+00	
Pic 3 Desc.	Secondary containment functional		Pic 4 Desc.	Secondary containment functional

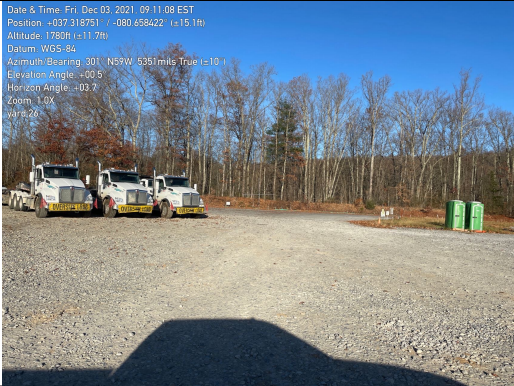
GPS Location	See photo		GPS Location	See photo	
Field Station#	12005+00		Field Station#	12005+00	
Pic 5 Desc.	RCE functional		Pic 6 Desc.	CFS perimeter controls functional

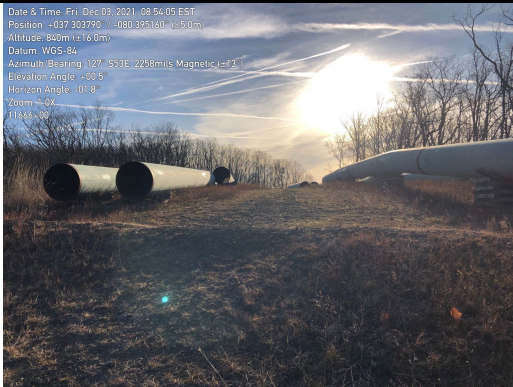
<p>Date & Time: Fri, Dec 03, 2021, 09:03:19 EST Position: +037.387287 / -080.394647 (+5.0m) Altitude: 780m (+6.0m) Datum: WGS 84 Azimuth/Bearing: 141.501E 230mils Magnetic (+13.1) Elevation Angle: +02.3 Horizon Angle: +02.2 Zoom: 1.0x 11658+00</p>			
GPS Location	On photo		GPS Location	On photo	
Field Station#	11666+00		Field Station#	11658+00	
Pic 1 Desc.	Slope breakers functional.		Pic 2 Desc.	Perimeter ECDs are in acceptable condition.

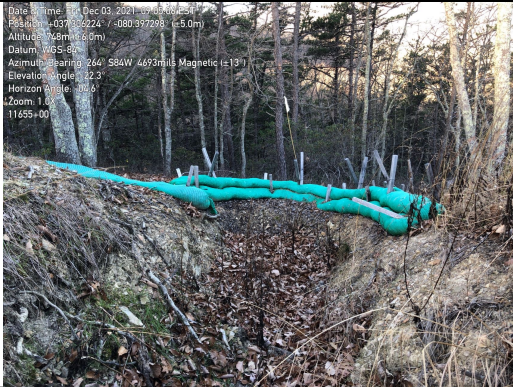
GPS Location	On photo		GPS Location	On photo	
Field Station#	11655+00		Field Station#	11654+00	
Pic 3 Desc.	End treatments are in place and in acceptable condition.		Pic 4 Desc.	Slope breakers are in place and functioning properly.

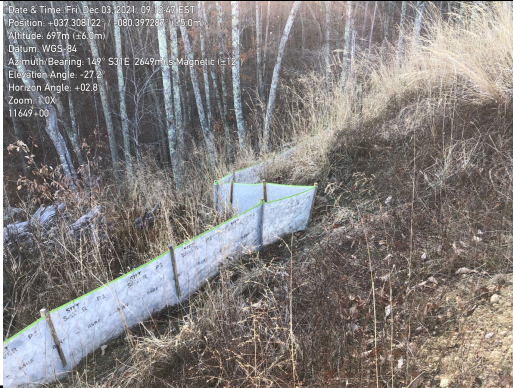
<p>Date & Time: Fri, Dec 03, 2021, 09:24:32 EST Position: +037.294581 / -080.386017 (+5.0m) Altitude: 535m (+5.0m) Datum: WGS 84 Azimuth/Bearing: 138.902W 334mils Magnetic (+13.1) Elevation Angle: +11.2 Horizon Angle: +00.0 Zoom: 1.0x 11634+00</p>			
GPS Location	On photo		GPS Location	On photo	
Field Station#	11649+00		Field Station#	11634+00	
Pic 5 Desc.	Perimeter ECDs are in good condition.		Pic 6 Desc.	End treatments are functional. All CFS to be replaced before any surface disturbance.

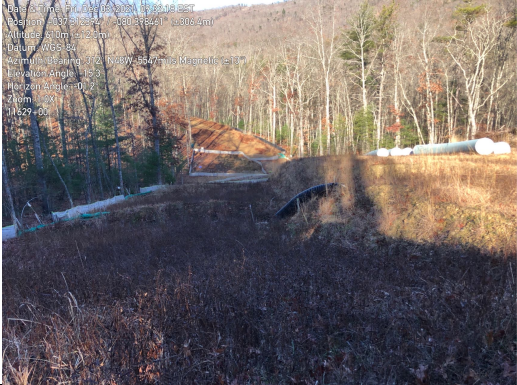
GPS Location	On photo	GPS Location	On photo		
Field Station#	11630+00	Field Station#	11629+00		
Pic 7 Desc.	Perimeter ECDs are in good condition.	Pic 8 Desc.	The ROW above the S-HH18 crossing is stable.

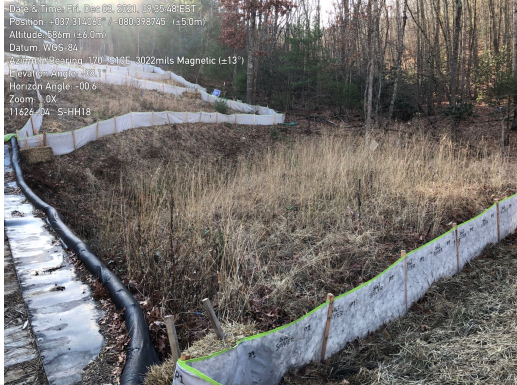
GPS Location	On photo	GPS Location	On photo		
Field Station#	11626+04	Field Station#	11614+20		
Pic 9 Desc.	The S-HH18 crossing is table.	Pic 10 Desc.	The S-RR14 crossing is stable.		
 				Insert image here	
GPS Location	On photo	GPS Location			
Field Station#	11608+17	Field Station#			
Pic 11 Desc.	The S-006 crossing is stable.	Pic 12 Desc.
