Visual Site Inspection Report

Project Name	H-600 Pipeline Spread G	AFE	124300137	Spread	H-600 Pipeline Spread G
Contractor	Precision			Report #	30913
Inspector	Patrick Shields			Date/Time	11/8/2021 2:16 PM
Permit #	TBD	Inspection Type	VA SWPP	Station Begin	10798+92
State	VA	Inspection Area	Full	Station End	10859+46
County	Giles	Ground	Dry	Temperature (°F)	64.00
Municipality	N/A	Weather	Sunny	Rain Gauge (in)	0.00
				Rain Accumulation Time (days)	1.00

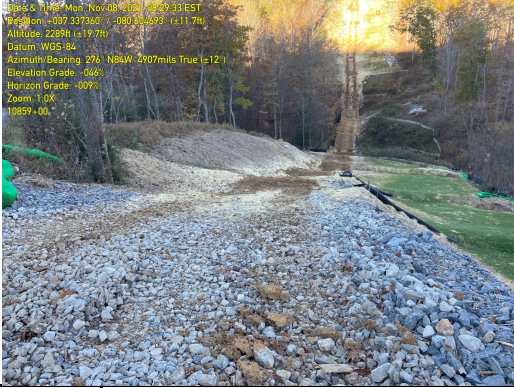
<p>Date & Time: Mon, Nov 08, 2021, 08:29:33 EST Position: +027.339365 / -080.606241 (-11.7m) Altitude: 2289ft (-19.7m) Datum: WGS 84 Azimuth Bearing: 274.18NW 2107mils True (-12.1) Elevation Grade: -002 Horizon Grade: -009 Zoom: 1.0X 10859+00</p>

<p>Date & Time: Mon, Nov 08, 2021, 08:34:27 EST Position: +027.339365 / -080.606241 (-11.7m) Altitude: 2334ft (-16.3m) Datum: WGS 84 Azimuth Bearing: 352.18NW 5208mils True (-12.1) Elevation Grade: -100 Horizon Grade: +003 Zoom: 1.0X 10857+77</p>		GPS Location	See photo
Field Station#	10859+00	Field Station#	10857+77	GPS Location	See photo
Pic 1 Desc.	RCE needs maintenance	Pic 2 Desc.	Slope drain needs adjusted	GPS Location	See photo

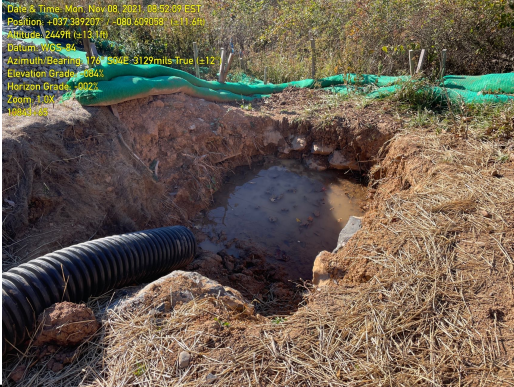
<p>Date & Time: Mon, Nov 08, 2021, 09:22:09 EST Position: +027.349207 / -080.590081 (-11.1m) Altitude: 2449ft (-13.1m) Datum: WGS 84 Azimuth Bearing: 111.18NE 3129mils True (-12.1) Elevation Grade: -004 Horizon Grade: -002 Zoom: 1.0X 10843+65</p>

Field Station#	10843+65	Field Station#	10798+92	GPS Location	See photo
Pic 3 Desc.	Sump needs cleaned out	Pic 4 Desc.	RCE in place	GPS Location	See photo

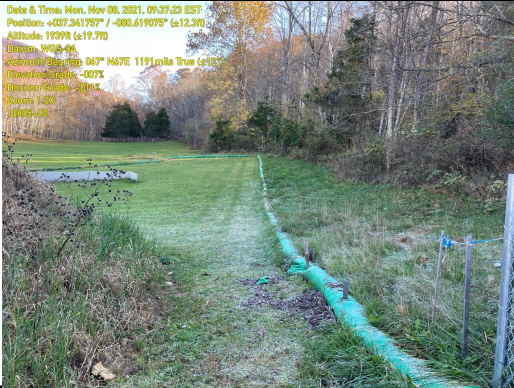
<p>Date & Time: Mon, Nov 08, 2021, 09:37:23 EST Position: +027.341797 / -080.619079 (-12.3m) Altitude: 1939ft (-19.7m) Datum: WGS 84 Azimuth Bearing: 047.16NE 1191mils True (-12.1) Elevation Grade: -007 Horizon Grade: -001 Zoom: 1.0X 10805+00</p>

<p>Date & Time: Mon, Nov 08, 2021, 09:36:43 EST Position: +027.341797 / -080.619079 (-12.3m) Altitude: 1939ft (-19.7m) Datum: WGS 84 Azimuth Bearing: 100.18NW 3038mils True (-12.1) Elevation Grade: -051 Horizon Grade: -001 Zoom: 1.0X 10806+00</p>		GPS Location	See photo
Field Station#	10805+00	Field Station#	10806+00	GPS Location	See photo
Pic 5 Desc.	CFS perimeter control in place	Pic 6 Desc.	Waterbars in place	GPS Location	See photo

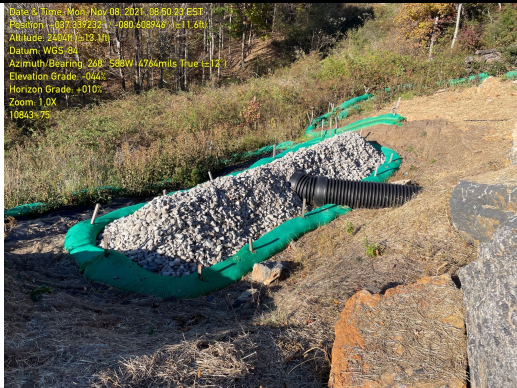
<p>Date & Time: Nov 08, 2021, 09:50:37 EST Location: 407.520283° / -90.01899° (-90.019°) Altitude: 2400ft (-90.019°) Datum: WGS-84 Azimuth/Bearing: 268° S58W 553mm True (±12°) Elevation Grade: -04% Horizon Grade: -01% Zoom: 1.0X 10843+75</p>

GPS Location	See photo	GPS Location	See photo		
Field Station#	10843+75	Field Station#	10855+00		
Pic 9 Desc.	Cleanwater diversion outlet protection in place	Pic 10 Desc.	Stream buffer in place

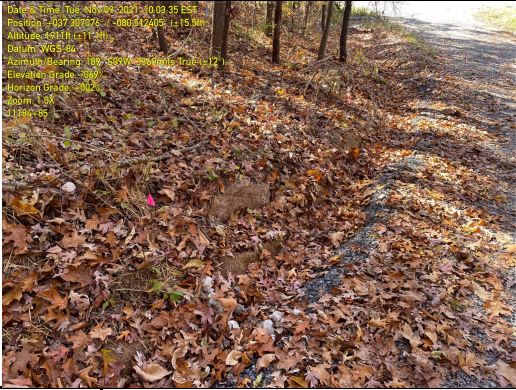
<p>Date & Time Tue, Nov 09, 2021, 09:35:25 EST Position: +037 315897 / -080 534597 (s46.84) Altitude: 5107ft (s45.83) Datum: WGS-84 Azimuth/Bearing: 160 S20E 2844mits True (s12°) Elevation Grade: -022° Horizon Grade: -004° Zoom: 1.0X 11184+85</p>

<p>Date & Time Tue, Nov 09, 2021, 09:40:18 EST Position: +037 315897 / -080 534597 (s46.84) Altitude: 5122ft (s45.87) Datum: WGS-84 Azimuth/Bearing: 160 S20E 2844mits True (s12°) Elevation Grade: -022° Horizon Grade: -004° Zoom: 1.0X 11122+00</p>			
GPS Location	See photo	GPS Location	See photo		
Field Station#	11184+85	Field Station#	11122+00		
Pic 1 Desc.	Rock check dams require maintenance	Pic 2 Desc.	Silt fence installed per punch list item

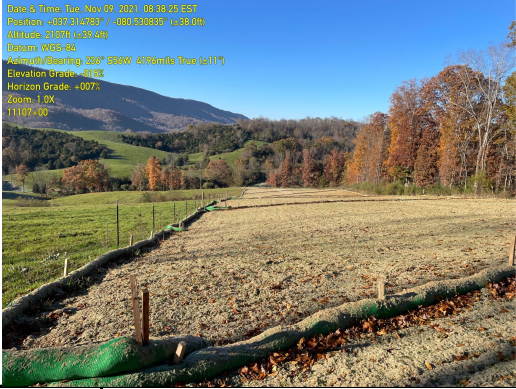
<p>Date & Time Tue, Nov 09, 2021, 09:35:25 EST Position: +037 315897 / -080 534597 (s46.84) Altitude: 5107ft (s45.83) Datum: WGS-84 Azimuth/Bearing: 200° S69W 4194mits True (s11°) Elevation Grade: -013° Horizon Grade: +007° Zoom: 1.0X 11107+00</p>

GPS Location	See photo	GPS Location	See photo		
Field Station#	11107+00	Field Station#	11112+50		
Pic 3 Desc.	CFS perimeter control in place	Pic 4 Desc.	Triple stack CFS perimeter control in place

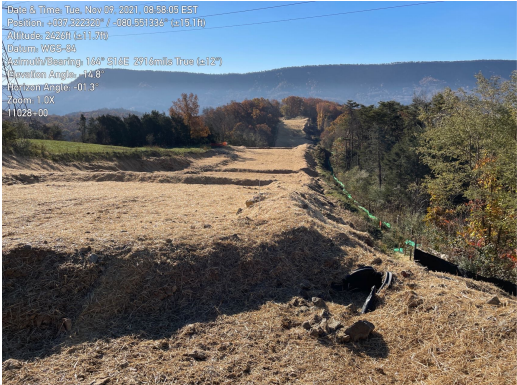
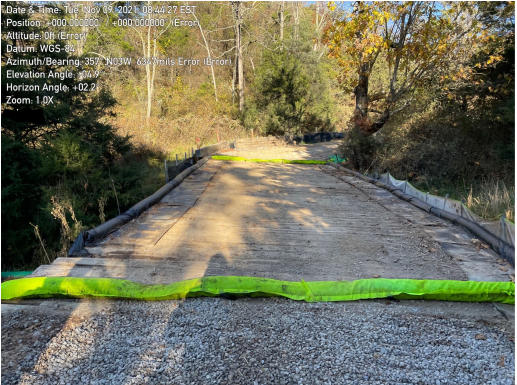
GPS Location	See photo	GPS Location	See photo		
Field Station#	11028+00	Field Station#	11023+80		
Pic 15 Desc.	ECD's in place	Pic 16 Desc.	S-IJ19 equipment bridge functional

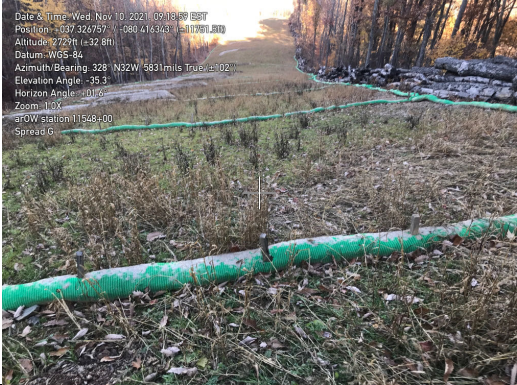
<p>Date & Time: Wed, Nov 10, 2021, 09:18:39 EST Position: +037.328797° / -080.416343° (+00.000000°) Altitude: 2824ft (+274ft) Datum: WGS-84 Azimuth/Bearing: 328° N32W 5831mils True (+102°) Elevation Angle: -35.3° Horizon Angle: -00.8° Zoom: 1.0X JNF station: 11548+00 Spread G</p>

<p>Date & Time: Wed, Nov 10, 2021, 09:20:56 EST Position: +037.325397° / -080.416489° (+00.000000°) Altitude: 2804ft (+274ft) Datum: WGS-84 Azimuth/Bearing: 147° S33E 2613mils True (+101°) Elevation Angle: -12.2° Horizon Angle: -02.8° Zoom: 1.0X ROW station: 11549+00 Spread G</p>			
GPS Location		See photo		GPS Location	
Field Station#		11548+00		Field Station#	
Pic 7 Desc.		Restored ROW		Pic 8 Desc.

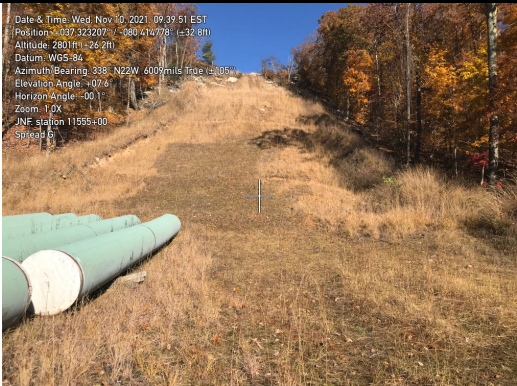
<p>Date & Time: Wed, Nov 10, 2021, 09:39:51 EST Position: +037.323207° / -080.416778° (+32.8ft) Altitude: 2801ft (+267ft) Datum: WGS-84 Azimuth/Bearing: 338° N22W 6009mils True (+105°) Elevation Angle: -07.4° Horizon Angle: -00.1° Zoom: 1.0X JNF station: 11555+00 Spread G</p>

GPS Location		see photo		GPS Location	
Field Station#		11550+00		Field Station#	
Pic 9 Desc.		JNF		Pic 10 Desc.

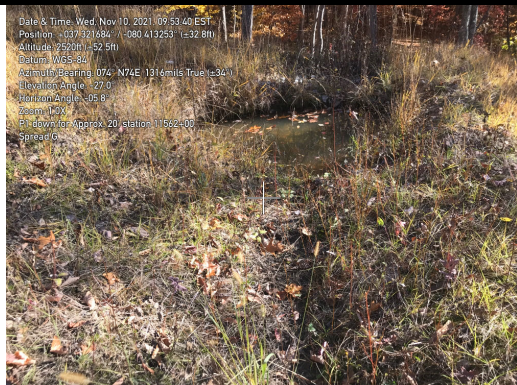
<p>Date & Time: Wed, Nov 10, 2021, 09:53:42 EST Position: +037.327682° / -080.413253° (+32.8ft) Altitude: 2820ft (+267ft) Datum: WGS-84 Azimuth/Bearing: 074° N74E 1316mils True (+34°) Elevation Angle: -27.0° Horizon Angle: -05.8° Zoom: 1.0X E. down for approx 20 station 11562+00 Spread G</p>

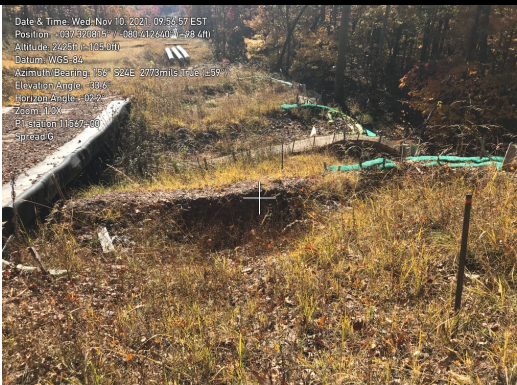
<p>Date & Time: Wed, Nov 10, 2021, 09:56:57 EST Position: +037.327651° / -080.412640° (+28.4ft) Altitude: 2825ft (+265ft) Datum: WGS-84 Azimuth/Bearing: 130° S24E 2773mils True (+59°) Elevation Angle: -48.8° Horizon Angle: -02.2° Zoom: 1.0X E. station 11567+00 Spread G</p>			
GPS Location		see photo		GPS Location	
Field Station#		11562+00		Field Station#	
Pic 11 Desc.		Sump JNF		Pic 12 Desc.

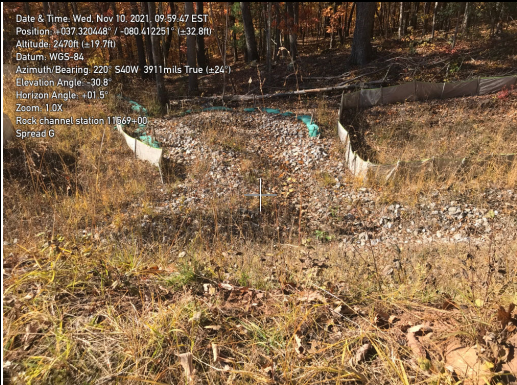
AFE	124300137	Date/Time	11/10/2021 12:20 PM	Report #	
Pictures					
<div><div><div>Date & Time: Wed, Nov 10, 2021, 09:59:47 EST Position: +037.320468° / -080.412251° (+32.8M) Altitude: 2478ft (+19.7M) Datum: WGS-84 Azimuth/Bearing: 220° S40W 3911mils True (+24°) Elevation Angle: -30.8° Horizon Angle: -01.5° Zoom: 1.0X Rock channel station 11569+00 Spread G</div><div>

</div></div></div>			
GPS Location	See photo		GPS Location	see photo	
Field Station#	11569+00		Field Station#	11579+00	
Pic 13 Desc.	Rock Channel		Pic 14 Desc.	Water bars	
<div><div><div>Date & Time: Wed, Nov 10, 2021, 10:11:44 EST Position: +037.317669° / -080.410031° (+32.8M) Altitude: 2137ft (+50.1M) Datum: WGS-84 Azimuth/Bearing: 185° S20E 2226mils True (+39°) Elevation Angle: -30.9° Horizon Angle: -00.6° Zoom: 1.0X P1 equipment bridge station 11585+00 Spread G</div><div>

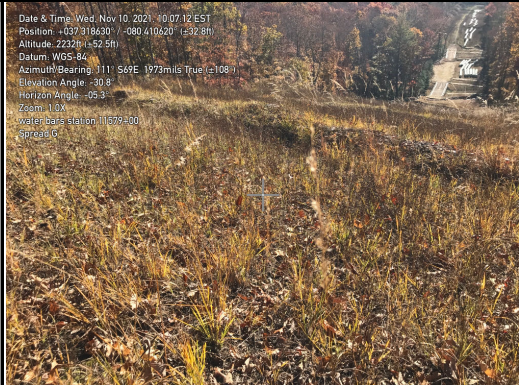
</div></div></div>		<div><div><div>Date & Time: Wed, Nov 10, 2021, 10:07:12 EST Position: +037.318630° / -080.410620° (+32.8M) Altitude: 2232ft (+52.5M) Datum: WGS-84 Azimuth/Bearing: 111° S69E 1973mils True (+106°) Elevation Angle: -30.8° Horizon Angle: -05.3° Zoom: 1.0X Water bars station 11579+00 Spread G</div><div>

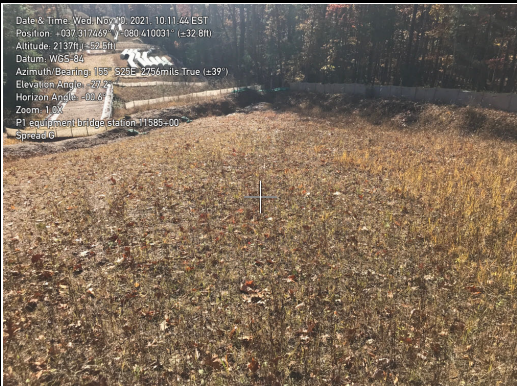
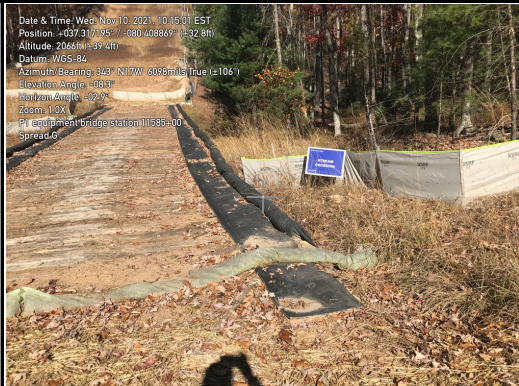
GPS Location	see photo		GPS Location	see photo	
Field Station#	11585+00		Field Station#	11585+00	
Pic 15 Desc.	P 1 equipment bridge		Pic 16 Desc.	Water body	
<div><div><div>Date & Time: Wed, Nov 10, 2021, 10:20:53 EST Position: +037.316279° / -080.405798° (+31.4M) Altitude: 2001ft (+19.8M) Datum: WGS-84 Azimuth/Bearing: 328° N22W 5831mils True (+28°) Elevation Angle: +02.6° Horizon Angle: -00.2° Zoom: 1.0X ROW station 11587+00 Spread G</div><div>

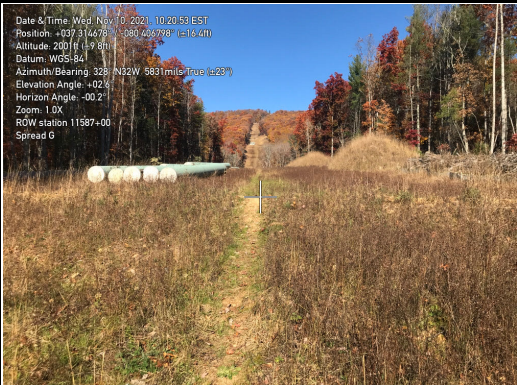
</div></div></div>		<div>Insert image here</div>			
GPS Location	see photo		GPS Location		
Field Station#	11587+00		Field Station#		
Pic 17 Desc.	ROW		Pic 18 Desc.

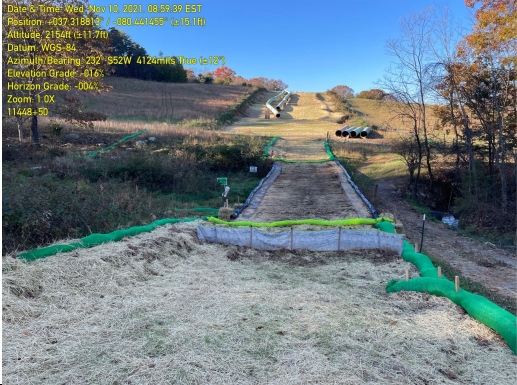
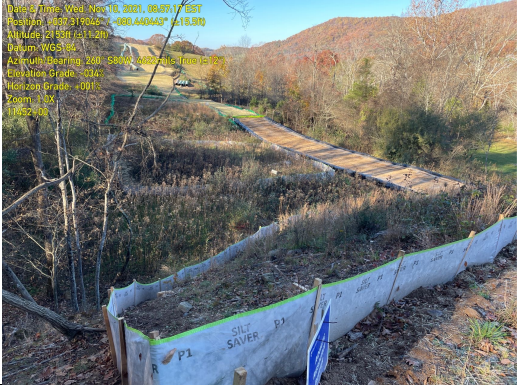
GPS Location	See photo		GPS Location	See photo	
Field Station#	11448+50		Field Station#	11452+00	
Pic 7 Desc.	Sediment filter logs in place		Pic 8 Desc.	Steam buffer in place

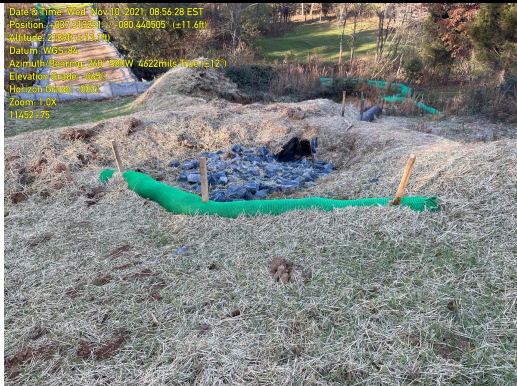
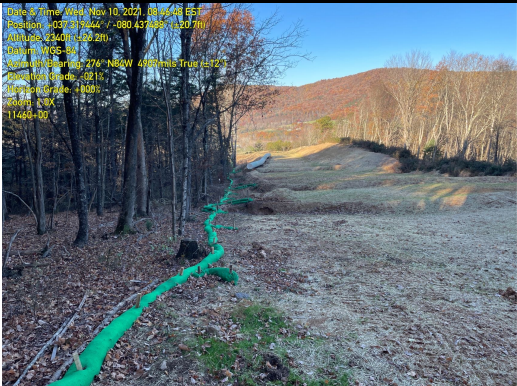
GPS Location	See photo		GPS Location	See photo	
Field Station#	11452+75		Field Station#	11460+00	
Pic 9 Desc.	Stone inlet protection in place		Pic 10 Desc.	CFS perimeter control in place

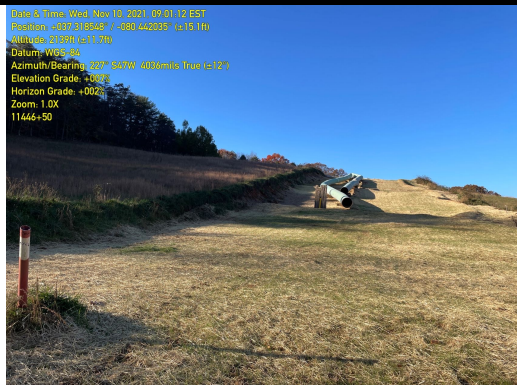
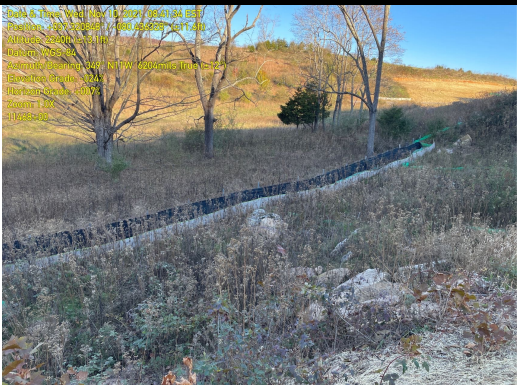
GPS Location	See photo		GPS Location	See photo	
Field Station#	11446+50		Field Station#	11468+00	
Pic 11 Desc.	Cleanwater diversion berm in place		Pic 12 Desc.	ECDs in place at karst feature

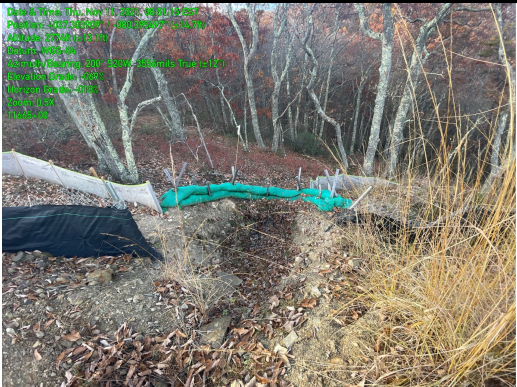
<p>Date & Time: Thu, Nov 11, 2021, 09:03:03 EST Position: +037.306302° / -080.397329° (±15.7m) Altitude: 2461ft (±10.9ft) Datum: WGS-84 Geoid Height: 328' NAD83 5531mils True (±12') Magnetic Declination: -10.1° Horizontal Accuracy: ±10.1m Vertical Accuracy: ±10.1m</p>	
GPS Location	See Photo		GPS Location	See Photo	
Field Station#	11165+00		Field Station#	11663+00	
Pic 1 Desc.	View of sump pit conditions		Pic 2 Desc.	View of P1 silt fence conditions

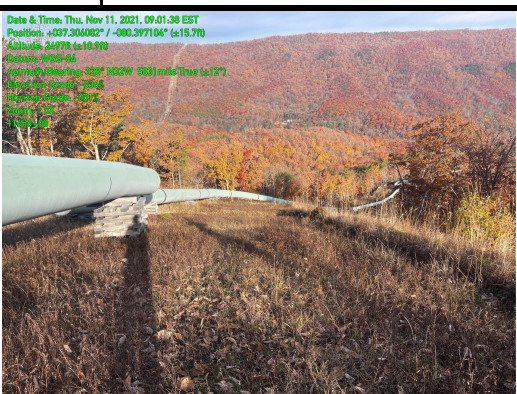
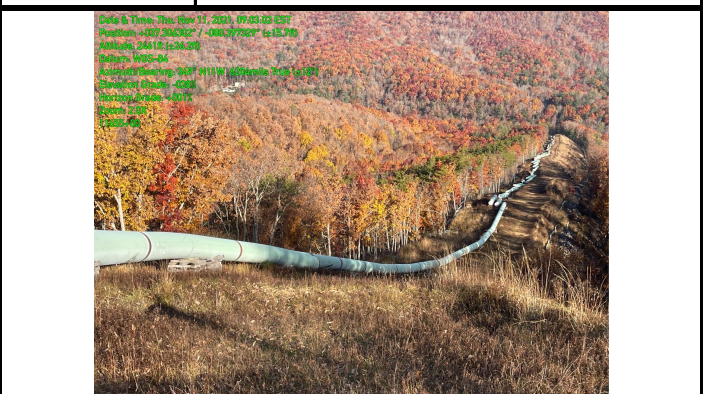
GPS Location	See Photo		GPS Location	See Photo	
Field Station#	11656+00		Field Station#	11655+00	
Pic 3 Desc.	View of heavy vegetation down the travel lane.		Pic 4 Desc.	View of row conditions

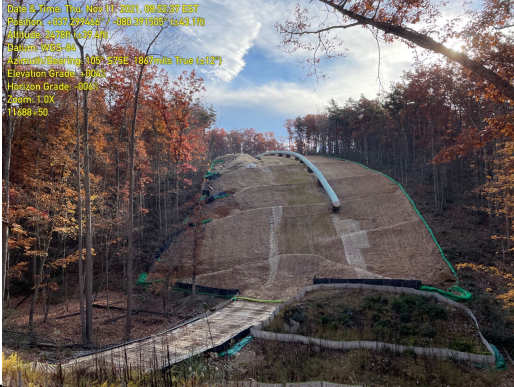
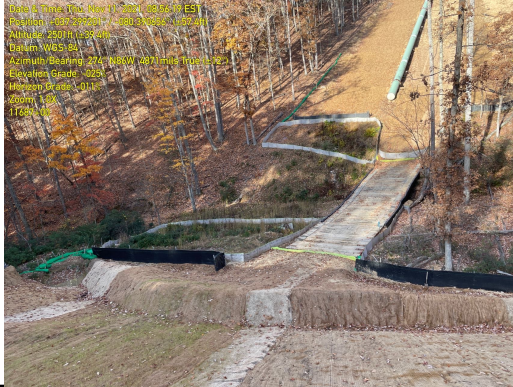
GPS Location	See photo	GPS Location	See photo		
Field Station#	11688+50	Field Station#	11687+00		
Pic 3 Desc.	Erosion control blanket in place	Pic 4 Desc.	Stream buffer in place

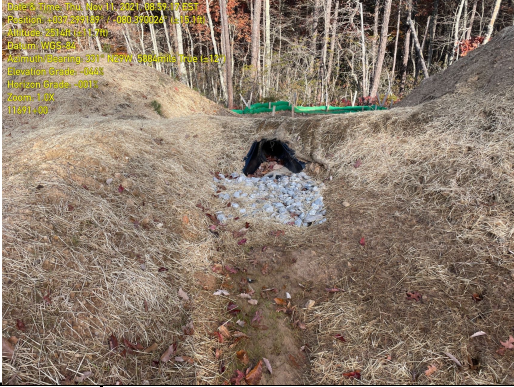
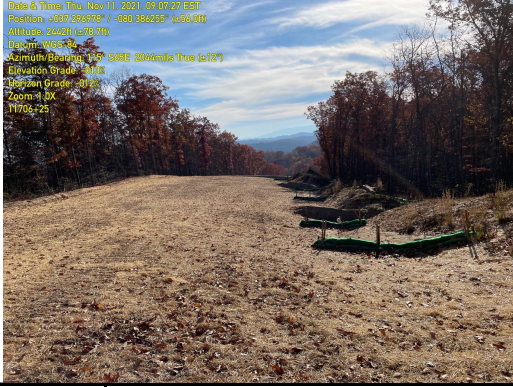
GPS Location	See photo	GPS Location	See photo		
Field Station#	11691+00	Field Station#	11706+25		
Pic 5 Desc.	Stone inlet protection in place	Pic 6 Desc.	CFS triple stack checks

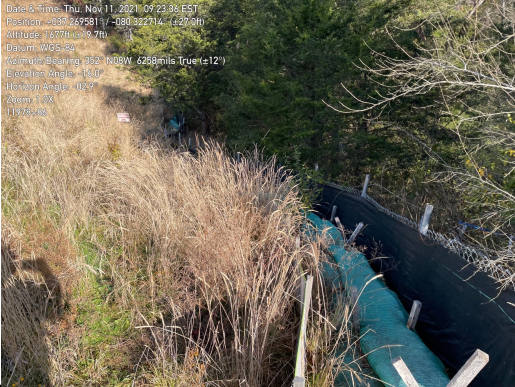
GPS Location	See photo	GPS Location	See photo		
Field Station#	11978+86	Field Station#	11978+86		
Pic 3 Desc.	AR 266 functional	Pic 4 Desc.	SSF functional		
<p>Date & Time: Thu, Nov 11, 2021, 09:19:34 EST Position: +097.277977 / +080.326678 (+11.2ft) Altitude: 2160ft (+13.1ft) Datum: WGS-84 Azimuth/Bearing: 130° S30E 570mils True (+12°) Elevation Angle: -15.9° Horizon Angle: +01.3° Zoom: 1.0X 11947+00</p>

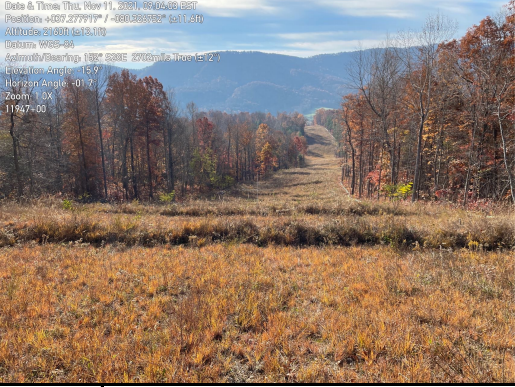
<p>Date & Time: Thu, Nov 11, 2021, 09:19:34 EST Position: +097.277977 / +080.326678 (+11.2ft) Altitude: 2160ft (+13.1ft) Datum: WGS-84 Azimuth/Bearing: 130° S30E 570mils True (+12°) Elevation Angle: -15.9° Horizon Angle: +01.3° Zoom: 1.0X 11947+00</p>  			
GPS Location	See photo	GPS Location	See photo		
Field Station#	11972+00	Field Station#	11947+00		
Pic 5 Desc.	Water bars in place	Pic 6 Desc.	Stabilization functional

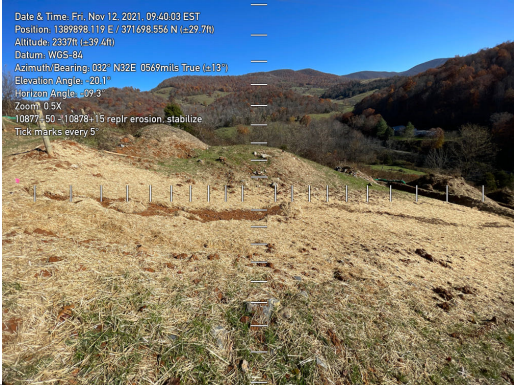
Field Station#		10877+50		GPS Location	4
Pic 3 Desc.		Representational photo of minor erosion and stabilization issues.		Pic 4 Desc.

<p>Date & Time: Fri, Nov 12, 2021, 09:40:03 EST Position: 1389898.119 E / 371698.956 N (±29.7ft) Altitude: 2337ft (±39.4ft) Datum: WGS-84 Azimuth/Bearing: 082° N32E 0567mils True (±13°) Elevation Angle: +20.1° Horizon Angle: +09.3° Zoom: 0.5X 10877+50 10878+15 repair erosion stabilize Tick marks every 5'</p>

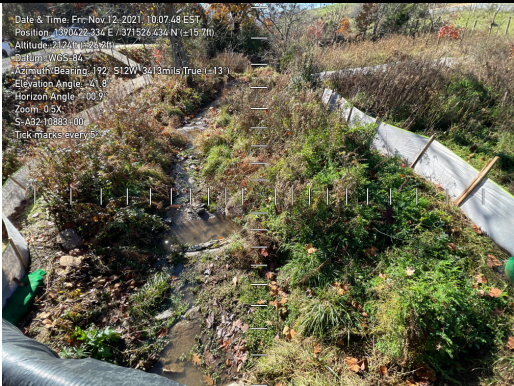
<p>Date & Time: Fri, Nov 12, 2021, 10:07:46 EST Position: 1390423.334 E / 371526.434 N (±15.7ft) Altitude: 2124ft (±39.5ft) Datum: WGS-84 Azimuth/Bearing: 192° S12W 3410mils True (±13°) Elevation Angle: +21.8° Horizon Angle: +00.9° Zoom: 0.5X S-A32 10883+00 Tick marks every 5'</p>

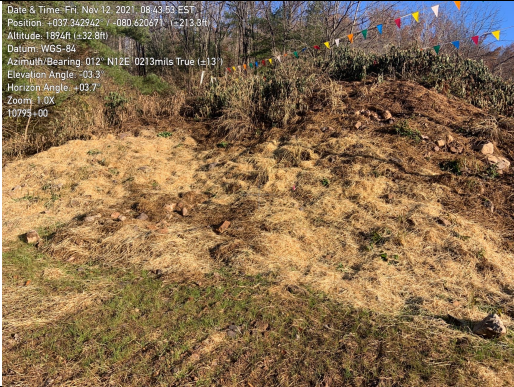
GPS Location	See photo	GPS Location	see photo		
Field Station#	10795+00	Field Station#	10771+53		
Pic 1 Desc.	Denuded soil from previous punch list have been stabilized	Pic 2 Desc.	Stone inlet protection is acceptable

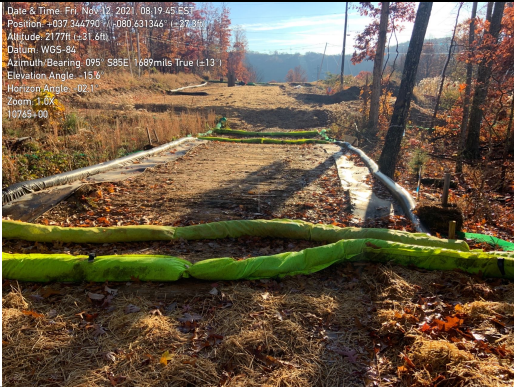
GPS Location	See photo	GPS Location	See photo		
Field Station#	10765+00	Field Station#	10765+80		
Pic 3 Desc.	Equipment bridge is maintained in acceptable condition	Pic 4 Desc.	Level spreader and perimeter controls are in acceptable condition

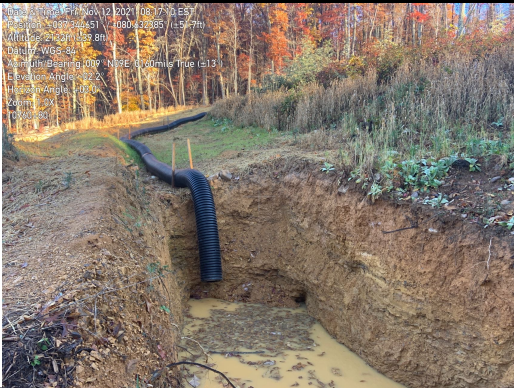
GPS Location	See photo	GPS Location	See photo		
Field Station#	10760+80	Field Station#	10757+79		
Pic 5 Desc.	Slope drain pipe and sump pit are acceptable	Pic 6 Desc.	Perimeter controls and sensitive resource signage are acceptable

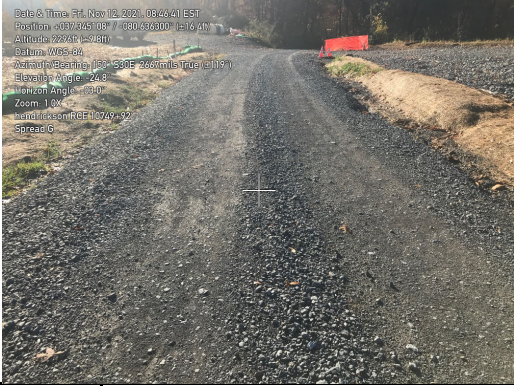
<p>Date & Time: Fri, Nov 12, 2021, 08:25:41 EST Position: +037.245108° / -080.636300° (±16.4ft) Altitude: 2321ft (±15.2ft) Datum: WGS-84 Azimuth/Bearing: 258° S88E 3687mils True (±109°) Elevation Angle: -21.6° Horizon Angle: -00.0° Zoom: 1.0X stop drain: sump10749+92 Spread G</p>

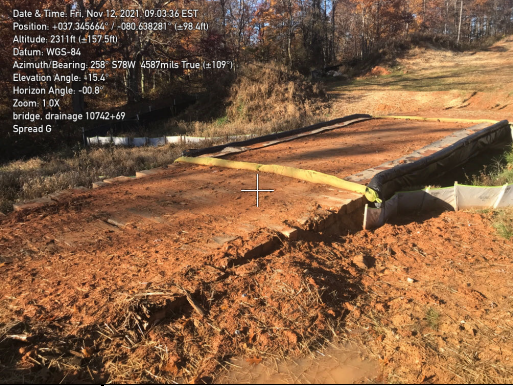
<p>Date & Time: Fri, Nov 12, 2021, 09:03:38 EST Position: +037.345664° / -080.638281° (±19.4ft) Altitude: 2311ft (±15.7ft) Datum: WGS-84 Azimuth/Bearing: 258° S88W 4687mils True (±109°) Elevation Angle: -15.4° Horizon Angle: -00.8° Zoom: 1.0X bridge drainage 10742+69 Spread G</p>		GPS Location	See photo
Field Station#	10749+92	Field Station#	10742+69	GPS Location	see photo
Pic 1 Desc.	Hendrickson	Pic 2 Desc.	Equipment bridge

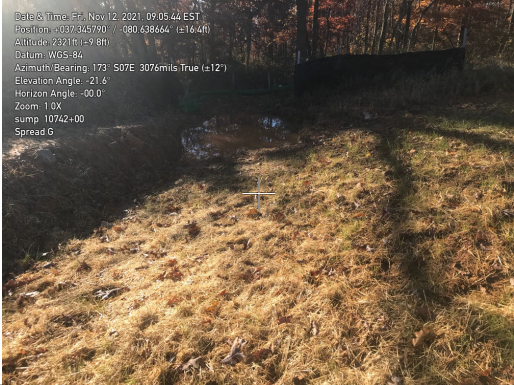
<p>Date & Time: Fri, Nov 12, 2021, 09:05:44 EST Position: +037.345790° / -080.638664° (±16.4ft) Altitude: 2321ft (±15.2ft) Datum: WGS-84 Azimuth/Bearing: 173° S07E 3076mils True (±12°) Elevation Angle: -21.6° Horizon Angle: -00.0° Zoom: 1.0X sump 10742+00 Spread G</p>

Field Station#	10742+00	Field Station#	10733+00	GPS Location	see photo
Pic 3 Desc.	Sump	Pic 4 Desc.	WZ 11		
  <p>Date & Time: Fri, Nov 12, 2021, 09:16:40 EST Position: +037.346654° / -080.642681° (±16.4ft) Altitude: 2341ft (±15.9ft) Datum: WGS-84 Azimuth/Bearing: 092° S88E 1636mils True (±101°) Elevation Angle: -31.1° Horizon Angle: -01.9° Zoom: 1.0X Spread G</p>		  <p>Date & Time: Fri, Nov 12, 2021, 09:21:38 EST Position: +037.347645° / -080.643648° (±16.4ft) Altitude: 2407ft (±13.1ft) Datum: WGS-84 Azimuth/Bearing: 242° S42W 4302mils True (±13°) Elevation Angle: -19.7° Horizon Angle: -06.9° Zoom: 1.0X stop drain: sump10725+42 Spread G</p>		GPS Location	see photo
Field Station#	10730+00	Field Station#	10725+42	GPS Location	See photo
Pic 5 Desc.	Water bars	Pic 6 Desc.	Slope drain

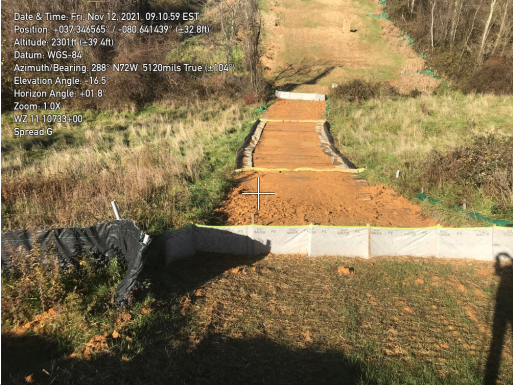
<p>Date & Time: Fri, Nov 12, 2021, 09:10:59 EST Position: +037.346565° / -080.641439° (±16.4ft) Altitude: 2301ft (±15.9ft) Datum: WGS-84 Azimuth/Bearing: 288° N22W 5120mils True (±104°) Elevation Angle: -16.5° Horizon Angle: -01.8° Zoom: 1.0X WZ 11 10733+00 Spread G</p>		GPS Location	see photo

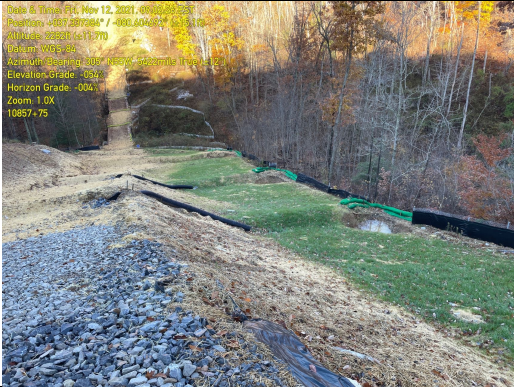
<p>Date & Time: Fri, Nov 12, 2021, 2:53:53 EST Position: +032.337830 / -000.604247 (+48.7ft) Altitude: 2232ft (+32ft) Datum: WGS-84 Azimuth Bearing: 010° N10E 0128mils True (+1.2°) Elevation Grade: -05% Horizontal Grade: -004% Zoom: 1.0X 10857+75</p>

<p>Date & Time: Fri, Nov 12, 2021, 2:55:17 EST Position: +032.337830 / -000.604247 (+48.7ft) Altitude: 2232ft (+32ft) Datum: WGS-84 Azimuth Bearing: 010° N10E 0128mils True (+1.2°) Elevation Grade: -05% Horizontal Grade: -016% Zoom: 1.0X 10858+50</p>			
GPS Location	See photo	GPS Location	See photo		
Field Station#	10857+75	Field Station#	10858+50		
Pic 1 Desc.	End treatments in place	Pic 2 Desc.	Supersilt fence perimeter control in place

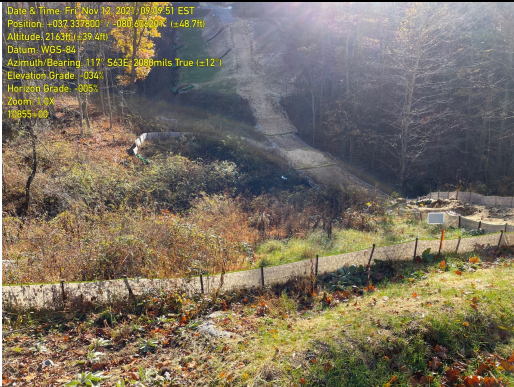
<p>Date & Time: Fri, Nov 12, 2021, 10:51:05 EST Position: +032.337830 / -000.604247 (+48.7ft) Altitude: 2163ft (+39.4ft) Datum: WGS-84 Azimuth Bearing: 117° S45E 2631mils True (+12.1°) Elevation Grade: -03% Horizontal Grade: -003% Zoom: 1.0X 10855+00</p>

GPS Location	See photo	GPS Location	See photo		
Field Station#	10855+00	Field Station#	10848+00		
Pic 3 Desc.	Stream buffer in place	Pic 4 Desc.	CFS perimeter control in place

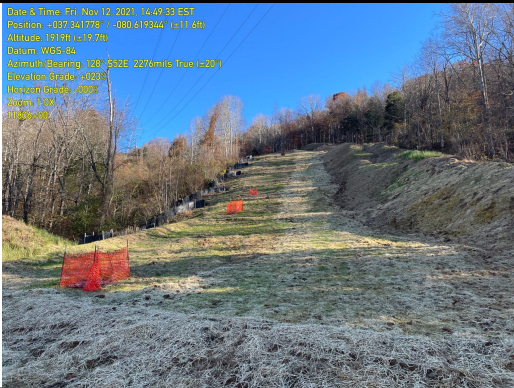
<p>Date & Time: Fri, Nov 12, 2021, 11:45:33 EST Position: +032.337830 / -000.604247 (+48.7ft) Altitude: 1915ft (+32ft) Datum: WGS-84 Azimuth Bearing: 120° S32E 2670mils True (+12.1°) Elevation Grade: -002% Horizontal Grade: -008% Zoom: 1.0X 11040+00</p>

<p>Date & Time: Fri, Nov 12, 2021, 11:52:55 EST Position: +032.337830 / -000.604247 (+48.7ft) Altitude: 1841ft (+32ft) Datum: WGS-84 Azimuth Bearing: 120° S32E 2670mils True (+12.1°) Elevation Grade: -002% Horizontal Grade: -008% Zoom: 1.0X 11040+00</p>			
GPS Location	See photo	GPS Location	See photo		
Field Station#	10806+00	Field Station#	10805+40		
Pic 5 Desc.	Waterbars in place	Pic 6 Desc.	Daylight drain in place

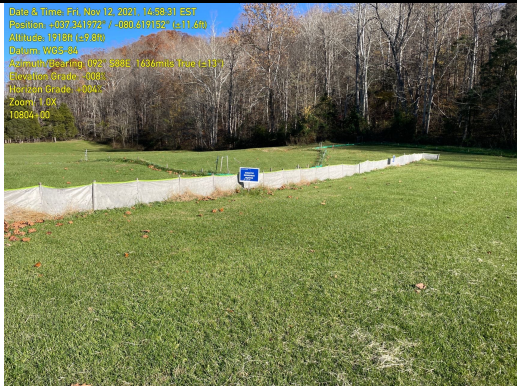
GPS Location	See photo		GPS Location	See photo	
Field Station#	10804+00		Field Station#	10859+00	
Pic 9 Desc.	P1 silt fence in place at buffer		Pic 10 Desc.	Stone inlet protection in place	
<p>Insert image here</p>			<p>Insert image here</p>		
GPS Location			GPS Location		
Field Station#			Field Station#		
Pic 11 Desc.			Pic 12 Desc.
