Visual Site Inspection Report

Project Name	H-600 Pipeline Spread G	AFE	124300137	Spread	H-600 Pipeline Spread G
Contractor	Precision			Report #	28706
Inspector	Patrick Shields			Date/Time	9/20/2021 6:48 PM
Permit #	TBD	Inspection Type	VA SWPP	Station Begin	11254+99
State	VA	Inspection Area	Full	Station End	11524+16
County	Giles	Ground	Damp	Temperature (°F)	75.00
Municipality	N/A	Weather	Cloudy	Rain Gauge (in)	0.20
				Rain Accumulation Time (days)	1.00

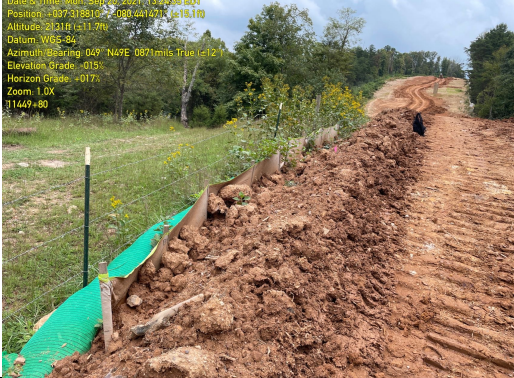
GPS Location		See photo		GPS Location	
Field Station#		11449+80		Field Station#	
Pic 1 Desc.		P1 silt fence overwhelmed		Pic 2 Desc.	
				Rock inlet needs cleaned out and refreshed	
<p>Date & Time: Mon, Sep 20, 2021, 13:14:11 EDT Position: +037.318333° / -080.443009° (+15.1m) Altitude: 2155ft (+11.7m) Datum: WGS-84 Azimuth Bearing: 042° N46E 1173mils True (+12°) Elevation Grade: -045% Horizon Grade: +003% Zoom: 1.0x 11444+90</p>

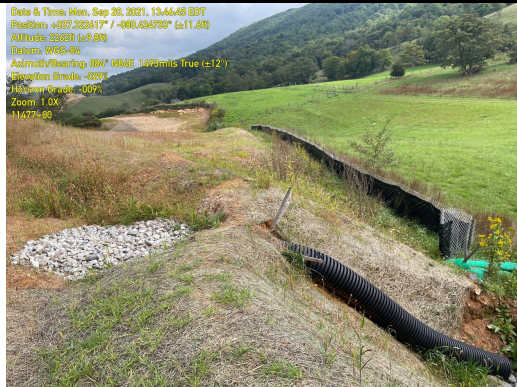
GPS Location	See photo	GPS Location	See photo		
Field Station#	11477+00	Field Station#	11293+50		
Pic 11 Desc.	Supersilt fence perimeter control in place	Pic 12 Desc.	Stream buffer in place

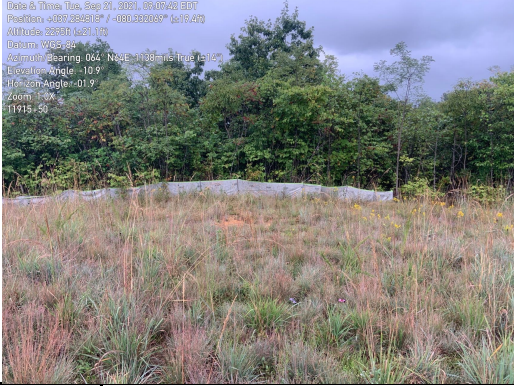
<p>Date & Time: Tue, Sep 21, 2021, 06:44:35 EDT Position: +037.235817° / -080.333534° (+17.47ft) Altitude: 2269ft (+52.6ft) Datum: WGS-84 Azimuth/Bearing: 006° N006° 00'00" True (+6°) Elevation Angle: -10.9° Horizon Angle: -01.9° Zoom: 1.0x 11928+50</p>			
GPS Location	See photo		GPS Location	See photo	
Field Station#	11915+50		Field Station#	11928+50	
Pic 1 Desc.	P1 silt fence functional		Pic 2 Desc.	Area of ROW with abundant vegetation

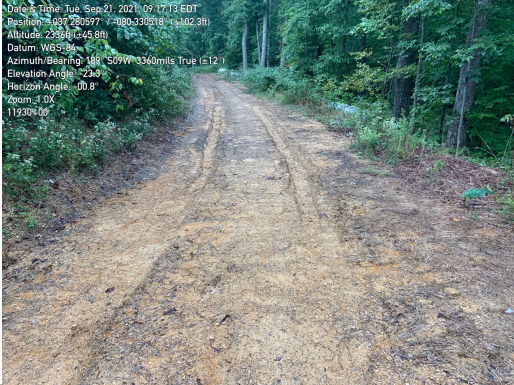
GPS Location	See photo		GPS Location	See photo	
Field Station#	11930+00		Field Station#	11930+00	
Pic 3 Desc.	AR266 needs maintenance		Pic 4 Desc.	Rill erosion along AR266

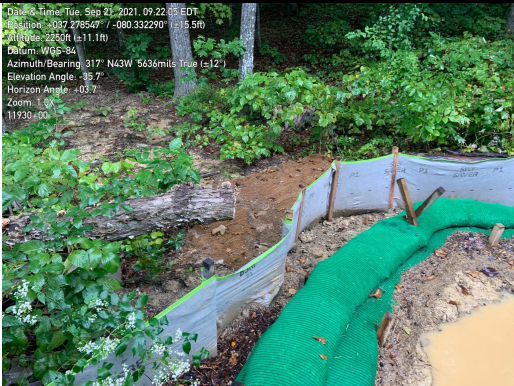
<p>Date & Time: Tue, Sep 21, 2021, 09:32:23 EDT Position: +037.232546° / -080.332290° (+15.5ft) Altitude: 2230ft (+51.1ft) Datum: WGS-84 Azimuth/Bearing: 317° N43W 5636mils True (+12°) Elevation Angle: -35.7° Horizon Angle: +03.7° Zoom: 1.0x 11930+00</p>			
GPS Location	See photo		GPS Location	See photo	
Field Station#	11930+00		Field Station#	11930+00	
Pic 5 Desc.	Erosion control blanket installed behind water bar end treatments from previous days punch list		Pic 6 Desc.	Rock check dams need maintenance along AR266

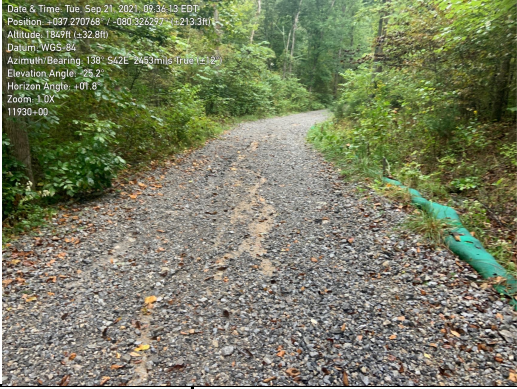
Insert image here			
GPS Location	See photo	GPS Location			
Field Station#	11930+00	Field Station#			
Pic 7 Desc.	Rill erosion on rocky area of AR266 need maintenance	Pic 8 Desc.			
Insert image here		Insert image here			
GPS Location		GPS Location			
Field Station#		Field Station#			
Pic 9 Desc.		Pic 10 Desc.			
Insert image here		Insert image here			
GPS Location		GPS Location			
Field Station#		Field Station#			
Pic 11 Desc.		Pic 12 Desc.

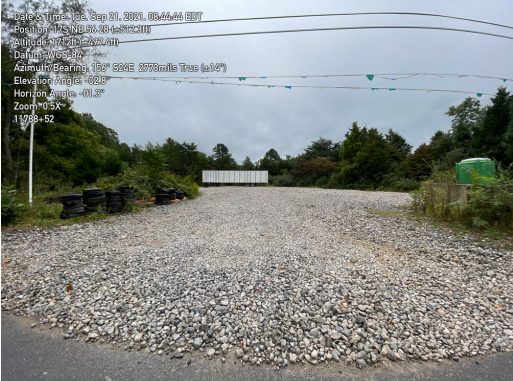
GPS Location	3	GPS Location	4		
Field Station#	11824+00	Field Station#	11788+52		
Pic 3 Desc.	Representational photo of wood chips needing spread to allow growth and proper amendments applied.	Pic 4 Desc.	RCE on the South side of Mt Tabor road crossing.

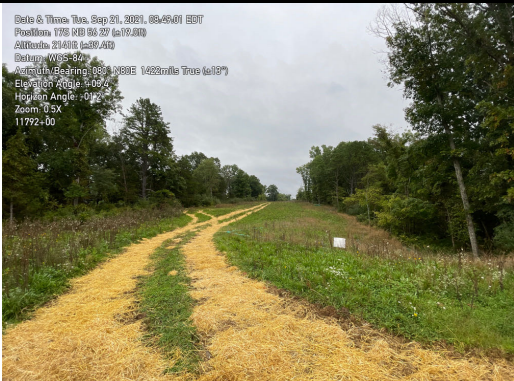
GPS Location	5	GPS Location	6		
Field Station#	11792+00	Field Station#	11838+00		
Pic 5 Desc.	Section of restored RoW showing conditions and controls.	Pic 6 Desc.	Section of restored RoW showing conditions and controls.

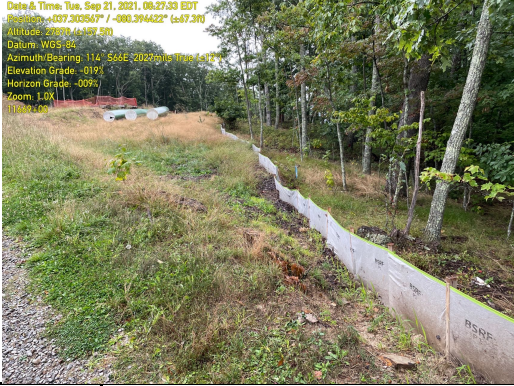
GPS Location	See photo	GPS Location	See photo		
Field Station#	11669+00	Field Station#	11678+00		
Pic 1 Desc.	P1 silt fence perimeter control in place	Pic 2 Desc.	End treatments in place		
<p>Date & Time: Tue, Sep 21, 2021, 08:40:39 EDT Position: +037.300061° / -080.406312° (±14.8ft) Altitude: 2572ft (±26.2ft) Datum: WGS-84 Azimuth/Bearing: 164° 54SE 2382mils True (±12°) Elevation Grade: -050° Horizon Grade: -004° Zoom: 1.0X 11684+00</p>

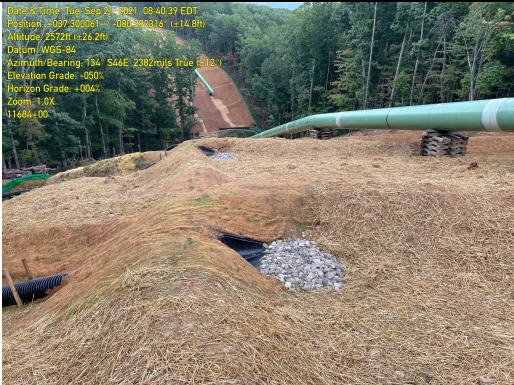
GPS Location	See photo	GPS Location	See photo		
Field Station#	11684+00	Field Station#	11690+00		
Pic 3 Desc.	Stone inlet protection in place	Pic 4 Desc.	Erosion control blanket in place		
<p>Date & Time: Tue, Sep 21, 2021, 08:53:39 EDT Position: +037.299334° / -080.390980° (±19.8ft) Altitude: 2514ft (±11.1ft) Datum: WGS-84 Azimuth/Bearing: 227° N83W 4924mils True (±12°) Elevation Grade: -019° Horizon Grade: -001° Zoom: 1.0X 11687+00</p>

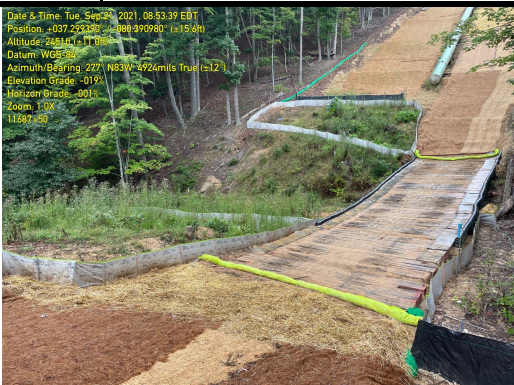
GPS Location	See photo	GPS Location	See photo		
Field Station#	11687+50	Field Station#	11696+00		
Pic 5 Desc.	Stream buffer in place	Pic 6 Desc.	Topsoil piles stabilized

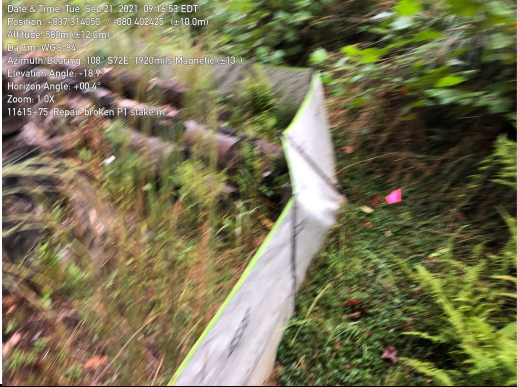
GPS Location	On photo	GPS Location	On photo		
Field Station#	11615+75	Field Station#	11614+20		
Pic 7 Desc.	Broken P1 stake to be replaced.	Pic 8 Desc.	The S-RR14 crossing is stable.		
<p><small>Date & Time: Tue, Sep 21, 2021, 09:25:16 EDT Position: +037.313613 / -080.402427 (+10.0m) Altitude: 579m (+12.0m) Datum: WGS-84 Azimuth/Bearing: 199° S19W 3538mils Magnetic (+12°) Elevation Angle: -07.1° Horizon Angle: +01.3° Zoom: 1.0X 11608+17</small></p>

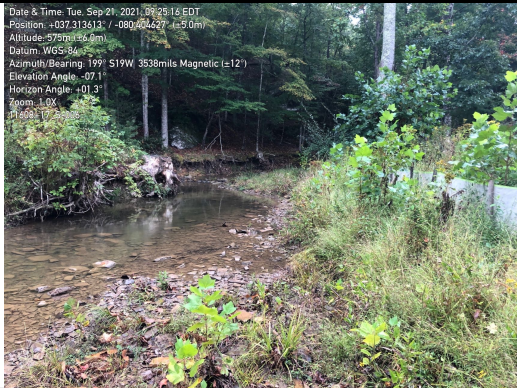
GPS Location	On photo	GPS Location	On photo		
Field Station#	11608+17	Field Station#	11611+00		
Pic 9 Desc.	The S-006 crossing is stable.	Pic 10 Desc.	ROW surface stable.		
<p><small>Date & Time: Tue, Sep 21, 2021, 09:44:39 EDT Position: +037.313443 / -080.402835 (+10.0m) Altitude: 594m (+8.0m) Datum: WGS-84 Azimuth/Bearing: 100° S80E 1775mils Magnetic (+12°) Elevation Angle: +12.1° Horizon Angle: -05.3° Zoom: 1.0X 11601+55</small></p>

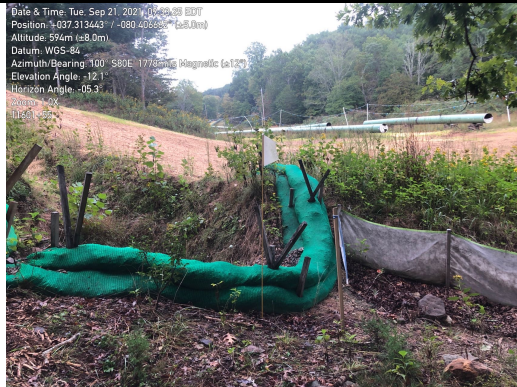
GPS Location	On photo	GPS Location	On photo		
Field Station#	11601+55	Field Station#	11626+04		
Pic 11 Desc.	Perimeter ECDs are in place and functional.	Pic 12 Desc.	The S-HH18 crossing is stable.

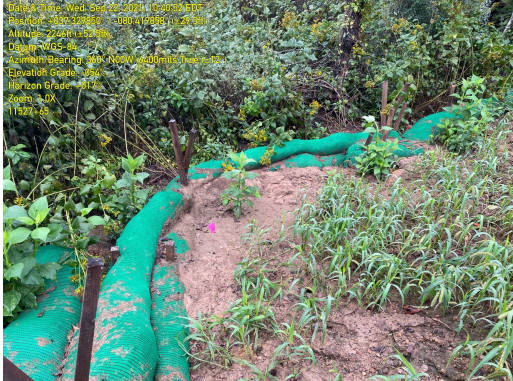
<p>Date & Time: Wed Sep 22, 2021, 10:53:37 EDT Position: -83.7742823, 35.00418659 (±31.9m) Altitude: 260ft (±37.0ft) Datum: WGS 84 Azimuth/Bearing: 282° N78W 5013mils True (±12°) Elevation Grade: -0.05° Horizon Grade: +0.20° Zoom: 1.0x 11534+25</p>			
GPS Location	See photo		GPS Location	See photo	
Field Station#	11527+65		Field Station#	11534+25	
Pic 1 Desc.	End treatment needs cleaned off		Pic 2 Desc.	Sediment needs removed from level spreader

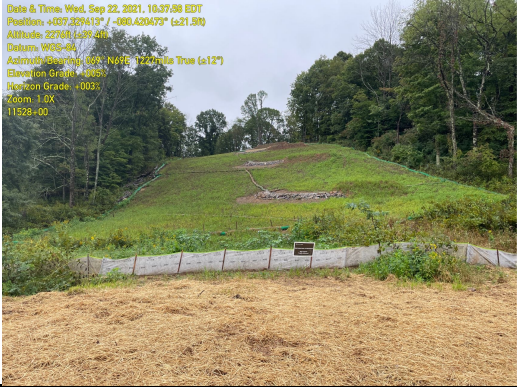
GPS Location	See photo	GPS Location	See photo		
Field Station#	11528+00	Field Station#	11532+00		
Pic 7 Desc.	P1 silt fence in place	Pic 8 Desc.	CFS controls in place		
<p><small>Date & Time: Wed, Sep 22, 2021, 12:10:49 EDT Position: +037.328223° / -080.414387° (±14.6ft) Altitude: 2279ft (±19.7ft) Datum: WGS-84 Azimuth/Bearing: 181° S30E 3006mils True (±12°) Elevation Grade: +014° Horizontal Grade: +009° Zoom: 1.0X 11545+50</small></p>

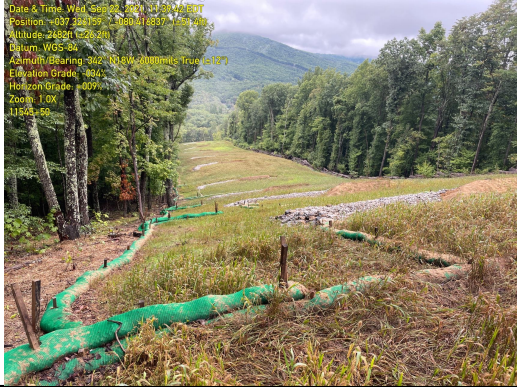
GPS Location	See photo	GPS Location	See photo		
Field Station#	11545+50	Field Station#	11564+00		
Pic 9 Desc.	Level spreaders in place	Pic 10 Desc.	Waterbars in place		
<p><small>Date & Time: Wed, Sep 22, 2021, 12:49:27 EDT Position: +037.314246° / -080.406509° (±11.8ft) Altitude: 1599ft (±9.8ft) Datum: WGS-84 Azimuth/Bearing: 171° S09E 3040mils True (±12°) Elevation Grade: +003° Horizontal Grade: +007° Zoom: 1.0X 11585+25</small></p>

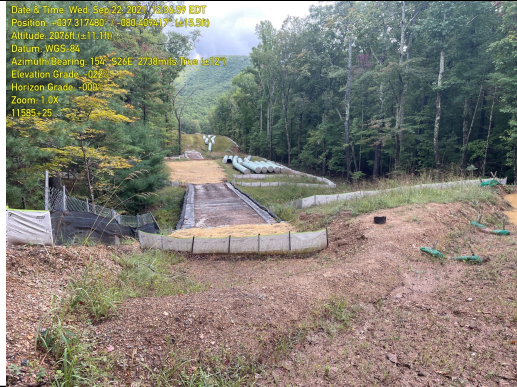
GPS Location	See photo	GPS Location	See photo		
Field Station#	11585+25	Field Station#	11599+50		
Pic 11 Desc.	Stream buffer in place	Pic 12 Desc.	RCE in place

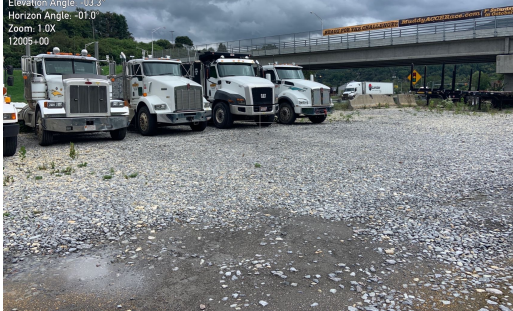
GPS Location				See photo				GPS Location				See photo			
Field Station#				12005+00				Field Station#				12005+00			
Pic 1 Desc.				Inspected parked vehicles for any visible leaks or spills				Pic 2 Desc.				Rock surface is in acceptable condition			
<p>Date & Time: Wed, Sep 22, 2021, 13:05:46 EDT Position: +48.935892° / -89.896132° (+18.31) Altitude: 1537ft (+11.47) Datum: WGS 84 Azimuth/Bearing: 050° N55E 0887mils True (+13.5) Elevation Angle: -01.1 Horizon Angle: -01.5 Zoom: 1.0X 12005+00</p>

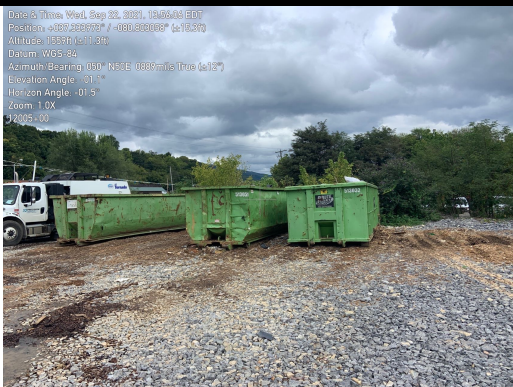
GPS Location				See photo				GPS Location				See photo			
Field Station#				12005+00				Field Station#				12005+00			
Pic 3 Desc.				Dumpsters are in place				Pic 4 Desc.				Secondary containment in place			
<p>Date & Time: Wed, Sep 22, 2021, 13:06:46 EDT Position: +48.935892° / -89.896132° (+18.31) Altitude: 1537ft (+11.47) Datum: WGS 84 Azimuth/Bearing: 182° S22W 5503mils True (+11.1) Elevation Angle: -05.5 Horizon Angle: -01.4 Zoom: 1.0X 12005+00</p>

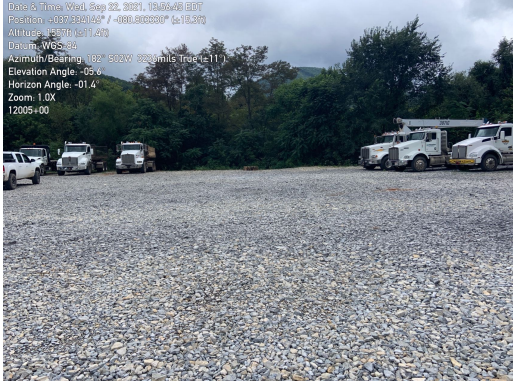
GPS Location				See photo				GPS Location				See photo			
Field Station#				12005+00				Field Station#				12005+00			
Pic 5 Desc.				Rock surface in acceptable condition				Pic 6 Desc.				CFS perimeter controls in place

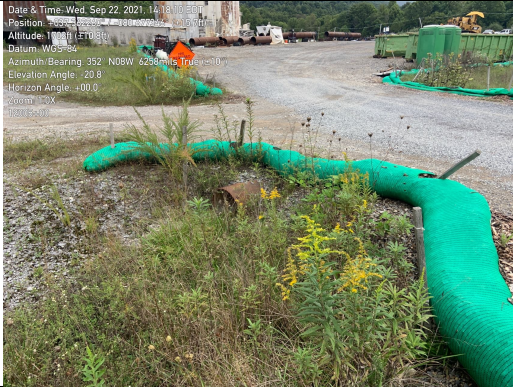
GPS Location	See photo		GPS Location	See photo	
Field Station#	12005+00		Field Station#	12005+00	
Pic 1 Desc.	18" CFS from punch list has need replaced		Pic 2 Desc.	Culvert in place and functional	
<p>Date & Time: Wed, Sep 22, 2021, 14:16:44 EDT Position: +437.34155° / +680.57774° (+15.5m) Altitude: 1699ft (+11.2m) Datum: WGS-84 Azimuth/Bearing: 352° N08W 6288mils True (+10°) Elevation Angle: -20.8° Horizon Angle: -00.0° Zoom: 1.0X 12005+00</p>

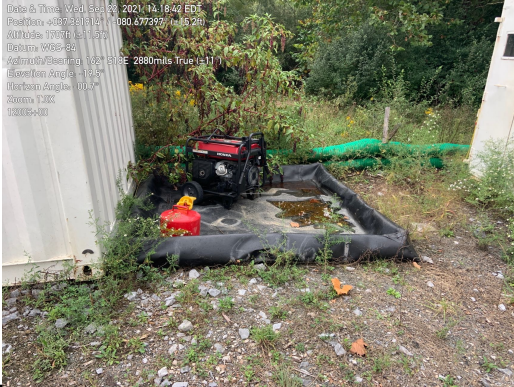
GPS Location	See photo		GPS Location	See photo	
Field Station#	12005+00		Field Station#	12005+00	
Pic 3 Desc.	Secondary containment in place		Pic 4 Desc.	Triple stacked CFS perimeter controls in place and functional	
<p>Date & Time: Wed, Sep 22, 2021, 14:20:47 EDT Position: +437.34155° / +680.57774° (+15.5m) Altitude: 1700ft (+13.1m) Datum: WGS-84 Azimuth/Bearing: 335° S45W 4000mils True (+11°) Elevation Angle: -04.1° Horizon Angle: -00.0° Zoom: 1.0X 12005+00</p>

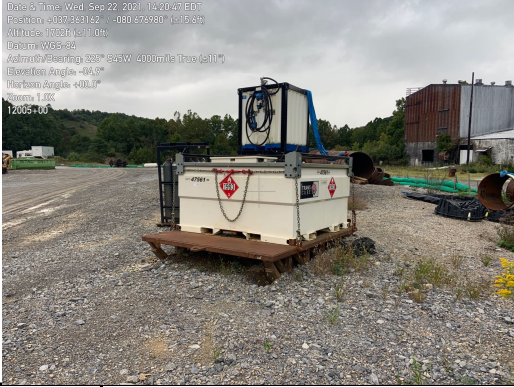
GPS Location	See photo		GPS Location	See photo	
Field Station#	12005+00		Field Station#	12005+00	
Pic 5 Desc.	Inspected fuel cell for any visible leaks or spills		Pic 6 Desc.	Dumpsters in place

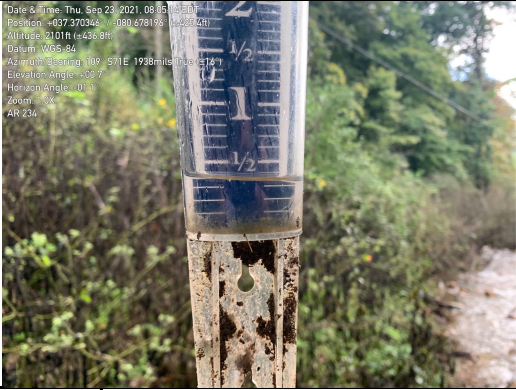
<p>Date & Time: Thu, Sep 23, 2021, 08:33:04 EDT Position: +037.34223° / -080.65327° (+123.5ft) Altitude: 2069ft (+62.8ft) Datum: WGS 84 Azimuth/Bearing: 230° S/W 4444mils True (+16°) Elevation Angle: +01.8° Horizon Angle: -03.2° Zoom: 1.0X Buffalo</p>			
GPS Location	See photo for GPS location.		GPS Location	See photo for GPS location.	
Field Station#	12005+00		Field Station#	10695+00	
Pic 1 Desc.	Rain gauge at access road 234 reads 0.4 inches.		Pic 2 Desc.	Rain gauge at Buffalo Anklets Road reads 0.6 inches.

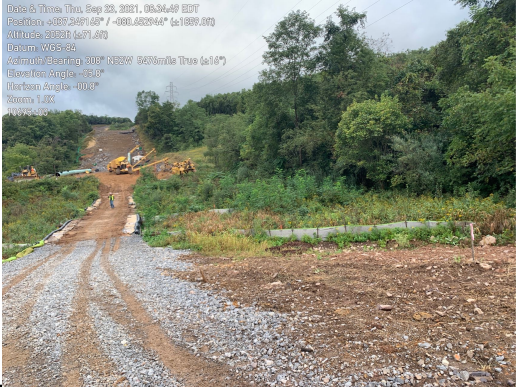
GPS Location	See photo for GPS location.		GPS Location	See photo for GPS location.	
Field Station#	10695+00		Field Station#	10695+00	
Pic 3 Desc.	Drainage feature before crew began work.		Pic 4 Desc.	Tie-in crew stripping topsoil.

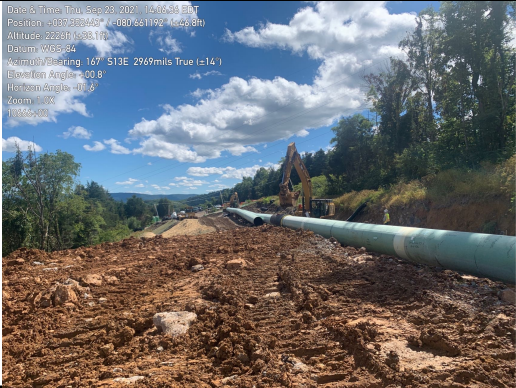
<p>Date & Time: Thu, Sep 23, 2021, 10:47:40 EDT Position: +037.349168° / -080.682944° (+1809.0ft) Altitude: 2220ft (+681.0ft) Datum: WGS 84 Azimuth/Bearing: 295° N/W 5246mils True (+16°) Elevation Angle: +03.5° Horizon Angle: -03.9° Zoom: 1.0X 10/65/500</p>			
GPS Location	See photo for GPS location.		GPS Location	See photo for GPS location.	
Field Station#	10666+00		Field Station#	10695+00	
Pic 5 Desc.	Ditching crew digging ditch and string soil in travel lane.		Pic 6 Desc.	Tie-in crew digging ditch through drainage feature.

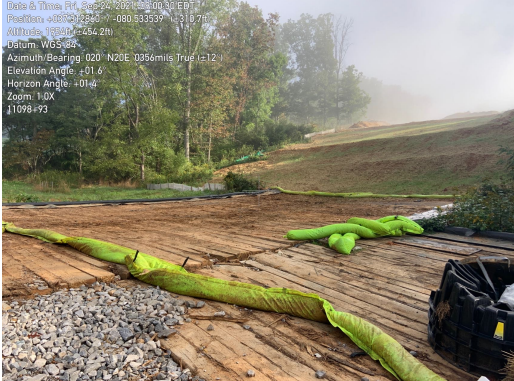
<p>Date & Time: Fri, Sep 24, 2021, 09:18:01 EDT Position: +037.31867° / -080.54034° (±34.0m) Altitude: 2177ft (±345.0m) Datum: WGS-84 Azimuth/Bearing: 291° N49W 512mils True (±12°) Elevation Angle: +04° Horizon Angle: 001.3° Zoom: 1.0X 11081+00</p>			
GPS Location	See photo	GPS Location	See photo		
Field Station#	11098+93	Field Station#	11081+00		
Pic 1 Desc.	Equipment bridge cleaned and acceptable	Pic 2 Desc.	Clean water diversion berm in acceptable condition

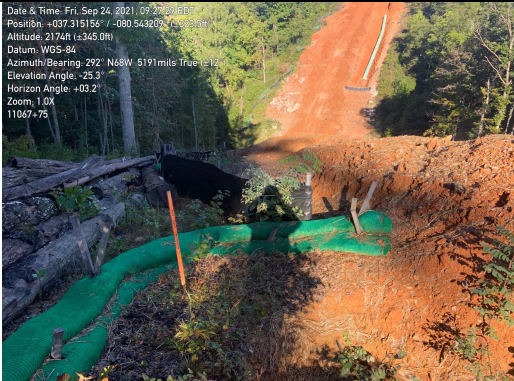
GPS Location	See photo	GPS Location	See photo		
Field Station#	11067+75	Field Station#	11072+17		
Pic 3 Desc.	CFS,SSF and sump acceptable	Pic 4 Desc.	Triangular foam booms are in place

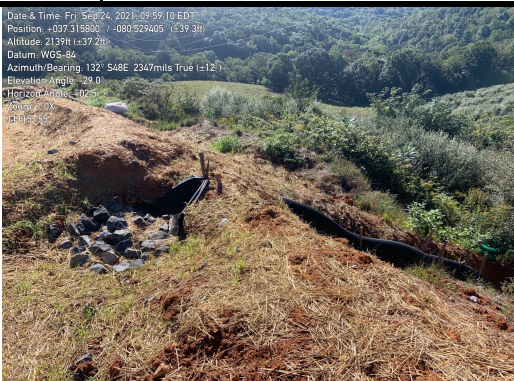
<p>Date & Time: Fri, Sep 24, 2021, 11:40:09 EDT Position: +037.320175° / -080.54025° (±45.0m) Altitude: 2205ft (±39.1m) Datum: WGS-84 Azimuth/Bearing: 136° N24W 5079mils True (±12°) Elevation Angle: -26.3° Horizon Angle: 105.1° Zoom: 1.0X 11217+80</p>			
GPS Location	See photo	GPS Location	See photo		
Field Station#	11115+55	Field Station#	11217+80		
Pic 5 Desc.	Stone inlet protection functional	Pic 6 Desc.	Permanent water bar and level spreader functional

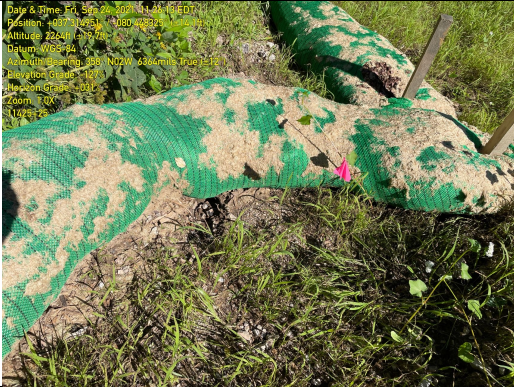
GPS Location	See photo	GPS Location	See photo		
Field Station#	11425+25	Field Station#	11262+00		
Pic 1 Desc.	End treatment undermined	Pic 2 Desc.	End treatments in place

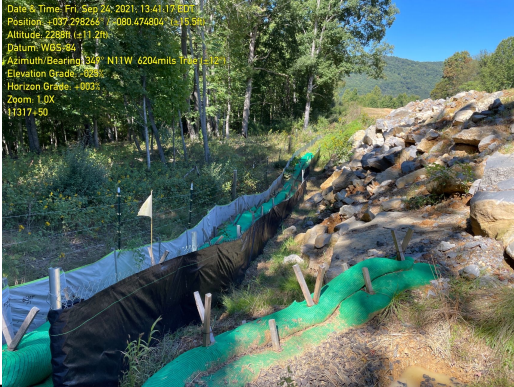
GPS Location	See photo	GPS Location	See photo		
Field Station#	11317+50	Field Station#	11328+75		
Pic 3 Desc.	ECDs in place at karst feature	Pic 4 Desc.	CFS checks in place

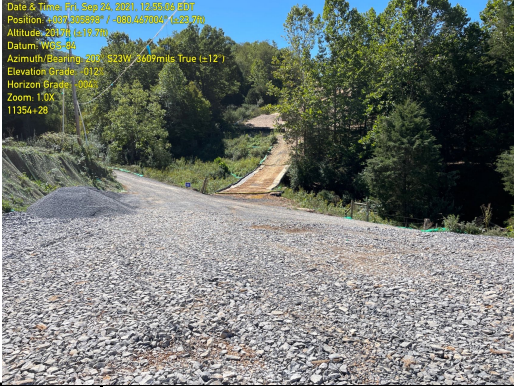
GPS Location	See photo	GPS Location	See photo		
Field Station#	11354+28	Field Station#	11400+00		
Pic 5 Desc.	RCE in place	Pic 6 Desc.	CFS perimeter control in place

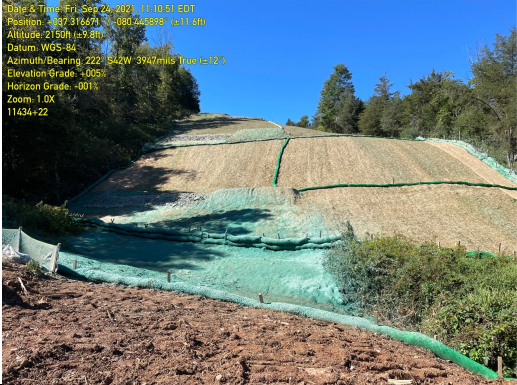
GPS Location	See photo	GPS Location	See photo		
Field Station#	11423+00	Field Station#	11434+22		
Pic 7 Desc.	CFS controls in place	Pic 8 Desc.	Erosion control blanket in place

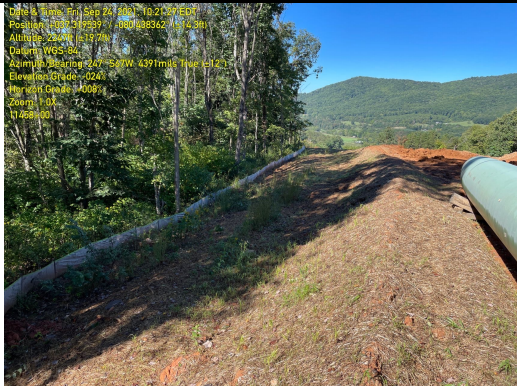
GPS Location	See photo	GPS Location	See photo		
Field Station#	11458+00	Field Station#	11475+00		
Pic 9 Desc.	P1 silt fence perimeter control in place	Pic 10 Desc.	Stone inlet protection in place
