Visual Site Inspection Report

| Project Name | H-600 Pipeline Spread G | AFE | 124300137 | Spread | H-600 Pipeline Spread G |
| Permit # | TBD | Inspection Type | VA SWPP | Station Begin | 11788+52 |

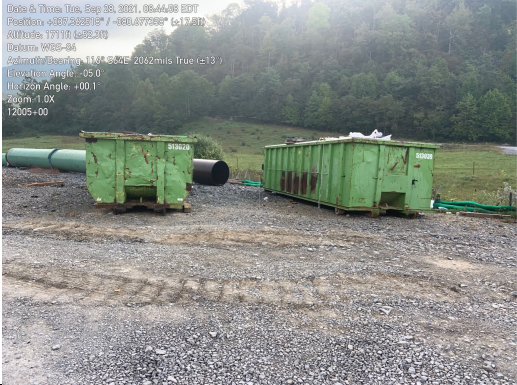
| Field Station# | 12005+00 | Field Station# | | | |

| Pic 7 Desc. | Dumpsters are in place | Pic 8 Desc. | | | |

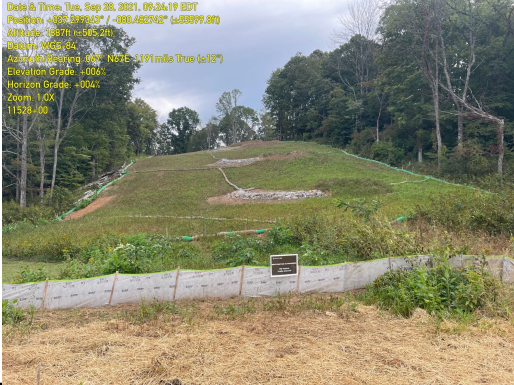
| Field Station# | 11528+00 | Field Station# | 11531+00 | | |

| Pic 3 Desc. | Proper signage in place | Pic 4 Desc. | Temporary CFS waterbars in place | | |

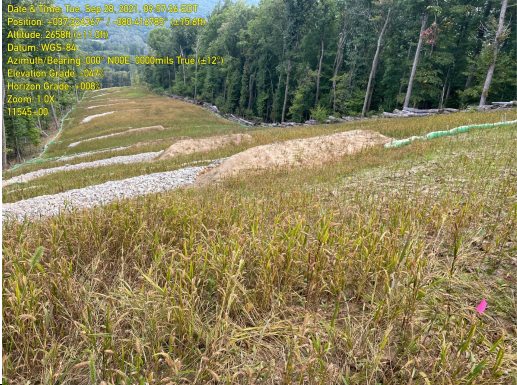
| Field Station# | 11545+00 | Field Station# | 11563+00 | | |

| Pic 7 Desc. | Permanent waterbars in place | Pic 8 Desc. | Waterbars in place | | |

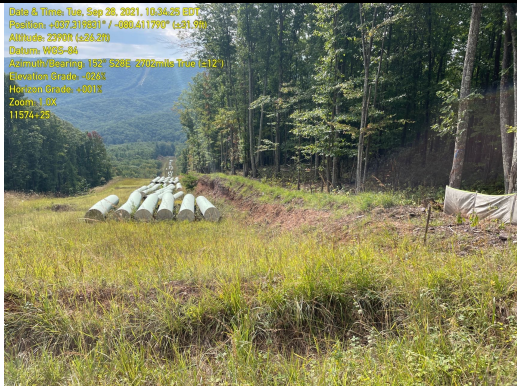
| Field Station# | 11574+25 | Field Station# | 11583+00 | | |

| Pic 9 Desc. | Clean water diversion berm in place | Pic 10 Desc. | P1 silt fence perimeter control in place | | |

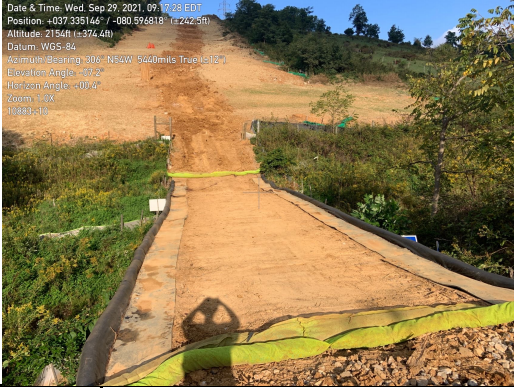
| Field Station# | 10883+10 | Field Station# | 10887+75 | | |

| Pic 1 Desc. | Equipment bridge acceptable | Pic 2 Desc. | Clean water diversion pipe and plunge pool acceptable | | |

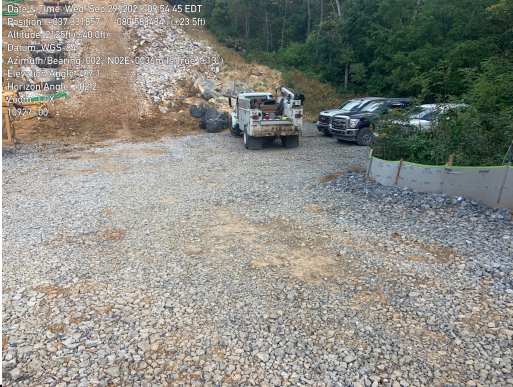
| Field Station# | 10911+80 | Field Station# | 10927+00 | | |

| Pic 3 Desc. | Rill erosion in throat of water bar | Pic 4 Desc. | RCE is maintained and in acceptable condition | | |

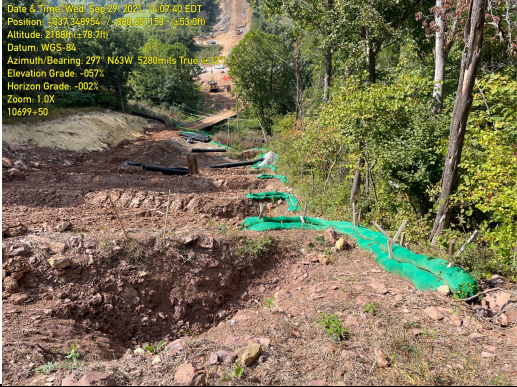
| AFE 124300137 | | Date/Time | 9/29/2021 5:46 PM | Report # | |
|--|--|---|---|---|--|
| Field Station# | | 10699+50 | | Field Station# | |

| AFE 124300137 | | Date/Time | 9/29/2021 5:46 PM | Report # | |
|--|--|---|---|---|--|
| Pic 7 Desc. | | End treatments in place | | Pic 8 Desc. | |

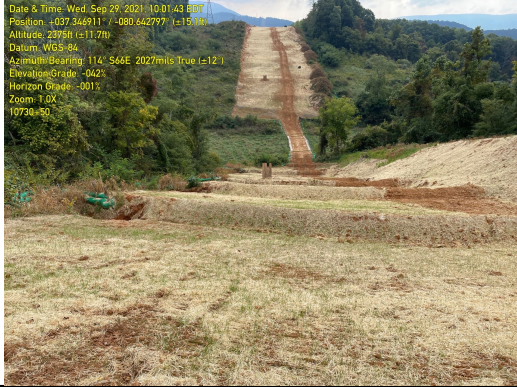
| AFE 124300137 | | Date/Time | 9/29/2021 5:46 PM | Report # | |
|--|--|---|---|---|--|
| Field Station# | | 10730+50 | | Field Station# | |

| AFE 124300137 | | Date/Time | 9/29/2021 5:46 PM | Report # | |
|--|--|---|---|---|--|
| Pic 9 Desc. | | Waterbars in place | | Pic 10 Desc. | |

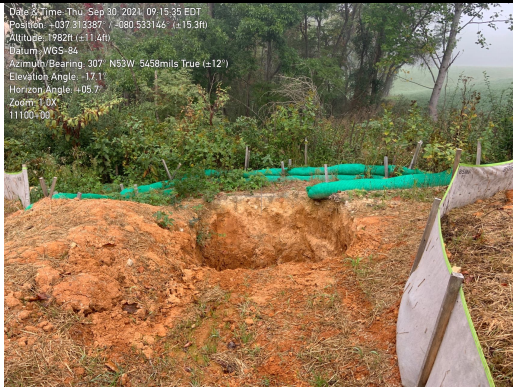
| AFE 124300137 | | Date/Time 9/30/2021 3:36 PM | | Report # | |
|---|--|--|--|---|--|
| Field Station# 11098+93 | | Field Station# 11100+00 | | | |

| AFE 124300137 | | Date/Time 9/30/2021 3:36 PM | | Report # | |
|---|--|--|--|---|--|
| Pic 1 Desc. Erosion control blanket reapplied after subsidence issues had been addressed | | Pic 2 Desc. Sump and perimeter controls acceptable | | | |

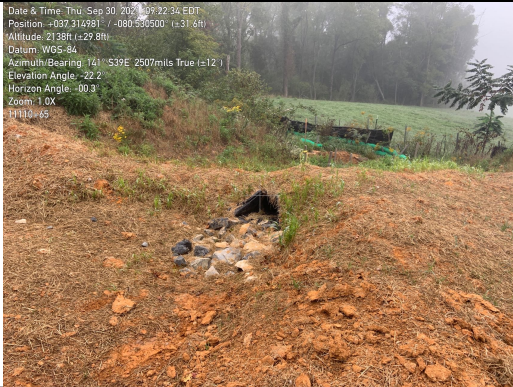
| AFE 124300137 | | Date/Time 9/30/2021 3:36 PM | | Report # | |
|---|--|--|--|---|--|
| Field Station# 11110+00 | | Field Station# 11123+00 | | | |

| AFE 124300137 | | Date/Time 9/30/2021 3:36 PM | | Report # | |
|---|--|--|--|---|--|
| Pic 3 Desc. Stone inlet protection functional | | Pic 4 Desc. Clean water diversion pipe and level spreader functional | | | |

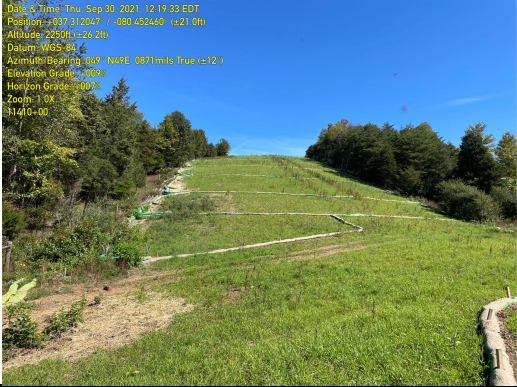
| Field Station# | 11410+00 | Field Station# | 11431+00 | | |

| Pic 7 Desc. | Temporary CFS waterbars in place | Pic 8 Desc. | Level spreaders in place | | |

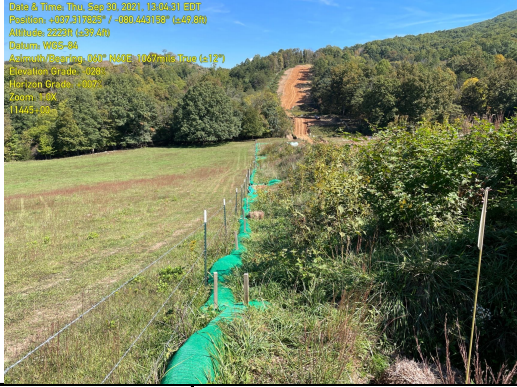
| Field Station# | 11445+00 | Field Station# | 11477+00 | | |

| Pic 9 Desc. | CFS perimeter control in place | Pic 10 Desc. | Supersilt fence perimeter control in place | | |

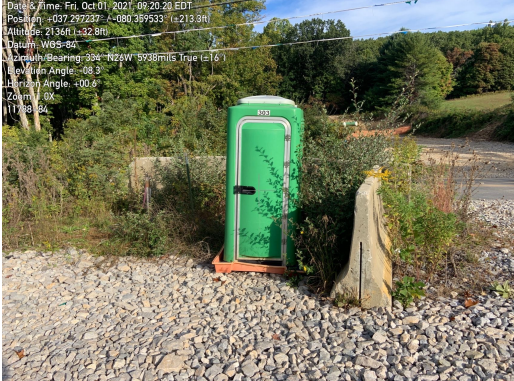
| Field Station# | 11788+84 | Field Station# | 11788+95 | | |

| Pic 1 Desc. | Secondary containment in place | Pic 2 Desc. | RCE clean and acceptable | | |

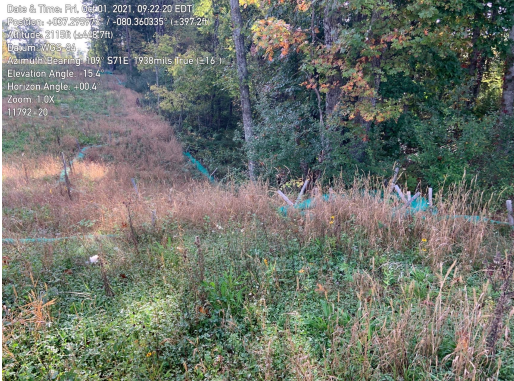
| Field Station# | 11792+20 | Field Station# | 11831+00 | | |

| Pic 3 Desc. | CFS in place and in acceptable condition | Pic 4 Desc. | Water bar and level spreader functional | | |

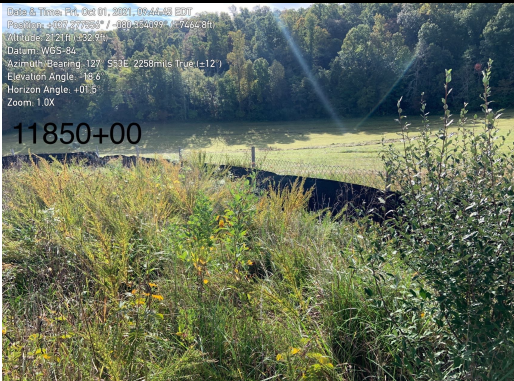
| Field Station# | 11850+00 | Field Station# | 11864+00 | | |

| Pic 5 Desc. | SSF in place | Pic 6 Desc. | P1 silt fence is in acceptable condition | | |

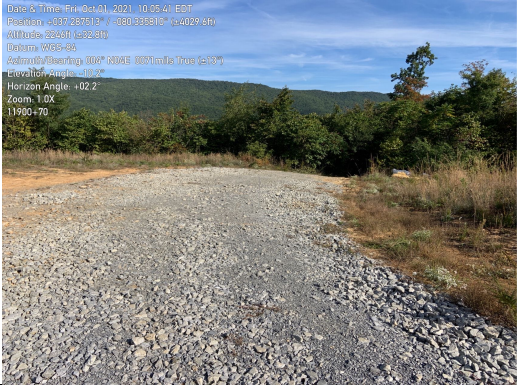
| Field Station# | 11900+70 | Field Station# | 11952+00 | | |

| Pic 7 Desc. | AR266.03 is in acceptable condition | Pic 8 Desc. | Vegetation and perimeter controls are in acceptable condition | | |

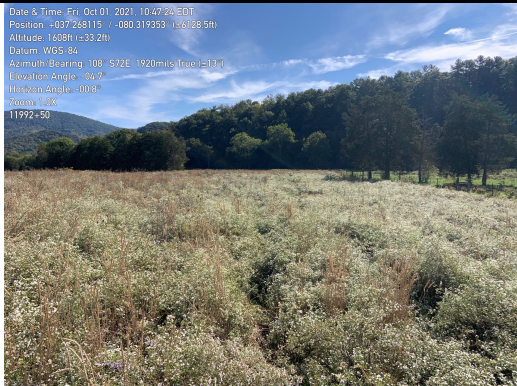
| Field Station# | 11992+50 | Field Station# | 11930+00 | | |

| Pic 9 Desc. | Adequate vegetation | Pic 10 Desc. | Rock check dams along upper area of AR266 are acceptable | | |

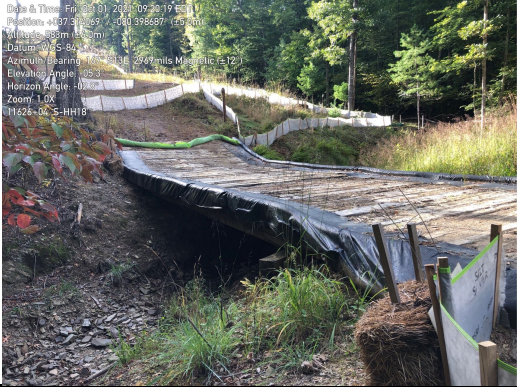
| Field Station# | 11626+04 | Field Station# | 11616+00 | | |

| Pic 7 Desc. | The S-HH18 crossing is stable. | Pic 8 Desc. | No rilling or channeling present. | | |

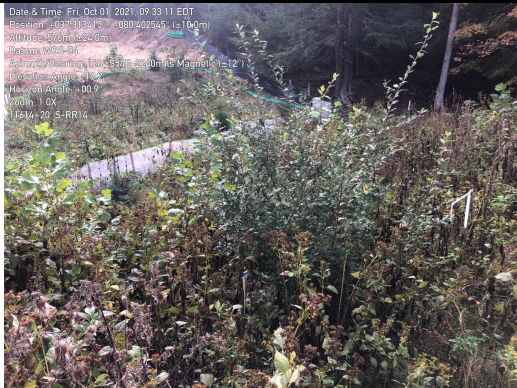
| Field Station# | 11614+20 | Field Station# | 11608+17 | | |

| Pic 9 Desc. | The S-RR14 crossing is stable. | Pic 10 Desc. | The S-006 crossing is stable. | | |
