Visual Site Inspection Report

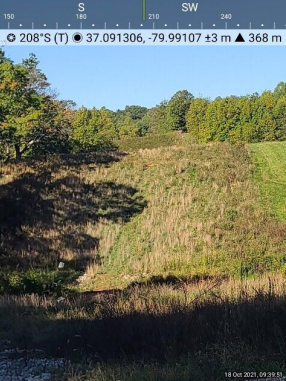
GPS Location	0000	GPS Location	00000		
Field Station#	13541+50	Field Station#	13643+70		
Pic 1 Desc.	Monitored row conditions throughout, observed equipment bridges and protection. No environmental issues observed at the time of inspection.		Pic 2 Desc.	Monitored p1 that was recently replaced during maintenance repairs.

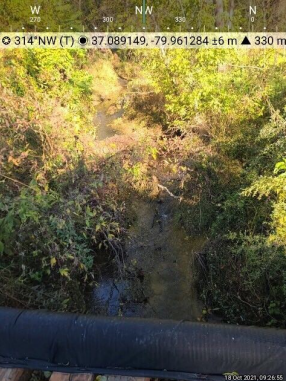
GPS Location	0000	GPS Location	0000		
Field Station#	13643+67	Field Station#	13643+67		
Pic 3 Desc.	Stream observation photo facing upstream during routine inspection today. No issues observed at the time of inspection.		Pic 4 Desc.	Stream observation photo facing down stream during routine inspection today. No environmental issues observed at the time of inspection.

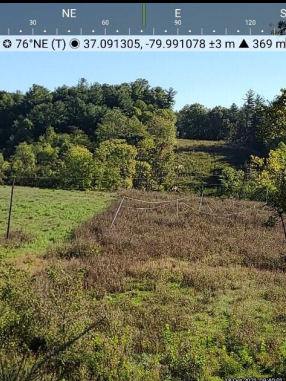
GPS Location	00000	GPS Location	00000		
Field Station#	13541+88	Field Station#	13643+63		
Pic 5 Desc.	Vegetation observation photo showing permanent vegetation.		Pic 6 Desc.	Monitored stream crossing equipment bridge was in place with all ECDs functioning at the time of inspection.

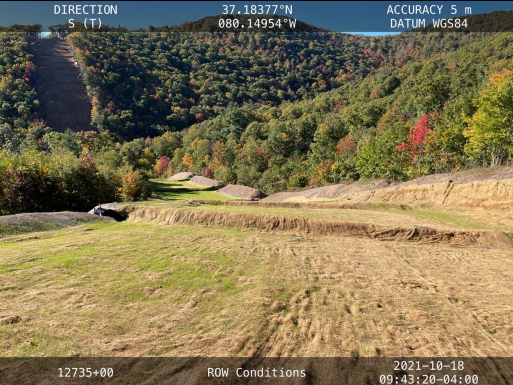
GPS Location	See photo		GPS Location	See photo	
Field Station#	12733+00		Field Station#	12735+00	
Pic 1 Desc.	Current ROW conditions. ROW is stable.		Pic 2 Desc.	Current ROW conditions. ROW is stable. Seed is has germinated.

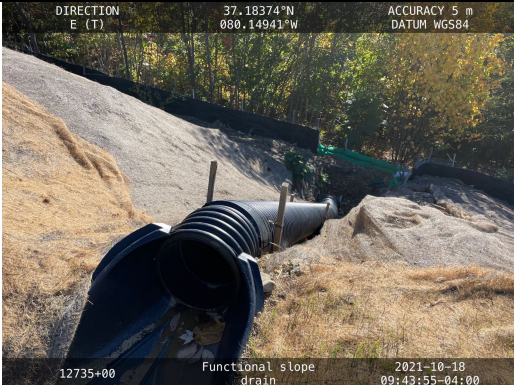
GPS Location	See photo		GPS Location	See photo	
Field Station#	12735+00		Field Station#	12743+84	
Pic 3 Desc.	Fill slope stabilized and slope drain is functional		Pic 4 Desc.	Equipment bridge over Stream S-EF34B

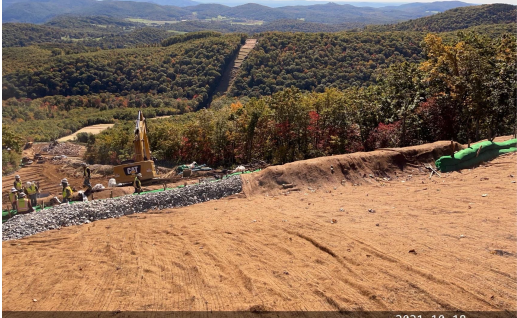
12692+00 ROW conditions 2021-10-18 10:55:22-04:00		DIRECTION SE (T) +37.19062° -080.15322° ACCURACY 15 ft DATUM WGS84

12704+00 ROW conditions 2021-10-18 11:07:47-04:00			
GPS Location	See photo		GPS Location	See photo	
Field Station#	12692+00		Field Station#	12704+00	
Pic 13 Desc.	Permanent slope breaker and level spreader are functional.		Pic 14 Desc.	Current ROW conditions. ROW is stable and ECDs functional.	
DIRECTION SE (T) +37.18787° -080.15138° ACCURACY 17 ft DATUM WGS84

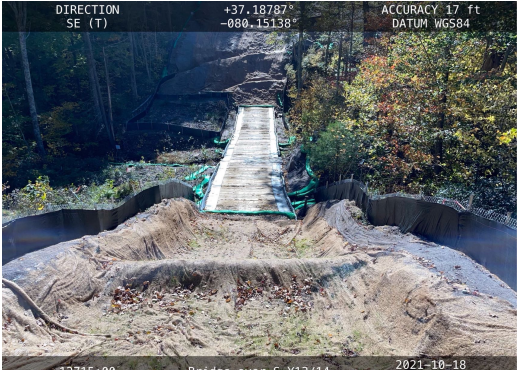
12715+00 Bridge over S-Y13/14 2021-10-18 11:15:40-04:00		DIRECTION E (T) +37.18773° -080.15118° ACCURACY 13 ft DATUM WGS84

Pic 15 Desc.	Equipment bridge over Stream S-Y13 and S-Y14		Pic 16 Desc.	Downstream of crossing at Stream S-Y13	
DIRECTION E (T) +37.18761° -080.15112° ACCURACY 16 ft DATUM WGS84

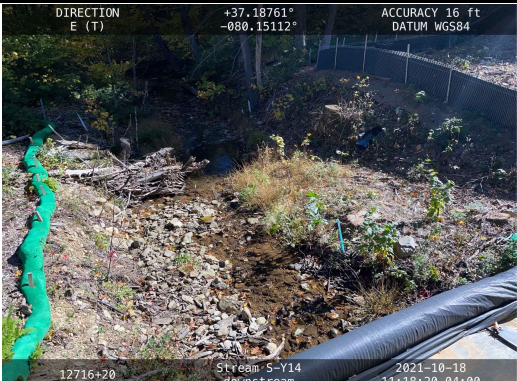
12716+20 Stream S-Y14 downstream 2021-10-18 11:18:20-04:00		DIRECTION NW (T) +37.19245° -080.17497° ACCURACY 15 ft DATUM WGS84

12635+00 ROW conditions 2021-10-18 11:49:30-04:00			
GPS Location	See photo		GPS Location	See photo	
Field Station#	12716+20		Field Station#	12635+00	
Pic 17 Desc.	Downstream of crossing at Stream S-Y14		Pic 18 Desc.	Current ROW conditions. ROW is stable. ECDs are functional.

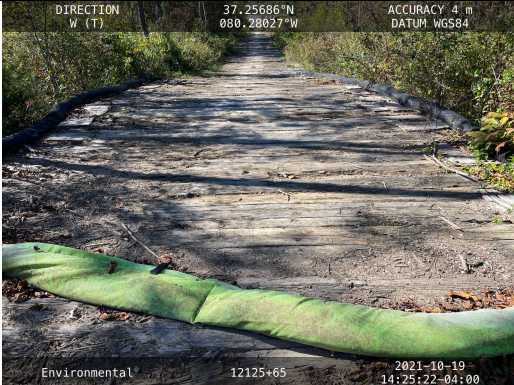
GPS Location	See photo	GPS Location	See photo		
Field Station#	12125+65	Field Station#	12132+74		
Pic 1 Desc.	Bridge and ECDs crossing stream S-MM31 in acceptable condition	Pic 2 Desc.	Bridge and ECDs crossing stream S-C29 in acceptable conditions

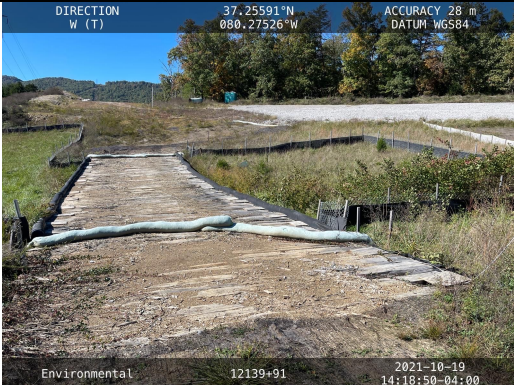
GPS Location	See photo	GPS Location	See photo		
Field Station#	12139+91	Field Station#	12144+47		
Pic 3 Desc.	Wetland crossing W-C6 in acceptable condition	Pic 4 Desc.	Bridge and ECDs crossing wetland W-C5 in acceptable condition

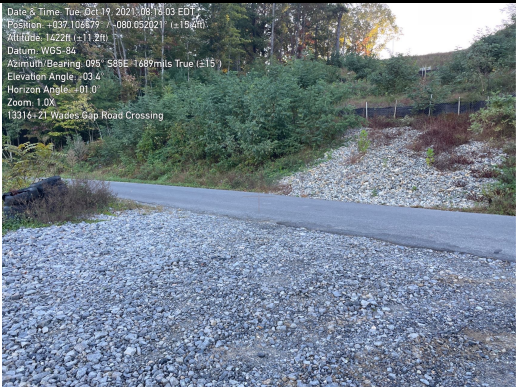
<p>Date & Time: Tue, Oct 19, 2021 08:18:03 EDT Position: -83.7106317, -400.052318 (±15.1ft) Altitude: 1422ft (±11.2ft) Datum: WGS-84 Azimuth/Bearing: 095.58SE 1689mils True (±15.1) Elevation Angle: -03.4 Horizon Angle: -01.0 Zoom: 1.0X 13316+21 Wades Gap Road Crossing</p>

<p>Date & Time: Tue, Oct 19, 2021 08:18:13 EDT Position: -83.7106498, -400.052318 (±15.1ft) Altitude: 1409ft (±11.2ft) Datum: WGS-84 Azimuth/Bearing: 271.80NW 4818mils True (±15.1) Elevation Angle: -14.0 Horizon Angle: -00.2 Zoom: 1.0X 13316+00</p>	
GPS Location	0	GPS Location	0	Field Station#	13316+21
Pic 1 Desc.	Wades Gap Road Crossing in good condition and RCE in good condition and functioning properly		Pic 2 Desc.	ROW and ECDs in good condition with good vegetation established across row

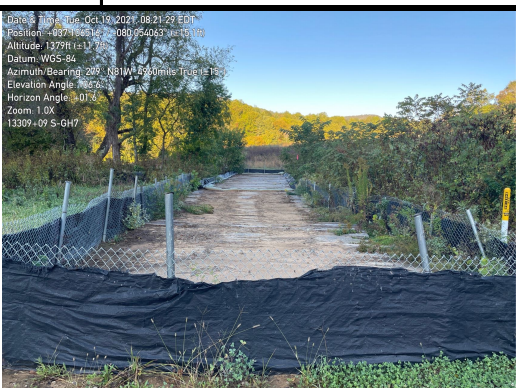
<p>Date & Time: Tue, Oct 19, 2021 08:21:22 EDT Position: -83.7114131, -400.0540937 (±15.1ft) Altitude: 1379ft (±11.2ft) Datum: WGS-84 Azimuth/Bearing: 282.13NW 4634mils True (±15.1) Elevation Angle: -02.5 Horizon Angle: -01.3 Zoom: 1.0X 13309+09 S-GH7</p>

GPS Location	0	GPS Location	0	Field Station#	13309+09
Pic 3 Desc.	MVP-S-GH7 and Corresponding buffer zone in good condition		Pic 4 Desc.	Flanders Road Crossing in good condition and RCE in good condition and functioning properly

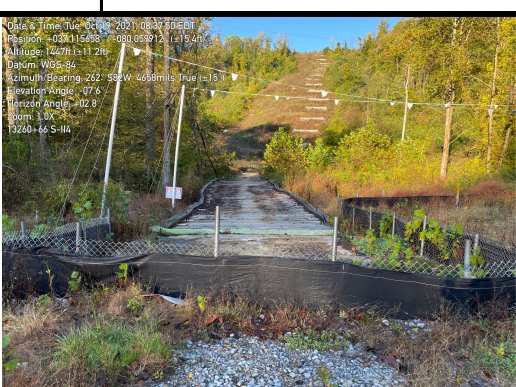
<p>Date & Time: Tue, Oct 19, 2021 08:37:50 EDT Position: -83.7115983, -400.060578 (±15.3ft) Altitude: 1426ft (±11.2ft) Datum: WGS-84 Azimuth/Bearing: 262.53SW 4658mils True (±15.1) Elevation Angle: -07.6 Horizon Angle: -02.8 Zoom: 1.0X 13260+66 S-II4</p>

<p>Date & Time: Tue, Oct 19, 2021 08:37:38 EDT Position: -83.7115983, -400.060578 (±15.3ft) Altitude: 1408ft (±11.4ft) Datum: WGS-84 Azimuth/Bearing: 277.83W 4924mils True (±12.1) Elevation Angle: -12.0 Horizon Angle: -01.1 Zoom: 1.0X 13259+00</p>	
GPS Location	0	GPS Location	0	Field Station#	13260+66
Pic 5 Desc.	MVP-S-II4 and Corresponding buffer zone in good condition		Pic 6 Desc.	ROW and ECDs in good condition with good vegetation established across row

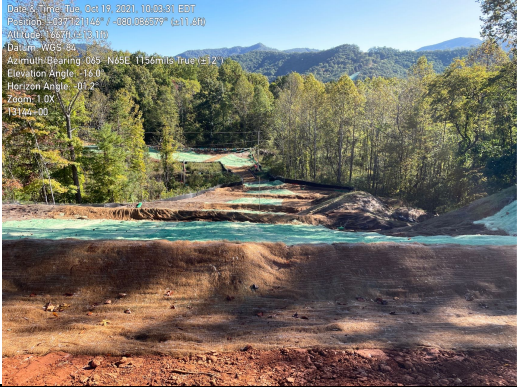
GPS Location 0		GPS Location 0			
Field Station# 13144+00		Field Station# 13146+56			
Pic 7 Desc. ROW and ECDs in good condition and stable		Pic 8 Desc. MVP-S-D12/13 and Corresponding buffer zone in good condition			
<p>Date & Time: Tue, Oct 19, 2021, 10:09:31 EDT Position: +037.122029 / -080.089546 (±14.0ft) Altitude: 1610ft (±13.4ft) Datum: WGS-84 Azimuth/Bearing: 351° N09W 620mils True (±12°) Elevation Angle: +01.2° Horizon Angle: +00.3° Zoom: 1.0X 13149+50</p>

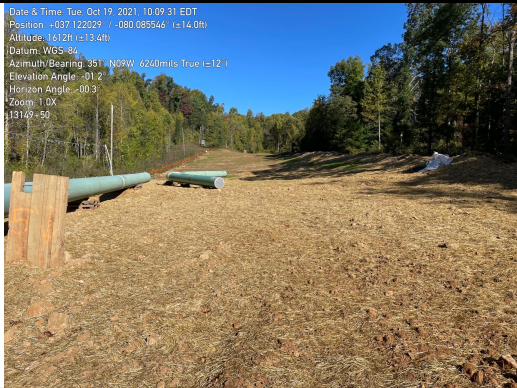
GPS Location 0		GPS Location 0			
Field Station# 13149+50		Field Station# 13151+00			
Pic 9 Desc. ROW and ECDs in good condition and stable		Pic 10 Desc. ROW and ECDs in good condition and stable			
<p>Date & Time: Tue, Oct 19, 2021, 10:15:18 EDT Position: +037.123599 / -080.088315 (±15.1ft) Altitude: 1630ft (±11.5ft) Datum: WGS-84 Azimuth/Bearing: 171° S89E 3040mils True (±12°) Elevation Angle: +10.0° Horizon Angle: +02.9° Zoom: 1.0X 13155+00</p>

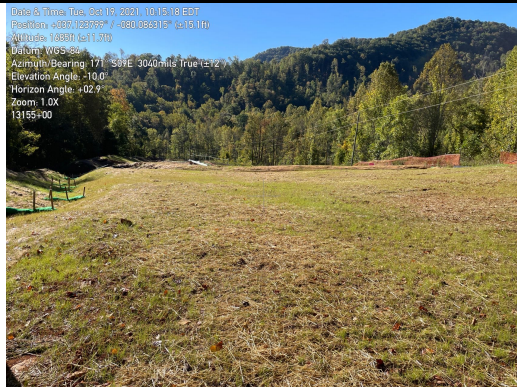
GPS Location 0		GPS Location 0			
Field Station# 13155+00		Field Station# 13157+22			
Pic 11 Desc. ROW and ECDs in good condition and stable		Pic 12 Desc. MVP-S-D11 and Corresponding buffer zone in good condition

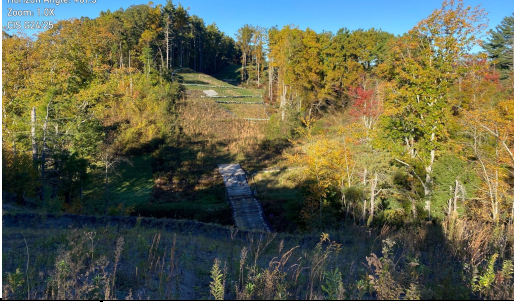
GPS Location	See photo for coordinates.		GPS Location	See photo for coordinates.	
Field Station#	13024+00		Field Station#	13012+53	
Pic 1 Desc.	ROW stable with good vegetative cover.		Pic 2 Desc.	ROW well vegetated on the CIS of the Blue Ridge Parkway.	
<p>Date & Time: Wed, Oct 20, 2021, 09:26:57 EDT Position: +037 128460 / -080 130146 (+90.1ft) Altitude: 2650ft (+24.1ft) Datum: WGS-84 Azimuth/Bearing: 105° S75E 1867mils True (+12°) Elevation Angle: -03.1° Horizon Angle: +00.0° Zoom: 1.0X GAS: 1291</p>

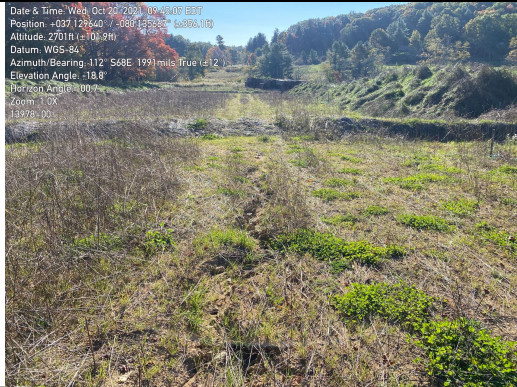
GPS Location	See photo for coordinates.		GPS Location	See photo for coordinates.	
Field Station#	12996+00		Field Station#	12978+00	
Pic 3 Desc.	GAS of HWY 221, ROW stable with good vegetative cover across LOD.		Pic 4 Desc.	ROW stabilized, waterbars in acceptable condition.	
<p>Date & Time: Wed, Oct 20, 2021, 09:45:22 EDT Position: +037 129555 / -080 135647 (+30.9ft) Altitude: 2672ft (+28.4ft) Datum: WGS-84 Azimuth/Bearing: 106° S74E 1884mils True (+12°) Elevation Angle: -34.7° Horizon Angle: -01.2° Zoom: 1.0X GAS: 12978+00</p>

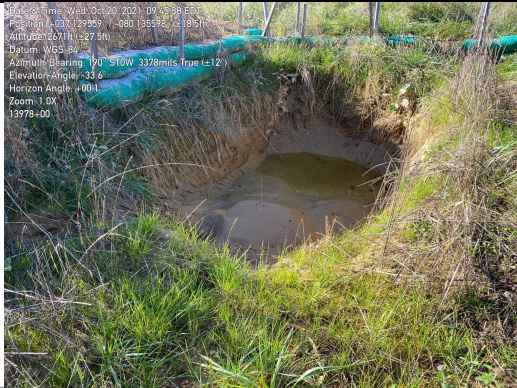
Pic 5 Desc.	Rilling noted and added to punch list as a 72 hour maintenance item.		Pic 6 Desc.	Sump requiring maintenance, associated with rilling, added to punch list as a 72 hours maintenance item.

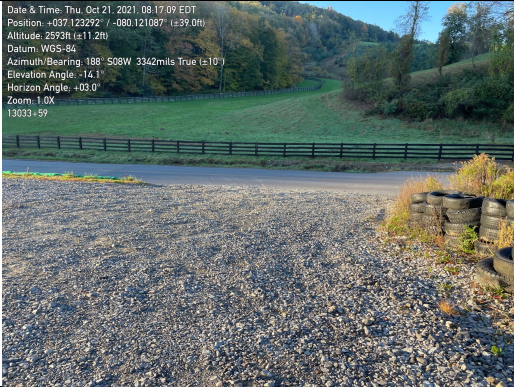
GPS Location	0	GPS Location	0		
Field Station#	13033+59	Field Station#	13033+00		
Pic 1 Desc.	RCE in good condition and functioning properly	Pic 2 Desc.	ROW and ECDs in good condition with good vegetation established across ROW		
<p>Date & Time: Thu, Oct 21, 2021, 08:34:25 EDT Position: +037.125806° / -080.119612° (+11.6ft) Altitude: 2720ft (+9.8ft) Datum: WGS-84 Azimuth/Bearing: 236° S56W 4196mils True (+13°) Elevation Angle: -04.5° Horizon Angle: +00.8° Zoom: 1.0X 13030+00</p>

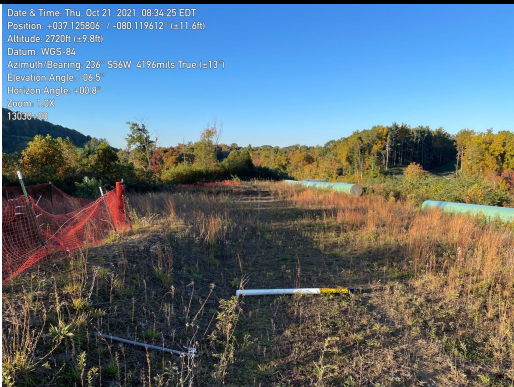
GPS Location	0	GPS Location	0		
Field Station#	13030+00	Field Station#	13024+06		
Pic 3 Desc.	ROW and ECDs in good condition with good vegetation established across ROW	Pic 4 Desc.	MVP-S-G24/25 and Corresponding buffer zone in good condition		
<p>Date & Time: Thu, Oct 21, 2021, 08:41:24 EDT Position: +037.124358° / -080.118678° (+15.1ft) Altitude: 2727ft (+11.7ft) Datum: WGS-84 Azimuth/Bearing: 048° N48E 0853mils True (+13°) Elevation Angle: +04.0° Horizon Angle: -01.0° Zoom: 1.0X 13036+00</p>

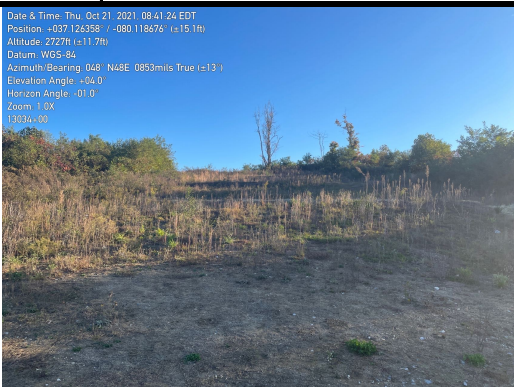
GPS Location	0	GPS Location	0		
Field Station#	13034+00	Field Station#	13061+44		
Pic 5 Desc.	ROW and ECDs in good condition with good vegetation established across ROW	Pic 6 Desc.	Equipment bridge in good condition

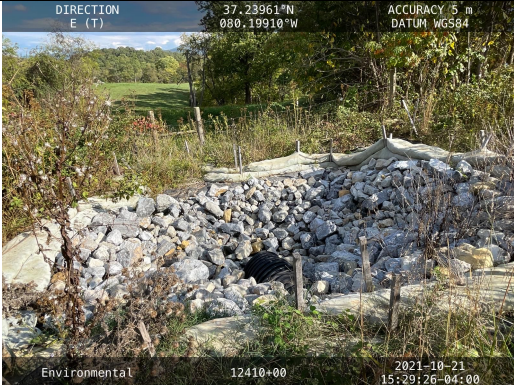
GPS Location	See photo		GPS Location	see photo	
Field Station#	12410+00		Field Station#	12403+00	
Pic 1 Desc.	Clean water crossing pipe outlet in acceptable condition		Pic 2 Desc.	Stabilized ROW in acceptable condition

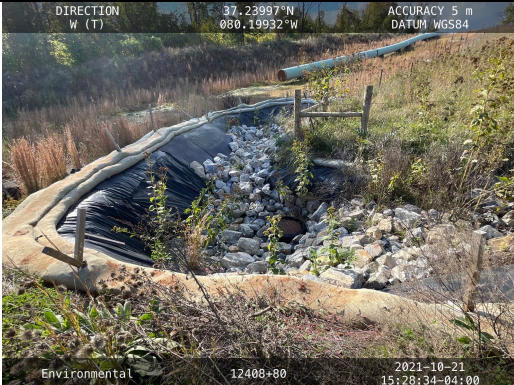
GPS Location	See photo		GPS Location	See photo	
Field Station#	12408+80		Field Station#	12409+36	
Pic 3 Desc.	Clean water crossing pipe inlet in acceptable condition		Pic 4 Desc.	Stabilized ROW in acceptable condition

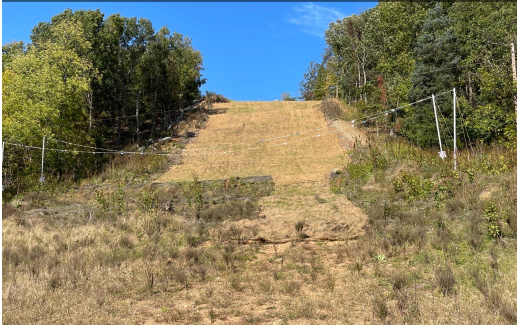
Environmental 12418+00 2021-10-21 15:06:24-04:00		Environmental 12421+00 2021-10-21 15:05:52-04:00			
GPS Location	see photo		GPS Location	See photo	
Field Station#	12418+00		Field Station#	12421+00	
Pic 7 Desc.	Stabilized slope in acceptable condition		Pic 8 Desc.	Clean water crossing pipe inlet in acceptable condition	
DIRECTION W (T) 37.23312°N ACCURACY 9 m 080.19837°W DATUM WGS84		DIRECTION NE (T) 37.23317°N ACCURACY 16 m 080.19792°W DATUM WGS84

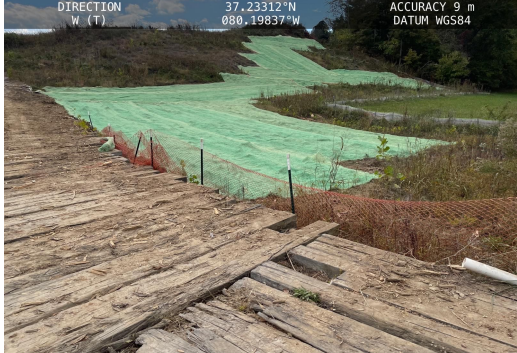
Environmental 12437+70 2021-10-21 14:55:48-04:00		Environmental 12435+50 2021-10-21 14:55:15-04:00			
GPS Location	See photo		GPS Location	See photo	
Field Station#	12437+70		Field Station#	12435+50	
Pic 9 Desc.	Stabilized slope where crew removed log piles		Pic 10 Desc.	Stream crossing S-NN16 in acceptable condition

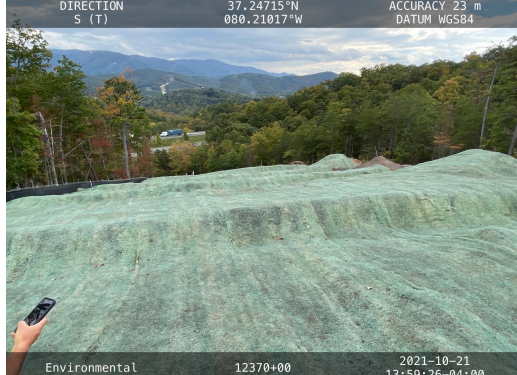
Environmental 12370+00 2021-10-21 13:59:26-04:00		Environmental 12361+00 2021-10-21 13:54:33-04:00			
GPS Location	See photo		GPS Location	See photo	
Field Station#	12370+00		Field Station#	12361+00	
Pic 11 Desc.	Stabilized ROW conditions		Pic 12 Desc.	Stabilized ROW conditions

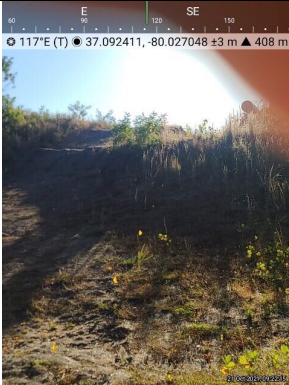
GPS Location	00000	GPS Location	00000		
Field Station#	13417+00	Field Station#	13420+00		
Pic 1 Desc.	Monitored erosion control blanket on hill side above stream crossing . Hill side stabilized with no environmental issues observed at the time of inspection.		Pic 2 Desc.	Work space showing new winter stabilization growth.

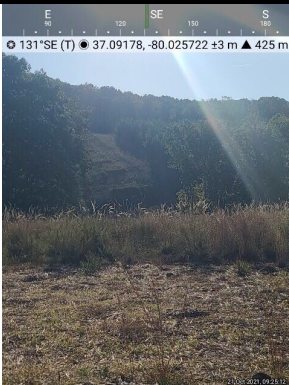
GPS Location	00000	GPS Location	00000		
Field Station#	13424+50	Field Station#	13437+40		
Pic 3 Desc.	Row photo showing vegetation in permanent area . No environmental issues observed at the time of inspection.		Pic 4 Desc.	Permanent vegetation area showing good coverage.

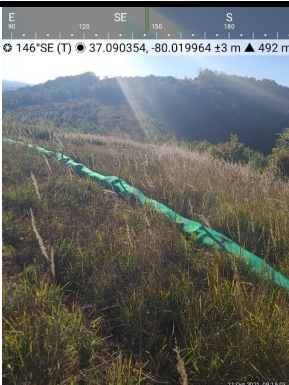
GPS Location	00000	GPS Location	00000		
Field Station#	13437+75	Field Station#	13419+00		
Pic 5 Desc.	Monitored ECDs throughout the row. No environmental issues observed at the time of inspection.		Pic 6 Desc.	Row photo showing open ditch at kickoff , no environmental issues observed at the time of inspection.

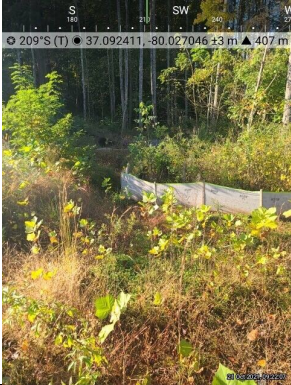
GPS Location	0000	GPS Location	00000		
Field Station#	13415+90	Field Station#	13438+44		
Pic 7 Desc.	Monitored ECDs along the LOD at CAHAS#1 , no environmental issues observed at the time of inspection.		Pic 8 Desc.	Monitored vegetation in permanent area of row, good coverage noted.	
Insert image here		Insert image here			
GPS Location		GPS Location			
Field Station#		Field Station#			
Pic 9 Desc.		Pic 10 Desc.			
Insert image here		Insert image here			
GPS Location		GPS Location			
Field Station#		Field Station#			
Pic 11 Desc.		Pic 12 Desc.

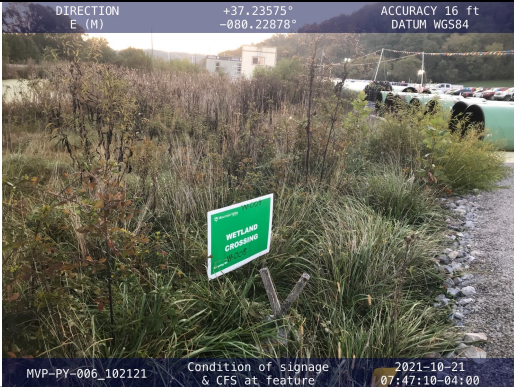
GPS Location	MVP-PY-006 See photo for gps data	GPS Location	MVP-PY-006 See photo for gps data		
Field Station#	+0	Field Station#	+0		
Pic 3 Desc.	Condition of triple stack compost filter sock and signage at feature W-008. Over grown with vegetation. Looking E.	Pic 4 Desc.	Trays and containment under toilets. Trays holding some fluids. Looking SW.

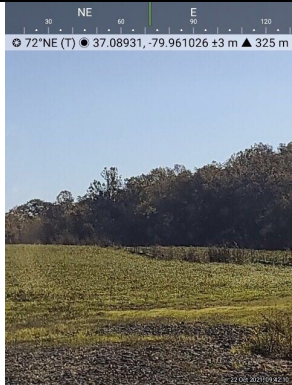
GPS Location	00000	GPS Location	00000		
Field Station#	13644+73	Field Station#	13645+10		
Pic 3 Desc.	Monitored P1 at road crossings . No environmental issues observed at the time of inspection.		Pic 4 Desc.	Monitored RCE and permanent vegetation area. No environmental issues observed at the time of inspection.

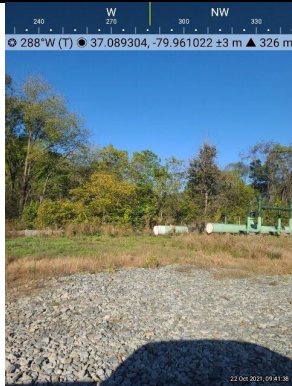
GPS Location	0000	GPS Location	0000		
Field Station#	13560+10	Field Station#	13644+80		
Pic 5 Desc.	Row observation photo showing vegetation growth in permanent area in natural drain location, all ECDs up to date and functioning at the time of inspection.		Pic 6 Desc.	Monitored ECDs around work space area at Leaning Oak rd. No environmental issues observed at the time of inspection.

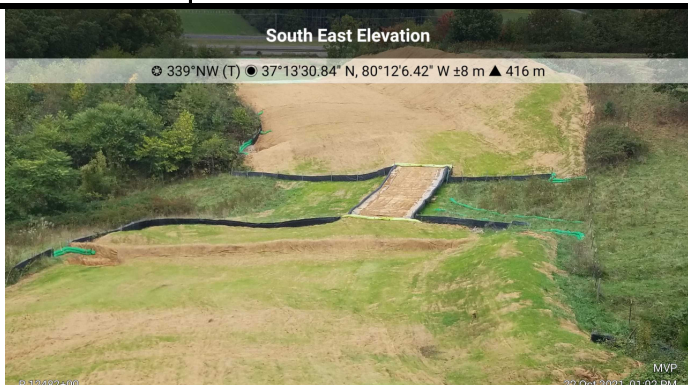
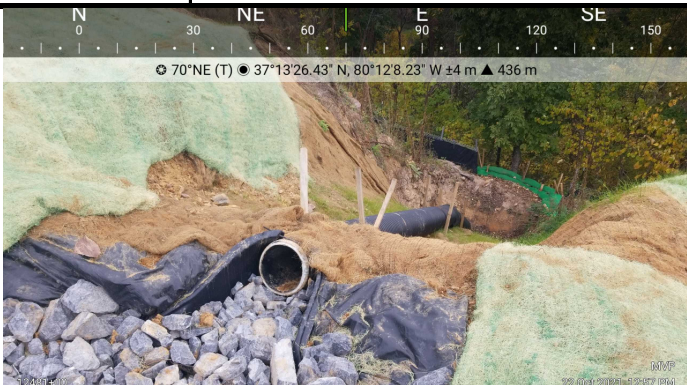
GPS Location	See Above		GPS Location	See Above	
Field Station#	12455+21		Field Station#	12460+76	
Pic 3 Desc.	Overview of Waterbody S-CD12b. ECDs are functional and ROW is stable.		Pic 4 Desc.	Overview of Wetland W-KL58. ECDs are functional and ROW is stable.

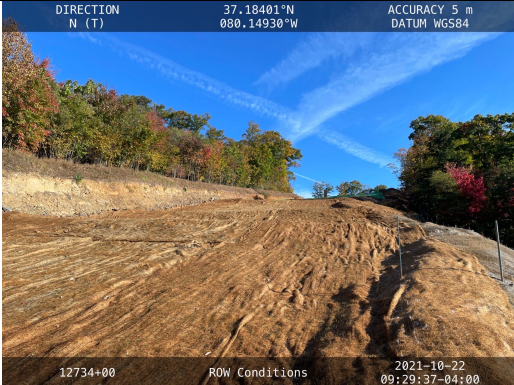
GPS Location	See photo		GPS Location	See photo	
Field Station#	12734+00		Field Station#	12735+00	
Pic 1 Desc.	Current ROW conditions. ROW is stable		Pic 2 Desc.	Current ROW conditions. ROW is stable

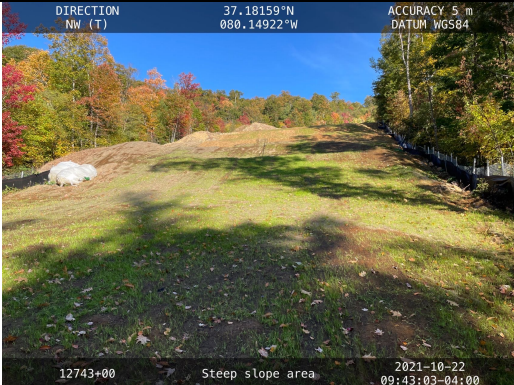
GPS Location	See photo		GPS Location	See photo	
Field Station#	12743+00		Field Station#	12744+00	
Pic 3 Desc.	Current ROW conditions. ROW is stable		Pic 4 Desc.	Steep slope area is well stabilized and ECDs functional

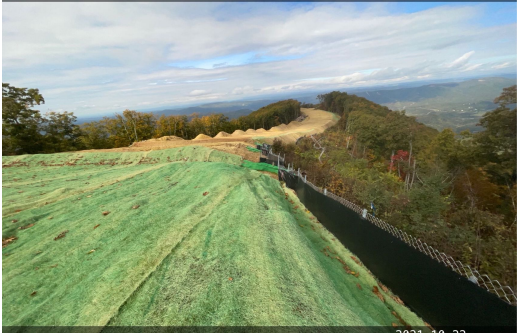
12630+00 ROW conditions 2021-10-22 11:31:50-04:00		DIRECTION SE (T) +37.19514° -080.17819° ACCURACY 12 ft DATUM WGS84

12624+00 Stabilized ROW 2021-10-22 11:42:06-04:00			
GPS Location	See photo		GPS Location	See photo	
Field Station#	12630+00		Field Station#	12624+00	
Pic 13 Desc.	Current ROW conditions. ROW is stable. Perimeter controls are functional.		Pic 14 Desc.	Current ROW conditions. ROW is stable	
DIRECTION SE (T) +37.19063° -080.15315° ACCURACY 18 ft DATUM WGS84

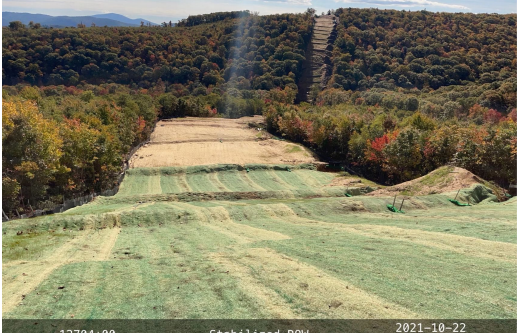
12704+00 Stabilized ROW 2021-10-22 11:06:09-04:00		DIRECTION E (T) 37.17916°N 080.14102°W ACCURACY 8 m DATUM WGS84

12776+75 S-EF33 2021-10-22 18:09:20-04:00			
GPS Location	See photo		GPS Location	See photo	
Field Station#	12704+00		Field Station#	12776+75	
Pic 15 Desc.	Current ROW conditions. ROW is stable		Pic 16 Desc.	Downstream of crossing at Stream S-EF33

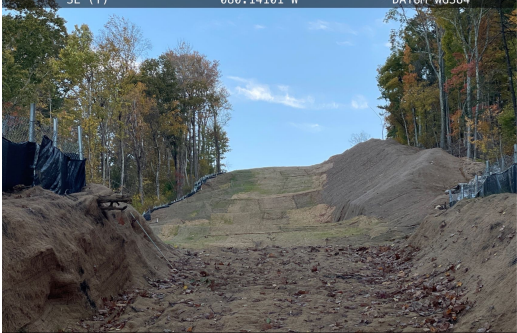
12762+00 ROW Conditions 2021-10-22 18:09:35-04:00		DIRECTION N (T) 37.17954°N 080.14042°W ACCURACY 5 m DATUM WGS84

12776+52 S-EF32 2021-10-22 18:10:30-04:00			
GPS Location	See photo		GPS Location	See photo	
Field Station#	12762+00		Field Station#	12776+52	
Pic 17 Desc.	Steep slope area is well stabilized and ECDs functional.		Pic 18 Desc.	Upstream of crossing at Stream S-EF32

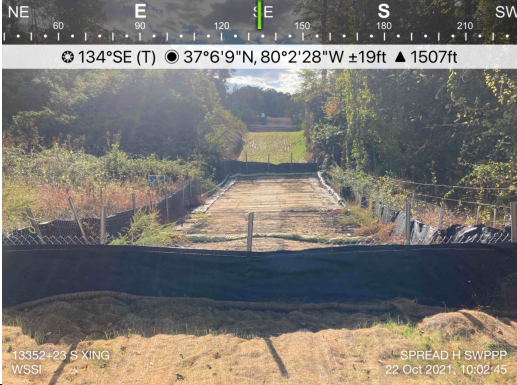
<p>13352+23 S XING WSSI</p> <p>SPREAD H SWPPP 22 Oct 2021, 10:02:45</p>

<p>13328+00, SUMP PIT WSSI</p> <p>SPREAD H SWPPP 22 Oct 2021, 09:25:16</p>			
GPS Location	See photo watermark		GPS Location	See photo watermark	
Field Station#	13352+23		Field Station#	13328+00	
Pic 7 Desc.	Installed SSF on ROW in good condition. No maintenance needed.		Pic 8 Desc.	Sump pits installed along the ROW in good condition. No maintenance needed.

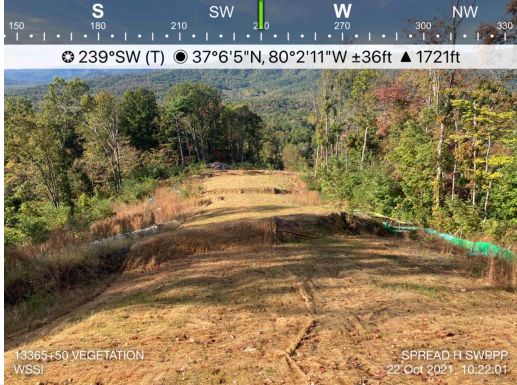
<p>13365+50 VEGETATION WSSI</p> <p>SPREAD H SWPPP 22 Oct 2021, 10:22:07</p>

<p>13317+33 WSSI</p> <p>SPREAD H SWPPP 22 Oct 2021, 09:08:09</p>			
GPS Location	See photo watermark		GPS Location	See photo watermark	
Field Station#	13365+50		Field Station#	13317+33	
Pic 9 Desc.	Installed waterbars and temporary vegetation along the ROW in good condition. No maintenance needed.		Pic 10 Desc.	Trench drains installed along the ROW in good condition. No maintenance needed.

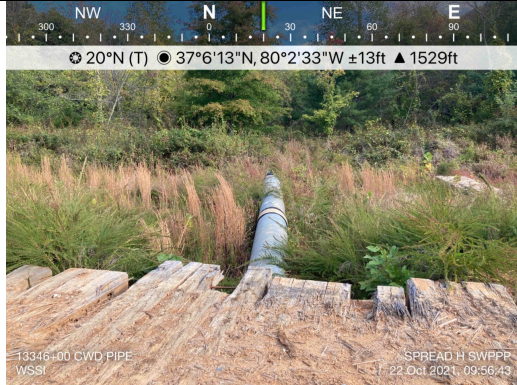
<p>13346+00 CWD PIPE WSSI</p> <p>SPREAD H SWPPP 22 Oct 2021, 09:56:43</p>

<p>13362+50 ROCK LEVEL SPREADER WSSI</p> <p>SPREAD H SWPPP 22 Oct 2021, 10:16:27</p>			
GPS Location	See photo watermark		GPS Location	See photo watermark	
Field Station#	13346+00		Field Station#	13362+50	
Pic 11 Desc.	CWD pipe in good condition, no maintenance needed.		Pic 12 Desc.	Rock level spreaders installed along the ROW in good condition. No maintenance needed.
