Visual Site Inspection Report

Project Name	H-600 Pipeline Spread H	AFE	124300138	Spread	H-600 Pipeline Spread H
Contractor	Precision			Report #	30262
Inspector	Jason Nielsen			Date/Time	10/25/2021 11:49 PM
Permit #	TBD	Inspection Type	VA SWPP	Station Begin	12119+17
State	VA	Inspection Area	Partial	Station End	12284+75
County	Montgomery	Ground	Dry	Temperature (°F)	68.00
Municipality	N/A	Weather	Sunny	Rain Gauge (in)	0.00
				Rain Accumulation Time (days)	0.00

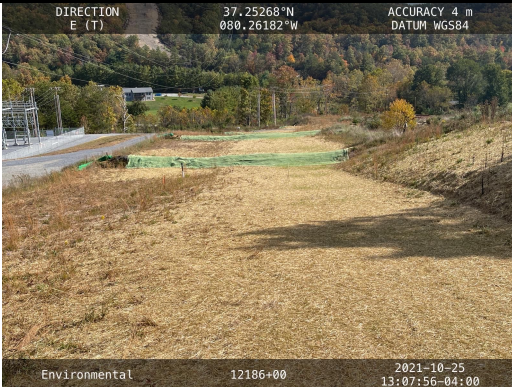
GPS Location	See photo		GPS Location	See photo	
Field Station#	12186+00		Field Station#	12173+00	
Pic 1 Desc.	Stabilized ROW In Acceptable condition		Pic 2 Desc.	Stabilized ROW In Acceptable condition

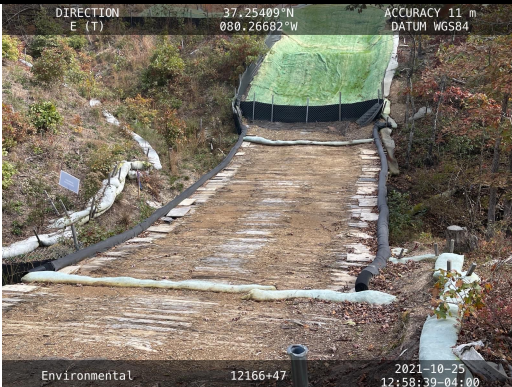
GPS Location	See photo		GPS Location	See photo	
Field Station#	12166+47		Field Station#	12163+05	
Pic 3 Desc.	Bridge and ECDs crossing S-C24 in acceptable condition		Pic 4 Desc.	Bridge and ECDs crossing stream s-C25 In Acceptable condition

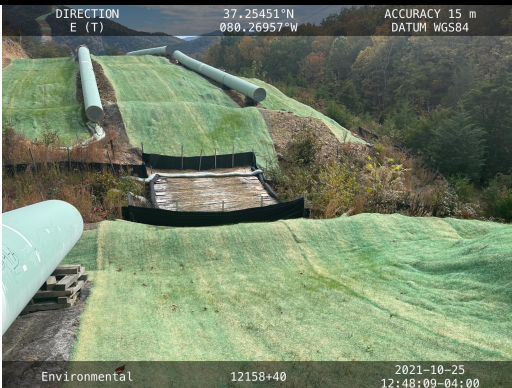
GPS Location	see photo		GPS Location	See photo	
Field Station#	12158+40		Field Station#	12154+00	
Pic 5 Desc.	Clean water crossing in acceptable condition		Pic 6 Desc.	Stabilized ROW In Acceptable condition

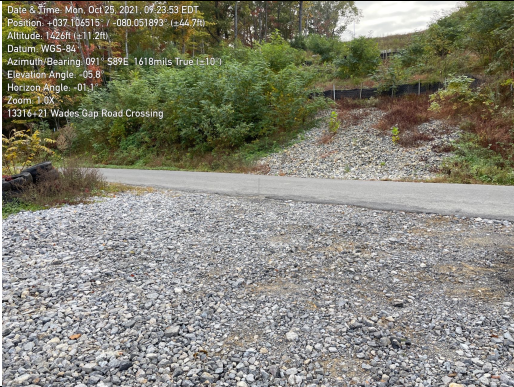
GPS Location	0	GPS Location	0		
Field Station#	13316+21	Field Station#	13314+00		
Pic 1 Desc.	Wades Gap Road Crossing in good condition and RCE in good condition and functioning properly		Pic 2 Desc.	ROW and ECDs in good condition with good vegetation established across ROW	
<p>Date & Time: Mon, Oct 25, 2021, 09:43:01 EDT Position: +037.115654 / -080.052988 (+15.2ft) Altitude: 1435ft (+11.0ft) Datum: WGS-84 Azimuth/Bearing: 253° S73W 4498mils True (+14°) Elevation Angle: -06.3° Horizon Angle: -00.5° Zoom: 1.0X 13260+64 S-114</p>

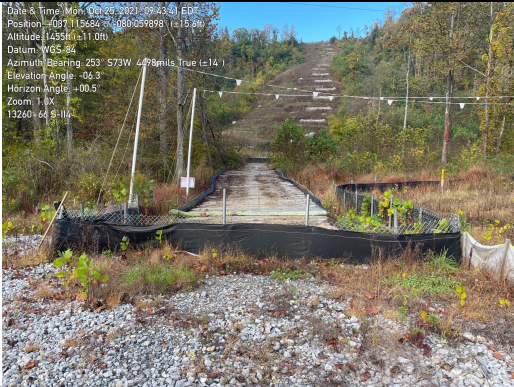
GPS Location	0	GPS Location	0		
Field Station#	13260+66	Field Station#	13259+00		
Pic 3 Desc.	MVP-S-II4 and Corresponding buffer zone in good condition		Pic 4 Desc.	ROW and ECDs in good condition with good vegetation established across ROW	
<p>Date & Time: Mon, Oct 25, 2021, 10:27:15 EDT Position: +037.114165 / -080.085597 (+15.1ft) Altitude: 1410ft (+11.7ft) Datum: WGS-84 Azimuth/Bearing: 056° N56E 0936mils True (+13°) Elevation Angle: -10.0° Horizon Angle: -01.7° Zoom: 1.0X 13145+55 S-D12/13</p>

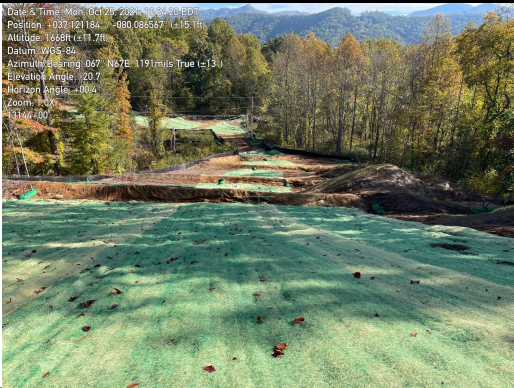
GPS Location	0	GPS Location	0		
Field Station#	13144+00	Field Station#	13146+56		
Pic 5 Desc.	ROW and ECDs in good condition and stable		Pic 6 Desc.	MVP-S-D12/13 and Corresponding buffer zone in good condition

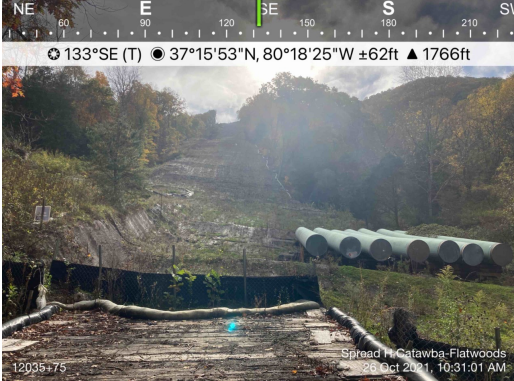
GPS Location	See photo above		GPS Location	See photo above	
Field Station#	12035+75		Field Station#	12035+00	
Pic 1 Desc.	Timber mat stream crossing and material storage is well maintained.		Pic 2 Desc.	Material storage is in good condition, no maintenance needed.

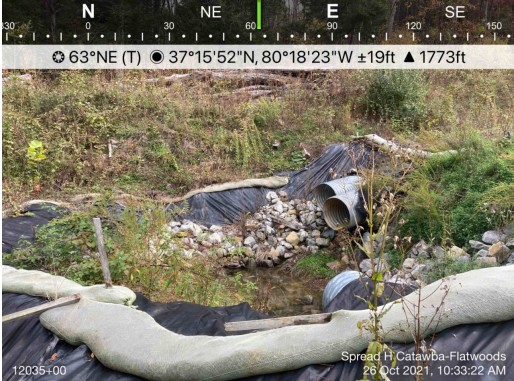
GPS Location	See photo above		GPS Location	See photo above	
Field Station#	12035+00		Field Station#	12035+00	
Pic 3 Desc.	Clean water diversion pipes are present and no maintenance is needed.		Pic 4 Desc.	Clean water diversion berm is functioning properly.

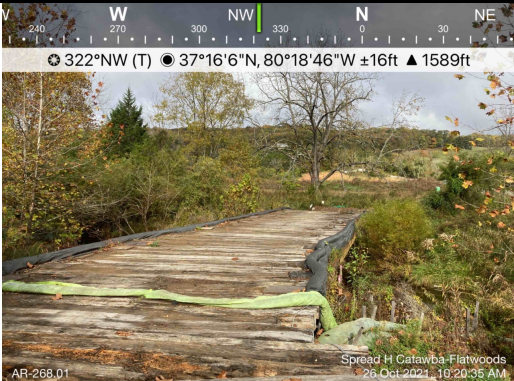
GPS Location	See photo above		GPS Location	See photo above	
Field Station#	12008+00		Field Station#	12100+90	
Pic 5 Desc.	Timber mat stream crossing is in good condition and needs no maintenance.		Pic 6 Desc.	Sump pits are present and functional.

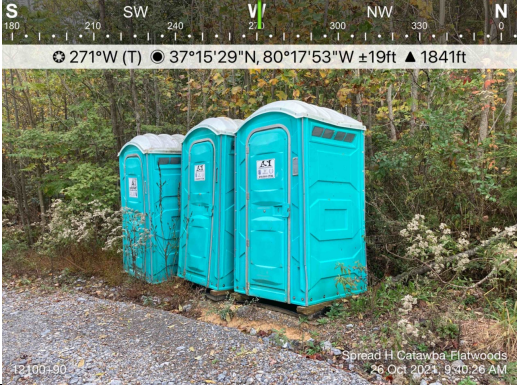
GPS Location	See photo above		GPS Location	See photo above	
Field Station#	12100+90		Field Station#	12100+90	
Pic 7 Desc.	Portable toilets are within secondary containment and no maintenance needed.		Pic 8 Desc.	Waterbars and end treatment in acceptable condition.

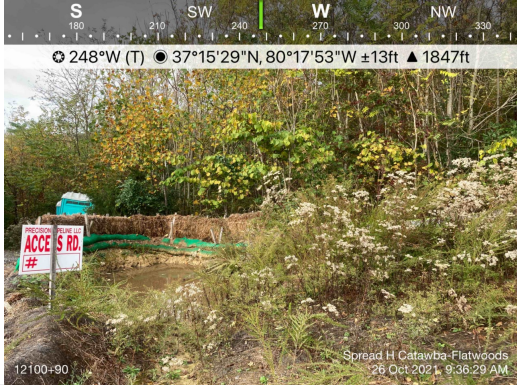
GPS Location	See photo above		GPS Location	See photo above	
Field Station#	12100+90		Field Station#	12100+90	
Pic 9 Desc.	Controls on access road are in place and functioning properly.		Pic 10 Desc.	Temporary vegetative controls are present and germinating.

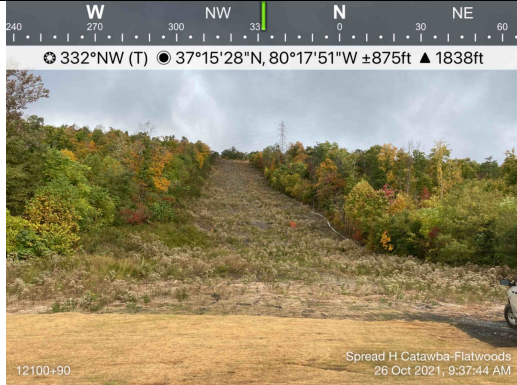
GPS Location	See photo above		GPS Location	See photo above	
Field Station#	12100+90		Field Station#	12100+90	
Pic 11 Desc.	Waterbars are stabilized and in good condition on the going away side of Catawba.		Pic 12 Desc.	ESC blanketing is torn however ground is compacted/stabilized, monitor this area for any signs of erosion.

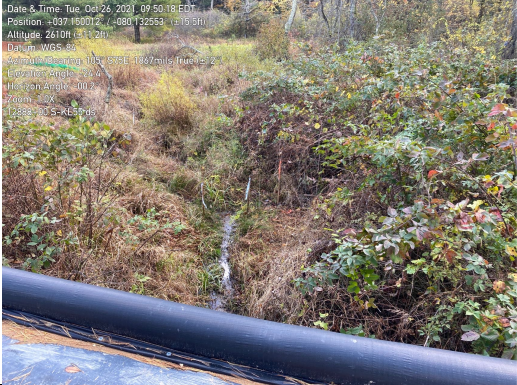
GPS Location	See photo for coordinates.		GPS Location	See photo for coordinates.	
Field Station#	12888+00		Field Station#	12888+00	
Pic 7 Desc.	S-KL55, looking downstream, water flowing clear, banks well vegetated, no ROW impacts observed.		Pic 8 Desc.	ROW stabilized on the GAS of resource S-KL55 crossing, perimeter controls in acceptable condition.

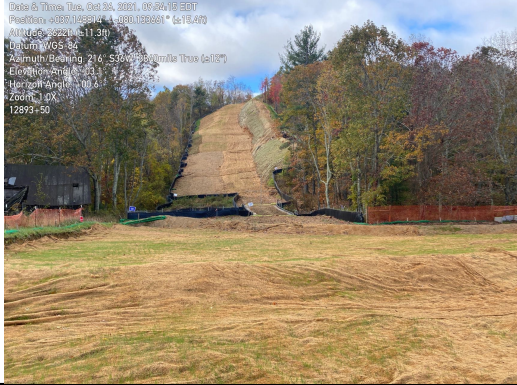
<p><small>Date & Time: Tue, Oct 26, 2021, 09:55:43 EDT Position: +037.146122, -080.133533, +219.511 Altitude: 2623ft (+12.10ft) Datum: WGS-84 Azimuth/Bearing: 214° S30W 378ftmils True (+12°) Elevation Angle: -2.1° Horizon Angle: +02.9° Zoom: 1.0X 12893+50</small></p>

GPS Location	See photo for coordinates.		GPS Location	See photo for coordinates.	
Field Station#	12893+50		Field Station#	12895+50	
Pic 9 Desc.	ROW stabilized: erosion control blanket in acceptable condition.		Pic 10 Desc.	S-IJ12 and W-MN7, looking downstream of equipment bridge, no ROW impacts observed, stream banks well vegetated.	
<p><small>Date & Time: Tue, Oct 26, 2021, 10:00:00 EDT Position: +037.146122, -080.133533, +219.511 Altitude: 2623ft (+12.10ft) Datum: WGS-84 Azimuth/Bearing: 223° N40W 378ftmils True (+12°) Elevation Angle: -07.3° Horizon Angle: +03.3° Zoom: 1.0X 12908+00</small></p>

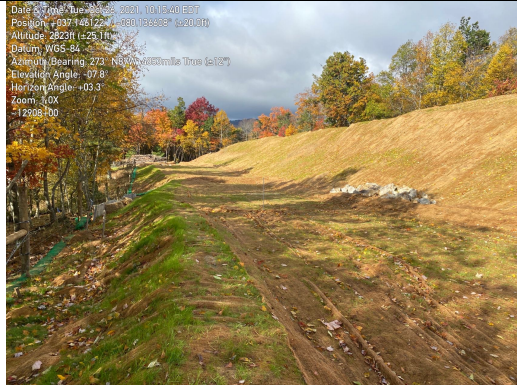
GPS Location	See photo for coordinates.		GPS Location	See photo for coordinates.	
Field Station#	12908+00		Field Station#	12912+00	
Pic 11 Desc.	ROW stabilized, erosion control blanket in acceptable condition across LOD and soil piles.		Pic 12 Desc.	ROW stabilized, waterbars functioning acceptably.

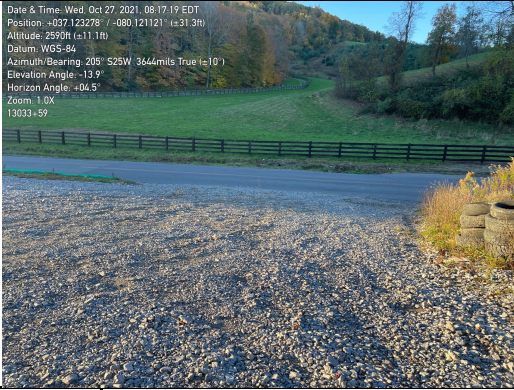
GPS Location	0	GPS Location	0		
Field Station#	13033+59	Field Station#	13033+00		
Pic 1 Desc.	RCE in good condition and functioning properly	Pic 2 Desc.	ROW and ECDs in good condition with good vegetation established across ROW		
<p>Date & Time: Wed, Oct 27, 2021, 08:36:24 EDT Position: -037.125787° / -080.119623° (±11.6ft) Altitude: 2720ft (±9.8ft) Datum: WGS-84 Azimuth/Bearing: 235° S55W 4178mils True (±13°) Elevation Angle: -05.9° Horizon Angle: -00.9° Zoom: 1.0x 13030+00</p>

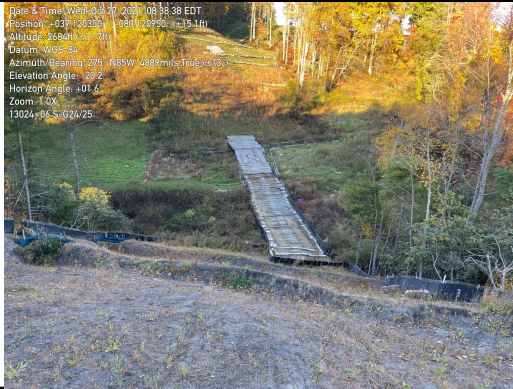
GPS Location	0	GPS Location	0		
Field Station#	13030+00	Field Station#	13024+06		
Pic 3 Desc.	ROW and ECDs in good condition with good vegetation established across ROW	Pic 4 Desc.	MVP-S-G24/25 and Corresponding buffer zone in good condition		
<p>Date & Time: Wed, Oct 27, 2021, 08:41:58 EDT Position: -037.125116° / -080.118568° (±11.6ft) Altitude: 2714ft (±9.8ft) Datum: WGS-84 Azimuth/Bearing: 045° N45E 0800mils True (±13°) Elevation Angle: +05.6° Horizon Angle: -00.3° Zoom: 1.0x 13036+00</p>

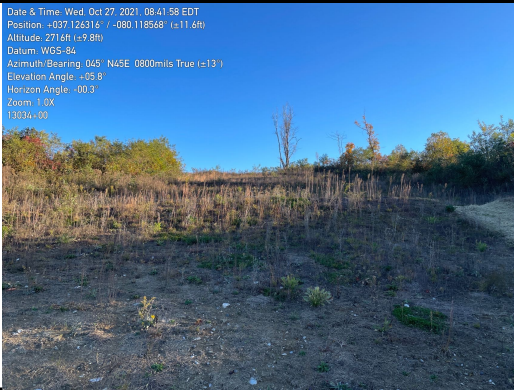
GPS Location	0	GPS Location	0		
Field Station#	13034+00	Field Station#	13061+44		
Pic 5 Desc.	ROW and ECDs in good condition with good vegetation established across ROW	Pic 6 Desc.	Equipment bridge in good condition

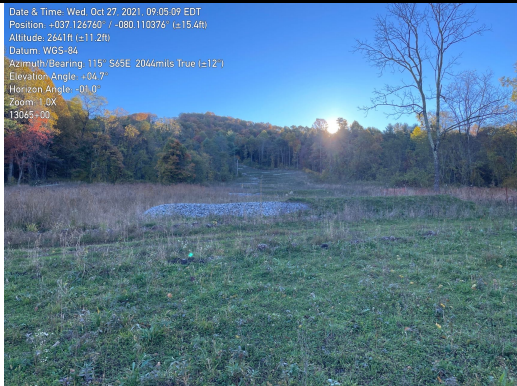
GPS Location 0		GPS Location 0			
Field Station# 13065+00		Field Station# 13115+00			
Pic 9 Desc. ROW and ECDs in good condition with good vegetation established across ROW		Pic 10 Desc. ROW and ECDs in good condition and stable			
<p>Date & Time: Wed, Oct 27, 2021, 09:43:21 EDT Position: +037.122274° / -080.096823° (+11.6ft) Altitude: 2726ft (+9.8ft) Datum: WGS-84 Azimuth/Bearing: 022° N33W 5910mils True (+12°) Elevation Angle: -08.6° Horizon Angle: -00.4° Zoom: 1.0X 13113+00</p>

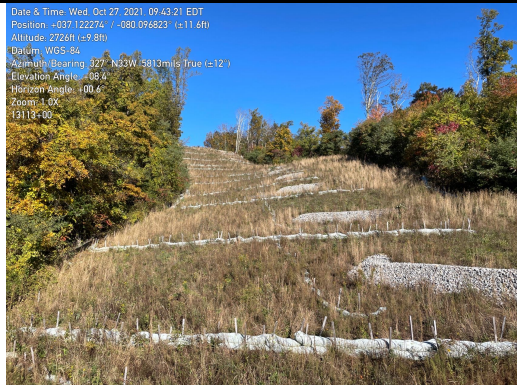
GPS Location 0		GPS Location 0			
Field Station# 13113+00		Field Station# 13118+00			
Pic 11 Desc. ROW and ECDs in good condition with good vegetation established across ROW		Pic 12 Desc. ROW and ECDs in good condition and stable

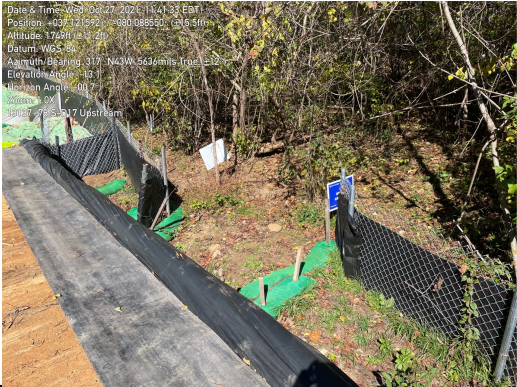
GPS Location	0	GPS Location	0		
Field Station#	13147+78	Field Station#	13137+78		
Pic 15 Desc.	MVP-S-D17 Upstream and Corresponding buffer zone in good condition	Pic 16 Desc.	MVP-S-D17 Downstream and Corresponding buffer zone in good condition

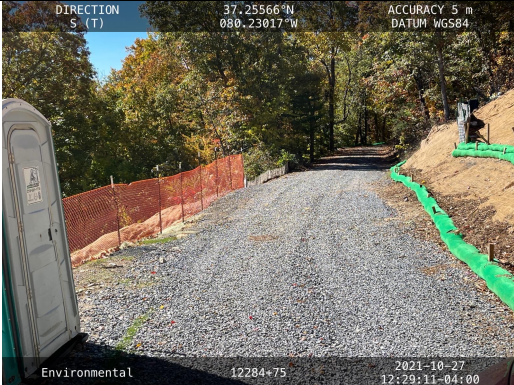
GPS Location	See photo		GPS Location	See photo	
Field Station#	12284+75		Field Station#	12299+00	
Pic 1 Desc.	Access Road crossing MVP-MN-276.03 in acceptable condition		Pic 2 Desc.	Stabilized ROW in acceptable condition

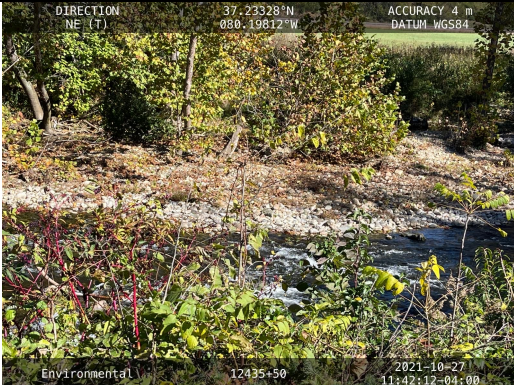
GPS Location	See photo		GPS Location	See photo	
Field Station#	12435+50		Field Station#	12437+70	
Pic 3 Desc.	Stream crossing S-NN16 in acceptable condition		Pic 4 Desc.	Stabilized ROW in acceptable condition

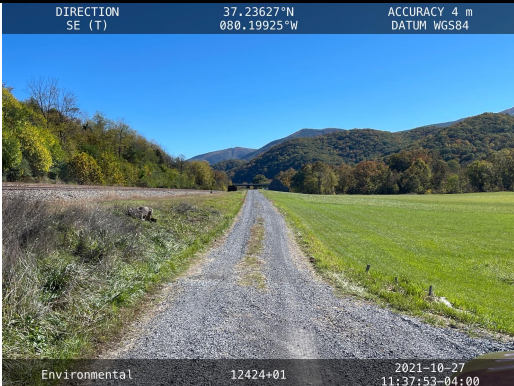
GPS Location	See photo		GPS Location	See photo	
Field Station#	12424+01		Field Station#	12421+00	
Pic 5 Desc.	Access Road MVP-MN-279 in acceptable condition		Pic 6 Desc.	Clean water crossing pipe inlet in acceptable condition

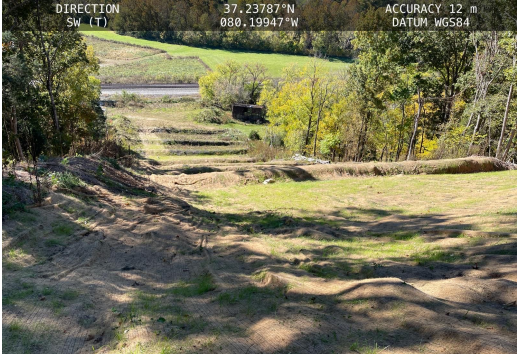
<div>Environmental12410+202021-10-27 11:20:33-04:00</div> </div>	
GPS Location	See photo		GPS Location	See photo	
Field Station#	12418+00		Field Station#	12410+20	
Pic 7 Desc.	Stabilized ROW in acceptable condition		Pic 8 Desc.	Clean water crossing pipe outlet in acceptable condition	
<div> <div>DIRECTION NE (T)</div> <div>37.24014°N 080.19927°W</div> <div>ACCURACY 5 m DATUM WGS84</div>

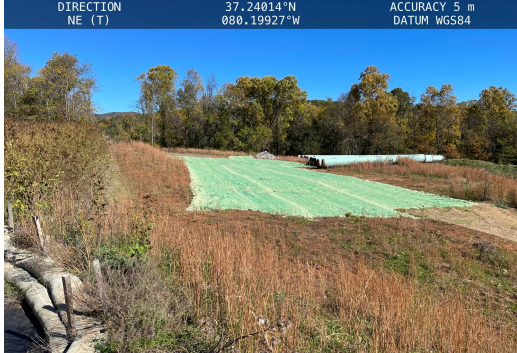
GPS Location	See photo		GPS Location	See photo	
Field Station#	12409+00		Field Station#	12408+80	
Pic 9 Desc.	Stabilized ROW in acceptable condition		Pic 10 Desc.	Clean water crossing pipe inlet in acceptable condition	
<div> <div>DIRECTION SE (T)</div> <div>37.24080°N 080.20111°W</div> <div>ACCURACY 4 m DATUM WGS84</div>

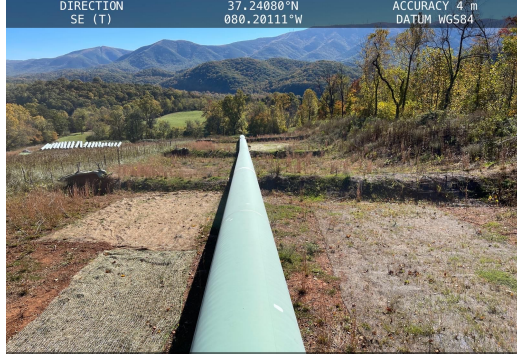
<div>Environmental12399+002021-10-27 11:10:56-04:00</div> </div>	
GPS Location	See photo		GPS Location	See photo	
Field Station#	12405+00		Field Station#	12399+00	
Pic 11 Desc.	Stabilized ROW in acceptable condition		Pic 12 Desc.	Stabilized ROW in acceptable condition

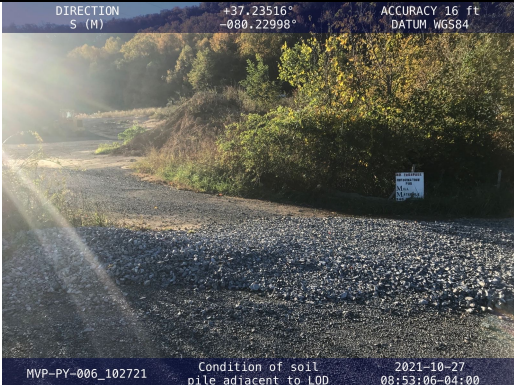
GPS Location	MVP-PY-006 See photo for data		GPS Location	MVP-PY-006 See photo for data	
Field Station#	+0		Field Station#	+0	
Pic 3 Desc.	Check condition of soil pile adjacent to LOD. Soil pile not stabilized. Looking S.		Pic 4 Desc.	Secondary containments under stored equipment holding some fluids. Looking S.

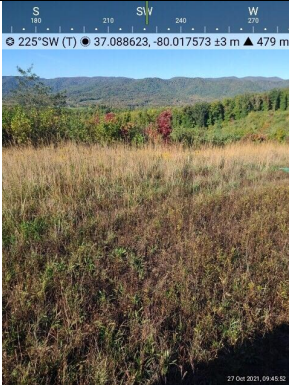
GPS Location	0000	GPS Location	0000		
Field Station#	13444+93	Field Station#	13465+00		
Pic 1 Desc.	Vegetation in stream location , good coverage noted . No environmental issues observed at the time of inspection.		Pic 2 Desc.	Row photo showing good permanent vegetation growth.

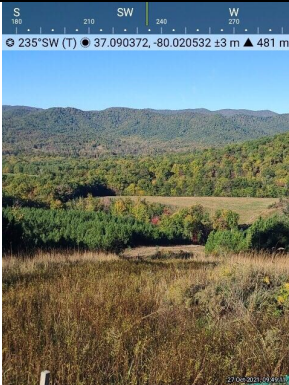
GPS Location	0000	GPS Location	0000		
Field Station#	13436+33	Field Station#	13463+00		
Pic 3 Desc.	Permanent vegetation area showing good coverage , ECDs in area at the time of inspection with no environmental issues observed.		Pic 4 Desc.	Stabilization in permanent area observed with no environmental issues observed at the time of inspection.

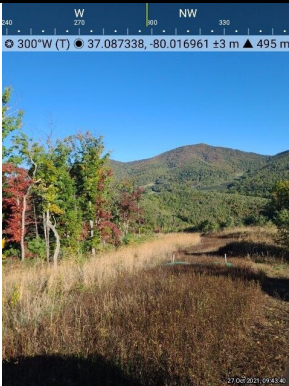
GPS Location	0000	GPS Location	0000		
Field Station#	13460+00	Field Station#	13461+40		
Pic 5 Desc.	Row photo showing good coverage. No environmental issues observed at the time of inspection.		Pic 6 Desc.	Side slop stabilization showing good vegetation.

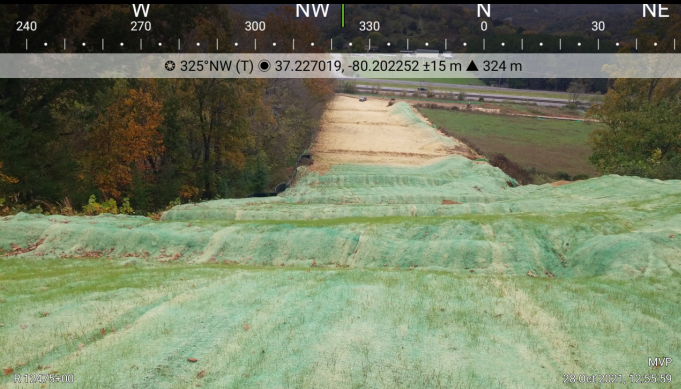
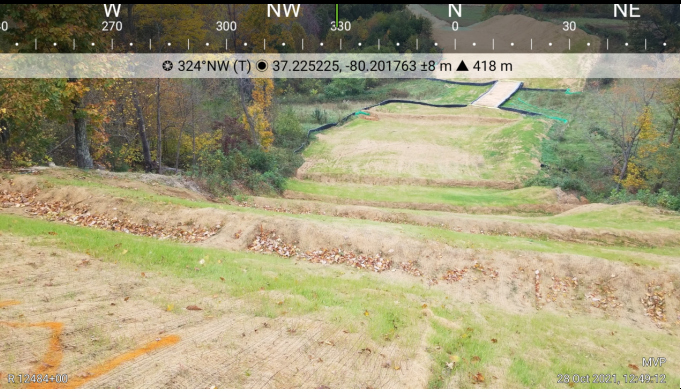
GPS Location		See Above		GPS Location		See Above	
Field Station#		12475+00		Field Station#		12484+00	
Pic 7 Desc.		(reroute stationing) ROW Overview (temporary stabilization). ECDs are functional and ROW is stable.		Pic 8 Desc.		(reroute stationing) ROW Overview (temporary stabilization). ECDs are functional and ROW is stable.

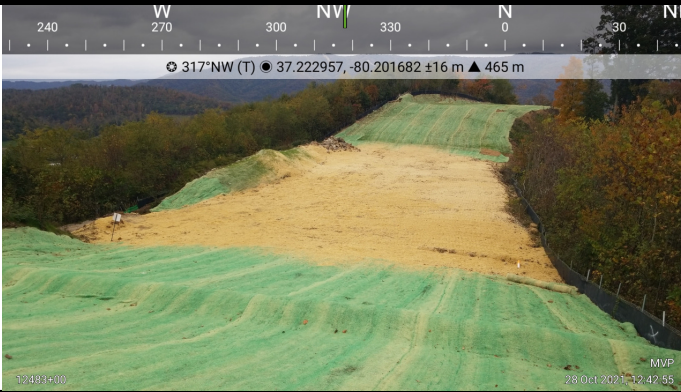
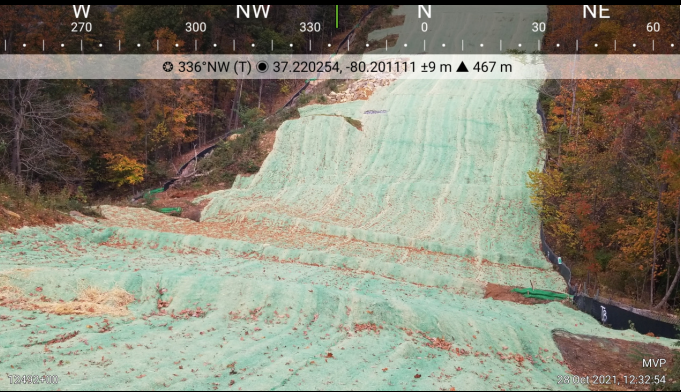
GPS Location		See Above		GPS Location		See Above	
Field Station#		12483+00		Field Station#		12492+00	
Pic 9 Desc.		ROW Overview. ECDs are functional and ROW is stable.		Pic 10 Desc.		ROW Overview. ECDs are functional and ROW is stable.

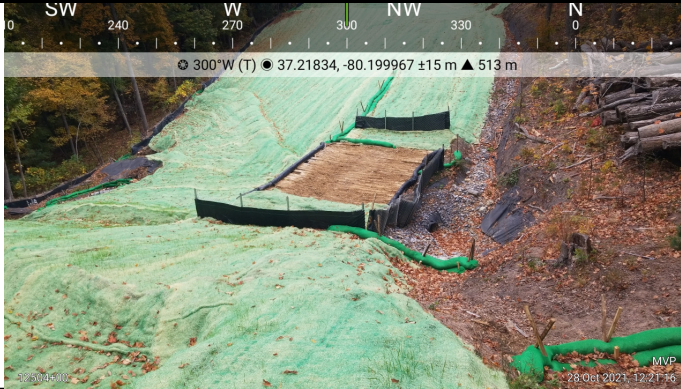
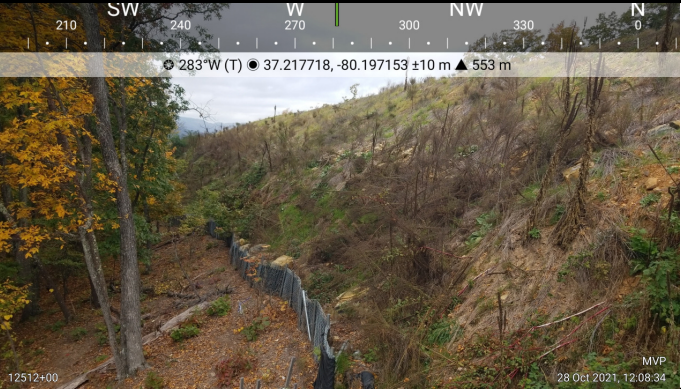
GPS Location		See Above		GPS Location		See Above	
Field Station#		12504+00		Field Station#		12512+00	
Pic 11 Desc.		ROW Overview. ECDs are functional and ROW is stable.		Pic 12 Desc.		ROW Overview. ECDs are functional and ROW is stable.

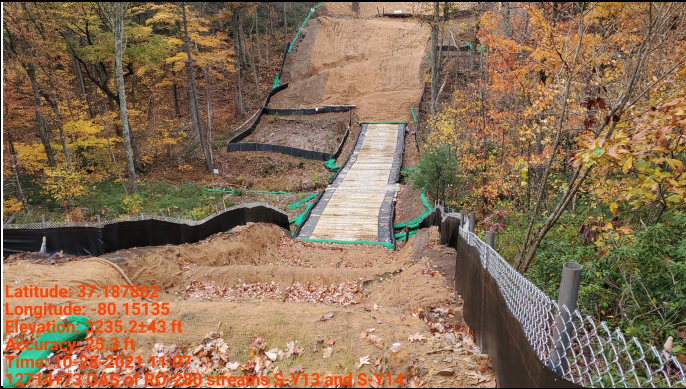
Latitude: 37.187892 Longitude: -80.15135 Elevation: 2235.2±43 ft Accuracy: 28.3 ft Time: 10-28-2021 11:02 12714+73 GAS of RO-280 stream S-Y13 and S-Y14			Latitude: 37.187849 Longitude: -80.151175 Elevation: 2110.86±28 ft Accuracy: 19.7 ft Time: 10-28-2021 11:11 12715+79 GAS of RO-280 stream S-Y13		
GPS Location	See pic for GPS location.		GPS Location	See pic for GPS location.	
Field Station#	12714+73		Field Station#	12715+79	
Pic 7 Desc.	Stream crossings S-Y13 and S-Y14 from the CIS.		Pic 8 Desc.	Downstream side of stream S-Y13.

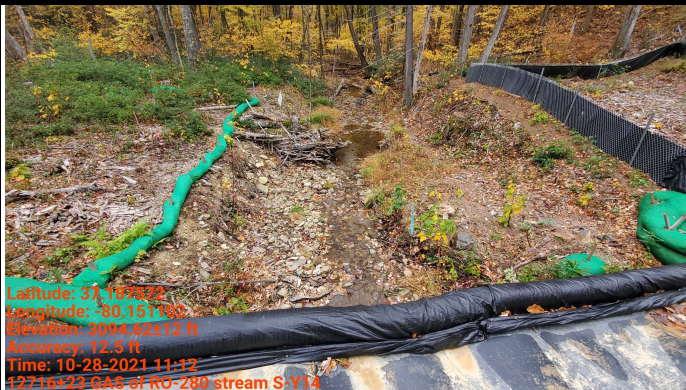
GPS Location	See pic for GPS location.		GPS Location	See pic for GPS location.	
Field Station#	12716+23		Field Station#	12721+50	
Pic 9 Desc.	Downstream side of stream S-Y14.		Pic 10 Desc.	Current conditions of the ROW on the CIS of RO-281.

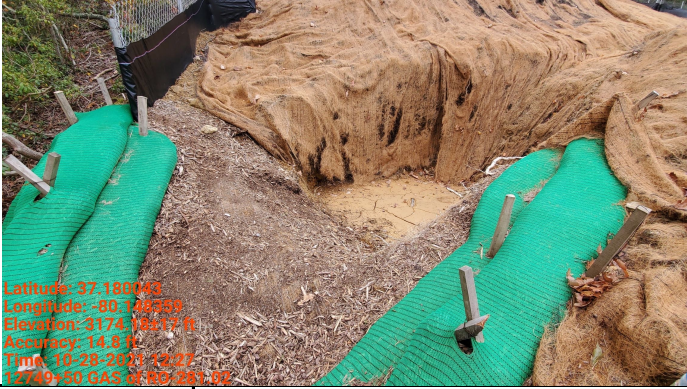
<p>Latitude: 37.180043 Longitude: -80.148553 Elevation: 3174.18±17 ft Accuracy: 14.8 ft Time: 10-28-2021 12:27 12749+50 GAS of RO-281.02</p>			
GPS Location	See pic for GPS location.		GPS Location	See pic for GPS location.	
Field Station#	12744+00		Field Station#	12749+50	
Pic 13 Desc.	Upstream side of stream S-EF34b.		Pic 14 Desc.	Sump at or above 50% capacity added to the Punch List to be cleaned out by the contractor.

E&S BMPs	Compliance Level	Corrective Action	Corrective Time Frame	Date Repaired
Waterbar	Acceptable			
Waterbar End Treatment	Acceptable			
Sump Pit	Communication	Clean out sumps above 50% cap.	Addressed	10/28/2021
Compost Filter Sock	Acceptable			
Silt Fence (Filter Fabric Fence)	Acceptable			
Silt Fence (Reinforced Filter Fabric Fence)	Acceptable			
Erosion Control Blanket	Acceptable			
Equipment Bridge	Acceptable			
Rock Construction Entrance	Acceptable

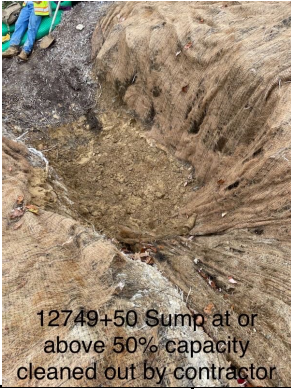
<p>12749+50 Sump at or above 50% capacity cleaned out by contractor</p>

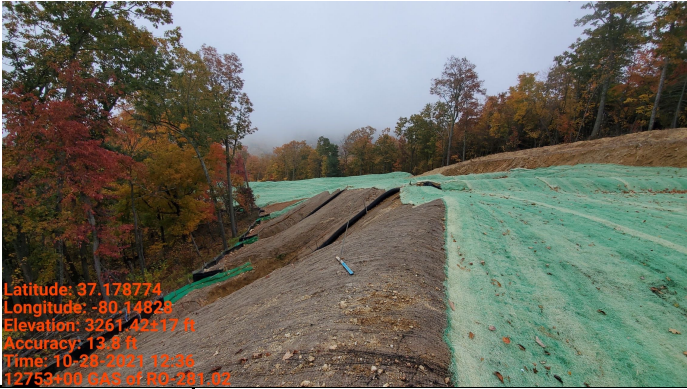
Field Station#	12749+50		Field Station#	12753+00	
Pic 15 Desc.	Sump cleaned out by the contractor.		Pic 16 Desc.	Current conditions of the ROW on the CIS of RO-282.

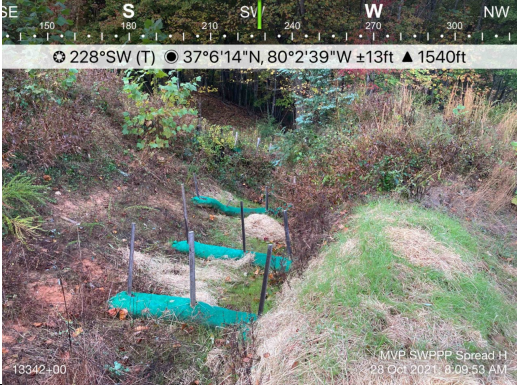
GPS Location	See image above		GPS Location	See image above	
Field Station#	13342+00		Field Station#	13341+50	
Pic 7 Desc.	Sump pits are functioning as intended. No maintenance needed.		Pic 8 Desc.	Vegetation is maintained along inactive sections of the ROW.

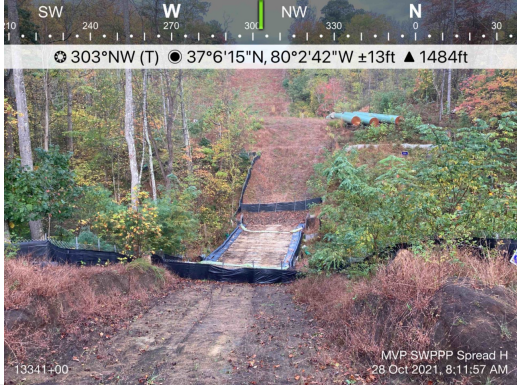
GPS Location	See image above		GPS Location	See image above	
Field Station#	13341+00		Field Station#	13337+00	
Pic 9 Desc.	Timber mat crossing and surrounding SF is in good condition.		Pic 10 Desc.	SSF remains functional and no maintenance is needed.

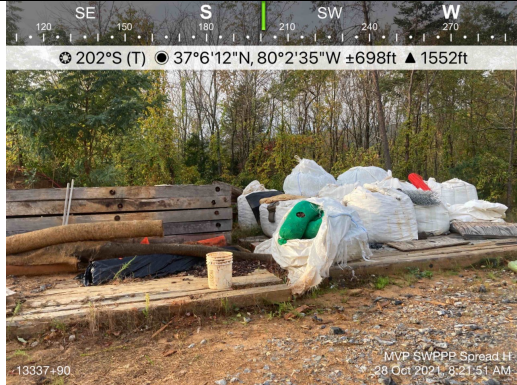
GPS Location	See image above		GPS Location	See image above	
Field Station#	13337+90		Field Station#	13339+00	
Pic 11 Desc.	On site materials are present along the ROW and in acceptable condition.		Pic 12 Desc.	CLD pipe is functioning properly and no maintenance is needed.

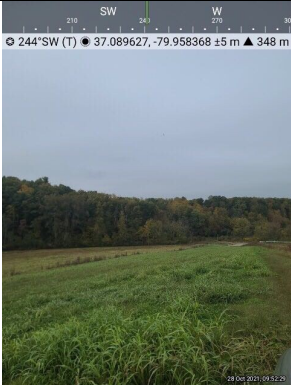
GPS Location	0000	GPS Location	0000		
Field Station#	13650+00	Field Station#	13540+90		
Pic 1 Desc.	Row photo showing good permanent grass growth.		Pic 2 Desc.	Row photo showing RCE, vegetation and equipment bridge, no environmental issues observed at the time of inspection.

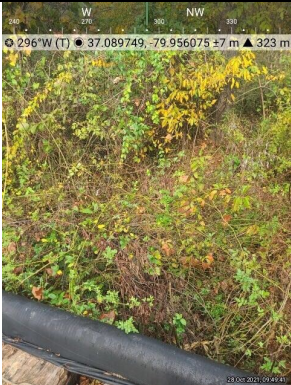
GPS Location	0000	GPS Location	0000		
Field Station#	13659+04	Field Station#	13659+03		
Pic 3 Desc.	Stream observation photo facing upstream during routine inspection, S-GH3		Pic 4 Desc.	Stream observation photo facing upstream, S-S-GH4. No environmental issues observed at the time of inspection.

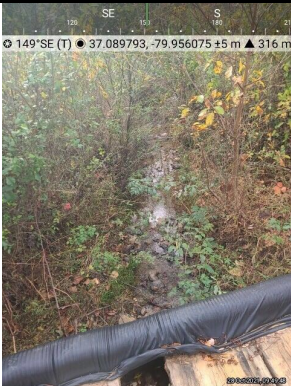
GPS Location	0000	GPS Location	0000		
Field Station#	13659+04	Field Station#	13652+50		
Pic 5 Desc.	S-GH4 stream observation photo facing downstream during routine inspection today, no environmental issues observed at the time of inspection.		Pic 6 Desc.	3rd party damage to CFS, requires maintenance, documented and added to the punch list for repair. Recommended adding orange CFS to allow passage.

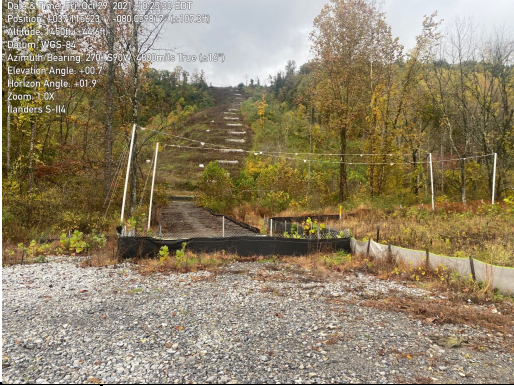
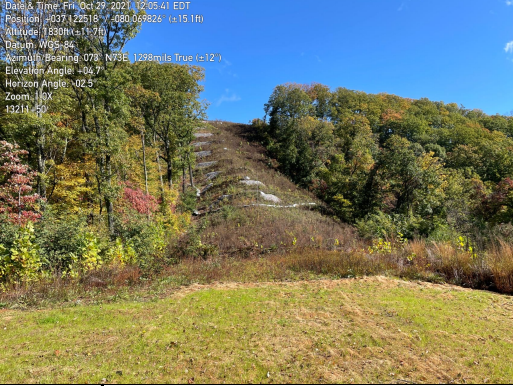
<p>Date & Time: Fri, Oct 29, 2021 12:05:41 EDT Position: +037.122927, -080.071368 (+15.5 ft) Altitude: 1593 ft (+11.2 ft) Datum: WGS-84 Azimuth/Bearing: 278 N30E 428mils True (+12.1) Elevation Angle: +00.7 Horizon Angle: +01.9 Zoom: 1.0X 13260+66</p>			
GPS Location		0		GPS Location	
Field Station#		13260+66		Field Station#	
Pic 1 Desc.		MVP-S-II4 and Corresponding buffer zone in good condition		Pic 2 Desc.

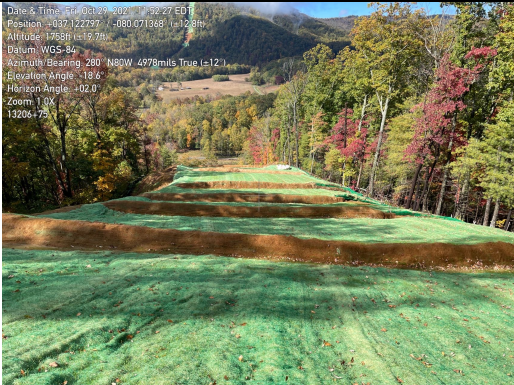
GPS Location		0		GPS Location	
Field Station#		13206+75		Field Station#	
Pic 3 Desc.		ROW and ECDs in good condition and stable		Pic 4 Desc.

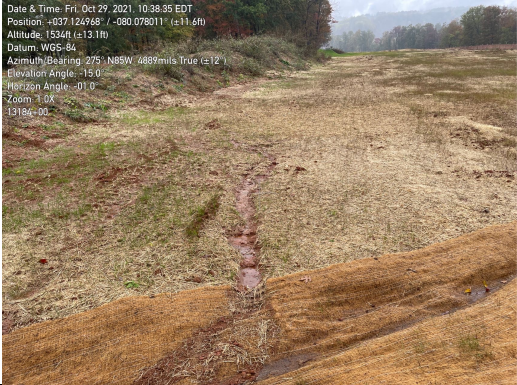
GPS Location 0		GPS Location 0			
Field Station# 13184+00		Field Station# 13184+00			
Pic 13 Desc. Minor rilling needs repaired - 72hr maintenance item		Pic 14 Desc. ROW and ECDs in good condition			
<p>Date & Time: Fri, Oct 29, 2021, 10:37:48 EDT Position: +037.124552° / -080.083989° (±11.8ft) Altitude: 1693ft (±13.1ft) Datum: WGS-84 Azimuth/Bearing: 265° N33W 491mils True (±12°) Elevation Angle: -03.4° Horizon Angle: -01.7° Zoom: 1.0X 13169+00</p>

E&S BMPs	Compliance Level	Corrective Action	Corrective Time Frame	Date Repaired
Vegetative Stabilization (Temporary)	Communication	Minor rilling needs repaired - 72hr ite		10/30/2021
Compost Filter Sock	Communication	Sock checks need cleaned - 72hr ite		10/30/2021
Equipment Bridge	Acceptable			
Erosion Control Blanket	Acceptable			
Rock Construction Entrance	Acceptable			
Silt Fence (Reinforce Filter Fence)	Acceptable			
Silt Fence (Reinforced Filter Fabric Fence)	Communication	Repair SSF fabric- 72hr item		10/30/2021
Slope Drain Pipe	Communication	Clean out inlets - 72hr item		10/30/2021
Waterbar	Acceptable

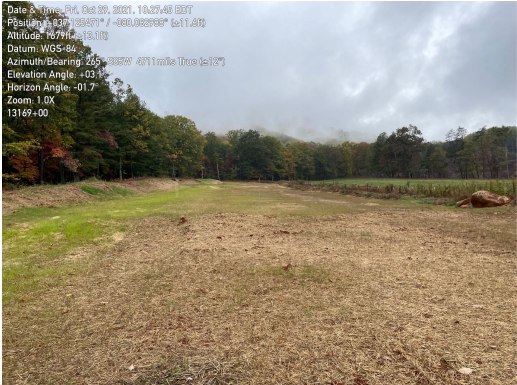
GPS Location 0		GPS Location 0			
Field Station# 13169+00		Field Station# 13167+00			
Pic 15 Desc. ROW and ECDs in good condition and stable		Pic 16 Desc. Minor rilling needs repaired - 72hr maintenance item			
<p>Date & Time: Fri, Oct 29, 2021, 10:16:14 EDT Position: +037.124353° / -080.086299° (±11.8ft) Altitude: 1693ft (±13.1ft) Datum: WGS-84 Azimuth/Bearing: 044° N44E 109mils True (±12°) Elevation Angle: -26.6° Horizon Angle: -02.9° Zoom: 1.0X 13158+00</p>

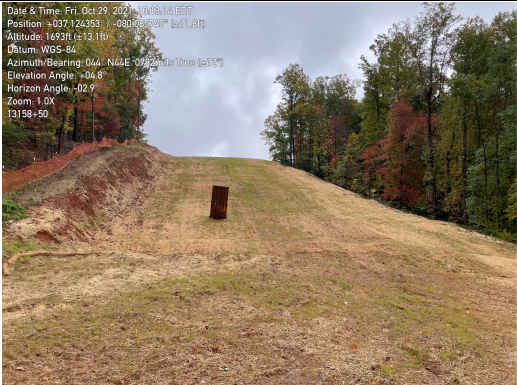
GPS Location 0		GPS Location 0			
Field Station# 13158+50		Field Station# 13157+22			
Pic 17 Desc. ROW and ECDs in good condition and stable		Pic 18 Desc. MVP-S-D11 and Corresponding buffer zone in good condition

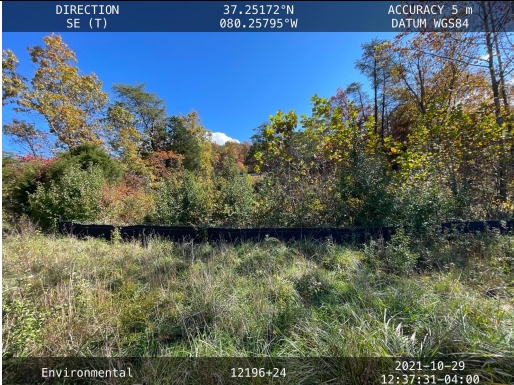
GPS Location	See photo		GPS Location	See photo	
Field Station#	12196+24		Field Station#	12192+50	
Pic 1 Desc.	CIS of stream crossing S-OO11 in acceptable condition		Pic 2 Desc.	Down stream of stream crossing S-C21 clear and acceptable

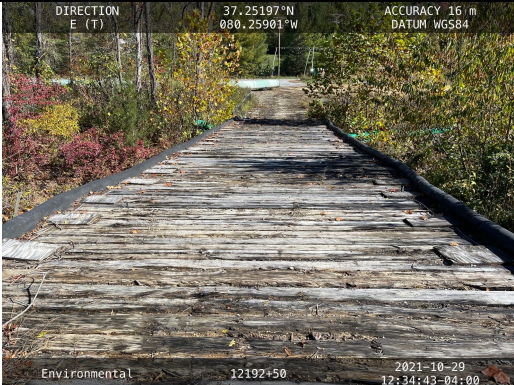
GPS Location	See photo		GPS Location	See photo	
Field Station#	12192+50		Field Station#	12187+00	
Pic 3 Desc.	Bridge and ECDs crossing stream S-C21 in acceptable condition		Pic 4 Desc.	Stabilized ROW In Acceptable condition

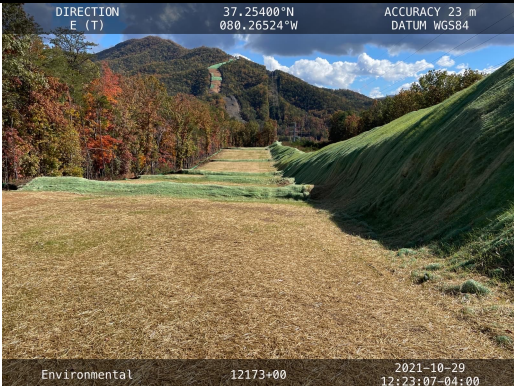
GPS Location	See photo		GPS Location	See photo	
Field Station#	12173+00		Field Station#	12166+47	
Pic 5 Desc.	Stabilized ROW in acceptable condition		Pic 6 Desc.	Bridge and ECDs crossing stream S-C24 in acceptable condition

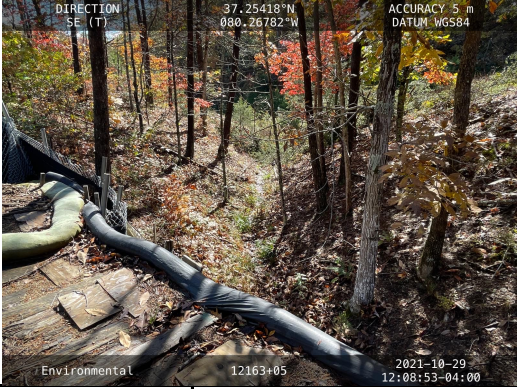
GPS Location	See photo	GPS Location	See photo		
Field Station#	12163+05	Field Station#	12163+05		
Pic 7 Desc.	Down stream of S-C25 in acceptable condition	Pic 8 Desc.	Bridge and ECDs crossing stream S-C25 in acceptable condition

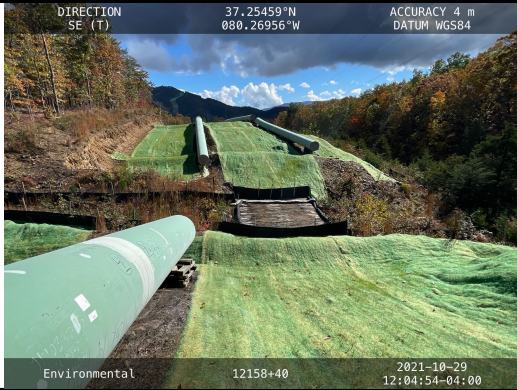
GPS Location	See photo	GPS Location	see photo		
Field Station#	12158+40	Field Station#	12154+00		
Pic 9 Desc.	Clean water crossing in acceptable condition	Pic 10 Desc.	Stabilized ROW in acceptable condition

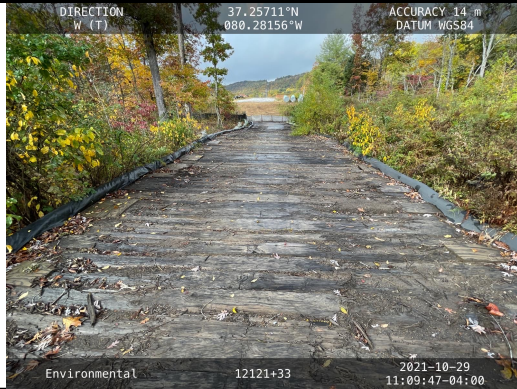
GPS Location	See photo	GPS Location	See photo		
Field Station#	12121+33	Field Station#	12125+65		
Pic 11 Desc.	Bridge and ECDs at stream crossing S-C33 in acceptable condition	Pic 12 Desc.	Bridge and ECDs crossing stream S-MM31 In Acceptable condition

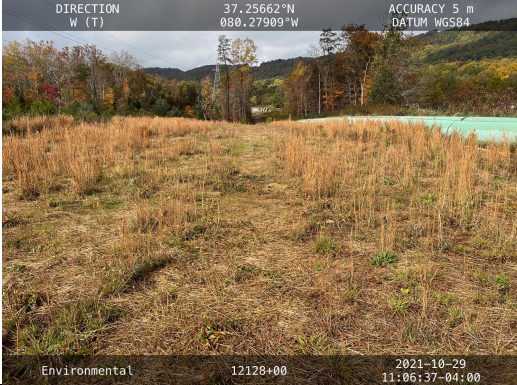
GPS Location	See photo		GPS Location	See photo	
Field Station#	12128+00		Field Station#	12132+73	
Pic 13 Desc.	Stabilized ROW in acceptable condition		Pic 14 Desc.	Bridge and ECDs crossing stream S-C29 in acceptable condition

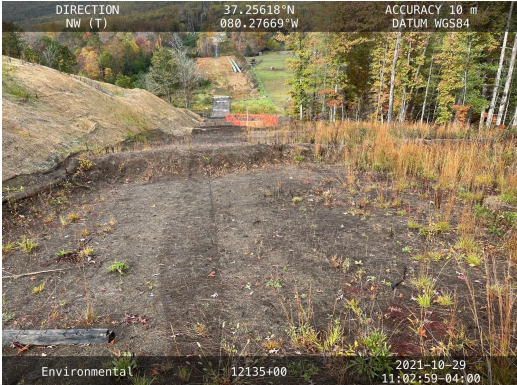
GPS Location	See photo		GPS Location	See photo	
Field Station#	12135+00		Field Station#	12139+91	
Pic 15 Desc.	Stabilized ROW in acceptable condition		Pic 16 Desc.	Wetland crossing W-C6 in acceptable condition

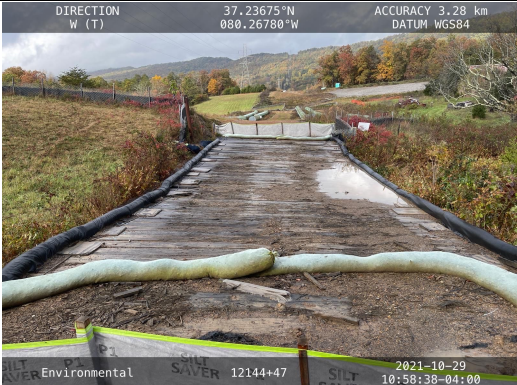
GPS Location	See photo		GPS Location	See photo	
Field Station#	12144+47		Field Station#	12150+90	
Pic 17 Desc.	Wetland crossing W-C5 in acceptable condition		Pic 18 Desc.	Stabilized drainage feature in acceptable condition
