# Visual Site Inspection Report

<b>Project Name</b>	H-600 Pipeline Spread H	<b>AFE</b>	124300138	<b>Spread</b>	H-600 Pipeline Spread H
<b>Contractor</b>	Precision			<b>Report #</b>	29306
<b>Inspector</b>	Joe Scott			<b>Date/Time</b>	10/4/2021 6:04 PM
<b>Permit #</b>	TBD	<b>Inspection Type</b>	VA SWPP	<b>Station Begin</b>	12865+00
<b>State</b>	VA	<b>Inspection Area</b>	Partial	<b>Station End</b>	13024+00
<b>County</b>	Roanoke	<b>Ground</b>	Wet	<b>Temperature (°F)</b>	71.00
<b>Municipality</b>	N/A	<b>Weather</b>	Cloudy	<b>Rain Gauge (in)</b>	0.60
				<b>Rain Accumulation Time (days)</b>	1.00

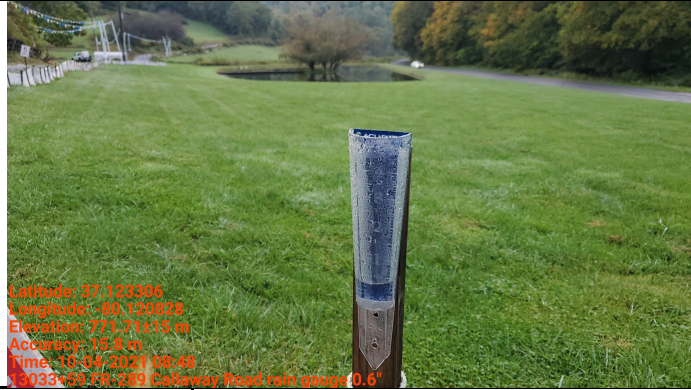
<p>Latitude: 37.123396 Longitude: -80.124828 Elevation: 2711.01±1.5 m Accuracy: 15.4 m Time: 10-04-2021 09:49 13033+59 GAS of the BRP motorway</p>

<p>Latitude: 37.125418 Longitude: -80.121483 Elevation: 2528.37±1.4 m Accuracy: 14.4 m Time: 10-04-2021 09:35 13024+00 GAS of the BRP streams S-G24 and S-G25</p>			
<b>GPS Location</b>	See pic for GPS location.		<b>GPS Location</b>	See pic for GPS location.	
<b>Field Station#</b>	13033+59		<b>Field Station#</b>	13024+00	
<b>Pic 1 Desc.</b>	Callaway Road rain gauge 0.6" total precipitation.		<b>Pic 2 Desc.</b>	Downstream side of streams S-G24 and S-G25.

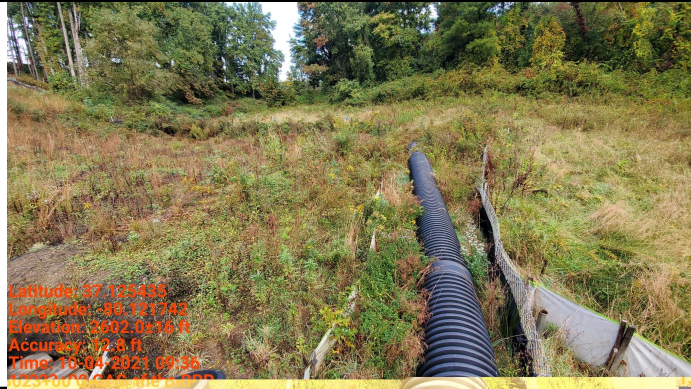
<p>Latitude: 37.125433 Longitude: -80.121743 Elevation: 2502.0±1.6 m Accuracy: 17.6 m Time: 10-04-2021 09:36 13023+00 GAS of the BRP</p>

<b>GPS Location</b>	See pic for GPS location.		<b>GPS Location</b>	See pic for GPS location.	
<b>Field Station#</b>	13023+00		<b>Field Station#</b>	13023+00	
<b>Pic 3 Desc.</b>	CWDB and CWDP on GAS of the BRP property.		<b>Pic 4 Desc.</b>	CWDP and Plunge Pool on GAS of the BRP property.

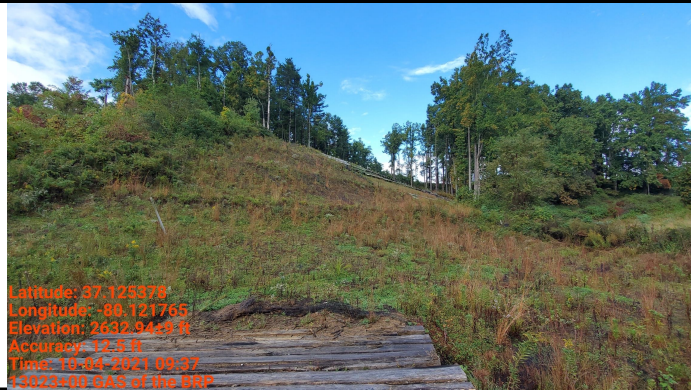
<p>Latitude: 37.125378 Longitude: -80.121765 Elevation: 2632.94±1.4 m Accuracy: 17.5 m Time: 10-04-2021 09:37 13023+00 GAS of the BRP</p>

<p>Latitude: 37.125934 Longitude: -80.125255 Elevation: 2701.61±1.2 m Accuracy: 12.5 m Time: 10-04-2021 09:52 13012+80 GAS of the BRP motorway</p>			
<b>GPS Location</b>	See pic for GPS location.		<b>GPS Location</b>	See pic for GPS location.	
<b>Field Station#</b>	13023+00		<b>Field Station#</b>	13012+80	
<b>Pic 5 Desc.</b>	Temporary stabilization on the GAS of the BRP.		<b>Pic 6 Desc.</b>	Current ROW conditions on the GAS of the BRP motorway.

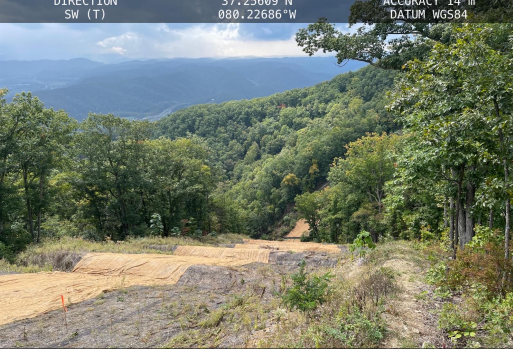
<div>Environmental</div> <div>12295+00</div> <div>2021-10-05 13:32:41-04:00</div> </div>			
<b>GPS Location</b>	See photo		<b>GPS Location</b>	See photo	
<b>Field Station#</b>	12441+00		<b>Field Station#</b>	12295+00	
<b>Pic 1 Desc.</b>	Stabilized ROW in acceptable condition		<b>Pic 2 Desc.</b>	Stabilized ROW in acceptable condition	
<div> <div>DIRECTION S (T)</div> <div>37.25580°N 080.22609°W</div> <div>ACCURACY 4 m DATUM WGS84</div>

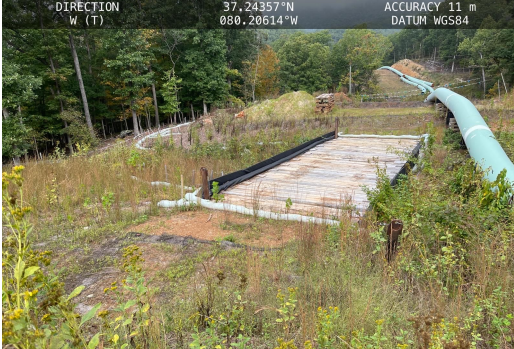
<div>Environmental</div> <div>12383+93</div> <div>2021-10-05 10:47:33-04:00</div> </div>		<div> <div>DIRECTION W (T)</div> <div>37.24344°N 080.20555°W</div> <div>ACCURACY 4 m DATUM WGS84</div>

<div>Environmental</div> <div>12386+00</div> <div>2021-10-05 10:45:50-04:00</div> </div>			
<b>GPS Location</b>	See photo		<b>GPS Location</b>	See photo	
<b>Field Station#</b>	12383+93		<b>Field Station#</b>	12386+00	
<b>Pic 5 Desc.</b>	Clean water crossing in acceptable condition		<b>Pic 6 Desc.</b>	Stabilized ROW in acceptable condition

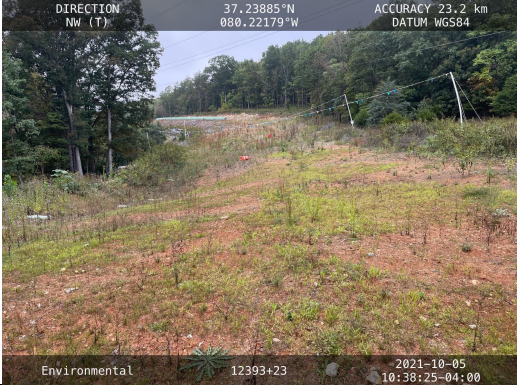
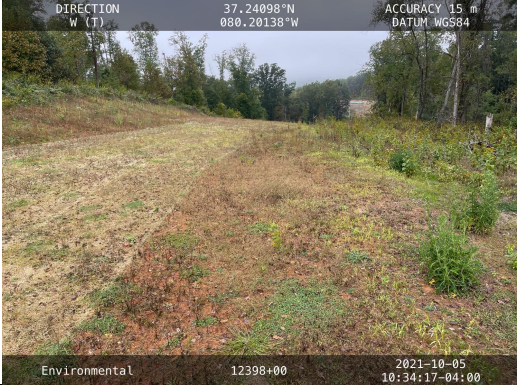
<b>GPS Location</b>	See photo		<b>GPS Location</b>	See photo	
<b>Field Station#</b>	12393+23		<b>Field Station#</b>	12398+00	
<b>Pic 7 Desc.</b>	Stabilized ROW in acceptable condition		<b>Pic 8 Desc.</b>	Stabilized ROW in acceptable condition

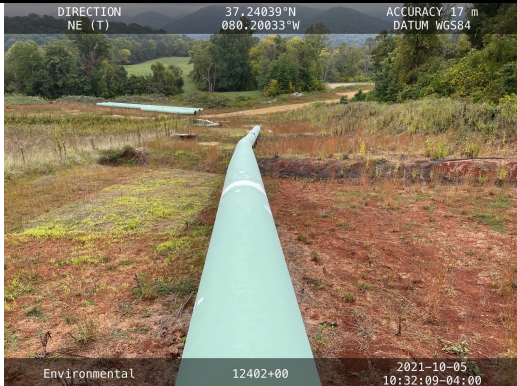
<b>GPS Location</b>	See photo		<b>GPS Location</b>	See photo	
<b>Field Station#</b>	12402+00		<b>Field Station#</b>	12408+80	
<b>Pic 9 Desc.</b>	Stabilized ROW in acceptable condition		<b>Pic 10 Desc.</b>	Clean water crossing pipe inlet in acceptable condition

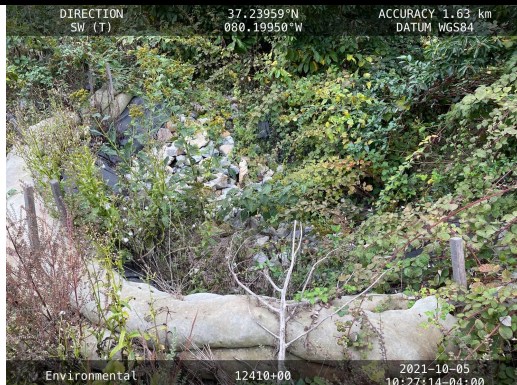
<b>GPS Location</b>	See photo		<b>GPS Location</b>	See photo	
<b>Field Station#</b>	12410+00		<b>Field Station#</b>	12410+20	
<b>Pic 11 Desc.</b>	Clean water crossing pipe inlet in acceptable condition		<b>Pic 12 Desc.</b>	Clean water crossing pipe outlet in acceptable condition

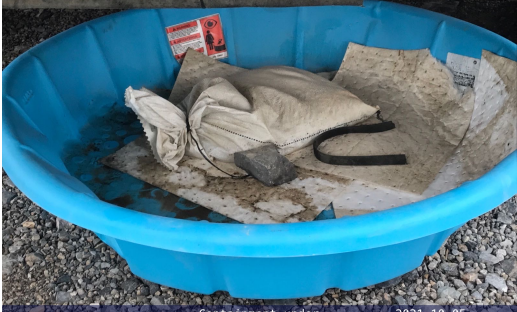
MVP-LY-049_100521 Containment under stored vehicle 2021-10-05 08:52:53-04:00				DIRECTION S (M) +37.27070° -080.12076° ACCURACY 16 ft DATUM WGS84

MVP-LY-049_100521 Containment under stored trailer 2021-10-05 08:53:02-04:00	
<b>GPS Location</b>	MVP-LY-049 See photo for gps data		<b>GPS Location</b>	MVP-LY-049 See photo for gps data	
<b>Field Station#</b>	+0		<b>Field Station#</b>	+0	
<b>Pic 7 Desc.</b>	Secondary containment under stored vehicle. Holding some fluids. Looking S.		<b>Pic 8 Desc.</b>	Secondary containment under stored trailer. Holding some fluids. Looking S.	
DIRECTION SW (M) +37.27060° -080.12354° ACCURACY 164 ft DATUM WGS84

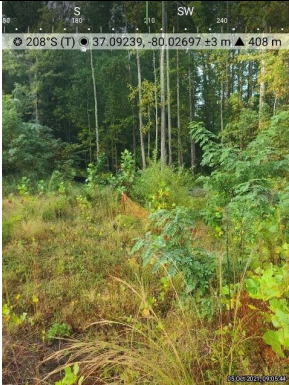
<b>GPS Location</b>	0000	<b>GPS Location</b>	00000		
<b>Field Station#</b>	13416+60	<b>Field Station#</b>	13417+20		
<b>Pic 1 Desc.</b>	Vegetation observation photo showing coverage, monitored sump pit and ECDs in the area. No environmental issues observed at the time of inspection.		<b>Pic 2 Desc.</b>	Erosion control blanket inspection on hill side above road crossing, no issues observed at the time of inspection.

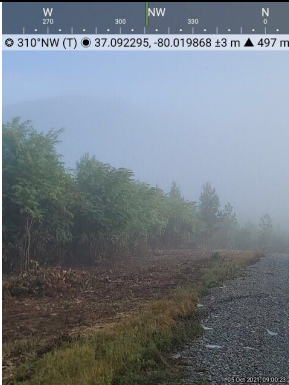
<b>GPS Location</b>	0000	<b>GPS Location</b>	0000		
<b>Field Station#</b>	13437+75	<b>Field Station#</b>	13416+00		
<b>Pic 3 Desc.</b>	3rd party mowing activities along access rd MVP-FR-293.02, Documented as non project related activities.		<b>Pic 4 Desc.</b>	Monitored ECDs at CAHAS#1 rd crossing after recent rain events, no environmental issues observed at the time of inspection.

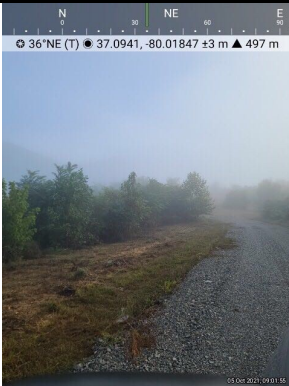
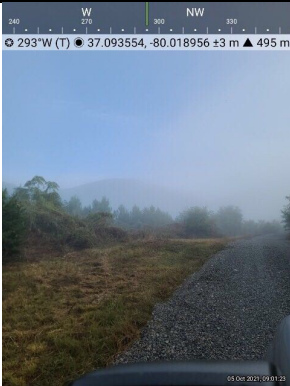
<b>GPS Location</b>	0000	<b>GPS Location</b>	00000		
<b>Field Station#</b>	13437+75	<b>Field Station#</b>	13437+75		
<b>Pic 5 Desc.</b>	Additional photo showing 3rd party mowing activities along access rd MVP-FR-293.02, Documented as non project related activities.		<b>Pic 6 Desc.</b>	Additional photo showing 3rd party mowing activities along access rd MVP-FR-293.02, Documented as non project related activities.

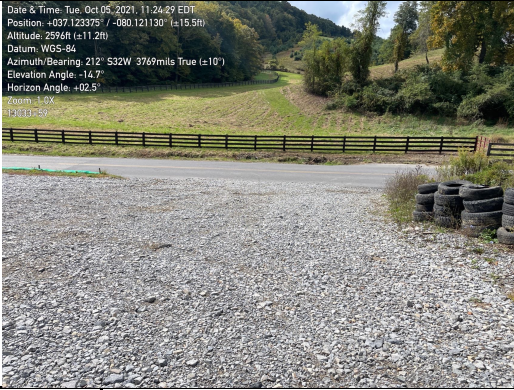
<b>GPS Location</b>	0	<b>GPS Location</b>	0		
<b>Field Station#</b>	13033+59	<b>Field Station#</b>	13024+06		
<b>Pic 1 Desc.</b>	RCE in good condition and functioning properly	<b>Pic 2 Desc.</b>	MVP-S-G24/25 and Corresponding buffer zone in good condition		
<p>Date &amp; Time: Tue, Oct 05, 2021, 11:06:00 EDT  Position: +037.108594° / +080.118994° (+15.4N)  Altitude: 2730ft (+13.1ft)  Datum: WGS-84  Azimuth/Bearing: 261° S65W 408/mils True (+12°)  Elevation Angle: -33.1°  Horizon Angle: +00.5°  Zoom: 1.0x  13030+00</p>

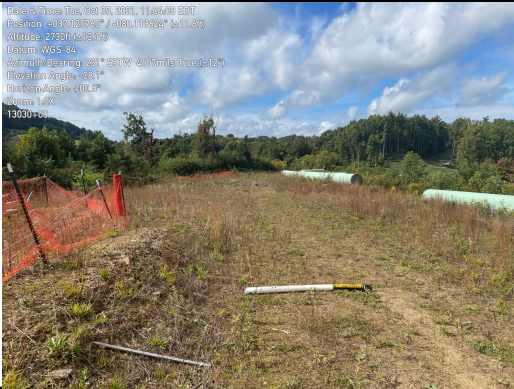
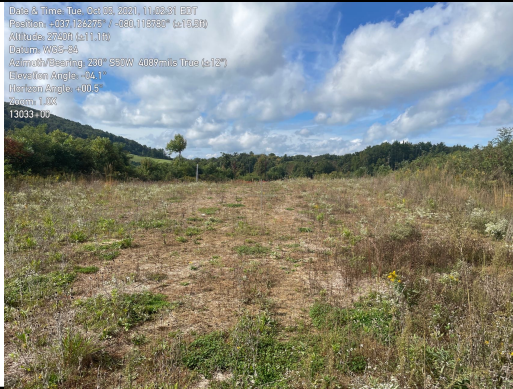
<b>GPS Location</b>	0	<b>GPS Location</b>	0		
<b>Field Station#</b>	13030+00	<b>Field Station#</b>	13033+00		
<b>Pic 3 Desc.</b>	ROW and ECDs in good condition with good vegetation established across ROW	<b>Pic 4 Desc.</b>	ROW and ECDs in good condition with good vegetation established across ROW		
<p>Date &amp; Time: Tue, Oct 05, 2021, 11:02:14 EDT  Position: +037.124334 / +080.118492 (+15.5N)  Altitude: 2730ft (+13.1ft)  Datum: WGS-84  Azimuth/Bearing: 060° N45E 1057/mils True (+12°)  Elevation Angle: +33.8°  Horizon Angle: +01.7°  Zoom: 1.0x  13030+00</p>

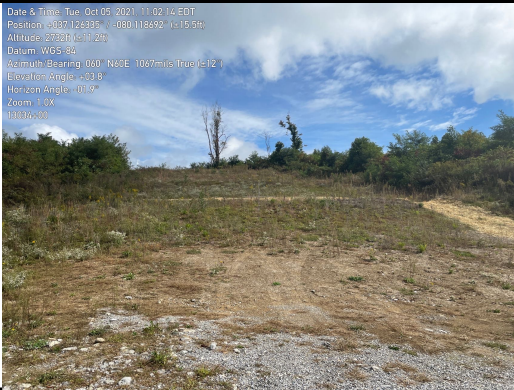
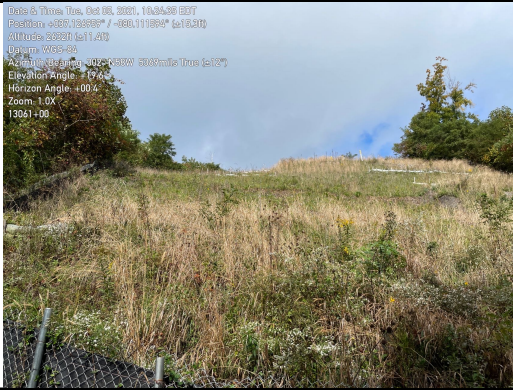
<b>Pic 5 Desc.</b>	ROW and ECDs in good condition with good vegetation established across ROW	<b>Pic 6 Desc.</b>	ROW and ECDs in good condition with good vegetation established across ROW

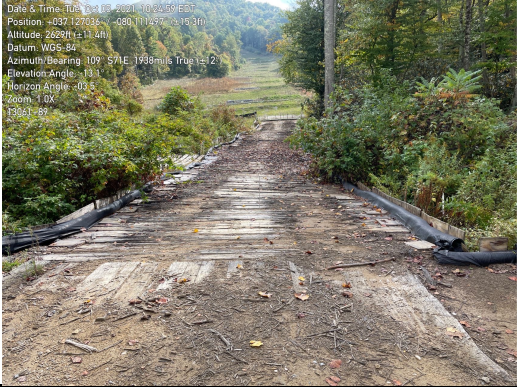
<b>GPS Location</b> 0		<b>GPS Location</b> 0			
<b>Field Station#</b> 13061+89		<b>Field Station#</b> 13062+96			
<b>Pic 7 Desc.</b> MVP-S-G26 and Corresponding buffer zone in good condition		<b>Pic 8 Desc.</b> MVP-S-G27 and Corresponding buffer zone in good condition			
<p>Date &amp; Time: Tue Oct 05 2021 10:28:24 EDT  Position: +037.124825° / -080.110775° / +1936'  Altitude: 2520ft (+11.4M)  Datum: WGS 84  Azimuth/Bearing: 109° S71E 1936m/s True (+2.7)  Elevation Angle: +07.6  Horizon Angle: +00.8  Zoom: 1.0X  13064+00</p>

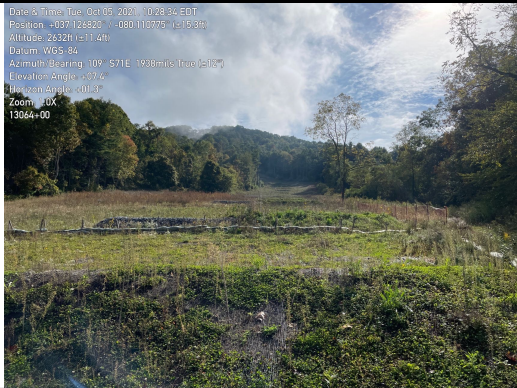
<b>GPS Location</b> 0		<b>GPS Location</b> 0			
<b>Field Station#</b> 13064+00		<b>Field Station#</b> 13061+44			
<b>Pic 9 Desc.</b> ROW and ECDs in good condition with good vegetation established across ROW		<b>Pic 10 Desc.</b> Equipment bridge and access road in good condition			
<p>Date &amp; Time: Tue Oct 05 2021 10:13:24 EDT  Position: +037.123415° / -080.113362° / +1935.5M  Altitude: 2581ft (+11.2M)  Datum: WGS 84  Azimuth/Bearing: 259° S70W 2606m/s True (+3.0)  Elevation Angle: +03.0  Horizon Angle: +02.7  Zoom: 1.0X  13061+44</p>

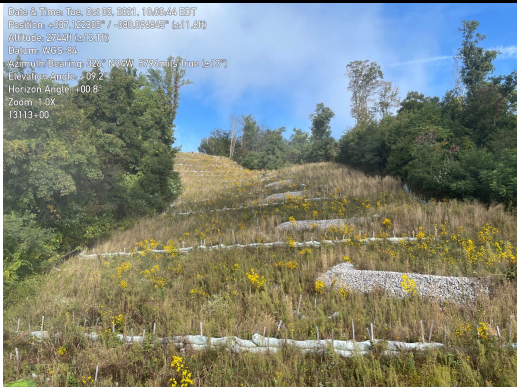
<b>Pic 11 Desc.</b> Access road and ECDs in good condition		<b>Pic 12 Desc.</b> ROW and ECDs in good condition with good vegetation established across ROW

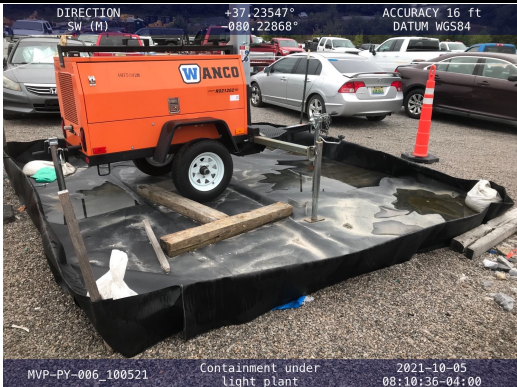
<p>DIRECTION N (M) +37.23439° -080.22800° ACCURACY 16 ft DATUM WGS84 MVP-PY-006_100521 Trays &amp; containment under toilets 2021-10-05 08:00:43-04:00</p>

<p>DIRECTION SW (M) +37.23547° -080.22868° ACCURACY 16 ft DATUM WGS84 MVP-PY-006_100521 Containment under light plant 2021-10-05 08:10:36-04:00</p>			
<b>GPS Location</b>	MVP-PY-006 See photo for gps data		<b>GPS Location</b>	MVP-PY-006 See photo for gps data	
<b>Field Station#</b>	+0		<b>Field Station#</b>	+0	
<b>Pic 17 Desc.</b>	Trays and secondary containment under toilets holding stormwater. Looking N.		<b>Pic 18 Desc.</b>	Secondary containments under light plants were holding some stormwater. Looking SW.

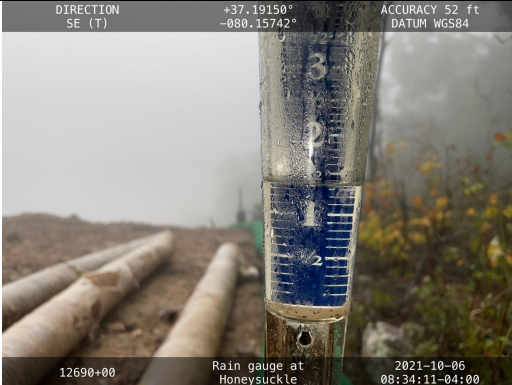
<p>DIRECTION SE (T) +37.19150° -080.15742° ACCURACY 52 ft DATUM WGS84</p> <p>12690+00 Rain gauge at Honeysuckle 2021-10-06 08:34:11-04:00</p>

<p>DIRECTION E (T) +37.19107° -080.15624° ACCURACY 16 ft DATUM WGS84</p> <p>12693+00 to 12700+00 Clean out water bars 2021-10-06 09:29:36-04:00</p>			
<b>GPS Location</b>	See photo for gps location data		<b>GPS Location</b>	See photo for gps location data	
<b>Field Station#</b>	12690+00		<b>Field Station#</b>	12693+00	
<b>Pic 1 Desc.</b>	Photo shows the rain gauge at Honeysuckle. 1.4 inches of rainfall within the last 24 hours.		<b>Pic 2 Desc.</b>	Photo shows the sediment accumulated in the water bars.

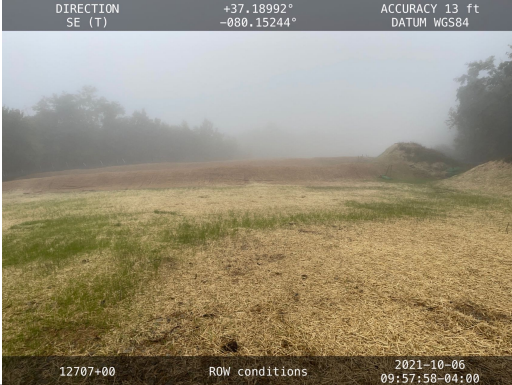
<p>DIRECTION SE (T) +37.18992° -080.15244° ACCURACY 13 ft DATUM WGS84</p> <p>12707+00 ROW conditions 2021-10-06 09:57:58-04:00</p>

<b>GPS Location</b>	See photo for gps location data		<b>GPS Location</b>	See photo for gps location data	
<b>Field Station#</b>	12707+00		<b>Field Station#</b>	12710+00	
<b>Pic 3 Desc.</b>	Photo shows the stabilized ROW		<b>Pic 4 Desc.</b>	Photo shows the ROW condition

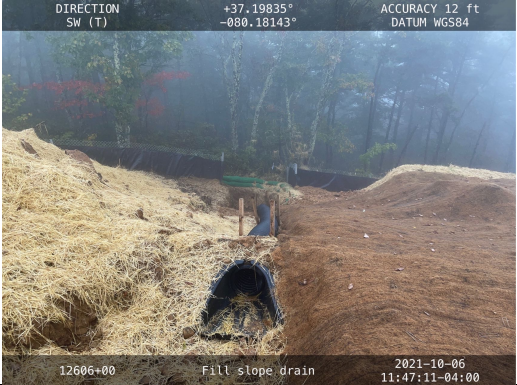
<p>DIRECTION SW (T) +37.19835° -080.18143° ACCURACY 12 ft DATUM WGS84</p> <p>12606+00 Fill slope drain 2021-10-06 11:47:11-04:00</p>			
<b>GPS Location</b>	See photo for gps location data		<b>GPS Location</b>	See photo for gps location data	
<b>Field Station#</b>	12615+00		<b>Field Station#</b>	12606+00	
<b>Pic 13 Desc.</b>	Photo shows the stabilized stockpiles		<b>Pic 14 Desc.</b>	Photo shows a fill slope drain

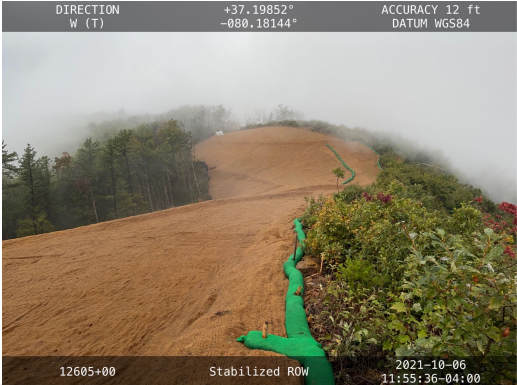
<p>DIRECTION W (T) +37.19852° -080.18144° ACCURACY 12 ft DATUM WGS84</p> <p>12605+00 Stabilized ROW 2021-10-06 11:55:36-04:00</p>

<b>GPS Location</b>	See photo for gps location data		<b>GPS Location</b>	See photo for gps location data	
<b>Field Station#</b>	12605+00		<b>Field Station#</b>	12698+00	
<b>Pic 15 Desc.</b>	Photo shows the stabilized ROW		<b>Pic 16 Desc.</b>	Photo shows the waterbars after the sediment was cleaned out

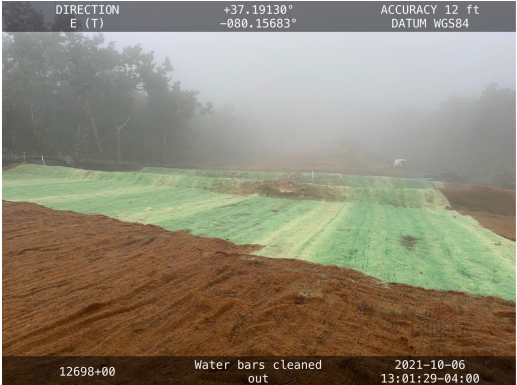
<p>DIRECTION E (T) +37.19130° -080.15683° ACCURACY 12 ft DATUM WGS84</p> <p>12698+00 Water bars cleaned out 2021-10-06 13:01:29-04:00</p>

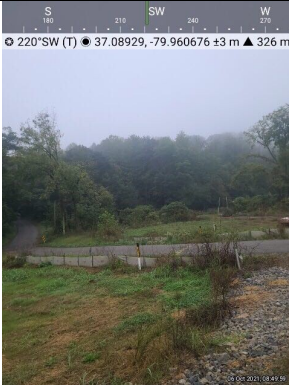
<b>GPS Location</b>	0000	<b>GPS Location</b>	0000		
<b>Field Station#</b>	13644+99	<b>Field Station#</b>	13563+60		
<b>Pic 1 Desc.</b>	Monitored ECDs at road crossings during light rain events. No environmental issues observed at the time of inspection.		<b>Pic 2 Desc.</b>	Row photo showing vegetation, light rain events with foggy conditions, no environmental issues observed at the time of inspection.

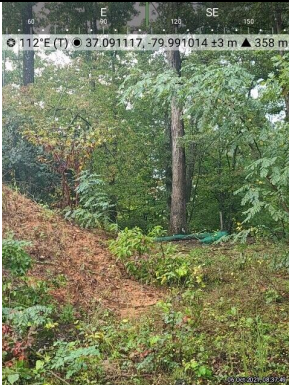
<b>GPS Location</b>	0000	<b>GPS Location</b>	0000		
<b>Field Station#</b>	13542+99	<b>Field Station#</b>	13645+00		
<b>Pic 3 Desc.</b>	Monitored CFS around spoil piles at road crossings. No environmental issues observed at the time of inspection.		<b>Pic 4 Desc.</b>	Vegetation observation photo during light rain events.

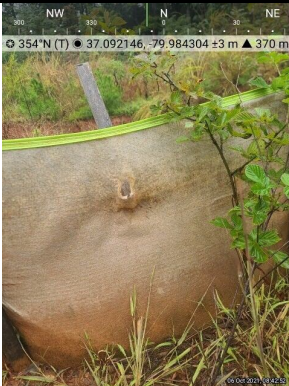
<b>Field Station#</b>	13562+30	<b>Field Station#</b>	13560+99		
<b>Pic 5 Desc.</b>	P1 requires maintenance due to broken stake, documented and added to the punch list.		<b>Pic 6 Desc.</b>	Vegetation observation photo during light rain events.

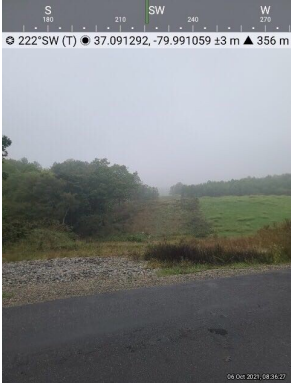
<p>GPS data: S 185, SW 210, W 270          222°SW (T) ● 37.091292, -79.991059 ±3 m ▲ 356 m          06 Oct 2021 16:36:21</p>		<p>Insert image here</p>		<p>Insert image here</p>	
<b>GPS Location</b>	0000	<b>GPS Location</b>			
<b>Field Station#</b>	13541+50	<b>Field Station#</b>			
<b>Pic 7 Desc.</b>	Monitored row conditions at road crossings during light rain events today. No environmental issues observed at the time of inspection.		<b>Pic 8 Desc.</b>		
<p>Insert image here</p>		<p>Insert image here</p>			
<b>GPS Location</b>		<b>GPS Location</b>			
<b>Field Station#</b>		<b>Field Station#</b>			
<b>Pic 9 Desc.</b>			<b>Pic 10 Desc.</b>		
<p>Insert image here</p>		<p>Insert image here</p>			
<b>GPS Location</b>		<b>GPS Location</b>			
<b>Field Station#</b>		<b>Field Station#</b>			
<b>Pic 11 Desc.</b>			<b>Pic 12 Desc.</b>

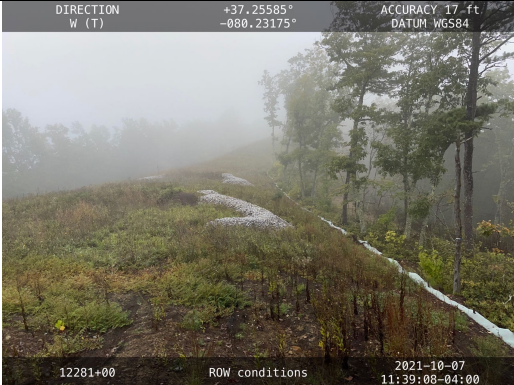
<b>GPS Location</b>	See photo for gps location data		<b>GPS Location</b>	See photo for gps location data	
<b>Field Station#</b>	12281+00		<b>Field Station#</b>	12283+00	
<b>Pic 1 Desc.</b>	Photo shows the ROW condition		<b>Pic 2 Desc.</b>	Photo shows the excavated trench

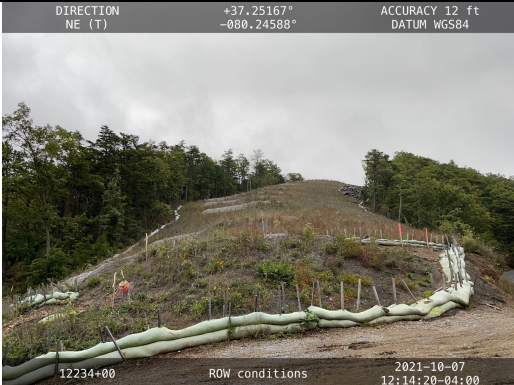
<b>GPS Location</b>	See photo for gps location data		<b>GPS Location</b>	See photo for gps location data	
<b>Field Station#</b>	12234+00		<b>Field Station#</b>	12229+00	
<b>Pic 3 Desc.</b>	Photo shows the ROW condition		<b>Pic 4 Desc.</b>	Photo shows a fill slope drain

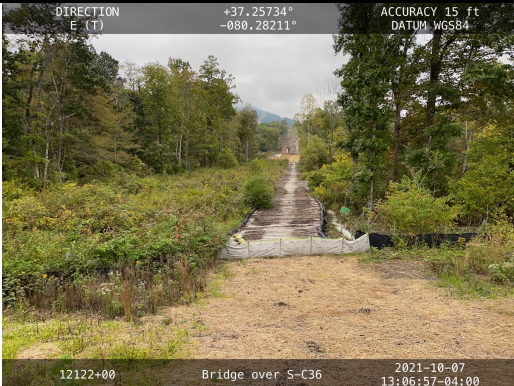
<b>GPS Location</b>	See photo for gps location data		<b>GPS Location</b>	See photo for gps location data	
<b>Field Station#</b>	12122+00		<b>Field Station#</b>	12132+00	
<b>Pic 5 Desc.</b>	Photo shows the bridge over stream S-C36		<b>Pic 6 Desc.</b>	Photo shows the bridge over stream S-C29

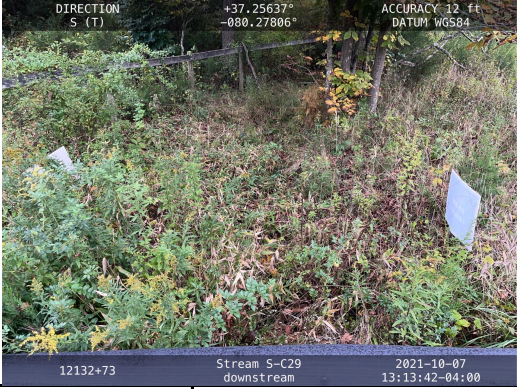
<b>GPS Location</b>	See photo for gps location data		<b>GPS Location</b>	See photo for gps location data	
<b>Field Station#</b>	12132+73		<b>Field Station#</b>	12139+50	
<b>Pic 7 Desc.</b>	Photo shows stream S-C29 downstream from the bridge		<b>Pic 8 Desc.</b>	Photo shows the bridge over wetland W-C6

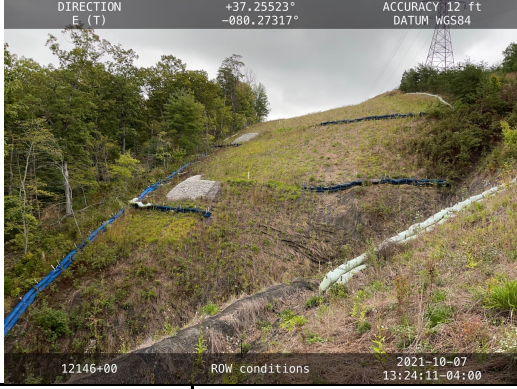
<b>GPS Location</b>	See photo for gps location data		<b>GPS Location</b>	See photo for gps location data	
<b>Field Station#</b>	12146+00		<b>Field Station#</b>	12154+00	
<b>Pic 9 Desc.</b>	Photo shows the ROW condition		<b>Pic 10 Desc.</b>	Photo shows the ROW condition

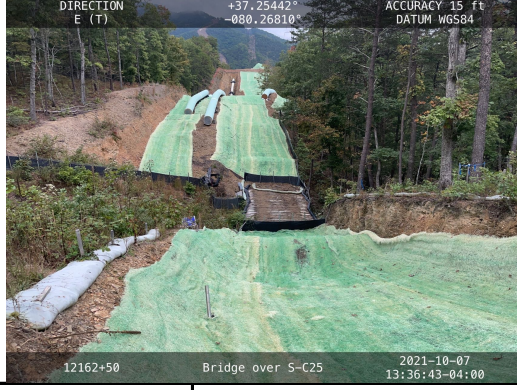
<b>GPS Location</b>	See photo for gps location data		<b>GPS Location</b>	See photo for gps location data	
<b>Field Station#</b>	12162+50		<b>Field Station#</b>	12163+05	
<b>Pic 11 Desc.</b>	Photo shows the bridge over stream S-C25		<b>Pic 12 Desc.</b>	Photo shows stream S-C25 downstream from the bridge

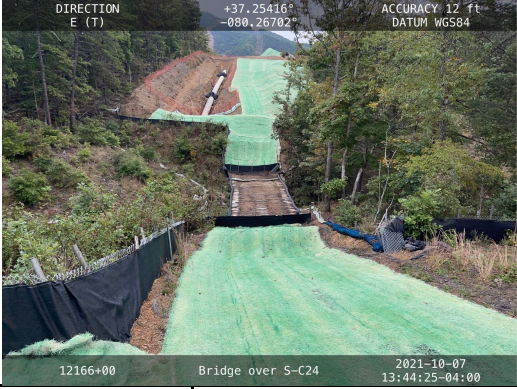
<b>GPS Location</b>	See photo for gps location data		<b>GPS Location</b>	See photo for gps location data	
<b>Field Station#</b>	12166+00		<b>Field Station#</b>	12166+47	
<b>Pic 13 Desc.</b>	Photo shows the bridge over stream S-C24		<b>Pic 14 Desc.</b>	Photo shows stream S-C24 downstream from the bridge

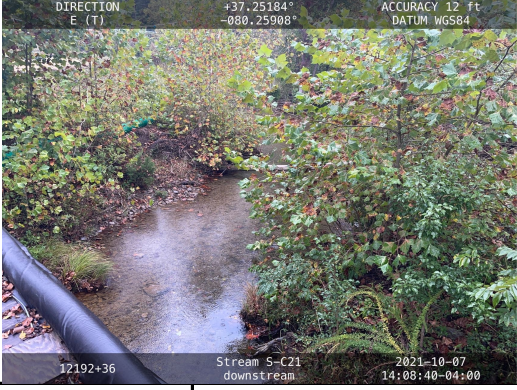
<b>GPS Location</b>	See photo for gps location data		<b>GPS Location</b>	See photo for gps location data	
<b>Field Station#</b>	12192+00		<b>Field Station#</b>	12192+36	
<b>Pic 17 Desc.</b>	Photo shows the bridge over stream S-C21		<b>Pic 18 Desc.</b>	Photo shows stream S-C21 downstream from the bridge

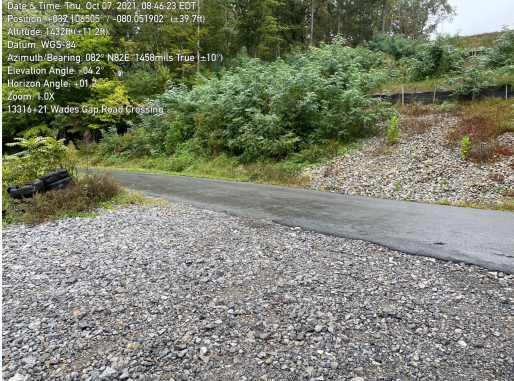
<b>GPS Location</b>	0	<b>GPS Location</b>	0		
<b>Field Station#</b>	13316+21	<b>Field Station#</b>	13314+00		
<b>Pic 1 Desc.</b>	Wades Gap Road Crossing in good condition and RCE in good condition and functioning properly		<b>Pic 2 Desc.</b>	ROW and ECDs in good condition with good vegetation established across ROW

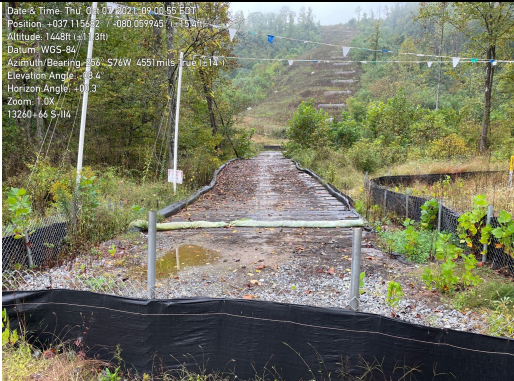
<b>GPS Location</b>	0	<b>GPS Location</b>	0		
<b>Field Station#</b>	13260+66	<b>Field Station#</b>	13259+00		
<b>Pic 3 Desc.</b>	MVP-S-II4 and Corresponding buffer zone in good condition		<b>Pic 4 Desc.</b>	ROW and ECDs in good condition with good vegetation established across ROW

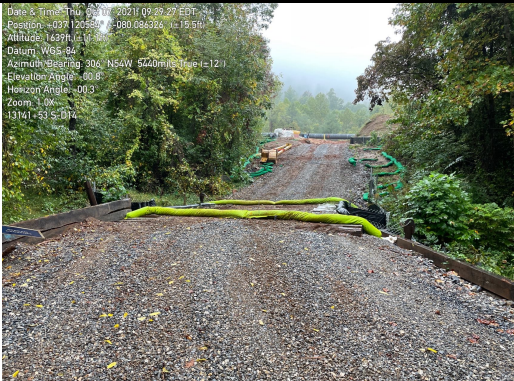
<b>GPS Location</b>	0	<b>GPS Location</b>	0		
<b>Field Station#</b>	13141+53	<b>Field Station#</b>	13144+00		
<b>Pic 5 Desc.</b>	MVP-S-D14 and Corresponding buffer zone in good condition		<b>Pic 6 Desc.</b>	ROW and ECDs in good condition and stable
