Visual Site Inspection Report

Project Name	H-600 Pipeline Spread H	AFE	124300138	Spread	H-600 Pipeline Spread H
Contractor	Precision			Report #	31181
Inspector	Tanner Cullop			Date/Time	11/15/2021 1:21 PM
Permit #	TBD	Inspection Type	VA SWPP	Station Begin	13316+21
State	VA	Inspection Area	Partial	Station End	13422+00
County	Franklin	Ground	Damp	Temperature (°F)	43.00
Municipality	N/A	Weather	Sunny	Rain Gauge (in)	0.00
				Rain Accumulation Time (days)	0.00

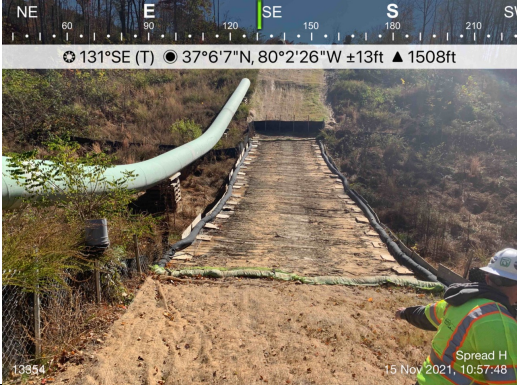
GPS Location	See photo above		GPS Location	See photo above	
Field Station#	13354+00		Field Station#	13415+19	
Pic 13 Desc.	Timber mat crossing S-RR10 is in good condition.		Pic 14 Desc.	Equipment bridge crossing the wetland near Cahas Mountain Rd. is in good condition.

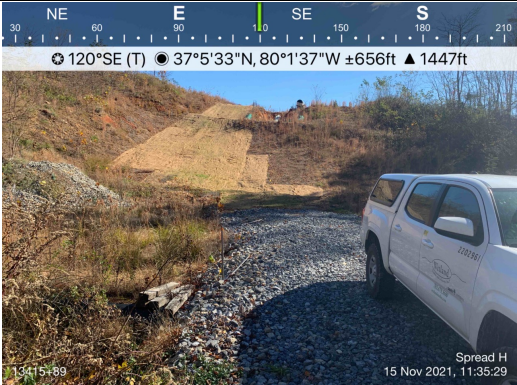
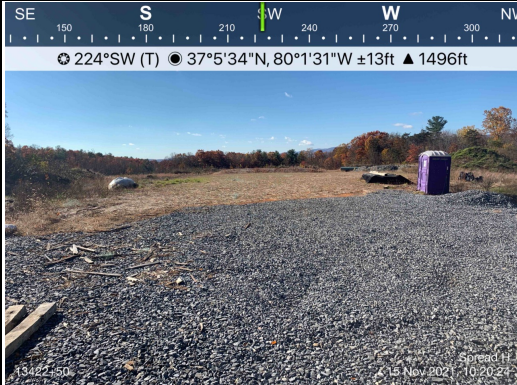
GPS Location	See photo above		GPS Location	See photo above	
Field Station#	13417+00		Field Station#	13417+50	
Pic 15 Desc.	Timber mat bridge and super silt fence is in acceptable condition crossing S-IJ1.		Pic 16 Desc.	Slope has been stabilized and controls are functioning properly.

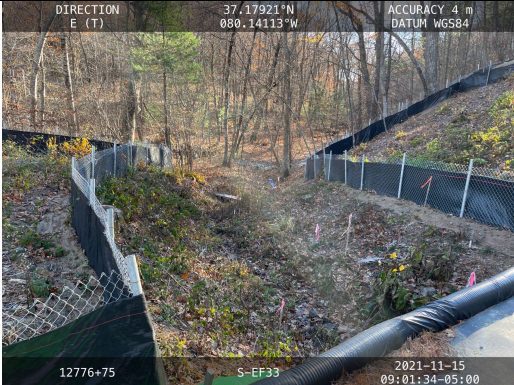
GPS Location	See photo		GPS Location	See photo	
Field Station#	12776+75		Field Station#	12768+00	
Pic 1 Desc.	Downstream of crossing at Stream S-EF33		Pic 2 Desc.	Steep slope area is stable and ECDs are functional

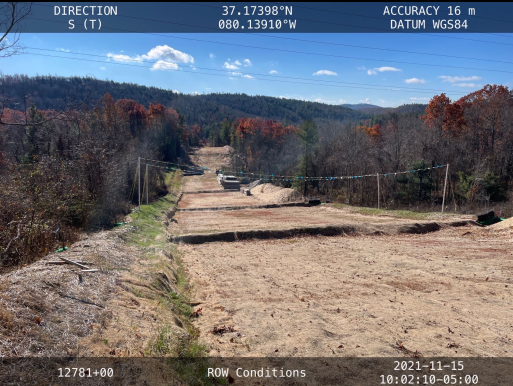
GPS Location	See photo		GPS Location	See photo	
Field Station#	12775+50		Field Station#	12781+00	
Pic 5 Desc.	Level spreader is functional		Pic 6 Desc.	Current ROW conditions. ROW is stable.

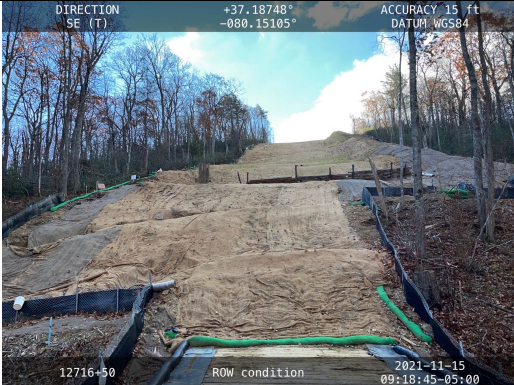
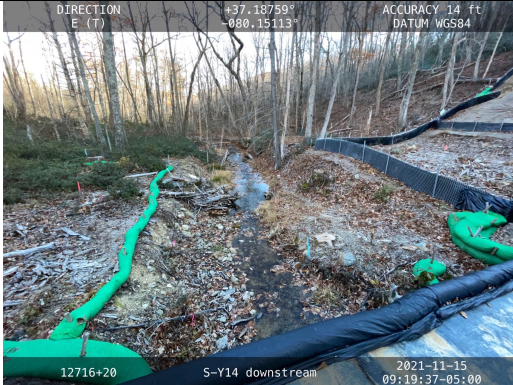
GPS Location	See photo for gps location data.		GPS Location	See photo for gps location data.	
Field Station#	12716+50		Field Station#	12716+20	
Pic 1 Desc.	Photo shows the ROW condition. ECDs are installed and functioning as designed.		Pic 2 Desc.	Photo shows stream S-Y14 down stream from the bridge.

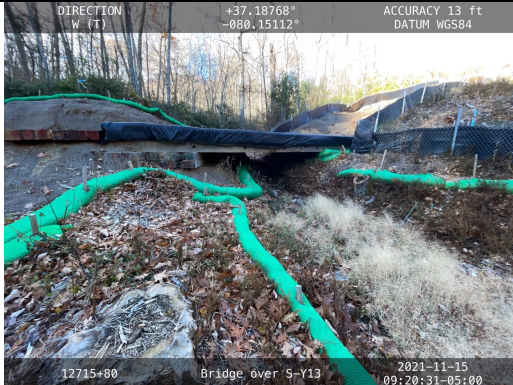
GPS Location	See photo for gps location data.		GPS Location	See photo for gps location data.	
Field Station#	12716+20		Field Station#	12715+80	
Pic 3 Desc.	Photo shows the bridge over stream S-Y14.		Pic 4 Desc.	Photo shows the bridge over stream S-Y13.

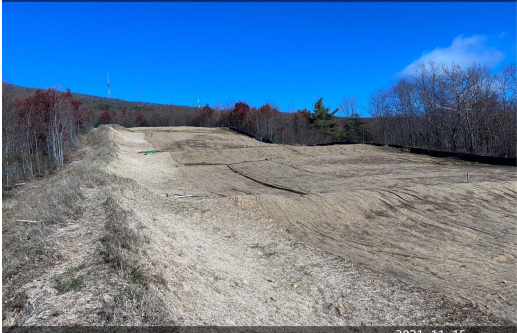
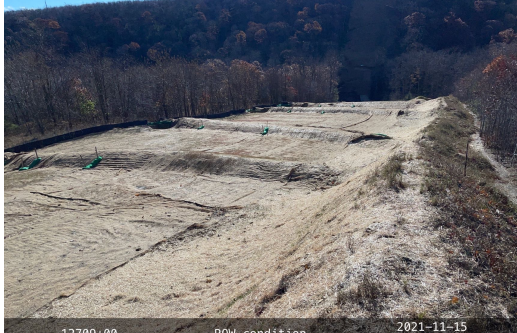
12712+00 ROW condition 2021-11-15 09:26:04-05:00			
GPS Location	See photo for gps location data.		GPS Location	See photo for gps location data.	
Field Station#	12712+00		Field Station#	12712+00	
Pic 7 Desc.	Photo shows the ROW condition. ECDs are installed and functioning as designed.		Pic 8 Desc.	Photo shows the ROW condition. ECDs are installed and functioning as designed.	
DIRECTION SE (T) +37.18933° -080.15229° ACCURACY 13 ft DATUM WGS84

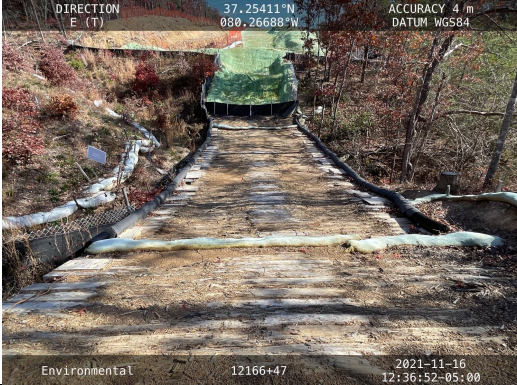
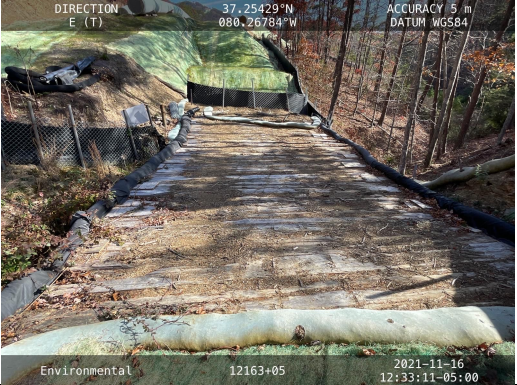
<p>DIRECTION E (T) 37.25429°N 080.26784°W ACCURACY 5 m DATUM WGS84</p> <p>Environmental 12163+05 2021-11-16 12:33:11-05:00</p>			
GPS Location	See photo		GPS Location	See photo	
Field Station#	12166+47		Field Station#	12163+05	
Pic 13 Desc.	Bridge and ECDs crossing stream S-C24 in acceptable condition		Pic 14 Desc.	Bridge and ECDs crossing stream S-C25 in acceptable condition

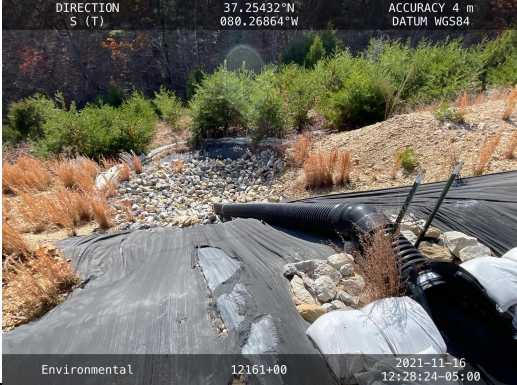
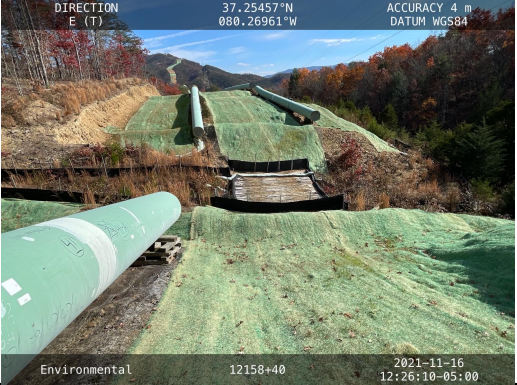
Pic 15 Desc.	Fill slope drain outlet		Pic 16 Desc.	Clean water crossing

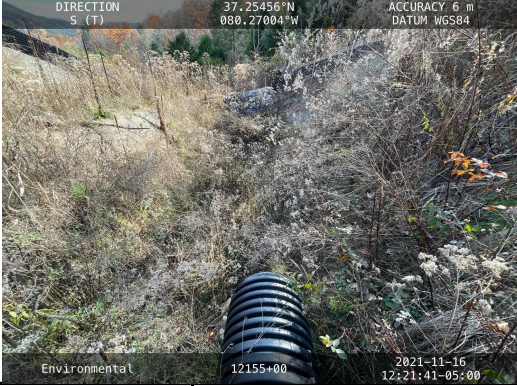
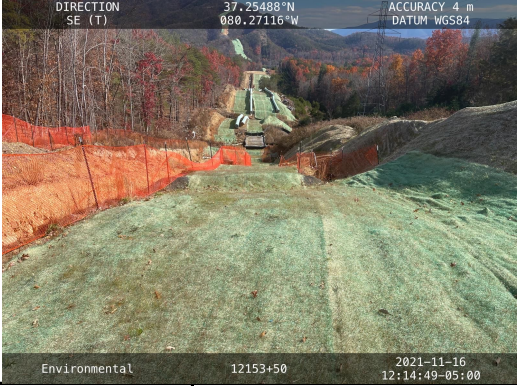
<p>DIRECTION SE (T) 37.25488°N 080.27116°W ACCURACY 4 m DATUM WGS84</p> <p>Environmental 12153+50 2021-11-16 12:14:49-05:00</p>			
GPS Location	See photo		GPS Location	See photo	
Field Station#	12155+00		Field Station#	12153+50	
Pic 17 Desc.	End sump drains outlet		Pic 18 Desc.	Stabilized ROW conditions

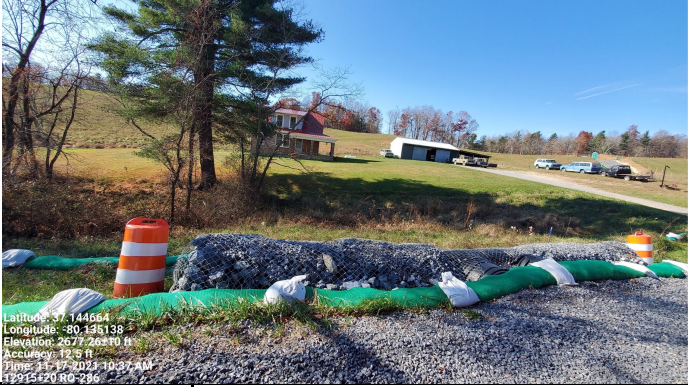
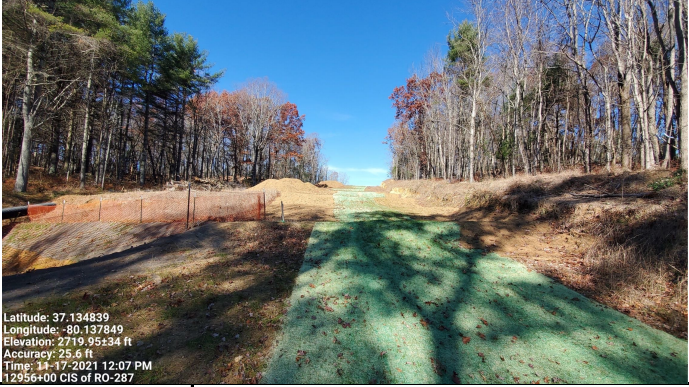
<p>Latitude: 37.134839 Longitude: -80.137849 Elevation: 2719.55±34 ft Accuracy: 25.6 ft Time: 11-17-2021 12:07 PM 12956+00 CIS of RO-287</p>			
GPS Location	See pic for GPS location.		GPS Location	See pic for GPS location.	
Field Station#	12915+20		Field Station#	12956+00	
Pic 7 Desc.	Clean water crossing and level spreader on access RO-286.		Pic 8 Desc.	Current condition of the ROW on the CIS of RO-287.

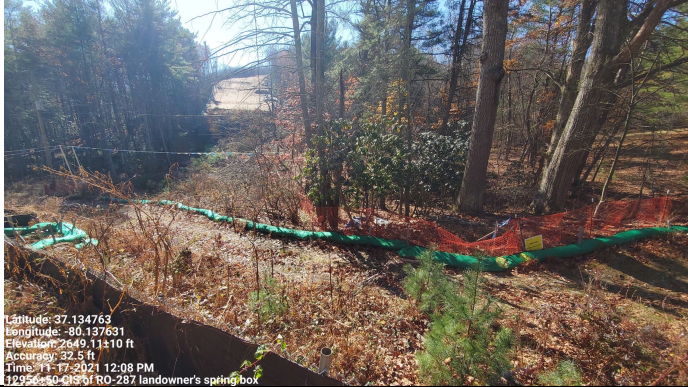
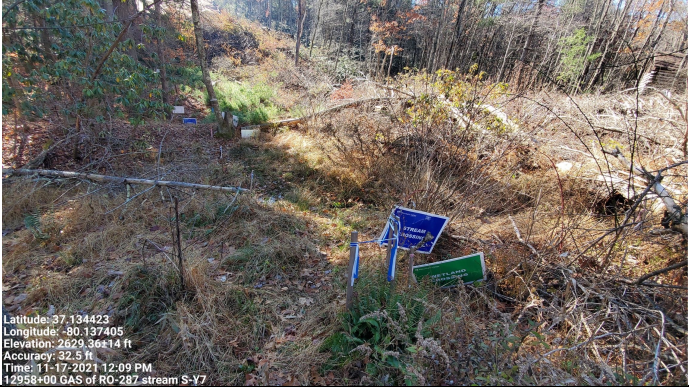
GPS Location	See pic for GPS location.		GPS Location	See pic for GPS location.	
Field Station#	129556+50		Field Station#	12958+00	
Pic 9 Desc.	Landowner's spring box at RO-287.		Pic 10 Desc.	Stream S-Y7 on the GAS of RO-287.

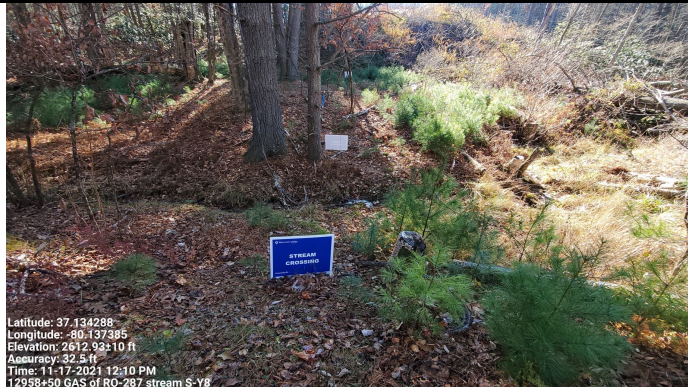
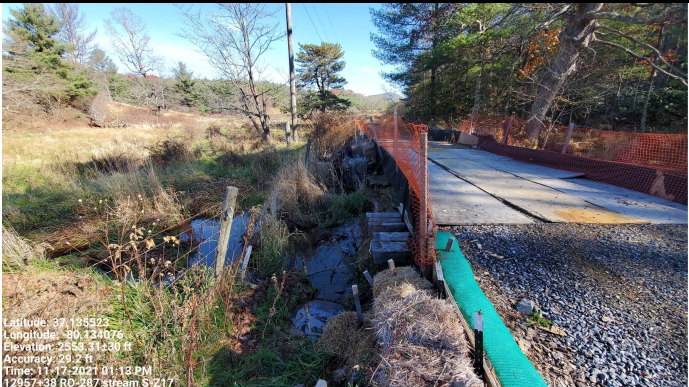
<p>Latitude: 37.135222 Longitude: -80.134876 Elevation: 2554.31±38 ft Accuracy: 29.2 ft Time: 11-17-2021 01:12 PM 12957+38 RO-287 stream S-Z17</p>			
GPS Location	See pic for GPS location.		GPS Location	See pic for GPS location.	
Field Station#	12958+50		Field Station#	12957+38	
Pic 11 Desc.	Stream S-Y8 on the GAS of RO-287.		Pic 12 Desc.	Stream crossing S-Z17 on RO-287.

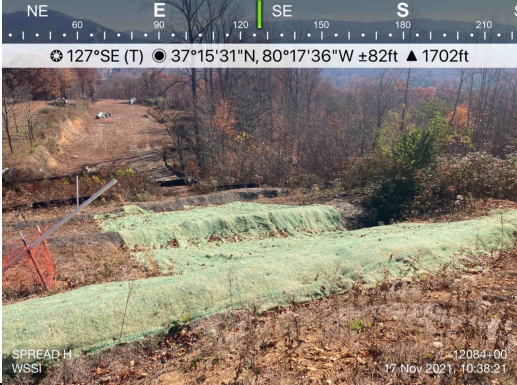
GPS Location	See photo watermark		GPS Location	See photo watermark	
Field Station#	12084+00		Field Station#	12048+00	
Pic 15 Desc.	Recently installed erosion control matting in good condition with no signs of erosion.		Pic 16 Desc.	Temporary vegetation on the ROW in good condition.

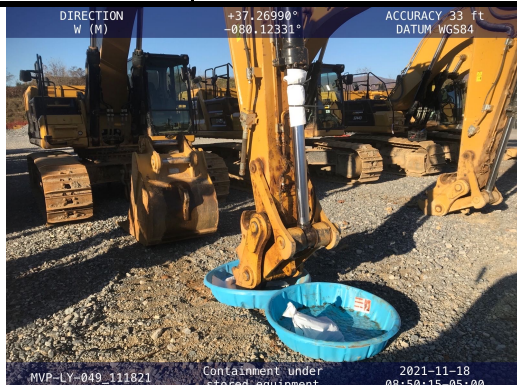
GPS Location	MVP-LY-049 See photo for gps data		GPS Location	MVP-LY-049 See photo for gps data	
Field Station#	+0		Field Station#	+0	
Pic 11 Desc.	Secondary containment under stored equipment. Looking NW.		Pic 12 Desc.	Compost filter sock in place and functioning around sand pile. Looking SW.

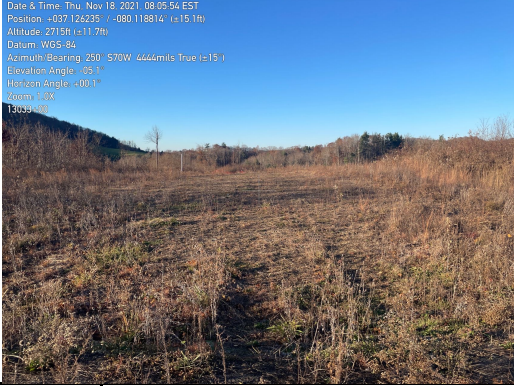
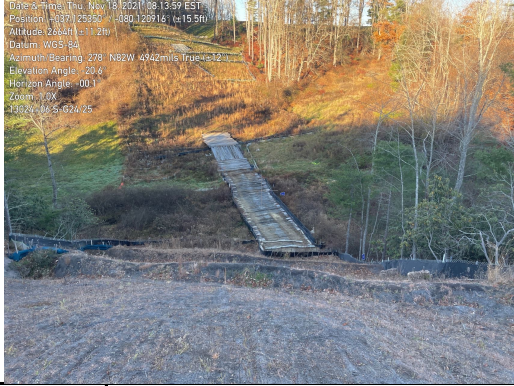
GPS Location	0	GPS Location	0		
Field Station#	13033+00	Field Station#	13024+06		
Pic 1 Desc.	ROW and ECDs In good condition and stable		Pic 2 Desc.	MVP-S-G24/25 and Corresponding buffer zone in good condition	
<p>Date & Time: Thu Nov 18, 2021, 08:21:06 EST Position: +037 123362 / -080 121074 (±14.8ft) Altitude: 2591ft (±19.7ft) Datum: WGS-84 Azimuth/Bearing: 214° 53'40" N 380mils True (±12.1) Elevation Angle: -12.0° Horizon Angle: +01.3° Zoom: 1.0X 13033+59</p>

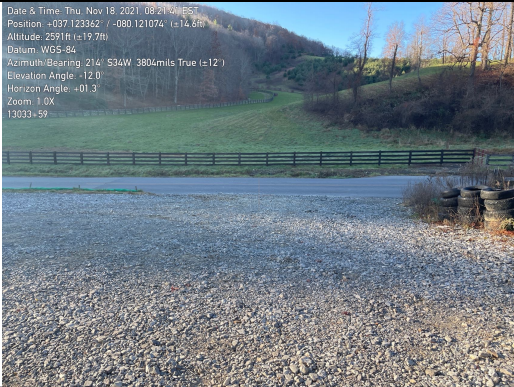
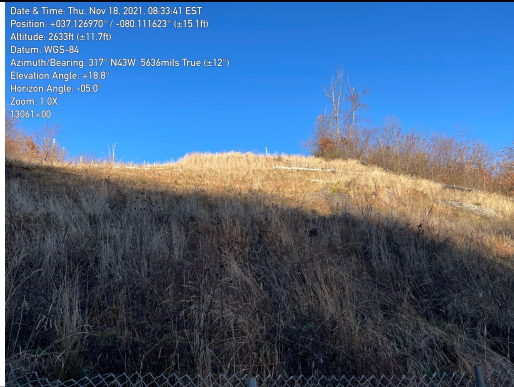
GPS Location	0	GPS Location	0		
Field Station#	13033+59	Field Station#	13061+00		
Pic 3 Desc.	RCE in good condition and functioning properly		Pic 4 Desc.	ROW and ECDs In good condition with good vegetation established across ROW	
<p>Date & Time: Thu Nov 18, 2021, 08:34:06 EST Position: +037 124222 / -080 111524 (±15.1ft) Altitude: 2618ft (±11.7ft) Datum: WGS-84 Azimuth/Bearing: 105° S 71E 193mils True (±12.1) Elevation Angle: -11.0° Horizon Angle: +00.0° Zoom: 1.0X 13061+89</p>

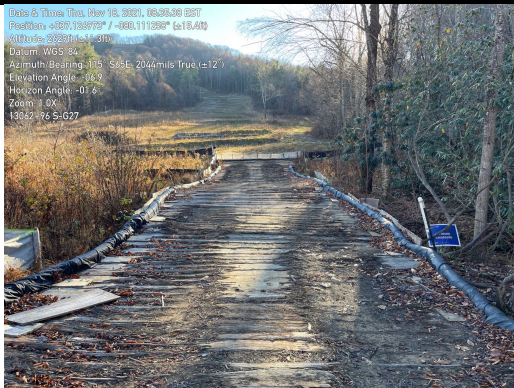
GPS Location	0	GPS Location	0		
Field Station#	13061+89	Field Station#	13062+96		
Pic 5 Desc.	MVP-S-G26 and Corresponding buffer zone in good condition		Pic 6 Desc.	MVP-S-G27 and Corresponding buffer zone in good condition

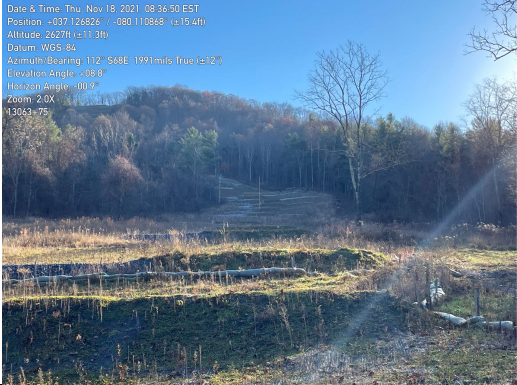
GPS Location		0		GPS Location	
Field Station#		13063+75		Field Station#	
Pic 7 Desc.		ROW and ECDs In good condition with good vegetation established across ROW		Pic 8 Desc.	
				Equipment bridge in good condition	
<p>Date & Time: Thu, Nov 18, 2021 09:24:45 EST Position: +037.122362 / -080.094828 (-s15.1m) Altitude: 2691ft (-s11.7m) Datum: WGS-84 Azimuth-Bearing: 319.141W, 5671mils True (-s12°) Elevation-Angle: -11.5 Horizon-Angle: -02.0 Zoom: 1.0X 13113+00</p>

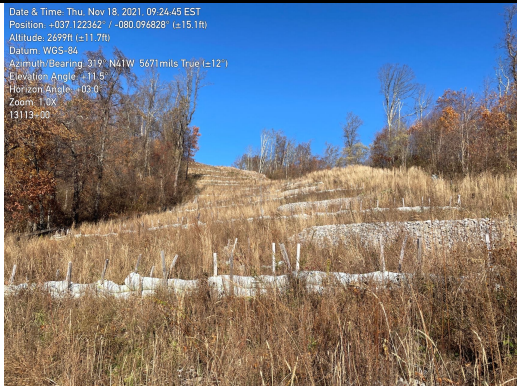
GPS Location		0		GPS Location	
Field Station#		13113+00		Field Station#	
Pic 9 Desc.		ROW and ECDs In good condition with good vegetation established across ROW		Pic 10 Desc.	
				Waterbar maintenance ongoing	
<p>Date & Time: Thu, Nov 18, 2021 12:31:30 EST Position: +037.121662 / -080.092730 (-s15.2m) Altitude: 2484ft (-s9.7m) Datum: WGS-84 Azimuth-Bearing: 088.108E, 1582mils True (-s11°) Elevation-Angle: -04.4 Horizon-Angle: -02.7 Zoom: 1.0X 13120+00</p>

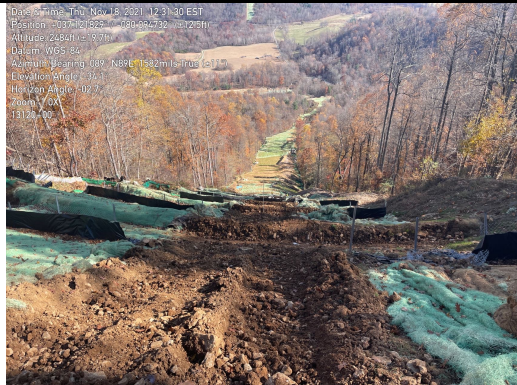
GPS Location		0		GPS Location	
Field Station#		13120+00		Field Station#	
Pic 11 Desc.		Waterbar maintenance ongoing		Pic 12 Desc.	
				Environmental crews working on installing Curlex on hillside

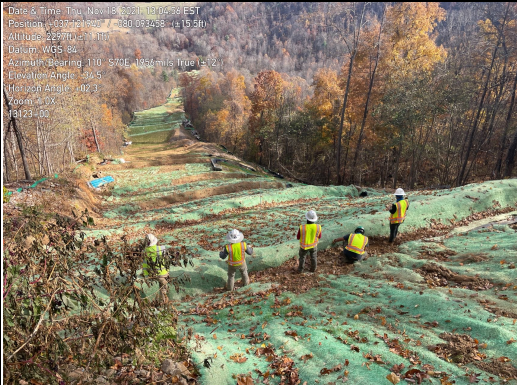
GPS Location		0		GPS Location		0					
Field Station#		13123+00		Field Station#		13123+00					
Pic 13 Desc.		Crew clearing waterbar of rock and debris		Pic 14 Desc.		Gripple pins installed at 2' spacing

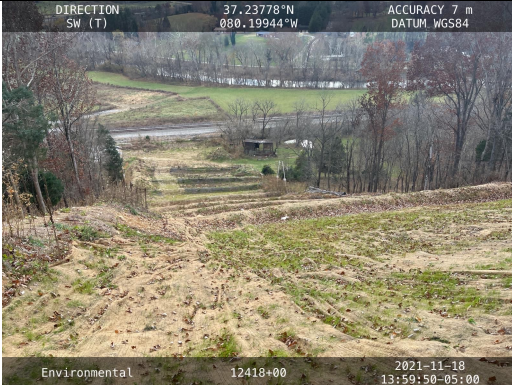
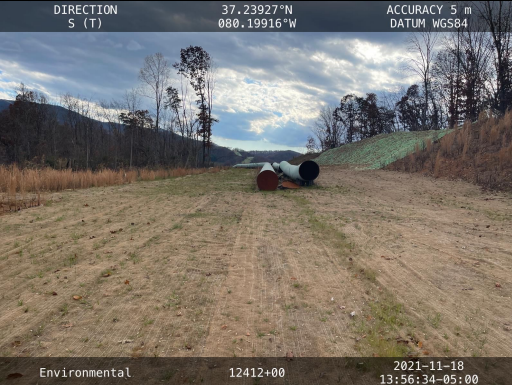
GPS Location	See photo		GPS Location	See photo	
Field Station#	12418+00		Field Station#	12412+00	
Pic 1 Desc.	Stabilized ROW conditions		Pic 2 Desc.	Stabilized ROW conditions

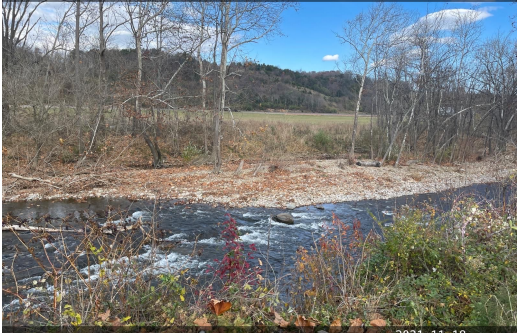
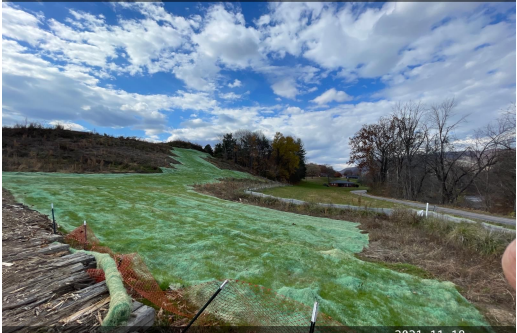
<div>Environmental 12437+70 2021-11-18 12:36:22-05:00</div> </div>			
GPS Location	See photo		GPS Location	See photo	
Field Station#	12435+50		Field Station#	12437+70	
Pic 13 Desc.	Stream crossing S-NN16		Pic 14 Desc.	Stabilized ROW conditions	
<div> <div>DIRECTION NW (T)</div> <div>37.23244°N 080.19882°W</div> <div>ACCURACY 5 m DATUM WGS84</div>

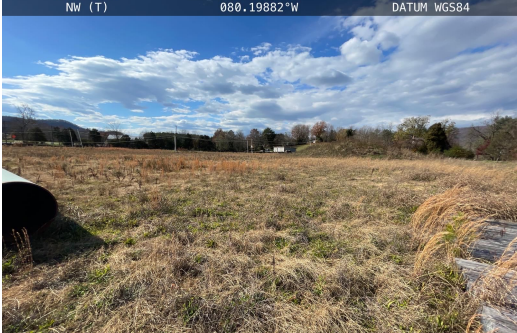
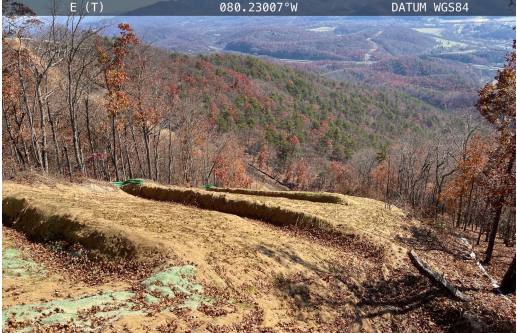
GPS Location	See photo		GPS Location	See photo	
Field Station#	12439+00		Field Station#	12286+00	
Pic 15 Desc.	Stabilized ROW conditions		Pic 16 Desc.	Stabilized ROW conditions	
<div> <div>DIRECTION NE (T)</div> <div>37.25537°N 080.23009°W</div> <div>ACCURACY 8 m DATUM WGS84</div>

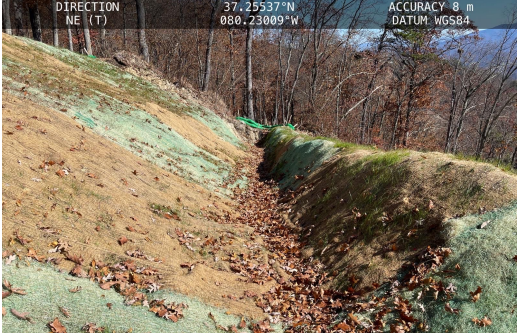
<div>Environmental 12286+00 2021-11-18 11:36:01-05:00</div> </div>		<div> <div>DIRECTION W (T)</div> <div>37.25567°N 080.23021°W</div> <div>ACCURACY 4 m DATUM WGS84</div>   <div>Environmental 12284+75 2021-11-18 11:36:26-05:00</div> </div>			
GPS Location	See photo		GPS Location	See photo	
Field Station#	12286+00		Field Station#	12284+75	
Pic 17 Desc.	Waterbar In Acceptable condition		Pic 18 Desc.	Access Road MVP-MN-276.03 ROW crossing

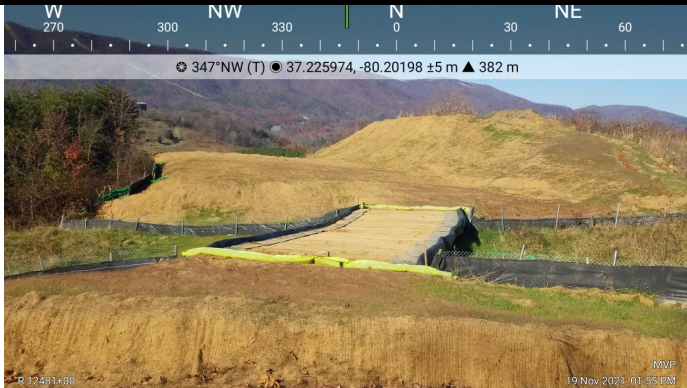
GPS Location	See Above	GPS Location	See Above		
Field Station#	12481+00	Field Station#	12488+00		
Pic 5 Desc.	(reroute stationing) ROW Overview (temporary stabilization). ECDs are functional and ROW is stable.	Pic 6 Desc.	(reroute stationing) ROW Overview (temporary stabilization). ECDs are functional and ROW is stable.

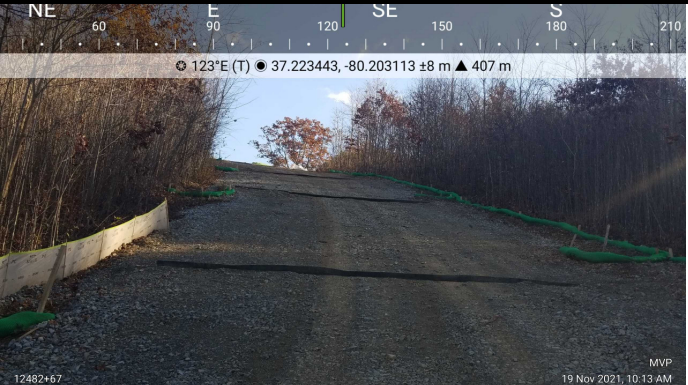
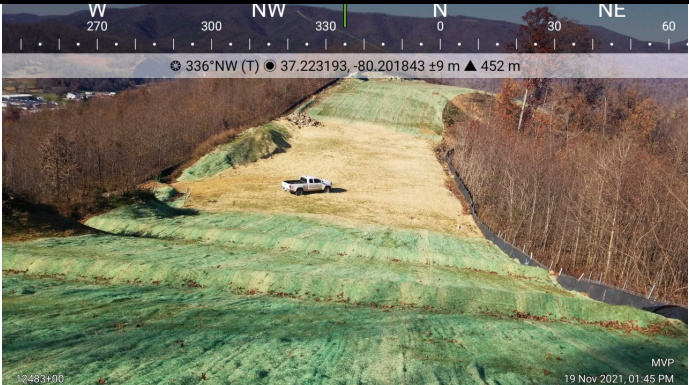
GPS Location	See Above		GPS Location	See Above	
Field Station#	12482+67		Field Station#	12483+00	
Pic 7 Desc.	MLV-28 overview. ECDs are functional and area is stable.		Pic 8 Desc.	ROW Overview (temporary stabilization). ECDs are functional and ROW is stable.

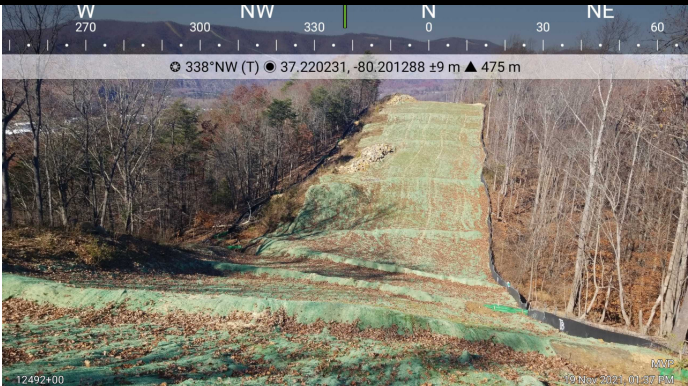
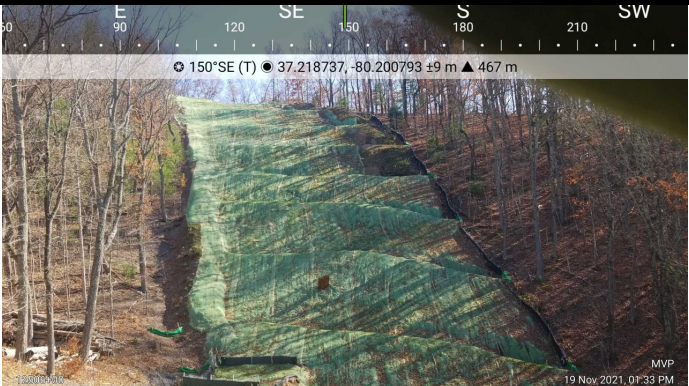
GPS Location	See Above		GPS Location	See Above	
Field Station#	12492+00		Field Station#	12506+00	
Pic 9 Desc.	ROW Overview (temporary stabilization). ECDs are functional and ROW is stable.		Pic 10 Desc.	ROW Overview (temporary stabilization). ECDs are functional and ROW is stable.

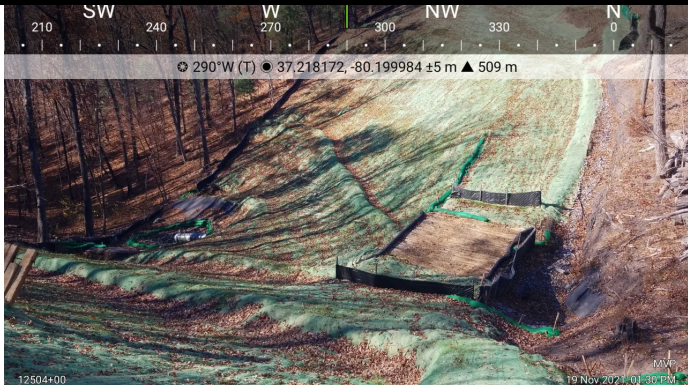
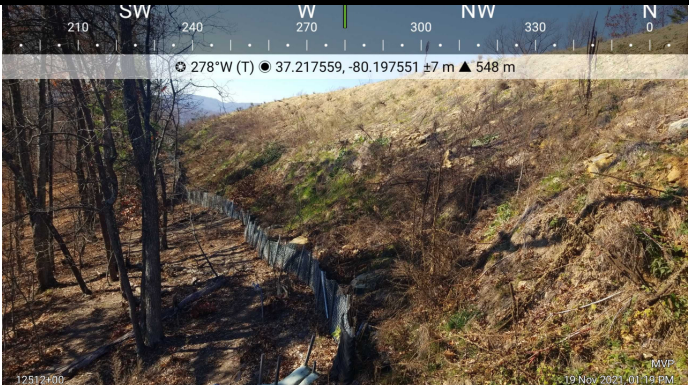
GPS Location	See Above		GPS Location	See Above	
Field Station#	12504+00		Field Station#	12512+00	
Pic 11 Desc.	ROW Overview (temporary stabilization). ECDs are functional and ROW is stable.		Pic 12 Desc.	ROW Overview (temporary stabilization). ECDs are functional and ROW is stable.

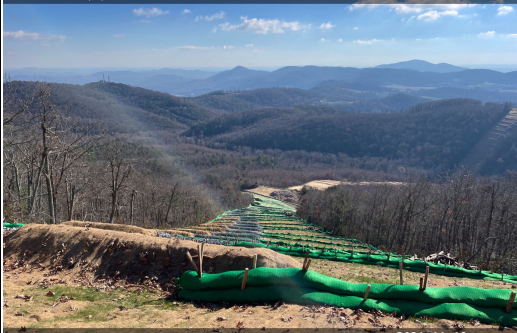
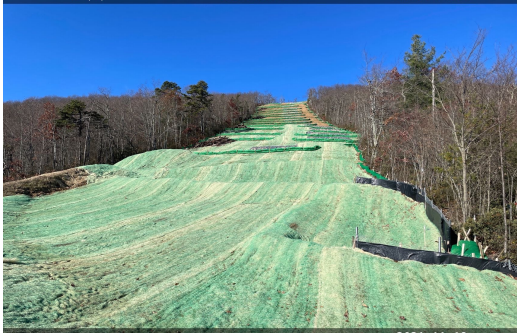
12692+00		12704+00			
ROW Conditions		ROW Conditions			
2021-11-19 09:52:14-05:00		2021-11-19 10:02:34-05:00			
GPS Location	See photo				
Field Station#	12692+00				
Pic 7 Desc.	Current ROW conditions. ROW is stable. ECDs are functional.				
<div>DIRECTION SE (T)</div> <div>37.19058°N 080.15326°W</div> <div>ACCURACY 5 m DATUM WGS84</div>

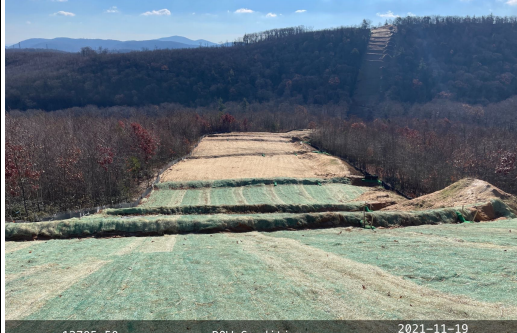
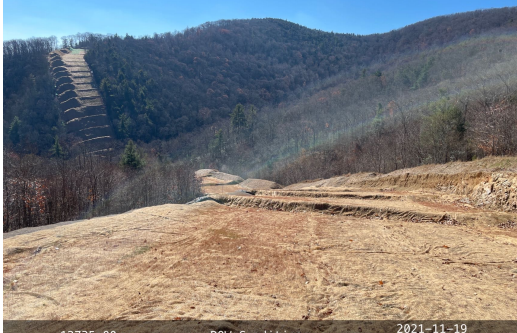
12705+50		12735+00			
ROW Conditions		ROW Conditions			
2021-11-19 10:03:36-05:00		2021-11-19 11:27:05-05:00			
GPS Location	See photo				
Field Station#	12705+50				
Pic 9 Desc.	Current ROW conditions. ROW is stable. ECDs are functional.

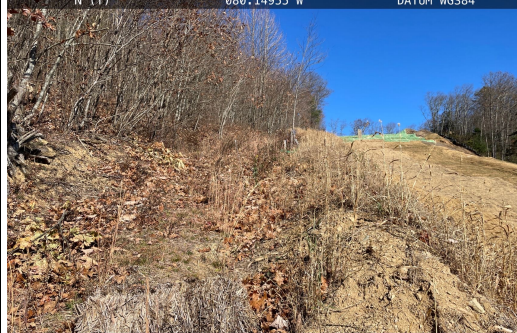
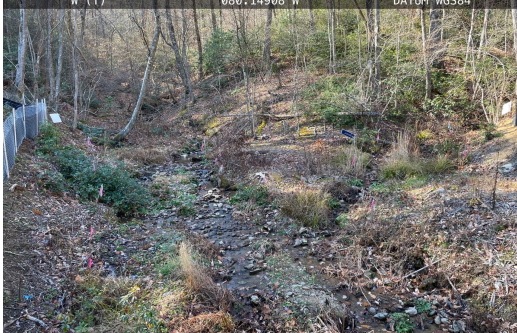
12734+00		12743+84			
CWD Berm		S-EF34B			
2021-11-19 11:20:26-05:00		2021-11-19 11:51:16-05:00			
GPS Location	See photo				
Field Station#	12734+00				
Pic 11 Desc.	CWD Berm is stable and functional				
<div>DIRECTION W (T)</div> <div>37.18140°N 080.14908°W</div> <div>ACCURACY 5 m DATUM WGS84</div>

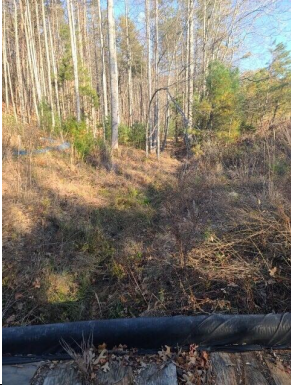
<p>Insert image here</p>		<p>Insert image here</p>	
GPS Location	0000	GPS Location			
Field Station#	13533+52	Field Station#			
Pic 7 Desc.	Stream observation photo facing upstream during routine inspection, no environmental issues observed at the time of inspection.		Pic 8 Desc.		
<p>Insert image here</p>		<p>Insert image here</p>			
GPS Location			GPS Location		
Field Station#			Field Station#		
Pic 9 Desc.			Pic 10 Desc.		
<p>Insert image here</p>		<p>Insert image here</p>			
GPS Location			GPS Location		
Field Station#			Field Station#		
Pic 11 Desc.			Pic 12 Desc.
