Visual Site Inspection Report

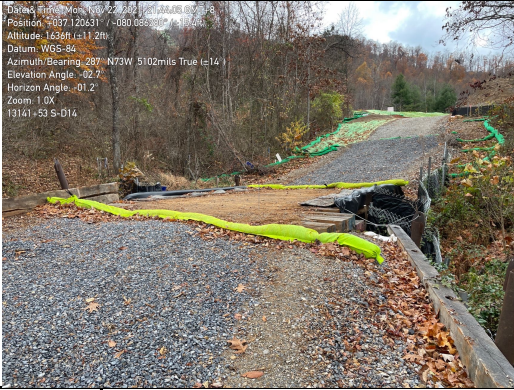
<p>Date & Time: Mon, Nov 22, 2021, 21:55:15 GMT+8 Position: +037.122419 / +080.086095 (±11.5m) Altitude: 1636ft (±11.2m) Datum: WGS-84 Azimuth/Bearing: 287° N73W 5102mils True (±14°) Elevation Angle: -02.7° Horizon Angle: -01.2° Zoom: 1.0X 13141+53 S-D14</p>		<p>GPS Location 0</p> <p>Field Station# 13141+53</p> <p>Pic 1 Desc. MVP-S-D14 and Corresponding buffer zone in good condition</p>

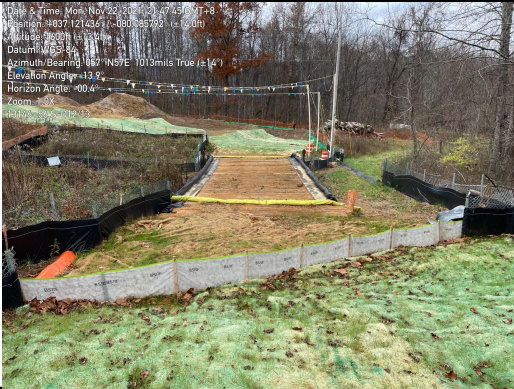
<p>Date & Time: Mon, Nov 22, 2021, 21:55:15 GMT+8 Position: +037.122419 / +080.086095 (±11.5m) Altitude: 1636ft (±11.2m) Datum: WGS-84 Azimuth/Bearing: 287° N73W 5102mils True (±14°) Elevation Angle: -02.7° Horizon Angle: -01.2° Zoom: 1.0X 13141+53 S-D14</p>		<p>GPS Location 0</p> <p>Field Station# 13146+56</p> <p>Pic 3 Desc. MVP-S-D12/13 and Corresponding buffer zone in good condition</p>

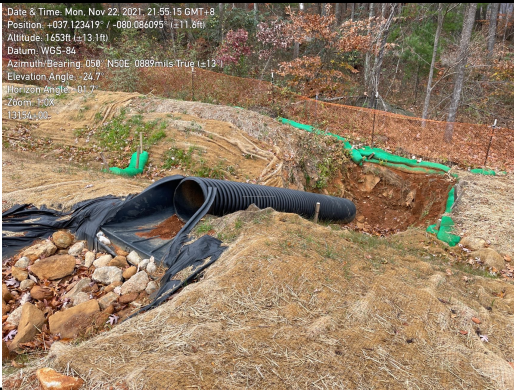
<p>Date & Time: Mon, Nov 22, 2021, 21:55:15 GMT+8 Position: +037.122419 / +080.086095 (±11.5m) Altitude: 1636ft (±11.2m) Datum: WGS-84 Azimuth/Bearing: 287° N73W 5102mils True (±14°) Elevation Angle: -02.7° Horizon Angle: -01.2° Zoom: 1.0X 13141+53 S-D14</p>		<p>GPS Location 0</p> <p>Field Station# 13154+00</p> <p>Pic 5 Desc. Slope drain pipe in good condition and functioning properly</p>

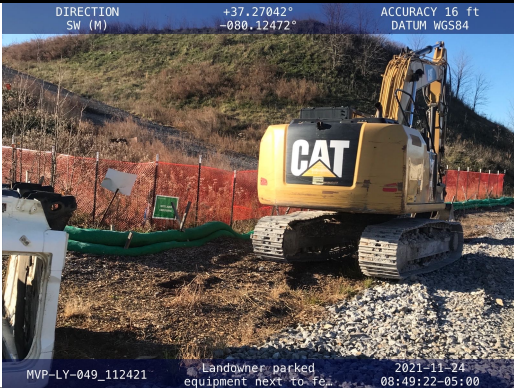
Pic 5 Desc.	Landowner parked equipment next to feature W-CV21B. Looking SW.	Pic 6 Desc.	Landowner soil disturbance and debris piled along triple stack compost filter sock and east of feature W-CV21B. Looking S.

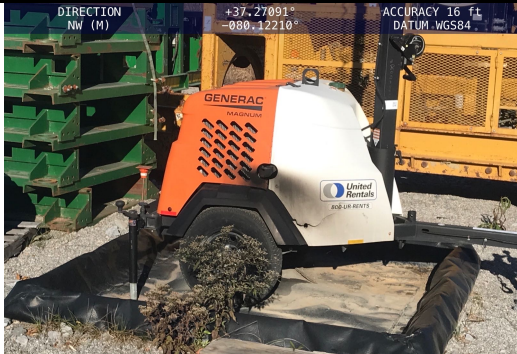
<p>DIRECTION NW (M) +37.27091° -080.12210° ACCURACY 16 ft DATUM WGS84</p> <p>MVP-LY-049_112421 Containment under light plant 2021-11-24 09:27:05-05:00</p>

GPS Location	MVP-LY-049 See photo for gps data		GPS Location	MVP-LY-049 See photo for gps data	
Field Station#	+0		Field Station#	+0	
Pic 9 Desc.	Secondary containment under light plant free of fluids. Looking NW.		Pic 10 Desc.	Trays and containment under toilets. Trays free of fluids. Looking NE.	
  <p>DIRECTION S (M) +37.27059° -080.12038° ACCURACY 33 ft DATUM WGS84</p> <p>MVP-LY-049_112421 Containment under stored trailer 2021-11-24 09:28:15-05:00</p>

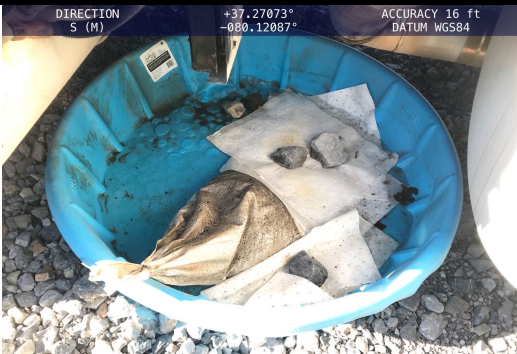
<p>DIRECTION S (M) +37.27073° -080.12087° ACCURACY 16 ft DATUM WGS84</p> <p>MVP-LY-049_112421 Containment under stored vehicle 2021-11-24 09:28:39-05:00</p>			
GPS Location	MVP-LY-049 See photo for gps data		GPS Location	MVP-LY-049 See photo for gps data	
Field Station#	+0		Field Station#	+0	
Pic 11 Desc.	Secondary containment under stored trailer. Holding fluids. Looking S.		Pic 12 Desc.	Secondary containment under stored vehicle. Holding fluids. Looking S.

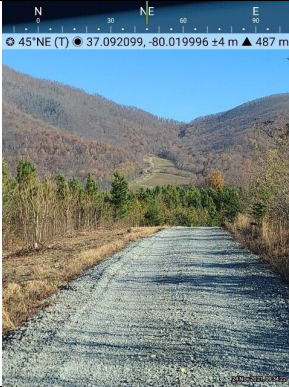
GPS Location	00000	GPS Location	0000		
Field Station#	13437+75	Field Station#	13419+70		
Pic 1 Desc.	Photo showing access road and area where 3rd party mowing was done previously. No environmental issues observed at the time of inspection.	Pic 2 Desc.	Monitored erosion control blanket on hill side above road crossing showing some winter vegetation, no environmental issues observed at the time of inspection.

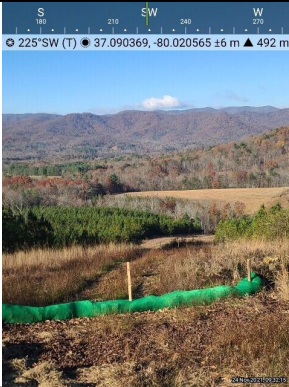
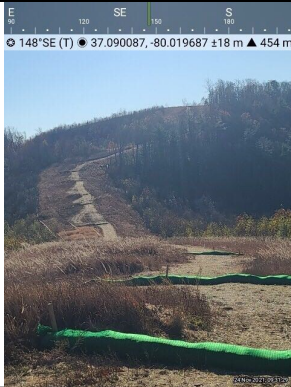
GPS Location	0000	GPS Location	0000		
Field Station#	13435+00	Field Station#	13438+90		
Pic 3 Desc.	Monitored ECDs and vegetation, no environmental issues observed at the time of inspection.	Pic 4 Desc.	Monitored ECDs and vegetation, no environmental issues observed at the time of inspection.

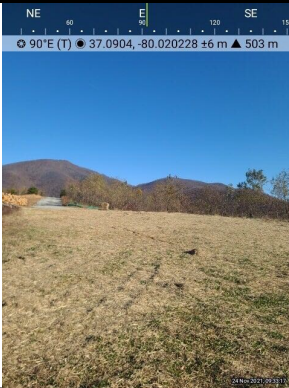
GPS Location	0000	GPS Location	0000		
Field Station#	13438+00	Field Station#	13423+30		
Pic 5 Desc.	Stabilization photo showing winter vegetation growth in work space, no environmental issues observed at the time of inspection	Pic 6 Desc.	Row photo taken in permanent area of row showing vegetation, no environmental issues observed at the time of inspection

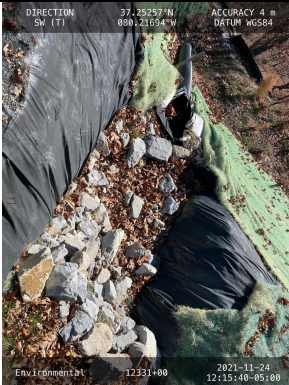
GPS Location	See photo		GPS Location	See photo	
Field Station#	1232+00		Field Station#	12331+00	
Pic 7 Desc.	Stabilized ROW conditions		Pic 8 Desc.	Fill slope drain

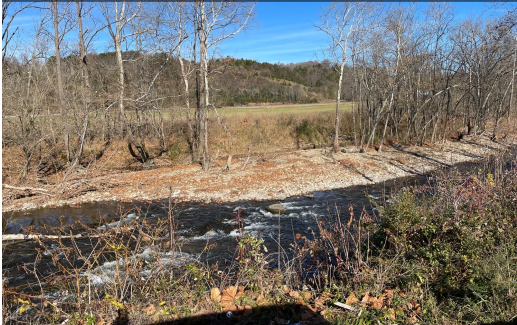
Environmental 12435+50 2021-11-24 13:05:40-05:00		DIRECTION SW (T) 37.23322°N 080.19818°W ACCURACY 5 m DATUM WGS84

Environmental 12437+70 2021-11-24 13:06:07-05:00			
GPS Location	See photo		GPS Location	See photo	
Field Station#	12435+50		Field Station#	12437+70	
Pic 13 Desc.	Stream crossing S-NN16 in acceptable condition		Pic 14 Desc.	Stabilized ROW conditions	
DIRECTION NE (T) 37.23670°N 080.19958°W ACCURACY 4 m DATUM WGS84

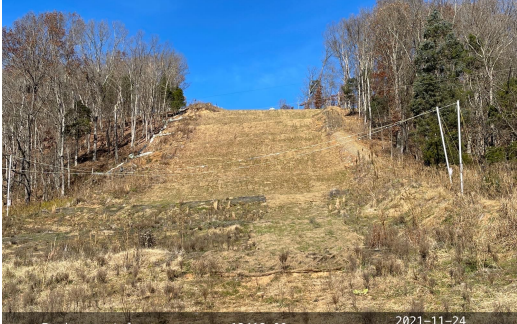
Environmental 12418+00 2021-11-24 13:13:54-05:00		DIRECTION SW (T) 37.23541°N 080.19545°W ACCURACY 4 m DATUM WGS84

Environmental 12424+01 2021-11-24 13:16:59-05:00			
GPS Location	See photo		GPS Location	See photo	
Field Station#	12418+00		Field Station#	12424+01	
Pic 15 Desc.	Stabilized ROW conditions		Pic 16 Desc.	Access Road MVP-MN-279 in acceptable condition

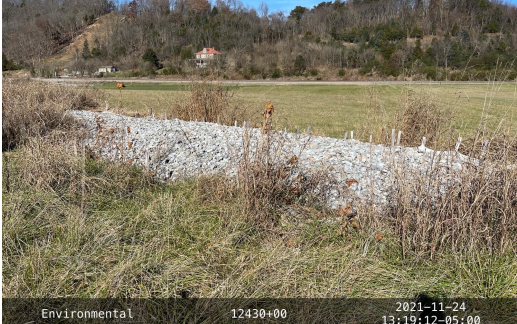
Environmental 12430+00 2021-11-24 13:19:12-05:00		DIRECTION NW (T) 37.23465°N 080.19865°W ACCURACY 4 m DATUM WGS84

Environmental 12426+00 2021-11-24 13:20:02-05:00			
GPS Location	See photo		GPS Location	See photo	
Field Station#	12430+00		Field Station#	12426+00	
Pic 17 Desc.	Clean water crossing level spreader outlet		Pic 18 Desc.	Stabilized ROW conditions

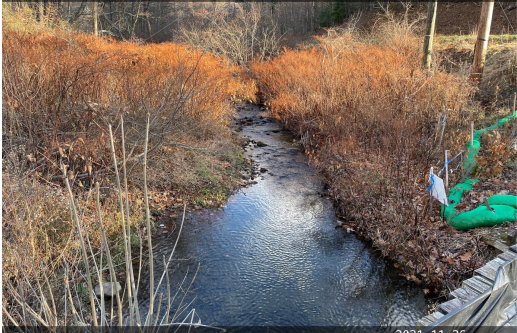
12777+52 S-EF32 2021-11-26 08:57:34-05:00			
GPS Location	See photo		GPS Location	See photo	
Field Station#	12772+00		Field Station#	12777+52	
Pic 7 Desc.	Stockpile is well stabilized		Pic 8 Desc.	Upstream of crossing at Stream S-EF32	
DIRECTION S (T) 37.17948°N 080.14048°W ACCURACY 5 m DATUM WGS84

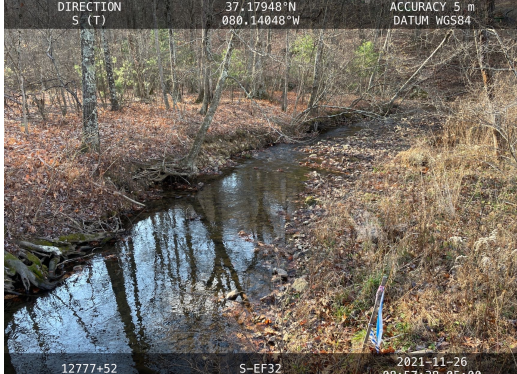
12777+52 S-EF32 2021-11-26 08:57:38-05:00		DIRECTION W (T) 37.18185°N 080.14656°W ACCURACY 5 m DATUM WGS84   12728+74 RO-281 2021-11-26 09:04:02-05:00			
GPS Location	See photo		GPS Location	See photo	
Field Station#	12777+52		Field Station#	12728+74	
Pic 9 Desc.	Downstream of crossing at Stream S-EF32		Pic 10 Desc.	Access Road RO-281 is well maintained

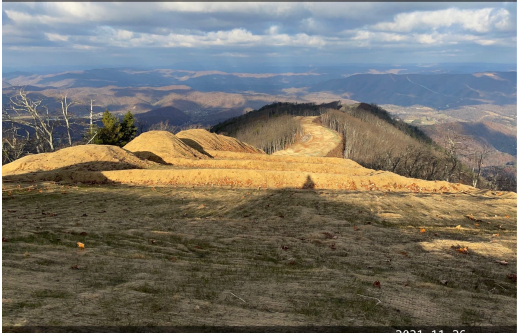
12635+00 ROW condition 2021-11-26 08:57:39-05:00		DIRECTION W (T) +37.19245° -080.17512° ACCURACY 15 ft DATUM WGS84

12634+00 Slope drain 2021-11-26 08:58:00-05:00			
GPS Location	See photo for gps location data		GPS Location	See photo for gps location data	
Field Station#	12635+00		Field Station#	12634+00	
Pic 7 Desc.	Photo shows the ROW condition. ECDs are installed and functioning as designed.		Pic 8 Desc.	Photo shows the slope drain	
DIRECTION NW (T) +37.19241° -080.15866° ACCURACY 12 ft DATUM WGS84

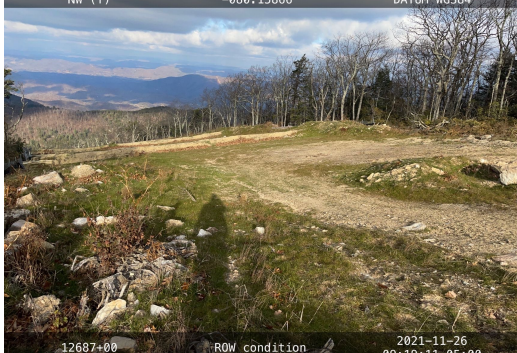
Field Station#	12687+00		Field Station#	12689+00	
Pic 9 Desc.	Photo shows the ROW condition. ECDs are installed and functioning as designed.		Pic 10 Desc.	Photo shows the ROW condition. ECDs are installed and functioning as designed.	
DIRECTION SE (T) +37.19187° -080.15723° ACCURACY 12 ft DATUM WGS84

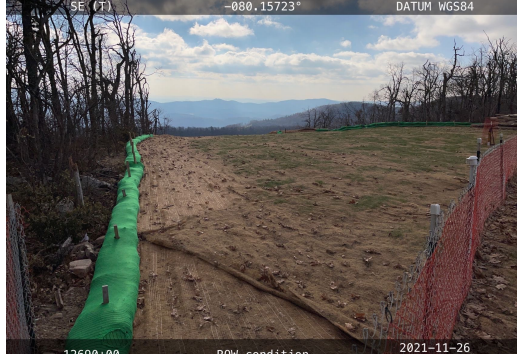
12690+00 ROW condition 2021-11-26 09:21:43-05:00		DIRECTION S (T) +37.19168° -080.15701° ACCURACY 15 ft DATUM WGS84

12691+00 Permanent water bar 2021-11-26 09:22:22-05:00			
GPS Location	See photo for gps location data		GPS Location	See photo for gps location data	
Field Station#	12690+00		Field Station#	12691+00	
Pic 11 Desc.	Photo shows the ROW condition. ECDs are installed and functioning as designed.		Pic 12 Desc.	Photo shows the ROW condition. ECDs are installed and functioning as designed.

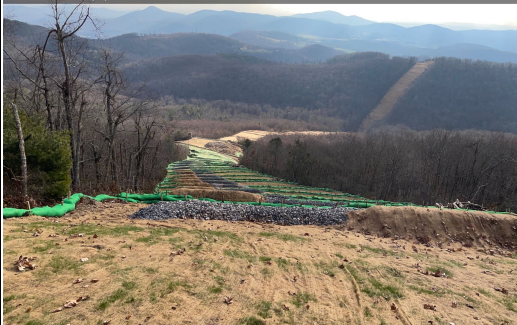
<div>12693+00 ROW condition 2021-11-26 09:23:00-05:00</div>		<div>DIRECTION NW (T) +37.18654° -080.15984° ACCURACY 15 ft DATUM WGS84</div>

<div>12703+04 RO-280 2021-11-26 09:30:24-05:00</div>			
GPS Location	See photo for gps location data		GPS Location	See photo for gps location data	
Field Station#	12693+00		Field Station#	12703+04	
Pic 13 Desc.	Photo shows the ROW condition. ECDs are installed and functioning as designed.		Pic 14 Desc.	Photo shows the condition of access road RO-280.	
<div>DIRECTION W (T) +37.19078° -080.15374° ACCURACY 15 ft DATUM WGS84</div>

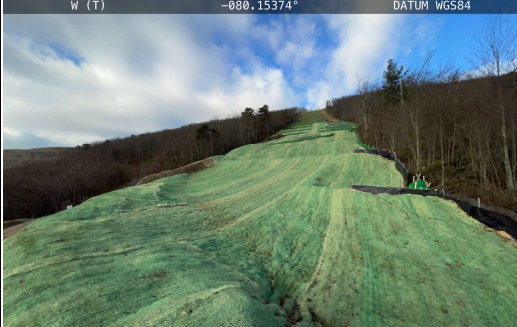
<div>12702+00 ROW condition 2021-11-26 09:34:16-05:00</div>		<div>DIRECTION NE (T) +37.19073° -080.15382° ACCURACY 15 ft DATUM WGS84</div>

GPS Location	See photo for gps location data		GPS Location	See photo for gps location data	
Field Station#	12702+00		Field Station#	12702+00	
Pic 15 Desc.	Photo shows the ROW condition. ECDs are installed and functioning as designed.		Pic 16 Desc.	Photo shows the sump pit and end treatment.	
<div>DIRECTION E (T) +37.19074° -080.15377° ACCURACY 15 ft DATUM WGS84</div>

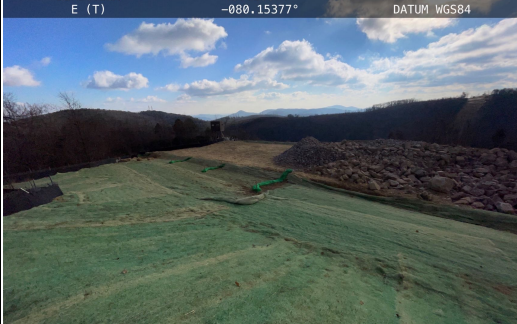
<div>12703+00 ROW condition 2021-11-26 09:34:50-05:00</div>		<div>DIRECTION S (T) +37.19063° -080.15322° ACCURACY 15 ft DATUM WGS84</div>

<div>12704+00 ROW condition 2021-11-26 09:35:51-05:00</div>			
GPS Location	See photo for gps location data		GPS Location	See photo for gps location data	
Field Station#	12703+00		Field Station#	12704+00	
Pic 17 Desc.	Photo shows the ROW condition. ECDs are installed and functioning as designed.		Pic 18 Desc.	Photo shows the ROW condition. ECDs are installed and functioning as designed.

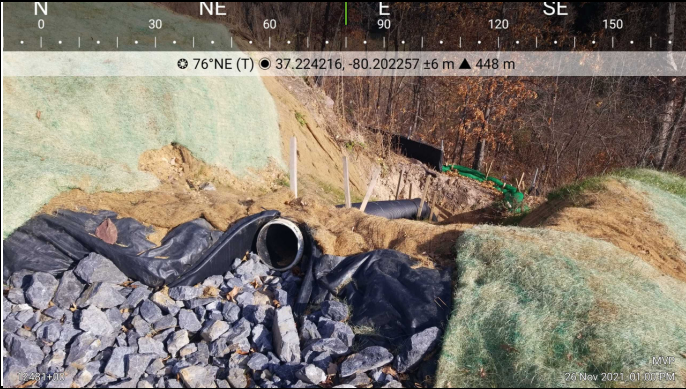
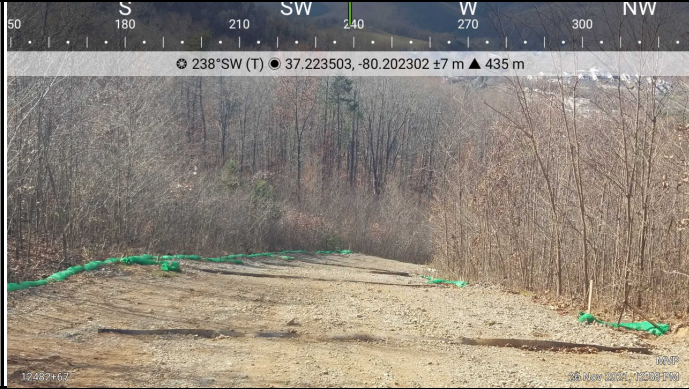
GPS Location	See Above		GPS Location	See Above	
Field Station#	12481+00		Field Station#	12482+67	
Pic 7 Desc.	ROW Overview (temporary stabilization). ECDs are functional and ROW is stable.		Pic 8 Desc.	MLV-28 overview. ECDs are functional and area is stable.

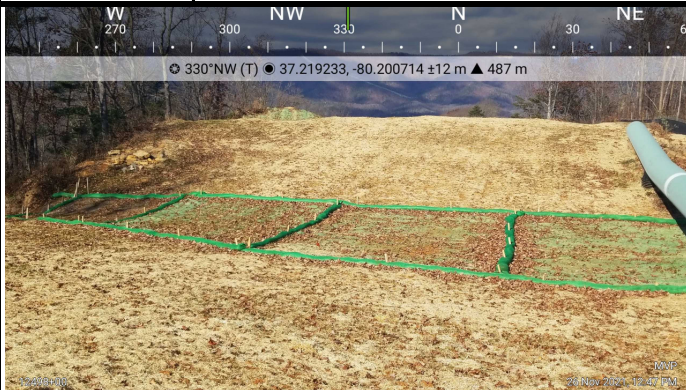
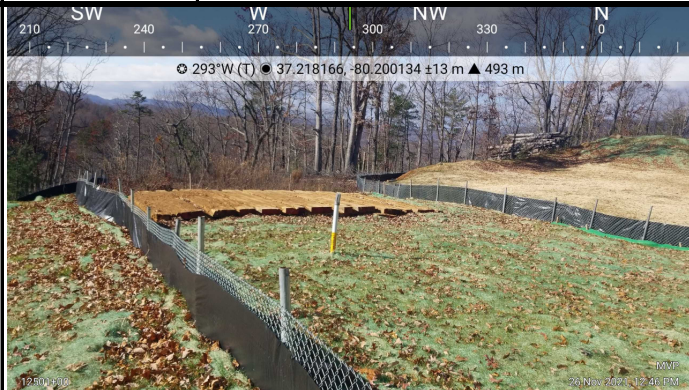
GPS Location	See Above		GPS Location	See Above	
Field Station#	12498+00		Field Station#	12501+00	
Pic 9 Desc.	ROW Overview (temporary stabilization). ECDs are functional and ROW is stable.		Pic 10 Desc.	ROW Overview (temporary stabilization). ECDs are functional and ROW is stable.

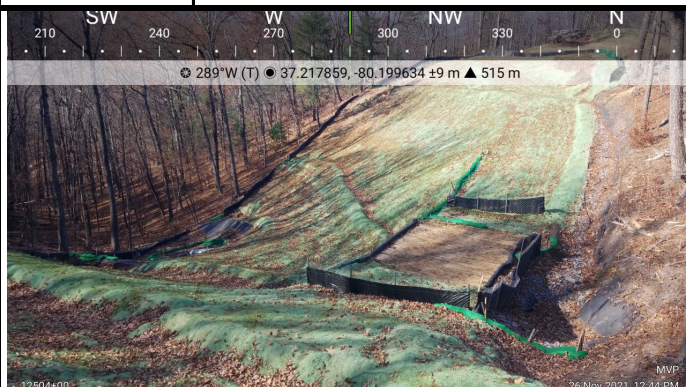
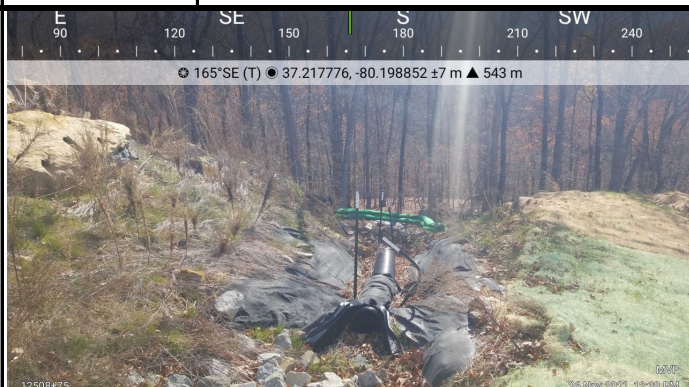
GPS Location	See Above		GPS Location	See Above	
Field Station#	12504+00		Field Station#	12508+75	
Pic 11 Desc.	ROW Overview (temporary stabilization). ECDs are functional and ROW is stable.		Pic 12 Desc.	ROW Overview (temporary stabilization). ECDs are functional and ROW is stable.

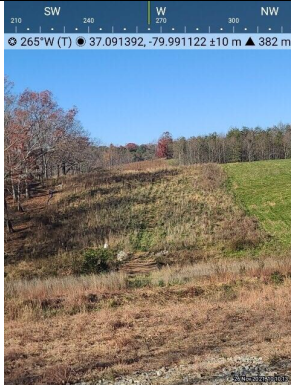
GPS Location	00000	GPS Location	00000		
Field Station#	13541+82	Field Station#	13541+50		
Pic 1 Desc.	Observed ECDs and vegetation on hill side above stream crossing. No environmental issues observed at the time of inspection.		Pic 2 Desc.	Row photo showing permanent vegetation near stream crossing.

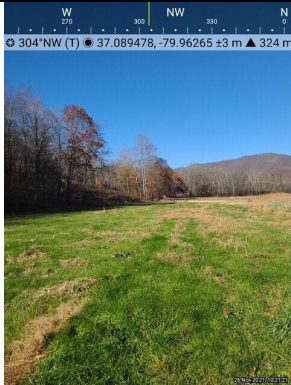
GPS Location	00000	GPS Location	00000		
Field Station#	13541+82	Field Station#	13636+70		
Pic 3 Desc.	Row observation photo showing stream crossing and vegetation, no environmental issues observed at the time of inspection.		Pic 4 Desc.	Vegetation observation photo up row from stream crossing, no environmental issues observed at the time of inspection.

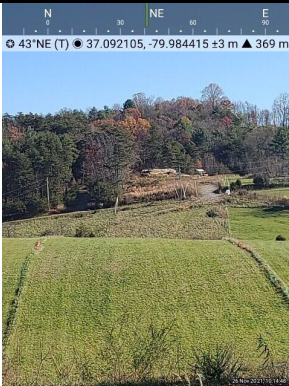
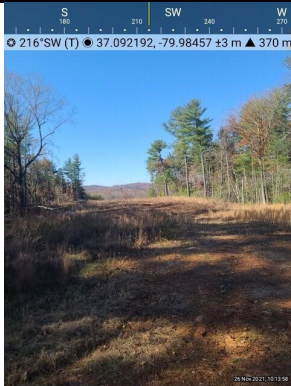
GPS Location	00000	GPS Location	00000		
Field Station#	13563+00	Field Station#	13560+00		
Pic 5 Desc.	Vegetation observation photo in permanent area of row , no environmental issues observed at the time of inspection.		Pic 6 Desc.	Row photo showing vegetation, no environmental issues observed at the time of inspection.
