Visual Site Inspection Report

Project Name	H-600 Pipeline Spread H	AFE	124300138	Spread	H-600 Pipeline Spread H
Contractor	Precision			Report #	31692
Inspector	Bryan Cole			Date/Time	11/29/2021 2:25 PM
Permit #	TBD	Inspection Type	VA SWPP	Station Begin	13141+65
State	VA	Inspection Area	Partial	Station End	13316+21
County	Franklin	Ground	Dry	Temperature (°F)	36.00
Municipality	N/A	Weather	Sunny	Rain Gauge (in)	0.00
				Rain Accumulation Time (days)	0.00

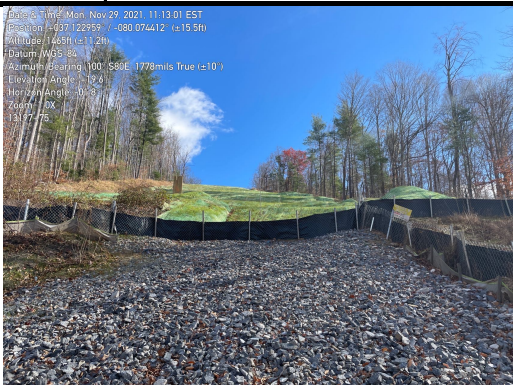
GPS Location	0	GPS Location	0		
Field Station#	13259+00	Field Station#	13197+75		
Pic 5 Desc.	ROW and ECDs In good condition with good vegetation established across ROW	Pic 6 Desc.	ROW and ECDs In good condition and stable

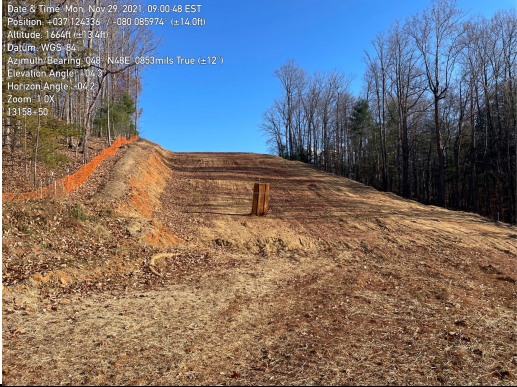
GPS Location 0		GPS Location 0			
Field Station# 13158+50		Field Station# 13157+22			
Pic 13 Desc. ROW and ECDs In good condition and stable		Pic 14 Desc. MVP-S-D11 and Corresponding buffer zone in good condition			
<p>Date & Time: Mon, Nov 29, 2021, 09:57:24 EST Position: +037.123426 / -080.088107 / +11.8m Altitude: 1659ft (+13.1m) Datum: WGS 84 Azimuth/Bearing: 057° NSE 1013mils True (+12°) Elevation Angle: -23.7° Horizon Angle: -02.1° Zoom: 1.0X 13154+00</p>

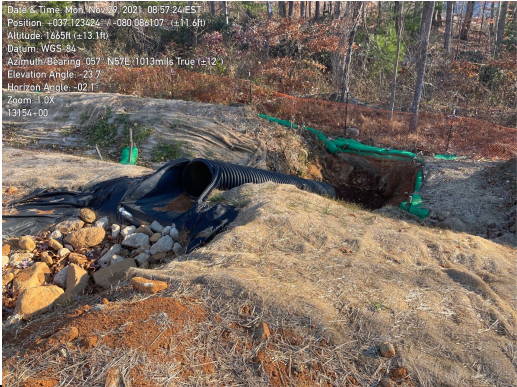
GPS Location 0		GPS Location 0			
Field Station# 13154+00		Field Station# 13146+56			
Pic 15 Desc. Slope drain pipe in good condition and functioning properly		Pic 16 Desc. MVP-S-D12/13 and Corresponding buffer zone in good condition			
<p>Date & Time: Mon, Nov 29, 2021, 09:50:13 EST Position: +037.1401326 / -080.088388 / +11.3m Altitude: 1673ft (+13.1m) Datum: WGS 84 Azimuth/Bearing: 075° NSE 1033mils True (+12°) Elevation Angle: -18.3° Horizon Angle: -00.1° Zoom: 1.0X 13144+00</p>

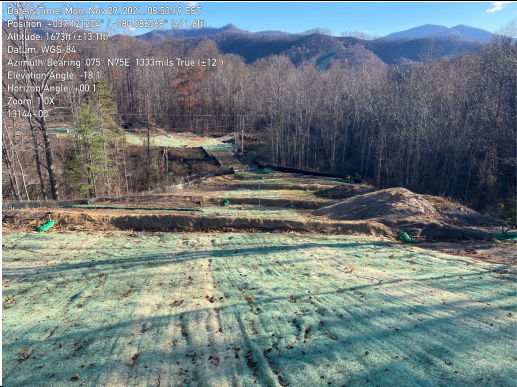
GPS Location 0		GPS Location 0			
Field Station# 13144+00		Field Station# 13141+53			
Pic 17 Desc. ROW and ECDs In good condition and stable		Pic 18 Desc. MVP-S-D14 and Corresponding buffer zone in good condition

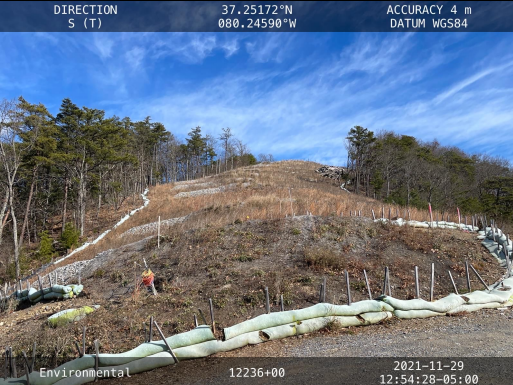
<p>DIRECTION S (T) 37.25172°N 080.24590°W ACCURACY 4 m DATUM WGS84</p> <p>Environmental 12236+00 2021-11-29 12:54:28-05:00</p>			
GPS Location	See photo		GPS Location	see photo	
Field Station#	12230+00		Field Station#	12236+00	
Pic 1 Desc.	Stabilized ROW Conditions		Pic 2 Desc.	Stabilized ROW conditions

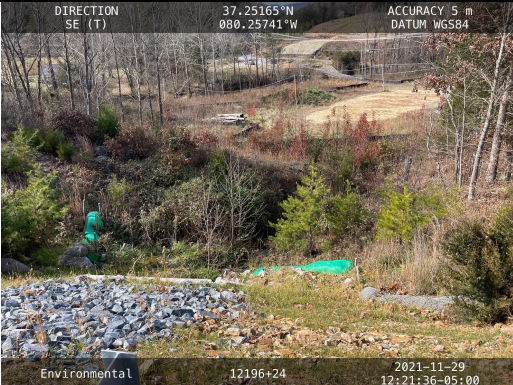
<p>DIRECTION SE (T) 37.25165°N 080.25741°W ACCURACY 5 m DATUM WGS84</p> <p>Environmental 12196+24 2021-11-29 12:21:36-05:00</p>			
GPS Location	See photo		GPS Location	See photo	
Field Station#	12283+00		Field Station#	12196+24	
Pic 3 Desc.	Stabilized ROW conditions		Pic 4 Desc.	Stream crossing S-Oo11 in acceptable condition

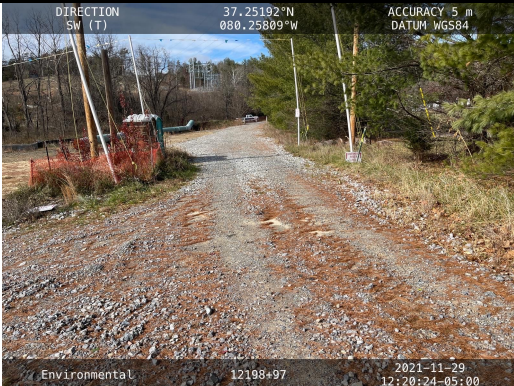
<p>DIRECTION NE (T) 37.25184°N 080.25904°W ACCURACY 4 m DATUM WGS84</p> <p>Environmental 12192+50 2021-11-29 12:18:57-05:00</p>			
GPS Location	See photo		GPS Location	See photo	
Field Station#	12198+97		Field Station#	12192+50	
Pic 5 Desc.	Access Road MVP-MN-275		Pic 6 Desc.	Down stream of S-C21 in acceptable condition

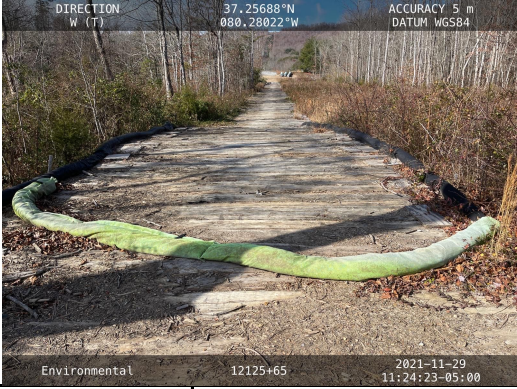
<p>DIRECTION NW (T) 37.25639°N 080.27780°W ACCURACY 5 m DATUM WGS84</p> <p>Environmental 12132+73 2021-11-29 11:20:49-05:00</p>			
GPS Location	See photo		GPS Location	See photo	
Field Station#	12125+65		Field Station#	12132+73	
Pic 13 Desc.	Stream crossing S-MM31 in acceptable condition		Pic 14 Desc.	Stream crossing S-C29 in acceptable condition

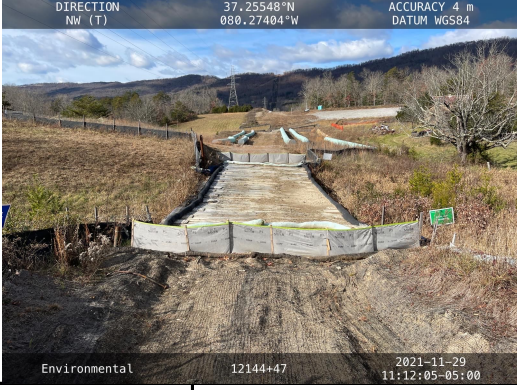
<p>DIRECTION N (T) 37.25505°N 080.27274°W ACCURACY 4 m DATUM WGS84</p> <p>Environmental 12150+90 2021-11-29 11:00:36-05:00</p>			
GPS Location	See photo		GPS Location	See photo	
Field Station#	12144+47		Field Station#	12150+90	
Pic 17 Desc.	Wetland W-C5 crossing in acceptable condition		Pic 18 Desc.	Stabilized drainage feature in acceptable condition

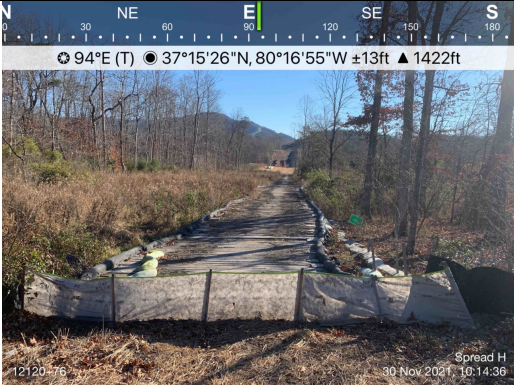
GPS Location	See photo above		GPS Location	See photo above	
Field Station#	12120+76		Field Station#	12118+50	
Pic 1 Desc.	Equipment bridge at wetland crossing is in acceptable condition.		Pic 2 Desc.	Compost filter socks are functional and in good condition.

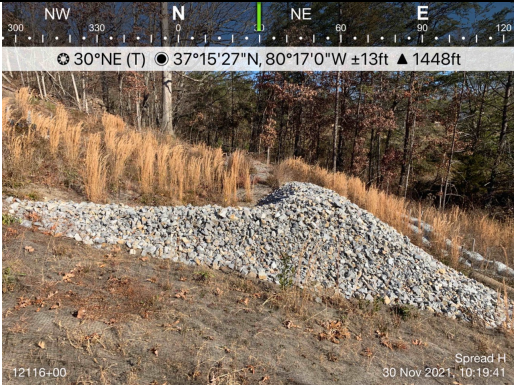
GPS Location	See photo above		GPS Location	See photo above	
Field Station#	12116+00		Field Station#	12119+15	
Pic 3 Desc.	Stone level spreaders are in good condition.		Pic 4 Desc.	Aquatic resource buffers are in place and functioning correctly. No maintenance needed.

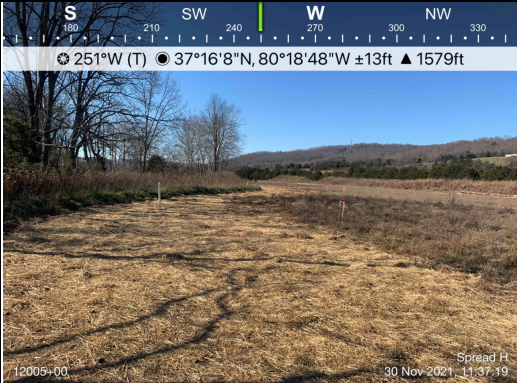
GPS Location	See photo above		GPS Location	See photo above	
Field Station#	12005+00		Field Station#	12031+51	
Pic 13 Desc.	Area near S-G36 flood zone have been recently stabilized and are in good condition. No maintenance needed.		Pic 14 Desc.	Compost filter socks and erosion control blankets under the timber mat bridge at S-G39 are in good condition.

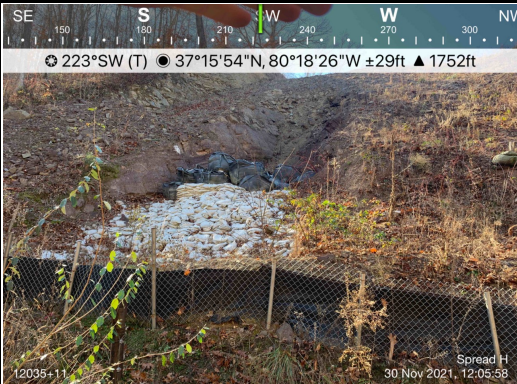
GPS Location	See photo above		GPS Location	See photo above	
Field Station#	12035+11		Field Station#	12037+00	
Pic 15 Desc.	Sand bag and silt fence at S-G40 are in good condition. No active erosion observed.		Pic 16 Desc.	Slopes have been stabilized and are in good condition.

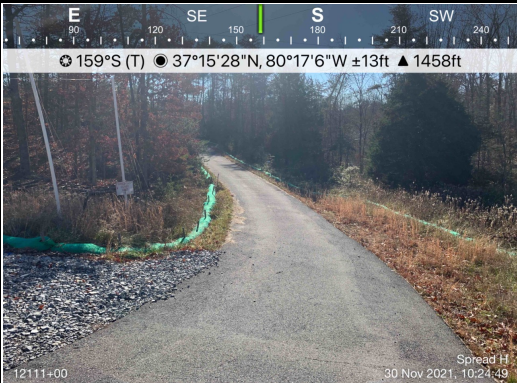
GPS Location	See photo above		GPS Location	See photo above	
Field Station#	12111+00		Field Station#	12037+00	
Pic 17 Desc.	Access roads are properly protected and are in acceptable condition.		Pic 18 Desc.	Plunge pools are functioning properly and are in good condition.

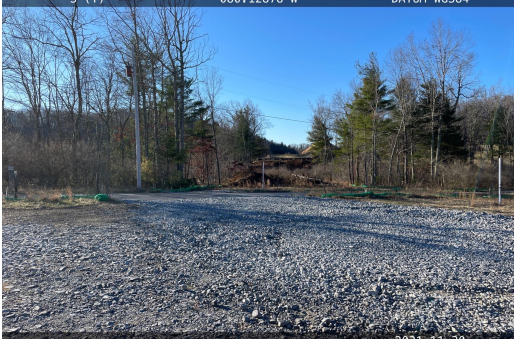
<div>12866+00</div> <div>Topsoil stockpile well stabilized</div> <div>2021-11-30 09:07:46-05:00</div> </div>			
GPS Location	See photo		GPS Location	See photo	
Field Station#	12866+00		Field Station#	12866+00	
Pic 1 Desc.	Bottom Creek Road Crossing. RCEs are well maintained		Pic 2 Desc.	Topsoil stockpile is well stabilized	
<div> <div>DIRECTION SE (T)</div> <div>37.15450°N 080.12923°W</div> <div>ACCURACY 4 m DATUM WGS84</div>

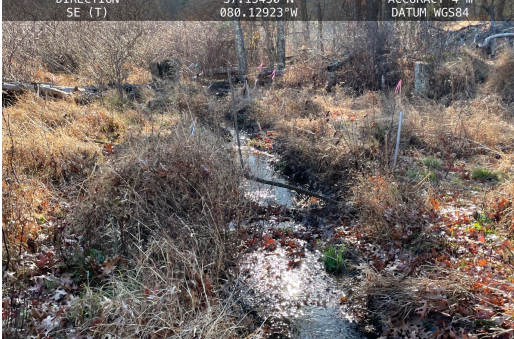
GPS Location	See photo		GPS Location	See photo	
Field Station#	12869+47		Field Station#	12873+00	
Pic 3 Desc.	Stream S-ST9B		Pic 4 Desc.	CWD Pipe and Level Spreader are functional	
<div> <div>DIRECTION S (T)</div> <div>37.15331°N 080.12986°W</div> <div>ACCURACY 4 m DATUM WGS84</div>

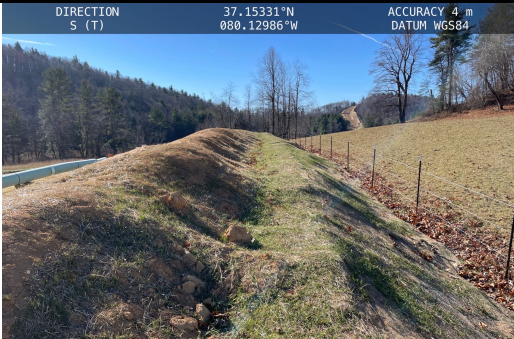
<div>12888+43</div> <div>S-KL55</div> <div>2021-11-30 10:33:55-05:00</div> </div>			
GPS Location	See photo		GPS Location	See photo	
Field Station#	12874+00		Field Station#	12888+43	
Pic 5 Desc.	Stockpiles are well stabilized		Pic 6 Desc.	Equipment Bridge over Stream s-KL55

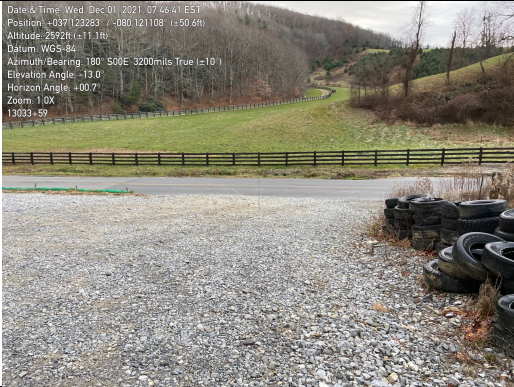
GPS Location		0		GPS Location	
Field Station#		13033+59		Field Station#	
Pic 1 Desc.		RCE in good condition and functioning properly		Pic 2 Desc.	
				ROW and ECDs In good and stable	
<p>Date & Time: Wed Dec 01, 2021, 08:58:19 EST Position: +037.126372° / -080.120712° (+15.5ft) Altitude: 2679ft (+11.1ft) Datum: WGS-84 Azimuth/Bearing: 275 N85W 4889mils True (+12°) Elevation Angle: -19.6° Horizon Angle: +00.9° Zoom: 1.0X 13024+06 S-G24/25</p>

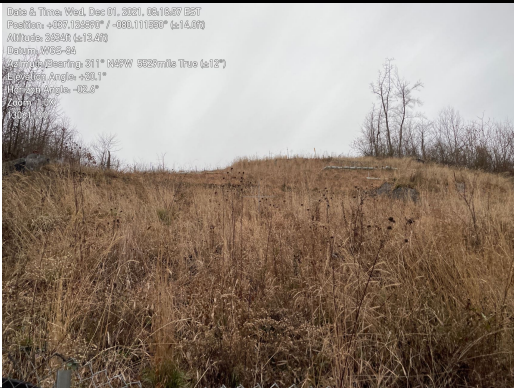
GPS Location		0		GPS Location	
Field Station#		13024+06		Field Station#	
Pic 3 Desc.		MVP-S-G24/25 and Corresponding buffer zone in good condition		Pic 4 Desc.	
				ROW and ECDs In good and stable	
<p>Date & Time: Wed Dec 01, 2021, 08:18:07 EST Position: +037.13495° / -080.111519° (+14.1ft) Altitude: 2630ft (+13.4ft) Datum: WGS-84 Azimuth/Bearing: 311° N45W 5535mils True (+12°) Elevation Angle: -03.1° Horizon Angle: -00.3° Zoom: 1.0X 13061+00</p>

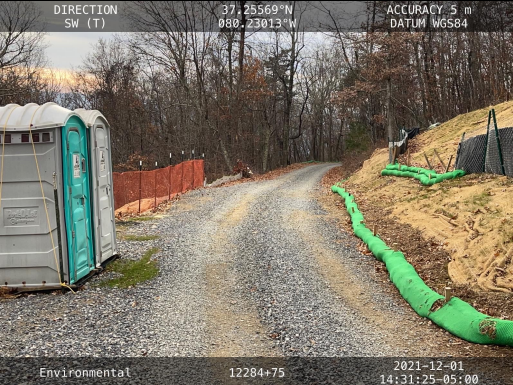
GPS Location	See photo		GPS Location	See photo	
Field Station#	12284+75		Field Station#	12284+75	
Pic 1 Desc.	Stabilized ROW conditions		Pic 2 Desc.	Access Road MVP-MN-276.03 ROW crossing in acceptable condition

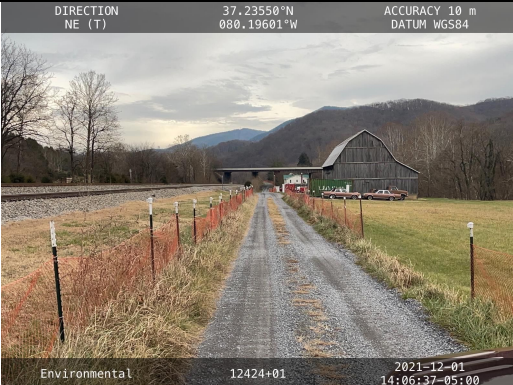
GPS Location	See photo		GPS Location	See photo	
Field Station#	12297+27		Field Station#	12424+01	
Pic 3 Desc.	Stabilized access Road in acceptable condition		Pic 4 Desc.	Access Road MVP-MN-279 In Acceptable condition

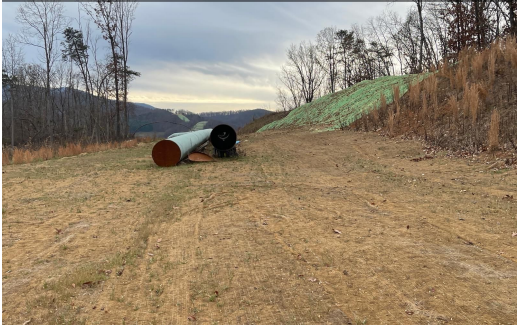
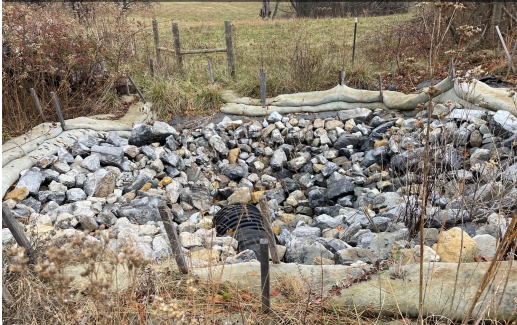
<div>Environmental12410+202021-12-01 13:25:09-05:00</div> </div>	
GPS Location	See photo		GPS Location	See photo	
Field Station#	12412+00		Field Station#	12410+20	
Pic 7 Desc.	Stabilized ROW conditions		Pic 8 Desc.	Clean water crossing pipe outlet in acceptable condition	
<div> <div>DIRECTION NE (T)</div> <div>37.23996°N 080.19937°W</div> <div>ACCURACY 5 m DATUM WGS84</div>

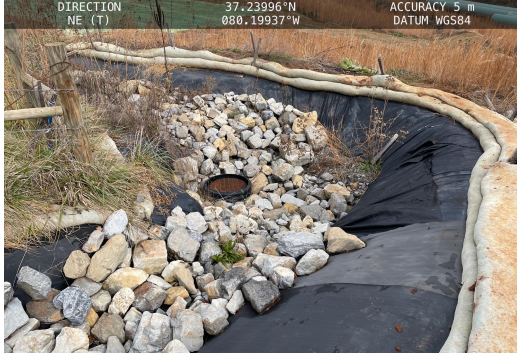
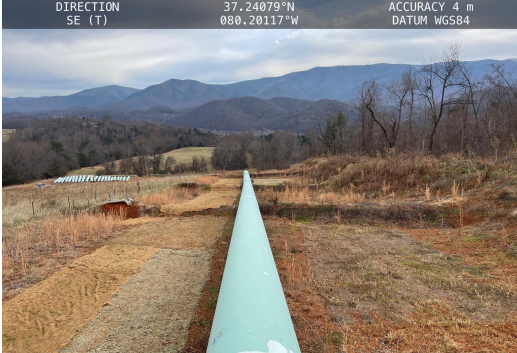
GPS Location	See photo		GPS Location	See photo	
Field Station#	12408+80		Field Station#	12402+00	
Pic 9 Desc.	Clean water crossing pipe inlet in acceptable condition		Pic 10 Desc.	Stabilized ROW conditions	
<div> <div>DIRECTION NE (T)</div> <div>37.24314°N 080.20364°W</div> <div>ACCURACY 6 m DATUM WGS84</div>

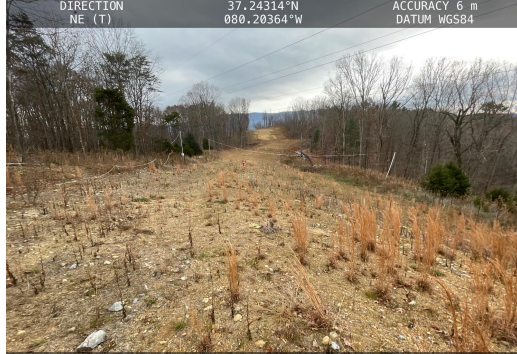
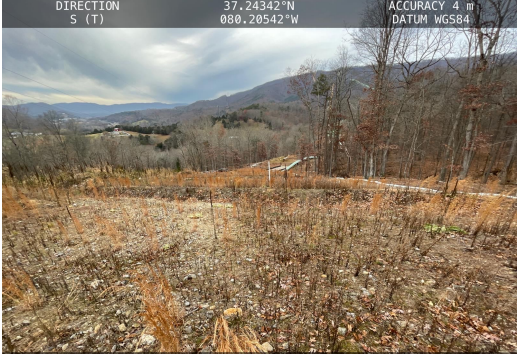
<div>Environmental12386+002021-12-01 13:04:35-05:00</div> </div>	
GPS Location	See photo		GPS Location	See photo	
Field Station#	12393+23		Field Station#	12386+00	
Pic 11 Desc.	Stabilized ROW conditions		Pic 12 Desc.	Stabilized ROW conditions

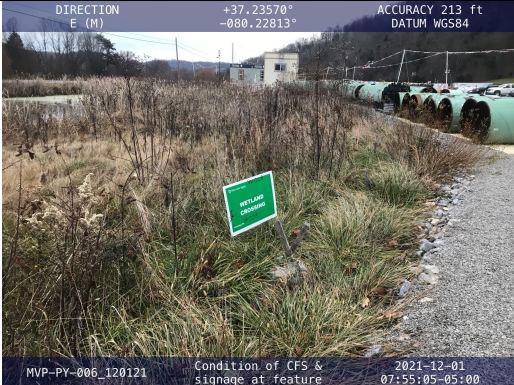
GPS Location	MVP-PY-006 See photo for gps data	GPS Location	MVP-PY-006 See photo for gps data		
Field Station#	+0	Field Station#	+0		
Pic 1 Desc.	Condition of triple stack compost filter sock and signage at feature W-008. Overgrown with vegetation. Looking E.	Pic 2 Desc.	Secondary containment under light plant. Free of fluids. Looking SE.

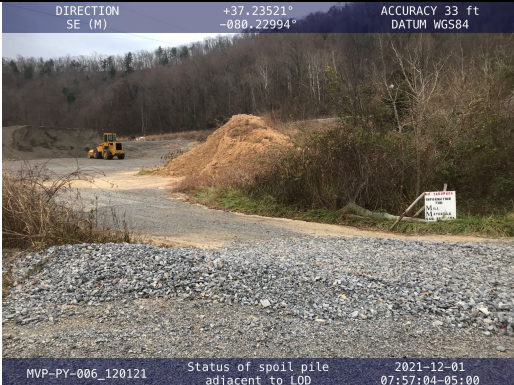
GPS Location	MVP-PY-006 See photo for gps data	GPS Location	MVP-PY-006 See photo for gps data		
Field Station#	+0	Field Station#	+0		
Pic 3 Desc.	Status of spoil pile adjacent to LOD. Soil pile not stabilized. Looking SW.	Pic 4 Desc.	Secondary containments under stored equipment. Looking SW.

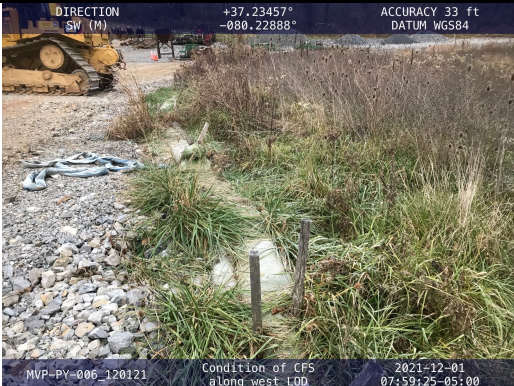
GPS Location	MVP-PY-006 See photo for gps data	GPS Location	MVP-PY-006 See photo for gps data		
Field Station#	+0	Field Station#	+0		
Pic 5 Desc.	Condition of triple stack compost filter sock along west LOD. Overgrown with vegetation. Looking SW.	Pic 6 Desc.	Condition of triple stack compost filter sock along south LOD. Overgrown with vegetation. Looking E.

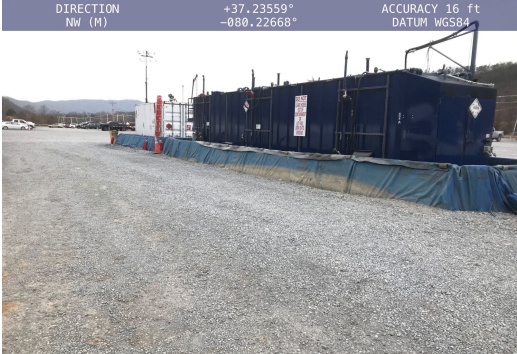
<p>DIRECTION NW (M) +37.23559° -080.22668° ACCURACY 16 ft DATUM WGS84</p> <p>MVP-PY-006_120121 No fuel spills south of tanks 2021-12-01 08:09:16-05:00</p>

<p>DIRECTION W (M) +37.23572° -080.22694° ACCURACY 33 ft DATUM WGS84</p> <p>MVP-PY-006_120121 No leaky internal fittings 2021-12-01 08:09:56-05:00</p>			
GPS Location	MVP-PY-006 See photo for gps data		GPS Location	MVP-PY-006 See photo for gps data	
Field Station#	+0		Field Station#	+0	
Pic 13 Desc.	Blue Bulk Fuel tanks no fuel spills south of the tanks. Looking NW.		Pic 14 Desc.	Blue Bulk Fuel tanks no leaky internal fittings. Looking W.

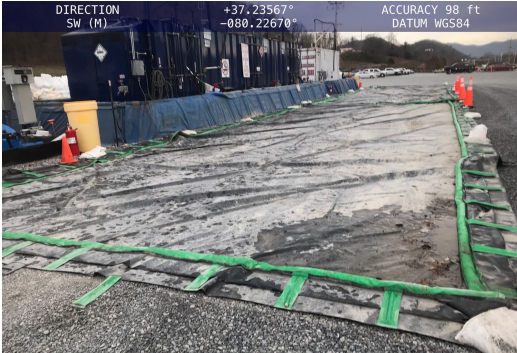
<p>DIRECTION SW (M) +37.23567° -080.22670° ACCURACY 98 ft DATUM WGS84</p> <p>MVP-PY-006_120121 Secondary containment in place for tankers 2021-12-01 08:10:52-05:00</p>

GPS Location	MVP-PY-006 See photo for gps data		GPS Location	MVP-PY-006 See photo for gps data	
Field Station#	+0		Field Station#	+0	
Pic 15 Desc.	Both secondary containments in place for tankers offloading fuel. Looking SW.		Pic 16 Desc.	Off Road Fuel unit condition of internal drip pan. Free of fluids. Looking W.

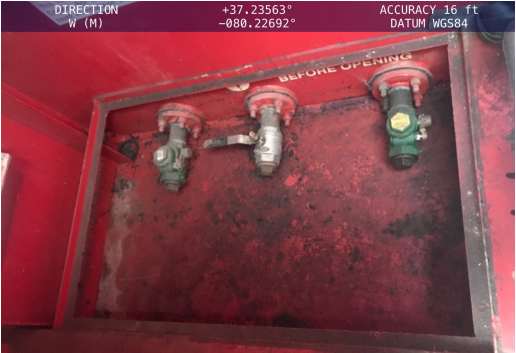
<p>DIRECTION W (M) +37.23563° -080.22692° ACCURACY 16 ft DATUM WGS84</p> <p>MVP-PY-006_120121 Condition of internal drip pan 2021-12-01 08:12:28-05:00</p>

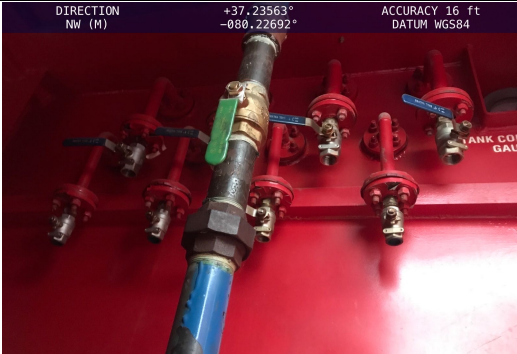
<p>DIRECTION NW (M) +37.23563° -080.22692° ACCURACY 16 ft DATUM WGS84</p> <p>MVP-PY-006_120121 No leaky internal fittings 2021-12-01 08:12:35-05:00</p>

<p>DIRECTION S (M) +37.23622° -080.22755° ACCURACY 33 ft DATUM WGS84</p> <p>MVP-PY-006_120121 Condition of posted project documents 2021-12-01 08:18:27-05:00</p>			
GPS Location	MVP-PY-006 See photo for gps data		GPS Location	MVP-PY-006 See photo for gps data	
Field Station#	+0		Field Station#	+0	
Pic 17 Desc.	Off Road Fuel unit no leaky internal fittings. Looking NW.		Pic 18 Desc.	Condition of posted project documents at main entrance. Looking NW.

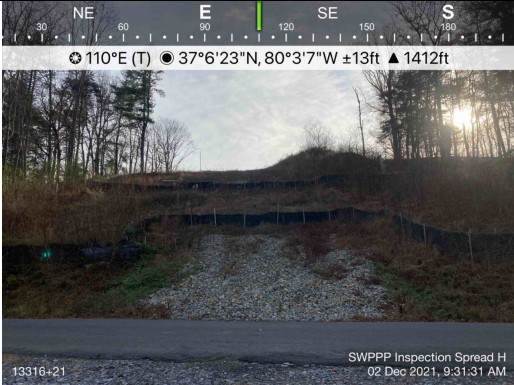
GPS Location	See Photo Watermark		GPS Location	See Photo Watermark	
Field Station#	03316+21		Field Station#	13317+31	
Pic 1 Desc.	Rock construction entrance and silt fence along the ROW are in good condition. No maintenance needed.		Pic 2 Desc.	Compost filter sock and silt fence are functioning properly along the ROW.

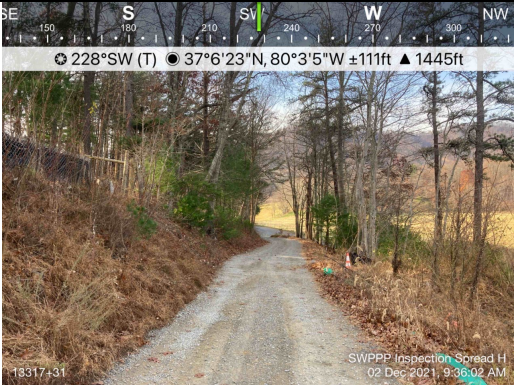
GPS Location	See Photo Watermark		GPS Location	See Photo Watermark	
Field Station#	13317+30		Field Station#	13342+32	
Pic 3 Desc.	Access road off of Wades Gap Road is well graveled and in good condition.		Pic 4 Desc.	Construction entrances off of access roads are in good condition. No signs of tracked material present.

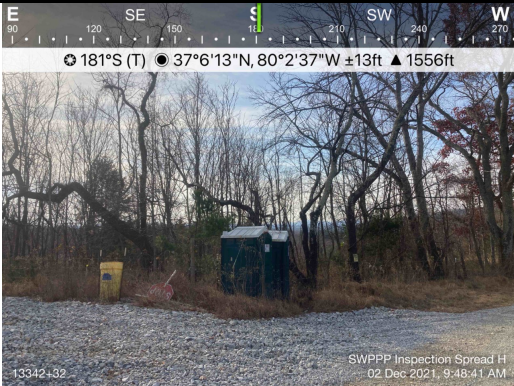
GPS Location	See Photo Watermark		GPS Location	See Photo Watermark	
Field Station#	13342+32		Field Station#	13343+40	
Pic 5 Desc.	Portable toilets are present in site and are in good condition. No leaks observed.		Pic 6 Desc.	Erosion control blanketing is present and applied properly. No maintenance is needed.

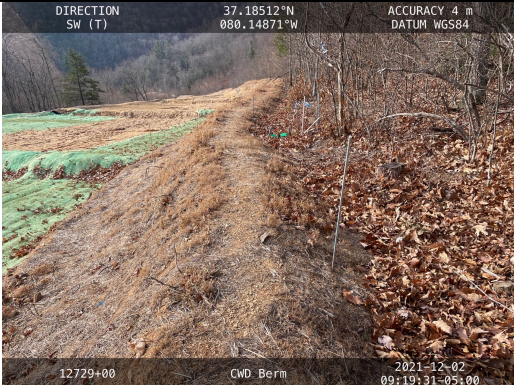
GPS Location	See photo		GPS Location	See photo	
Field Station#	12729+00		Field Station#	12729+00	
Pic 3 Desc.	CWD Berm is stabilized and functional.		Pic 4 Desc.	Current ROW conditions. ROW is stable. ECDs are functional.

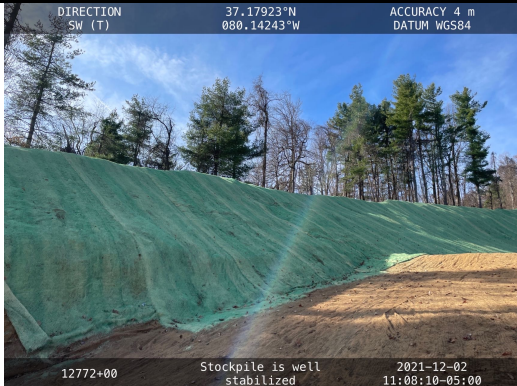
GPS Location	See photo		GPS Location	See photo	
Field Station#	12772+00		Field Station#	12774+00	
Pic 9 Desc.	Stockpiles is well stabilized		Pic 10 Desc.	Current ROW conditions. ROW is stable. ECDs are functional.

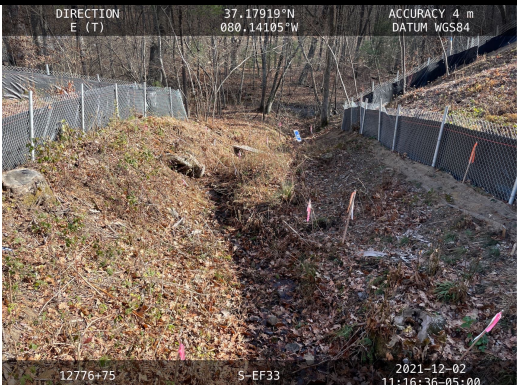
GPS Location	See photo		GPS Location	See photo	
Field Station#	12776+52		Field Station#	12776+75	
Pic 11 Desc.	RCE is functional.		Pic 12 Desc.	Downstream of crossing at Stream S-EF33

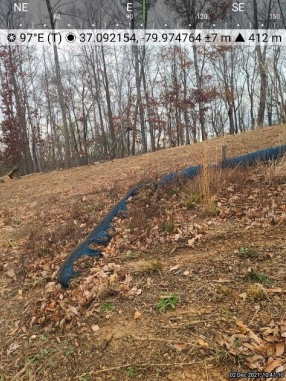
GPS Location	0000		GPS Location	0000	
Field Station#	13596+30		Field Station#	13610+66	
Pic 1 Desc.	CFS requires maintenance due to 3rd party activities.		Pic 2 Desc.	3rd party damages to water bar , documented and added to the punch list for repair and stabilization.

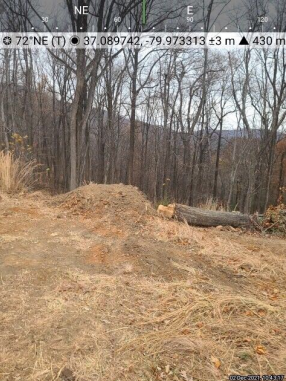
GPS Location	0000		GPS Location	0000	
Field Station#	13609+70		Field Station#	13614+92	
Pic 3 Desc.	Photo showing 3rd party tree cutting on the edge of the LOD, documented and non project related, CFS will need to be replaced.		Pic 4 Desc.	3rd party damages to water bar , documented and added to the punch list for repair and stabilization.

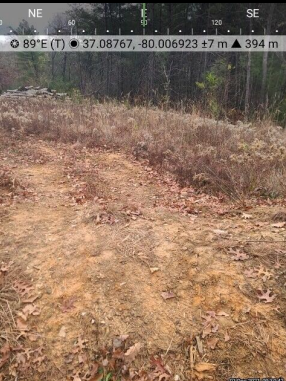
GPS Location	0000		GPS Location	0000	
Field Station#	13615+50		Field Station#	13613+92	
Pic 5 Desc.	Photo showing 3rd party travel on row, will continue to monitor the stabilization in the area.		Pic 6 Desc.	3rd party damages to water bar , documented and added to the punch list for repair and stabilization.

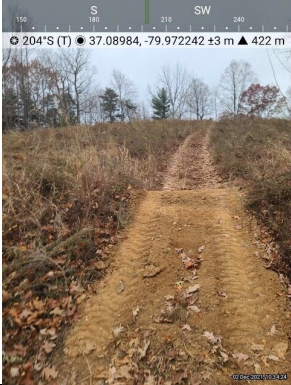
GPS Location	0000	GPS Location	0000		
Field Station#	13612+40	Field Station#	13600+00		
Pic 7 Desc.	3rd party damages to water bar , documented and added to the punch list for repair and stabilization.	Pic 8 Desc.	3rd party activities on row requires stabilization, documented and added to the punch list.

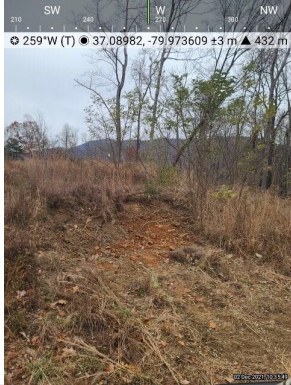
GPS Location	0000	GPS Location	0000		
Field Station#	13609+00	Field Station#	13609+70		
Pic 9 Desc.	3rd party disturbance to water bar, documented and added to the punch list for repair and stabilization	Pic 10 Desc.	CFS damaged during 3rd party tree cutting on the edge of the LOD. Documented and added to the punch list.

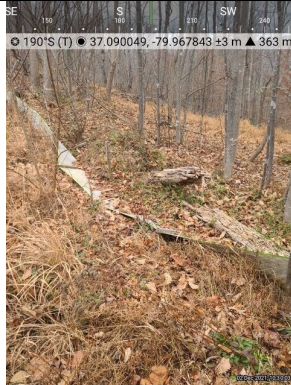
<p style="text-align: center;">Insert image here</p>			
GPS Location	00000	GPS Location			
Field Station#	13622+40	Field Station#			
Pic 11 Desc.	P1 requires maintenance due being weathered and stakes broken. Documented and added to the punch list.	Pic 12 Desc.

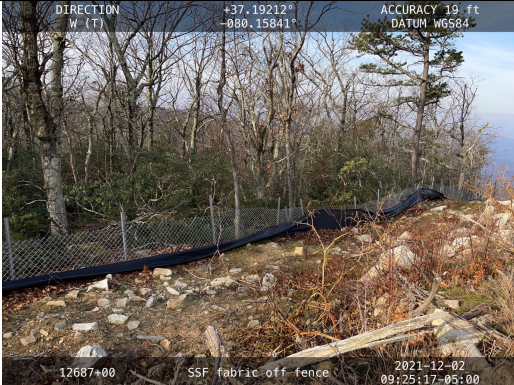
GPS Location	See photo for gps location data.		GPS Location	See photo for gps location data.	
Field Station#	12687+00		Field Station#	12687+00	
Pic 1 Desc.	Photo shows the damaged SSF fabric.		Pic 2 Desc.	Photo shows the repaired SSF fabric.

7. Identify all remedial measures that have been taken since the previous inspection was conducted. The following mitigation measures were performed in this area since the last SWPPP inspection: 12685+50 to 12687+00: damaged SSF fabric was repaired					
Comments (Reference above questions as appropriate.) I traveled to the ROW near Honeysuckle Road this morning. No measurable rainfall was recorded at Honeysuckle Road within the last 24 hours. I performed a SWPPP inspection of the disturbed portions of the ROW between stations 12600+00 and 12725+00 to observe conditions of ECDs, stream crossings and general ROW conditions. The stream crossings observed in this area included S-IJ50, S-Y13 and S-Y14. I also observed the RCEs at RO-279.01, RO-280, and Honeysuckle Road. The RCEs appear to be clean and in good condition. The disturbed portions of the ROW appear to be stable. The SSF fabric from 12685+50 to 12687+00 had been blown off the chain link fence. I notified Precision and their crew repaired the SSF today. No additional environmental issues, off-ROW sediment or stream impacts were observed during this SWPPP inspection.

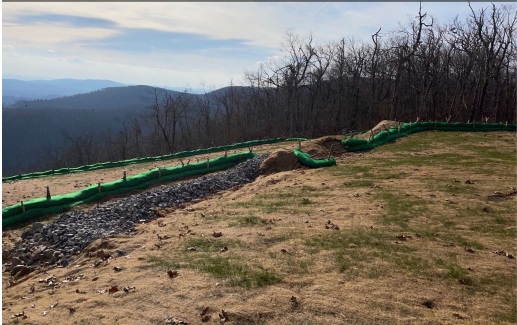
12691+00 Permanent water bar 2021-12-02 10:36:57-05:00		DIRECTION SE (T) +37.19143° -080.15684° ACCURACY 15 ft DATUM WGS84

12693+00 ROW condition 2021-12-02 10:37:34-05:00			
GPS Location	See photo for gps location data.		GPS Location	See photo for gps location data.	
Field Station#	12691+00		Field Station#	12693+00	
Pic 7 Desc.	Photo shows the permanent water bar.		Pic 8 Desc.	Photo shows the ROW condition. ECDs are installed and functioning as designed.	
DIRECTION W (T) +37.19077° -080.15374° ACCURACY 15 ft DATUM WGS84

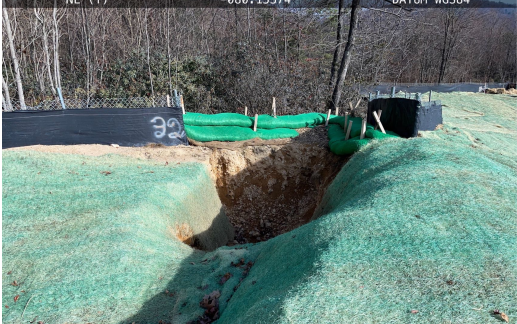
12702+20 Sump pit and end treatment 2021-12-02 10:54:43-05:00			
GPS Location	See photo for gps location data.		GPS Location	See photo for gps location data.

Field Station#	12702+00		Field Station#	12702+20	
Pic 9 Desc.	Photo shows the ROW condition. ECDs are installed and functioning as designed.		Pic 10 Desc.	Photo shows the sump pit and end treatment.	
DIRECTION E (T) +37.19081° -080.15369° ACCURACY 41 ft DATUM WGS84

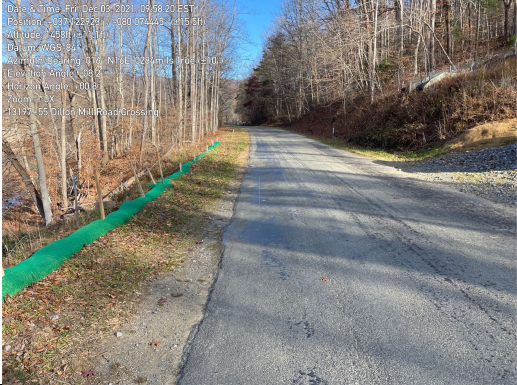
GPS Location	0	GPS Location	0		
Field Station#	13197+55	Field Station#	13197+85		
Pic 13 Desc.	Dillion Mill Road Crossing in good condition		Pic 14 Desc.	ROW and ECDs In good condition and stable

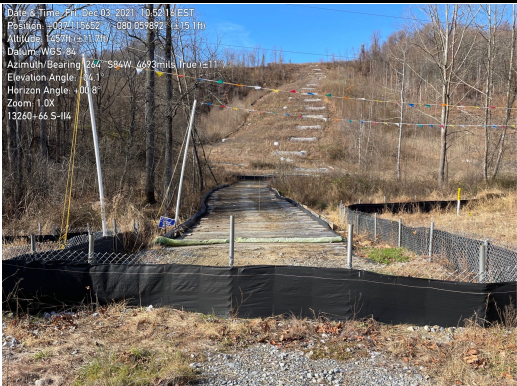
GPS Location	0	GPS Location	0		
Field Station#	13260+66	Field Station#	13159+00		
Pic 15 Desc.	MVP-S-II4 and Corresponding buffer zone in good condition		Pic 16 Desc.	ROW and ECDs In good condition with good vegetation established across ROW

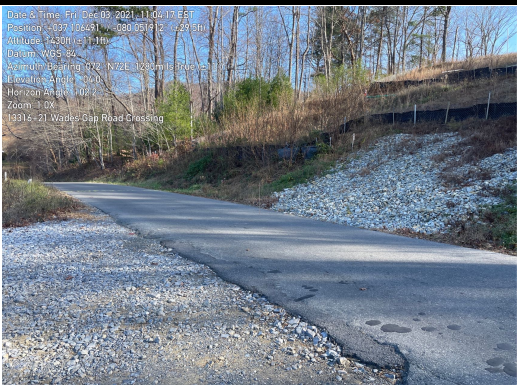
GPS Location	0	GPS Location	0		
Field Station#	13316+21	Field Station#	13314+00		
Pic 17 Desc.	Wades Gap Road Crossing in good condition		Pic 18 Desc.	ROW and ECDs In good condition with good vegetation established across ROW

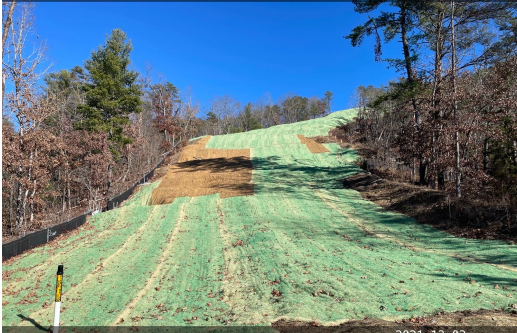
Environmental 12196+24 2021-12-03 13:11:00-05:00	
GPS Location	see photo		GPS Location	See photo	
Field Station#	12205+00		Field Station#	12196+24	
Pic 7 Desc.	Stabilized ROW conditions		Pic 8 Desc.	Stream crossing S-0011 In Acceptable condition	
DIRECTION W (T) 37.25185°N 080.25901°W ACCURACY 5 m DATUM WGS84

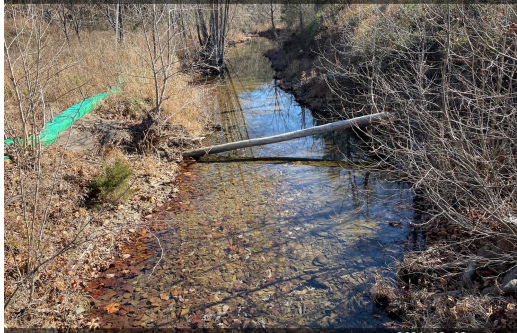
Environmental 12230+00 2021-12-03 12:34:44-05:00	
GPS Location	See photo		GPS Location	See photo	
Field Station#	12192+50		Field Station#	12230+00	
Pic 9 Desc.	Down stream of S-C21		Pic 10 Desc.	Stabilized ROW conditions

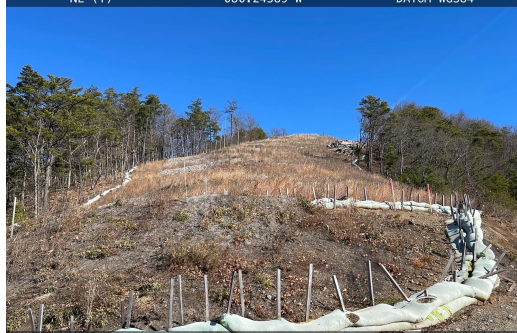
Environmental 12255+00 2021-12-03 12:10:50-05:00	
GPS Location	See photo		GPS Location	See photo	
Field Station#	12237+00		Field Station#	12255+00	
Pic 11 Desc.	Stabilized ROW conditions		Pic 12 Desc.	Stabilized ROW conditions
