Visual Site Inspection Report

Project Name	H-600 Pipeline Spread H	AFE	124300138	Spread	H-600 Pipeline Spread H
Contractor	Precision			Report #	28695
Inspector	Jonathan Altizer			Date/Time	9/20/2021 7:38 PM
Permit #	TBD	Inspection Type	VA SWPP	Station Begin	12600+00
State	VA	Inspection Area	Partial	Station End	12865+00
County	Roanoke	Ground	Dry	Temperature (°F)	78.00
Municipality	N/A	Weather	Cloudy	Rain Gauge (in)	0.30
				Rain Accumulation Time (days)	2.00

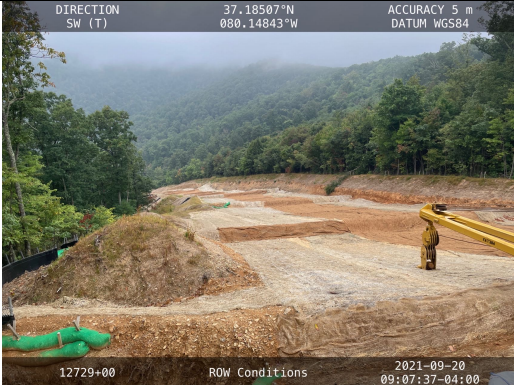
GPS Location	See photo		GPS Location	See photo	
Field Station#	12729+00		Field Station#	12742+00	
Pic 1 Desc.	Current ROW conditions. Waterbars are functional. ROW is stable.		Pic 2 Desc.	Current ROW conditions. Steep slope area stabilized.

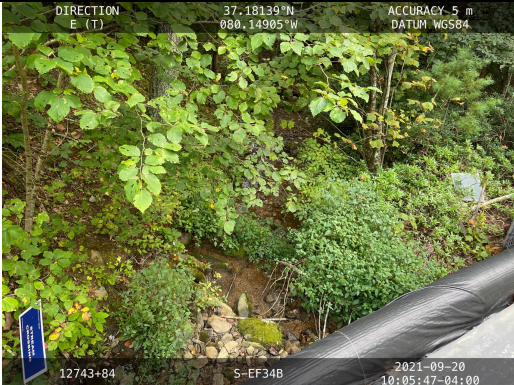
GPS Location	See photo		GPS Location	See photo	
Field Station#	12743+84		Field Station#	12744+00	
Pic 3 Desc.	Downstream of crossing at Stream S-EF34B		Pic 4 Desc.	Steep slope area stabilized. Waterbars functional.

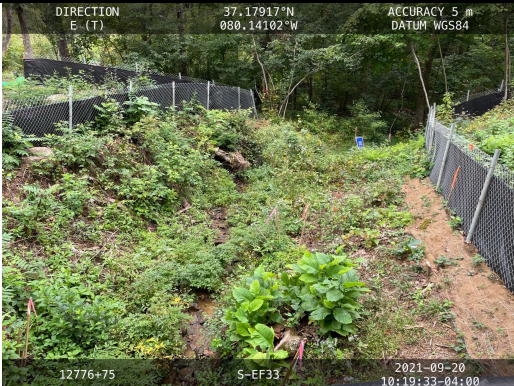
GPS Location	See photo		GPS Location	See photo	
Field Station#	12776+75		Field Station#	12767+50	
Pic 5 Desc.	Downstream of crossing at Stream S-EF33		Pic 6 Desc.	Steep slope area stabilized. Waterbars are functional.

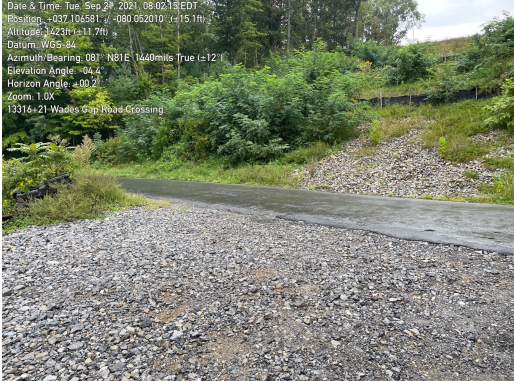
GPS Location	0	GPS Location	0		
Field Station#	13316+21	Field Station#	13314+00		
Pic 1 Desc.	Wades Gap Road Crossing in good condition and RCE in good condition and functioning properly		Pic 2 Desc.	ROW and ECDs in good condition with good vegetation established across ROW	
<p>Date & Time: Tue, Sep 21, 2021, 08:13:45 EDT Position: +037.115655° / -080.059957° (+15.4m) Altitude: 1436ft (+11.2m) Datum: WGS-84 Azimuth/Bearing: 242° S92W 4450mils True (+10.1°) Elevation Angle: -06.5° Horizon Angle: +00.8° Zoom: 1.0X 13263+00</p>

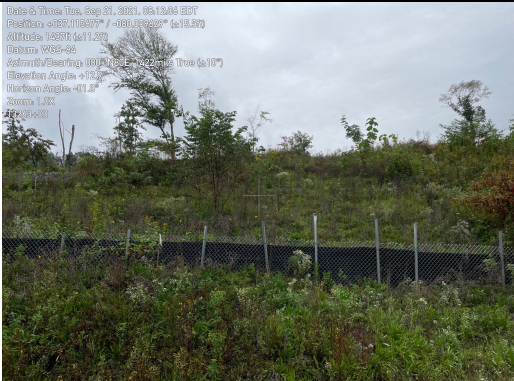
GPS Location	0	GPS Location	0		
Field Station#	13263+00	Field Station#	13260+66		
Pic 3 Desc.	ROW and ECDs in good condition with good vegetation established across ROW		Pic 4 Desc.	MVP-S-II4 and Corresponding buffer area in good condition	
<p>Date & Time: Tue, Sep 21, 2021, 08:14:01 EDT Position: +037.115655° / -080.06017° (+15.4m) Altitude: 1437ft (+11.2m) Datum: WGS-84 Azimuth/Bearing: 307° S67W 4950mils True (+12.1°) Elevation Angle: -01.6° Horizon Angle: +01.1° Zoom: 1.0X 13259+00</p>

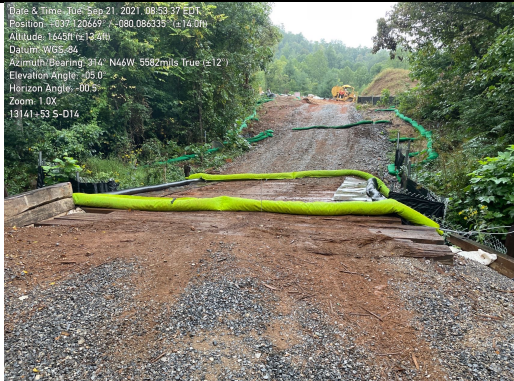
<p>Date & Time: Tue, Sep 21, 2021, 08:53:37 EDT Position: +037.120461° / -080.086335° (+14.4m) Altitude: 1455ft (+12.9m) Datum: WGS-84 Azimuth/Bearing: 316° N46W 5582mils True (+12.1°) Elevation Angle: -05.0° Horizon Angle: -00.3° Zoom: 1.0X 13141+53 S-D14</p>

GPS Location	0	GPS Location	0		
Field Station#	13259+00	Field Station#	13141+53		
Pic 5 Desc.	ROW and ECDs in good condition with good vegetation established across ROW		Pic 6 Desc.	MVP-S-D14 and Corresponding buffer area in good condition

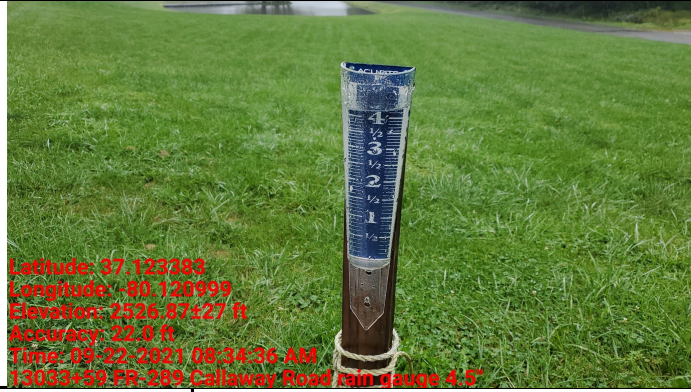
<p>Latitude: 37.123783 Longitude: -80.126999 Elevation: 2525.67±27 ft Accuracy: 22.0 ft Time: 09-22-2021 08:34:36 AM 13033+50 PR-289 Callaway Road rain gauge 4.5"</p>

<p>Latitude: 37.137085 Longitude: -80.12768 Elevation: 2701.62±149 ft Accuracy: 8850.3 ft Time: 09-22-2021 08:50:22 AM 12920+00 GAS of RO-286</p>			
GPS Location	See pic for GPS location.		GPS Location	See pic for GPS location.	
Field Station#	13033+50		Field Station#	12920+00	
Pic 1 Desc.	Callaway Road rain gauge 4.5" total precipitation.		Pic 2 Desc.	CFS overtopped added to punch list to be upgraded from 12" to 18" by the contractor when conditions allow. No sediment off LOD.

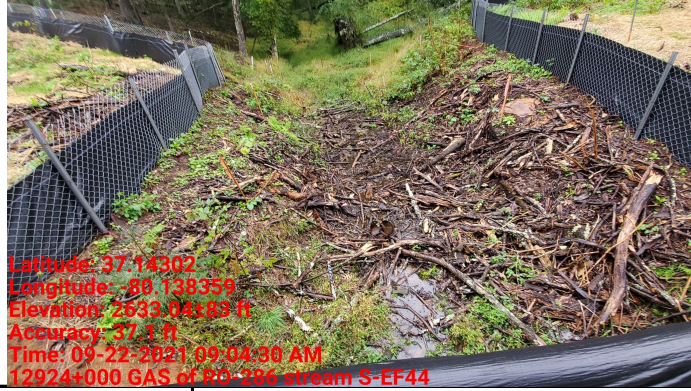
<p>Latitude: 37.14302 Longitude: -80.138359 Elevation: 2633.03±89 ft Accuracy: 37.1 ft Time: 09-22-2021 09:04:30 AM 12924+000 GAS of RO-286 stream S-EF44</p>

GPS Location	See pic for GPS location.		GPS Location	See pic for GPS location.	
Field Station#	12924+00		Field Station#	12931+00	
Pic 3 Desc.	No impacts observed at stream crossing S-EF44.		Pic 4 Desc.	Stabilized berm along fill slope eroded in the lowest portion. Sump to be added in low area.

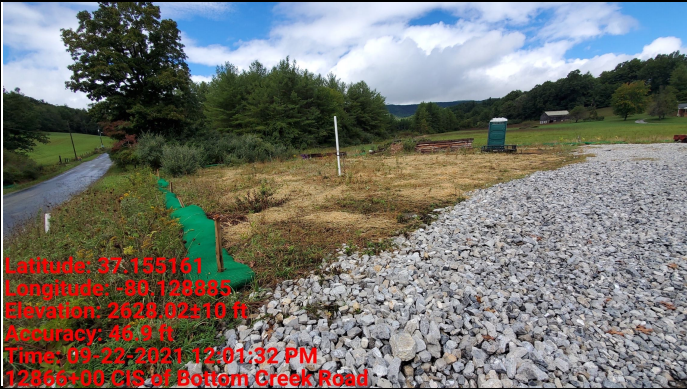
<p>Latitude: 37.155161 Longitude: -80.128885 Elevation: 2628.02±10 ft Accuracy: 46.9 ft Time: 09-22-2021 12:01:32 PM 12866+00 CIS of Bottom Creek Road</p>

<p>Latitude: 37.134811 Longitude: -80.137935 Elevation: 2493.01±52 ft Accuracy: 25.1 ft Time: 09-22-2021 01:14:27 PM 12956+00 CIS of RO-287 sediment trap</p>		
GPS Location	See pic for GPS location.		GPS Location	See pic for GPS location.	
Field Station#	12866+00		Field Station#	12956+00	
Pic 7 Desc.	CIS of Bottom Creek Road.		Pic 8 Desc.	Sediment trap on the CIS of RO-287.

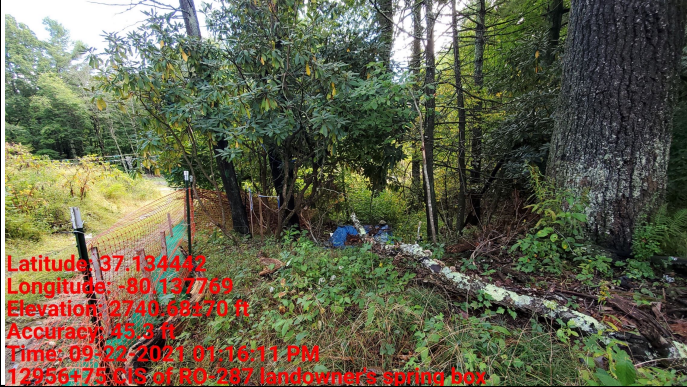
<p>Latitude: 37.134452 Longitude: -80.137769 Elevation: 2740.88±20 ft Accuracy: 35.3 ft Time: 09-22-2021 01:16:11 PM 12956+75 CIS of RO-287 landowner's spring box</p>

GPS Location	See pic for GPS location.		GPS Location	See pic for GPS location.	
Field Station#	12956+75		Field Station#	12958+00	
Pic 9 Desc.	Landowner's spring box at RO-287.		Pic 10 Desc.	GAS of RO-287 and streams S-Y7 and S-Y8.

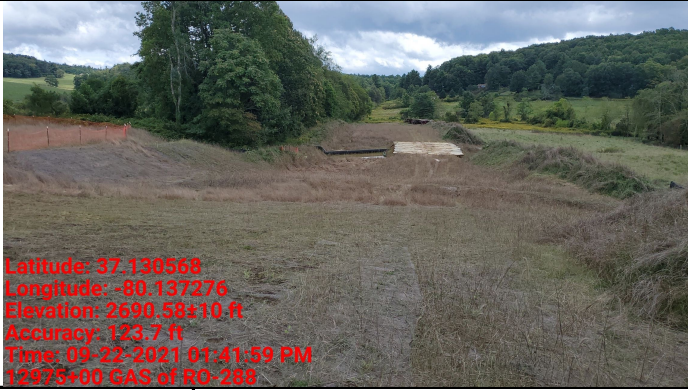
<p>Latitude: 37.135443 Longitude: -80.134025 Elevation: 2537.99±66 ft Accuracy: 40.0 ft Time: 09-22-2021 01:23:00 PM 12957+38 RO-287 stream S-Z17</p>

<p>Latitude: 37.136568 Longitude: -80.137276 Elevation: 2690.58±10 ft Accuracy: 123.7 ft Time: 09-22-2021 01:41:59 PM 12975+00 GAS of RO-288</p>		
GPS Location	See pic for GPS location.		GPS Location	See pic for GPS location.	
Field Station#	12957+38		Field Station#	12975+00	
Pic 11 Desc.	S-Z17 on the downstream side of access RO-287.		Pic 12 Desc.	GAS of RO-288.

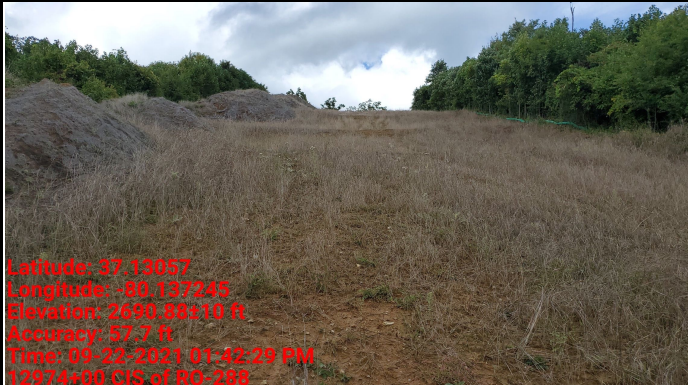
<p>Latitude: 37.130503 Longitude: -80.137272 Elevation: 2689.86±14 ft Accuracy: 46.3 ft Time: 09-22-2021 01:42:48 PM 12973+00 CIS of RO-288</p>		
GPS Location	See pic for GPS location.		GPS Location	See pic for GPS location.	
Field Station#	12974+00		Field Station#	12973+00	
Pic 13 Desc.	CIS of RO-288.		Pic 14 Desc.	Waterbar sump and end treatment on the CIS of RO-288.

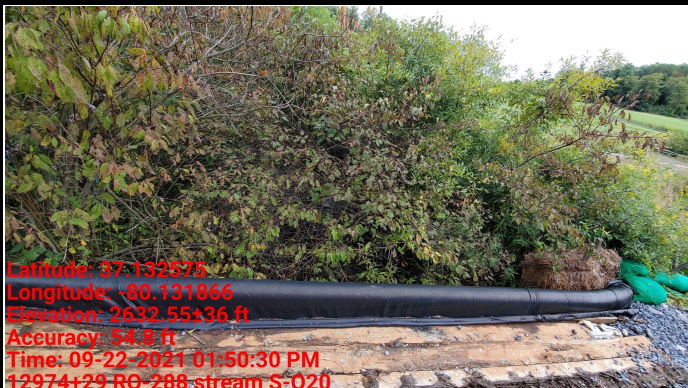
Field Station#	12974+29		Field Station#	12994+30	
Pic 15 Desc.	S-Q20 on the downstream side of access RO-288.		Pic 16 Desc.	GAS of the US-221 road crossing.

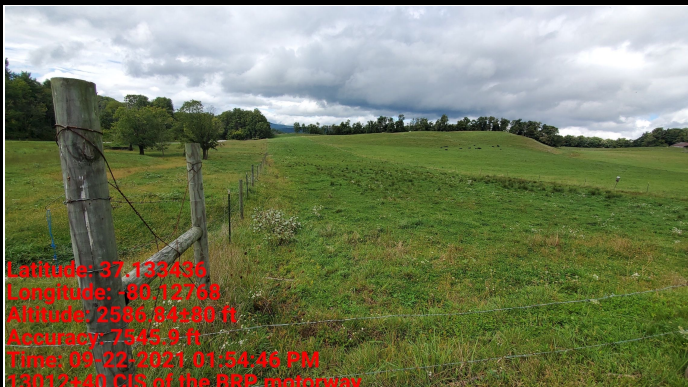
<p>Latitude: 37.126129 Longitude: -80.125441 Elevation: 2624.64±41 ft Accuracy: 48.2 ft Time: 09-22-2021 01:55:23 PM 13012+80 GAS of the BRP motorway</p>		
GPS Location	See pic for GPS location.		GPS Location	See pic for GPS location.	
Field Station#	13012+40		Field Station#	13012+80	
Pic 17 Desc.	CIS of the BRP motorway.		Pic 18 Desc.	GAS of the BRP motorway.

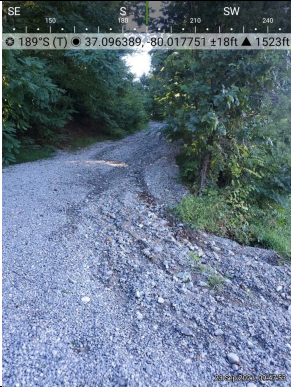
GPS Location	0	GPS Location	0		
Field Station#	0+00	Field Station#	0+00		
Pic 1 Desc.	MVP-FR-293.02 Washout on access road	Pic 2 Desc.	MVP-FR-293.02 Gravel washing onto blacktop

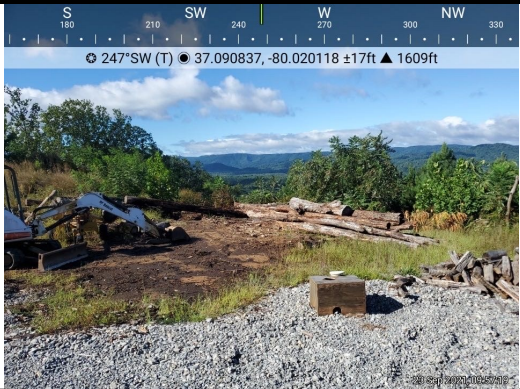
GPS Location	0	GPS Location	0		
Field Station#	0+00	Field Station#	13437+75		
Pic 3 Desc.	MVP-FR-293.02 Repairs	Pic 4 Desc.	3rd party activities processing Timber with ground disturbance

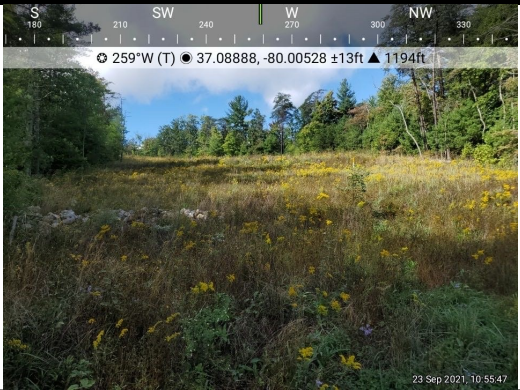
GPS Location	0	GPS Location	0		
Field Station#	13442+00	Field Station#	13496+00		
Pic 5 Desc.	Existing slip after heavy rains	Pic 6 Desc.	CIS Cahas Mtn #2 with Waterbar outlet

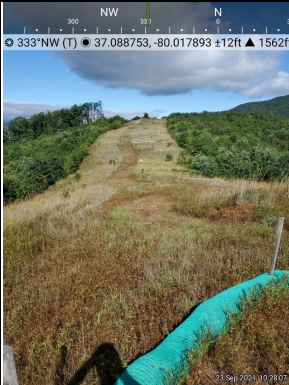
GPS Location	0	GPS Location	0		
Field Station#	13446+00	Field Station#	13465+00		
Pic 7 Desc.	Permanent vegetation	Pic 8 Desc.	Sideslope vegetation

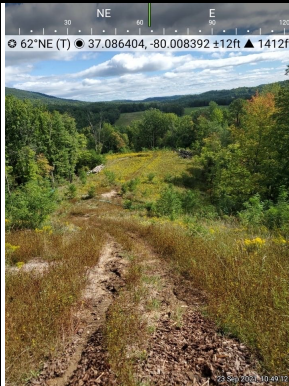
GPS Location	0	GPS Location	0		
Field Station#	13486+00	Field Station#	12488+00		
Pic 9 Desc.	Minor washing in field road	Pic 10 Desc.	Permanent vegetation

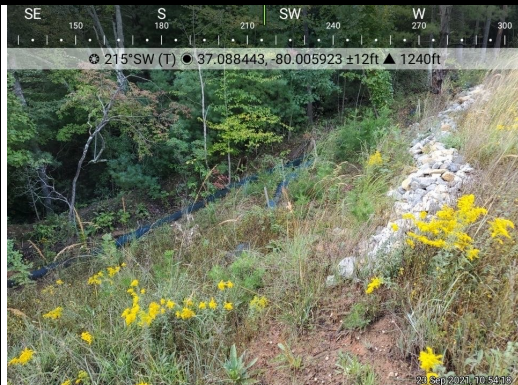
GPS Location	0	GPS Location	0		
Field Station#	13491+00	Field Station#	13497+50		
Pic 11 Desc.	Sideslope stabilization	Pic 12 Desc.	S-IJ10 After heavy rains

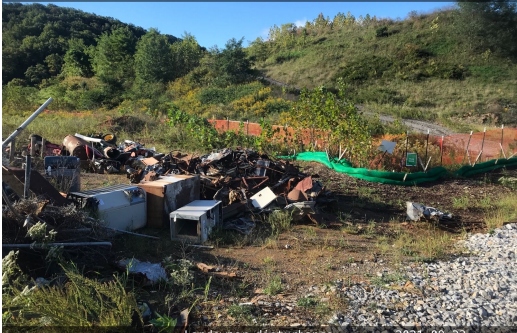
MVP-LY-049_092321 Landowner disturbance & debris piled 2021-09-23 09:02:44-04:00		DIRECTION W (M) +37.27041° -080.12466° ACCURACY 16 ft DATUM WGS84

MVP-LY-049_092321 Landowner disturbance along feature 2021-09-23 09:02:52-04:00			
GPS Location	MVP-LY-049 See photo for gps data		GPS Location	MVP-LY-049 See photo for gps data	
Field Station#	+0		Field Station#	+0	
Pic 13 Desc.	Landowner soil disturbance and debris piled along triple stack compost filter and east of feature W-CV21B. Looking S.		Pic 14 Desc.	Landowner soil disturbance along edge of feature W-CV21A. Area not stabilized. Looking NW.	
DIRECTION S (M) +37.27052° -080.12380° ACCURACY 16 ft DATUM WGS84

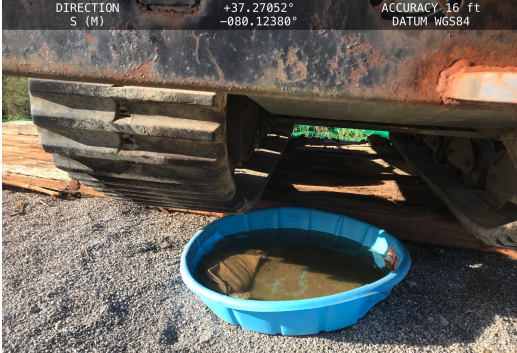
MVP-LY-049_092321 Containment under stored equipment 2021-09-23 09:03:57-04:00		DIRECTION SW (M) +37.27055° -080.12361° ACCURACY 33 ft DATUM WGS84

GPS Location	MVP-LY-049 See photo for gps data		GPS Location	MVP-LY-049 See photo for gps data	
Field Station#	+0		Field Station#	+0	
Pic 15 Desc.	Condition of containment under stored equipment. Holding stormwater. Looking S.		Pic 16 Desc.	No loose trash around north dumpster or in the yard. Looking SW.	
DIRECTION W (M) +37.27051° -080.12346° ACCURACY 16 ft DATUM WGS84

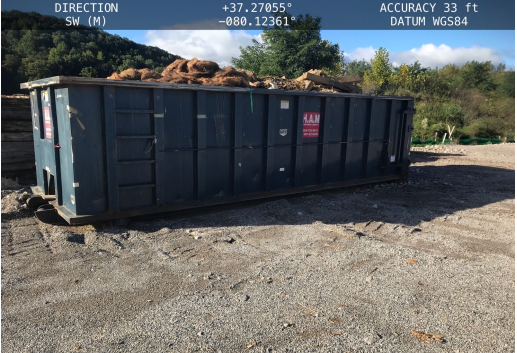
MVP-LY-049_092321 No loose trash around north dumpster 2021-09-23 09:04:17-04:00

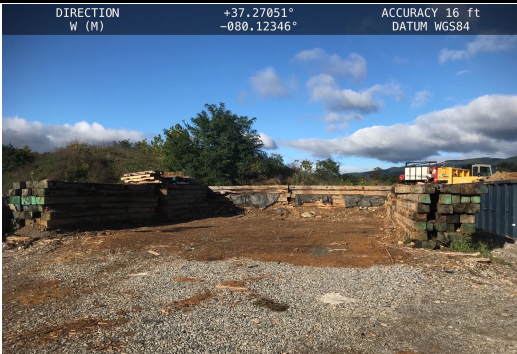
MVP-LY-049_092321 Condition of temporary trash transfer pit 2021-09-23 09:04:36-04:00		DIRECTION W (M) +37.26936° -080.12379° ACCURACY 164 ft DATUM WGS84

MVP-LY-049_092321 CFS in place around sand pile 2021-09-23 09:07:44-04:00			
GPS Location	MVP-LY-049 See photo for gps data		GPS Location	MVP-LY-049 See photo for gps data	
Field Station#	+0		Field Station#	+0	
Pic 17 Desc.	Condition of temporary trash transfer pit. Debris has been placed in dumpsters. Looking W.		Pic 18 Desc.	Compost filter sock in place around sand pile. Looking W.

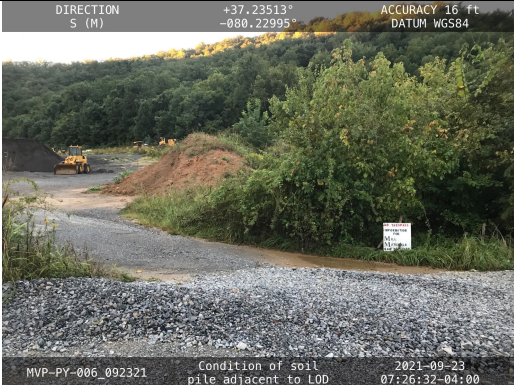
GPS Location	MVP-PY-006 See photo for gps data		GPS Location	MVP-PY-006 See photo for gps data	
Field Station#	+0		Field Station#	+0	
Pic 1 Desc.	Condition of soil pile adjacent to LOD. Soil pile not stabilized. Looking S.		Pic 2 Desc.	Condition of trays and containment under toilets. Trays holding stormwater. Looking NW.

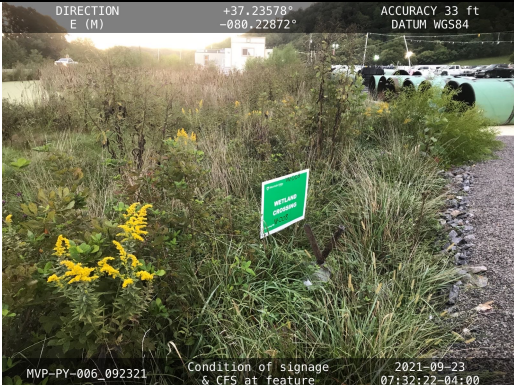
GPS Location	MVP-PY-006 See photo for gps data		GPS Location	MVP-PY-006 See photo for gps data	
Field Station#	+0		Field Station#	+0	
Pic 3 Desc.	Condition of signage and triple stack compost filter sock along feature W-008. Over grown with vegetation. Looking E.		Pic 4 Desc.	Condition of containment under light plant. Holding stormwater. Looking SE.

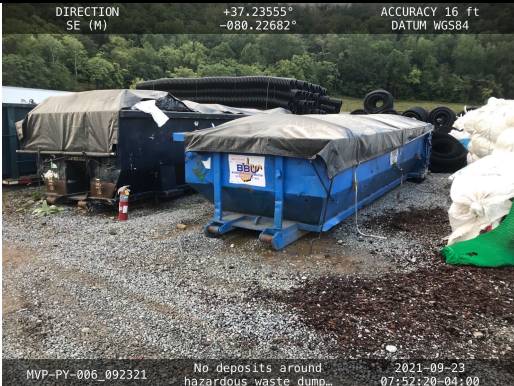
Pic 5 Desc.	No fluids or deposits around hazardous waste dumpsters. Looking SE.		Pic 6 Desc.	No loose trash around dumpsters or in the yard. Looking E.

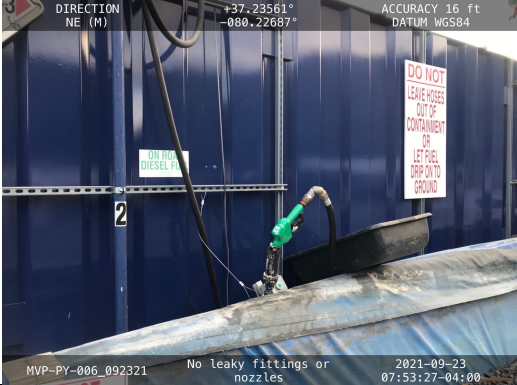
<p>DIRECTION NE (M) +37.23561° -080.22687° ACCURACY 16 ft DATUM WGS84 MVP-PY-006_092321 No leaky fittings or nozzles. 2021-09-23 07:53:27-04:00</p>		
GPS Location	MVP-PY-006 See photo for gps data		GPS Location	MVP-PY-006 See photo for gps data	
Field Station#	+0		Field Station#	+0	
Pic 7 Desc.	Blue Bulk Fuel tanks no fuel spills south of the tanks. Looking NE.		Pic 8 Desc.	Blue Bulk Fuel tanks no leaky fittings or nozzles. Looking NE.

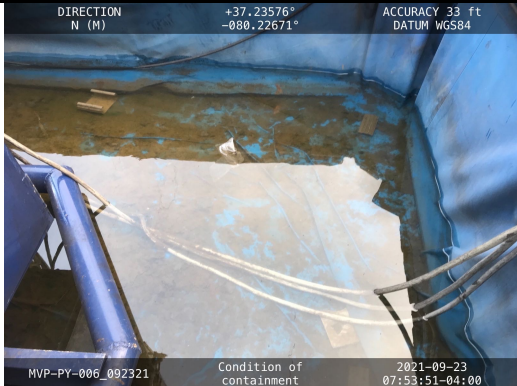
<p>DIRECTION N (M) +37.23576° -080.22671° ACCURACY 33 ft DATUM WGS84 MVP-PY-006_092321 Condition of containment. 2021-09-23 07:53:51-04:00</p>

GPS Location	MVP-PY-006 See photo for gps data		GPS Location	MVP-PY-006 See photo for gps data	
Field Station#	+0		Field Station#	+0	
Pic 9 Desc.	Blue Bulk Fuel tanks containment holding stormwater. A sheen was noted. Looking N.		Pic 10 Desc.	Blue Bulk Fuel tanks no leaky internal fittings. Looking NW.

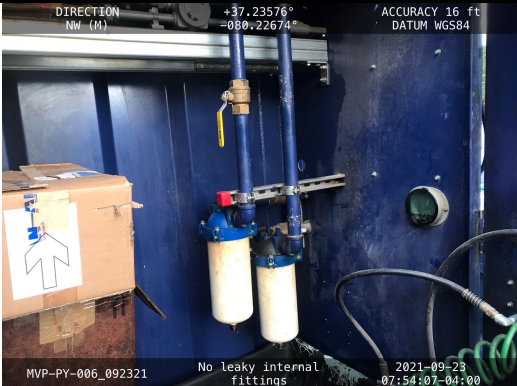
<p>DIRECTION NW (M) +37.23576° -080.22674° ACCURACY 16 ft DATUM WGS84 MVP-PY-006_092321 No leaky internal fittings. 2021-09-23 07:54:07-04:00</p>

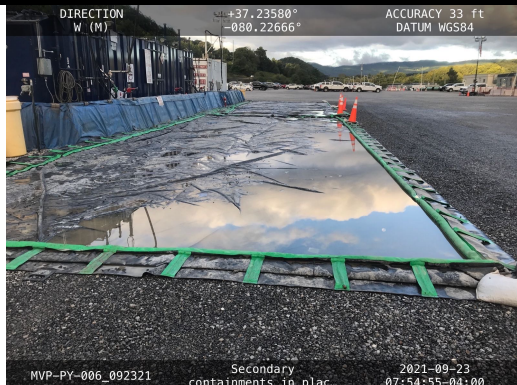
<p>DIRECTION W (M) +37.23580° -080.22666° ACCURACY 33 ft DATUM WGS84 MVP-PY-006_092321 Secondary containments in place. 2021-09-23 07:54:55-04:00</p>

<p>DIRECTION NW (M) +37.23563° -080.22684° ACCURACY 98 ft DATUM WGS84 MVP-PY-006_092321 Condition of containment. 2021-09-23 07:55:45-04:00</p>		
GPS Location	MVP-PY-006 See photo for gps data		GPS Location	MVP-PY-006 See photo for gps data	
Field Station#	+0		Field Station#	+0	
Pic 11 Desc.	Blue Bulk Fuel tanks secondary containments in place for tankers offloading fuel. Looking W.		Pic 12 Desc.	Off Road Fuel unit containment holding stormwater. A sheen noted. Looking NW.

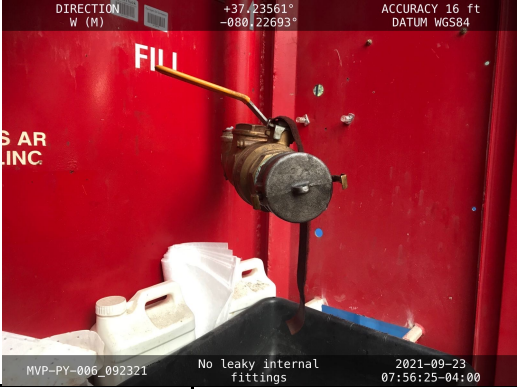
GPS Location	MVP-PY-006 See photo for gps data		GPS Location	MVP-PY-006 See photo for gps data	
Field Station#	+0		Field Station#	+0	
Pic 13 Desc.	Off Road Fuel unit no leaky internal fittings. Looking W.		Pic 14 Desc.	Off Road Fuel unit condition of internal drip pan. Free of fluids. Looking SW.

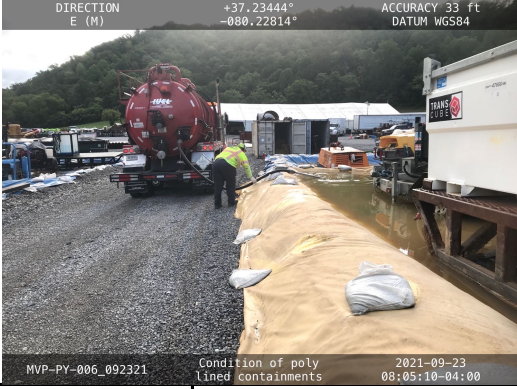
GPS Location	MVP-PY-006 See photo for gps data		GPS Location	MVP-PY-006 See photo for gps data	
Field Station#	+0		Field Station#	+0	
Pic 15 Desc.	3rd Party on site pumping stormwater from containments. All containments are slated to be pumped. Looking E.		Pic 16 Desc.	Condition of containment under hazardous waste dumpsters. Holding some fluids. Looking E.

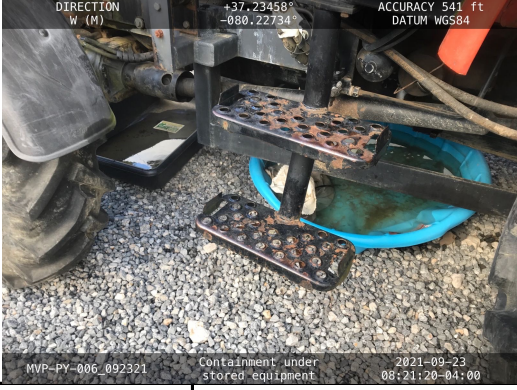
GPS Location	MVP-PY-006 See photo for gps data		GPS Location	MVP-PY-006 See photo for gps data	
Field Station#	+0		Field Station#	+0	
Pic 17 Desc.	Condition of containments under stored equipment. Holding stormwater. Looking W.		Pic 18 Desc.	Condition of posted project documents at main entrance. Looking SW.

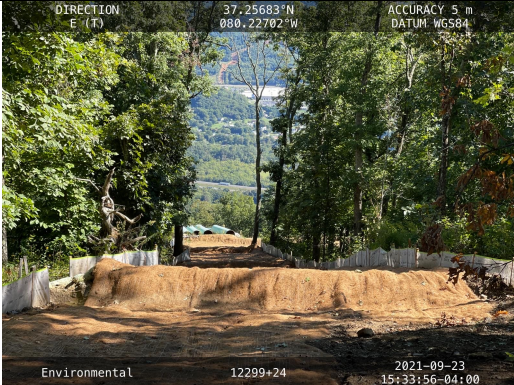
GPS Location	See photo		GPS Location	See photo	
Field Station#	12299+24		Field Station#	12284+75	
Pic 1 Desc.	Stabilized access Road condition		Pic 2 Desc.	Access Road MVP-MN-276.03 crossing

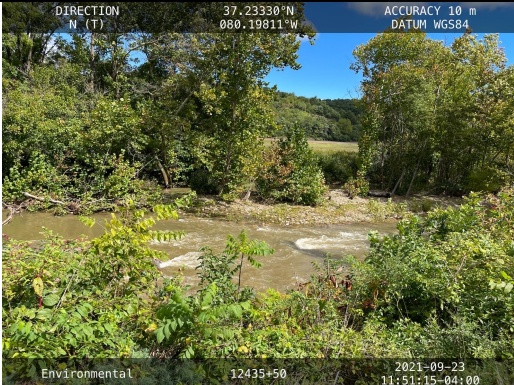
GPS Location	See photo		GPS Location	See photo	
Field Station#	12435+50		Field Station#	12437+70	
Pic 3 Desc.	Stream crossing S-NN16		Pic 4 Desc.	Stabilized slope conditions

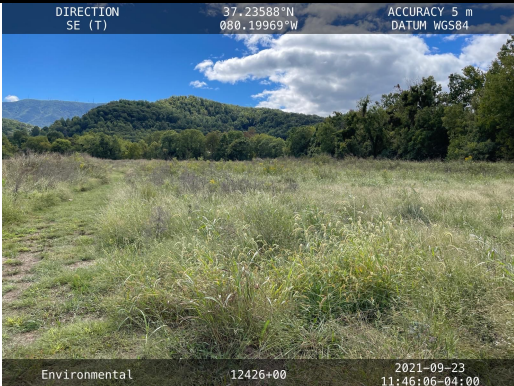
GPS Location	see photo		GPS Location	See photo	
Field Station#	12426+00		Field Station#	12424+01	
Pic 5 Desc.	Stabilized ROW conditions		Pic 6 Desc.	Access Road MVP-MN-279 conditions

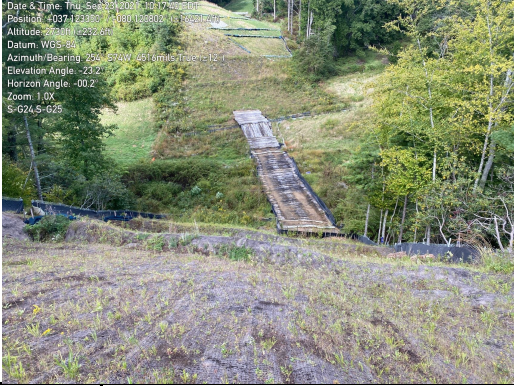
<p>Date & Time: Thu, Sep 23, 2021, 10:17:55 EDT Position: +037.125496 / -080.120618 (±16421.4ft) Altitude: 2732ft (±47.1ft) Datum: WGS-84 Azimuth/Bearing: 205.5W 69.0mils True (±12.1) Elevation Angle: -23.2 Horizon Angle: -00.2 Zoom: 1.0x S-G24-S-G25</p>

<p>Date & Time: Thu, Sep 23, 2021, 10:24:33 EDT Position: +037.125496 / -080.120618 (±16421.4ft) Altitude: 2676ft (±140.1ft) Datum: WGS-84 Azimuth/Bearing: 045° N45E 0800mils True (±13.1) Elevation Angle: -02.7 Horizon Angle: -00.8 Zoom: 1.0x S-G26-S-G27</p>			
GPS Location	See photo for coordinates.		GPS Location	See photo for coordinates.	
Field Station#	13025+00		Field Station#	13027+00	
Pic 1 Desc.	S-G24, S-G25, and W-ST2 complex, ROW stable, ECDs functioning acceptably.		Pic 2 Desc.	ROW stable with good vegetative cover.

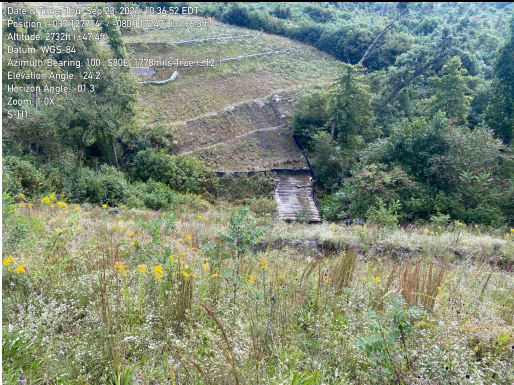
<p>Date & Time: Thu, Sep 23, 2021, 10:24:57 EDT Position: +037.126427 / -080.118409 (±16421.4ft) Altitude: 2732ft (±47.1ft) Datum: WGS-84 Azimuth/Bearing: 100.5W 69.0mils True (±12.1) Elevation Angle: -22.2 Horizon Angle: -01.3 Zoom: 1.0x S-H1</p>

GPS Location	See photo for coordinates.		GPS Location	See photo for coordinates.	
Field Station#	13042+00		Field Station#	13034+00	
Pic 3 Desc.	S-H1, ROW stable on both the coming in and going away side of stream crossing, ECDs in acceptable condition.		Pic 4 Desc.	Sediment accumulated in throat of waterbar, maintenance required, stabilization requested.

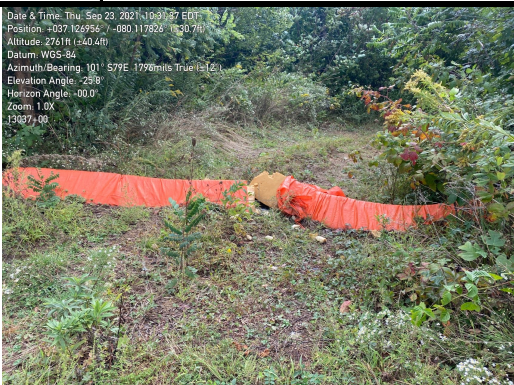
<p>Date & Time: Thu, Sep 23, 2021, 10:51:37 EDT Position: +037.124992 / -080.117626 (±16307ft) Altitude: 2751ft (±40.4ft) Datum: WGS-84 Azimuth/Bearing: 101.57E 179.0mils True (±12.1) Elevation Angle: -25.9 Horizon Angle: -00.0 Zoom: 1.0x 13037+00</p>

Field Station#	13037+00		Field Station#	13061+89	
Pic 5 Desc.	Triangular foam diversion dike damaged, maintenance required.		Pic 6 Desc.	S-G27, upstream, no turbidity observed, banks well vegetated.

E&S BMPs	Compliance Level	Corrective Action	Corrective Time Frame	Date Repaired
Cleanwater Diversion Berm	Acceptable			
Compost Filter Sock	Acceptable			
Equipment Bridge	Acceptable			
Rock Construction Entrance	Acceptable			
Stone Inlet Protection	Communication	Repair; 24 hr		
Waterbar	Communication	Repair; 72 hr		
Erosion Control Blanket	Communication	Repair/replace on soil pile; 72 hr		
Other - Explain in Comments	Communication	Repair triangular dike; 72 hr		
Sump Pit	Communication	Clean; 72 hr

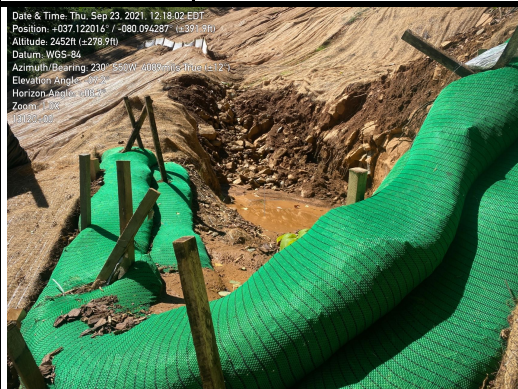
<p>Date & Time: Thu, Sep 23, 2021, 12:18:02 EDT Position: +037.122016 / -080.094287 (±15.9ft) Altitude: 2452ft (±15.9ft) Datum: WGS-84 Azimuth/Bearing: 230.553W 4000mils True (±12.1) Elevation Angle: +03.4 Horizon Angle: +03.4 Zoom: 1.0X 13120+25</p>

Pic 11 Desc.	Sump requiring maintenance.		Pic 12 Desc.	Waterbar failure, maintenance and repair required.

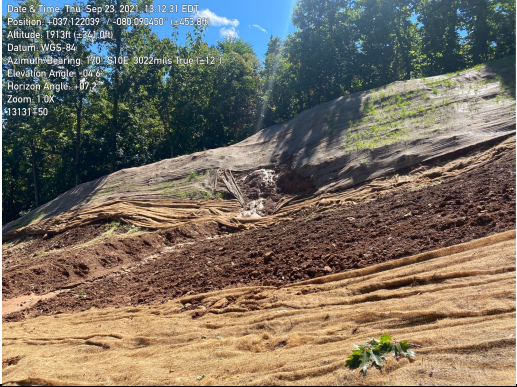
<p><small>Date & Time: Thu, Sep 23, 2021, 12:12:31 EDT Position: +027.12209°N -080.093043°W (+45.88ft) Altitude: 1913ft (+584.0ft) Datum: WGS-84 Azimuth/Bearing: 170° S/E 3022mils True (+12°) Elevation Angle: +05.2° Horizon Angle: +07.2° Zoom: 1.0X 13131+50</small></p>			
GPS Location	See photo for coordinates.	GPS Location	See photo for coordinates.		
Field Station#	13126+00	Field Station#	13131+50		
Pic 13 Desc.	Fill slope drain inlets filled with rock and sediment, maintenance required.	Pic 14 Desc.	Subsoil pile sloughing, erosion control blanket maintenance required.

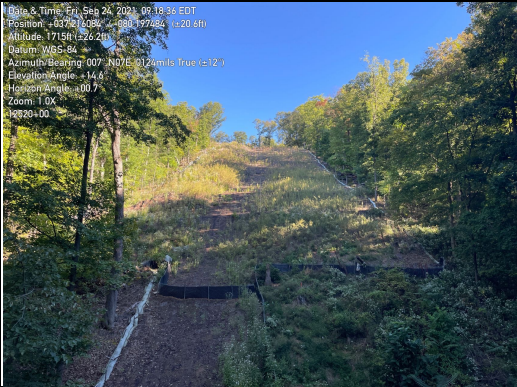
</div></div></div>			
GPS Location		0		GPS Location	
Field Station#		12520+00		12527+00	
Pic 13 Desc.		ROW and ECDs in good condition with good vegetation established across ROW		Pic 14 Desc.	
				ROW and ECDs in good condition with good vegetation established across ROW

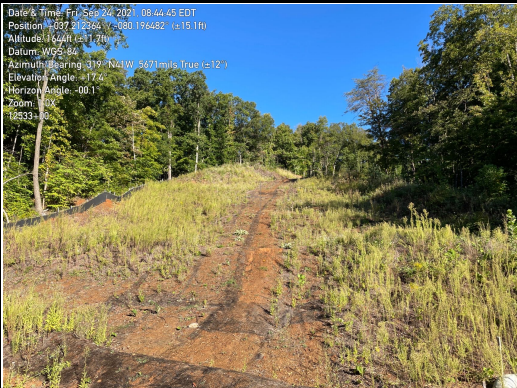
</div></div></div>			
GPS Location		0		GPS Location	
Field Station#		12533+00		12540+00	
Pic 15 Desc.		ROW and ECDs in good condition with good vegetation established across ROW		Pic 16 Desc.	
				ROW and ECDs in good condition and stable	
<div><div><div>Date & Time: Fri, Sep 24, 2021, 08:31:30 EDT Position: +037.210964, -080.193559 (±14 ft) Altitude: 1483ft (±14 ft) Datum: WGS-84 Azimuth/Bearing: 271° (N)W 0.10mils True (±14°) Elevation Angle: +18.9° Horizon Angle: +03.5° Zoom: 1.0X 12544+06</div><div>

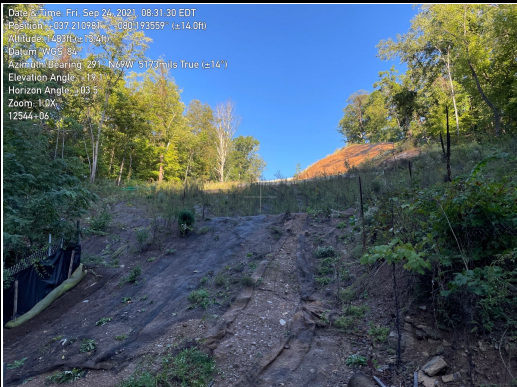
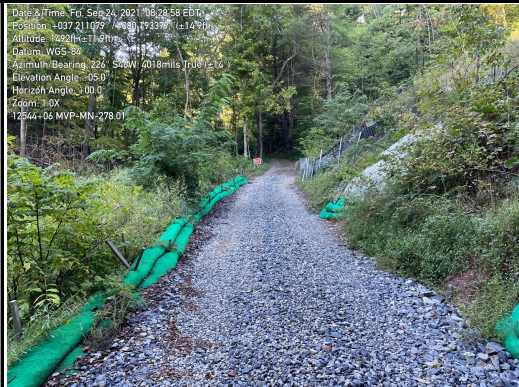
GPS Location		0		GPS Location	
Field Station#		12544+06		12544+06	
Pic 17 Desc.		ROW and ECDs in good condition and stable		Pic 18 Desc.	
				MVP-MN-278.01 Crossing, in good condition and stable

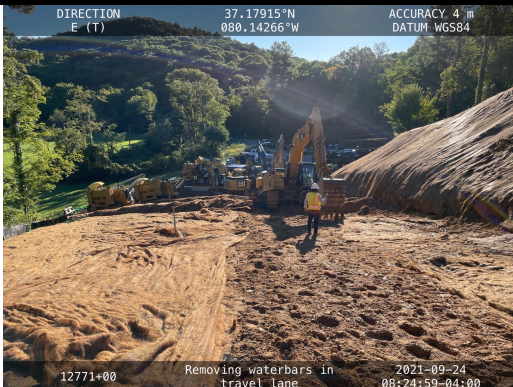
<p>DIRECTION E (T)</p> <p>37.17915°N 080.14266°W</p> <p>ACCURACY 4 m DATUM WGS84</p> <p>12771+00</p> <p>Removing waterbars in travel lane</p> <p>2021-09-24 08:24:59-04:00</p>

<p>DIRECTION SW (T)</p> <p>37.17927°N 080.14514°W</p> <p>ACCURACY 4 m DATUM WGS84</p> <p>12763+00</p> <p>ROW conditions</p> <p>2021-09-24 09:08:02-04:00</p>		
GPS Location	See photo		GPS Location	See photo	
Field Station#	12771+00		Field Station#	12763+00	
Pic 1 Desc.	Removing waterbars in travel lane		Pic 2 Desc.	Current ROW conditions. ROW is stable

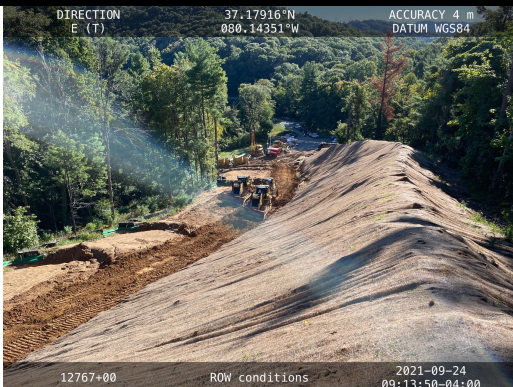
GPS Location	See photo		GPS Location	See photo	
Field Station#	12767+00		Field Station#	12729+00	
Pic 3 Desc.	Current ROW condition. Stockpiles are stabilized.		Pic 4 Desc.	Current ROW conditions. ROW is stable.

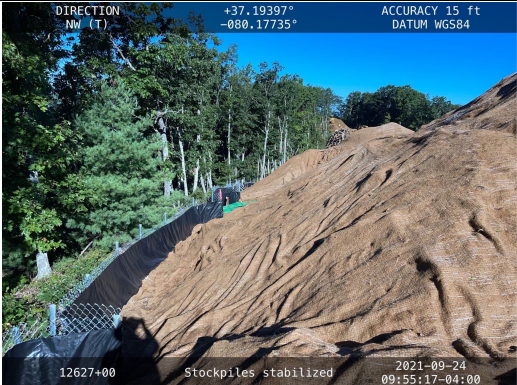
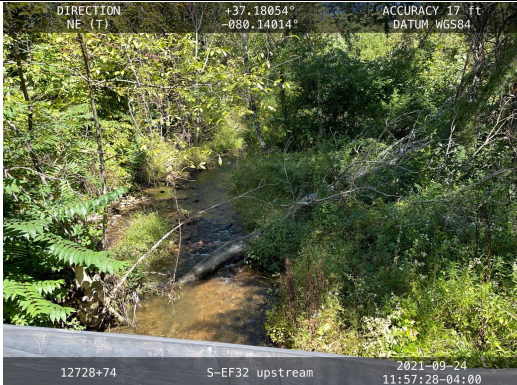
GPS Location	See photo		GPS Location	See photo	
Field Station#	12627+00		Field Station#	12728+74	
Pic 17 Desc.	Stockpiles well stabilized with curlex		Pic 18 Desc.	Upstream of crossing at Stream S-EF32

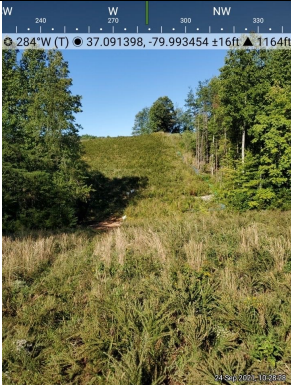
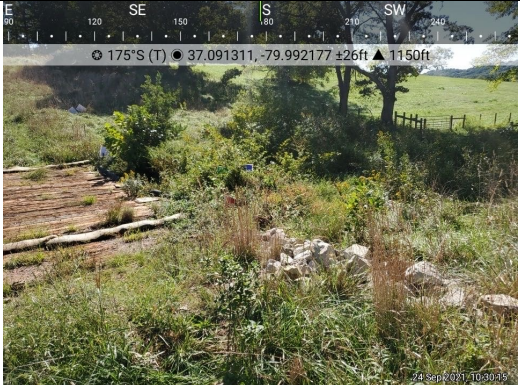
GPS Location	0	GPS Location	0		
Field Station#	13535+00	Field Station#	13538+00		
Pic 1 Desc.	GAS S-II8	Pic 2 Desc.	CIS W-II8

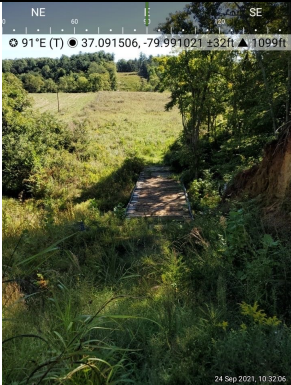
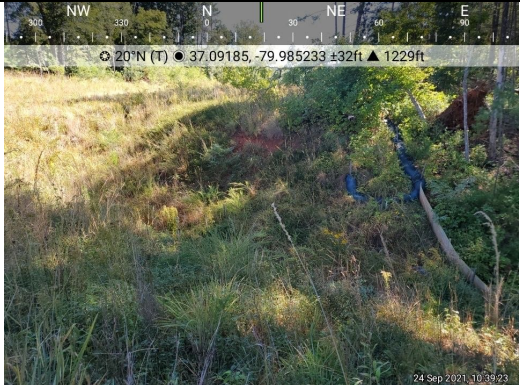
GPS Location	0	GPS Location	0		
Field Station#	13542+00	Field Station#	13557+00		
Pic 3 Desc.	GAS House Rock Rd	Pic 4 Desc.	Sideslope vegetation

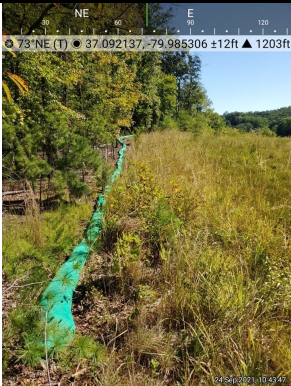
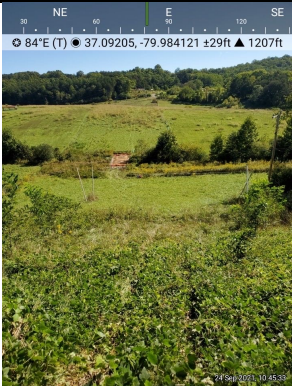
GPS Location	0	GPS Location	0		
Field Station#	13555+00	Field Station#	13563+00		
Pic 5 Desc.	Perimeter CFS	Pic 6 Desc.	GAS Bethlehem Rd

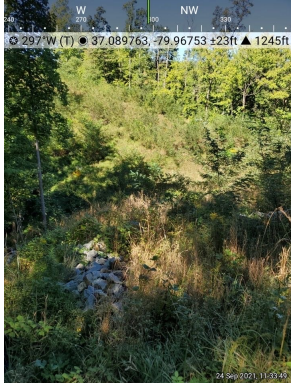
GPS Location	0	GPS Location	0		
Field Station#	13604+00	Field Station#	13632+00		
Pic 9 Desc.	Waterbar outlet	Pic 10 Desc.	Hillside vegetation

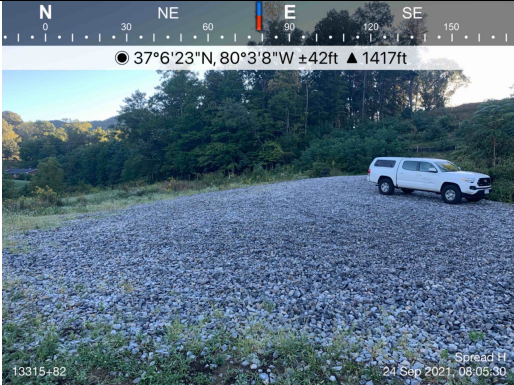
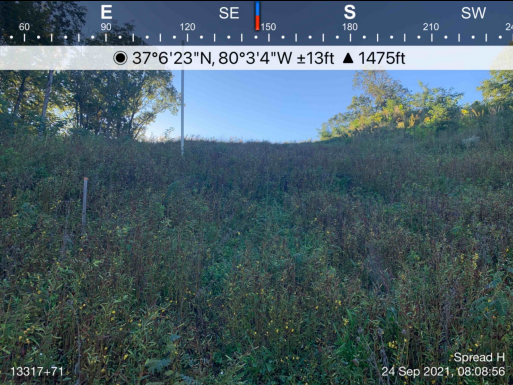
GPS Location	See Photograph		GPS Location	See Photograph	
Field Station#	13315+82		Field Station#	13317+71	
Pic 1 Desc.	Rock consecution entrance and ATWS off of Wades Gap Road is in acceptable condition.		Pic 2 Desc.	ROW is well vegetated and in acceptable condition.

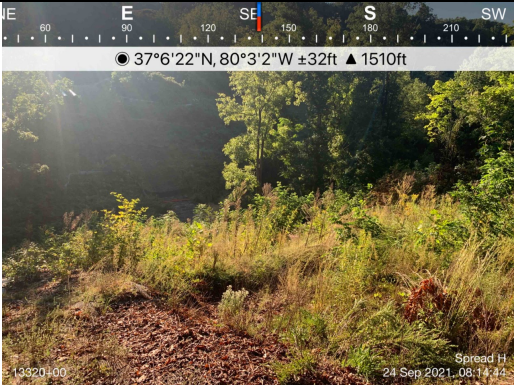
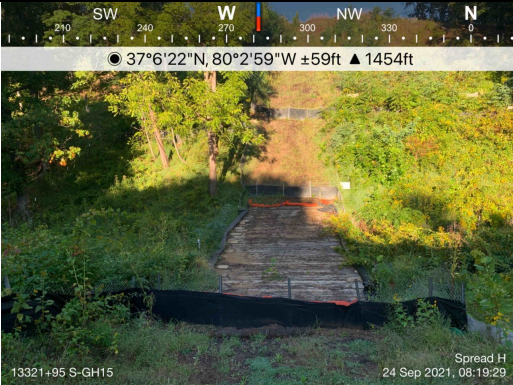
GPS Location	See Photograph		GPS Location	See Photograph	
Field Station#	13320+00		Field Station#	13321+95	
Pic 3 Desc.	Waterbars along slopes are stable and in acceptable condition.		Pic 4 Desc.	Equipment Bridge crossing at S-GH15 is in acceptable condition

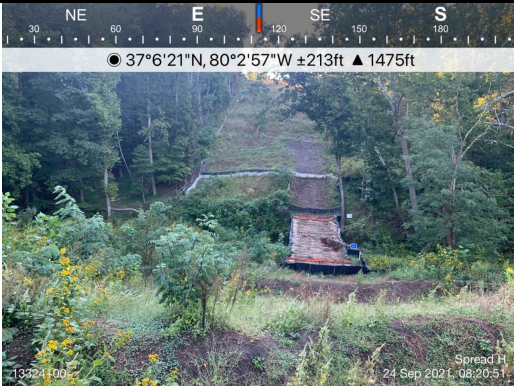
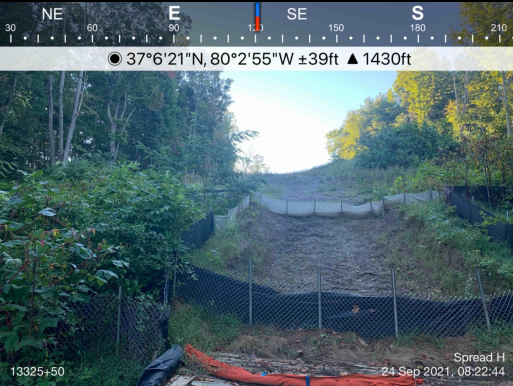
GPS Location	See Photograph		GPS Location	See Photograph	
Field Station#	13324+00		Field Station#	13325+50	
Pic 5 Desc.	Equipment Bridge crossing at S-GH14 is in acceptable condition.		Pic 6 Desc.	Aquatic resource buffer controls are in acceptable condition.
