# Visual Site Inspection Report

<b>Project Name</b>	H-600 Pipeline Spread H	<b>AFE</b>	124300138	<b>Spread</b>	H-600 Pipeline Spread H
<b>Contractor</b>	Precision			<b>Report #</b>	29017
<b>Inspector</b>	Bryan Cole			<b>Date/Time</b>	9/27/2021 5:32 PM
<b>Permit #</b>	TBD	<b>Inspection Type</b>	VA SWPP	<b>Station Begin</b>	13141+65
<b>State</b>	VA	<b>Inspection Area</b>	Partial	<b>Station End</b>	13316+21
<b>County</b>	Franklin	<b>Ground</b>	Damp	<b>Temperature (°F)</b>	70.00
<b>Municipality</b>	N/A	<b>Weather</b>	Sunny	<b>Rain Gauge (in)</b>	0.00
				<b>Rain Accumulation Time (days)</b>	0.00

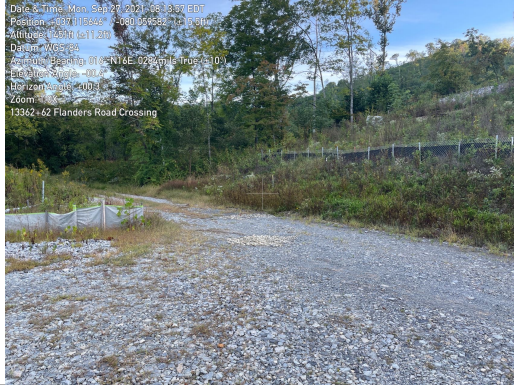
<b>GPS Location</b>	0	<b>GPS Location</b>	0		
<b>Field Station#</b>	13309+09	<b>Field Station#</b>	13362+62		
<b>Pic 3 Desc.</b>	MVP-S-GH7 and Corresponding buffer zone in good condition	<b>Pic 4 Desc.</b>	Flanders Road Crossing in good condition		
<p>Date &amp; Time: Mon, Sep 27, 2021, 08:14:40 EDT  Position: +037.118446, -080.059935 (+15.40)  Altitude: 1444ft (+11.20)  Datum: WGS-84  Azimuth/Bearing: 253.574W 4516mils True (+10.1)  Elevation Angle: -04.7  Horizon Angle: +03.9  Zoom: 1.0X  13360+66 S-II4</p>

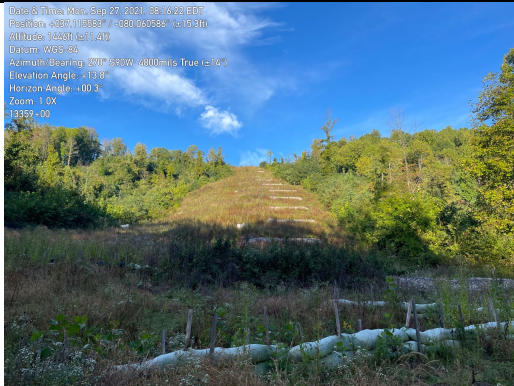
<b>GPS Location</b>	0	<b>GPS Location</b>	0		
<b>Field Station#</b>	13360+66	<b>Field Station#</b>	13359+00		
<b>Pic 5 Desc.</b>	MVP-S-II4 and Corresponding buffer zone in good condition	<b>Pic 6 Desc.</b>	ROW and ECDs in good condition with good vegetation established across ROW

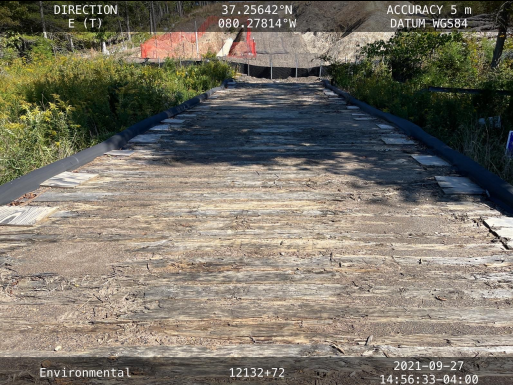
<b>GPS Location</b>	See photo		<b>GPS Location</b>	See photo	
<b>Field Station#</b>	12128+00		<b>Field Station#</b>	12132+72	
<b>Pic 1 Desc.</b>	Stabilized row conditions acceptable		<b>Pic 2 Desc.</b>	Bridge and ECDs crossing stream S-C29 in acceptable condition.

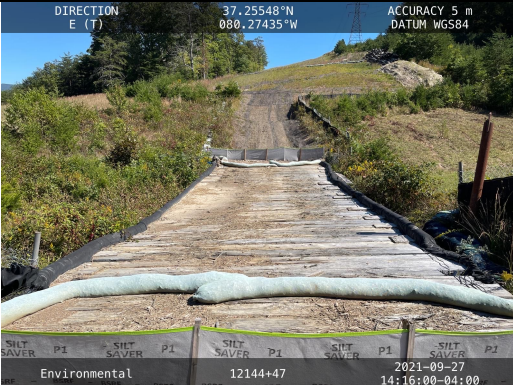
<b>GPS Location</b>	See photo		<b>GPS Location</b>	See photo	
<b>Field Station#</b>	12135+00		<b>Field Station#</b>	12144+47	
<b>Pic 3 Desc.</b>	Stabilized slope in acceptable condition		<b>Pic 4 Desc.</b>	Wetland crossing W-C5 in acceptable condition

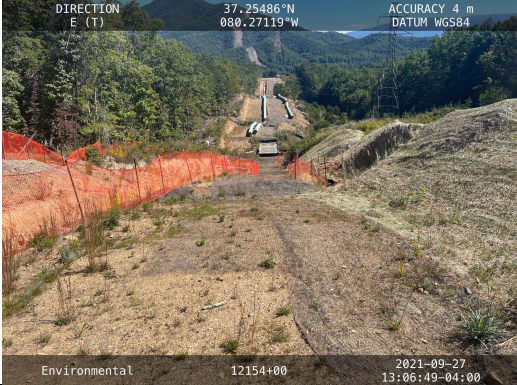
<b>GPS Location</b>	See photo		<b>GPS Location</b>	See photo	
<b>Field Station#</b>	12154+00		<b>Field Station#</b>	12185+00	
<b>Pic 7 Desc.</b>	Stabilized ROW in acceptable condition		<b>Pic 8 Desc.</b>	Stabilized row conditions acceptable

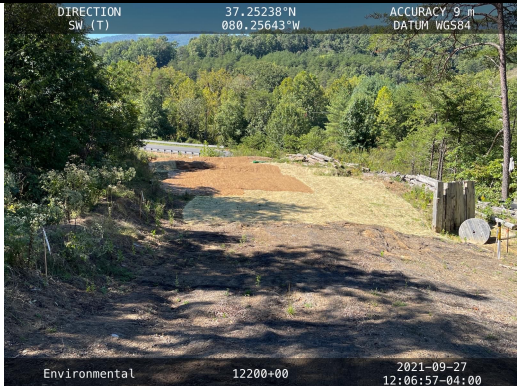
<b>GPS Location</b>	See photo		<b>GPS Location</b>	See photo	
<b>Field Station#</b>	12200+00		<b>Field Station#</b>	12207+00	
<b>Pic 9 Desc.</b>	Stabilized ROW conditions acceptable		<b>Pic 10 Desc.</b>	Stabilized ROW conditions acceptable

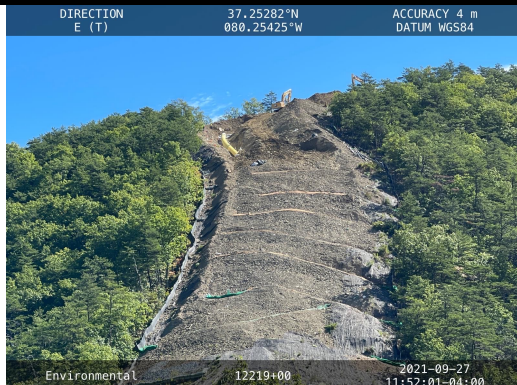
<b>GPS Location</b>	See photo		<b>GPS Location</b>	See photo	
<b>Field Station#</b>	12219+00		<b>Field Station#</b>	12214+00	
<b>Pic 11 Desc.</b>	Tie in crew moving pipe down to lower in and make a weld.		<b>Pic 12 Desc.</b>	Stabilized slope conditions acceptable

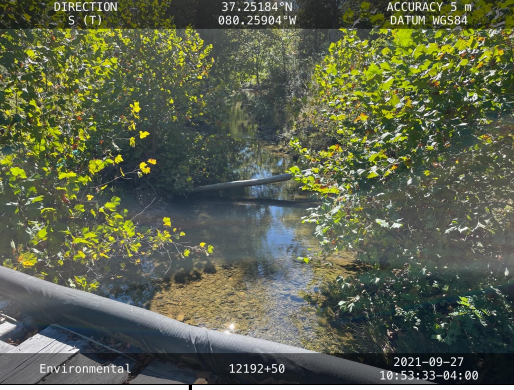
<b>Field Station#</b>	12196+24		<b>Field Station#</b>	12198+90	
<b>Pic 15 Desc.</b>	S-OO11 on down stream side of newly build road.		<b>Pic 16 Desc.</b>	Access Road MVP-MN-275	
  <p>DIRECTION SE (T) 37.25200°N 080.25847°W ACCURACY 5 m DATUM WGS84</p> <p>Environmental 12194+00 2021-09-27 10:54:28-04:00</p>

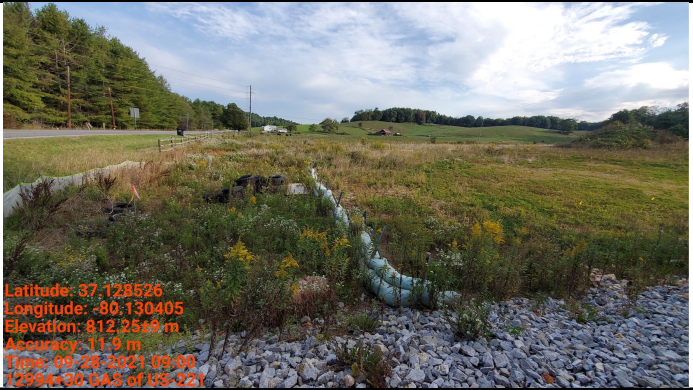
<p>Latitude: 37.128526 Longitude: -80.130405 Elevation: 812.2545 m Accuracy: 11.9 m Time: 09-28-2021 09:00 12994+30 GAS of the US-221 road crossing</p>			
<b>GPS Location</b>	See pic for GPS location.	<b>GPS Location</b>	See pic for GPS location.		
<b>Field Station#</b>	13012+80	<b>Field Station#</b>	12994+30		
<b>Pic 5 Desc.</b>	GAS of the BRP motorway.	<b>Pic 6 Desc.</b>	GAS of the US-221 road crossing.

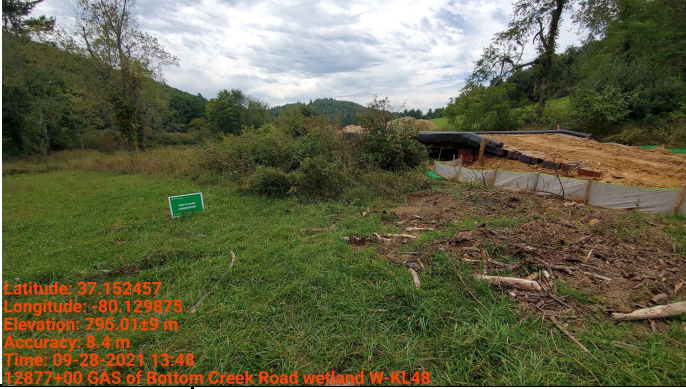
<p>Latitude: 37.139506 Longitude: -80.132946 Elevation: 795.2317 m Accuracy: 6.5 m Time: 09-28-2021 14:16 12891+00 GAS of Bottom Creek Road stream S-KL55 and wetlands W-KL49 W-KL51</p>			
<b>GPS Location</b>	See pic for GPS location.		<b>GPS Location</b>	See pic for GPS location.	
<b>Field Station#</b>	12877+00		<b>Field Station#</b>	12891+00	
<b>Pic 13 Desc.</b>	Wetland crossing W-KL48.		<b>Pic 14 Desc.</b>	Stream S-KL55 and wetlands from the GAS.

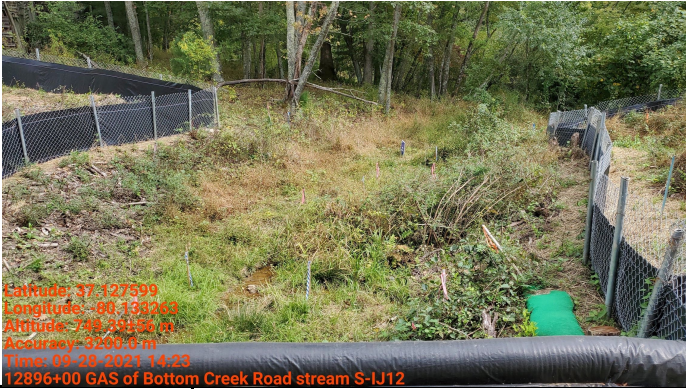
<b>GPS Location</b>	See pic for GPS location.		<b>GPS Location</b>	See pic for GPS location.	
<b>Field Station#</b>	12896+00		<b>Field Station#</b>	12865+25	
<b>Pic 15 Desc.</b>	Downstream side of stream S-IJ12.		<b>Pic 16 Desc.</b>	Perimeter CFS on CIS of Bottom Creek Road.

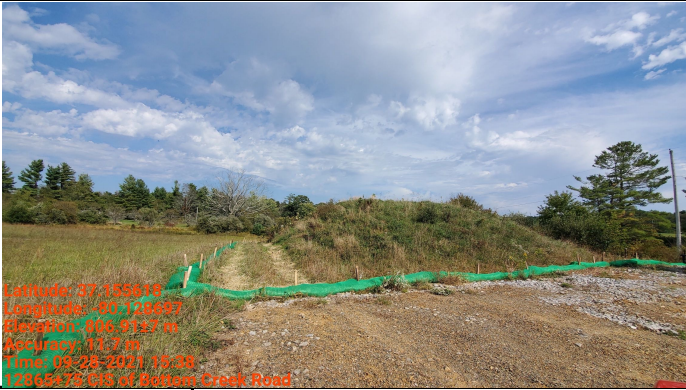
<p>Latitude: 37.135819 Longitude: -80.130837 Elevation: 806.91±1 m Accuracy: 12.7 m Time: 09-28-2021 15:39 12865+75 CIS of Bottom Creek Road</p>			
<b>GPS Location</b>	See pic for GPS location.		<b>GPS Location</b>	See pic for GPS location.	
<b>Field Station#</b>	12865+75		<b>Field Station#</b>	12866+75	
<b>Pic 17 Desc.</b>	Topsoil pile on the CIS of Bottom Creek Road.		<b>Pic 18 Desc.</b>	Current condition of the GAS of Bottom Creek Road.

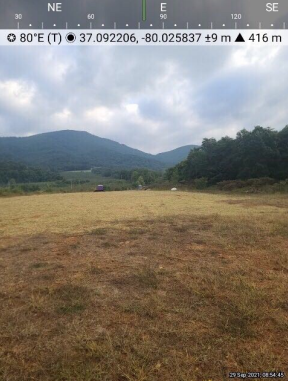
<b>GPS Location</b>	00000	<b>GPS Location</b>	0000		
<b>Field Station#</b>	13420+00	<b>Field Station#</b>	13438+70		
<b>Pic 1 Desc.</b>	Photo showing work space stabilized at CAHAS#1		<b>Pic 2 Desc.</b>	Safety fence requires maintenance around monitored natural drain area, documented and added to the punch list for repair.

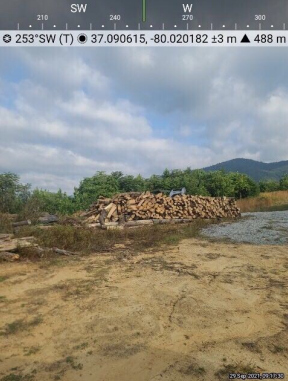
<b>GPS Location</b>	00000	<b>GPS Location</b>	0000		
<b>Field Station#</b>	13437+78	<b>Field Station#</b>	13437+78		
<b>Pic 3 Desc.</b>	Additional photo showing area where land owner activities continue.		<b>Pic 4 Desc.</b>	Land owner continues cutting fire wood from log pile inside the LOD , monitored equipment for leaks. No environmental issues observed at the time of inspection.

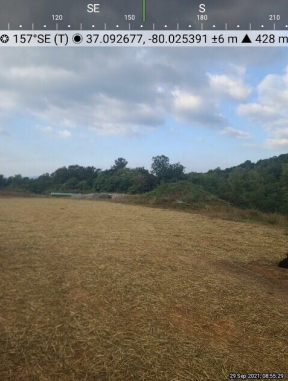
<b>Pic 5 Desc.</b>	Additional photo of work space at CAHAS#1 after stabilization activities were completed.		<b>Pic 6 Desc.</b>	Monitored stream crossing, all ECDs in place and functioning at the time of inspection.

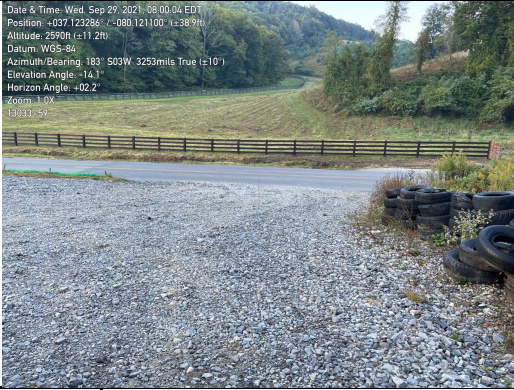
<b>GPS Location</b>	0	<b>GPS Location</b>	0		
<b>Field Station#</b>	13033+59	<b>Field Station#</b>	13030+00		
<b>Pic 1 Desc.</b>	RCE in good condition and functioning properly	<b>Pic 2 Desc.</b>	ROW and ECDs in good condition with good vegetation established across ROW		
<p>Date &amp; Time: Wed, Sep 29, 2021, 08:50:36 EDT  Position: +0370 123175 / -080 120512 (±15.4m)  Altitude: 2650ft (±11.0m)  Datum: WGS-84  Azimuth/Bearing: 219° N52W 4942mils True (±13°)  Elevation Angle: -03.3°  Horizon Angle: -00.2°  Zoom: 1.0X  13024+06 S-624 G25</p>

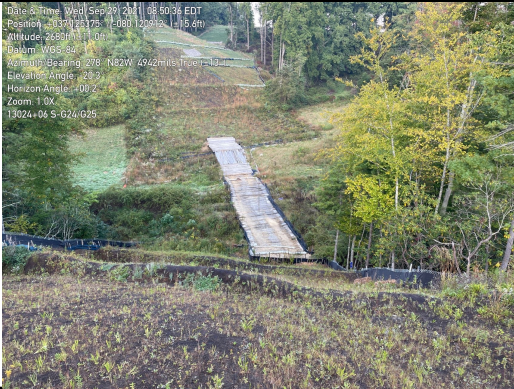
<b>GPS Location</b>	0	<b>GPS Location</b>	0		
<b>Field Station#</b>	13024+06	<b>Field Station#</b>	13034+00		
<b>Pic 3 Desc.</b>	MVP-S-G24/G25 and Corresponding buffer zone in good condition	<b>Pic 4 Desc.</b>	ROW and ECDs in good condition with good vegetation established across ROW, travel lane used by the landowner recently stabilized		
<p>Date &amp; Time: Wed, Sep 29, 2021, 09:38:39 EDT  Position: +037 122937 / -080 112418 (±15.5m)  Altitude: 2759ft (±11.2m)  Datum: WGS-84  Azimuth/Bearing: 315° N45W 5480mils True (±16°)  Elevation Angle: -03.0°  Horizon Angle: -00.2°  Zoom: 1.0X  13058+50</p>

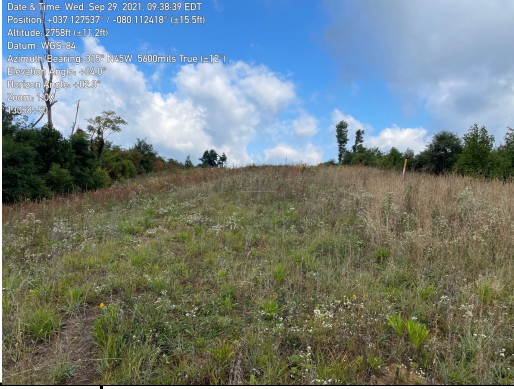
<b>Field Station#</b>	13058+50	<b>Field Station#</b>	13060+00		
<b>Pic 5 Desc.</b>	ROW and ECDs in good condition with good vegetation established across ROW	<b>Pic 6 Desc.</b>	ROW and ECDs in good condition with good vegetation established across ROW

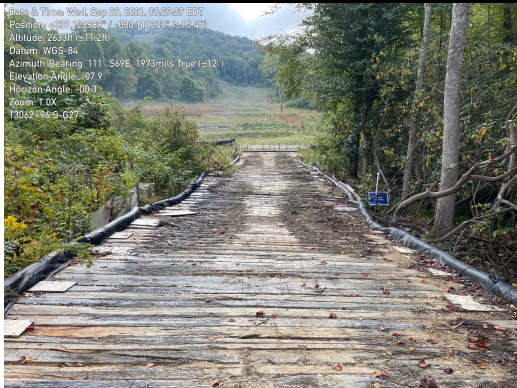
<b>GPS Location</b>	0	<b>GPS Location</b>	0		
<b>Field Station#</b>	13062+96	<b>Field Station#</b>	13064+00		
<b>Pic 9 Desc.</b>	MVP-S-G27 and Corresponding buffer zone in good condition	<b>Pic 10 Desc.</b>	ROW and ECDs in good condition with good vegetation established across ROW

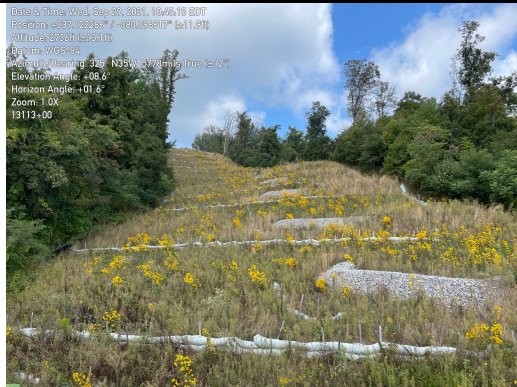
<b>GPS Location</b>	0	<b>GPS Location</b>	0		
<b>Field Station#</b>	13113+00	<b>Field Station#</b>	13116+00		
<b>Pic 11 Desc.</b>	ROW and ECDs in good condition with good vegetation established across ROW	<b>Pic 12 Desc.</b>	Crew working on waterbars on hill below 291, in good condition

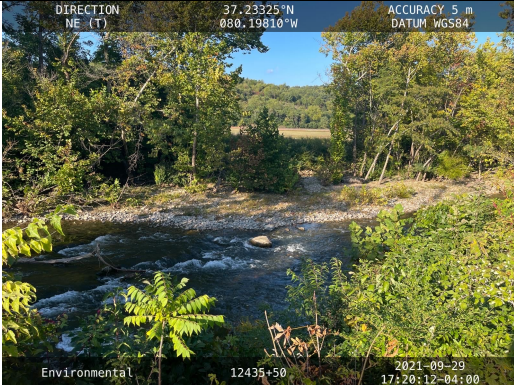
<p>DIRECTION NE (T) 37.23325°N 080.19810°W ACCURACY 5 m DATUM WGS84</p> <p>Environmental 12435+50 2021-09-29 17:20:12-04:00</p>

<p>DIRECTION NE (T) 37.23672°N 080.19927°W ACCURACY 9 m DATUM WGS84</p> <p>Environmental 12421+00 2021-09-29 17:10:53-04:00</p>			
<b>GPS Location</b>	see photo		<b>GPS Location</b>	See photo	
<b>Field Station#</b>	12435+50		<b>Field Station#</b>	12421+00	
<b>Pic 1 Desc.</b>	Stream crossing S-NN16		<b>Pic 2 Desc.</b>	Clean water crossing pipe inlet

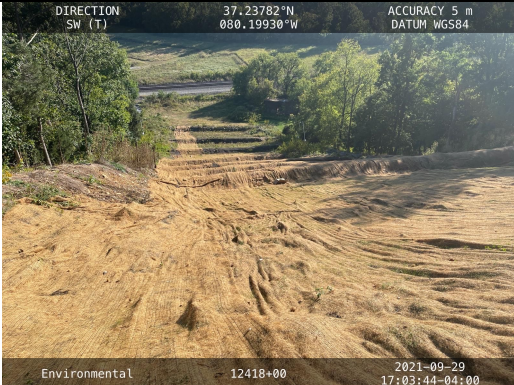
<p>DIRECTION SW (T) 37.23782°N 080.19930°W ACCURACY 5 m DATUM WGS84</p> <p>Environmental 12418+00 2021-09-29 17:03:44-04:00</p>

<b>Field Station#</b>	12418+00		<b>Field Station#</b>	12408+80	
<b>Pic 3 Desc.</b>	Stabilized ROW Conditions acceptable		<b>Pic 4 Desc.</b>	Clean water crossing pipe inlet

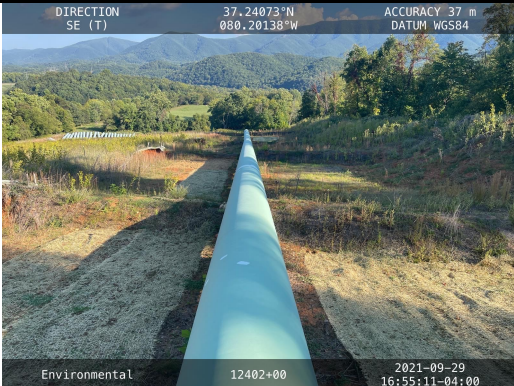
<p>DIRECTION SE (T) 37.24073°N 080.20138°W ACCURACY 37 m DATUM WGS84</p> <p>Environmental 12402+00 2021-09-29 16:55:11-04:00</p>

<p>DIRECTION SE (T) 37.24315°N 080.20364°W ACCURACY 13 m DATUM WGS84</p> <p>Environmental 12393+23 2021-09-29 16:49:47-04:00</p>			
<b>GPS Location</b>	See photo		<b>GPS Location</b>	See photo	
<b>Field Station#</b>	12402+00		<b>Field Station#</b>	12393+23	
<b>Pic 5 Desc.</b>	Stabilized ROW Conditions acceptable		<b>Pic 6 Desc.</b>	Stabilized ROW Conditions acceptable

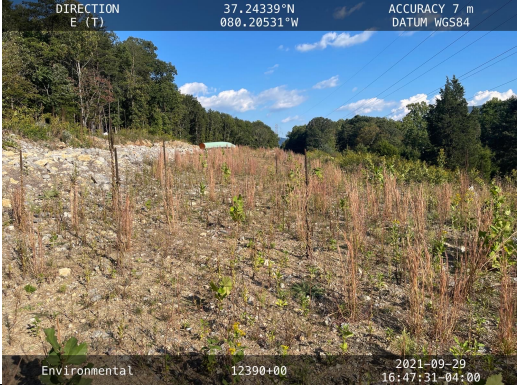
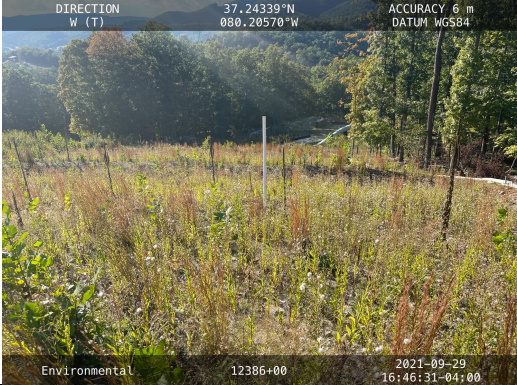
<b>GPS Location</b>	See photo		<b>GPS Location</b>	See photo	
<b>Field Station#</b>	12390+00		<b>Field Station#</b>	12386+00	
<b>Pic 7 Desc.</b>	Stabilized ROW Conditions acceptable		<b>Pic 8 Desc.</b>	Stabilized ROW Conditions acceptable

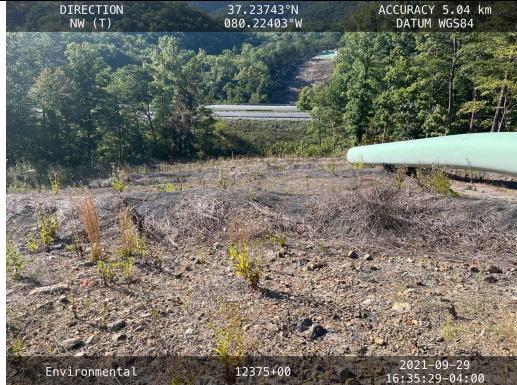
<b>GPS Location</b>	See photo		<b>GPS Location</b>	See photo	
<b>Field Station#</b>	12375+00		<b>Field Station#</b>	12374+16	
<b>Pic 11 Desc.</b>	Stabilized ROW Conditions acceptable		<b>Pic 12 Desc.</b>	Stream crossing S-0016

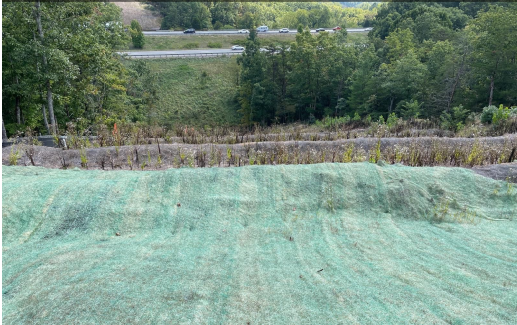
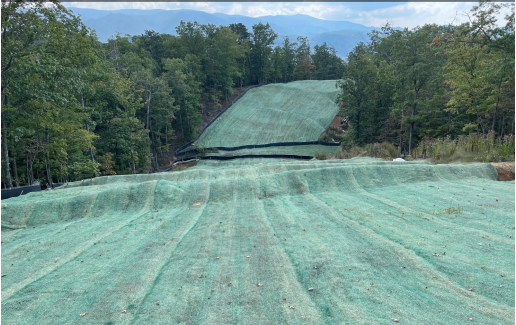
Environmental 12361+02 2021-09-29 12:56:36-04:00			
<b>GPS Location</b>	See photo		<b>GPS Location</b>	See photo	
<b>Field Station#</b>	12370+00		<b>Field Station#</b>	12361+02	
<b>Pic 13 Desc.</b>	Stabilized ROW Conditions acceptable		<b>Pic 14 Desc.</b>	Stabilized ROW Conditions acceptable	
DIRECTION E (T) 37.25274°N 080.21537°W ACCURACY 5 m DATUM WGS84

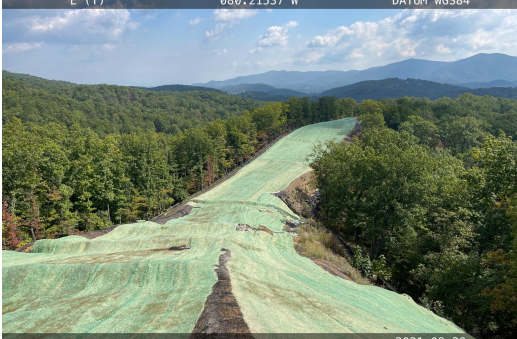
<b>Pic 15 Desc.</b>	Stabilized ROW Conditions acceptable		<b>Pic 16 Desc.</b>	Fill slope drain inlet acceptable	
DIRECTION E (T) 37.25395°N 080.22303°W ACCURACY 59 m DATUM WGS84

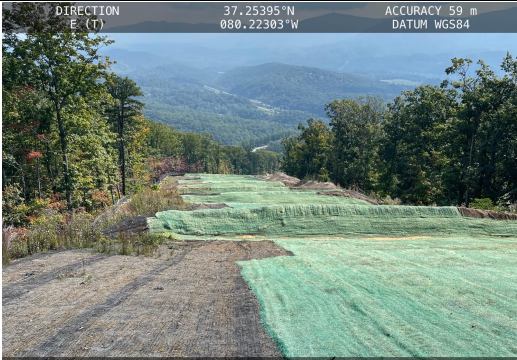
Environmental 12291+00 2021-09-29 10:57:17-04:00			
<b>GPS Location</b>	See photo		<b>GPS Location</b>	See photo	
<b>Field Station#</b>	12310+00		<b>Field Station#</b>	12291+00	
<b>Pic 17 Desc.</b>	Stabilized ROW Conditions acceptable		<b>Pic 18 Desc.</b>	Excavator packing down blasted materials and removing rocks that slid down during blast.

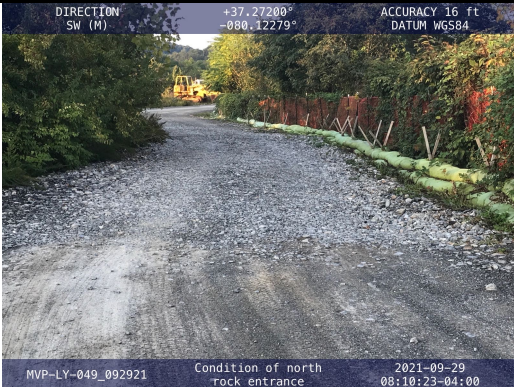
<b>GPS Location</b>	MVP-LY-049 See photo for gps data	<b>GPS Location</b>	MVP-LY-049 See photo for gps data		
<b>Field Station#</b>	+0	<b>Field Station#</b>	+0		
<b>Pic 1 Desc.</b>	Condition of rock entrance on north drive. No sediment on stone. Looking SW.	<b>Pic 2 Desc.</b>	Condition of triple stack compost filter sock and safety fence along north LOD. Looking W.

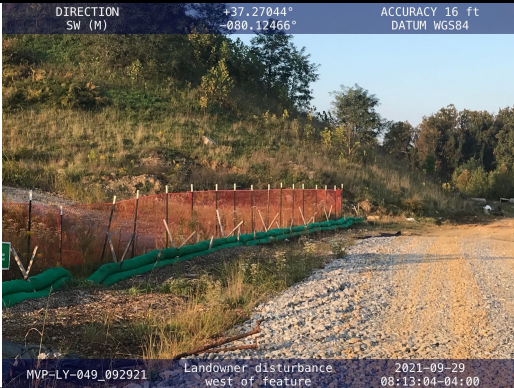
<b>GPS Location</b>	MVP-LY-049 See photo for gps data	<b>GPS Location</b>	MVP-LY-049 See photo for gps data		
<b>Field Station#</b>	+0	<b>Field Station#</b>	+0		
<b>Pic 5 Desc.</b>	Landowner soil disturbance west of feature W-CV21B. Areas not stabilized. Looking SW.	<b>Pic 6 Desc.</b>	Landowner soil disturbance and debris piled along triple stack compost filter sock and east of feature W-CV21B. Looking S.

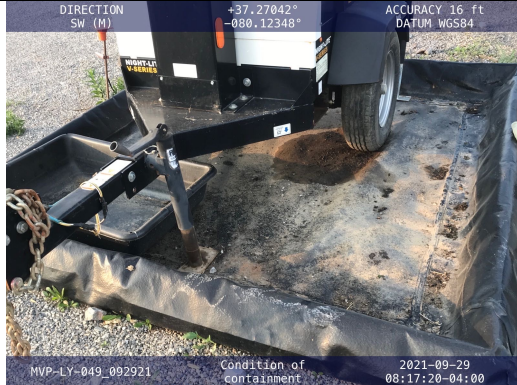
<b>GPS Location</b>	MVP-LY-049 See photo for gps data		<b>GPS Location</b>	MVP-LY-049 See photo for gps data	
<b>Field Station#</b>	+0		<b>Field Station#</b>	+0	
<b>Pic 11 Desc.</b>	Containment under light plant free of fluids and stormwater. Looking SW.		<b>Pic 12 Desc.</b>	Compost filter sock in place around sand pile. Looking SW.

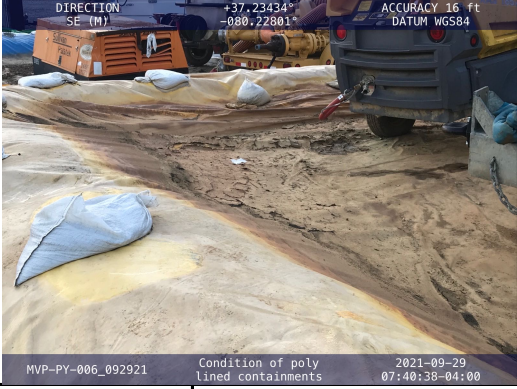
<b>GPS Location</b>	MVP-PY-006 See photo for gps data		<b>GPS Location</b>	MVP-PY-006 See photo for gps data	
<b>Field Station#</b>	+0		<b>Field Station#</b>	+0	
<b>Pic 15 Desc.</b>	Condition of poly lined rock berm containments. Free of stormwater and fluids. Looking SE.		<b>Pic 16 Desc.</b>	Condition of soil pile adjacent to LOD. Pile not stabilized. Looking SE.

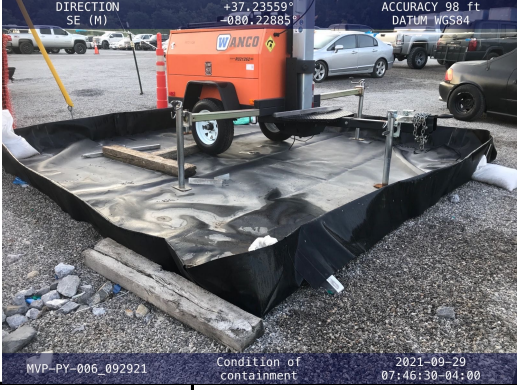
<b>Pic 17 Desc.</b>	Containment under light plant free of fluids and stormwater. Looking SE.		<b>Pic 18 Desc.</b>	Condition of posted project documents at the main entrance. Looking W.

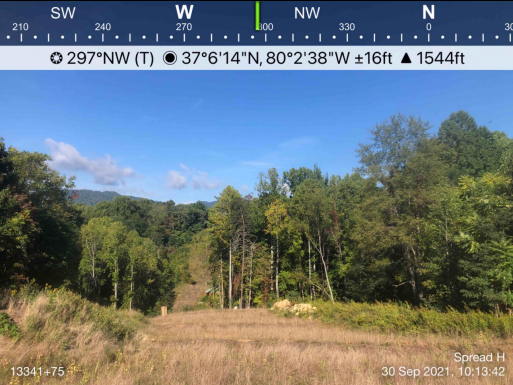
<b>GPS Location</b>	See photo		<b>GPS Location</b>	See photo	
<b>Field Station#</b>	13363+00		<b>Field Station#</b>	13341+75	
<b>Pic 1 Desc.</b>	Road Crossing near MLV-AR-29 in good condition.		<b>Pic 2 Desc.</b>	Waterbars are stabilized and in acceptable condition on this slope

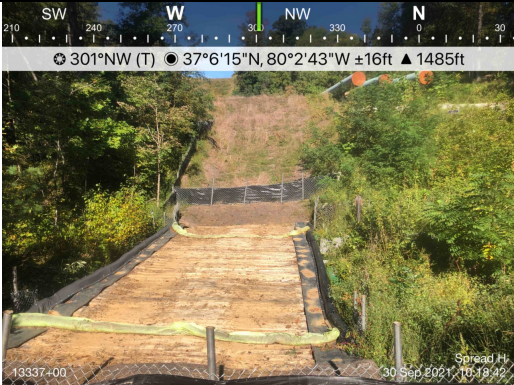
<b>GPS Location</b>	See photo		<b>GPS Location</b>	See photo	
<b>Field Station#</b>	13337+00		<b>Field Station#</b>	13343+46	
<b>Pic 3 Desc.</b>	Timbermatting and SSF controls in good condition at this stream crossing.		<b>Pic 4 Desc.</b>	ATWS and Rock CE on Websters Corner Rd in good condition.

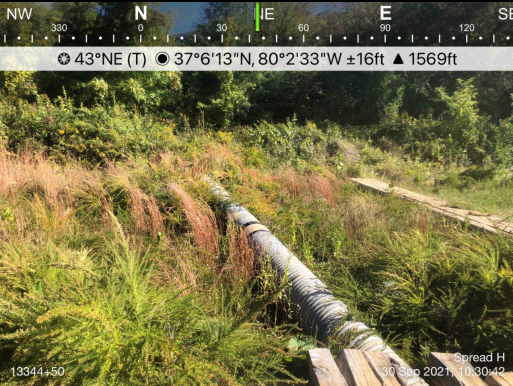
<b>GPS Location</b>	See photo		<b>GPS Location</b>	See photo	
<b>Field Station#</b>	13343+46		<b>Field Station#</b>	13344+50	
<b>Pic 5 Desc.</b>	New erosion control blanketing was installed in this area and is in good condition.		<b>Pic 6 Desc.</b>	CWD berm and pipe in good condition.

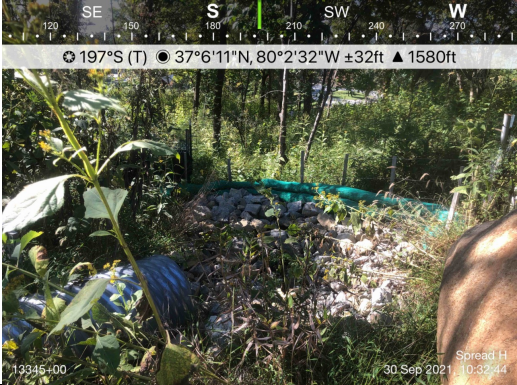
<b>GPS Location</b>	See photo	<b>GPS Location</b>	See photo		
<b>Field Station#</b>	13345+00	<b>Field Station#</b>	13348+00		
<b>Pic 7 Desc.</b>	CWD outlet in good condition.	<b>Pic 8 Desc.</b>	Waterbars and other controls are in good condition on this slope.

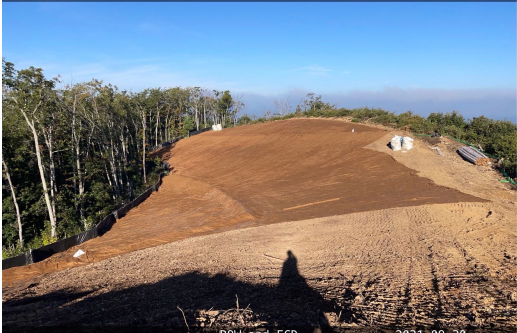
12603+00 ROW and ECD conditions 2021-09-30 09:06:44-04:00		12735+00 ROW conditions 2021-09-30 10:31:34-04:00			
<b>GPS Location</b>	See photo		<b>GPS Location</b>	See photo	
<b>Field Station#</b>	12603+00		<b>Field Station#</b>	12735+00	
<b>Pic 13 Desc.</b>	Current ROW conditions. ROW is stable.		<b>Pic 14 Desc.</b>	Current ROW conditions. ROW is stable.	
DIRECTION E (T) +37.18777° -080.15129° ACCURACY 27 ft DATUM WGS84		DIRECTION E (T) +37.18759° -080.15123° ACCURACY 19 ft DATUM WGS84

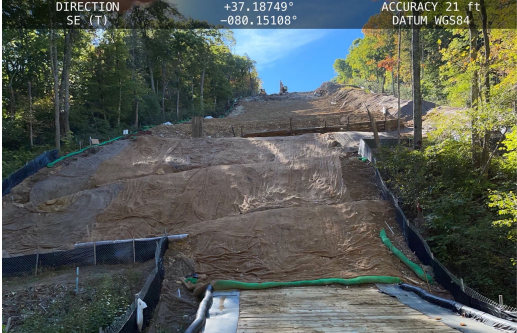
12716+50 ROW conditions 2021-09-30 10:42:47-04:00		12716+20 Bridge over S-Y14 2021-09-30 10:41:45-04:00			
<b>GPS Location</b>	See photo		<b>GPS Location</b>	See photo	
<b>Field Station#</b>	12716+50		<b>Field Station#</b>	12716+20	
<b>Pic 17 Desc.</b>	Current ROW conditions. ROW is stable.		<b>Pic 18 Desc.</b>	Equipment bridge over Stream S-Y14/Y13

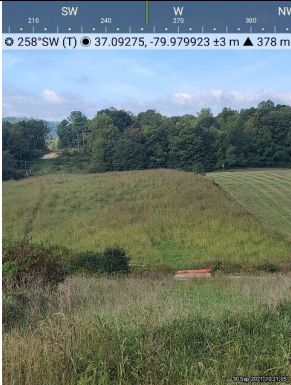
<b>GPS Location</b>	00000	<b>GPS Location</b>	0000		
<b>Field Station#</b>	13574+30	<b>Field Station#</b>	13644+37		
<b>Pic 1 Desc.</b>	Monitored permanent vegetation area, inspected equipment bridges and protection , no environmental issues observed at the time of inspection	<b>Pic 2 Desc.</b>	Observed P1 at road crossing, all up to date and functioning at the time of inspection.

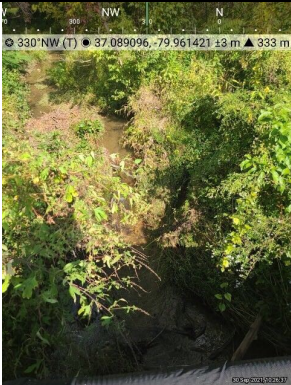
<b>GPS Location</b>	00000	<b>GPS Location</b>	0000		
<b>Field Station#</b>	13643+67	<b>Field Station#</b>	13643+67		
<b>Pic 3 Desc.</b>	Stream observation photo facing upstream during routine inspection today, no environmental issues observed at the time of inspection	<b>Pic 4 Desc.</b>	Stream observation photo facing downstream during routine inspection today, no environmental issues observed at the time of inspection

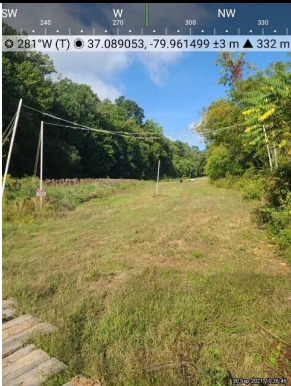
<b>GPS Location</b>	0000	<b>GPS Location</b>	00000		
<b>Field Station#</b>	13643+58	<b>Field Station#</b>	13543+60		
<b>Pic 5 Desc.</b>	Row photo showing vegetation coverage up row from stream crossing. No environmental issues observed at the time of inspection	<b>Pic 6 Desc.</b>	Row photo showing good permanent vegetation.

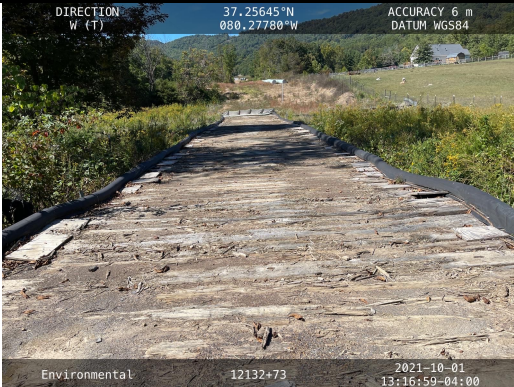
<b>GPS Location</b>	See photo		<b>GPS Location</b>	See photo	
<b>Field Station#</b>	12132+73		<b>Field Station#</b>	12139+91	
<b>Pic 1 Desc.</b>	Bridge and ECDs crossing stream S-C29		<b>Pic 2 Desc.</b>	Bridge and ECDs crossing wetland W-C6

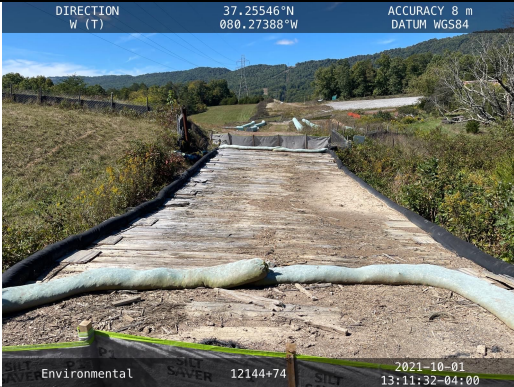
<b>GPS Location</b>	See photo		<b>GPS Location</b>	See photo	
<b>Field Station#</b>	12144+74		<b>Field Station#</b>	12158+40	
<b>Pic 3 Desc.</b>	Bridge and ECDs crossing wetland W-C5		<b>Pic 4 Desc.</b>	Clean water crossing

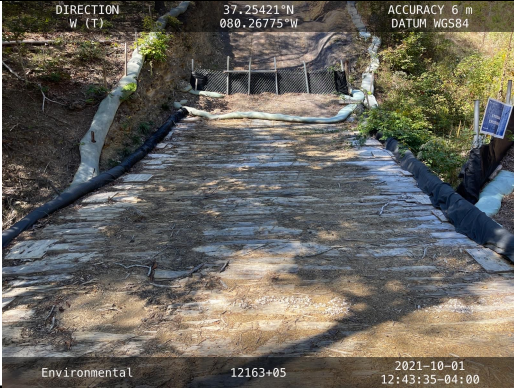
<b>GPS Location</b>	See photo		<b>GPS Location</b>	See photo	
<b>Field Station#</b>	12163+05		<b>Field Station#</b>	12166+47	
<b>Pic 5 Desc.</b>	Bridge and ECDs at stream crossing S-C25		<b>Pic 6 Desc.</b>	ECDs and bridge at stream crossing S-C24

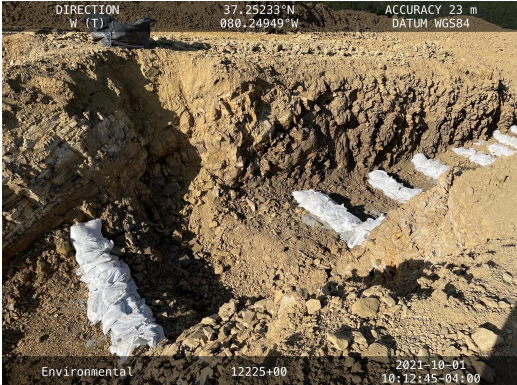
<b>GPS Location</b>	See photo		<b>GPS Location</b>	See photo	
<b>Field Station#</b>	12225+00		<b>Field Station#</b>	12228+00	
<b>Pic 15 Desc.</b>	Keyed in section for next trench breaker.		<b>Pic 16 Desc.</b>	Fill slope drain inlet

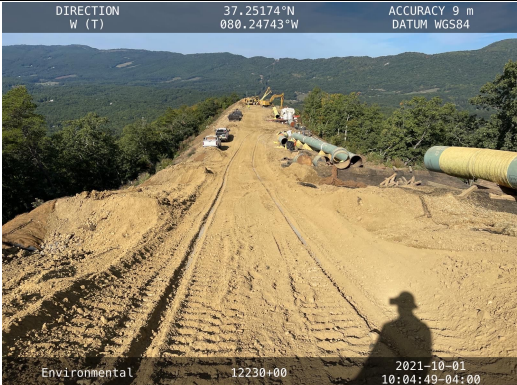
<b>GPS Location</b>	See photo		<b>GPS Location</b>	See photo	
<b>Field Station#</b>	12230+00		<b>Field Station#</b>	12283+00	
<b>Pic 17 Desc.</b>	Construction ROW Conditions		<b>Pic 18 Desc.</b>	Tie in crew working on lowering in.

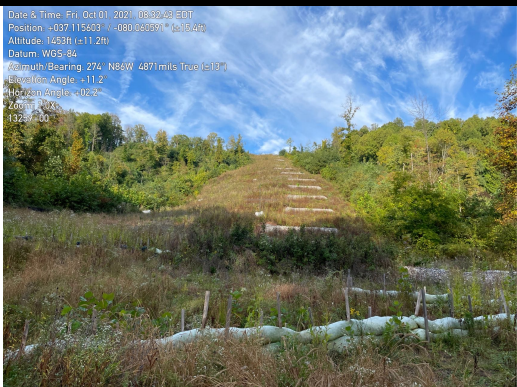
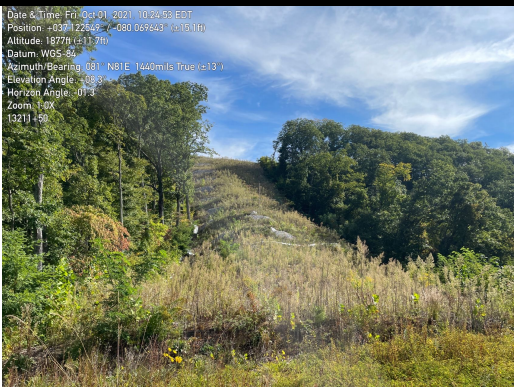
GPS Location	0	GPS Location	0		
Field Station#	13259+00	Field Station#	13211+50		
Pic 3 Desc.	ROW and ECDs in good condition with good vegetation established across ROW		Pic 4 Desc.	ROW and ECDs in good condition with good vegetation established across ROW

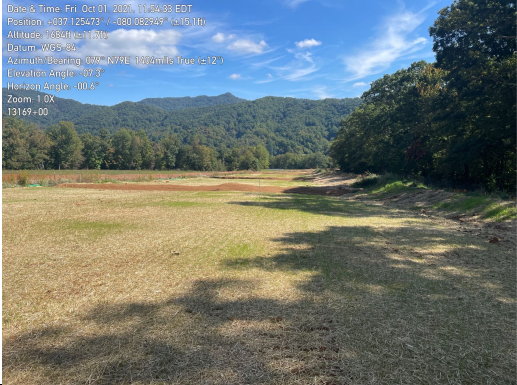
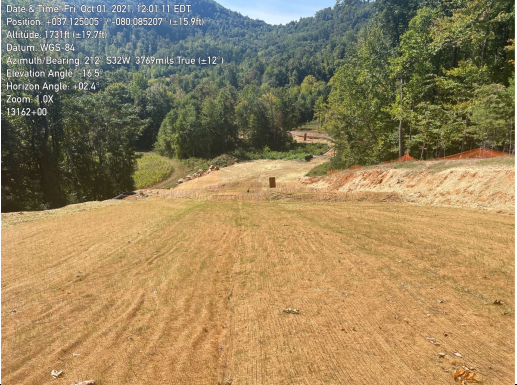
<b>GPS Location</b> 0		<b>GPS Location</b> 0			
<b>Field Station#</b> 13169+00		<b>Field Station#</b> 13162+00			
<b>Pic 13 Desc.</b> ROW and ECDs in good condition with good vegetation established across ROW		<b>Pic 14 Desc.</b> ROW and ECDs in good condition with good vegetation established across ROW

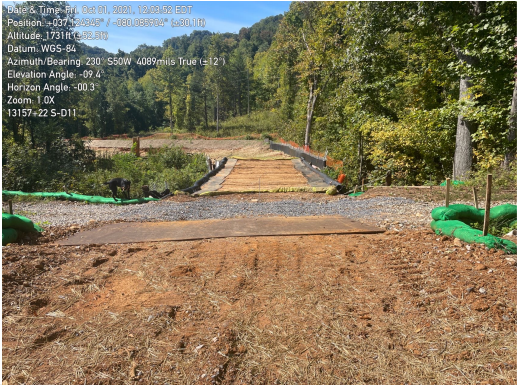
<b>GPS Location</b> 0		<b>GPS Location</b> 0			
<b>Field Station#</b> 13157+22		<b>Field Station#</b> 13154+00			
<b>Pic 15 Desc.</b> MVP-S-D11 and Corresponding buffer zone in good condition		<b>Pic 16 Desc.</b> ROW and ECDs in good condition with good vegetation established across ROW			
<p>Date &amp; Time: Fri, Oct 01, 2021, 12:10:44 EDT  Position: +037.121620° / -080.085448° (+17.0h)  Altitude: 16031ft (+38.4h)  Datum: WGS-84  Azimuth/Bearing: 238° S55W 4178mils True (+12°)  Elevation Angle: +05.9°  Horizon Angle: +00.8°  Zoom: 1.0X  13144+39 S-D12/D3</p>

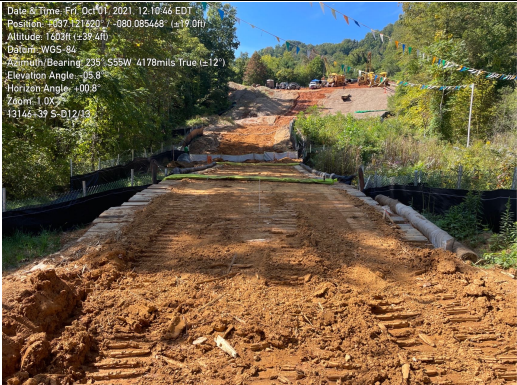
<b>GPS Location</b> 0		<b>GPS Location</b> 0			
<b>Field Station#</b> 13146+39		<b>Field Station#</b> 13145+00			
<b>Pic 17 Desc.</b> MVP-S-D12/D13 and Corresponding buffer zone in good condition		<b>Pic 18 Desc.</b> ROW and ECDs in good condition with good vegetation established across ROW
