Visual Site Inspection Report

Project Name	H-600 Pipeline Spread I	AFE	124300139	Spread	H-600 Pipeline Spread I
Contractor	Precision			Report #	29592
Inspector	Ben Davenport			Date/Time	10/11/2021 11:04 AM
Permit #	TBD	Inspection Type	VA SWPP	Station Begin	14694+77
State	VA	Inspection Area	Partial	Station End	14802+19
County	Franklin	Ground	Damp	Temperature (°F)	74.00
Municipality	N/A	Weather	Cloudy	Rain Gauge (in)	0.10
				Rain Accumulation Time (days)	1.00

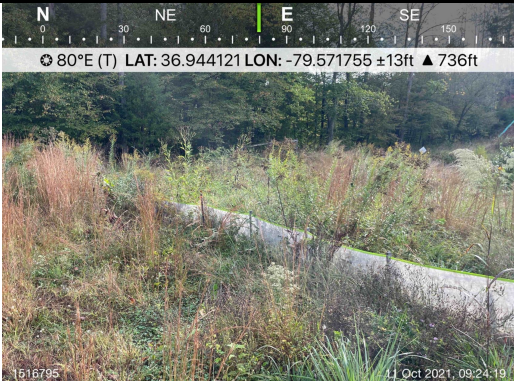
GPS Location	See photo		GPS Location	See photo	
Field Station#	15167+95		Field Station#	15167+95	
Pic 5 Desc.	P1 is in good condition at stream buffer.		Pic 6 Desc.	Equipment bridge ECDs are in place and functioning.

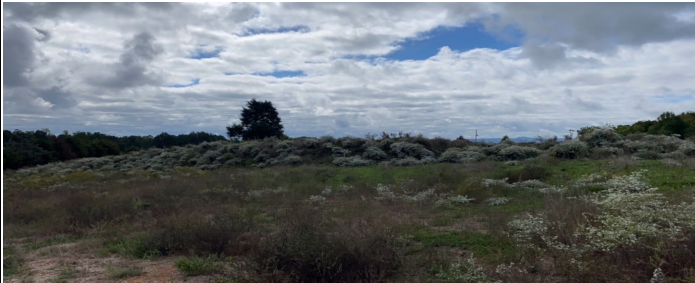
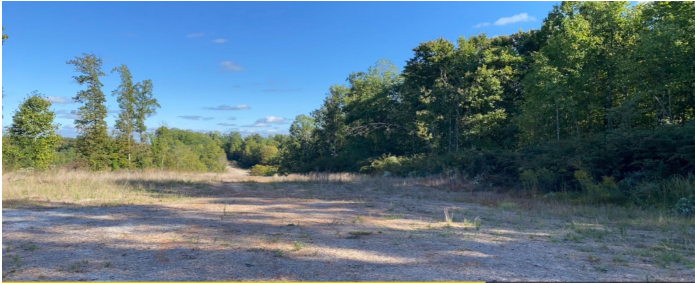
36°58'20" N 79°39'55" W 125°SE COURSE 147' GPS 1120 Listening Hill Rd, Penhook, VA 24137, United States 10.12.2021 11:00:58 Accur +/-15.4 Ft ALT 992 Ft			36°58'17" N 79°39'35" W 202°S COURSE 334' GPS 1760 Bar Ridge Rd, Penhook, VA 24137, United States 10.12.2021 15:50:37 Accur +/-19.4 Ft ALT 988 Ft		
GPS Location	5		GPS Location	6	
Field Station#	14848+00		Field Station#	14866+00	
Pic 5 Desc.	Temporary diversion berm stabilized and vegetated		Pic 6 Desc.	Picture of temporary stabilization and vegetation along ROW

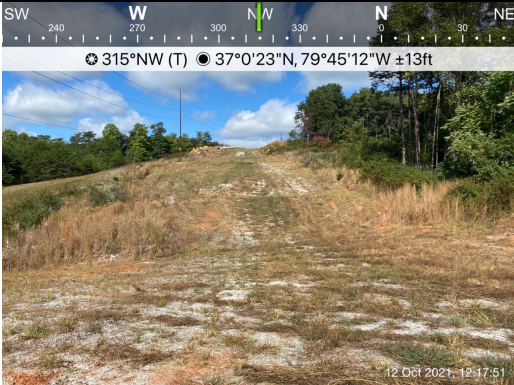
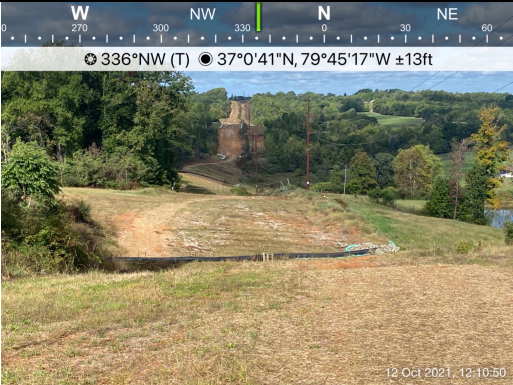
GPS Location	0	GPS Location	0		
Field Station#	14540+00	Field Station#	14520+00		
Pic 3 Desc.	Approximately 14540+00. Overview of ROW.	Pic 4 Desc.	Approximately 14520+00. Overview of ROW.

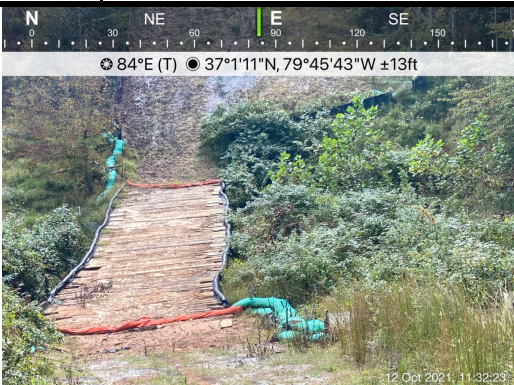
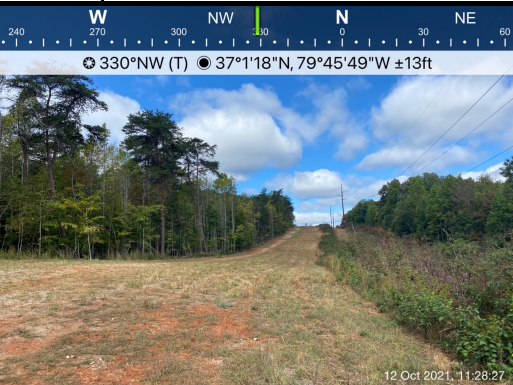
GPS Location	0	GPS Location	0		
Field Station#	14486+60	Field Station#	14470+00		
Pic 5 Desc.	Approximately 14486+60. Overview of stream crossing, equipment bridge and ECDs at stream S-G22.	Pic 6 Desc.	Approximately 14470+00. Overview of ROW.

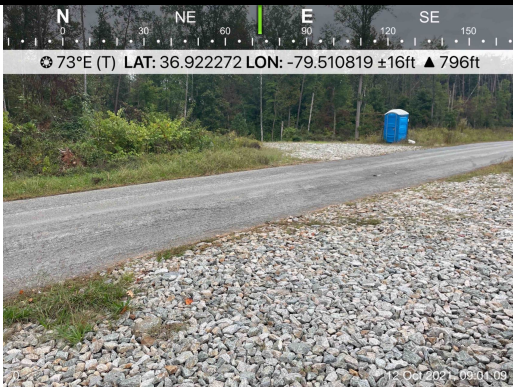
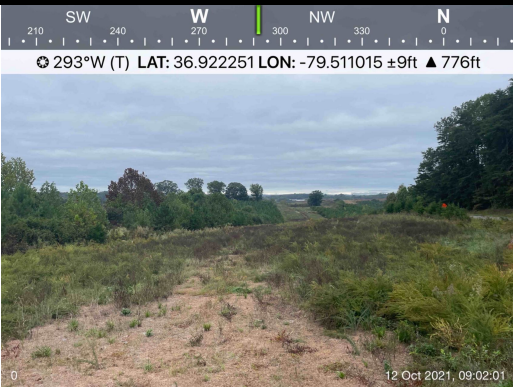
GPS Location	See photo		GPS Location	See photo	
Field Station#	15370+62		Field Station#	15370+00	
Pic 1 Desc.	RCEs are in good condition at all road crossings.		Pic 2 Desc.	Vegetation continues to fill in throughout this section.

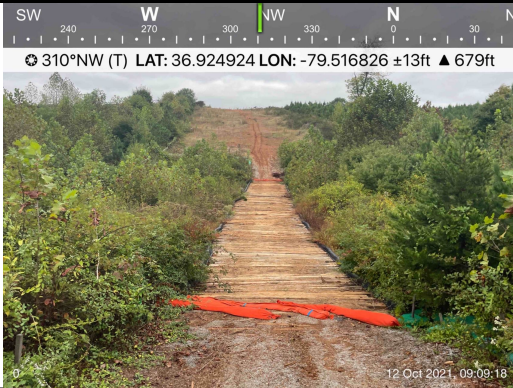
GPS Location	See photo		GPS Location	See photo	
Field Station#	15346+87		Field Station#	15343+34	
Pic 5 Desc.	Equipment bridge ECDs are in good condition and functioning.		Pic 6 Desc.	Waterbar channel needs to be reestablished and stabilized.

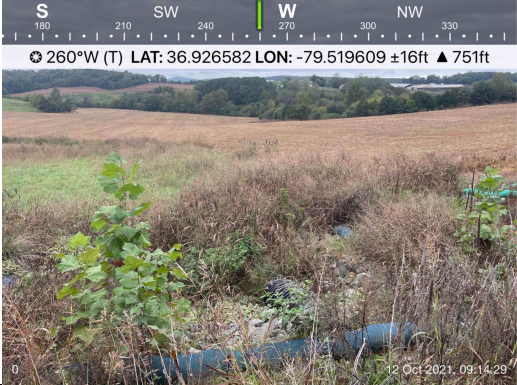
GPS Location	See photo	GPS Location	See photo		
Field Station#	15343+34	Field Station#	15338+00		
Pic 7 Desc.	Environmental crew has corrected this issue.	Pic 8 Desc.	CWD is functioning as intended.

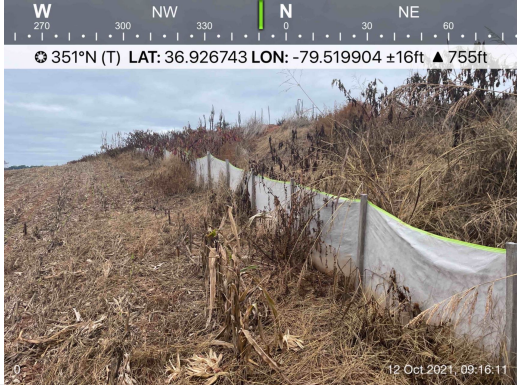
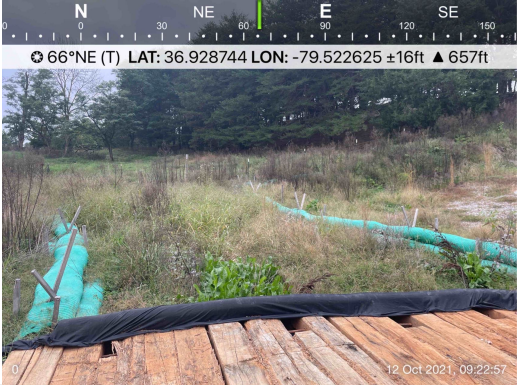
GPS Location	See photo	GPS Location	See photo		
Field Station#	15337+00	Field Station#	15327+00		
Pic 9 Desc.	Perimeter P1 is in good condition.	Pic 10 Desc.	Drainage feature ECDs are in good condition and functioning.

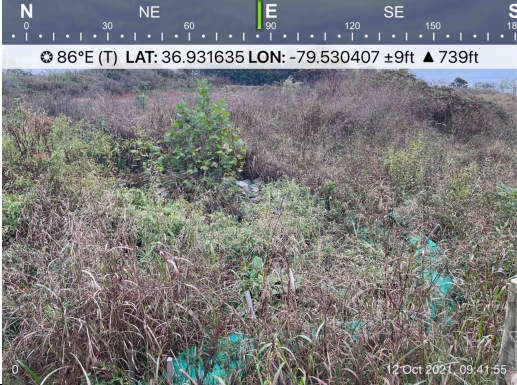
<p>Insert image here</p>			
GPS Location	See photo	GPS Location			
Field Station#	15299+00	Field Station#			
Pic 13 Desc.	CWD is functioning as intended.	Pic 14 Desc.			
<p>Insert image here</p>		<p>Insert image here</p>			
GPS Location		GPS Location			
Field Station#		Field Station#			
Pic 15 Desc.		Pic 16 Desc.			
<p>Insert image here</p>		<p>Insert image here</p>			
GPS Location		GPS Location			
Field Station#		Field Station#			
Pic 17 Desc.		Pic 18 Desc.

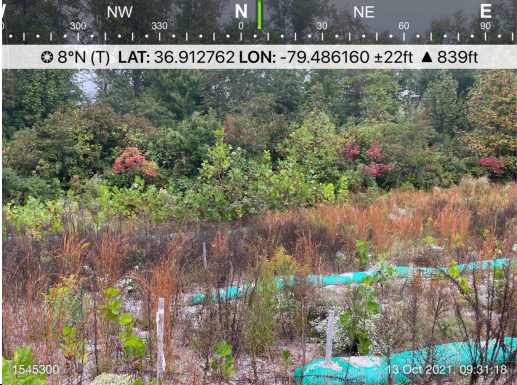
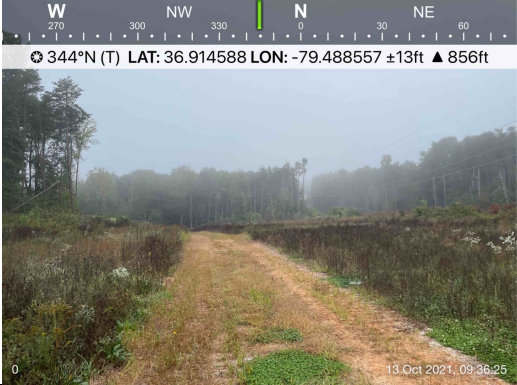
GPS Location	See photo		GPS Location	See photo	
Field Station#	15453+00		Field Station#	15440+00	
Pic 7 Desc.	CWD is functioning as intended.		Pic 8 Desc.	Vegetation continues to fill in throughout this section.

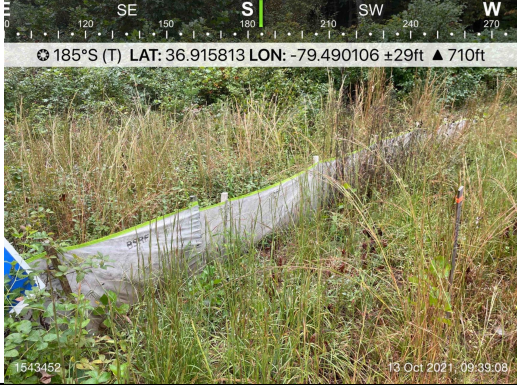
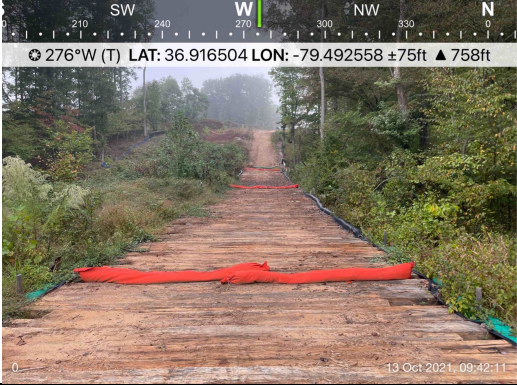
GPS Location	See photo		GPS Location	See photo	
Field Station#	15434+52		Field Station#	15427+00	
Pic 9 Desc.	P1 is in good condition at all stream and wetland buffers.		Pic 10 Desc.	Equipment bridge ECDs are in place and functioning.

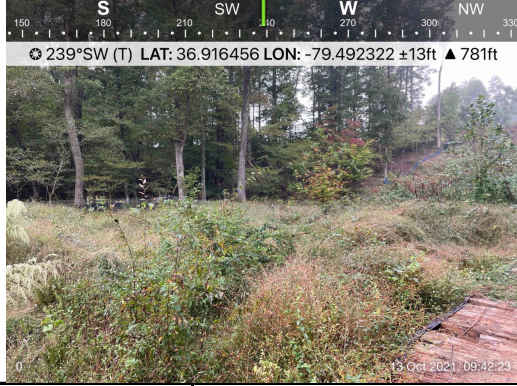
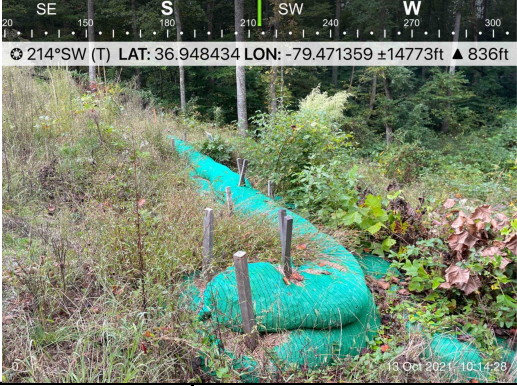
GPS Location	See photo		GPS Location	See photo	
Field Station#	15427+00		Field Station#	15385+00	
Pic 11 Desc.	Resource buffers remain in good condition.		Pic 12 Desc.	CFS is in good condition throughout this section.

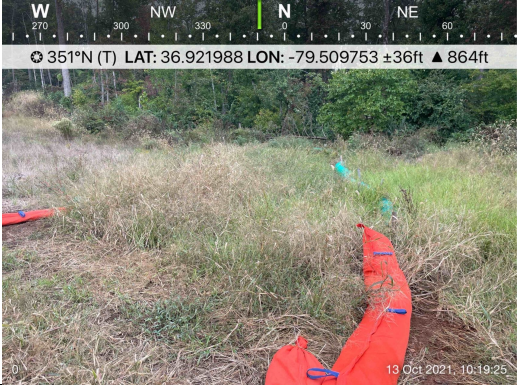
GPS Location	See photo	GPS Location			
Field Station#	15375+00	Field Station#			
Pic 13 Desc.	Drainage feature ECDs are in good condition and functioning.	Pic 14 Desc.			
Insert image here		Insert image here			
GPS Location		GPS Location			
Field Station#		Field Station#			
Pic 15 Desc.		Pic 16 Desc.			
Insert image here		Insert image here			
GPS Location		GPS Location			
Field Station#		Field Station#			
Pic 17 Desc.		Pic 18 Desc.

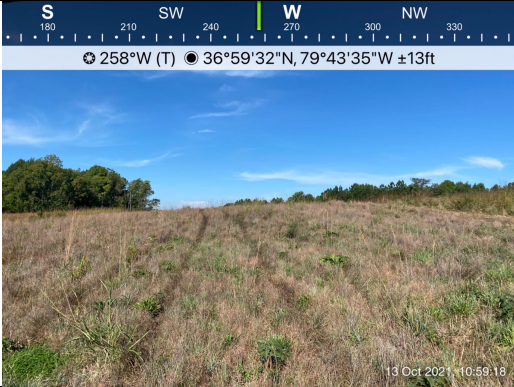
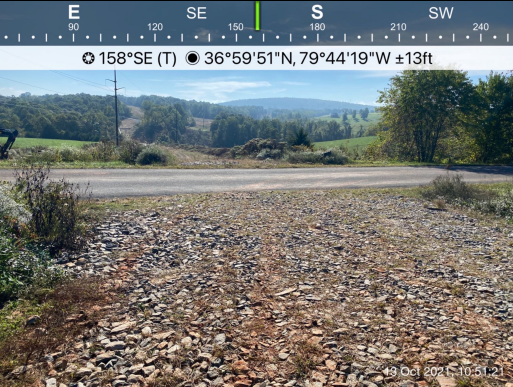
GPS Location	0	GPS Location	0		
Field Station#	14638+00	Field Station#	14599+00		
Pic 1 Desc.	Approximately 14638+00. Overview of ROW.	Pic 2 Desc.	Approximately 14599+00. Overview of road crossing and RCEs.

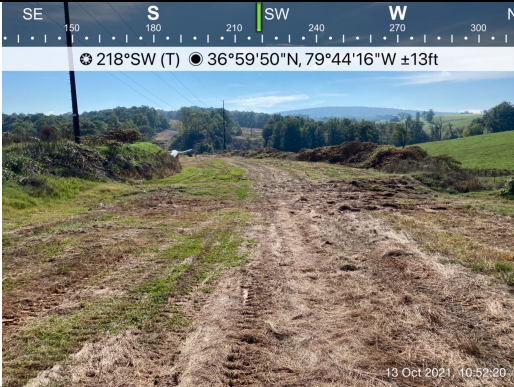
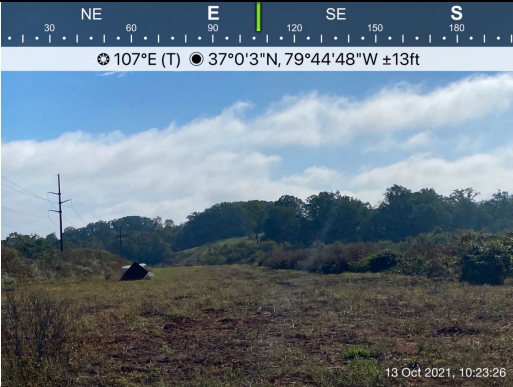
GPS Location	0	GPS Location	0		
Field Station#	14602+00	Field Station#	14575+00		
Pic 3 Desc.	Approximately 14602+00. Overview of ROW.	Pic 4 Desc.	Approximately 14575+00. Overview of ROW.

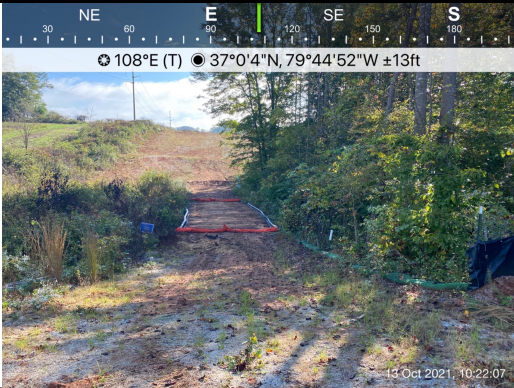
GPS Location	0	GPS Location	0		
Field Station#	14568+10	Field Station#	14606+00		
Pic 5 Desc.	Approximately 14568+10. Overview of stream crossing, equipment bridge and ECDs at stream S-E18.	Pic 6 Desc.	Approximately 14606+00. CFS at end treatment busted and torn. Routine maintenance.

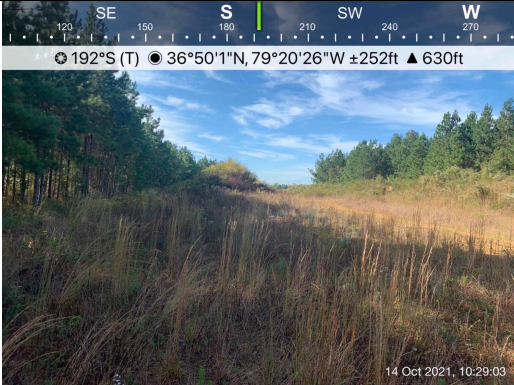
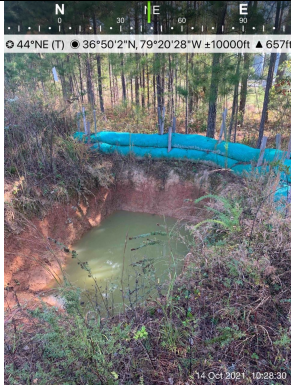
GPS Location	O	GPS Location	O		
Field Station#	6+00	Field Station#	8+00		
Pic 1 Desc.	Observing temporary stabilization		Pic 2 Desc.	Observing temporary stabilization, sump and end treatment

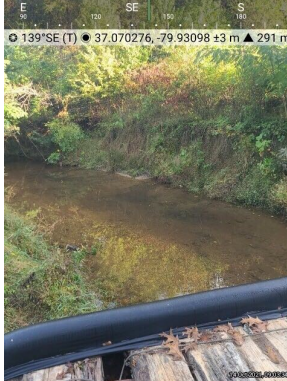
GPS Location	00000	GPS Location	00000		
Field Station#	13794+90	Field Station#	13790+47		
Pic 1 Desc.	Row photo showing good winter vegetation coverage. No environmental issues observed at the time of inspection.		Pic 2 Desc.	Stream observation photo facing upstream during routine inspection today, no environmental issues observed at the time of inspection.

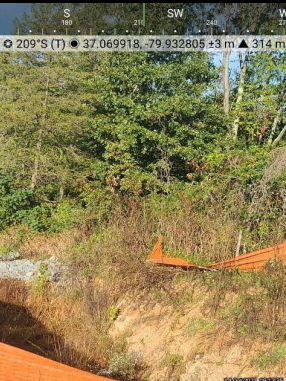
GPS Location	00000	GPS Location	00000		
Field Station#	13784+30	Field Station#	13803+15		
Pic 5 Desc.	Safety fence around sump pit requires maintenance due to being weathered. Added to the punch list for repair.		Pic 6 Desc.	Row photo showing good winter vegetation coverage. No environmental issues observed at the time of inspection.

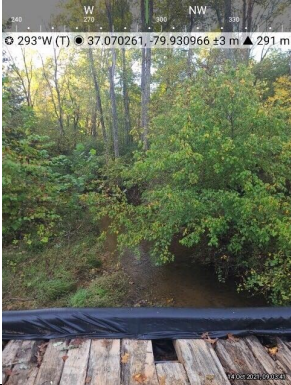
GPS Location	00000	GPS Location	00000		
Field Station#	13790+47	Field Station#			
Pic 7 Desc.	Stream observation photo facing downstream during routine inspection today, no environmental issues observed at the time of inspection.		Pic 8 Desc.

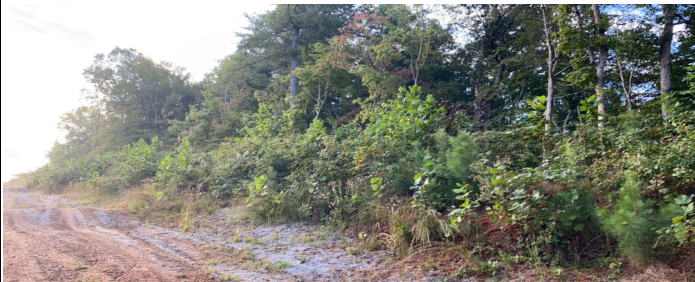
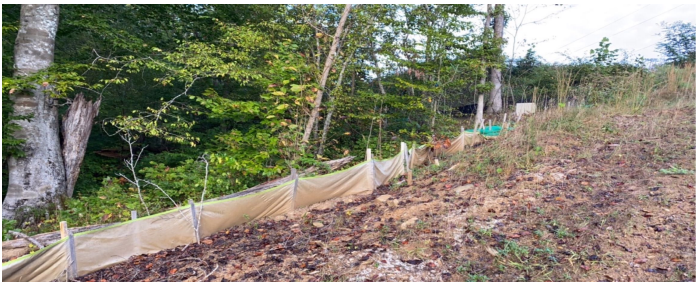
36°58'39" N 79°40'49" W 183°S COURSE 144° GPS Penhook, VA 24137, United States 10.15.2021 08:32:19 Accur +/-15.3 Ft ALT 904 Ft			36°58'41" N 79°40'51" W 32°NE COURSE -1° GPS Union Hall, VA 24176, United States 10.15.2021 08:31:20 Accur +/-15.4 Ft ALT 886 Ft		
GPS Location	1	GPS Location	2		
Field Station#	14773+00	Field Station#	14788+25		
Pic 1 Desc.	Temporary diversion berm stabilized and vegetated	Pic 2 Desc.	Perimeter P1 silt fence in place and functional

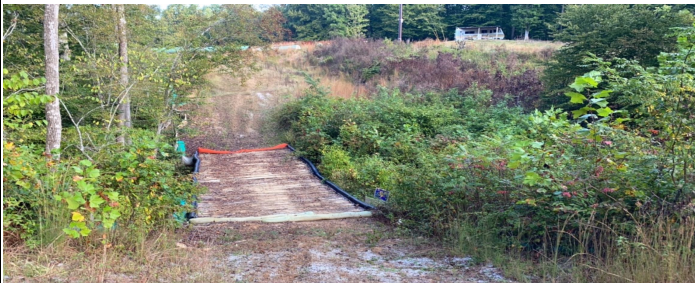
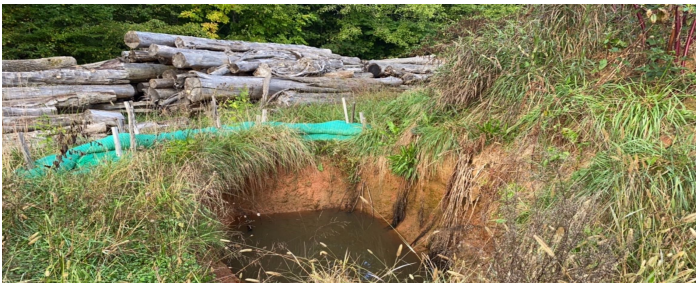
36°58'40" N 79°40'50" W 53°NE COURSE 345° GPS Union Hall, VA 24176, United States 10.15.2021 08:30:48 Accur +/-15.3 Ft ALT 875 Ft			36°58'37" N 79°40'43" W 328°NW COURSE 127° GPS Union Hall, VA 24176, United States 10.15.2021 08:28:03 Accur +/-42.3 Ft ALT 948 Ft		
GPS Location	3	GPS Location	4		
Field Station#	14793+78	Field Station#	14800+00		
Pic 3 Desc.	Equipment bridge and surrounding ECDs in place and functional at stream crossing and resource buffer	Pic 4 Desc.	Sump pit and CFS end treatment performing intended functions

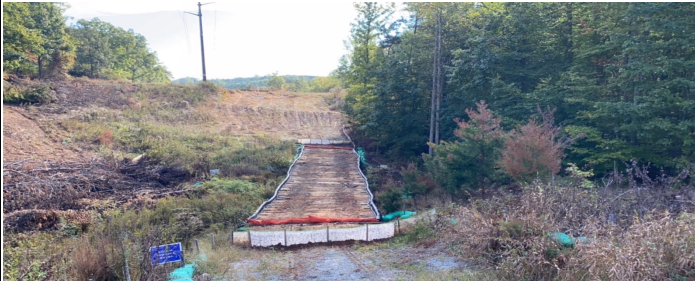
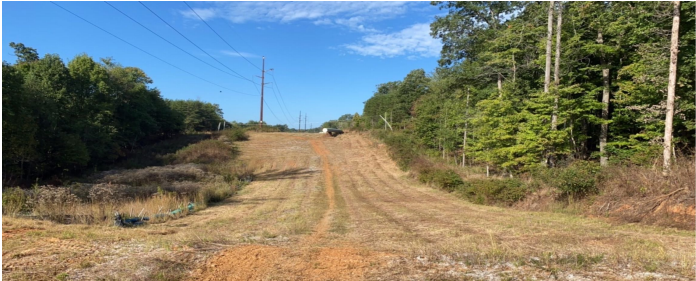
36°59'16" N 79°42'11" W 131°SE COURSE 28° GPS Sorry no results found 10.15.2021 10:19:56 Accur +/-45.6 Ft ALT 0 Ft			36°59'17" N 79°42'17" W 264°W COURSE 198° GPS Sorry no results found 10.15.2021 10:22:25 Accur +/-169.4 Ft ALT 912 Ft		
GPS Location	5	GPS Location	6		
Field Station#	14716+92	Field Station#	14707+00		
Pic 5 Desc.	Equipment bridge and surrounding ECDs in place and functional at stream crossing and resource buffer	Pic 6 Desc.	Recently mown area of ROW by contractor to prepare for seeding and stabilization

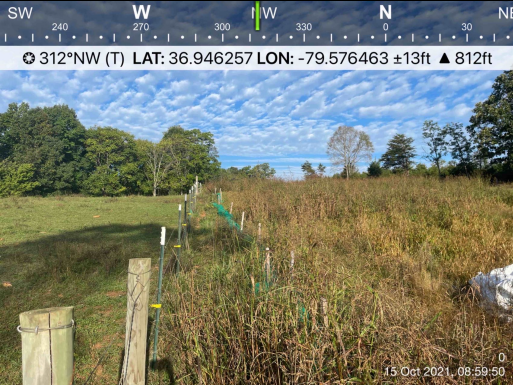
GPS Location	See photo		GPS Location	See photo	
Field Station#	15142+66		Field Station#	15150+00	
Pic 1 Desc.	RCE is in good condition at Rockcreek Rd.		Pic 2 Desc.	Perimeter CFS is in good condition throughout this section.

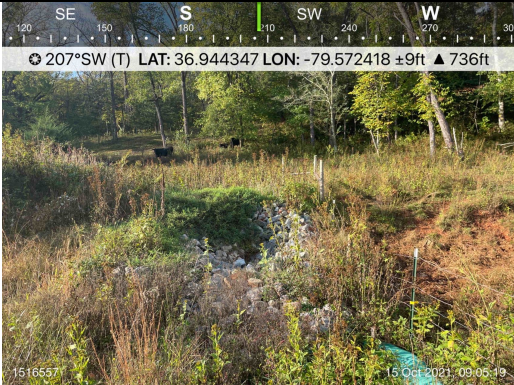
GPS Location	See photo		GPS Location	See photo	
Field Station#	15165+57		Field Station#	15166+00	
Pic 3 Desc.	Rock filter inlet remains in good condition.		Pic 4 Desc.	Rock filter outlet remains in good condition.

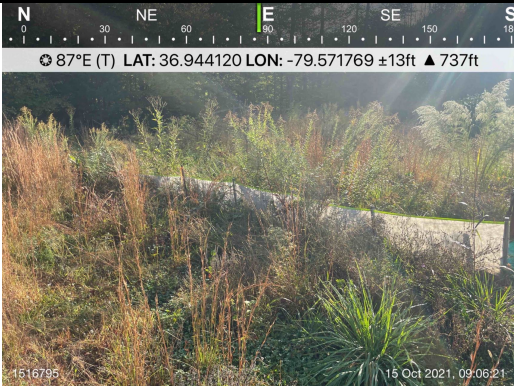
GPS Location	See photo		GPS Location	See photo	
Field Station#	15167+95		Field Station#	15167+95	
Pic 5 Desc.	P1 is in good condition at stream buffer.		Pic 6 Desc.	Equipment bridge ECDs are in place and functioning.
